1. Report No. FHWA/TX-15/0-6741-1		2. Government Accession No.		3. Recipient's Catalog No.	
4. Title and Subtitle NEW LABORATORY DESIGN TOOLS AND FIELD PERFORMANCE MONITORING EQUIPMENT FOR PERMEABLE FRICTION COURSES				5. Report Date Published: March 2016

# **NEW LABORATORY DESIGN TOOLS AND FIELD PERFORMANCE MONITORING EQUIPMENT FOR PERMEABLE FRICTION COURSES**

Report 0-6741-1

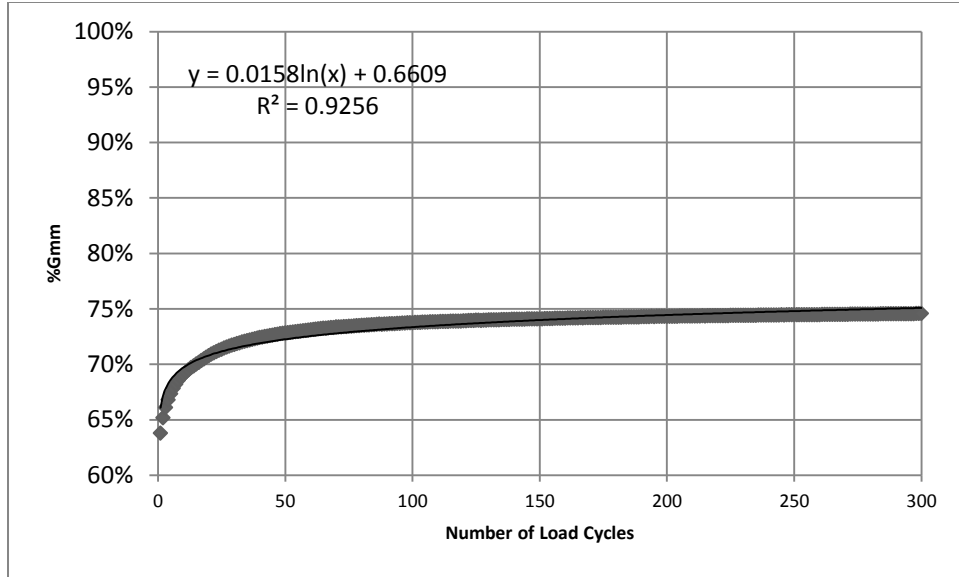
**Figure 1. SGC Compaction Curve for 100 Percent Fordyce Gravel Mix.**

The use of the gravel improved the performance of either of the limestone mixtures alone in terms of the locking point. Based on these data and the known quality of the materials being used in the mixes, a locking point maximum limit of 100 gyrations is proposed as a preliminary criterion.

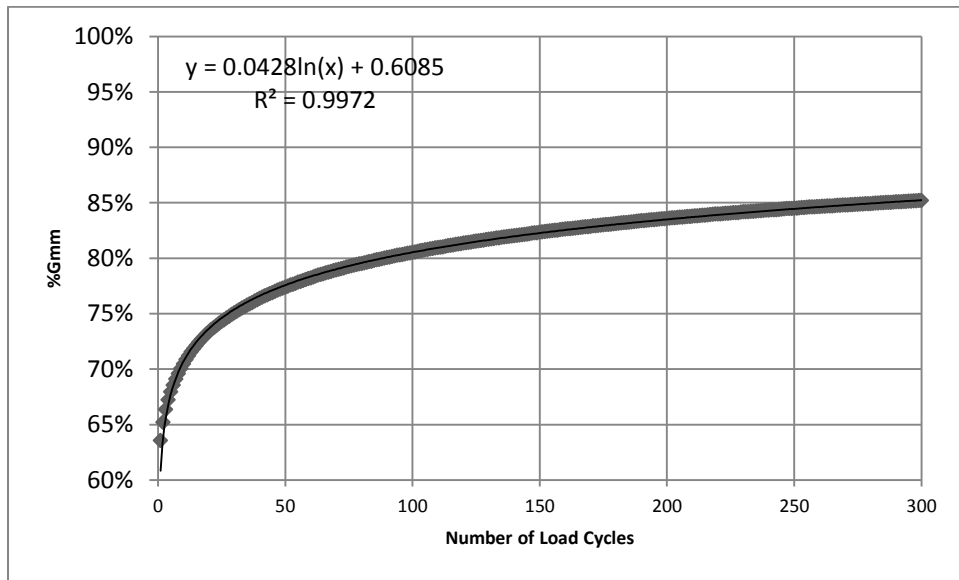
**Figure 2. SGC Compaction Curve for 100 Percent Beckman Limestone Mix.**

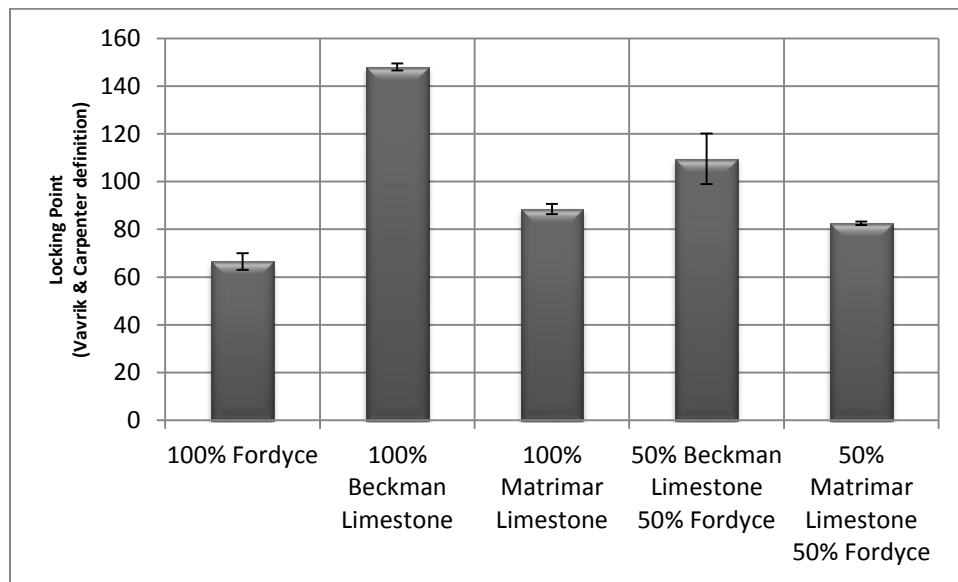
**Figure 6. Locking Point Results.**

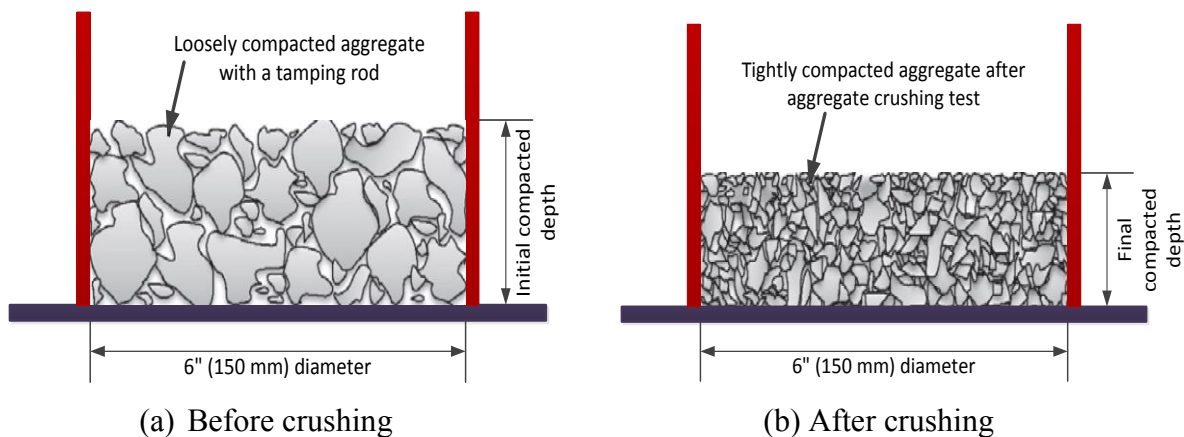
**Figure 7. Schematic Diagram before/after ACV Test.**

ACV is also a measure of aggregate quality but uses only the coarse aggregate fraction alone. ACV was measured in accordance with the British Standard 812-110. As shown in Figure 7, the main principle of the test is to compact and crush a loose aggregate specimen in a test cylinder by applying a constant load rate of 40 kN/min (4 ton/min) through a plunger. After the load reaches 400 kN (40 tons), the applied load was removed and the aggregates were emptied from the test cylinder and sieved to determine the extent of crushing, which the amount of crushed particles passing a 2.36 mm (No. 8) sieve has established.

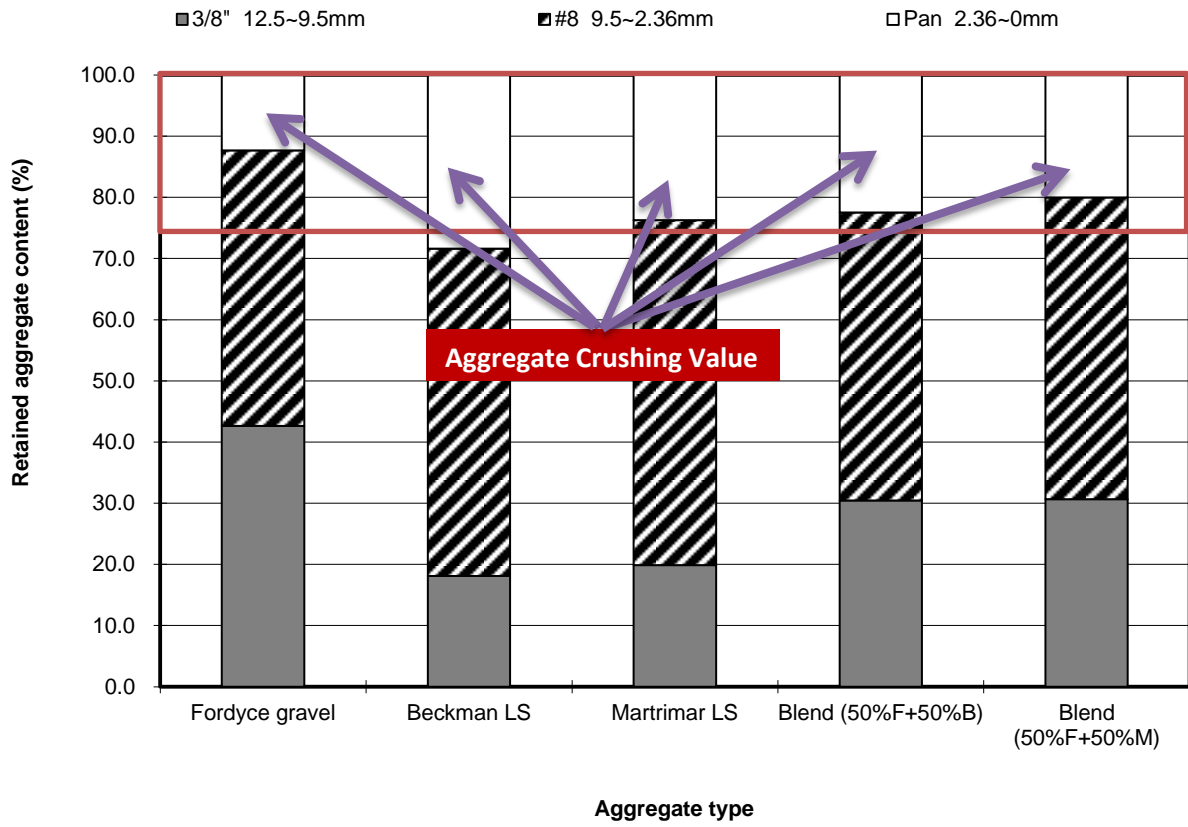
**Figure 8. Aggregate Crushing Values.**

After crushing, the aggregates were separated into  $+3/8$ , +No. 8 and -No. 8. These fractions for each aggregate and aggregate blend are shown in Figure 8 and Figure 9. Figure 10 and Figure 11 show only the  $+3/8$  material after crushing and separated into the gravel and limestone fractions. These photos show that most of the crushing that occurs in the blended aggregates occurs in the limestone portions of the blends. Even though there is a significant difference in the soundness values of the Beckman and Matrimar limestones, the crushing occurring in each type seems to be similar.

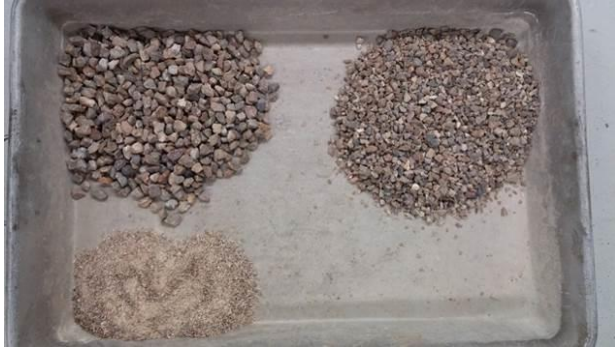
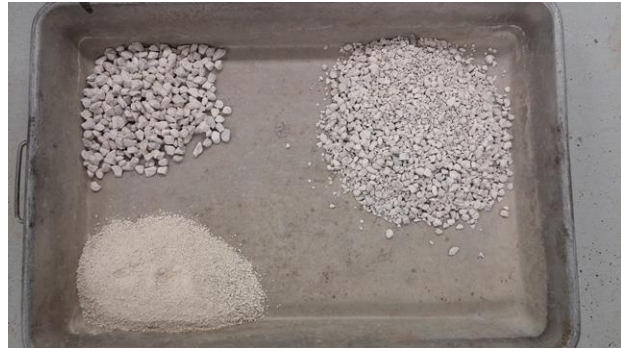
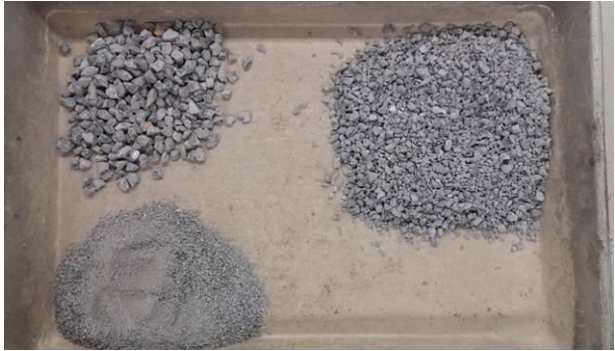
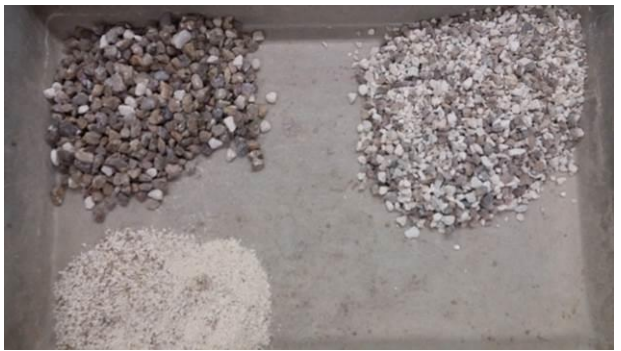
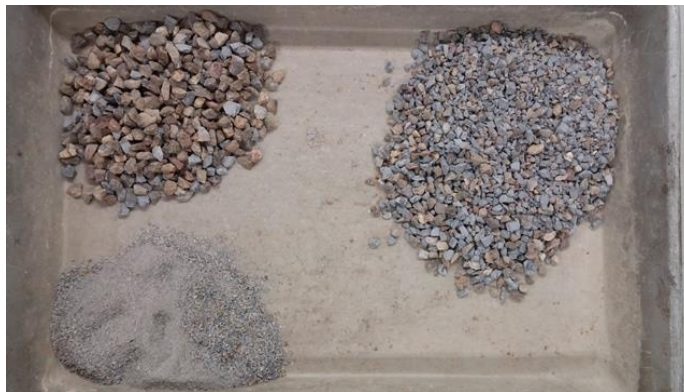
**Figure 9. Aggregate Samples after ACV Test Separated into  $\frac{3}{8}$  Inch, +No. 8, and -No. 8 Mesh Fractions.**

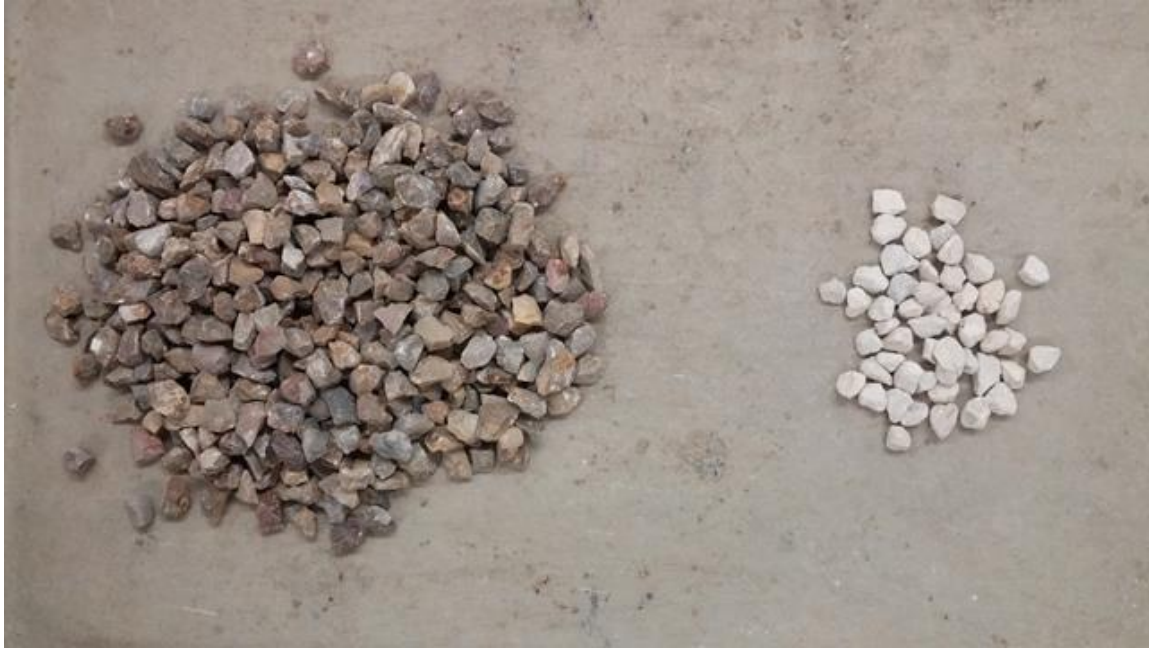
**Figure 10. Remaining  $\frac{3}{8}$ -Inch Materials after ACV Test from Original 50/50 Blend of Fordyce Gravel and Beckman Limestone.**

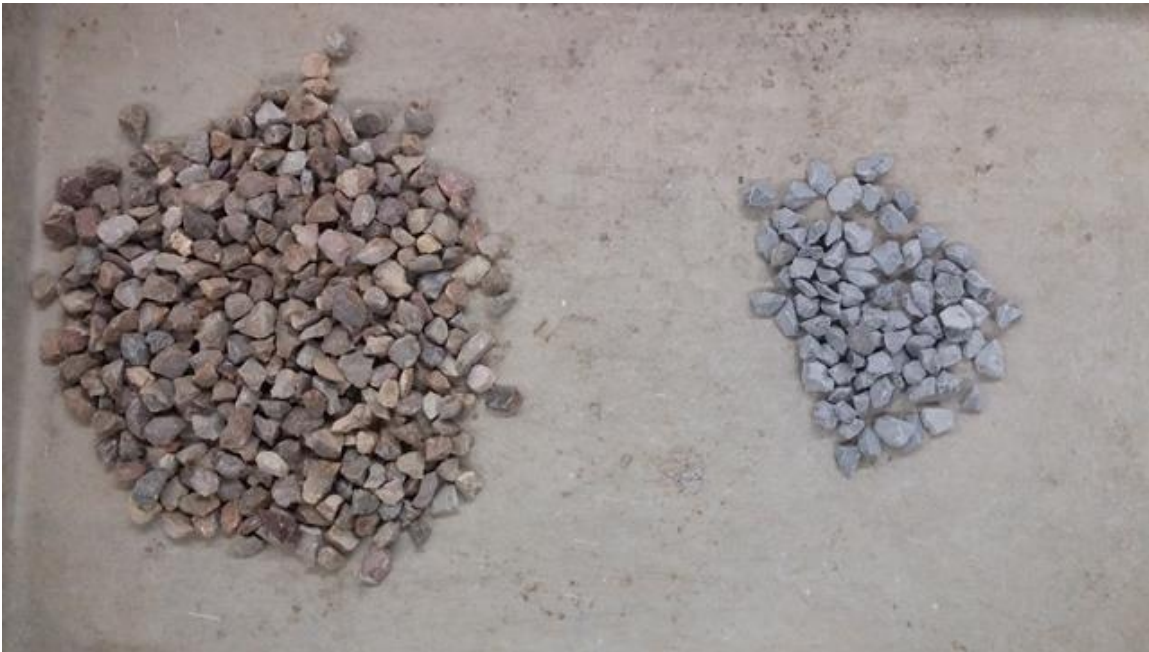
**Figure 11. Remaining  $\frac{3}{8}$ -Inch Materials after ACV Test from Original 50/50 Blend of Fordyce Gravel and Beckman Limestone.**

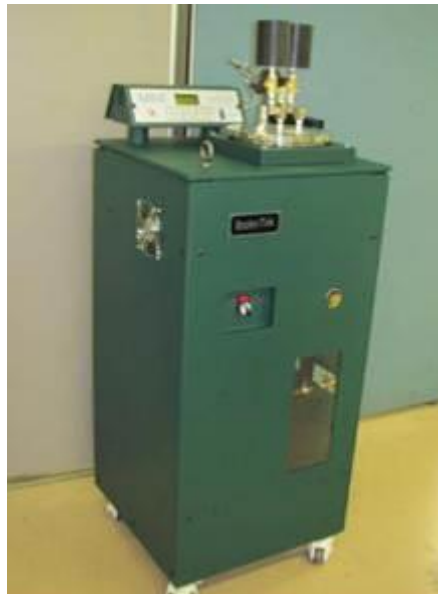
**Figure 12. Moisture-Induced Stress Tester Equipment.**

Researchers chose to run the MIST (Figure 12) at 40 psi, 140°F, and 1000 cycles as the moisture condition method most appropriate for PFC mixes since it most closely approximates field conditions.

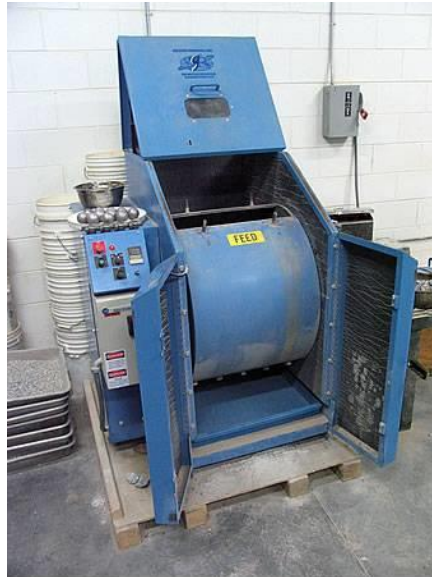
Figure 13. Los Angeles Abrasion Testing Equipment ([www.pavementinteractive.org](http://www.pavementinteractive.org)).

This test was performed following TxDOT procedure Tex-245-F on 6-inch (152 mm) diameter by 4.5-inch (115 mm) height specimens. After the compacted specimen was weighed, it was placed in the Los Angeles Abrasion (LAA) testing machine without the steel balls (Figure 13). The machine was run at 30–33 revolutions per minute for 300 revolutions. After the 300 revolutions, the test specimen was weighed, and any loose material was discarded. The Cantabro loss was recorded as the relative difference between the initial and final weights. Current TxDOT Special Specification #3269 requires a maximum Cantabro loss of 20 percent for all types of PFC mixtures.

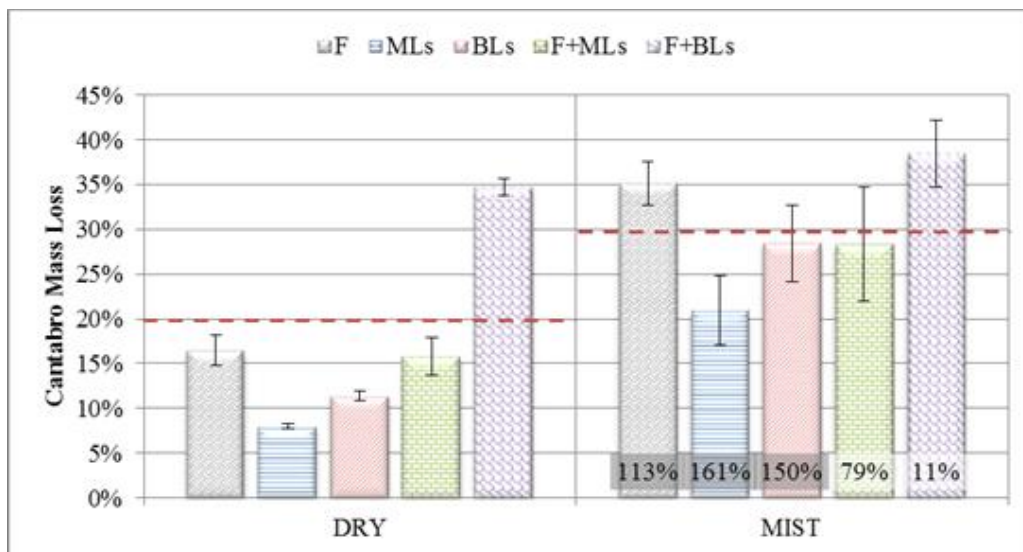
Figure 14. Cantabro Loss for Dry and MIST-Conditioned Specimens.

Figure 14 presents both dry and MIST condition Cantabro results. The Fordyce Gravel mixture has exhibited premature raveling in the field due to stripping. This property seems to be reflected in the MIST-conditioned 100 percent Fordyce specimens. All of the mixtures showed significant

increases in Cantabro loss after MIST with the exception of the 50/50 Fordyce/Beckman mixture, which had even a failing dry Cantabro. The 100 percent Fordyce mixture is the only mixture that had an acceptable dry Cantabro but had more than a 30 percent loss after conditioning, indicating it is prone to stripping as has been observed in the field.

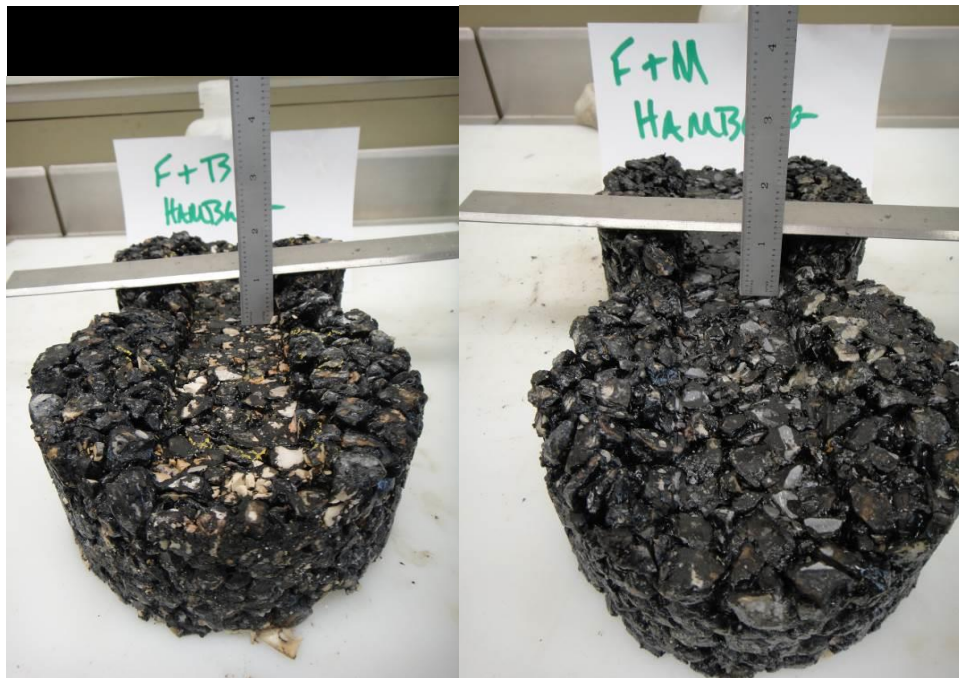
**(a) Failed at 13,750 cycles**

**(b) Lasted to 20,000 cycles**

HWTT is a common test procedure that TxDOT uses to determine mixture susceptibility to rutting and moisture damage. A minimum requirement of 10,000 load cycles to 12.5 mm rut depth is now part of the Special Specification # 3269 for fine PG-PFCs. This test was performed according to TxDOT procedure Tex-242-F on 6-inch (152 mm) diameter by 2.5-inch (64 mm) height specimens. Figure 15 shows the results of HWTT. This test seems to clearly indicate that

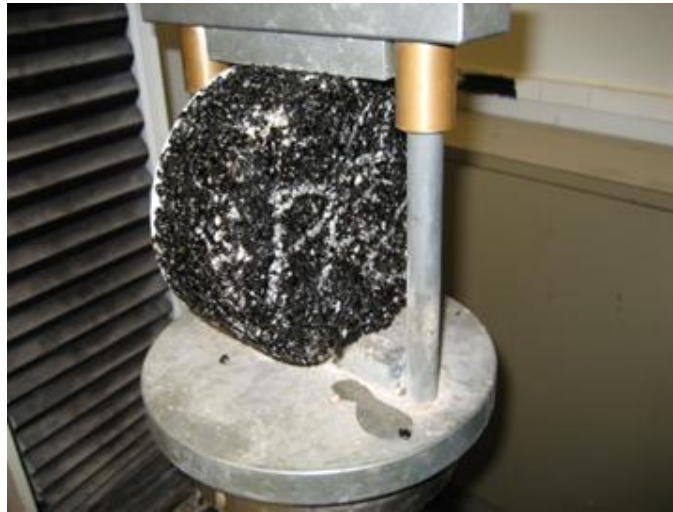
**Figure 17. IDT Strength Test Setup.**

The IDT strength test was performed following TxDOT procedure Tex-226-F on 6-inch (152 mm) diameter by 2.5-inch (64 mm) height specimens. The specimens were set up in a loading frame between two 0.75-inch (19 mm) square steel loading strips as shown in Figure 17. A constant compressive load at a controlled deformation rate of 2 inches (50 mm) per minute was then applied until failure. The maximum vertical load at failure was used to calculate the tensile strength of the specimen. In addition, the ratio of the average IDT strength of the MIST conditioned specimens to the average IDT strength of the dry specimens or tensile strength ratio (TSR) was calculated.

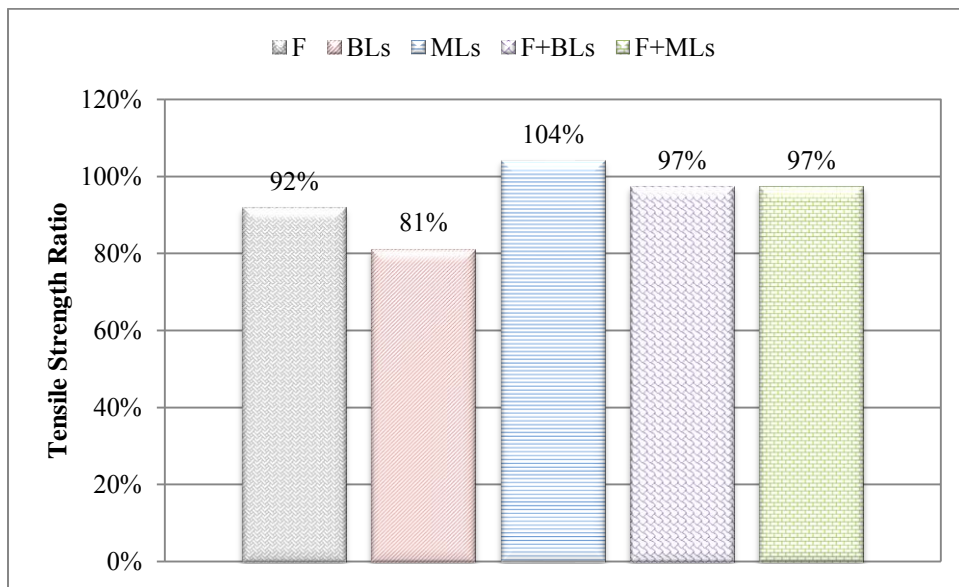
**Figure 19. TSR Results.**

Figure 18 and Figure 19 present the results for all five mixtures. Except for the 100 percent Beckman Limestone mix, all of the mixes suffered a decrease in IDT after MIST. However, this test is not distinguishing the Fordyce gravel as a stripping-susceptible mix as in both Cantabro and HWTT testing results. Previously, researchers recommended an IDT ratio of 80 percent after MIST for PFC mixtures. However, these data do not support that recommendation since the 100 percent Fordyce Gravel mix would pass that requirement yet based on field performance and Hamburg/Cantabro results the mix is clearly prone to stripping. The IDT test is therefore not recommended for PFC performance evaluation.

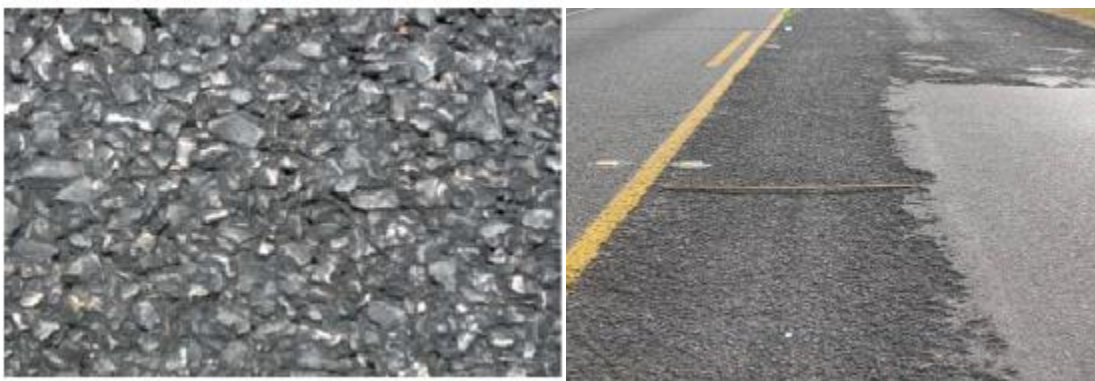
**Figure 20. Nondraining and Raveling PFC Reported by Houston with AR PFC Binders.**

For several years, the Houston District has reported inferior long-term performance for AR PFCs designed according to the prevailing Item 342 spec with the required fine master gradation shown in Table 3 of that spec and with a binder content ranging from 8 to 10 percent. For these PFCs, Jeff Volk, the current Area Engineer in Waller County, measured water flows in excess of 5 minutes shortly after placement. These were not acting as PFC, and several sections started to ravel severely. Figure 20 shows photos of a closed and raveled AR PFC.

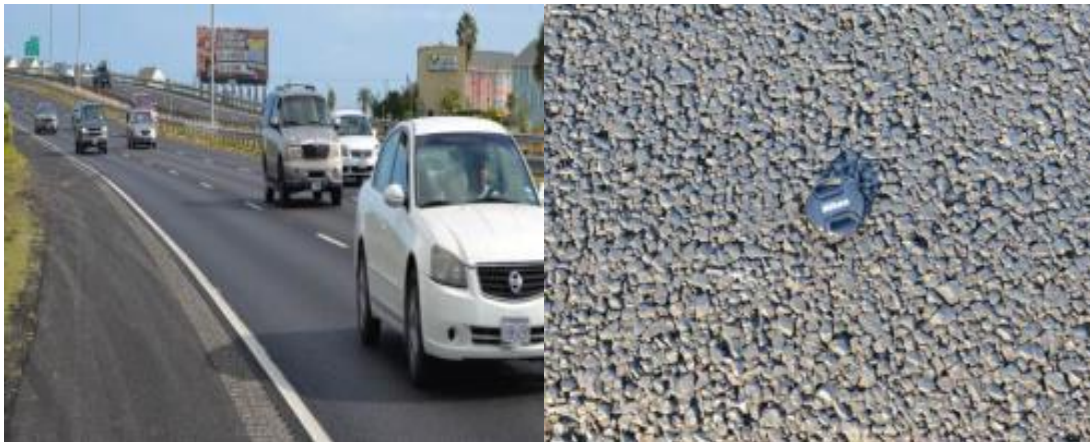
Figure 22. Coarse Graded AR PFC in Service on IH 45 in Houston.

During construction, water flows on this section were measured to be less than 20 seconds, and unlike other AR PFC in Houston, it is draining well after two years in service. Figure 23 shows that ground penetrating radar (GPR) data were collected on the section in both 2013 and 2014. The measured surface dielectric is an indicator of mat density and uniformity; the measured dielectrics found in IH 45 are very low and uniform. This shows that the surface densities are uniform and not changing. The coarser gradation appears to be part of the answer. Researchers propose more monitoring and more sections for construction.

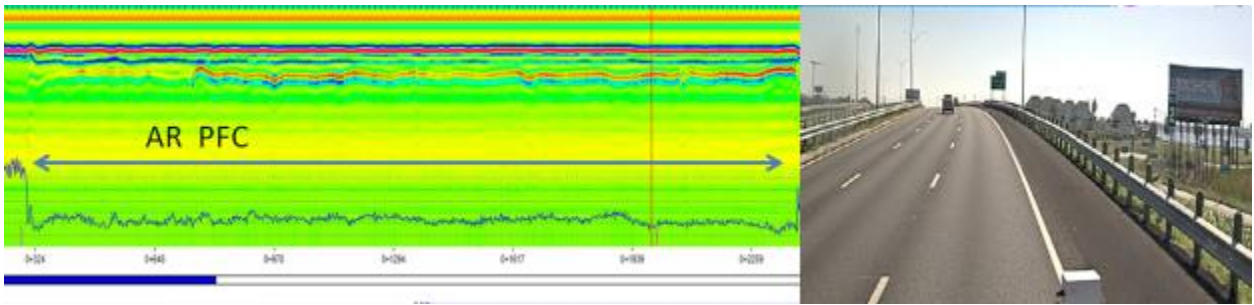
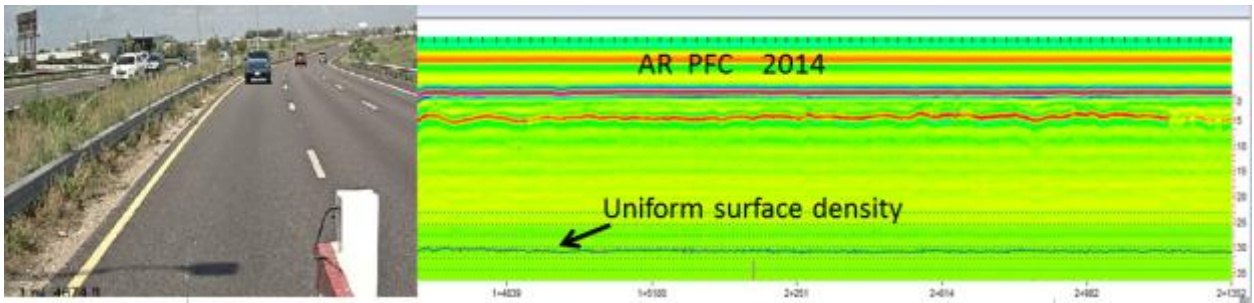
a) 2013 GPR data

b) 2014 GPR data

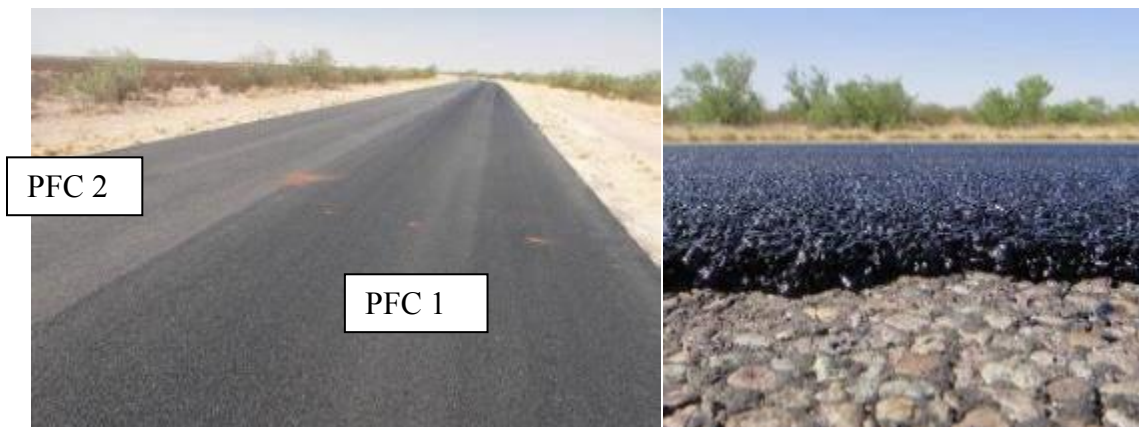
**Figure 24. PFC Mix on Pecos Facility Entrance Road.**

The mixtures were placed side by side on the entry road to the facility as shown in Figure 24. Standard equipment for asphalt concrete pavement construction was used, including a material transfer vehicle, paver equipped with an infrared monitoring system, and three passes with a 13.5-ton tandem steel wheel roller operated in static mode.

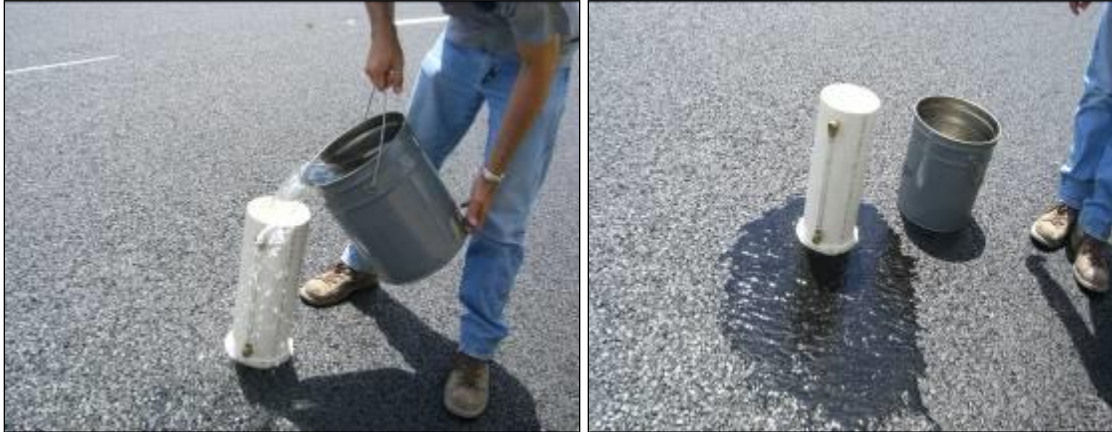
**Figure 25. Test Method Tex-246-F, Field Water Flow Test.**

The PFC mixtures were evaluated immediately after construction for drainage characteristics using a field water flow test shown in Figure 25 (Tex 246-F). The test evaluates the time required to discharge a given volume of water channeled onto the pavement surface through a 6-inch diameter opening. The time corresponds to the water flow value (WFV) and is expressed in seconds.

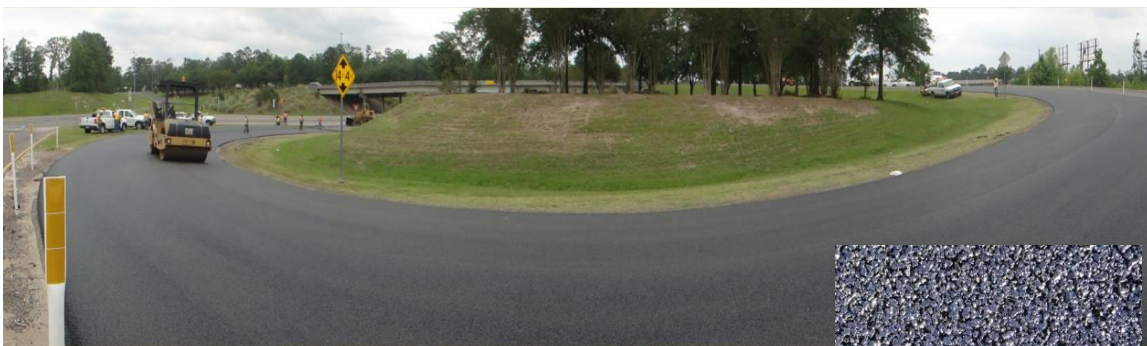
***Very Thin, Fine-Graded PFC Placed on Cloverleaf Exit Ramp of US 59 Near Lufkin District Office. Maintenance needed a mix to address the numerous wet weather accidents occurring on this ramp.***

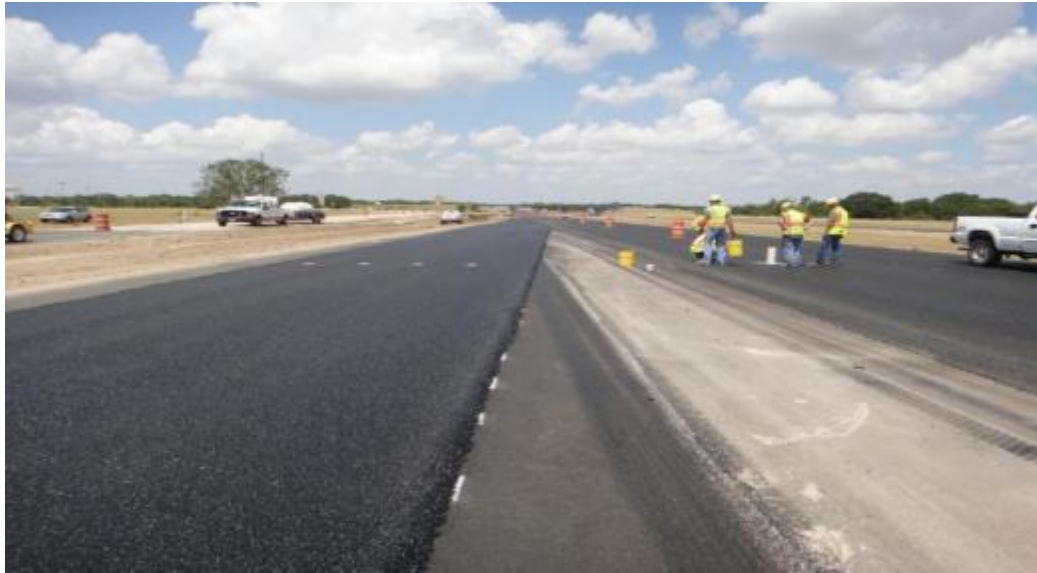
**Figure 27. Construction of the Bryan Fine PFC Exit Ramp.**

The Bryan District used the fine PFC as a test section to surface the newly constructed exit ramp off SH 6 to the district office. This design was the same as that used in Lufkin, but was placed with a local Bryan contractor, Knife River. Researchers observed a similar performance to that seen in Lufkin (Figure 27).

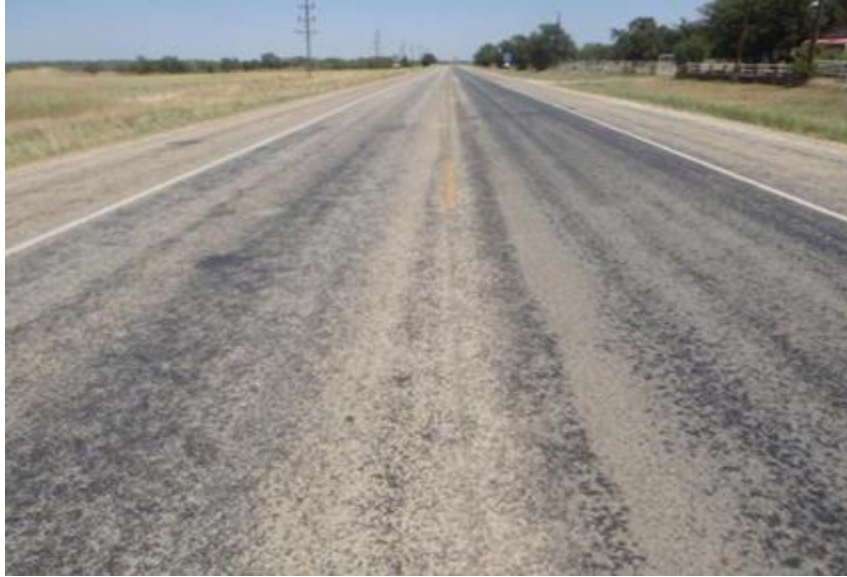
**Figure 28. US 183 Bleeding Surface Treatment prior to PFC Surfacing.**

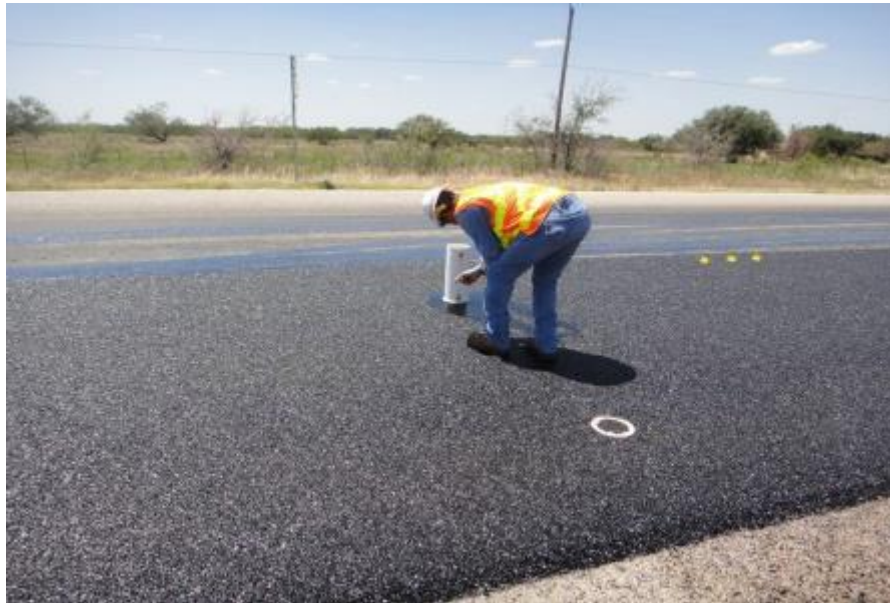
**Figure 29. Water Flow Testing on US 183 Fine PFC.**

Since there were no Class A materials available in the area, researchers wrote the specs to allow a higher quality Class B material. Local limestone aggregates were used to produce the mix, and water flow measurements taken during construction were less than 20 seconds (Figure 29).

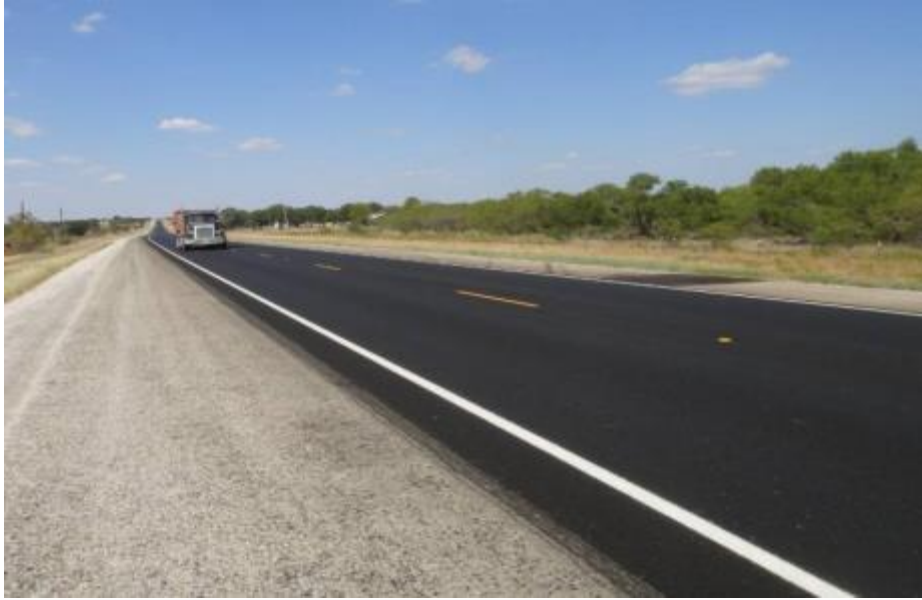
**Figure 30. US 183 PFC Three Months after Construction.**

Recent discussions with the district engineer have revealed that after nine months of service, the PFC is in excellent condition and TxDOT is pleased with the performance. The surface has also given the district good public relations with the local citizens because the previous project had performed so poorly and was a source of many public complaints. Figure 30 shows the surface three months after construction.

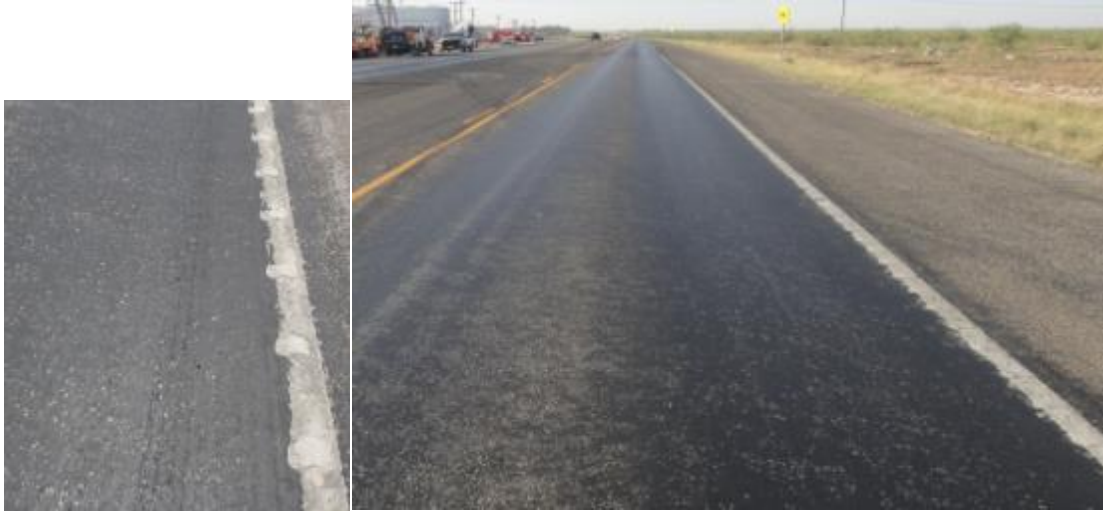
**Figure 31. Preexisting Condition for Loop 338 Odessa District.**

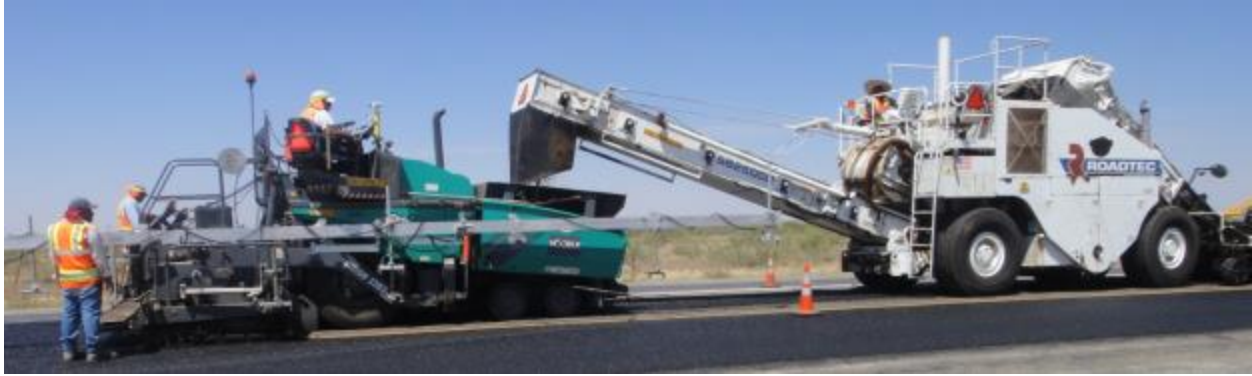
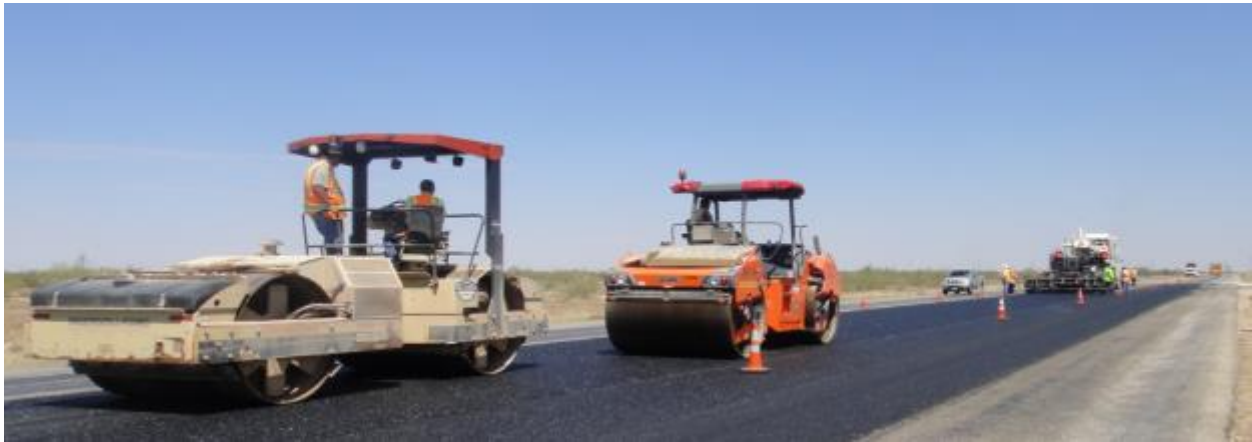
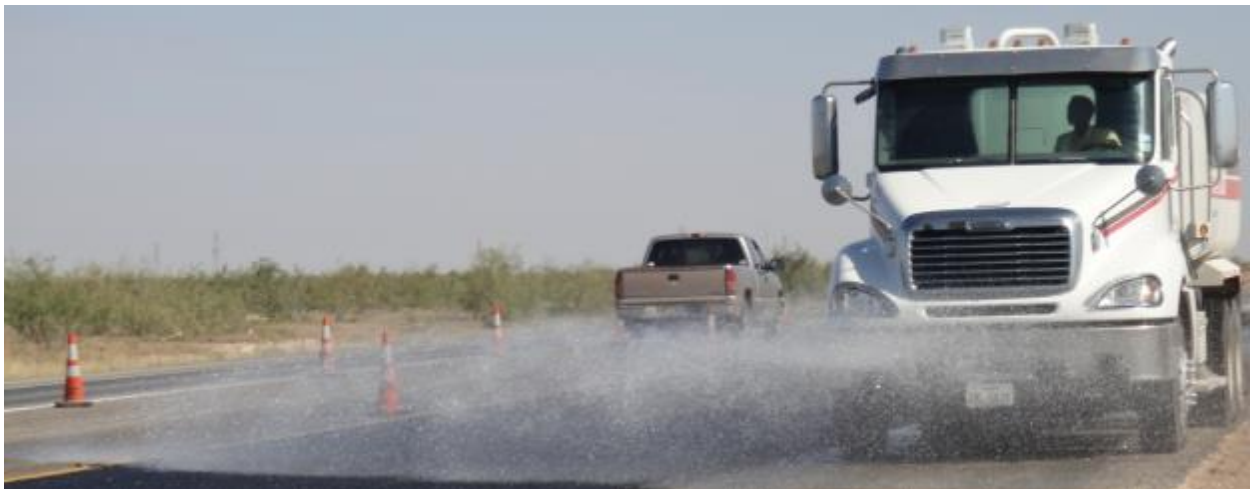
**a) Belly dump trucks with RoadTec pickup**

**b) One pass of two steel wheel rollers, (no backing up)**

**c) Sprinkling before opening the PFC to traffic**

A contract was awarded to Reece Albert Inc. to place the fine PFCs; this company did the original construction at the test track. The Loop 338 construction was completed on August 8, 2014. Figure 32 shows photos of the construction sequence.

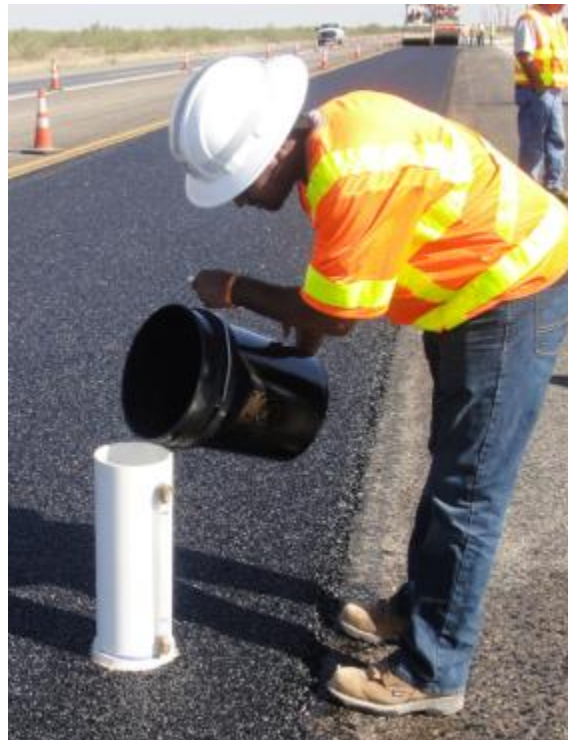
**Figure 33. Water Flow Being Conducted on the New PFC.**

To check the adequacy of the mix, researchers run the water flow test shown in Figure 33. The measured flow time was 9 seconds, which is identical to that measured at the Pecos test track. This proved that the single-pass rolling was adequate.

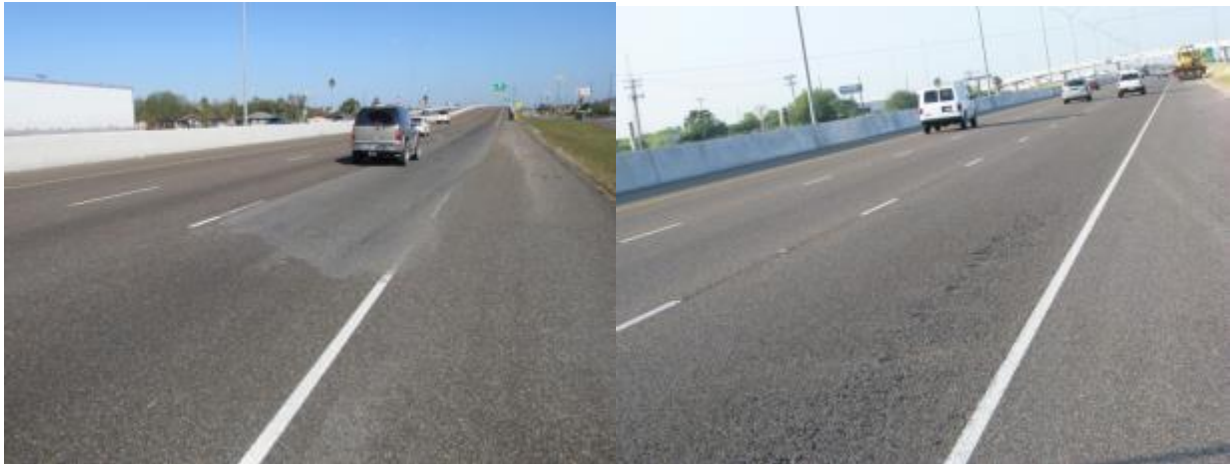
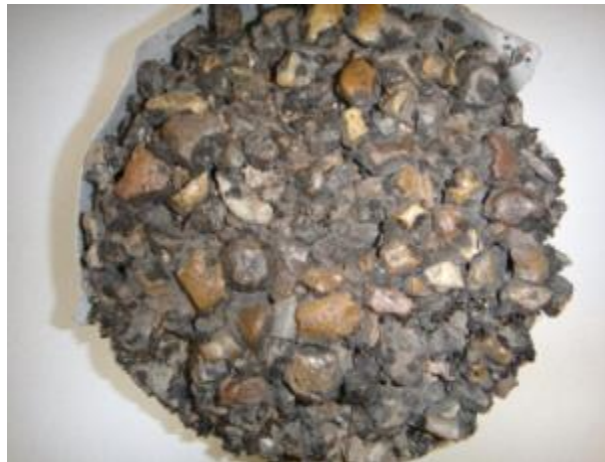
In January 2014, the Pharr District banned the use of PFCs on highways because of the poor performance of PFCs over the past 10 years. The major concern is raveling and the district has experienced numerous failures with its main aggregate source crushed gravel. Figure 34 shows photos of a typical raveling issue.

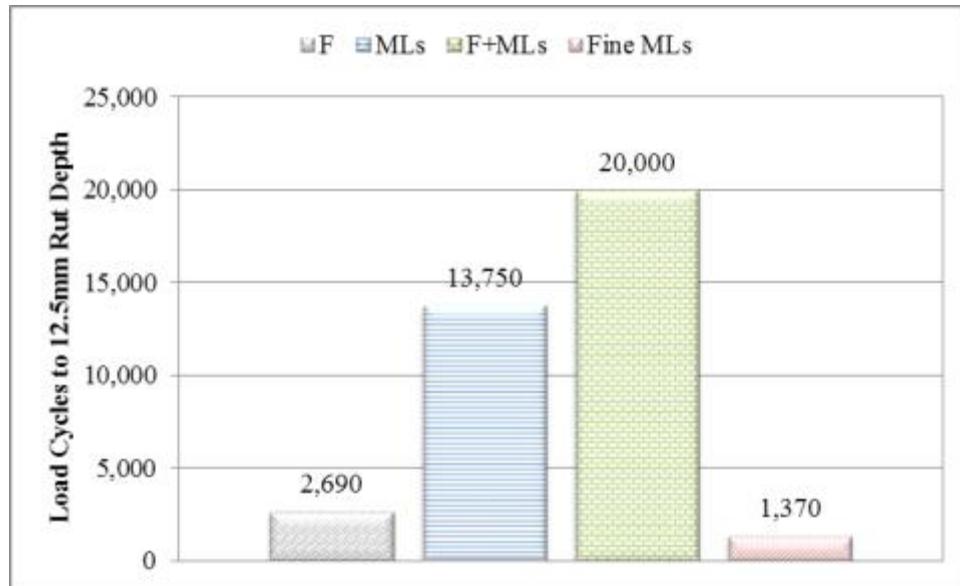
**Figure 36. HWTT Number of Load Cycles to Failure and Stripping for the PFC Mixtures.**

Figure 36 shows the HWTT results for the four mixtures. In the figure, each bar represents the average of two replicate results. The results indicate that Mixtures 1 and 4 are susceptible to rutting and stripping. The other two mixtures exceeded 10,000 cycles before failure. Mixture 3 had the best performance, lasting 20,000 cycles before failure and showing no signs of stripping. Mixture 2 also had an acceptable performance. Mixture 4, however, demonstrated the worse performance of all four mixtures with less than 2,000 cycles to 12.5 mm rut depth. Visual observation of Mixture 4 after testing showed no clear signs of stripping as shown in Figure 37.

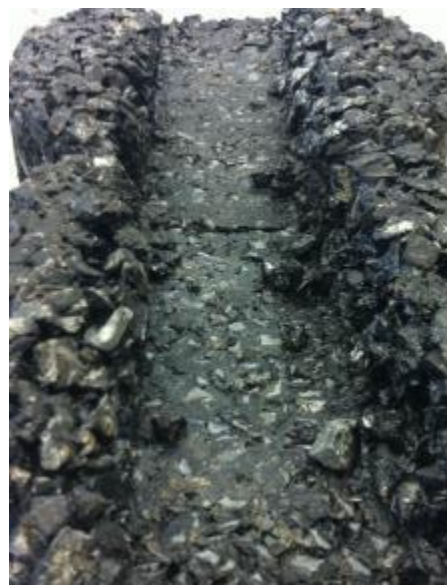
**Figure 37. HWTT Specimen Showing Excessive Rutting and Minimal Stripping.**

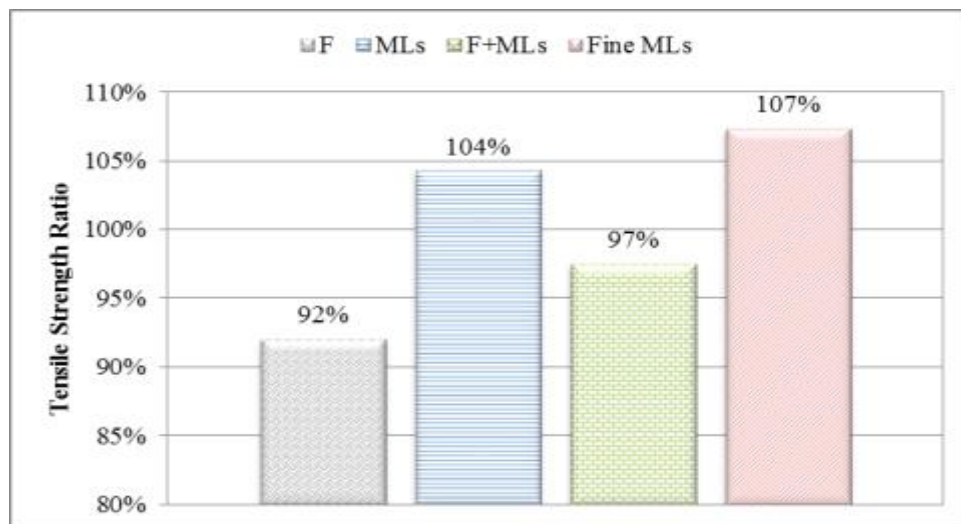
**Figure 39. TSR Results.**

Figure 39 shows the TSR. Usually a TSR value  $\geq 80$  percent is considered acceptable in terms of moisture susceptibility. The TSR values for all mixtures were above this threshold. As previously noted in the Technical Memorandum for Task 5 and confirmed with these results, the IDT test is not recommended for PFC performance evaluation.

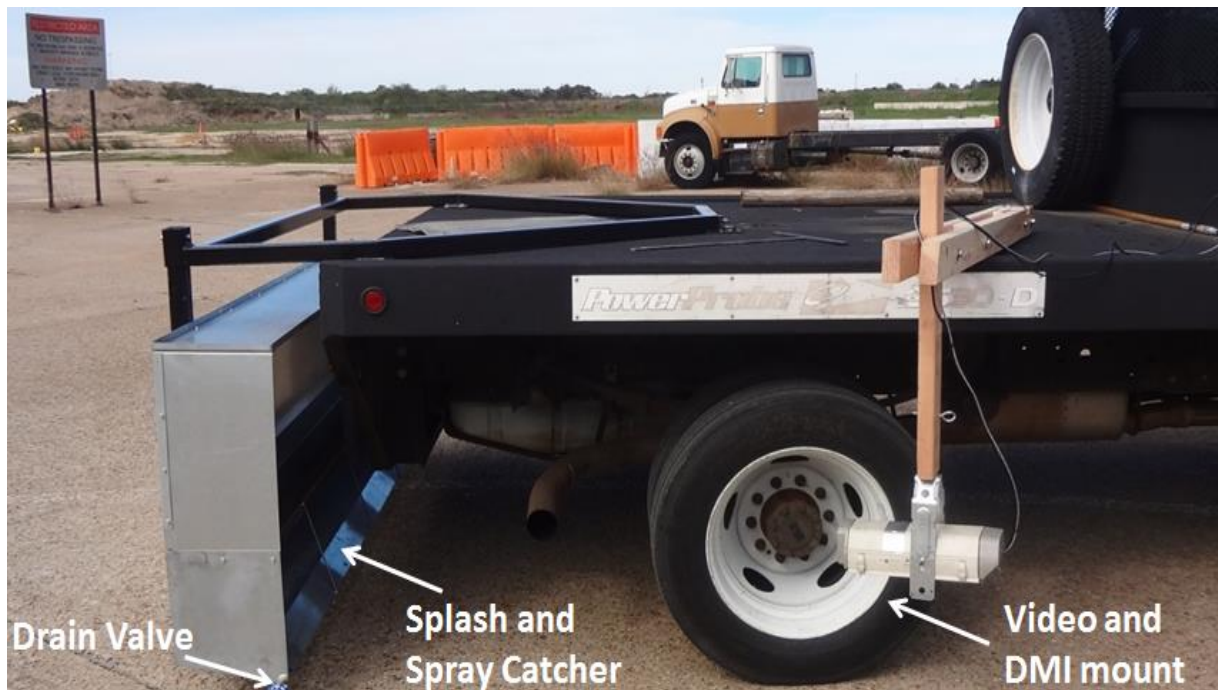
Figure 41. Prototype Splash and Spray Catcher.

This section documents the development and initial testing of the prototype equipment for measuring the amount of splash and spray. This system provides a direct measurement of the amount of water that the tires of the test vehicle picked up and sprayed onto a catch basin. Figure 41 shows the prototype equipment on which the initial tests were conducted.
