1. Report No. FHWA/TX-15/0-6741-1		2. Government Accession No.		3. Recipient's Catalog No.	
4. Title and Subtitle NEW LABORATORY DESIGN TOOLS AND FIELD PERFORMANCE MONITORING EQUIPMENT FOR PERMEABLE FRICTION COURSES				5. Report Date Published: March 2016

# **NEW LABORATORY DESIGN TOOLS AND FIELD PERFORMANCE MONITORING EQUIPMENT FOR PERMEABLE FRICTION COURSES**

Report 0-6741-1

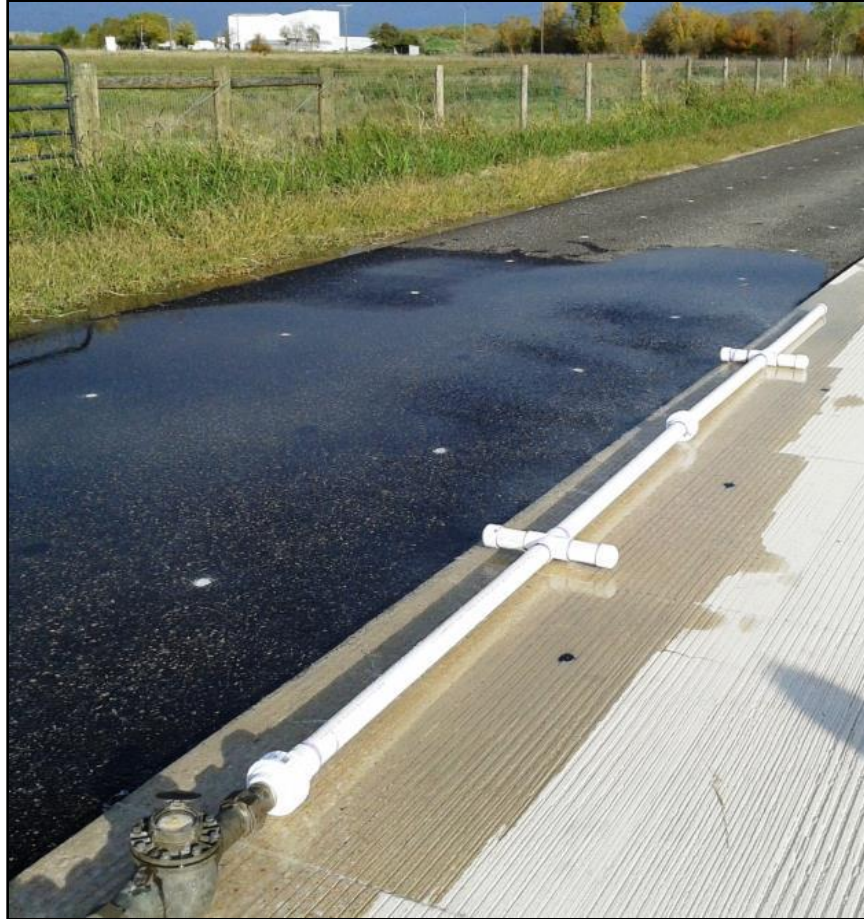
**Figure 42. Test Setup between Stations 390 to 410.**

Researchers turned on the water valve at the truck, and allowed water to run through the pipes and into the test lane. As shown in Figure 42, researchers wetted the test segment over its width. The wetting time took approximately two minutes. The team then made test runs at different times after turning off the water supply, and determined the volume of water collected in the catcher basin from each run. All runs were made at 30 mph.

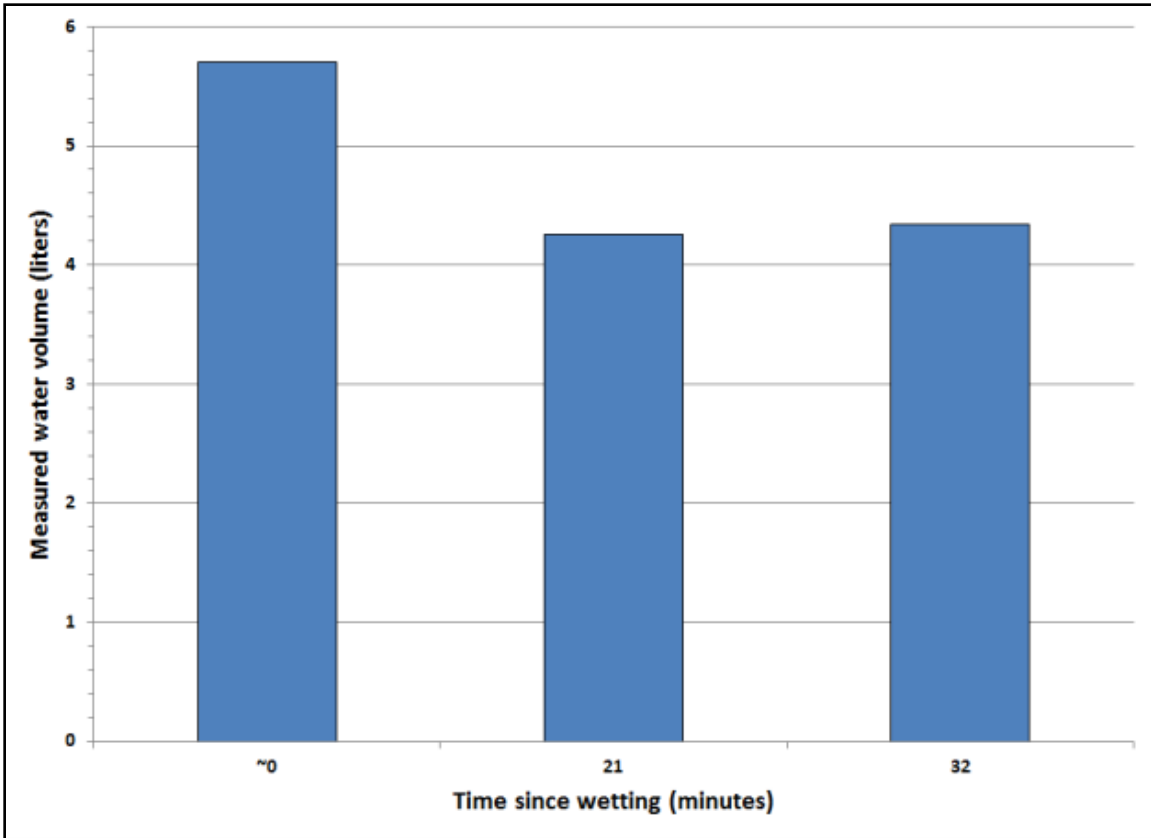
**Figure 43. Measured Water Volumes between Stations 390 to 410.**

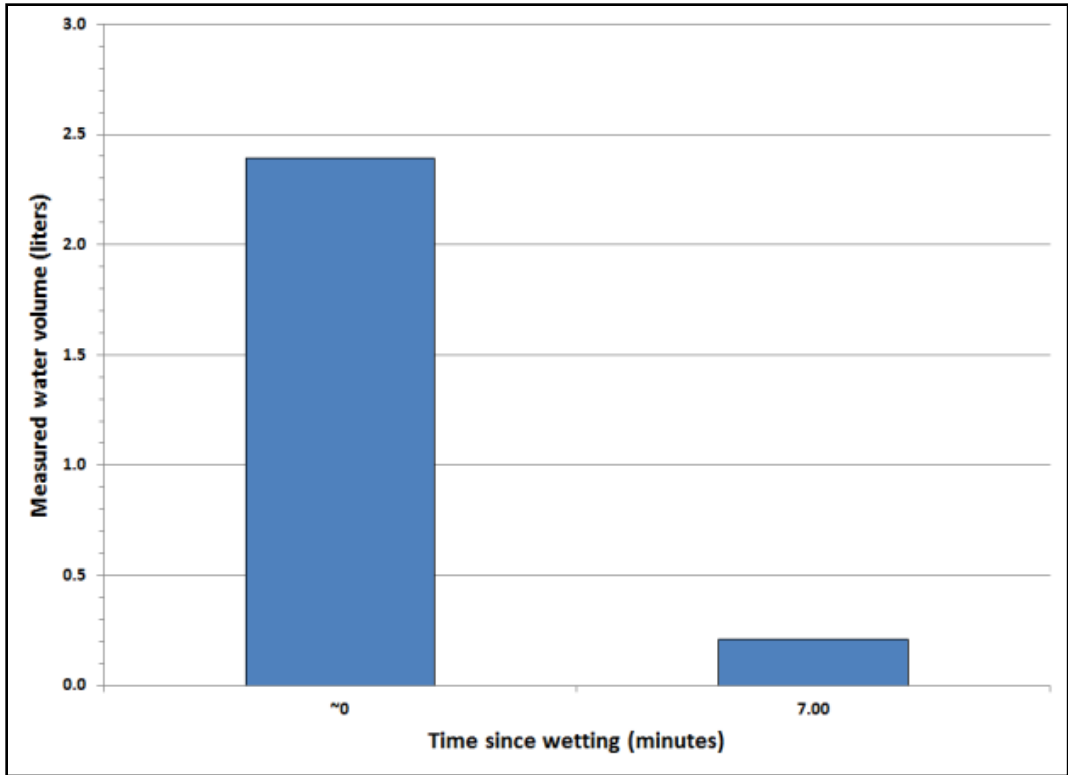
**Figure 44. Measured Water Volumes between Stations 555 to 575.**

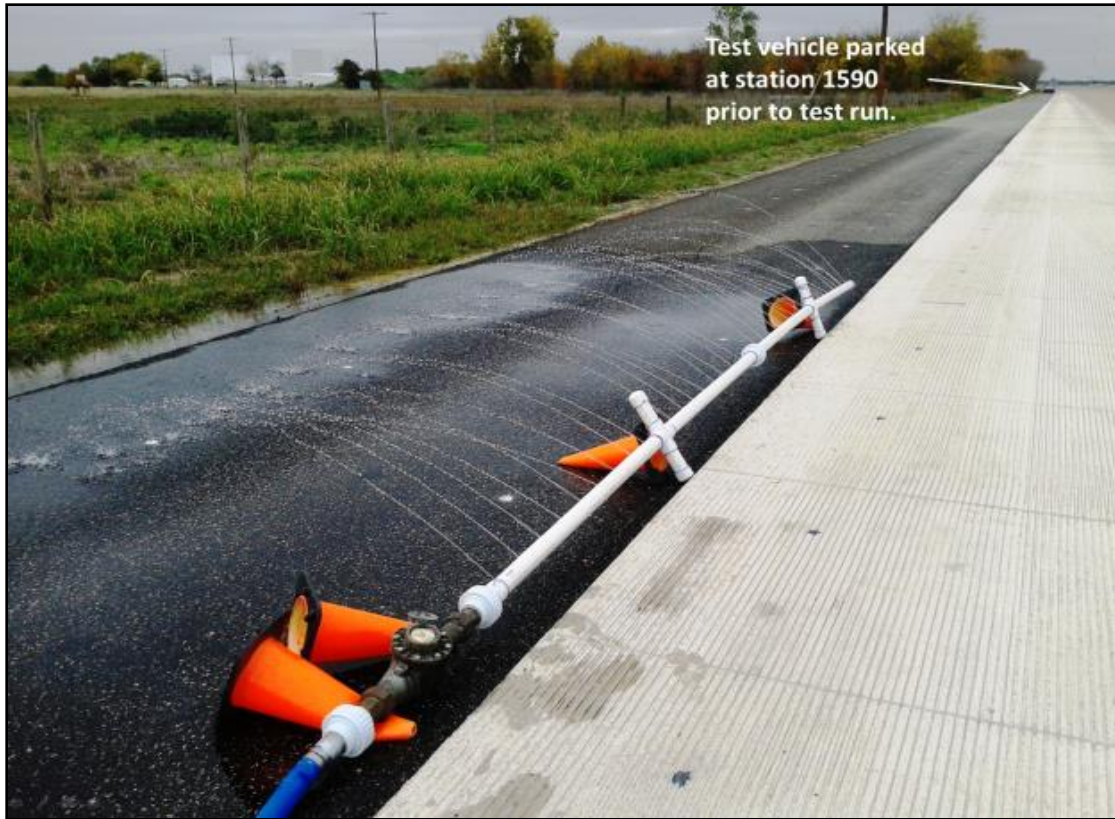
**Figure 45. West Wheel Path Wetted prior to Test Run between Stations 555 and 575.**

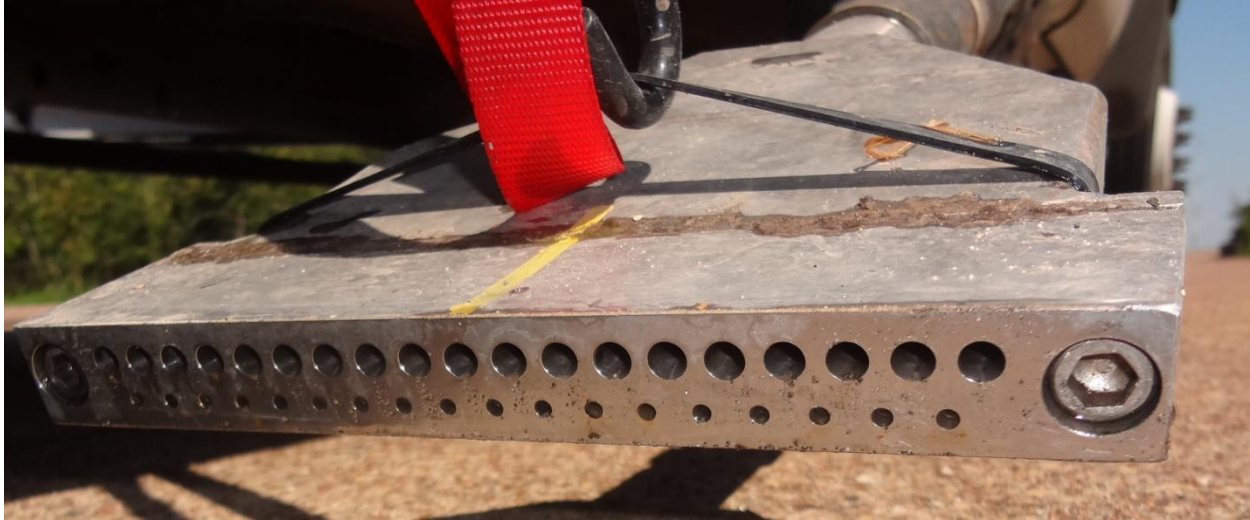
Figure 48. Water Nozzle.

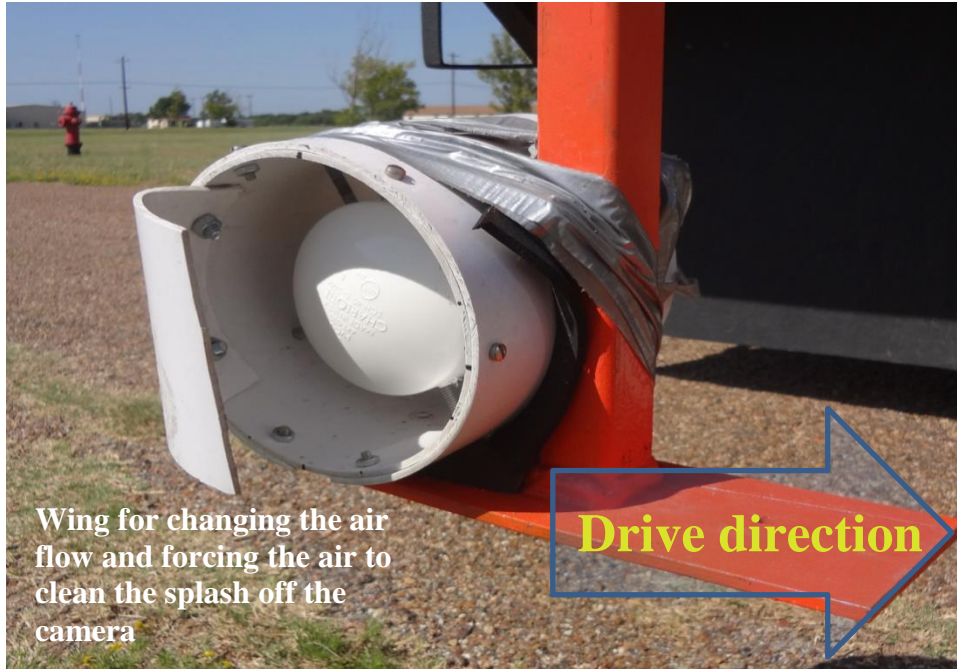
**Figure 52. Splash Protect Cover's Back View (Extra Wing Will Force the Air to Clean the Lens).**

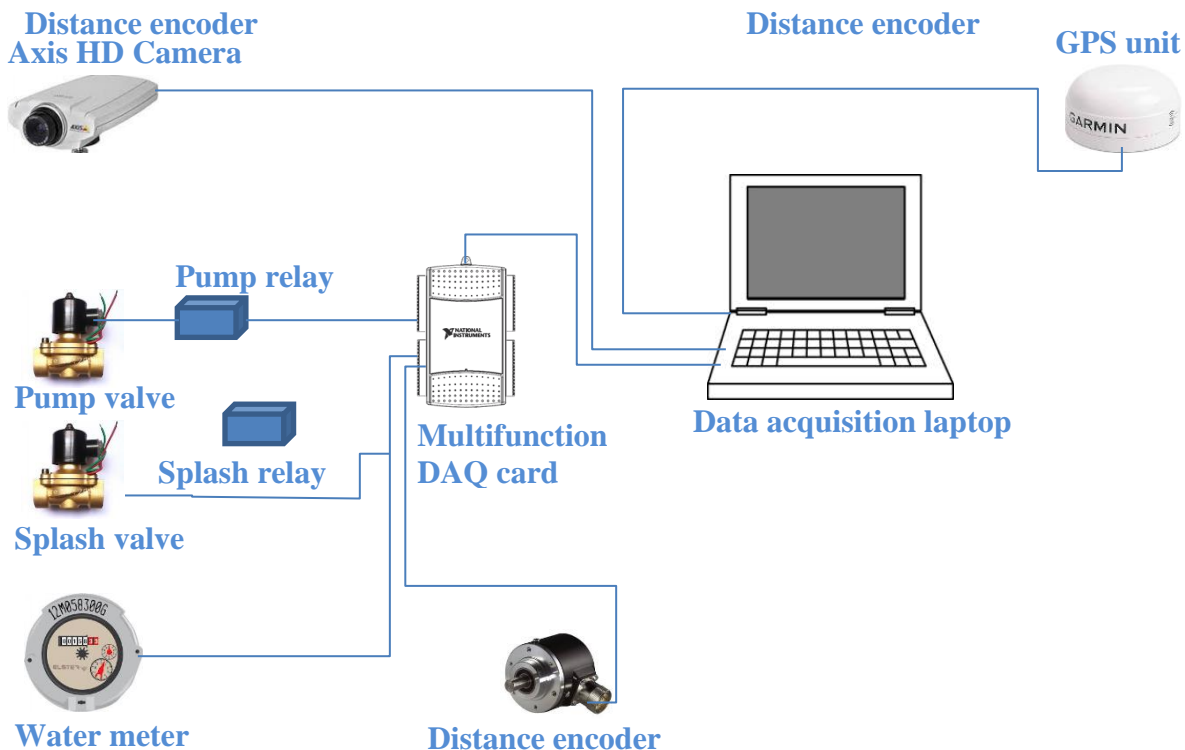
**Figure 54. The Splash Spray Data Acquisition System.**

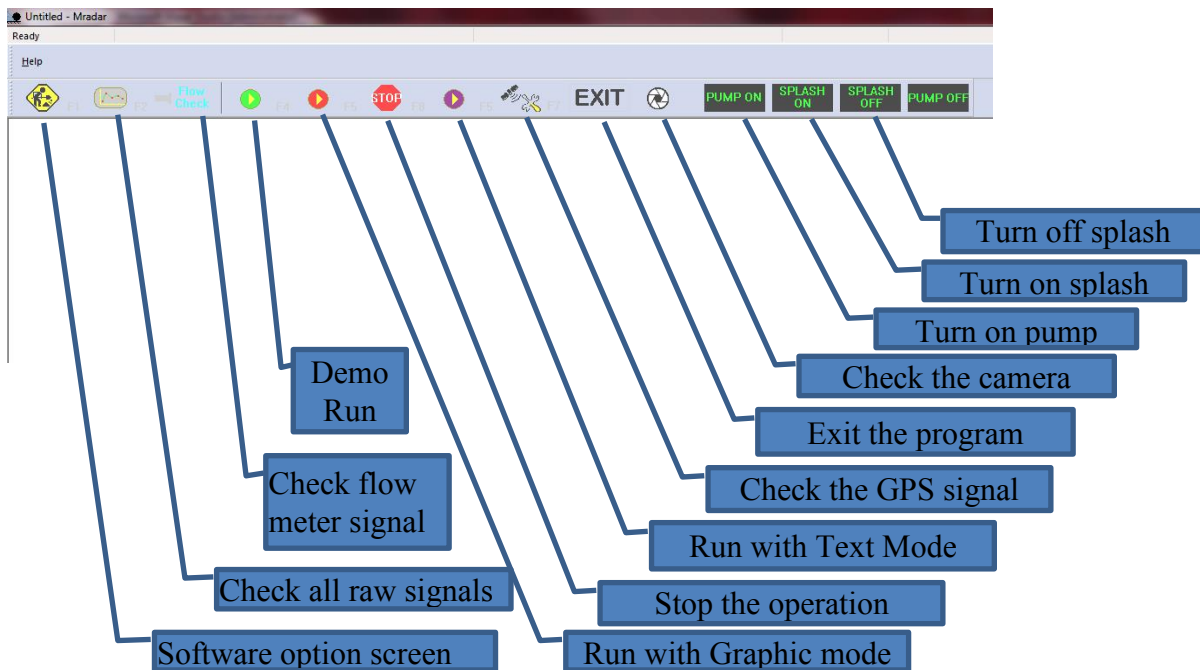
**Figure 56. The Interface of the Splash Spray Data Acquisition System.**

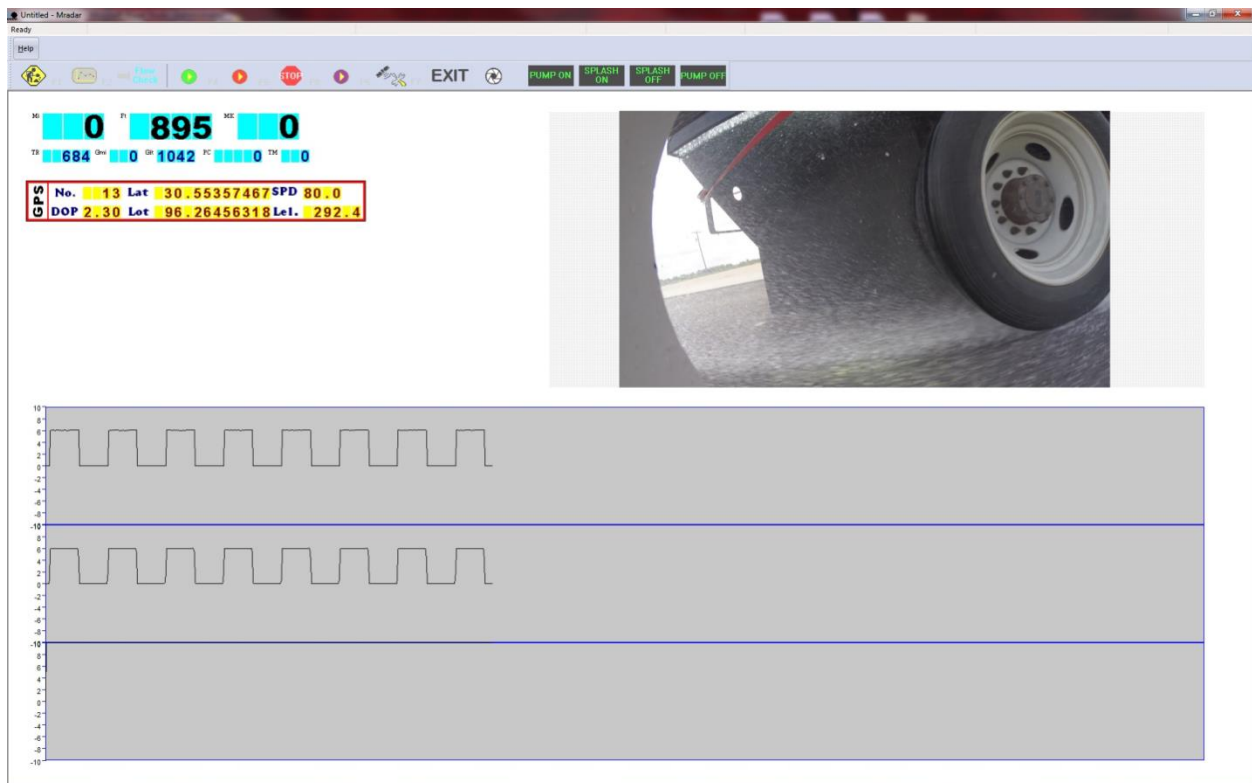
**Figure 57. Typical Splash Image Observed during Data Collection.**

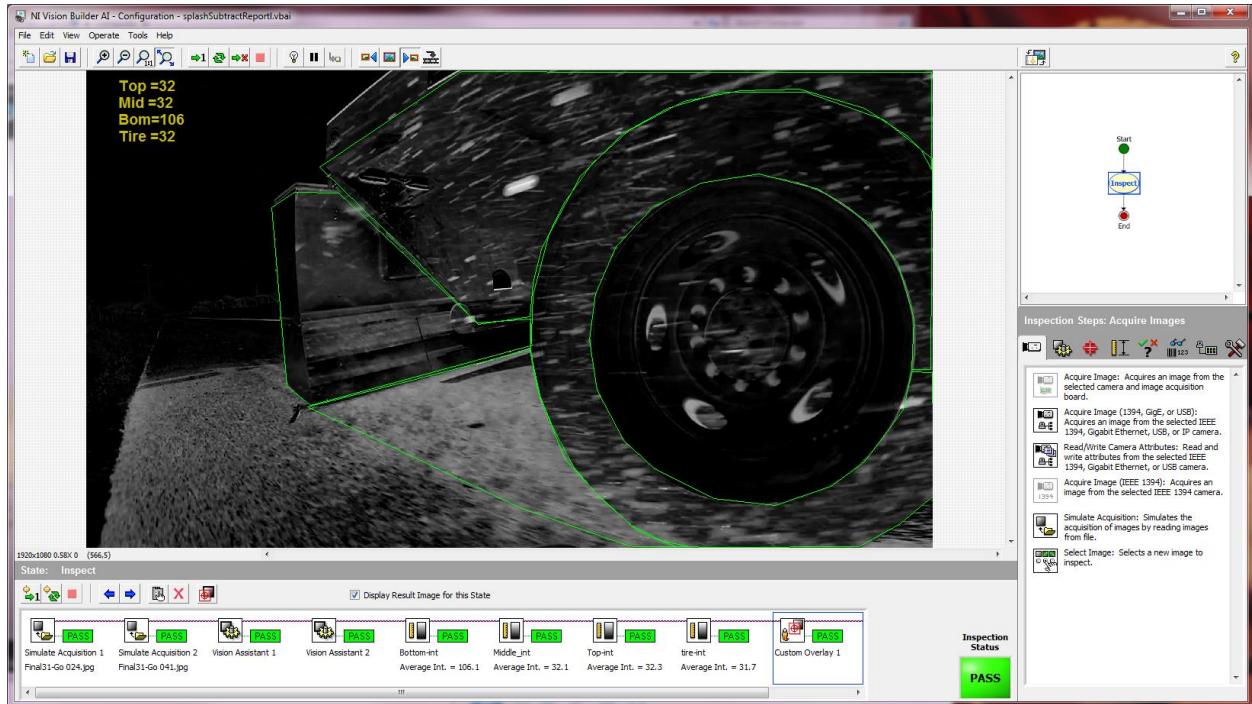
**Figure 58. National Instruments Image Processing Package Vision Builder 2011.**

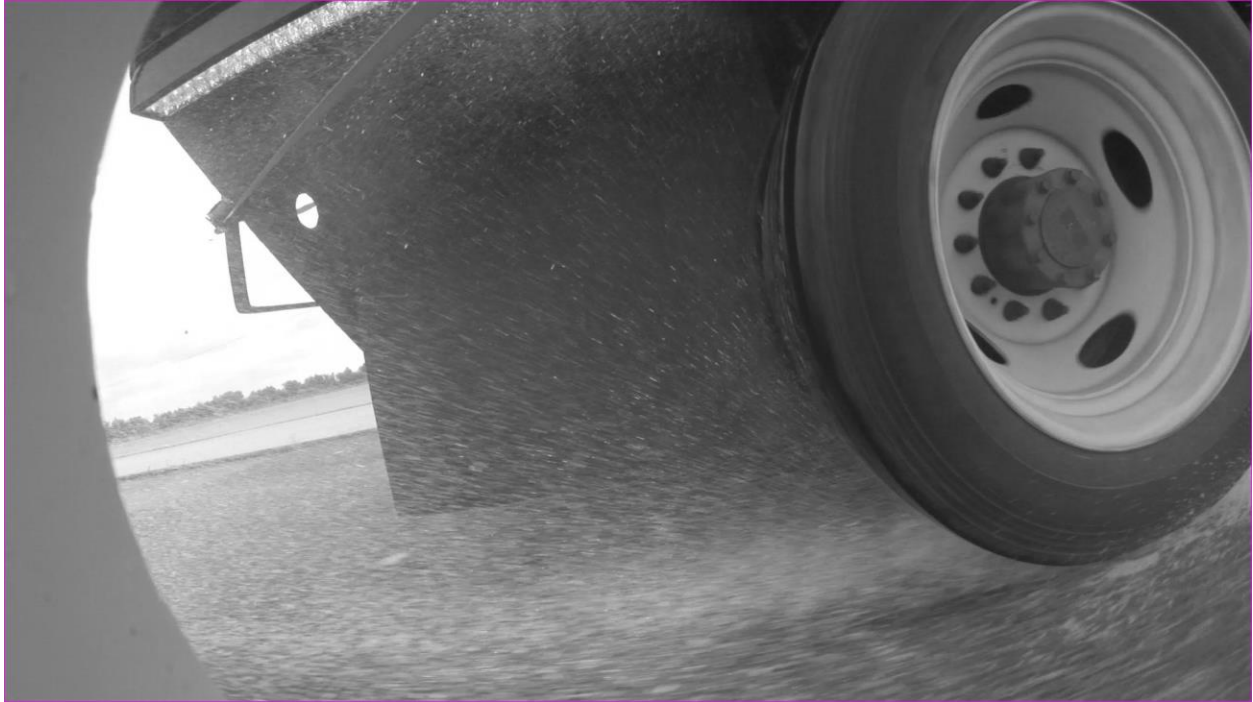
**Figure 59. Grayscale Image Showing Surface Splash.**
