### Technical Report 16-15

#### *Advanced Bridge Safety Initiative: Phase 2*

#### *Task 3- Instrumentation During Live Load Testing and Load Rating of Five Reinforced Concrete Slab Bridges*

*May 2016*

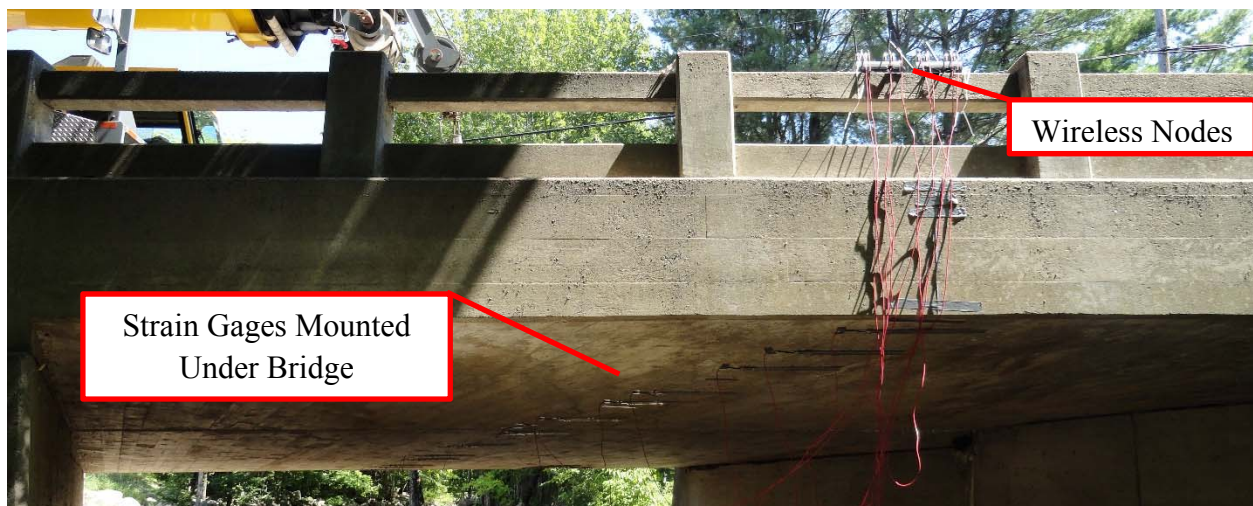
Figure 1: Typical strain sensors mounted under bridge connected to wireless nodes

The strain measurement system utilized in this research is a partially Wireless Structural Testing System (STS-WiFi) by Bridge Diagnostics Inc. (BDI). The system used for this testing utilized a mobile base station to communicate with up to 6 nodes with up to 4 strain sensors per node and an additional autoclicker node for monitoring tire rotation of loading vehical. This system communicated with a dedicated laptop running BDI specific WinSTS data acquisition software. This system was fully verified in the laboratory prior to use in the field. This verification consisted of first mounting the gages to steel spacers utilized in calibrated tension testing servo-hydraulic Instron actuators and verifying that measured strains were as predicted. Next, the system was utilized to instrument a 35 ft. long concrete beam undergoing bending testing. Strains were predicted utilizing both mechanics based calculations and advanced three-dimensional finite element analysis, and matched measured strains well. A sample setup in the field is shown in Figure 1, with strain sensors mounted under the bridge at mid-span connected to battery operated wireless nodes connected to the guardrail. A clear diagram of the entire network is shown in Figure 2 including strain sensors, wireless nodes, the wirelss base station, autoclicker, and the data recording laptop.

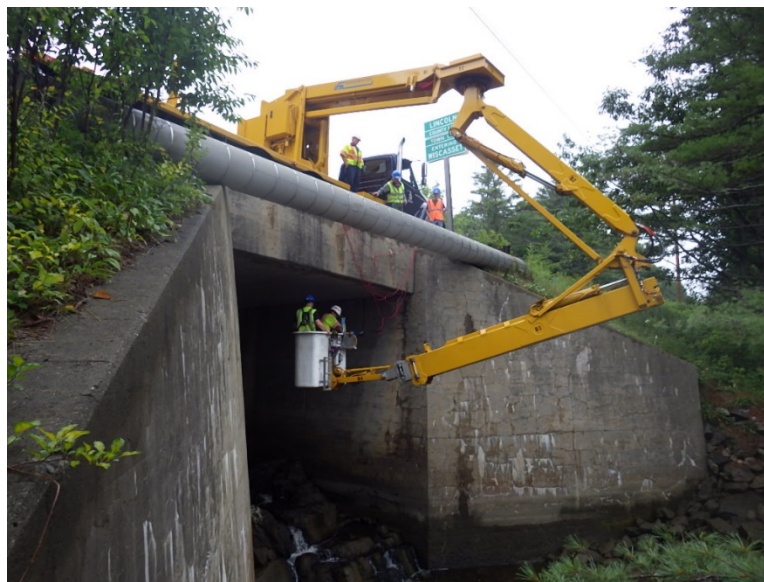
Figure 3: MaineDOT UBIT utilized to install sensors

Strain sensors were mounted under the bridges using a MaineDOT Under Bridge Inspection Truck (UBIT) as shown in Figure 3. The sensors were mounted to the concrete by first grinding the concrete to a fresh surface, cleaning the surface, then using the recommended concrete adhesive to connect the strain sensor tabs to the concrete. Strain sensor layout was optimized for each bridge, with individual sensor layouts shown in the appendices.

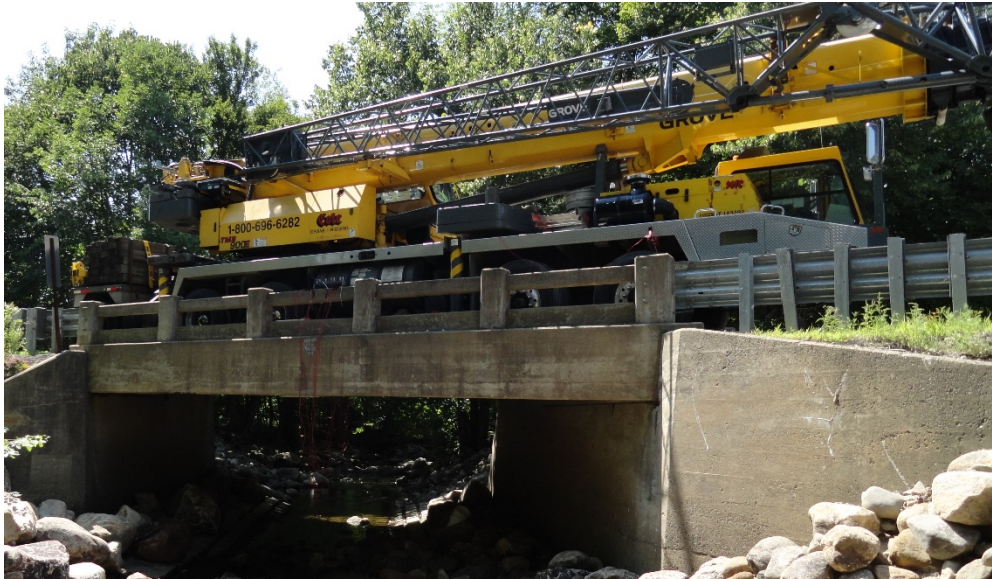
Figure 4: Grove TMS 900E crane used for bridge loading

The crane used for this testing was a Grove TMS900E as shown in Figure 4. The crane was weighed using state patrol certified portable scales as shown in Figure 5. Each test was run with crane moving both directions on each side of the road in optimized load paths as is detailed in the appendices. In general, this was as close to the curb on both sides as possible to maximize the moment along the free edge of the bridge. The autoclicker was utilized to create marks in the data acquisition system at each wheel rotation to determine the vehicle location during the test, and the setup is shown in Figure 6.

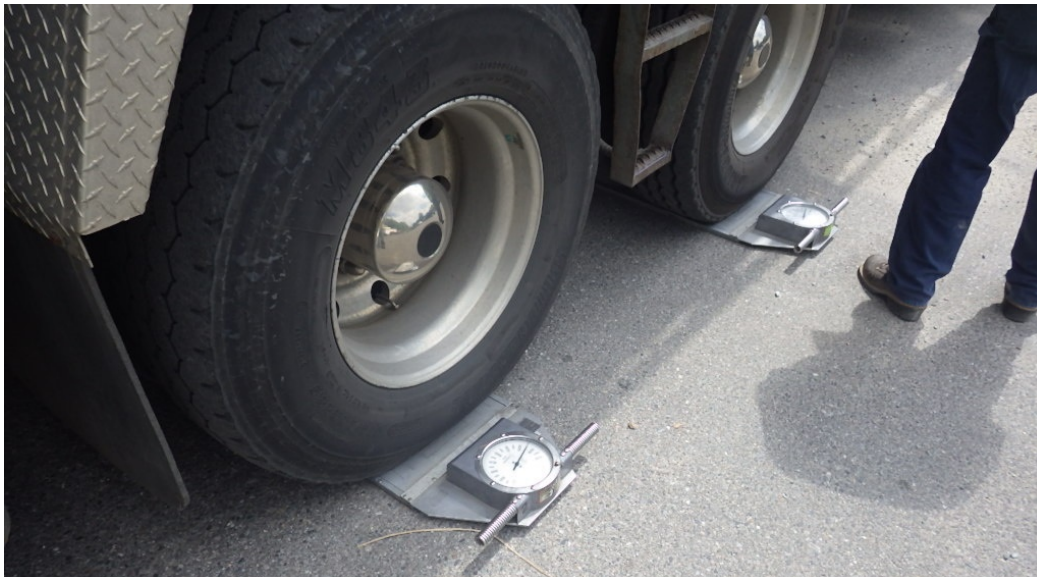
Figure 5: State highway patrol certified portable crane scales used to verify vehicle weight for each test

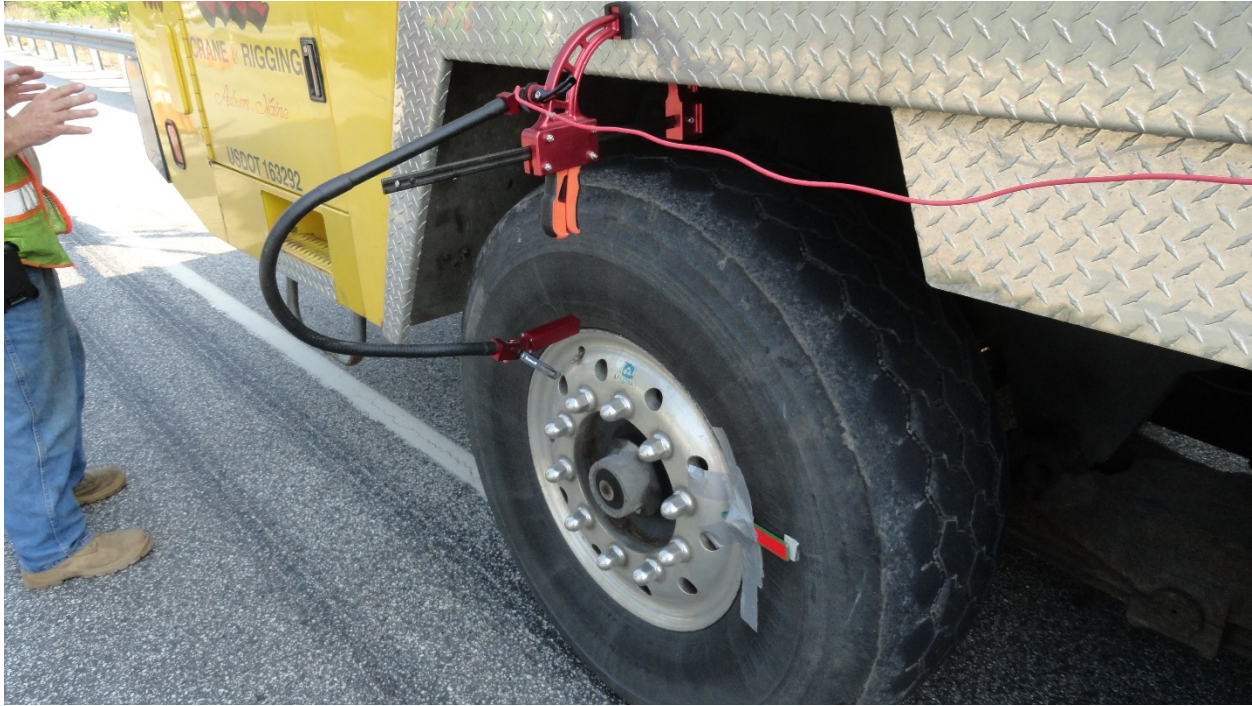
Figure 6: Autoclicker setup to measure wheel rotations for data analysis

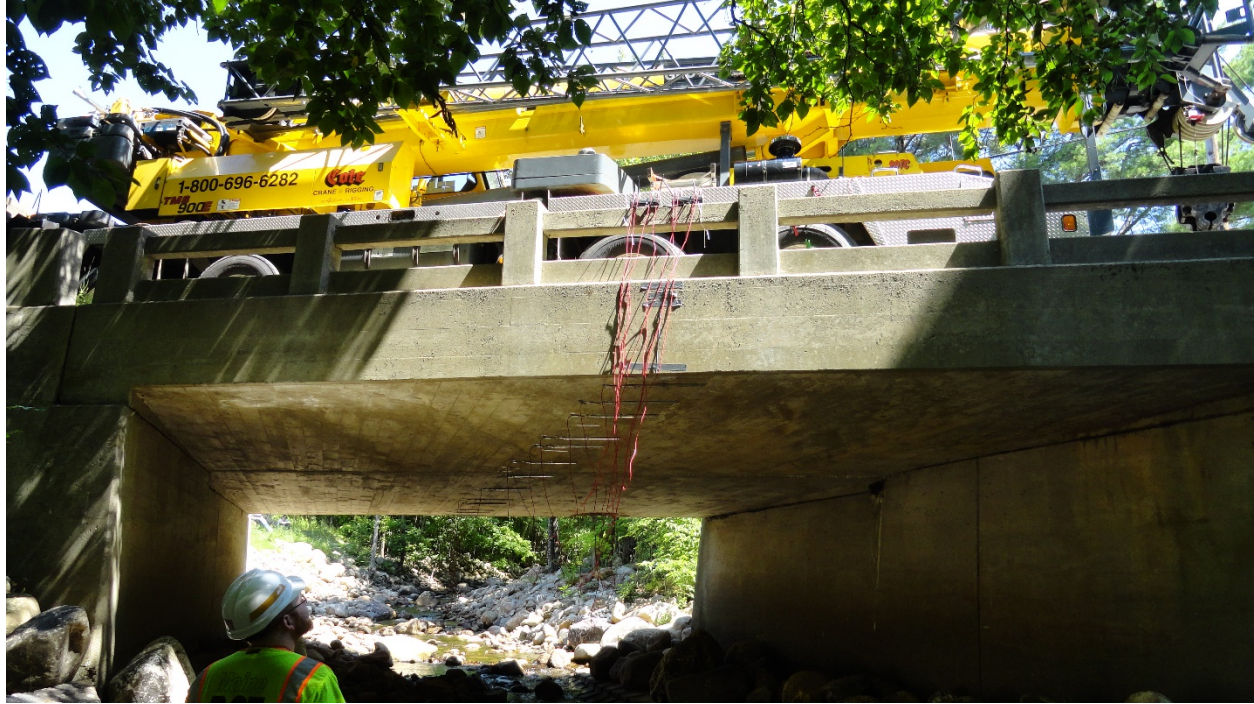
Figure 7: Weld No. 5361 general condition

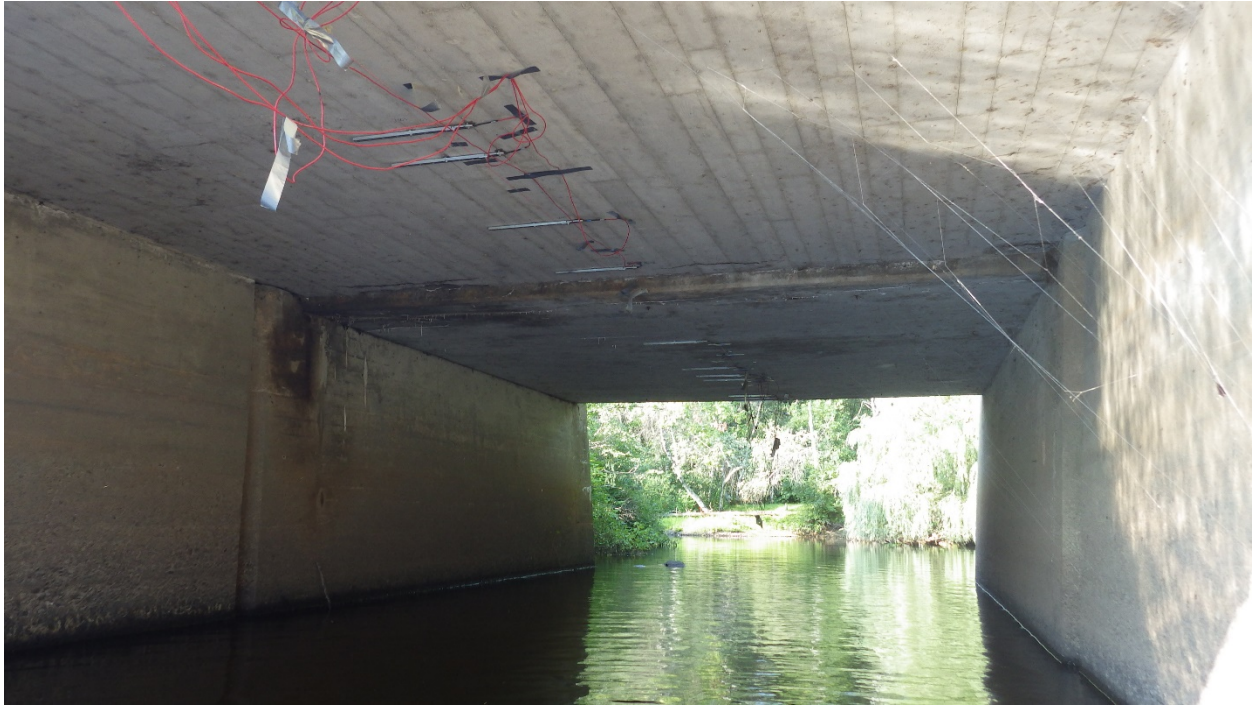
Figure 8: West Paris No. 2582 joint and general condition

The highest measured strains were recorded during Test 08 in the widened portion of the structure. This is consistent with the thinner slab (16.5 in) in the widened portion compared with the original 20 in slab. The two slabs are separated by a cold joint containing a bond breaker as shown in Figure 8, and therefore should behave largely independently. This was confirmed by the very small measured strains in the original portion of the structure when the widened portion was loaded. The finite-element analysis of the slab was thus performed for the critical, widened portion of the structure only. The slab width tapers from 18 ft 7 in to 20 ft 7 in with a 1 ft curb. An average overall width of 19 ft 7 in was assumed for all analyses, and the effect of the thickened curbs was not modeled. A full-depth, un-cracked section was assumed for all analyses, which is consistent with the small measured longitudinal strains of less than 40  $\mu\epsilon$ . The model had 20 elements in both the longitudinal and transverse directions, and strains were interpolated at the gauge locations using nodal values output by the model.

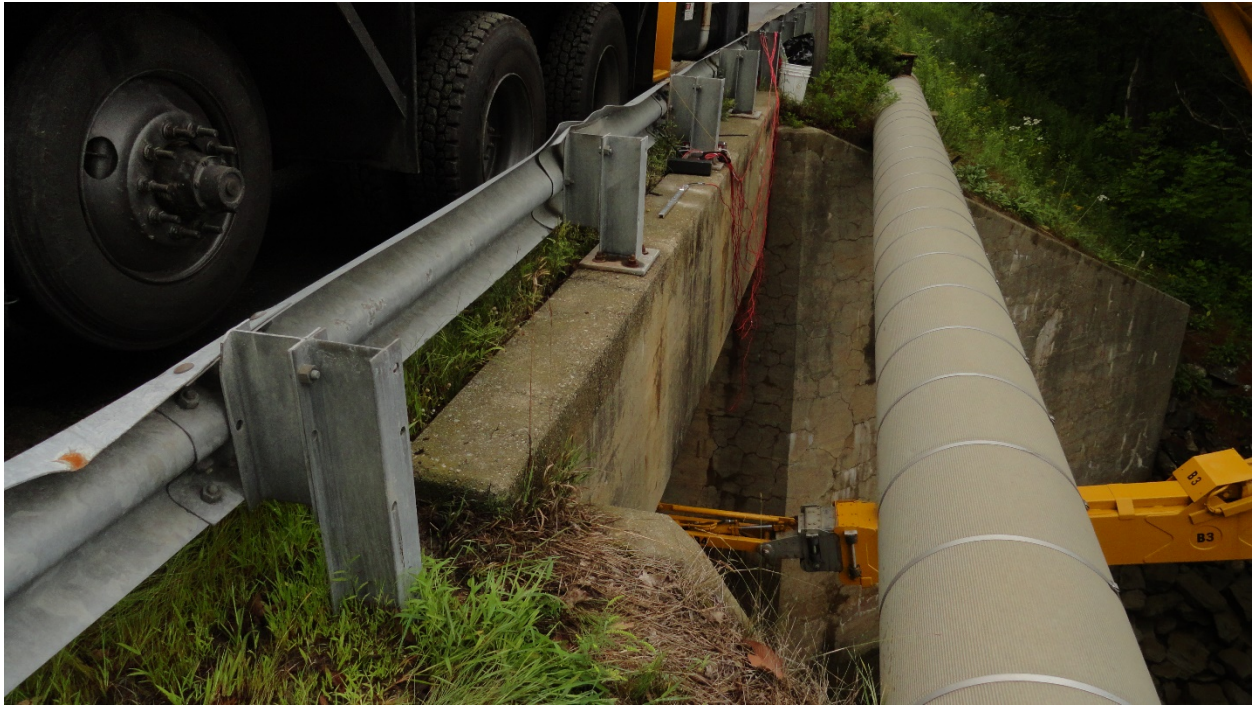
Figure 10: Woolwich No. 2577 showing integral curb and fill thickness

For load tests of bridge No. 2577, the crane produced only 62% of a single lane of HL-93 live loading with impact. As discussed previously, the measured strains were quite low (less than 20  $\mu\epsilon$  maximum positive strain for all loadings). This is likely due to several factors. First, the bridge has approximately 20 inches of fill over the top of the slab, which will tend to spread the wheel loads significantly. Secondly, the crane was not placed as close to the slab edge as in other tests. Third, the crane's heavy axles were relatively light for this test compared to the test at Weld and West Paris. Finally, the exterior edge of the slab, to which the crane was placed closest for the slow speed passes, has a significant integral curb. The general condition is shown in Figure 10. The effectiveness of this integral curb in carrying moments at the slab edge is

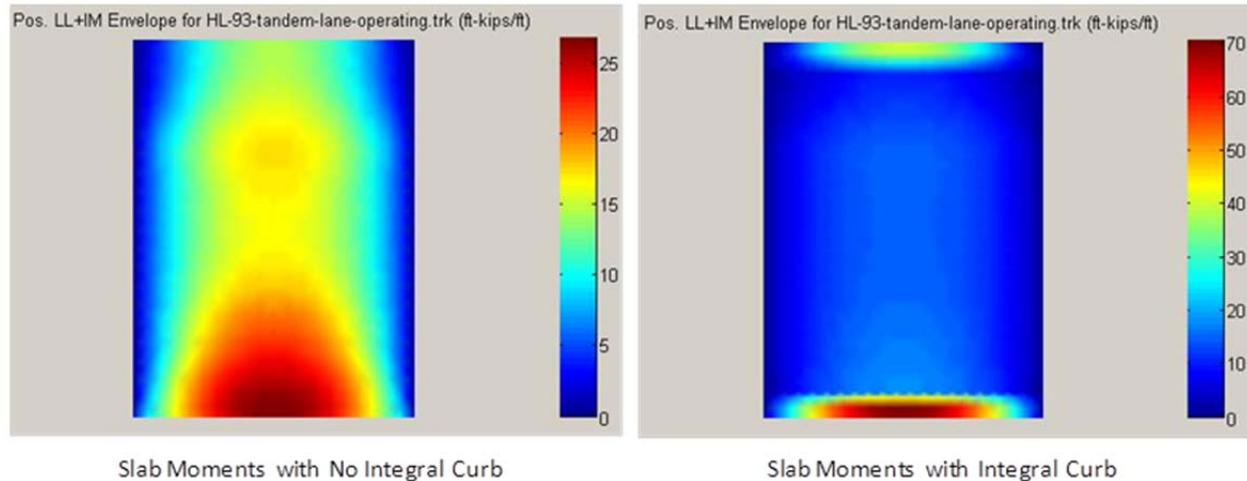
Figure 13: Effect of integral curb on predicted slab moments

The critical location for the rating factor is, as expected, at the interior slab edge. However, this edge has a buried integral curb, which will increase capacity at this location. To explore this, an additional rating was conducted using the above assumptions, but the *SlabRate* FE model was modified to incorporate 32 inch thick, 18 inch wide elements at each slab edge to capture the effect of the thickened curb. The thickened curb sections are significantly stiffer than the slab alone, and tend to increase moments substantially at the slab edge. This is illustrated in Figure 13 with scaled color maps of HL-93 tandem with impact plus lane load moments in the constant thickness slab and the slab with thickened edge elements that account for the curb.

The largest moments will in general be carried by the section of slab plus curb. A hand calculation was performed assuming the combined slab and curb to be an 18 inch wide by 32 inch deep beam reinforced with 3-#9 bars per the original plans. Using the capacity of this deeper section and the DC, DW and LL moments predicted at the outer slab edge, the operating rating factor at the curb increase to 1.01 for the HL-93 tandem<sup>3</sup>.

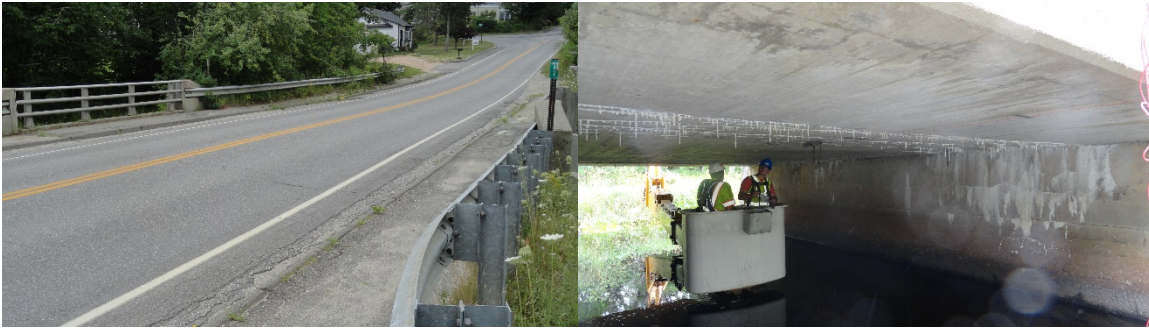
Figure 14: Penobscot No. 3297 overall configuration with sidewalks and new/ old/ new underneath

effectively transfer shear and could transfer significant longitudinal bending. Consistent with the MaineDOT load ratings and the uncertainty of load transfer across the joint, the initial FE models ignored the new sections of slab and conservatively treated the old portion of the slab as an independent structure. The general condition is shown in Figure 14, with the stelactites indicating the two joints between new/ old/ and new sections.

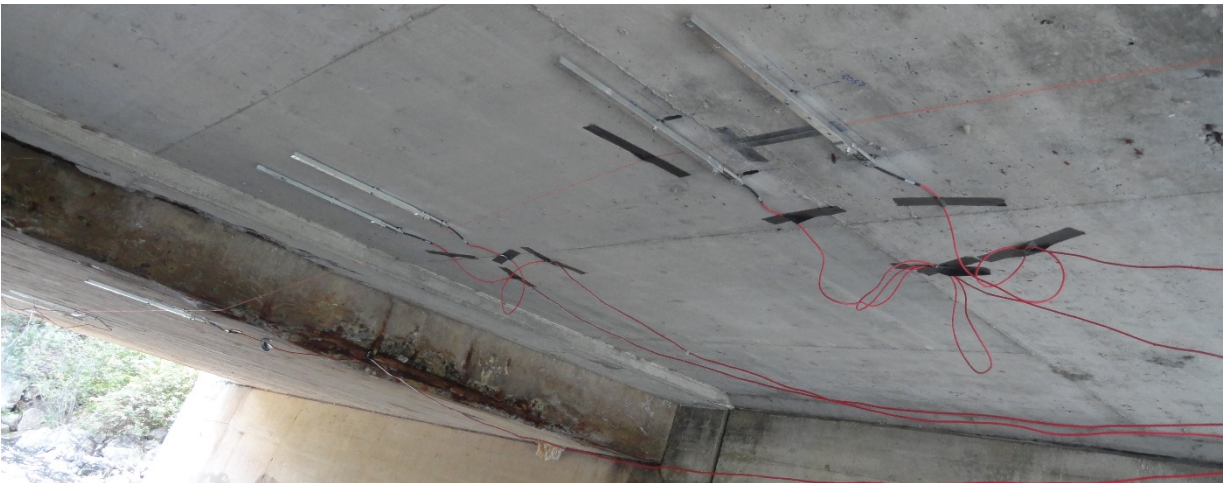
Figure 16: Smyrna No. 2250 underside general condition with joint detail

The Smyrna bridge consists of an original section and widened portions at both edges. The original portion of the structure represents approximately 70% of the roadway width between the curbs, and only the new portion on the north (upstream) side carries significant traffic. The general condition is shown in Figure 16 focused on a joint between old and new slabs.

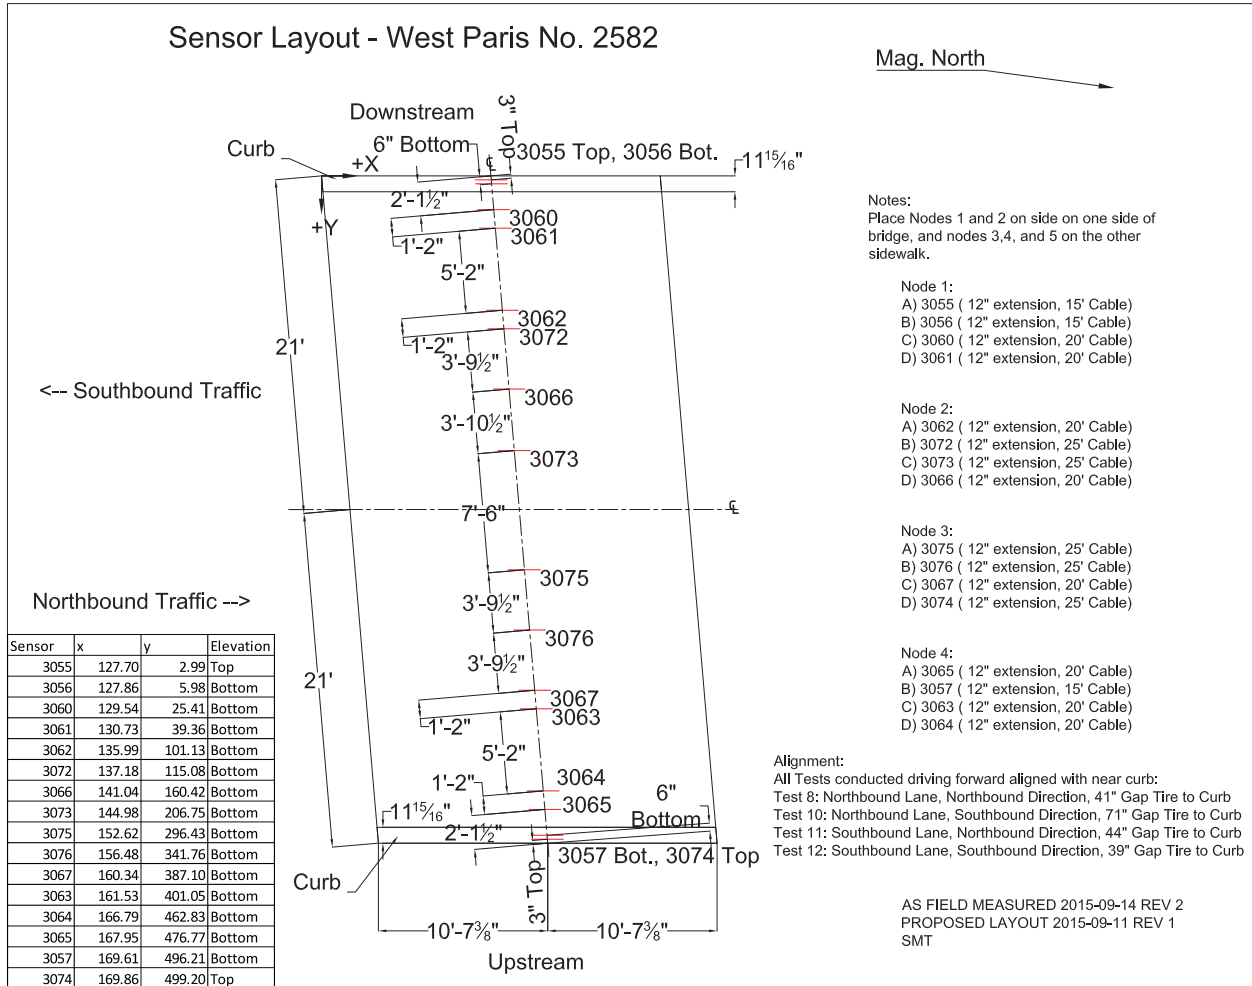
Figure 24: West Paris No. 2582 sensor layout

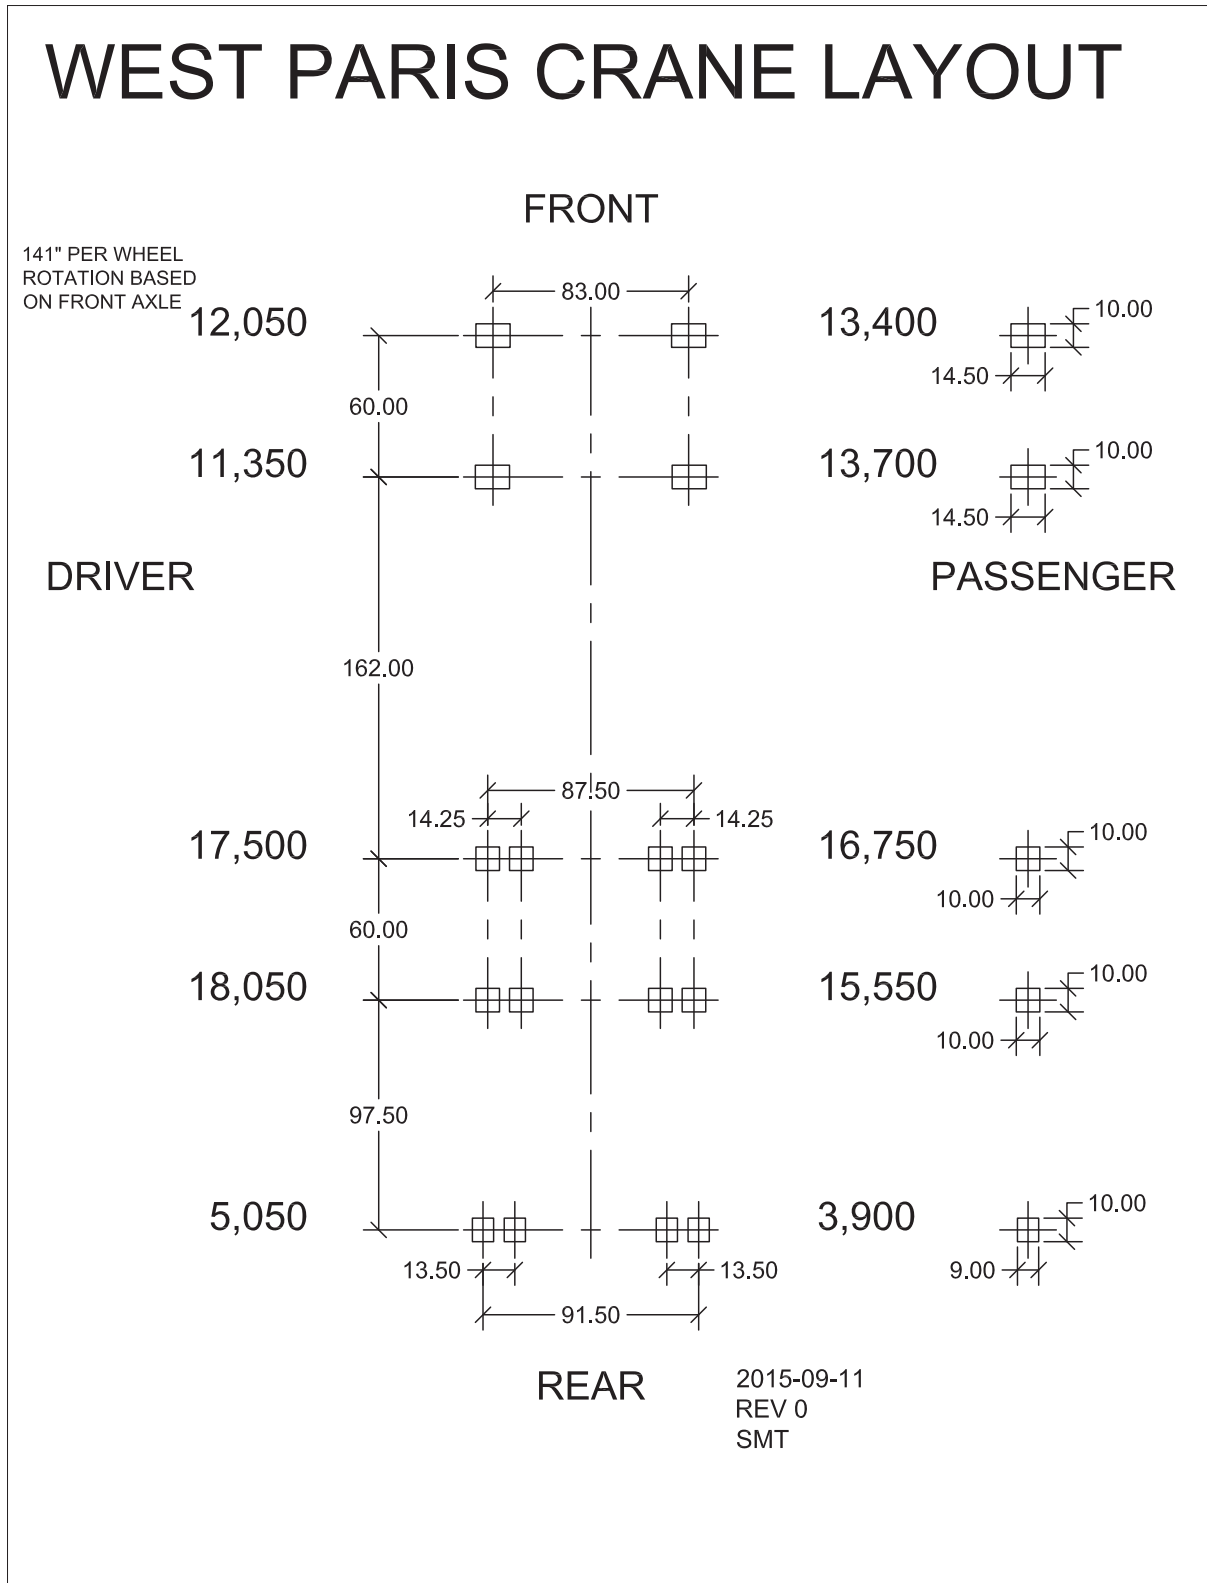
Figure 25: West Paris No. 2582 crane layout

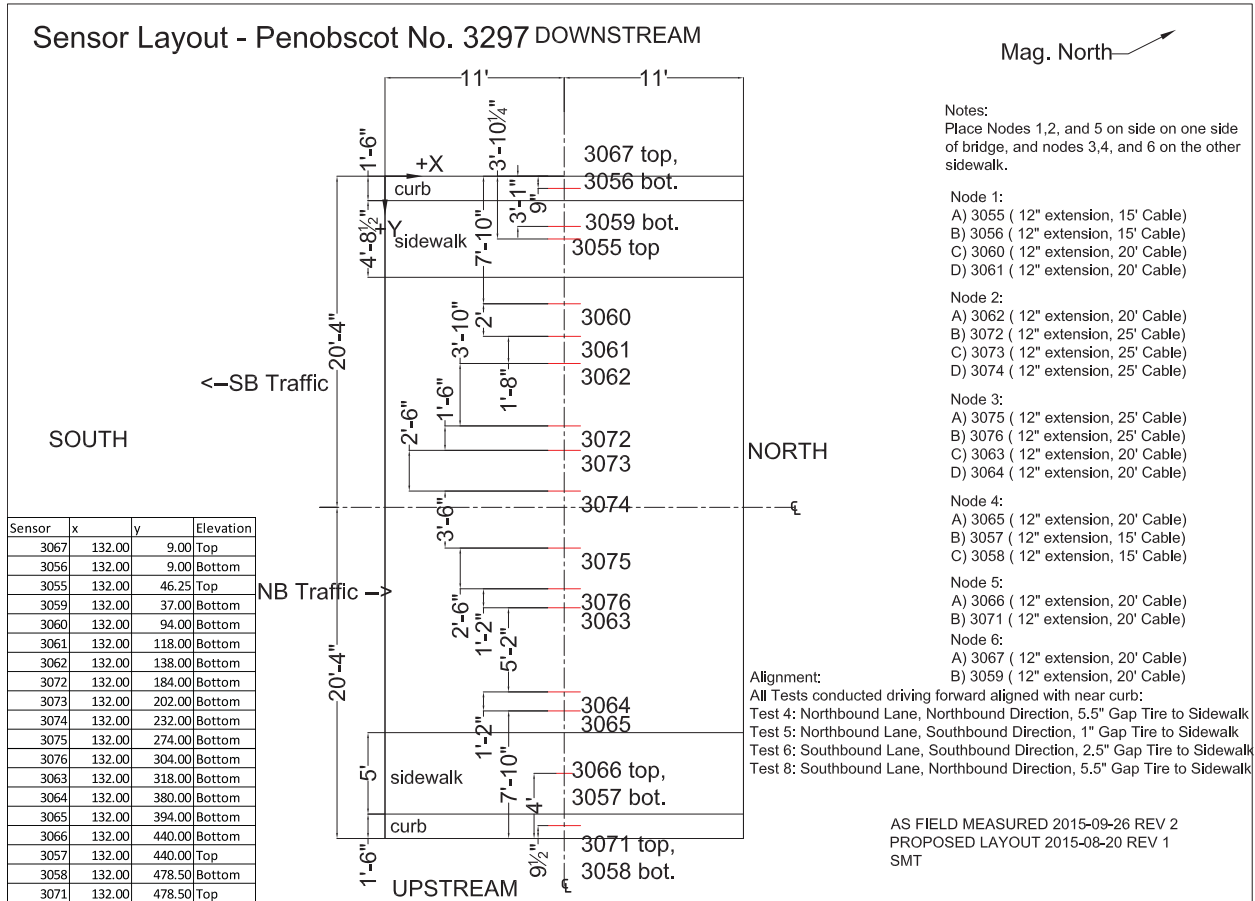
Figure 38: Penobscot No. 3297 sensor layout
