# Corrosion Forecasting and Failure Projection of Post-Tension Tendons in Deficient Cementitious Grout

PUBLICATION NO. FHWA-HRT-17-074

MAY 2018

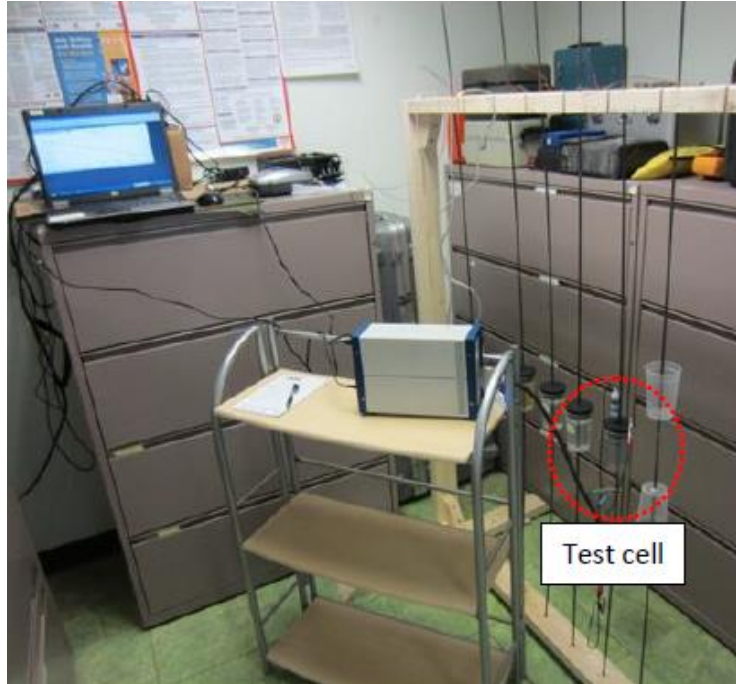
**Figure 4. Photo. Multiple unstressed single-wire specimens and test cells.<sup>(1)</sup>**

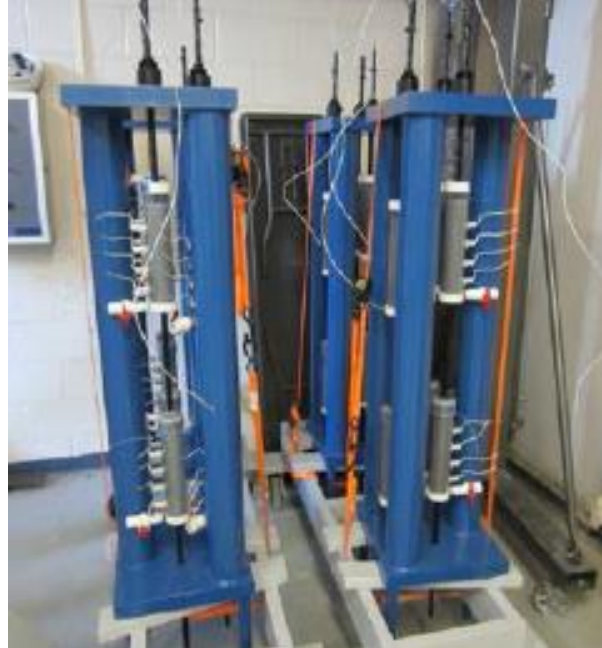
**Figure 7. Photo. Grouted single-strand specimens in loading frames.<sup>(1)</sup>**

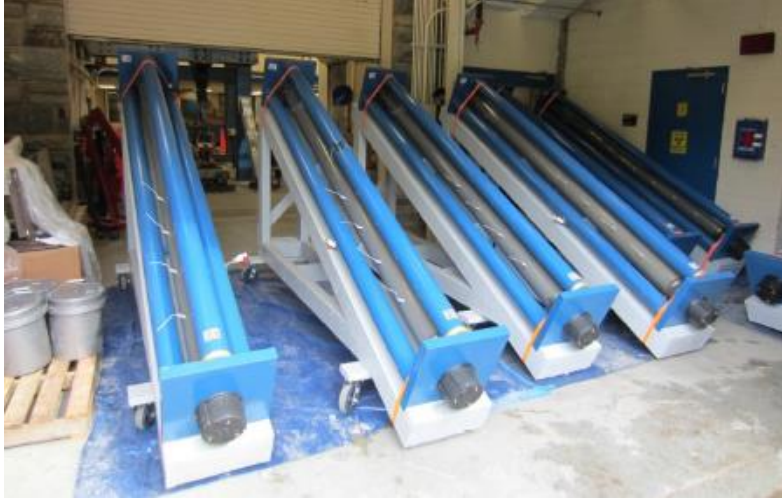
**Figure 9. Photo. Multistrand specimens in loading frames under test.<sup>(1)</sup>**

A total of eight tendons in this category were fabricated and tested (figure 8 and figure 9), and table 11 lists these according to designation and grout chloride concentration. Observations made on exposure termination, dissection, and analysis revealed the following:

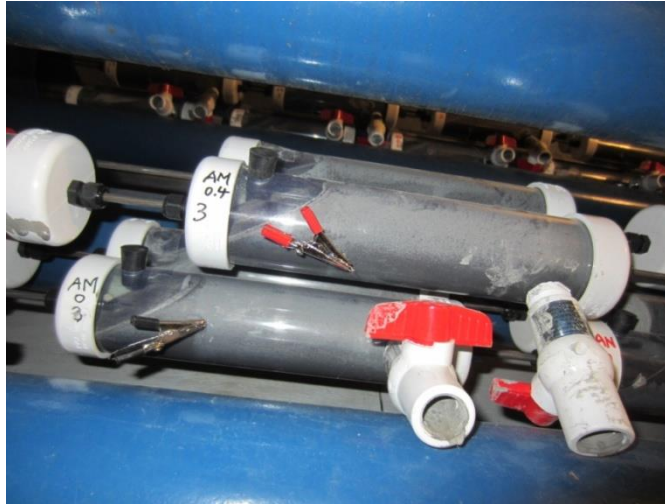
**Figure 11. Photo. Test specimens.**

The stainless steel mesh served as the counter electrode in relation to a section of the encased wire (working electrode), which was stressed to 60 percent of GUTS. Both ends of the pipe were fitted with PVC caps. A pair of cord grips inserted into the center of the top and bottom caps was used to hold the wire and pipe together at a predetermined location without leaking. The specimens were partially filled with fresh grout to create an inclined artificial air void as shown in figure 10. A 0.5-inch ball valve installed at the bottom of the pipe allowed the injection of fresh grout mix, and this was permanently closed when the grout reached the target level. A 0.75-inch hole and a matching rubber plug were introduced at the top of the pipe for purging air during grout pumping and injecting recharging water to the void space during the exposure testing. Figure 11 shows a photograph of several specimens.

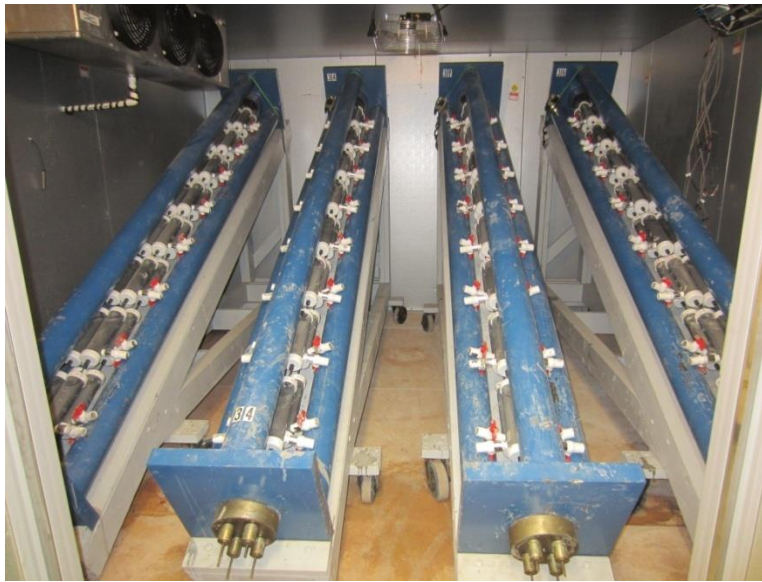
**Figure 13. Photo. Test setup in an environmental chamber.**

The majority of specimens were tested in two walk-in environmental chambers at 40 °C with relative humidity maintained at 80 to 95 percent. In most cases, three specimens were fabricated per test condition. This resulted in a total of 63 specimens for each grout product as indicated in table 1. Each loading frame accommodated four 12-ft-long center wires that were stressed individually at 60 percent of GUTS with each wire having eight specimens in series. With this arrangement, there were 32 specimens per loading frame, and 192 specimens could be tested concurrently. Figure 12 illustrates specimens arranged in a loading frame, and figure 13 shows actual specimens in an environmental chamber.

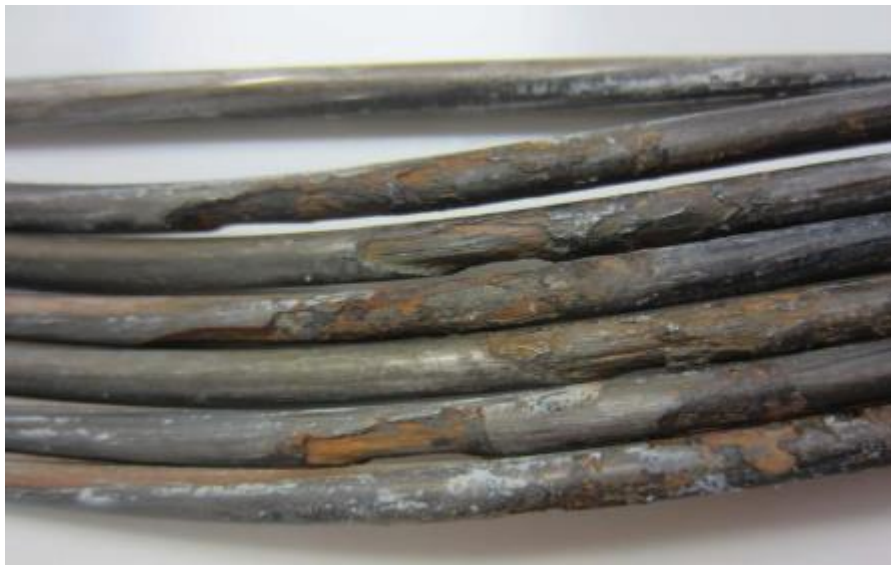
**Figure 16. Photo. Corroded wires of a strand as reproduced from figure 217 from the phase 1 study.<sup>(1)</sup>**

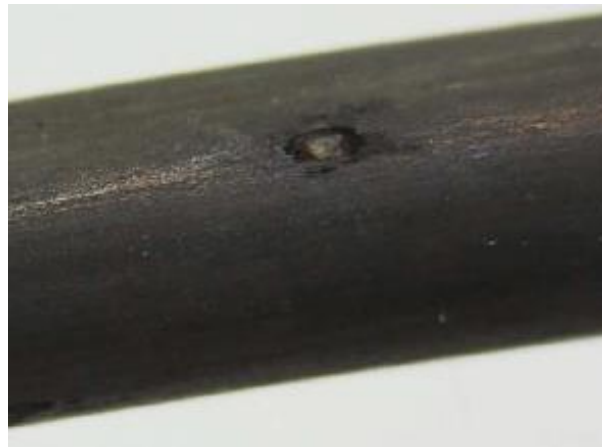
**Figure 19. Photo. Example of initial localized corrosion on a wire from a fully grouted single-strand specimen of the phase 1 study (figure 239) for which grout chloride concentration was 0.80 wt% (pit depth is 4.7 mils).<sup>(1)</sup>**

Based on the above, the fundamental input to the present failure projection modeling is the remaining cross-sectional area of the wires at the most corroded location, which is where fracture is assumed to occur, and how this remaining area decreases with exposure time. FHWA studies reported depths of localized attack along wires, and from these data, the corresponding corrosion rate was calculated. However, while the initial corrosion morphology consisted of spherical or conical depressions, these were considered to have morphed with time into a planar front. As examples, figure 19 shows a photograph of initial localized corrosion on a wire from the phase 1 study, and figure 20 provides an example of more advanced attack. As indicated in the figure 20 caption, depth of corrosion was 18 mils. Based on the width of attack around the wire circumference, wire dimensions, and geometry, and assuming a planar corrosion front, a corrosion depth of 16 mils was calculated, which is in good agreement with the measured value (18 mils). Figure 21 shows a micrograph of a heavily corroded wire from another study, which further supports the planar front assumption; however, as is apparent in the latter, there can be multiple initiation sites around the circumference.

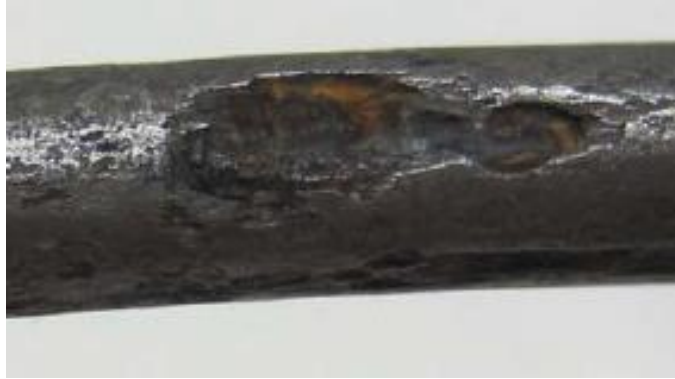
**Figure 20. Photo. Example of a more advanced attack on a wire from a single-strand specimen with a grout void from the phase 1 study (figure 243) for which grout chloride concentration was 2.00 wt% (pit depth is 18 mils).<sup>(1)</sup>**

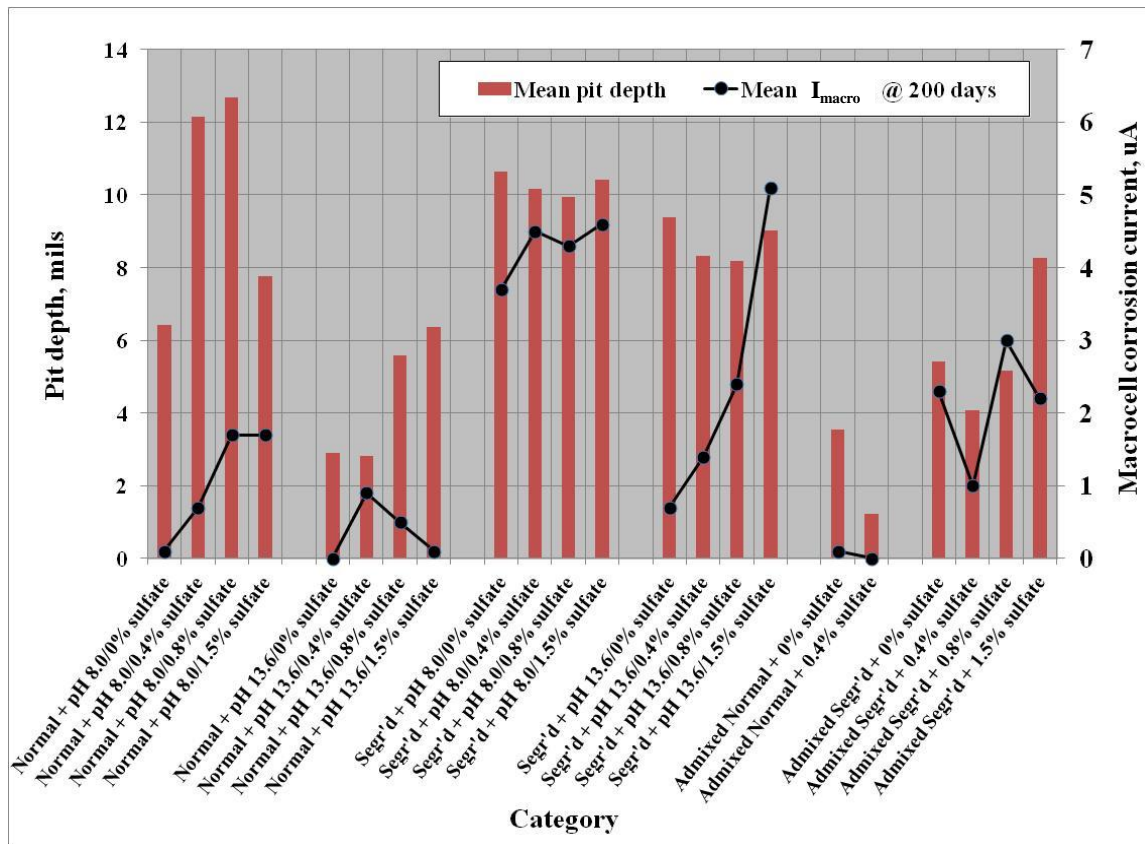
Figure 35 shows a plot of mean pit depth versus mean  $I_{macro}$  at 200 d for each of the three groups. No clear correlation is apparent between the two variables. A lack of any correlation is thought to be due to the fundamentally different characteristics of these parameters; that is, pits are formed by localized corrosion, whereas  $I_{macro}$  is related to the macroscopic corroding area, which could not be determined accurately.

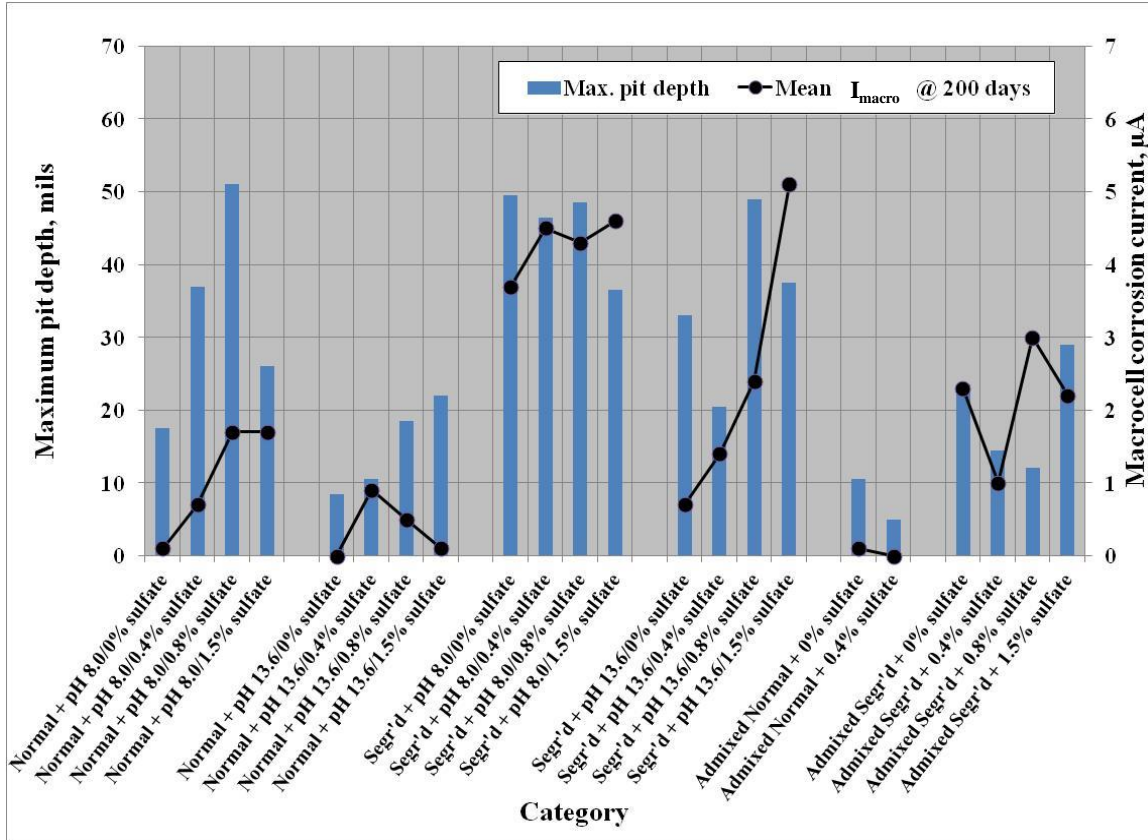
Figure 36 shows maximum pit depth and mean  $I_{macro}$  at 200 d for the same groups of specimens. Like figure 35, no correlations were found between the two variables for the same reason; that is, the maximum pit depth is related to the localized corrosion process, and  $I_{macro}$  is related to the macroscopic corrosion process.

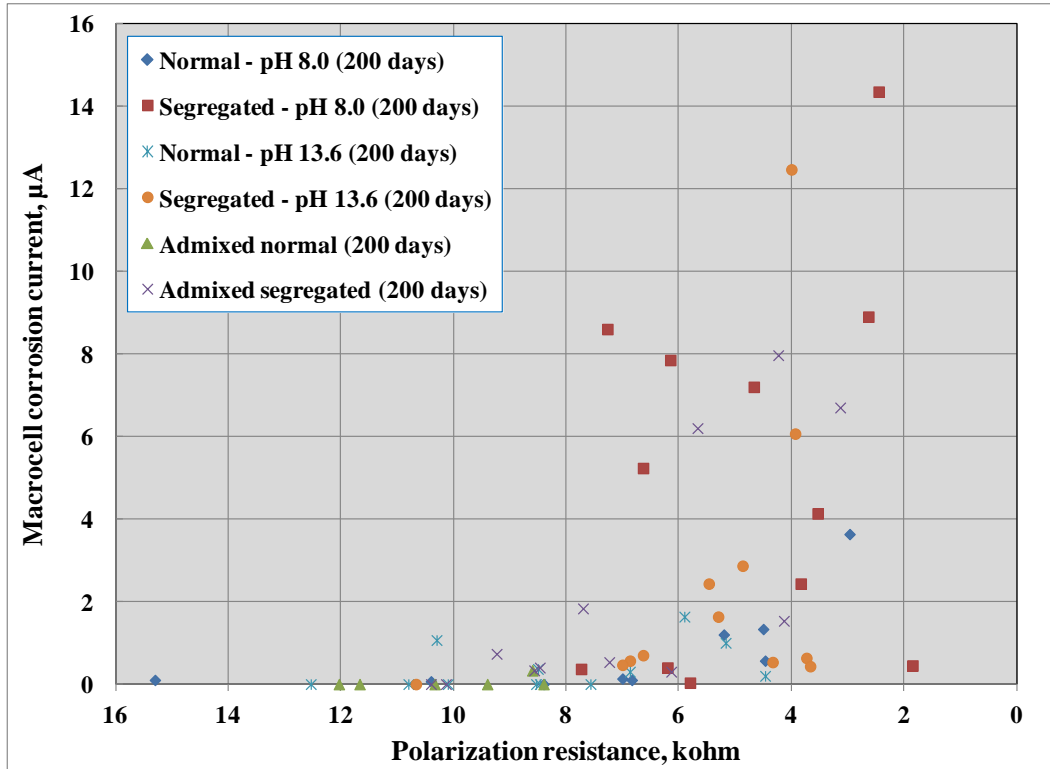
Figure 37 is a scatterplot of  $R_p$  versus  $I_{macro}$  at 200 d. Even though there is no well-defined one-to-one relationship, the specimens exhibiting lower  $R_p$  (i.e., a higher corrosion rate) tended to yield larger  $I_{macro}$ . The segregated grout specimens showed this trend more definitively than the normal grout specimens.

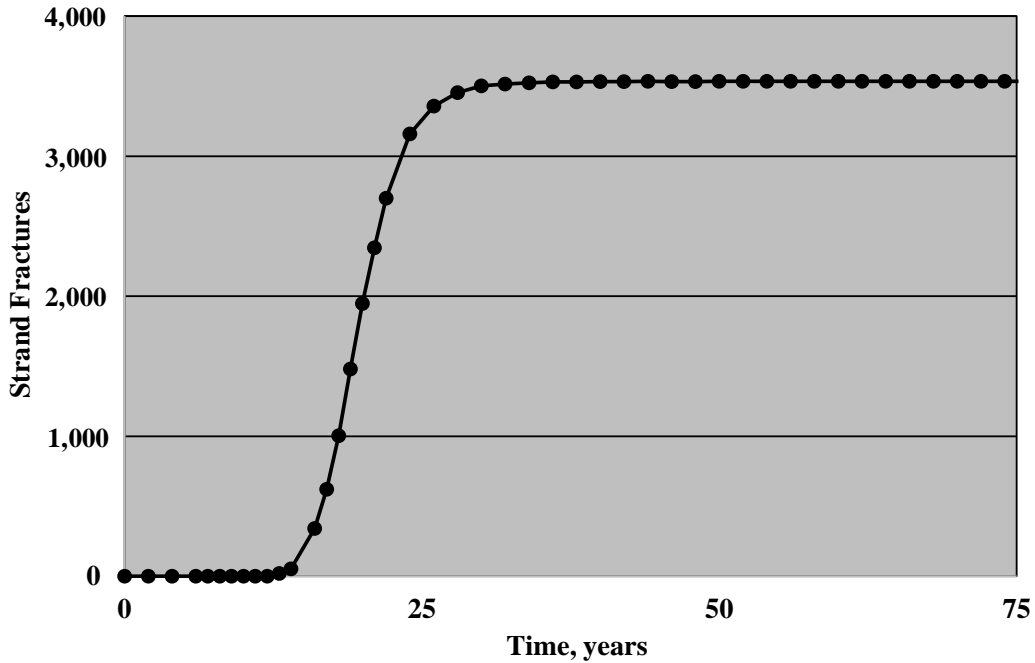
**Figure 39. Graph. Number of strand fractures as a function of time for the case of sound grout with 0.80 wt% chloride based on pit depth determinations for phase 1 Specimen Number 0.8%-F-S.<sup>(1)</sup>**

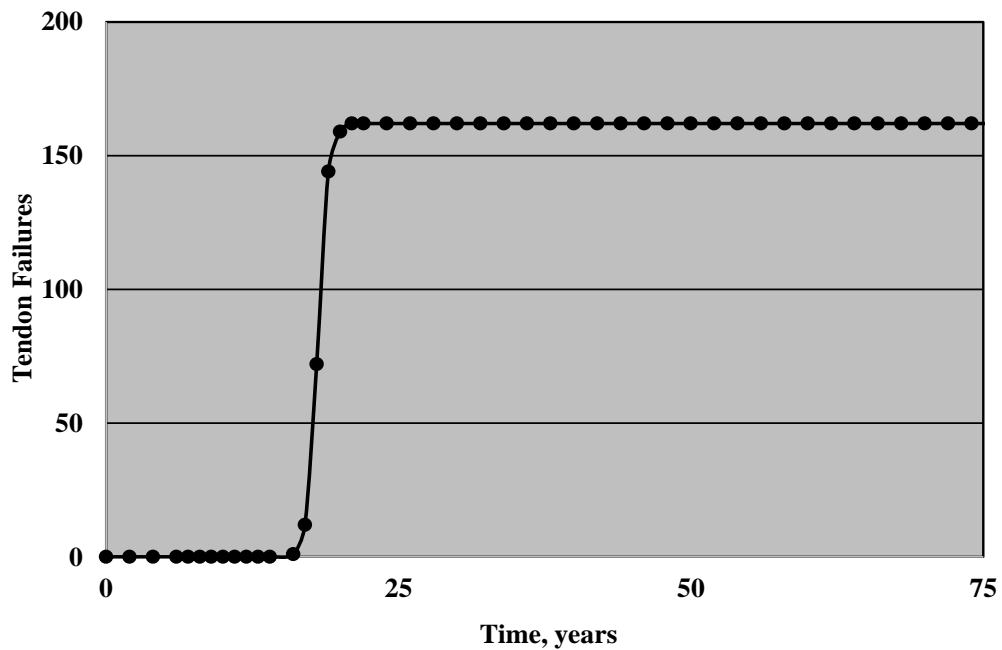
**Figure 40. Graph. Number of tendon failures as a function of time for the case of sound grout with 0.80 wt% chloride based on pit depth determinations for phase 1 Specimen Number 0.8%-F-S.<sup>(1)</sup>**

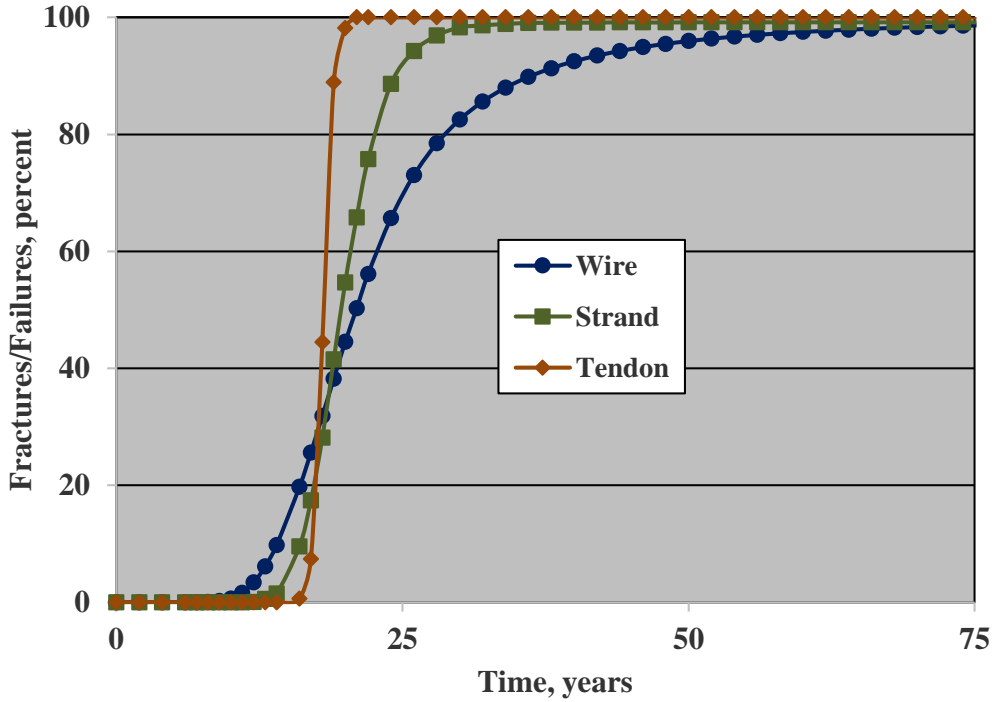
**Figure 41. Graph. Combined plot of the percentage of wire and strand fractures and tendon failures as a function of time based on pit depth determinations for phase 1 Specimen Number 0.8%-F-S.<sup>(1)</sup>**

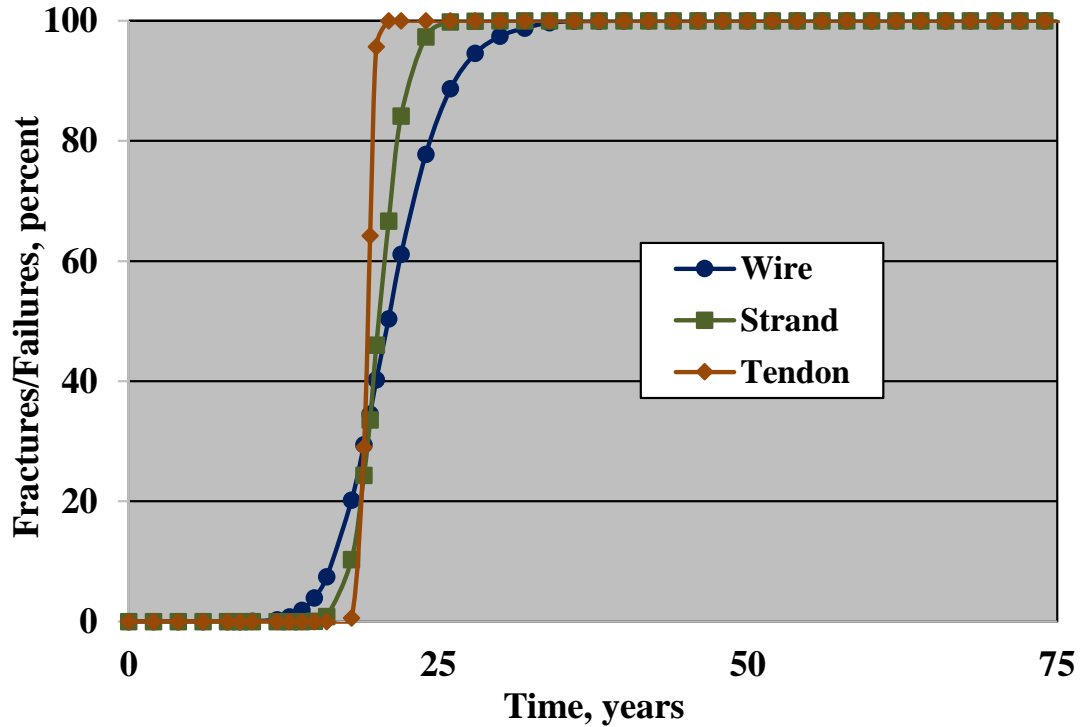
**Figure 43. Graph. Plot of the percentage of wire and strand fractures and tendon failures as a function of time for the case of sound grout with 0.80 wt% chloride and  $\sigma(CRE)$  on corrosion rate equal to  $0.30 \mu(CRE)$ .**

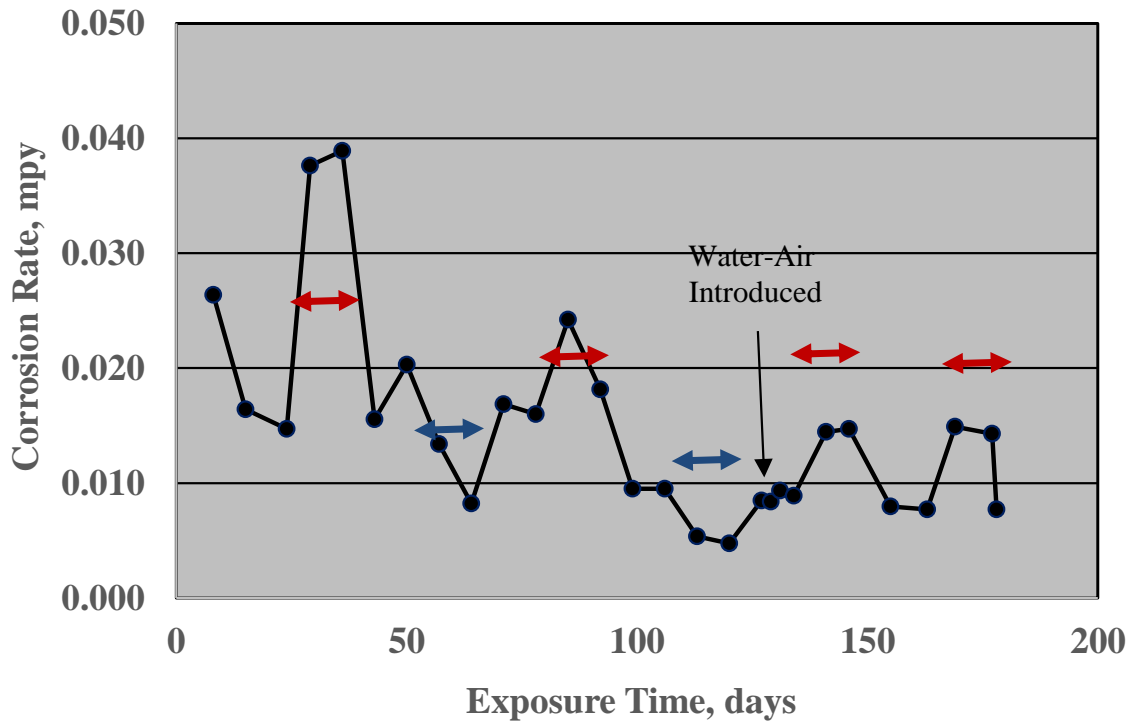
**Figure 46. Graph. Plot of corrosion rate versus time for Specimen Number 1.0%-V-US.**

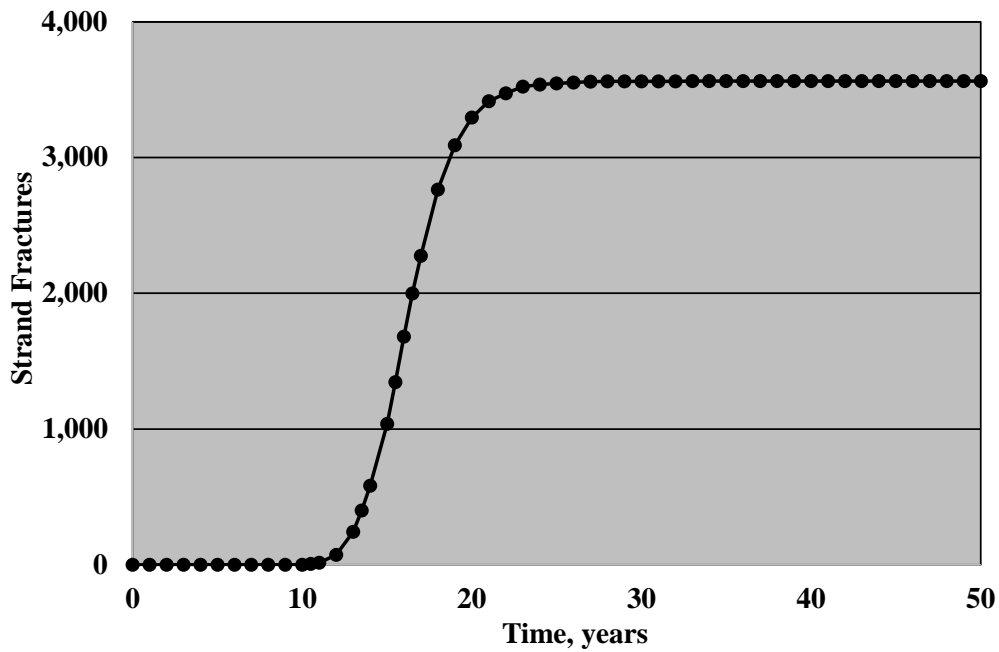
**Figure 53. Graph. Plot of the number of strand fractures as a function of time for Specimen Number 1.0%-V-S (grout with 1.0 wt% chloride and an air void).**

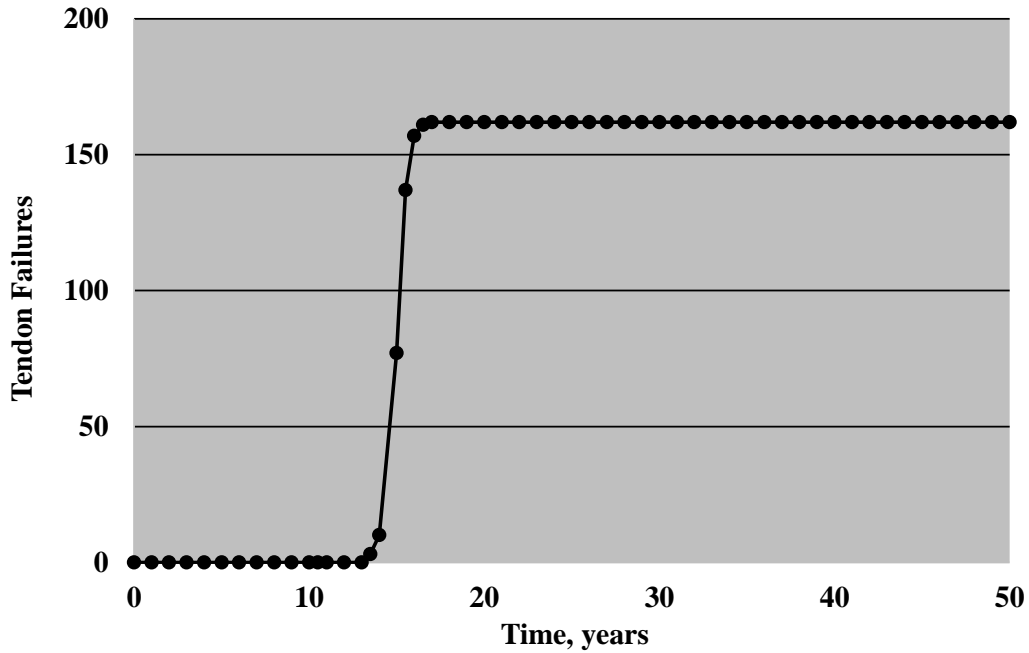
**Figure 54. Graph. Plot of the number of tendon failures as a function of time for Specimen Number 1.0%-V-S (grout with 1.0 wt% chloride and an air void).**

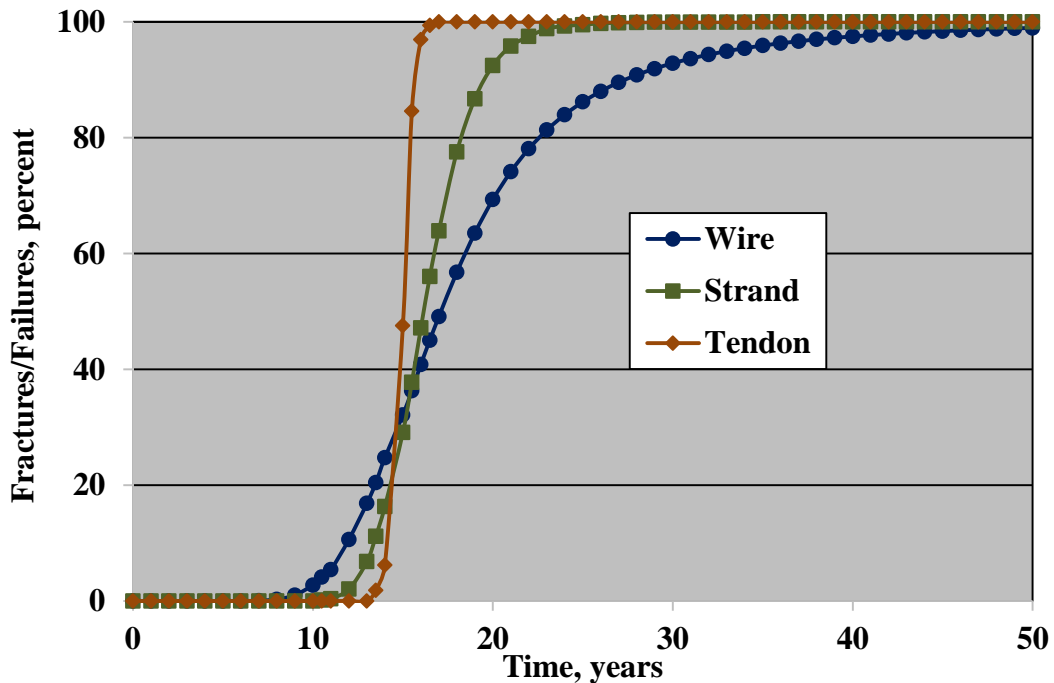
**Figure 55. Graph. Plot of the percentage of wire and strand fractures and tendon failures as a function of time based on phase 1 corrosion data for Specimen Number 1.0%-V-S (grout with 1.0 wt% chloride and an air void).<sup>(1)</sup>**

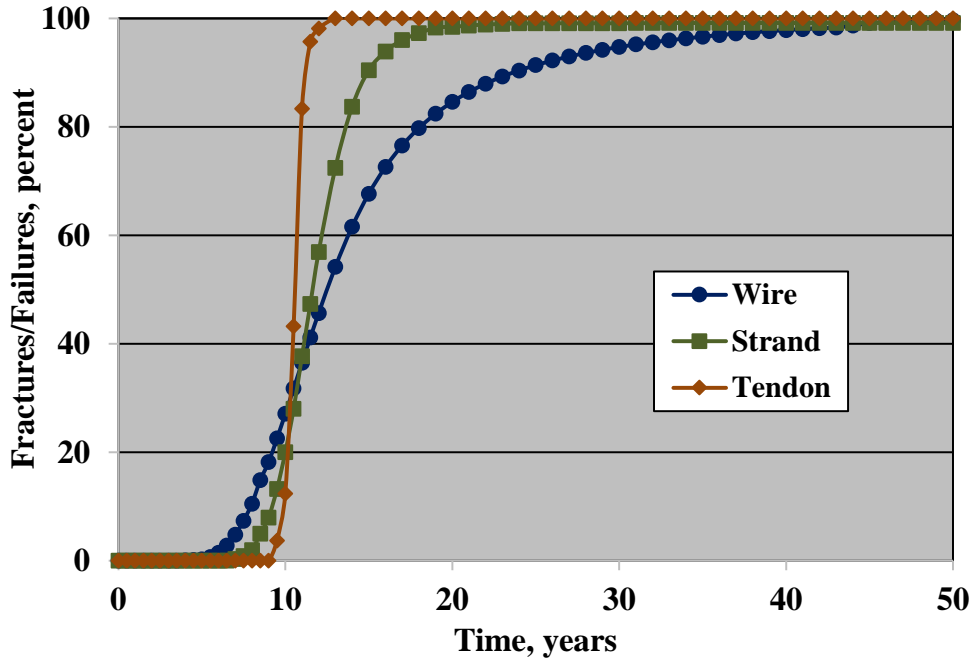
**Figure 56. Graph. Plot of the percentage of wire and strand fractures and tendon failures as a function of time based on phase 1 corrosion data for Specimen Number 1.0%-V-US (grout with 1.0 wt% chloride and an air void).<sup>(1)</sup>**

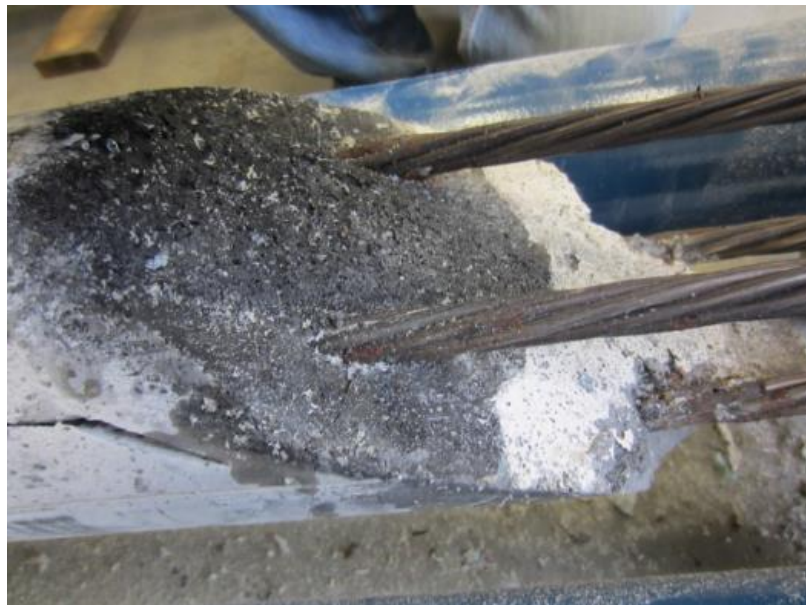
**Figure 59. Photo. Appearance of black deposits at the void/grout interface as shown by figure 213 from the phase 1 report.<sup>(1)</sup>**

- Corrosion of the stressed strands was greatest at or near the void/grout interface.
- Specimens with grout chloride concentrations 0, 0.40, and 2.00 wt% chloride exhibited a black deposit on the grout near the void/grout interface, an example of which is shown in figure 59, and exceptionally high corrosion losses occurred locally here. The deposits were determined to have a relatively high concentration of soluble sulfates, and the high corrosion rates at this location were attributed to this.
- For specimens that did not develop high-sulfate deposits, ones with less than 0.80 wt% chloride exhibited mostly localized rusting, and relatively little pit depth data were recorded for these.

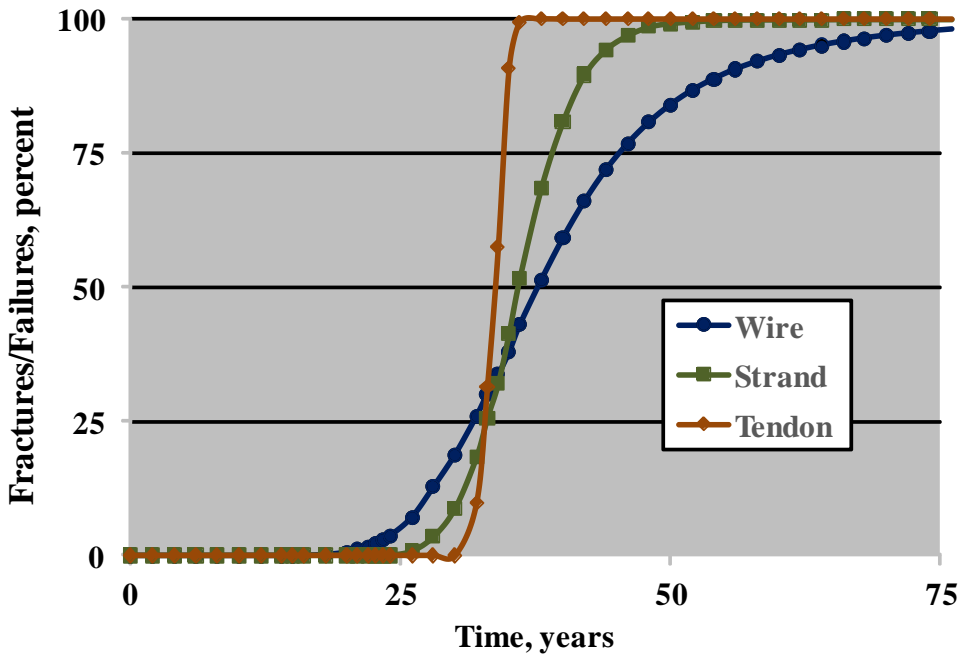
**Figure 69. Graph. Plot of the percentage of wire and strand fractures and tendon failures as a function of time based on a mean wire corrosion rate of 2.0 mpy and standard deviation 0.3 of the mean.**

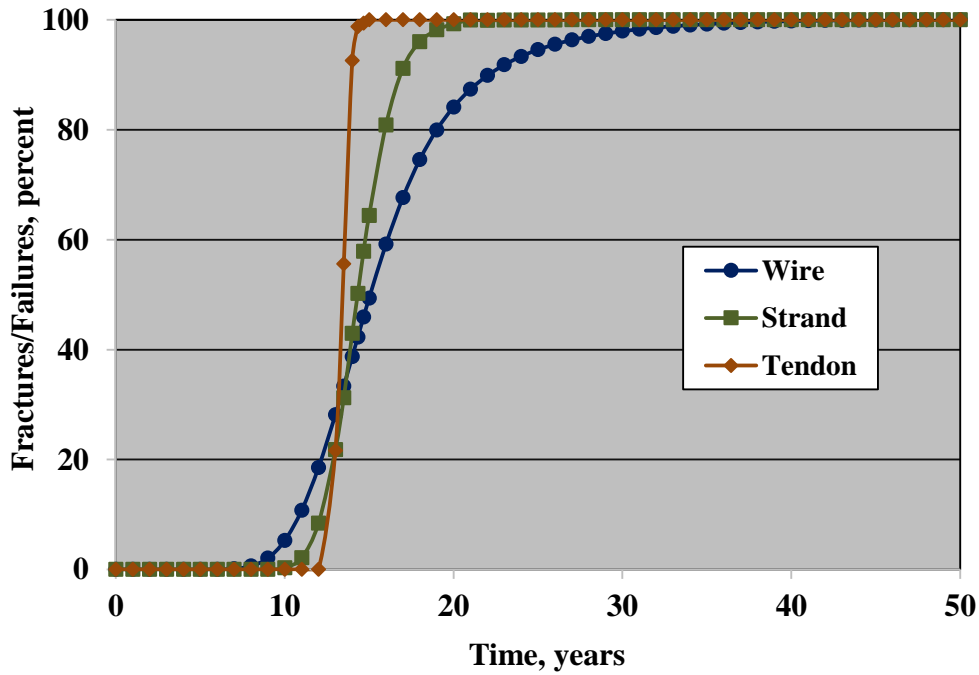
**Figure 72. Graph. Plot of the percentage of wire and strand fractures and tendon failures as a function of time based on a mean wire corrosion rate of 5.0 mpy and standard deviation 0.3 of the mean.**

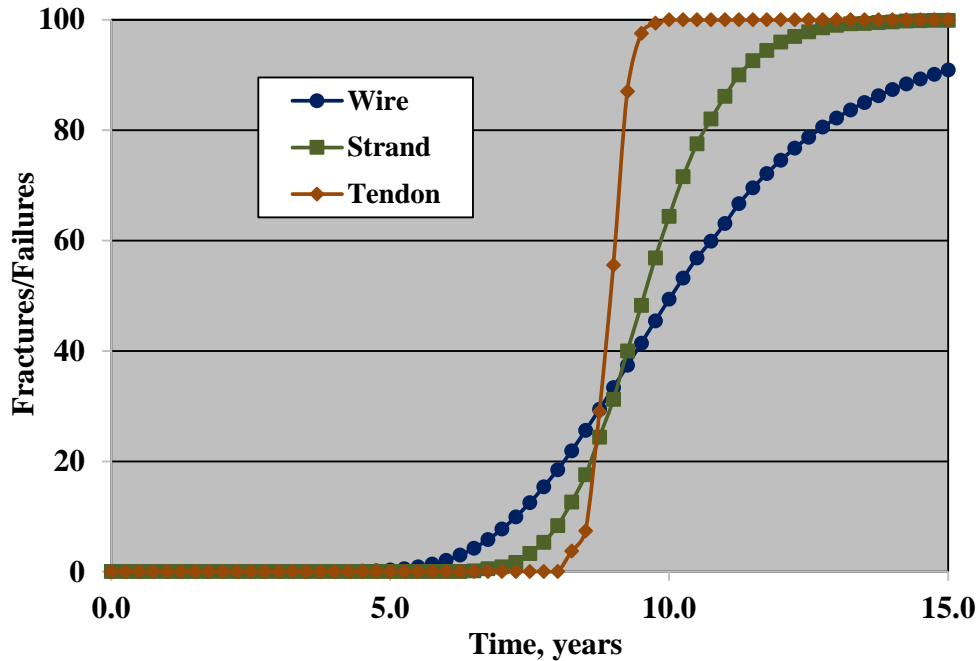
**Figure 73. Graph. Plot of the percentage of wire and strand fractures and tendon failures as a function of time based on a mean wire corrosion rate of 7.5 mpy and standard deviation 0.3 of the mean.**

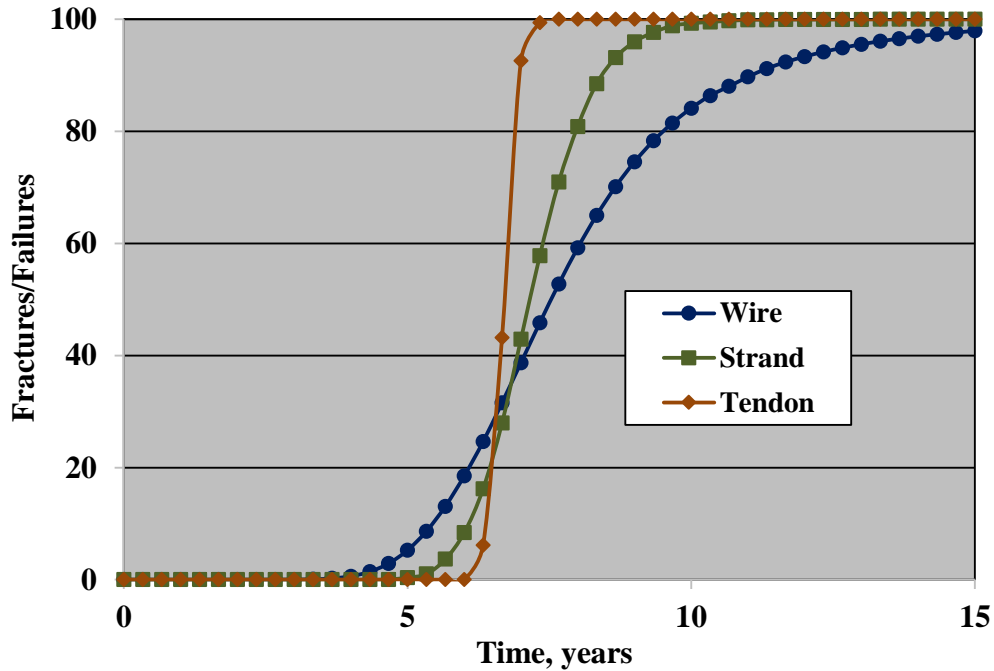
**Figure 74. Graph. Plot of the percentage of wire and strand fractures and tendon failures as a function of time based on a mean wire corrosion rate of 10.0 mpy and standard deviation 0.3 of the mean.**

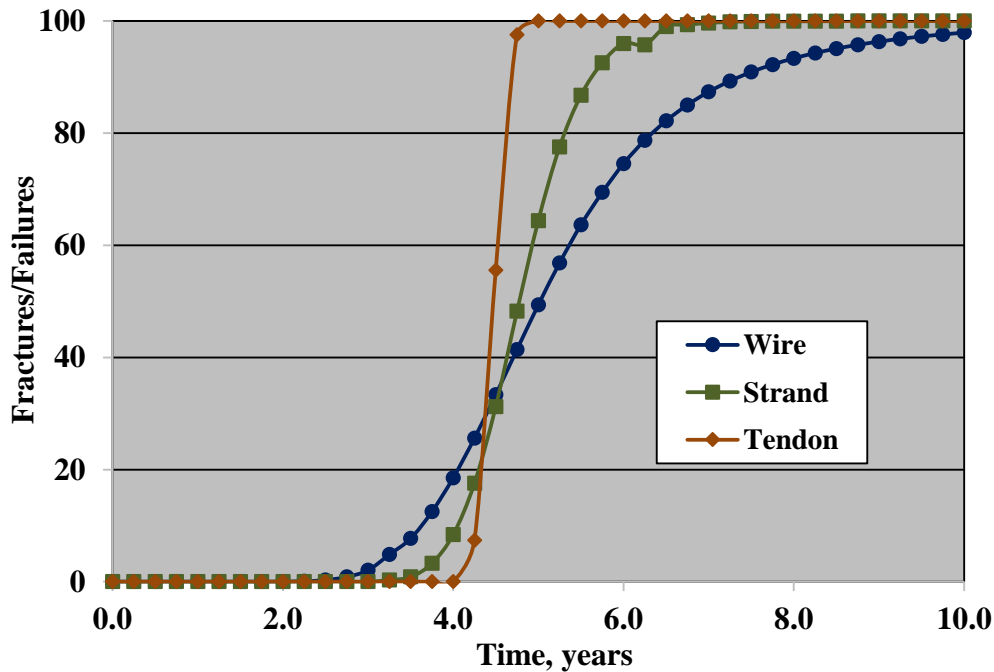
**Figure 75. Graph. Plot of the percentage of wire and strand fractures and tendon failures as a function of time based on a mean wire corrosion rate of 15.0 mpy and standard deviation 0.3 of the mean.**

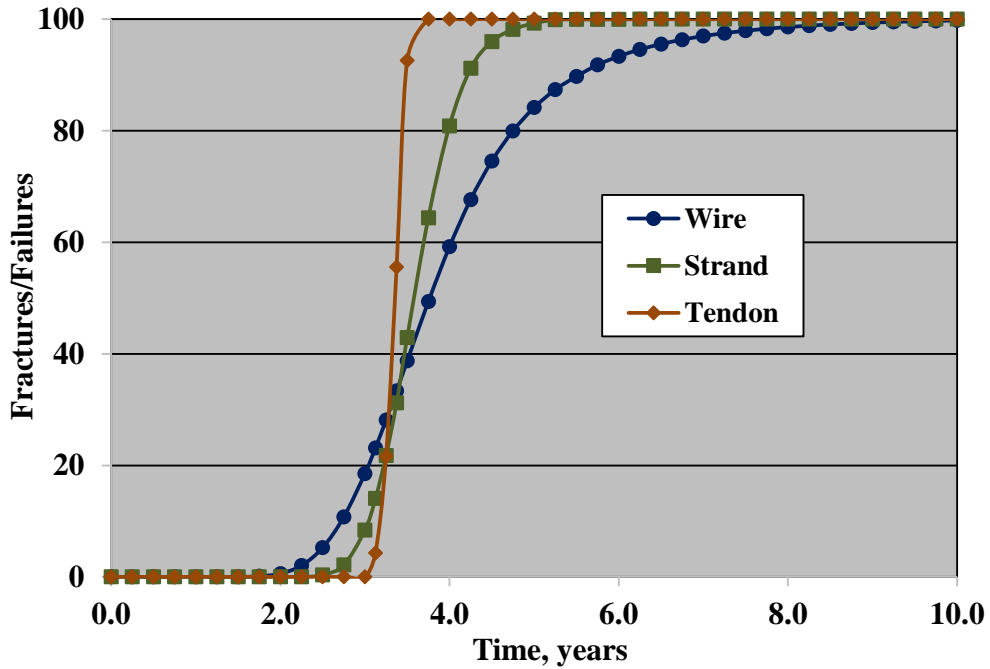
**Figure 76. Graph. Plot of the percentage of wire and strand fractures and tendon failures as a function of time based on a mean wire corrosion rate of 20.0 mpy and standard deviation 0.3 of the mean.**

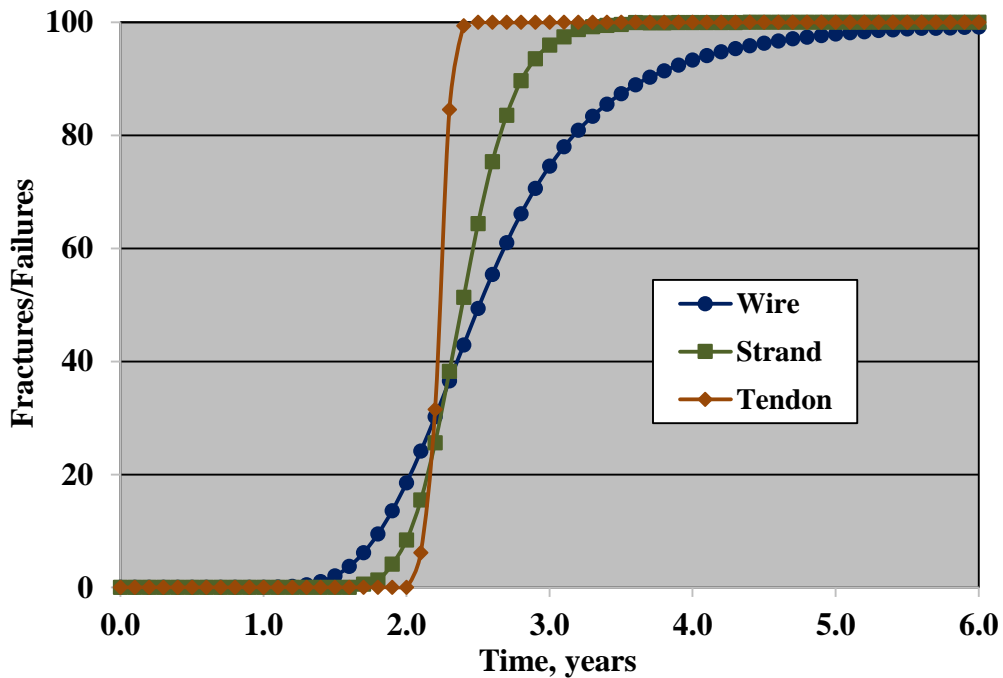
**Figure 77. Graph. Plot of the percentage of wire and strand fractures and tendon failures as a function of time based on a mean wire corrosion rate of 30.0 mpy and standard deviation 0.3 of the mean.**

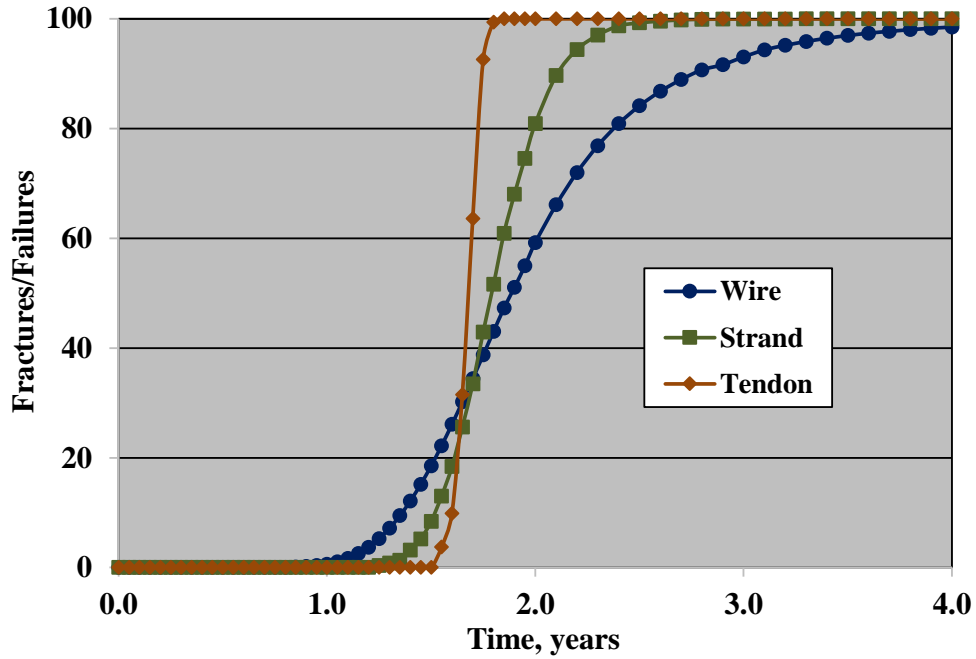
**Figure 78. Graph. Plot of the percentage of wire and strand fractures and tendon failures as a function of time based on a mean wire corrosion rate of 40.0 mpy and standard deviation 0.3 of the mean.**

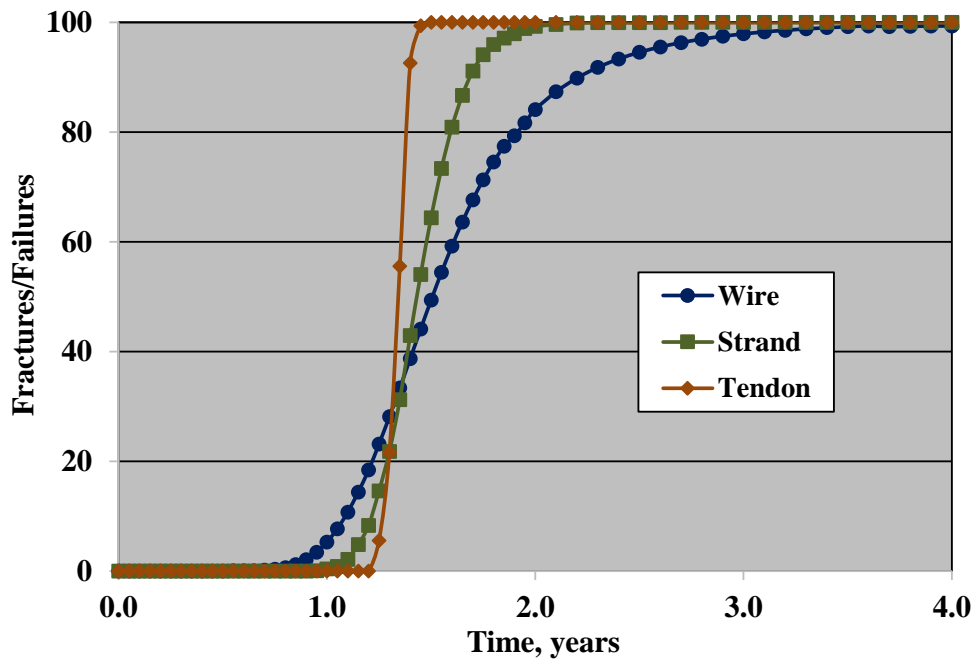
**Figure 79. Graph. Plot of the percentage of wire and strand fractures and tendon failures as a function of time based on a mean wire corrosion rate of 50.0 mpy and standard deviation 0.3 of the mean.**

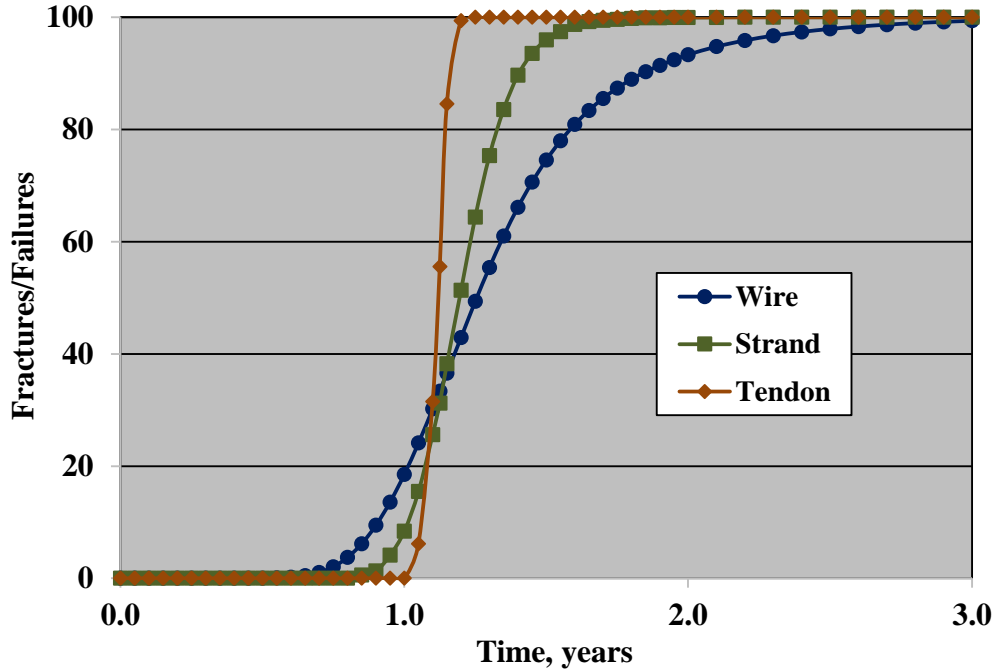
**Figure 80. Graph. Plot of the percentage of wire and strand fractures and tendon failures as a function of time based on a mean wire corrosion rate of 60.0 mpy and standard deviation 0.3 of the mean.**

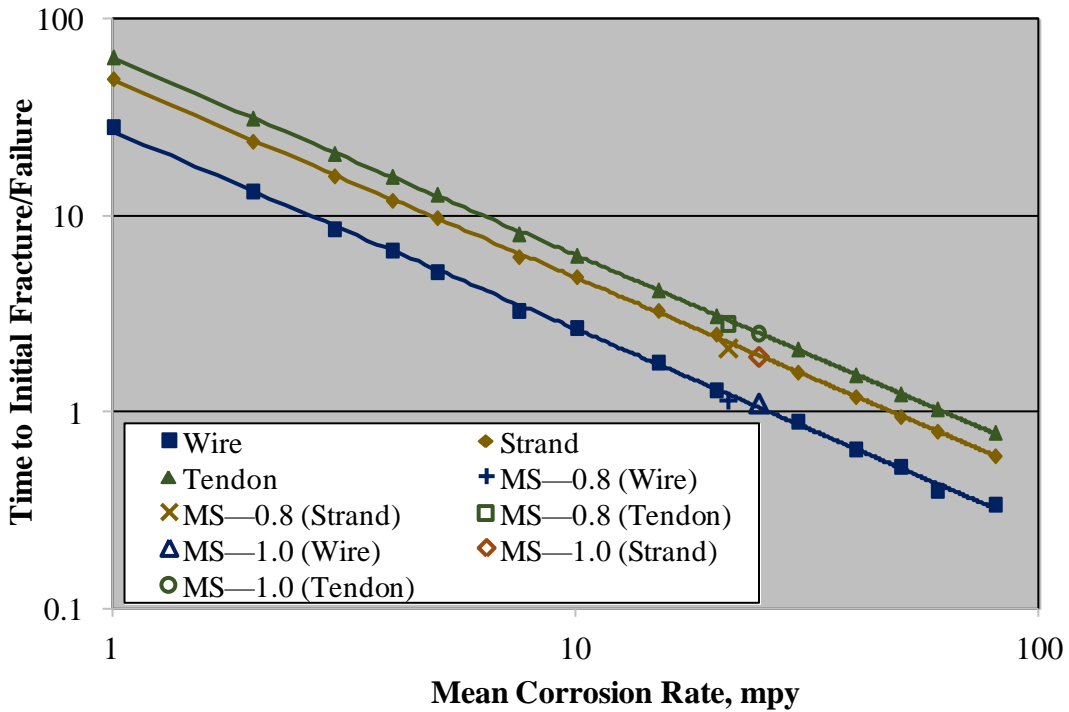
**Figure 82. Graph. Plot of  $T_f$  for wires, strands, and tendons as a function of corrosion rate as determined from the results in tables 10, 12, and 20-33.**

reproduces the three trend lines from figure 82 but with  $T_f$  data for Specimens MS-0.0, MS-0.4, and MS-2.0, which had relatively high soluble sulfates added.
