# Corrosion Forecasting and Failure Projection of Post-Tension Tendons in Deficient Cementitious Grout

PUBLICATION NO. FHWA-HRT-17-074

MAY 2018

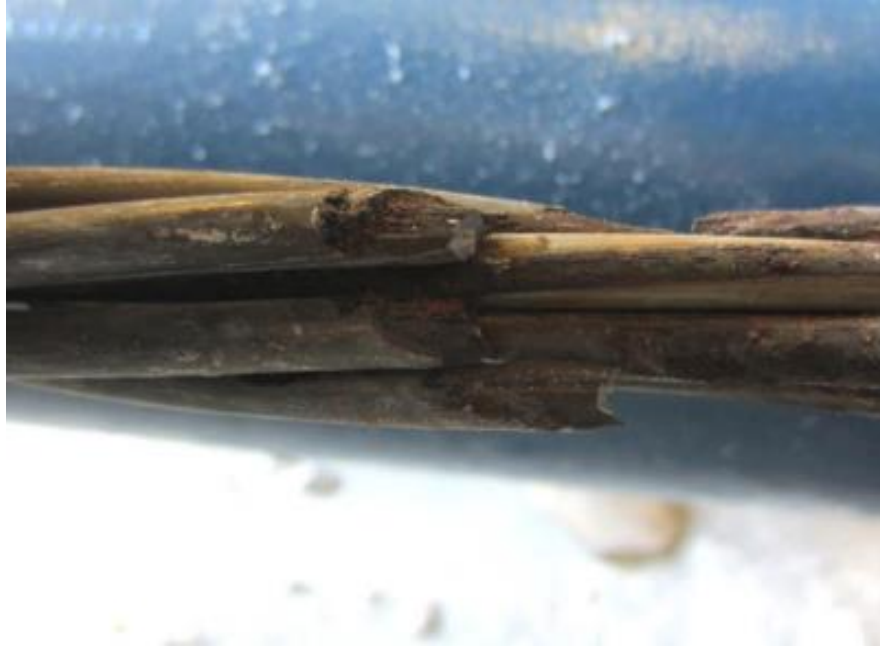
**Figure 88. Photo. Closeup view of the strand in figure 87 showing fractured wires.<sup>(1)</sup>**

Two opportunities arose whereby a degree of validation for the proposed fracture/failure methodology could be made. One occurred in conjunction with detensioning of Specimen Number MS-0.4, during which three wires on one strand fractured near the void/grout interface. Figure 88 reproduces figure 219 from the phase 1 report and shows this strand, where the red arrow identifies the three broken wires, and gray arrows point to black, sulfate-rich deposits. Further, figure 88 reproduces figure 220 from that report, showing a closeup view of the strand with fractured wires. Although the wire fractures were triggered by the detensioning activities, it is likely that they were on the verge of occurring irrespective of this. Consequently,  $T_f$  for these was taken as 0.60 yr (detensioning took place after 178 d, or 0.49 yr), considering that they would have remained unfractured for slightly longer than was actually the case.

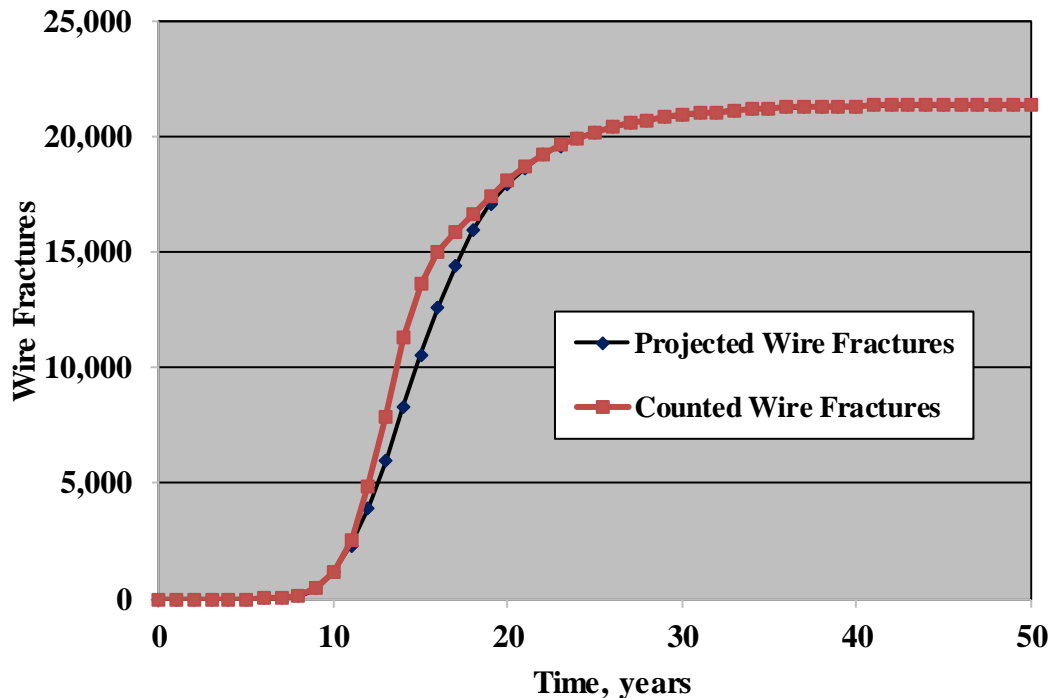
**Figure 89. Graph. Plot of the number of both model projected and actual count wire fractures versus time for  $\mu(CRE) = 5.0$  mpy and  $\sigma(CRE) = 0.5$  of the mean.**

It should be recognized that the actual number of wire and strand fractures can differ from projection because the model does not count wires that fracture because of strand overload and, likewise, strands that fracture because of tendon overload. Thus, as noted above, strands fracture when three wires exhibit sufficient corrosion that they fracture, leading to seven fractures total but with only three projected by the model. Likewise, tendons fail on 7 strand fractures; however, this results in fracture of all 22 strands, even though only 7 fractures are projected by the model. Where this might become an issue is if all fractured wires or strands (or both) are being counted in one or more failed tendons with expectation that these should conform to model projections. Figure 89 plots the number of projected wire fractures versus time compared to the total number of such fractures that should be present. Likewise, figure 90 does the same for strands. In both cases,  $\mu(CRE) = 5.0$  mpy and  $\sigma(CRE) = 0.5$  of the mean. The plots demonstrate that any assessment of wire and strand fractures in tendons for the purpose of verifying model projections must take the above considerations into account.

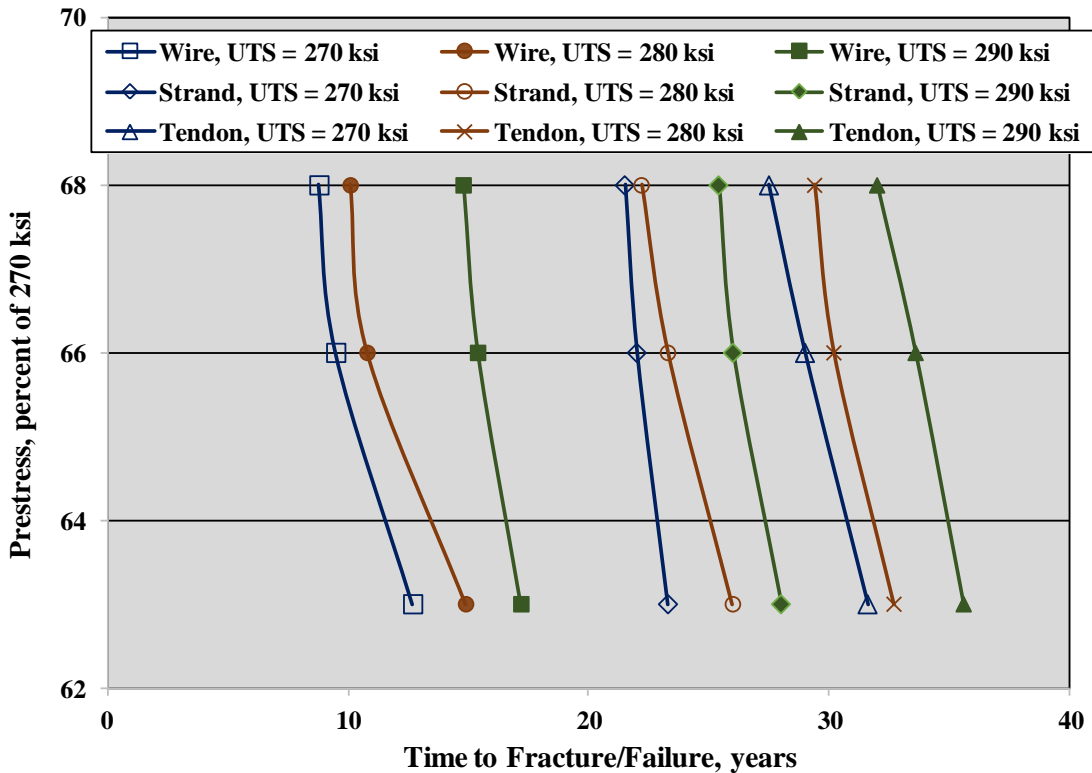
**Figure 92. Graph. Plot of  $T_f$  for wires, strands, and tendons as a function of post-tension stress and wire/strand strength for mean corrosion rates of 2.0 mpy and standard deviation 0.3 of the mean.**

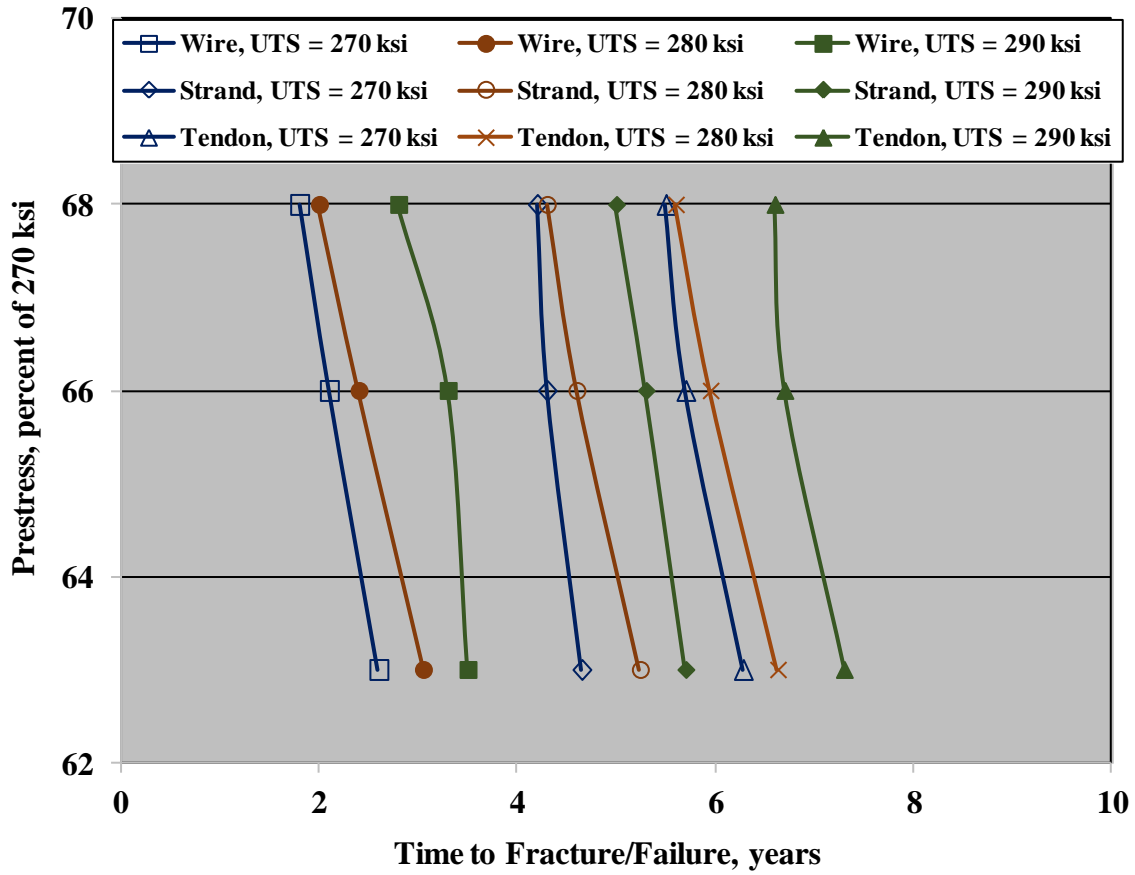
**Figure 93. Graph. Plot of  $T_f$  for wires, strands, and tendons as a function of post-tension stress and wire/strand strength for mean corrosion rates of 10.0 mpy and standard deviation 0.3 of the mean.**

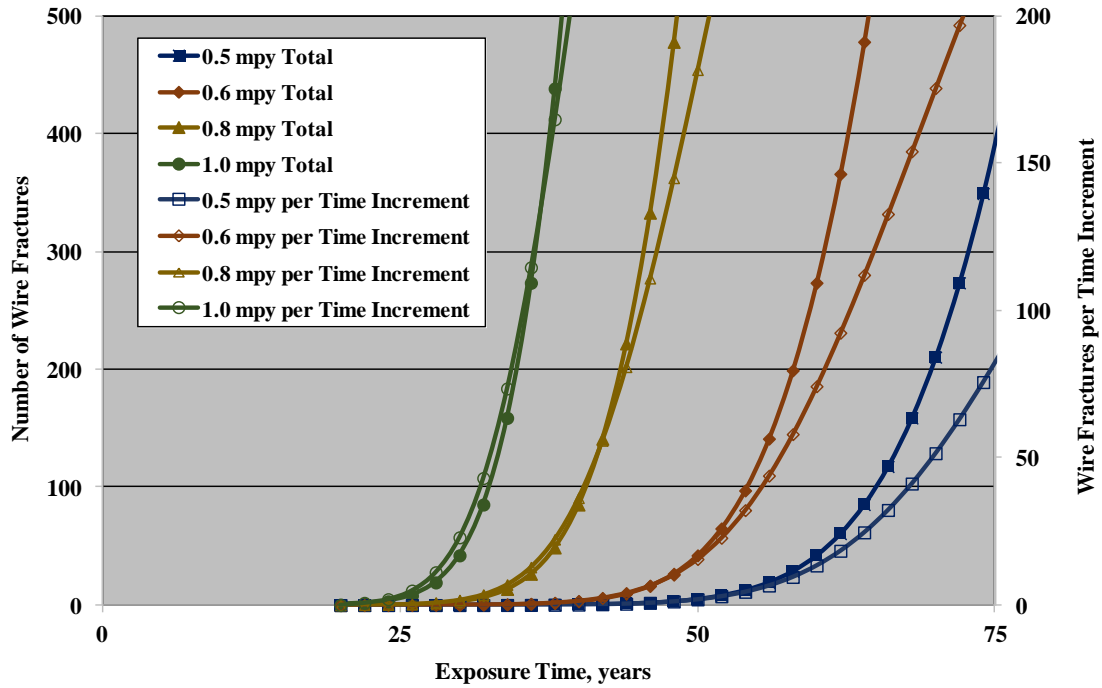
**Figure 99. Graph. Number of wire fractures and number per time increment versus time for  $\mu(CRE) = 0.5, 0.6, 0.8,$  and  $1.0$  mpy and  $\sigma(CRE)/\mu(CRE) = 0.5$ .**

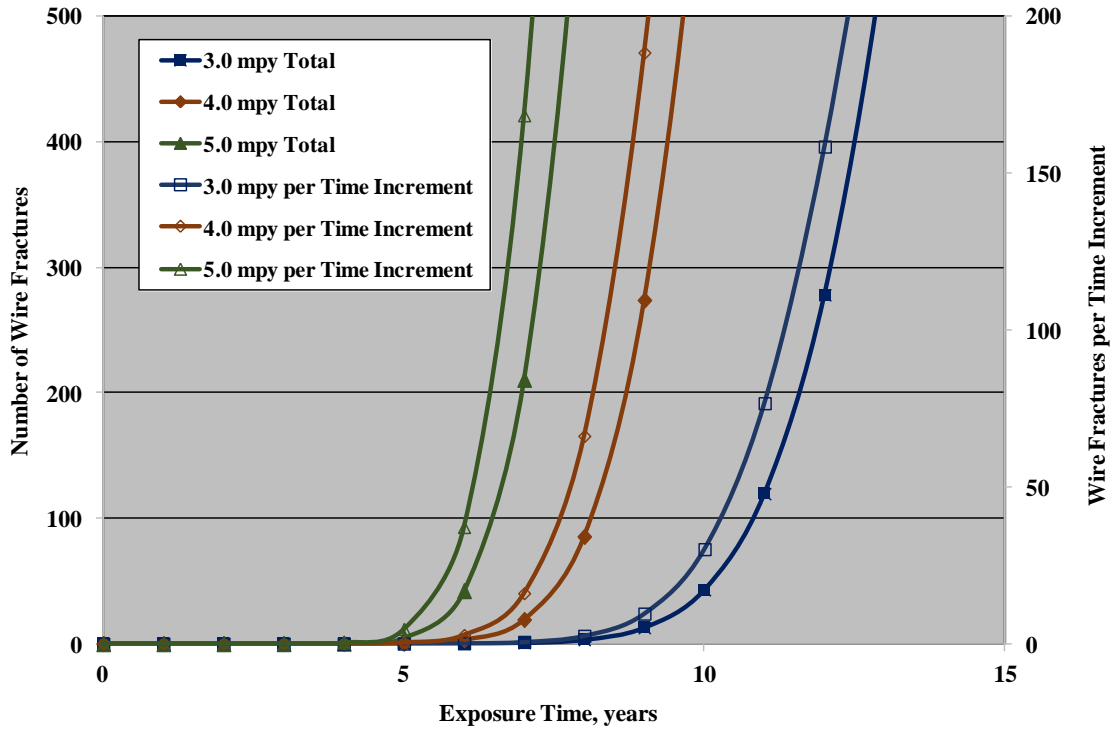
**Figure 101. Graph. Number of wire fractures and number per time increment versus time for  $\mu(CRE) = 3.0, 4.0,$  and  $5.0$  mpy and  $\sigma(CRE)/\mu(CRE) = 0.5$ .**

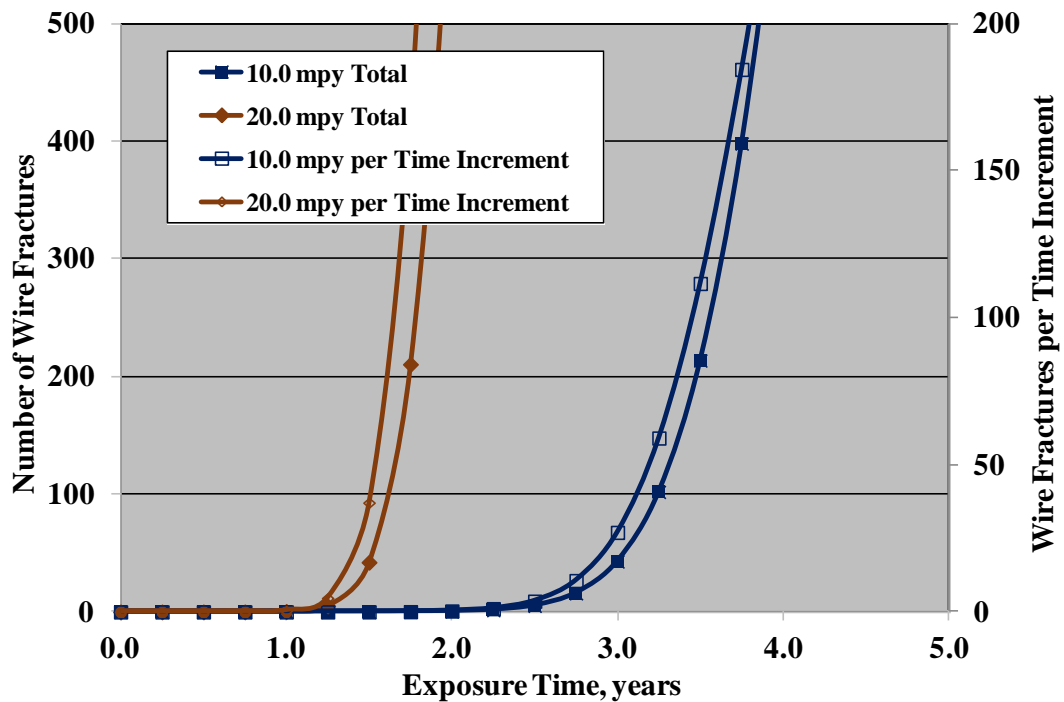
**Figure 103. Graph. Number of wire fractures and number per time increment versus time for  $\mu(CRE) = 10.0$  and  $20.0$  mpy and  $\sigma(CRE)/\mu(CRE) = 0.5$ .**

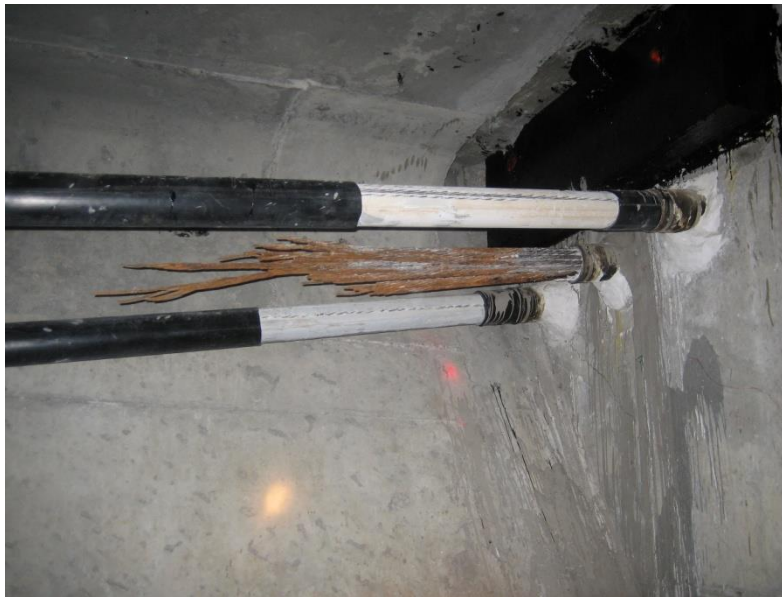
**Figure 137. Photo. Photograph of a failed tendon on the Varina-Enon Bridge.**

As noted above, a failed tendon was disclosed on this bridge in 2007, some 17 yr after construction. Figure 137 shows a photograph of this tendon. In response to this, an NDE of selected tendons was performed using the permanent magnet-type magnetic main flux method (MMFM) for the purpose of identifying tendons containing corrosion damage. It was determined that this particular MMFM can detect as little as 1.5-percent section loss. Figure 138 shows the MMFM device mounted on a tendon, and figure 139 shows the MMFM testing on this bridge.

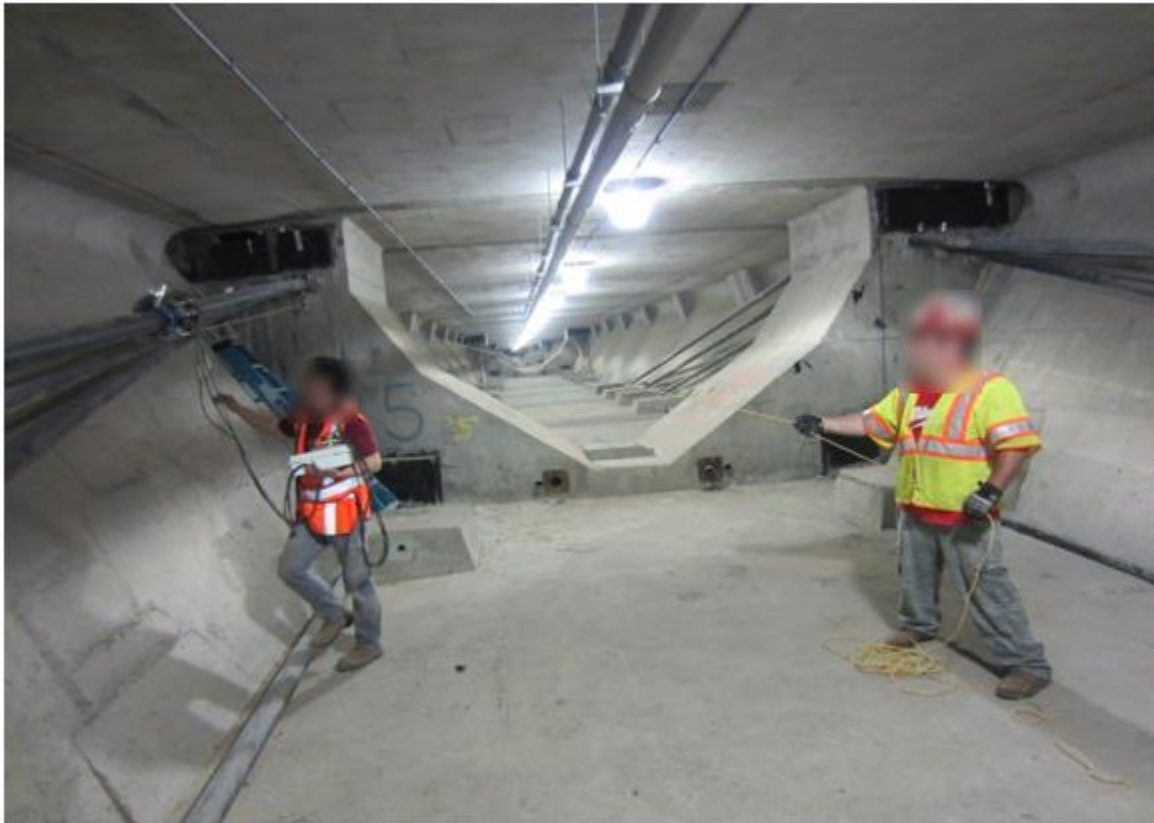
**Figure 139. Photo. MMFM field testing.**

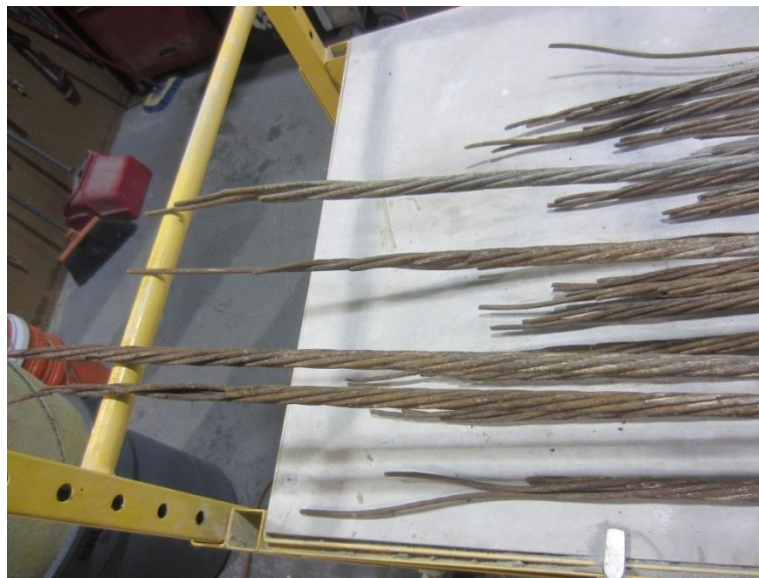
**Figure 142. Photo. Selected strand samples.**

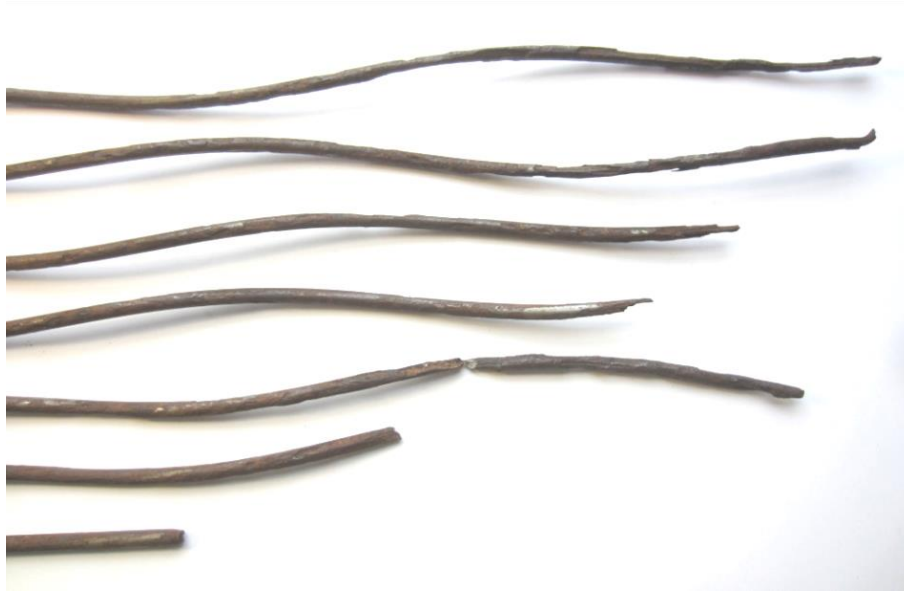
**Figure 143. Photo. Cleaned strand sample exhibiting the worst corrosion damage.**

A total of 367 pit depth measurements were made on 48 wires. Table 108 summarizes statistics of the pit depth data. The diameter of the intact outer wires was 198 mils, and the measured deepest pit was 162.5 mils, which is equivalent to a corrosion rate of 21.5 mpy considering a 7.5-yr

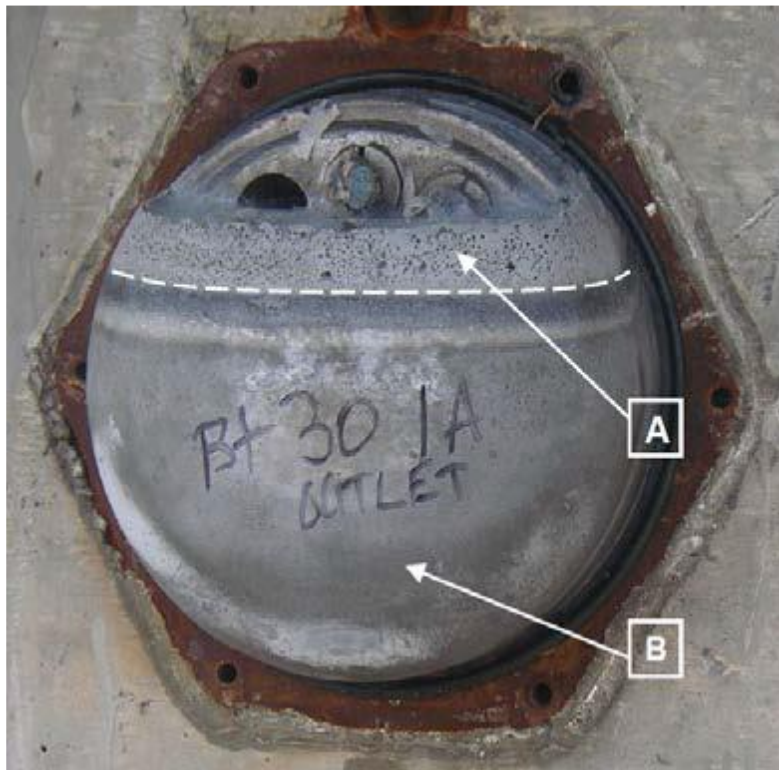
**Figure 144. Photo. Anchorage region of a tendon from the Carbon Plant Road Bridge subsequent to endcap removal. Part A was soft, segregated, and wet grout, and part B was gray, hardened, and dry grout.<sup>(15)</sup>**
