Report No. K-TRAN: KSU-02-4  
FINAL REPORT

## **OPERATIONAL PERFORMANCE OF KANSAS ROUNDBOUTS: PHASE II**

Eugene R. Russell  
Srinivas Mandavilli  
Margaret J. Rys

Kansas State University  
Manhattan, Kansas

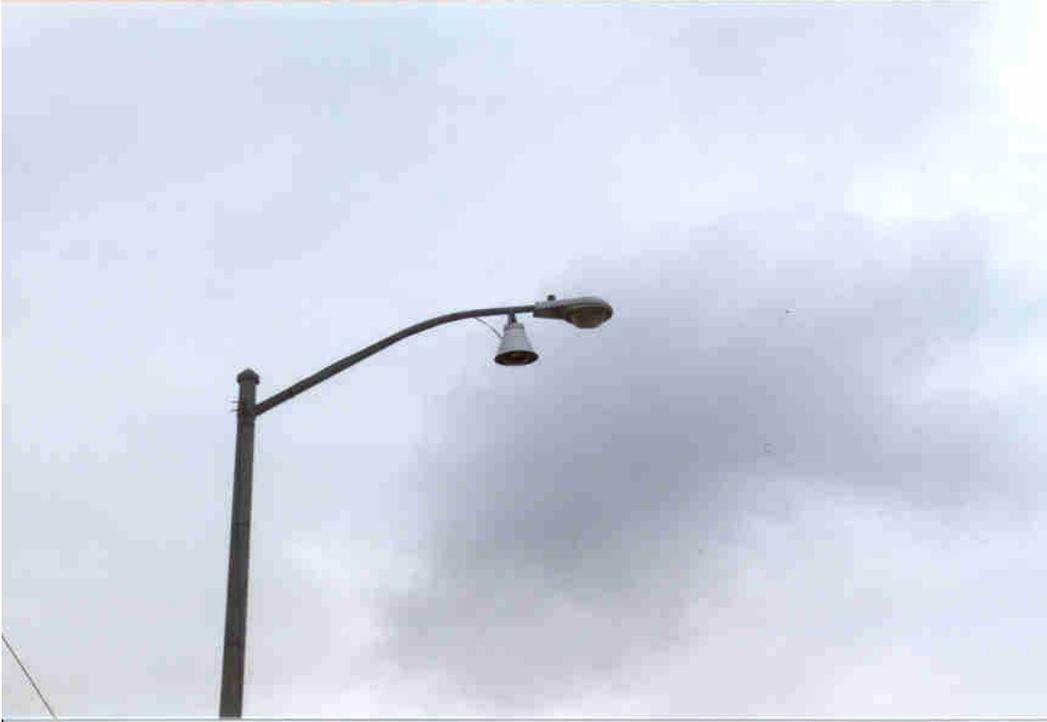
**FIGURE 4.1: Camera Mounted on a Lamp Pole**  
(Photo courtesy: Dr. Russell)

The benefit of using this method for data collection is that all the data is recorded on videotapes and can be accessed and retrieved at a later time. Also, the tapes serve as a permanent record for verification of data. A specially designed 360°-omni directional, video camera and videocassette recorder were used for data collection at each location. The camera was designed by Intelligent Highway systems, Inc., (White Plains, NY). The camera was designed to provide a full 360° view when mounted above the intersection.

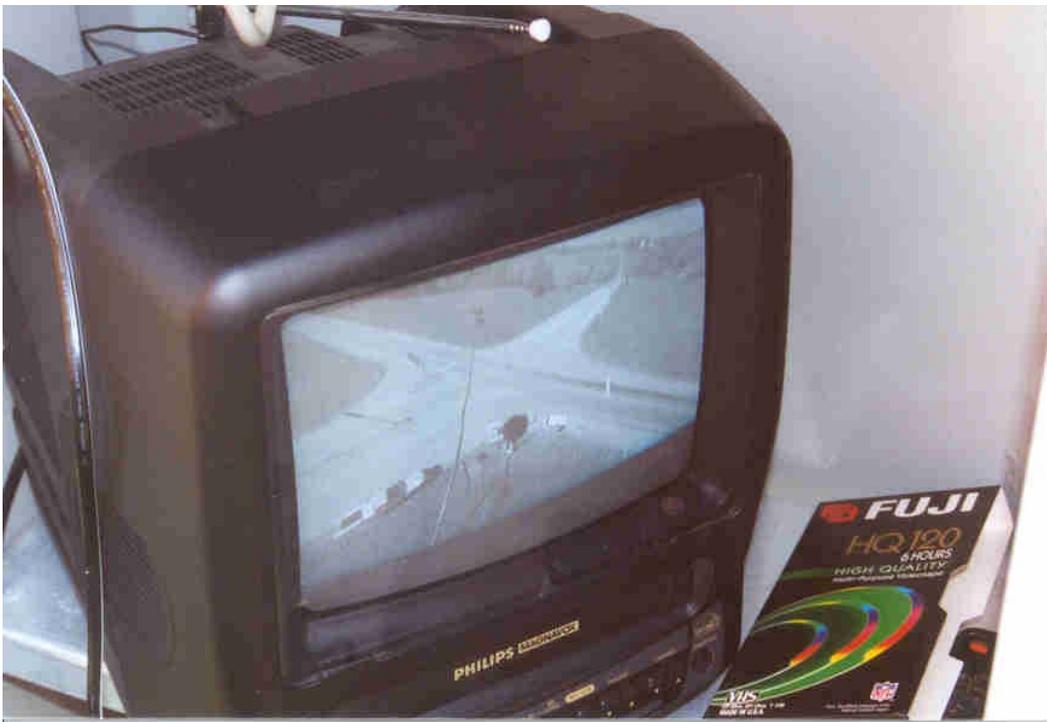
**FIGURE 4.2: TV/VCR Used for Recording**  
(Photo courtesy: Dr. Russell)

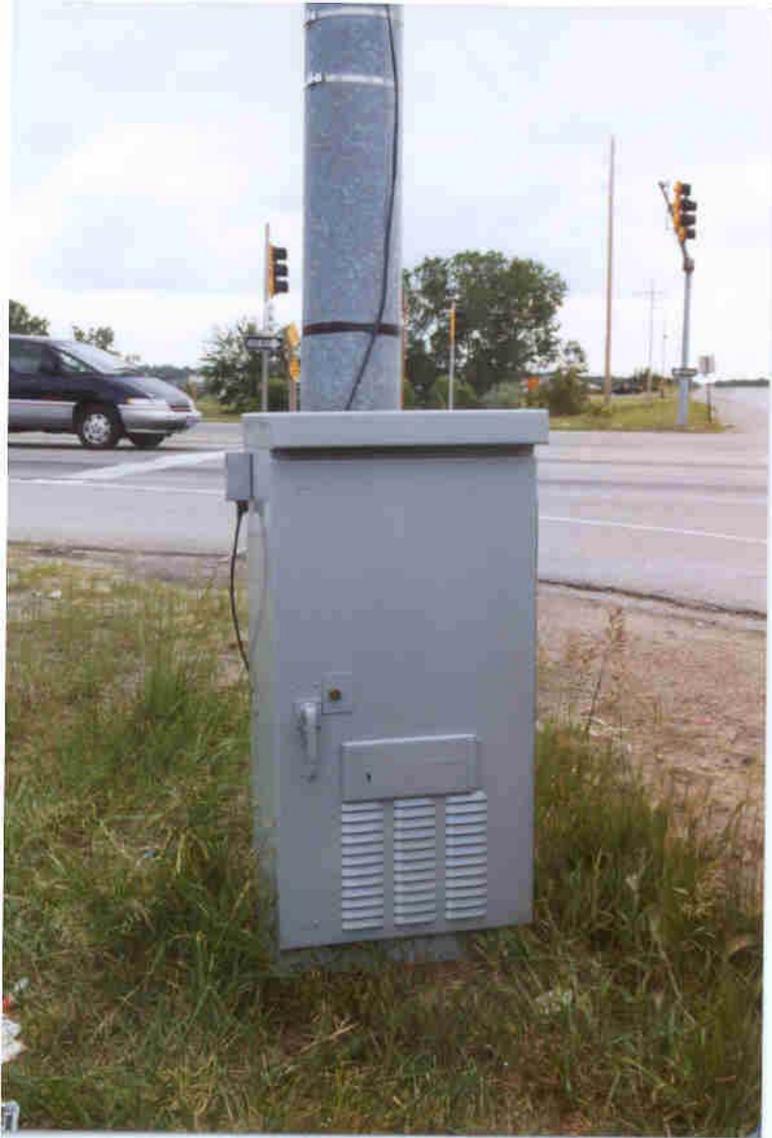
**FIGURE 4.3: VCR/TV Signal Steel Cabinet**  
(Photo courtesy: Dr. Russell)

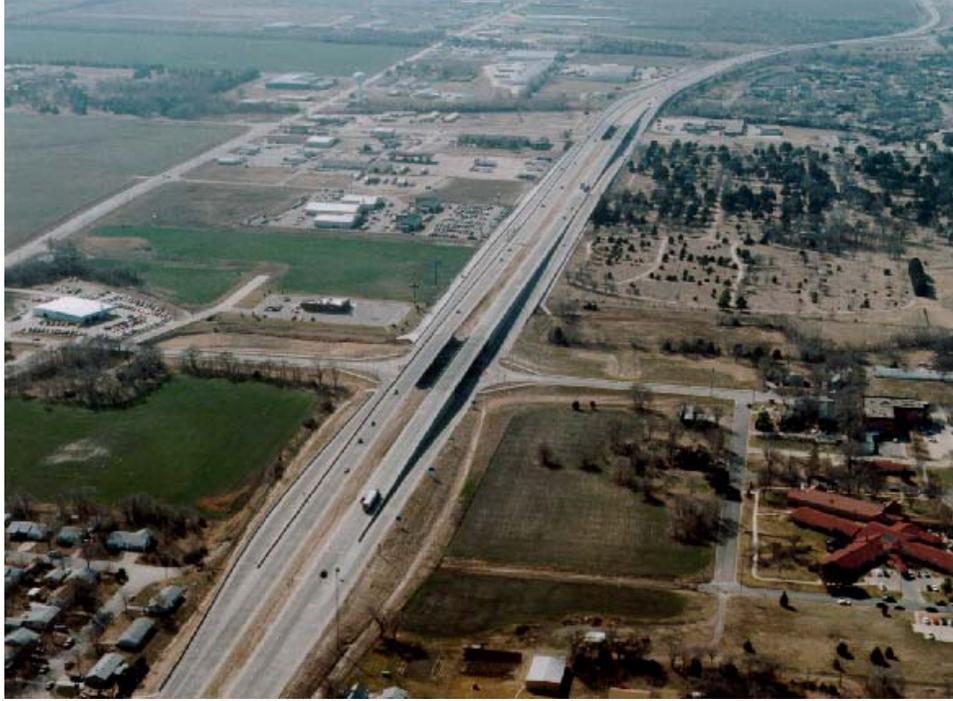
**FIGURE 6.33: Proposed Intersection Alternative 1: Roundabout**  
(Source: KDOT)

See Figures 6.33 for a sketch of the proposed grade changes with a roundabout and Figure 6.34 for an artistic sketch of the assumed signal alternative used, for the before condition at the two Newton intersections.

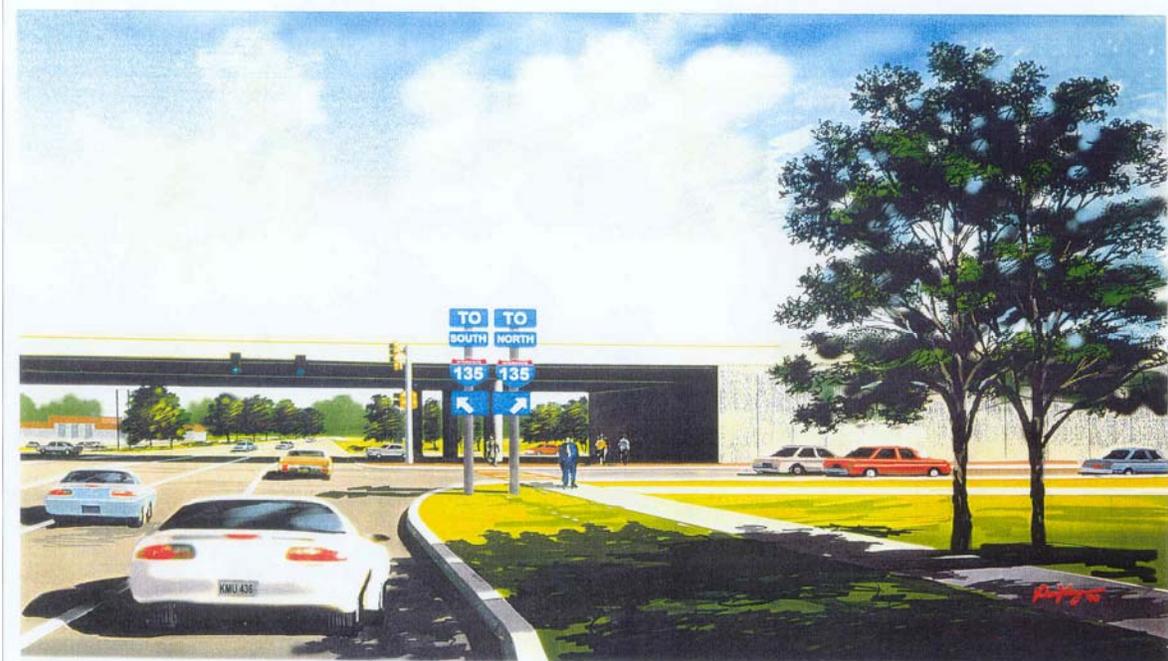
**FIGURE 6.34: Proposed Intersection Alternative 2: Traffic Signal**  
(Artist Sketch, source KDOT)

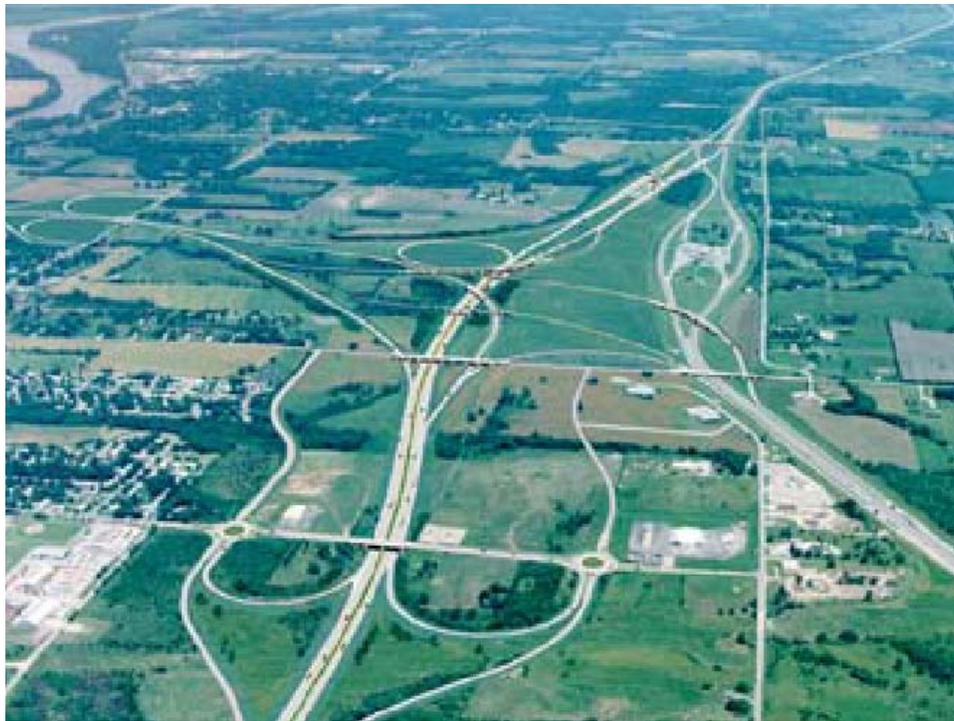
**FIGURE 6.38: Aerial View of the Realigned Interstate 70 (I-70) and Rice Road Intersection Roundabouts**  
(Source KDOT)

Figure 6.38 shows the aerial view of the roundabouts.

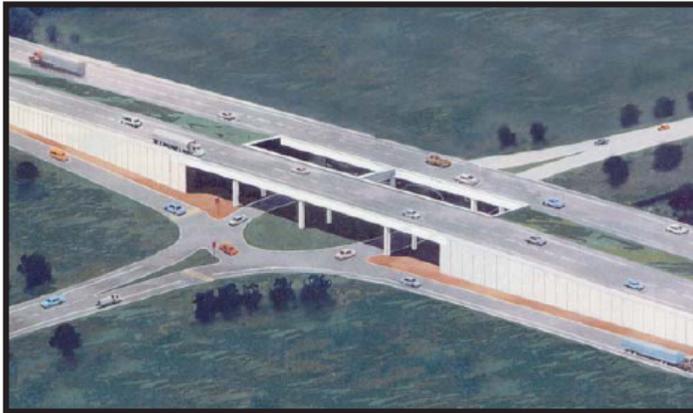
**FIGURE 6.49: Figure Showing US-75 and NW 46<sup>th</sup> Street in After Condition**  
(Artist sketch provided by KDOT)

- **Geometric parameters - After condition:** The roundabout has a circulating lane width ( $W_c$ ) of 16 feet (5m) on a flat terrain (zero gradient on all the approaches). During the study there was one circulating lane. The lane width is 12 feet (3.7 m). See Figures 6.48 for detailed drawing of the roundabout and 6.49 for artist sketch. See Figure 6.50 for hourly turning movements.

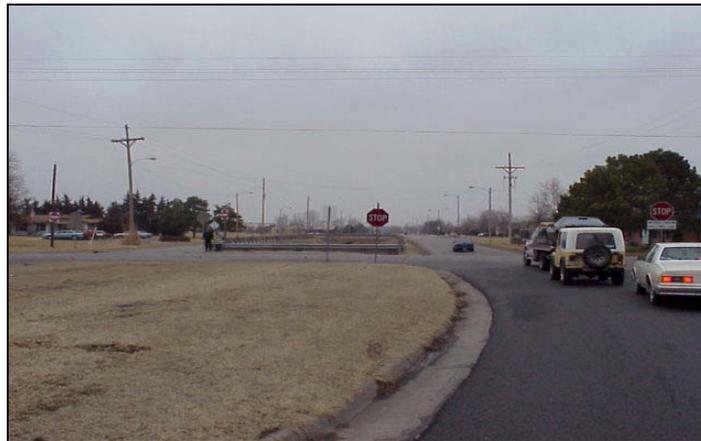
**FIGURE 6.53 Two-Way Stop Control at 23<sup>rd</sup> Avenue and Severance Street**

- **Geometric parameters - Before condition:** Severance Street (N-S) has lane widths of 4.2 m (14 feet) and a 10.5 m (35 feet) median (drainage ditch) on both the approaches (see Figure 4.1). The major street, 23<sup>rd</sup> Avenue (E-W) has 3.6 m (12 feet) lane widths on the 23<sup>rd</sup> Avenue (E-W) with no median (see Figure 6.53). All the approaches are single lane. The posted speed limit is 48 km/h (30 mph) on all the approaches. Spot speeds obtained during a site visit indicated that the operating speeds on the approaches was 52 km/h (32 mph) on 23<sup>rd</sup> Avenue (E-W) and 61 km/h (38 mph) on Severance Street (N-S).
