# EVALUATION OF PAVEMENT PERFORMANCE ON DEL 23

Shad Sargand and staff

Prepared in cooperation with the  
Ohio Department of Transportation  
Office of Research and Development

State Job Number 14768(0)

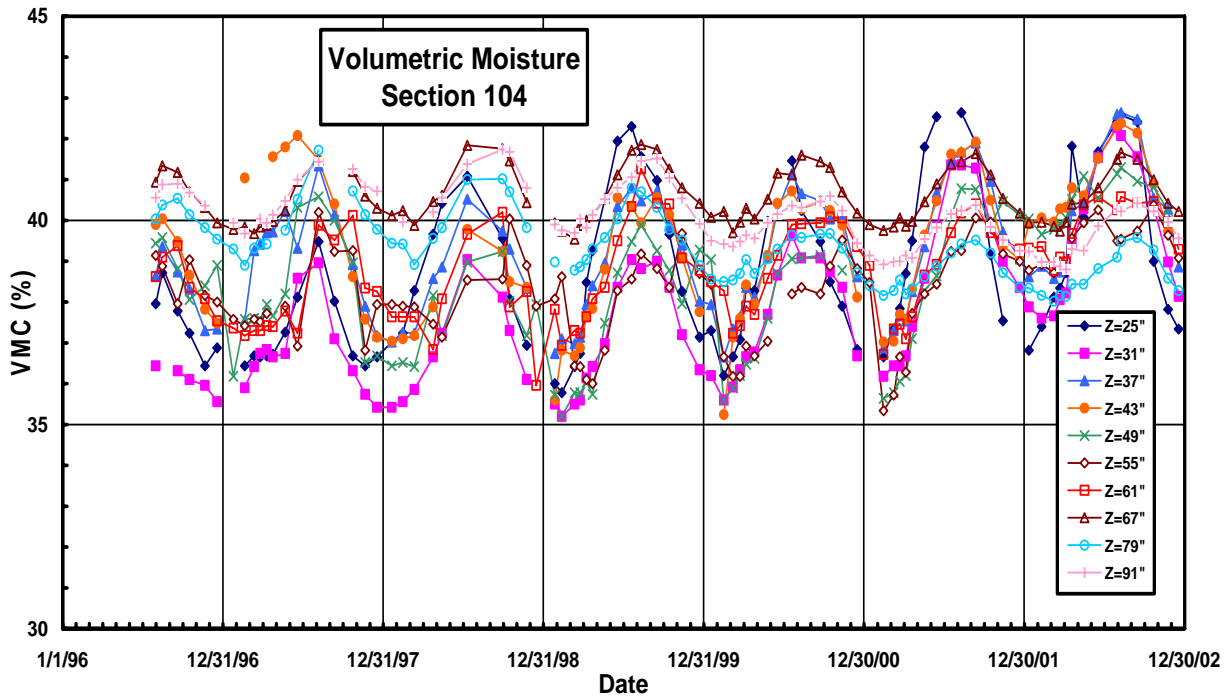
**Figure 2.2 - Seasonal Changes in Volumetric Moisture - Section 104**

Figure 2.2 shows subsurface moisture plotted over time in Section 104, and Figure 2.3 shows vertical moisture profiles on two dates representing periods of high and low moisture, and the average profile for all dates. Figures 2.4 and 2.5 show comparable data for Section 108. In general, Section 104, which is located in the southern half of the project, was wetter than Section 108, which is in the northern half of the project. Both sections show clear seasonal oscillations in moisture, but the TDRs in Section 104 ranged between 35 - 43%, while those in the Section 108 subgrade were lower at 22 - 40%. The top TDR in Section 108, located 15" below the pavement surface and mid-depth in the DGAB layer, ranged from 15-22%. TDRs at depths of 33-57" in Section 108 increased gradually over a three-year period after the test road was opened to traffic in August 1996. The vertical moisture gradients in Figures 2.3 and 2.5 illustrate that, while the moisture content may vary, the shape of the moisture profiles at each location tended to remain relatively constant over time. While moisture levels vary from section to section, there does appear to be a trend of maximum moisture occurring in July and August, and minimum moisture occurring in January and February.

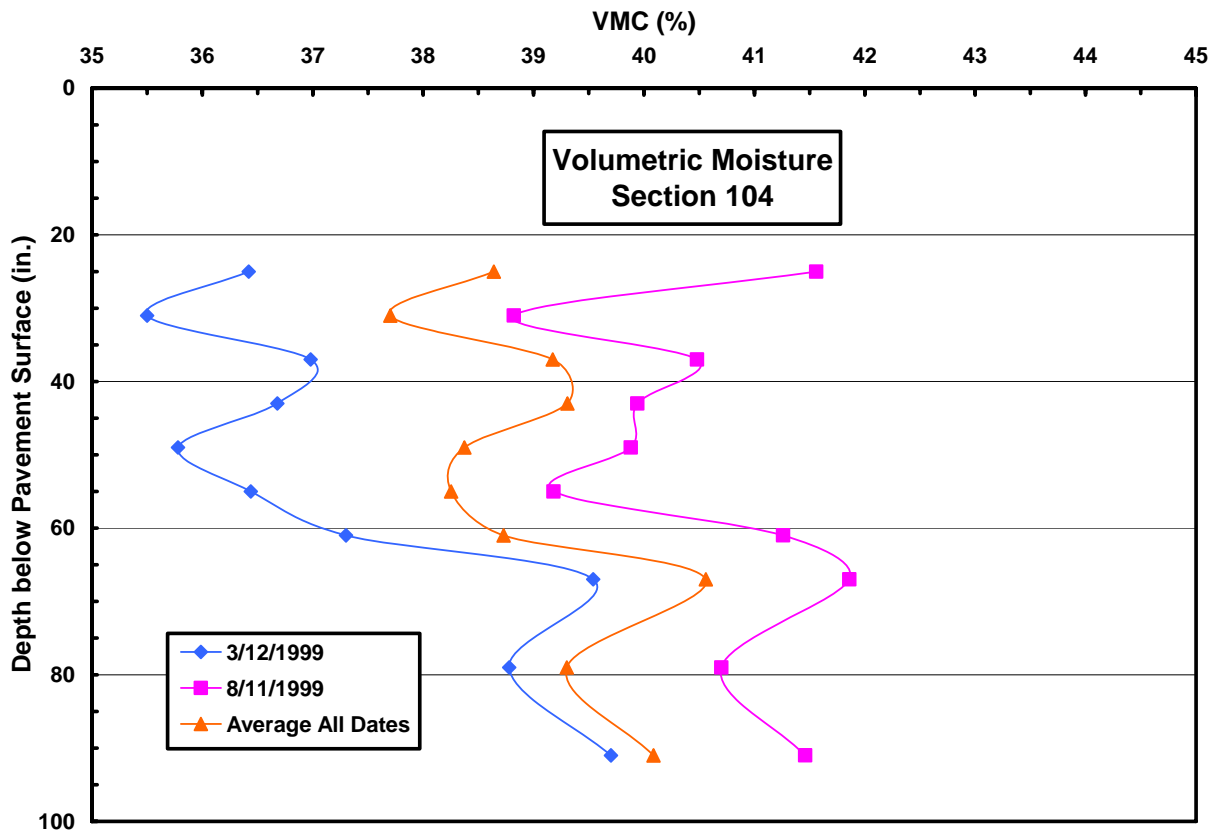
**Figure 2.3 – Volumetric Moisture Profiles in Sections 104**

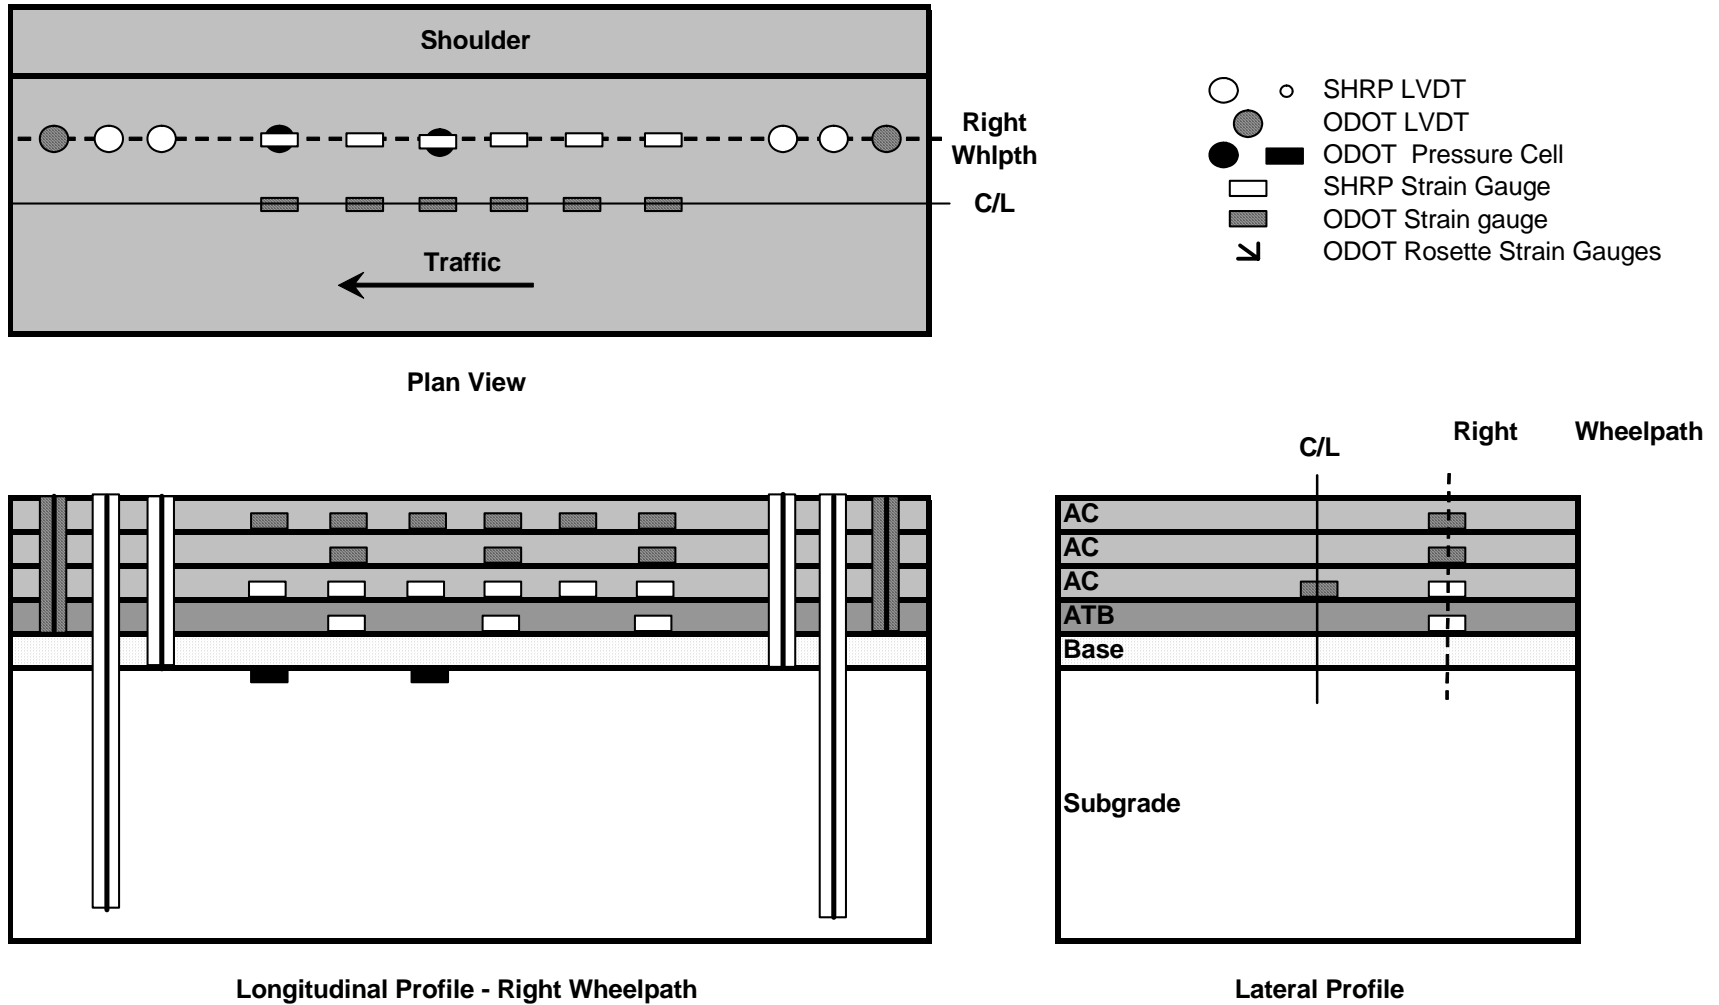
## Dynamic Sensor Locations in AC Pavement Sections

Figure 2.8 - Typical Instrumentation Placed in AC Pavement Sections

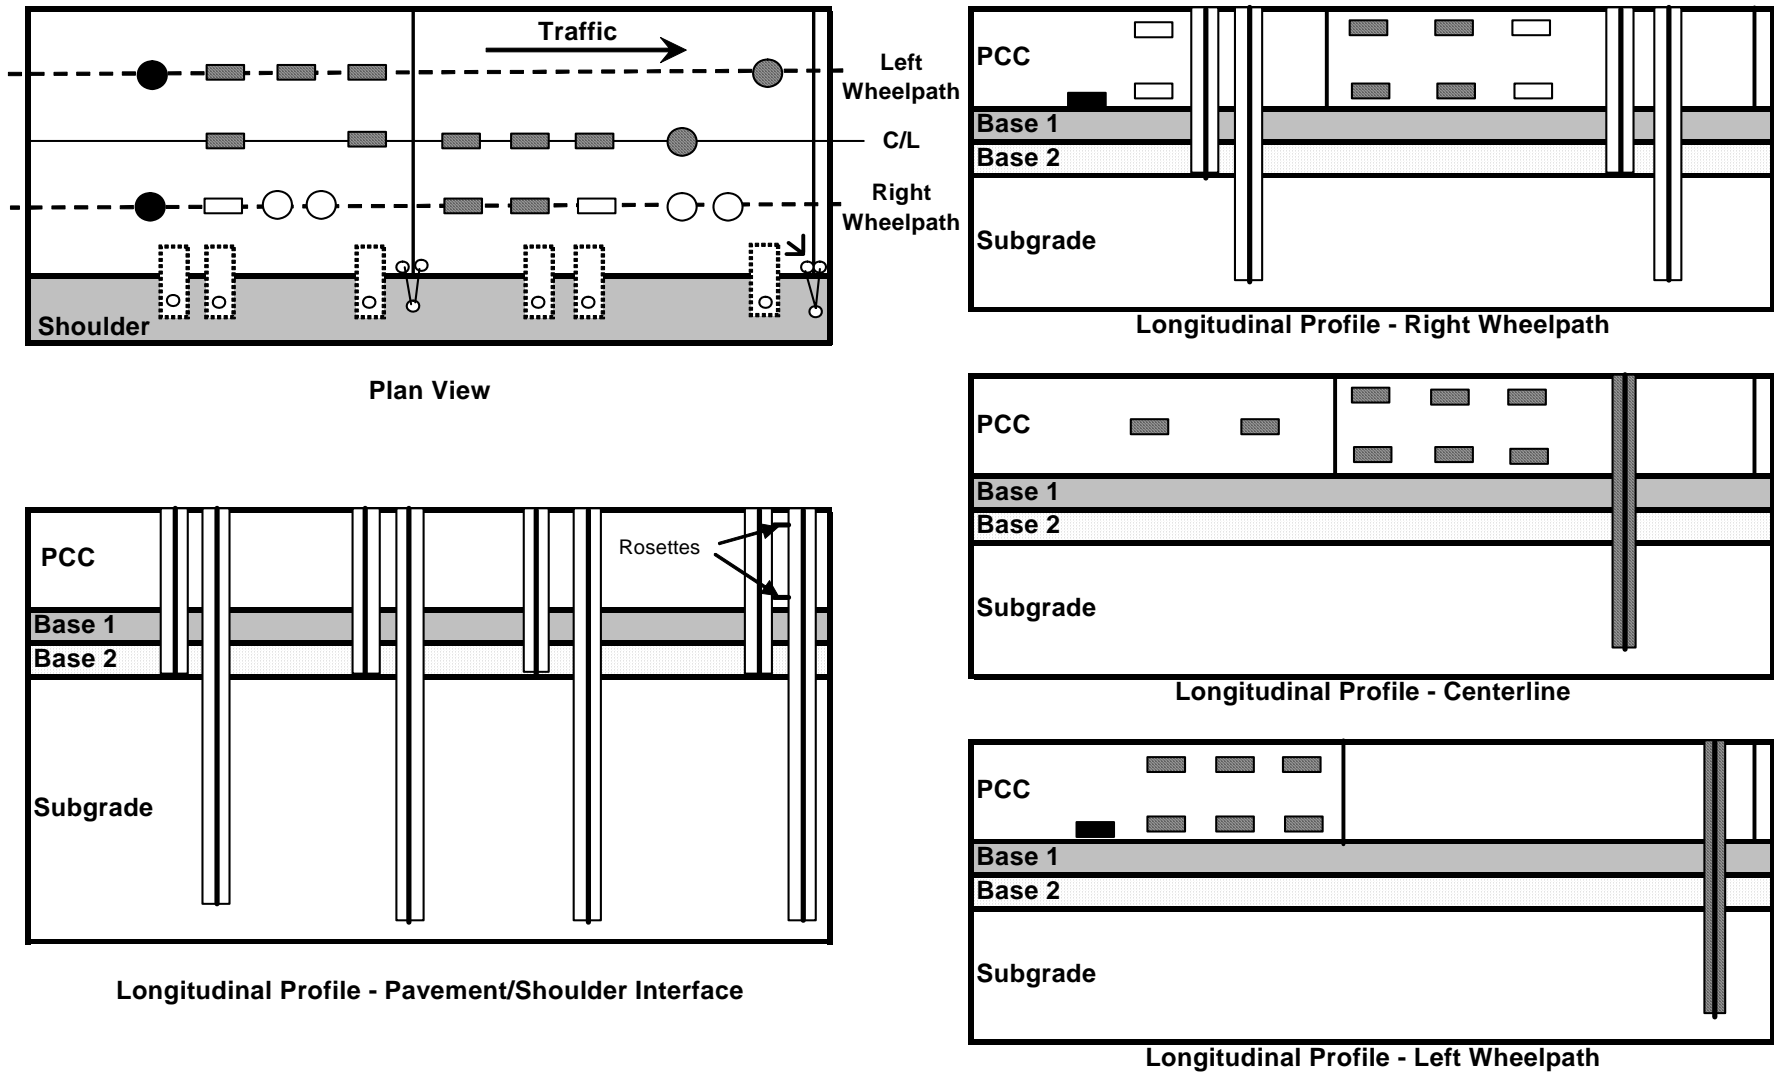
## Dynamic Sensor Locations in PCC Pavement Sections

Figure 2.9 - Typical Instrumentation Placed in PCC Pavement Sections

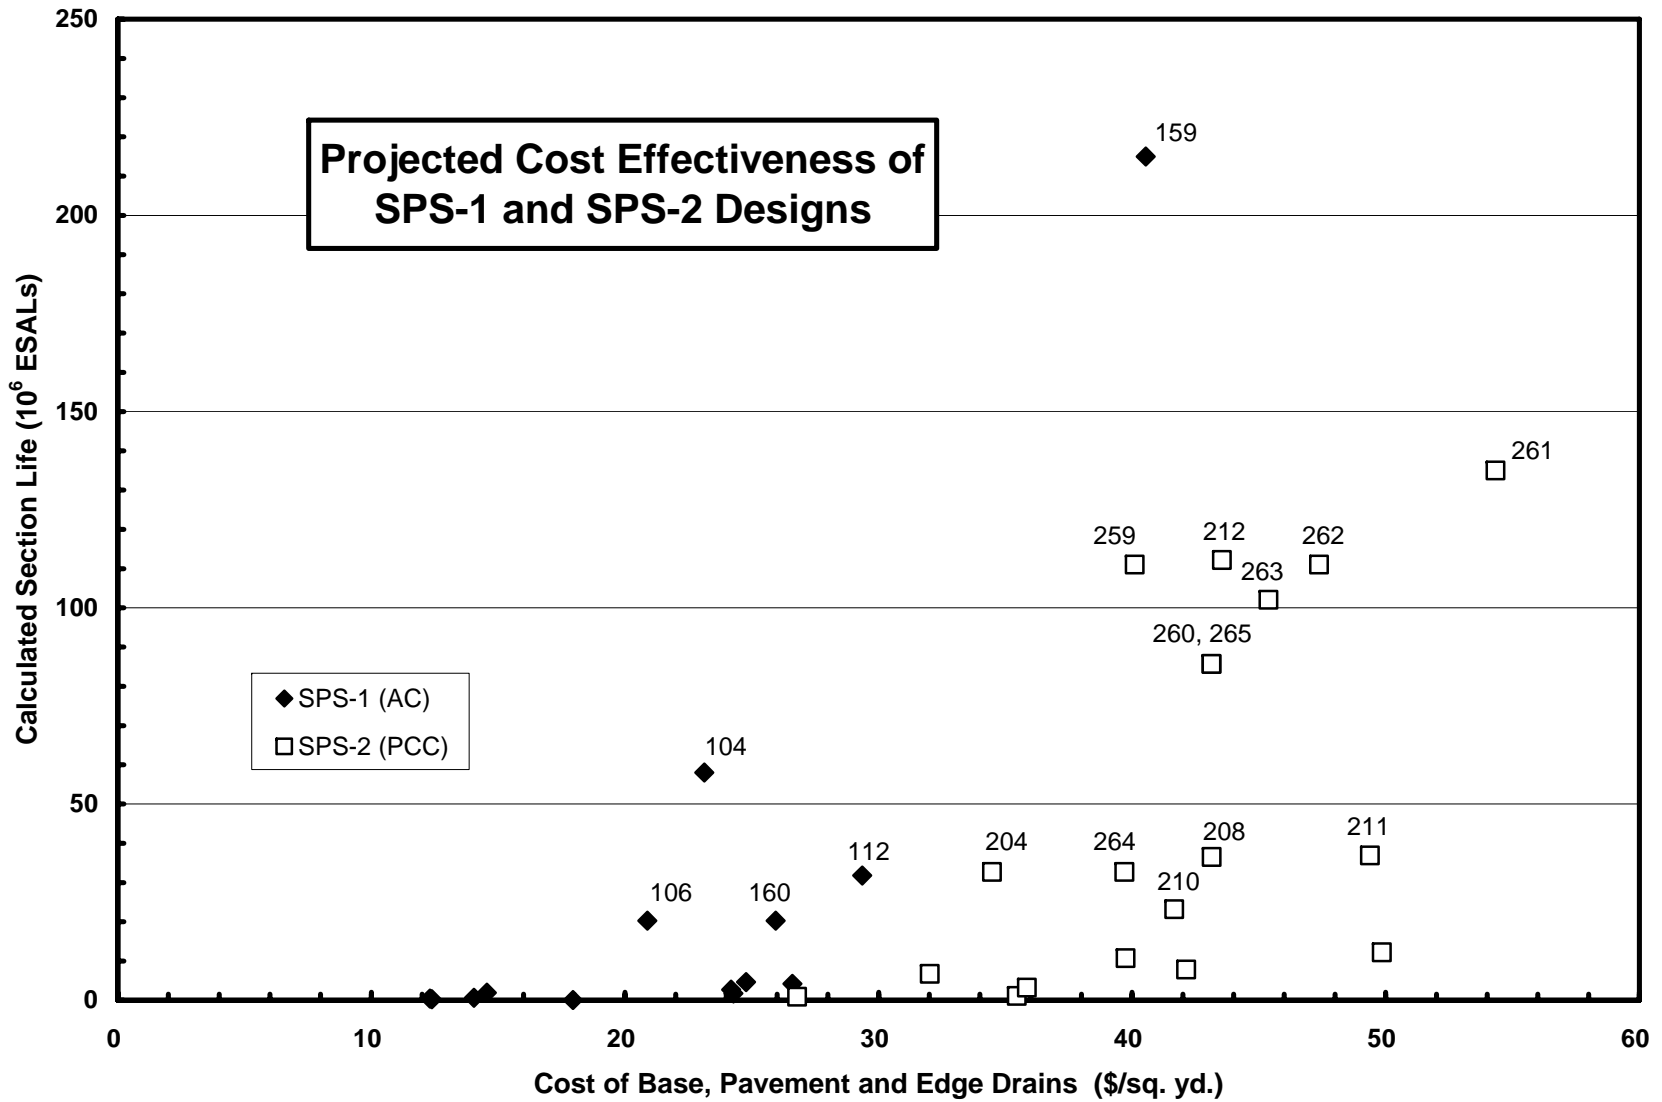
Figure 2.14 – Section Cost vs. Calculated Life for SPS-1 and SPS-2 Sections

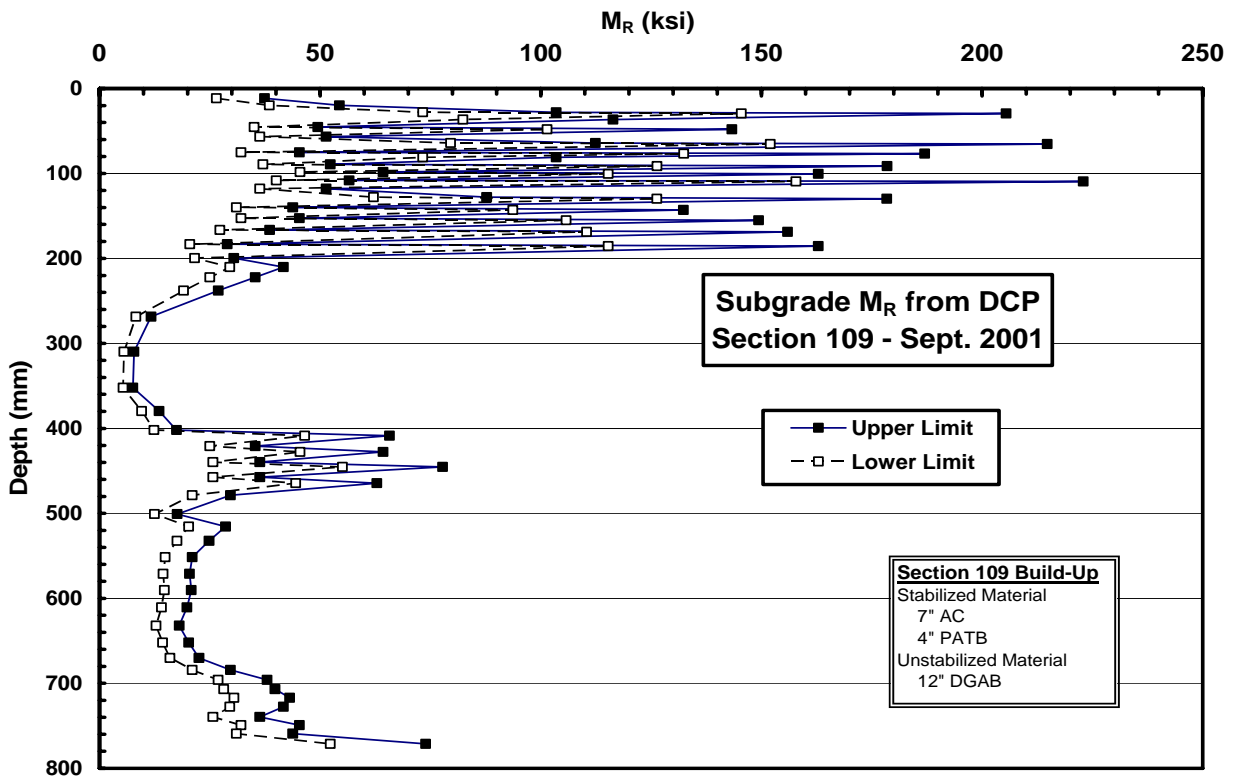
Figure 2.16 - DCP Profile from Section 109

A second set of DCP measurements were made at the north end of Section 103 in September 2003 when the NJ base, DGAB and cement treated subgrade had been placed for the replacement of Sections 103, 108, 109 and 110. These profiles are shown in Appendix M.

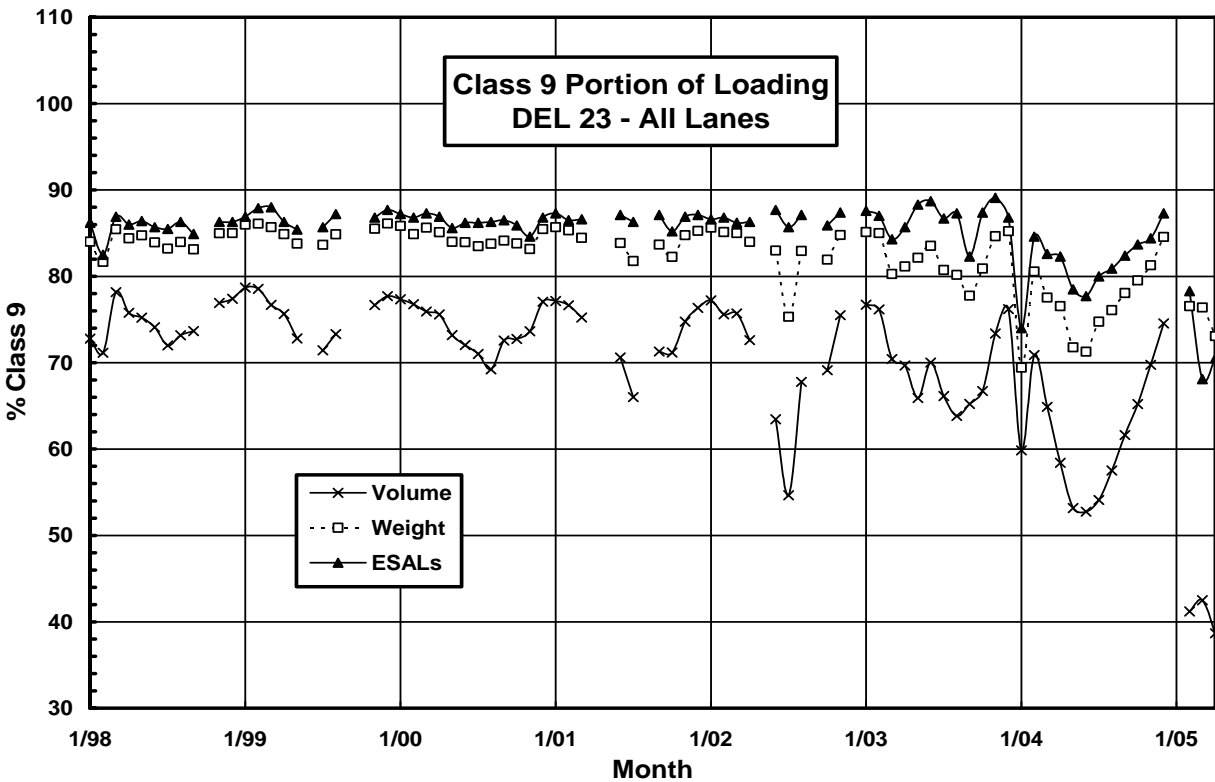
Figure 3.22 – Percentage of Class 9 Loading

As observed earlier, Class 9 trucks (i.e. standard 18 wheelers) comprised the vast majority of trucks in the DEL 23 traffic stream. Figure 3.22 summarizes the percentage of Class 9 loading for all lanes combined on the test road expressed as volume, weight and ESALs. Class 9 weight and ESALs were more than 80% of the total, with the percentage of ESALs being slightly higher than the percentage of weight. The volume of Class 9 trucks varied from 70-80% with a definite seasonal cycling probably caused by a higher number of smaller trucks on the road during the warm months. These trends were relatively consistent from 1998-2000, less consistent in 2001-2003 as weight and volume percentages became somewhat variable, and highly inconsistent in 2004 and 2005 when the percentages dropped off further, probably from the increased number of Class 4 and 5 trucks. From the trends shown earlier, the first four to five years would seem to provide the most accurate information on Class 9 loading.

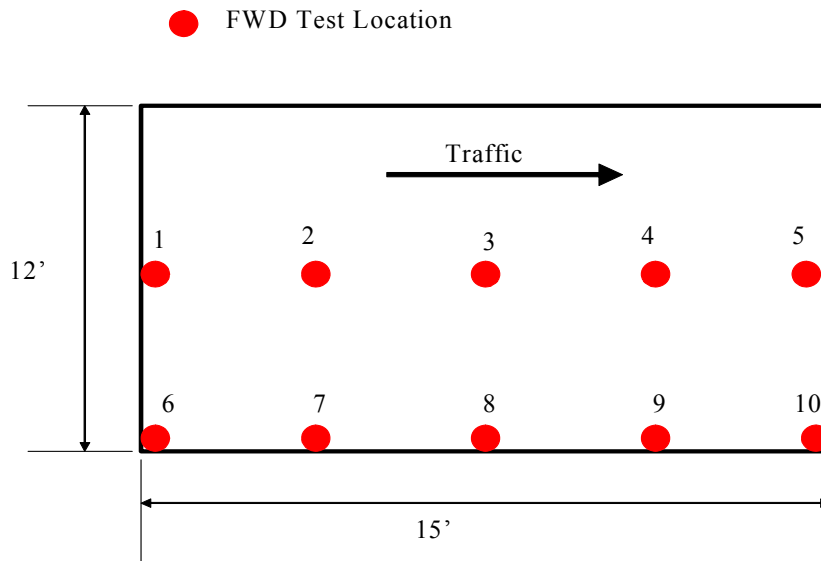
**Figure 4.6 - FWD Test Locations on JCP Slab**

The concrete slabs were 12 feet wide and 15 feet long, resulting in the six-foot deflection basin extending beyond the joint at test locations 4, 5, 9, and 10 in Figure 4.6, which are the third quarter and the approach side of the joint. Because these basins included the joint, which is a discontinuity, they were excluded from the data analysis.

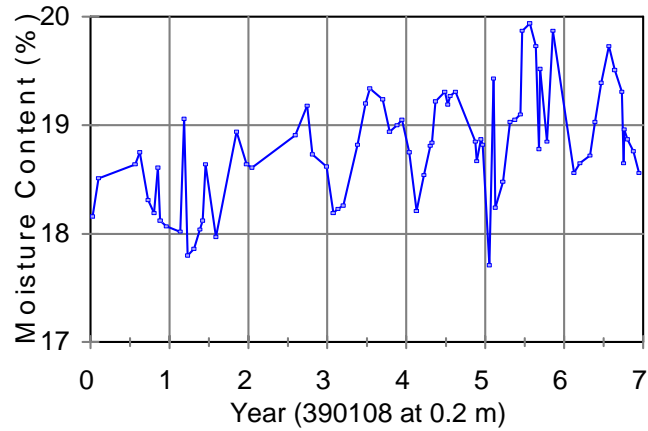
**Figure 5.11 - Annual Subgrade Moisture Cycles**

Data from on-site environmental monitoring stations indicated that soil moisture cycles annually, as shown in Figure 5.10. Moisture 0.07 to 0.23 meters (3 to 9 inches) from the top of the subgrade oscillated between 17% and 21% with peaks in July and lows in January. See Figure 5.11.

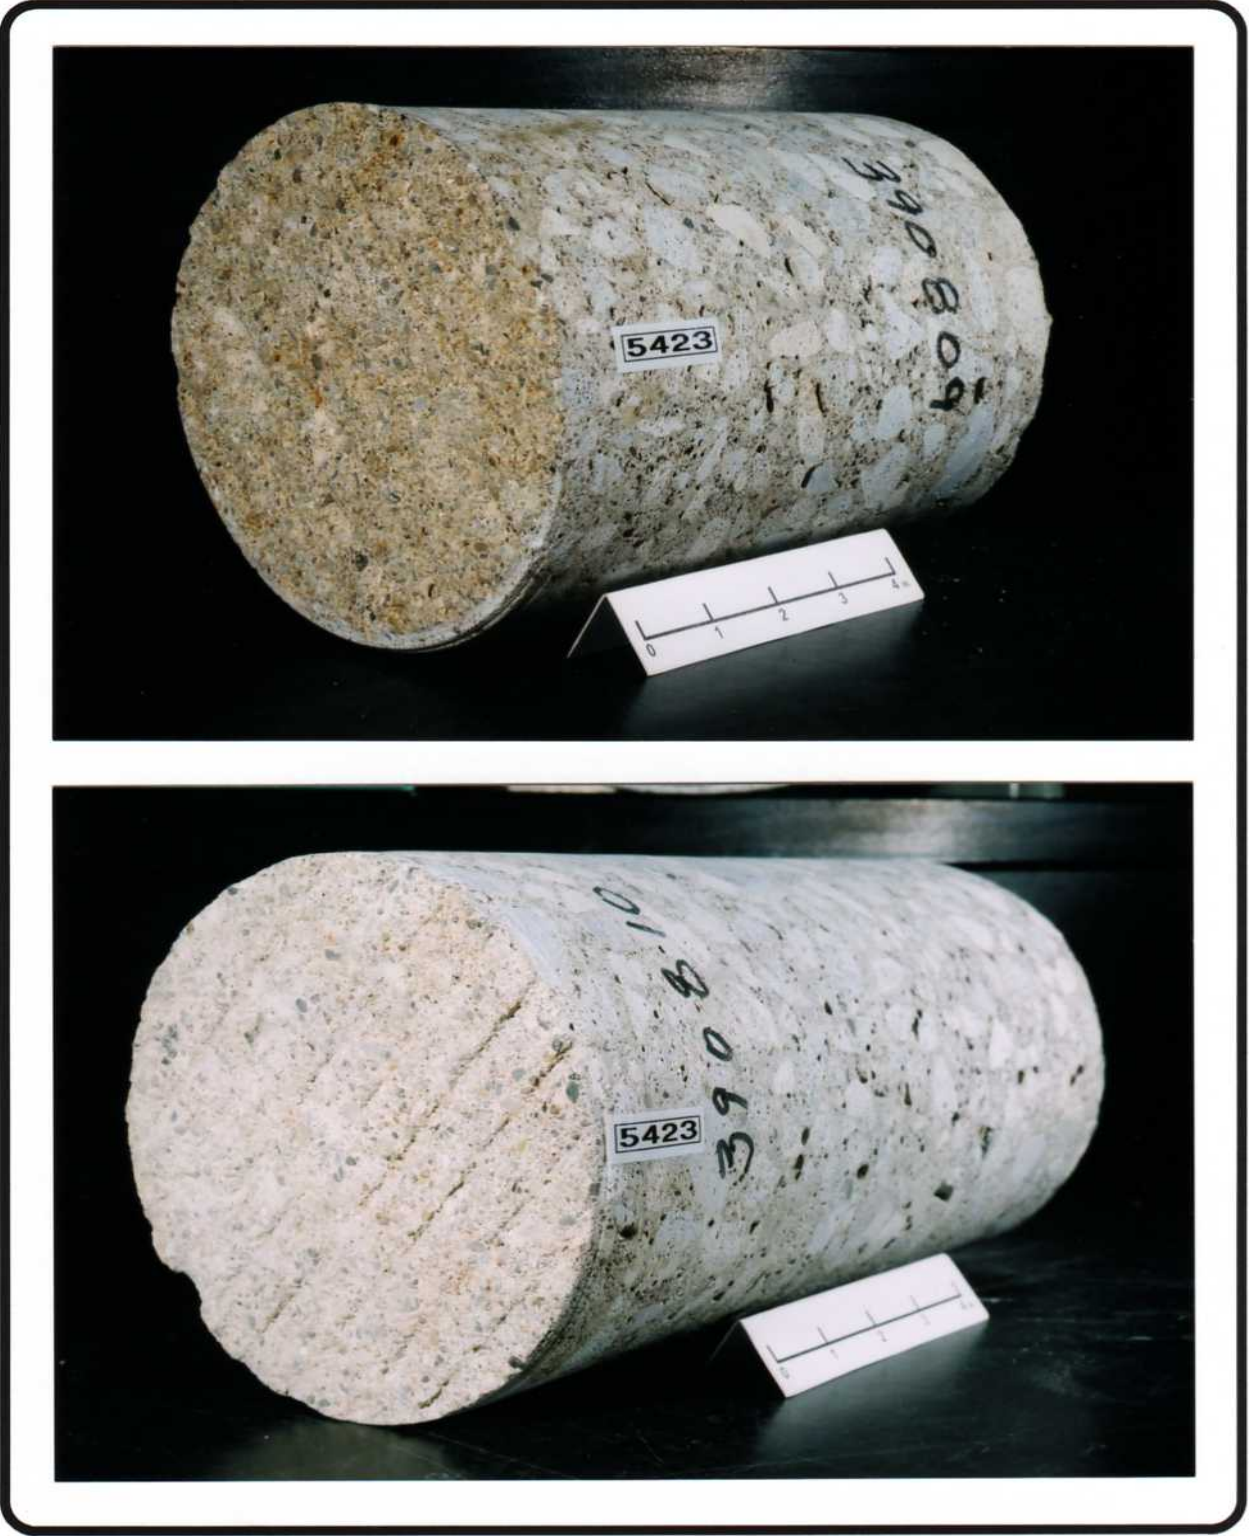
Figure 6.9 - Photographs of Cores 809 and 810

One full-depth core was taken from each of these test sections and identified in this report as Cores 809 and 810. The site for the 8-inch core in Test Section 809 is identified as "Station 26 + 40". The site for the 11-inch core in Test Section 810 is identified as "Station 26 + 90". The pavement target thickness values were met by both of these cores. Photographs of the cores are shown in Figure 6.9. Both of these cores were receive intact, and neither was taken through a crack in the ramp pavement. One end surface of the cores is the existing grooved wearing surface of the test pavement slabs. The other end surface is the bottom of the cores cast on the DGAB. The southbound ramp pavement shows only a small amount of cracking.

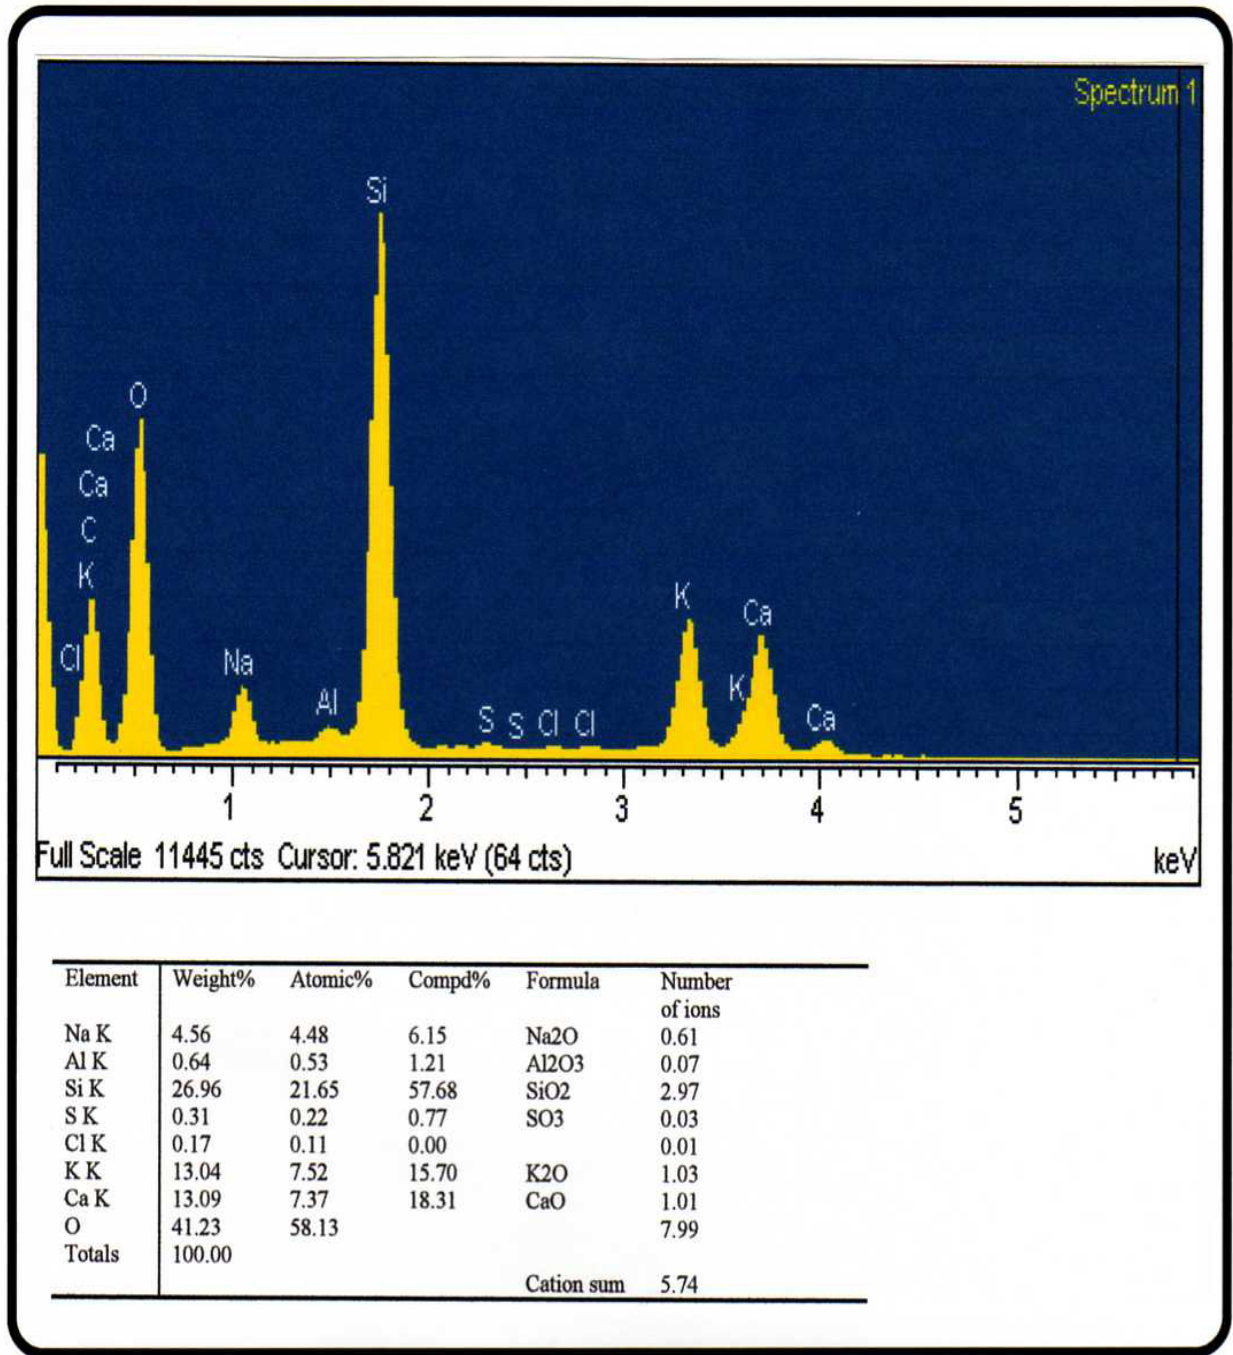
**Figure 6.11 - Energy Dispersive X-ray Spectroscopy (EDS) Spectrum of Material Deposited as Efflorescence - Section 206**
