A Comparative Laboratory Study of Metallic Reinforcing Steels for Corrosion Protection of Reinforced Concrete Bridge Structures

PUBLICATION NO. FHWA-HRT-15-078

JUNE 2018

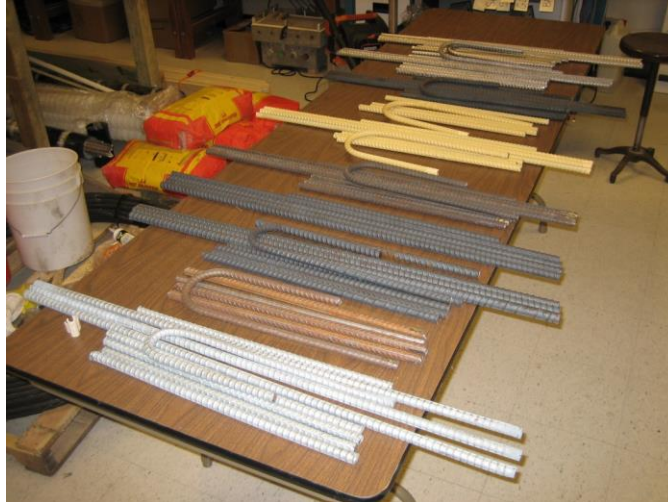
Figure 1 shows some of the bar products as they were delivered for testing. It was assumed that the acquired products were representative of those sold to actual construction projects and that they conformed to their respective specifications, including pickling treatment, if required. As such, they were tested with as-received surface condition. The only exception was that artificial coating defects were introduced to some of the coated bars to simulate field conditions (which is discussed further in the next section related to table 2 and figure 3). The other products (i.e., LSS2 and SSR1) were donated by the Florida Department of Transportation (FDOT). These bars were left over from earlier unpublished FDOT studies.

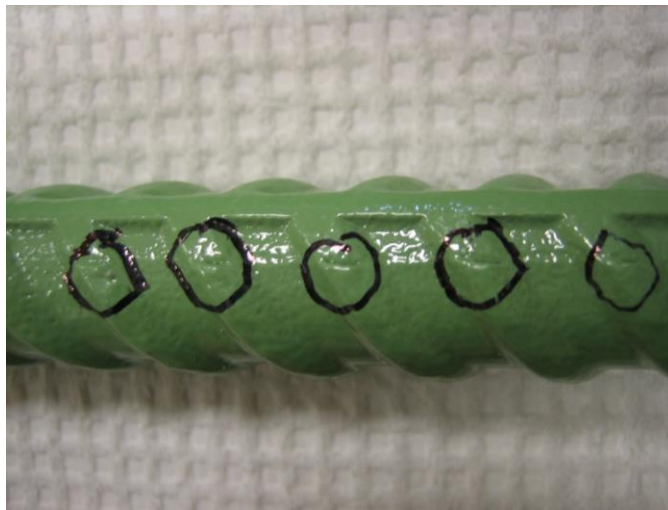
| Figure 2. Photo. Example of as-received ECR defects..... | 8 |

As the first step of introducing target coating damage, as-received (natural) coating defects on ECR and DCR were located using a low-voltage holiday detector. Figure 2 shows five as-received coating defects identified on an ECR, which are circled in black.

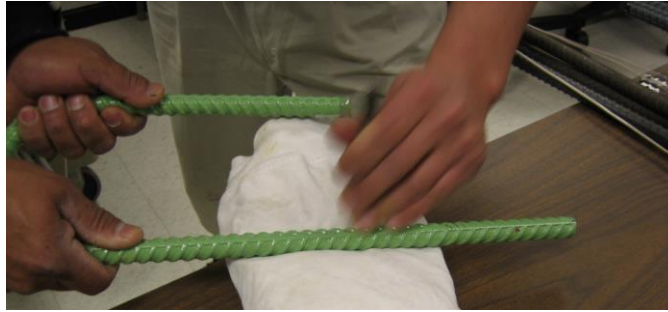
Figure 3. Photo. Creation of artificial coating damage.

If a target damage level (as identified in table 2) could not be met by the number of as-received defects, more coating defects were artificially introduced using a 0.125-inch puncher with an assumption that each as-received defect is equivalent to an artificial defect made with the puncher. Figure 3 and figure 4 show the creation of an artificial coating defect and a close-up view of such a defect on an ECR, respectively. The red dot in figure 4 was used to indicate where an artificial defect would be made. The red permanent marker did not influence the outcome of the study.

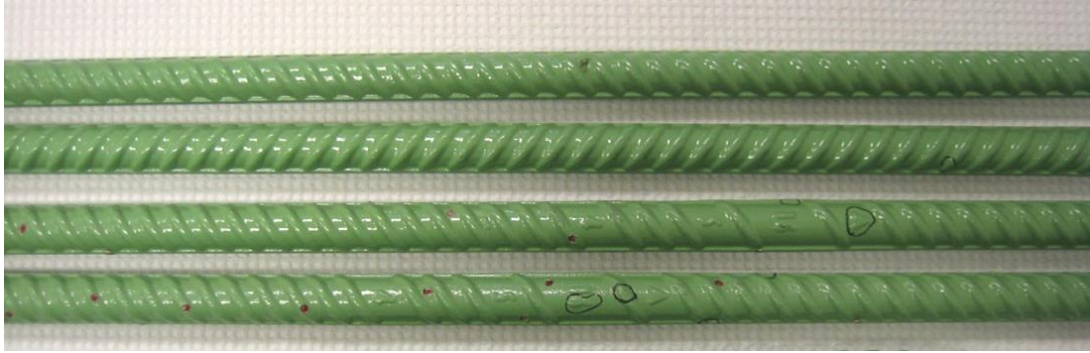
Figure 5. Photo. ECR samples with various types of coating damage.

Figure 5 shows a photograph of five ECR bars that contained as-received defects (indicated by black circles) and artificial defects (indicated by red dots). Figure 6 shows typical intentional damage created on an HDG bar (indicated by a red dot).

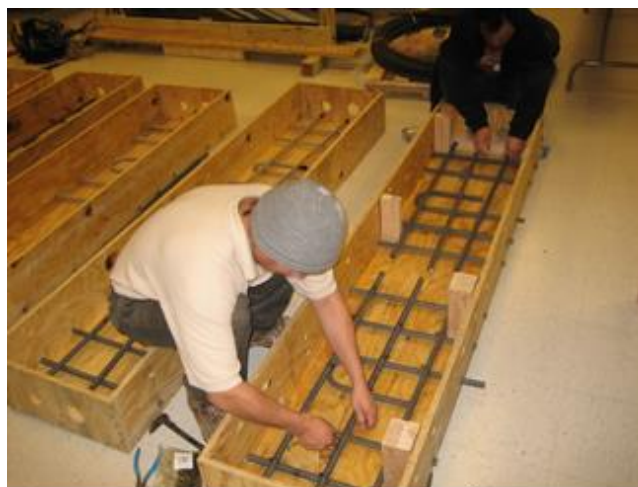
Figure 9. Photo. Fabrication of two bottom mats.

All of the bottom transverse and longitudinal bars were made electrically continuous using steel tie wire so that they could act as a single macro-cathode. Even though coated tie wire has been used for ECR in the field for over 20 yr, this study purposely used the uncoated steel tie wire for the sake of electrical continuity of the ECR bottom mat. Such a deviation from the standard field practice was expected to create more severe conditions for ECR compared to electrically isolated cases. Only one electrical connection was made to the bottom mat. Figure 9 shows a bottom mat being fabricated, and figure 10 shows a close-up view of two crossing bars and a tie wire.

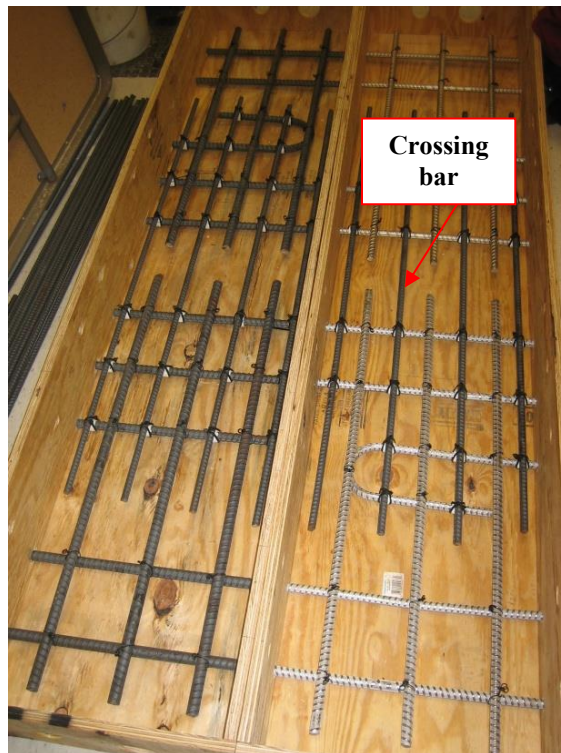
Figure 11 shows four completed bottom mats placed in two molds. The figure also shows four electrically isolated #4 crossing bars interconnecting two bottom mats. These crossing bars were added to prevent concrete fracture at the boundary between two slab sections during slab handling.

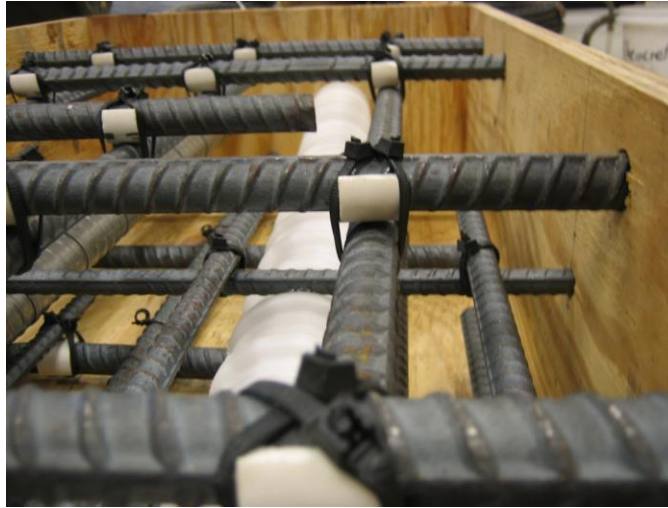
Figure 12. Photo. Close-up view of transverse and longitudinal bars in the top mat.

The top mat utilized a matching set of reinforcement made with the same material. One exception was slab 2R, which was made with ECR in the top mat and black bars in the bottom mat to simulate old ECR concrete bridge decks. Bar arrangement of the top mat was identical to that of the bottom mat as shown in figure 7 and figure 8. However, all of the transverse and longitudinal bars were electrically isolated by placing an insulator between them at every crossing point. This arrangement is illustrated in parts A and B of figure 7, and an actual contact point is shown in figure 12.

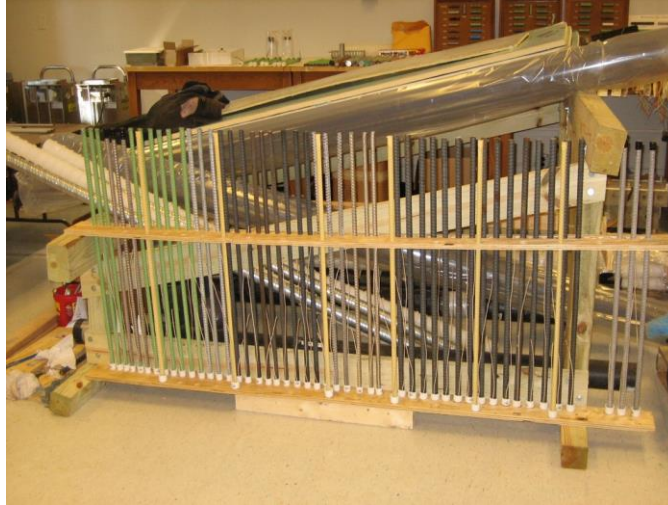
Figure 13. Photo. Encapsulating cut ends of top mat longitudinal bars.

Since individual top mat bars had to be electrically isolated, a separate electrical connection had to be made at one cut end of each bar for corrosion tests. An electrical connection was made by attaching a solid copper wire to one exposed end of each transverse bar. Since longitudinal bars were to be completely embedded in concrete, one cut end of each longitudinal bar was connected to a solid copper wire and then encapsulated with a polyvinyl chloride (PVC) cap and epoxy resin. Figure 13 shows the PVC encapsulation work in progress. Three encapsulated SCR2 longitudinal bars are also shown in figure 8.

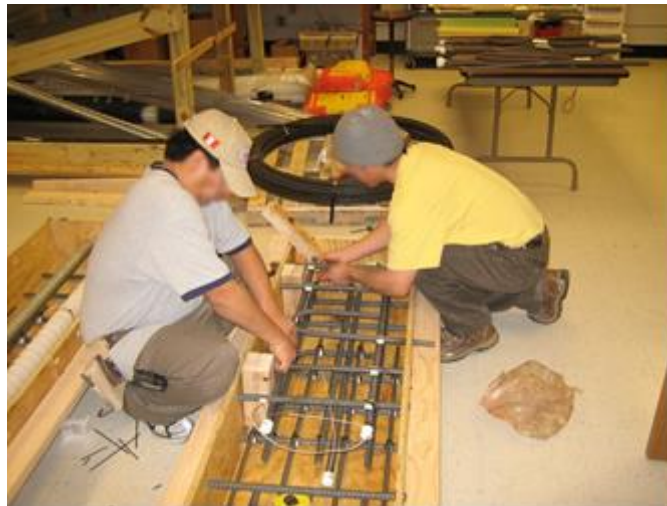
Figure 14. Photo. Fabrication of a top mat.

Figure 14 shows a top mat being fabricated, and figure 15 shows two completely fabricated top mats, including six longitudinal bars/wires penetrating through a mold. The latter also shows two internal PT ducts installed between top and bottom mats.

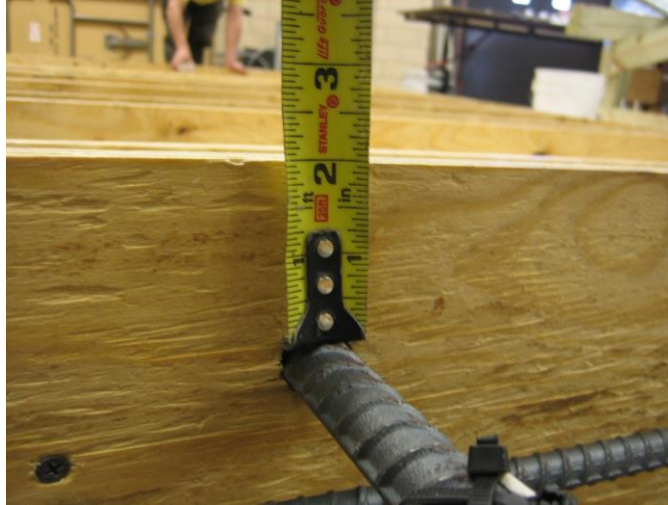
Figure 17. Photo. Top mat with 2-inch clear cover.

Figure 16 shows an identification system for top mat bars. A clear concrete cover for the top mat was set at 2 inches, as shown in figure 17.

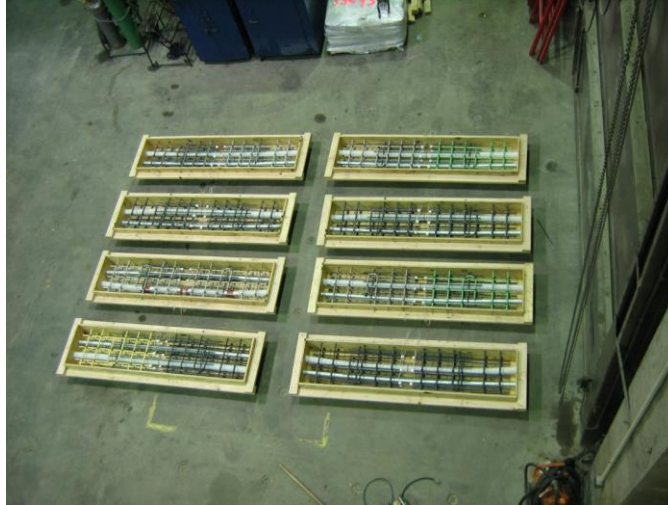
Figure 21. Photo. Concrete molds ready for casting.

Figure 19 and figure 20 show several molds containing fully fabricated reinforcements. Figure 21 shows a bird's-eye view of all eight molds ready for concrete casting, and figure 22 shows concrete casting in progress. After 48 h, the slabs were demolded (see figure 23) and placed outdoors under plastic sheets for 26 d of curing with occasional water spray (see figure 24). After completing 28-d curing, the slabs were brought into the FHWA Coatings and Corrosion Laboratory (see figure 25). A ponding well was installed on the top surface of each slab using 2-inch-wide clear PVC strips and a silicon caulking material (see figure 26).

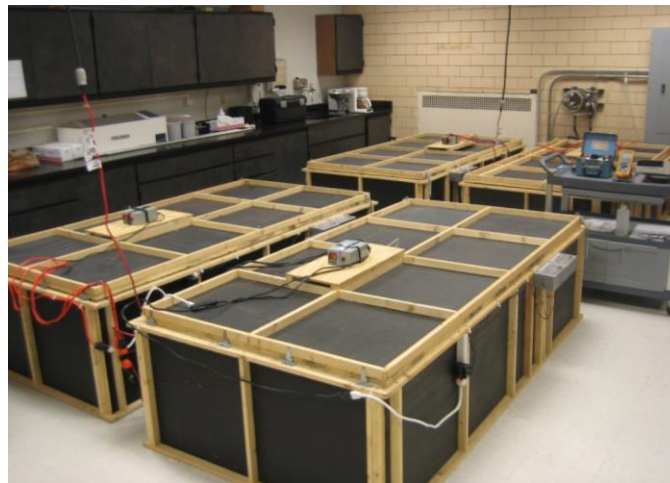
Figure 27. Photo. Closed heat tents during a drying cycle.

An accelerated corrosion testing protocol was employed for this study. It consisted of a 3-d wetting cycle in 15 weight percent chloride solution at 77 °F and a 4-d drying cycle at 100 °F. The 15 weight percent sodium chloride (NaCl) solution was made with an automated salt water mixer, which agitated a mixture of NaCl and tap water with compressed air overnight. Each wetting cycle used a fresh salt solution. For the drying cycles, the slabs were placed inside four heat tents that were constructed with rigid insulation board and permanently installed in the laboratory. Each heat tent was equipped with three flood lamps and a digital thermostat, which maintained the target temperature with an accuracy of ± 1 °F. During the wetting cycles, the top panel of each heat tent was opened, and a large clear PVC lid was placed over each ponding well to minimize evaporation of the NaCl solution. Figure 27 and figure 28 show the heat tents during a drying cycle and a wetting cycle, respectively.

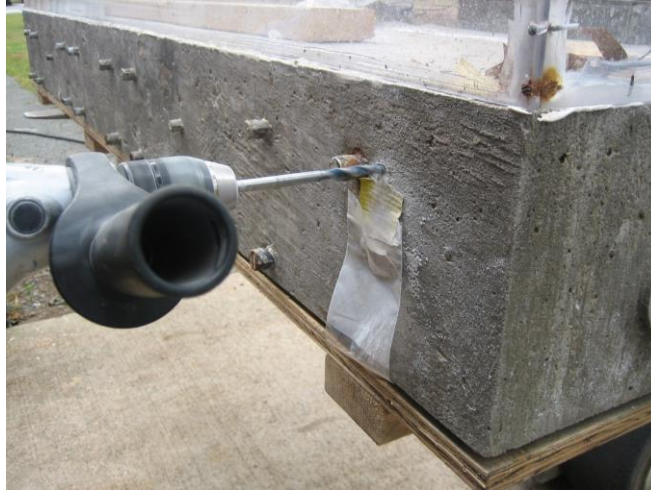
Figure 35 shows concrete powder sampling work near a top mat transverse bar. Final chloride analysis is discussed in the Autopsy of Test Slabs section.

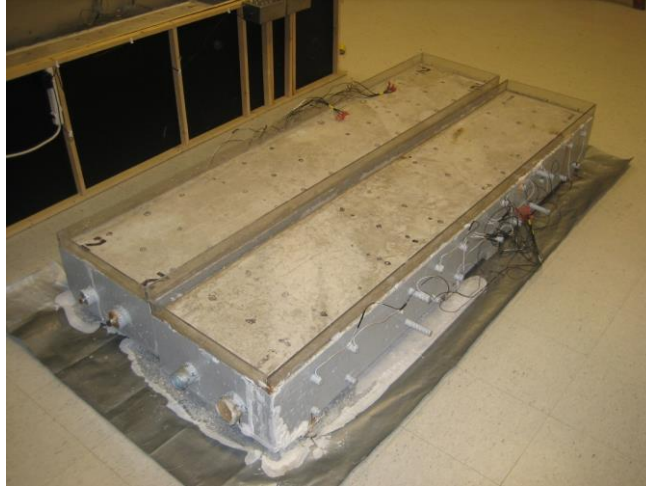
| Figure 36. Photo. Concrete slabs with leaking ponding wells..... | 32 |

In the early stages of corrosion testing, NaCl solution leaked through some of the ponding wells and reached some bottom mats. Because every bottom mat had only a 0.5-inch clear cover, Cl⁻ reached the bottom mat bars much faster than the top mat bars, which had a 2-inch clear cover. Consequently, corrosion initiated prematurely on those affected bottom mats. After several attempts to repair the leaky ponding wells, it was concluded that all slabs needed a systematic and thorough repair to eliminate the possibility of reoccurrence. Figure 36 shows two slabs with dried NaCl deposits on the exterior surfaces and floor. When the exposure testing was suspended after 172 d, the slabs were cleaned with tap water followed by complete drying for several weeks. Next, slightly smaller ponding wells were installed inside the existing wells. Figure 26 shows the old and new ponding wells. Following repeated water tightness tests with tap water and some minor repairs, the exposure testing resumed after 284 d. The leaking problem caused nearly 4 mo of interruption and unintended corrosion of some bottom mats.

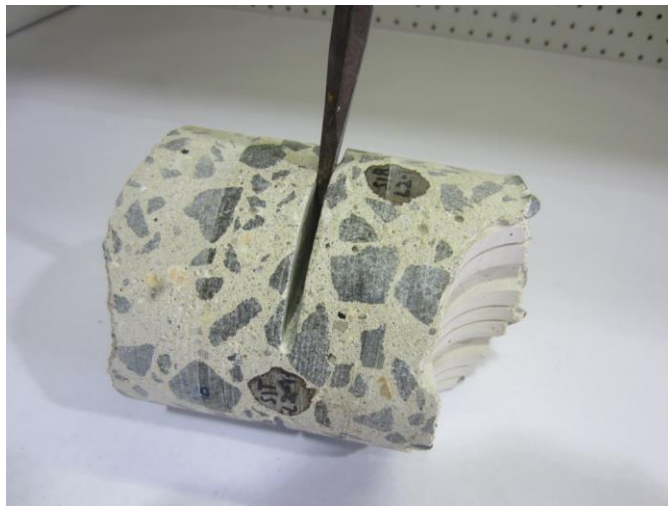
Figure 42. Photo. Splitting a core at the transverse bar depth.

When core documentation was completed, 192 cores containing straight transverse/longitudinal bars were chosen for bar extraction and final chloride analysis. The remaining cores containing bent bars were reserved in case more work needs to be done in the future. Only transverse bars were extracted for autopsy, as the longitudinal bars embedded in the deeper depth were not likely to reveal valuable information due to lower chloride concentration compared to the transverse bar depth. To separate the cores cleanly at the transverse bar level, two saw cuts were made into either side of the bar, and a chisel was used to exert the splitting force (see figure 42).

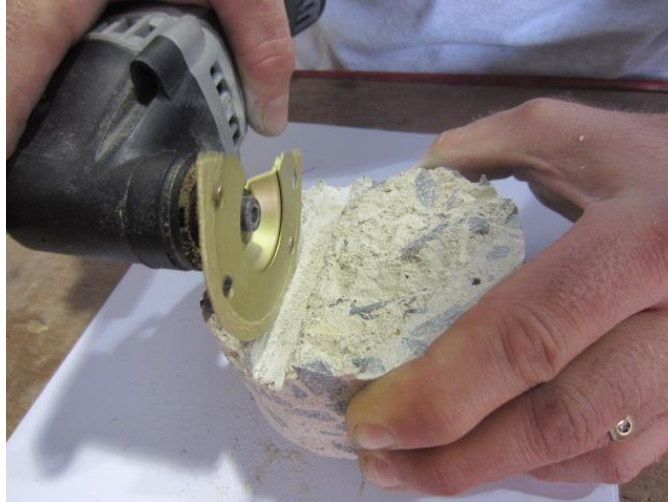
Figure 44. Photo. Concrete powder sampling from upper bar imprint of a core.

After a transverse bar was removed, a concrete powder sample was taken from the upper bar imprint by gently shaving the bar trace with an oscillating saw (see figure 44). These samples were used to determine chloride concentration at a bar depth of 2 inches ($[Cl^-]_{\text{interface@2-inch}}$).

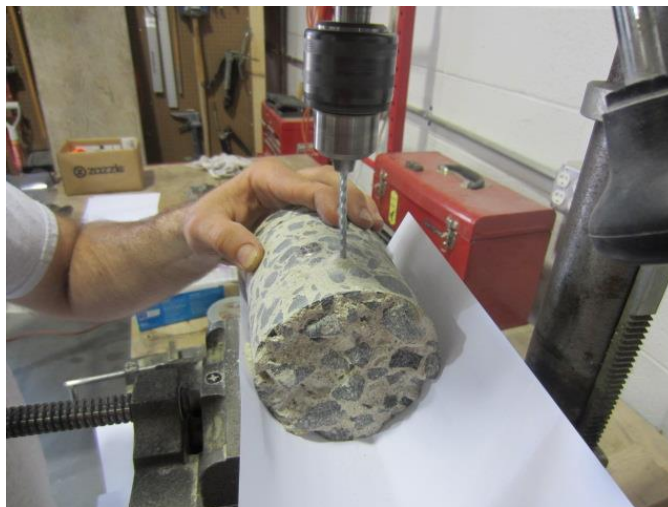
Figure 45. Photo. Concrete powder sampling by drilling.

The cores taken from the 1-inch cover slab sections containing black bars were disintegrated during coring due to severe corrosion damage. Therefore, three cores from each slab section with a 2-inch clear cover were chosen for 5-depth chloride profiling and subsequent determination of chloride diffusion coefficients. Full-depth concrete powder samples were taken at 0.125, 0.5, 1, 2, and 4 inches. After the top 0.03125 inch was shaved off using a diamond blade masonry saw, the first chloride sample at 0.125 inch was prepared from a slice between depths of 0.03125 and 0.25 inch. Other samples at deeper depths were collected by drilling the core with a 0.1875-inch masonry drill bit. Figure 45 and figure 46 show core drilling and a sampled hole, respectively. The latter figure also shows a band of duct tape, which prevented cross-contamination with powder residues falling from already sampled holes. Drilling was performed from the deepest depth toward shallower depths to minimize the risk of cross-contamination.

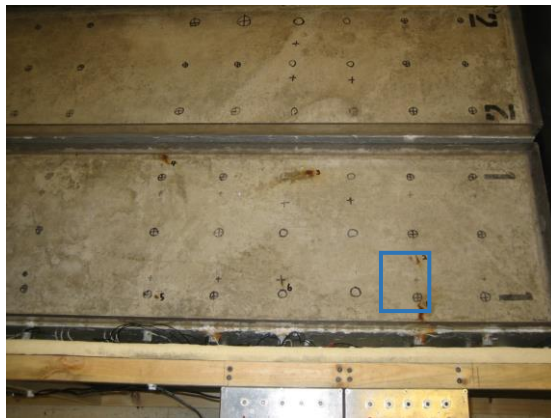
A. Cracked concrete.

Figure 47-B shows a close-up view of the cracked concrete. The condition of the slab worsened with more cracks and rust stains over time. The other black bar slab section with a 1-inch cover (slab 8R), which was added at a later time, also developed small rust stains after 70 d of salt water exposure.

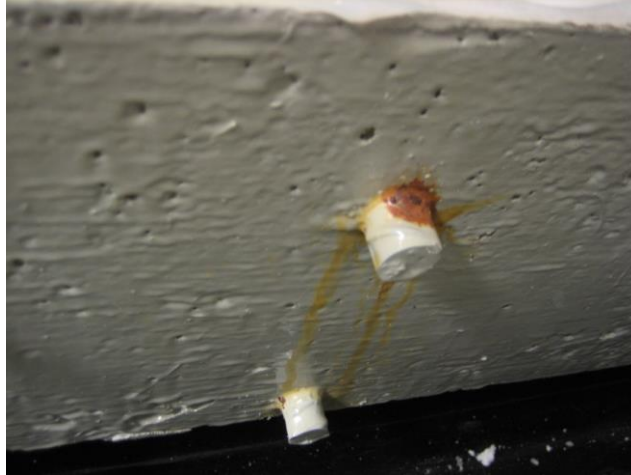
| Figure 48. Photo. Rust oozing out of a top mat transverse bar. | 40 |

Slab 5, which contained HSR (left section) and SSR1 (right section), exhibited rust oozing out through the lateral face of the slab where top mat transverse bars entered. An example of this condition is shown in figure 48.

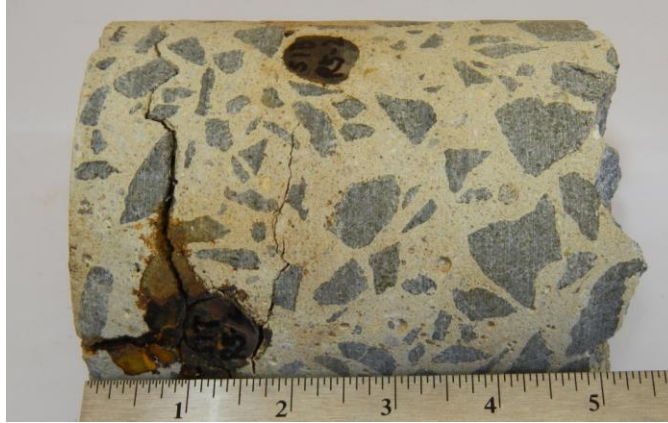
Figure 88. Photo. Corrosion-damaged slab 1R with a 5-2 core ID (black bar at 1-inch cover).

The cores taken from 1-inch black bar slab sections (slab 1R) were either cracked or fractured during coring, and the extracted bars were severely corroded, as shown in figure 88 and figure 89. Those taken from slab 8R with a 1-inch cover were also severely damaged, even though the slab was added to the study at a later time. No chloride analysis could be done with the disintegrated cores, but excessive chloride accumulation at the shallow cover must have been responsible for these conditions.

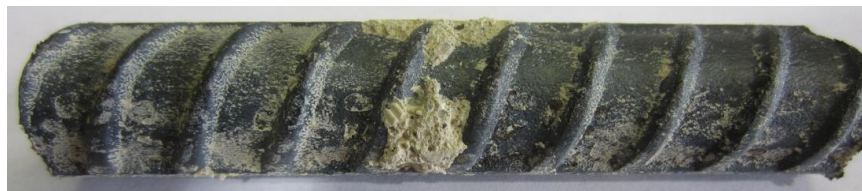
Figure 90. Photo. Extracted black bar from slab 1L with a 2-1 core ID ($[Cl^-]_{\text{interface@2-inch}} = 1,298$ ppm).

Figure 90 shows a black bar sample in slab 1L exposed to the lowest $[Cl^-]_{\text{interface@2-inch}}$ of 1,298 ppm, and figure 91 shows a close-up view of corrosion on the same bar.

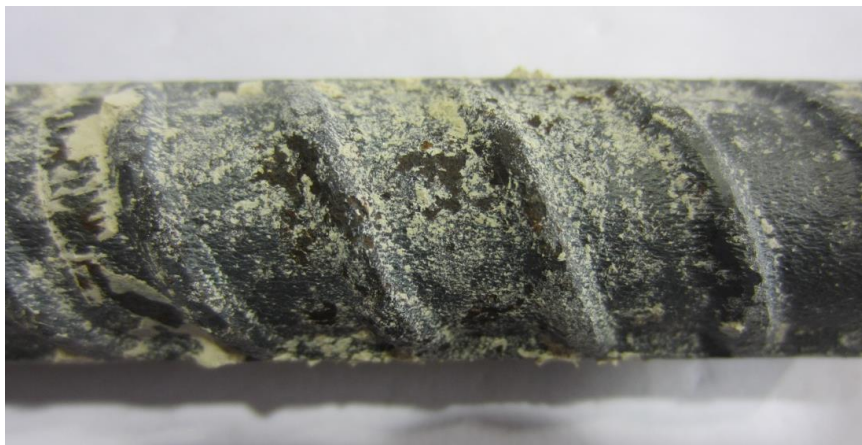
Figure 95. Photo. Close-up view of the bar shown in figure 94.

Figure 94 shows a black bar sample exposed to the lowest $[Cl^-]_{\text{interface@2-inch}}$ of 525 ppm in slab 8L, and figure 95 shows a close-up view of corrosion on the same bar.

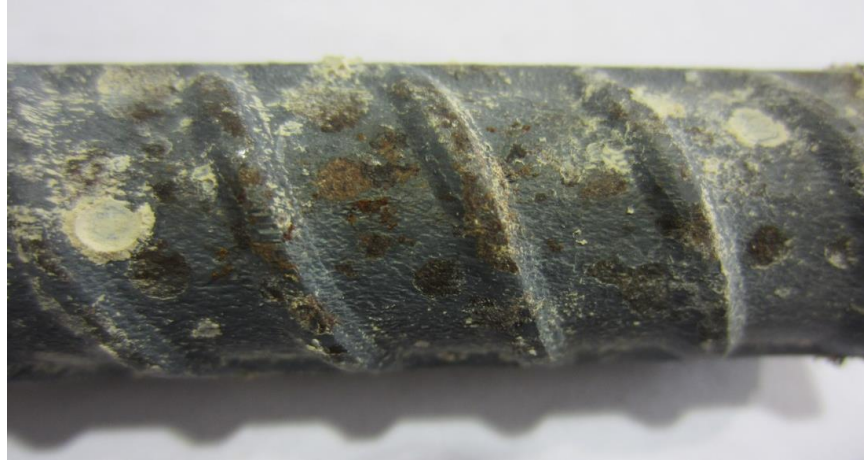
Figure 97. Photo. Close-up view of the bar shown in figure 96.

Figure 96 and figure 97 show another bar exposed to the highest $[Cl^-]_{\text{interface@2-inch}}$ of 2,499 ppm. The level of corrosion observed on four black bar samples with a 2-inch cover was insignificant compared to that observed on samples with a 1-inch cover due to relatively low chloride concentrations.

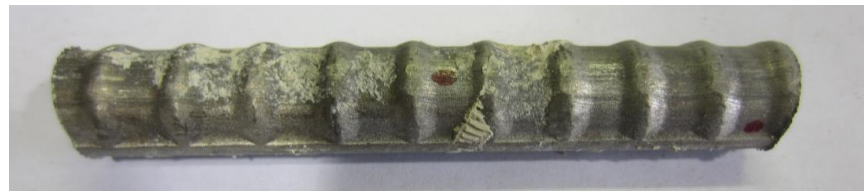
Figure 98. Photo. Extracted SCR1 from slab 2L with a 5-1 core ID ($[Cl^-]_{\text{interface@2-inch}} = 1,114$ ppm).

Figure 98 shows an SCR1 sample exposed to the lowest $[Cl^-]_{\text{interface@2-inch}}$ of 1,114 ppm in slab 2L, and figure 99 shows a close-up view of the same bar.

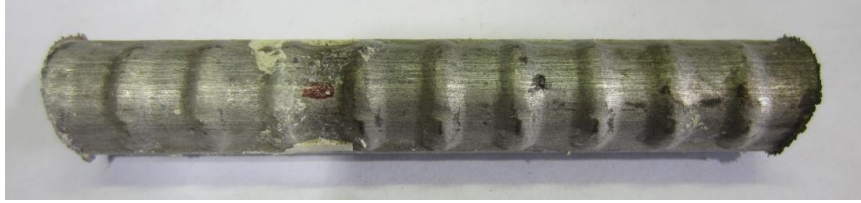
Figure 100. Photo. Extracted SCR1 from slab 2L with a 2-3 core ID ($[Cl^-]_{\text{interface@2-inch}} = 4,265 \text{ ppm}$).

Figure 100 and figure 101 show another SCR1 bar exposed to the highest $[Cl^-]_{\text{interface@2-inch}}$ of 4,265 ppm in slab 2L.

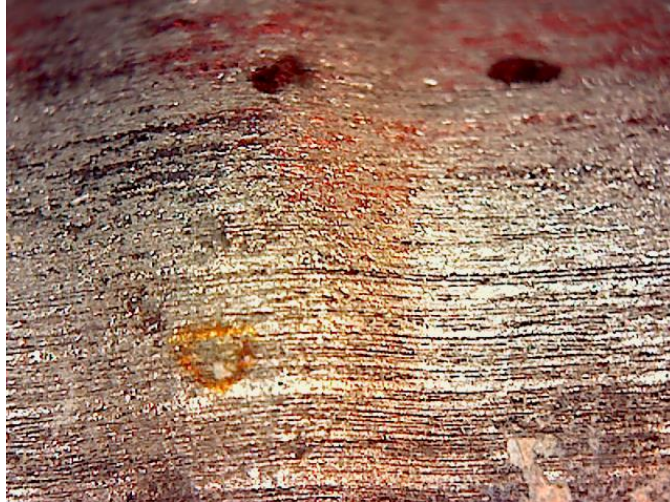
Figure 102. Photo. Rust spot and two pits observed on an SCR1 sample from slab 2L with a 6-1 core ID ($[Cl]_{\text{interface@2-inch}} = 1,578$ ppm).

The extracted SCR1 samples showed a clean condition with some dark spots regardless of $[Cl^-]_{\text{interface@2-inch}}$. Magnified dark spots revealed rust stains and small pits, as shown in figure 102 and figure 103. The same figures show many tiny ridge lines parallel to the bar length, which served as pit initiation sites (see figure 103). Although these corrosion spots were insignificant compared to the entire bar surface, the long-term implications of this type of defect are currently unknown.

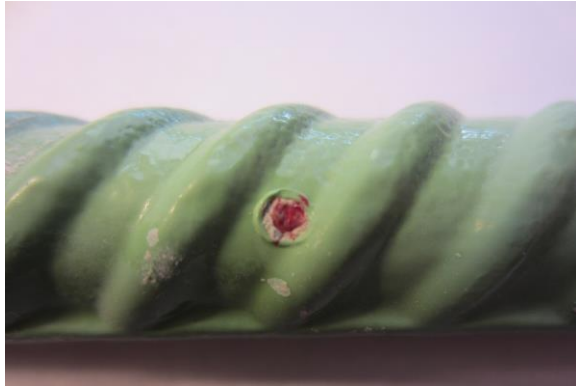
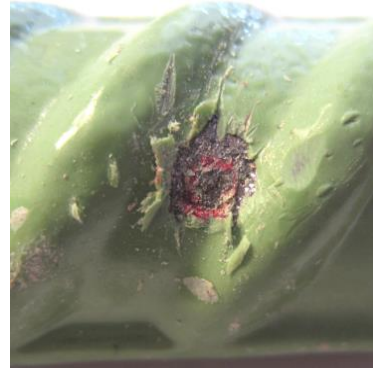
Figure 105. Photos. Close-up view of the bar shown in figure 104.

Figure 104 shows an ECR sample exposed to the lowest $[Cl]_{\text{interface@2-inch}}$ of 353 ppm in slab 2R. Figure 105 and figure 106 show close-up views of the same bar after artificial coating defects were peeled off. Figure 105-A shows an artificial coating defect, and figure 106-A shows a knife adhesion spot next to another artificial coating defect. Figure 105-B and figure 106-B show conditions after the coating was removed. Coating adhesion appeared to be strong with minimal detachment.

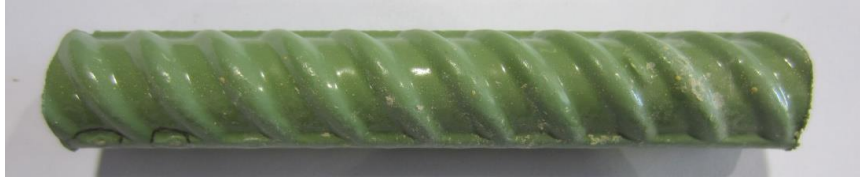
Figure 107. Photo. Extracted ECR from slab 2R with a 5-1 core ID ($[Cl^-]_{\text{interface@2-inch}} = 1,745 \text{ ppm}$).

Figure 107 shows another ECR exposed to the highest $[Cl^-]_{\text{interface@2-inch}}$ of 1,745 ppm in slab 2R. Figure 108-A and figure 109-A show close-up views of two as-received defects and a knife adhesion test spot, respectively, before coating was removed, while figure 108-B and figure 109-B show conditions after the coating was removed. Coating adhesion was weak with moderate detachment.

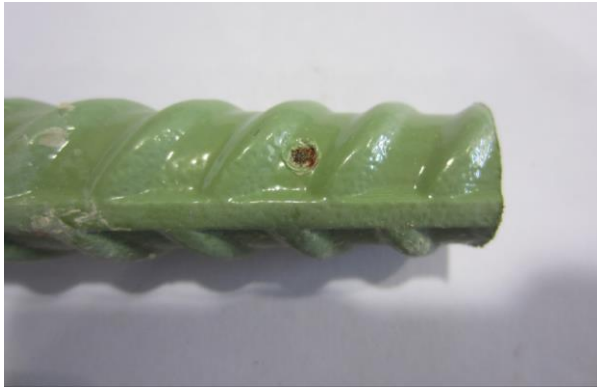
Figure 110. Photo. Extracted ECR from slab 2R with a 2-3 core ID ($[Cl]_{\text{interface@2-inch}} = 1,332 \text{ ppm}$).

Figure 110 shows an ECR sample exhibiting corrosion at an artificial coating defect. Figure 111 shows a close-up of the defect before and after coating was removed (see figure 111-A and figure 111-B, respectively). $[Cl^-]_{\text{interface@2-inch}}$ was 1,332 ppm, which was not considered a high level. An autopsy of the coating defect revealed superficial corrosion, as shown in figure 111-B. Figure 112 shows the condition of the same bar after another coating defect was peeled off and a knife adhesion test was performed. Coating adhesion varied between strong and weak.

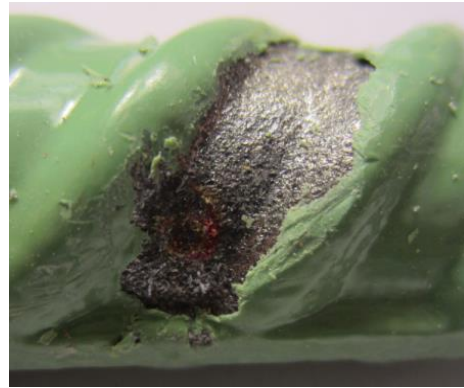
Figure 111. Photos. Close-up views of the bar shown in figure 110 before and after an artificial coating defect was peeled off.

A. Before coating removal.

B. After coating removal.

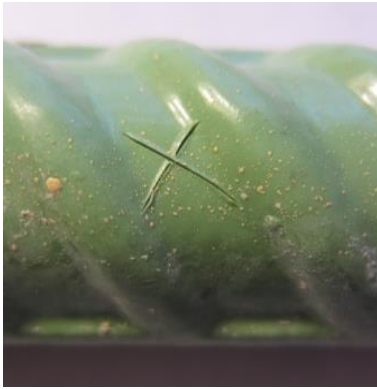
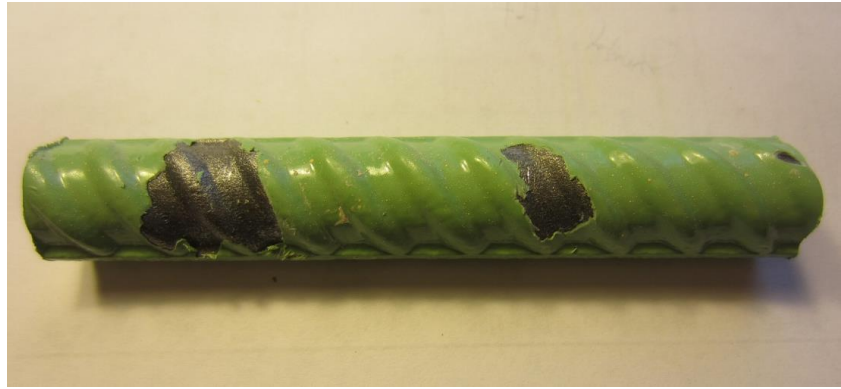
Figure 113. Photos. The most significant disbondment on an ECR from slab 2R with a 5-3 core ID ($[Cl^-]_{\text{interface@2-inch}} = 1,434$ ppm).

Figure 113 shows the conditions before and after a knife adhesion test of an ECR sample. The sample exhibited the largest coating disbondment observed in this study. No correlation was found between the extent of coating disbondment and $[Cl^-]_{\text{interface@2-inch}}$.

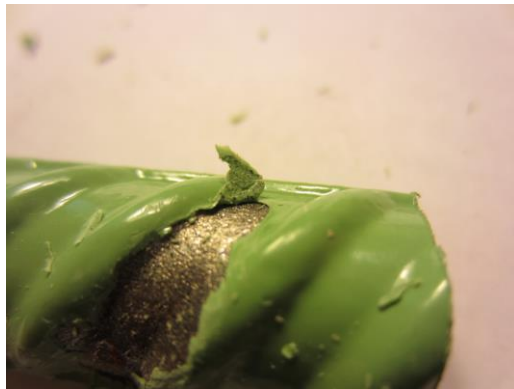
Figure 114 shows a representative condition of coating backside after coating was peeled off. The backside contamination appeared to be normal.

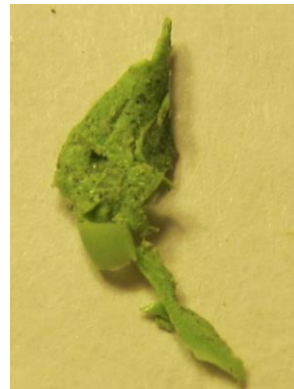
B. Backside of the removed coating.

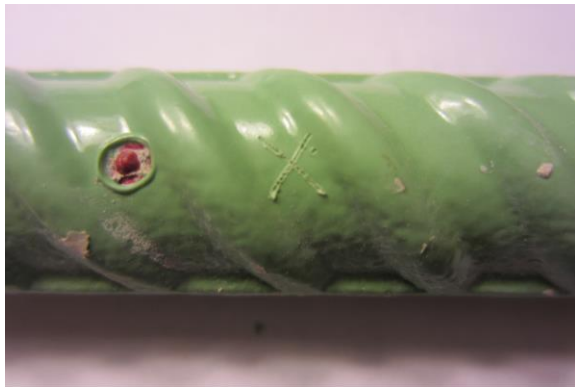
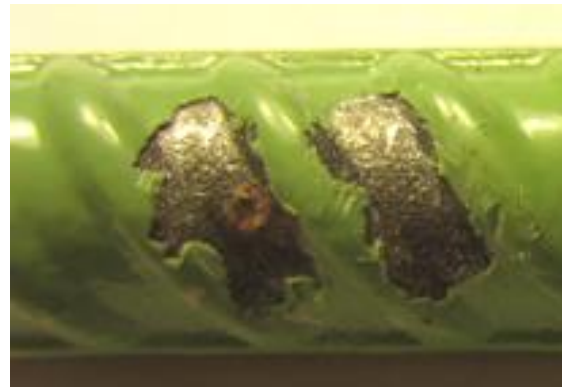
Figure 116. Photos. Close-up views of the bar shown in figure 115.

Figure 115 shows an ECR sample exposed to the lowest $[Cl^-]_{\text{interface@2-inch}}$ of 1,026 ppm in slab 3L. Figure 116 shows a close-up view of the same bar before an artificial coating defect was removed (see figure 116-A) and a knife adhesion spot was autopsied (see figure 116-B). A moderate coating detachment can be seen after the coating was removed.

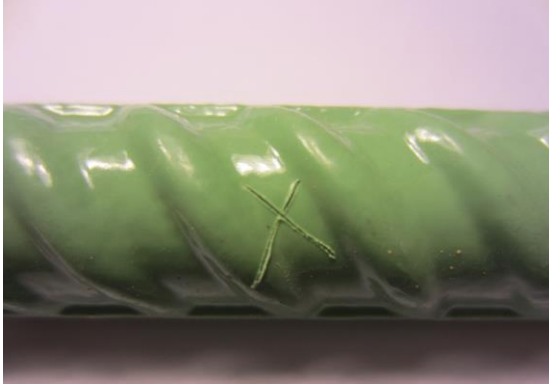
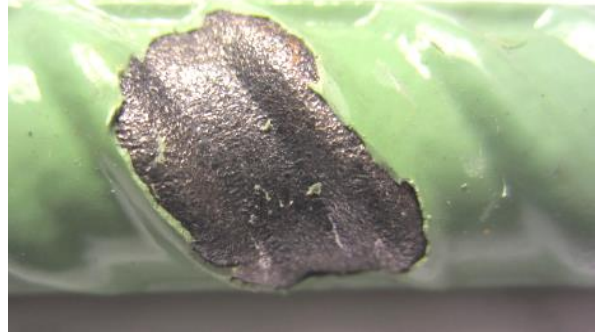
Figure 118. Photos. Close-up views of the bar shown in figure 117.

Figure 117 shows another ECR sample exposed to the highest $[Cl^-]_{\text{interface@2-inch}}$ of 3,602 ppm in slab 3L. Figure 118 shows of the conditions before and after a knife adhesion test was performed. It reveals a moderate coating disbondment.

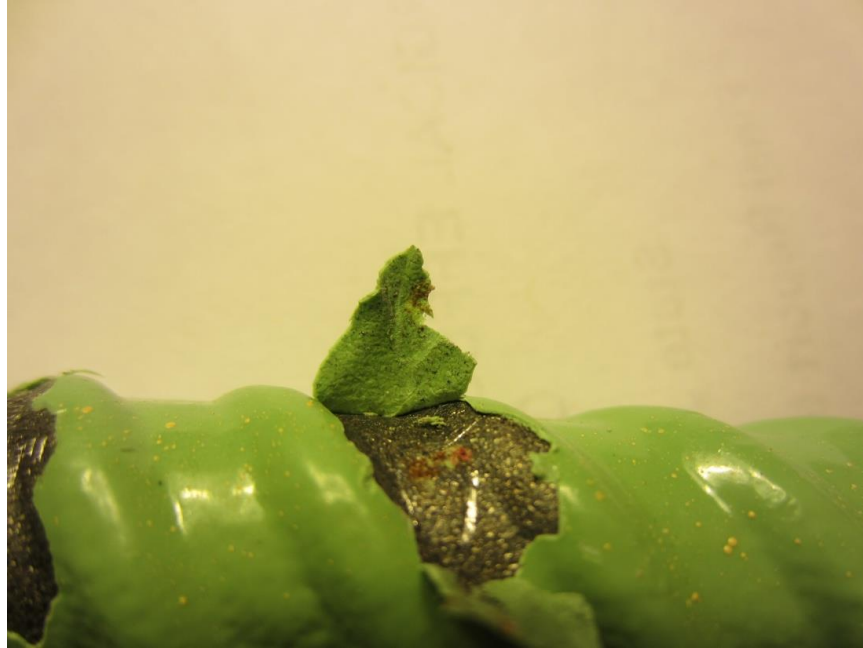
Figure 120. Photo. Coating backside of an ECR from slab 3L with a 5-2 core ID ($[Cl^-]_{\text{interface@2-inch}} = 2,153$ ppm).

Figure 119 shows the condition of an ECR sample after an artificial coating defect was removed. A powdery corrosion product can be seen beneath the disbonded coating. Figure 120 shows the backside contamination of the epoxy coating, which appeared to be normal.

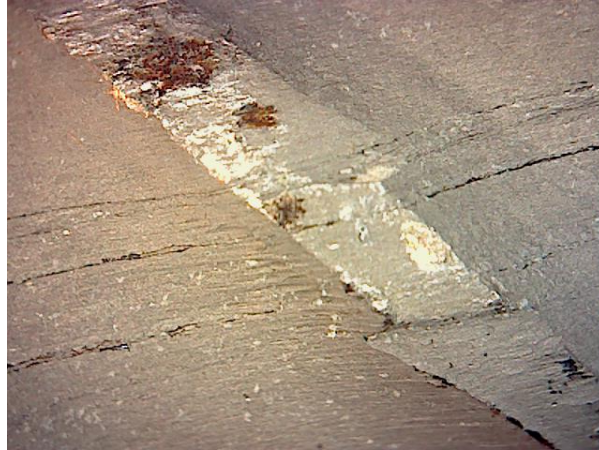
Figure 126. Photo. Close-up view of manufacturing defects and rust spots shown in figure 125.

Figure 125 also shows dark spots (one such area is indicated by a red square) on the deformation lugs, and figure 126 shows a magnified dark spot, which turned out to be rust. Figure 126 also shows crack-like fine parallel lines on the bar surface, which seemed to be manufacturing defects.

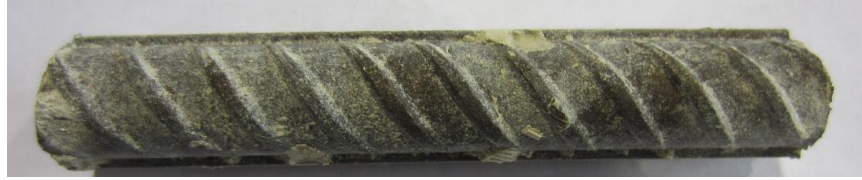
Figure 128. Photo. Extracted LSS2 from slab 4L with a 1-3 core ID ($[Cl^-]_{\text{interface@2-inch}} = 641 \text{ ppm}$).

Figure 128 shows an LSS2 sample exposed to the lowest $[\text{Cl}^-]_{\text{interface@2-inch}}$ of 641 ppm in slab 4L, and figure 129 shows a close-up view of the same bar exhibiting superficial light corrosion.

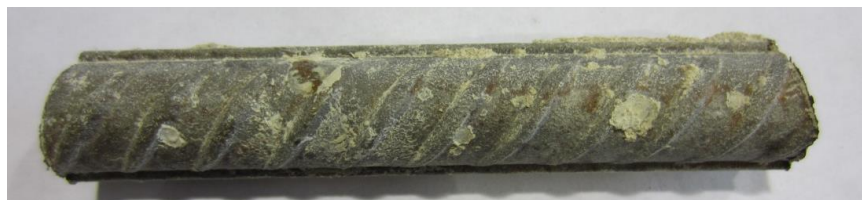
Figure 130. Photo. Extracted LSS2 from slab 4L with a 5-2 core ID ($[Cl^-]_{\text{interface@2-inch}} = 2,713 \text{ ppm}$).

Figure 130 shows another LSS2 bar exposed to the highest $[Cl^-]_{\text{interface@2-inch}}$ of 2,713 ppm in the same slab section, and figure 131 shows a close-up view of the same bar exhibiting corrosion. Even though $[Cl^-]_{\text{interface@2-inch}}$ was much higher than in the bar shown in figure 129, both bars showed the same corrosion morphology.

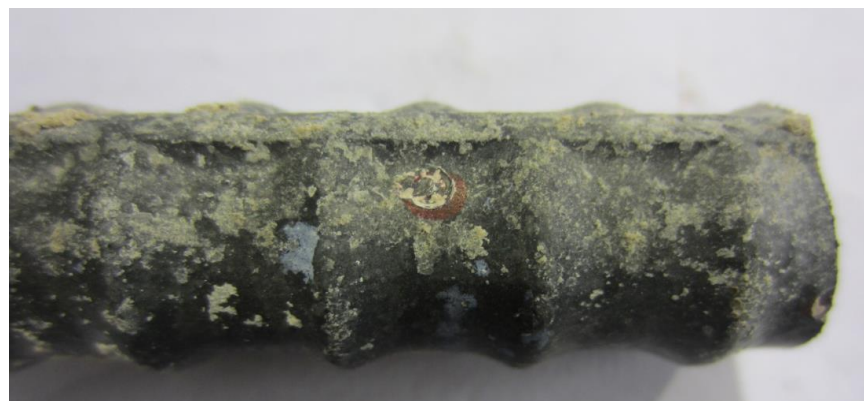
Figure 133. Photo. Close-up view of the bar shown in figure 132.

Figure 132 shows an HDG sample exposed to the lowest $[Cl^-]_{\text{interface@2-inch}}$ of 785 ppm in slab 4R, and figure 133 shows a close-up view of the same bar. It is apparent that the original shiny zinc coating became dark or blackish in color, indicating that zinc was passivated.

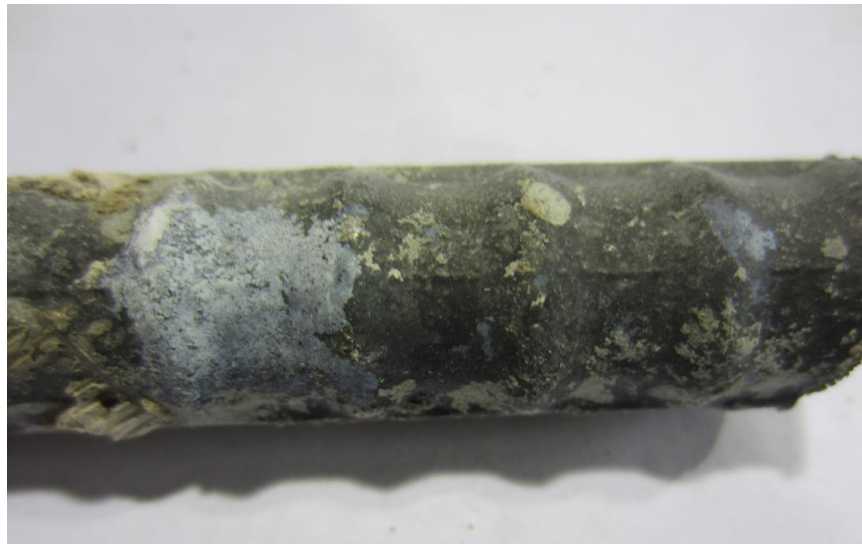
Figure 135. Photo. Close-up view of the bar shown in figure 134.

Figure 134 shows another bar exposed to the highest $[Cl^-]_{\text{interface@2-inch}}$ of 2,982 ppm in slab 4R, and figure 135 shows a close-up view of the same bar exhibiting a gray corrosion product.

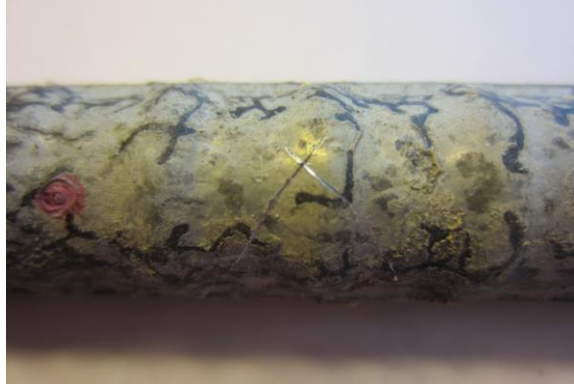
Figure 136. Photos. Remaining zinc coating on the bar shown in figure 132.

Figure 136-A shows the remaining zinc layer on the underside of the bar shown in figure 132. Upon scratching the dull gray-colored zinc surface, bright zinc was exposed (see Figure 136-B). When the zinc coating was consumed, a red corrosion product was observed. An example of active corrosion highlighted in a red square is shown in Figure 137-A, and a magnified corrosion product is shown in figure 137-B.

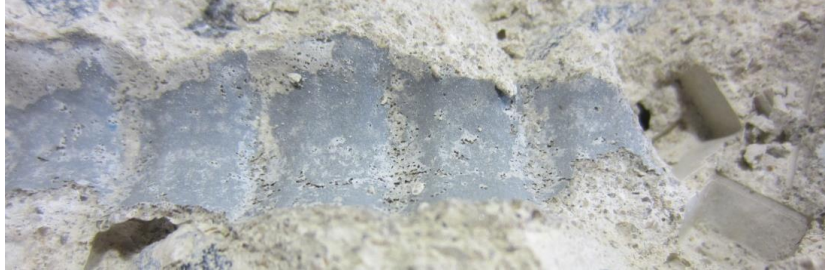
Figure 138. Photo. Bar imprint in slab 4R with a 2-1 core ID ($[Cl^-]_{\text{interface@2-inch}} = 854 \text{ ppm}$).

One unique feature of HDG is bar imprints covered with zinc that must be transferred from HDG. Figure 138 and figure 139 show an example of a gray-colored bar imprint and the matching HDG sample, respectively. $[Cl^-]_{\text{interface@2-inch}}$ was low at 854 ppm.

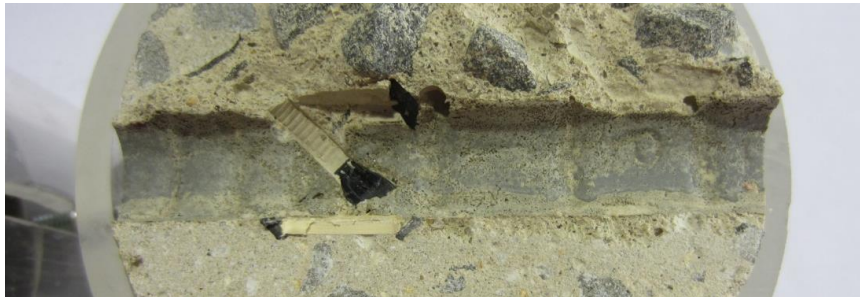
Figure 140. Photo. Rebar imprint in slab 4R with a 2-2 core ID ($[Cl^-]_{\text{interface@2-inch}} = 2,233 \text{ ppm}$).

Figure 140 and figure 141 show another pair consisting of a bar imprint and the matching HDG sample found with a high $[Cl^-]_{\text{interface@2-inch}}$ of 2,233 ppm. Figure 141 also shows a distinct color difference between intact zinc (gray) and passivated zinc (black).

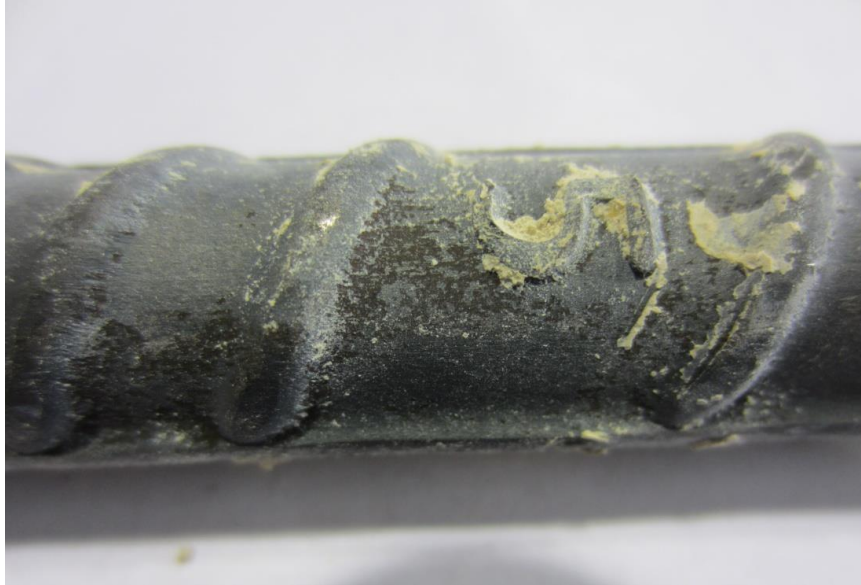
Figure 143. Photo. Close-up view of the bar shown in figure 142.

Figure 142 shows an HSR sample exposed to the lowest $[Cl^-]_{\text{interface@2-inch}}$ of 961 ppm in slab 5L, and figure 143 shows a close-up view of the same bar. The figure shows superficial light corrosion formed in some areas.

Figure 144 shows another HSR bar exposed to the highest $[Cl^-]_{\text{interface@2-inch}}$ of 2,398 ppm in the same slab section, and figure 145 shows a close-up view of the same bar exhibiting similar corrosion conditions to those observed on the bar shown in figure 143.

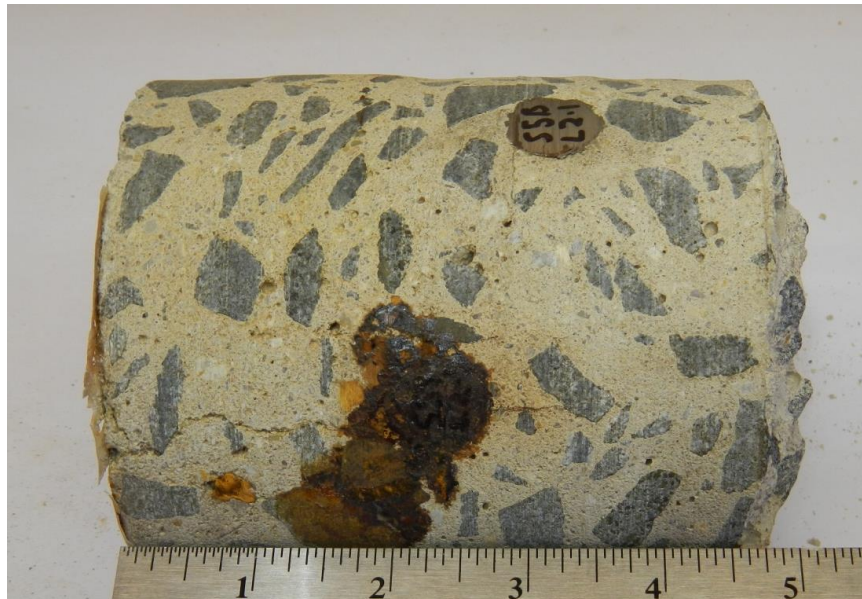
Figure 146. Photo. Cracked slab 5L with a 2-1 core ID ($[\text{Cl}^-]_{\text{interface@2-inch}} = 6,630$ ppm).

Figure 146 shows the only non-black-bar core that contained a vertical crack extending to the top surface. Because salt water was able to penetrate the crack and reach the bar during the accelerated corrosion testing, $[\text{Cl}^-]_{\text{interface@2-inch}}$ was 6,630 ppm, which was the highest concentration found in this study. Figure 147 shows a severely corroded HSR bar extracted from the cracked core.

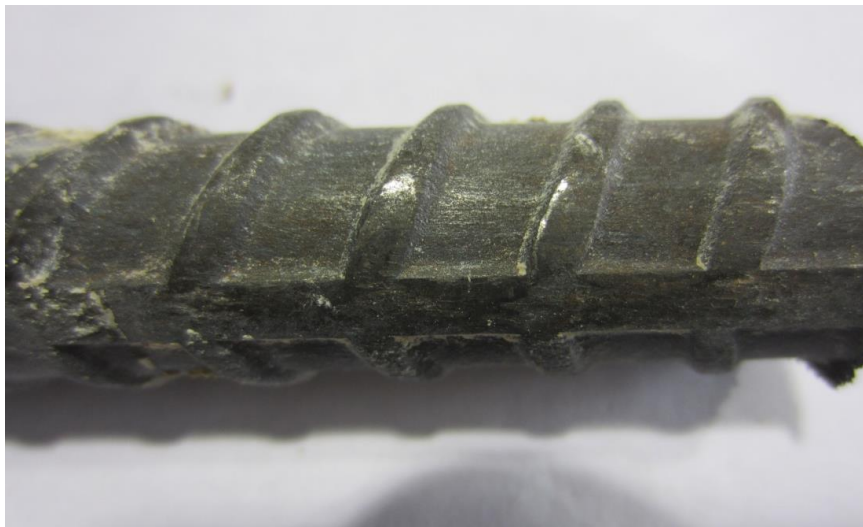
Figure 149. Photo. Close-up view of the bar shown in figure 148.

Figure 148 shows an SSR1 sample exposed to the lowest $[Cl^-]_{\text{interface@2-inch}}$ of 774 ppm in slab 5R, and figure 149 shows a close-up view of the same bar. It shows negligible corrosion product formed in some surface areas.

Figure 150 shows another SSR1 bar exposed to the highest $[Cl^-]_{\text{interface@2-inch}}$ of 4,153 ppm in slab 5R, and figure 151 shows a close-up view of the same bar exhibiting the same kind of corrosion product observed on the bar shown in figure 149. Figure 152 through figure 154 also show similar surface condition, regardless of $[Cl^-]_{\text{interface@2-inch}}$.

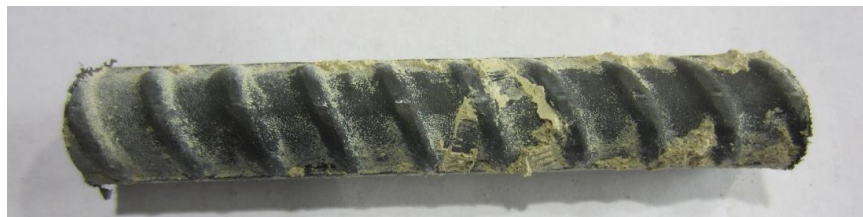
Figure 155. Photo. Extracted LSS1 from slab 6L with a 6-1 core ID ($[Cl^-]_{\text{interface@2-inch}} = 621$ ppm).

Figure 155 shows an LSS1 sample exposed to the lowest $[Cl^-]_{\text{interface@2-inch}}$ of 621 ppm in slab 6L, and figure 156 shows a close-up view of the same bar. It shows a light superficial corrosion product formed in some surface areas.

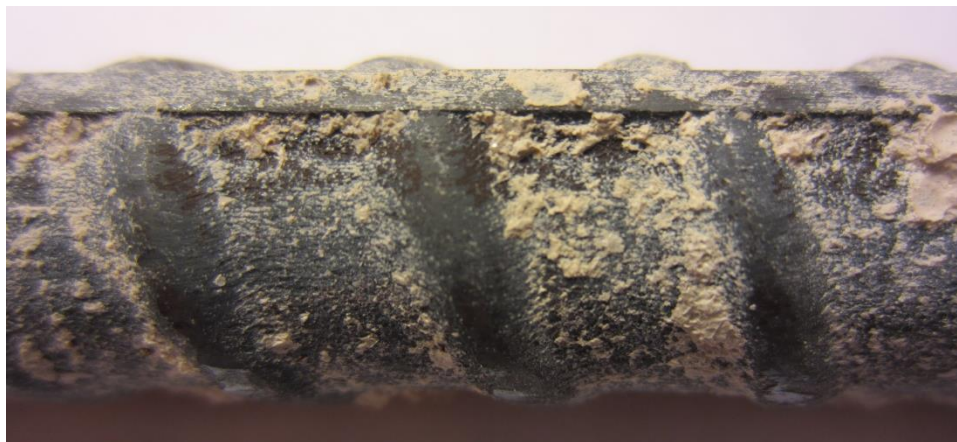
Figure 158. Photo. Close-up view of the bar shown in figure 157.

Figure 157 shows another LSS1 bar exposed to the highest $[Cl^-]_{\text{interface@2-inch}}$ of 2,936 ppm in slab 6L, and figure 158 shows a close-up view of the same bar exhibiting the same kind of corrosion product observed on the bar shown in figure 156. This bar material also exhibited negligible corrosion regardless of $[Cl^-]_{\text{interface@2-inch}}$.

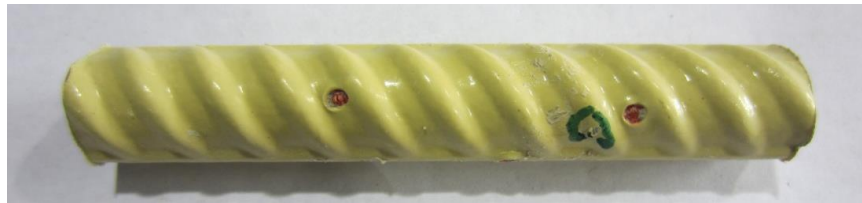
Figure 159. Photo. Extracted DCR from slab 6R with a 1-1 core ID ($[Cl^-]_{\text{interface@2-inch}} = 305$ ppm).

Figure 159 shows a DCR sample exposed to the lowest $[Cl^-]_{\text{interface@2-inch}}$ of 305 ppm in slab 6R. Figure 160-A shows a close-up view of the same bar before coat removal, and figure 160-B shows the condition of an artificial defect and a knife adhesion test spot after the coating was peeled off. A moderate disbondment without corrosion can be seen. Figure 161 shows two other areas with the coating removed on the same bar. Similar to figure 160, a moderate coating disbondment was observed. A black ring around the artificial coating defect suggests that the coating disbondment took place in the radial direction, followed by corrosion of the zinc coating in the presence of water and chloride beneath the delaminated coating. Figure 162-A shows the condition of peeled coating, and Figure 162-B shows coating backside that revealed zinc residue adhered to the peeled epoxy coating.
