A Comparative Laboratory Study of Metallic Reinforcing Steels for Corrosion Protection of Reinforced Concrete Bridge Structures

PUBLICATION NO. FHWA-HRT-15-078

JUNE 2018

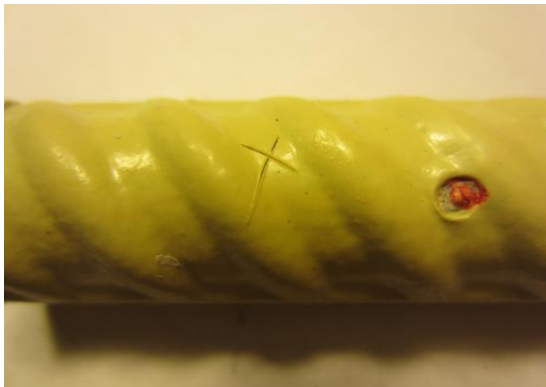
Figure 160. Photos. Close-up views of the bar shown in figure 159.

Figure 159 shows a DCR sample exposed to the lowest $[Cl^-]_{\text{interface@2-inch}}$ of 305 ppm in slab 6R. Figure 160-A shows a close-up view of the same bar before coat removal, and figure 160-B shows the condition of an artificial defect and a knife adhesion test spot after the coating was peeled off. A moderate disbondment without corrosion can be seen. Figure 161 shows two other areas with the coating removed on the same bar. Similar to figure 160, a moderate coating disbondment was observed. A black ring around the artificial coating defect suggests that the coating disbondment took place in the radial direction, followed by corrosion of the zinc coating in the presence of water and chloride beneath the delaminated coating. Figure 162-A shows the condition of peeled coating, and Figure 162-B shows coating backside that revealed zinc residue adhered to the peeled epoxy coating.

A. Before coating removal.

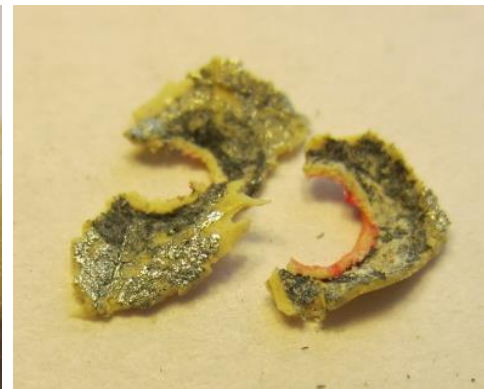
Figure 162. Photos. Removed coating from the bar shown in figure 159.

B. Backside of the removed coating.

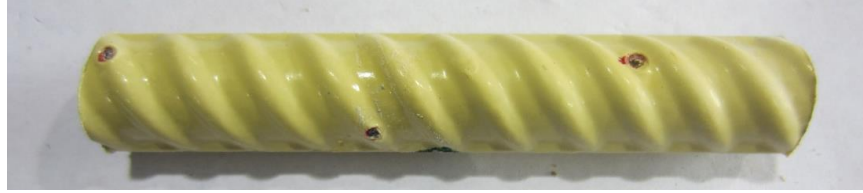
Figure 163. Photo. Extracted DCR from slab 6R with a 1-3 core ID ($[Cl^-]_{interface@2-inch} = 2,138 \text{ ppm}$).

Figure 163 shows another DCR bar exposed to the highest $[Cl^-]_{interface@2-inch}$ of 2,138 ppm in slab 6R, and figure 164 shows a close-up view of the same bar containing an artificial coating defect filled with corrosion product. Small coating cracks were also formed around the defect. Figure 165-A shows a severely corroded area beneath the coating defect shown in figure 164. Figure 165-B shows the bar condition after the delaminated coating was completely removed. The exposed area exhibited the typical corrosion morphology of steel surrounded by gray-colored zinc corrosion product. The fine coating cracks were caused by active corrosion under the delaminated coating. The coating fragments removed from a corroding area shown in figure 166 showed a mixture of intact zinc layer and reddish corrosion product on their backside.

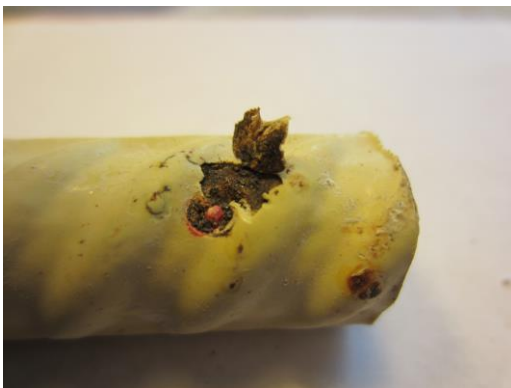
Figure 165. Photos. Autopsy of the area shown in figure 164.

A. After partial coating removal.

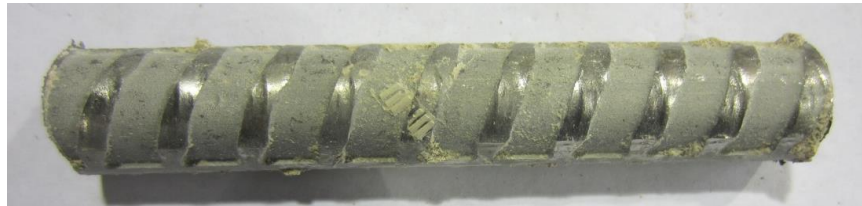
Figure 167. Photo. Extracted SSR2 from slab 7L with a 1-3 core ID ($[Cl^-]_{\text{interface@2-inch}} = 330$ ppm).

Figure 167 shows an SSR2 sample exposed to the lowest $[Cl^-]_{\text{interface@2-inch}}$ of 330 ppm in slab 7L, and figure 168 shows another SSR2 bar exposed to the highest $[Cl^-]_{\text{interface@2-inch}}$ of 2,452 ppm in the same slab section.

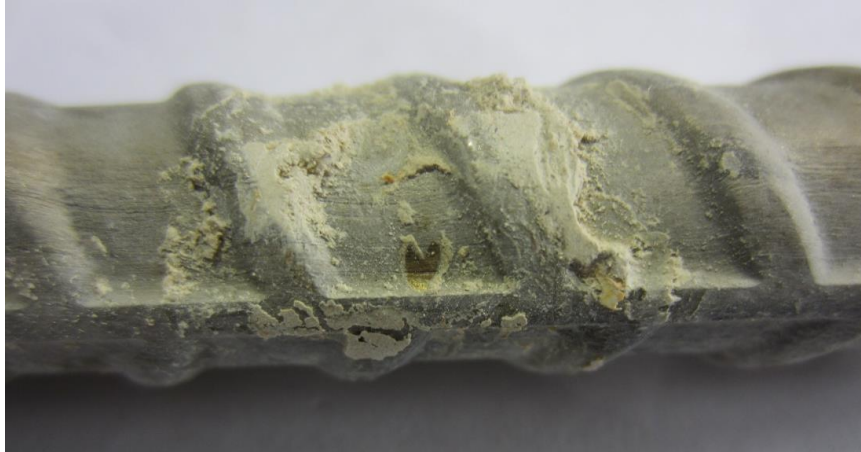
Figure 174. Photo. Close-up view of the bar shown in figure 173.

Figure 173 shows another SSR3 bar exposed to the highest $[Cl^-]_{\text{interface@2-inch}}$ of 4,288 ppm in the same slab section, and figure 174 shows a close-up view of the same bar exhibiting a small corrosion spot.

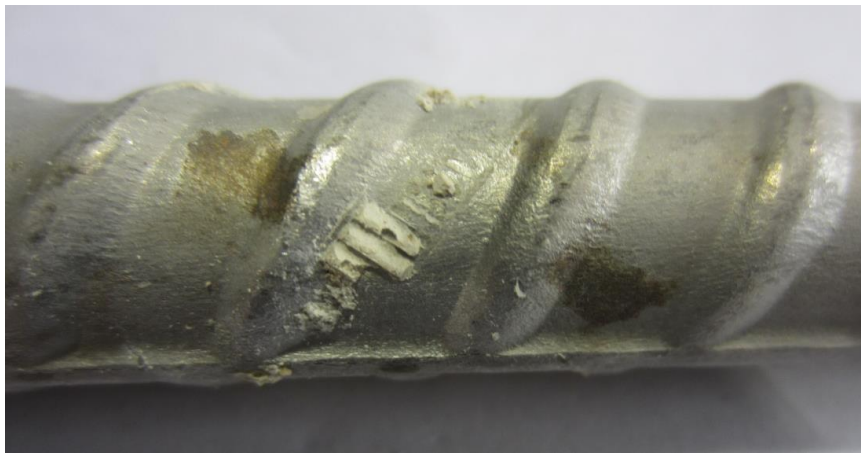
Figure 175 and figure 176 show distinctive signs of surface corrosion, which is rarely seen on solid stainless steel bars.

Figure 175. Photo. Rust on the bar shown in figure 173.

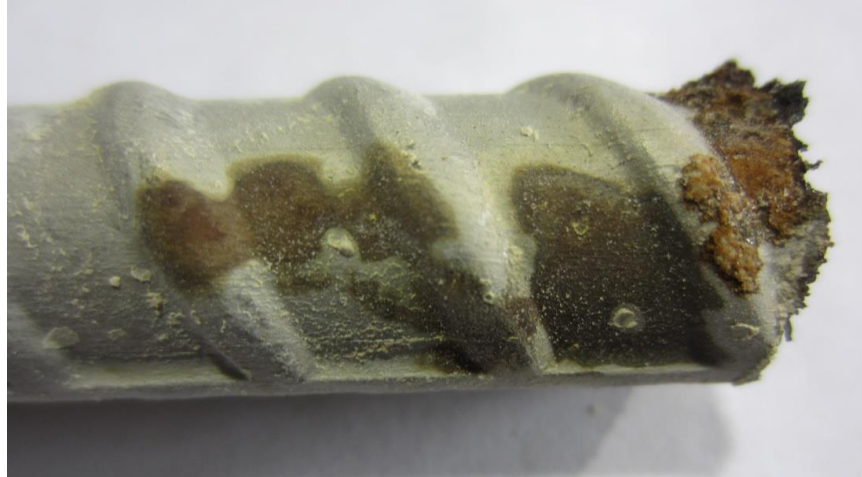
Figure 176. Photo. Powderous corrosion product on an SSR3 bar sample from slab 7R with a 2-3 core ID ($[Cl^-]_{\text{interface@2-inch}} = 4,012 \text{ ppm}$).

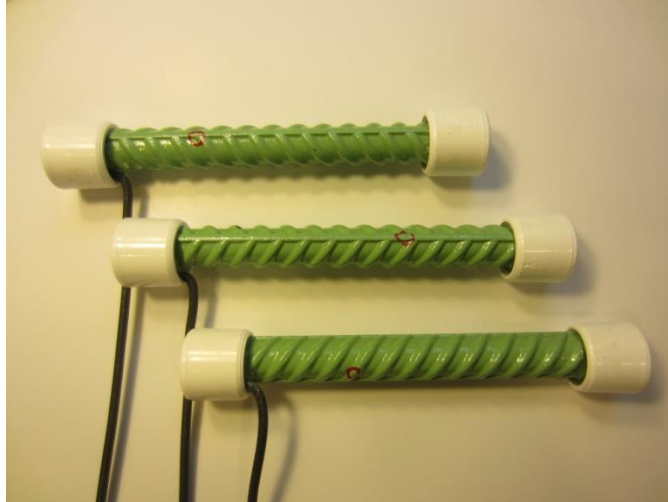
Figure 182. Photo. ECR bars.

A total of 39 cylindrical concrete specimens were cast using 4- by 8-inch plastic molds. They were fabricated to measure OCPs and rates of corrosion by the LPR method. Figure 181 through figure 193 show conditions of the individual bar types prior to casting. Three bars of each type were prepared. Each bar was 6 inches long and was suspended from a wood strip that was spanned over the mouth of the mold, as shown in figure 194.

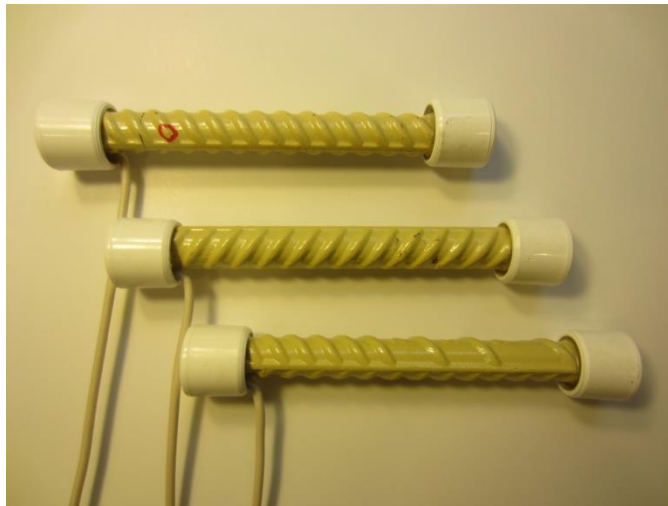
Figure 183. Photo. DCR bars.

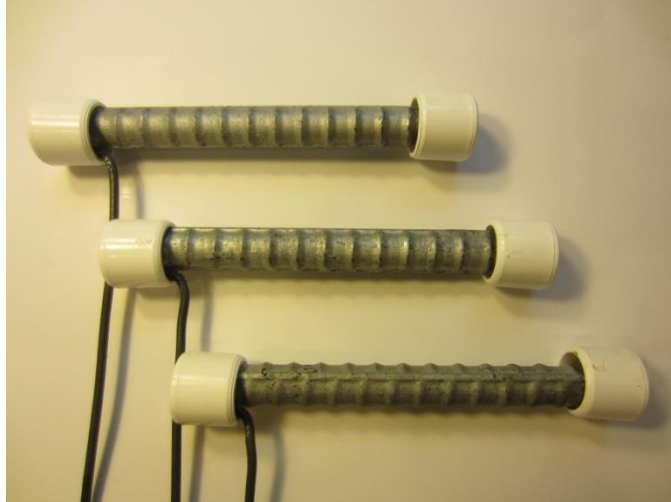
Figure 184. Photo. HDG bars.

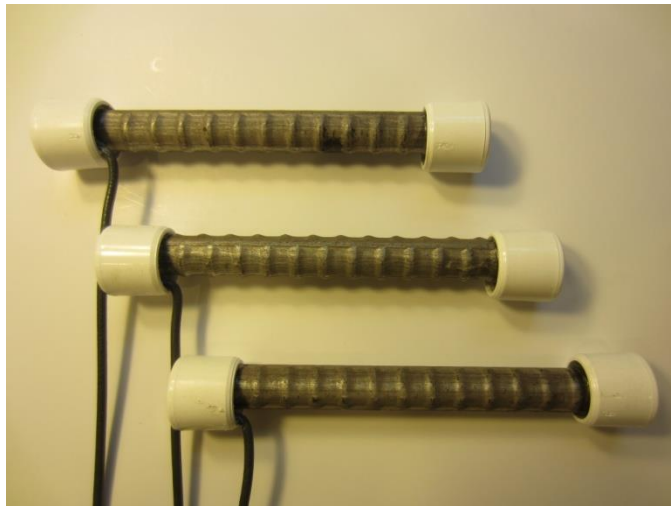
Figure 185. Photo. SCR1 bars.

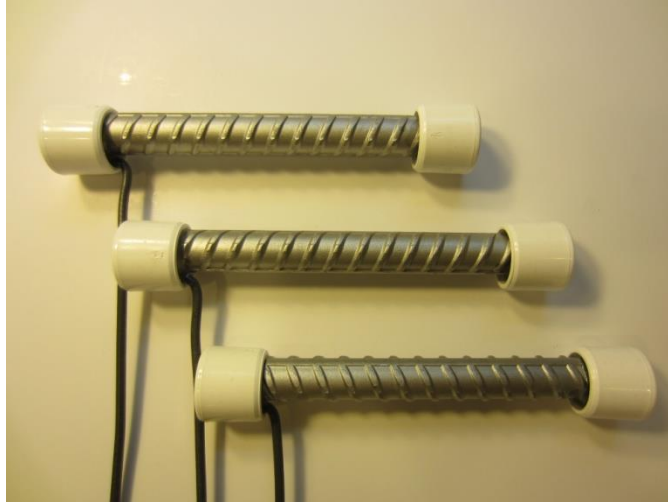
Figure 188. Photo. Pickled SSR1 bars.

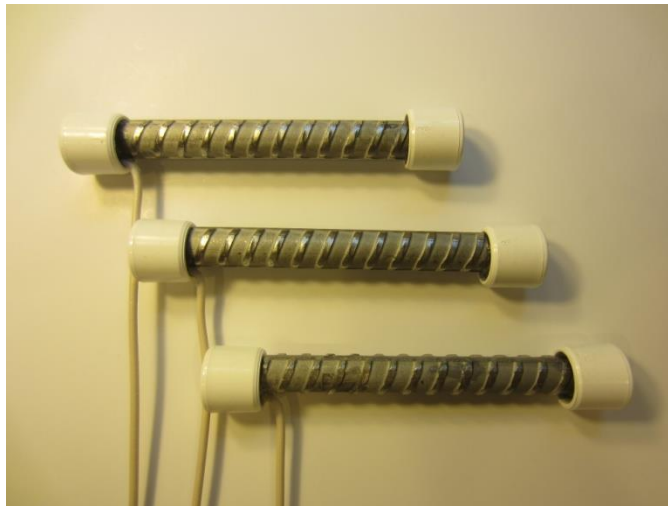
Figure 189. Photo. SSR2 bars.

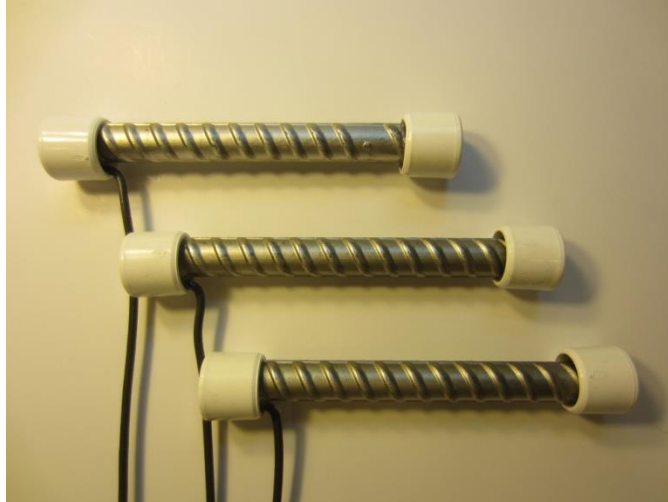
Figure 190. Photo. SSR3 bars.

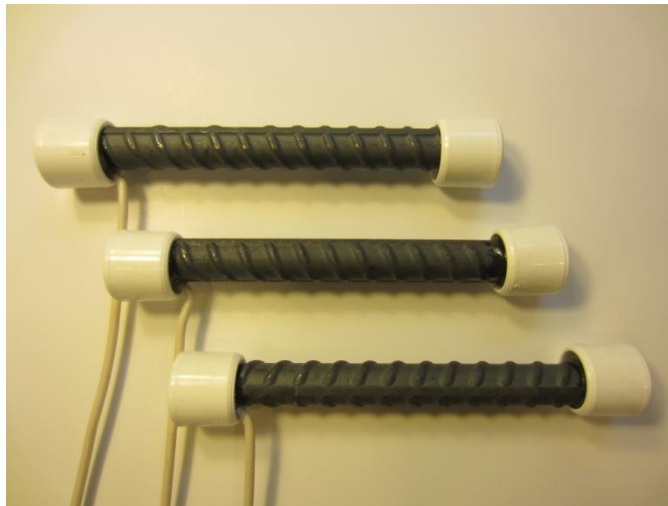
Figure 191. Photo. HSR bars.

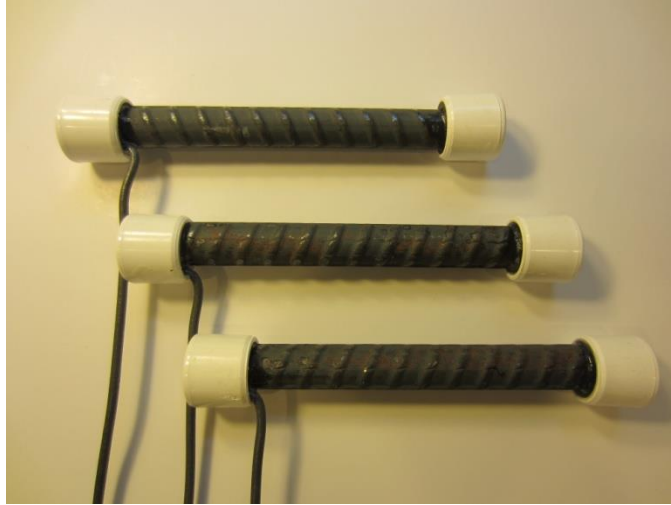
Figure 192. Photo. LSS1 bars.

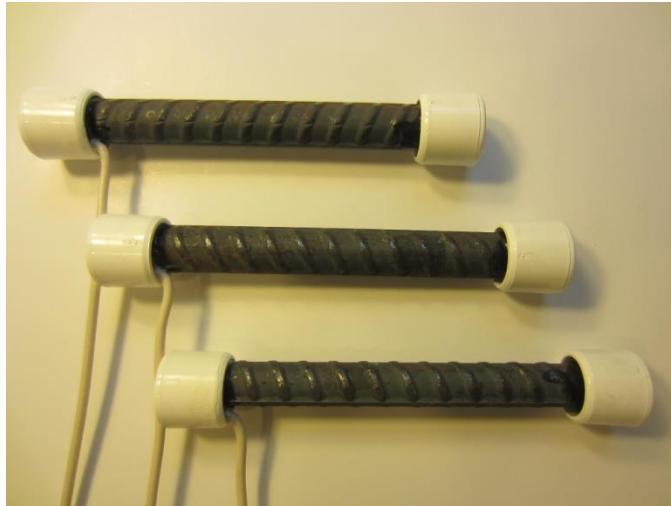
Figure 193. Photo. LSS2 bars.

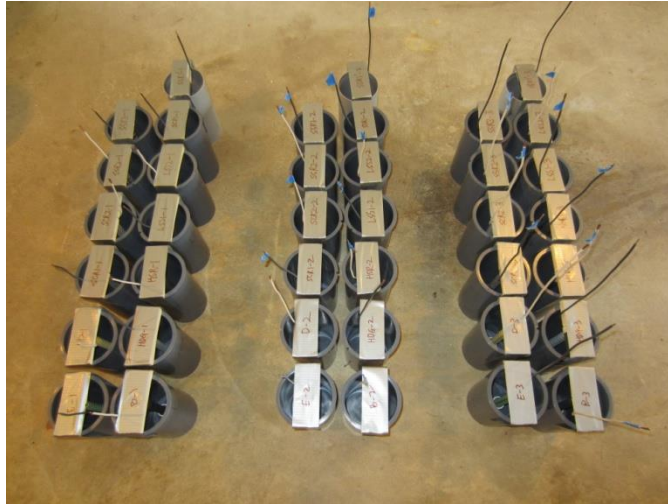
Figure 197. Photo. 4- by 8-inch cylindrical molds ready for casting.

Commercial ready-mix concrete bags (60 lb each) were used to fabricate all of the concrete specimens. The recommended amount of mixing water was used to ensure good-quality concrete representing typical old-generation bridge deck concrete. Figure 197 shows 39 cylindrical molds before pouring concrete. Figure 198 and figure 199 show slab molds that contained the preassigned bars and a stainless steel mesh at the bottom of the mold.

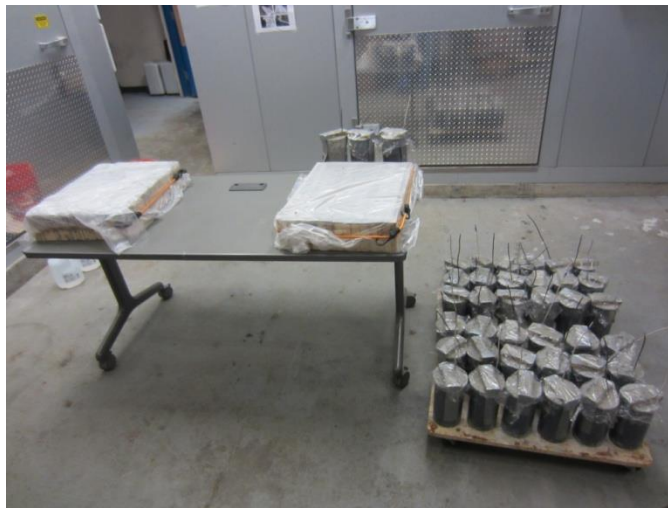
After concrete casting, the specimens covered with plastic sheeting went through 28-d air curing in the laboratory. Figure 200 shows the concrete specimens being cured, and Figure 201 shows the specimens after they were demolded.

Figure 200. Photo. Specimen curing.

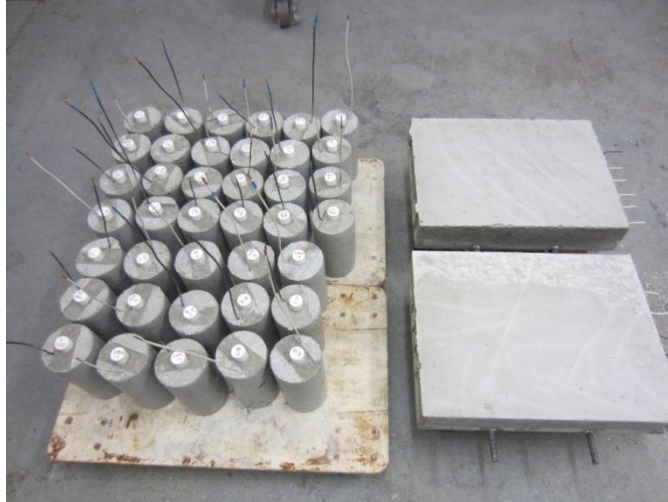
Figure 201. Photo. Demolded concrete specimens.

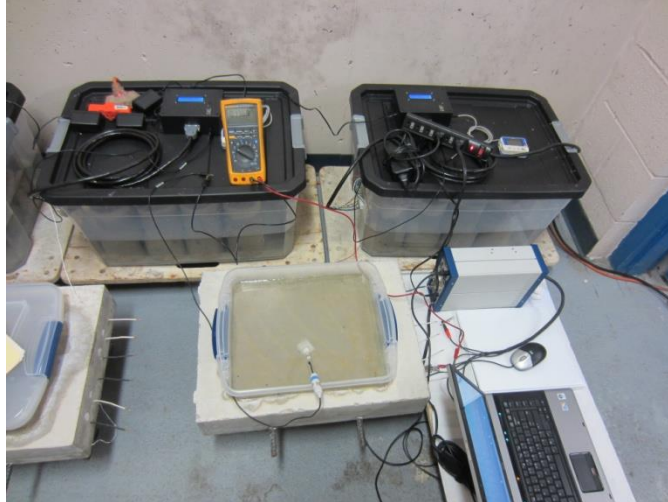
Figure 203. Photo. OCP and $I_{macro-cell}$ measurements of slab #2 specimen.

This follow-up study employed three electrochemical testing methods: OCP for all specimens, rate of corrosion by LPR method for the cylindrical specimens, and $I_{macro-cell}$ for the slab specimens. At the beginning of the experiment, baseline data were collected. Figure 202 shows the OCP and LPR measurements in progress. The two-electrode system and a potentiostat were used for the LPR measurements. To avoid chloride contamination in the reference electrode (RE) being submerged in the salt solution, a glass body silver–silver chloride (Ag/AgCl) RE was used for the potential readings instead of conventional CSE. Figure 203 shows the OCP and $I_{macro-cell}$ measurement of the slab #2 specimen.

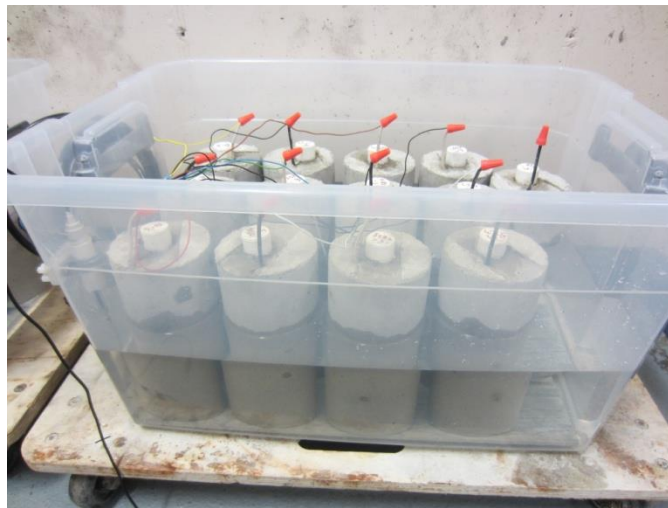
After the baseline data were collected, the cylindrical specimens were divided into three groups and placed in three plastic containers that were filled with 15 weight percent NaCl solution, as shown in figure 204. A temporary heat tent was fabricated with insulation boards for the specimens, as shown in figure 205. With three flood lamps and two digital thermostats, temperature inside the heat tent was maintained at 85–90 °F. Even though the temperature was set at 104 °F as the original study, it could not reach the target temperature due to poor insulation quality of the heat tent.

Figure 204. Photo. Cylindrical specimens in a plastic container.

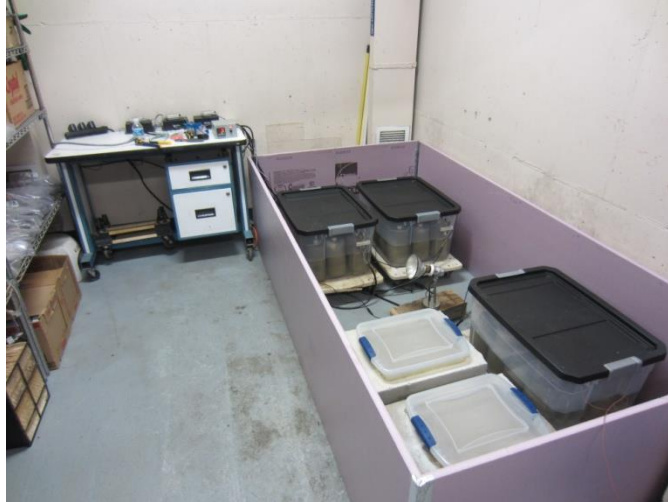
Figure 205. Photo. Arrangement of specimens in a temporary heat tent with lid removed.
