JOINT TRANSPORTATION RESEARCH PROGRAM

Field Trials of Rapid-Setting Repair Materials

Ram, P. V., J. Olek, and J. Jain. *Field Trials of Rapid-Setting Repair Materials*. Publication FHWA/IN/JTRP-2013/02. Joint Transportation Research Program, Indiana Department of Transportation and Purdue University, West Lafayette, Indiana, 2013. doi: 10.5703/1288284315185.

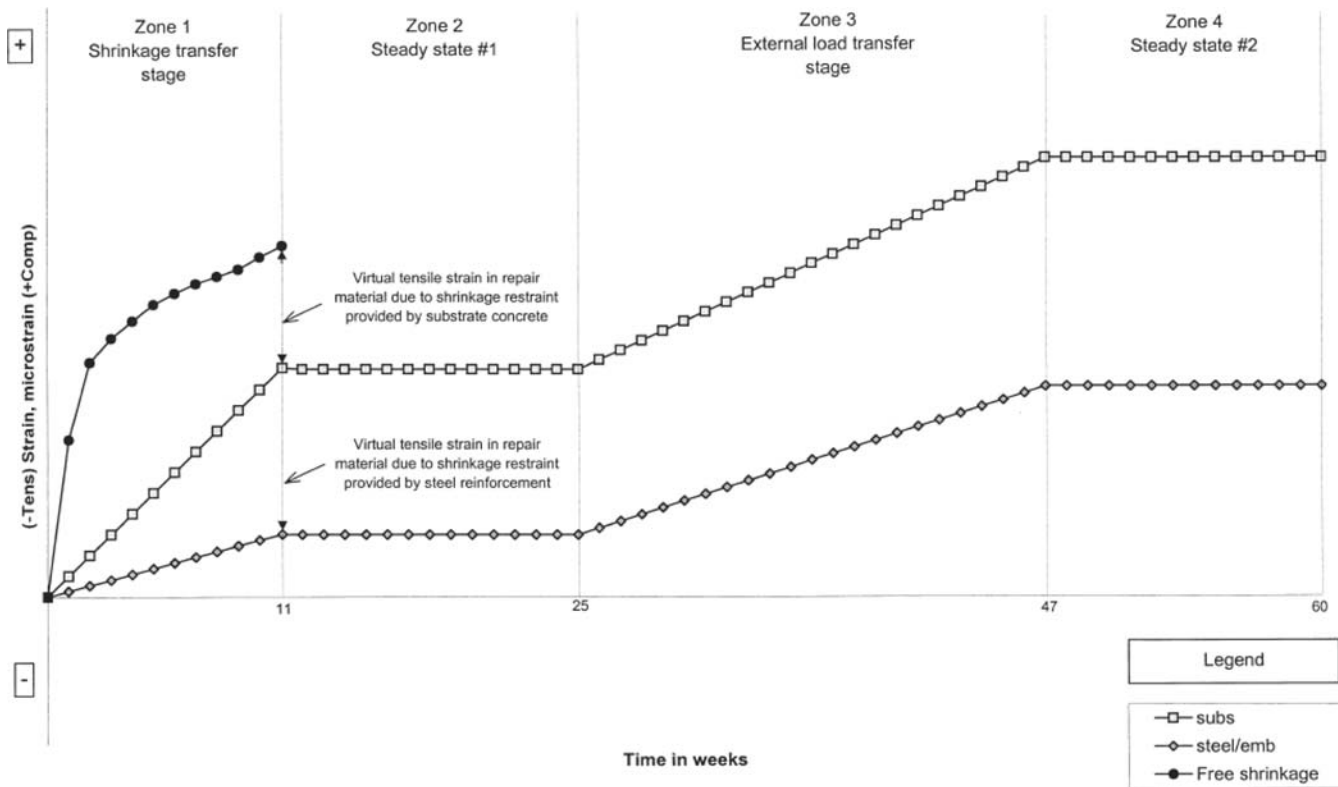
Figure 2.3 Schematic representation of strain distribution with time within a repair patch when $E_{rm} > E_{sub}$ (12).

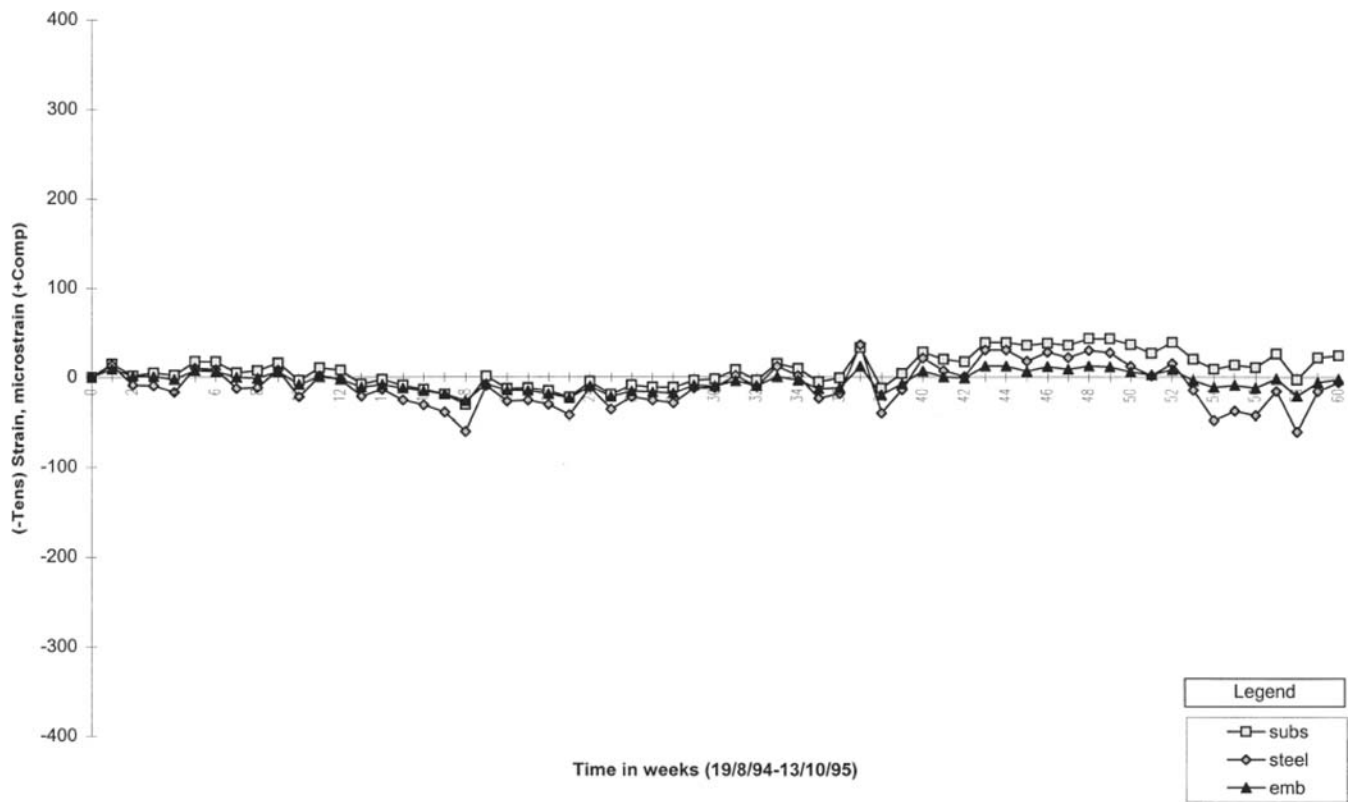
Figure 2.5 Strain-time relationships for repair patch of material G3 (12).

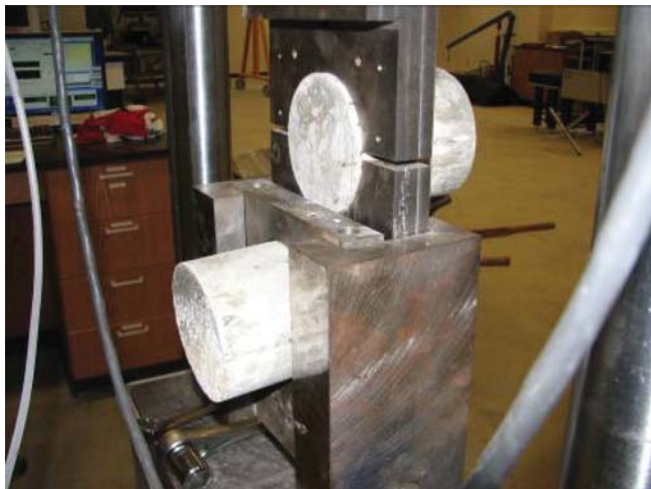
Figure 2.11 Test setup for the Iowa shear test.

The Iowa Shear Test (generally used to evaluate shear bond strengths between asphalt overlays and substrate concrete) is another test method used to determine the shear strength of the bond between new and old concrete. Like in the bi-surface shear test, the interface between the repair material and the concrete substrate in a state of pure shear. The test apparatus consists of a loading jig which can accommodate a 4 in.

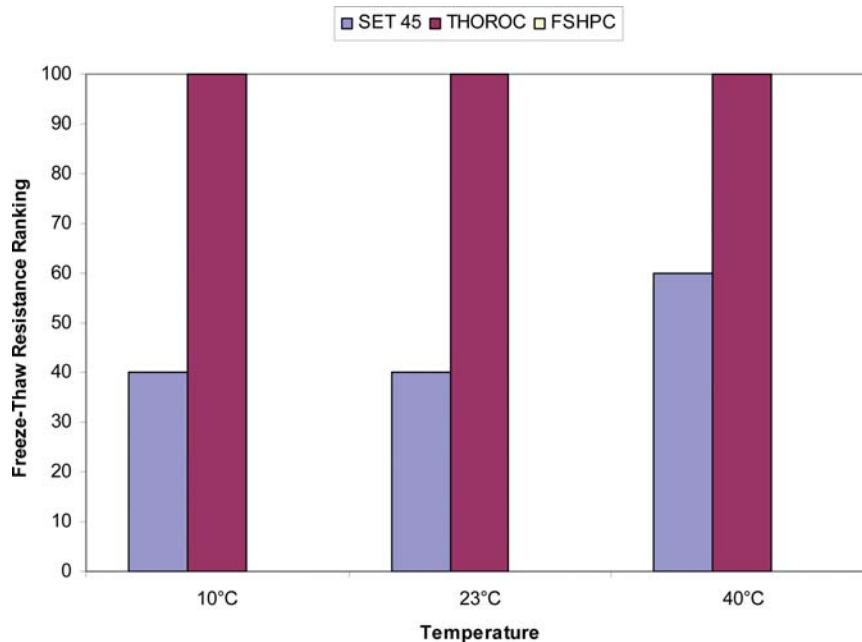
Figure 2.17 Freeze-thaw resistance ranking (21).

The ranking for the freeze-thaw resistance of the materials is shown in Figure 2.17. THOROC exhibited the best freeze-thaw performance in all temperature conditions and FSHPC displayed the worst freeze-thaw

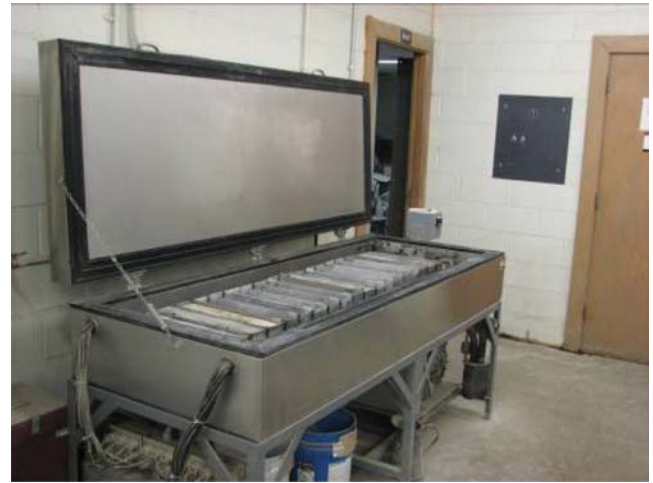
Figure 3.9 Free-thaw chamber.

The freeze-thaw specimens cast in the field were de-molded 12 hours after addition of water and were exposed to the natural environment (stored in conditions similar to the repair site) for 12 days. The specimens were then brought to the laboratory environment and immersed in lime water at room temperature 48 hours before the test. The test for the field specimens was also commenced 14 days after they were cast. A view of the freeze-thaw chamber used for the test is shown in Figure 3.9.

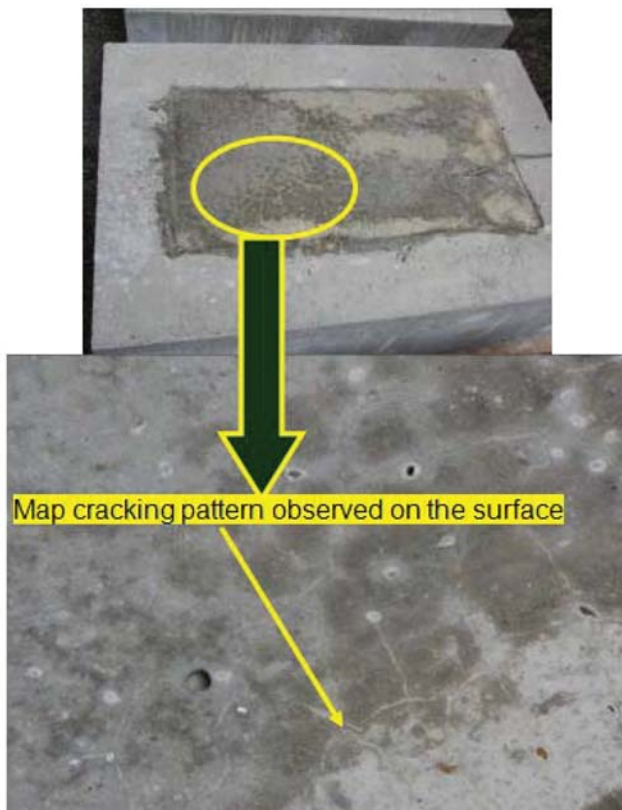
Figure 4.37 Dur-R mock-up repair—close-up view.

- All the mock-up repairs seemed to perform well after 4 months of exposure except for Dur-R which showed a map-cracking pattern on the surface.

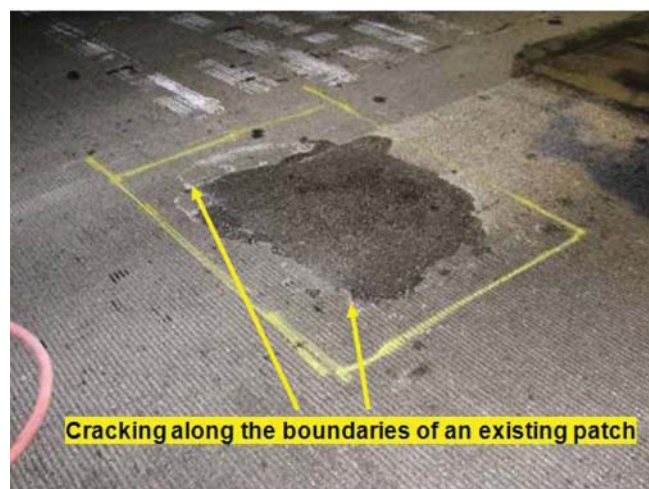
Figure 5.3 Distress I: cracking along boundaries of an existing patch (southbound direction).

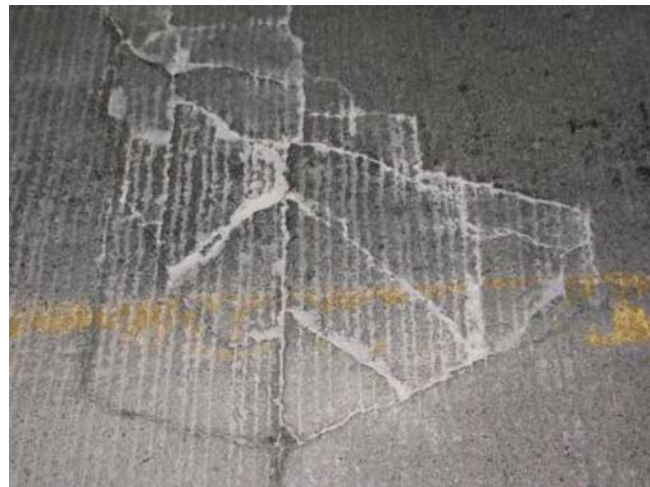
Figure 5.4 Distress II: severe cracking of existing concrete (northbound direction).

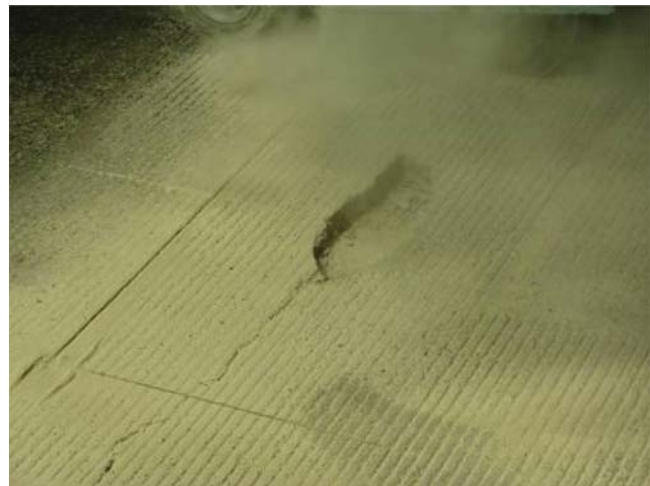
Figure 5.5 Distress III: pothole (spall) in the existing concrete (northbound direction).

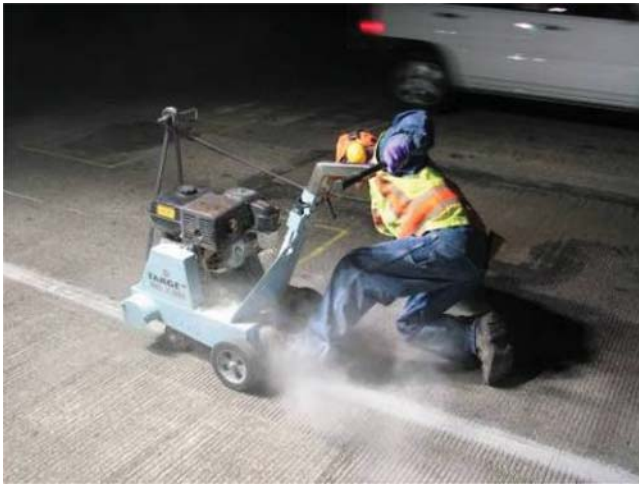
Figure 5.6 Saw-cutting operation.

boundaries of deteriorated areas. The removal of concrete from these areas was accomplished using concrete saws (Figure 5.6) and pneumatic jackhammers (Figure 5.7). If rebars were present, the concrete was removed to the depth of 1 inch below the rebars.

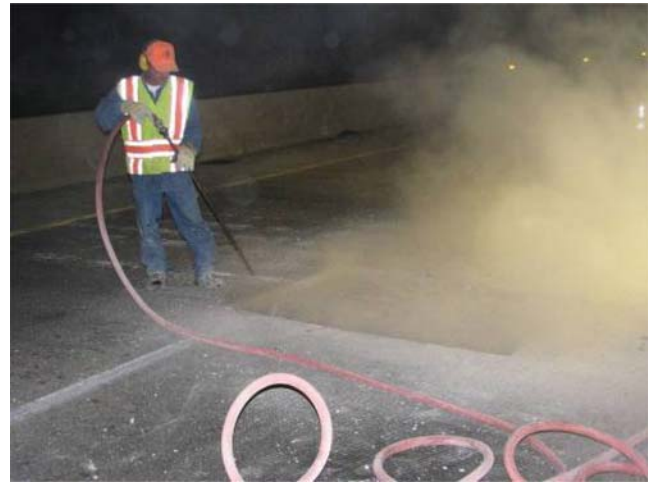
Figure 5.8 Cleaning operation.

The repair area was then cleared using a blast of high pressure air (Figure 5.8). The cleared surface was then wetted to avoid removal of mixture water from the repair material by the existing/dry concrete. An example of repair area prepared for patching is shown in Figure 5.9.

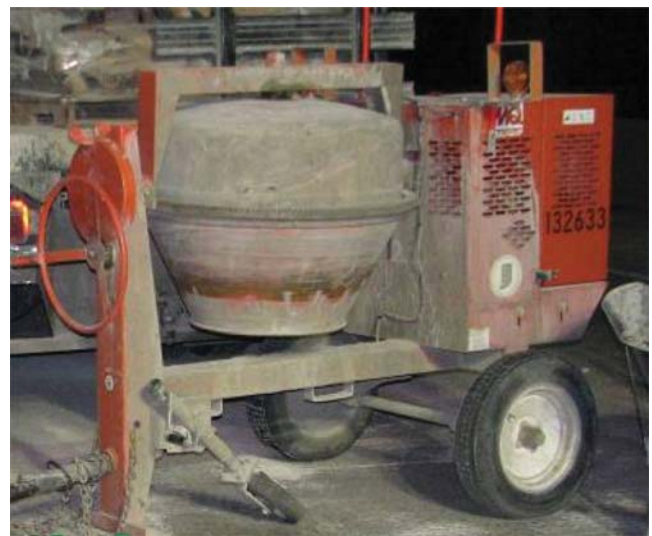
Figure 5.10 Drum mixer used on-site.

After the preparation of the patch area was completed, the repair material was mixed on-site, typically in a drum mixer (for all the materials except SET 45), shown in Figure 5.10 in one or more batches depending upon the size of the patch. For SET 45, a

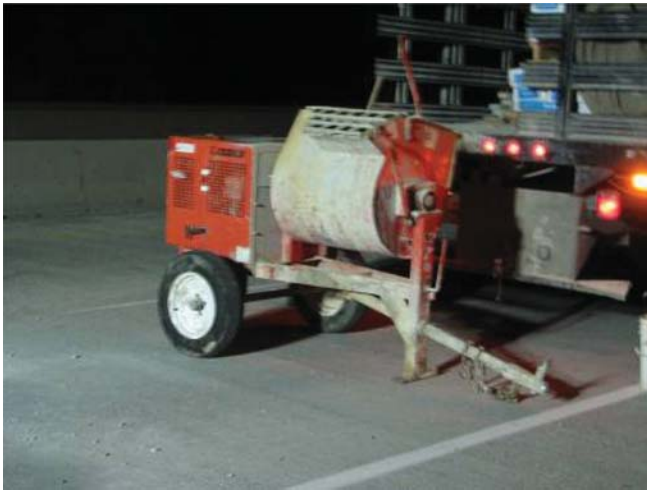
Figure 5.11 Mortar mixer used on-site for SET 45.

mortar mixer was used (Figure 5.11). A three bag mix was typically used for small patches and a six bag mix was used for larger patches.

First, the water and the aggregates were introduced into the mixer and the mixer was switched on. The material was then added into the mixer as the mixing was being carried out. The material was added directly from the bags. The aggregates were not weighed. A judgmental approximation to the mass was performed before they were introduced into the mixer. The water was added using 1 gallon containers. The mix water and the mixing time varied from batch to batch. Based upon the visual observation of the material in the mixer, extra water was added by the manufacturer to achieve better workability.

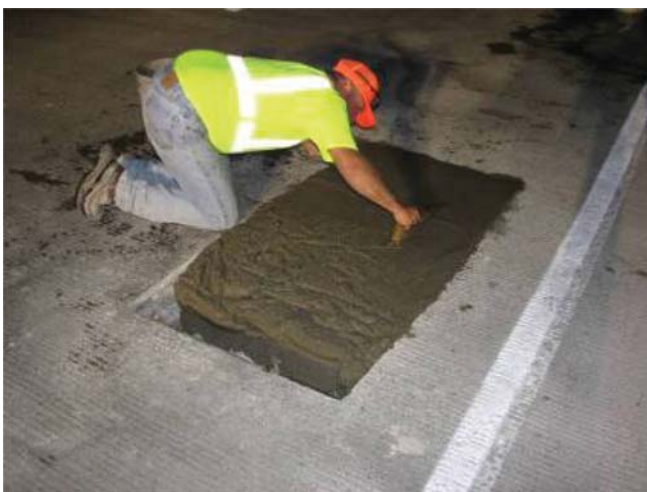
Figure 5.12 Finishing operation.

After mixing, the material was discharged to the wheel barrows and delivered to the place of installation. After discharging from the wheel barrow, the repair material was consolidated in the patch area by tamping with the shovels. The surface of the newly placed patches was finished with concrete trowels (Figure 5.12)

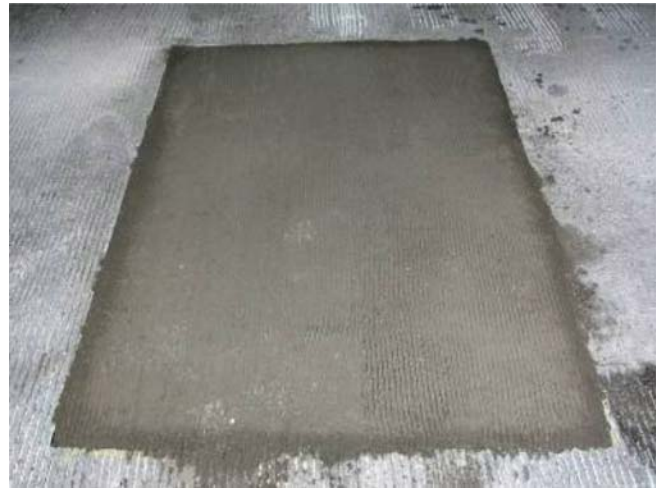
Figure 5.13 Finished patch (HD).

and textured using a broom. Except for TR, no specific curing regime was recommended by the representatives of all other material manufacturers present on site. As a result, those patches were not cured after placement. For TR, the placed material was covered with a plastic sheet. Figure 5.13 shows a sample patch after finishing. More details on the location and installation of the patches using the individual materials are given in section 5.5.

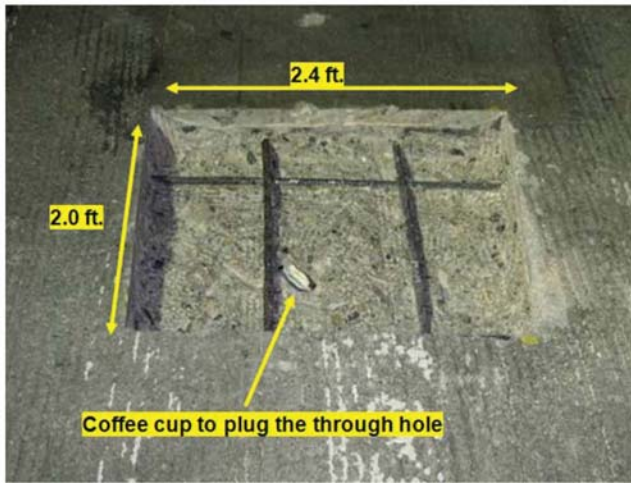
Figure 5.15 HD-50: patch area-II.

The second patch installed with HD-50 is shown in Figure 5.15. This patch was not located along the wheel path of the traffic. A coffee cup can be seen in the image. This was used to block the through-hole (to hold the freshly placed material within the patch) that was created in the bridge deck during the jack-hammering operation. The concrete beneath this repair area was heavily deteriorated which led to the formation of the through-hole while the concrete was being chipped out in preparation for the placement of the patch.

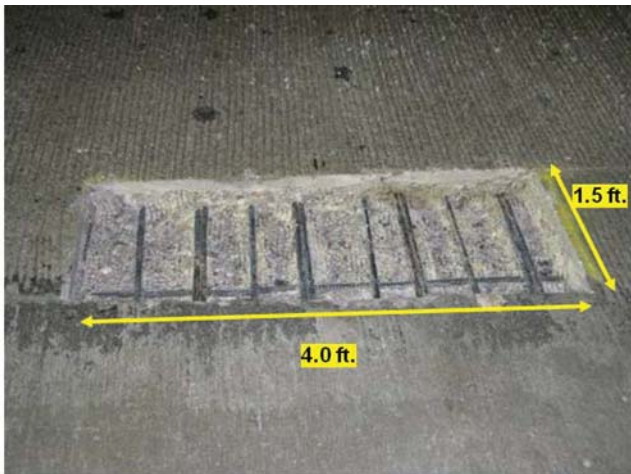
Figure 5.16 HD-50 patch area-III.

The third patch installed with HD-50 is shown in Figure 5.16. This patch was located along the dividing line. All HD-50 mixes produced were very consistent with respect to the appearance and the workability aspects.

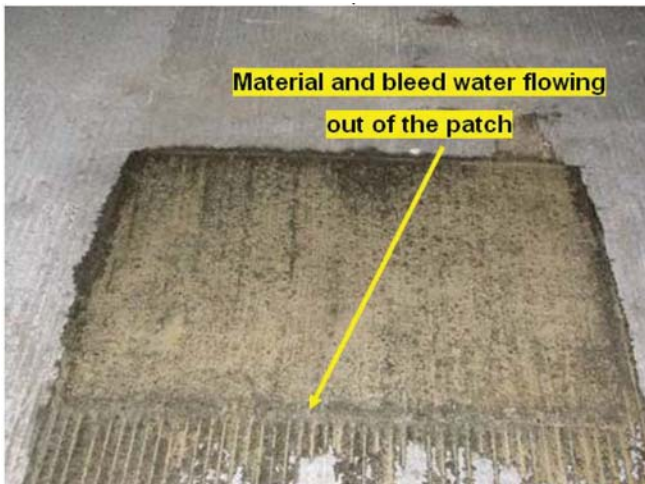
Figure 5.21 SQ-1000: finished patch.

The finished SQ-1000 patch is shown in Figure 5.21. As can be seen from the figure, the material exhibited excessive bleeding. The mix was slightly over-watered which was the cause for the bleeding. Also, due to the slope of the surface, the material in its fresh state flowed out of the patch, which resulted in uneven edges of the hardened patch.

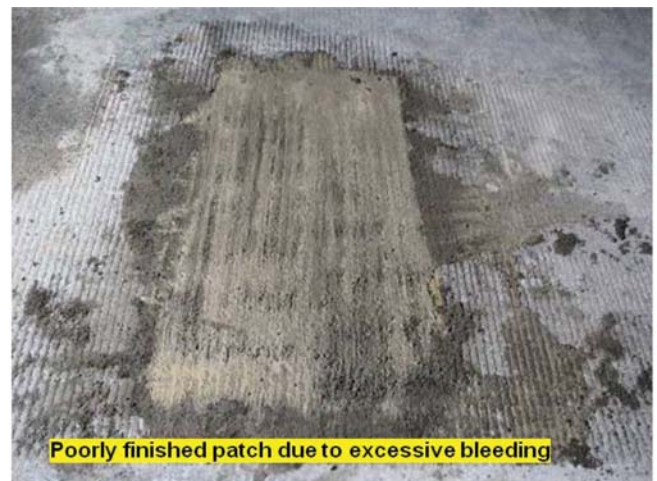
Figure 5.24 SQ-2500: finished patch-I.

The finished patches are shown in Figures 5.24 and 5.25. The mix in patch-I had excessive water which led to heavy bleeding and poor finishing (Figure 5.24). The mix in patch-II had better consistency and, as a result, did not show signs of excessive bleeding upon finishing.

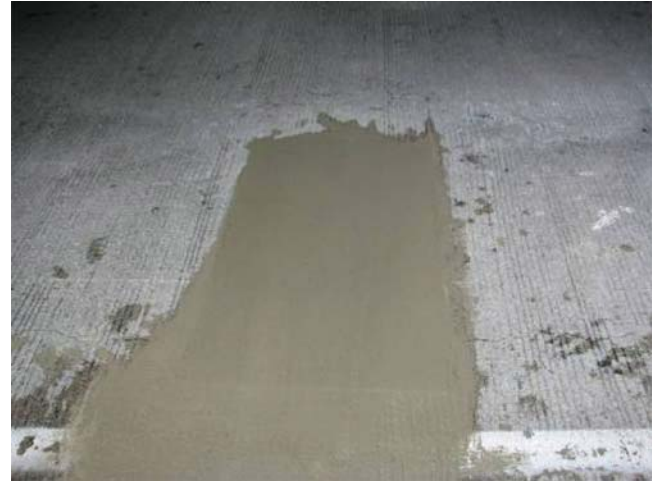
Figure 5.28 FX-928: finished patch-I.

All mixes produced with FX-928 were very consistent with respect to the workability and the appearance. The finished patches are shown in Figures 5.28 and 5.29.

The edges of the patches were not properly sealed and small gaps were visible between the new and the old concrete.

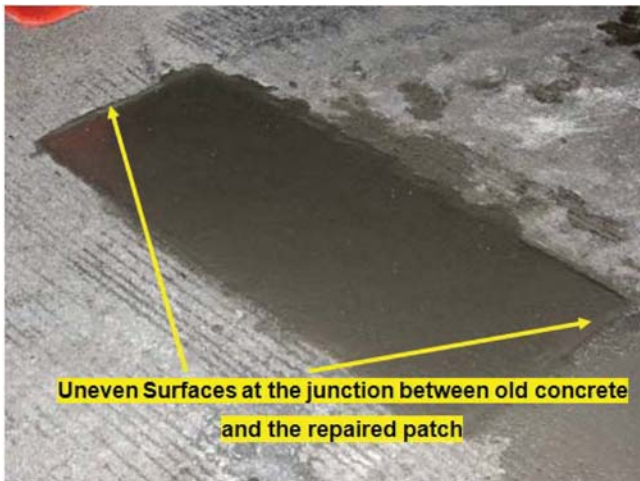
Figure 5.37 SET 45 Hot Weather: finished patch.

delayed setting time, the material flowed out of the patch due the grade of the surface, leading to uneven surfaces near the edges.

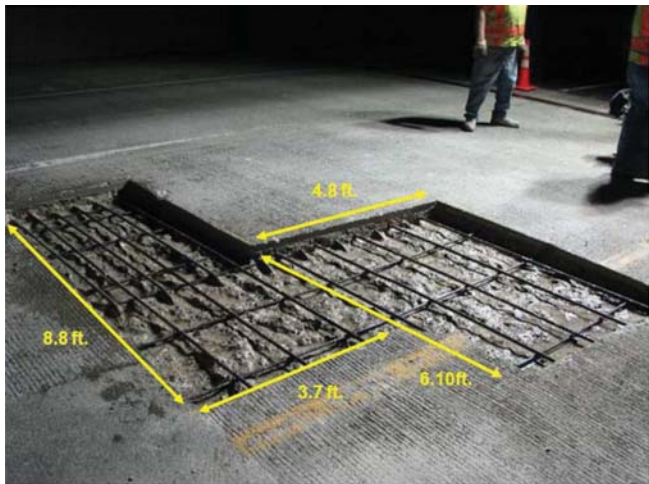
Figure 5.40 Duracal-AE and Duracal-AE-F: patch area.

As mentioned earlier, each of these two materials was installed in a single patch beside each other—due to the large size of the patch. This was approved by the material manufacturer representative present on site, who confirmed that placing the two materials side-by-side will not result in any compatibility issues as the constituent ingredients in both binders are the same—the only difference being the added fibers. The patch prepared for repair is shown in Figure 5.40. The patch was located along the wheel path (northbound direction).

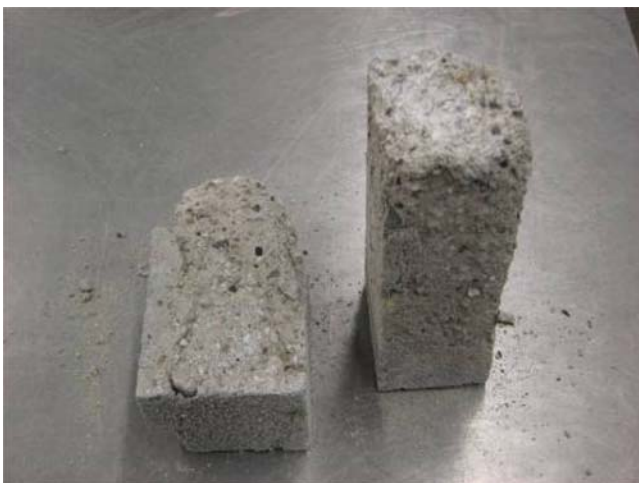
Figure 8.2 SET 45-R specimens after 30 F-T cycles.

The appearance of the SET 45-R specimens after 30 F-T cycles is shown in Figure 8.2. It is quite obvious that the specimens were severely damaged. The appearance of these F/T specimens was very similar to the appearance of the deteriorated patch constructed using the same the SET 45-R material (see Figure 8.3).

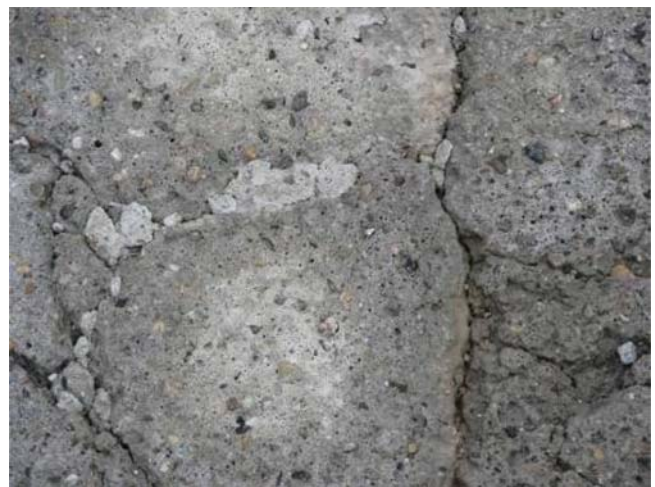
Figure 8.3 Appearance of the SET 45-R material in the deteriorated patch.

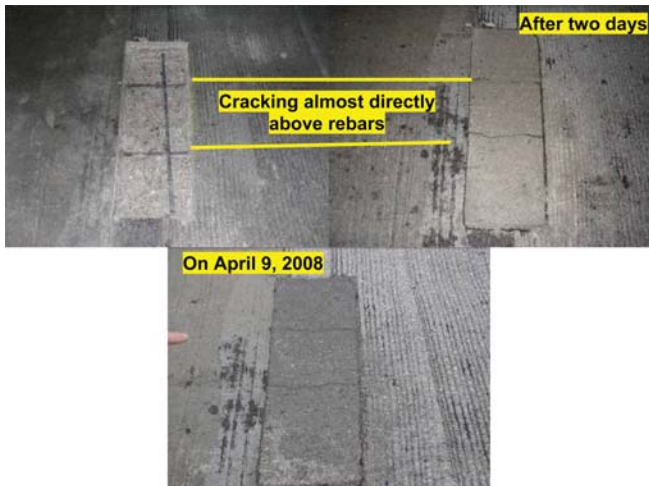
Figure A.9 SikaQuick-2500 patch-II: overview.

in earlier cases, these patches also underwent abrasion along the edge in the direction of the traffic.

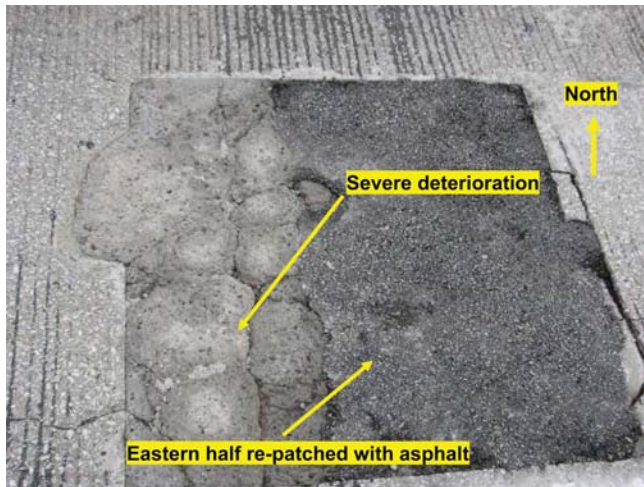
Figure A.13 SET 45 Regular patch.

The SET 45 Regular patch (Figure A.13) had undergone the most severe deterioration. The eastern half of the patch had completely deteriorated in the freezing weather and an emergency closure was imposed on that section of the bridge-deck during the winter to patch the deteriorated section with asphalt concrete. The west-end of the patch was falling apart at the time of inspection and this patch will have to be replaced in the near future. It is very evident that the SET 45 Regular material does not work well with the locally available pea-gravel aggregate used for extension purposes.

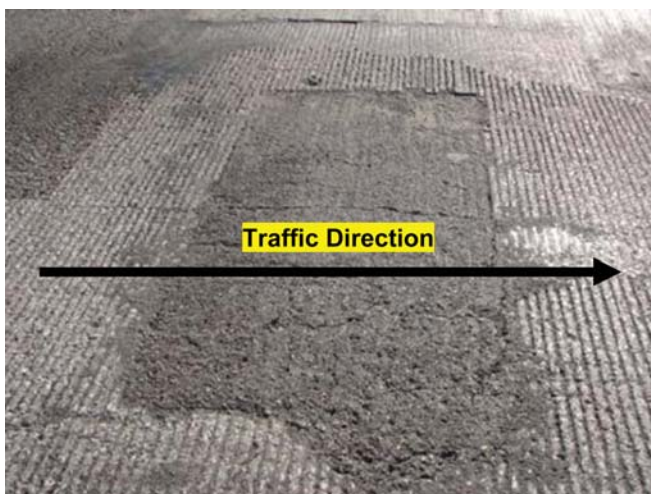
Figure B.5 SikaQuick-2500 patch-I.

Figure B.5 shows a view of the SikaQuick-2500 patch-I. The patch had undergone moderate scaling and had developed multiple cracks on the surface. The poor performance of the

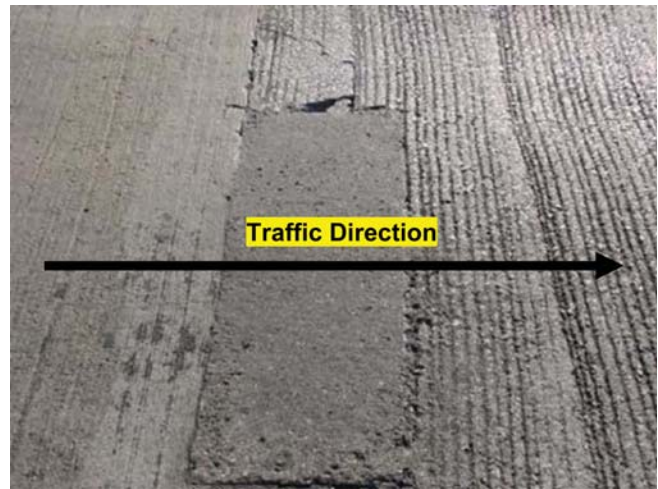
Figure B.6 SikaQuick-2500 patch-II.

patch can be attributed to the improper mix proportioning of the material during the installations. As in the case of SQ-1000, the SQ-2500 patches had extra water added at the time of mixing.

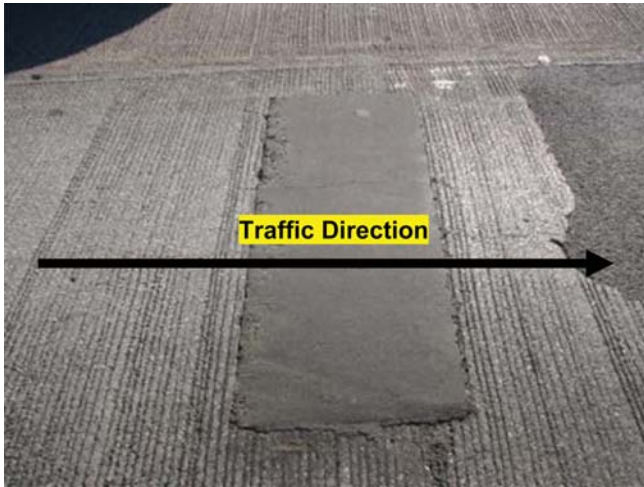
Figure B.9 ThoRoc 10-60 patch.

During the previous inspection, the patch contained only one crack. The overall condition of the patch has not changed much since the last inspection.

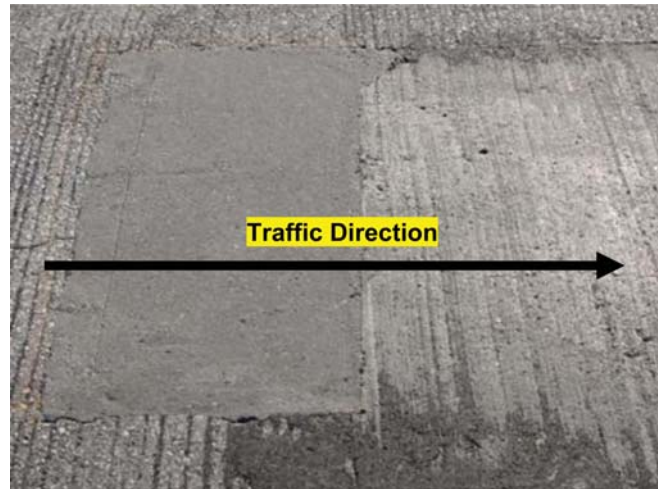
Figure B.11 SET 45 Hot Weather patch that has been replaced.

The Set 45 Hot Weather patch has also been completely replaced by the same material which was used to replace the Set 45 Regular patch. The Set 45 Hot Weather patch area that has been replaced by another material is shown in Figure B.11.

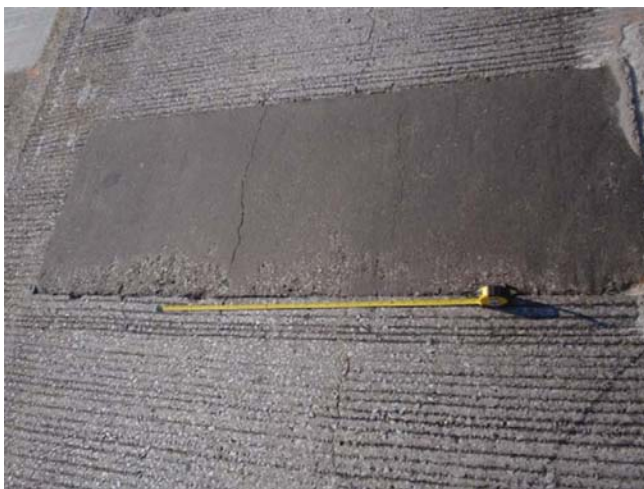
Figure C.8 ThoRoc 10-60.

Figure C.8 shows the condition of the ThoRoc 10-60 patch. The patch exhibited two cracks along the direction of the traffic which were first observed during the 2009 inspection. No more cracks formed after that and the overall condition of the patch has not degraded much since the last inspection.

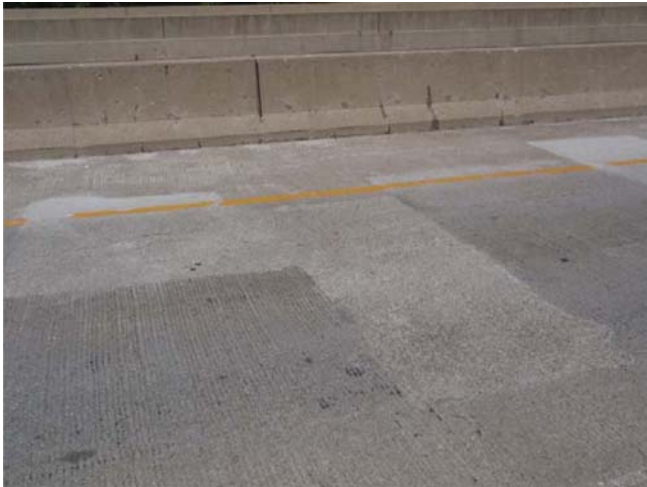
Figure C.12 Duracal AE Additional patches inspection.

Figure C.12 shows the Duracal AE patches which are in good condition.

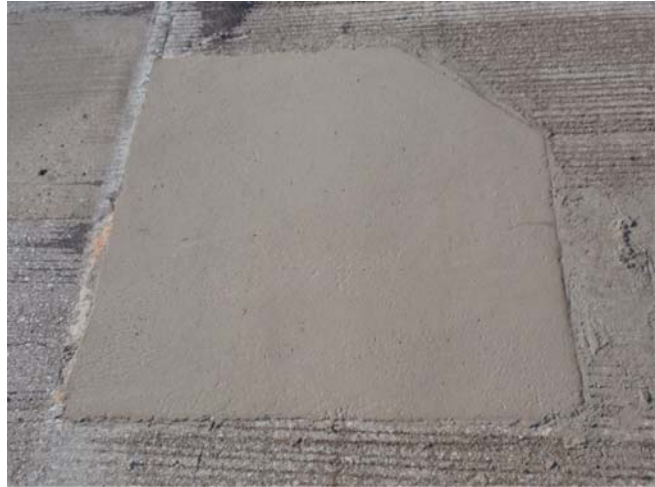
Figure C.14 Fastrak patch-I.

Figure C.14 to Figure C.16 show patches installed using Fastrak material. It was observed that Fastrak material was very cohesive at the time of placement and was very easy to work with. Only one little crack was observed in patch-I during the current inspections of these 2 weeks old patches.

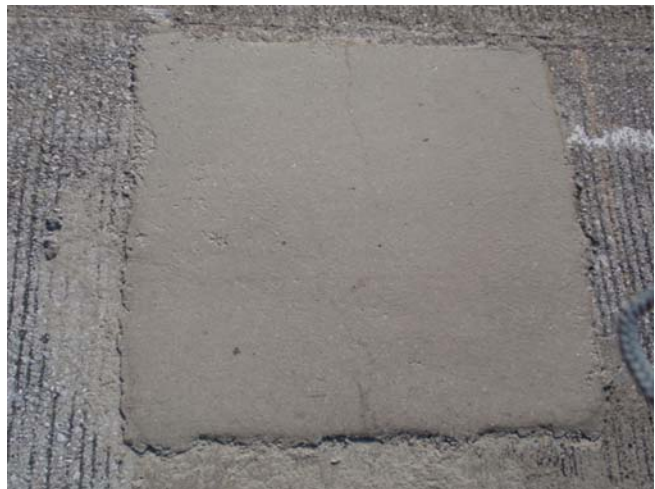
Figure C.15 Fastrak patch-II.

Patches II and III also exhibited some cracking but their overall condition was very good, even at the integrate with the old concrete.

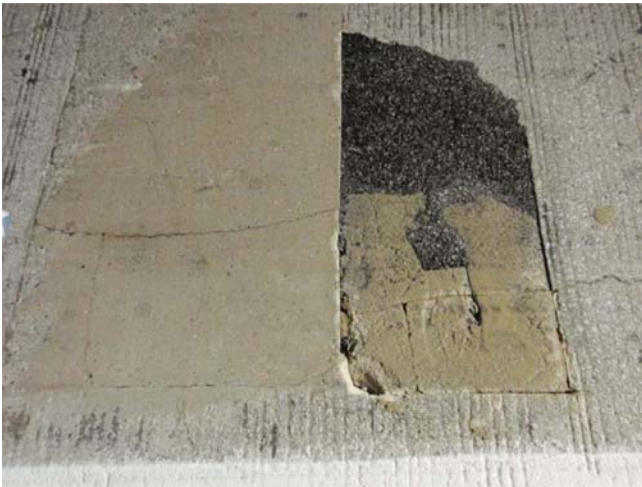
Figure D.6 FX-928 patch-I.

Figure D.6 and Figure D.7 show the conditions of the FX-928 patches. The condition of patch-I (Figure D.6) has not changed since the previous inspection performed in 2010. The adjacent

portion, which was replaced with Pro-Poxy 2500 seem to have deteriorated. The concrete near this replaced section appears to have been replaced with asphalt concrete (Figure D.6).

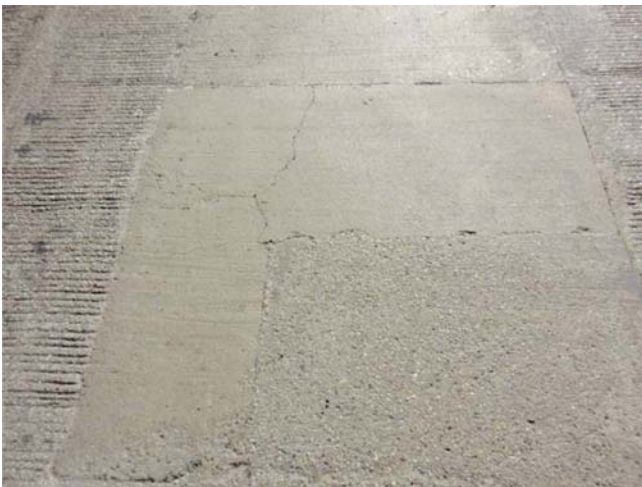
Figure D.7 FX-928 patch-II.

As noted during the previous inspection patch-II (Figure D.7) had not undergone any more cracking and the deteriorated portion of the patch (which has been replaced with another repair material (potentially Duracal)) exhibited cracks.

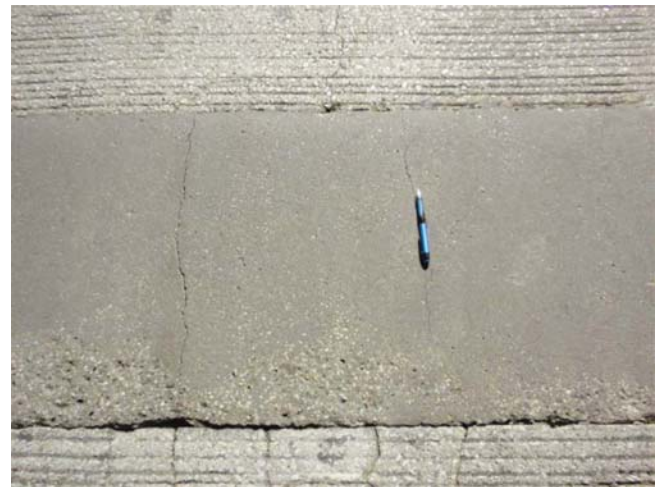
Figure D.8 ThoRoc 10-60.

Figure D.8 shows the condition of the ThoRoc 10-60 patch. The patch exhibited two cracks along the direction of the traffic. Since the previous inspection in 2010, these cracks did not deteriorate further. Also, the overall condition of this patch has not changed much since the last inspection in 2010.

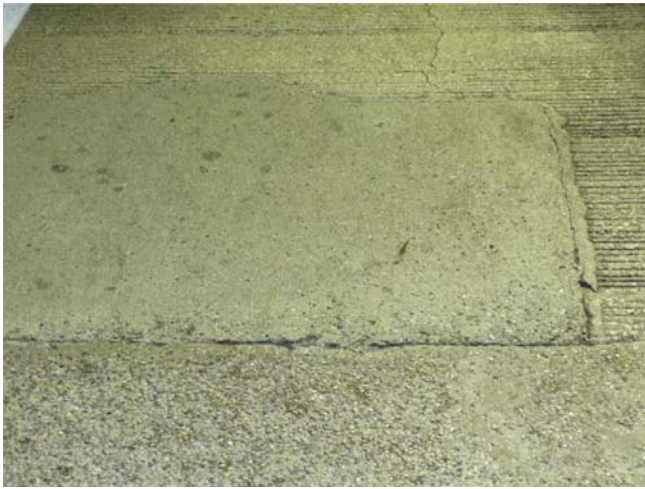
Figure D.9 SET 45 R patch area.

The SET 45 Regular patch had undergone severe deterioration prior to the previous inspection, and portions of the patch had been replaced by asphalt concrete. By the time of the 2010 inspection this patch has been completely replaced by another cementitious repair (potentially Duracal). Figure D.9 shows the original SET 45 Regular patch area that has now been replaced by another material.

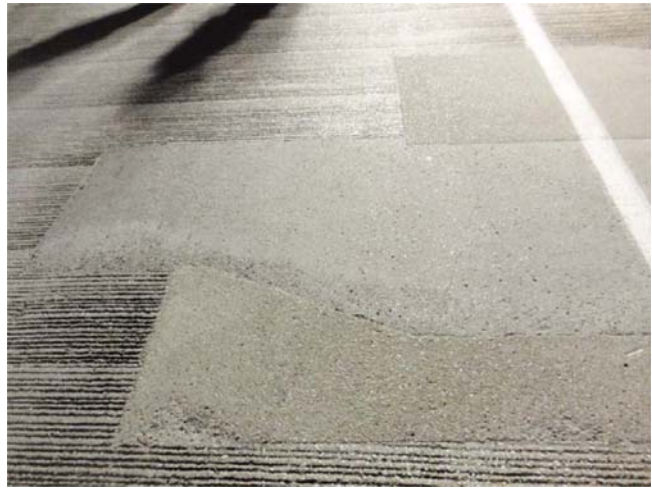
Figure D.11 SET 45 50/50 patch-II.

Figure D.10 shows SET 45 HW patch which did not deteriorate further since the last inspection. Also, these cracks which were observed during the last inspection appear to look the same. The condition of SET 45 50/50 patch-II also did not change since the last inspection (see Figure D.11).

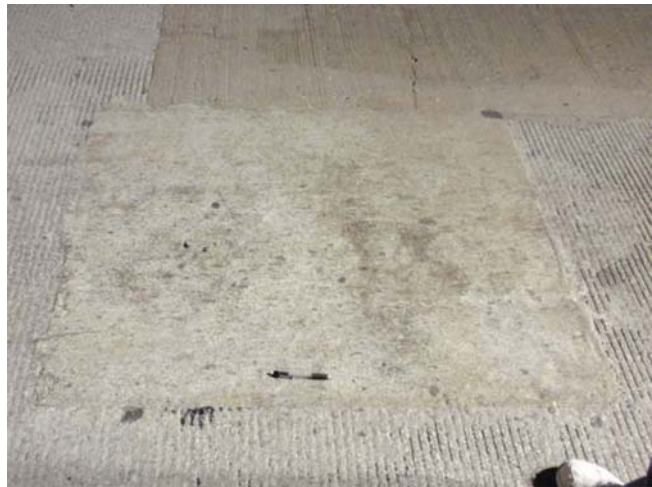
Figure D.12 MG-Krete patch-I.

Figure D.12 shows the patch-I with MG-Krete which was placed in summer 2010. This material has exposed to different weather conditions including exposure to deicing chemicals and looks very good after 1 winter cycle. Figure D.13 shows MG-Krete patch-II which exhibited some cracking but areas which have no cracks look good.

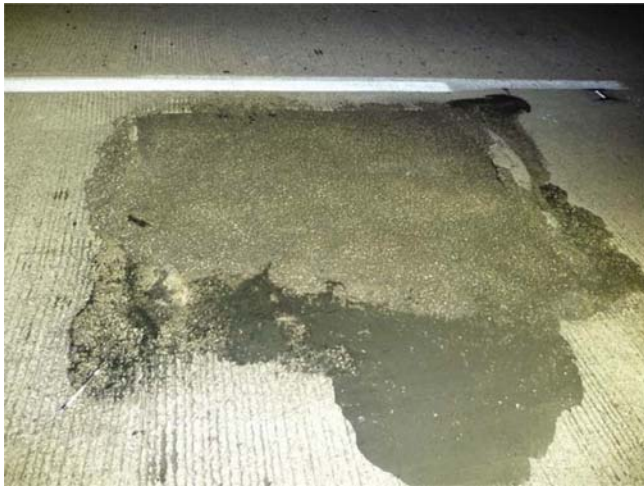
Figure D.14 Asphalt concrete in place of Zero C materials.

The patch with Zero C material was replaced with asphalt concrete due to early deterioration of this material (see Figure D.14). This deterioration could be due to very low strength after 1 day of placement. This mixture did not gain sufficient strength in field as well as laboratory.

- Zero-C material from BASF which was removed after initial installations due to very low strength and even did not perform well during the second placement. This material does not have good early strength. Also it was difficult to mix it, especially, in larger quantities.

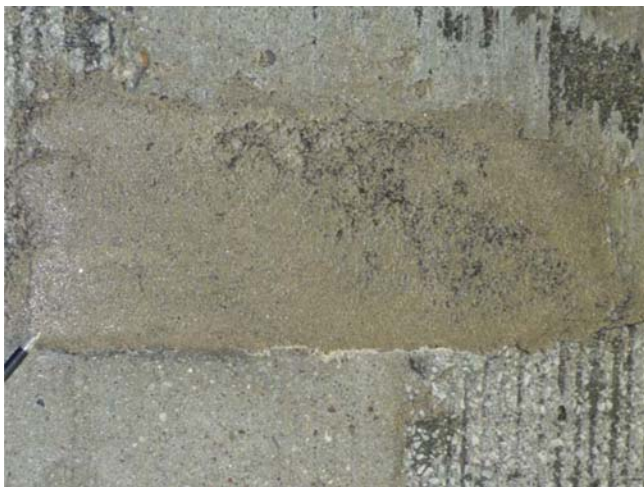
Figure D.15 Propoxy 2500 patch-I.

Figure D.15 shows the patch-I with Propoxy 2500 after 1 year of placement and thus exposed to deicing chemicals and low temperatures during one winter season. It really looks excellent with no cracks. The little rough surface is observed which is due to early setting time of this material. Overall this patch looks good. Patch-II also looks good as can be seen from Figure D.16 The third patch of Propoxy is replaced partially with asphalt concrete (see Figure D.17).
