Technical Brief (10 – 4)

*Second Year Evaluation of the Viking -
Cives Tow Plow*

June, 2010

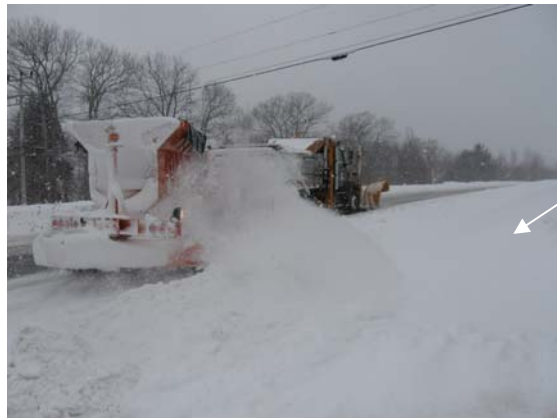
Photo 1: Clearing Travel Lane and Shoulder

The Tow Plow was used in the fully deployed position for both the truck lane areas and areas with one travel lane and a wide, paved shoulder (See Photo #1). On the several occasions when it was not fully extended, both the operator and supervisor noted the plow did not clean the pavement as well as when it was in the fully deployed position.

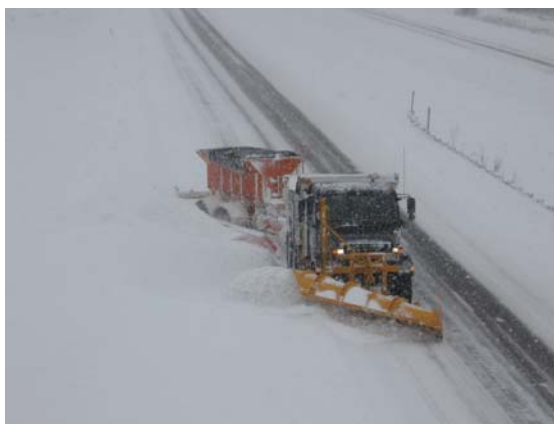
Photo 2: Interstate Application

The Tow Plow was used several times on Interstate 95 to clear the travel lane and shoulder (see Photo 2). This application worked very well and the Supervisor indicated that he believes the Tow Plow might have the most value in a more rural, Interstate setting.
