Paul G. Spry and Robert D. Cody
Department of Geological & Atmospheric Sciences
Iowa State University

**Reduction of Concrete Deterioration by Ettringite
Using Crystal Growth Inhibition Techniques: Part II
Field Evaluation of Inhibitor Effectiveness**

July, 2004

Iowa DOT Project TR - 469

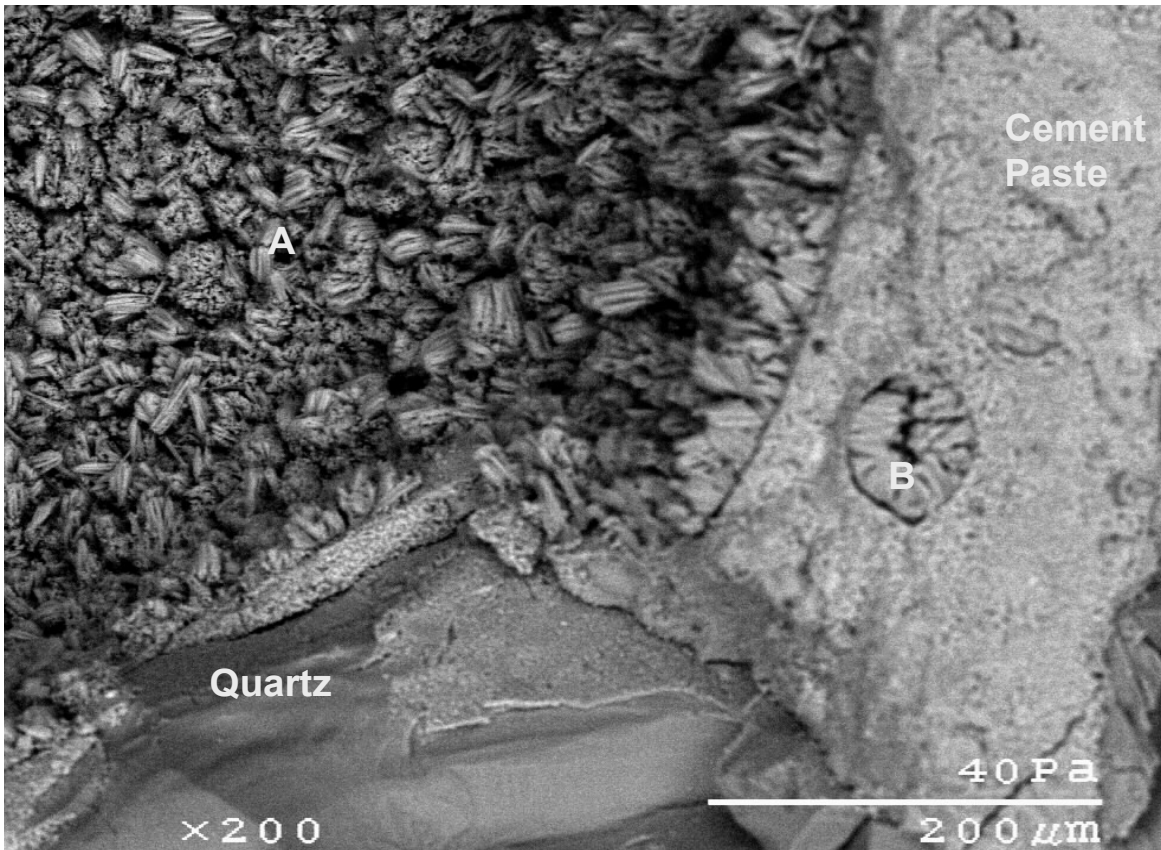
Figure 1. SEM micrograph of large (A) and small (B) air voids lined with well-formed, euhedral ettringite crystals, approximately 20 μm in length in sample “H” treated with sodium sulfate solution

Delayed ettringite in Iowa highways commonly fills microscopic pores and small air voids (<100 μm in diameter) and lines the margins of large air voids (> 100 μm in diameter) (Fig. 1) and occasional cracks. There is considerable controversy in the literature concerning whether cracking in cement paste is caused by the expansive growth of ettringite [1-6] or whether ettringite forms after crack development [7-11]. Regardless of its role in concrete deterioration, previous research has shown the expansive nature of delayed ettringite, but the mechanisms involving expansion remain in doubt since it is unclear whether they are topochemical in nature or due to through solution [1]. Where delayed

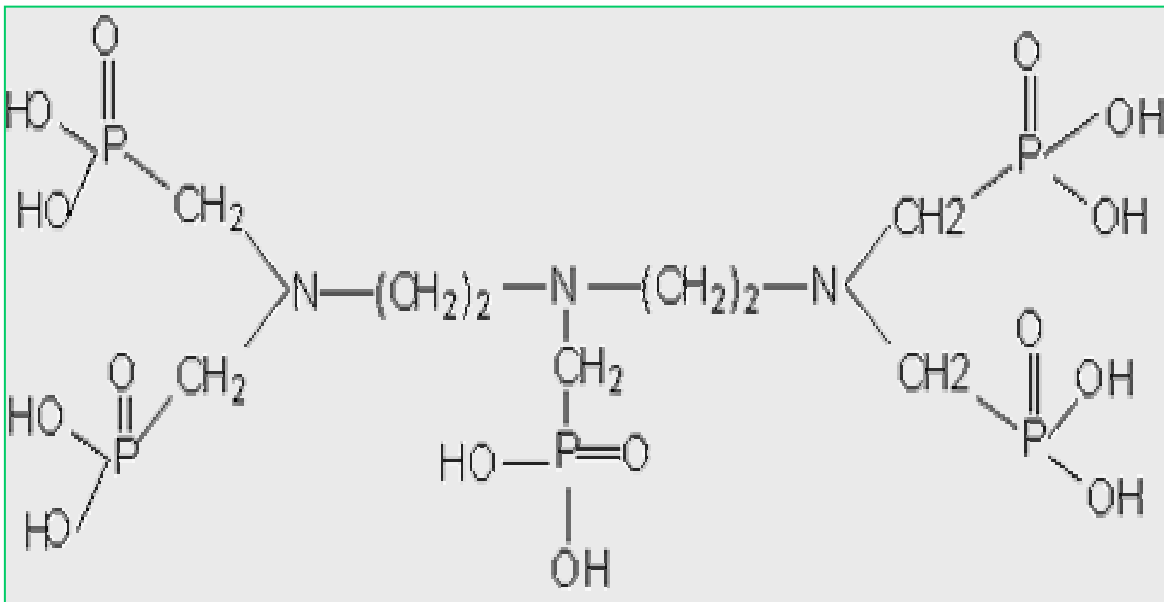
Figure 2. Illustration of Dequest 2060S (DTPMP) molecule - Diethylenetriamine penta (methylene phosphonic acid).

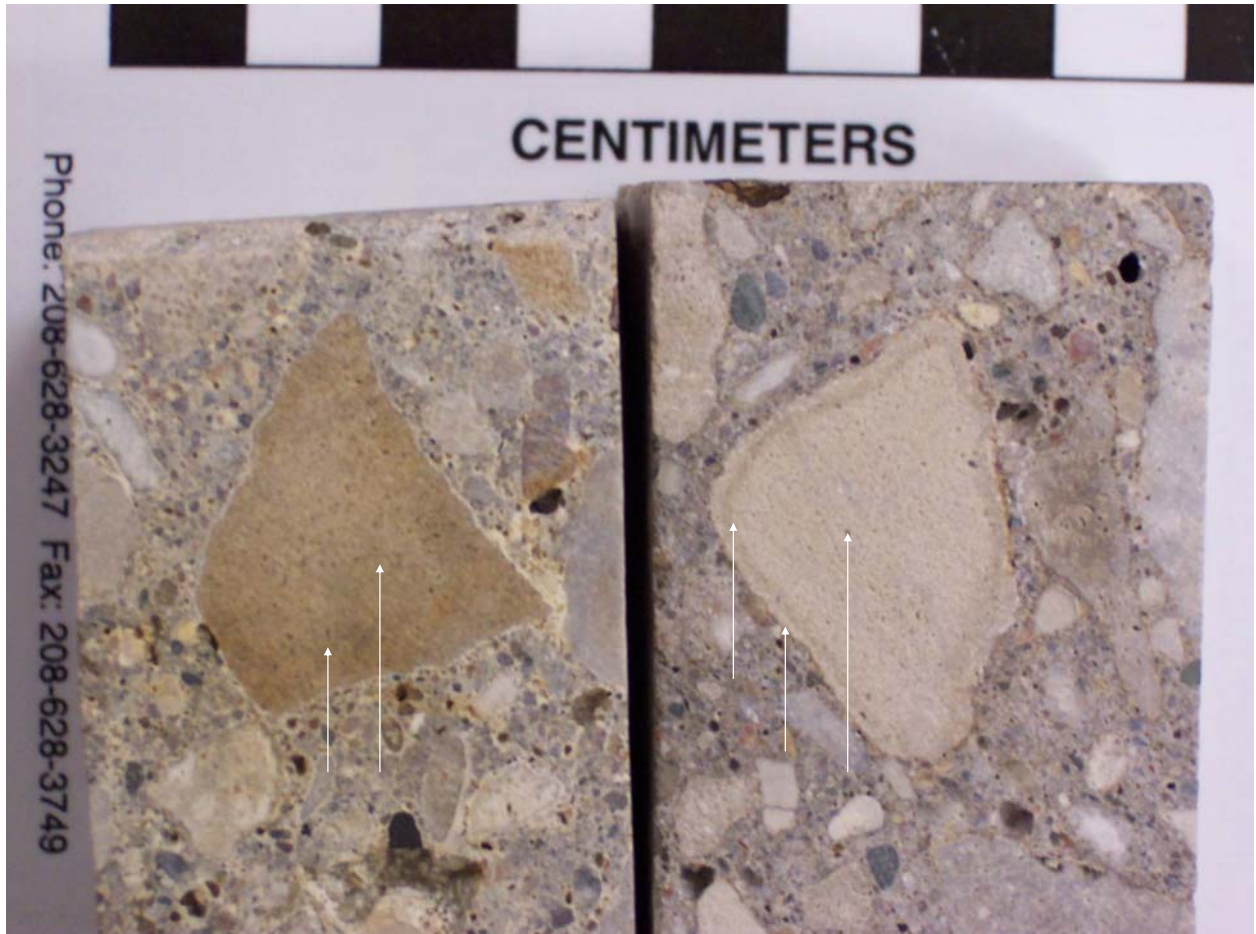
Figure 3. Concrete samples O5BB (left) and P3TB (right) showing compositional rims on dolomite particles that formed by dedolomitization reactions associated with the application of NaCl deicing salts.

DTPMP at different concentrations under wet-dry, freeze-thaw and real weather conditions. It should be noted that some coarse dolomite aggregates show compositional rims (Fig. 3) that primarily result from dedolomitization reactions associated with the application of deicing salts to the highway [17].

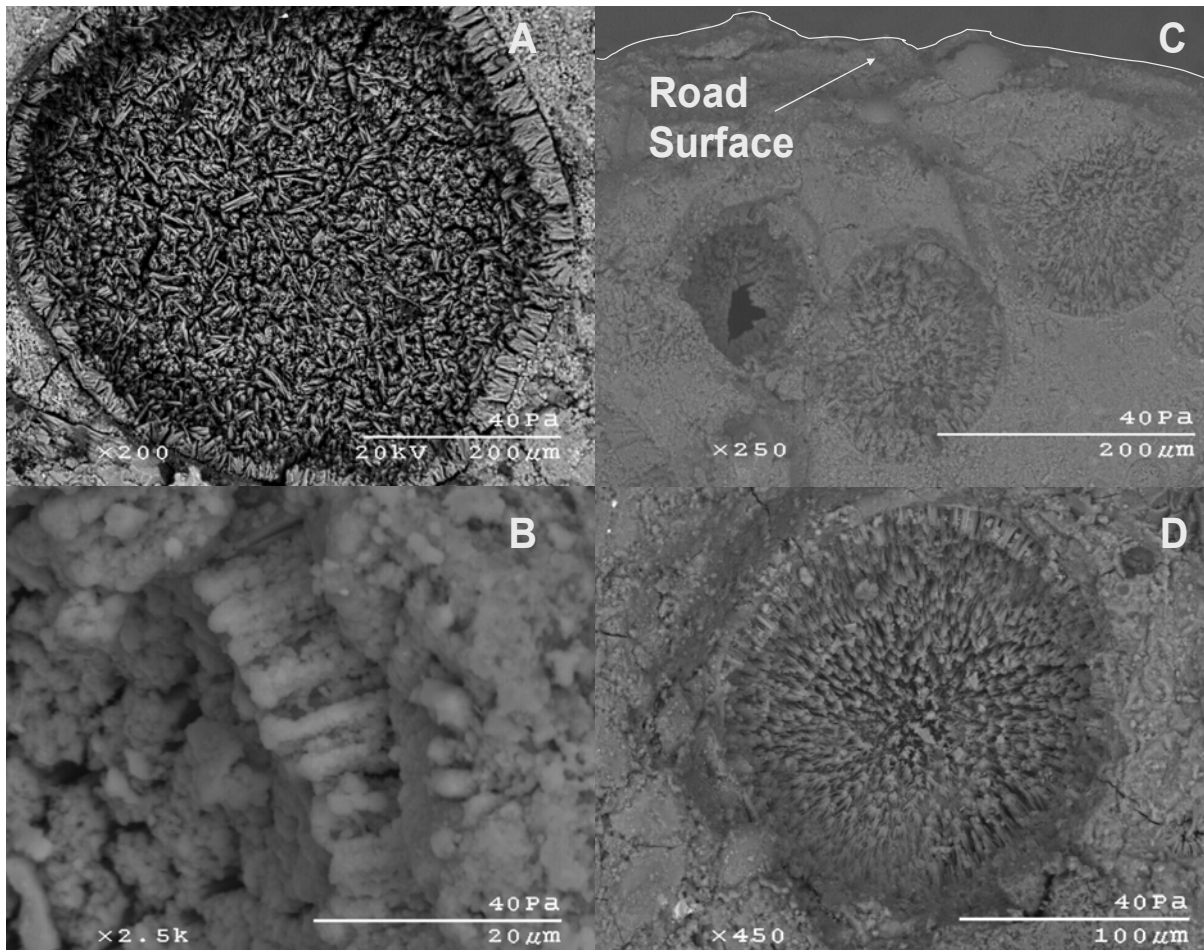
Figure 4. SEM micrographs of treated core samples from the westbound lane of U.S. 20 near Williams, Iowa. A. Ettringite crystals from core sample (E1TB) prior to treatment with inhibitor solution. B. Treated sample of core #1 U.S. 20 westbound, showing very short crystals, 0.23 mm directly below the road surface, coated with portlandite (these crystals are only $\sim 10\mu\text{m}$ and less in length). C. Profile of treated sample of core #4 U.S. 20 westbound, showing air voids 0.33 mm below road surface. Ettringite crystals are $\sim 20\mu\text{m}$ in length but exhibit a different morphology than is normally seen for ettringite. D. Closeup of treated sample of core #2 U.S. 20 westbound, showing unusual morphology.

The field test conducted on the westbound lanes yielded completely different results than the non-reactive eastbound section. The westbound section of U.S. 20 is composed of a C-3 cement mix and is devoid of slag. SEM studies show the presence of abundant ettringite in air voids and large pores throughout the cores obtained prior to and after the deicer-inhibitor applications. SEM images show that the inhibitor solution clearly affected ettringite growth ~ 0.3 to 0.5 mm below the surface of the highway (Fig. 4). In non-treated cores (i.e. prior to inhibitor application) ettringite near the surface is ~15-20 μm in

length (Fig. 4A), with some crystals approaching ~50 μm in length, whereas ettringite crystals in treated cores were $< \sim 10 \mu\text{m}$ in length (Fig. 4B). The middle and bottom sections of treated and non-treated cores exhibited ettringite crystals in air voids in the ~ 20 to $50 \mu\text{m}$ range. The morphology of crystals varied from euhedral, elongate (20 to $25 \mu\text{m}$) crystals (Fig. 4A) to squat, irregular-shaped crystals approximately 5 to $15 \mu\text{m}$ in length. Some of these crystals are coated with portlandite (Fig. 4B) whereas others show no spatial association to portlandite but are also stunted (Figs. 4C and 4D).

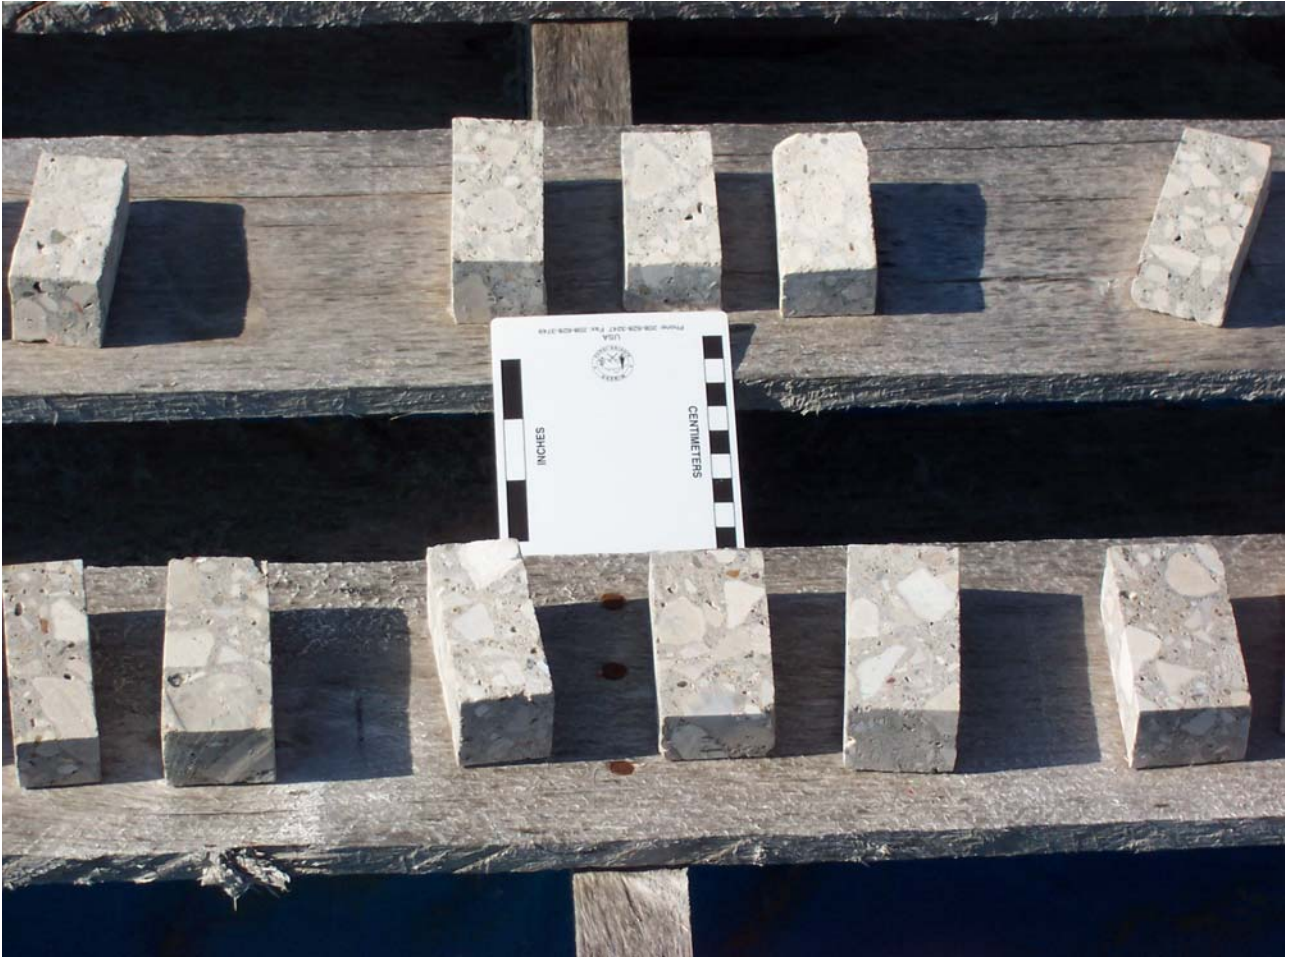
Figure 5. Layout of highway concrete samples on the roof of Science I at Iowa State University.

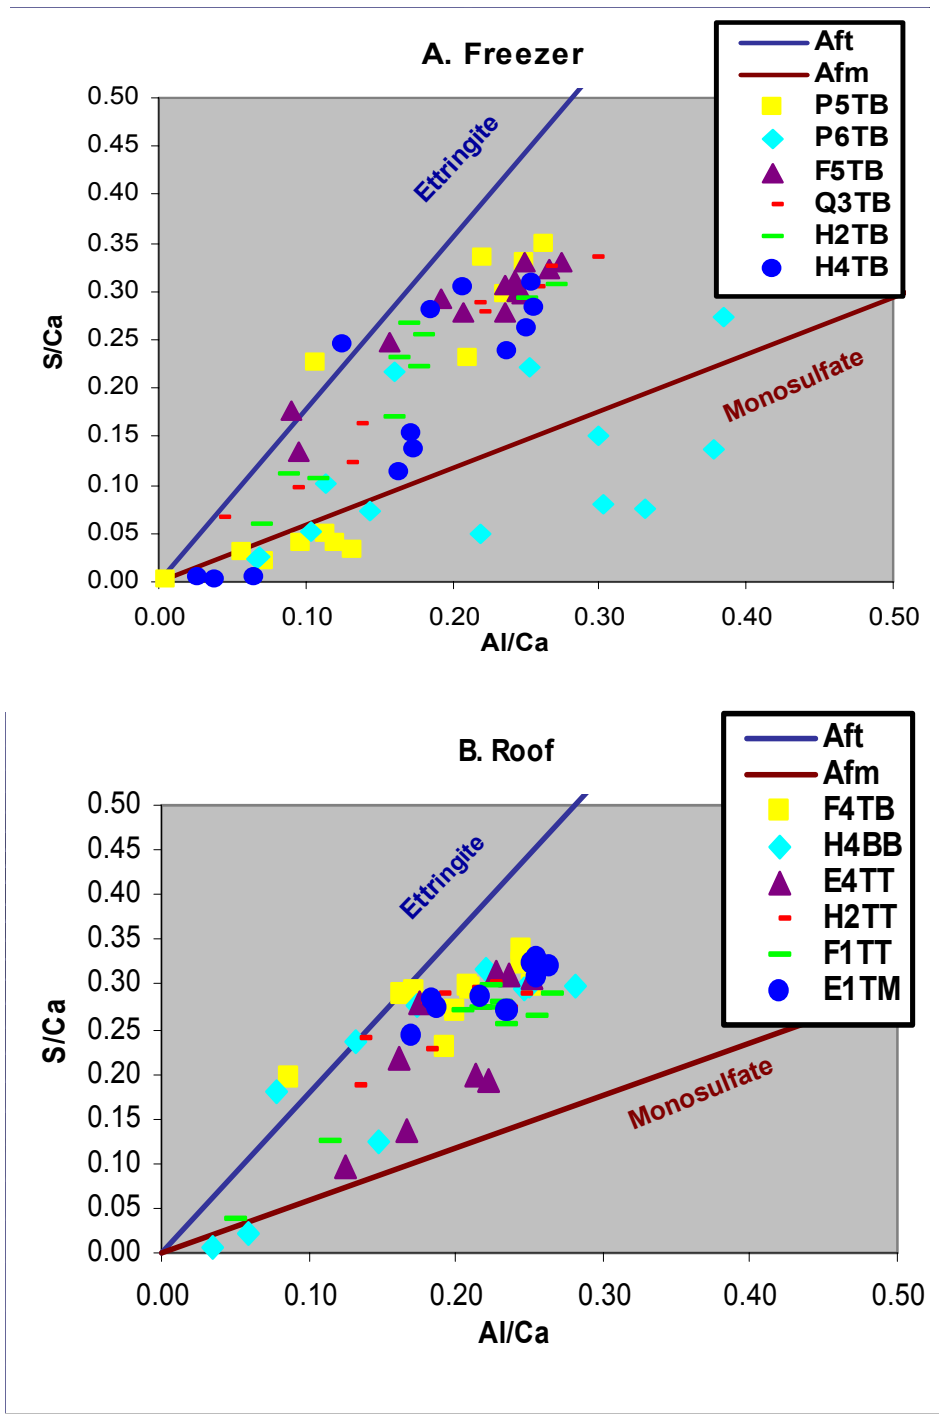
Figure 6. Atomic ratio plots of S/Ca vs. Al/Ca of hydrated Ca-Al sulfate in concrete samples from: A. Experiments conducted on the roof of Science I at Iowa State University; and B. Controlled freeze-thaw experiments. Note that for both sets of experiments the sulfate is primarily ettringite with lesser amounts of monosulfate.

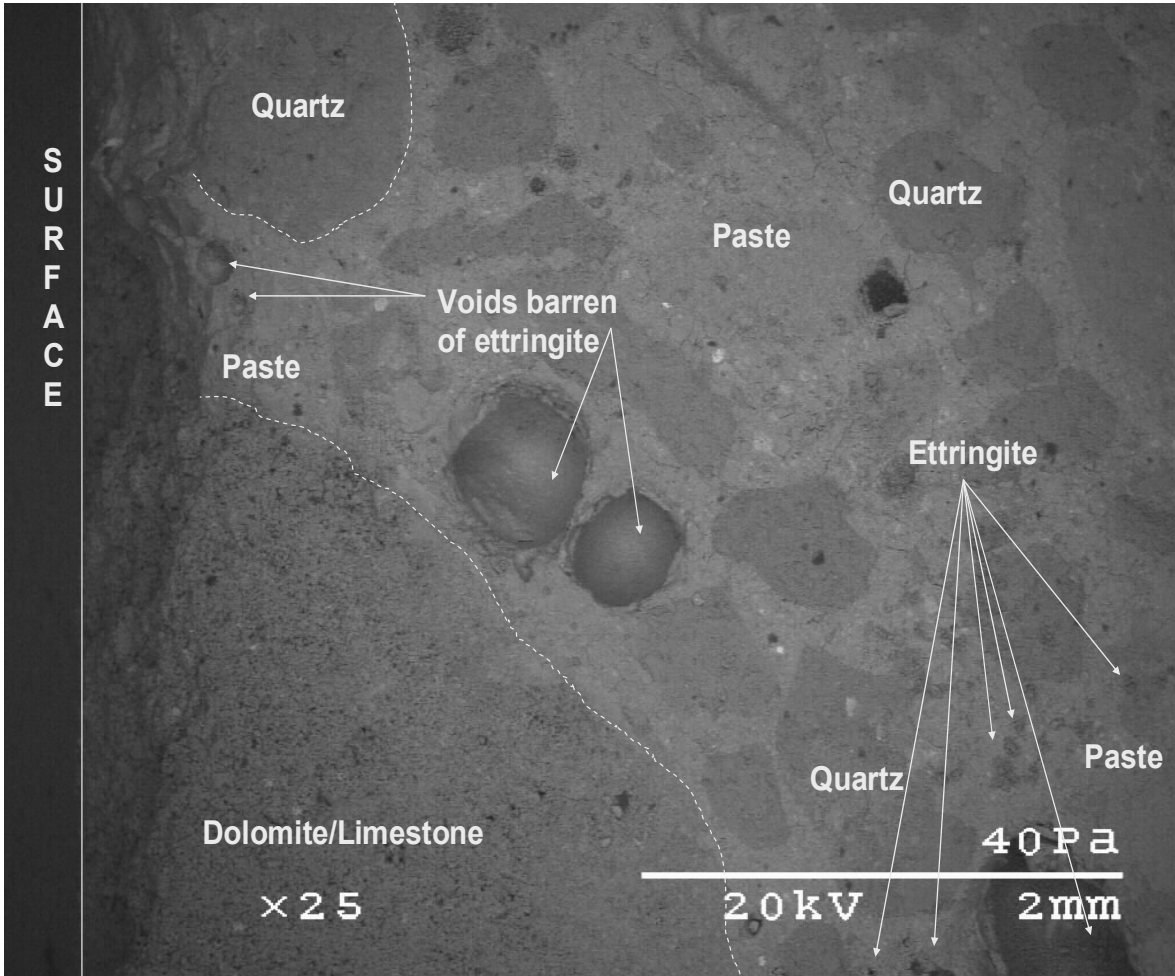
Figure 7. SEM micrograph of roof sample Q3TM showing a pathway of air voids close to the sample surface that are devoid of ettringite. At a distance of approximately 4 mm from the surface, ettringite remains in the air voids showing the distance the chelating phosphonate solution penetrated.

SEM images of samples to which DTPMP-bearing solutions were applied on a weekly basis show that phosphonate had penetrated beneath the surface of the concrete, to depths of between 1 and 6 mm. Pathways of air voids normally filled or lined with ettringite were either absent or lined with stunted or corroded ettringite crystals (Fig. 7). Below these depths, all voids and large pores were filled or lined with ettringite similar in morphology to that in untreated samples.

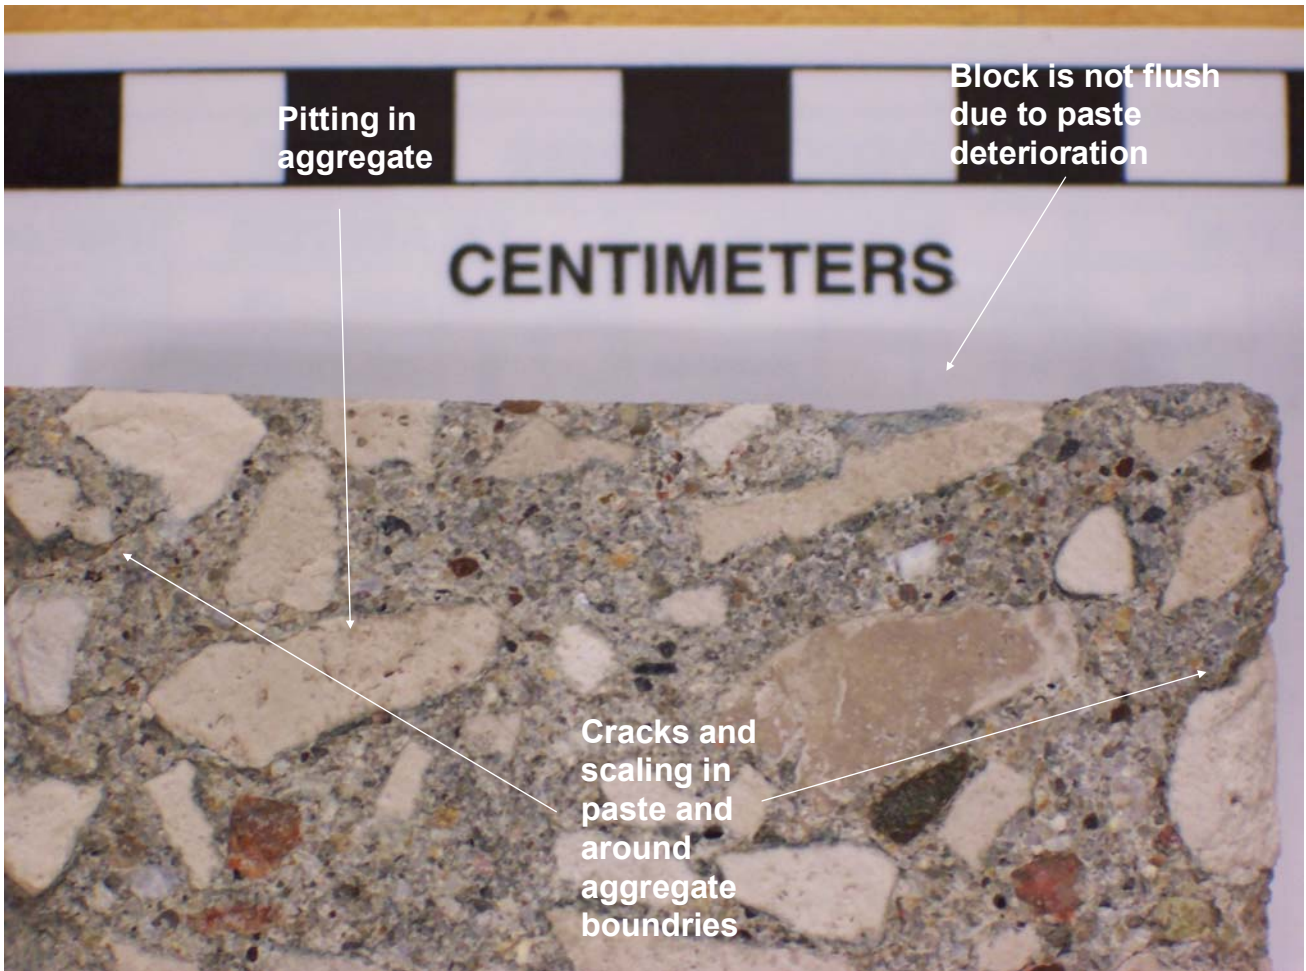
Figure 8. Sample Q3TB was subject to freeze-thaw cycling and application of Dequest 2060S over a one year period and shows signs of pitting, scaling, and cracking.

Concrete samples subject to freeze-thaw experiments at the end of one year were structurally intact, although there was scaling on the surface of sample Q3TB, with deterioration of cement paste around the margins of aggregate particles (Fig. 8). Samples immersed in 0.75M Na₂SO₄ and 0.1 vol % DTPMP exhibited scaling along the aggregate-cement paste interface whereas cracks up to 1 cm in length also occurred near the corners of blocks. Samples immersed in 0.75M Na₂SO₄ with 0.1 vol % DTPMP contained abundant ettringite throughout the blocks, and were clearly unaffected by the DTPMP presumably due to the disproportionately high concentration of Na₂SO₄. Similarly, samples sprayed with 0.1 vol % DTPMP and 5 vol. % Na₂SO₄ were also unaffected by the presence of the inhibitor. However, for these samples, Na₂SO₄ crystals grew in spaces adjacent to aggregate particles during the thaw period when samples were exposed to air for 24 hours. For samples sprayed with 0.01 vol % DTPMP and distilled water, 0.1 vol % DTPMP and distilled water, and 0.1 vol % DTPMP and distilled water with 0.75M NaCl, SEM images combined with EDAX point analysis showed the presence of corroded and stunted ettringite crystals in air voids ~1-6 mm from the surface of the block. Such crystal morphologies mimic those that formed during the roof experiments. Figure 6B shows that SEM point compositions of the hydrated Ca-Al sulfate crystals in samples P5TB, P6TB, Q3TB, H2Tb, and H4TB were primarily of ettringite with a minor amount of monosulfate. These compositions are similar to those reported for the roof

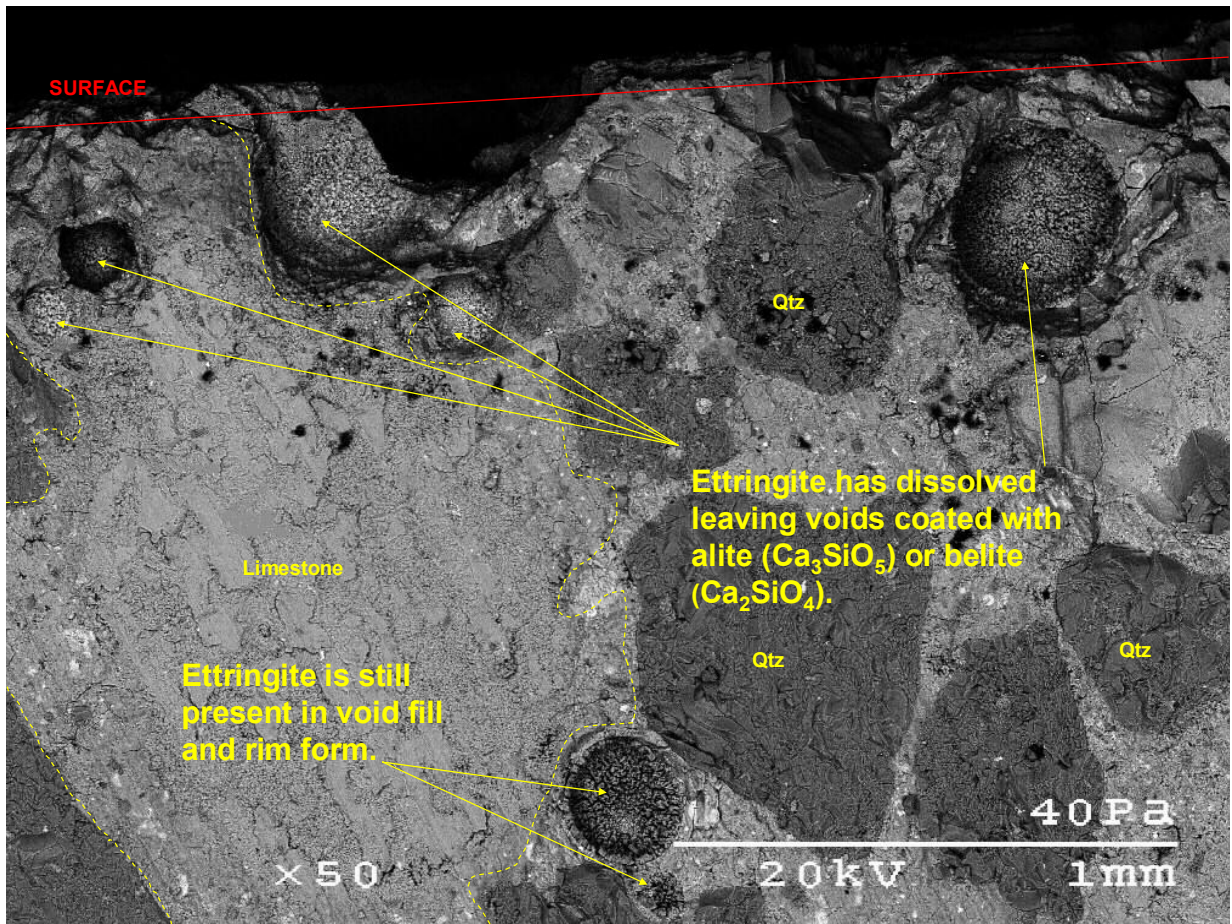
Figure 9. SEM micrograph of sample Q3TB. Near the surface, air voids contain no ettringite but instead trace amounts of alite and belite. At a distance of 2 mm from the surface, euhedral crystals of ettringite line the walls of the air voids.

experiments. In sample Q3BT, minor amounts of alite (Ca_3SiO_5) and belite (Ca_2SiO_4), as indicated by SEM point analyses, occur as minute grains along the walls of some air voids (Fig. 9). Rather than forming as a product of the ettringite-consuming reaction, alite and belite are natural products found in Portland cement and were likely present in the walls of the void. However, where DTPMP-bearing (Na_2SO_4 -free) solutions were applied, ettringite crystals diminished in size to 10 to 15 μm within one month (Fig. 10). In samples, treated with 0.1 vol. % DTPMP and 0.75 M. NaCl, the random distribution of NaCl crystals throughout the concrete paste was relatively common. Although this appeared to have no major effect on the degree of deterioration of the concrete, the spatial distribution of these crystals clearly demonstrates that the infiltration of the NaCl brine was considerable. In sample P5TB, for example, an almost continuous zone of NaCl crystals from one end of the block to the other shows that the solution penetrated a minimum of 3.6 cm. There was no evidence that this zone was spatially related to fractures in the sample suggesting that the solution primarily permeated through the sample along connected pores.

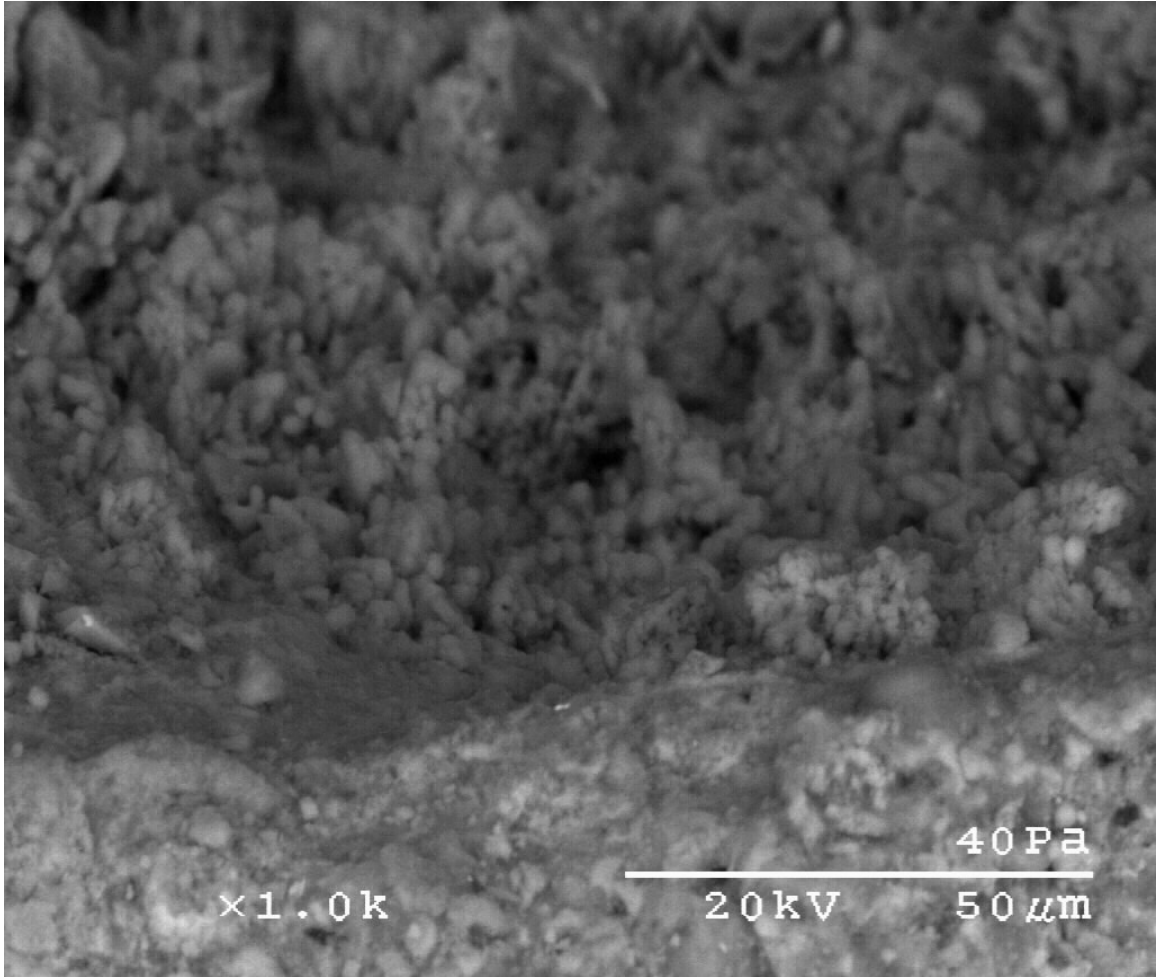
Figure 10. SEM micrograph of stunted ettringite crystals (~10-15 μm in length) in sample H4TB

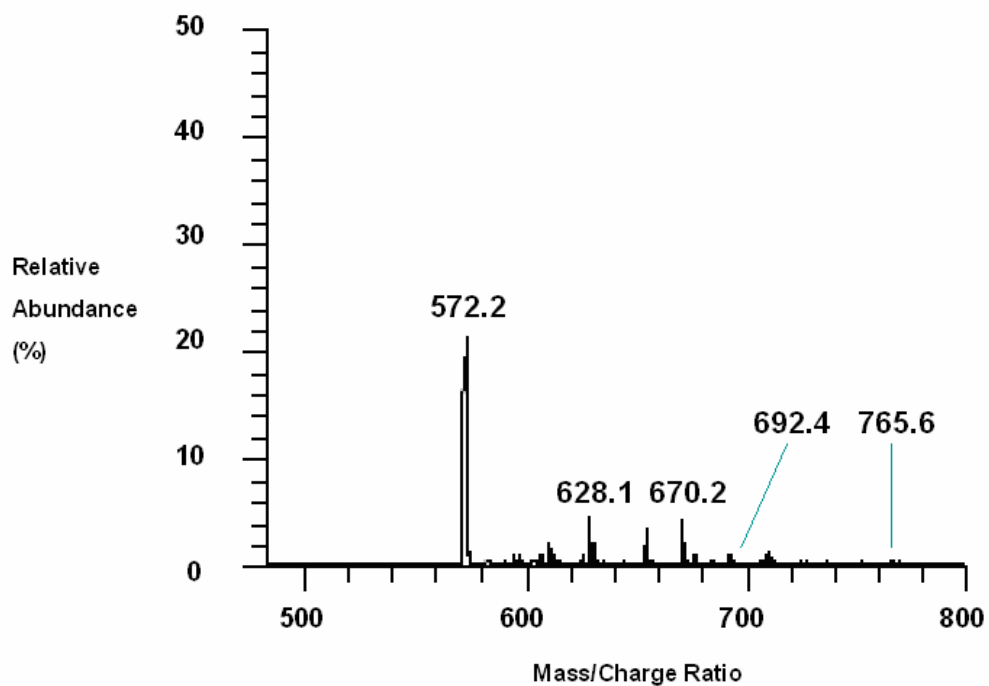
Figure 11. Electrospray mass spectrometry spectrum in negative ionization mode of deprotonated DTPMP molecule (molecular weight = 572.2), with a Ca^{2+} and a water molecule adsorbed onto the phosphonate molecule (molecular weight = 628.1) and other unidentifiable species.

using electrospray mass spectrometry suggests that the stunting of ettringite growth is caused by the adsorption of a Ca^{2+} ion and a water molecule to deprotonated DTPMP on the surface of the {0001} face of ettringite. It is anticipated that by using a DTPMP concentration of between 0.001 and 0.01 vol % for the extended life of a highway (i.e. >20 years), deterioration caused by the expansive growth of ettringite will be markedly reduced.
