Report No. KS-06-3
FINAL REPORT

**SEQUENCE STRATIGRAPHY AND ENGINEERING
GEOLOGY OF LAWRENCE FORMATION (DOUGLAS
GROUP) IN NORTHEASTERN KANSAS**

Allen W. Archer, Ph.D.
Christopher J. Hogle
Kansas State University
Manhattan, Kansas

November 2007

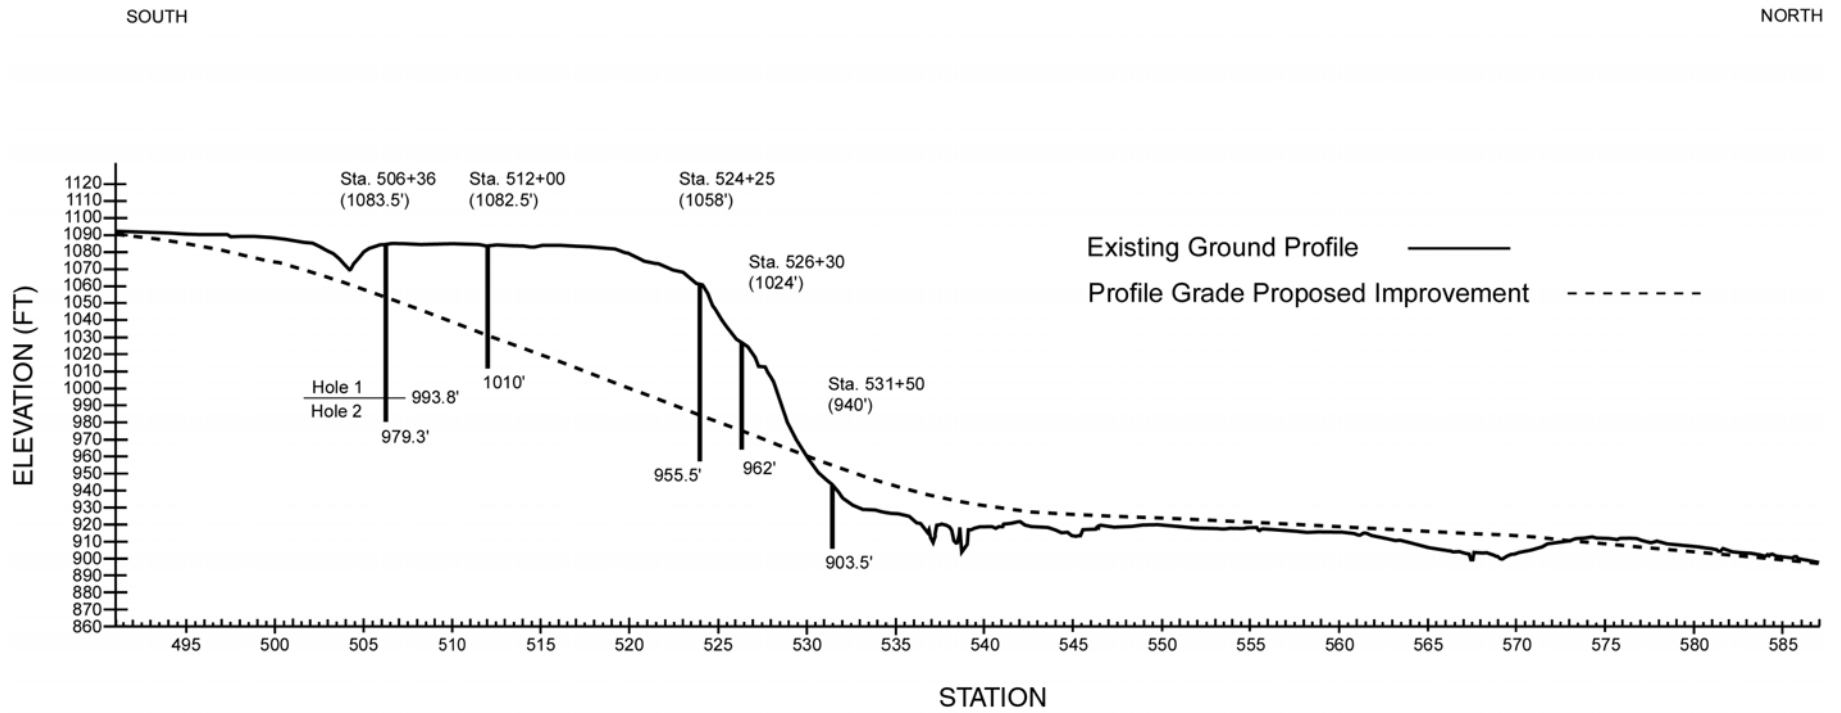
Figure 1.9: Profile of Pleasant Grove Hill with Borehole Locations and Elevations

*Surface elevation (ft) is given in parentheses, while bottom-hole elevation (ft) is not given in parentheses.

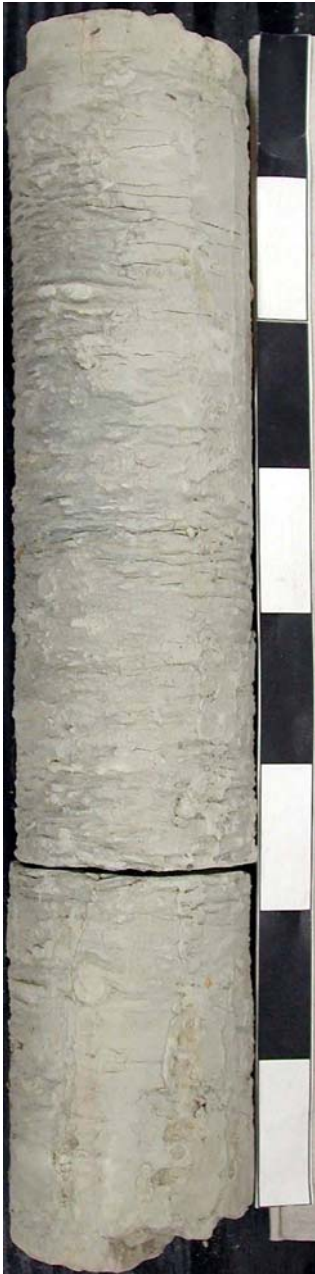
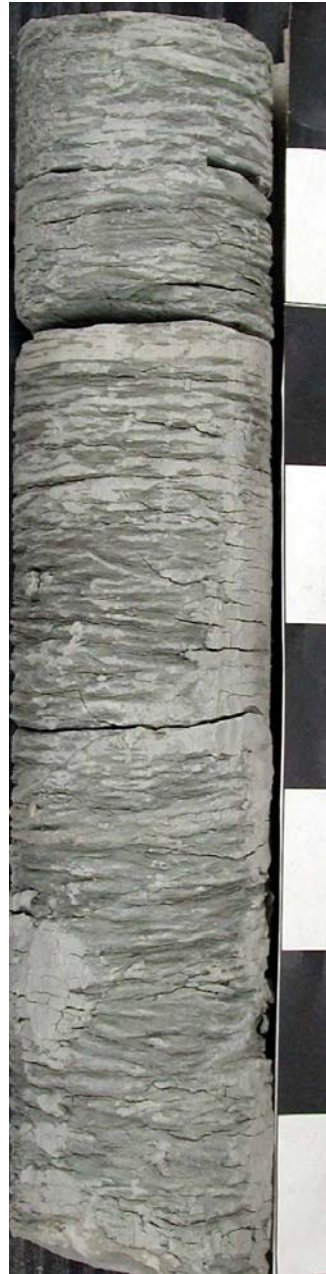
Figure 2.4: Churned Shale microfacies

Scale in both core photos is 1/10'.

**a) Churned Shale;
Lenticular/Streaked Bedding**

b) Churned Shale; Bivalves

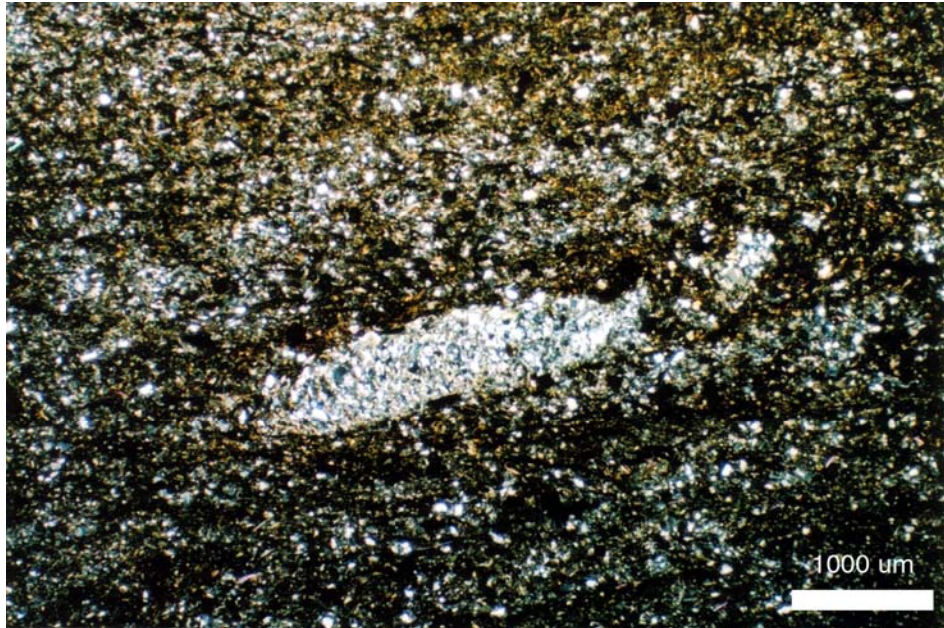
(a) cross-polarized; 5x total magnification

b) lenticular shale with disturbed bedding generated by bioturbation; root (right) and disrupted silty lense in upper left.

Frame length in both photomicrographs is 6650 μm (6.65 mm).

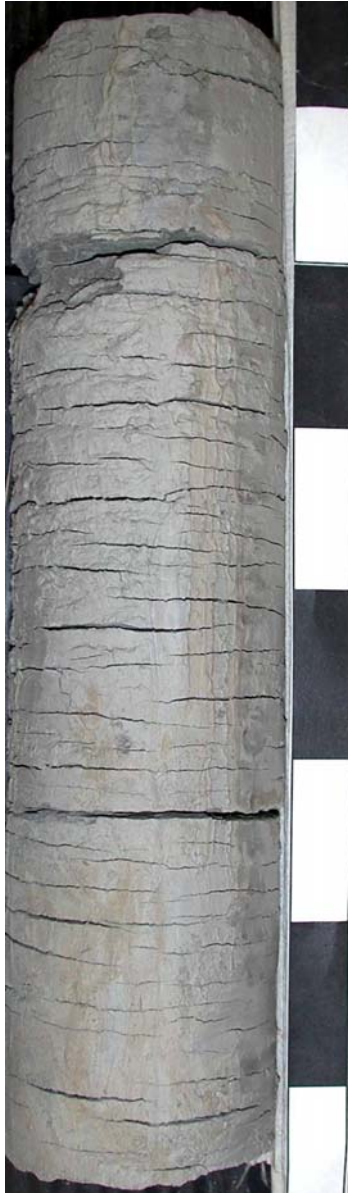
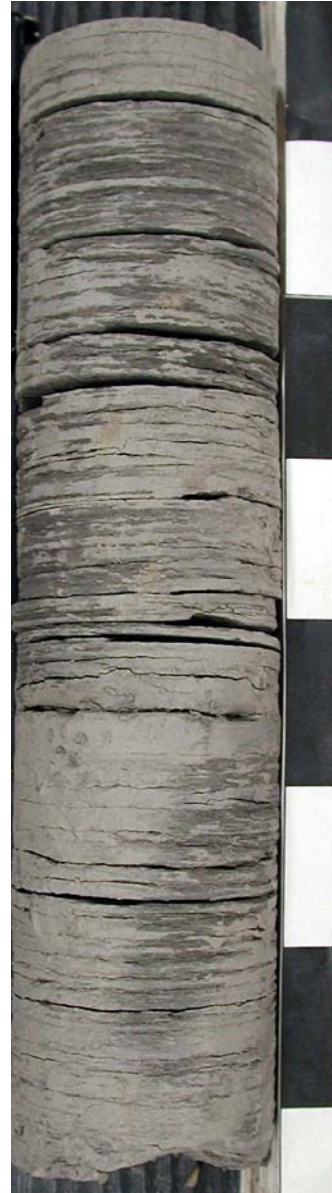
a) Light gray clay-rich shale with abundant fractures that are irregular (shrink/swell) and parallel to the horizontal bedding plane.

b) Medium gray shale that lacks the irregular fractures (shrink/swell clay) as in (a), with flat, parallel fractures along horizontal bedding plane. Scale is 1/10" in core photos.

a) Clay-rich Shale

b) Shale

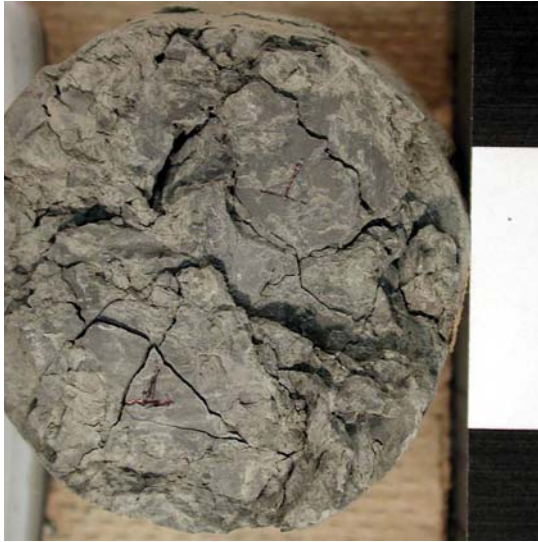
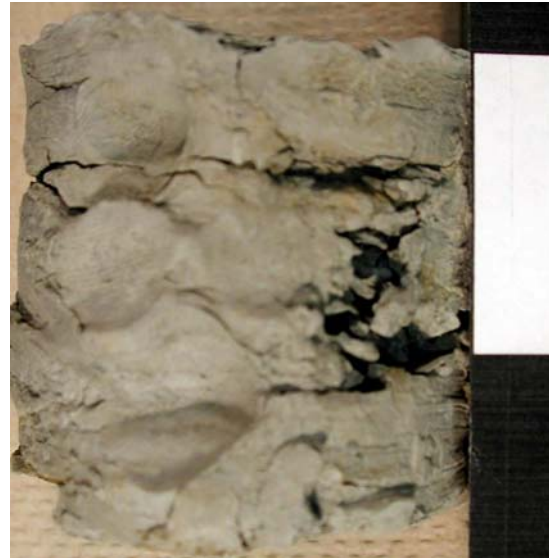
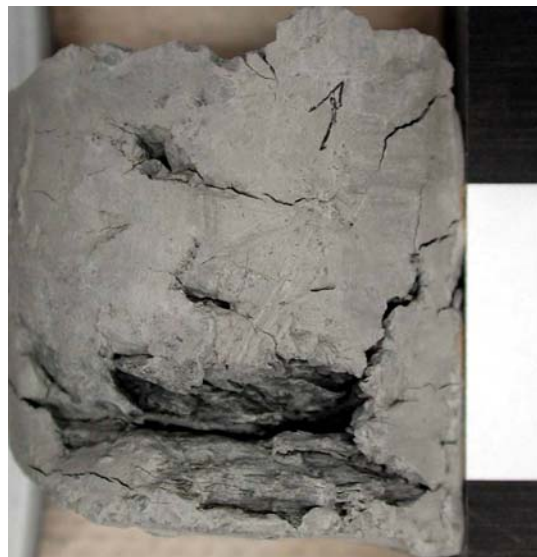
Figure 2.7: Displays the abundance of irregular fractures through out the friable clayshale.

Fig. 3.11: Light gray clayshale showing the thinly laminated structure within the core. Scale in all core photos is 1/10'.

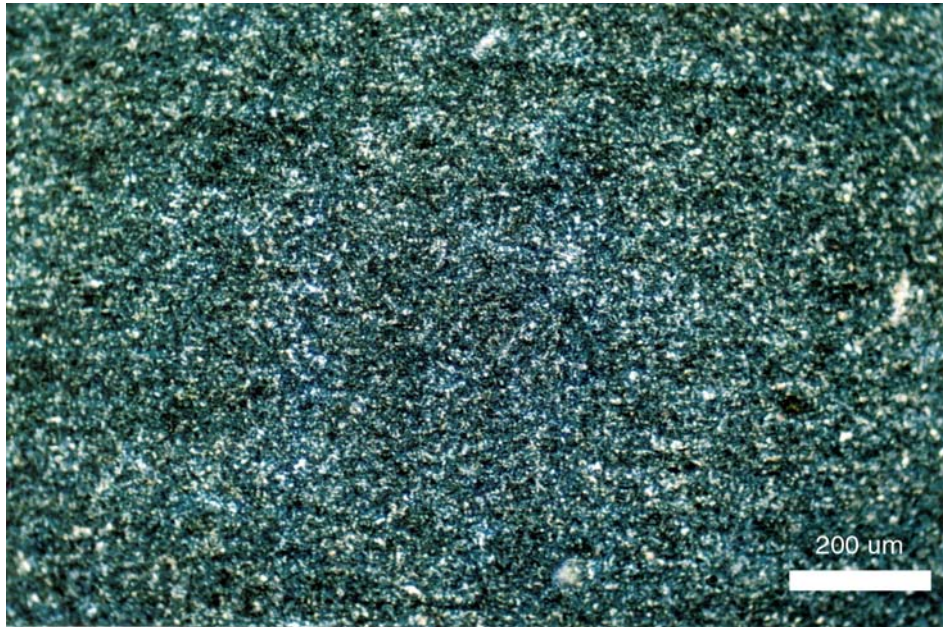
(a) crossed polarized; 25x total magnification

b) rotated 45°, the high birefringence of the oriented clays displays the bistrial b-fabric (micromass) where two intersecting sets of oriented clays can be seen.

Frame length in both photomicrographs is 1330 μm (1.33 mm).

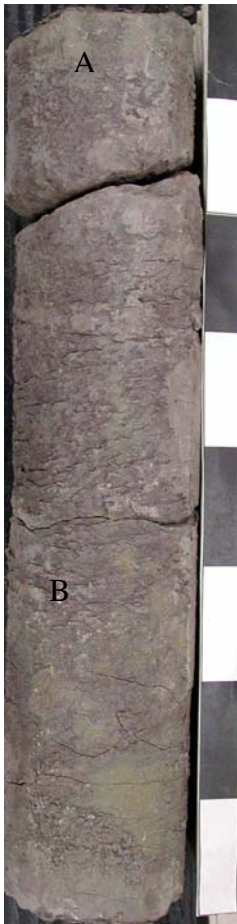
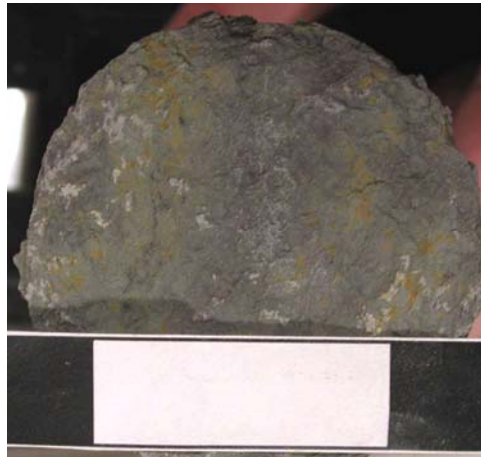
Figure 2.10: Paleosol Core Photographs

- a) Purplish-gray, fine platy, paleosol with an angled shear plane (A) containing slickensides. Bottom of core becomes finely mottled with yellow drab-haloed root traces (B).
 - b) Close-up of yellow drab-haloed root traces within grayish red purple paleosol.
 - c) Gray clay-rich paleosol with desiccation cracks (shrink/swell). Bottom of core displays its columnar ped structure.
- 1/10' scale in all core photos.

a) Paleosol

b) Paleosol

Interpretation: Paleosols are relicts of ancient soils that represent the conditions present during soil formation. Paleosols can be distinguished by the presence of ped structure, root traces, and fossils. Any one of these characteristics, for this study, is interpreted as a paleosol forming from weathering and pedogenic (soil-forming) processes during subaerial exposure.

Few paleosols for this project exhibit red to purplish red color indicating oxidizing environments. The gray to greenish gray color dominating the paleosols within the Lawrence Shale indicates environments with reducing conditions, such as waterlogged regions (swamp, marshes, or bogs). Jockel (1994) suggests the paleosols show a strong resemblance to modern Vertisols.

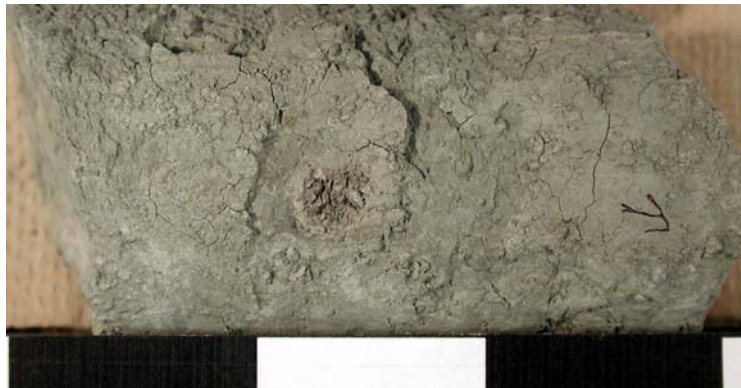
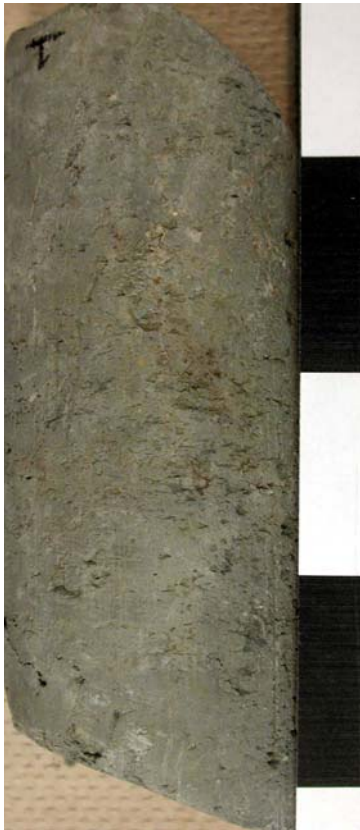
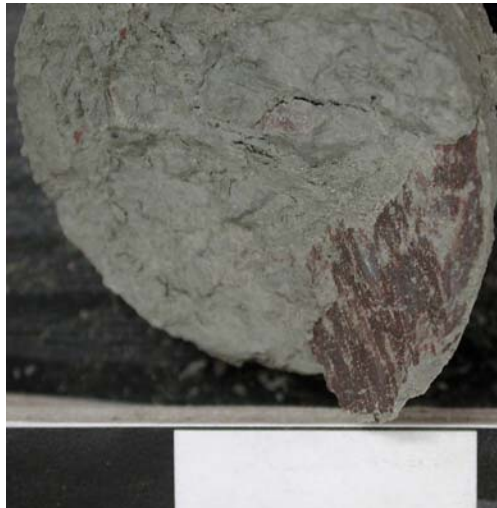
Figure 2.11: Paleosol Microfacies

- a) Light greenish gray paleosol containing a recrystallized, pale brown, calcite root cast (A).
 - b) Indurated churned shale to weak paleosol with irregularly distributed wisps on the side of the core. These wisps represent root traces causing minor disorientation of the bedding. Shear planes (with slickensides) on the top and bottom of the core.
 - c) Paleosol with red clay coated slickenside (angled shear plane).
- All scales in core photos are 1/10'.

a) Paleosol

b) Paleosol

c) Paleosol - slickenside

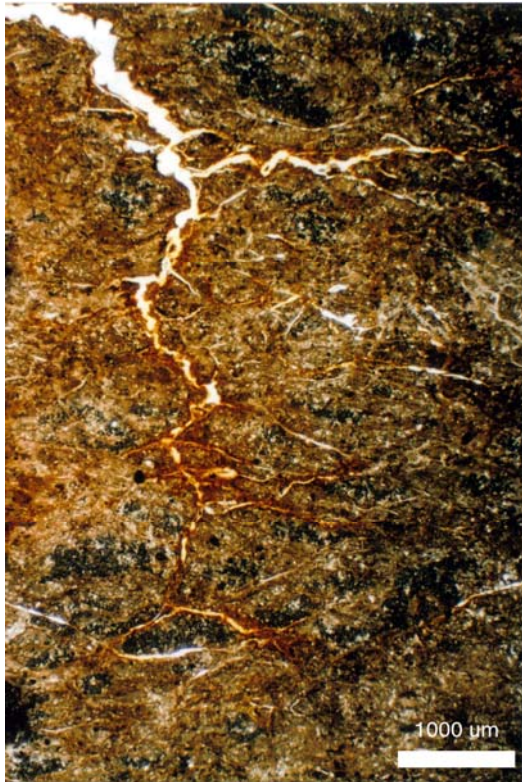
(a) cross-polarized; 5x total magnification

- a) dendritic root channel with abundant rootlets branching into clay/silt matrix. Root traces lined with a red clay coating (ferri-argillan).
 - b) root channel with fine branching rootlets with ferri-argillans.
 - c) abundant root traces, within clay/silt matrix, with ferri-argillans.
- Frame length in all photomicrographs is 6650 μ (6.65 mm).

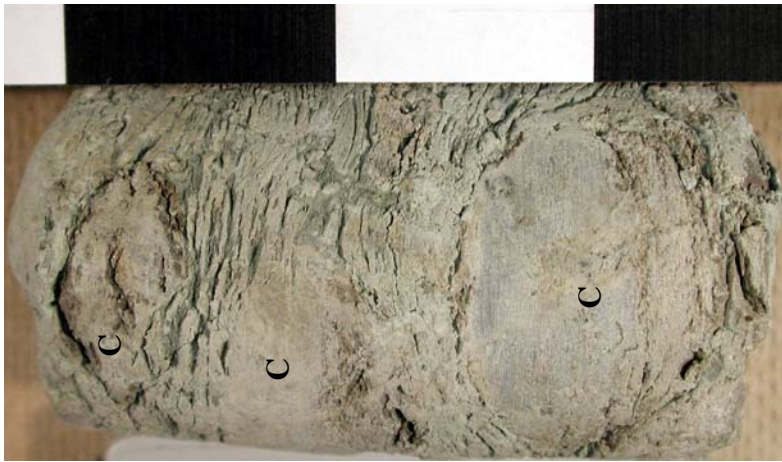
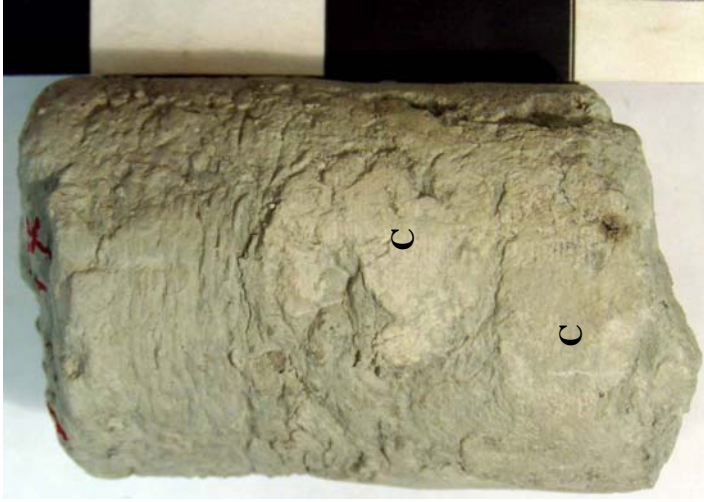
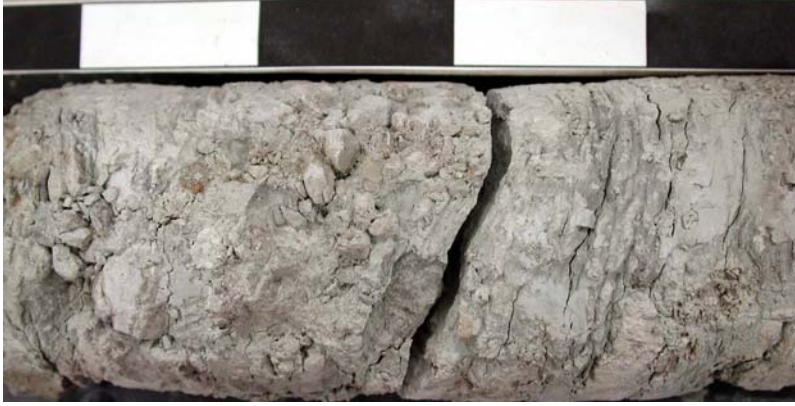
Figure 2.13) Carbonate-rich Core Photographs. a,b) Carbonate-rich shale consisting of hard/dense carbonate nodules (C). c) Pebble-like carbonate nodules within the shale. Scale in all core photos is 1/10'.

Interpretation: The nodular carbonate concretions within the Lawrence Shale are believed to have at least two origins, both marine and pedogenic. Joekel (1994) suggested that the carbonate, underlying the paleosols, is entirely related to pedogenic processes (caliche-like nodules). However, further work by Feldman and Archer (1995) identified shell fossils within some of these carbonate nodules, which indicates original deposition of marine limestone. The limestone is suggested as being the discontinuous Amazonian Limestone that was subaerially exposed due to a fall in sea level. This resulted in paleosol development on top of the Amazonian Limestone, which incorporated pedogenic carbonate and limestone fracturing within the facies.

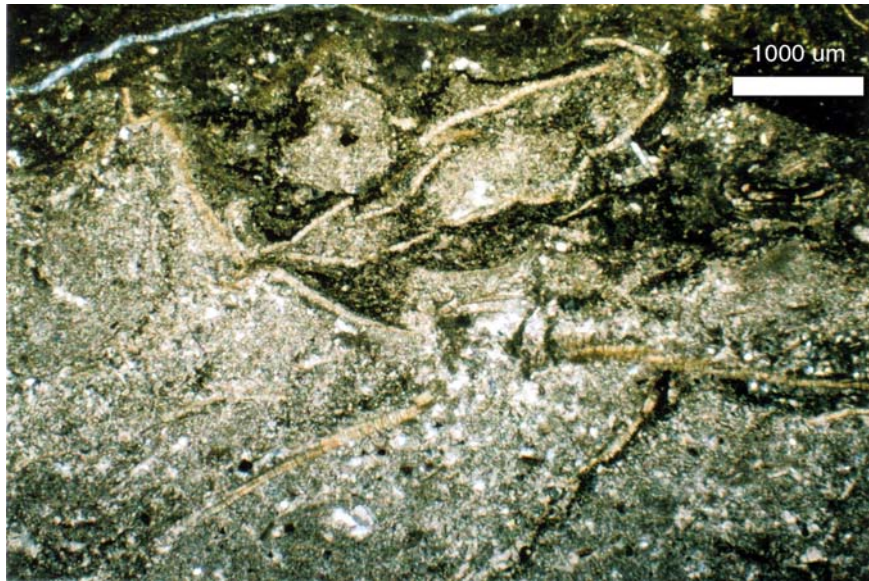
Figure 2.14: Carbonate-Rich Shale microfacies

b) micrite nodule, with shell fragments, surrounded by micritic matrix; notice how fractures occur at matrix and nodule interface.

Frame length in all photomicrographs is 6650 μm (6.65 mm).

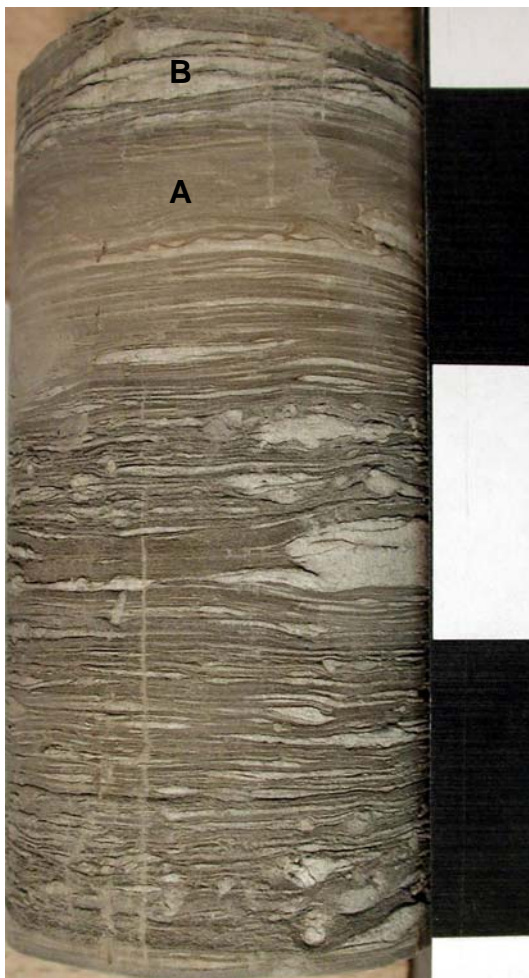
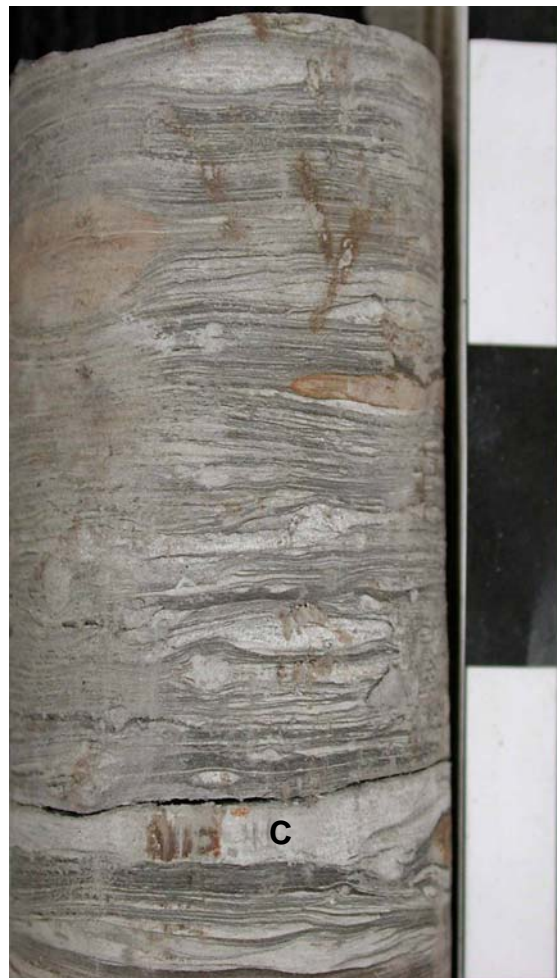
b) Lenticular Shale displaying more continuous sandstone lenticels (C). Bedding slightly disturbed (loading or bioturbation). Notice in both figures how the shale fractures along the sandstone/mud interface.

Scale in both core photos is 1/10'.

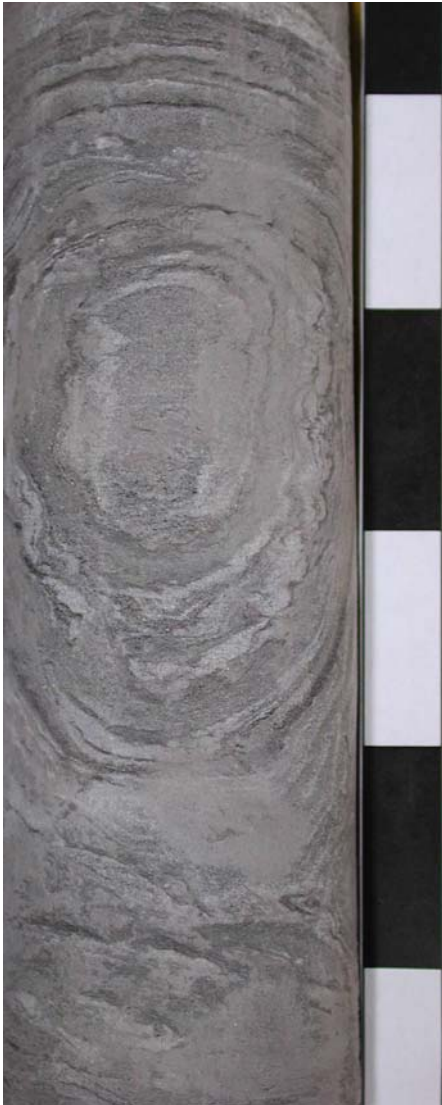
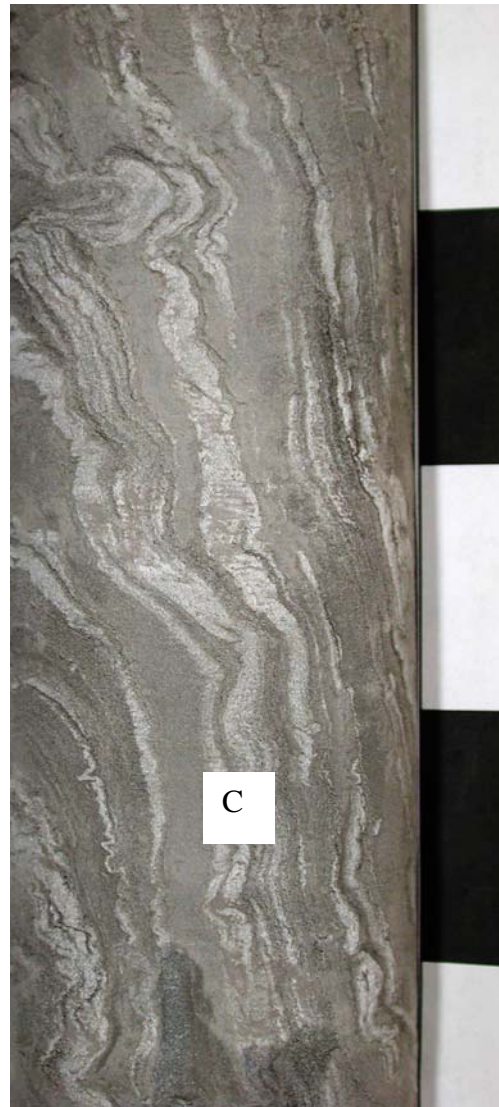
Figure 2.18: Lenticular microfacies

a) Lenticular shale displaying convolute bedding; related to sandy mudflow or slumping activity.
b) Lenticular Shale displaying vertical bedding; consisting of very fine sand to silt, wavy/crenulated laminations. Sandstone lenticels (C). Bedding slightly disturbed (loading or bioturbation).
Scale in both core photos is 1/10'.

a) Lenticular Shale; Deformed

b) Lenticular Shale; Deformed

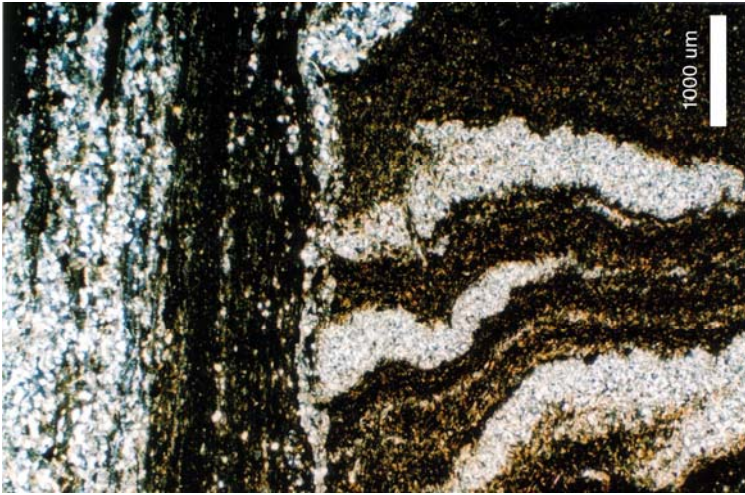
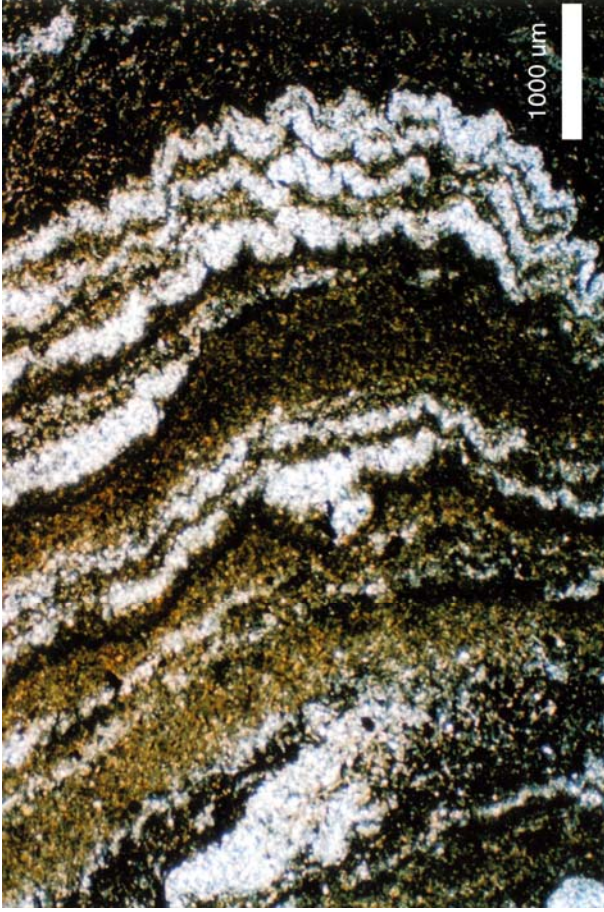
Figure 2.19: Lenticular Shale Microphotographs

(a) cross-polarized; 5x total magnification

(b) cross-polarized; 5x total magnification

Interpretation: The incomplete or starved ripples are generated by an insufficient supply of sand with conditions favoring the deposition and preservation of mud. The formation of these lenticular shales depends upon alternating periods of both high energy (turbulent water) and low energy (slack water) depositional events. The sand ripples are deposited on a muddy substratum, during limited intervals of current or wave action, and preserved by mud deposition from slack water suspension fallout.

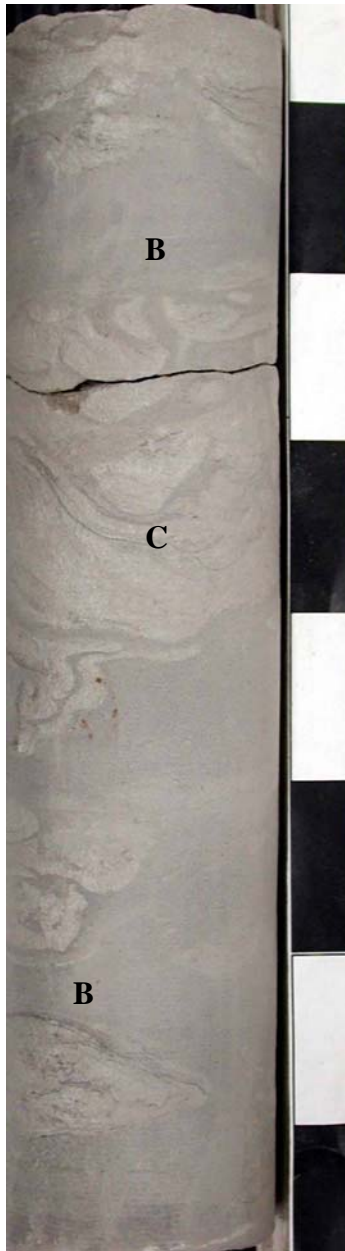
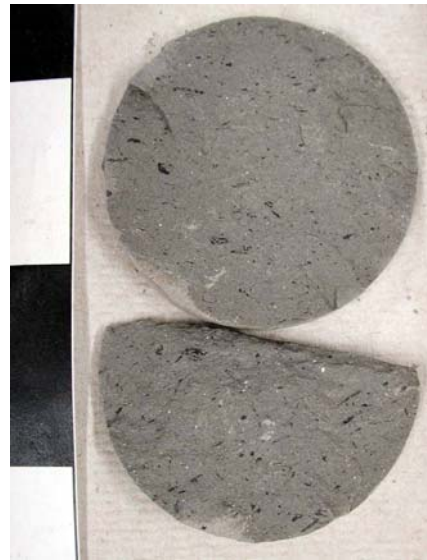
- a) Massive gray, sandy shale/siltstone with an isolated sandstone load structure (A) in the middle of the core.
 - b) Massive, light gray, silty/sandy shale with fine sandstone ball-and-pillow structure (B) and contorted soft sediment deformation (C). Notice how resistant the cores are in both figures, with very few fractures.
 - c) Abundant sand, mica, and macroscopic organics within sandy/silty shale.
- Scale in all core photos is 1/10'.

Interpretation: The ball-and-pillow structure is generated by a disturbance within the deposit (e.g. applied shock, loading or slumping activity) that results in the overlying sandy layers to be broken into “pillows”. These sandy pillows then sink into the underlying mud. In some cases, rather than being broken into pillows, a larger portion of the sandy layer is vertically displaced causing contorted/convolute bedding to develop (Fig. 2.20 b).

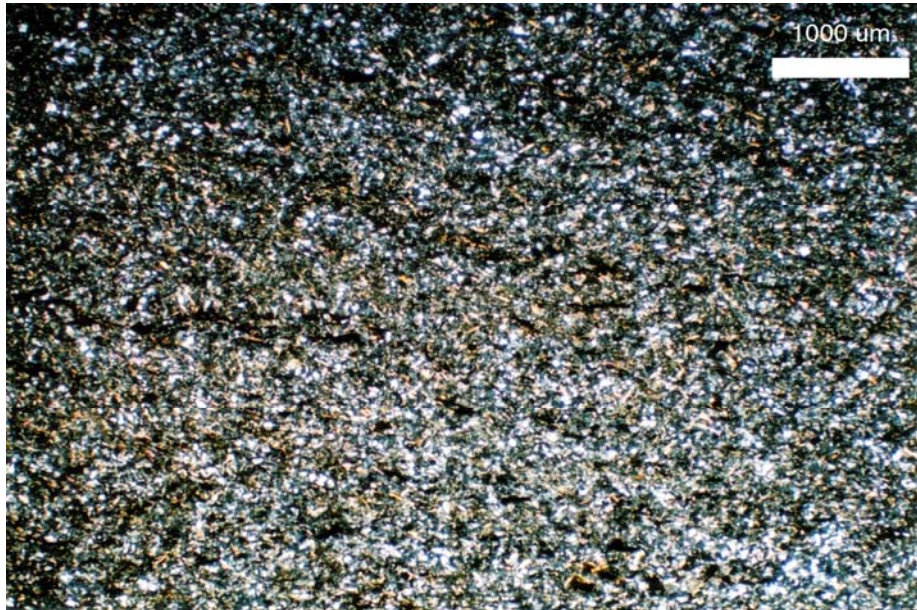
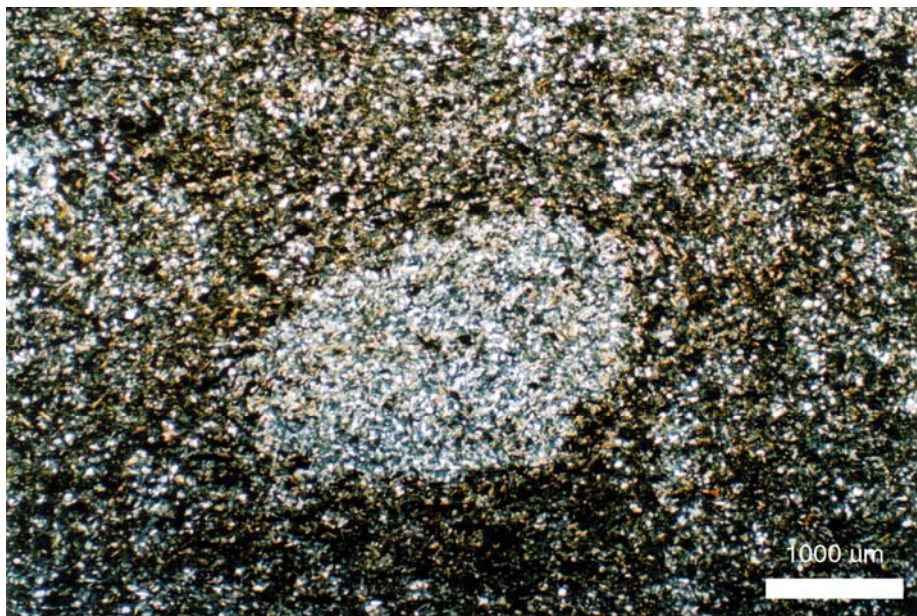
Figure 2.22: Silty/Sandy Shale Photomicrographs

b) well sorted, very fine sand “sunken” pillow preserved within very fine sand, silt, and clay matrix with abundant black organic debris.

Frame length in both photomicrographs is 6650 μm (6.65 mm).

(a) cross-polarized light; 5x total magnification

(b) cross-polarized light; 5x total magnification

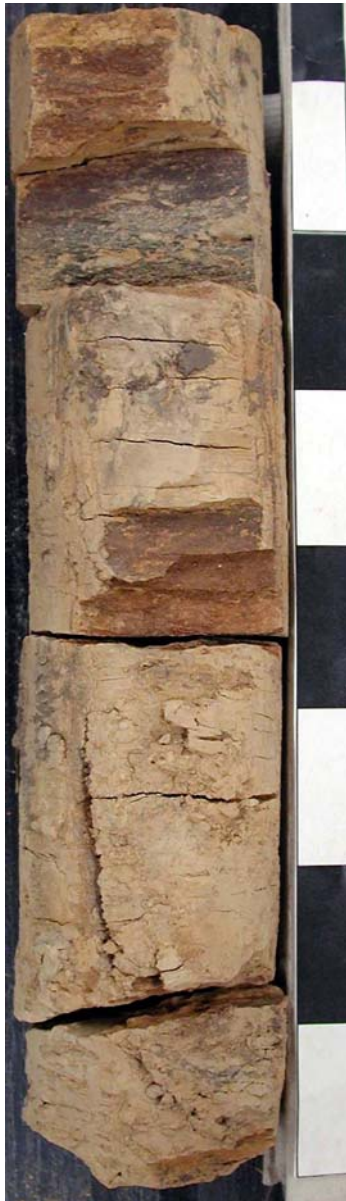
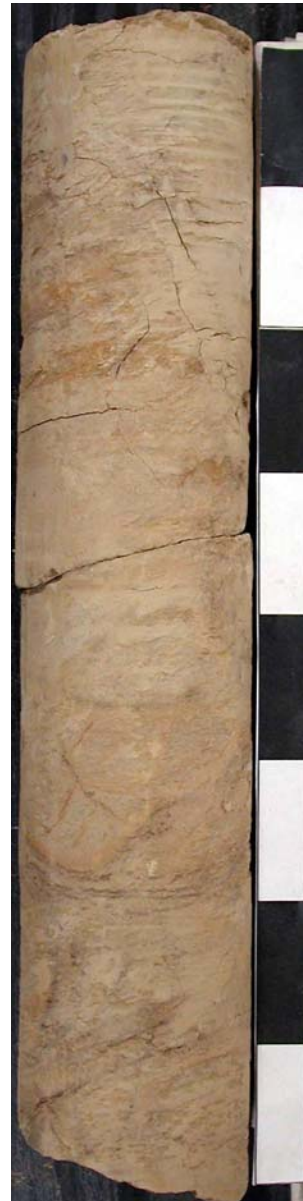
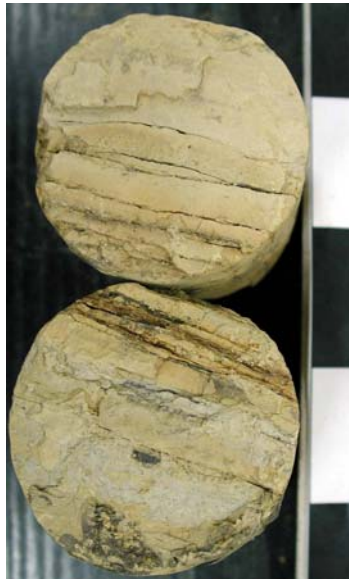
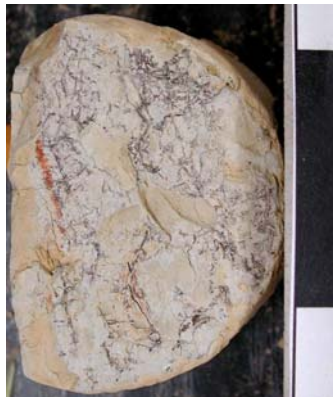
- a) Weathered and fractured shale.
 - b) Orangish-Gray weathered shale with shear plane (A) in the middle of the core.
 - c) Weathered shale exhibiting prominent vertical fractures.
 - d) Modern root development within weathered shale; notice the drabe halos (light green) forming around the rootlets.
- 1/10' scale on all core photos.

The weathered shale microfacies is classified as high-medium concern for rock/slope instability as the slake durability average was 31.5% with a range of 4-39.4%. This microfacies was originally a member of the more resistant sandy/silty shale microfacies, found toward the base of Pleasant Grove Hill. However, because the material is located at the toe of the back slope and with close proximity to the ground surface, modern weathering and pedogenic processes have altered the material to its weathered shale microfacies. The effects of weathering and pedogenic processes, on rock materials close to the surface, are most extensive at the base or toe of the hill. Abundant fractures and oxidation of the Lawrence Shale is a result of the high amounts of water accumulation/percolation, due to surface runoff from hill slopes, and more vegetative growth (root penetration). Along the slopes of the hill, the degree and extent of weathering and pedogenesis is less. The most distinguishing feature throughout the weathered shale microfacies was the abundant vertical fractures. This will not only lead to rock/slope stability problems when exposed on the road-cut, but it may also cause problems beneath the subgrade of the new highway. It is recommended to consider removing the interval of weathered shale where exposed during road-cut excavation.

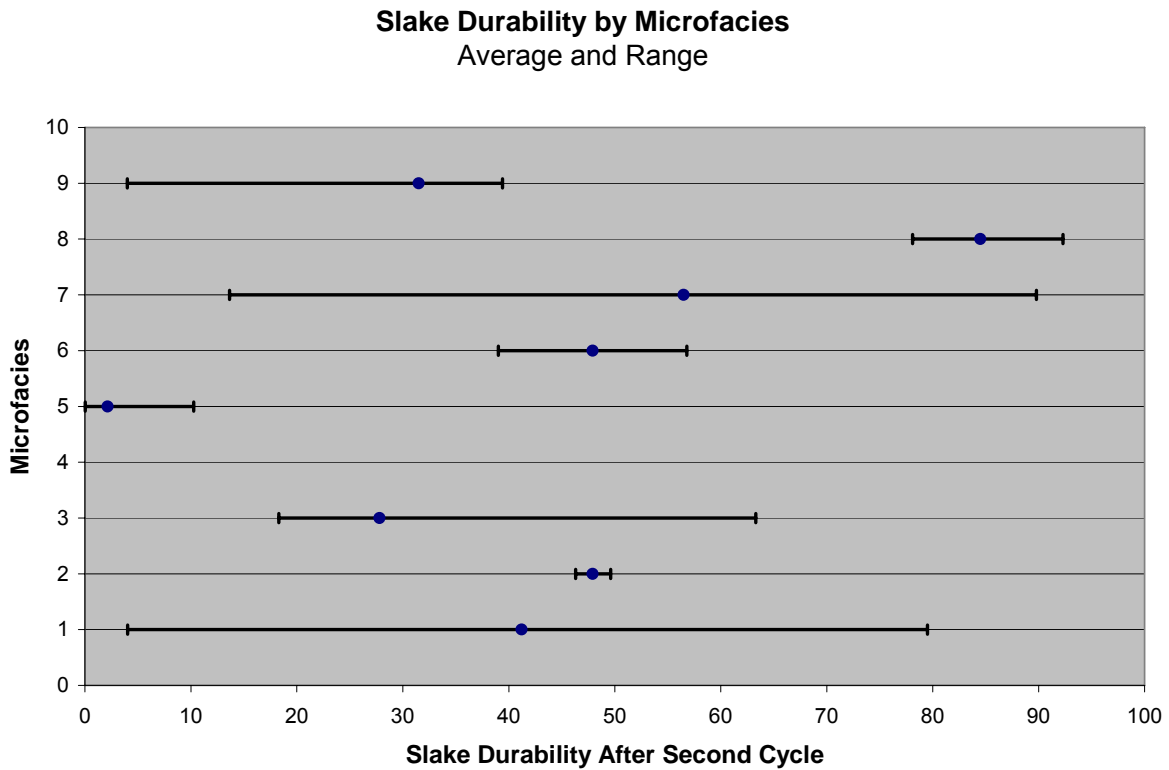
Figure 3.1: Slake Durability by Microfacies; average and range values

Arranging the data in order of increasing slake durability, there is a strong relationship between the microfacies within the Lawrence Shale. Based on the slake durability results, after two cycles, the paleosols are designated as being the least durable ($I_d = 0-10.7$) and thus most susceptible to rock/slope failure. The sandy/silty shales represent the microfacies that are more resistant to slaking and are located at greater depths. Figure 3.1 provides slake durability results by microfacies.

The paleosols are the most susceptible microfacies for potentially inducing rock/slope failure. The slake durability average was 2.15% with a range of 0-10.27%. The paleosols contain abundant ancient root traces/channels and angled shear planes with slickensides. The root traces/channels provide conduits for water to infiltrate into the paleosol and result in the high water absorption values (33.5 – 42.9), supported by the Jar Slake test. The water disrupts the thin platy ped structure of the paleosols causing the material to disintegrate into a pile of flakes, as indicated by the slake durability results. Throughout the paleosol, numerous angled shear planes, with slickensides, occur at various directions and angles. The shear planes were generated by either one or a combination of the following processes: pedogenesis, compactional/overburden forces, or shrink/swell. Most of the angled shear planes were identified as having smooth, striated, and thinly coated clay surfaces which create numerous planes of weakness within the paleosol.

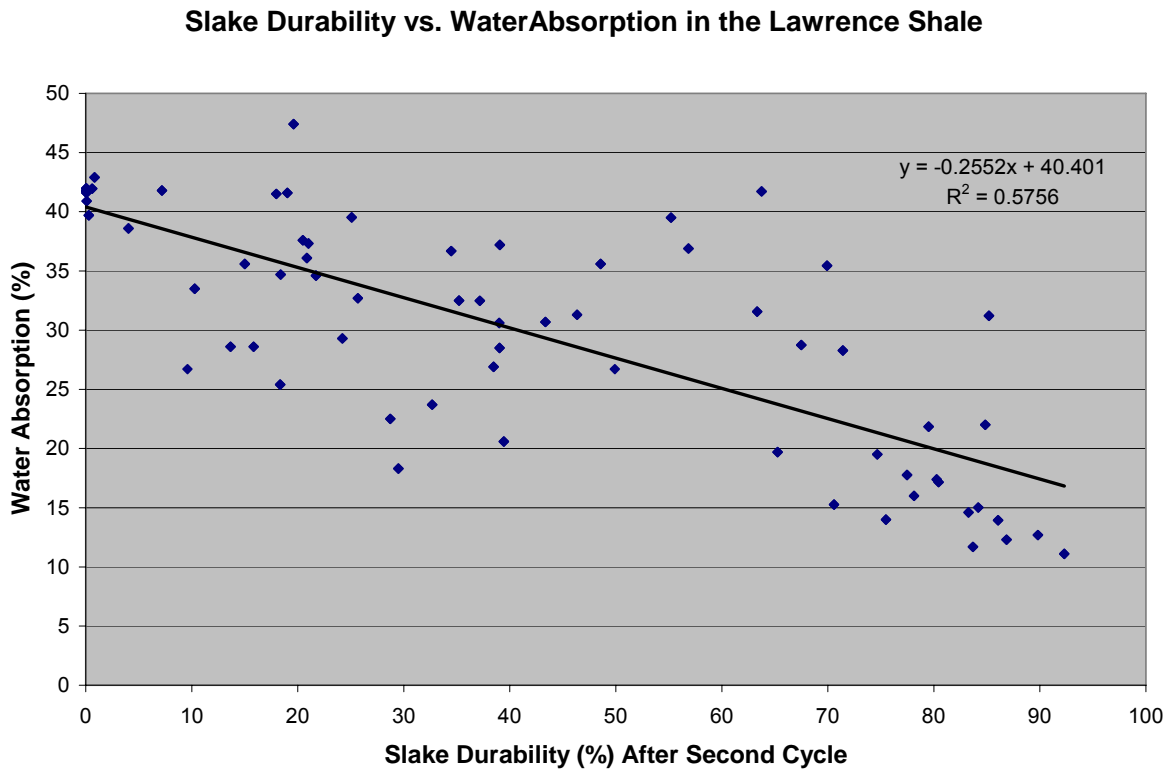
Figure 3.2: Slake Durability vs. Water Absorption in the Lawrence Shale

The Jar Index is a simple and fast test to identify the effects of submersing a rock sample in water. As a secondary procedure to the jar index, water absorption can be calculated. There is an adequate relationship between the slake durability and water absorption within the Lawrence Formation. As water absorption increases, the durability of the material is reduced (Fig. 3.2).

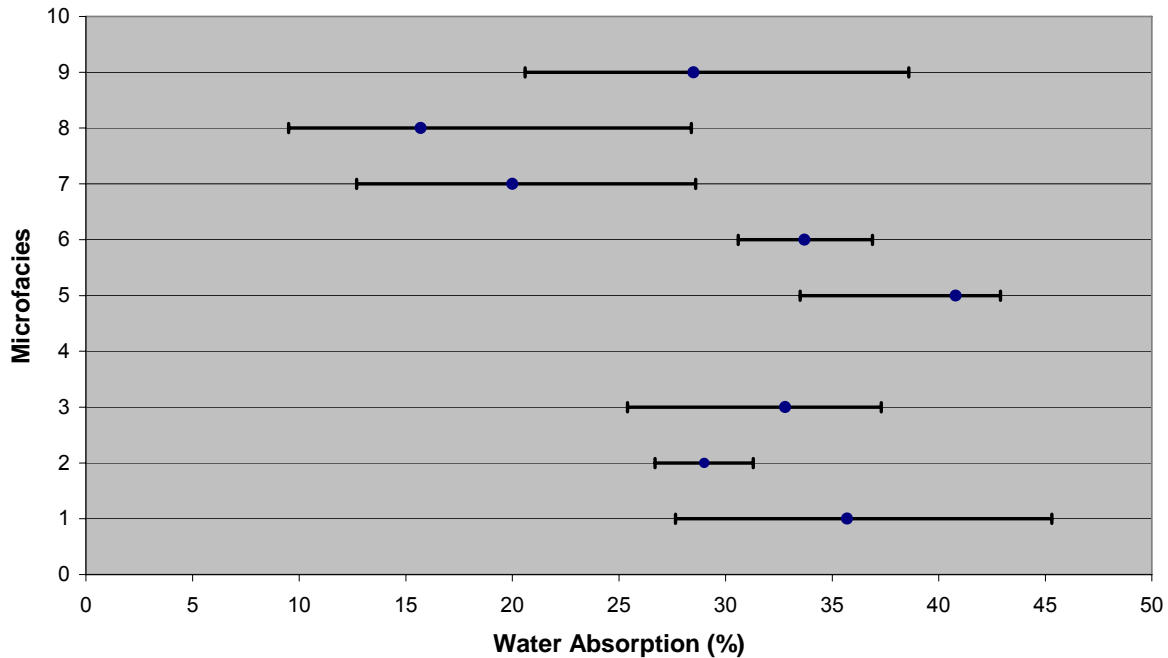
Figure 3.3: Percent Water Absorption by Microfacies; average and range values

* Microfacies: (1) Churned Shale; (2) Shale; (3) Clayshale; (4) Coal (N/A); (5) Paleosol; (6) Carbonate-rich Shale; (7) Lenticular Shale; (8) Sandy/Silty Shale; (9) Weathered Shale. Average and range of percent calcium carbonate are indicated by a circle and whiskers.

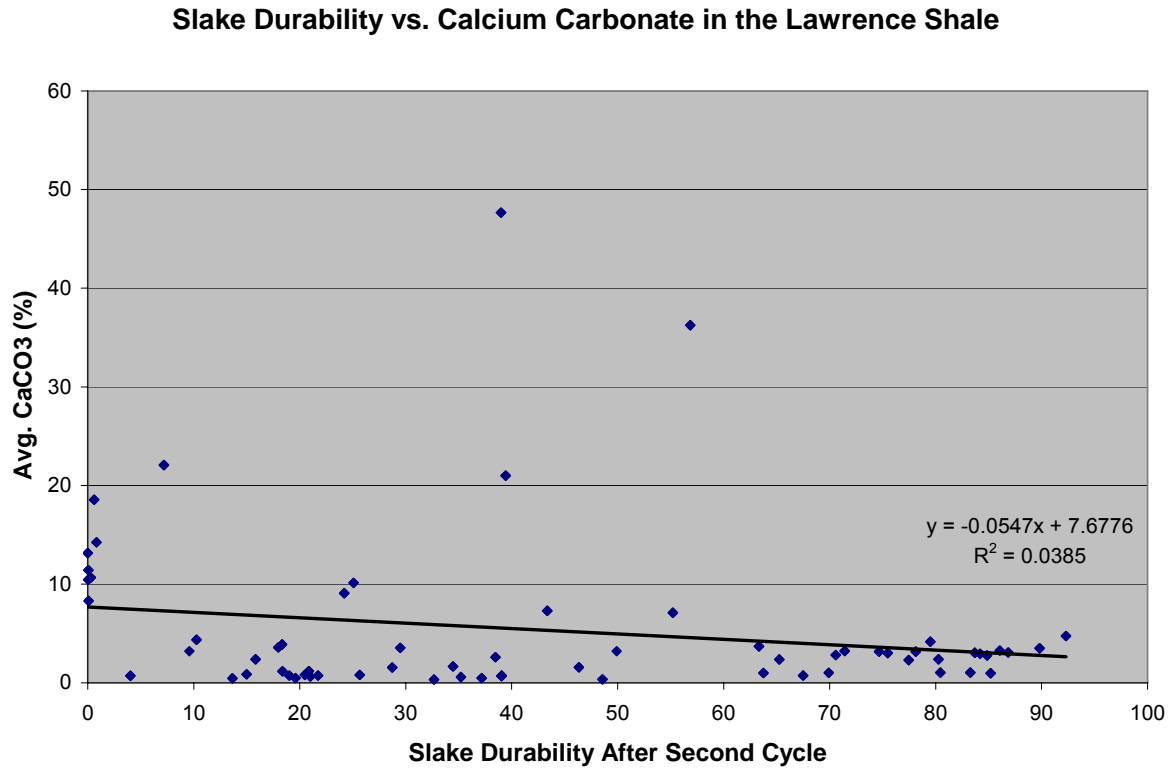
Figure 3.4: Slake Durability vs. Calcium Carbonate in the Lawrence Shale

The high “outliers” in Figure 3.4 are due to the high concentration of calcium carbonate in the Carbonate-rich Shale and Paleosol microfacies.

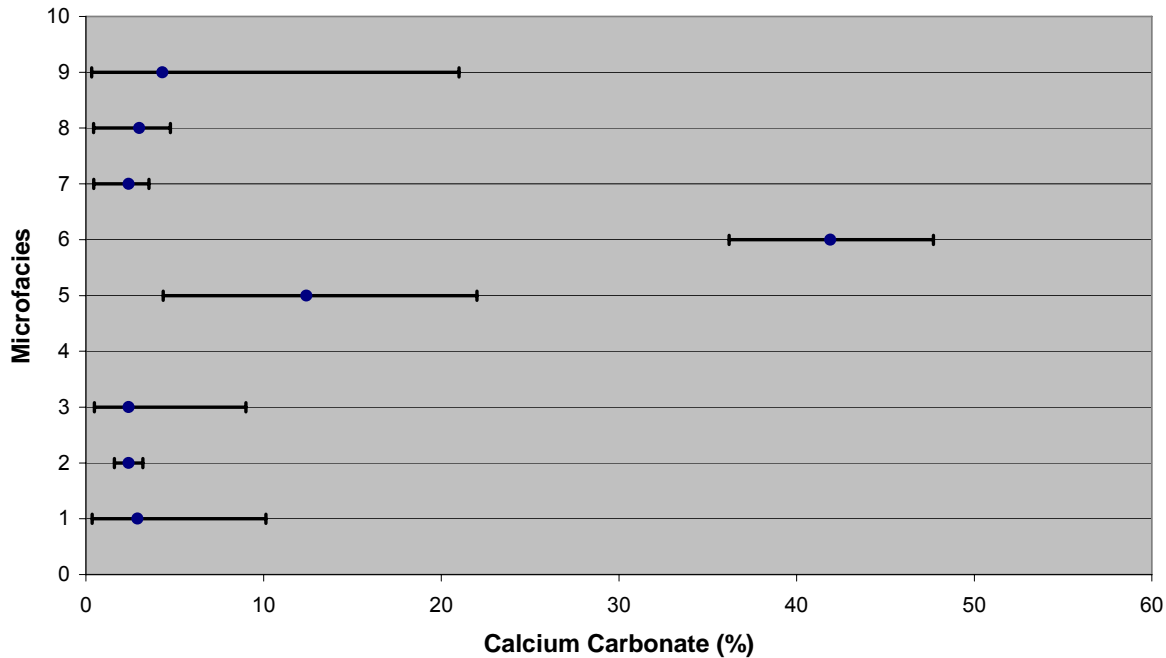
Figure 3.5: Percent Calcium Carbonate by Microfacies; average and range values

* Microfacies: (1) Churned Shale; (2) Shale; (3) Clayshale; (4) Coal (N/A); (5) Paleosol; (6) Carbonate-rich Shale; (7) Lenticular Shale; (8) Sandy/Silty Shale; (9) Weathered Shale. Average and range of percent calcium carbonate are indicated by a circle and whiskers.
