Superpave Mix Designs for Low-Volume Roads

Final Report
Iowa Highway Research Board
Project TR-414

October 2004

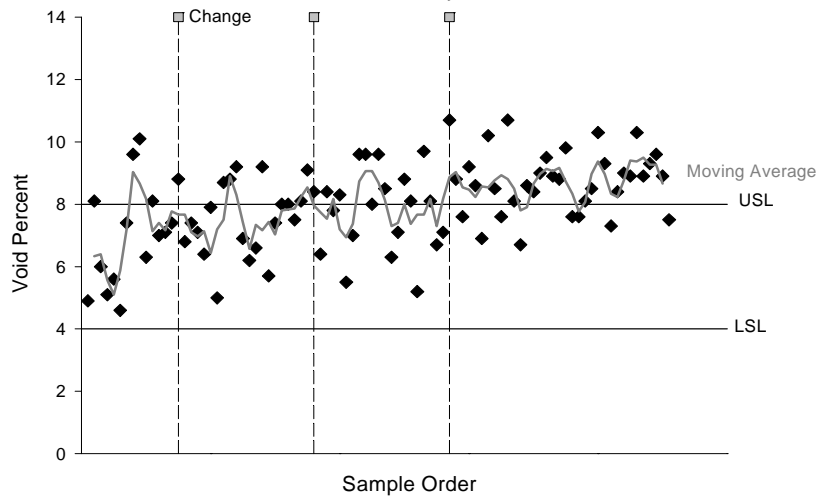
Figure 3
Field Voids
Scott County

The term Field Voids refers to the void content measured in samples cored from the road after paving. Figure 3 shows the data from this project. While the lab voids began too low and progressed into the specified zone with adjustments to the mix; the field voids began within specified limits and progressed above the upper limit. This upward trend in field voids may be an indication of the increasing difficulty of compacting an increasingly coarse mix.

Field voids above the upper specification limit are of significant concern - they can indicate problems with high permeability and early aging of the ACC. Field voids should probably be included in Construction Issues, because they are mostly a result of the level of compaction in the field. They are discussed here to provide an easier comparison with the lab voids data.

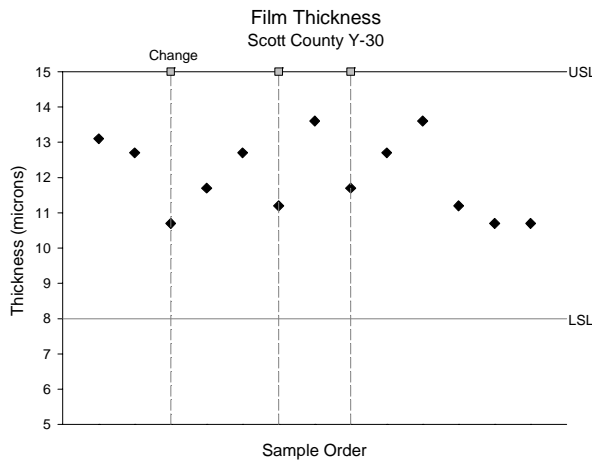
The last of the data to be considered is film thickness. This calculated value is the thickness of the film of asphalt on each particle in the mix, measured in microns. If the film thickness is too low, the pavement will be at risk for stripping, raveling and cracking; too high and there will be stability problems. Figure 4 shows the data for film thickness on this project.

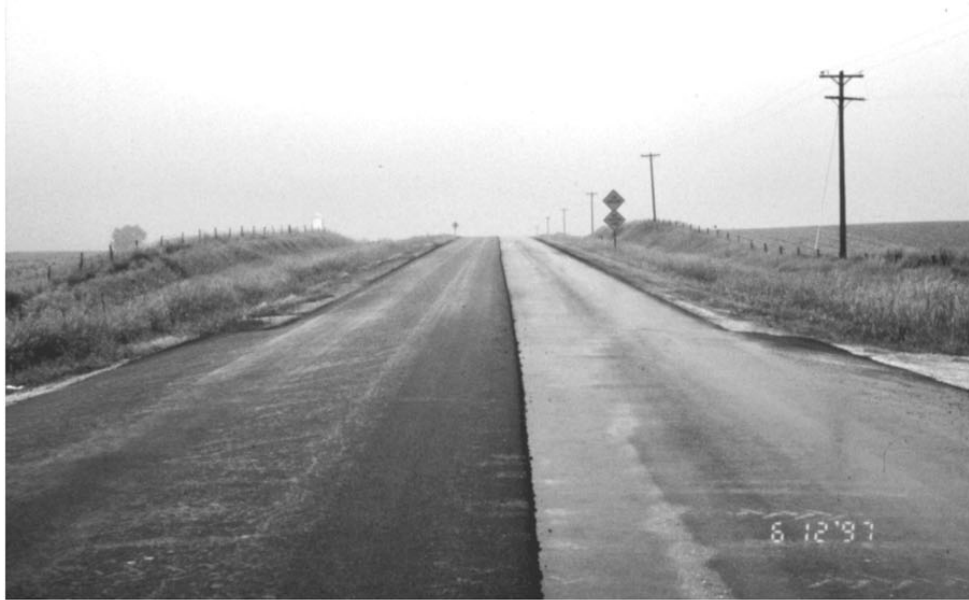
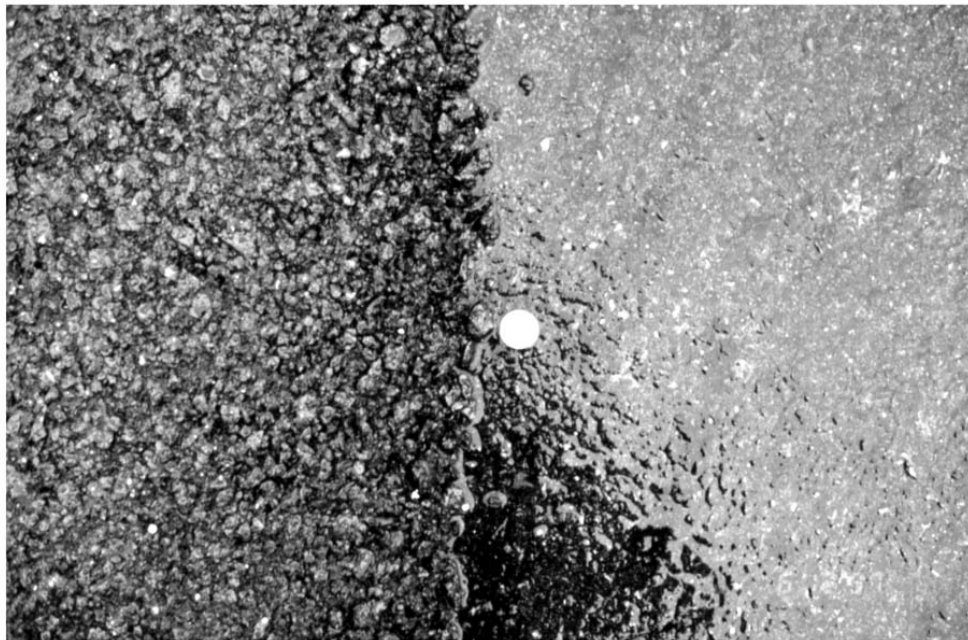
Figure 5
Scott County Highway Y-30

These photographs show the difference in texture before (smooth) and after (coarse) a mix design change on this project. Note that the pavement is wet from rain and that the circle in the bottom photograph is approximately 25mm.

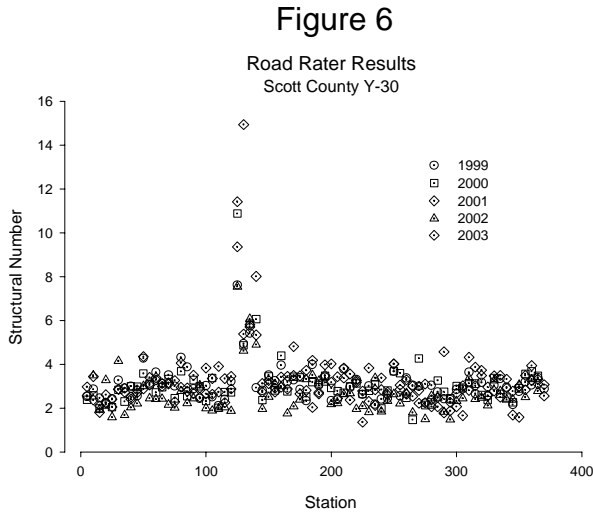
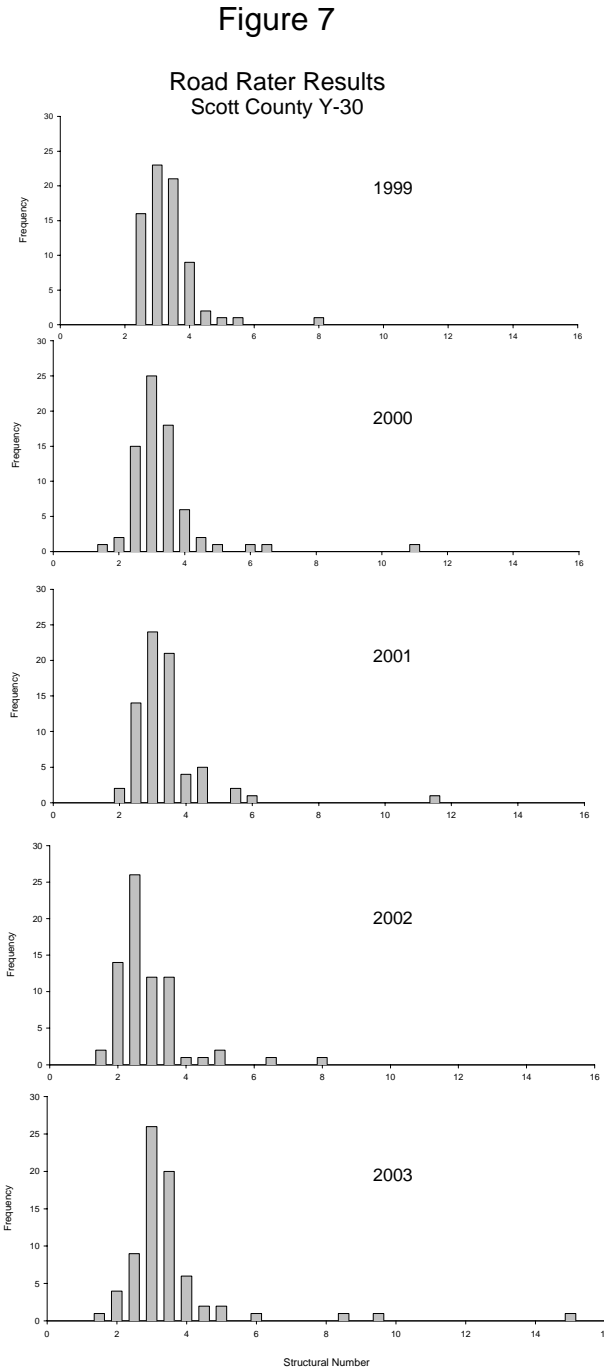
Road Rater results for this project are shown in Figures 6 and 7. The Road Rater provides a measurement of the structural support exhibited by a pavement. Figure 6 shows the structural data by station along the road while Figure 7 contains histograms by date of the same data. In Figure 6, the high values around station 130 are a result of the paving around the truck stop and on the bridge approaches. Figure 7 shows overall structural values over time. There is no significant evidence of any changes in structure values over time.

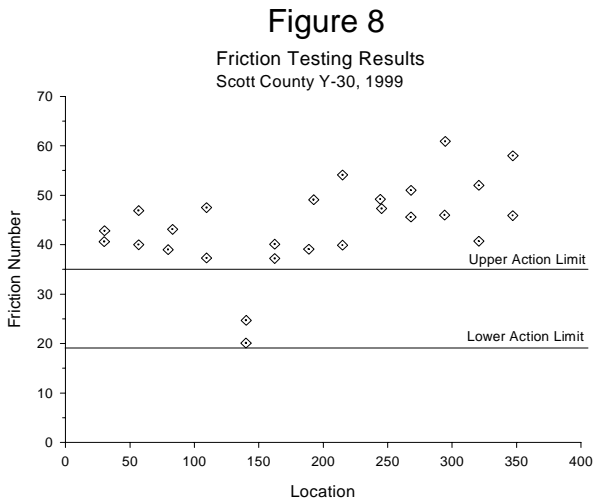
Figure 8 shows the results of friction testing on this project. There are lower limits for friction set in the Iowa DOT Policies and Procedures manual (Policy No. 600.01). Any result below 35 results in review by the assistant district engineer. Values less than 19 may merit installation of “Slippery When Wet” signs.

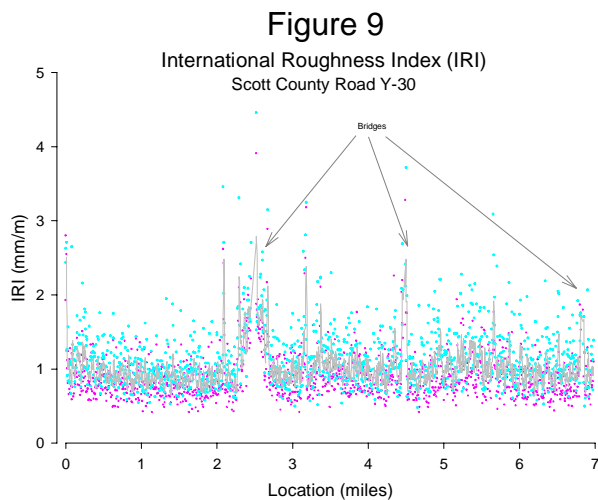
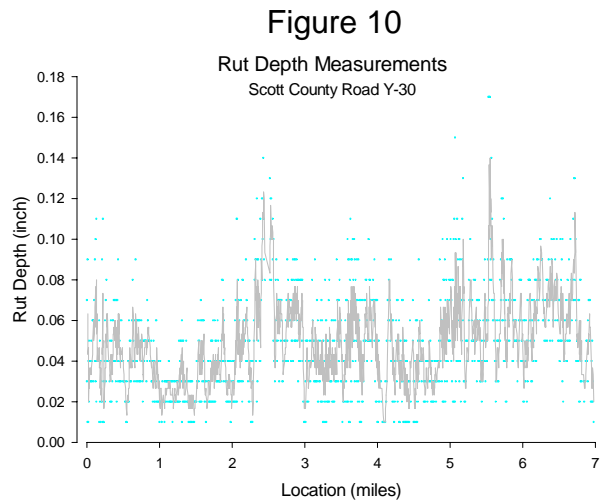
Smoothness data are broken into inside and outside wheel-path data (crosses and dots respectively) plus an overall running average (line) using three samples per average. Most of the peaks in the smoothness data occur at bridges—the large one at approximately 2.5 miles is the bridge and approaches for the overpass of I-80. Note that the inside and outside wheel-path average values are different. The inside wheel-path tends to be smoother because of added support in the center of the pavement.

Rutting seems to be related to the location of at least the large bridge and approaches. This could place some doubt on the effectiveness of the asphalt additive. However, no detailed analysis has been performed on the short section of treated pavement. Also, until closure of the truck stop, there was a large amount of truck traffic in that short segment. Even there, the deepest of the ruts was just over 0.10 inch. As a rule-of-thumb, rutting is not considered significant until it is at least that deep.

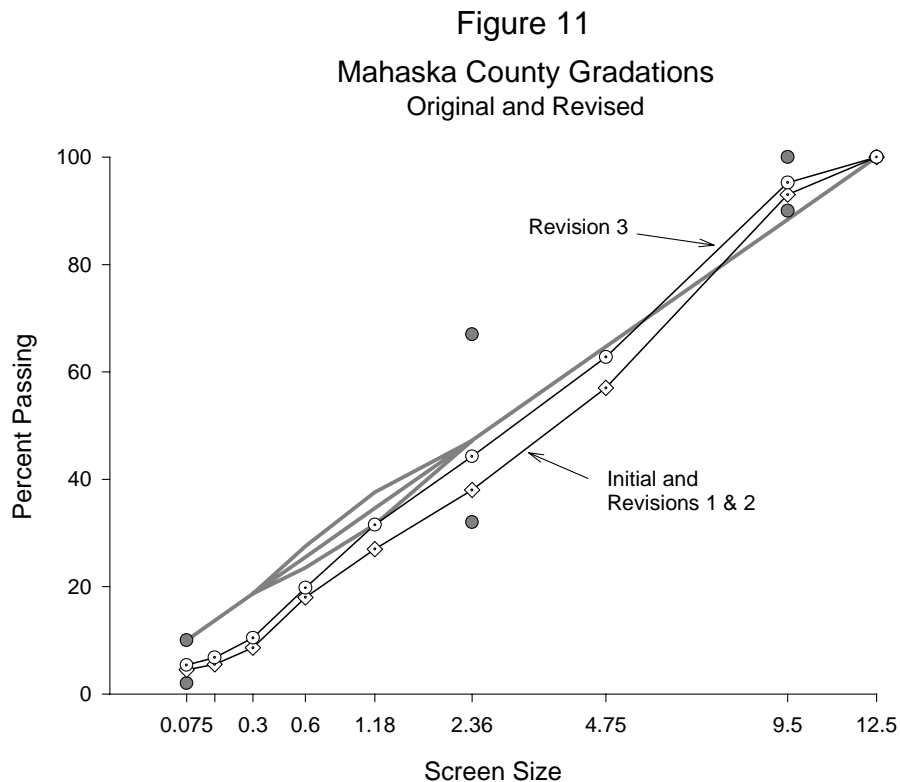
This project specified a 9.5 mm mix. Figure 11 shows a graph of the gradation power curve for this mix. Notice that this curve has a less pronounced "S" shape and is closer to the maximum density line than the Scott County curve (Figure 1).

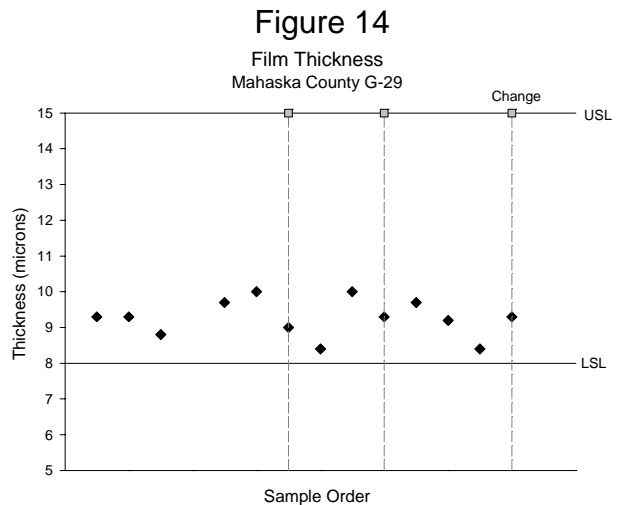
Film thicknesses (Figure 14) were within the specified limits although the values remained near the lower limit. This is consistent with a small mix size. For comparisons refer to the film thicknesses of the Scott County project (Figure 4) - a large and coarse mix, and those of the Dubuque County project (Figure 41) - a large and fine mix. For a discussion of mix sizes see Appendix B.

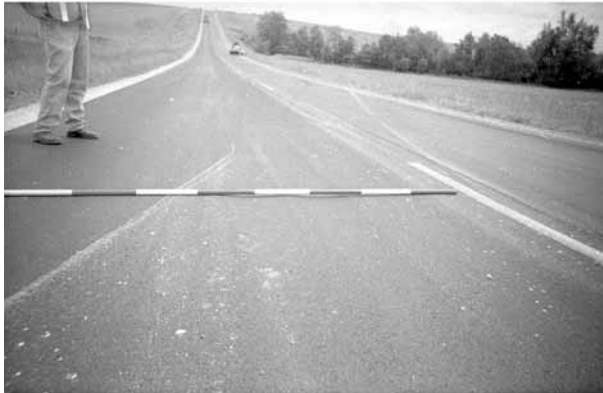
Figure 15

Rutting in the newly-placed first lift.

There were no reports of problems with placement compared to a conventional mix. However, this project provided a good test of ACC pavement under unusual conditions. Photographs of some of the conditions are shown in Figures 15 and 16.

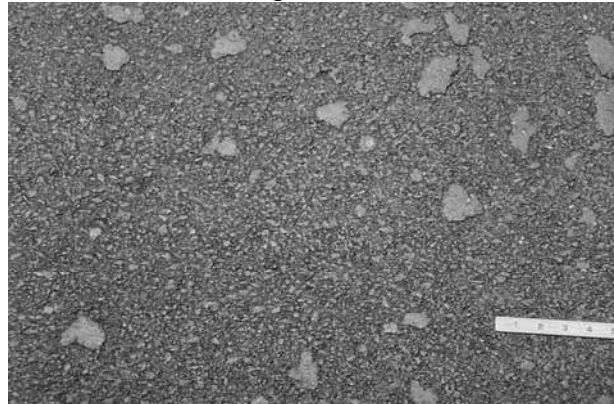
Figure 16

"Patties of AC on pavement surface due to inadequate roller tire temperature.

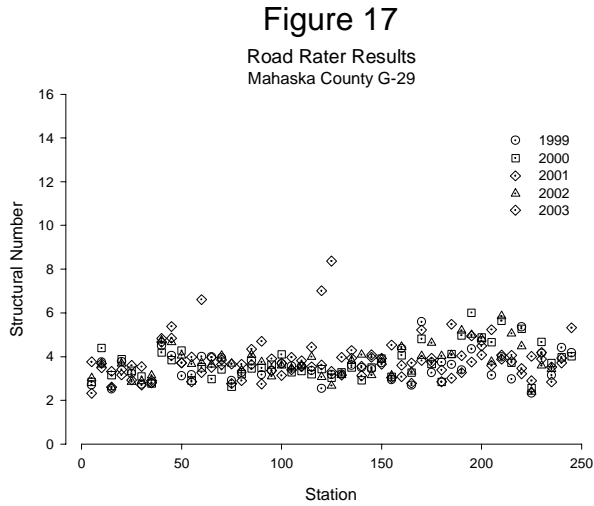
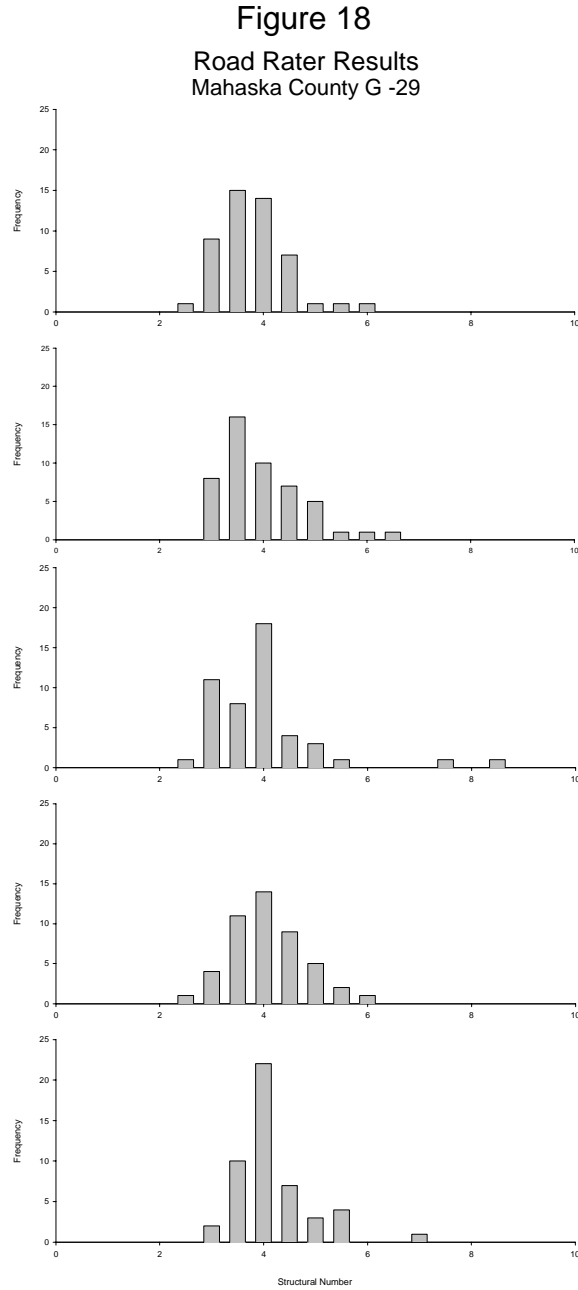
Graphs of Road Rater data are shown in Figures 17 and 18. Note the increased ratings with a gap at approximately station 140 and the overall increase in structural rating from approximately station 175 onward. In the former case, the gap is due to a bridge over the railroad tracks near Lacey and the increase is due to the pavement composition inside the city limits. In the latter case, the increase is most likely correlated strongly to excess pavement thickness. The histograms in Figure 18 show no evidence of a change in average structural ratings over time.

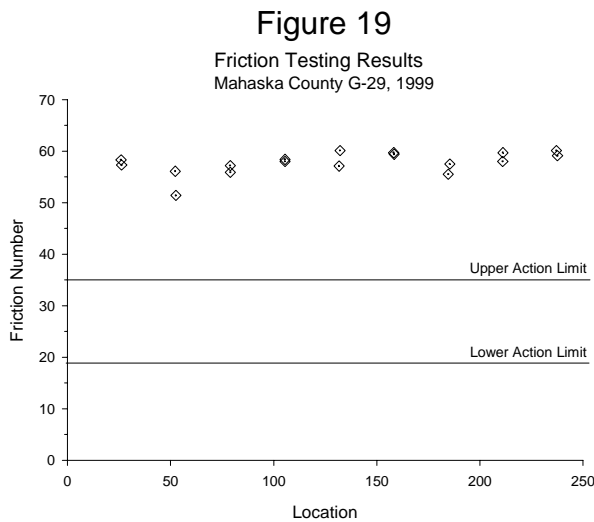
Friction data are shown in Figure 19. All of the values are well above the minimum thresholds.

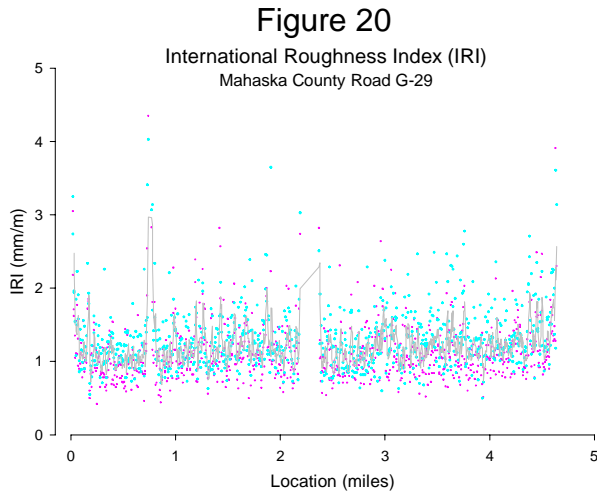
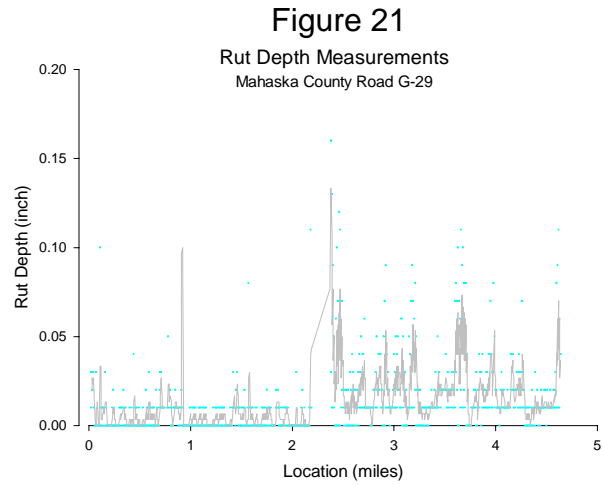
Smoothness and rutting data are shown below in Figures 20 and 21. The two large peaks in the smoothness data represent two major bridges, one over the railroad tracks east of Lacey and the other a bridge with concrete approaches approximately two miles east of Lacey. Rut depth measurements strongly indicate the thickness change in the latter half of the project. Very thick lifts are more difficult to compact and compaction by traffic tends to occur in the wheel-paths as rutting. However, even here, the ruts are well below 0.1 inch.

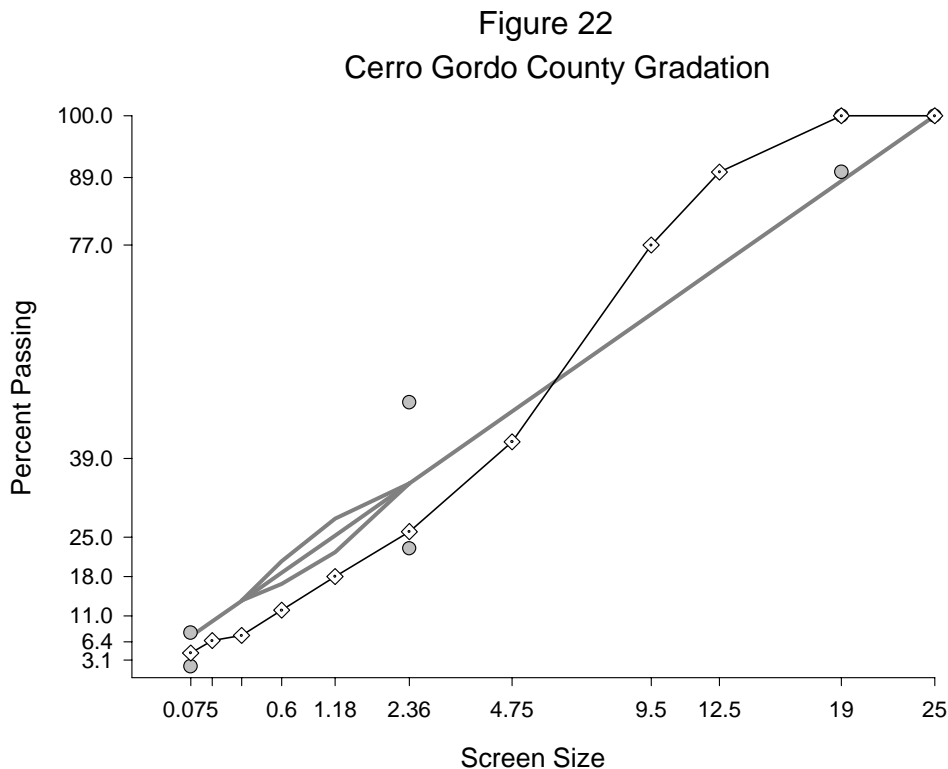
Because the two projects were paved at the same time with the same materials, the data will be evaluated as if from one project. These projects used a 19 mm mix. Figure 22 shows a graph of the gradation power curve for the mix.

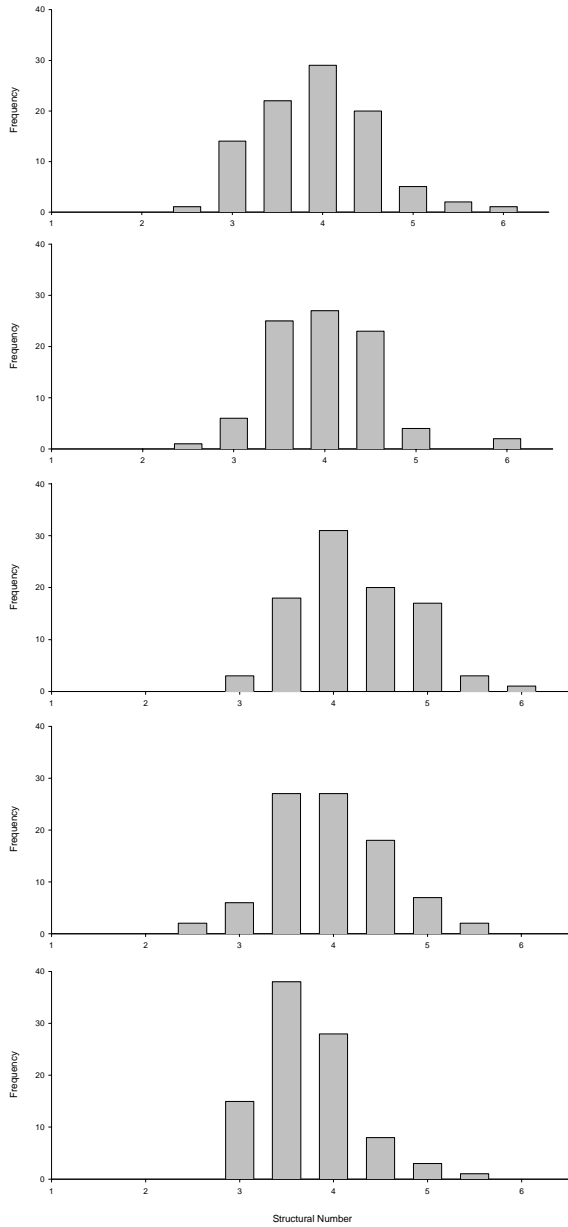
Figure 28
Road Rater Results
Cerro Gordo County B - 60

The histograms of Road Rater data (Figures 28 and 29) do not indicate any significant change in structural values over time. They do indicate a significant difference in structure between the two projects with structural numbers on B-60 averaging about 4 and on S-70 averaging about 3. This is most notable in the histograms.

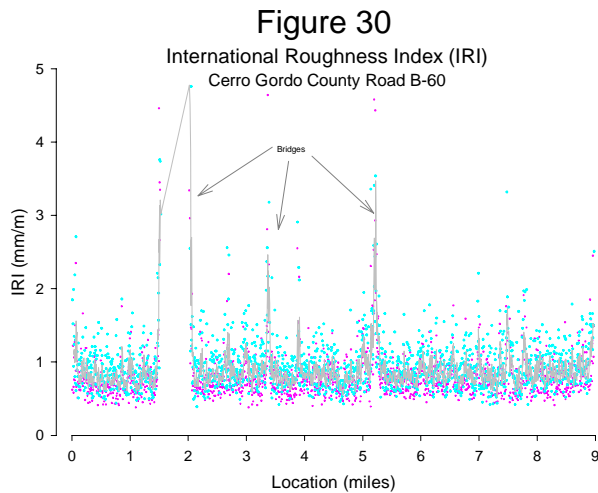
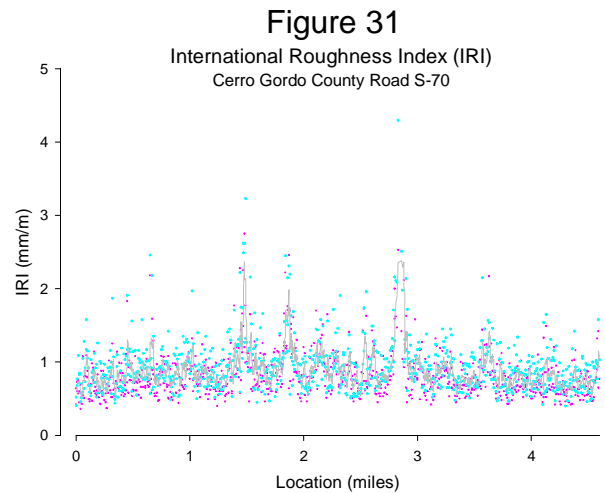
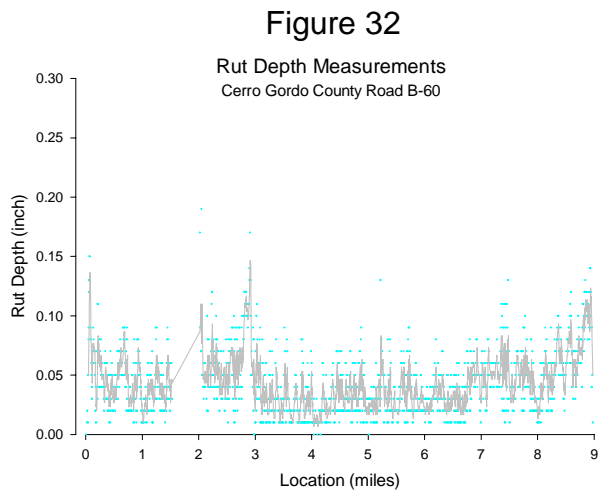
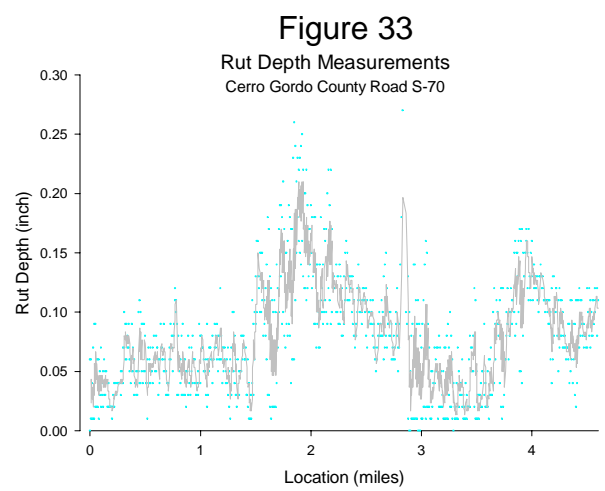
There was no significant difference in the smoothness data between the two projects (Figures 30 and 31). As before, the spikes visible in the data involve bridges and intersections.

Rutting and crack data present a more complex picture. In the project on B-60, other than some minor cracking on bridge approaches, there were no cracks visible at all. Rutting on this road was not significant either (Figures 32 and 33).

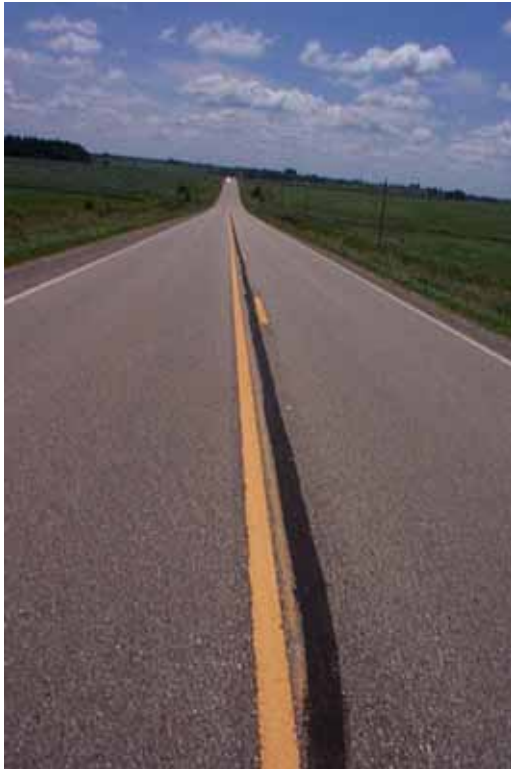
Figure 34

On S-70, there was some longitudinal cracking in the first half of the project. Most of the cracks were along the centerline (see Figure 34). In addition there were three full transverse cracks.

to display lower structural values than the rest of the first half. The road from near this point north had the surface lift placed full-width (in Figure 35, no central joint is visible compared to Figure 34). All of the cracks in this project were routed prior to being filled with crack sealant.

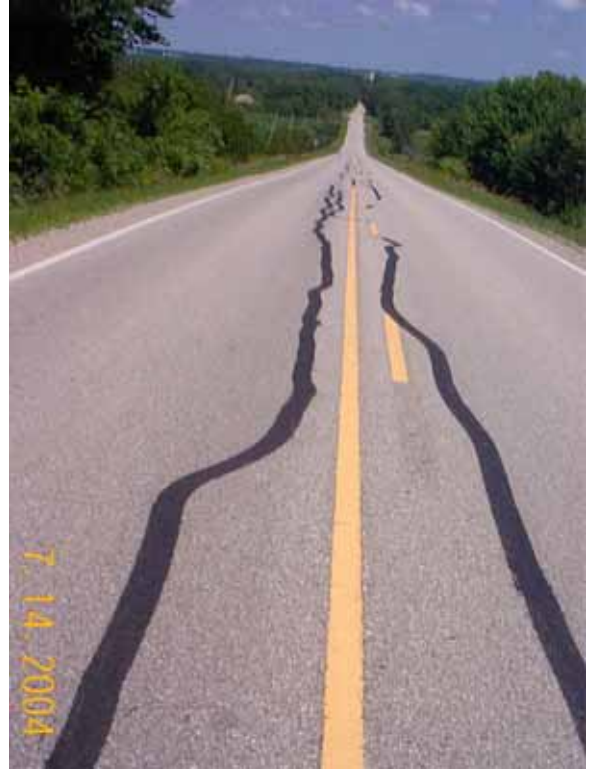
Figure 35

From approximately station 108 to 134 (corresponding to the peak in rutting visible in Figure 33), was a long relatively steep hill. This hill had lots of longitudinal cracking near the centerline. Photographs of the two situations are shown in Figures 34 and 35. We're not at all certain of the cause of this cracking. The rutting is expected because of the long hill, but the cracks represent a puzzle. Figure 36 shows a slightly modified plot of the Road Rater data. The two vertical grey lines indicate the location of the hill. One can see that the entire first half of the project has weaker values than the second half (where there were no cracks). But the hill doesn't seem

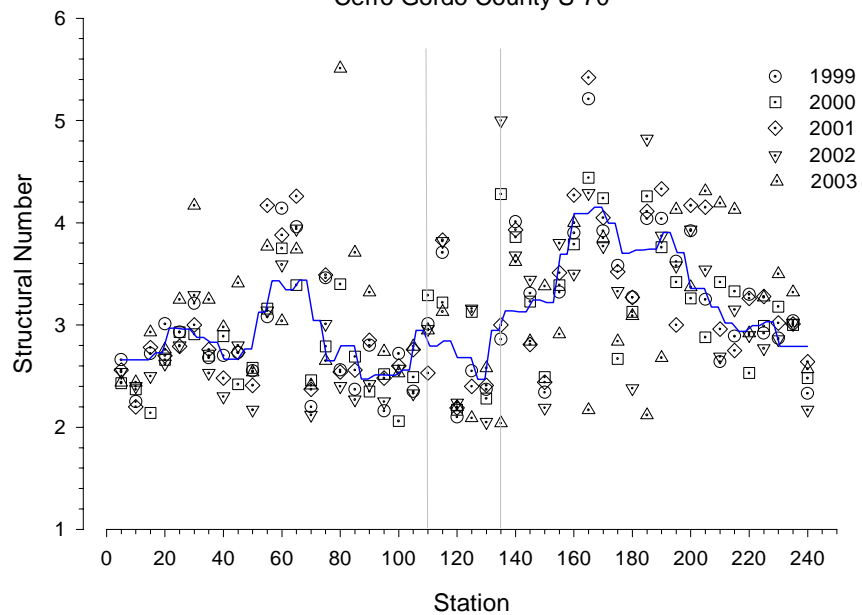
Figure 36

Road Rater Results
Cerro Gordo County S-70

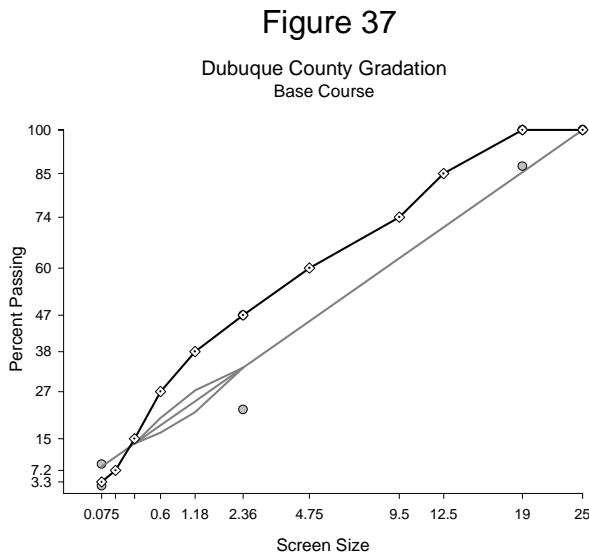
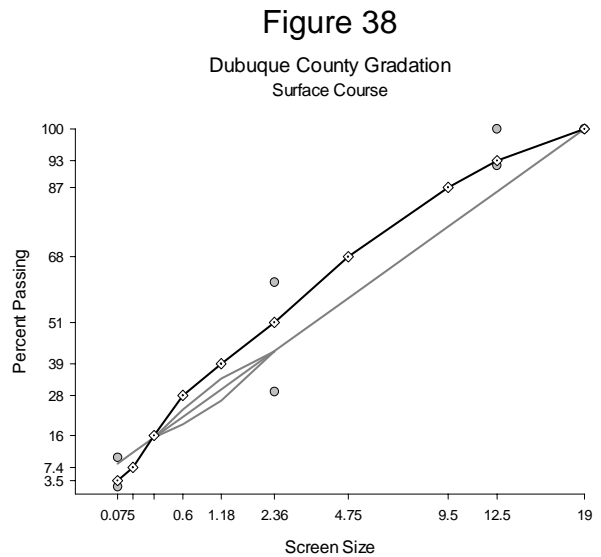
In contrast with the other projects, this mix design used a very fine gradation (for a description of gradation terms see Appendix B). Note in Figures 37 and 38 that the gradation power curve is almost entirely above the maximum density line and above the restricted zone. The paving consisted of a 19 mm mix for the base lift and a 12.5 mm mix for the surface lift.

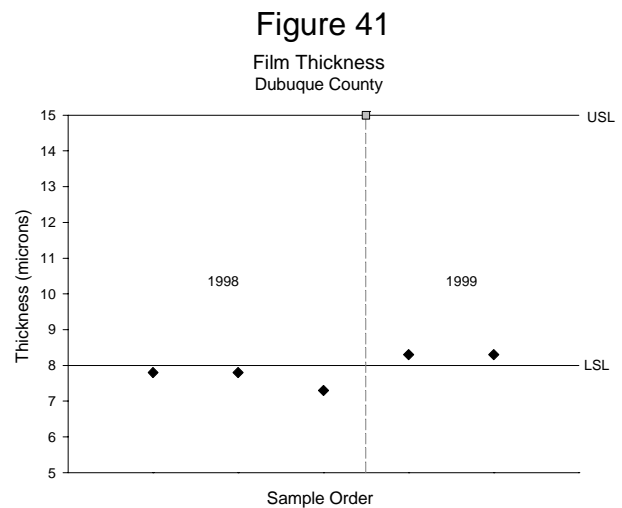
Film thickness data for this project are shown in Figure 41. These values are quite low, which is consistent with a very fine mix.

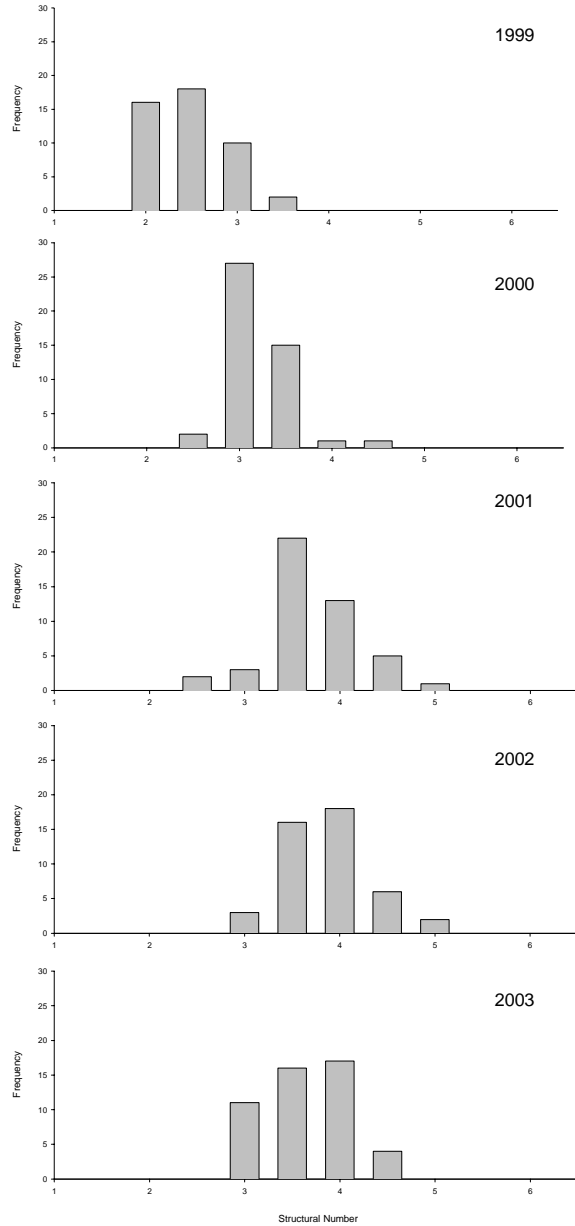
Figure 43
Road Rater Results
Dubuque County 966

Note that the data for 1999 are significantly lower than those for the other years. This is because the data was obtained in May of that year, before the surface course had been placed. So the graph is showing rather directly the amount of support being provided by the top lift of ACC pavement.

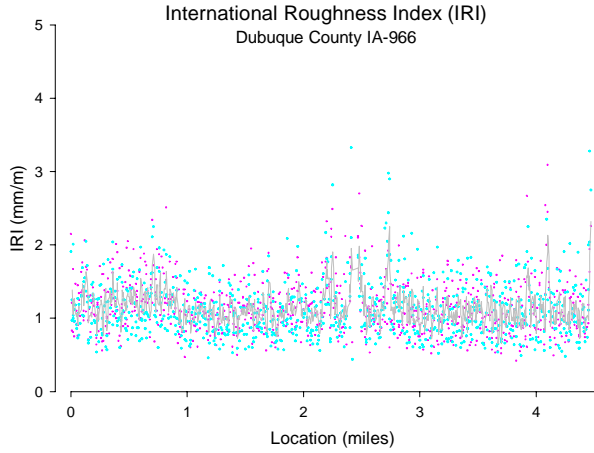
Figure 45

Smoothness and rutting on this project (Figures 45 and 46) were mostly unremarkable. Rutting was significantly worse in the eastern third of the project. This is likely due to heavy truck traffic and a hill along that portion as well as some areas with weak sub-grade (described below).

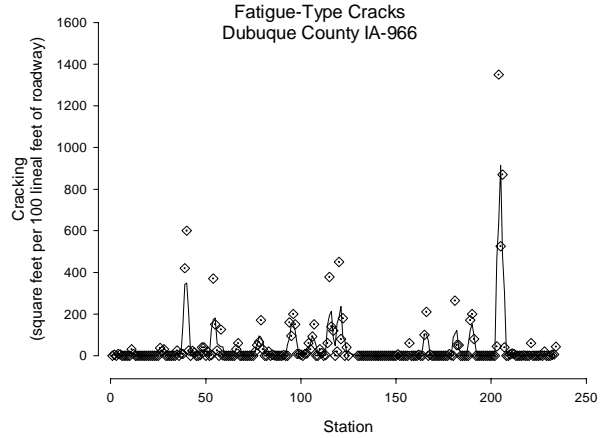
Figure 47

Very little cracking showed up in this project for the first four years. The data shown in Figures 47 to 49 are from a comprehensive crack survey performed in 2004.

Around station 121 are an aggregate/concrete plant and an petroleum storage/distribution facility. These plants (which were not located there at the time of paving) produce a large amount of heavy truck traffic. The larger amount of fatigue type cracking in this area is probably strongly related to that truck traffic, most of which travels to the east (up-station).

There are several important items to note in the fatigue crack data. The fatigue cracking graph is the only one showing a distinct pattern of cracked and non-cracked areas—the cracked areas are quite localized. This is consistent with the local environments. To the west of station 120 (down-station) is a long, steep hill (~1.5 miles, 6 percent grade). Trucks traveling up this hill do so at a very slow speed, which puts the pavement and subgrade under considerable stress. Cracked areas other than these two are likely to be areas of localized weak subgrade. The county excavated and replaced many weak spots at the time of paving. It's quite plausible to think that these localized fatigue-type cracks are related to additional areas with weak subgrades.

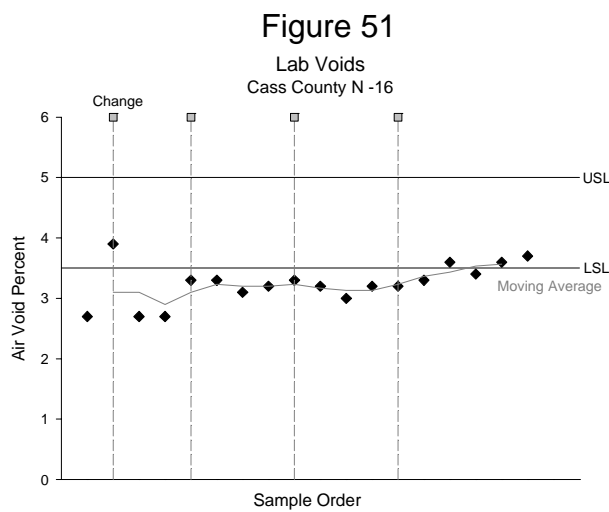
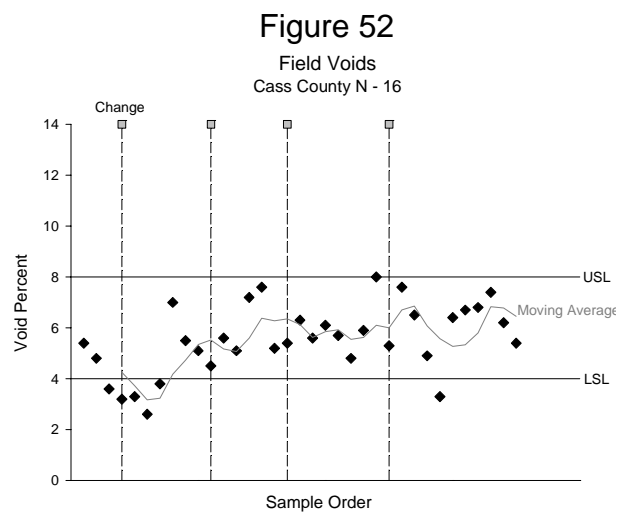
The lab voids were low throughout this project (see Figure 51). The AC percent was decreased by 0.1 in each of the three changes attempting to increase the lab voids. Field voids (Figure 52) remained consistently within specified limits after the first few samples and film thicknesses were unremarkable.

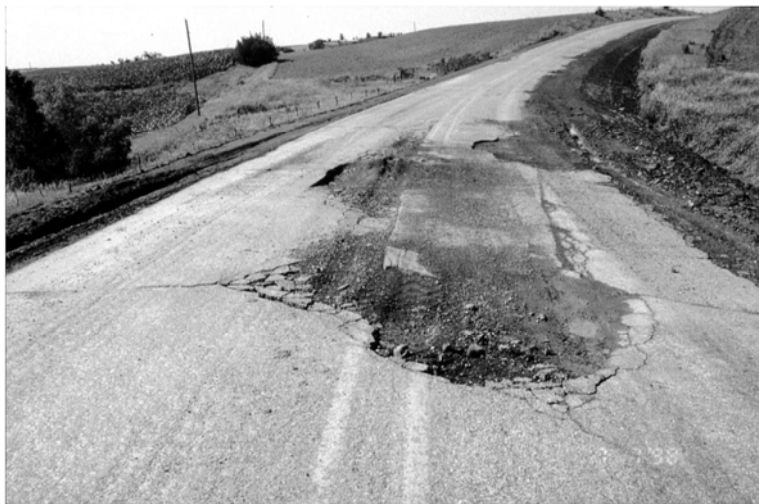
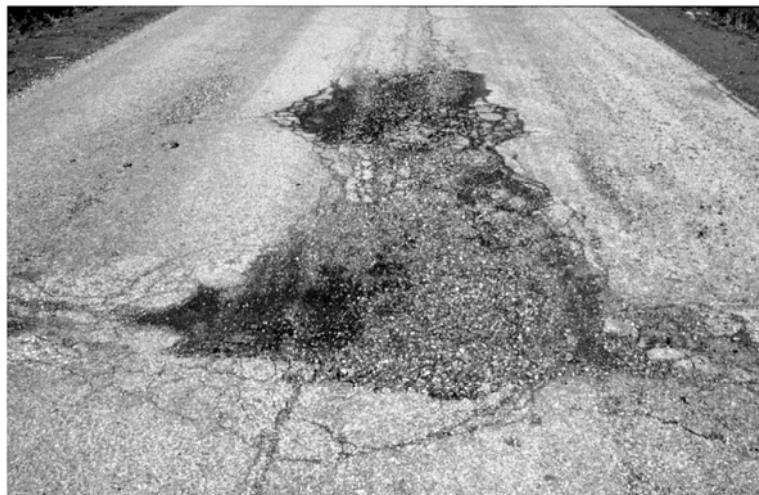
Cass County Highway M-56

These photographs show the distress that existed prior to paving. The weakened-subgrade areas were excavated and replaced.

Construction of this roadway was hampered by subgrade difficulties. These were exacerbated by exceptionally heavy rain and flooding shortly before paving was due to begin. Areas that had marginal structure before were completely destroyed by a combination of poor subgrade, high water and construction truck traffic (see photographs in Figure 61). The county engineer decided to excavate all of the distressed areas down to approximately six inches below grade and replace with two-inch minus stone.

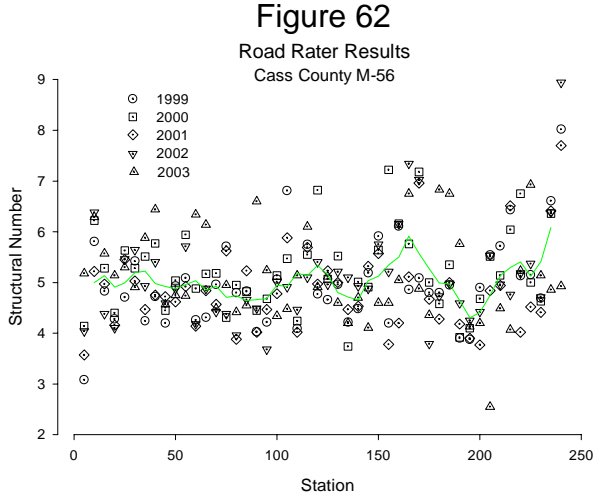
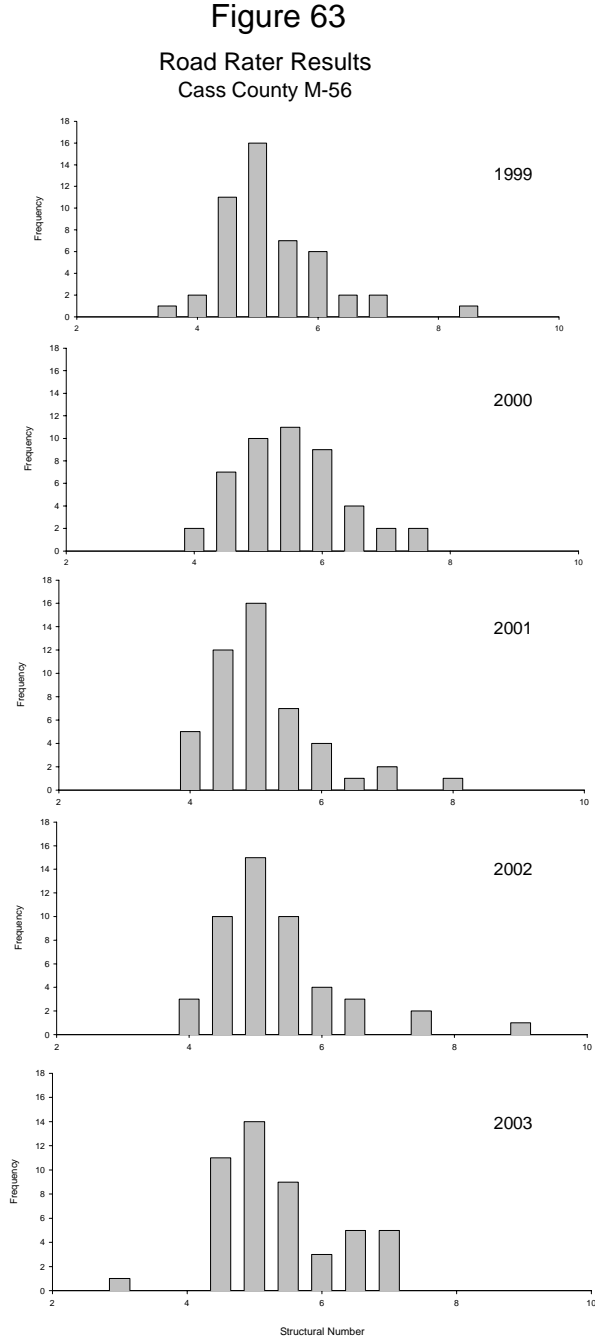
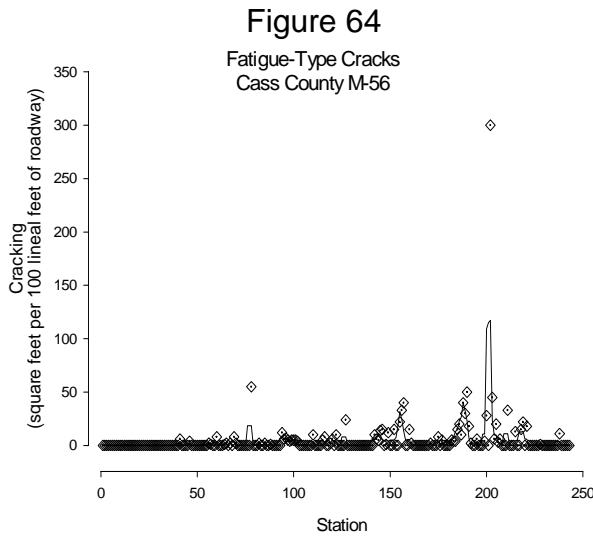
Road rater data are shown in Figures 62 and 63. The structural numbers over the length of the project and from one year to the next are quite stable.

The Road Rater data are interesting when viewed in context with the fatigue-type crack survey data in Figure 64. They are shown above vertically aligned for easier comparison. The area around station 200 is most heavily cracked and that corresponds to the weak area shown in the Road Rater data. The curious part about this is that the area in question is also where the excavation, replacement, and fabric were used.

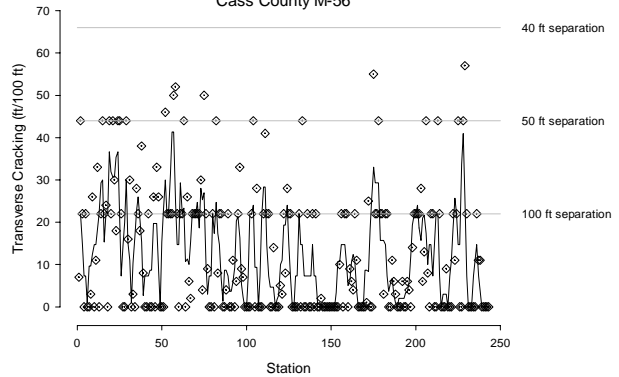
Transverse Cracks
Cass County M-56

The most significant type from the point of view of the Superpave mix design, is transverse cracking (shown in Figure 65). Along with feet of cracking per 100 feet of roadway, this graph shows the approximate spacing of transverse cracks. Transverse cracks caused by temperature effects often form in regular intervals. Looking at the length of these intervals gives a good measure of the quality of the pavement. In this case the majority of the transverse cracks occurred at an interval of approximately 100 feet. Just as a comparison, a very poorly performing asphalt pavement (that is to say, susceptible to thermal cracking), might have crack spacing of 15 to 20 feet. Note that this discussion is specifically covering just transverse cracking.

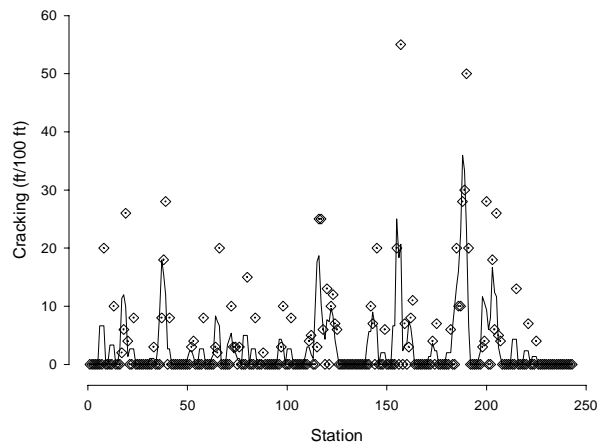
Figure 66

Longitudinal Cracks
Cass County M-56

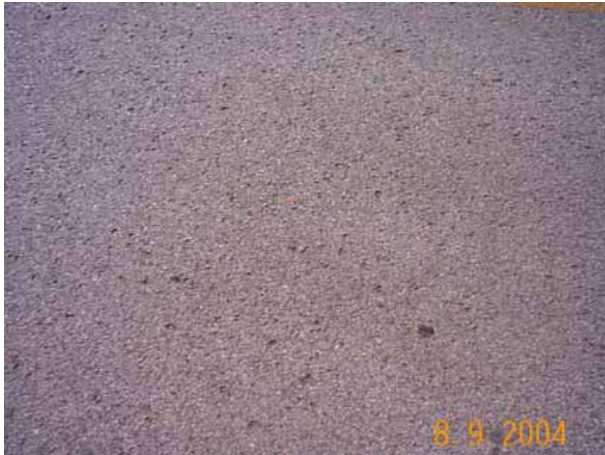
Figure 67

Photographs of the pavement surface on Cass County M-56 showing “pop-outs” of large aggregate pieces.

This pavement exhibited a large number of aggregate ‘pop-outs’, where aggregates on the surface have fractured and/or come loose from the ACC mixture. This was apparent throughout the length of the project (see Figures 67 and 68). From a visual examination, it appeared that all of the top sized aggregate on the surface had left the pavement. Cores from this pavement, along with the mix design containing aggregate sources (Appendix C) were evaluated by the IDOT geologists. The pop-outs are likely due to freeze-thaw susceptibility of some of the coarse aggregate. Performance of the pavement to-date appears unaffected.

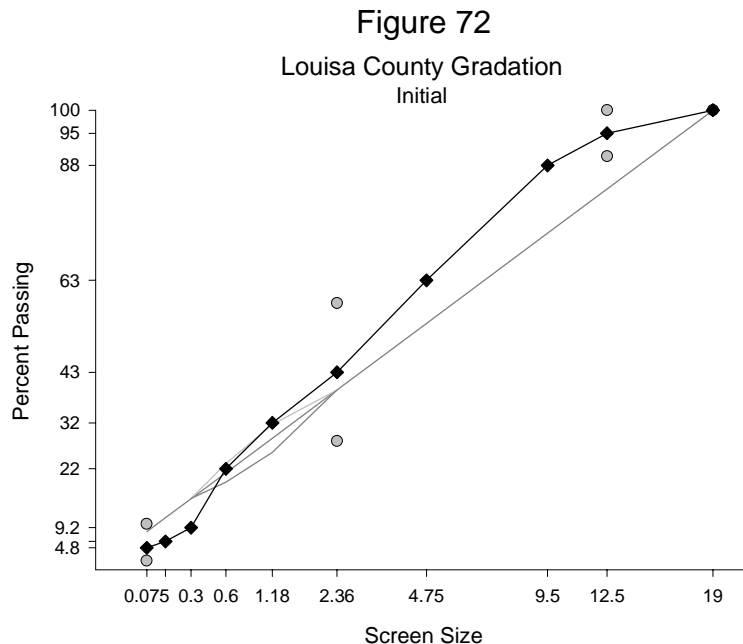
This project specified a 12.5 mm mix. Figure 72 shows the gradation power curve. Note that this gradation passes through the restricted zone. Another big difference between this project and the other seven projects in this research was the absorptive nature of the aggregate. Typically aggregates from this area have required the use of as much as 7.5 percent AC to reach the minimum film thicknesses and effective asphalt contents needed in the final mix. Because of the absorptive aggregate, this project was chosen for an additional research activity that examined the effect of an acrylic sealant. The sealant was intended to block some of the pores in the aggregate and reduce the amount of AC absorbed. As a result, some sections of pavement had a slightly modified mix design using less AC.

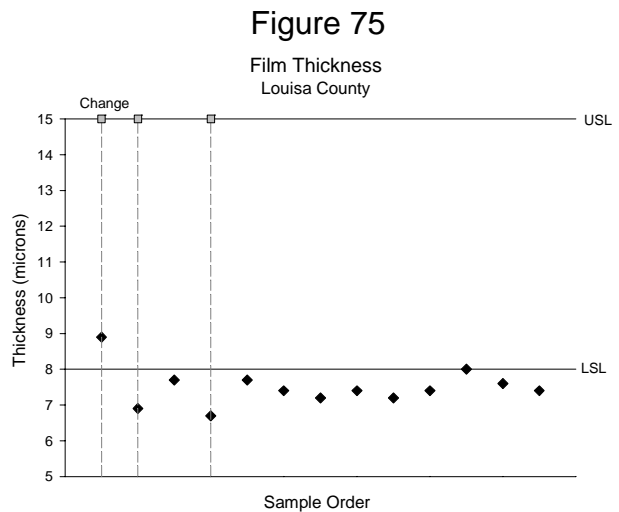
Film thicknesses were below specification throughout (Figure 75), despite the high asphalt content. The cause for this is unclear, however, is probably due to high absorption on the material heated and tested in the lab.
