Superpave Mix Designs for Low-Volume Roads

Final Report
Iowa Highway Research Board
Project TR-414

October 2004

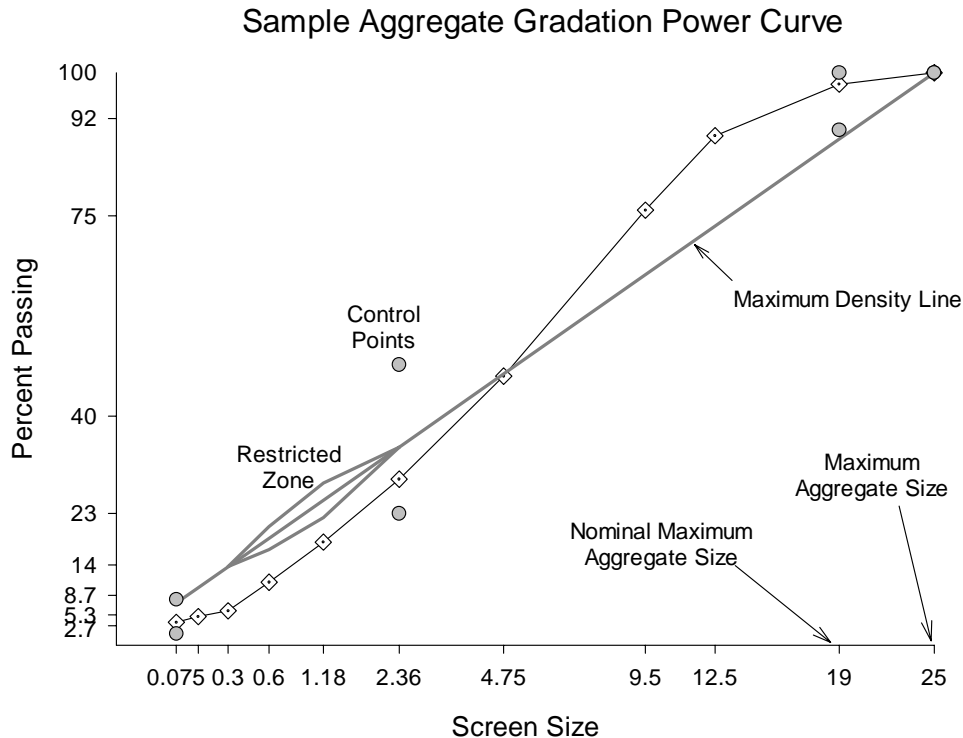
For the discussion of gradation in a Superpave mix design context, it is often helpful to look at the gradation plotted on a 0.45 power curve such as the one on the next page. This is simply a plot of the percent of the mix passing through each of a series of sieves. The plot has four major components: a maximum density line, a restricted zone, control points and the gradation data.

The horizontal axis represents the screen mesh size measured in millimeters, but scaled to the 0.45 power. That is, the 12.5 mm label is placed at a position value of $12.5^{(0.45)} = 3.12$ and so on. The vertical axis represents the percentage of the mix that passes through each screen. This means that the vertical difference between any two points represents the percentage of material that is larger than the mesh of the lower screen and smaller than that of the upper screen. The nominal maximum aggregate size is the sieve one size larger than the first sieve to retain more than ten percent of the combined aggregate. The maximum aggregate size is one sieve larger than the nominal maximum. General reference to the mix will refer to the nominal maximum size. So the mix above would be described as “a 19 mm mix”.

The maximum density line represents an approximation of the maximum density a specified mix could attain - essentially the most aggregate that could be packed into a unit volume. If the mix was truly at this maximum density, there would be almost no room for asphalt. This line provides a qualitative reference to which we can compare the shape of the actual gradation. The closer to this line the gradation gets, the less room there will be for asphalt and air voids in a well compacted mix.

The control points and restricted zone are defined by Superpave requirements. Generally speaking Superpave mix design gradations are expected to pass between the control points and around (below or occasionally above) the restricted zone.
