FINAL REPORT

STATE STUDY NO. 105

Evaluation of Structural Factors in the Design of HMA Pavements Over CRCP

**Research Division
Mississippi Department of Transportation**

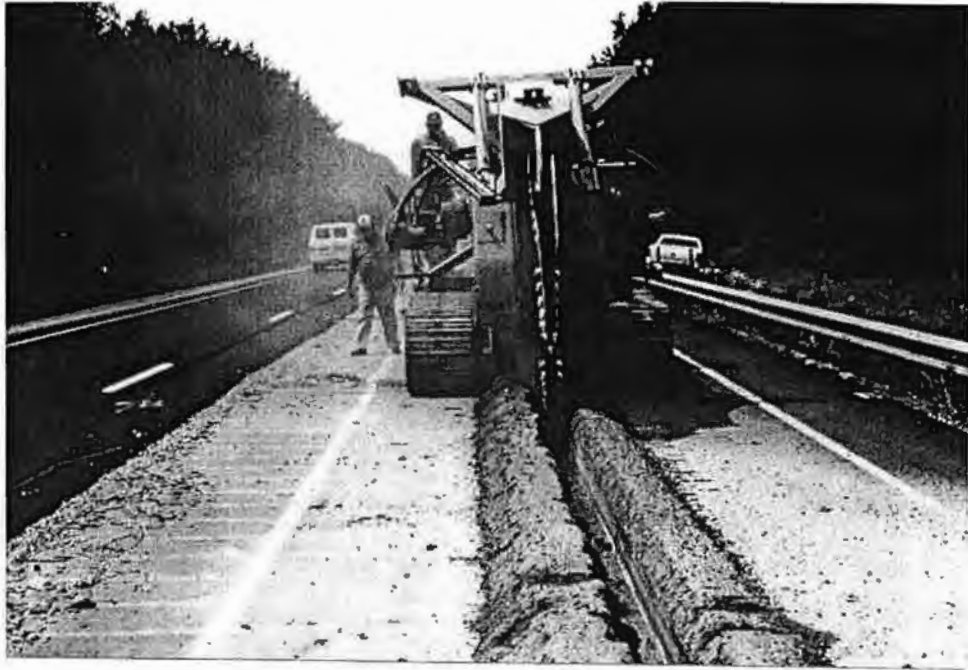
Figure 4. Trench cutting using a Ripper Saw

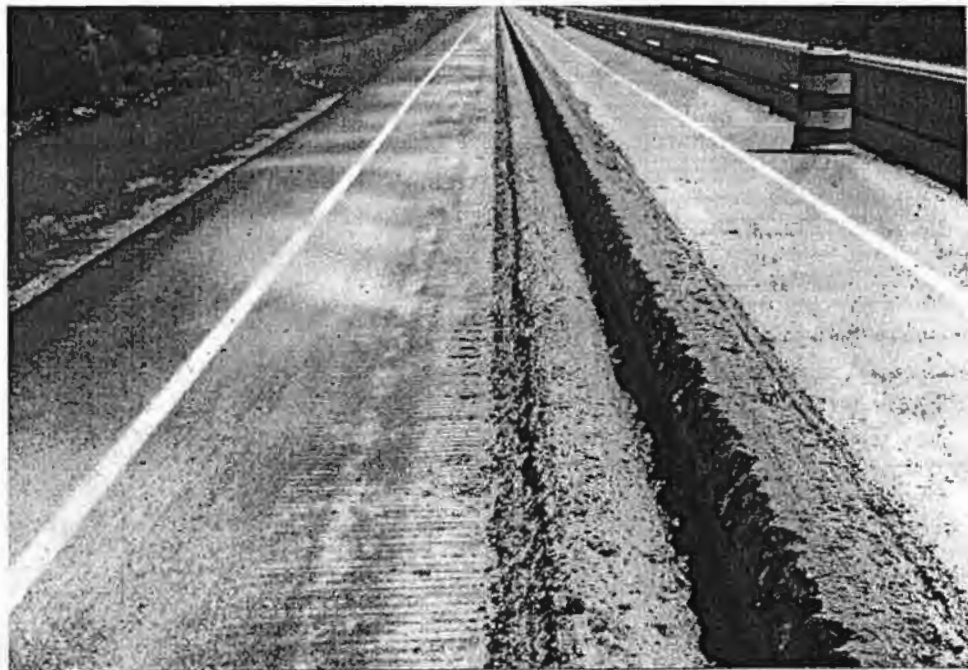
Figure 5. Trench for edge drain

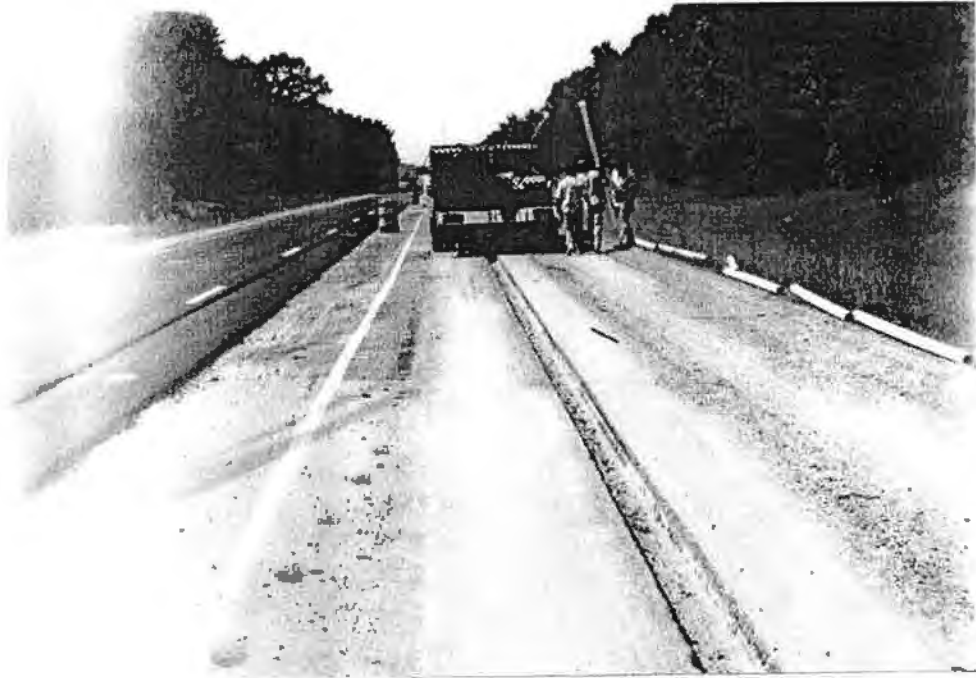
Figure 6. Installation of pipes

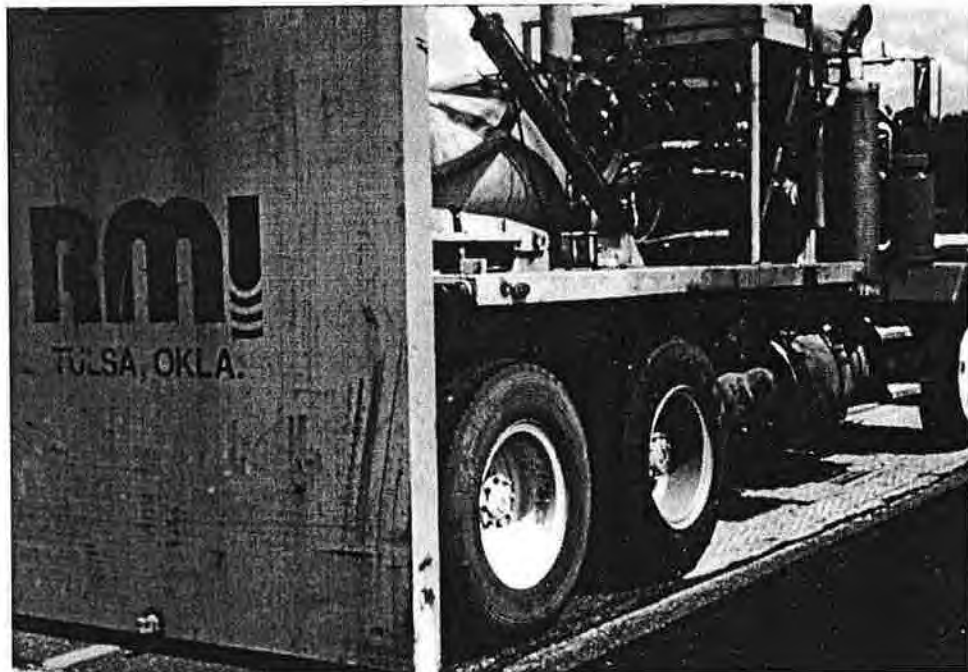
Figure 7. Guillotine Hammer used prior to rubblizing

In areas of existing cement treated base, if the Contractor requests authorization to pre-break the pavement using a guillotine-designed hammer, pre-cracking at 12" to 18" intervals will be permitted subject to the approval of the Engineer. Justification will be required.

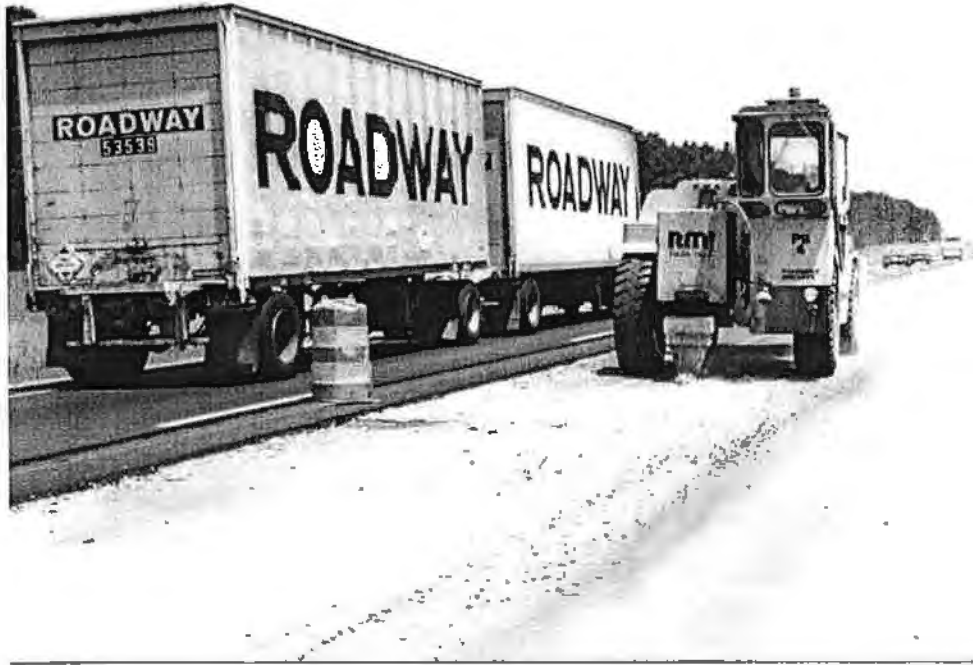
Figure 8. Rubblizing CRCP with a resonant pavement breaker

During rubblization, reinforcement of the existing CRCP was left in place. The breaking pattern proceeded in a longitudinal direction via transverse strips beginning at a free edge (shoulder or previously broken edge) and progressing towards the opposite shoulder. The compaction sequence of the rubblized material was an initial pass with a steel wheel vibratory roller, a pass with a pneumatic roller and a final pass with the steel wheel roller. Immediately prior to placing the first lift of HMA, a fourth pass was required using the vibratory roller. The steel wheel vibratory roller was specified to have a nominal gross weight of not less than 10 tons when operated in the vibration mode and the pneumatic roller was required to produce uniform ground contact pressures of more than 551 kPa. Rubblization of the CRCP was completed in August 1993.

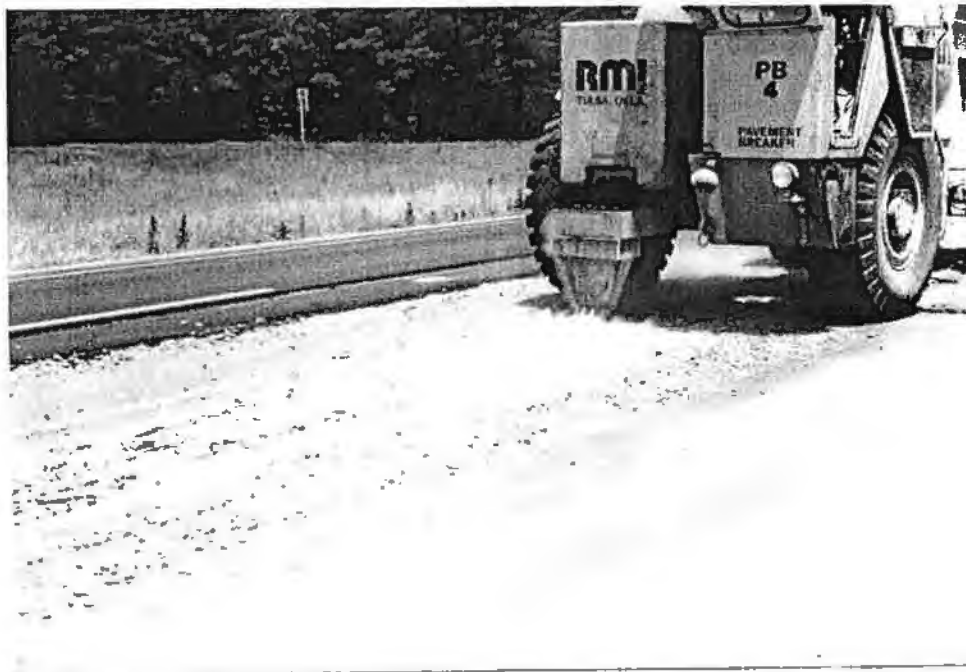
Figure 9. Rubblizing

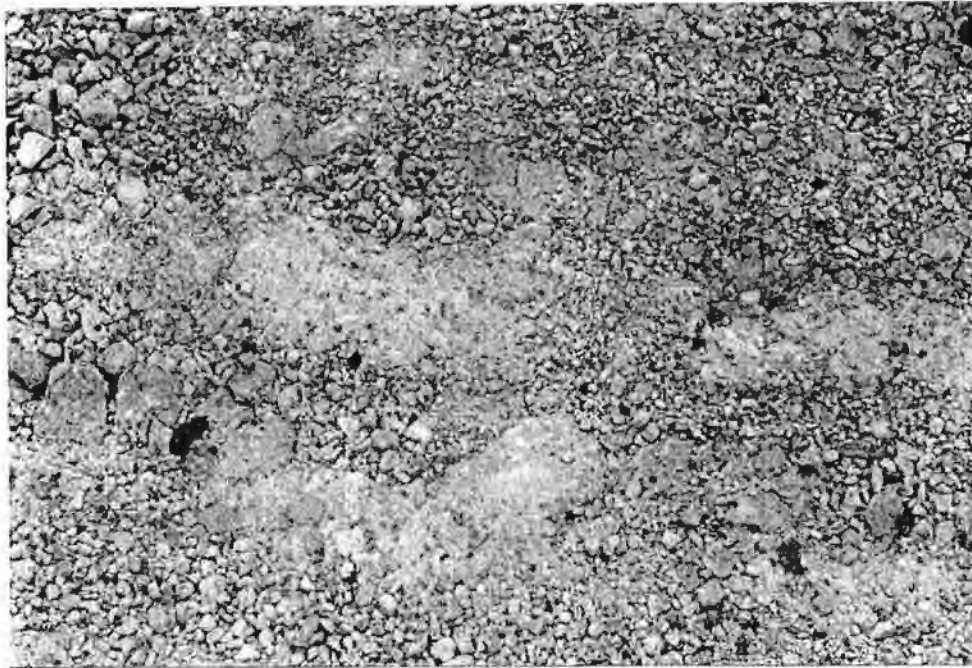
Figure 10. Rubblized continuously reinforced concrete surface
