Thin Film Concrete Coatings

Kentucky Transportation Center Research Report — KTC-16-03/SPR12-433-1F

November 2016

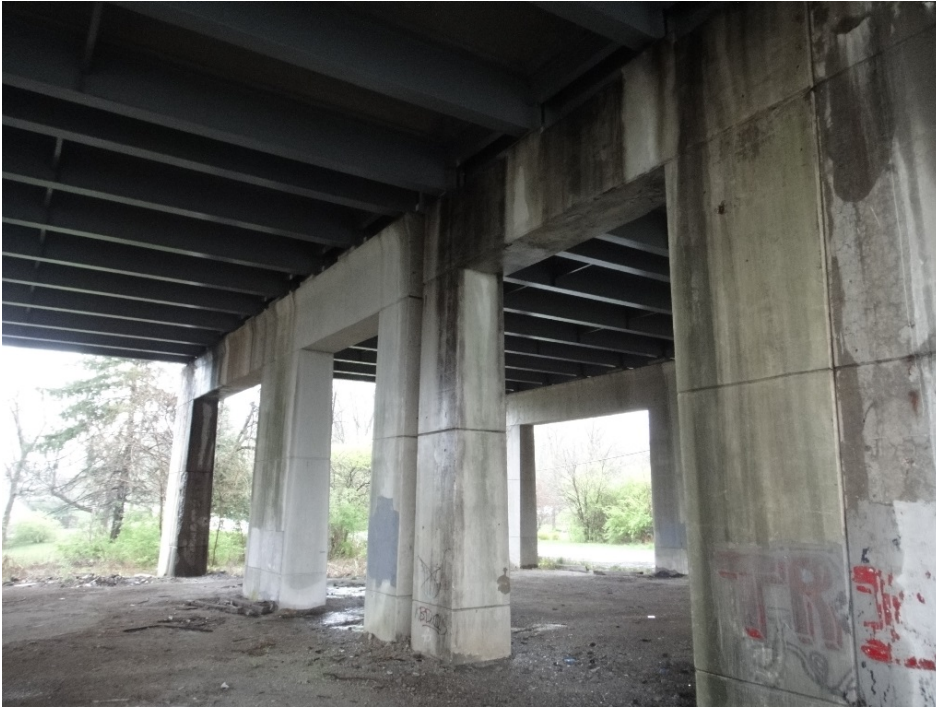
Figure 1. Deteriorated concrete columns and pier cap under leaking joint.

This site was chosen because it contained a leaking expansion joint that had allowed water and deicing chemicals to spill onto the pier. The leakage had been ongoing for years by the time KTC applied the coatings, and the leak continued after the field work was completed. This resulted in chloride contamination and spalling of the concrete columns and pier cap (Figure 1). Researchers applied the coatings on the three columns at locations that were not severely spalled. Before the coatings were applied, the concrete surfaces were pressure washed at 4,500 to 5,000 psi with a 0° oscillating tip from a distance of approximately one foot. The tip was oriented approximately perpendicular to the surface (Figure 2).

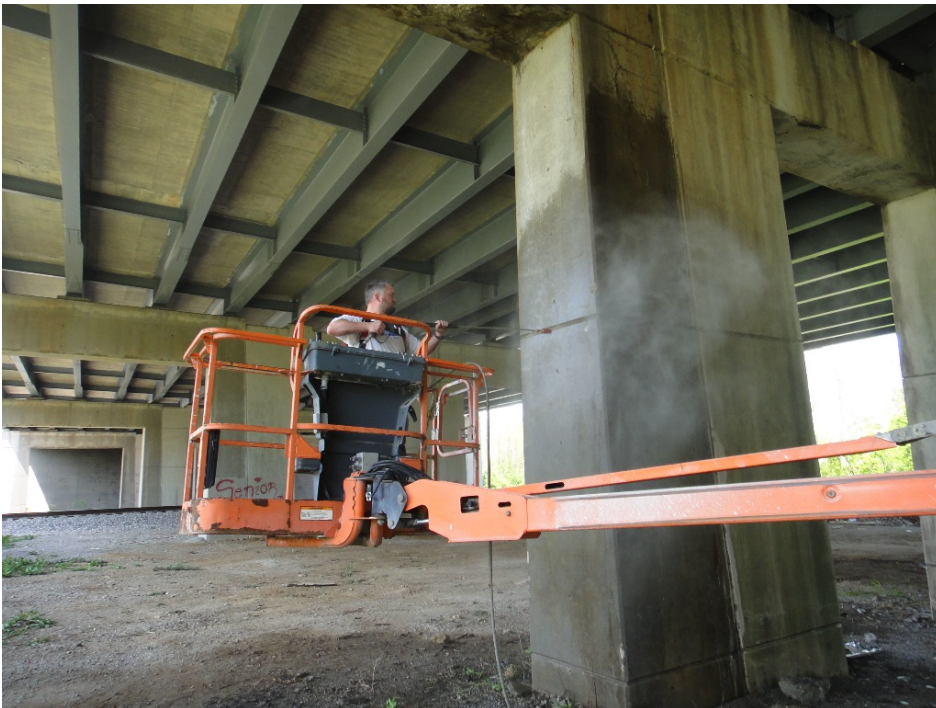
Figure 2. Pressure washing concrete substrate prior to coating.

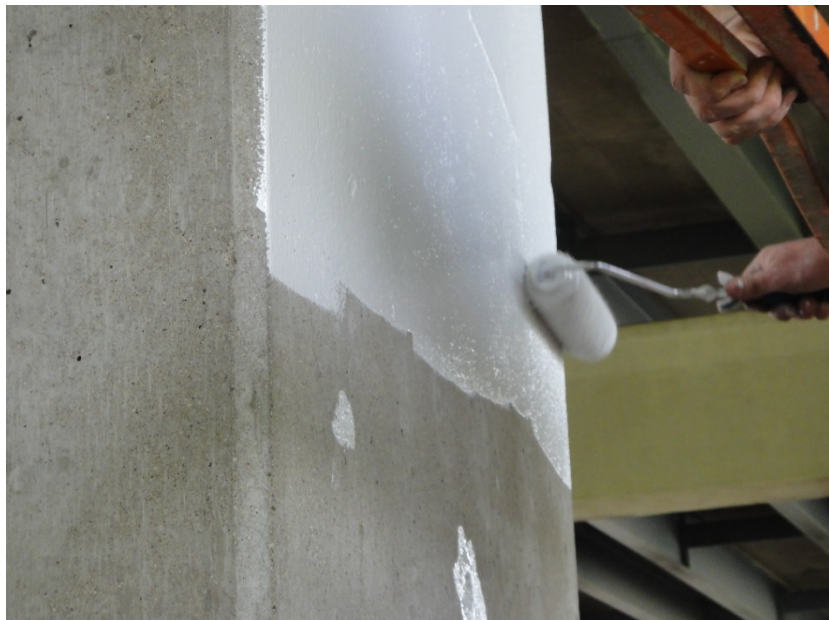
Figure 4. Applying coating to concrete on bridge column

All coatings, with the exception of System 5, were applied by roller. A brush was used to fill spalls or large bugholes, larger than one inch in diameter (Figure 4). Minimal effort was made to repair pinholes that developed with the roller application. That effort was limited to an additional pass with the roller. Based on this field work, it is likely that most coatings applied to concrete will develop many pinholes (Figure 5) unless special care is taken in an effort to eliminate them. Researchers believed that the pinholed coatings were indicative of what would likely occur in project application. The supplier of System 5 requested that KTC apply it with a spray gun. The system was supplied with a portable spray gun for that purpose — a Graco *Proshot HD*® (Figure 6).

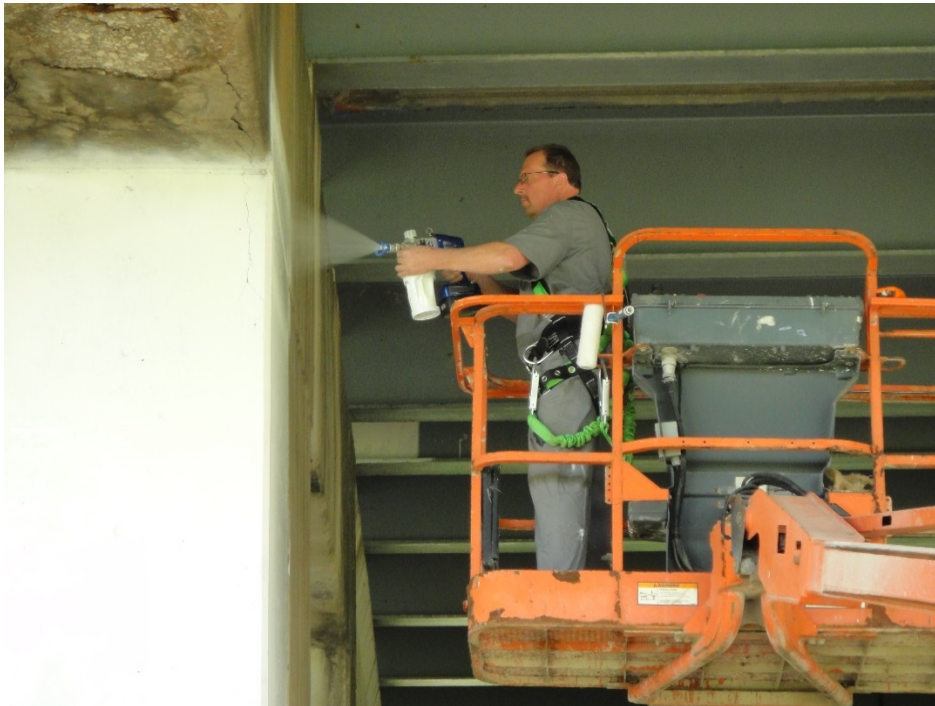
Figure 6. Spray application with a Graco ProShot HD

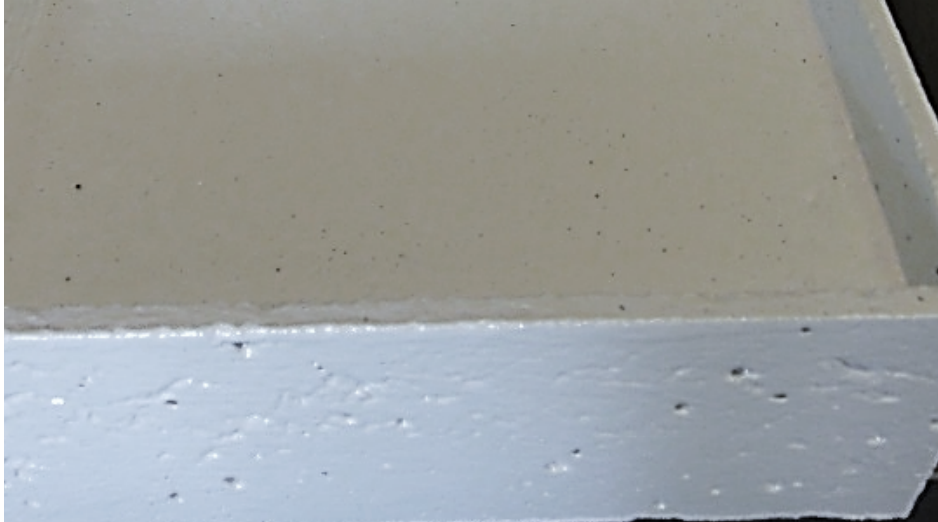
Figure 7. Coated concrete block with pinholes

Laboratory testing consisted of applying coatings to concrete specimens (panels and blocks) and evaluating coatings using various performance criteria. Concrete blocks were cast for performing AASHTO T259-02 (2006), Resistance of Concrete to Chloride Ion Penetration and T260-97 (2009), Sampling and Testing for Chloride Ion in Concrete and Concrete Raw Material. Blocks, 12" x 12" x 6", were cast using the standard KYTC AA concrete mix. After the concrete had cured for 28 days, the blocks' ponding surfaces were blast cleaned to an ICRI CSP3 condition. The coatings were then applied to the ponding surfaces by roller and left to cure 10 days prior to ponding (as per AASHTO T259). Figure 7 illustrates a typical coated concrete block with pinholes.

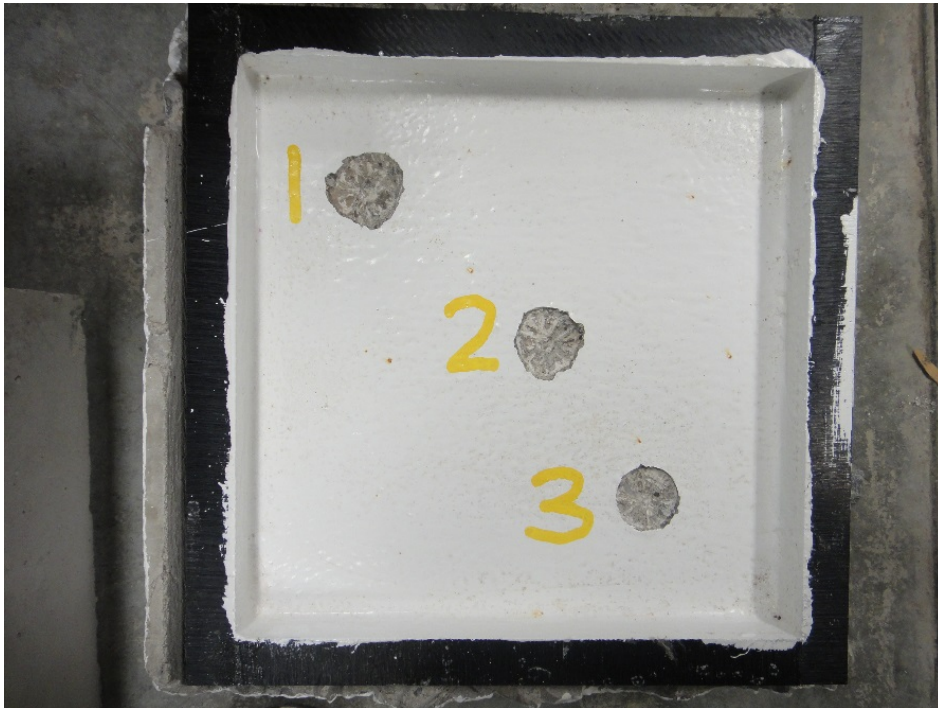
Figure 8. Salt ponding block after powder samples of concrete have been extracted after completion of the salt ponding test

One block was not coated prior to salt ponding. It served as a control to establish a baseline for unprotected concrete. After ponding, three locations of each block were sampled by drilling the concrete, collecting the dust, and combining them into one sample. Samples were collected at ¼" to ¾" (reported as ½") and ¾" to 1 1/4" (reported as 1") depths (Figure 8). The concrete samples were analyzed for chloride content; test results were corrected for chlorides in the concrete mix. As Figure 9 shows, Systems 1, 2, and 6 were more effective than the others at reducing chloride penetration.

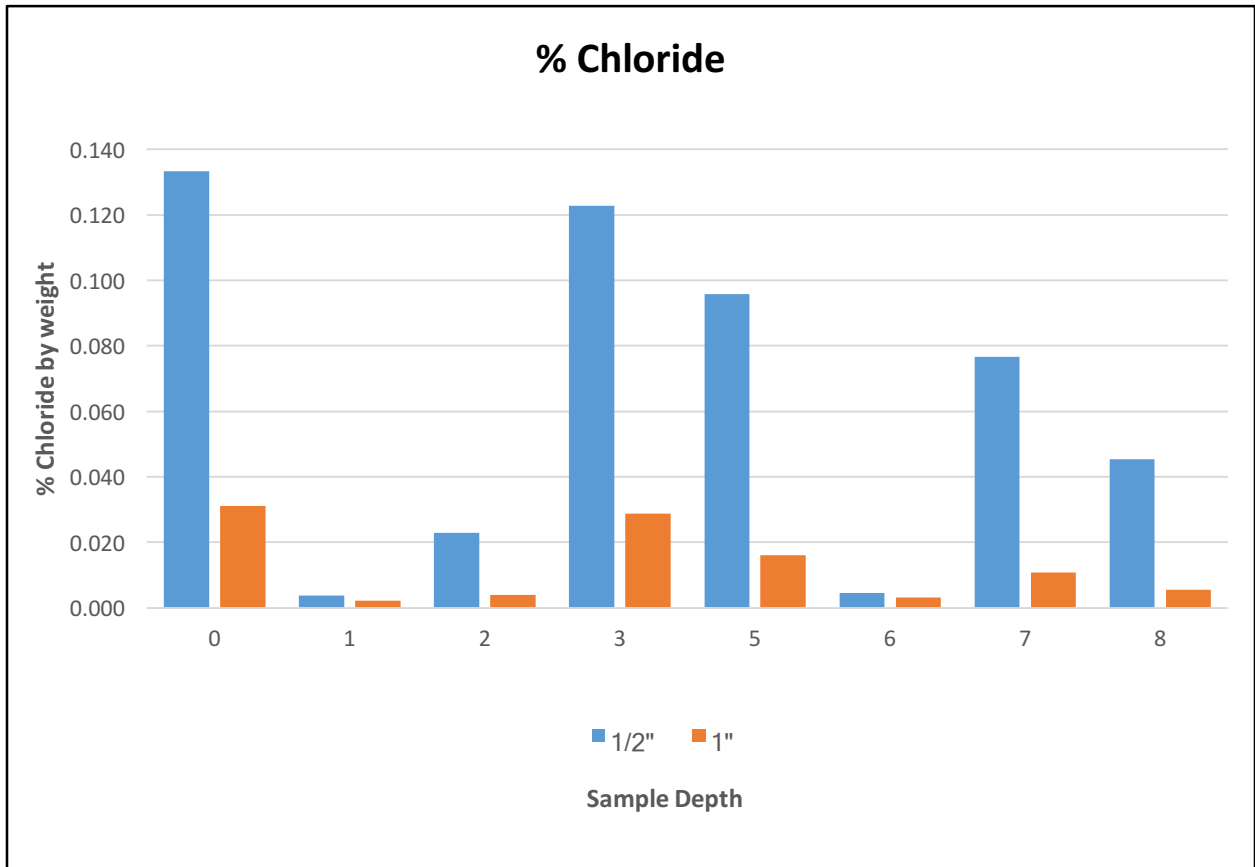
Figure 9. Chloride penetration of concrete after salt ponding

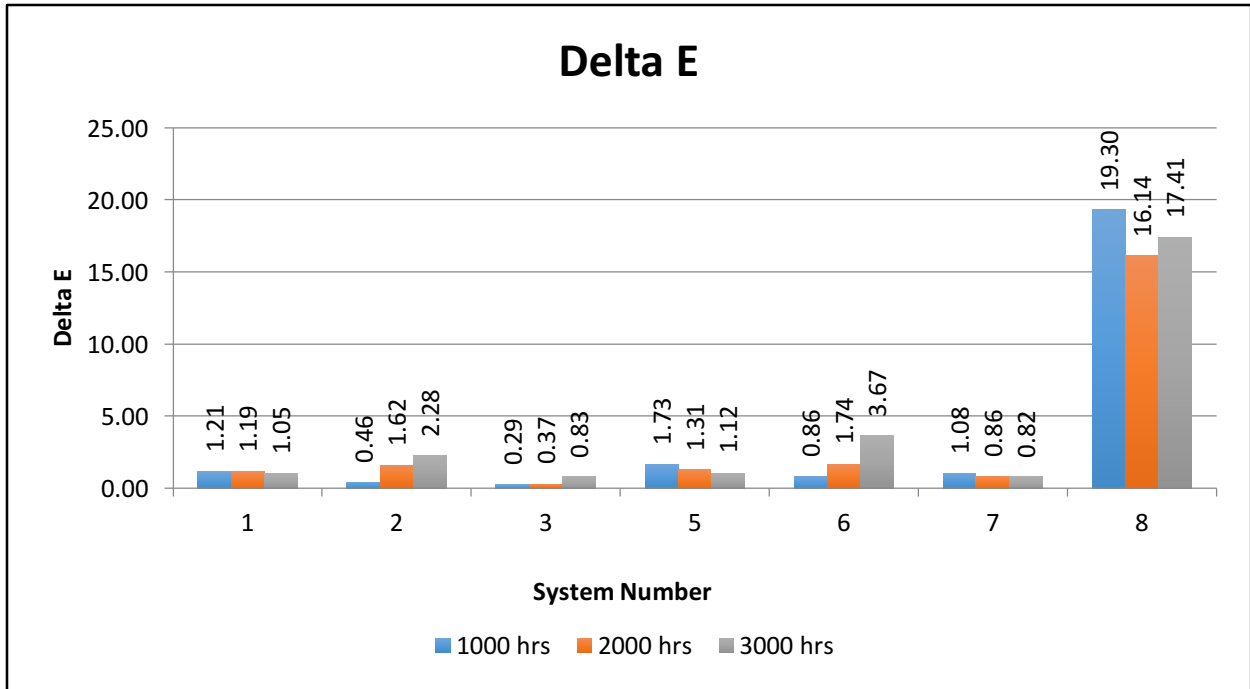
Figure 12. Color changes of laboratory weathered concrete coatings

Color and gloss retention are important characteristics to monitor to gauge coating performance (3). Changes in these characteristics indicate degradation of the coating at a basic level, even though protection of the substrate may still be available. For color monitoring, KTC uses a Color-Guide 45°/0° meter which measures L*a*b* (three dimensional) color values and calculates a Delta-E, or change in color. One Delta-E is the least color change discernable to the human eye.

Color and gloss baseline values were established before the coatings were weathered. Those characteristics were evaluated at 1,000-hour intervals thereafter. Seven of the systems had good color stability, with Delta-E less than 4. System 8 had a color change of nearly 20 Delta-E. Three of the systems had gloss changes of less than 5 GU but System 8 down glossed 45 units. Color and gloss data are presented in Figures 12 and 13.

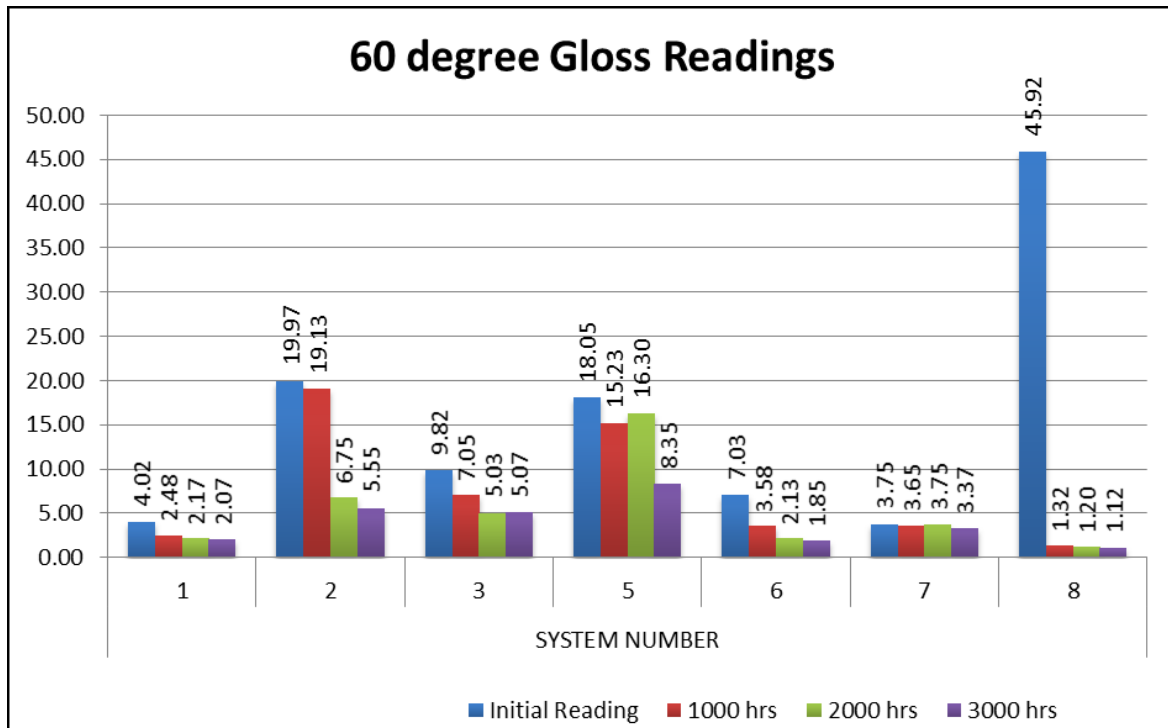
Figure 13. Down glossing of laboratory weathered coatings

Gloss is measured by shining a known amount of light on a surface and quantifying the reflectance. Down-glossing occurs in all weathered coatings and is indicative of micro-fracturing or other degradation. KTC uses a Novo-Gloss 60°/20° meter and records the 60° measurement.

The measurement scale, Gloss Units (GU), of a glossmeter is a scaling based on a highly polished reference black glass standard, which has a defined refractive index having a specular reflectance of 100GU at the specified angle. This standard is used to establish an upper point calibration of 100, with the lower end point established at 0 on a perfectly matte surface.
