Stormwater-Pavement Interface in Cold Climates

Liv Haselbach and Somayeh Nassiri
Department of Civil and Environmental Engineering
Washington State University University

05/27/2017

INE/AUTC 17.13

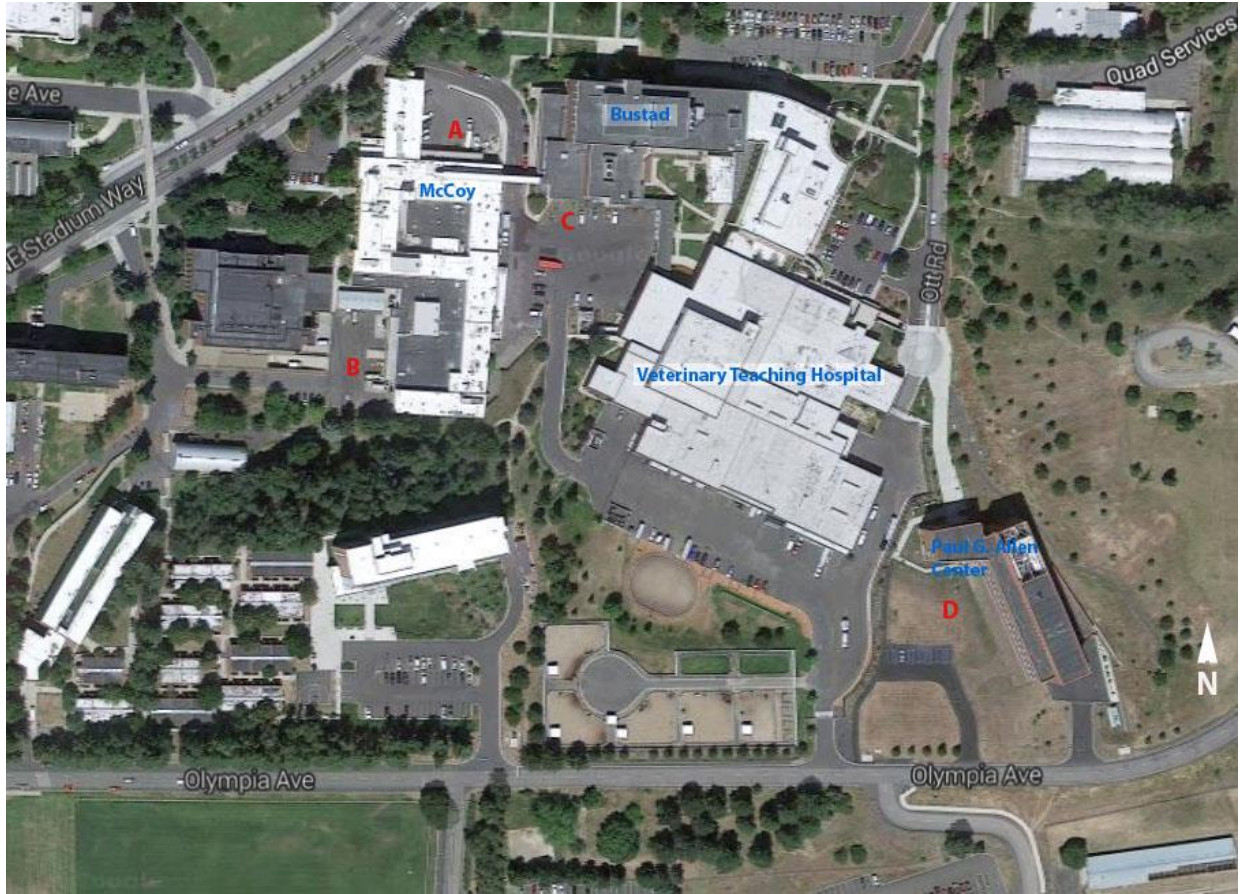
Figure 1.1 Areas of interest around the WSU campus veterinary facilities

The four sites surrounding the veterinary medical facilities were under consideration for modeling in Task 6.3. Site A, McCoy North, was not considered further due to gradation at the site. Installation of permeable pavements at this site could result in shunting of stormwater to the building foundation and basement, and replacement of deep sewer and drainage pipes in the area

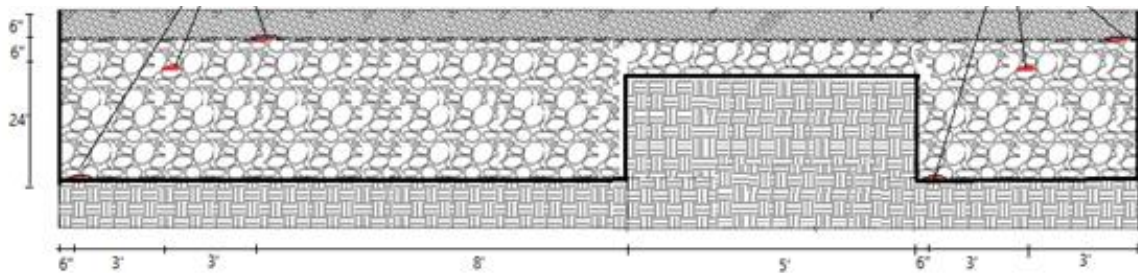
Figure 2.1 Profile of Community Hall pervious installation and subsurface dam (left is west, right is east)

The Community installation was completed in May 2015; it is unlike many other permeable pavement installations in that it contains a subsurface dam near the uphill (east) end. The Community installation has a 6-inch layer of pervious pavement on top of an aggregate storage bed layer. Most of this aggregate storage bed is 30 inches deep; however, 6.5 feet from

the east end of the installation is an impervious dam that rises 24 inches from the bottom of the installation. The dam is composed of subsurface soil covered by an impermeable layer of Stego Wrap. A 6-inch layer of aggregate is on top of the dam, between the dam and the pervious concrete layer. The dam is 5 feet long, and the remaining underground storage area below the dam is 14.5 feet long. The entire installation is 26 feet long and 36 inches deep. The bottom surface of the installation is covered by a layer of permeable Mirafi 500X geotextile fabric, in direct contact with the surrounding soil. Figure 2.1 is a diagram of this installation. There are two observation wells in the installation. The observation wells can be used now for draindown tests. As shown in Figure 2.2, the two observation wells are installed on the north face of the installation, one just above the dam, and one at the lowest corner of the installation.

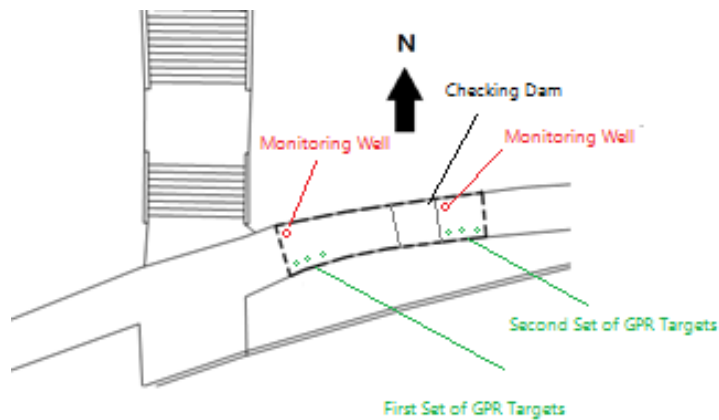
Figure 2.2 Plan view of position of installation, dam, observation wells, and ground penetrating radar (GPR) targets not used in this research.

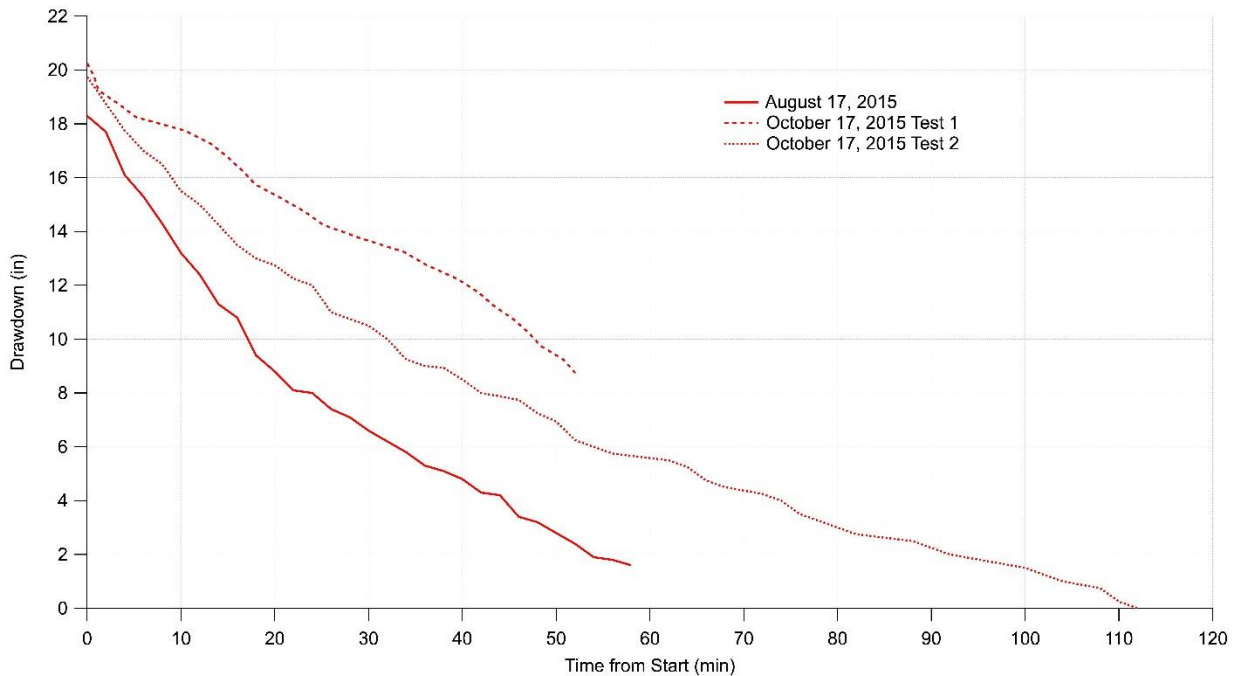
Figure 2.3 Draindown test results for 3 tests completed in August and October 2015

Figures 2.3 and 2.4 indicate that permeable pavement retention systems function well in soils similar to the Palouse region of Washington during both dry and wet seasons. Figure 2.4 provides more information for designers in determining retention volumes needed to handle various storms based on storm intensities and contributing areas.

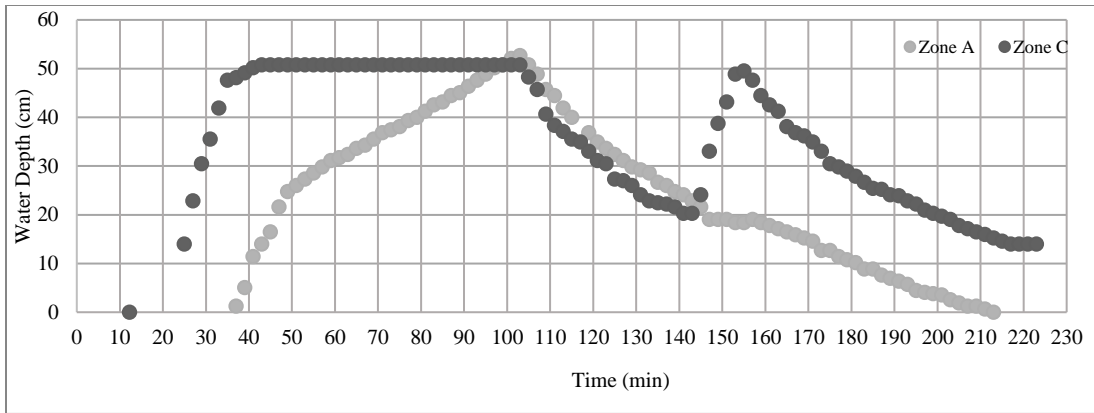
Figure 2.4 is a plot of the draindown test in April 2016. The upper zone (C) was flooded until the dam overflowed, and flooding continued until the lowest zone (A) reached water levels similar to the upper zone. Flooding stopped and water levels were recorded until they dropped to approximately 20 centimeters, and then Zone C was again flooded to the dam level. As can be seen in Figure 2.4, both zones drained similarly, indicative of little variation in the soils in either zone, such as drainage channels from roots. In addition, Zone C drained similarly during both consecutive flooding events on the same day, suggesting little negative impact from previous saturation. Under these damp spring conditions, the Community site fully drained in about 2 hours. Based on the volume of the storage bed and typical porosities of storage bed aggregate, the total depth of water that drained in 2 hours was approximately 10 inches. Thus, rainfall and contributions from run-on from upslope areas together at this depth are easily handled in similarly designed retention systems.

Figure 2-4 Draindown test results for April 2016 (Yekkalar et al. 2017)

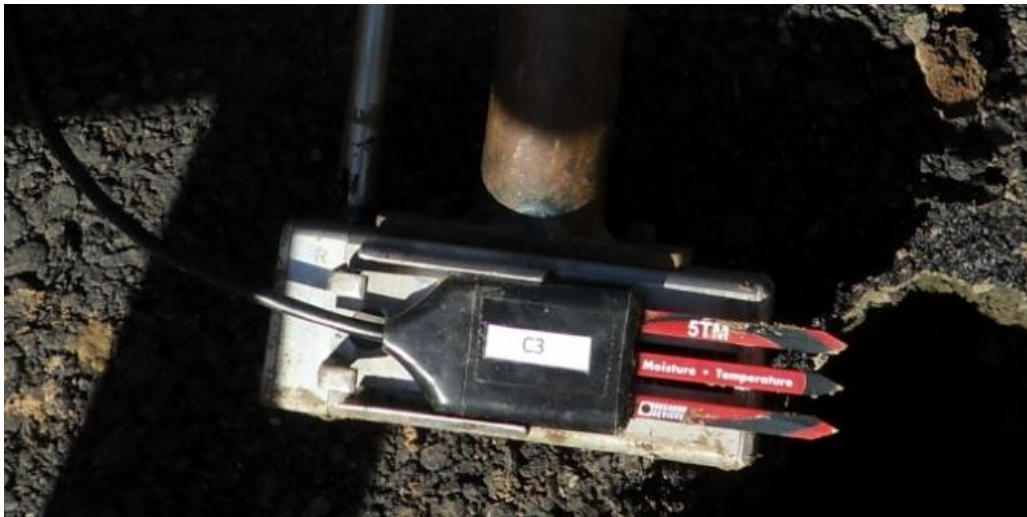
Figure 3.1 Moisture and temperature sensors

For Task 3, temperature and soil moisture sensors manufactured by Decagon Devices, Inc. (depicted in Figure 3.1) were installed in soils next to the underground aggregate storage beds at two locations. The first location is next to the pervious concrete sidewalk at Community Hall (*Community*) in Pullman, Washington, which was installed in late May 2015. The Community location has an underground storage bed that is essentially a retention system, with no underdrains. The second location is next to the porous asphalt parking lot at the Finch Arboretum (herein referred to as *Finch*) in Spokane, Washington, installed in early October 2015. The Finch location has underdrains in the bottom of the underground storage bed and is

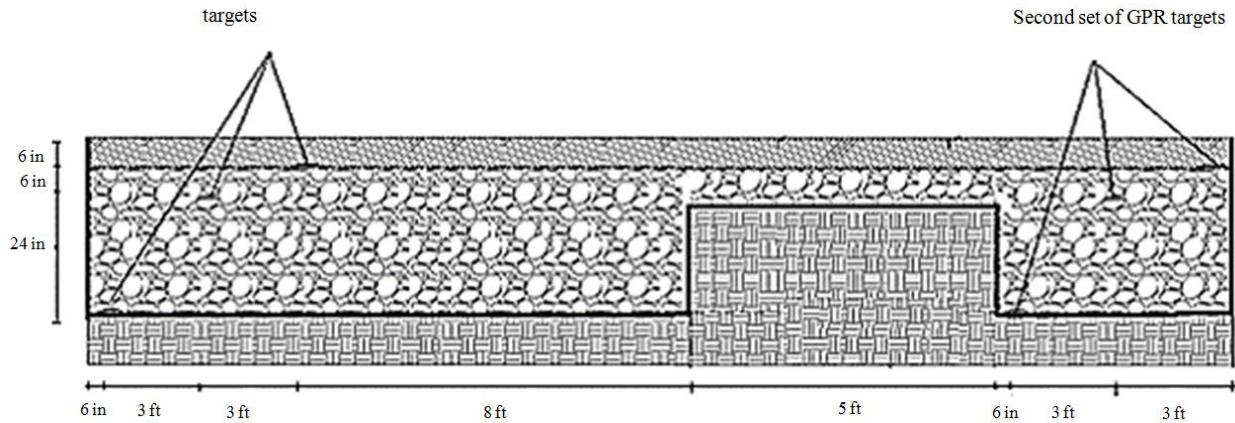
Figure 3.2 Profile of aggregate storage bed at Community Hall (→East)

research, although the GPR targets were not used in this research. A southern profile is depicted in Figure 3.2. The sidewalk and underground storage bed were installed by WSU Facilities Services as part of its sidewalk replacement program and funded as a match to this research.

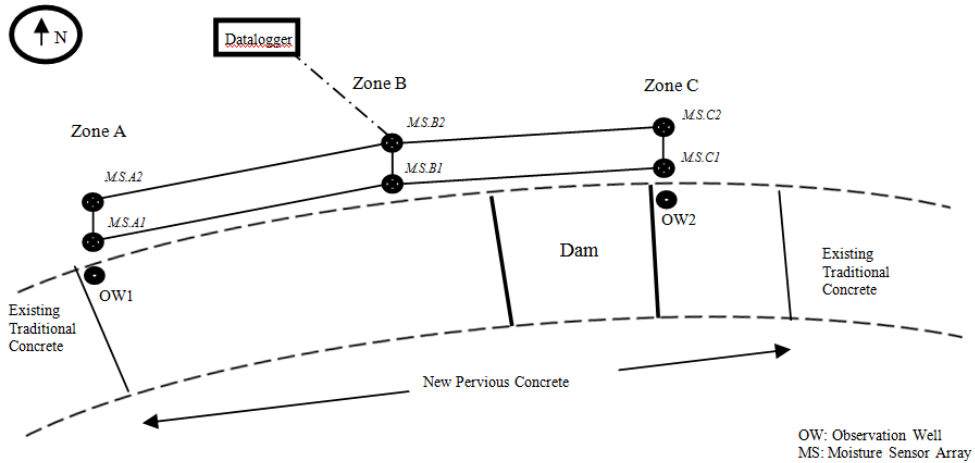
Figure 3.3 Sensor (MS) plan view of Zones A, B, and C at Community Hall

Soil moisture and temperature sensors were installed in the soil next to the Community Hall sidewalk on the side closest to the building (north side). The soil there, which was tested using ASTM D2488-09, was determined to be mainly clay type, which is typical of the Palouse region (ASTM 2009b). The sensors were installed in three zones—A, B, and C—with Zone A most downslope in the sidewalk (west) next to one observation well, Zone B upslope in this lower aggregate bed section, and Zone C just upslope of the dam in the upper aggregate storage bed section. Zone C is expected to receive the most stormwater from upslope run-on. Zone B is expected to receive very little runoff. Zone A is expected to receive somewhat less stormwater than Zone C. In each zone, one sensor array hole was dug close to the sidewalk (approximately 0.5 feet), and another was dug approximately 1 foot further away; 5TM sensors were installed at three depths in these six holes. The plan view shown in Figure 3.3 indicates where the zones and holes are located. Figure 3.4 contains profiles of the two rows of sensor arrays in the three zones.

Note in the plan view that the Community location has observation wells, and the relatively small storage volumes and natural conditions can be used for partially controlled water infiltration experiments, similar to the aforementioned draindown studies. Additional applicable weather data were collected by a weather station on the roof of Sloan Hall on the Pullman campus nearby and the station at Pullman (PUW) airport.

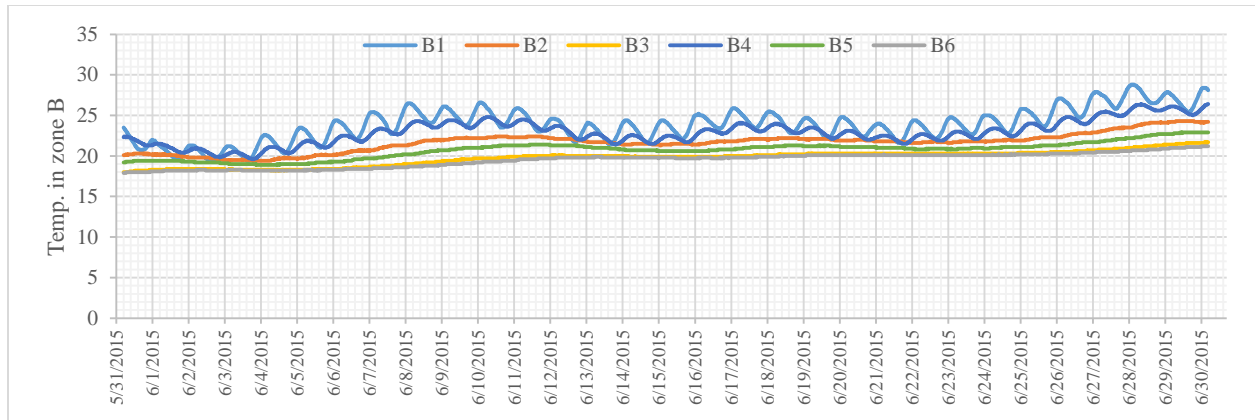
Figure 3.5 Temperature sensor readings June 2015 Zone B at Community Hall

precipitation in a Pullman summer. However, temperature profiles are already indicating a slight impact on neighboring soils from underground storage beds. Figure 3.5 depicts these profiles during June 2015 for Zone B. The most variation is seen at the top sensor closest to the pervious concrete (light blue at the top), with a bit less variation at the top sensor farther away (dark blue near the top of the graph). The two lines on the bottom represent the deepest sensors, and the two middle lines are the middle-depth sensors, the top one being closest to the underground aggregate bed. The wintertime results for the Community site are reported later in this section.

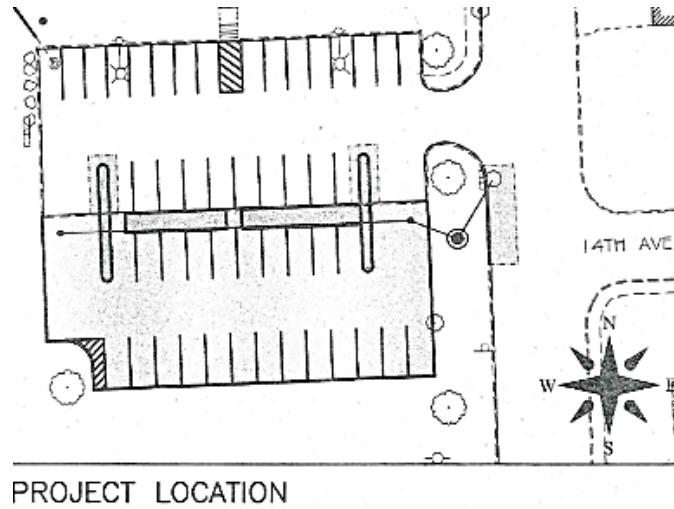
Figure 3.6 Location of the sensor installation at Finch parking at the northwest corner of the new porous asphalt area

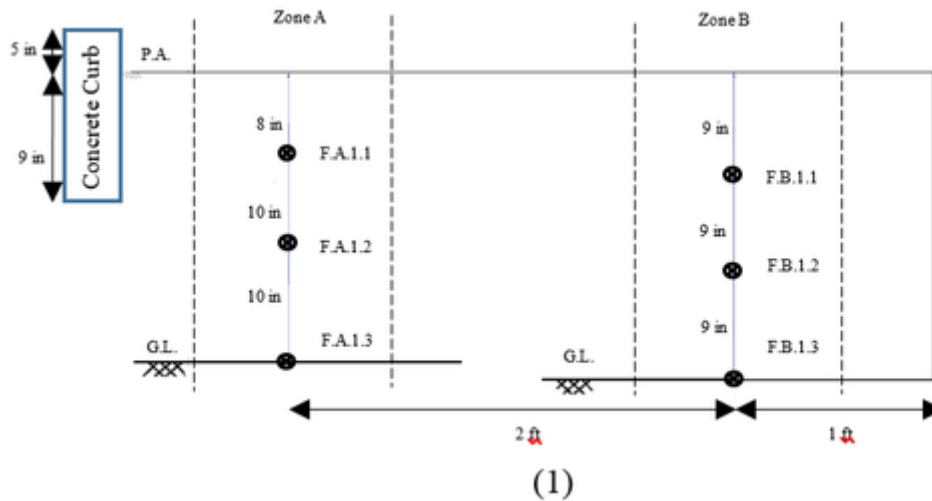
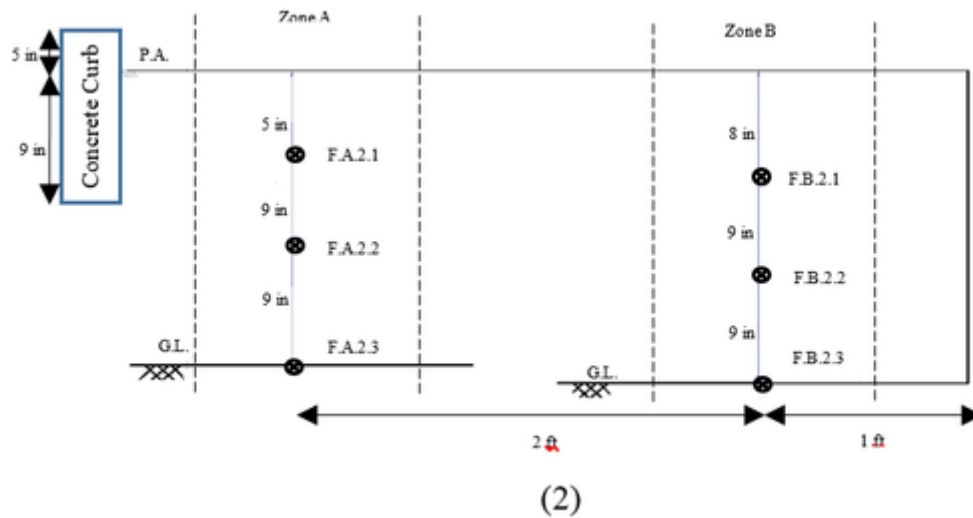
Figure 3.8 Sensor depths Zones A and B at Finch Arboretum porous asphalt parking lot in Rows 1 and 2 (note that soil height is level with the top of the concrete curb as shown)

Finch Arboretum Porous Asphalt Parking Lot, Spokane, Washington: In October 2015, twelve 5TE soil moisture and temperature sensors were installed in the slow-draining soil (predominantly clayey) next to the northwest corner of the new porous asphalt parking area at the Finch Arboretum in Spokane, as shown in Figure 3.6. This area is where the porous asphalt system is sloped to drain. Unlike the system at Community Hall, the Finch permeable pavement system is equipped with underdrains at the bottom of the underground storage bed, effecting a detention system. The sensors were installed in two zones: Zones A and B. In each zone, two holes were dug, and 5TE sensors were installed at three depths in these four holes as shown in Figures 3.7 and 3.8.

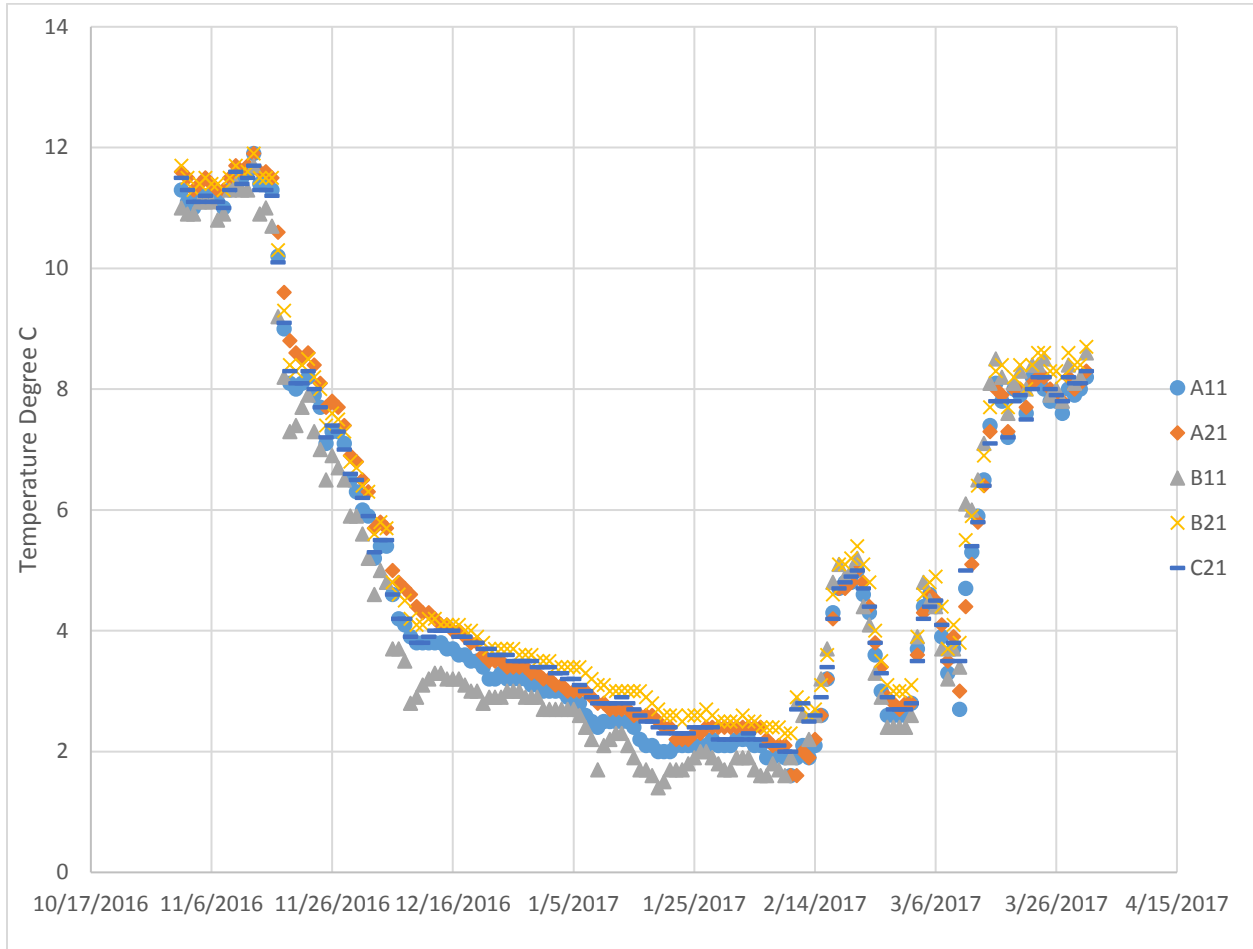
Figure 3.9 Shallow depth temperatures of Community neighboring soil, winter of 2016/2017 (midnight readings)

As can be seen in Figure 3.9, the temperature profiles at this shallow depth are similar regardless of nearness to the sidewalk, implying little or no impact from placement at these temperatures. The one exception is Sensor B11, which always read cooler than the others. However, it was noted in the field that after installation, the sod was not replaced on the soil above this sensor, and although some grass growth eventually formed here, the decreased insulation from an established sod layer above Sensor B11 might have impacted the data. Regardless, the temperatures at these shallow depths never dropped below zero, even under the coldest winter conditions. Without freezing conditions in the upper soils, little or no frost heave can be expected. However, it is still important to determine if these upper soils are saturated should an even deeper freeze occur. Figure 3.11 depicts the VWC (m^3/m^3) at these same shallow sensor locations during the same wintertime period.

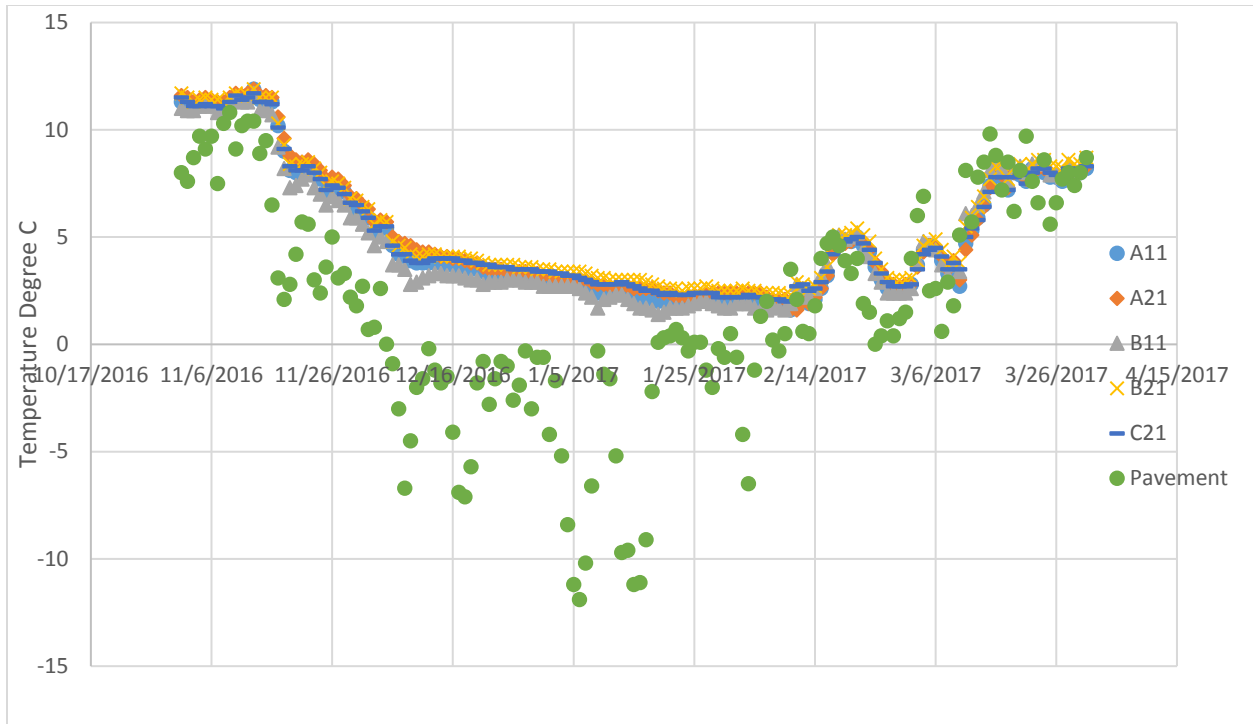
Figure 3.10 Shallow depth temperatures of Community neighboring soil and mid-depth temperatures in the pervious concrete layer, winter of 2016/2017 (midnight readings)

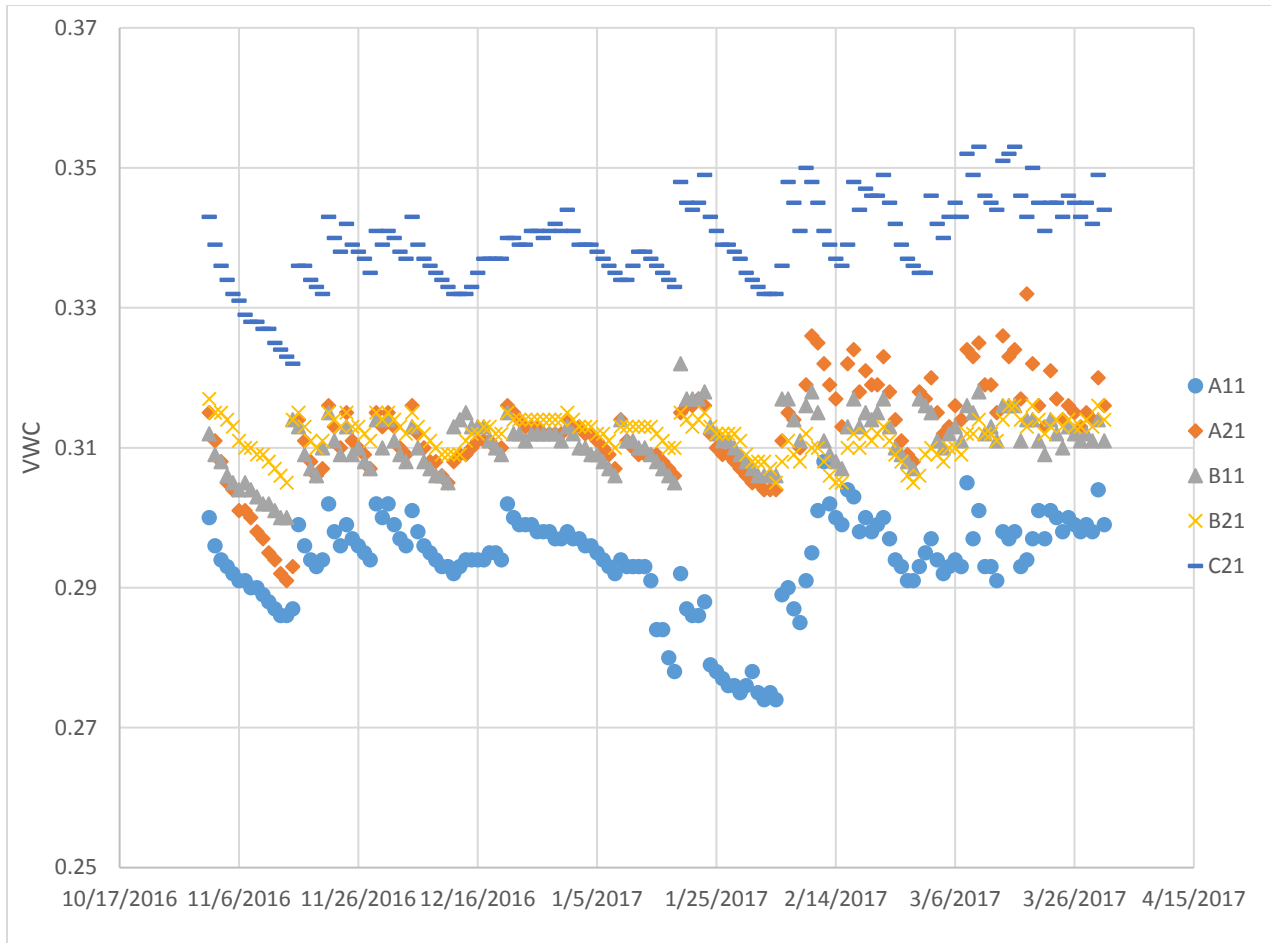
Figure 3.11 Community shallow depth volumetric water content of neighboring soil winter 2016/2017 (midnight readings)

With some exceptions, VWC is similar at shallow locations, with only slight variation over the entire winter, as seen in Figure 3.11. Sensor C21 consistently shows a higher VWC reading, and Sensor A11 consistently shows a lower VWC reading. However, these variations could be due to location, with more snowpack at one location and less at the other, but these variations are most likely due both to differences in sensor readings and slight variations in soil composition right next to each sensor. Regardless, the sensor readings for all shallow locations during the entire winter are well below a saturated condition. It was found during the previously draindown tests that the water content recorded in Sensor C12, the one closest to the

underground storage bed that was artificially flooded the most, reached a VWC of 0.417. This level was not seen in any soil sensors at the Community site except during artificial flooding events. In fact, soil moisture in the sensors did not vary much with location or time. For instance, during the entire winter season, the B sensors nearest the sidewalk, regardless of depth, recorded values only between 0.291 and 0.312. During the entire two-year period of record, the sensor most likely to receive stormwater impacts, Sensor C12 since it was nearest the first upslope aggregate storage bed, never recorded a VWC of greater than 0.37 except during artificial flooding events.

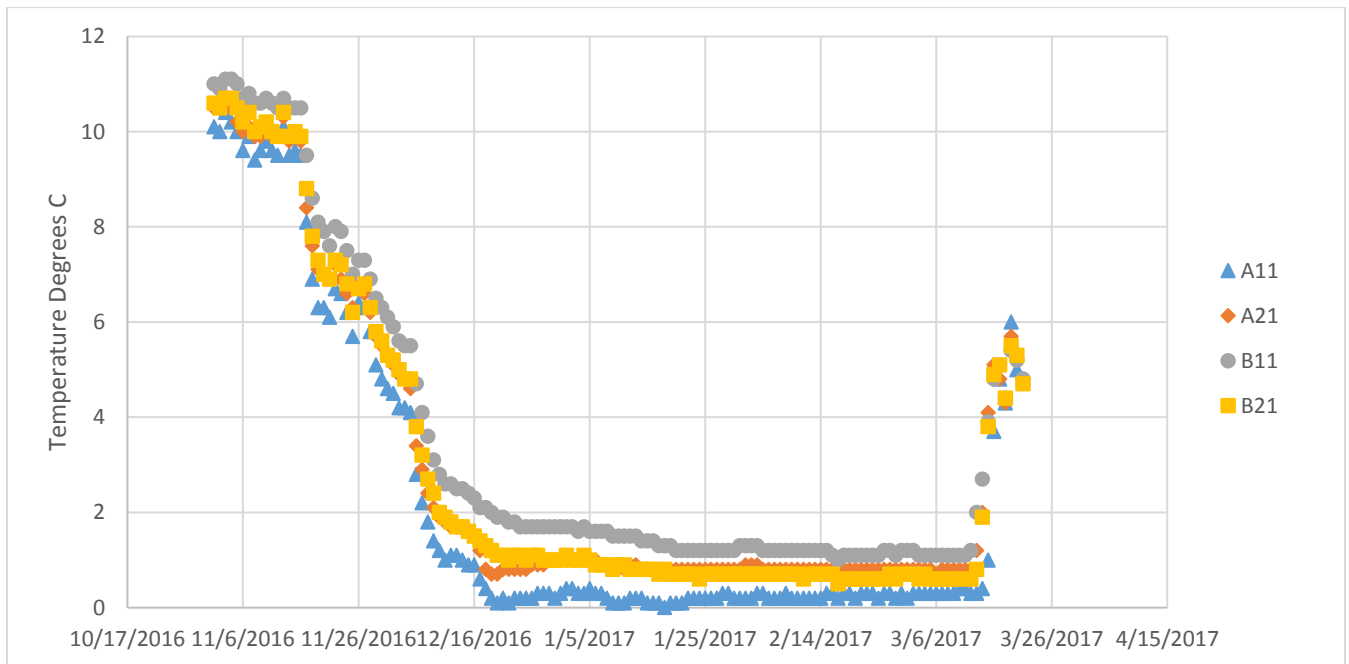
Figure 3.12 Shallow depth temperatures of Finch neighboring soil winter of 2016/2017 (midnight readings)

Figure 3.12 shows that the upper level temperatures farther away from the permeable pavement system, A21 and B21, are nearly the same. The closer sensor at A11 reads a slightly cooler temperature, and the closer sensor at B11 reads a slightly warmer temperature. It is postulated that since the row closest to the porous asphalt system in Zone A was disturbed with geotextiles and construction debris, the reading is not as valid for undisturbed soil such as in Zone B. However, in a real installation, many areas might be disturbed with irregular compaction, etc. Therefore, both might be representative of field conditions. Regardless, with the snowpack on top of the lawn area next to the porous asphalt system, the temperature never went below freezing at these shallow, approximately 12-inch depths.

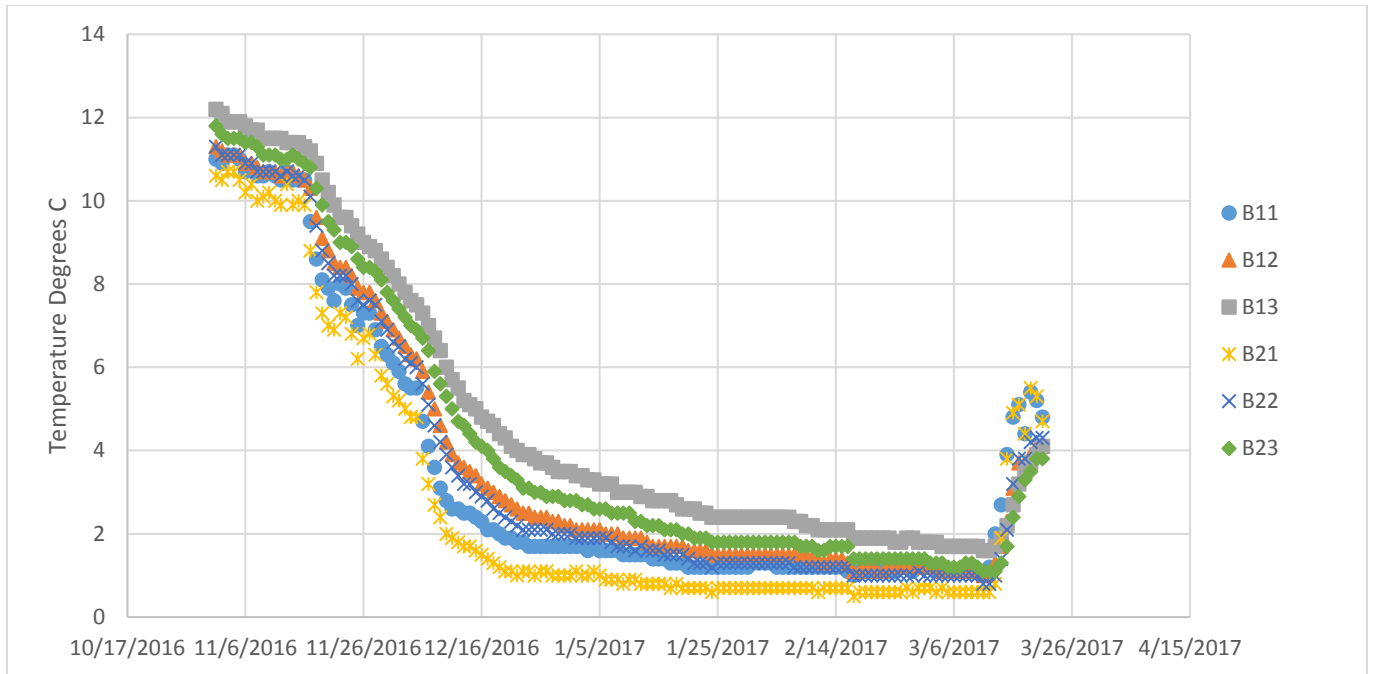
Figure 3.13 Zone B temperatures of Finch neighboring soil winter of 2016/2017 (midnight readings)

Figure 3.13 depicts the temperatures at all depths for Zone B. Even 3 feet down, the soil is very cold in this severe winter. In general, the sensors closer to the bed are slightly warmer than the sensors farther away during the worst part of winter. This was hypothesized, in that the insulating capabilities of the aggregate storage bed due to air voids would also have a small impact on the nearest soils.

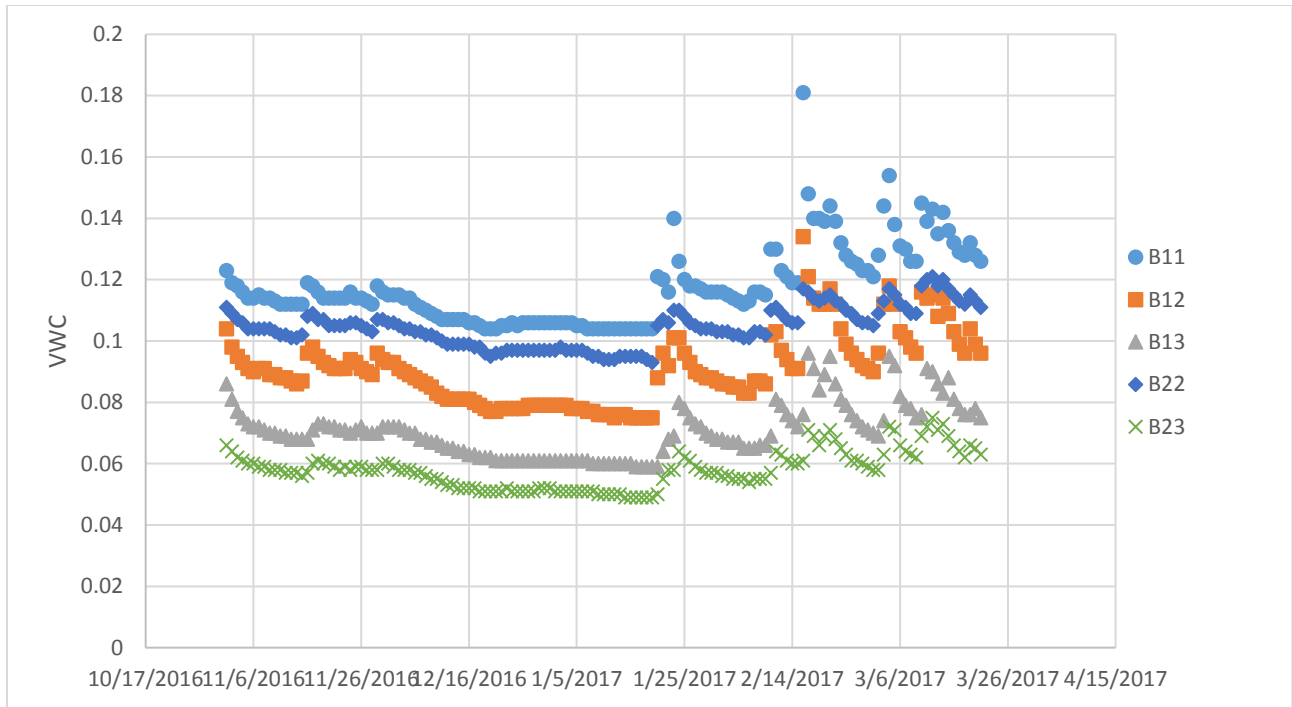
Figure 3.14 Zone B volumetric water content of Finch neighboring soil winter of 2016/2017 (midnight readings)

Since temperatures do drop so low in the soil, even at deeper depths, it is important to look at the VWC (m^3/m^3). Figure 3.14 is a plot of the VWCs in Zone B. Sensor B21 is not included since the reading remained at a constant 0.307 the entire time, indicative of a reading error. As can be seen, the soils are always drier lower down. It was expected that the aggregate storage bed would provide for positive drainage toward the bed from the soils. Based on these readings, it is likely that the water is entering from the top downward, not from the side of the aggregate storage bed inward.

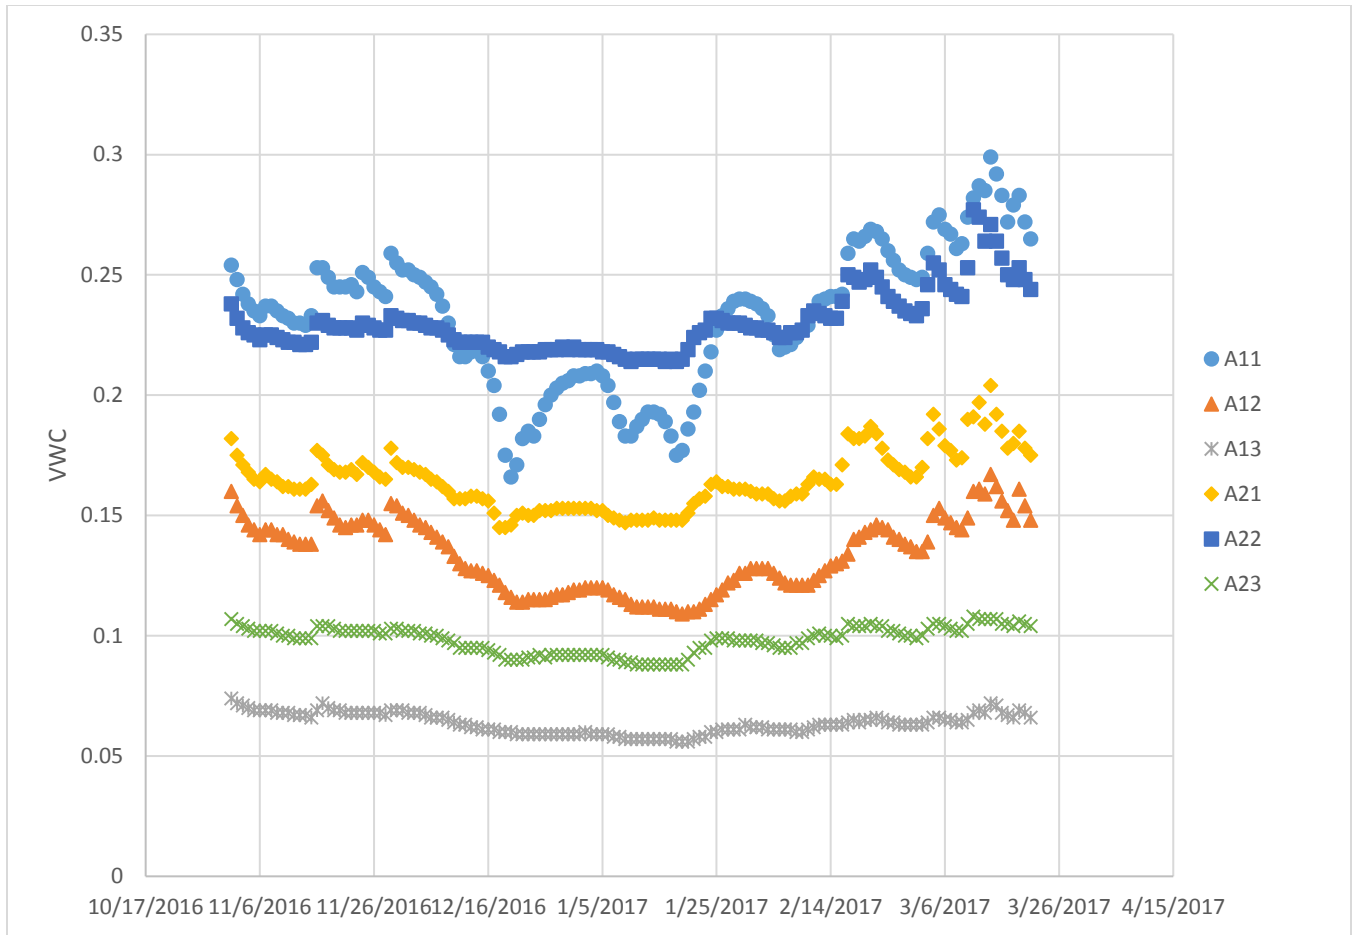
Figure 3.15 Zone A VWC of Finch neighboring soil, winter of 2016/2017 (midnight readings)

Figure 3.15, which is a plot of the VWC in Zone A, is an even better indicator of this drainage from the soil to the bed. As previously mentioned, the nearest sensor array in Zone A is in disturbed soil. This is evident in the varying VWC recorded by the upper sensor. Yet the lowest sensor has very low VWC, noticeably lower than the deep sensor farther away.

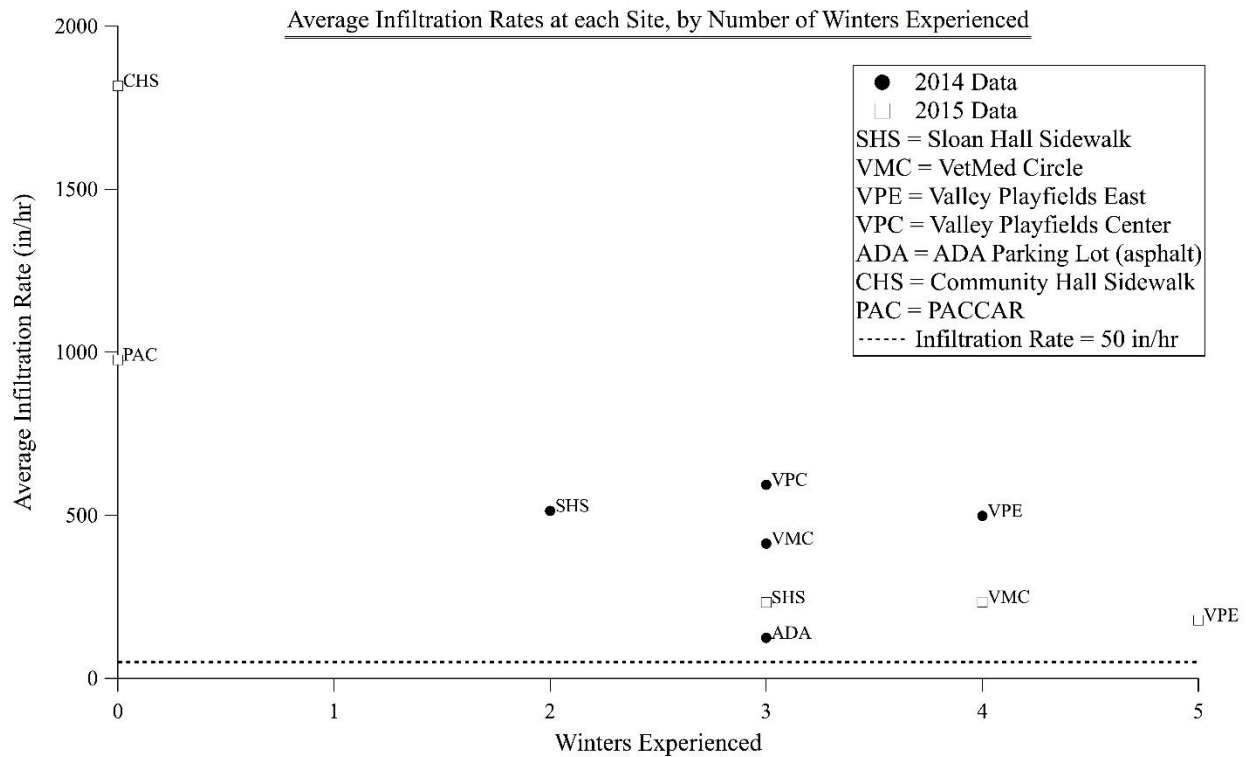
Figure 4.2 Average infiltration rates determined for each installation at varying ages, based on Table 4.1 data (the 2015 SHS data were taken after a partial cleaning of the pad)

functioning for several years without maintenance, and an annual cleaning for severely clogged areas or cleaning every 2 years appears to be sufficient.

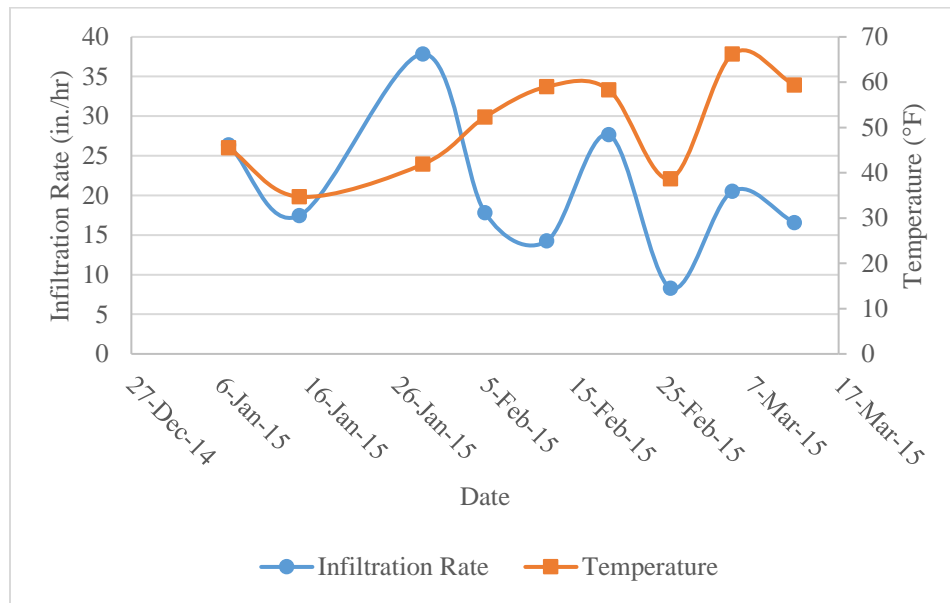
Figure 4.3 Infiltration rates and temperatures for SHS point B

A second factor to consider when monitoring infiltration rates of pervious installations is the temperature effects caused by seasonal temperature variations. Changes in temperature can affect the viscosity of the water, therein altering the hydraulic conductivity of the water (Werner and Haselbach 2016 and 2017, Emerson and Traver 2008). The infiltration rates of points B–D at SHS were monitored from January–October 2015, and the air temperature, surface temperature, and relative humidity were recorded for each test. Infiltration rates and temperature versus time have been plotted for each testing point, as shown in Figures 4.3–4.5. These figures were taken from Werner and Haselbach (2016). The traces for infiltration and temperature do not always exactly follow the same trends; however, they follow each other often enough to imply that

temperature can have a significant effect on infiltration rate. Infiltration rates were estimated to decrease by about 50% between freezing and 80°F (Werner and Haselbach 2016).

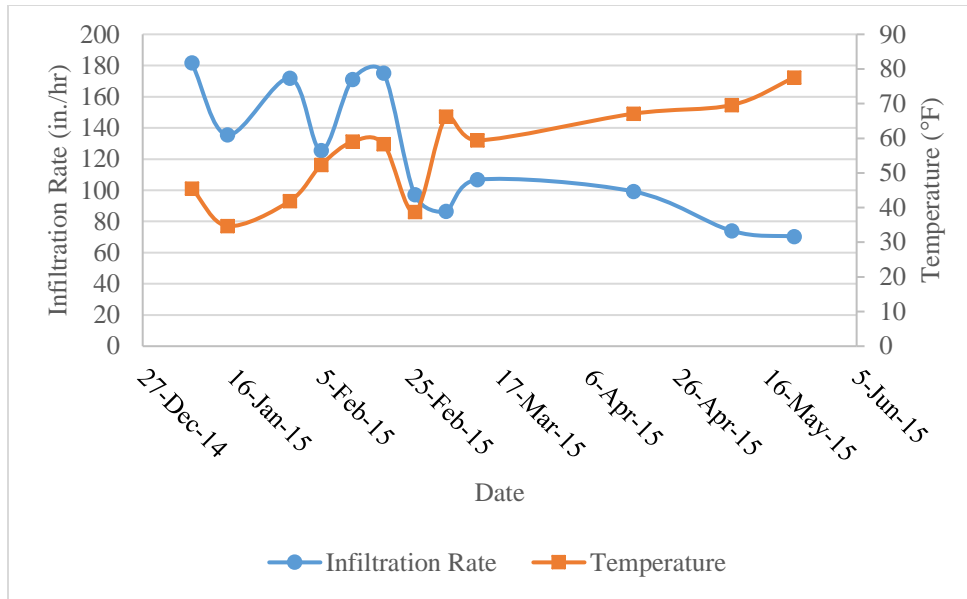
Figure 4.4 Infiltration rates and temperatures for SHS point C

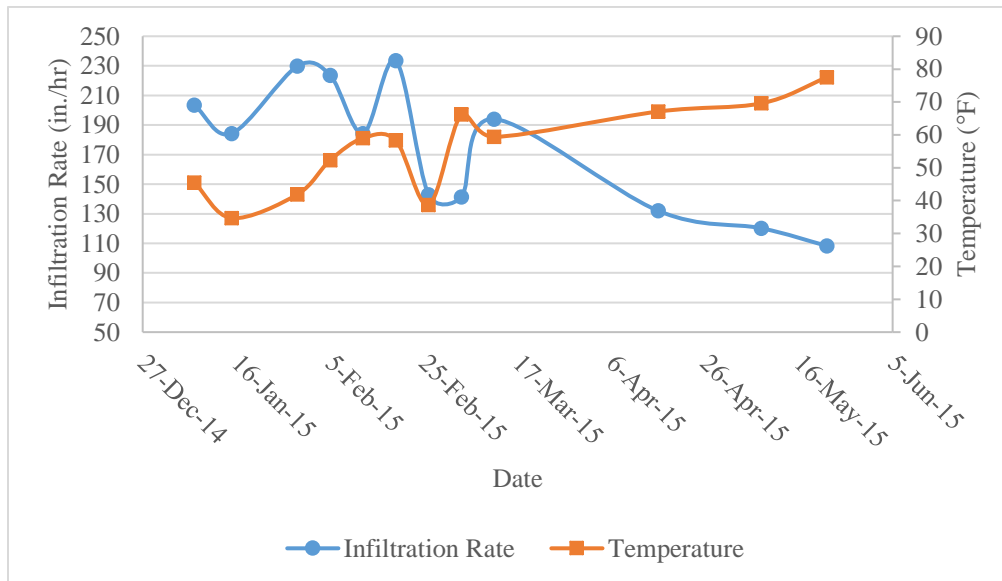
Figure 4.5 Infiltration rates and temperatures for SHS point D

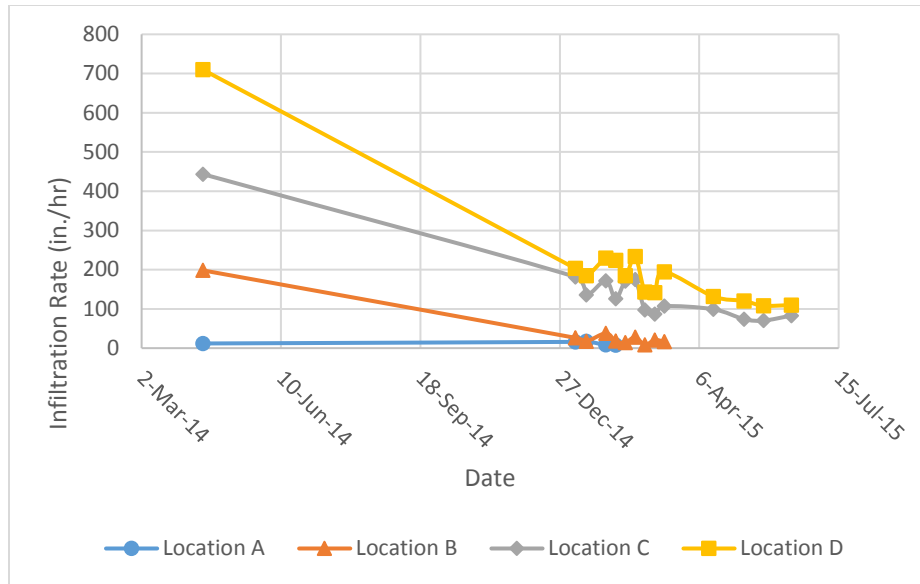
Figure 4.6 Infiltration rates for SHS points A–D from April 2014–June 2015

Though a clear seasonal temperature effect on infiltration rates is evident, clogging has a much larger influence. Figure 4.6, from Werner and Haselbach (2016), shows a year-long overall decreasing trend in infiltration rate due to clogging, and that changes in temperature produce only relatively minor oscillations in infiltration (Werner and Haselbach 2016 and 2017).

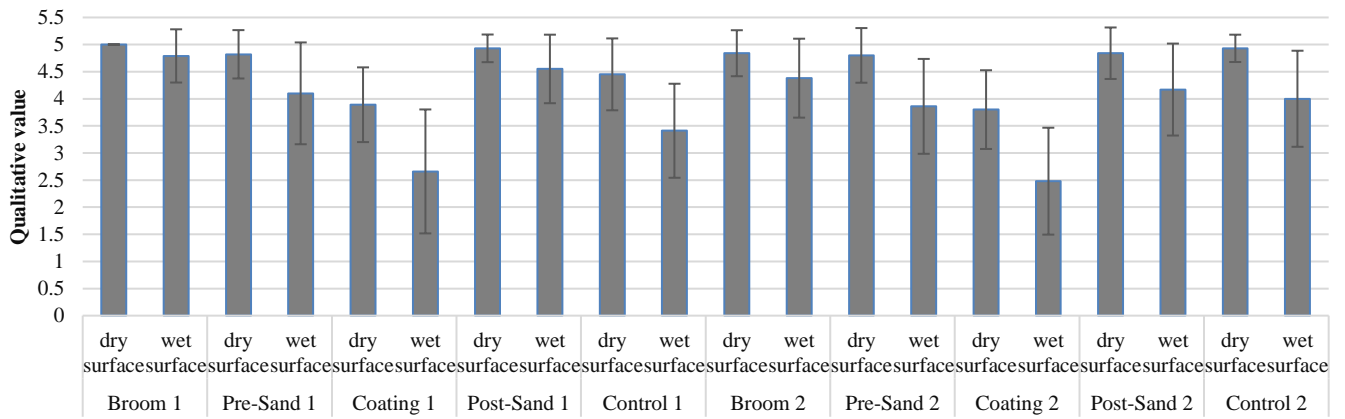
Figure 5.1 Summary of qualitative microtexture evaluation (Yekkar et al. 2016)

The adapted methodology for the qualitative “slipperiness” classification of the microtexture was mainly based on assessment by means of subjective inspection. For this purpose, the specimens were placed outdoors in a landscape bed next to a pervious concrete sidewalk, and during this period (1/25/2015 to 4/7/2015), the operator conducted qualitative assessment by sliding his/her foot on each specimen in order to gain a general idea about the performance of different treatments in terms of skid resistance. The specimens were not labeled as to the treatment type to avoid any possible prejudice. (This practice also allowed the specimens to weather under normal wear and exposure conditions for approximately a half year.) Using this method, a score of 5, 4, 3, 2, or 1, which corresponded to “considerable,” “high,” “medium,” “low,” and “negligible” skid resistance, respectively, was assigned to each specimen in a checklist designed for this purpose. The operator performing the test also noted the weather conditions so that the observations could be separated into either wet or dry surface conditions. Figure 5.1 provides the results from the qualitative evaluation as averaged for 74 daily observations on each specimen.

To compare the two methods visually, the values in Figures 5.1 and 5.2 were normalized. This was done by dividing the average values for each surface treatment by the highest average value for either the wet or the dry condition for the respective methodology. Figures 5.3 and 5.4 compare the normalized values of the surface evaluations for both the spring balance and the qualitative observations under dry and wet conditions.
