Stormwater-Pavement Interface in Cold Climates

Liv Haselbach and Somayeh Nassiri
Department of Civil and Environmental Engineering
Washington State University University

05/27/2017

INE/AUTC 17.13

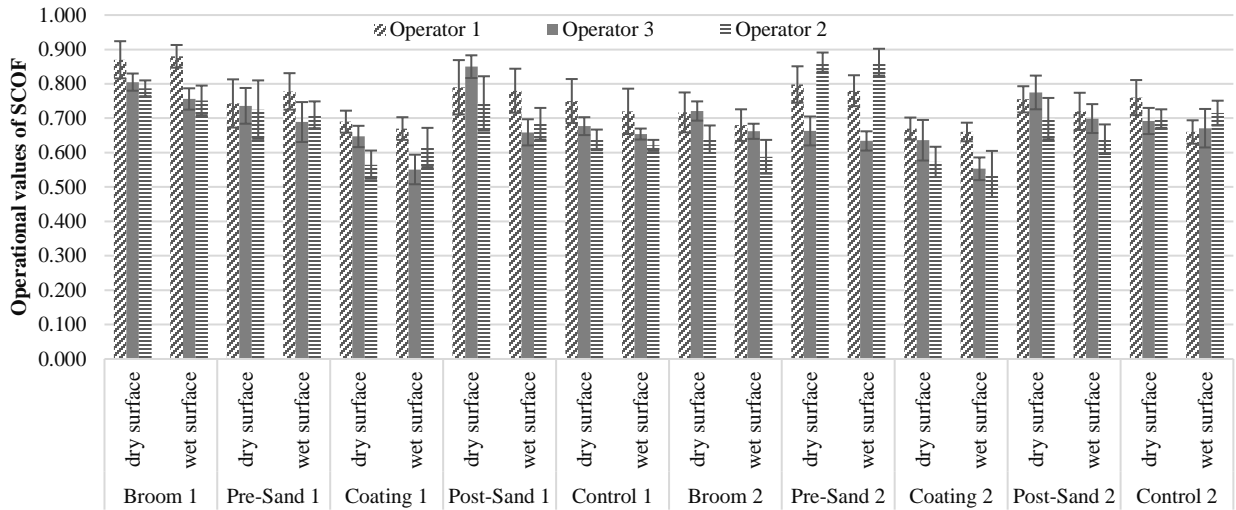
Figure 5.2 Summary of spring balance tests conducted by three operators (Yekkalar et al. 2016)

By using different combinations of weights on the board and their corresponding external forces, several “static coefficient of frictions” (SCOFs) are evaluated. As with other experimental measurements, it is suggested that the test be conducted in at least two different locations and three times for each location to increase the accuracy of the results. In this experimental setup, the tests at each location were done with three different normal forces, one test for each, and the SCOFs were averaged at each location. Conducting the test with different operators can be helpful for this purpose. In this way, 360 friction tests were conducted by three different operators on pairs of specimens with five different textures under both dry and wet surface conditions. Figure 5.2 is the summary of average values of measurements on two locations of each specimen (average of three trials for each location) reported by the three different operators for the spring balance method (Yekkalar et al. 2016).

To compare the two methods visually, the values in Figures 5.1 and 5.2 were normalized. This was done by dividing the average values for each surface treatment by the highest average value for either the wet or the dry condition for the respective methodology. Figures 5.3 and 5.4 compare the normalized values of the surface evaluations for both the spring balance and the qualitative observations under dry and wet conditions.

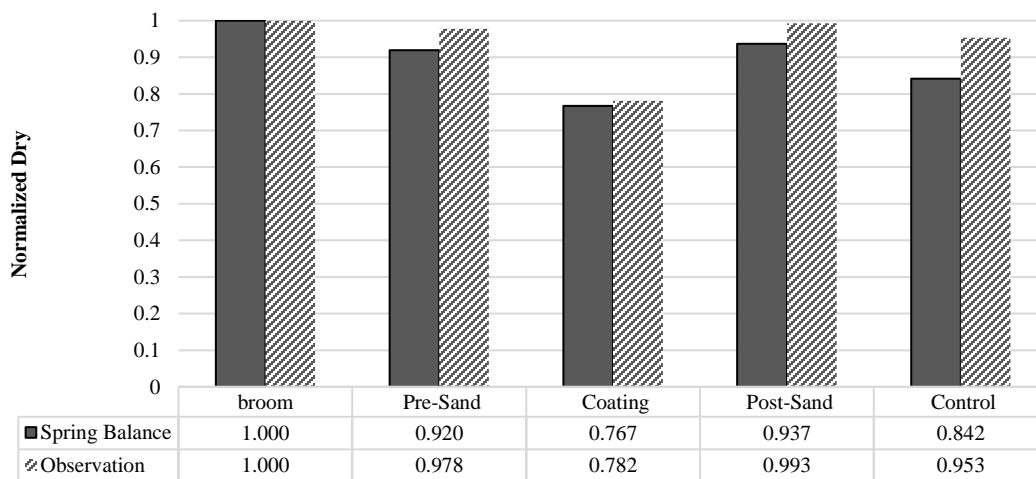
Figure 5.3 Normalized average results for both methods in dry conditions (Yekkalar et al. 2016)

The results from both the quantitative and the qualitative approaches show that broom finishing ranks the highest in terms of friction or lack of “slipperiness,” and it appears that sand treatments improve the microtexture of the surface under both dry and wet conditions. However, results show that the pre-compaction method is not as effective as the post-compaction method. Finally, the coating treatment seems to affect surface roughness negatively, especially under wet conditions.

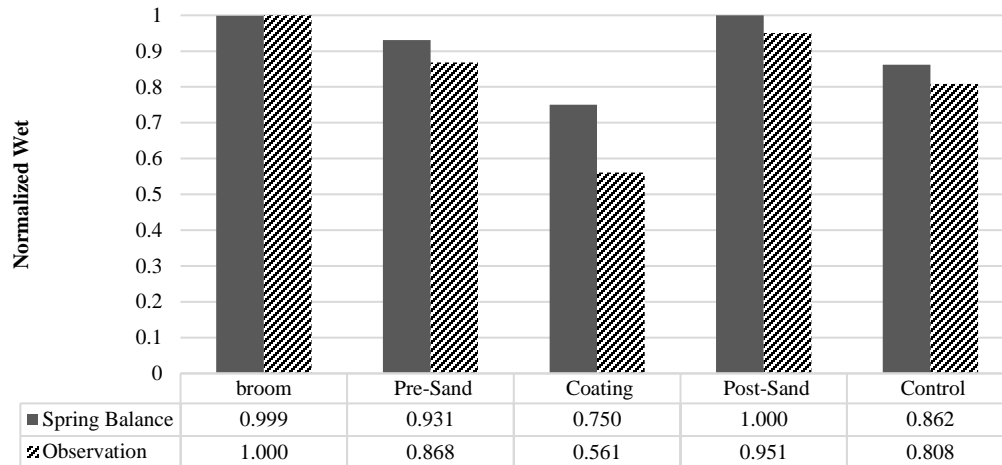
Figure 5.4 Normalized average results for both methods, in wet conditions (Yekkalar et al. 2016)
