RESEARCH PROJECT NO. 99-051
EVALUATION OF POLYETHYLENE SNAP-TITE PIPE LINER

FINAL REPORT
JULY 2006

EVALUATION OF “63-inch” HIGH DENSITY POLYETHYLENE SNAP-TITE™ PIPE LINER

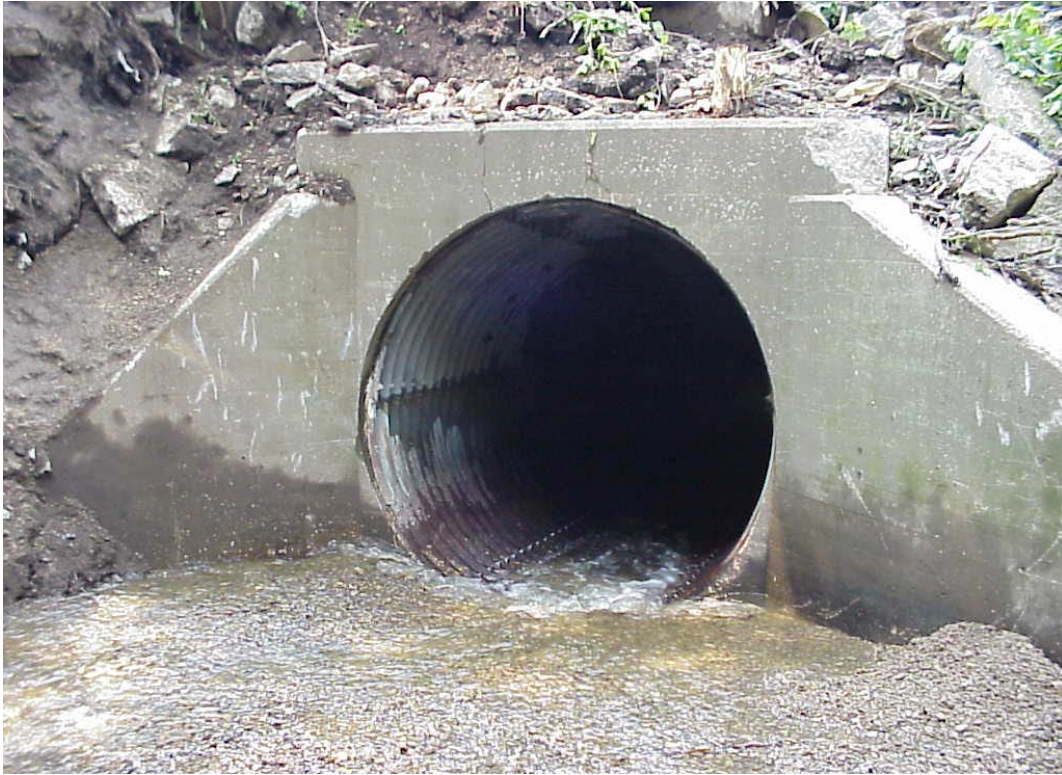
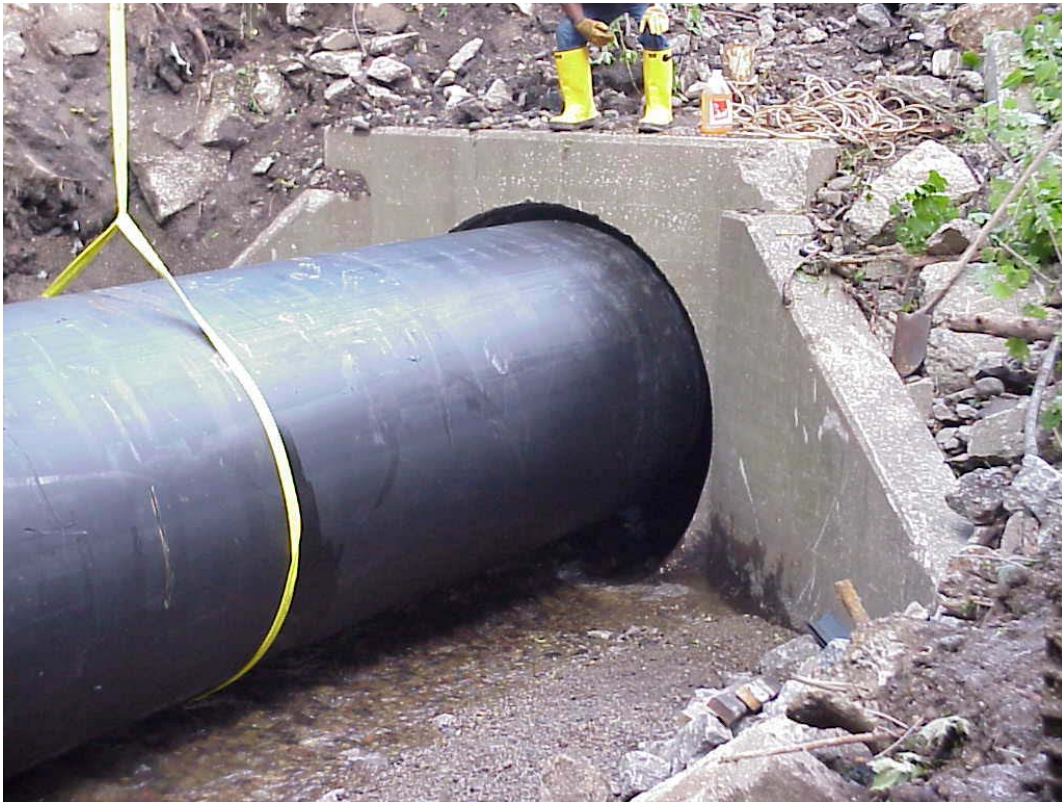
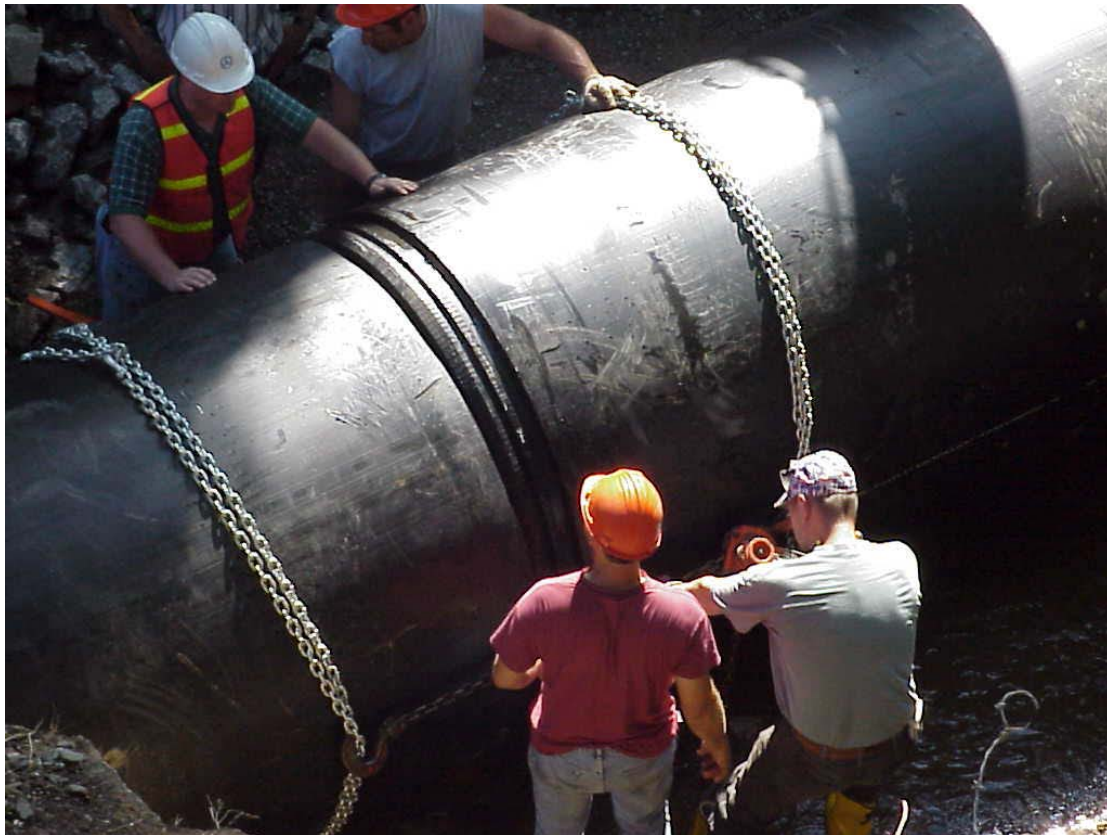
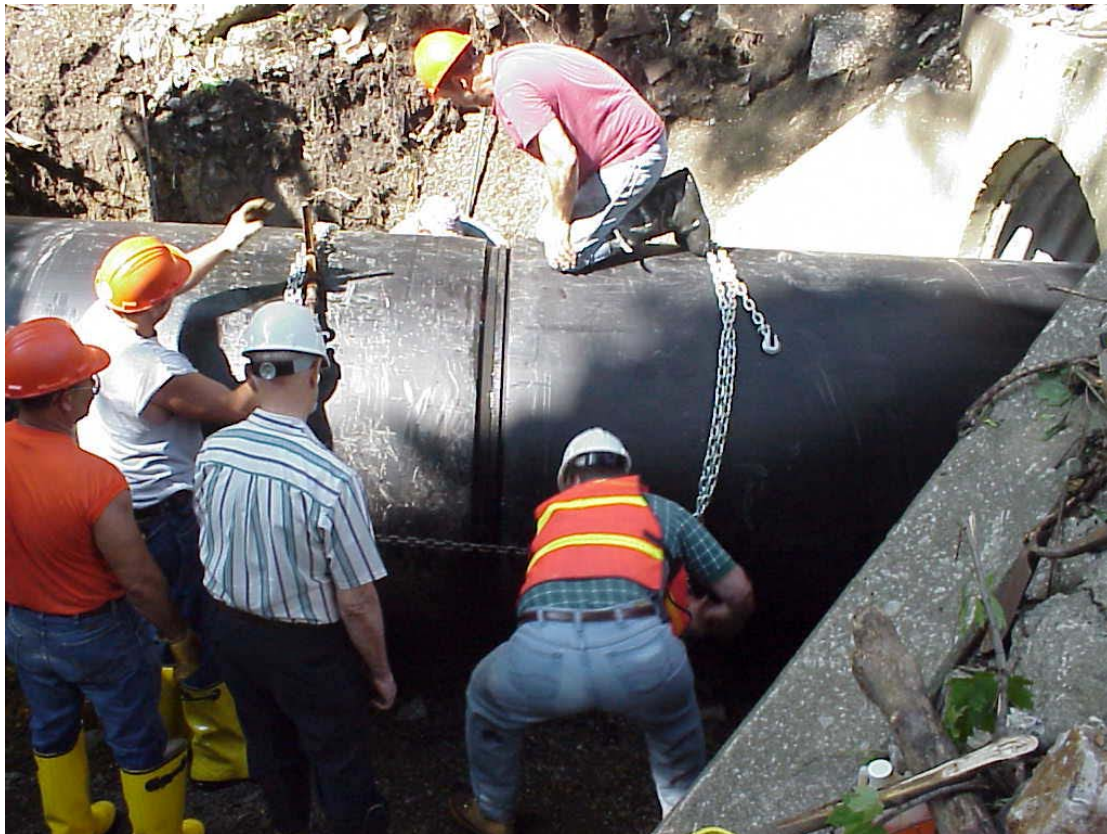
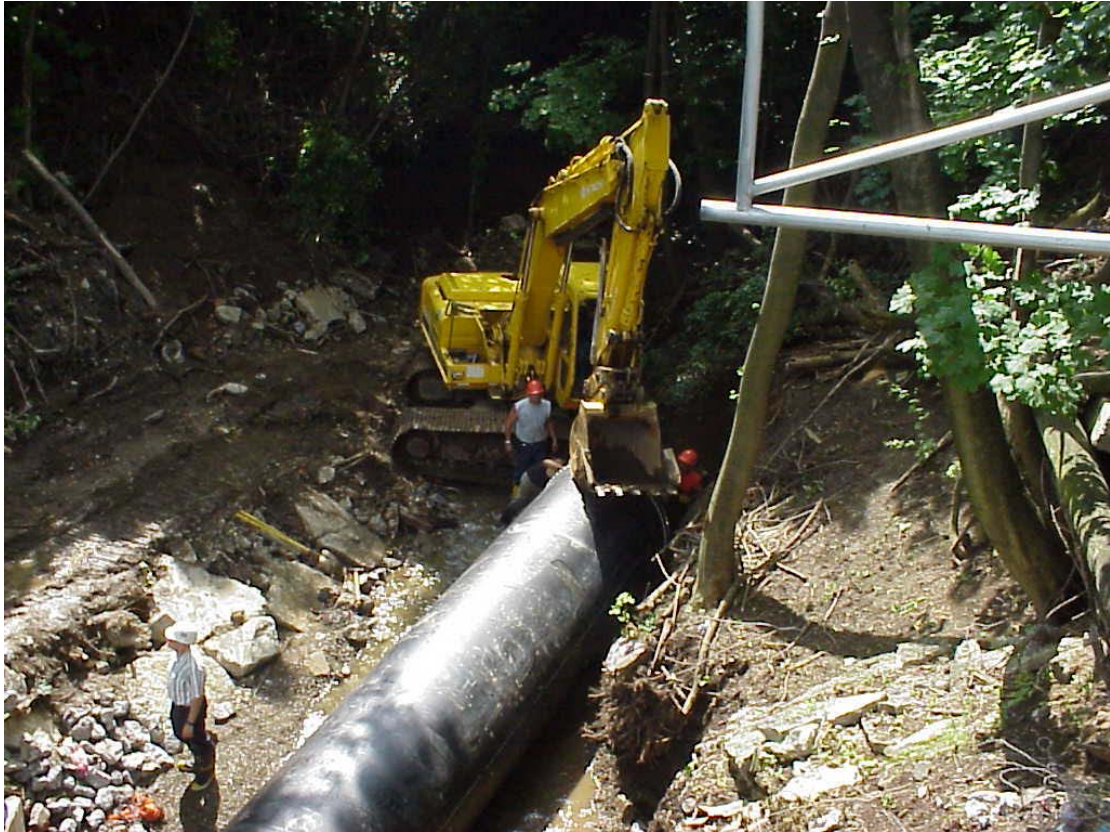
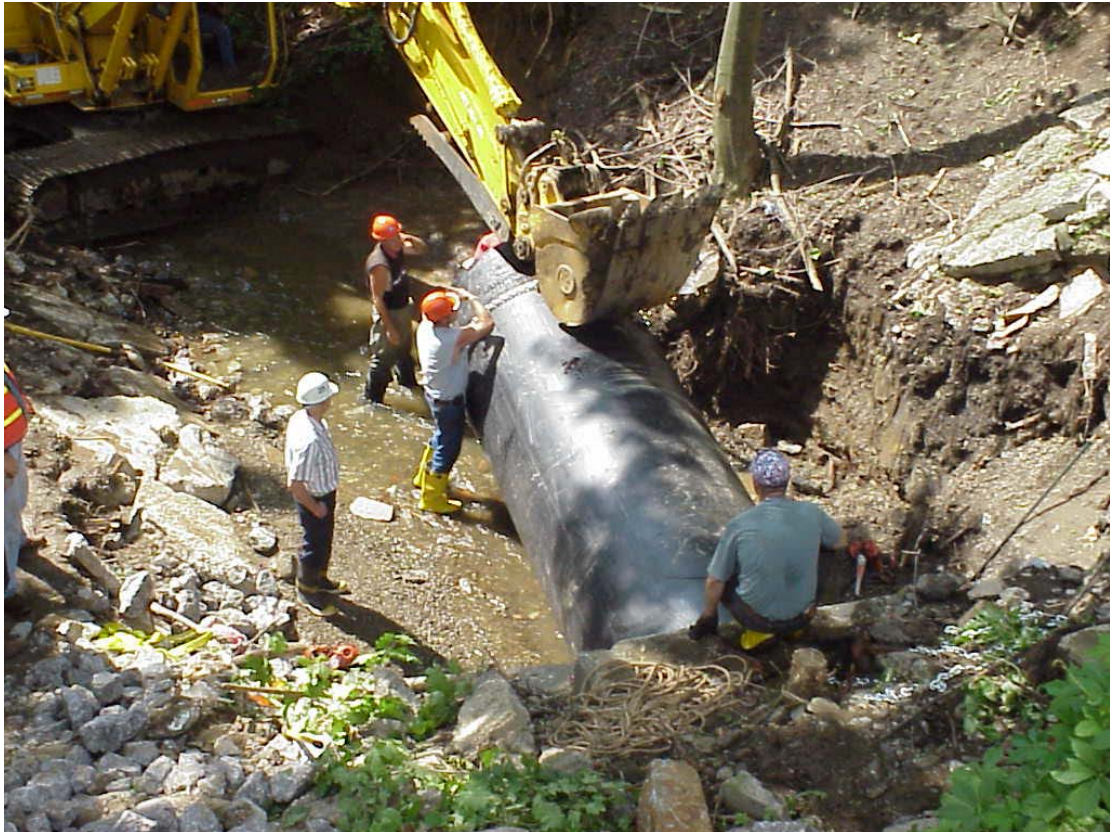
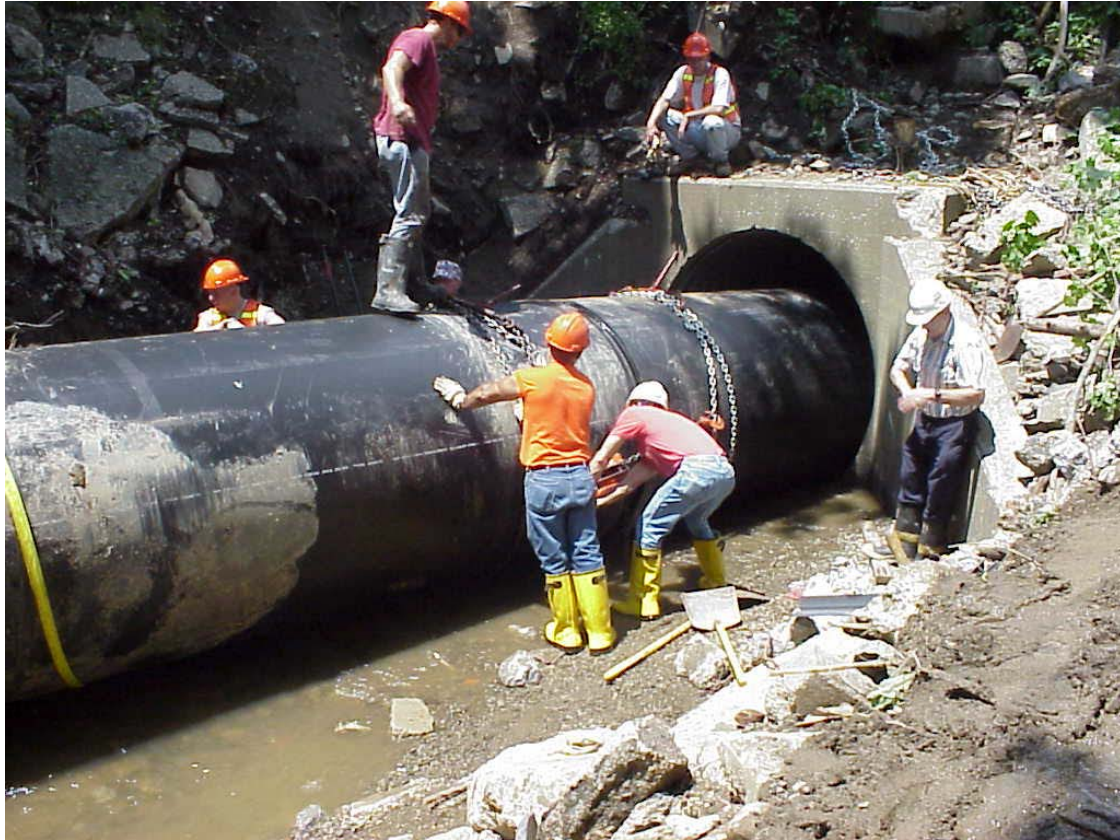
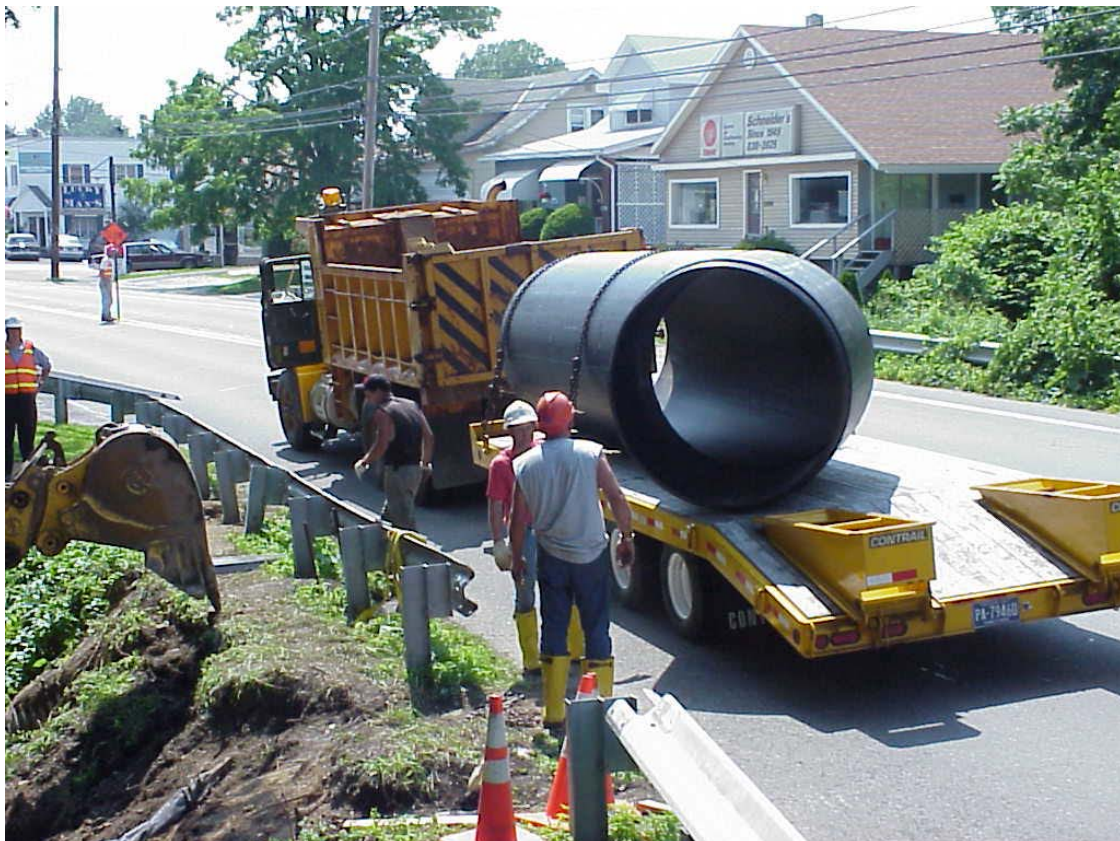
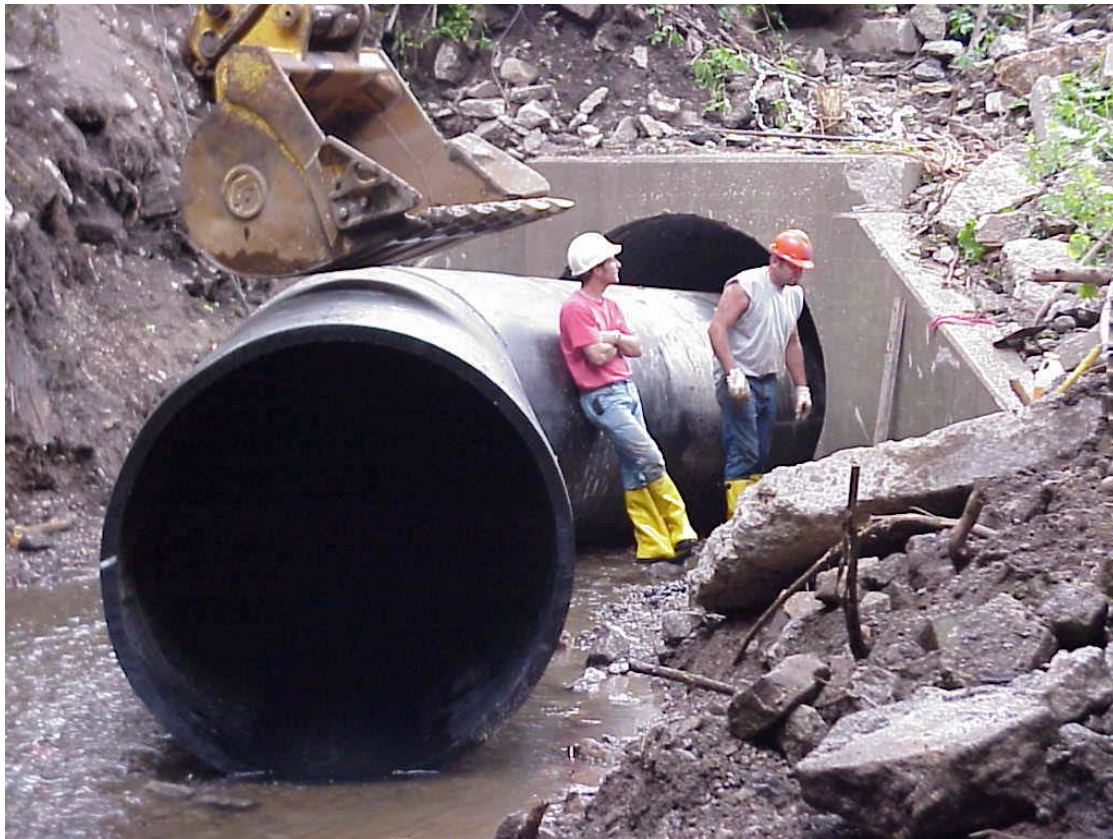
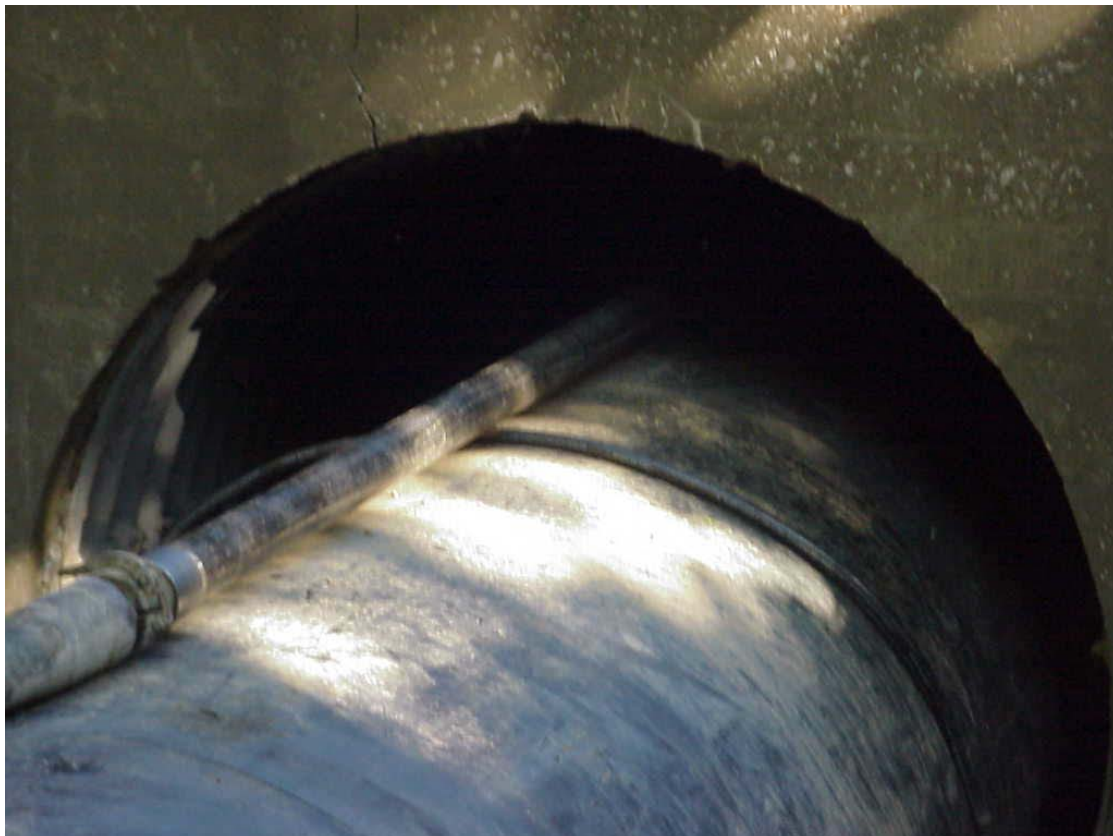
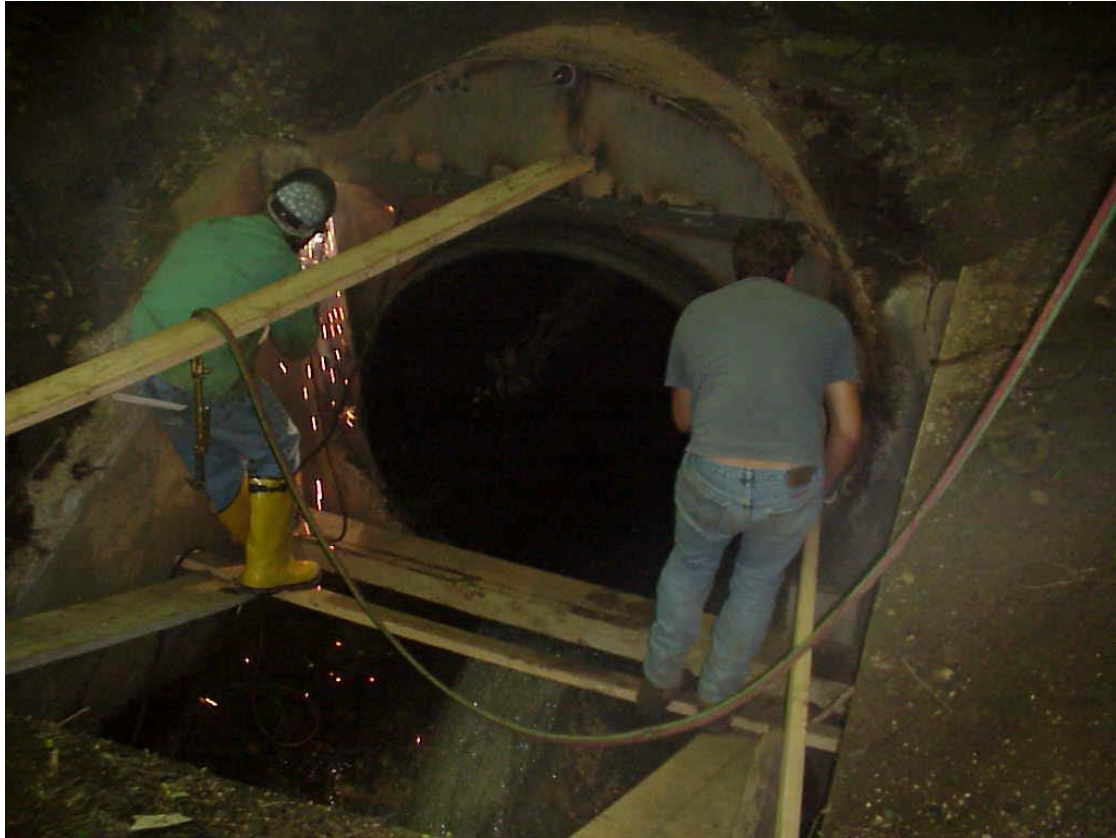
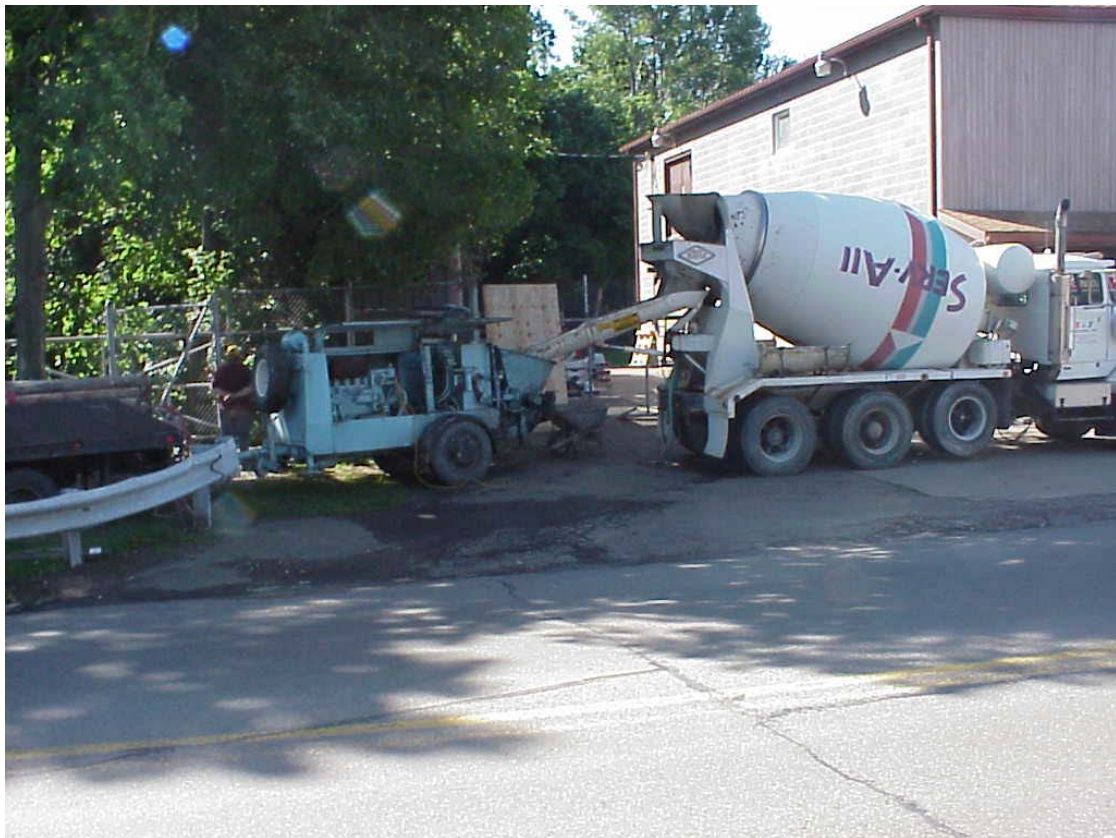
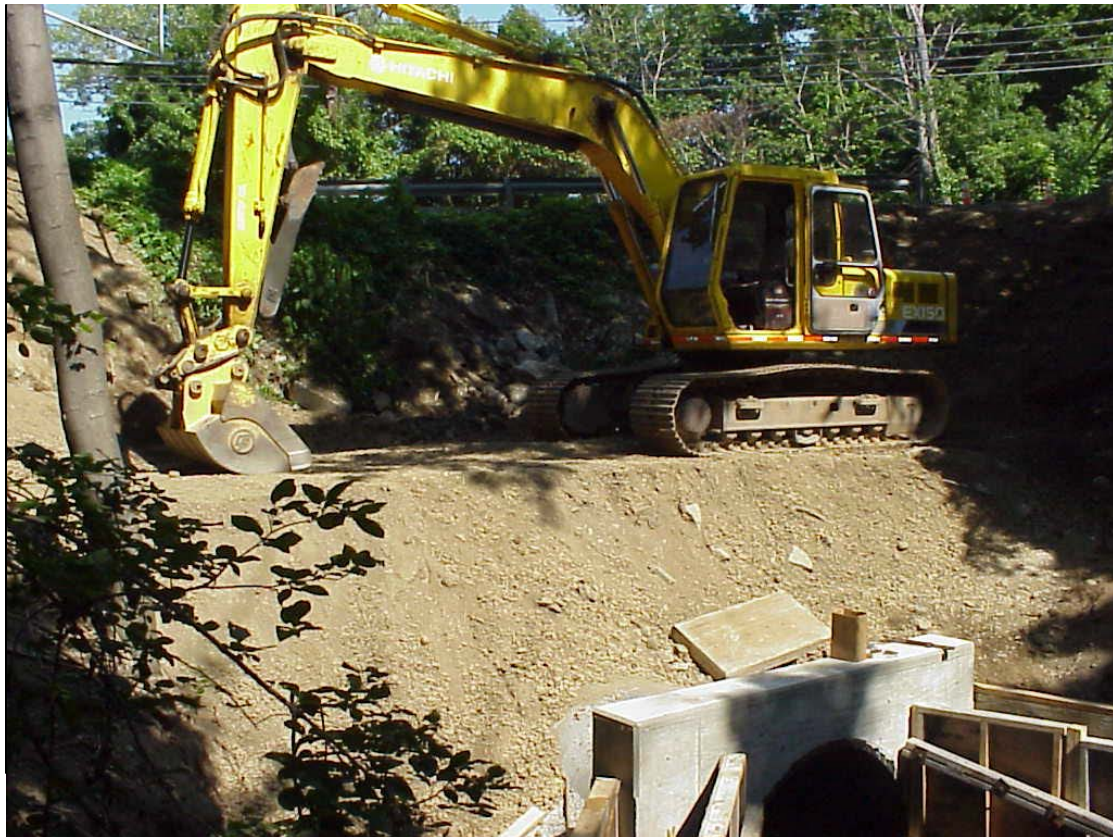
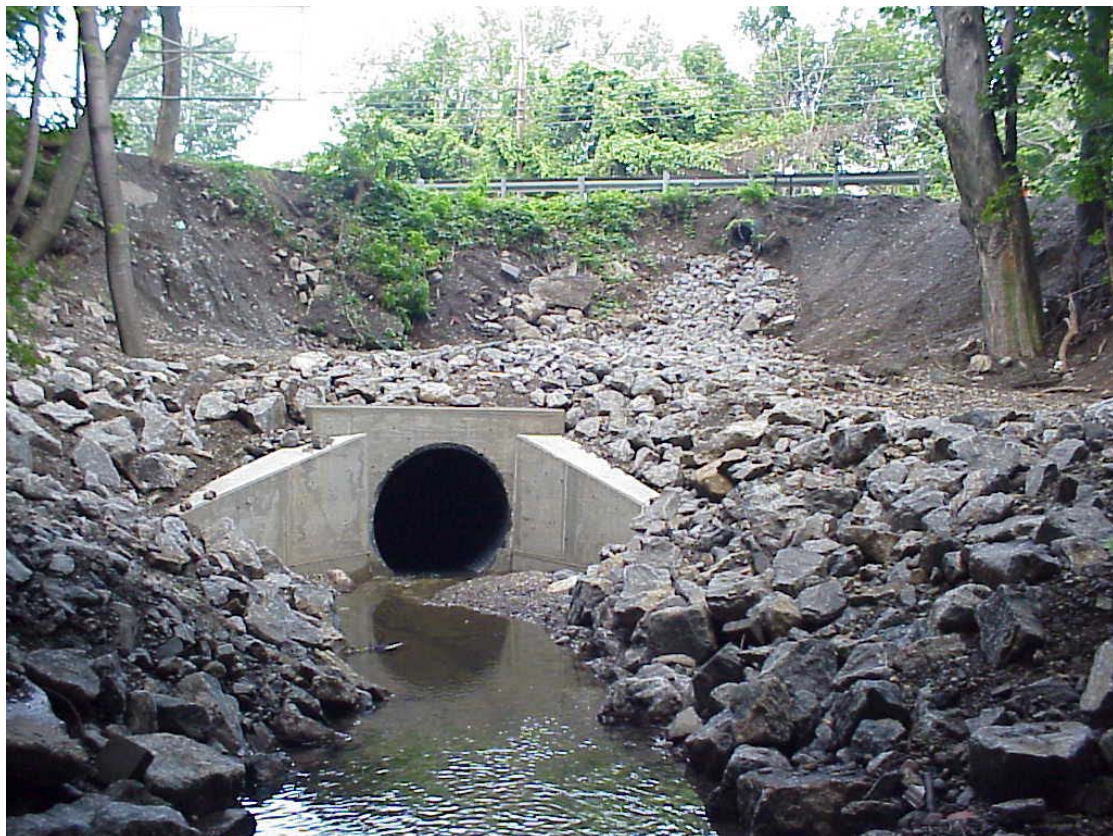
As a result of steep terrain a tracked excavator was used during the pipe liner installation. A minimal amount of excavation and tree removal occurred adjacent to the stream on the inlet side of the culvert in order to create a staging area for installation. The Snap-Tite pipe liner was installed according to the manufacturer's installation procedures which can be referenced in the Manufacturer's Installation Procedure section. This project occurred during a low flow period of the stream so the minimum amount of disturbance took place. Subsequent to the installation of the pipe liner the water flow was diverted back into it and the construction of a new D-W endwall was completed. Before the backfilling of the pipe extension a silt barrier fence was placed at the base of the slope in order to encompass the backfill area. While the embankment was being placed, R-4

rock-lined ditches were constructed down to the stream. In order to correct any of the minor disruptions to the environment, the disturbed areas were seeded and mulched after the completion of the embankment. After the permanent erosion and sediment controls were established the temporary controls were removed. Photos, with captions, of the actual pipe liner installation can be referenced in Construction Photos section of this report.
