FHWA REPORT NO. FHWA-HIF-17-001

FHWA PROJECT R05 IAP FUNDED PROJECT CASE STUDY

HONOLULU INTERSTATE H1 PRECAST CONCRETE PAVEMENT DEMONSTRATION PROJECT

October 2016

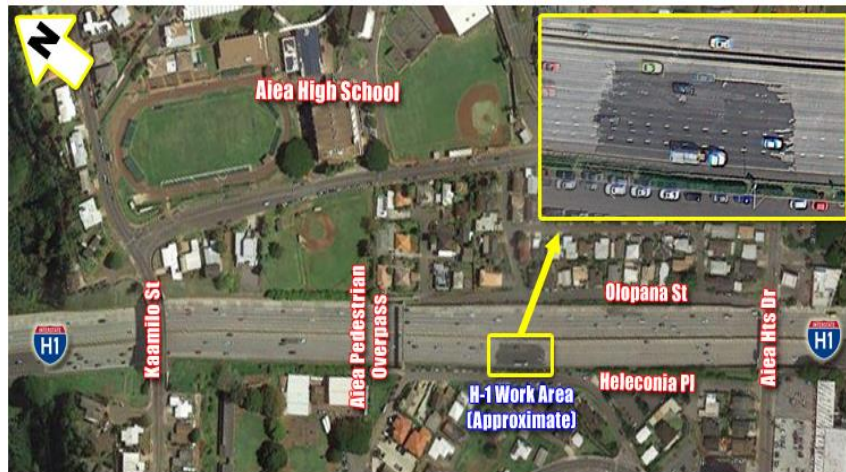
Figure 1. Photo. Location of the project.

As illustrated in figure 1, eastbound Hawaii Interstate H1 has six lanes at the project location, just east of the Aiea Pedestrian Overpass and parallel to Heleconia Place. At this location, a 165-ft section (from station 183+40 to station 185+05) had settled and had been repeatedly overlaid with asphalt concrete (AC) across all six lanes over the life of the freeway. The maximum settlement was about 3 to 4 inches. Figure 2 shows a view of the existing AC-overlaid section prior to installation of the PCP.

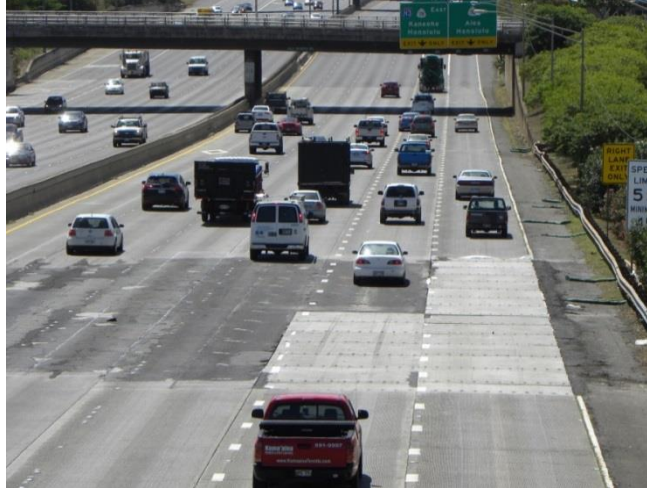
Figure 3. Photo. Lanes 5 and 6 partially replaced with precast panels.

Figure 3 shows the test section with lanes 5 and 6 (most outside lanes) partially replaced with precast panels.

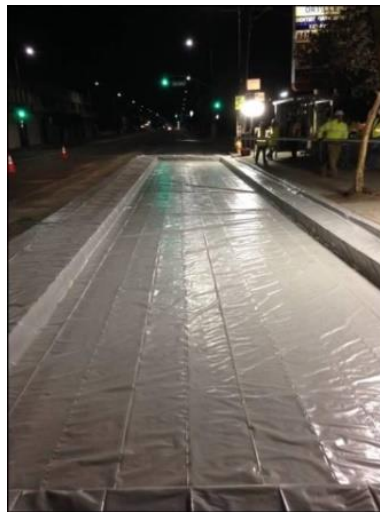
Figure 6. Diagram and photo. The Grout Containment system.

- Performance Plus RH Latex Fill Grout—This is a rapid hardening, non-shrink, free flowing, zero bleed, sanded, cementitious grout for filling dowel bar slots. The grout achieves a compressive strength of 3,000 psi within 1 hour and 8,000 psi at 28 days.
- Grout Containment system (figure 6)—The Grout Containment system is used to prevent the bedding grout from migrating under existing pavement. As shown in figure 6, it essentially consists of a polyethylene sheet that is placed over the base and the sides of adjacent panels before setting the precast panels.

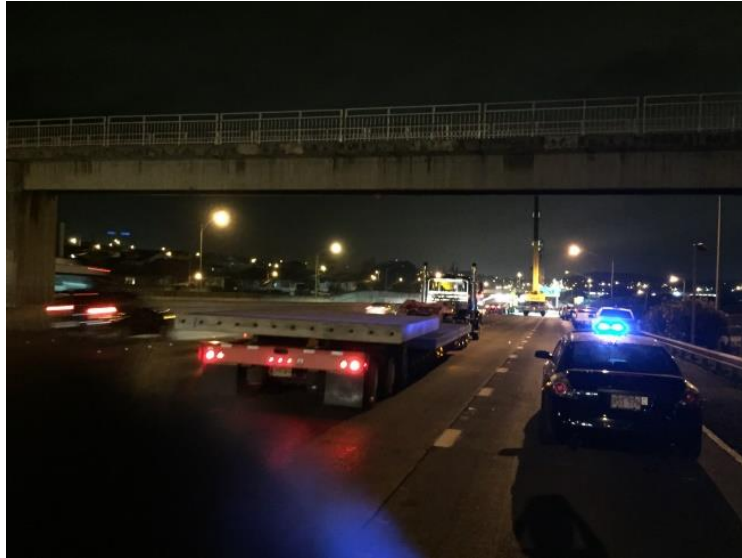
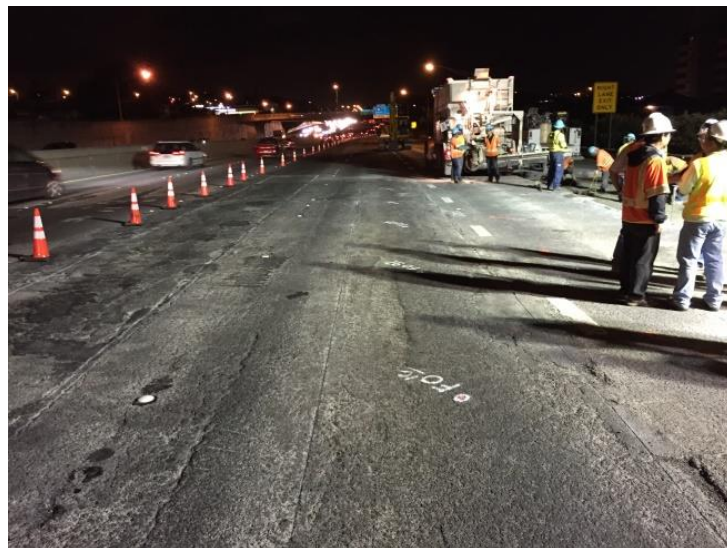
Figure 8. Photos. Typical nighttime lane closures and traffic flow.

For the Hawaii Interstate H1 project, two lanes (including the inside shoulder lane) were made available for traffic during the nighttime work. Installation of precast panels typically requires a minimum of two lane closures—one lane being worked upon and one lane for construction traffic, which includes trucks for removal of the excavated existing pavement, typically the concrete slab pieces and sometimes the existing base material, as well as trucks for delivery of the precast panels. Lane 6 was installed first, followed by lanes 5,4, 3, 2, and 1. Figure 8 shows a typical nighttime lane closure.

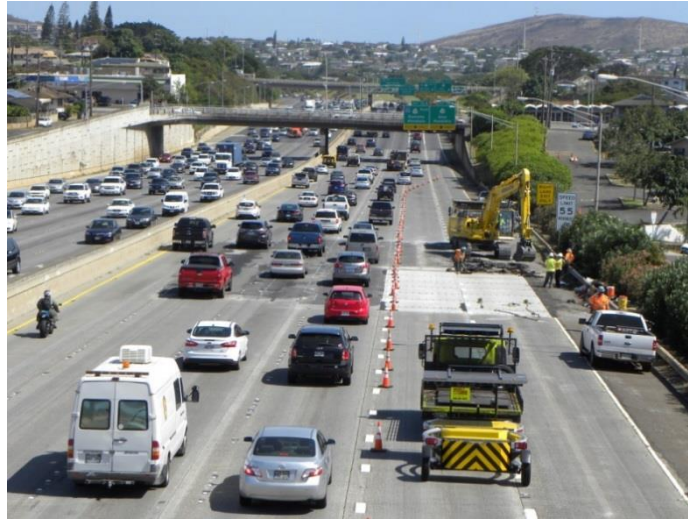
Figure 9. Photo. Daytime closures of lanes 5 and 6.

Figure 9 shows the morning lane closure and typical traffic flow. Generally, there was no traffic backup due to the nighttime lane closures because of the reduced volume of traffic at that time.

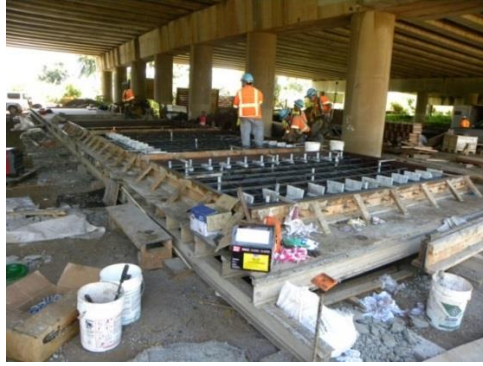
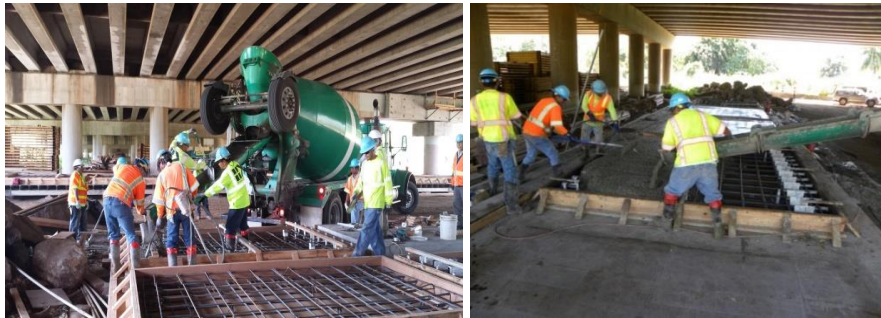
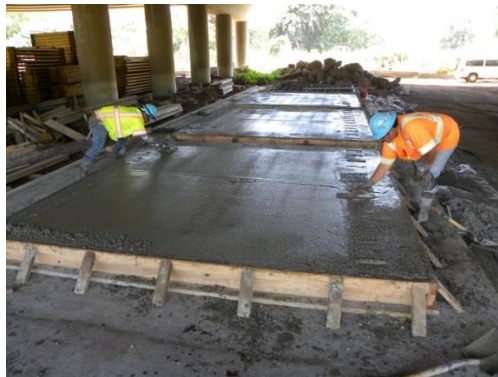
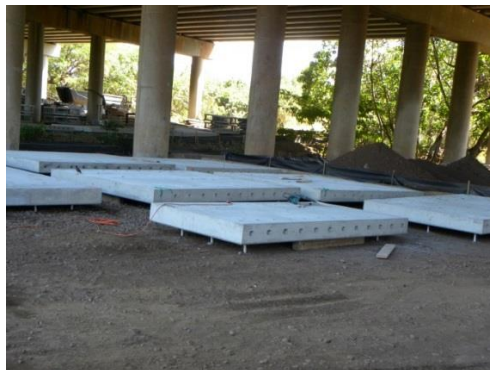
Figure 10. Photos. Panel fabrication.

The contractor prepared shop drawings for the panels showing the panel fabrication details, including the reinforcement, the leveling lift, and the jointing/load transfer details. The contractor elected to fabricate the panels near the project site, under a Hawaii Interstate H1 flyover that was being worked upon by the contractor. Precast panel casting tables were erected under the flyover, and wood/plywood formwork was used for casting the panels, as shown in figure 10. Six panels at a time were fabricated due the limitation on the availability of the dowel slot blockouts. Casting beds were in the shade under the flyover. The 84 panels were cast over a period of 30 days, requiring about 3,000 man-hours.

(a) Panel formwork ready for concrete placement

(b) Concrete placement

(c) Panel finishing

(d) Panel storage under the flyover

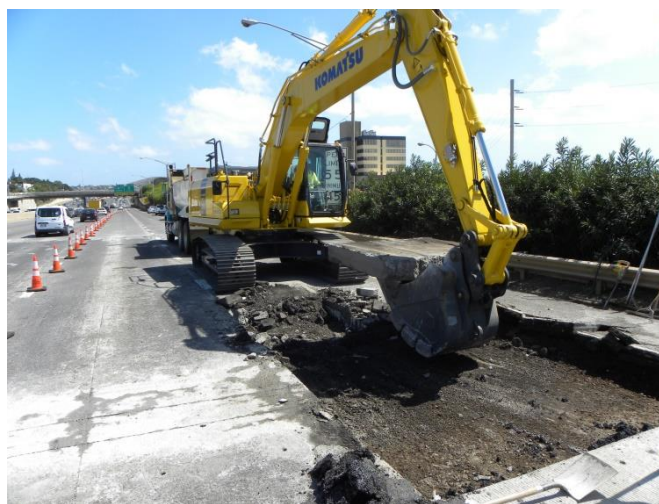
Figure 11. Photo. Existing pavement removal.

- The four left lanes on Hawaii Interstate H1 eastbound at the Aiea Pedestrian Overpass were closed from about 9:00 pm to about 4:00 am.
- The existing concrete pavement, including the AC overlay, was removed (see figure 11). The pavement removal and finishing the base for installation of seven panels, about 84 ft, required about 2.5 hours. The pavement removal was affected by the condition of the existing base. At times, good-quality CTB was encountered, requiring more effort and time to remove an additional 1 inch of the CTB to accommodate the 10-inch-thick precast panel.

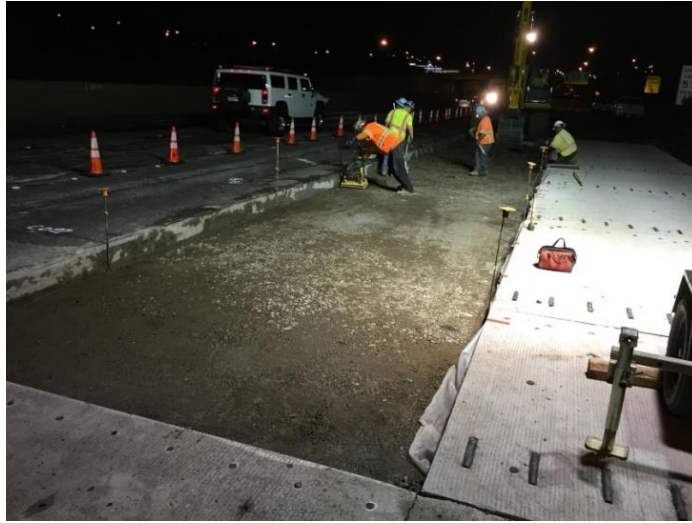
Figure 12. Photo. Existing base grading.

- The existing base was prepared and graded (see figure 12).

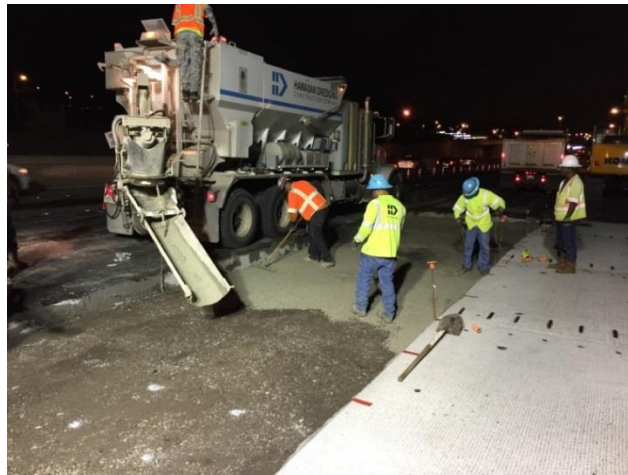
Figure 13. Photo. CTB placement using a mobile mixer.

- A mobile mixer was used to place the rapid setting CTB (see figure 13). The CTB placement required about 1 to 2.5 hours. The placement of the lean concrete mix was affected by the quantity required each night. Volumetric mixers (mobile mixers) were used because of the fast setting cement in the mix. Each of the two mixers used was capable of producing 7 to 8 cubic yards of the CTB. When the nightly quantity exceeded the capacity of both mixers, the turnaround time for a third load was about 90 minutes.

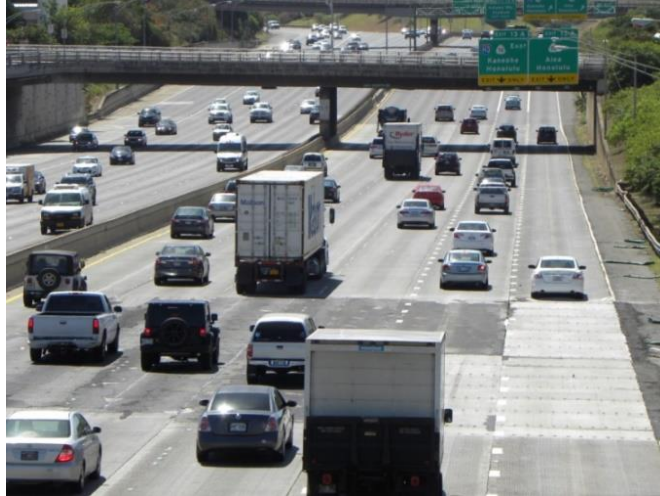
Figure 17. Stage 1 (next morning) opening to traffic.

- Completion of stage 1 operation allowed for traffic to use the repaired lane during peak hour traffic the next morning, as shown in figure 17.
- The stage 2 operation began by engaging the Gracie Leveling system to set panels at the planned elevation.

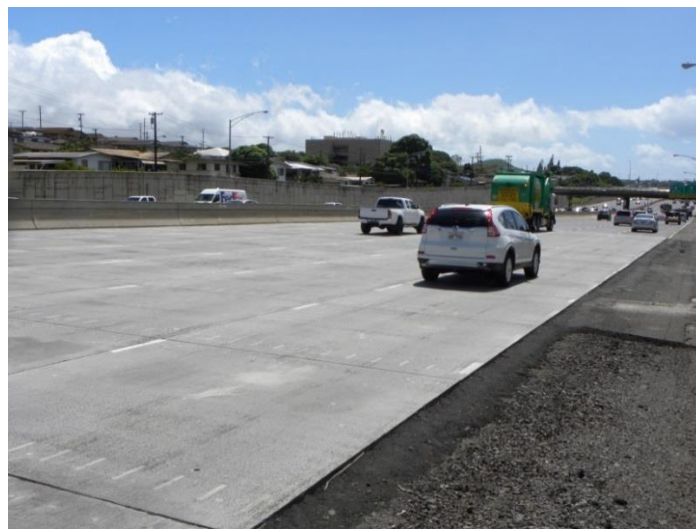
Figure 18. Photo. Completed Hawaii Interstate H1 PCP project.

For this first installation of PCP in Hawaii, panel installation at some locations did not meet the elevation tolerance of 0.25 in. at the transverse joint between adjacent panels. Spot grinding at these spots provided for a smoother ride that was recognized by the majority of the public surveyed. Figure 18 shows a view of the completed project.
