BUILDING VENTILATION STUDIES

FINAL REPORT

Stephen H. Kailing, P.E.

January 1987

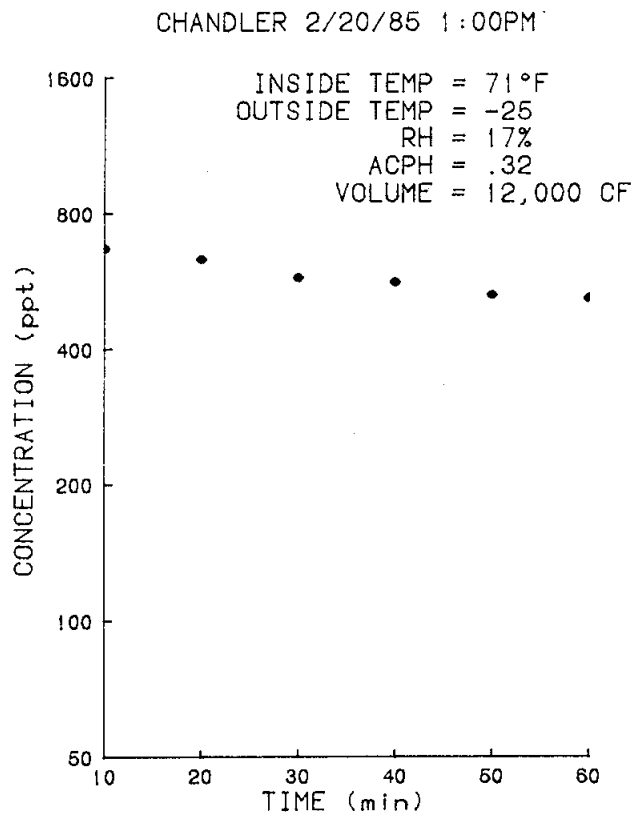
Figure 2 - Typical Plot of Air Exchange Test Data and Results

The SF₆ concentration of each sample, along with the time after release of the SF₆ dose (sampling time) were entered into a computer that had been programmed to solve the dilution equation in 2.1.1 above. An X-Y plotter was employed to show the linearity of the SF₆ concentration vs. time plot, and to print the air exchange rate, temperatures, relative humidity, building volume and any other desired variables. A visual analysis of each SF₆ vs. time plot was made to determine linearity. Sometimes, one or two out-of-line points were thrown out. On rare occasions the entire test was judged to be bad and the results thrown out; the test was then rerun, if possible.

A typical computer generated plot is given in Figure 2. As shown, the plot contains a summary of all the data collected during each test. Appendix A provides all the available data for homes. Additional data on larger buildings is contained in Appendices C & D. Data from the State

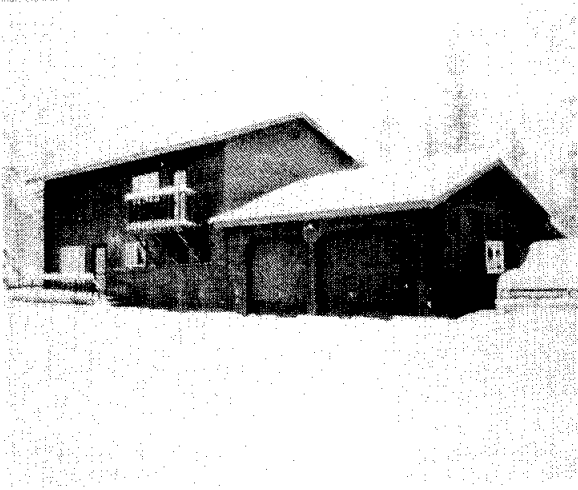
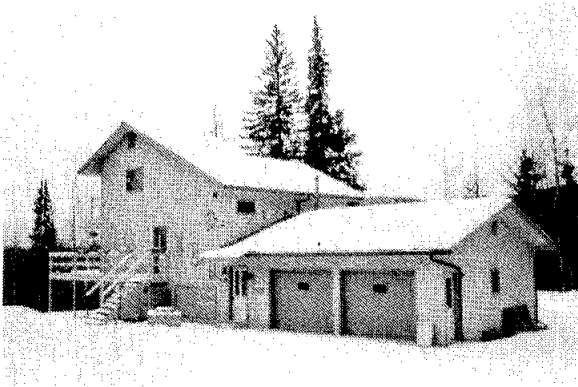
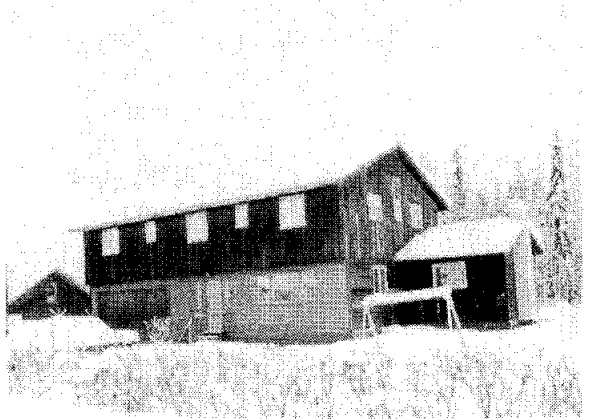
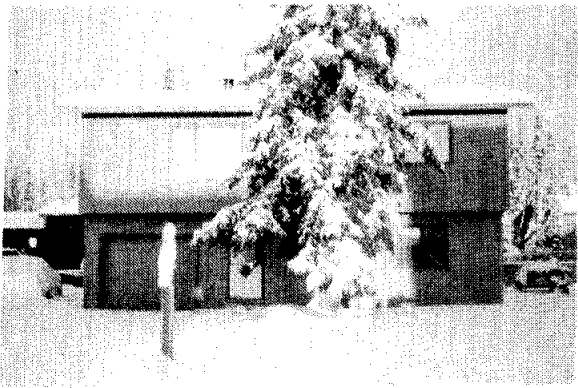
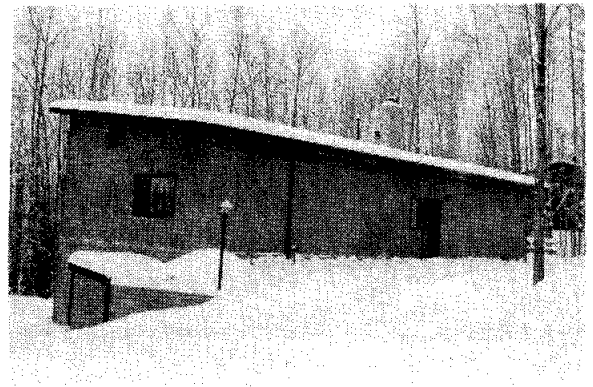
Figure 4 - Additional Homes Tested

Several more homes were selected during these two winters for repeated testing, and additional tests were performed on a few of the homes that had been tested previously. Pictures of the homes that were new to the testing program are presented in Figure 4. Some homes that were tested only once as a result of owner request are also included. Characteristics of all additional homes are presented in Table VIII.

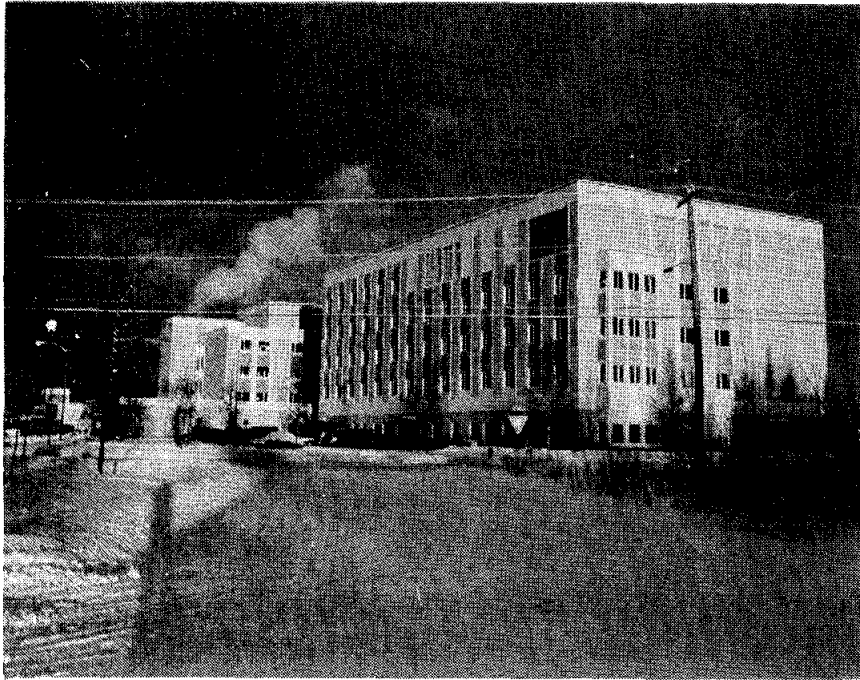
Figure 5 - Fairbanks Memorial Hospital, 1650 Cowles Street

In late 1982, Facilities Research was asked by Tom Kosatsky of the U.S. Department of Health and Social Services to assist with an investigation of five tuberculosis skin test conversions among nurses in the Intensive Care Unit (ICU) at Fairbanks Memorial Hospital. Dr. Kosatsky wished to evaluate the air flow characteristics of a room where a patient with a case of active tuberculosis was placed prior to being correctly diagnosed and moved to a medical ward. The door to the room was only about 15 feet from the patient room.

The study clearly showed the potential for spread of airborne bacteria and demonstrated how the nurses station area became contaminated when the tuberculosis patient was coughing inside the room, particularly during the time that the door was open. It also demonstrated the utility of tracer gas monitoring to show direction and velocity of flow. It established relative concentrations of airborne contaminants in adjacent areas caused by a point discharge of these contaminants in one or more of the areas.

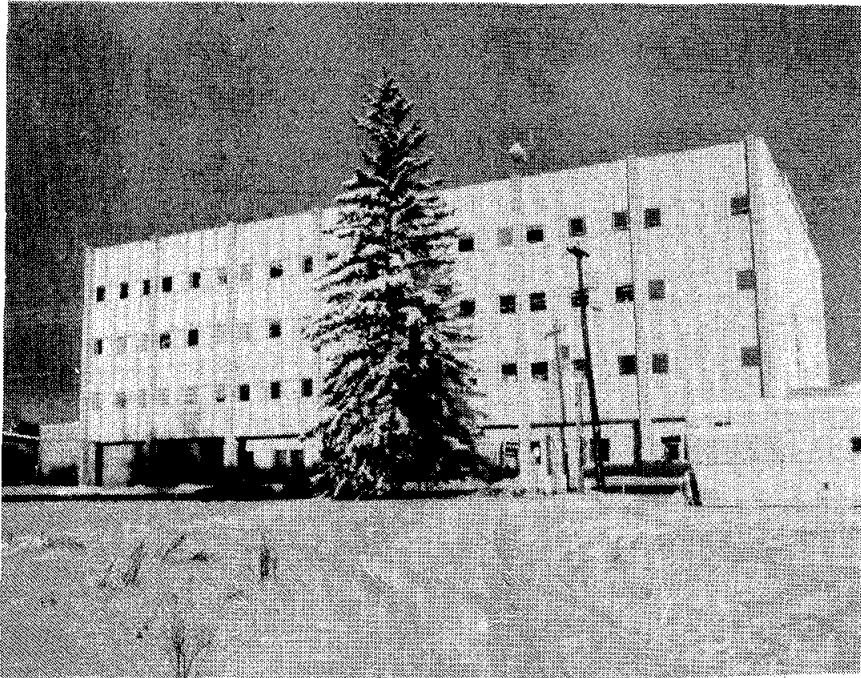
Figure 6 - State Court & Office Building, 604 Barnette St.

This study, which was performed during the 1982-83 Winter, resulted from the interest of Fred Barrett, then DOT&PF Buildings Manager, Northern Region. Mr. Barrett had been one of the recipients of repeated complaints about heat, cold and stuffiness in the State Court and Office Building in Fairbanks.

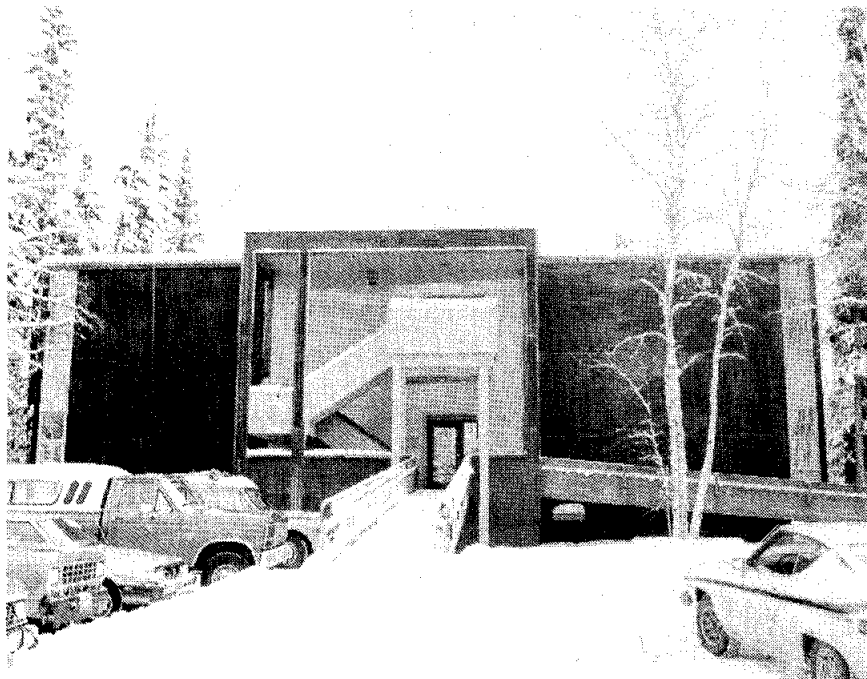
Figure 9 - University Plaza, 600 University Ave., Fairbanks

In early 1985, Facilities Research was asked to measure air exchange rates in the two connected buildings at 600 University Avenue which were occupied by DOT&PF Planning, Facilities Design and Right of Way. DOT&PF was leasing a large portion of each of these buildings to house the groups mentioned. Employee complaints ranged from headaches to eye strain to rapid fatigue, and many felt that the ventilation system was not providing enough fresh air.
