Report No. KS-04-4
FINAL REPORT

LATERAL DISTRIBUTION IN KANSAS DOT STEEL GIRDER BRIDGE WITH FRP DECK

John Schreiner
Michael Barker, Ph.D., P.E.,
University of Missouri – Columbia

AUGUST 2005

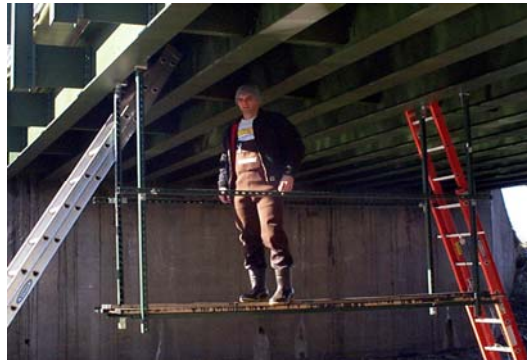
FIGURE 1: Scaffolding Used in January Test

of both a ladder and a hanging assembly (Figure 1), which was attached to the girder flanges.

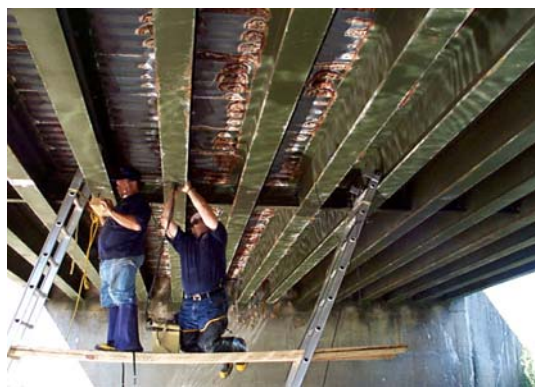
FIGURE 2: Spot Welding of Strain Gage onto Flange

- Gage Layout – Strain gages were positioned precisely at mid-span and along the longitudinal centerline of each girder. Measurements were made and marks were placed on each girder to allow for precise positioning.
- Gage Placement – Each weldable strain gage was attached to the flange face through the use of a weldable gage spot welder. Gages were welded with a pattern of ninety-six spot welds around their perimeter. The application of a strain gage is being performed in Figure 2 and a picture of the welded gage is shown in Figure 3.

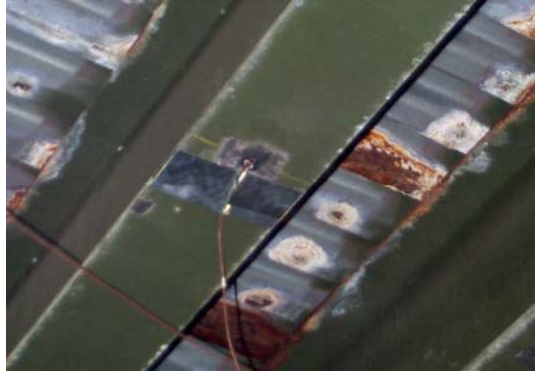
FIGURE 3: Welded Strain Gage

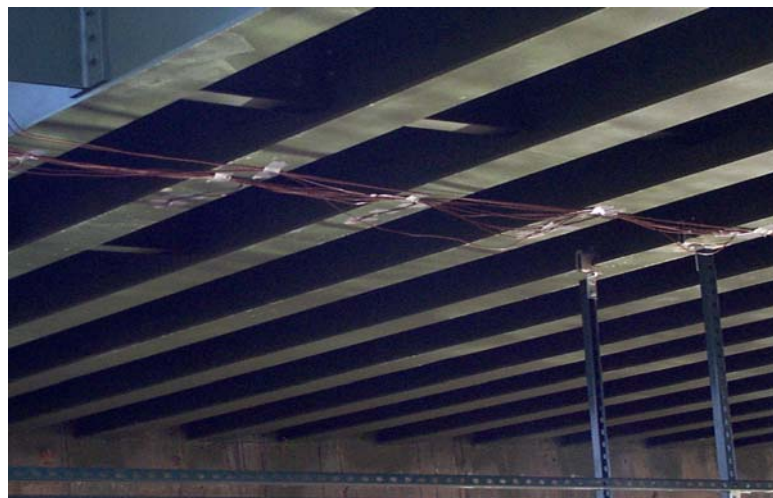
FIGURE 4: Instrumentation Lines Attached to Gages

- Instrumentation Wires – Once the strain gages had been installed, wires were attached to each gage, taped to remove slack, and connected into a collector box. The instrumentation wires attached to the strain gage can be seen in Figure 4. These wires were all connected to the data acquisition system onboard the University of Missouri’s Civil Engineering Bridge Field Test Vehicle (Figure 5).

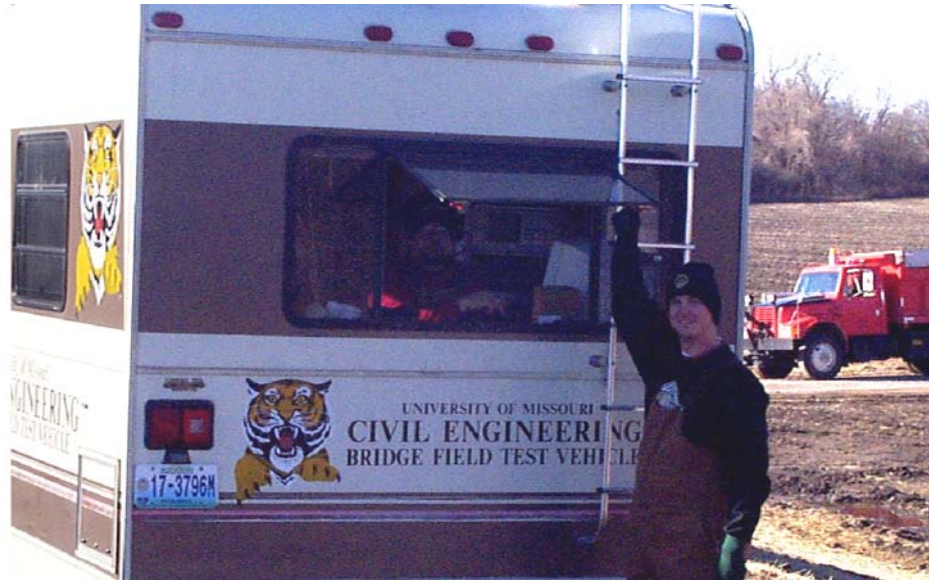
FIGURE 5: University of Missouri's Civil Engineering Bridge Field Test Vehicle

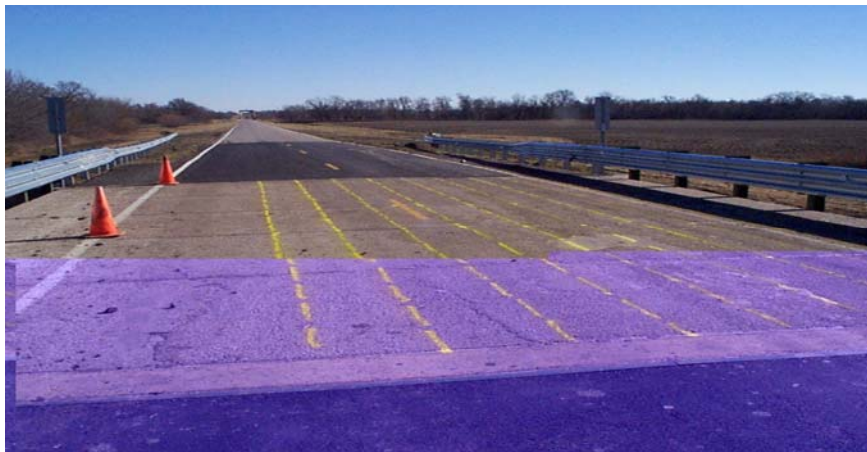
FIGURE 6: Load Pattern Layout on Bridge Deck

- Load Pattern Layout – A series of lines were painted on the surface of the bridge deck spaced at two-foot intervals (Figure 6). The first of these lines was positioned so the right front tire of the loaded truck would travel directly across the centerline of the first interior girder. Adjacent lines were then spaced laterally across the

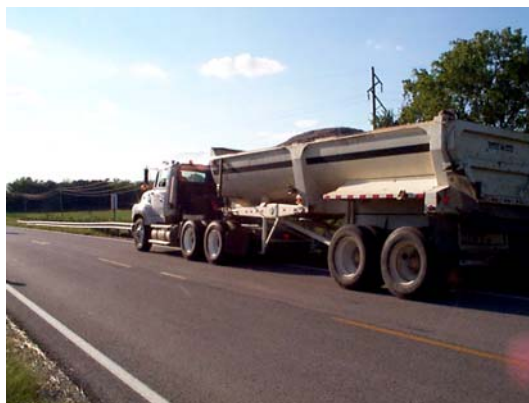
FIGURE 8: Test Load for Original Deck Approximately 78,400 lbs

- Test Vehicles – Kansas DOT supplied a loaded truck for each deck test. Upon arrival, trucks were weighed with portable digital scales. Figure 8 shows the truck used in the first original deck test. Figure 9 shows the truck used in the second FRP deck test being weighed.

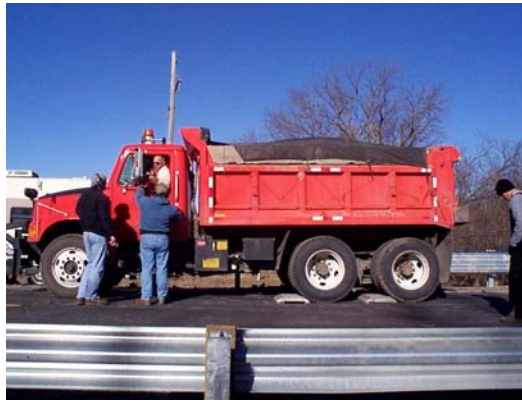
FIGURE 9: Test Load for FRP Deck Approximately 47,800 lbs

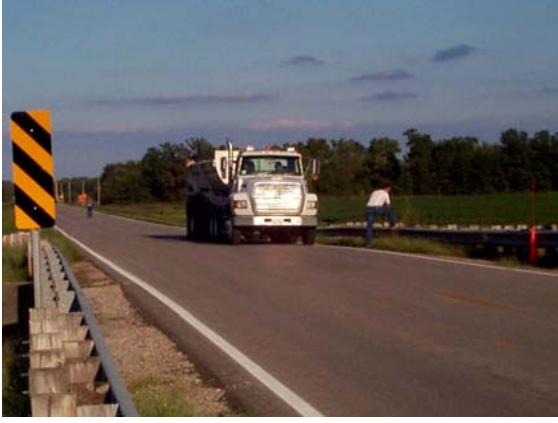
**FIGURE 10: Test in Progress
on Original Deck**

Two types of tests were performed on the bridge systems: static and dynamic. The static tests consisted of driving the loaded vehicle across the bridge at crawl speed, following the longitudinally painted lines with the left front tire. Crawl speed was as slow as the truck could travel without applying the brakes. Ten passes were made and ten sets of data were recorded for each deck configuration. The dynamic load tests consisted of driving the loaded vehicle across the bridge at crawl speed, 25 mph, and 50 mph. The driver was to position the vehicle in the center of the driving lane as the truck passed across the bridge (maximizing stresses in Girders 9, 10, & 11 ~ Pass 4 in Figure 7). Illustrations of the loading tests in progress are shown in Figures 10 and 11. Tests on the original deck were performed on September 11, 1999, and tests on the FRP deck on January 4, 2000.

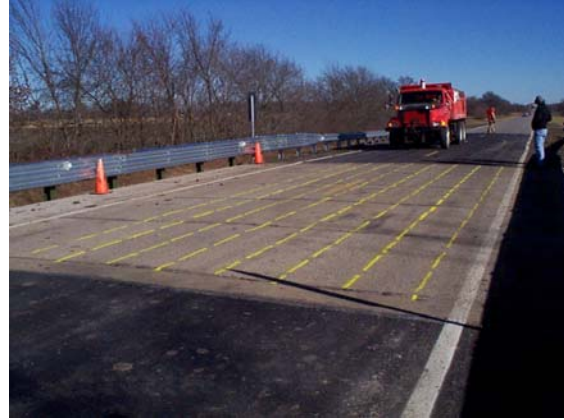
**FIGURE 11: Test in Progress
on FRP Deck**

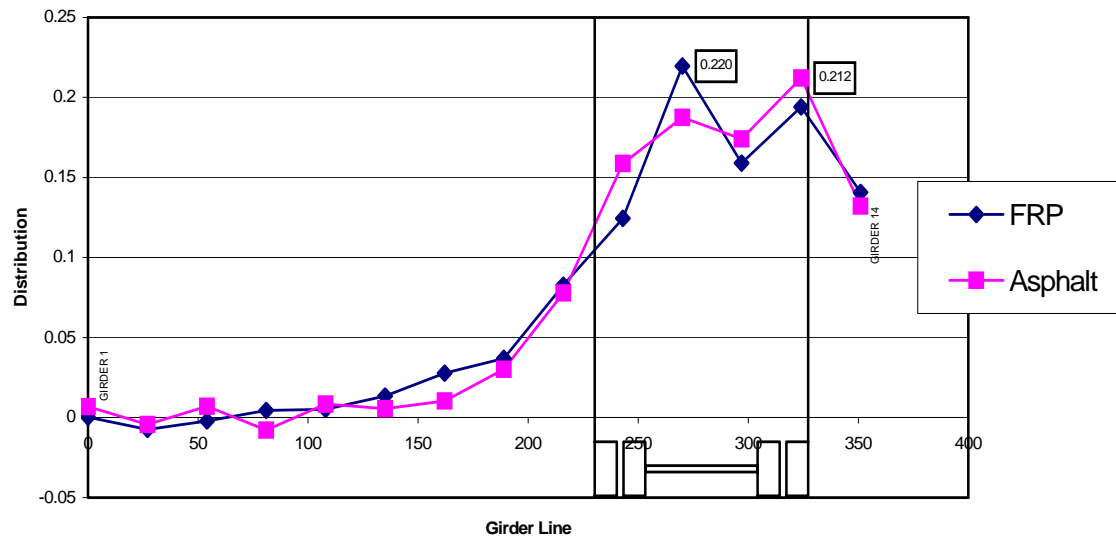
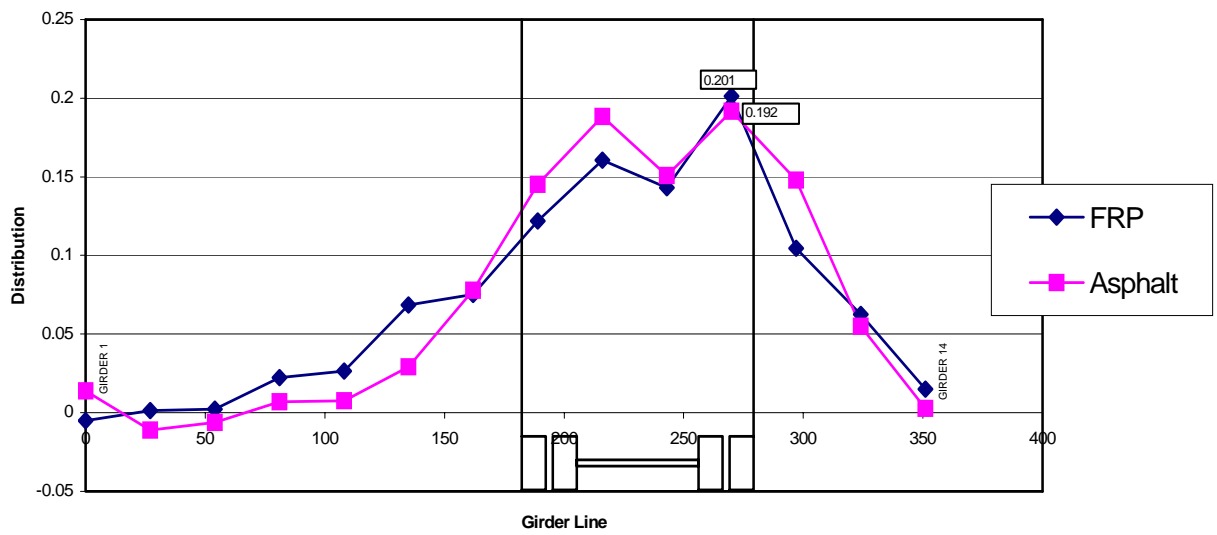
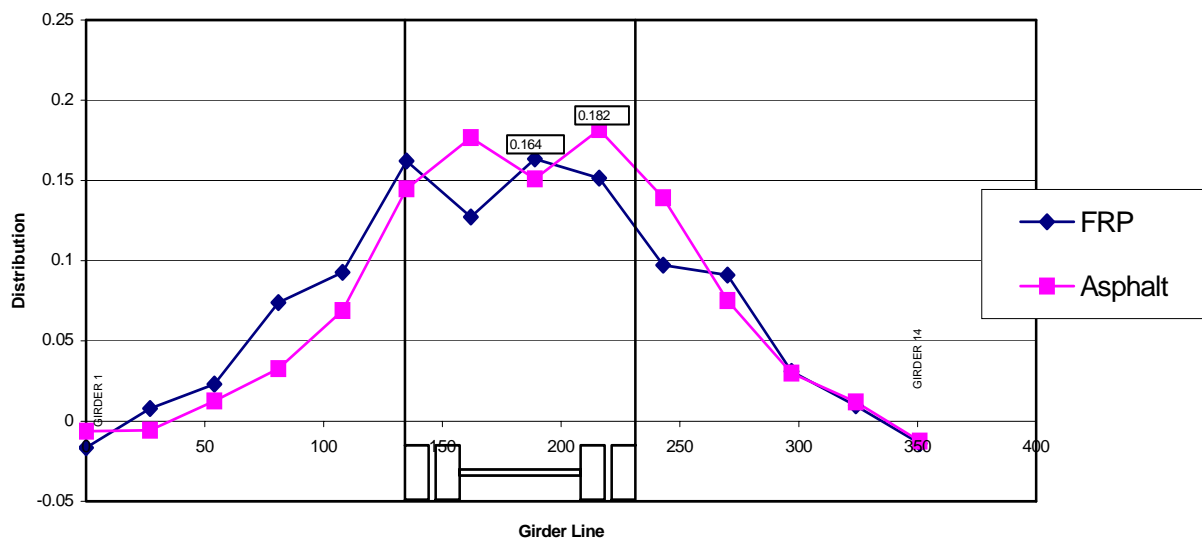
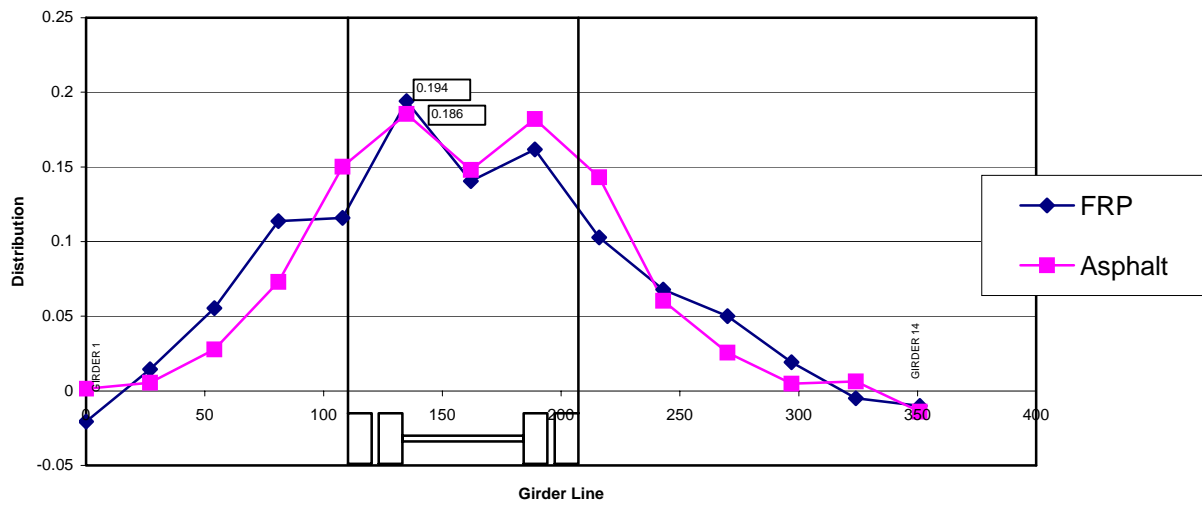
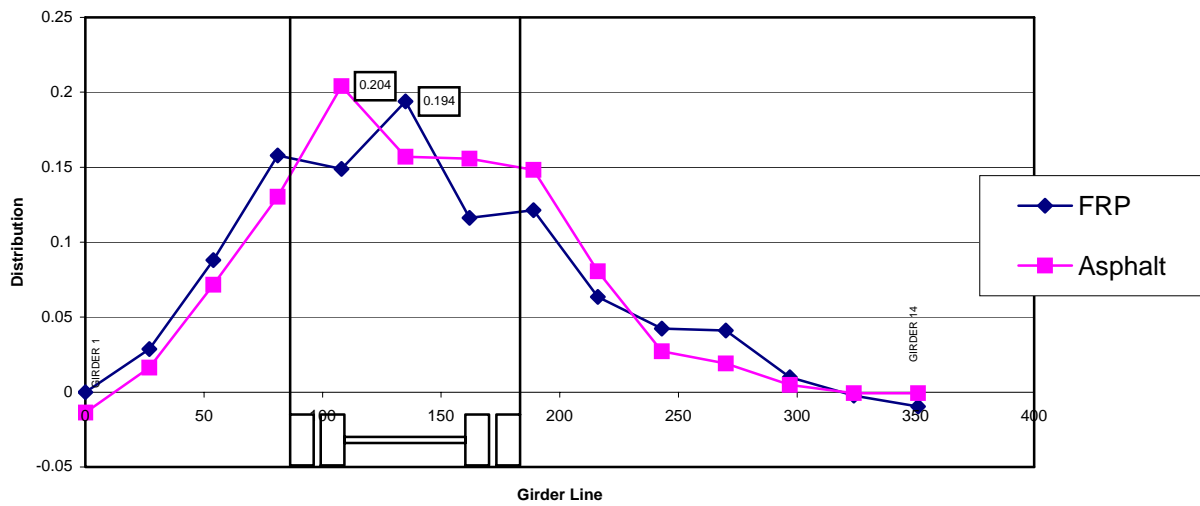
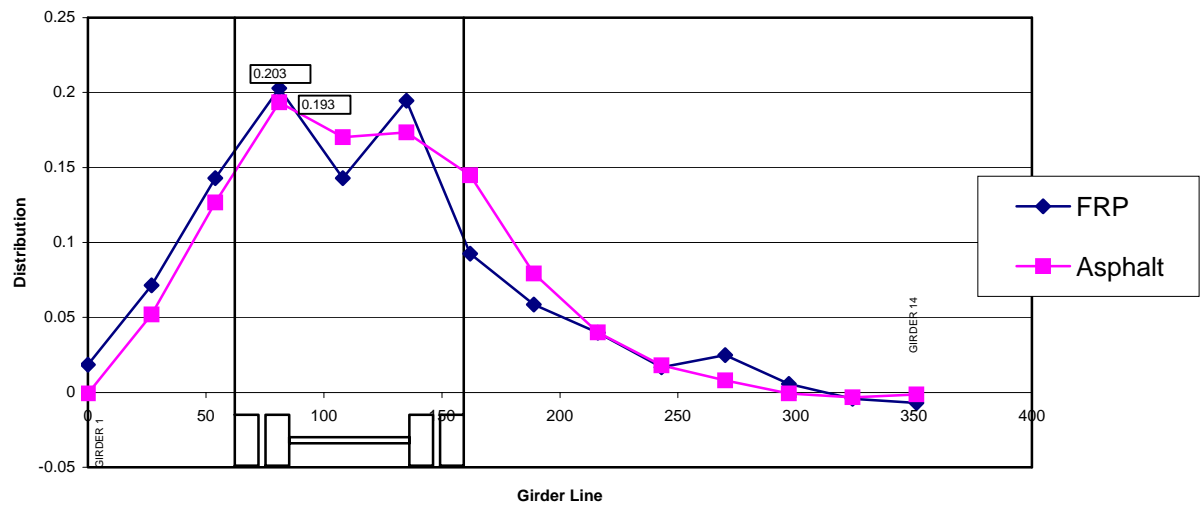
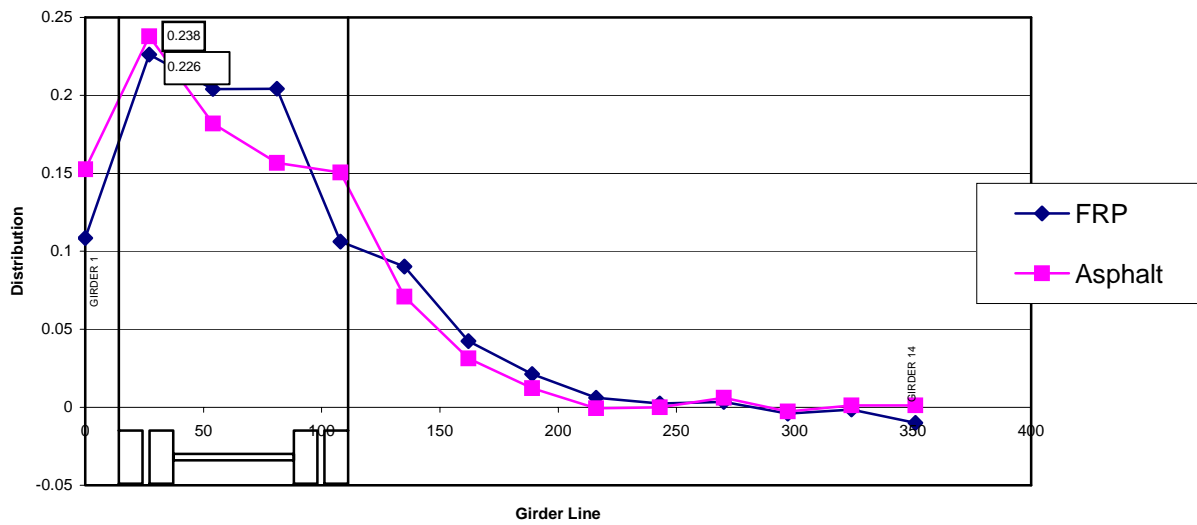
FIGURE 12: Lateral Distribution Load Position 1

FIGURE 13: Lateral Distribution Load Position 2

FIGURE 14: Lateral Distribution Load Position 3

FIGURE 15: Lateral Distribution Load Position 4

FIGURE 16: Lateral Distribution Load Position 5

FIGURE 17: Lateral Distribution Load Position 6

FIGURE 18: Lateral Distribution Load Position 7

FIGURE 19: Lateral Distribution Load Position 8

FIGURE 20: Lateral Distribution Load Position 9

FIGURE 21: Lateral Distribution Load Position 10

From the static load tests, ten graphs (Figures 12-21) have been created that illustrate the lateral stress distribution at maximum loading across the girders for each truck pass. Both data from the original deck and the FRP deck are shown for comparison. Each graph illustrates the transverse location of the rear axle line. The tests were run so the right front tire of the truck was positioned directly over Girder 13 on the first pass. Figure 7 displays the lateral position of all ten truck passes on the deck.

Stress values for each time increment were then added to find when the bridge was experiencing maximum global stress. Figure 22 shows, with a vertical line, where this occurred. This maximum global stress position was used to develop the lateral stress distribution plots. The lateral distribution (DF) values plotted are equal to the actual stress on a particular girder divided by the sum of the stresses on all the girders.

Bridge testing on concrete and FRP decking materials was performed. Fourteen steel girders were instrumented with strain gages and data from static and dynamic load testing were recorded. Lateral distribution of stress was computed and the results are plotted in Figures 12-21 and Figures 23-28. A summary of maximum values has been provided in Table 1. Testing also indicated very little change in the load distribution between the original deck system and the FRP deck system. The simple dynamic tests are not to be used for decisions or conclusions for dynamic allowance.

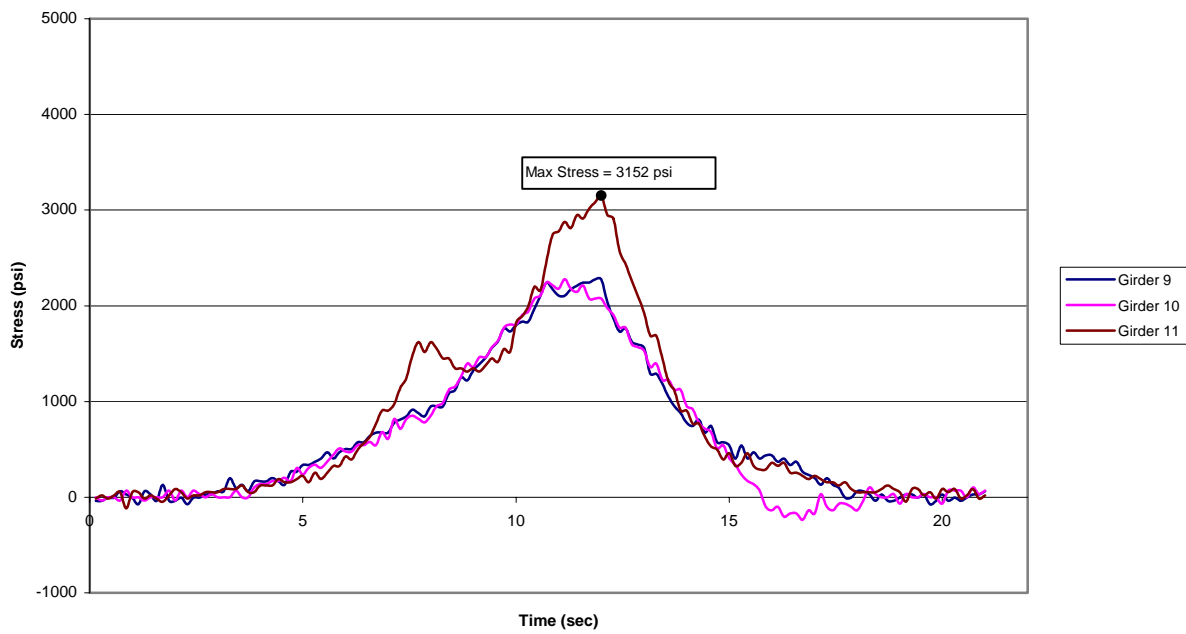
FIGURE 23: Stress for Original Deck, Crawl Speed

FIGURE 24: Stress for Original Deck, 25 mph

FIGURE 25: Stress for Original Deck, 50 mph

FIGURE 26: Stress for FRP Deck, Crawl Speed

FIGURE 27: Stress for FRP Deck, 25 mph

FIGURE 28: Stress for FRP Deck, 50 mph

From the dynamic load tests, six graphs (Figures 23-28) have been provided that show the actual stress experienced by girders 9, 10, and 11. Figure titles denote deck material and speed for the plotted data. Stresses were calculated in the same manner as those for the static tests.
