Investigation of Steel-Stringer Bridges: Superstructures and Substructures, Volume I

Final Report
October 2007

Sponsored by
the Iowa Highway Research Board (Project TR-522)
and the Iowa Department of Transportation (CTRE Project 04-184).

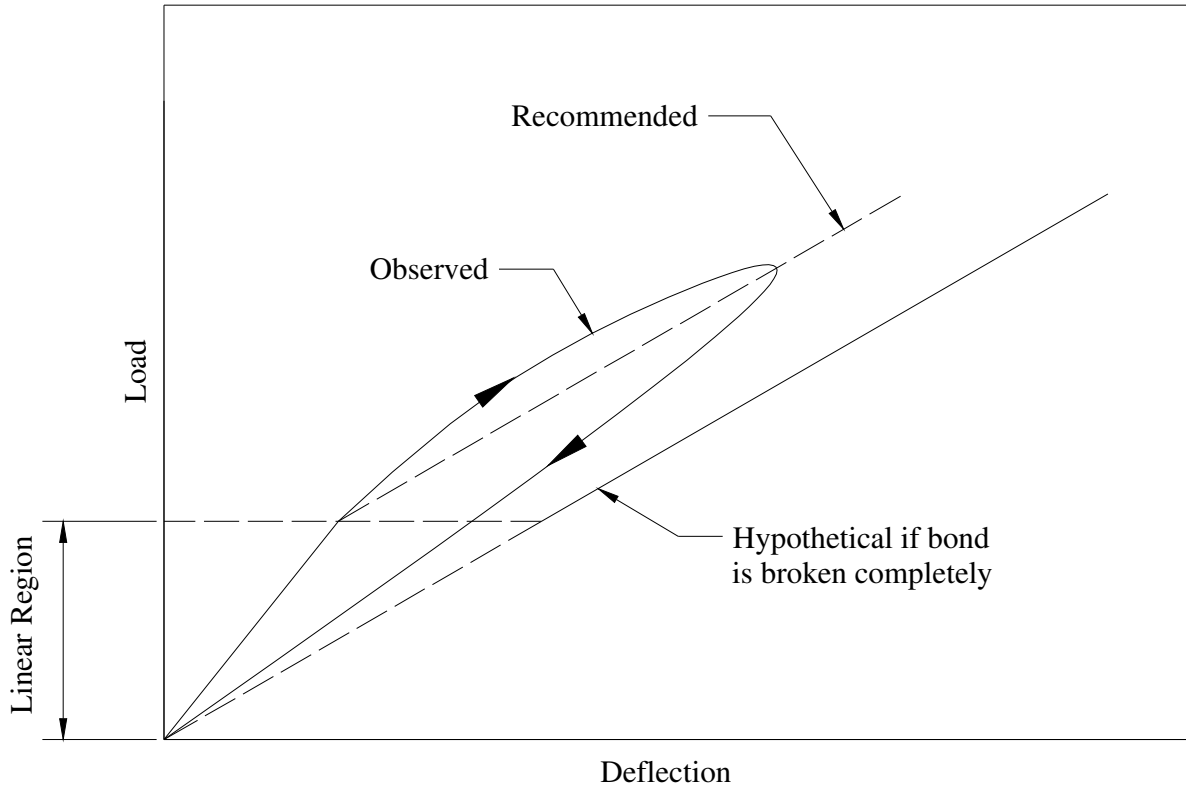
Figure 2.2. Load-Deflection Curve for a Girder With Composite Action.

In order to estimate the degree of composite action that can be relied upon beyond the loads applied during a diagnostic load test, the load-deflection curve for an actual load test must be analyzed. During the initial stages of loading, the load-deflection curve is linear and follows that of the predicted fully composite section. The linear region labeled in Figure 2.2 shows two lines; the line with the larger slope corresponds to a load-deflection curve for a composite girder. The observed load deflection line follows that of a composite section then, once the bond between the concrete and steel becomes compromised, the behavior is nonlinear. It is important to note though, that once the bond has been compromised a sudden increase in deflection is not observed, but rather there is a gradual decrease in the slope of the load-deflection curve. In other words, the bond strength is not completely compromised but gradually “deteriorates” with increased loading. Also, it is important to note that the “deterioration” of the bond strength under high load levels is not permanent. Lichtenstein proposed a load-deflection curve for an analytical model, as shown in Figure 2.2, having a linear relationship following the curve of a composite girder. This linear relationship terminates when the bond strength is compromised. At that point, the load-deflection curve is linear with the same slope as that of a non-composite section. Determining the load at which the bond strength becomes compromised is found through load testing.

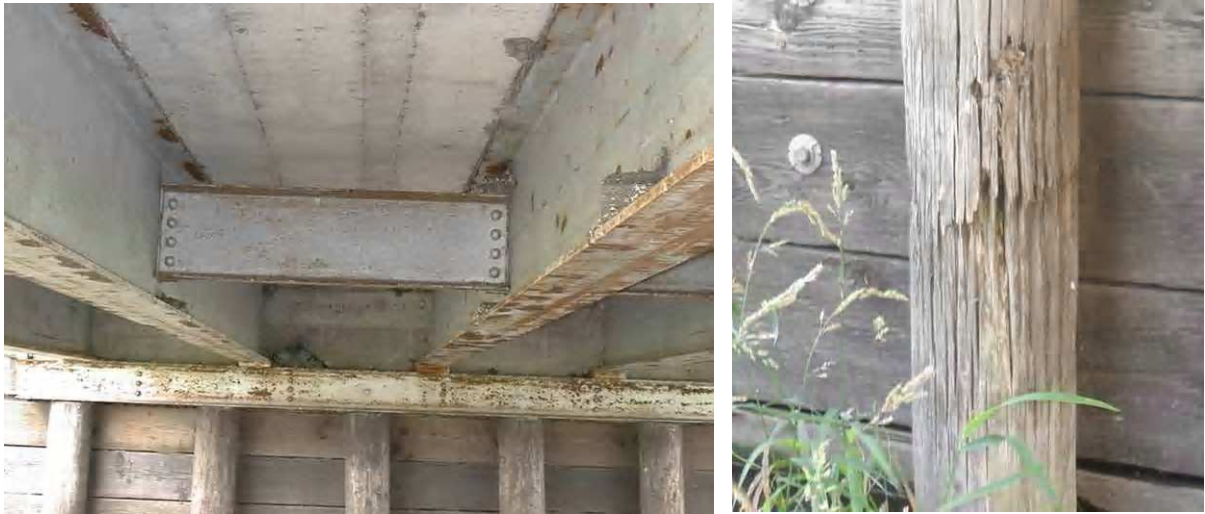
Figure 3.4. BCB Deterioration.

The superstructure appears to be in good condition with some minor rust in areas as shown in Figure 3.4(a). Typical decay that was found in some of the piles is shown in Figure 3.4(b). There were minor repairs made to the bridge in 1993 when the south bridge approach was washed away; the repairs consisted of the installation of a sheet pile wall behind the existing timber back wall and then filling the void with concrete. Shown in Figure 3.5(a) is the sheet pile wall while the concrete behind the top of the timber backwall is shown in Figure 3.5(b).

(a) Minor rust on girders

(b) Rotten pile

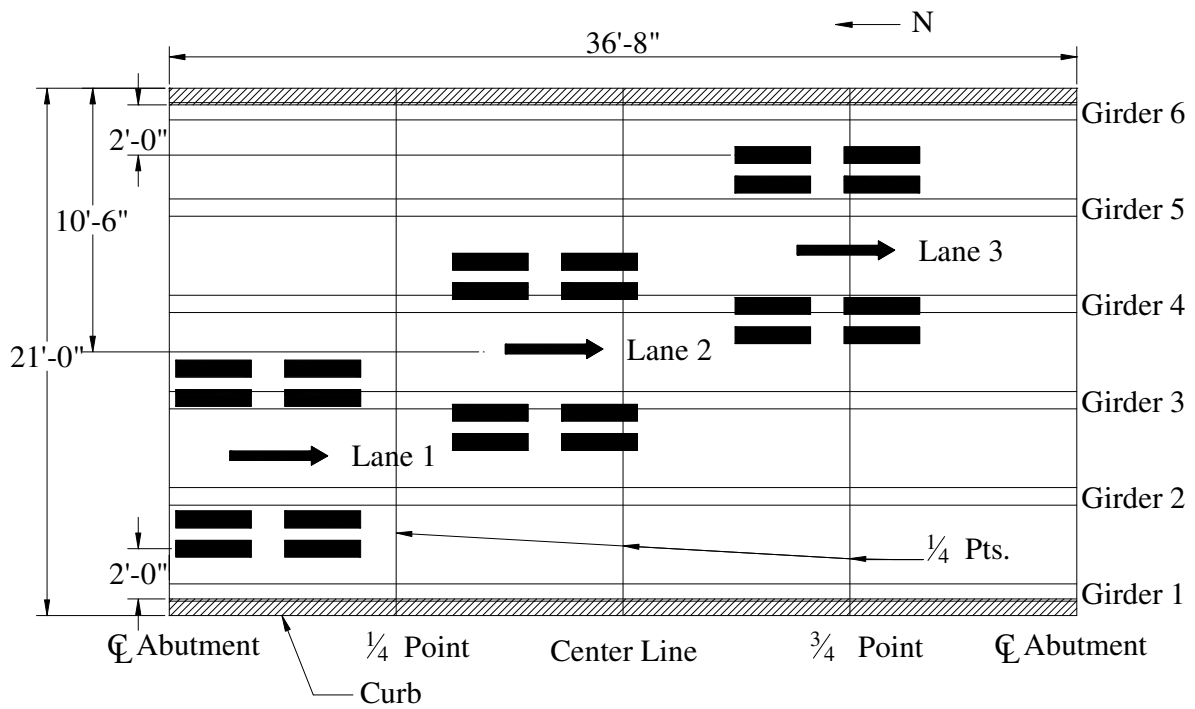
Figure 3.9. Plan View of Loading Lanes Used in BCB Test.

There were three paths or lanes, shown in Figure 3.9, selected for the truck to follow as it crossed the bridge. Each lane was tested twice for each load increment to check repeatability of the test results. Measurements (strains and deflections) were taken when the centroid of the tandem was at the centerline of each abutment and at each quarter point (see Figure 3.9). The location of the centerline of the abutments and each quarter point were painted on the bridge as shown in Figure 3.10; the location of the tandem axle centroid in relation to one of the transverse lines painted on the bridge is shown in Figure 3.11.

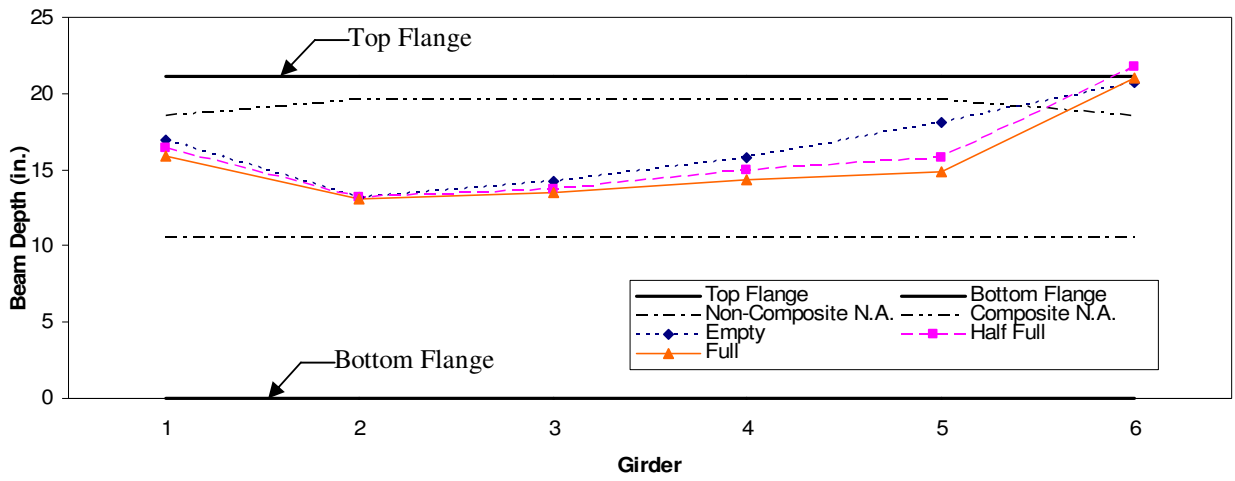
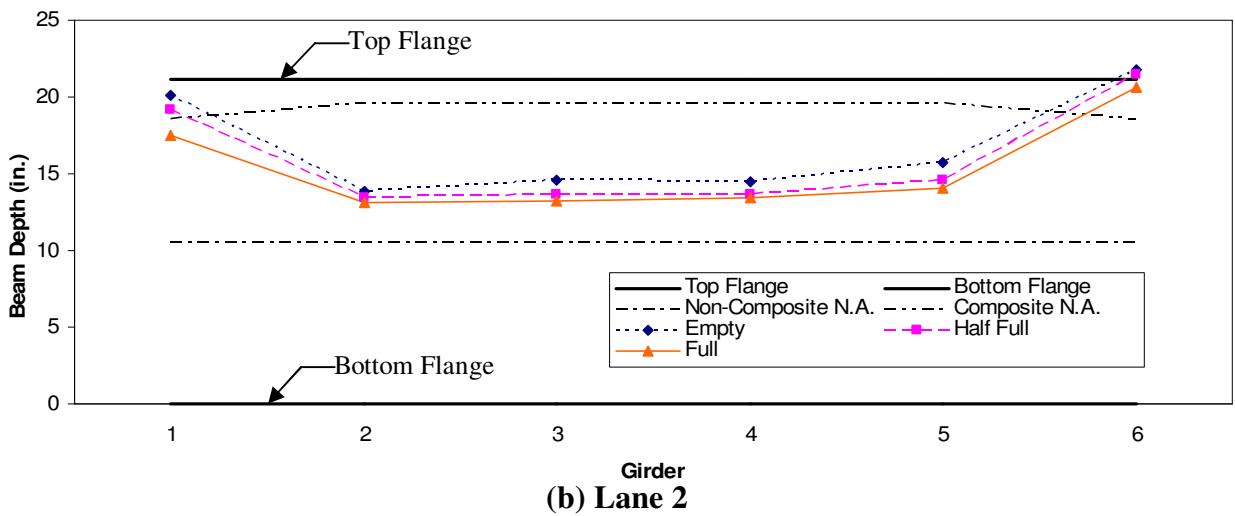
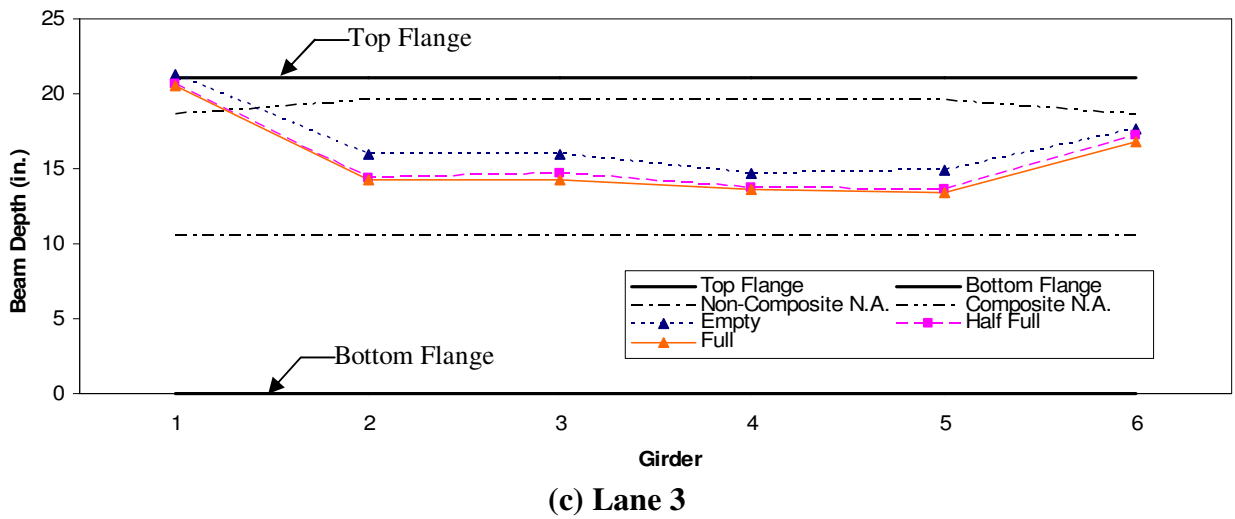
Figure 3.19. BCB Neutral Axis Locations.

A neutral axis location above the top flange, as observed in Figure 3.19(a) and (b) for Girder 6, indicates the neutral axis for the girder was located in the concrete deck. The two exterior girders exhibited considerably higher stiffnesses than the interior girders as determined by a much higher neutral axis location which is indicative of a composite section. When directly loaded, the neutral axis of the exterior girders was close to that of a fully composite girder, but when the load was on the opposite side of the bridge, the neutral axis location was above the theoretical composite neutral axis location. This can be attributed to the very small top flange strain values (1 and 0 microstrain in Lane 1 and Lane 3, respectively as displayed in Table 3.3) observed in the girders that were on the opposite side of the bridge as the loading. The increased stiffness can be attributed to the concrete curb and the steel railing which were not included in the calculation of the composite neutral axis location. Neutral axis profiles for Lane 1 and Lane 3 were close to the mirror images of each other which demonstrate bridge symmetry.

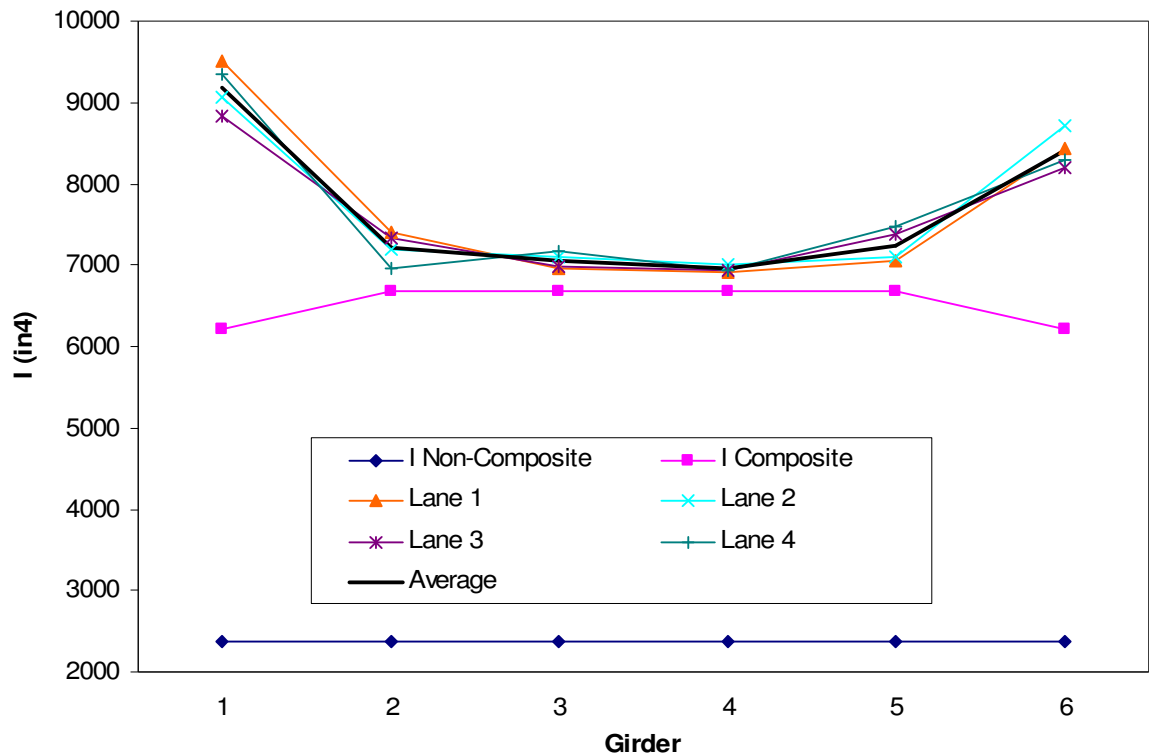
Figure 4.18. MCB Effective Moments of Inertia.

The bridge was once again modeled using software (WinGEN) provided by Bridge Diagnostics Inc. that utilizes the actual test data to create a model that is close to the actual bridge based on the response of the structure to the truck loadings. This bridge model consisted of modeling each girder separately so that the moment of inertia for each girder could be optimized. Even though the interior girders had moments of inertia close to the same as previously noted, it was important to model each girder separately to verify the similarity

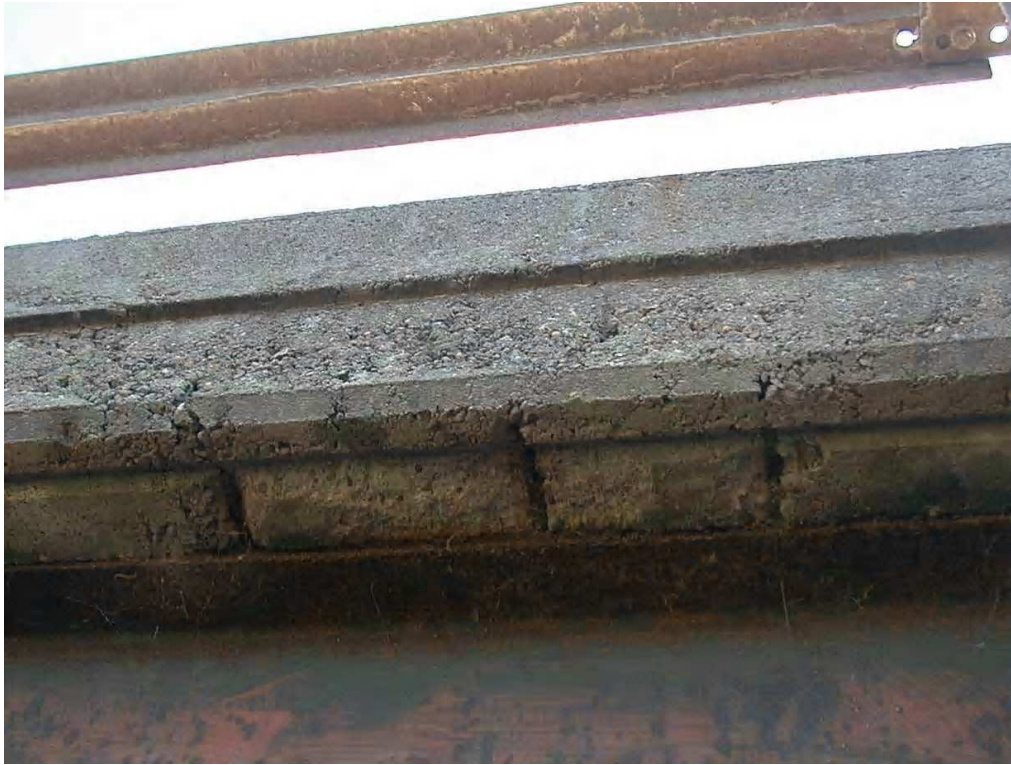
Figure 5.2. KCB1 Poor Concrete Consolidation.

The superstructure was in relatively good condition with only minor rust on the girders. Signs of poor concrete consolidation during the construction of the deck were observed on the underside of the deck where there were large voids near the midspan. The poor consolidation caused some of the reinforcing steel to be exposed as shown in Figure 5.2. There was also a large crack in the concrete deck located at the midspan of the bridge, a photograph of which is provided in Figure 5.3.

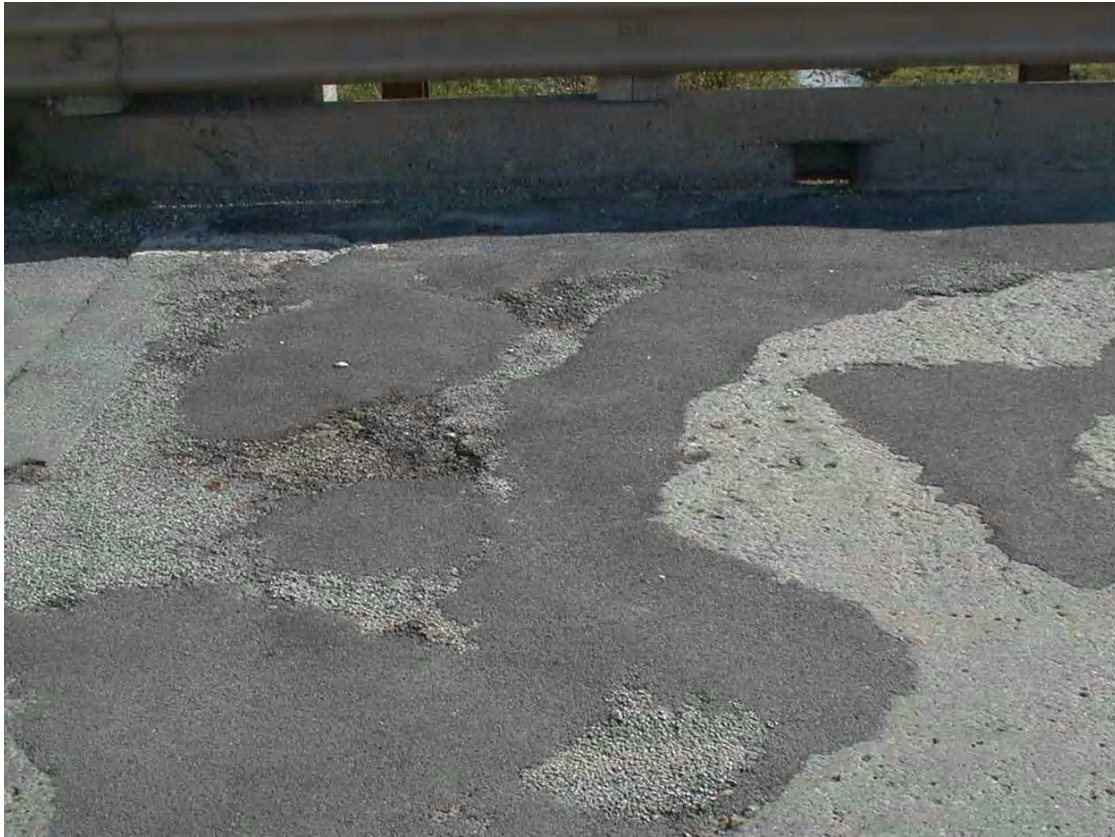
Figure 6.2. Asphalt Patches in CCB Concrete Deck.

The superstructure was in relatively good condition with only minor rust on the girders. The concrete deck however was in poor condition; there were areas of severe spalling on the wearing surface of the deck that had been patched with asphalt to create a smoother ride over the bridge. A photograph of the asphalt patches is shown in Figure 6.2.

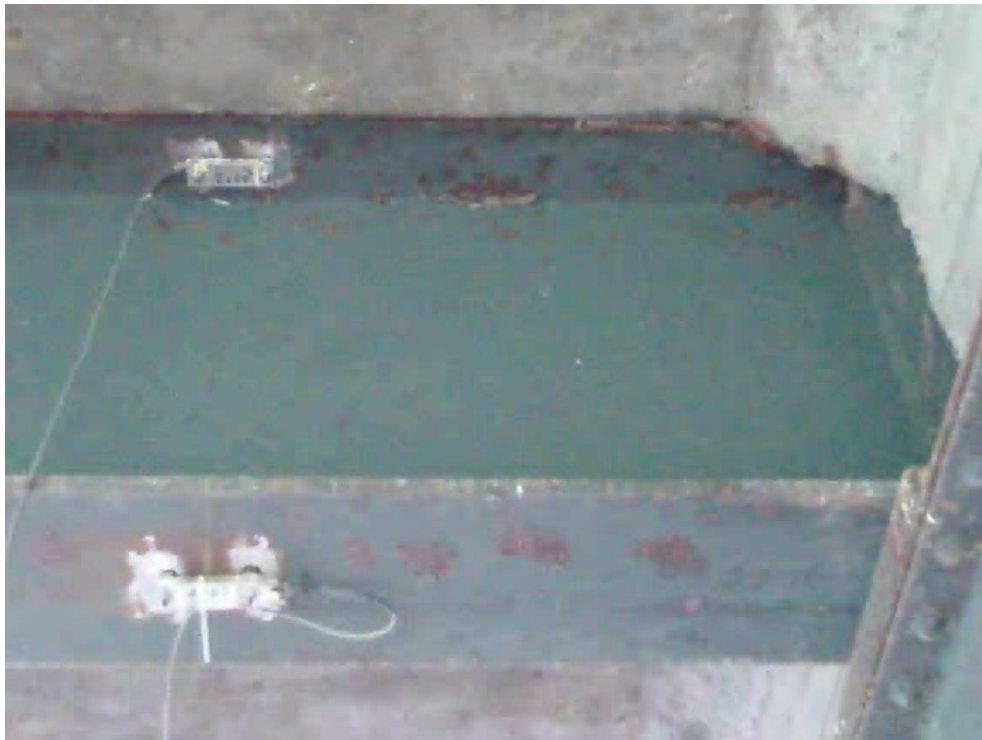
Figure 6.6. CCB Bearing Transducer Locations.

The bridge was instrumented 24 inches from the edge of the bearing at each abutment, at the north quarter point, and at the midspan. Figure 6.6 is a photograph showing the location of the strain transducers 24 inches from the edge of the bearing. In this test, the strain transducers near the abutment were moved from six inches away from the edge of the abutment cap to 24 inches from the abutment cap in an attempt to reduce the chance of

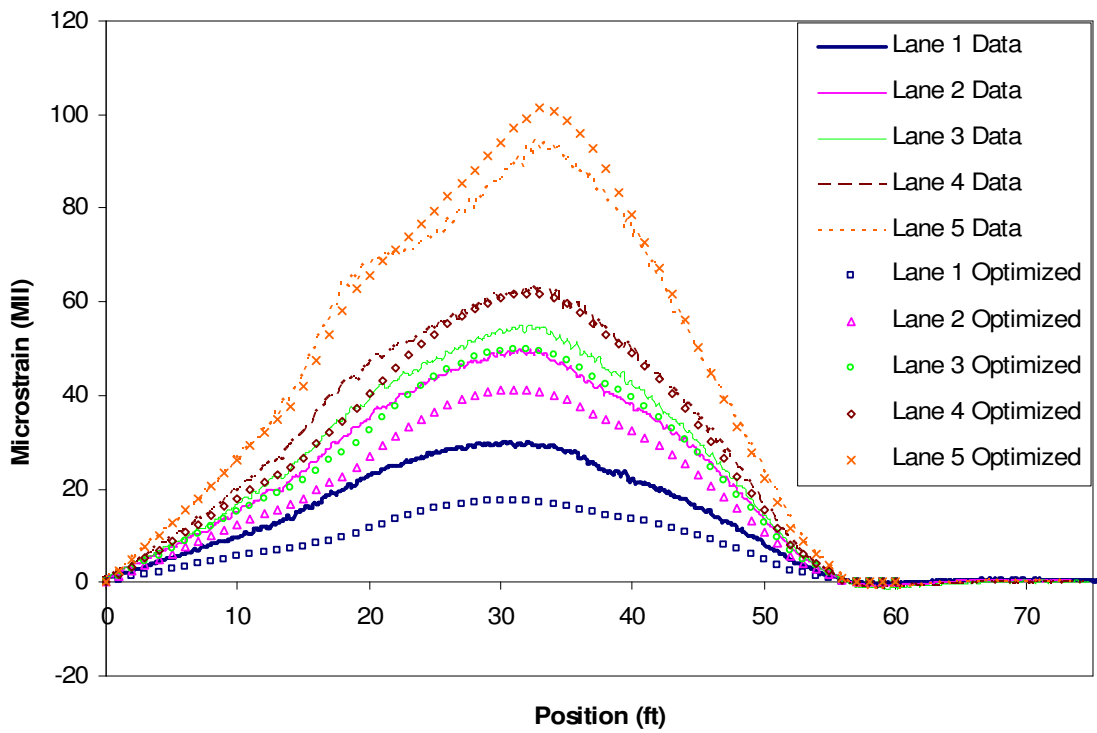
Girder	1	2	3	4	5	Average
Scale Error	2.8	0.4	7.4	4.2	0.3	3.0
Correlation	0.917	0.923	0.925	0.919	0.935	0.924
