U.S. Department of
Transportation

**Federal Railroad
Administration**

Rail Tank Car Total Containment Fire Testing

1. AGENCY USE ONLY (Leave blank)		2. REPORT DATE October 2018	3. REPORT TYPE AND DATES COVERED Technical Report – October 2015	
4. TITLE AND SUBTITLE Rail Tank Car Total Containment Fire Testing			5. FUNDING NUMBERS DTFR53-12-D-00004

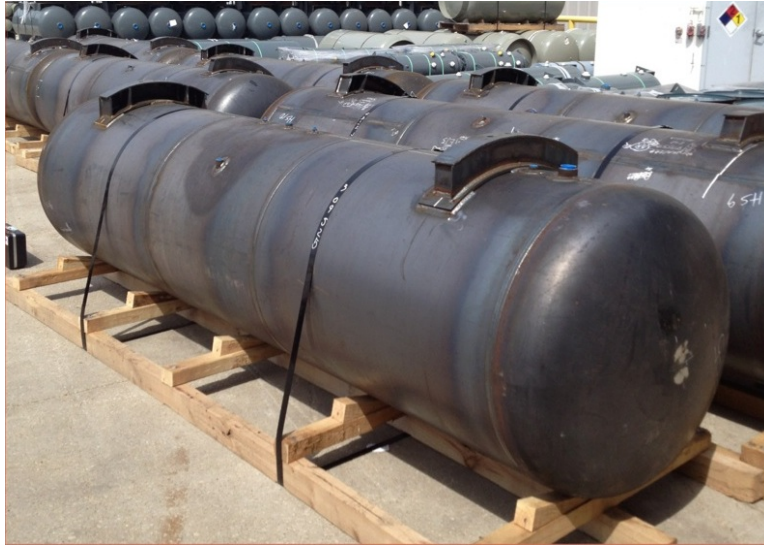
**Figure 1. Specimen Test Tanks
(shown upside-down)**

Several ports were added to the tank to allow loading and unloading (two top, two bottom), as well as to serve as feed-throughs for instrumentation (for thermocouples and pressure transducers), with the appropriate reinforcement. [Figure 1](#) contains a photograph of one of the specimen test tanks.

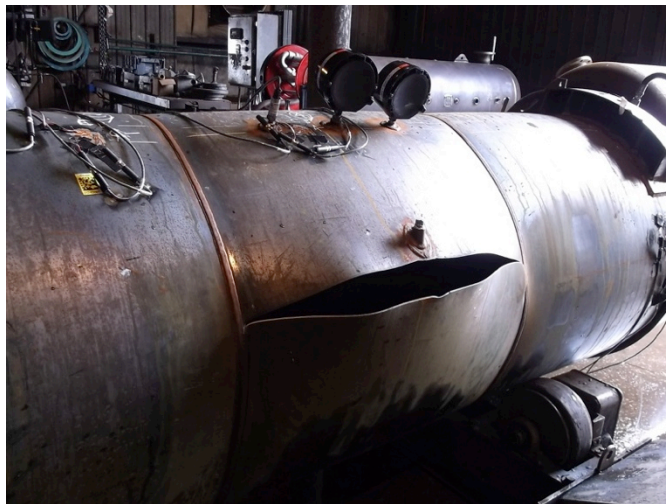
Figure 4. Burst Hydrostatic Tested Tank – Tensile Tear

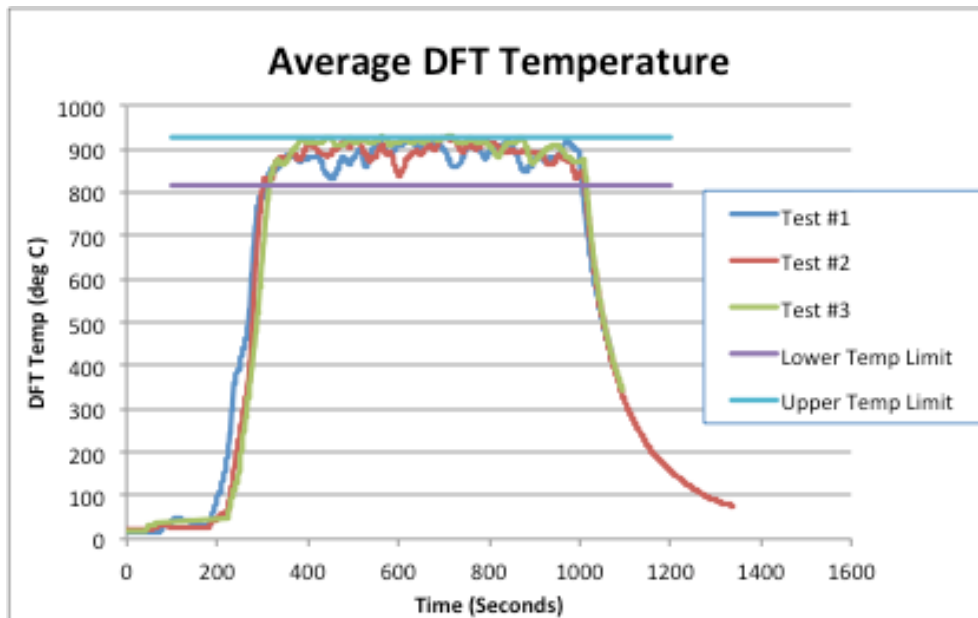
Figure 8. Plot of Average DFT Temperature vs. Time - Three Calibration Tests

The target average black body radiating temperature for the fire was between 816 and 927 °C (average 871 °C). All the test averages are in this range. The test repeatability was excellent, as seen in [Figure 8](#).

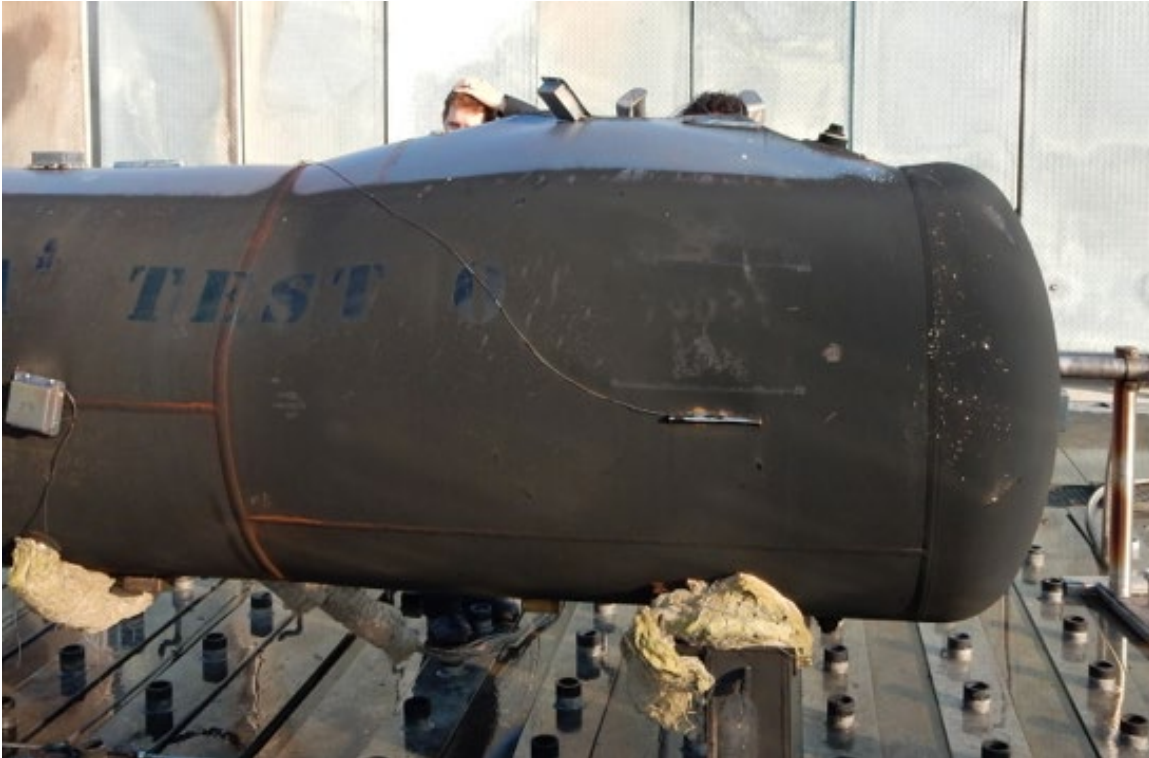
Figure 14. Test 0 - After Test - View of Deformed and Failed B-End

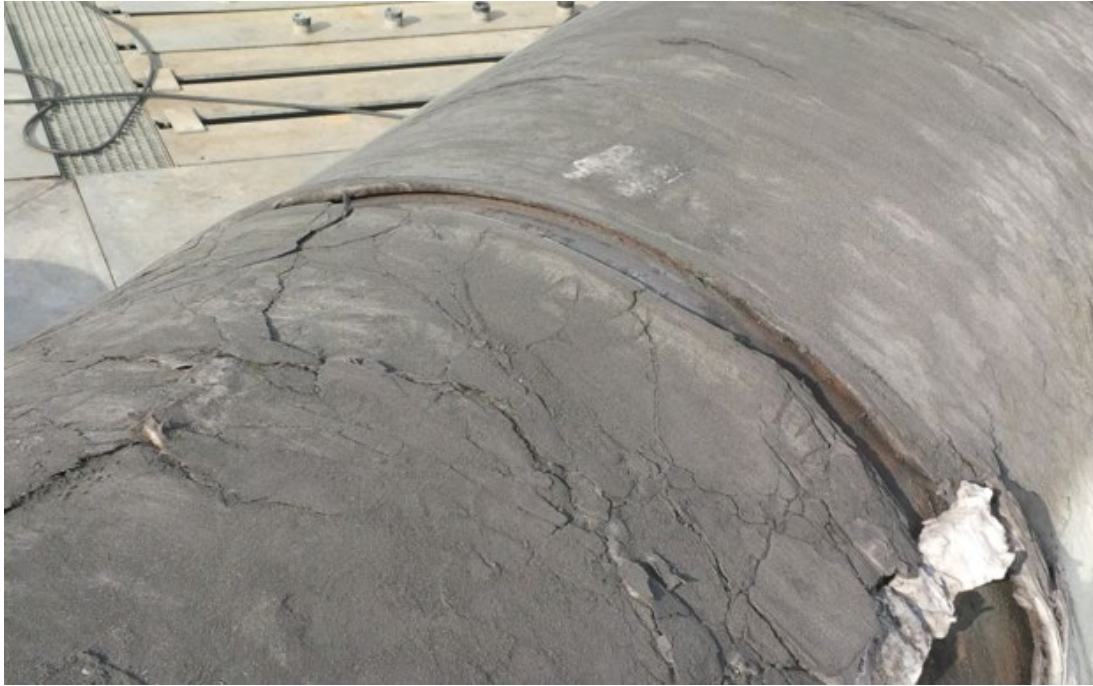
**Figure 15. Test 1 - View of Separated Insulation on Tank Top at Mid Span.
Picture also shows severe thinning of insulation.**

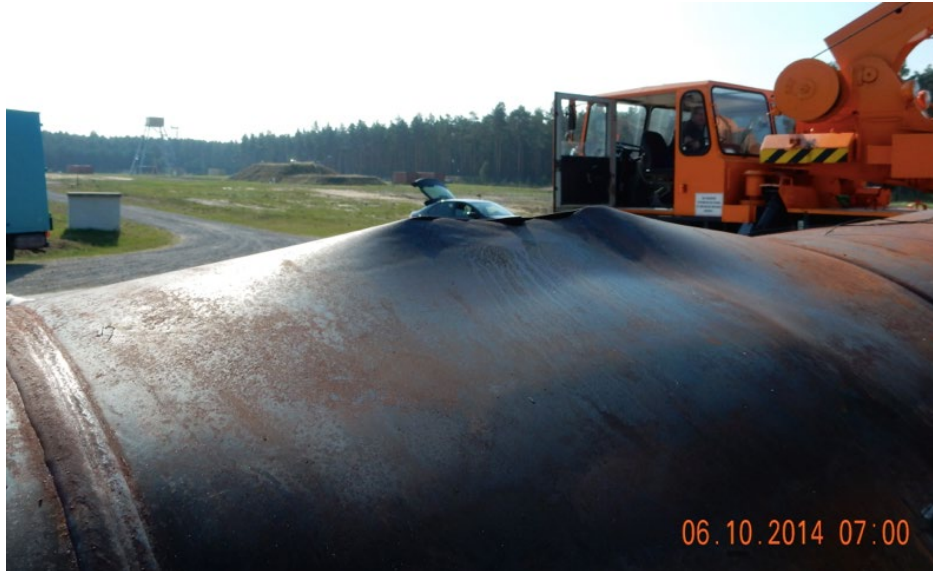
Figure 16. Test 1b - View of Vessel Rupture

1. This test lasted just over 6 minutes when the tank burst at 12 Barg due to high wall temperatures (see Figure 16).
2. This test was the second test for this tank and some plastic deformation of this tank was observed in the first test. Therefore, this tank was not in new condition.
3. The heat flux to the tank was about half of the bare tank test, due to the radiation shield effect from the jacket.

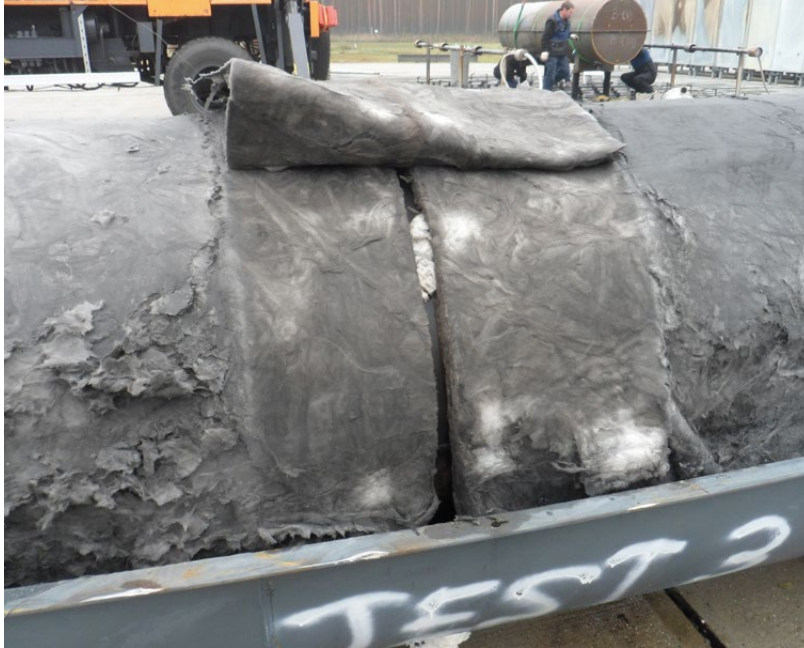
Figure 20. Test 3 - Second Layer of Insulation.
Note the condition of the protected insulation

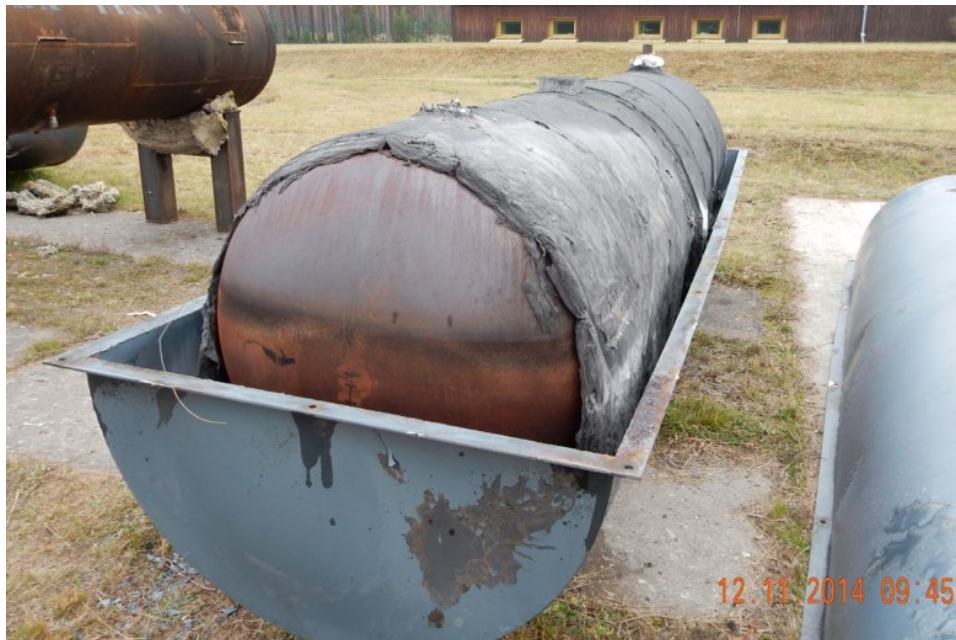
Figure 25. Test 4 - End View after Jacket Removal
Note liquid level markings on tank end. Tank was probably filled to 66%

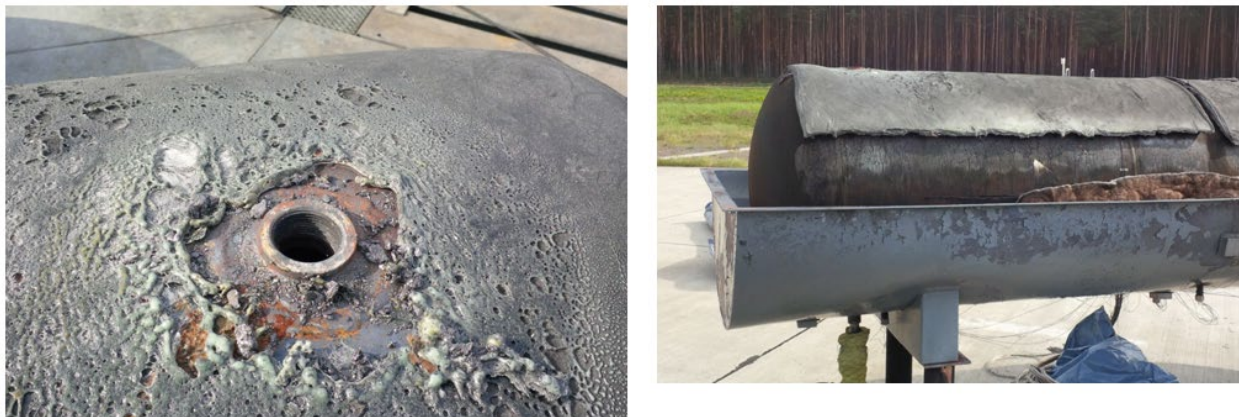
Figure 28. Test 1 – Images of Insulation Failure

A review of the insulation after Tests 1 and 2 indicated that the insulation was not completely failing within 5 minutes, as initially expected. It was also observed that, as the test progressed, the insulation would separate and sometimes fall away, which would lead to portions of the tank being exposed to additional thermal input. Failure modes of insulation included melting, burning, sagging, compacting, stretching and tearing, as well as dropping and separating. It is understood that such behavior is common and consistent with nominal tank car construction, and as such, it is expected that insulation behavior in Tests 1 and 2 was consistent with expected full-scale behavior.

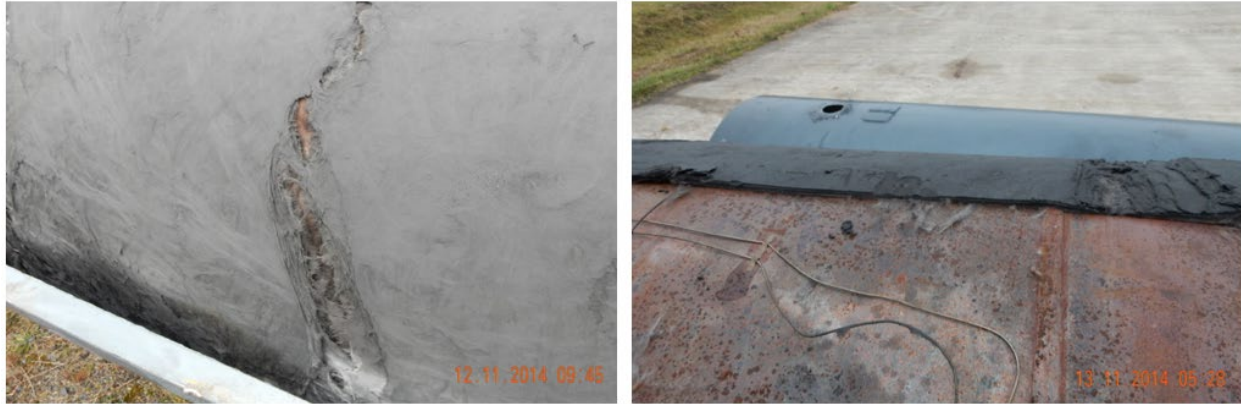
Figure 29. Test 4 – Images of Insulation Failure

seams that were likely to separate were covered with an additional layer of insulation, and additional constraints were employed to make sure that the insulation stayed. Therefore, we would consider the NaOH tanks to have a “premium” level of insulation compared to nominal full-scale tanks.

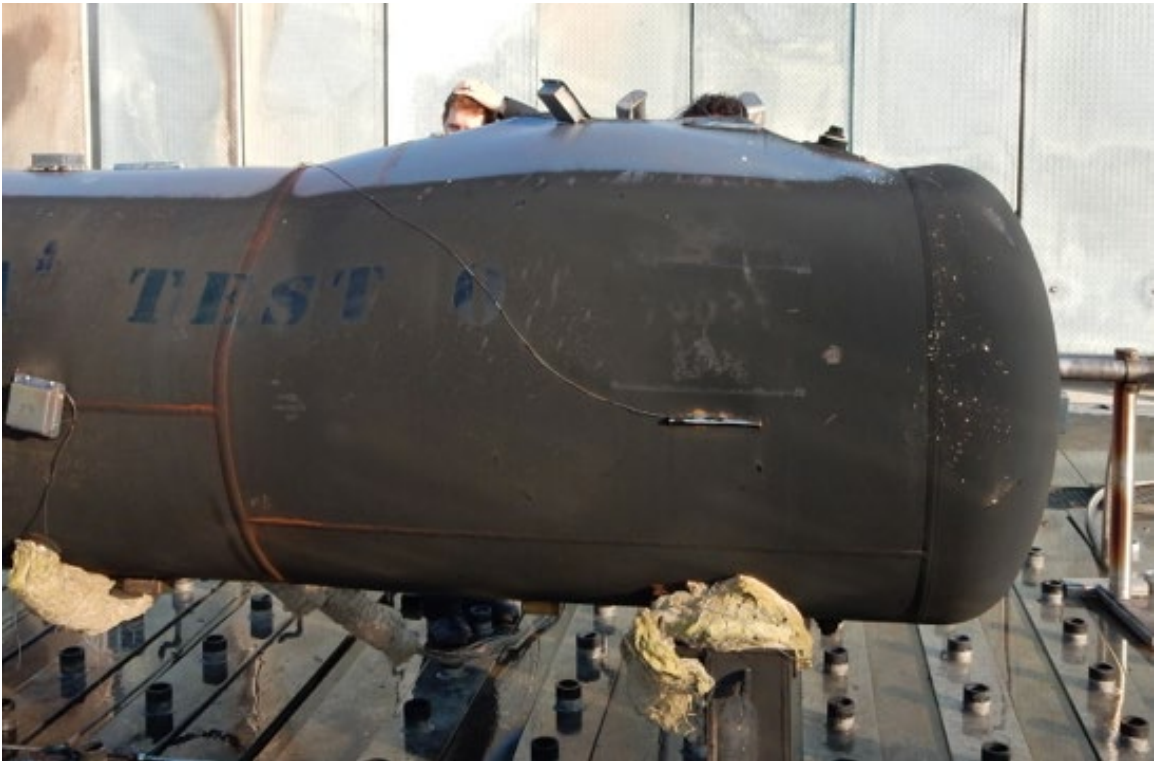
Figure 33. Test 0 - View of Deformed and Failed B-End

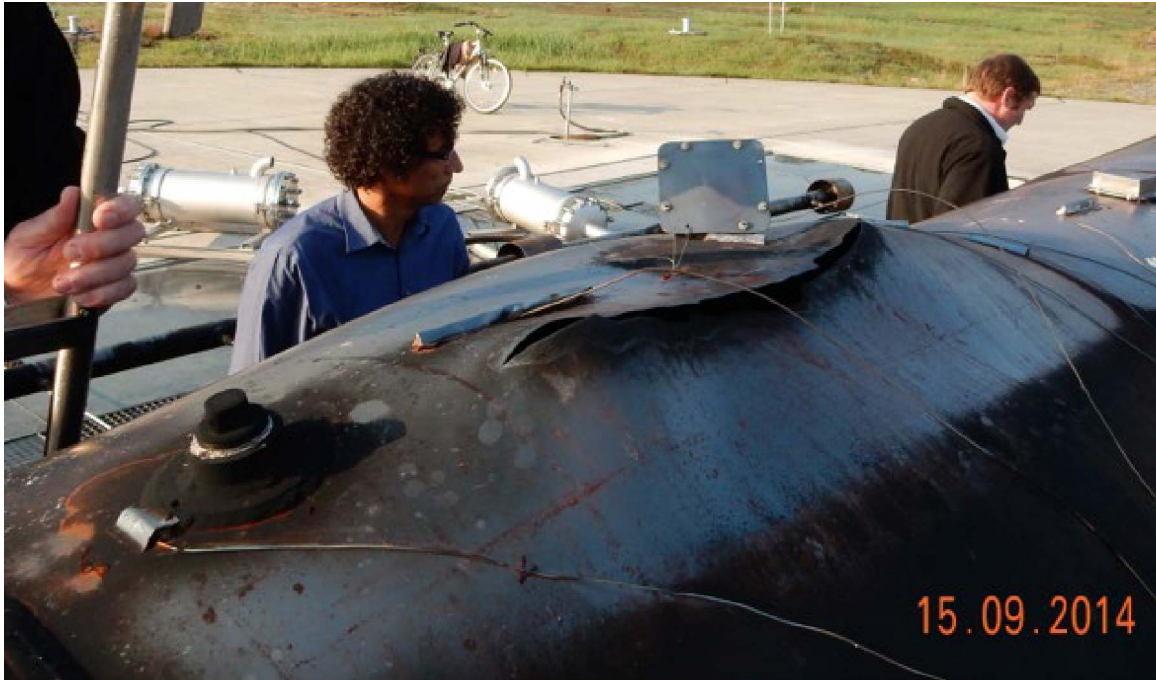
Figure 34. Test 0 - View of Deformation and Failure Opening.

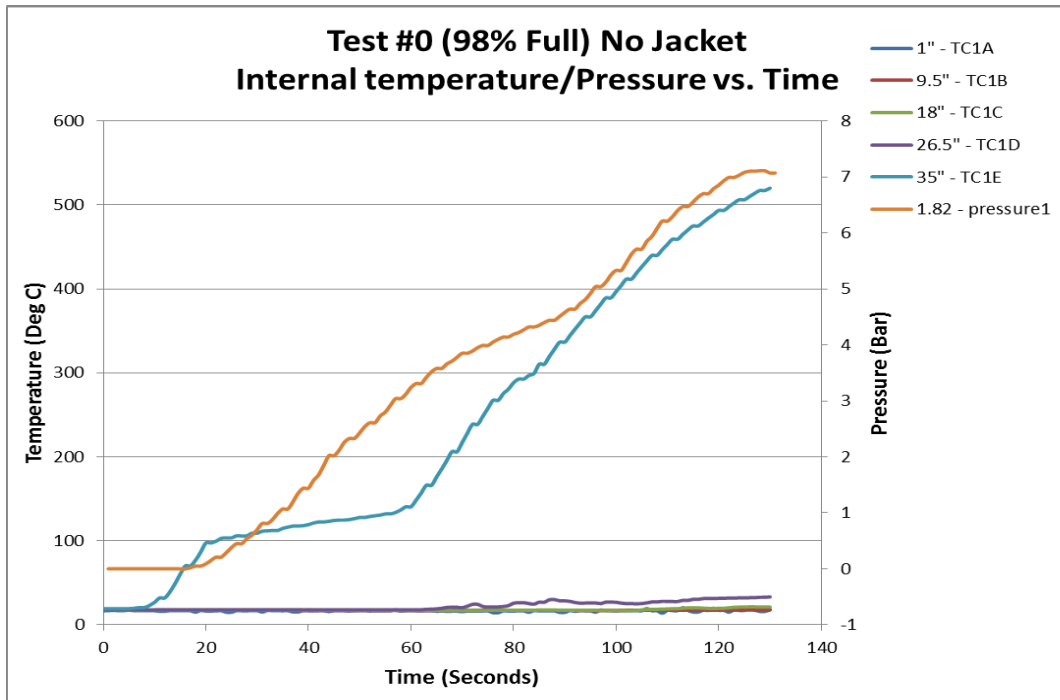
Figure 35. Test 0 (BAM 14031) - Internal Temperature/Tank Pressure vs. Time

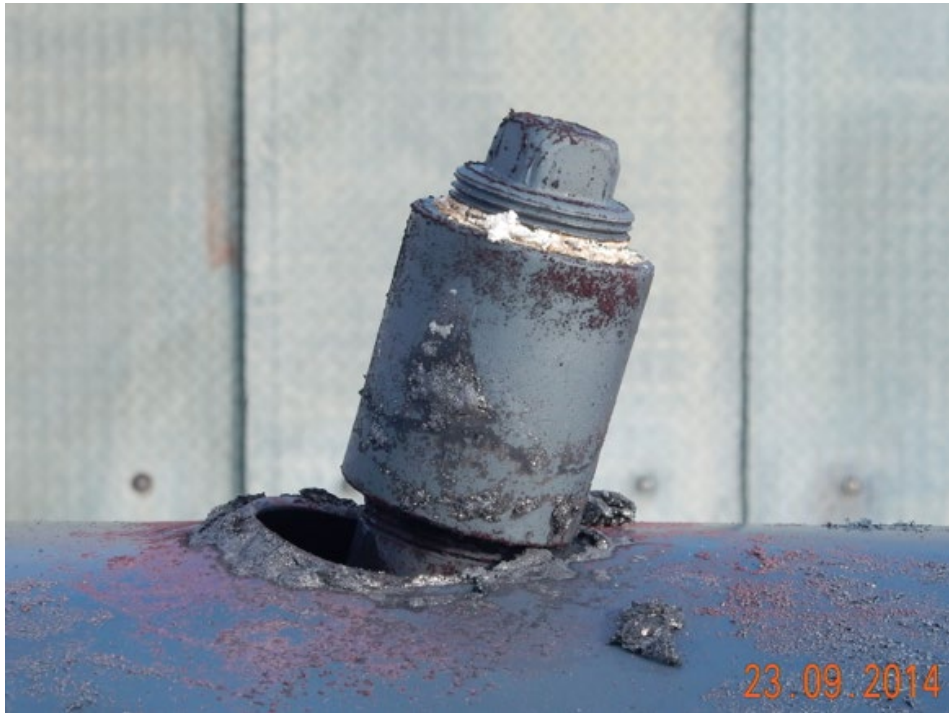
Figure 42. Test 1 - View of Damaged Fill Pipe on B-End (East) (Location of Minor Failure)

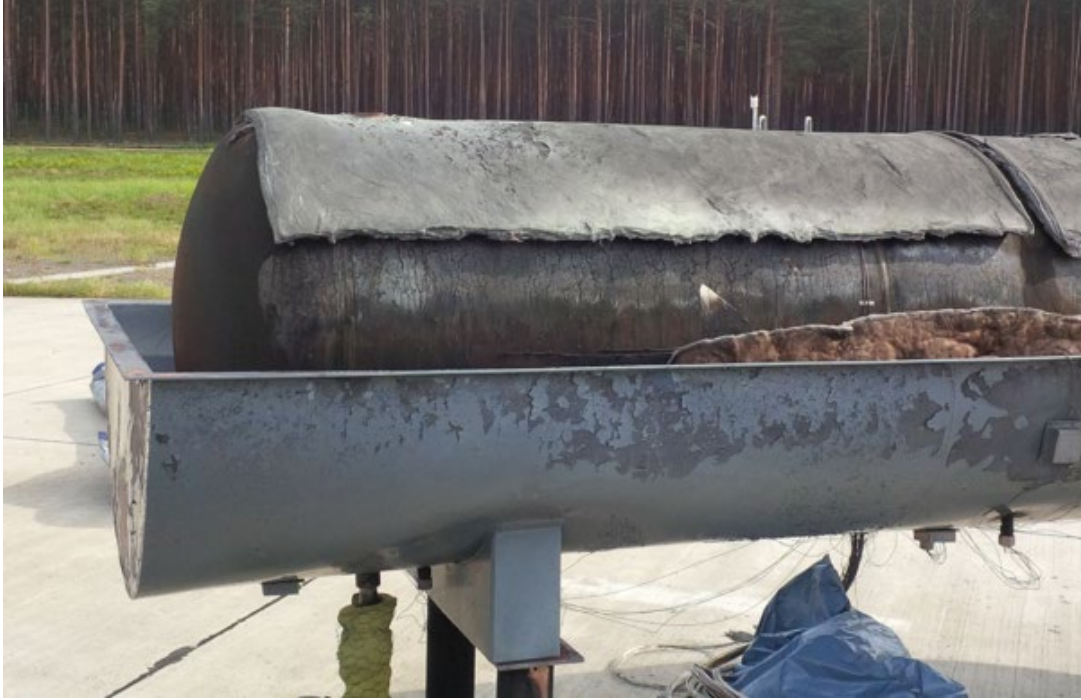
Figure 43. Test 1 - View of Dropped Down Insulation on West End and South Side

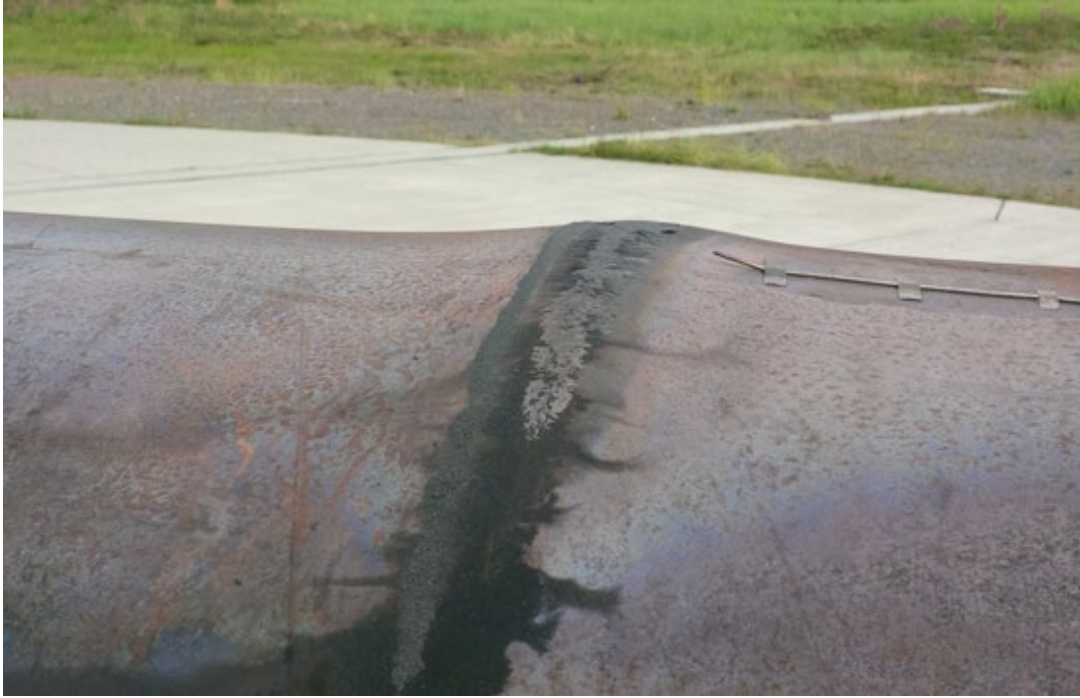
Figure 45. Test 1 - Plastic Deformation at Location of Separated Insulation

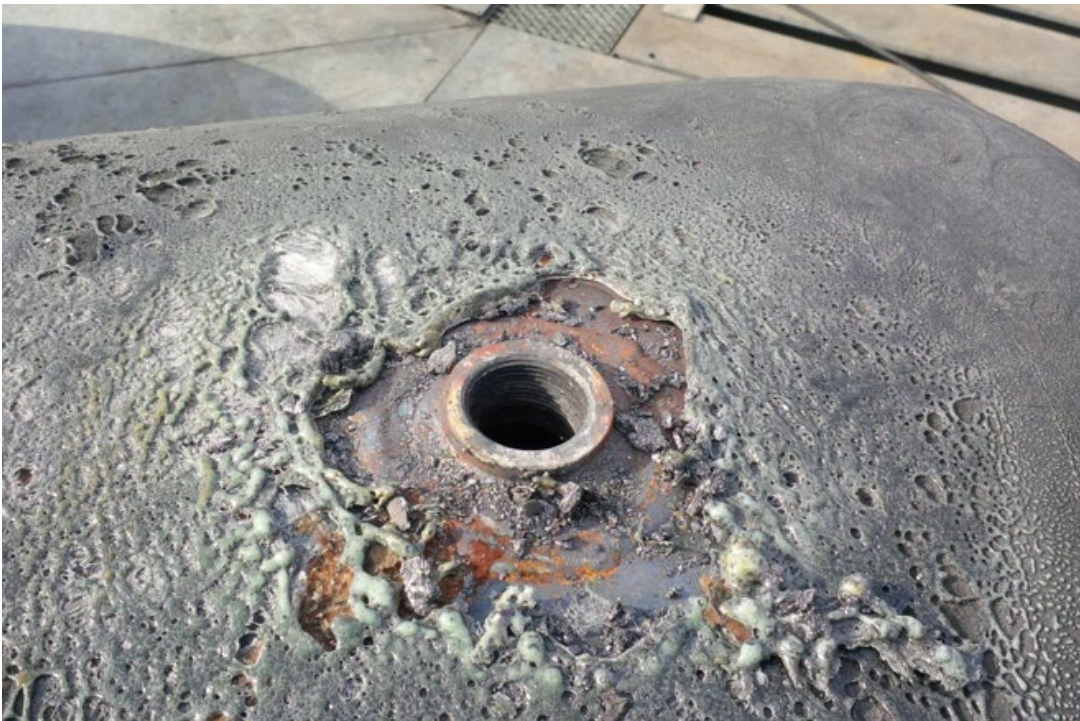
Figure 46. Test 1 - Burned Away Insulation at A-End Fill Fitting

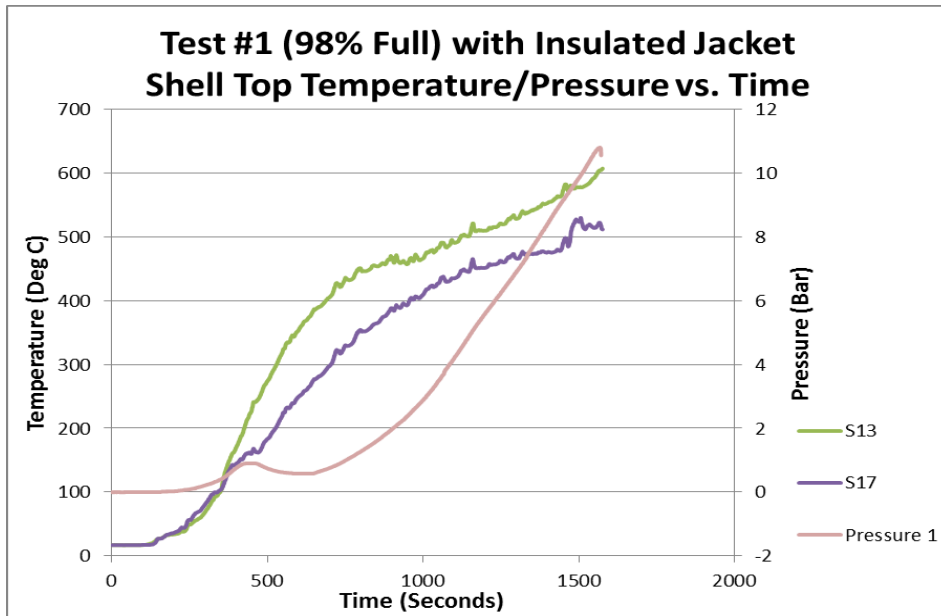
Figure 48. Test 1 - Shell Top Temperature/ Pressure vs. Time

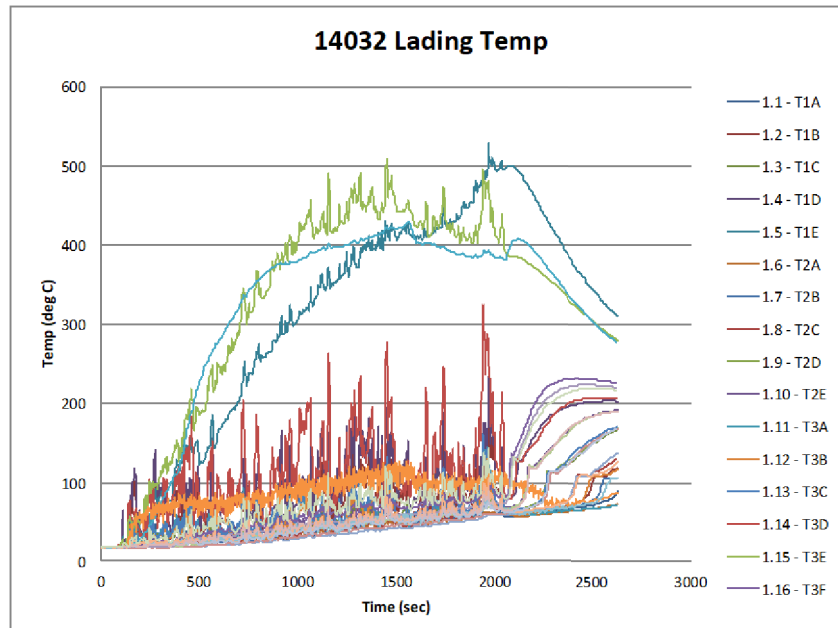
Figure 52. Test 1 - Wet Lading Temperatures

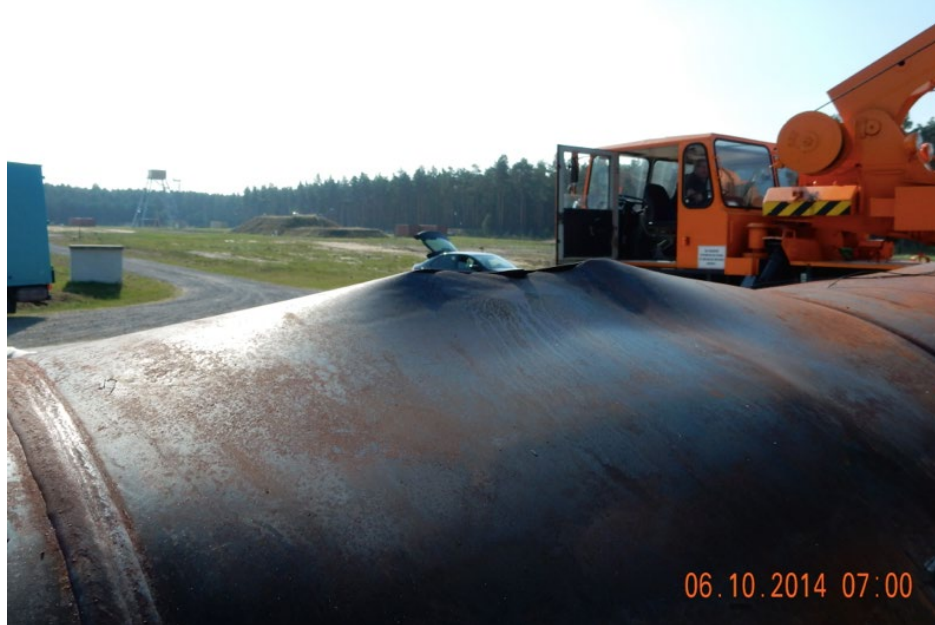
Figure 54. Test 1b - View of Vessel Rupture.

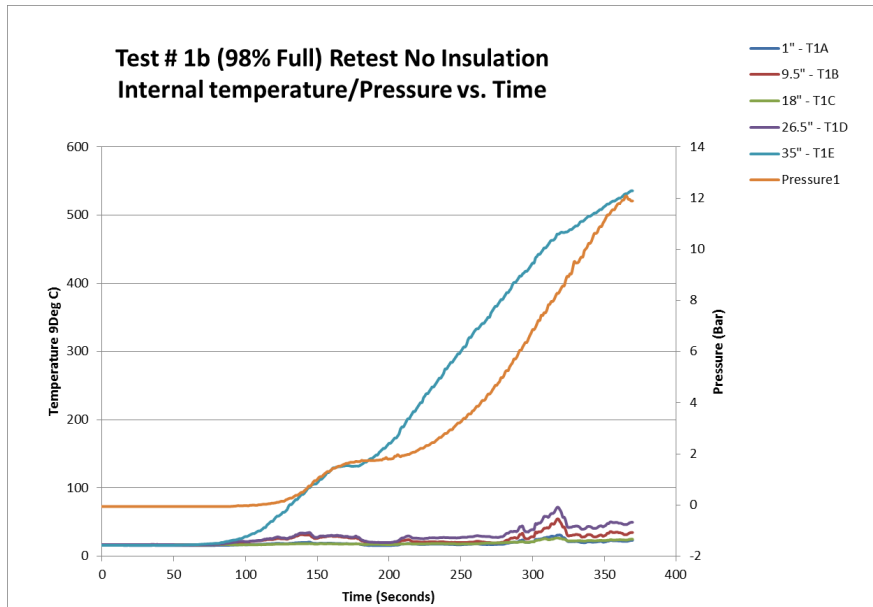
Figure 56. Test 1b - Internal Temperature/Tank Pressure vs. Time Tank Pressure

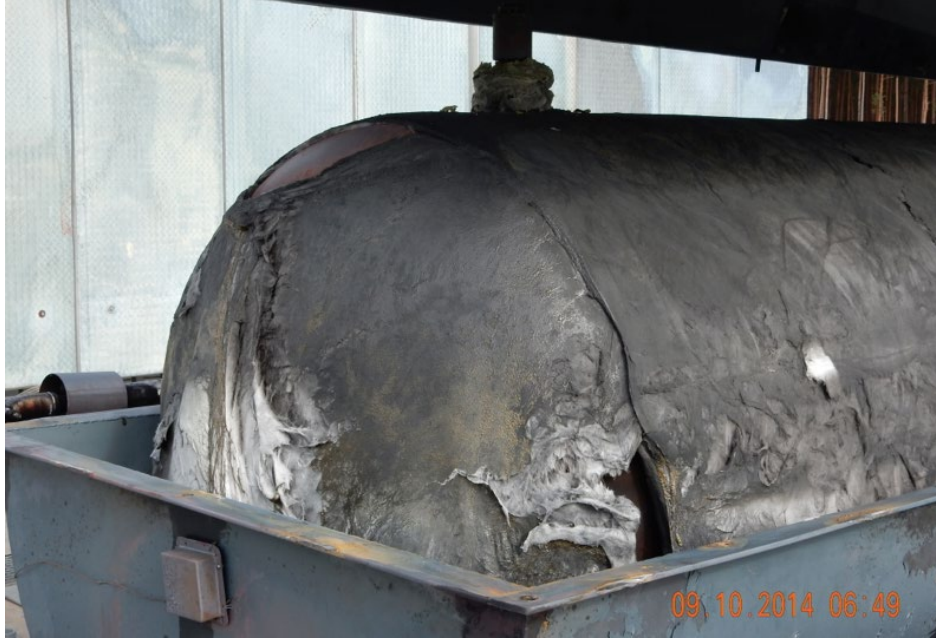
Figure 61. Test 2 - Insulation After Test

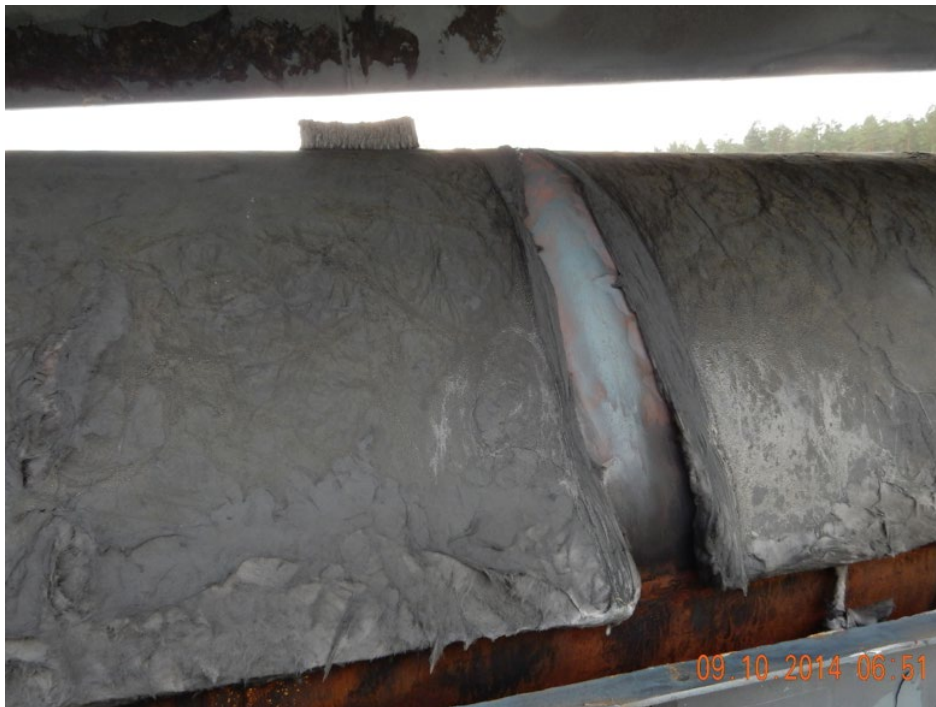
Figure 62. Test 2 - Insulation Gap at Mid Tank

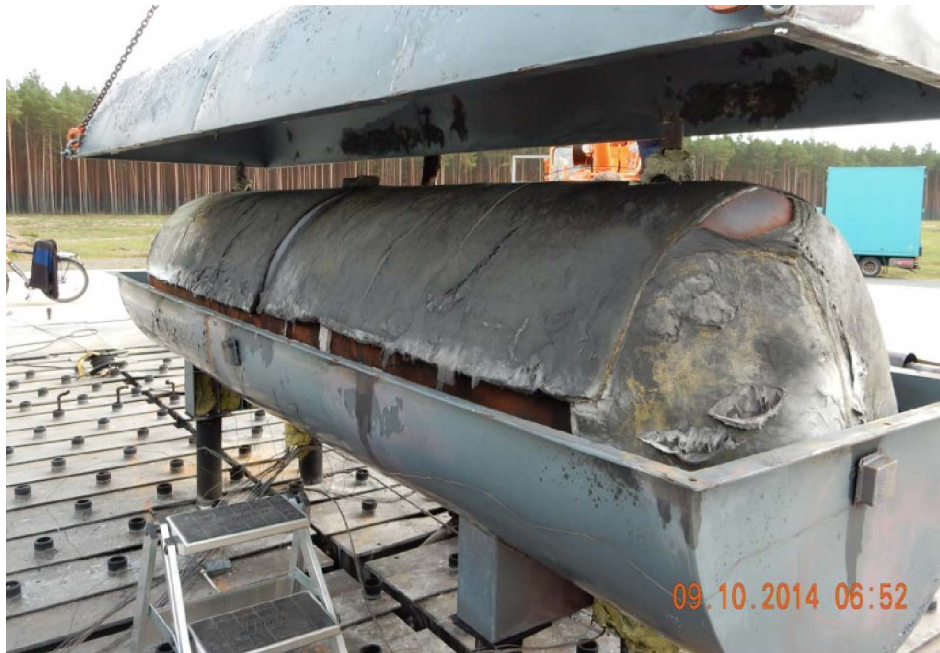
Figure 63. Test 2 - Insulation Dropped Down on Sides

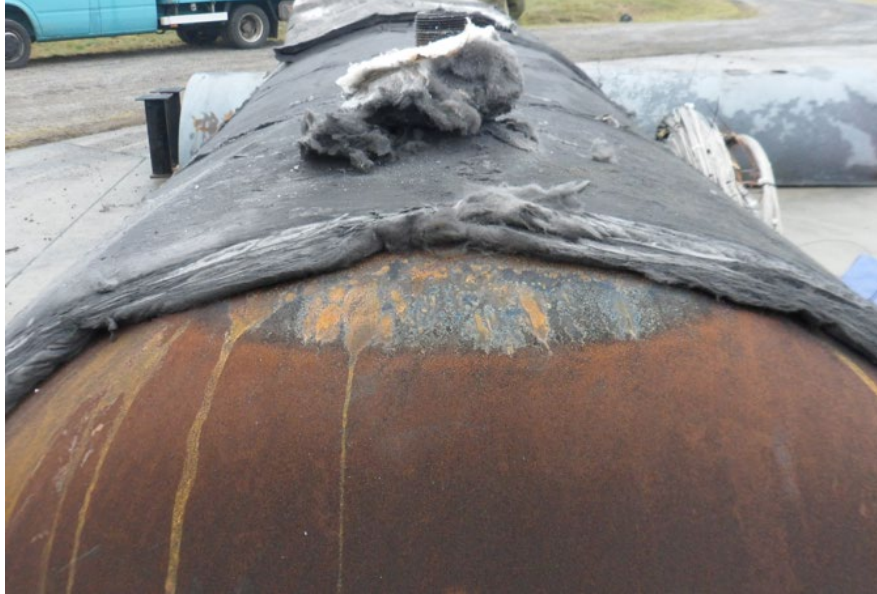
**Figure 70. Test 3 - End View of Tank after Test. Note Liquid Level Mark on Tank.
Note insulation on end dropped down.**

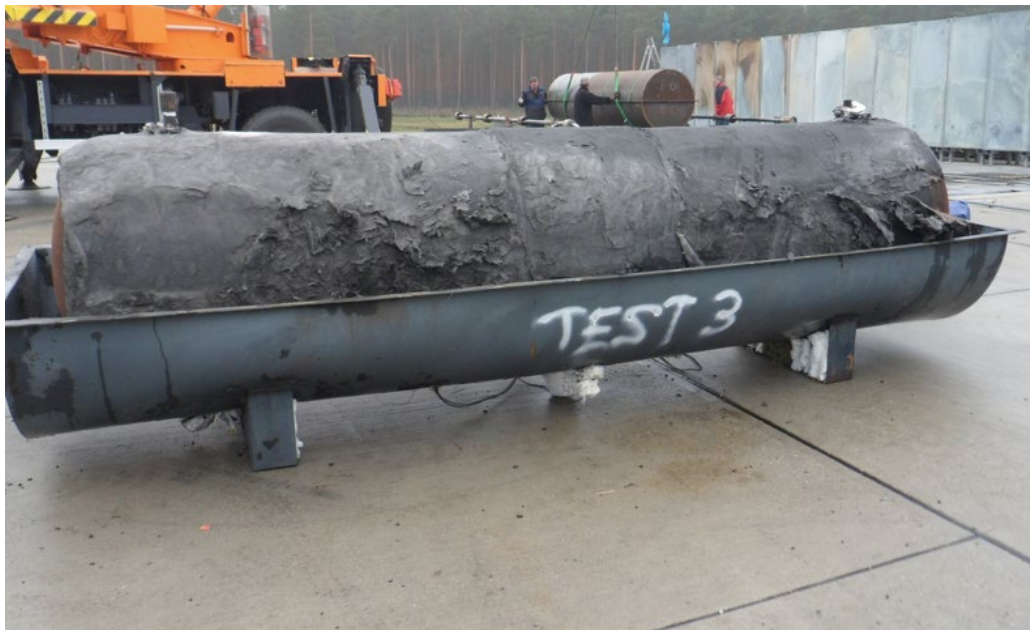
**Figure 71. Test 3 with Jacket Lifted Off
Note double layer of insulation at mid span**

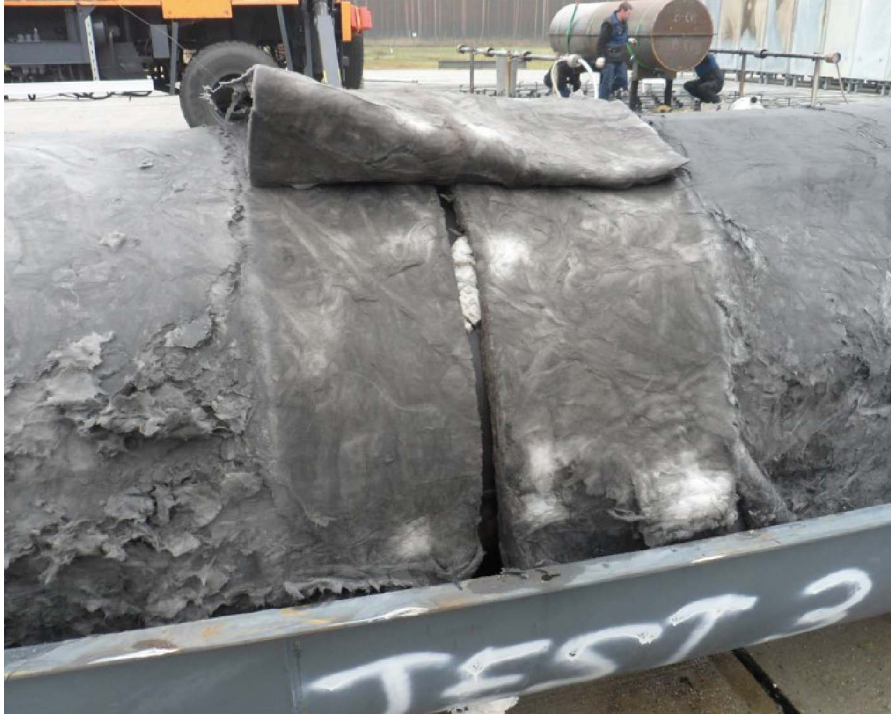
**Figure 72. Test 3 - View showing Second Layer of Insulation Lifted to Show Gap.
Note condition of protected insulation.**

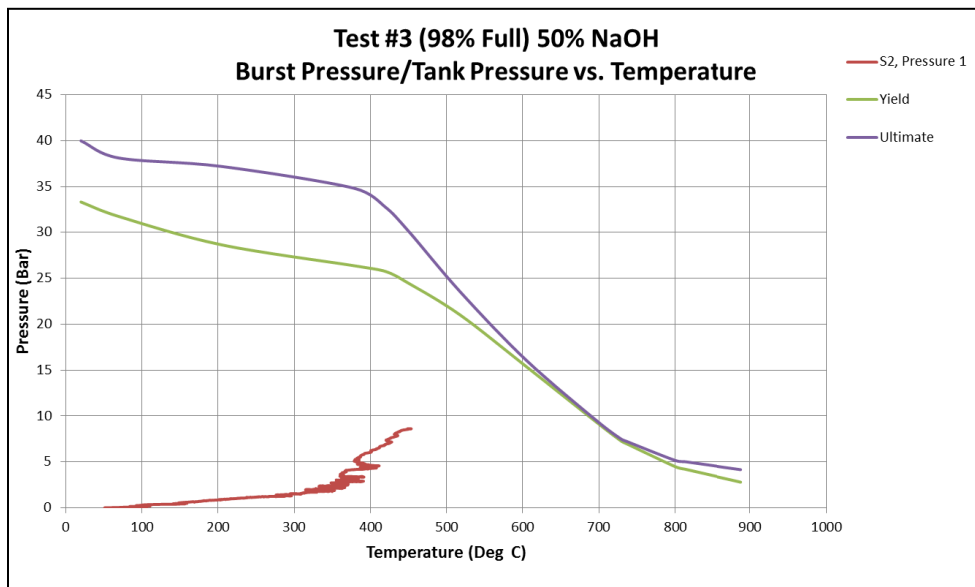
Figure 79. Test 3 - Burst Pressure and Tank Pressure vs. Wall Temperature

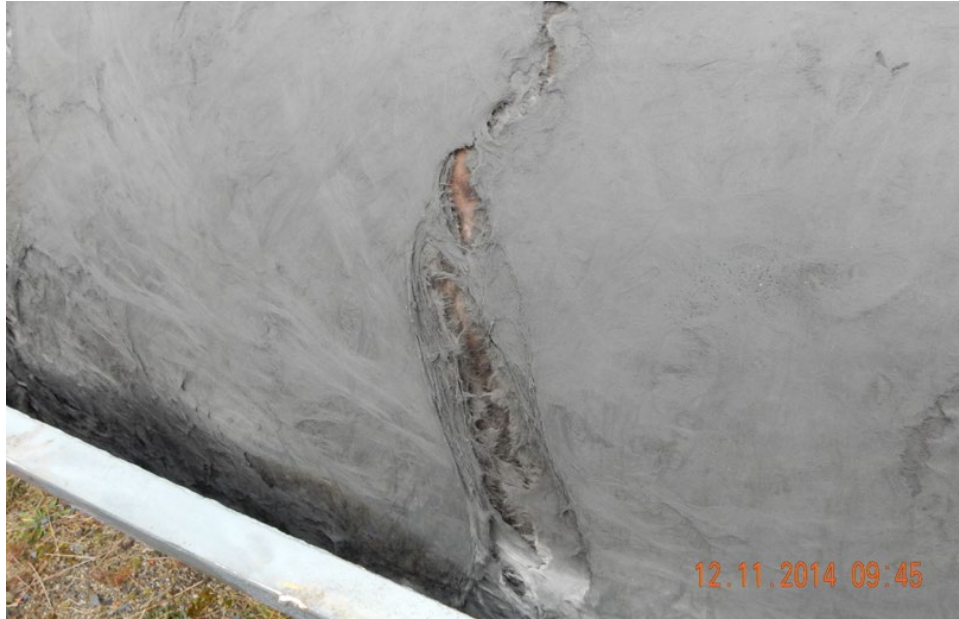
Figure 80. Test 4 - Insulation Stretch and Tearing on Tank Side

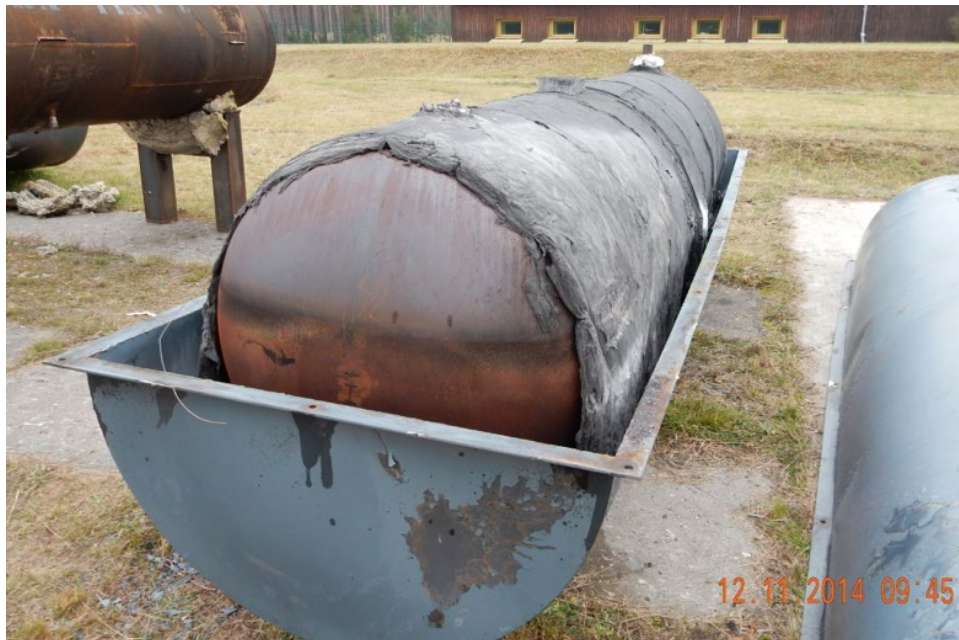
Figure 81. Test 4 - End view after Jacket Removal.
Note liquid level markings on tank end. Tank was probably filled to 66%

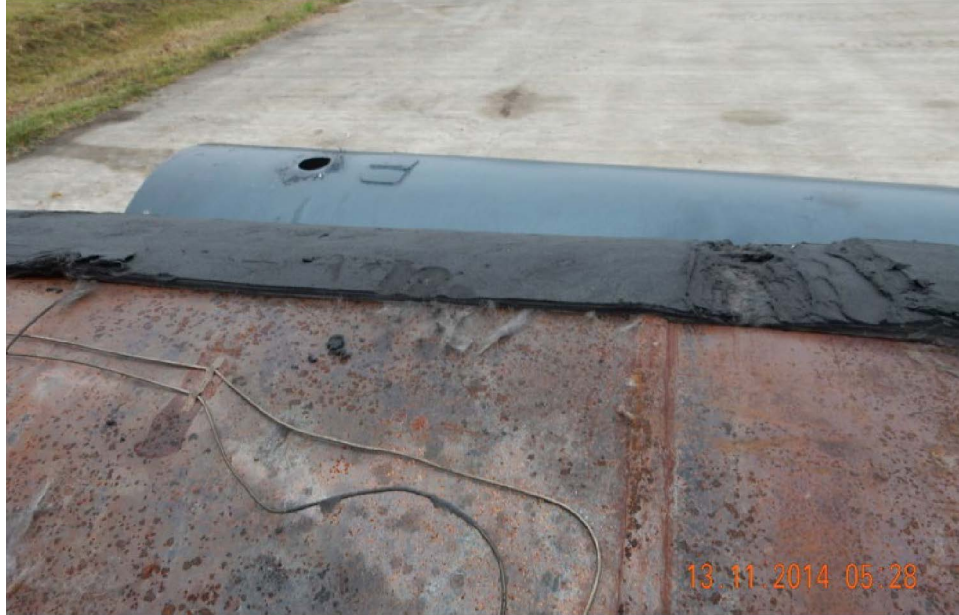
Figure 82. Test 4 - View of Insulation Thinning and Compaction

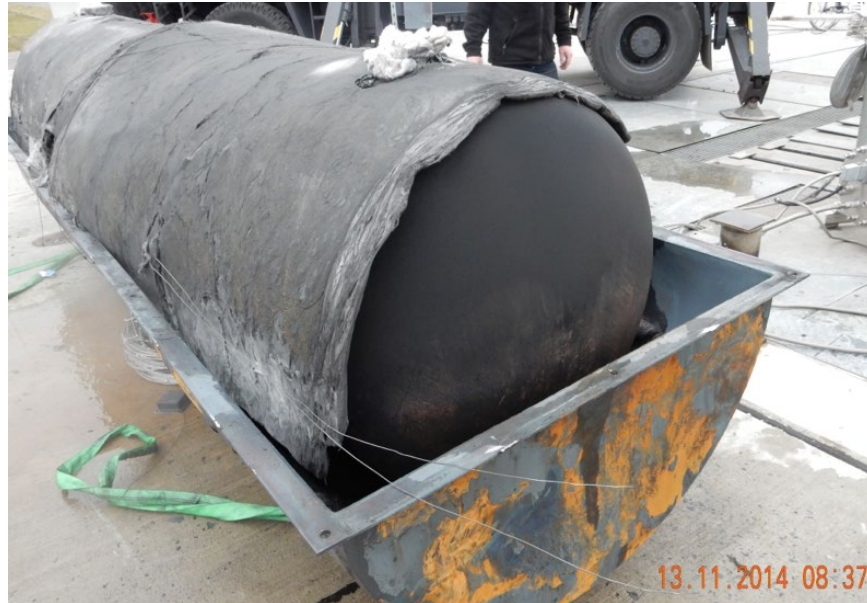
Figure 88. Test 5 with Jacket Removed. End Insulation Dropped Down

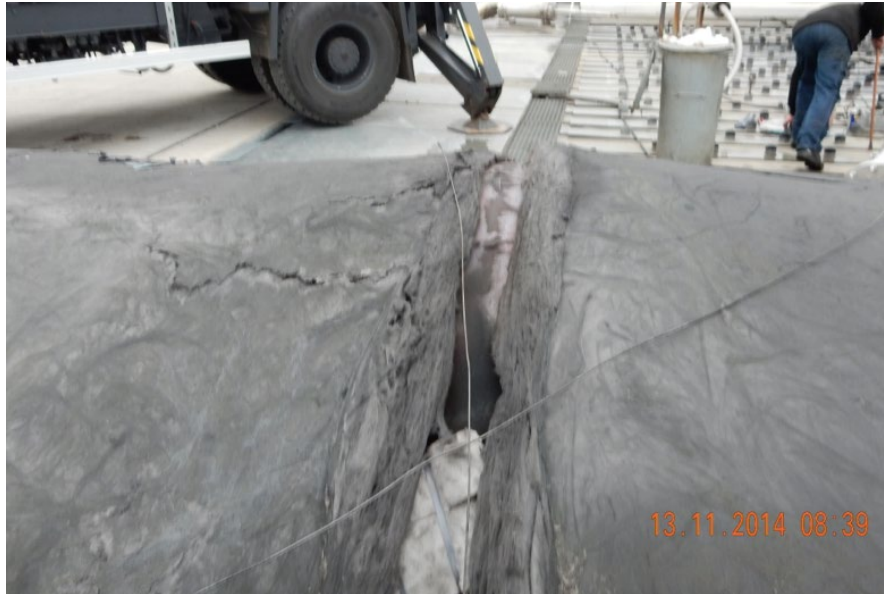
**Figure 90. Test 5 with View of Open Gap in Insulation
Note significant local plastic deformation to tank wall.**

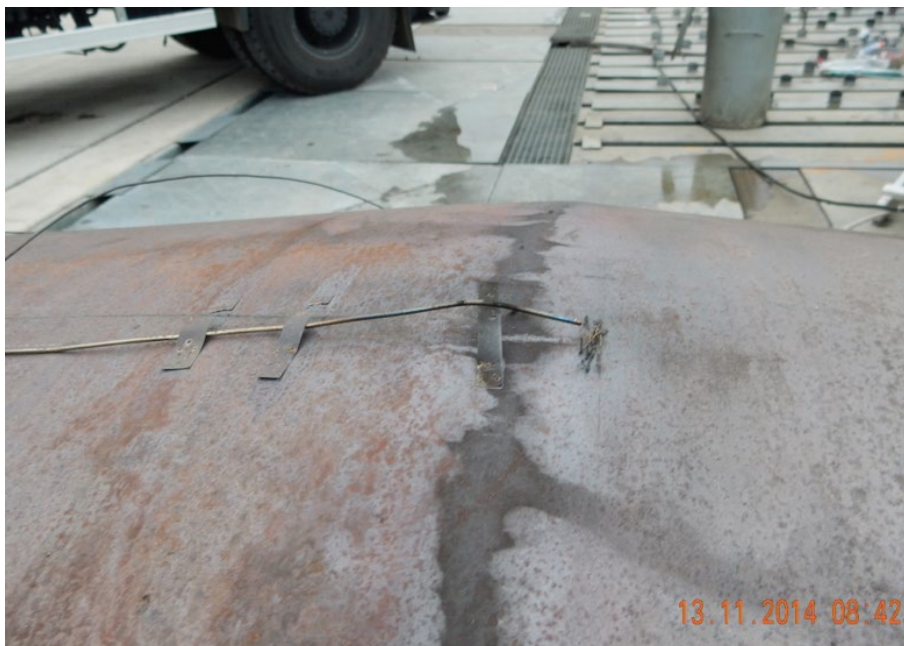
**Figure 91. Test 5 with Insulation Removed.
View of tank deformation at location of insulation gap and separated thermocouple.**

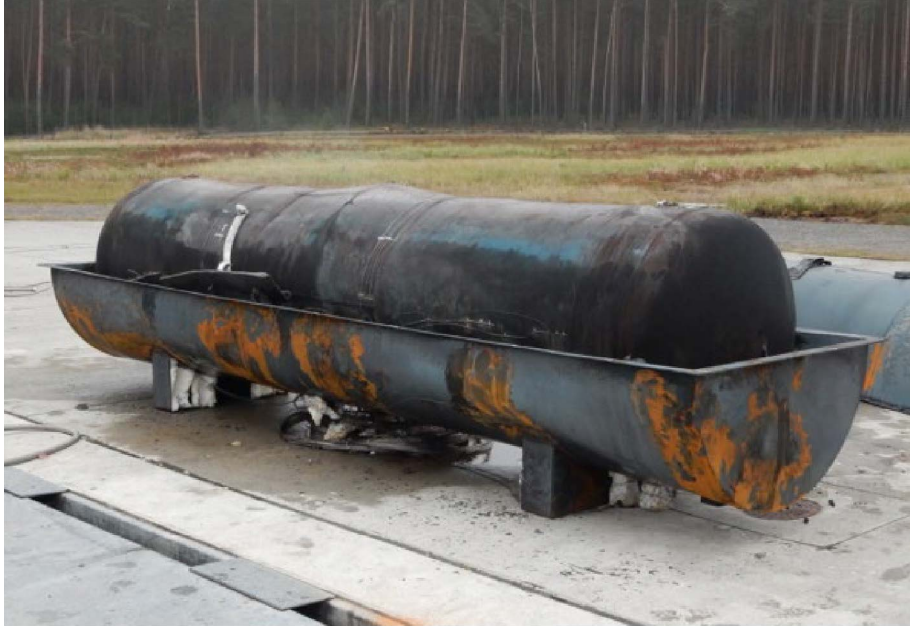
Figure 92. Test 5 Showing Tank with Plastic Deformation near Mid Span.
