U.S. Department of
Transportation

**Federal Railroad
Administration**

Rail Tank Car Total Containment Fire Testing

1. AGENCY USE ONLY (Leave blank)		2. REPORT DATE October 2018	3. REPORT TYPE AND DATES COVERED Technical Report – October 2015	
4. TITLE AND SUBTITLE Rail Tank Car Total Containment Fire Testing			5. FUNDING NUMBERS DTFR53-12-D-00004

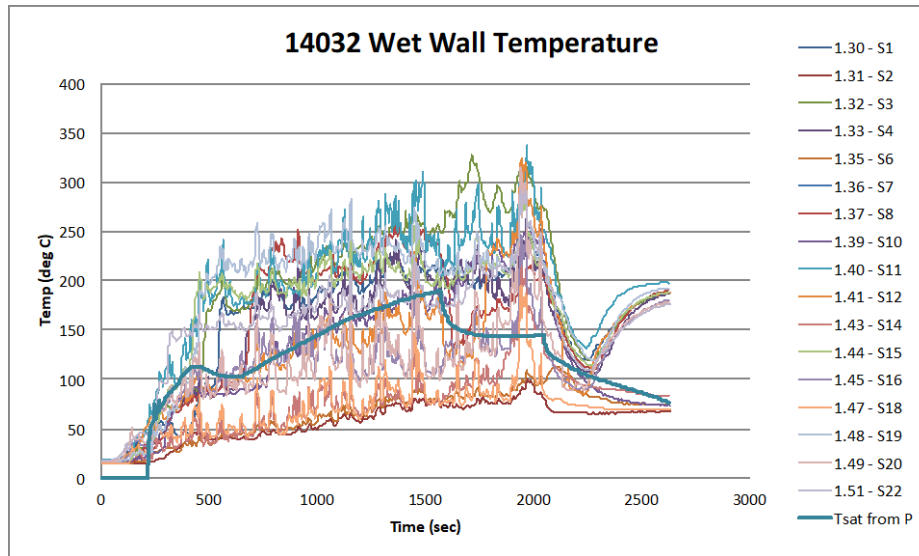
Figure 100. Test 1 (Water, 98%, Jacket and Insulation)

of 21 Barg, then the water must have been at least 217 °C and this suggests the tank wall in that location would have been around 237-327 °C on the outer surface exposed to the fire, assuming a 100 kW/m² fire heat flux. As seen below, the measured liquid wetted wall temperatures were of this order. Figure 100 and Figure 101 show the two 98% full cases with water and NaOH. The plots also show the liquid saturation temperature for the measured tank pressure.
