Final Report

Develop Epoxy Grout Pourback Guidance and Test Methods to Eliminate Thermal/Shrinkage Cracking at Post-Tensioning Anchorages

Phase II

January 2016

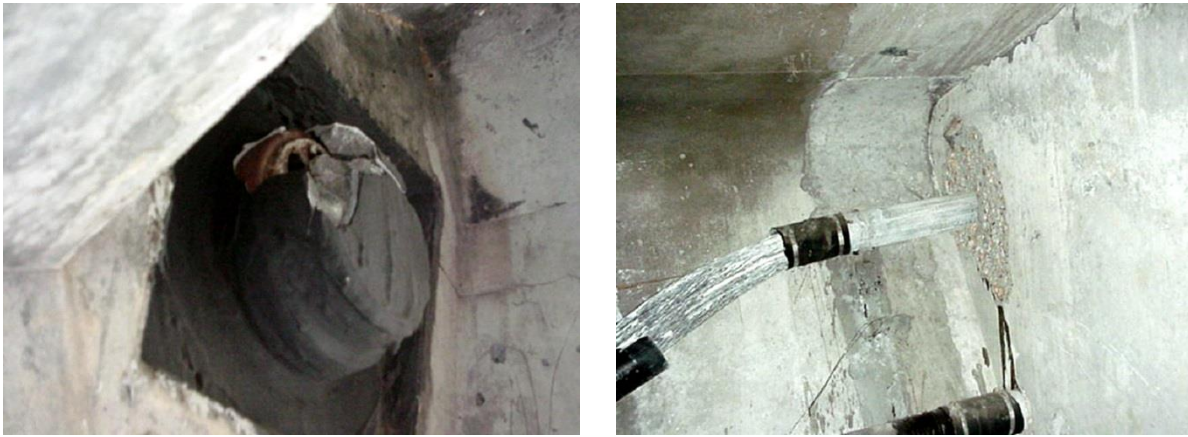
Figure 1-1: Tendon failure on the Mid-Bay Bridge

Pourbacks at end anchorages of post-tensioning tendons provide an essential level of corrosion protection. This is especially true when the anchorages are adjacent to expansion joints or other bridge deck discontinuities where water can flow freely to the tendon anchorage. Figure 1-1 shows an anchorage of a tendon in an expansion joint span of the Mid-Bay Bridge, where no pourback was provided. Water easily passed through the mastic coating and into the post-tensioning anchorage. Within seven years of installation, the tendon failed as a result of strand corrosion in the anchorage.

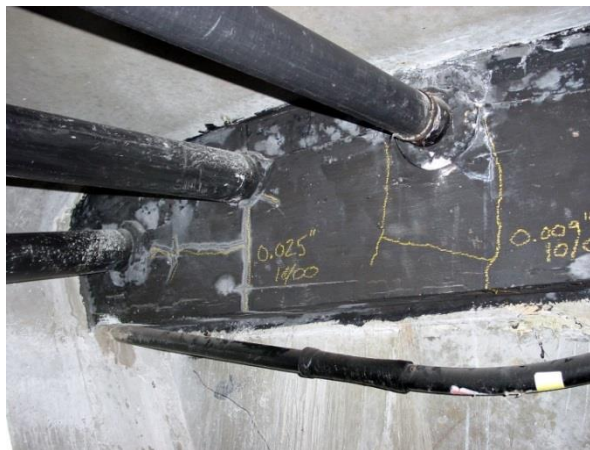
Figure 1-2: Pourback cracking on the Sunshine Skyway Bridge

Early segmental bridges incorporated cementitious pourbacks to protect end anchorages. Figure 1-2 shows a single pourback that encases three anchorages of the span-by-span approaches on the Sunshine Skyway Bridge. Unfortunately, the details of the pourbacks, and the methods of placing the materials, led to significant cracking of the pourbacks.

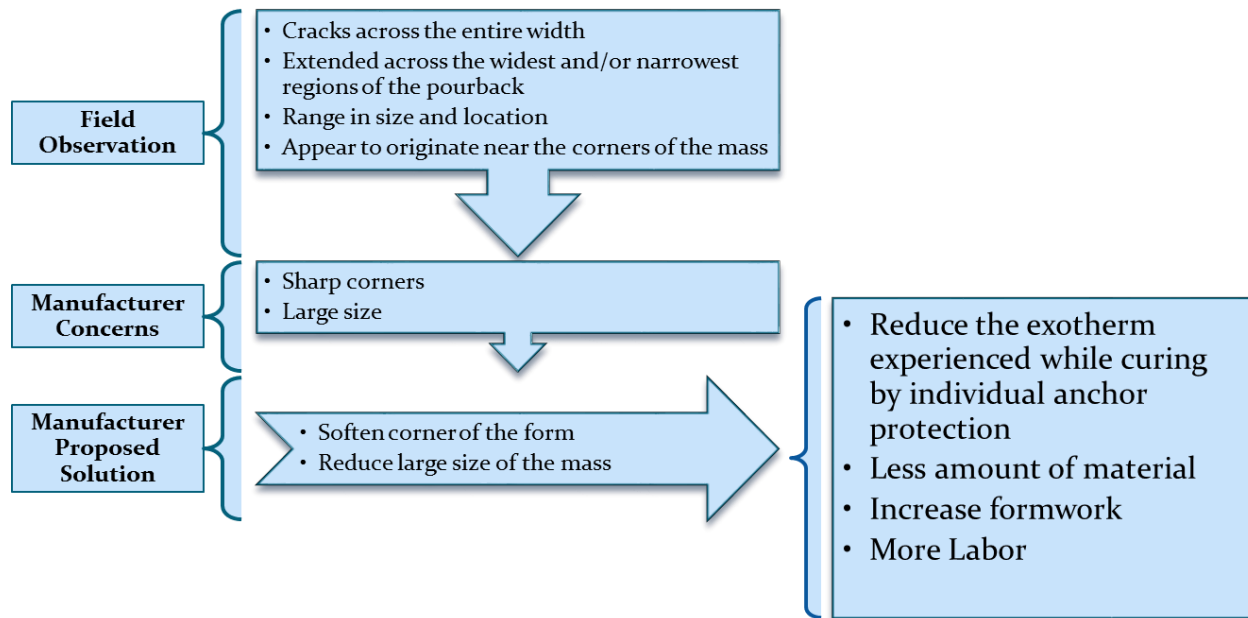
Figure 3-5: Summary of field inspection of epoxy grout pourbacks.

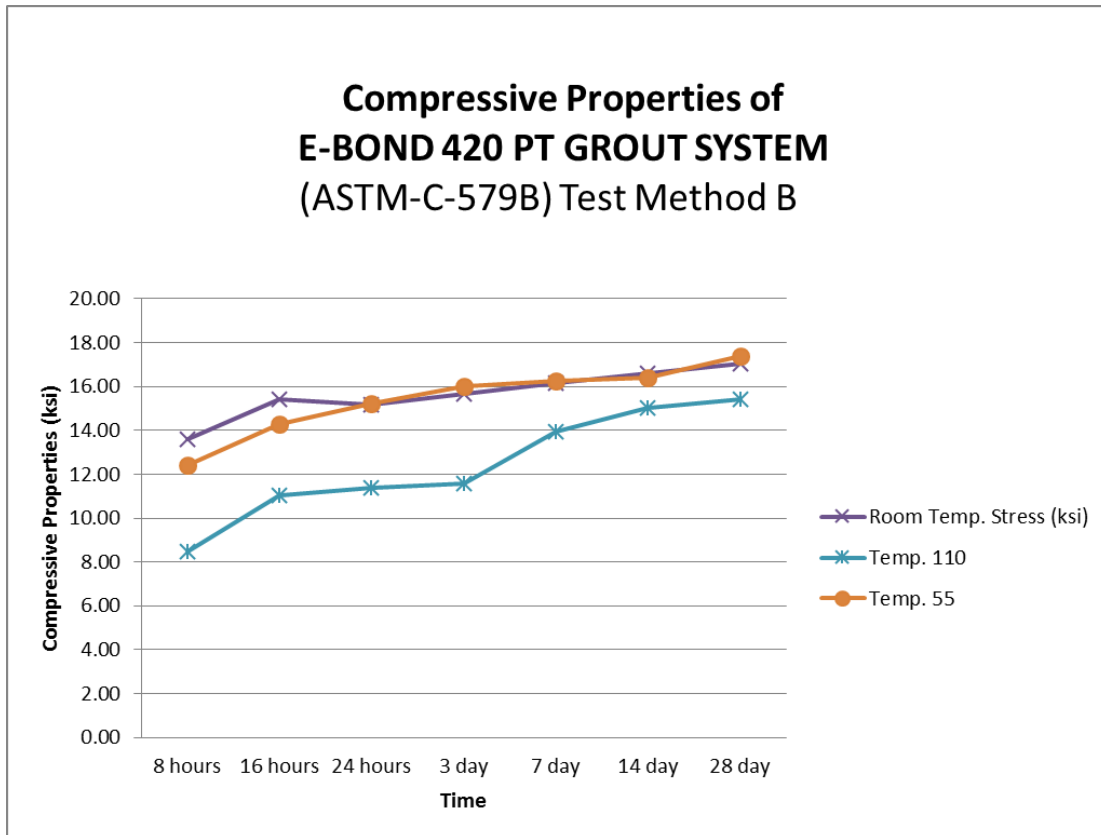
Figure 5-1: Compressive strength of epoxy grout specimens

Figure 5-1 illustrates the compressive strengths of epoxy grout cubes that were tested at three different temperatures, 75°F, 110°F, and 55°F. Overall, there is very little temperature effect on the compressive strength at later age (28 days compressive strength). However, at early-age, particularly during the first 3 days, the specimens exposed to 110°F had a 24% strength reduction when compared to specimens at the temperature of 55°F and 75°F. There are very little differences between the specimens exposed to 55°F and 75°F. The 7-day compressive strength at room temperature (16.17 ksi) compares very well with the data (14.25 ksi) provided in the manufacturer's data sheet for this product (Figure 2-4b).

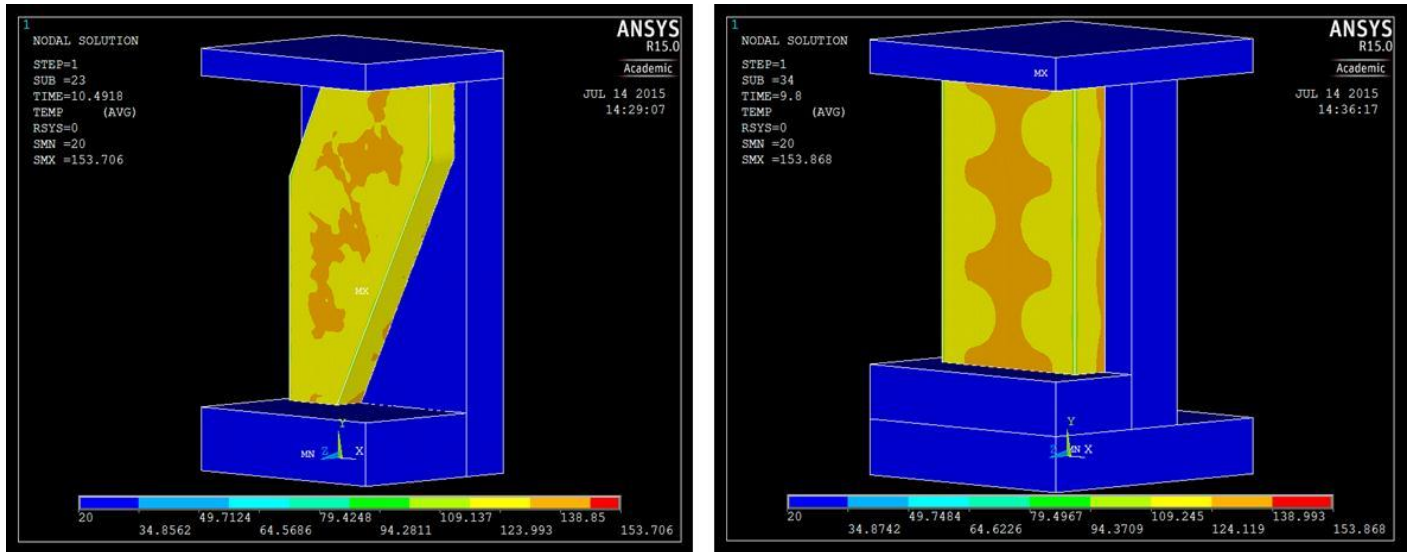
Pourback S3 (V/S=0.37)

Figure 5-6: Temperature contour plots obtained by FEM thermal analysis.

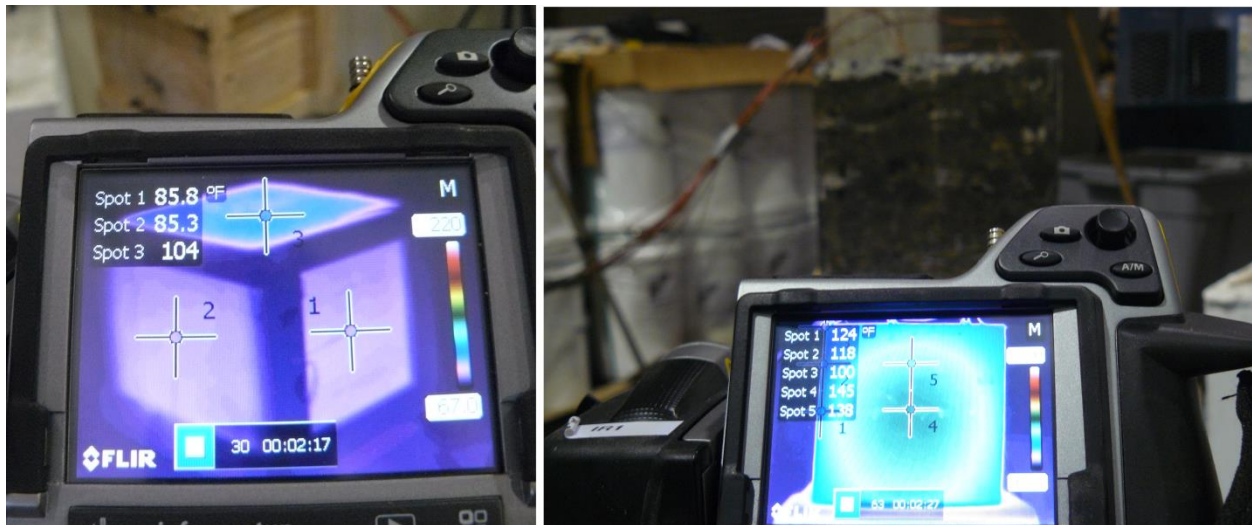
Figure A-16: Three spot-meters set for Camera 2 (left), and five spot-meters for Camera 1 (right)

The epoxy grout emissivity value was obtained through the calibration of the thermography image to match the corresponding temperature resulting from temperature sensors. This value was assumed constant throughout the entire experiment, with the value of 0.90, which lies within the usual range considered for concrete. The cameras were set to monitor the temperature from 67 F, almost ambient temperature, to 220 F, somewhat higher than expected surface temperature. The camera has the capability to set up to 5 spotmeters (Figure A-16).
