# **DEVELOPMENT OF A LOW-PROFILE BRIDGE RAIL FOR TEST LEVEL 2 APPLICATIONS**

## **MIDWEST ROADSIDE SAFETY FACILITY**

MwRSF Research Report No. TRP-03-109-02

August 20, 2002

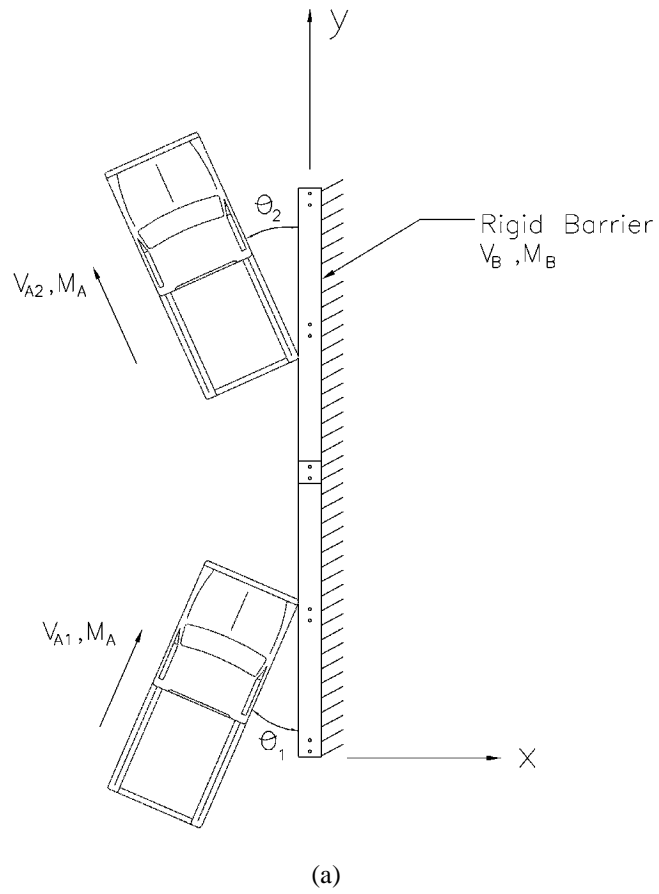
Figure 1. (a) Impact Schematic; and (b) Saw-Tooth Forcing Function

For an impact at 43.5 mph (70 km/hr) and 25 degrees,  $V_{A1}$  is as follows:

$$V_{A1} = 63.79 \text{ fps}(\sin 25^\circ \hat{i} + \cos 25^\circ \hat{j}) = 26.96 \text{ fps } \hat{i} + 57.81 \text{ fps } \hat{j} \quad (9)$$

Using the coefficient of restitution,  $e = 1.0$ , the conservation of momentum in the x-direction, and the x-component of  $V_{A1}$  in Equation 9, the x-component of  $V_{A2}$  can be found as follows:

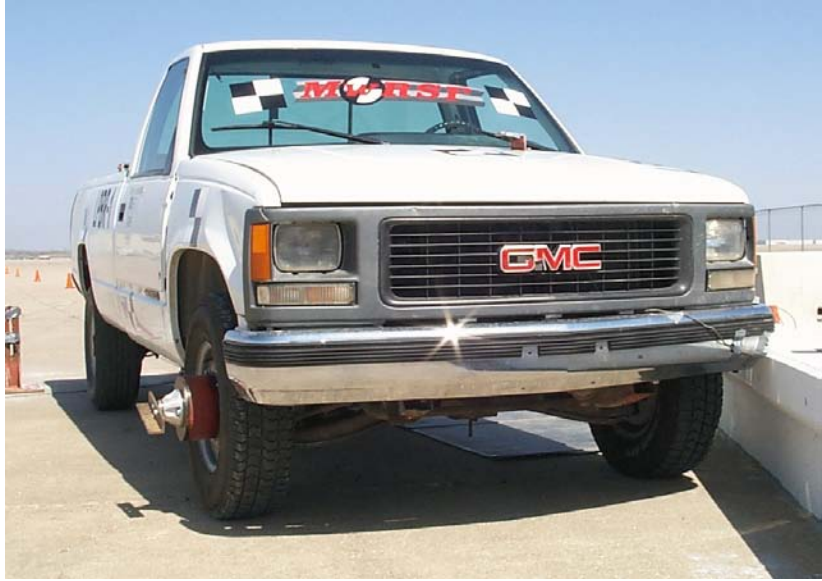
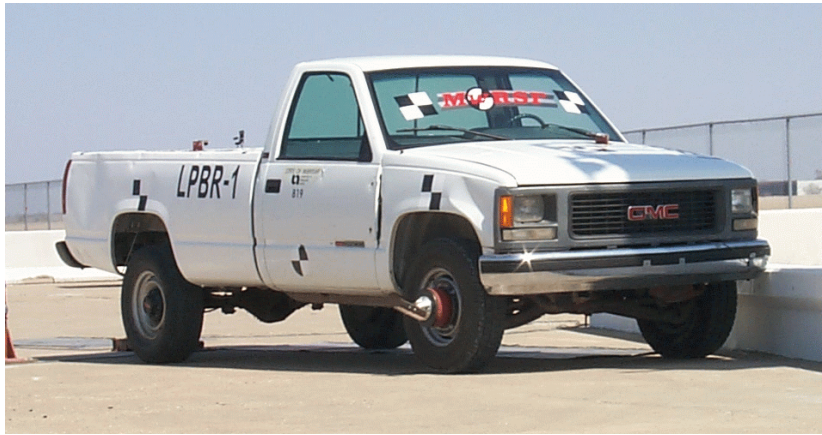
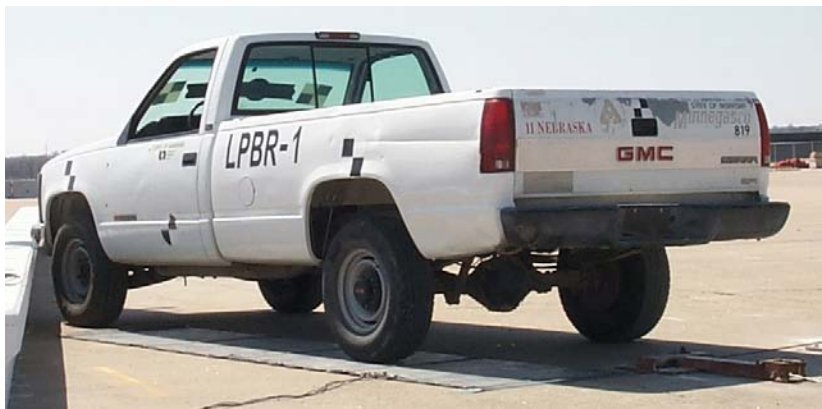
Figure 7. Test Vehicle, Test LPBR-1

For test LPBR-1, a 1995 GMC 2500 SL  $\frac{3}{4}$ -ton pickup truck was used as the test vehicle. The test inertial and gross static weights were 2,018 kg. The test vehicle is shown in Figure 7, and vehicle dimensions are shown in Figure 8.

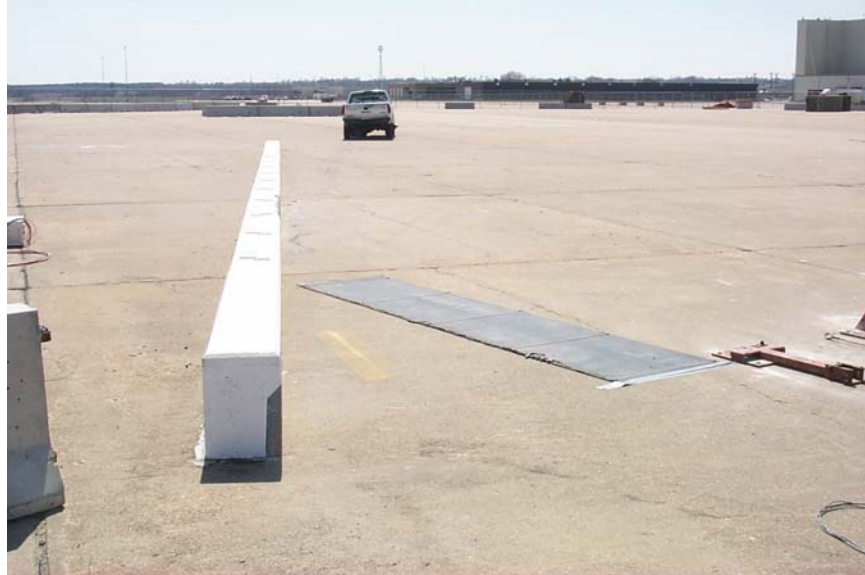
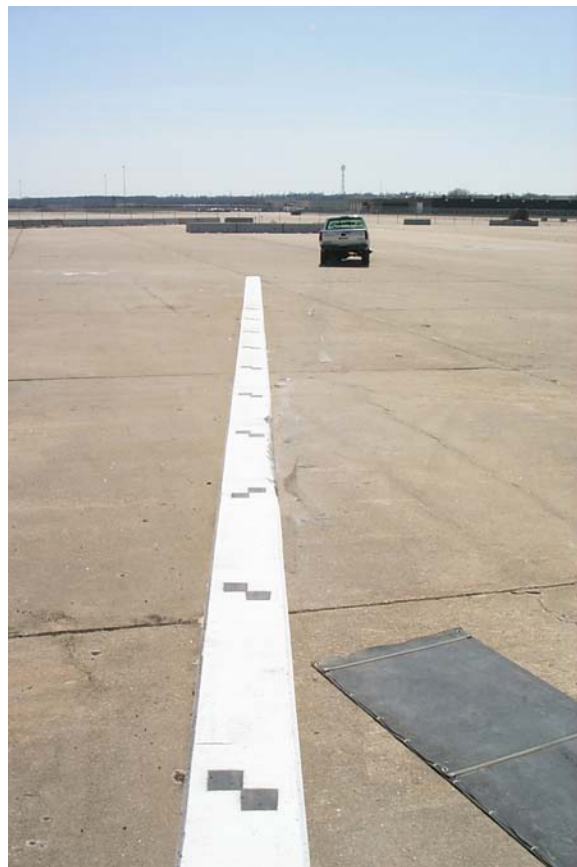
Figure 17. Overall Damage and Final Positions, Test LPBR-1

Damage to the barrier was minimal, as shown in Figures 17 through 19. Cracking of the bridge rail did not occur. Barrier damage consisted mostly of contact marks on the concrete face

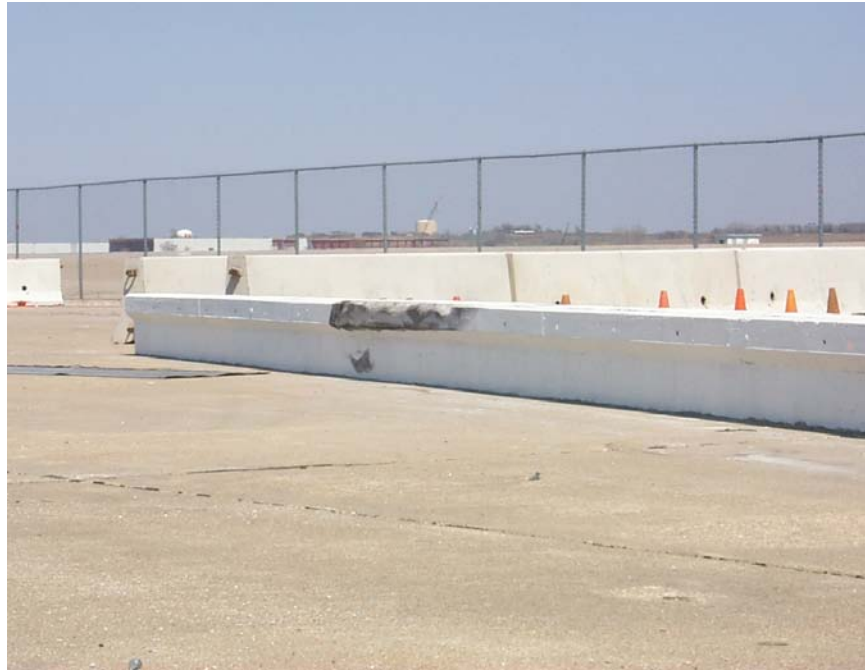
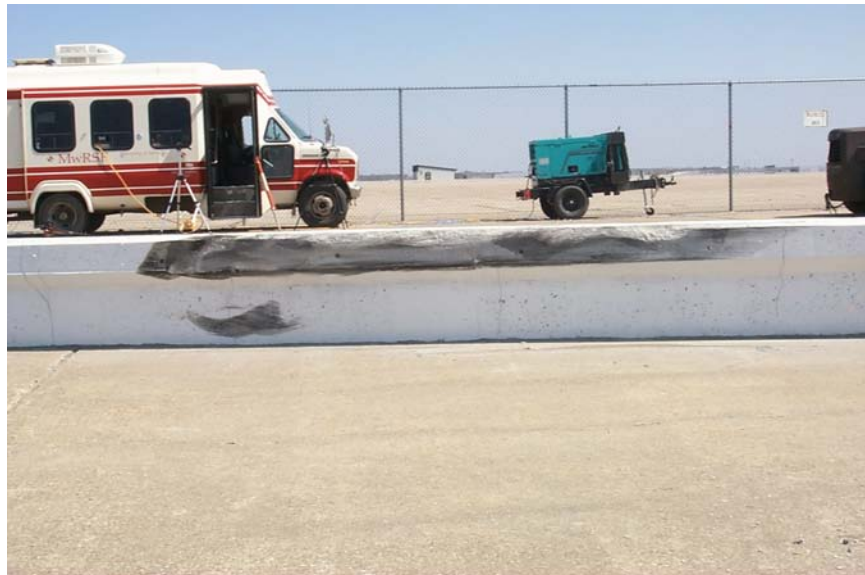
Figure 18. Low-Profile Bridge Rail Damage, Test LPBR-1

and minor spalling of the concrete. The length of vehicle contact along the concrete bridge rail was approximately 2.74 m. Minor spalling and black contact marks were found on the front face of the bridge rail. The lower front face of the bridge rail encountered 457 mm of contact marks originating at the impact point. Black contact marks and minor scrape mark were found on the concrete deck 7.62-m downstream from impact and 0.91-m laterally away from the traffic-side face of the rail.

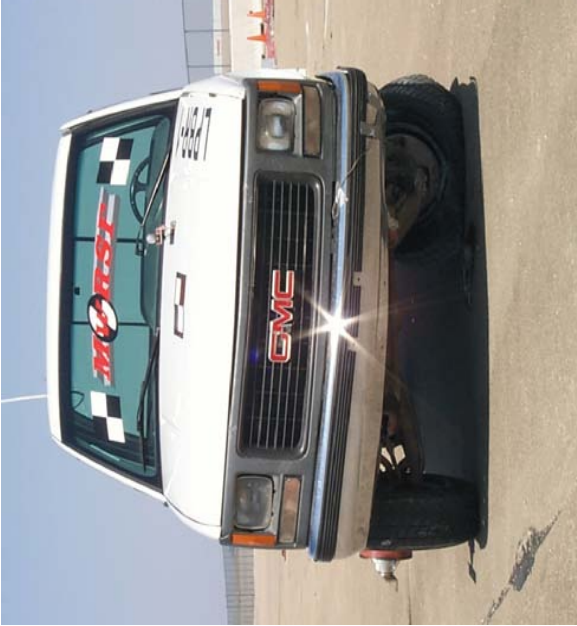
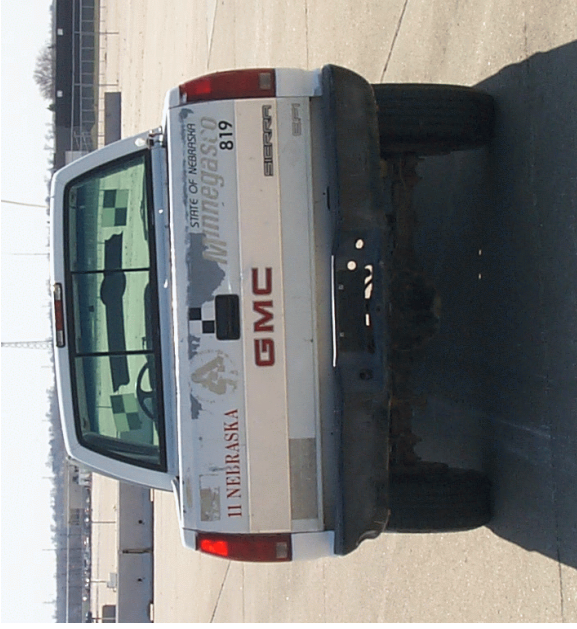
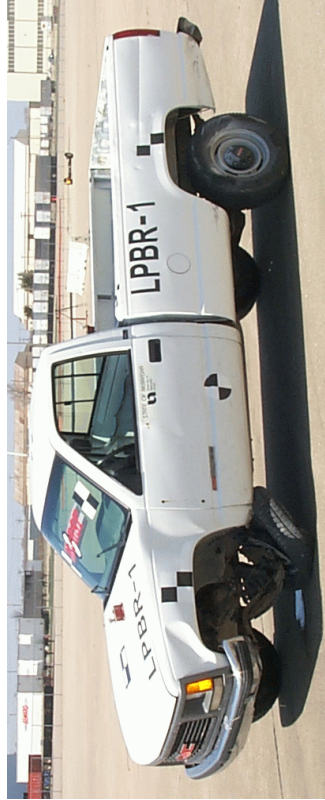
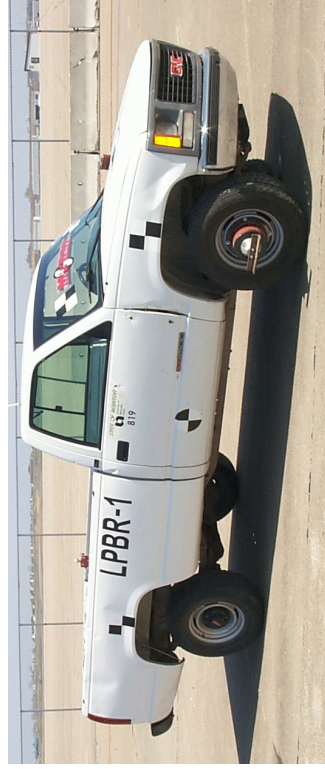
Figure 20. Vehicle Damage, Test LPBR-1

Exterior vehicle damage was moderate, as shown in Figures 20 through 22. The left-front side of the bumper was twisted in toward the engine compartment. The left-front fender was dented and deformed. Scrape marks and slight deformations were found on the lower portion of the box and the rear bumper. The box was also slightly twisted thereby increasing the gap between the cab and the box. Small scrape marks were found on the left-rear steel rim. Two 152-mm long scrape marks from the concrete rail were found on the left-rear wheel side wall. The left-front tire was almost pulled completely off of the steel rim. The left-front wheel disengaged from the upper A-frame control arm. The lower A-frame control arm was bent downward. The left-front tie rod disengaged. The sway bar was stretched but remained attached to the lower control arm. The left-front frame member encountered major deformations. The left side of the interior floorboard was deformed near the left toe pan and under the brake pedal, as shown in Figure 22. The roof, the hood, the right-side and left-side doors, and all the window glass remained undamaged.
