DEVELOPMENT OF A TEMPORARY CONCRETE BARRIER TO PERMANENT CONCRETE MEDIAN BARRIER APPROACH TRANSITION

MIDWEST ROADSIDE SAFETY FACILITY

MwRSF Research Report No. TRP-03-208-10

July 15, 2010

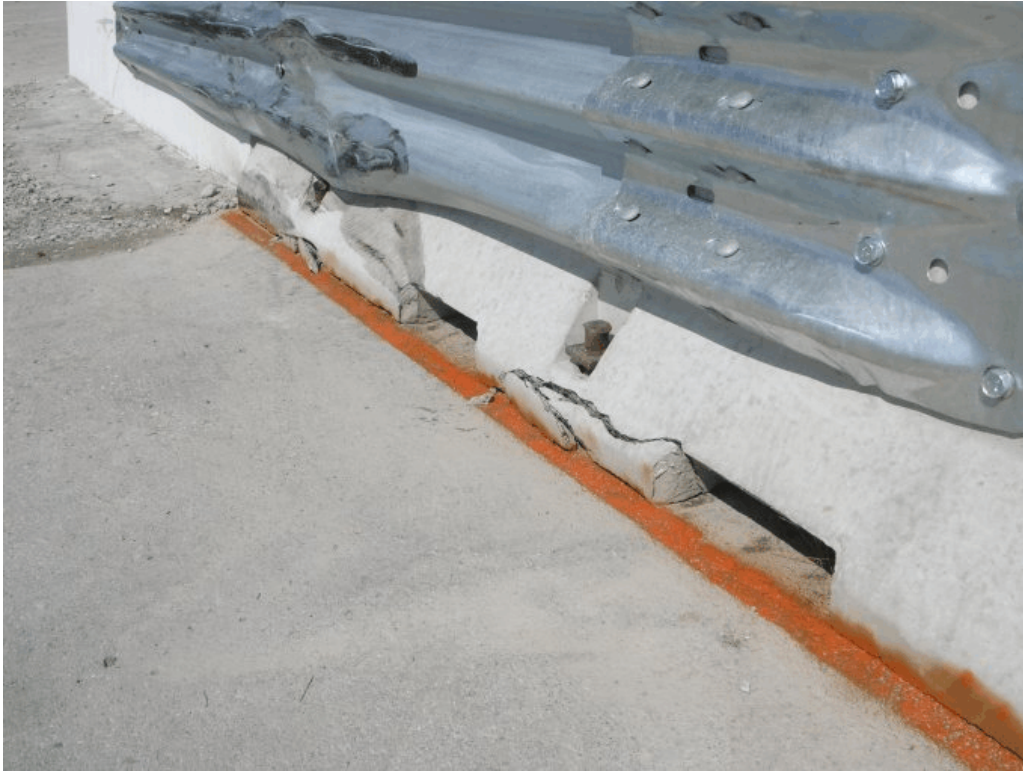
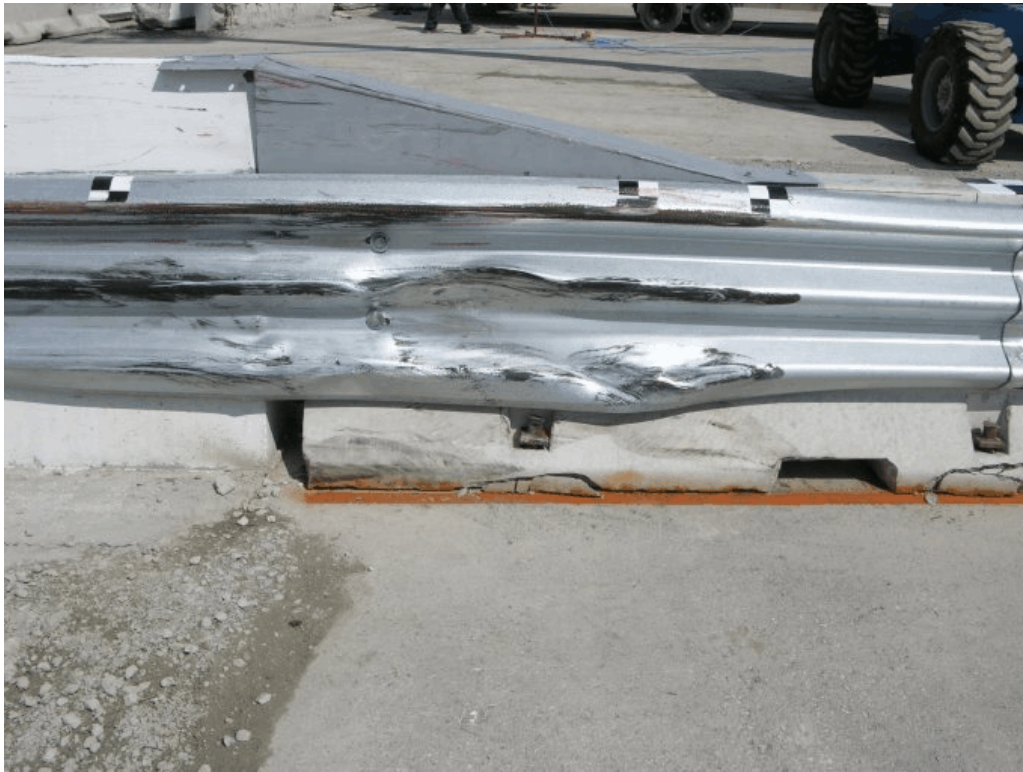
Figure 46. System Damage, Test No. TCBT-1

The permanent set of the barrier system is shown in Figure 46. The maximum lateral permanent set barrier deflection was $\frac{1}{4}$ in. (6 mm) at the downstream end of barrier no. 1. The maximum lateral dynamic barrier deflection was 2.6 in. (67 mm) on middle of the non-impact-side of the thrie beam, as determined from highspeed digital video analysis. The working width of the system was found to be 24 $\frac{7}{8}$ in. (632 mm).

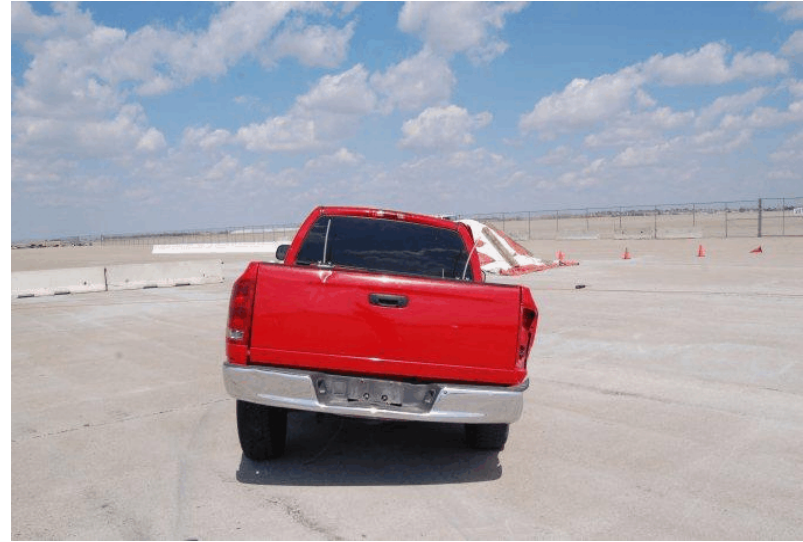
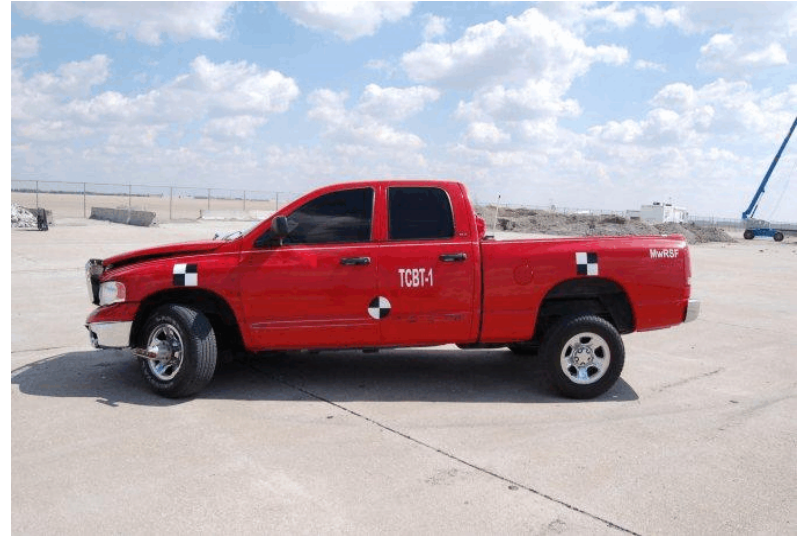
Figure 51. Vehicle Damage, Test No. TCBT-1

Vehicle damage was moderate, as shown in the Figures 51 through 54. Occupant compartment deformations to the right side of the floorboard were judged insufficient to cause serious injury to the vehicle occupants, as shown in Figure 54. Maximum longitudinal deflections of 6 in. (152 mm) were located near the front-center of the right-side floor pan. Maximum lateral deflections of 2 ¾ in. (70 mm) were located at the front-right of the right-side floor pan. Maximum vertical deflections of 5 ¼ in. (133 mm) were located near the front-center of the right-side floor pan. Complete occupant compartment deformations and the corresponding locations are provided in Appendix E.

Damage was concentrated on the right-front corner of the vehicle. The front bumper bent approximately 90 degrees 13 in. (330 mm) from the right side with the end in the wheel well area. The right-front corner was deformed inward toward the engine compartment. The right-front corner of the hood was deformed. The right-front wheel well is covered in black tire marks. The right-front upper and lower control arms were severely damaged. Scrapes and contact marks were found along the entire right side of the vehicle. Major sheet metal deformations were found above the right-side wheel well and along the lower portion of the right-side doors, not allowing the right side doors to open. The right side door buckled outward from the inside causing a 5-7 in. (127-178 mm) gap along the top frame of the door and a 1-6 in. (25-152 mm) gap along the side of the door. The right-rear bumper was deformed inward and flattened flush with rear quarter panel. Contact marks were found on the right-rear hubcap. The right-side taillight housing was dislodged. The right-front tire was cut severely about 6-8 in. (152-203 mm) and detached from the vehicle, except for the being attached only by the brake line. All other tires remained attached. Spider-web cracking was found on the

bottom, left, and right sides of the windshield. No other window damage occurred. The roof and the left side of the vehicle remained undamaged.

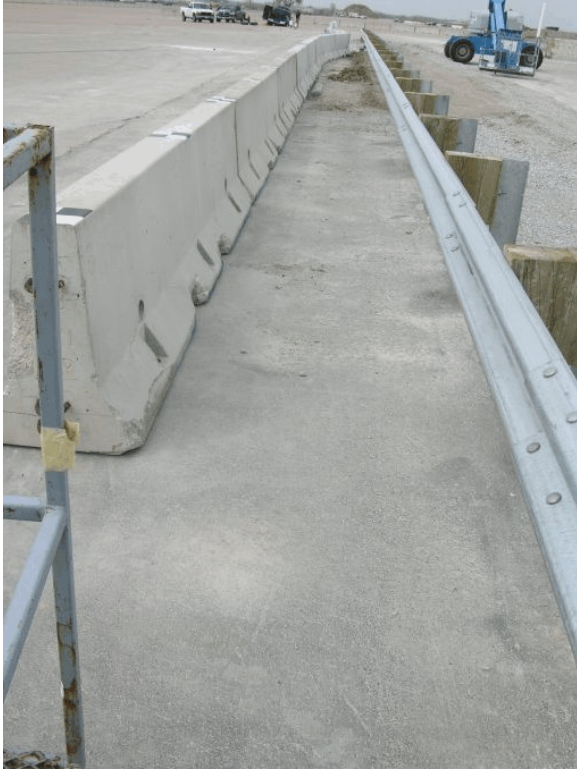
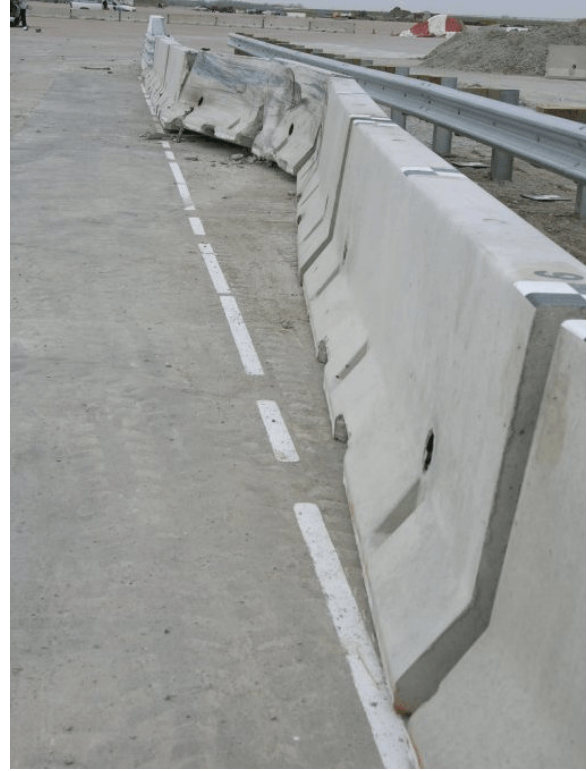
Figure 62. System Damage, Test No. TCBT-2

Damage to the system was moderate, as shown in Figures 62 through 64. Barrier damage consisted of scrapes, contact marks, and concrete spalling on temporary concrete barriers and asphalt pin deflections, cracking of temporary barrier sections, and fractured temporary barriers. The length of the vehicle contact along the transition was approximately 17 ft - 1 ½ in. (5.2 m), which spanned from 41 ¼ in. upstream of the downstream end of barrier no. 5 to 8 in. (203 mm) downstream from the upstream end of barrier no. 3.

The permanent set of the barrier system is shown in Figure 62. The maximum lateral permanent set barrier deflection was 34 in. (864 mm) at the downstream end of barrier no. 5, as measured in the field. It should be noted that the barrier segments upstream of impact had permanent set longitudinal deflections between 5 in. and 6 in. (127 mm and 152 mm) downstream. The maximum lateral dynamic barrier deflection was 34 in. (864 mm) at the upstream end of barrier no. 5, as determined from highspeed digital video analysis. The working width of the system was found to be 55.8 in. (1,117 mm).

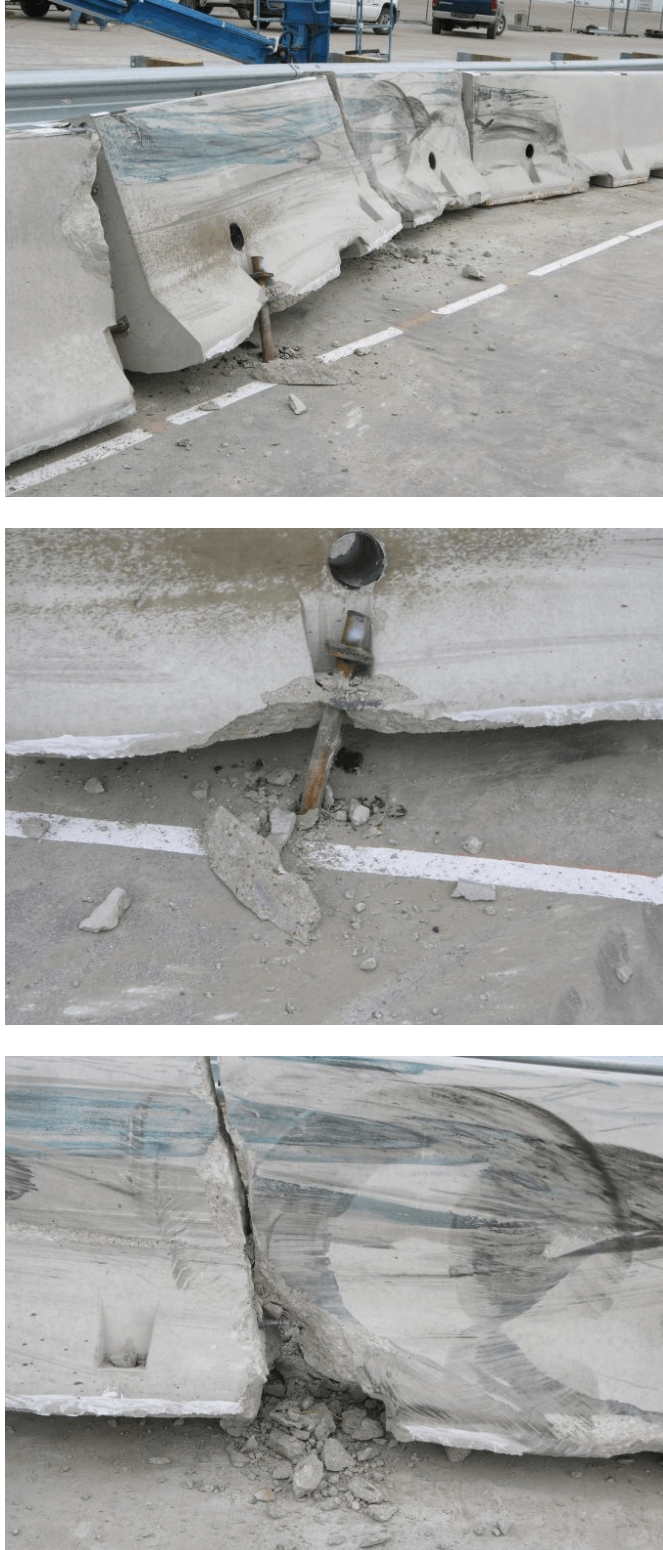
Figure 63. System Damage, Test No. TCBT-2

Tire marks, scrapes, and cracking of the concrete were visible on barrier segment nos. 3 through 5. The traffic-side of barrier no. 5 had concrete spalling on the upstream end of the barrier. Concrete spalling occurred around the rear upstream asphalt pin of barrier no. 3 which was 19 in. (483 mm) long by 7 in. (178 mm) high. Concrete spalling also occurred around the rear downstream asphalt pin of barrier no. 3 which began at the downstream end and continued for 44 in. (1,118 mm). The top of barrier no. 3 on the upstream end had significant contact marks. Barrier no. 4 rolled toward the back of the system exposing the upstream end of barrier no. 3 to the truck. Barrier no. 4 was cracked in half and rebar was fractured at the midsection. Concrete spalling was found on the backside of barrier no. 4 beginning at the lower downstream end and continued 32 in. (813 mm) along the bottom of the barrier. The traffic-side of barrier no. 5 had tire and minor contact marks on the downstream end.
