# Relating Ride Quality and Structural Adequacy for Pavement Rehabilitation/Design Decisions

PUBLICATION NO. FHWA-HRT-12-035

NOVEMBER 2012

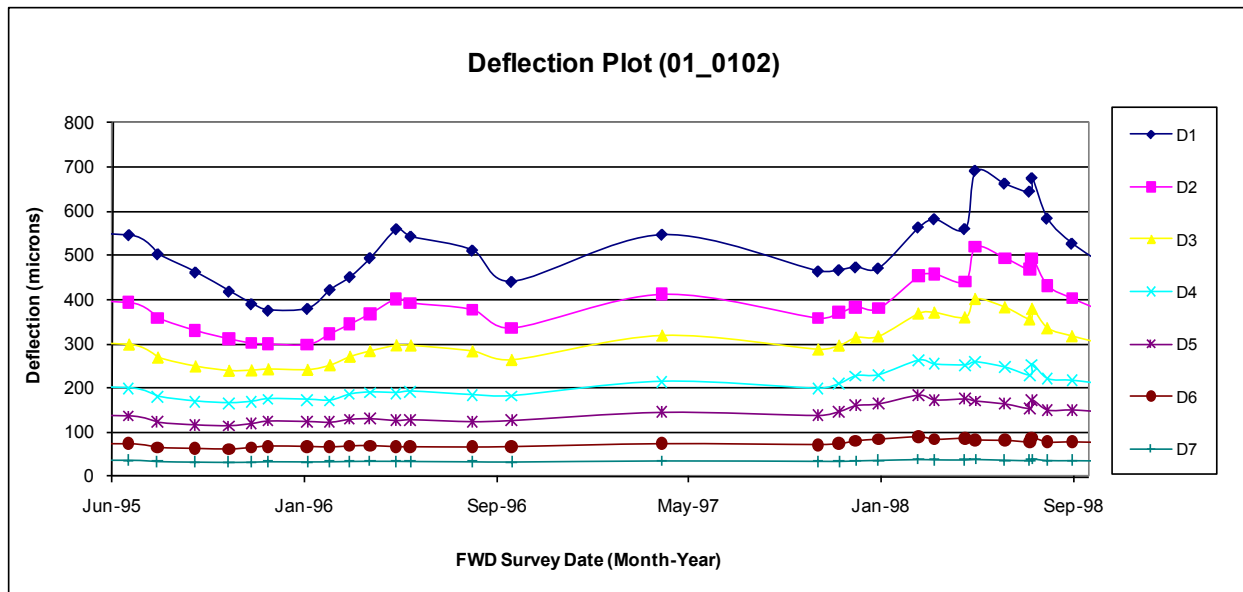
**Figure 2. Graph. Changes in deflection over time at LTPP SMP test section.**

Another factor making assessment of structural adequacy challenging is that pavement material properties change, sometimes drastically, with changes in surface and subsurface moisture and temperature conditions. Figure 2 shows changes in deflection for seven sensors at various radial distances over time at an LTPP Seasonal Monitoring Program (SMP) test section. The impact of moisture and temperature changes over time is clearly shown in this figure. Do ride quality or other performance indicators (e.g., distress and friction) change in a similar fashion?

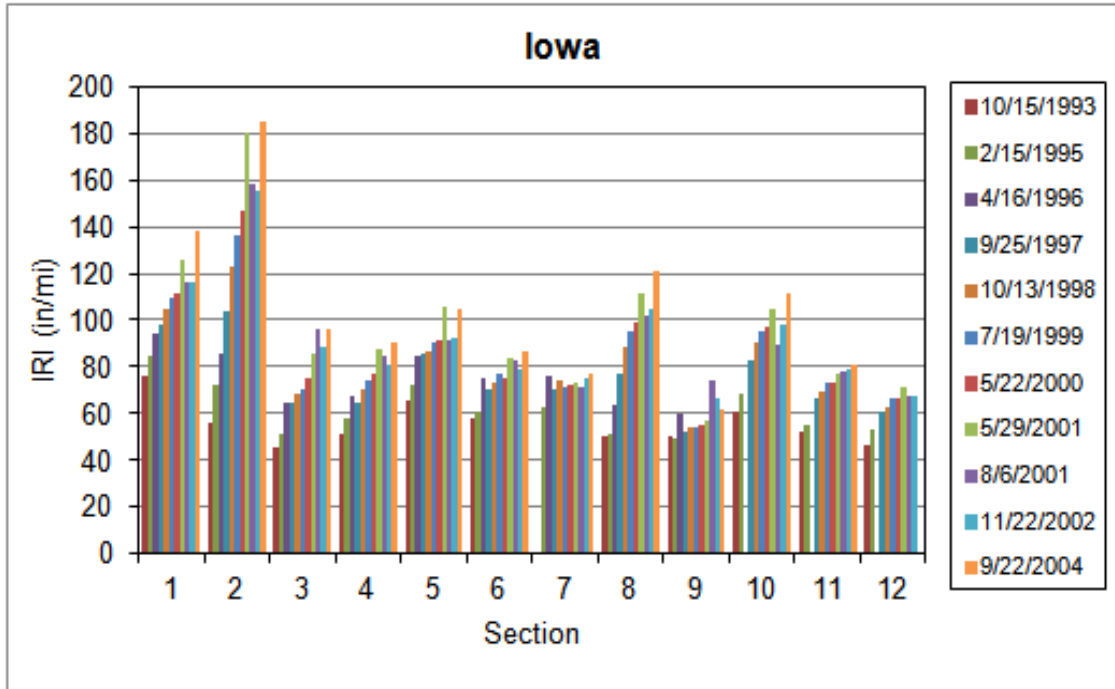
Figure 3. Graph. Changes in IRI over time for LTPP SPS-1 test sections in Iowa.

Table 1 shows the pavement structure of the LTPP Specific Pavement Study (SPS)-1 (new hot mix asphalt (HMA) pavement) test sections, and figure 3 and figure 4 show the roughness progression at some of the LTPP SPS-1 projects. All sections within a project appear to have close initial IRI values, but do sections that show a high rate of IRI deterioration have low structural capacity?

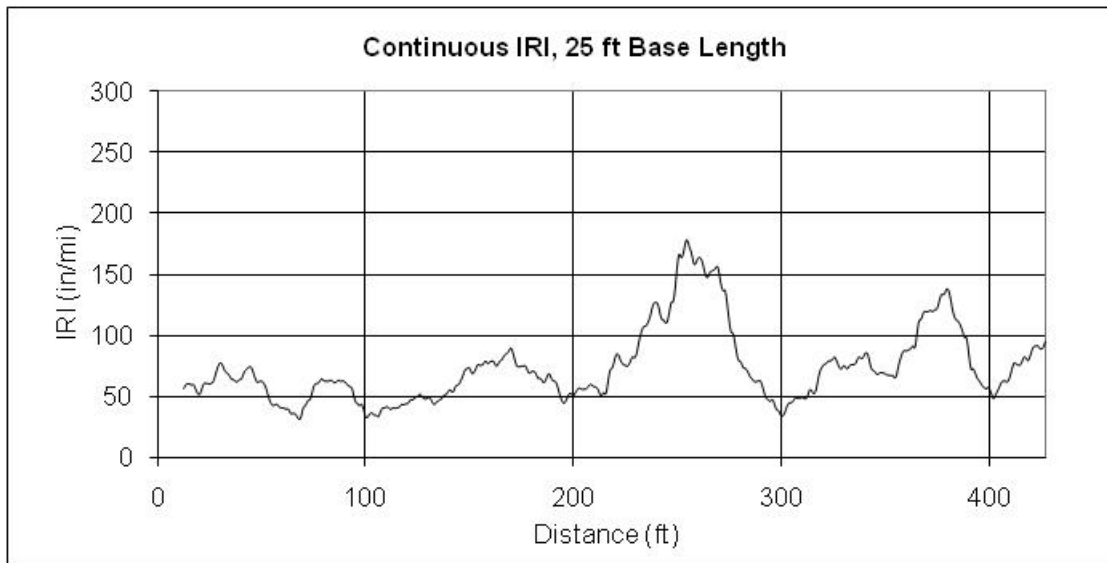
Figure 9 shows a 25-ft base length continuous IRI plot of a section of roadway. Any point on this plot shows the IRI of a 25-ft-long section that is centered at that location. For example, the IRI shown at 50 ft is the average IRI from 37.5 to 62.5 ft. The overall IRI of this roadway is 73 inches/mi.

**Figure 9. Graph. Continuous IRI plot of road profile.**

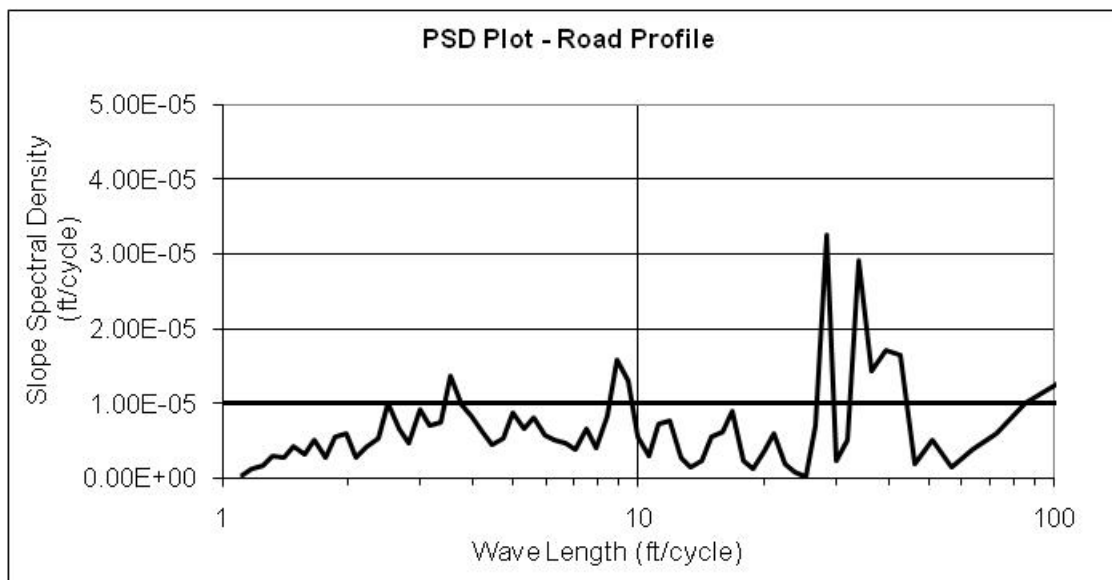
Figure 10 shows the power spectral density (PSD) plot of the profile data. A PSD function is a statistical representation of the importance of the various wavelengths contained in the profile. The PSD plot shows that there is significant spectral content close to a wavelength of about 30 ft. This value is close to the spatial frequency of the body bounce motion of the truck and can result in high dynamic loads being applied on the pavement.

**Figure 10. Graph. PSD plot of road profile.**

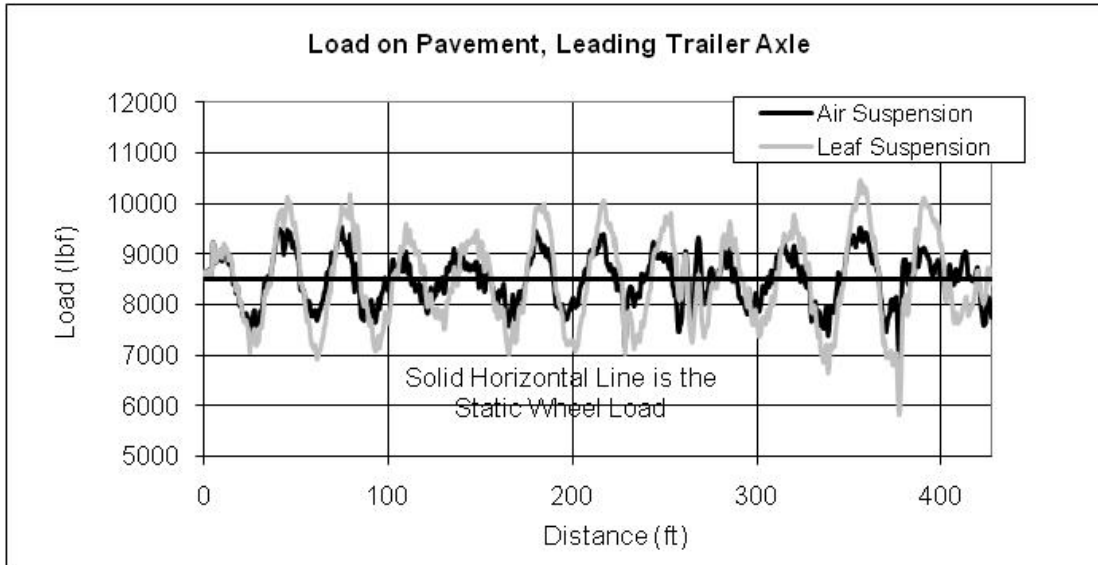
Figure 11 shows the dynamic loads that were predicted for the leading trailer axle by a truck simulation model. The dynamic loads predicted for a truck with air suspension and for a truck with leaf suspension are shown. This pavement section is a fairly smooth pavement with an overall IRI of 75 inches/mi. However, it had wavelengths that were close to the natural frequency of the body bounce motion of the truck. This caused high dynamic loads to be applied on the pavement. There could be other pavement sections that have an IRI of 75 inches/mi that

do not have significant wavelength content close to the natural frequency of the body bounce motion of this section. On such a section, the magnitude of the dynamic loads applied on the pavement is expected to be lower. Therefore, the IRI level by itself is not a predictor of dynamic loads imparted on the pavement.

**Figure 11. Graph. Dynamic loads applied to road profile.**

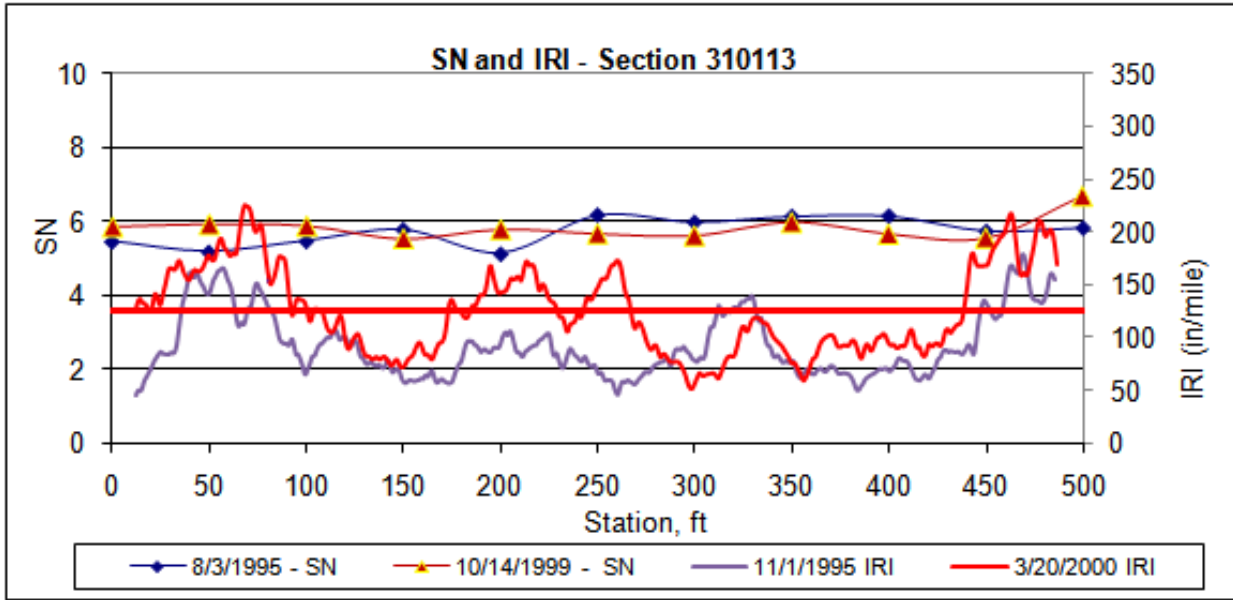
Figure 33 shows the first and last IRI and SN values for this section, and figure 34 shows the normalized IRI and SN plots. No major changes in IRI occurred at any localized location within the test section. A slight increase in SN occurred over time at about half of the test locations, and the other half showed a slight decrease in SN. No test location showed a change in SN that was vastly different than the rest of the test locations. No relationship was noted between the increase in IRI and the deflection below the load or the subgrade modulus.

Figure 33. Graph. SN and IRI for two test dates, section 310113 (Nebraska).

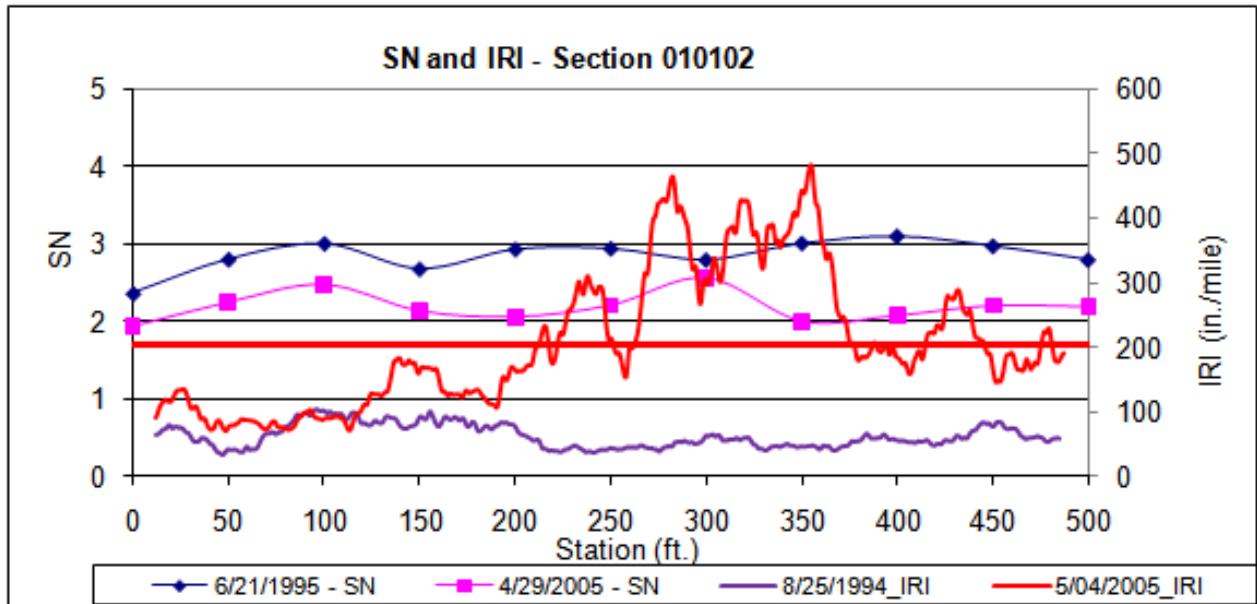
from 75 to 114 inches/mi, and IRI of the section from 200 to 500 ft increased from 53 to 271 inches/mi. The highest increase in IRI occurred between about 260 and 380 ft. The average decrease in SN for the first 200 ft was 0.59, and average decrease in SN between 250 and 500 ft was 0.74. Although the last 300 ft of the section had a higher increase in IRI and showed a larger decrease in SN when compared to the first 200 ft, the decrease in SN of the last 300 ft was only slightly higher than that for the first 200 ft. In addition, a small SN decrease of 0.24 was noted at 300 ft, which was within the limits that showed the highest increase in IRI for this section. No relationship was noted between the increase in IRI and the deflection below the load or the subgrade modulus.

Figure 35. Graph. SN and IRI for two test dates, section 010102 (Alabama).

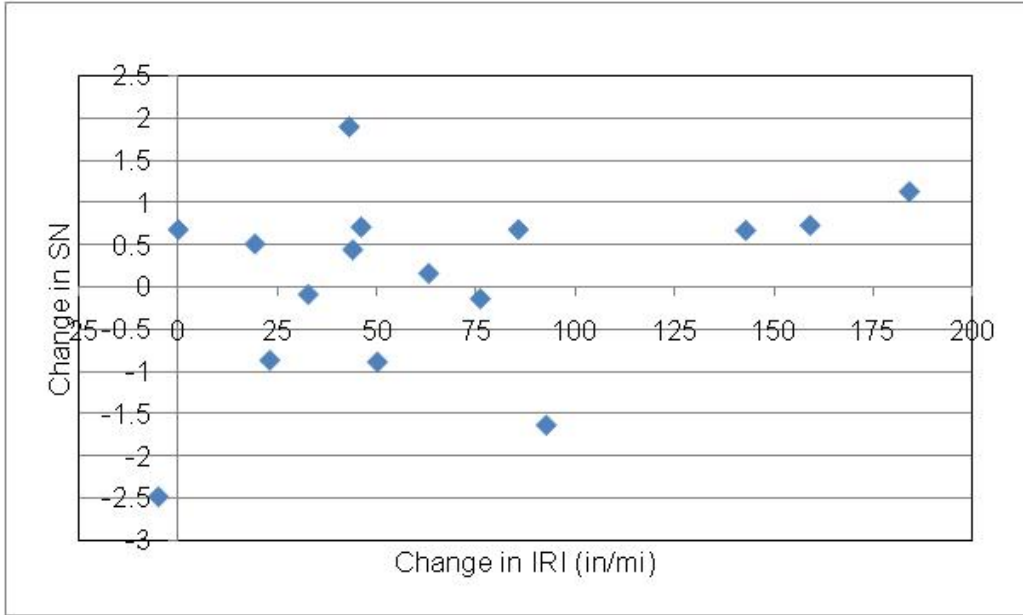
**Figure 73. Graph. Relationship between changes in IRI and SN.**
