Report No. UT-03.33

***FLEXURAL PERFORMANCE OF
DETERIORATED REINFORCED
CONCRETE CANTILEVERED
BENT CAPS – PART 1***

**Department of Civil &
Environmental Engineering
Brigham Young University
Provo, Utah**

**Utah Department of Transportation
Research Division**

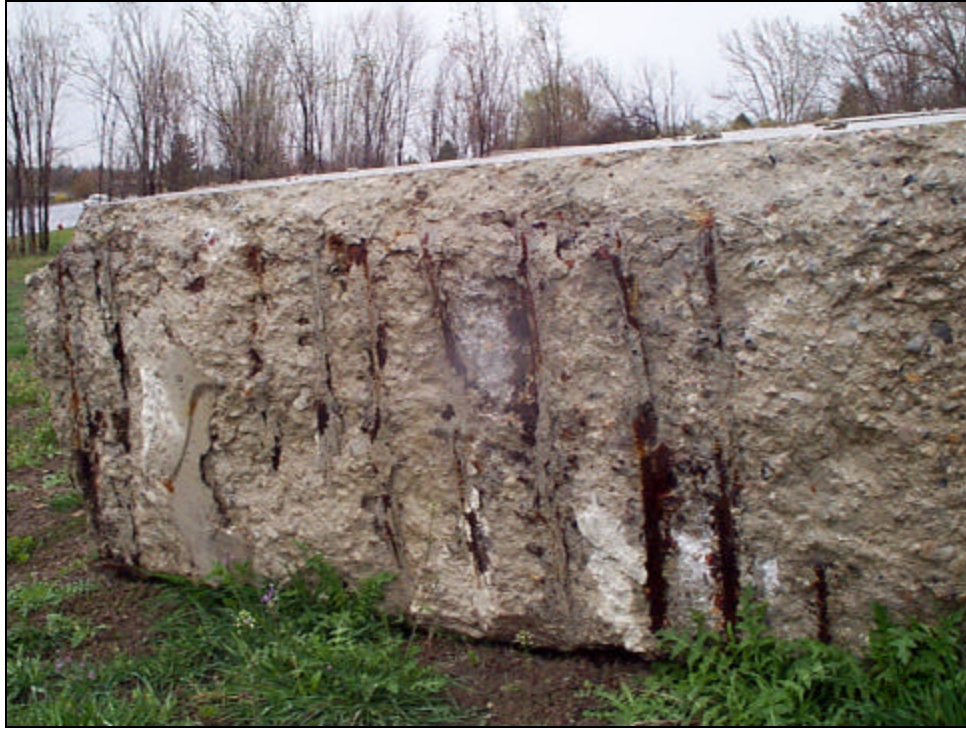
Figure 1.3 – Bent 12S, deterioration on underside of cantilever

The existing bent caps had suffered varying degrees of deterioration, including significant spalling of the concrete on the underside of the cantilever and corrosion of the stirrups. Several stirrups in each bent caps were corroded completely through on the underside of the cantilever.

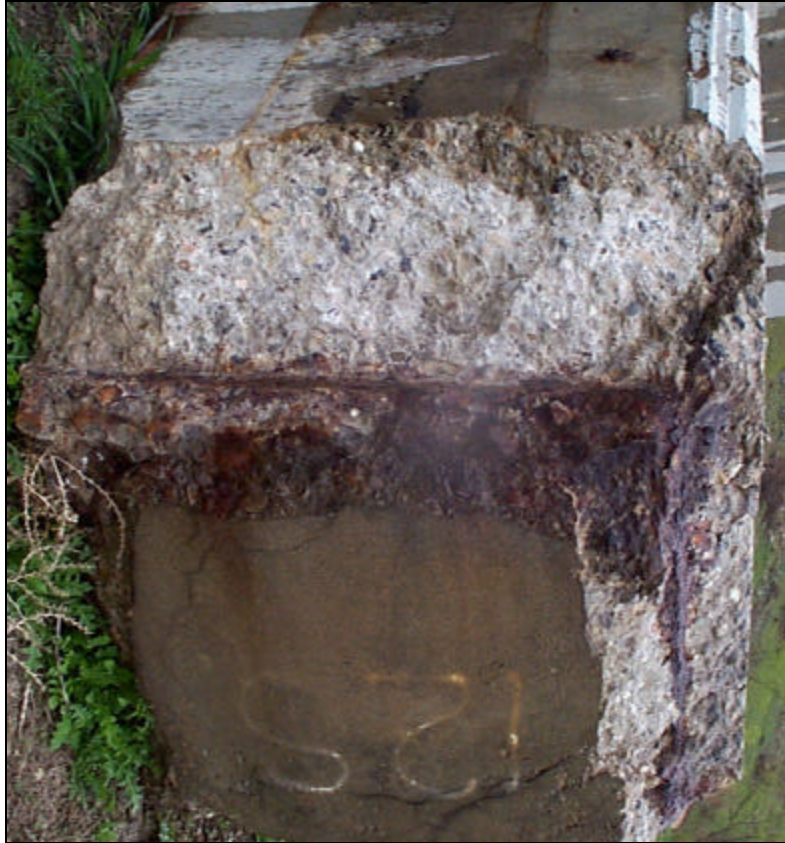
Figure 1.5 – Bent 12S, deterioration at tip of cantilever

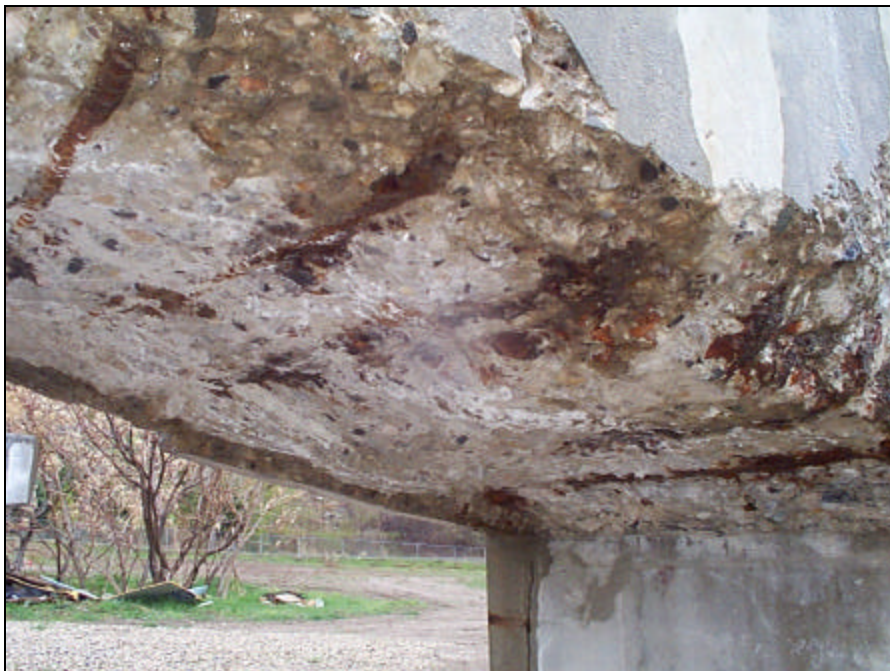
Figure 1.6 – Bent 12N, close up of deterioration on underside of cantilever

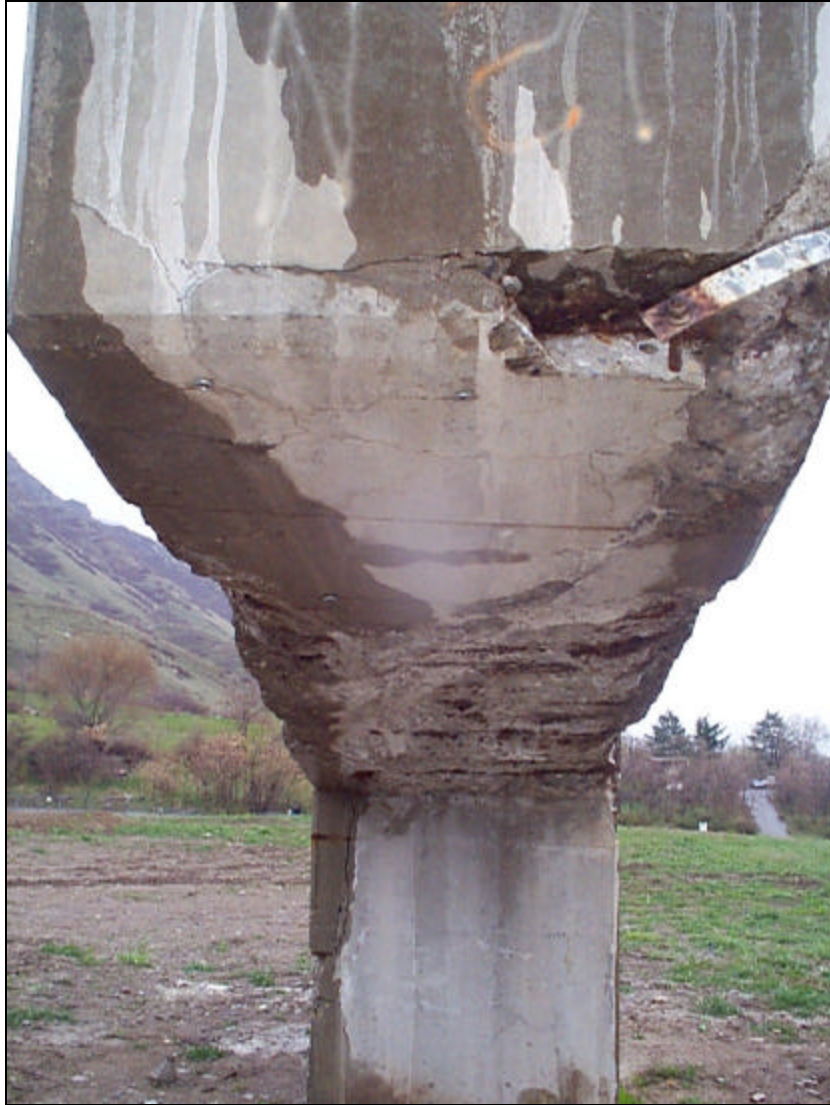
Figure 1.7 – Bent 12N, deterioration on underside of cantilever

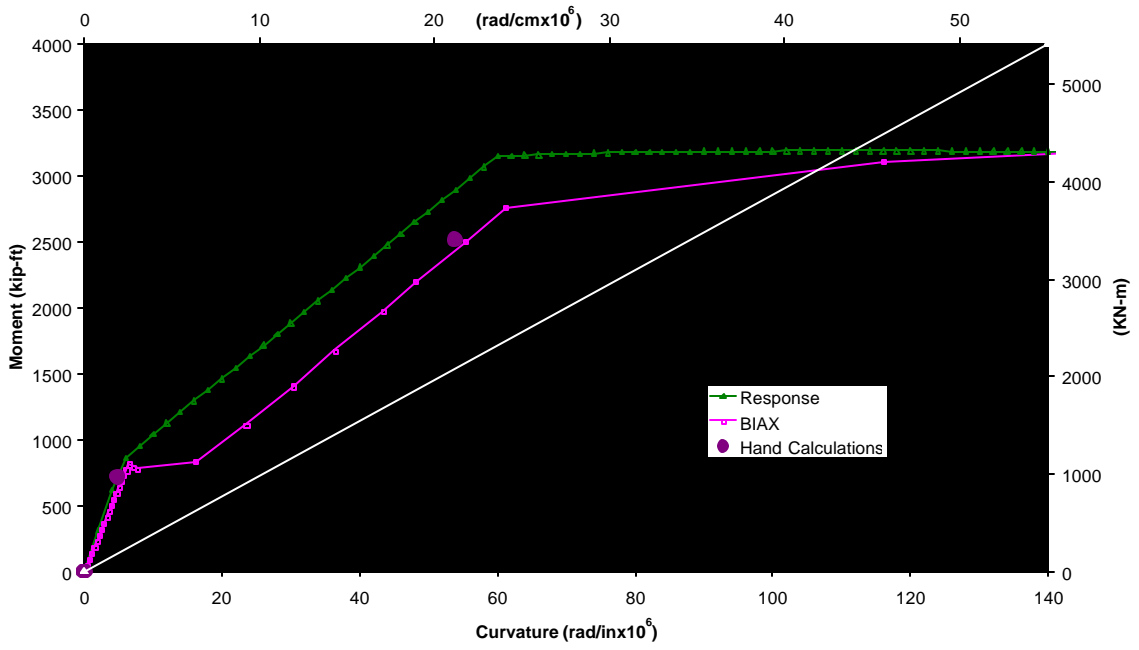
Figure 2.1 – Theoretical moment curvatures

Figure 2.1 shows the moment-curvature for the bent. Concrete cracking is shown by the stiffness occurred at a moment of 812 kip-ft (1,100 kN-m) and a curvature of 6.5×10^{-6} rad/in (2.6×10^{-6} rad/cm). Yield occurred at a moment of 2,757 kip-ft (3,738 kN-m) and a curvature of 61×10^{-6} rad/in (24×10^{-6} rad/cm).

Figure 2.1 shows the moment-curvature for the bent. The concrete section cracks at a moment of 859 kip-ft (1,165 kN-m) and a curvature of 6×10^{-6} rad/in (2.4×10^{-6} rad/cm). The yield point occurred at a moment of 3,144 kip-ft (4,263 kN-m) and a curvature of 60×10^{-6} rad/in (24×10^{-6} rad/cm).

Figure 2.1 shows the two calculated values. The concrete cracks at a moment of 716 kip-ft (971 kN-m) and a curvature of 5×10^{-6} rad/in (2.0×10^{-6} rad/cm). The section

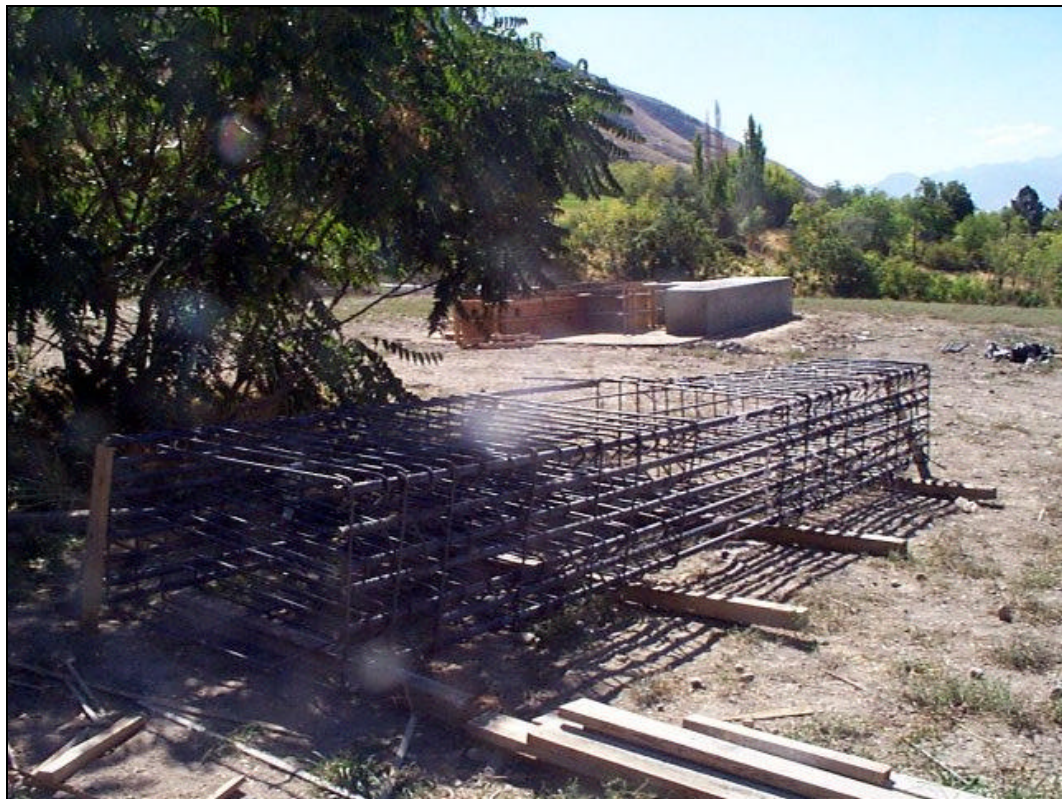
Figure 3.1 – Reinforcement cage for new bent.

Two new bents were constructed to compare with the old deteriorated bents. Construction was done according to structural drawings provided by the Utah Department of Transportation (UDOT). Figure 3.1 shows the reinforcement cage for one of the bents. Figure 3.2 shows the forms for one of the bents before the rebar cage was placed inside the forms. Figure 3.3 shows a new bent after the forms had been removed.

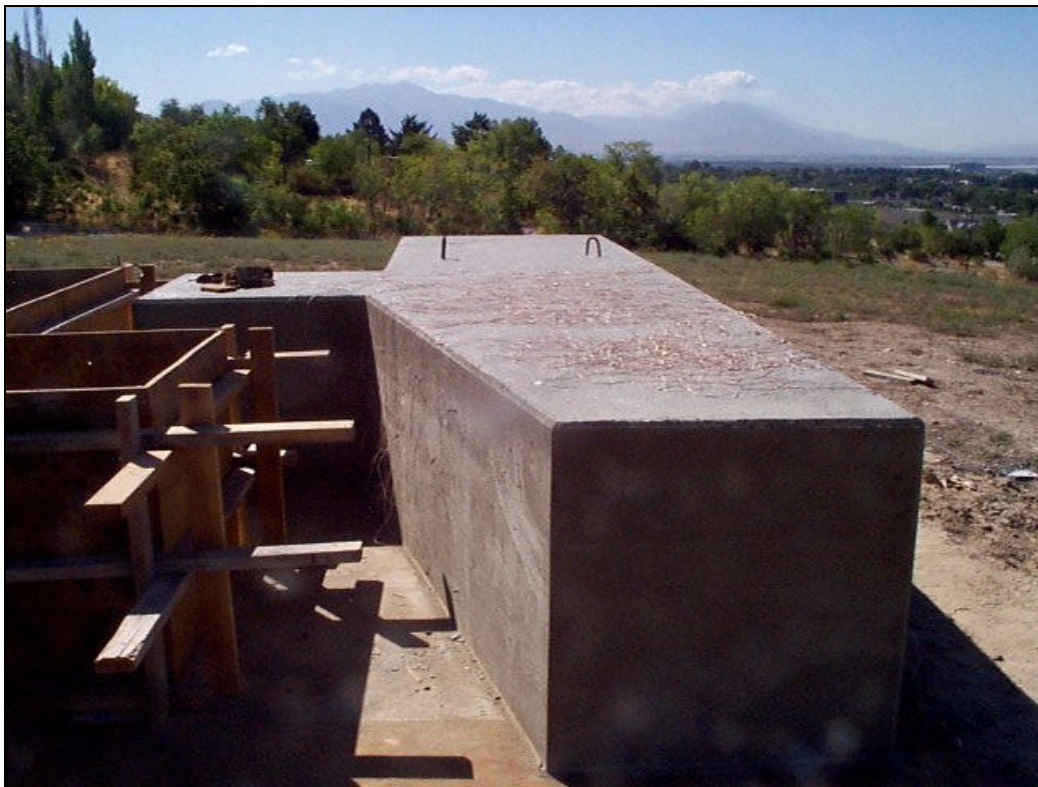
Figure 3.3 – New bent after removal of the forms.

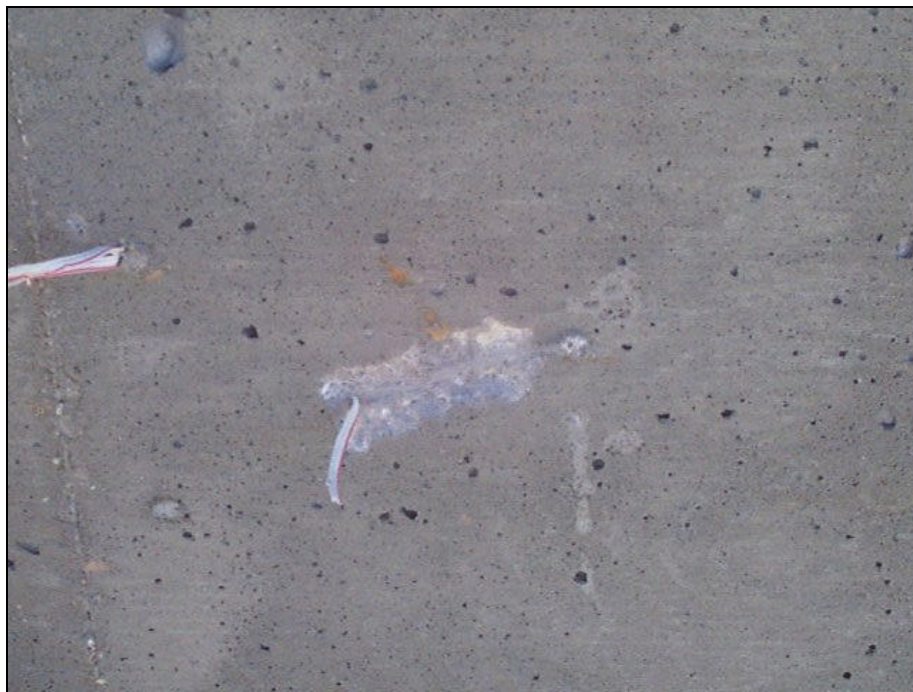
Figure 4.14 – Strain gauge lead wire torn off.

Some of the strain gauges were damaged during construction of the bents despite the best efforts of the workers to not harm them. To provide access after casting, the lead wires of the strain gauges were pulled out through holes in the forms of the bent. As the forms were pulled off, several lead wires broke near the surface of the concrete. The wires were spliced with new wires after chipping away a small area of concrete around the wire, as shown in Figure 4.14.

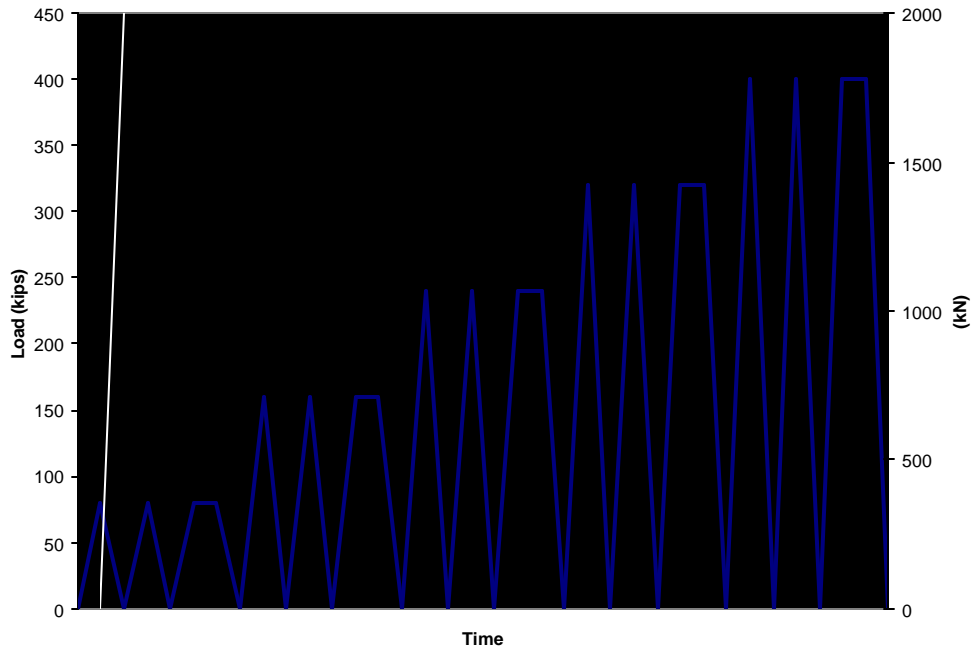
Fig. 4.17 – Loading Protocol for load controlled portion of all tests.

The bents were loaded in a cyclic manner. Figure 4.17 shows the loading protocol. For the bents tested to failure, 80 kip (356 kN) steps were taken to a load of 400 kips (1,780 kN). After 400 kips (1,780 kN), the test was displacement controlled. The yield displacement was estimated at 320 kips (1,424 kN) by assuming a yield

bent was then pushed to two times the estimated yield displacement, then three times the estimated yield displacement and continuing until failure. Three cycles were used for each load/displacement level.

For specimens tested to yield, 80 kip (356 kN) steps were used to load the bents up to 560 kips (2,492 kN). These bents were loaded to introduce sufficient cracking for investigation in the next phase of the project.

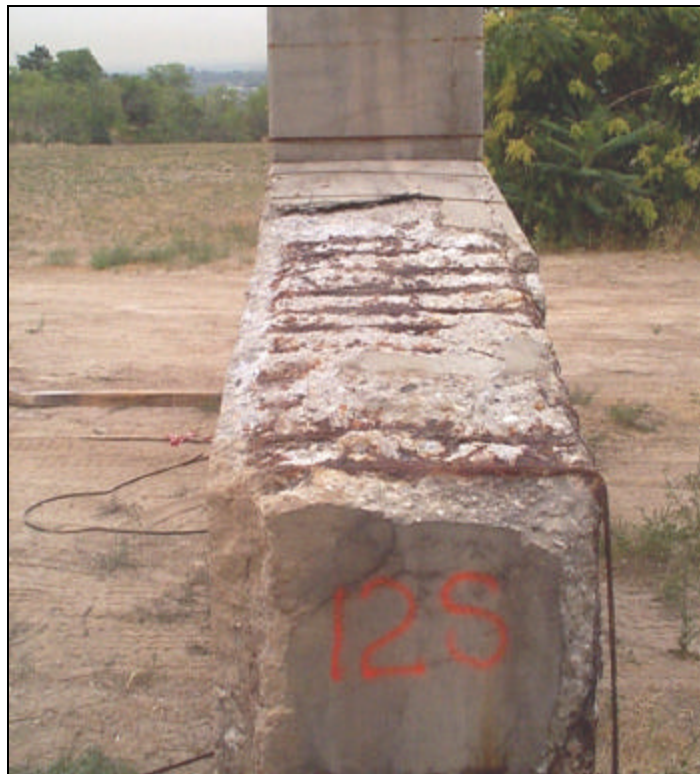
Figure 5.7 – Bent 12S, deterioration on underside of cantilever.

The first bent tested was Bent 12S, which was severely deteriorated on the underside of the cantilever. As shown in Figure 5.7, several stirrups had corroded completely through and significant spalling of the concrete had occurred.

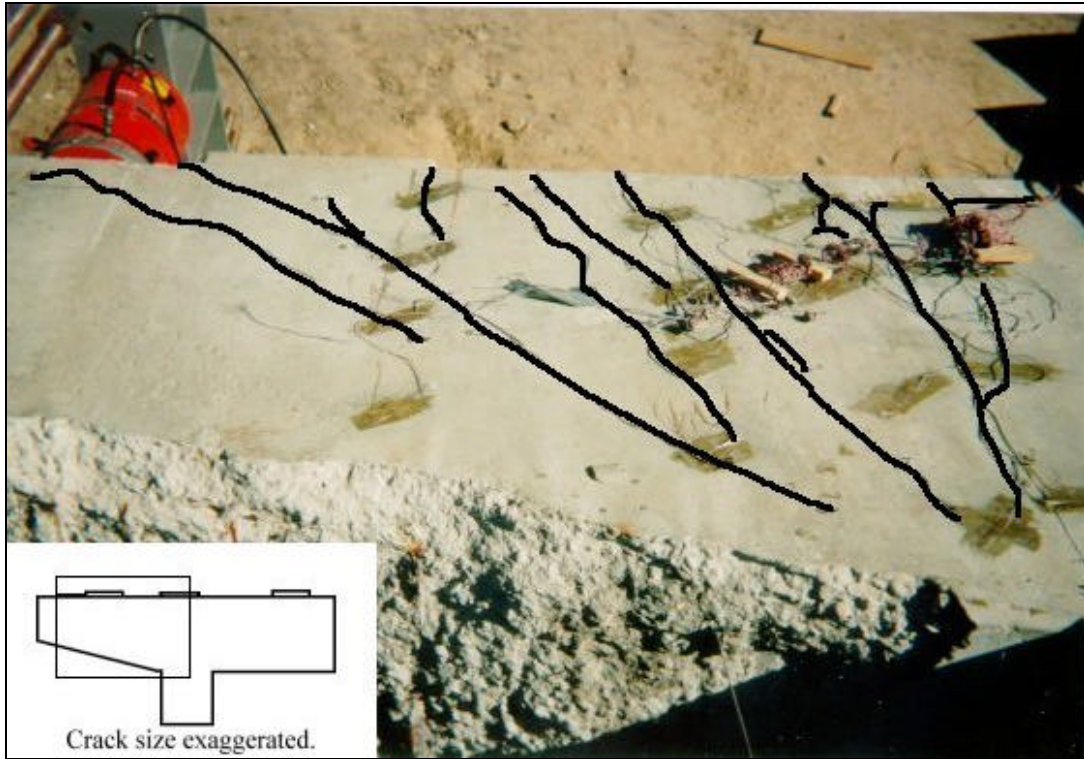
Figure 5.16 – Bent 12S, cracks on cycle 8.

On cycle 8, with a peak load of approximately 640 kips (2,840 kN), no new cracks appeared. The existing cracks are shown in Figure 5.16. These cracks extended a few inches further toward the reentrant corner. On cycle 9, also with a peak load of 640 kips (2,840 kN), a new crack developed on the upper portion of the cantilever beam. The previous cracks extended to within a couple of inches of the bottom of the cantilever beam, as shown in Figure 5.17. After cycle 9, existing cracks became wider and did not lengthen with each successive loading. As shown in Figure 5.18, the main cracks eventually widened to between 0.25 (6.4) and 0.375 in (9.5 mm).

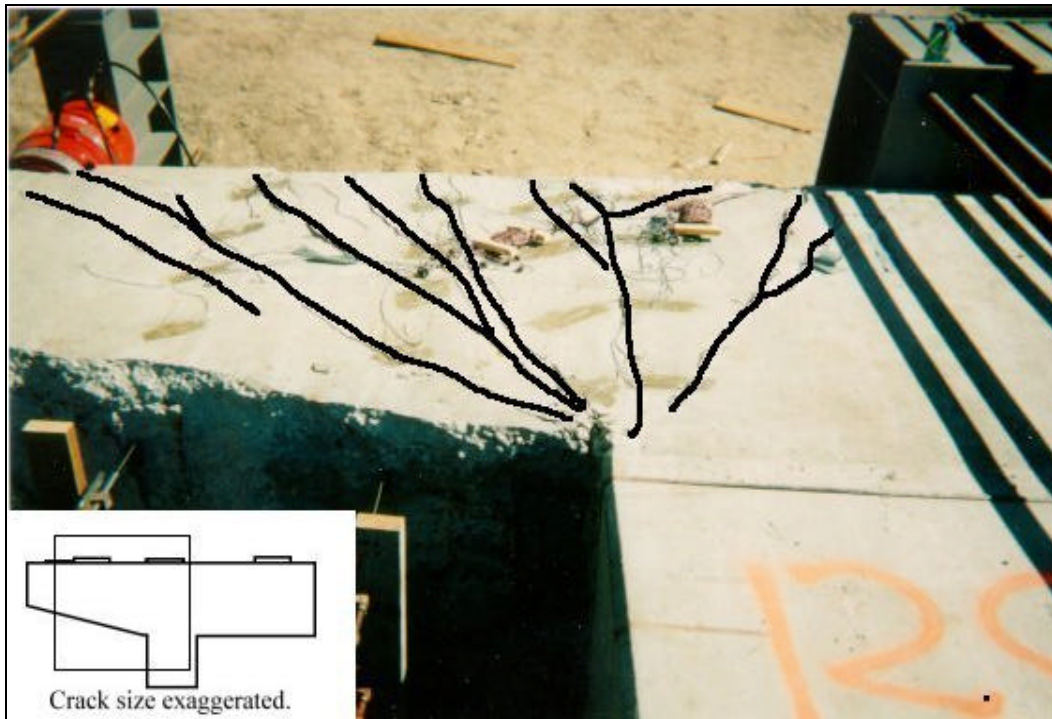
Figure 5.19 – Bent 12S, crack pattern at failure

The bent reached a maximum load of 709 kips (3,155 kN) on the first push of cycle 13. After yielding, crushing of the concrete in the compression zone of the cross-section began and continued until failure. Figure 5.19 shows the crack pattern after failure and Figure 5.20 shows the compression zone after failure.

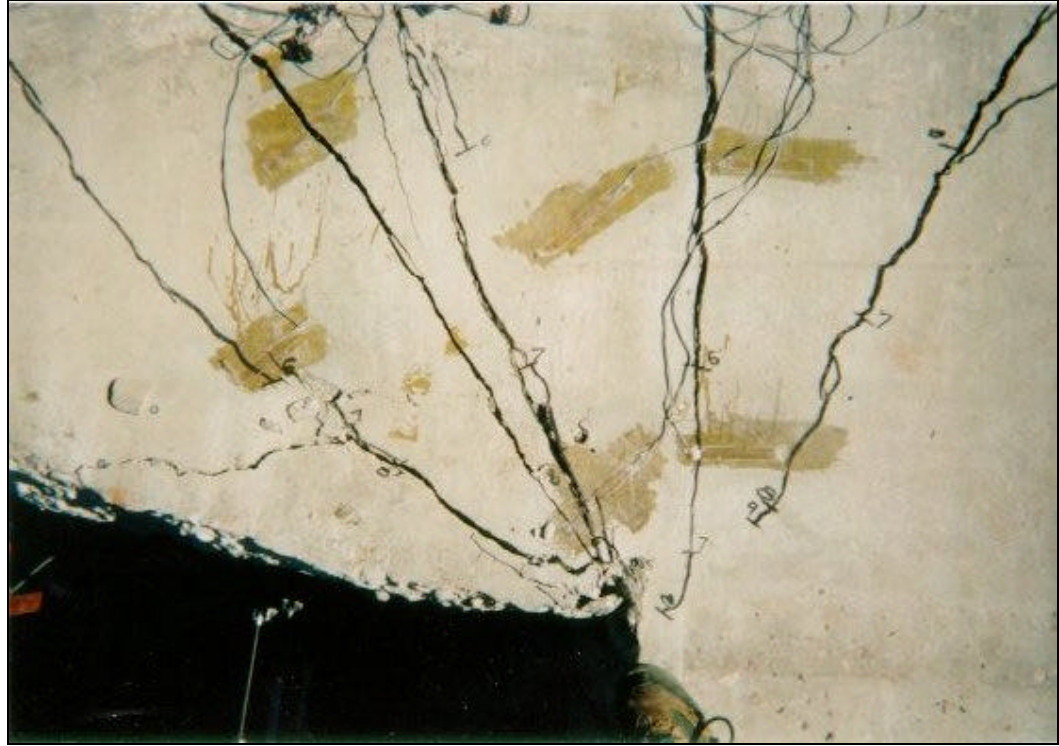
Figure 5.20 – Bent 12S, Compression zone after failure.

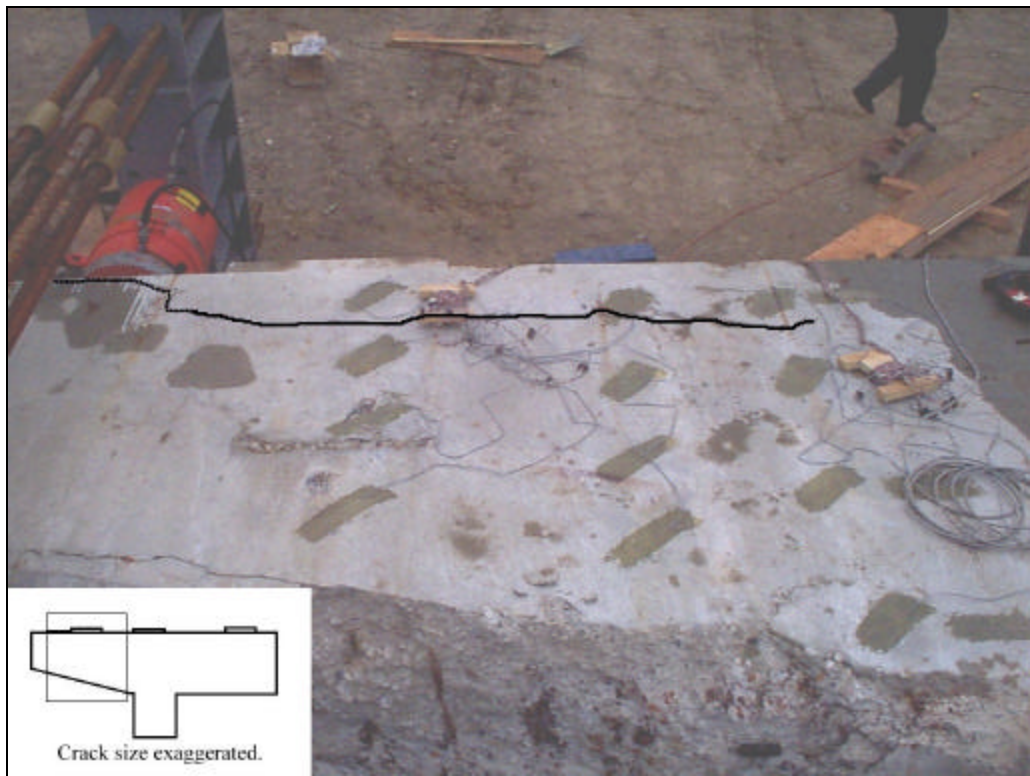
Figure 5.21 – Bent 12N, crack previous to testing, deterioration of underside of beam.

Bent 12N was also severely deteriorated on the underside of the cantilever portion, although not as severely as Bent 12S. Figure 5.21 shows the cantilever beam and the deterioration on the underside of the beam. Severe spalling had occurred exposing some of the stirrups that were significantly corroded.

There was one existing crack, shown in Figure 5.21, on the side of the bent before the test. The crack runs longitudinally down the main axis of the cantilever beam. A possible explanation for this crack is the expansion of the top rebar as it is corroded.

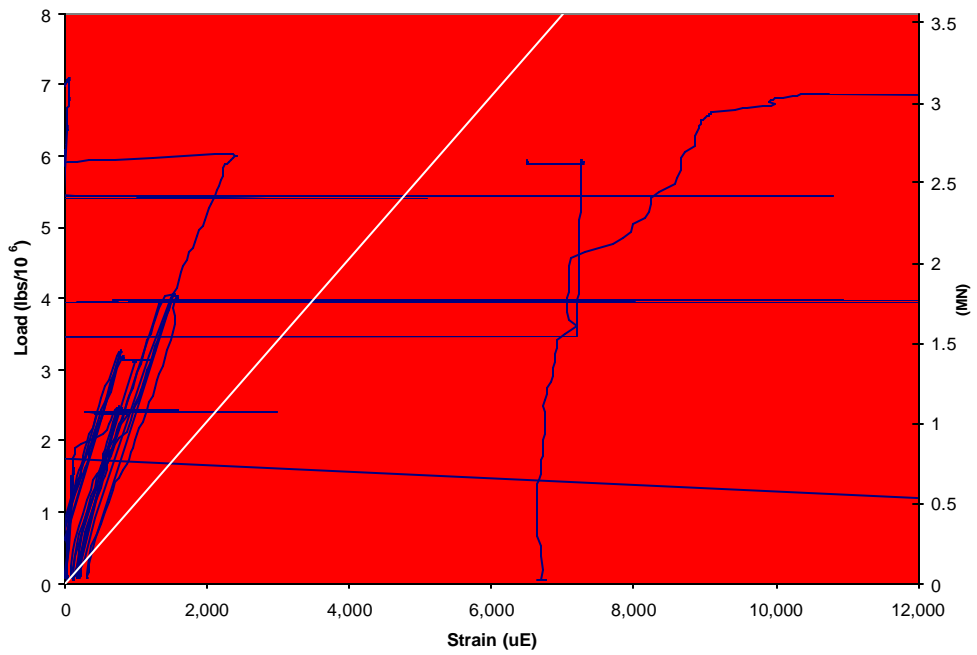
Figure 5.32 – Bent 1N, Strain on main flexural bar.

Figure 5.32 shows the strain gauge data from one of the main flexural bars. The load at which the concrete cracks is approximately 200 kips (890 kN). At this point the stress previously in the concrete is now concentrated in the reinforcement. The yield of the reinforcement can also be seen at approximately 2,000 microstrain. The strain gauge malfunctions immediately after yielding of the reinforcement and causes the irregular lines seen in the graph.

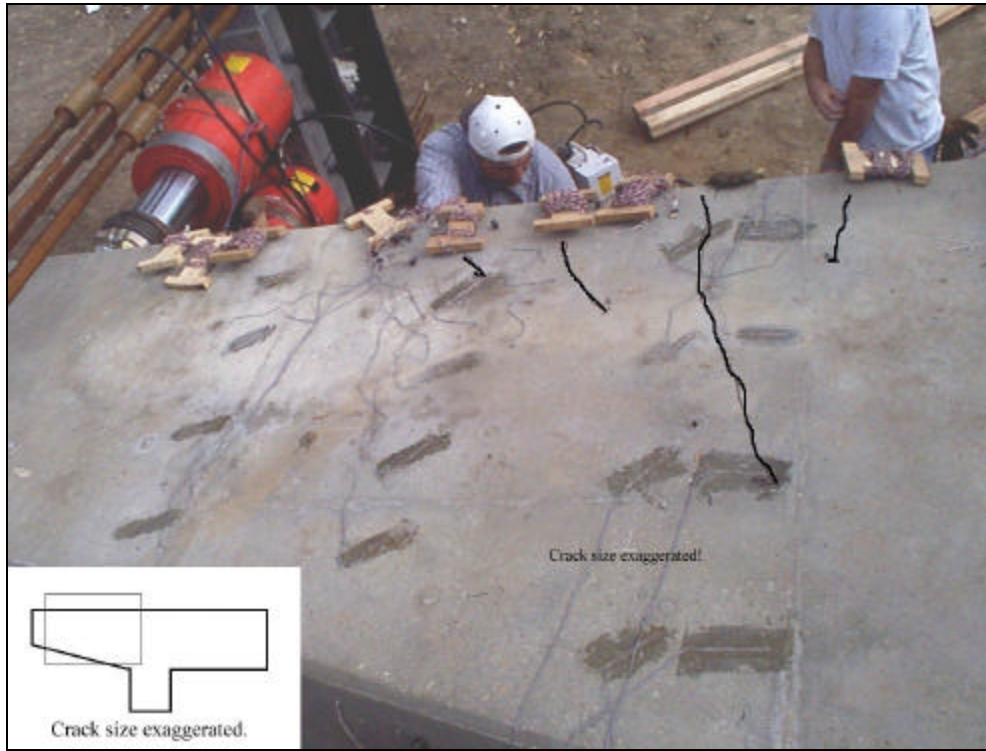
Figure 5.33 – Bent 1N, cracks on cycle 3.

Bent 1N began to crack on the first push of cycle 3, at a peak load of 247 kips (1,099 kN). Three small cracks extended several inches into the cross section. Another crack extended about halfway into the cross section, as shown in Figure 5.33. Cracks were spread evenly across the top of the bent. On cycle 4, at a load of 325 kips (1,447 kN), two new cracks developed farther away from column than the previous four. These cracks are shown in Figure 5.34.

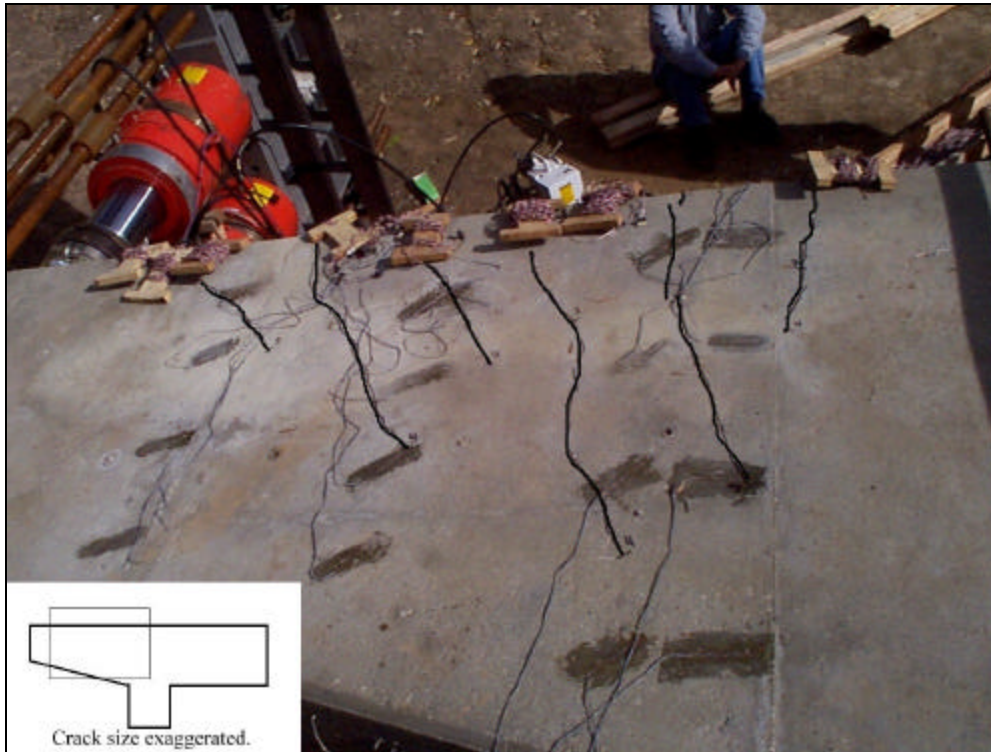
Figure 5.34 – Bent 1N, cracks on cycle 4.

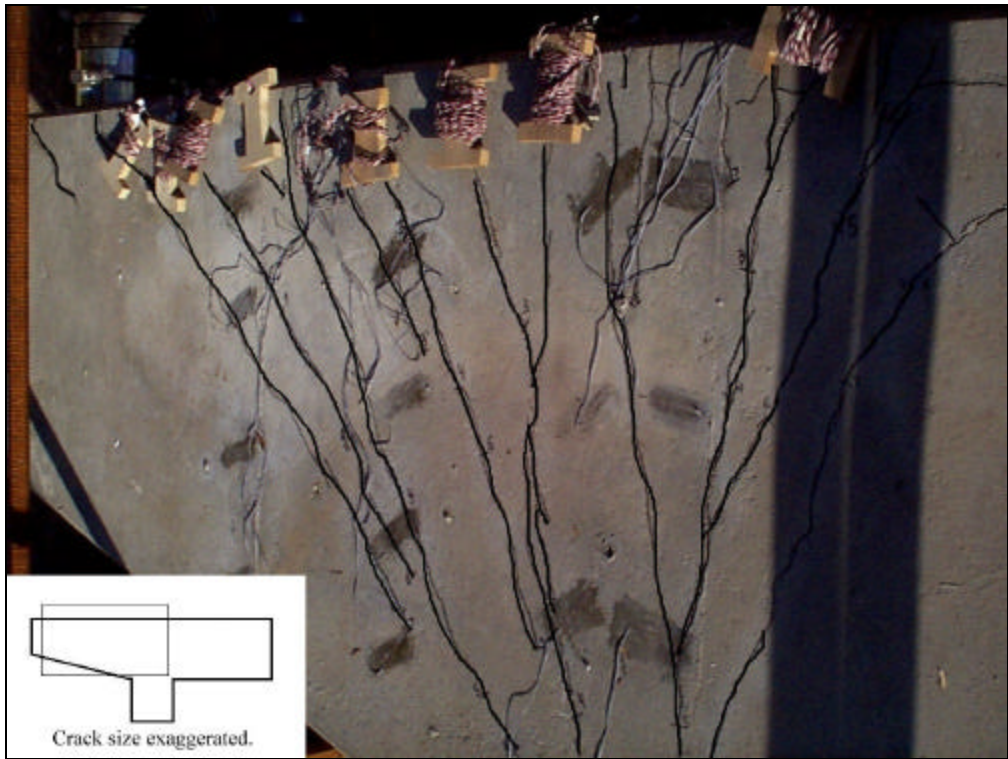
Figure 5.39 – Bent 1N, cracks on cycle 8.

No new cracks developed on cycle 8, which corresponded to a displacement level of 2.9 in (74 mm) and a peak load of 687 kips (3,057 kN). The crushing of the concrete on the underside of the cantilever beam continued with the cracks slightly progressing toward the reentrant corner. The cracks on this cycle are shown in Figure 5.39.

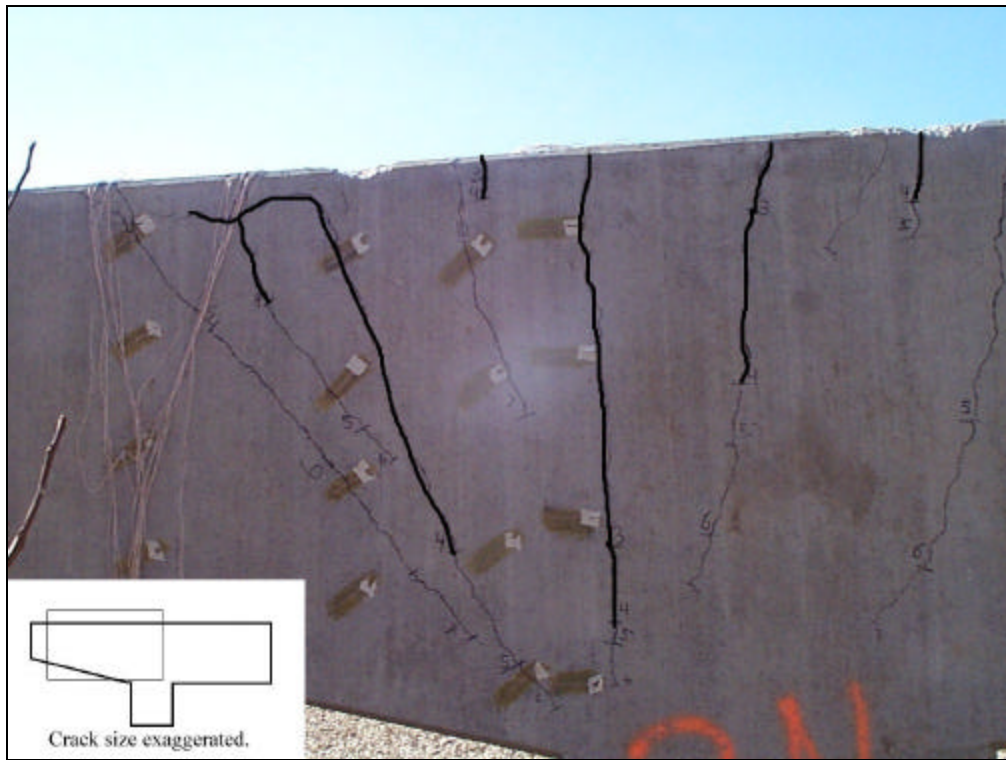
Figure 5.48 – Bent 2N, cracks on cycle 4.

Three new cracks developed on cycle 4, at a peak load of 325 kips (1,446 kN), as shown in Figure 5.48. One of these extended more than halfway through the cross section. The main crack, in line with the column face, extended another several inches.
