# **EVALUATION OF DITCH INLET PROTECTION PRODUCTS FOR SEDIMENT RETENTION**

Research Report No. FHWA-ICT-16-003

A white paper prepared as part of  
**ICT-R27-102**  
**Installation and Performance Testing of  
Ditch Checks and Inlet Protection Structures**

Illinois Center for Transportation

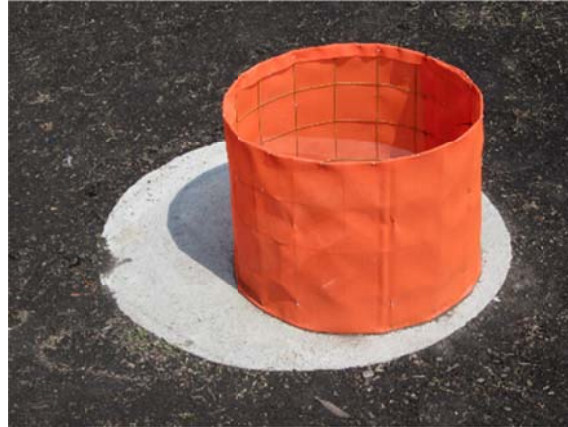
**Figure 3.1 Welded-wire woven monofilament around the lid.**

Once the fabric is around the lid tightly or trench 2 feet from the concrete pad, the loose ends must be securely joined. For the first installation method, only one product was needed to completely surround the lid (Figure 3.1). The loose ends were fastened tightly using zip ties with a few inches of overlap. The overlap was positioned away from the direct flow of water.

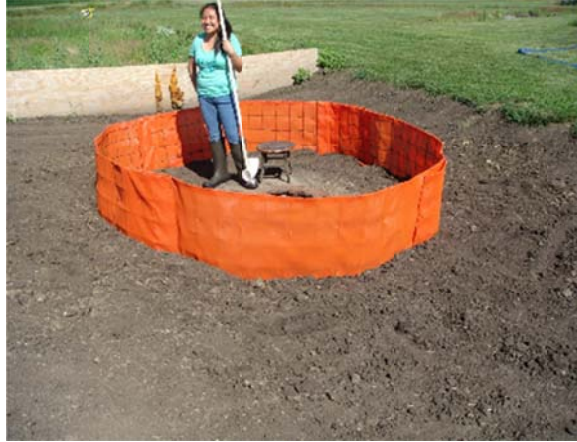
**Figure 3.2 Welded-wire woven monofilament with 2 foot gap.**

For the second installation method, a trench 6 inches deep was dug 2 feet away from the pad (Figure 3.2). The extra material was placed in the trench facing outward from the inlet. The trench was then backfilled and compacted. Three products were needed to surround the inlet in this test, and an overlap of about 5 inches was used when connecting each product. Again, zip ties were used and the overlaps were positioned away from the direct flow of water.

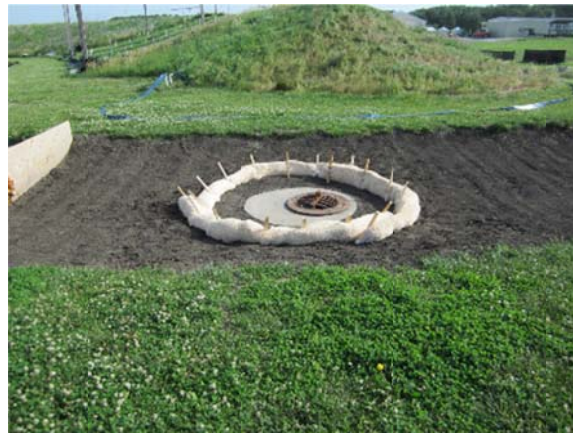
**Figure 3.3 Sediment log with no erosion control blanket.**

This product was tested using two different installation methods. The first installation method involved burying three sediment logs in a 6 inch deep trench dug 2 feet away from the concrete pad of the inlet. Typical sediment log installation protocols were followed. The sediment logs had a 2 foot overlap at each joining of two logs, stakes were staked in at a 45 degree angle against the flow, and stakes were placed at an interval of every 2 feet along the log (Figure 3.3).

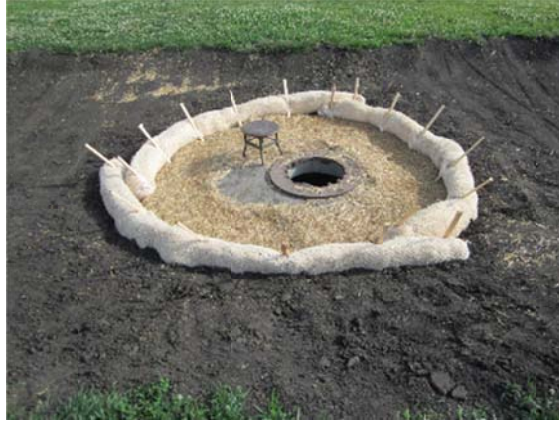
**Figure 3.4 Sediment log with erosion control blanket.**

The second installation method was the same; however, an erosion control blanket (ECB) was placed in the area between the log and the concrete pad (Figure 3.4). The blanket was an S31 blanket that was buried under the log in the trench. Staples were placed at an interval of every 2 feet in the ditch. In the area between the log and the concrete pad, the staples were placed at an interval of every 2 feet along the log and concrete pad.

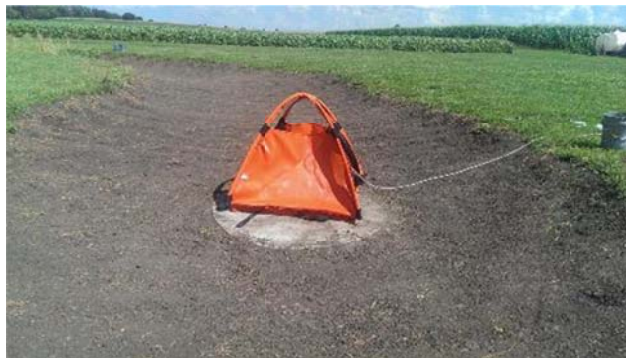
**Figure 3.5 Dandy Pop.**

The Dandy Pop is a manufactured, reusable inlet protection device that comes pre-assembled. It is propped up, and the inlet lid is slipped into the product, which is then placed back over the inlet (Figure 3.5). This product is made of a lightweight woven monofilament fabric. It works to reduce flow into the inlet, which promotes settling, and sediment is trapped in the fabric. This product requires no extra work for installation. The opening that the lid is slid through is sealed with Velcro and then placed on the downstream side of the flow.

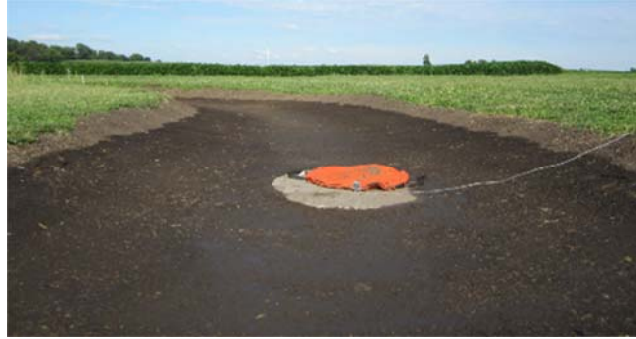
**Figure 3.6 Dandy Bag.**

The Dandy Bag is a manufactured, reusable inlet protection device that requires very little installation. It is made of a woven monofilament fabric (Figure 3.6). This product reduces flow, which promotes settling, and sediment is trapped in the fabric. The inlet lid is slid into the bag and then placed onto the inlet. The opening is sealed shut with Velcro and placed away from the direct flow of water.

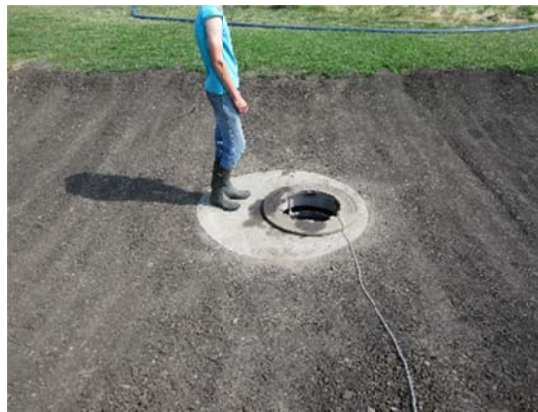
**Figure 3.7 Drop filter bag.**

The drop filter bag is a manufactured, temporary inlet protection device that comes pre-assembled and requires very little installation. It collects solids in the fabric and prevents them from entering the inlet. The wire frame is placed inside the inlet, resting on the edge of the inlet. The bag drops inside the inlet and catches sediment that flows in (Figure 3.7).

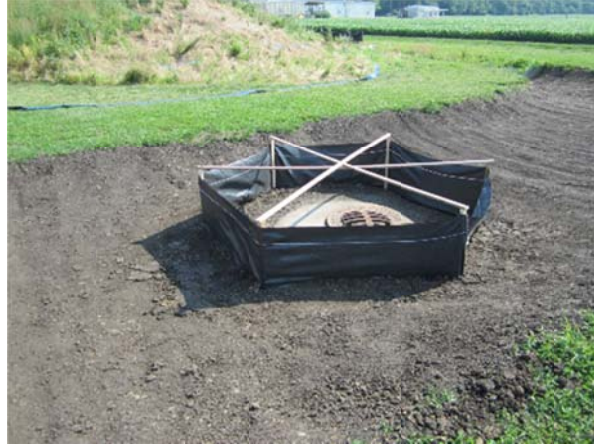
**Figure 3.8 Silt fence with 2 foot gap.**

This product is a manufactured, temporary inlet protection device. It is made of a woven, slit tape fabric. The product reduces the flow of water into the inlet, which promotes settling of the sediment outside of the inlet. For installation, a hexagon trench 6 inches deep was dug 2 feet away from the edge of the concrete pad of the lid. The six stakes were stapled to the fabric, the fabric was placed inside the trench, and the stakes were inserted 1 foot deep into the ground (Figure 3.8). The trench was then backfilled and compacted.

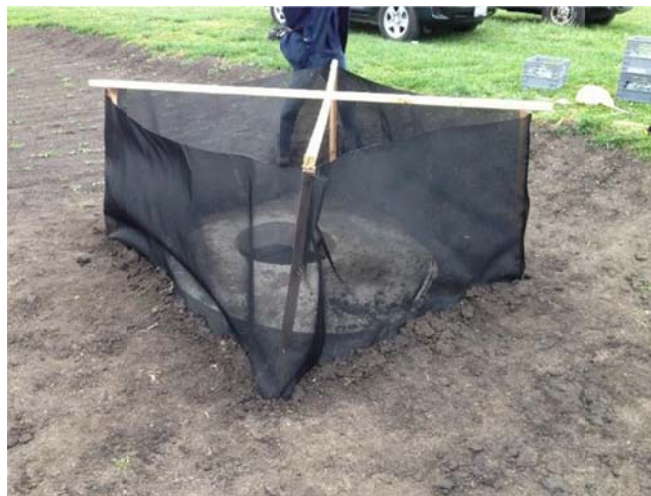
**Figure 3.9 Silt fence with woven monofilament fabric.**

This product is almost identical to the silt fence described in the previous section, except it is made of a different fabric (Figure 3.9). It follows the same general installation protocol of trenching the bottom of the product 6 inches deep and then stapling it to the stakes, which should be spread out so the product is taut. Cross braces must be placed to ensure stability. The product was set up in a square with the corners 2 feet from the concrete pad. Backfill must be compacted to ensure that little undercutting will occur. This particular setup used a more porous fabric that allows better water flow through it, which should help ensure less ponding and less product failure.

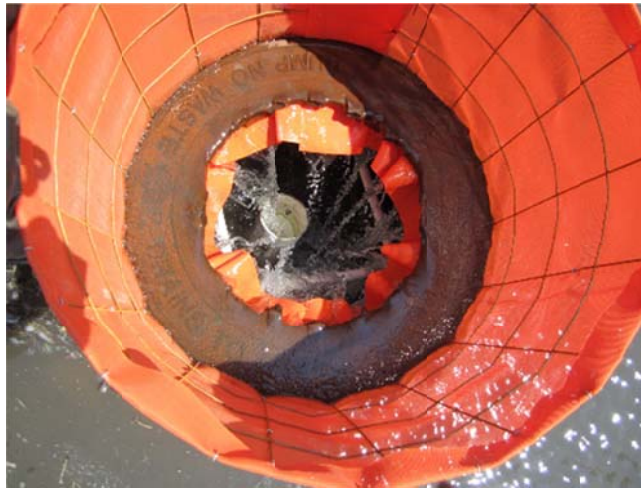
**Figure 4.1** Inside of the welded-wire woven monofilament at 79 gpm (5 L/s).

Testing began with the designated flow rate of 79 gpm (5 L/s). The product's porous nature resulted in a fairly quick time of breach. As the test continued, ponding began around the inlet (Figure 4.1). Ponding was kept steady, however, and did not continue to increase though the first flow rate. Due to the porous nature of the material, water flowed through easily and did not begin to fill the entire channel (Figure 4.2). At 40 minutes, the flow rate was increased to 158 gpm (10 L/s), per testing protocols. The product remained fairly stable and did not fail under the increased flow. Undercutting was never observed during the duration of the test. Clearly visible sediment deposits remained on fabric after the test was concluded. Buildup of other biological debris was also observed against the product.

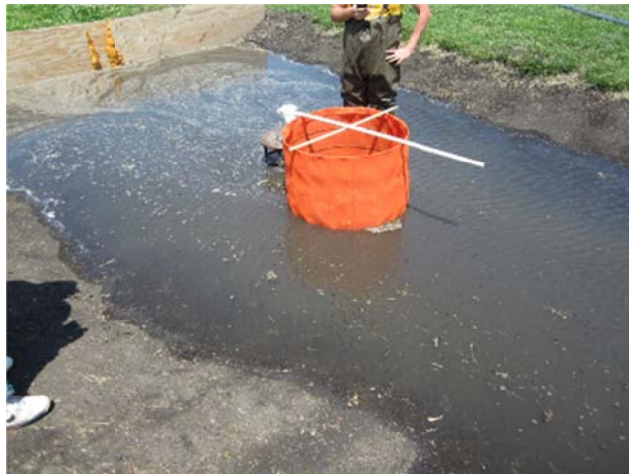
**Figure 4.2** Channel ponding during the welded-wire woven monofilament lid test at 79 gpm (5 L/s).

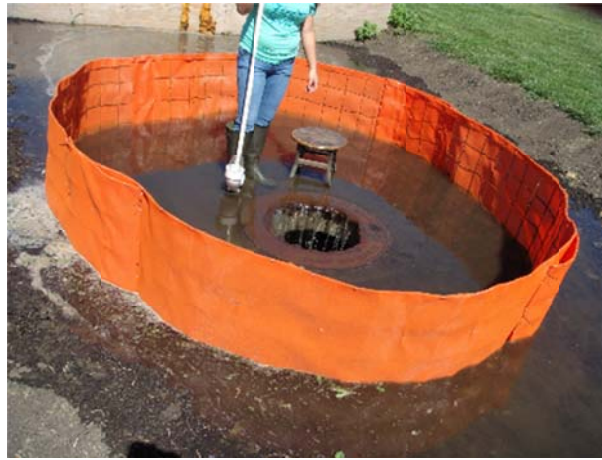
**Figure 4.3 Welded-wire woven monofilament with 2 foot gap under 79 gpm (5 L/s) flow rate.**

Testing began with the designated flow rate of 79 gpm (5 L/s). Like the previous welded-wire installation, this installation also allowed easy flow of water through the product. Due to the large circular area that the product formed, and the ease with which the fabric allowed water through, ponding never became an extreme issue (Figure 4.3). Ponding depths were observed and recorded every 10 minutes outside of the product. Water did not flow around the product's sides until the flow rate was increased at 40 minutes to 158 gpm (10 L/s). At that flow rate, the product remained operational and did not fail. Settled sediment could be observed on the concrete pad during testing. Undercutting was largely a non-factor. At overlap points, some water could be observed flowing through the slight gaps between the ends of the product (Figure 4.4). Clear sediment buildup on the fabric could be observed after the test. Buildup of other biological debris was observed against the product.

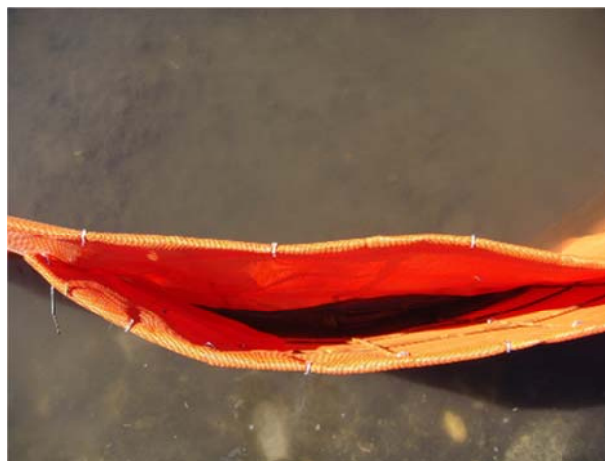
**Figure 4.4 Welded-wire woven monofilament with 2 foot gap under 79 gpm (5 L/s) flow rate, with overlap failure.**

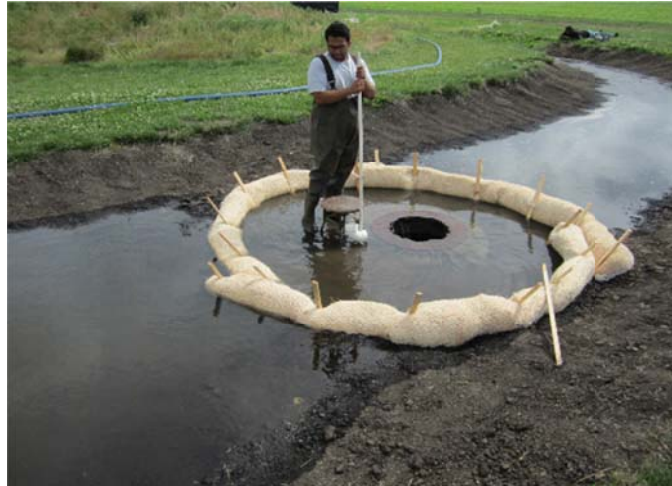
**Figure 4.5 Sediment log without erosion control blanket, under 79 gpm (5 L/s) flow rate.**

Testing began with the designated flow rate of 79 gpm (5 L/s). Due to the large diameter of the circle that the product formed and its porous nature, ponding never became an extreme issue (Figure 4.5). Minor undercutting could be observed early on near the overlaps of the logs. Ponding depth was observed and recorded every 10 minutes outside of the product. Water did not flow around the sides of the product until a flow rate of 158 gpm (10 L/s) was established. At that flow rate, the product remained operational and did not fail. Sediment began settling out on the concrete pad of the inlet, as seen in Figure 4.6. After the test, sediment was observed to have built up in the wooden fibers of the sediment log. Biological debris was also built up on the outside of the product.

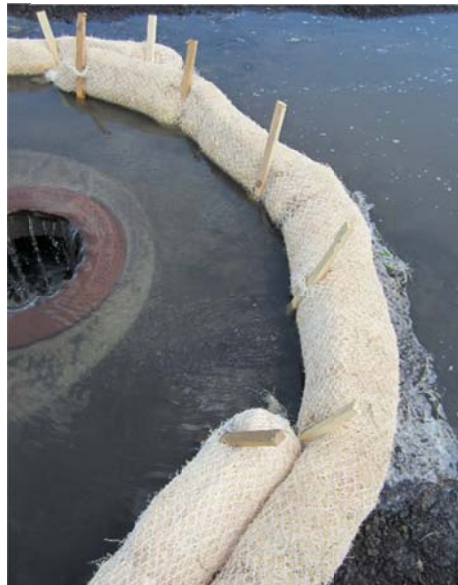
**Figure 4.6 sediment settling on the concrete pad of the inlet.**

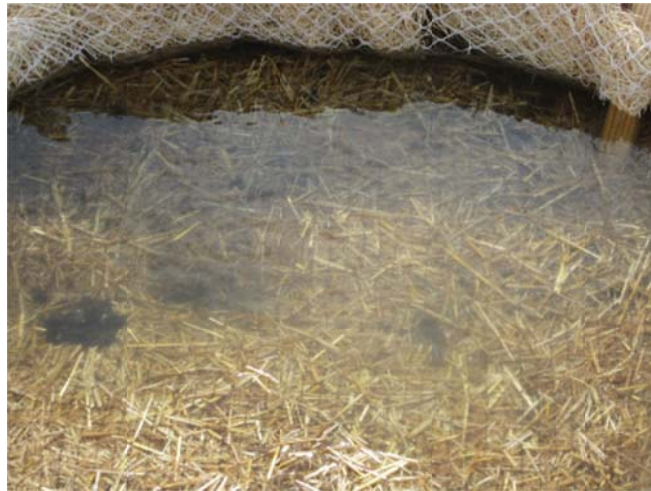
**Figure 4.7 Sediment log with erosion control blanket, at 79 gpm (5 L/s) flow rate and showing sediment settling on the blanket.**

Testing began with the designated flow rate of 79 gpm (5 L/s). Ponding depth was observed and recorded every 10 minutes outside of the product. Minor undercutting could be observed early on near the overlaps of the logs. Biological debris also built up on the outside of the product. Sediment was observed to begin settling out on the concrete pad of the inlet. Settled-out sediment was also observed on the erosion control blanket laid down in the 2 foot gap (Figure 4.7). Due to the large diameter of the circle that the product formed and its porous nature, ponding never became an extreme issue (Figure 4.8). Water did not flow around the sides of the product until the flow rate was raised to 158 gpm (10 L/s). At that flow rate, the product remained operational and did not fail. After the test, sediment was observed to have built up in the wooden fibers of the sediment log and in the straw fibers in the erosion control blanket.

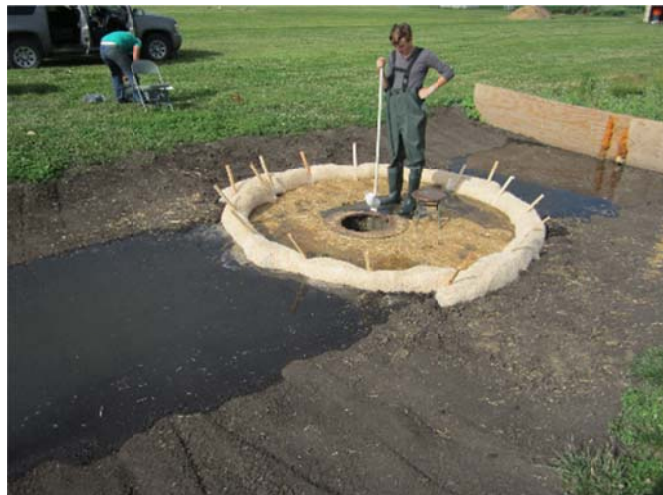
**Figure 4.8 Sediment log with erosion control blanket, at 79 gpm (5 L/s) flow rate, with water not flowing around it.**

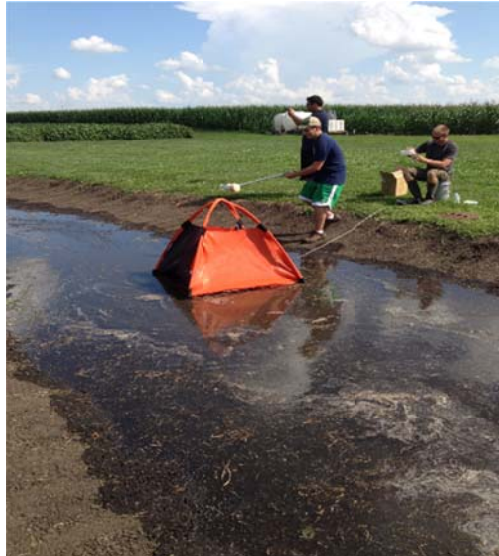
Figure 4.9 Dandy Pop testing at 79 gpm (5 L/s) flow rate.

Testing began with the designated flow rate of 79 gpm (5 L/s). Due to the small size of the product, water was able to flow completely around it (Figure 4.9). A minute before sample-taking time, any water trapped in the line was pumped out in order to get a clean sample for that time period (Figure 4.10). When the flow was increased to 158 gpm (10 L/s), the product remained operational and did not fail. Because of pump failure, the last two samples were collected inside of main tent of the product. Those two samples had not flowed through the final bottom section of fabric over the manhole. At the end of testing, sediment had collected on the fabric of the product. Biological debris also built up against the product.

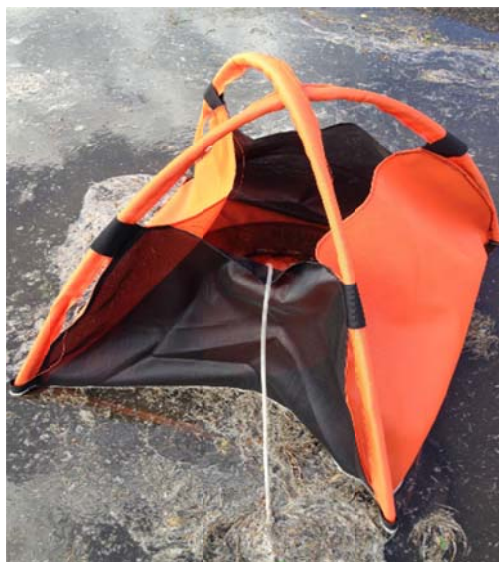
Figure 4.10 Dandy Pop at 79 gpm (5 L/s) flow rate, inside.

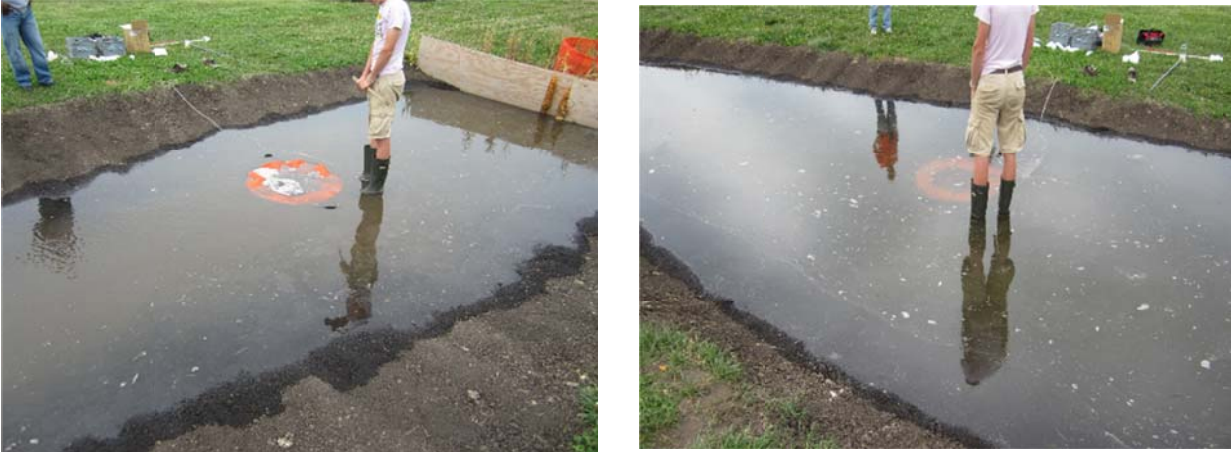
Figure 4.11 Dandy Bag at 79 gpm (5 L/s) flow rate.

Testing began with the designated flow rate of 79 gpm (5 L/s). The product was fully submerged under water during the testing (Figure 4.11). The ponding became more severe when the flow rate was increased to 158 gpm (10 L/s).

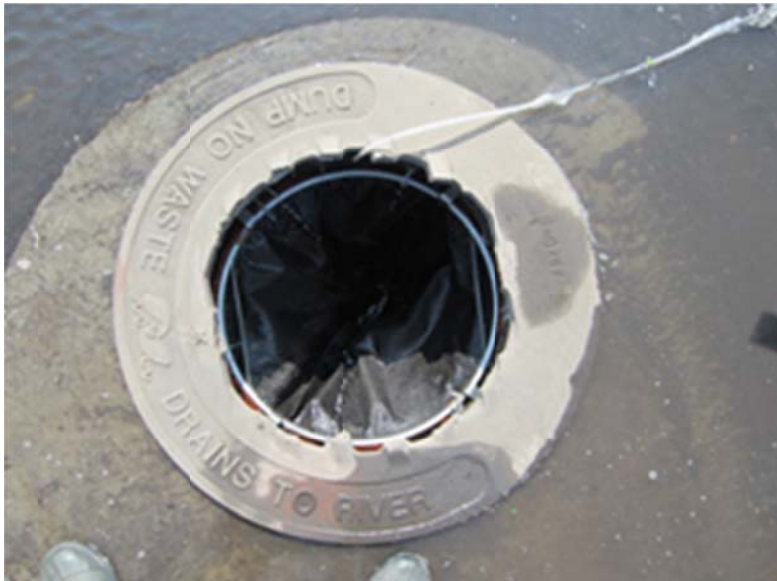
Figure 4.13 Filter bag at 79 gpm (5 L/s) flow rate, inside.

Testing began with the designated flow rate of 79 gpm (5 L/s). The water soon overwhelmed the filter bag (Figure 4.13), and it overflowed around 12 minutes after the experiment started (Figure 4.14). During the intervals, a hand pump was used to collect samples from underneath the inlet. At around 60 minutes, when most of the flow had started to go around the product, it became very difficult to acquire samples from under the product. This occurred until the test concluded, which prevented any data from being acquired after that time.

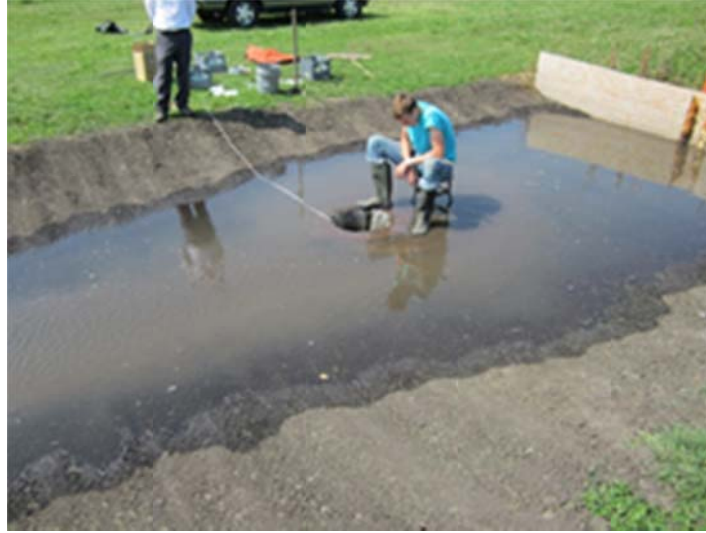
**Figure 4.14 Filter bag at 158 gpm (10 L/s) flow rate.**

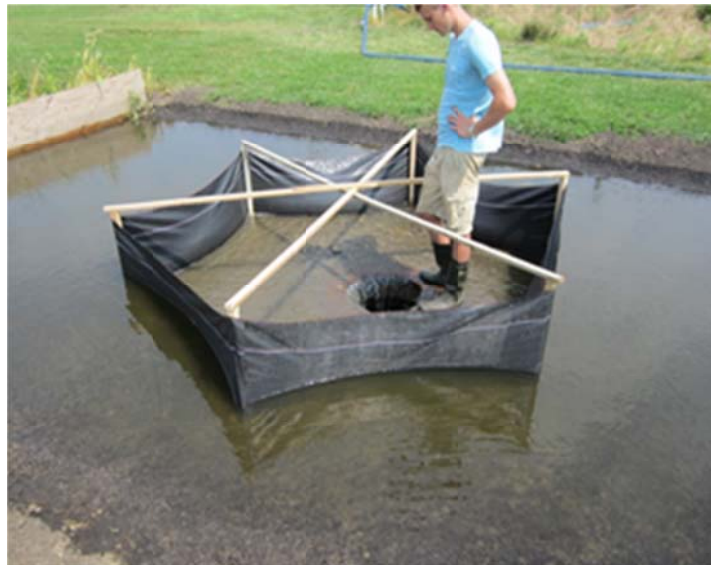
**Figure 4.15 Silt fence at 79 gpm (5 L/s) flow rate, inside.**

The test began at a fixed flow rate of 79 gpm (5 L/s) (Figure 4.15). A slight rip near the base of the fabric was observed (Figure 4.16); weatherproof tape was used to cover the rip. Water entered the inlet 9 minutes after the experiment started. Undercutting began to occur at the north stake of the product at around 44 minutes. Undercutting occurred at the southeast stake at around 46 minutes, the southeast fabric at around 47 minutes, and the northeast stake at around 48 minutes. With this gradual progression of stake failure, the northernmost stake failed at 50 minutes 30 seconds. Undercutting can be observed in Figures 4.17 and 4.18.

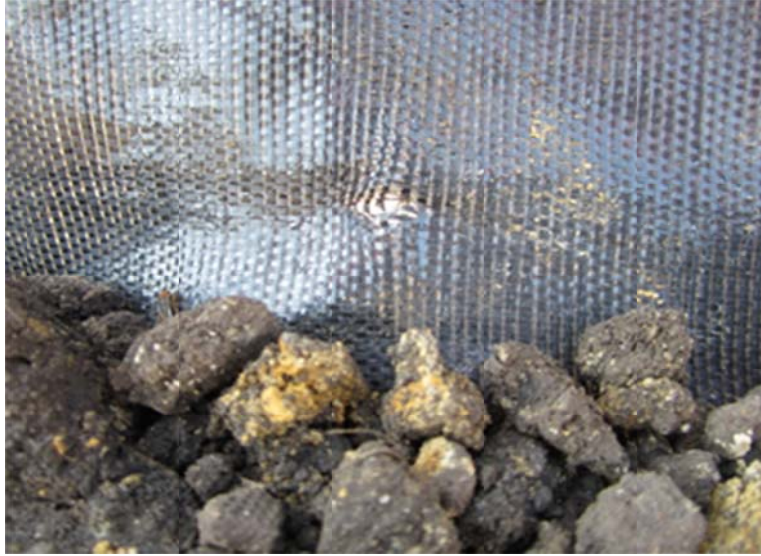
**Figure 4.16 Tear in silt fence.**

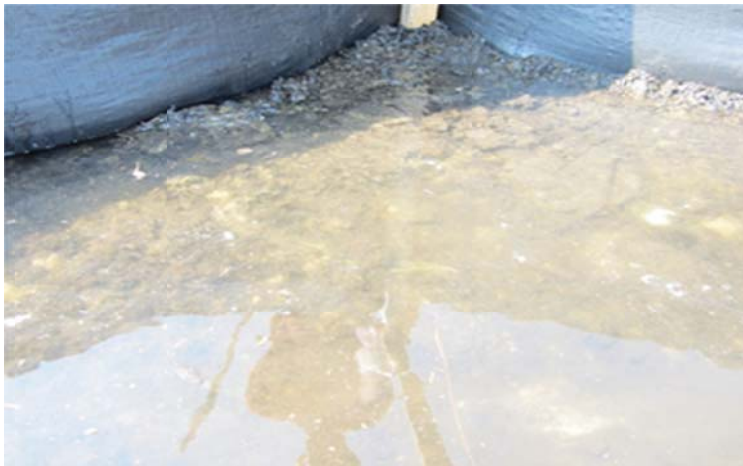
**Figure 4.17 Undercutting of silt fence.**

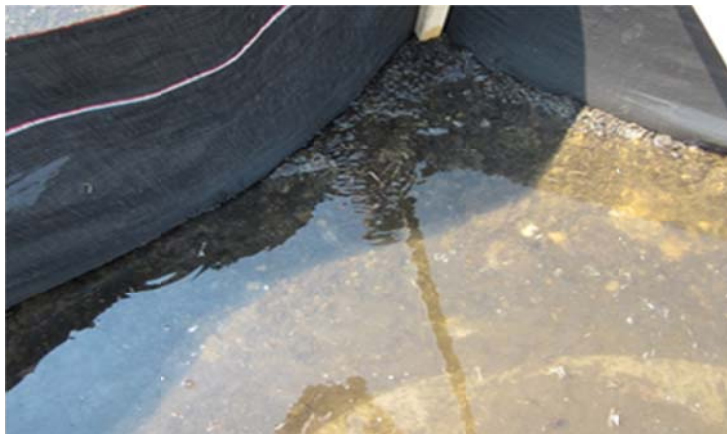
**Figure 4.18 More undercutting of silt fence.**

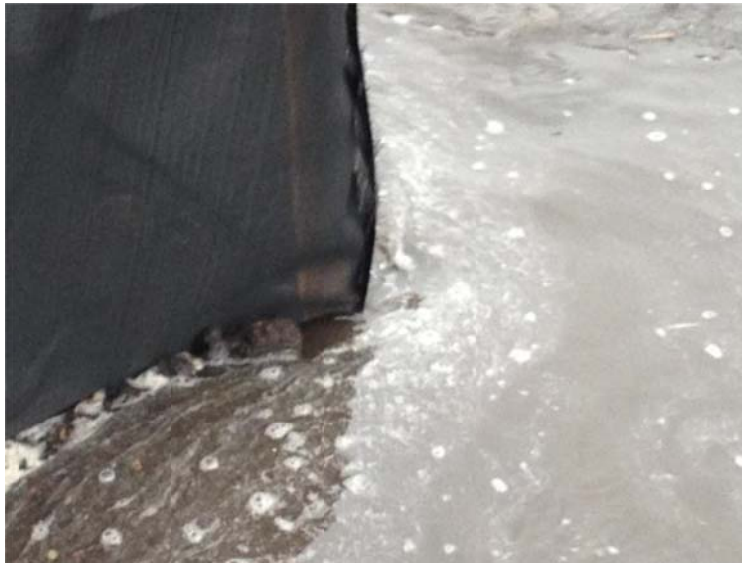
**Figure 4.19 Rapid flow around the side of the silt fence (monofilament fabric).**

The test began at the designated flow rate of 79 gpm (5 L/s). The flow through the fabric was slow to start. The water instead quickly flowed around the sides of the product and infiltrated primarily from the sides and back as ponding occurred (Figure 4.19). This is probably due to a buildup of sediment on the front of the product because the first water to contact it was carrying a high level of sediment. The product held up well and did not create high levels of ponding (Figure 4.20). At 40 minutes into the test, the flow rate was increased to 158 gpm (10 L/s). There was no visible sign of undercutting; ponding increased slightly but remained constant. The product didn't fail throughout the higher flow rate. After testing concluded, debris such as sediment and biological material was built up on the front and sides of the product.

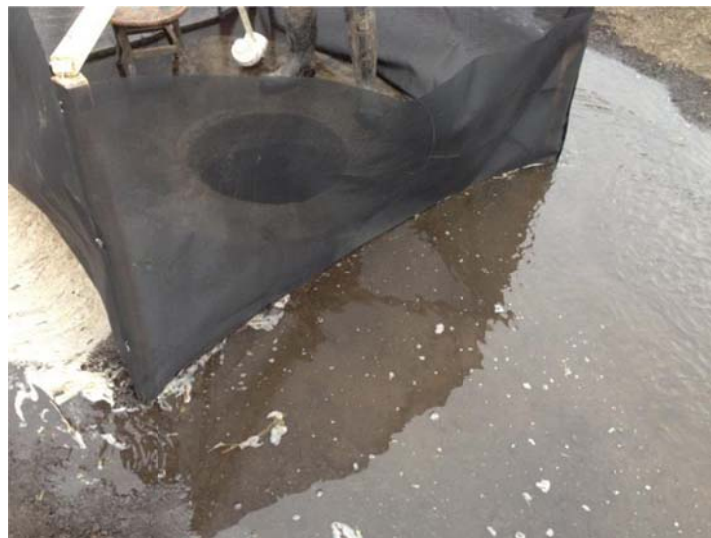
**Figure 4.20 Front of the silt fence (monofilament fabric) during testing.**

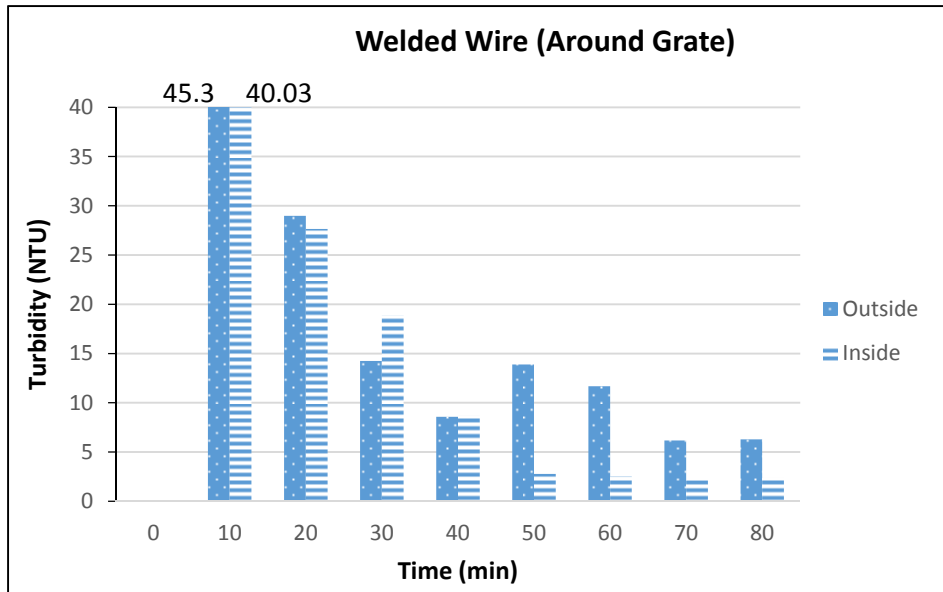
Analysis of water samples indicated that sediment concentration (Figure 5.1) and turbidity (Figure 5.2) were lower inside than outside the product. The trend indicates that the product effectively filtered out sediment.

Figure 5.2 Turbidity values for welded-wire woven monofilament protector.

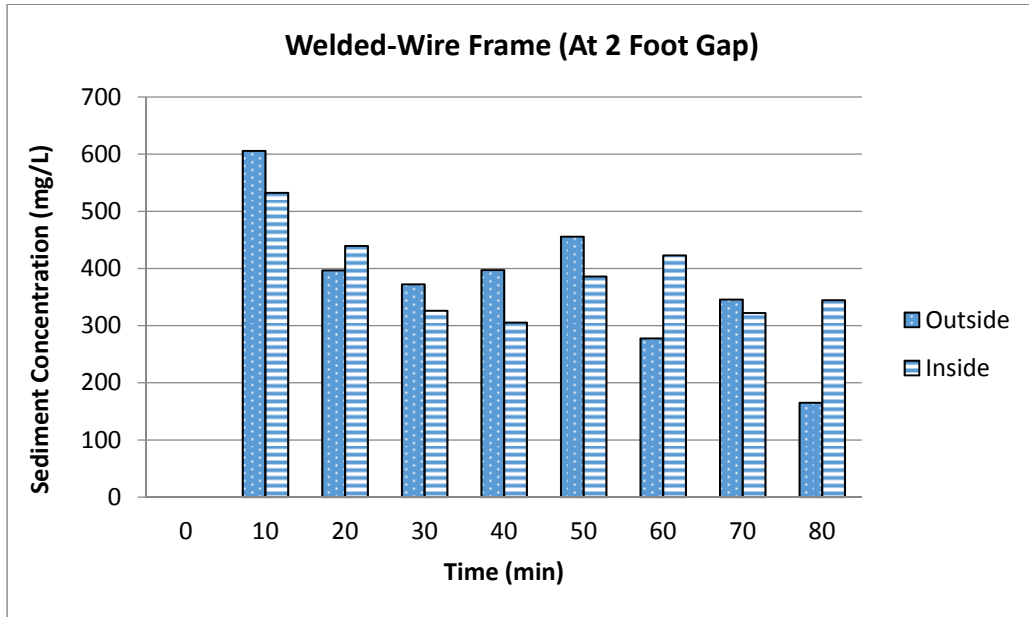
For the majority of the water samples analyzed, sediment concentration (Figure 5.3) and turbidity (Figure 5.4) were lower inside the inlet than outside the product. The trend was more prominent for turbidity compared to sediment concentration. The result indicates that the product effective in filtering out sediment.

Figure 5.3 Sediment concentrations for welded-wire woven monofilament with 2 foot gap.

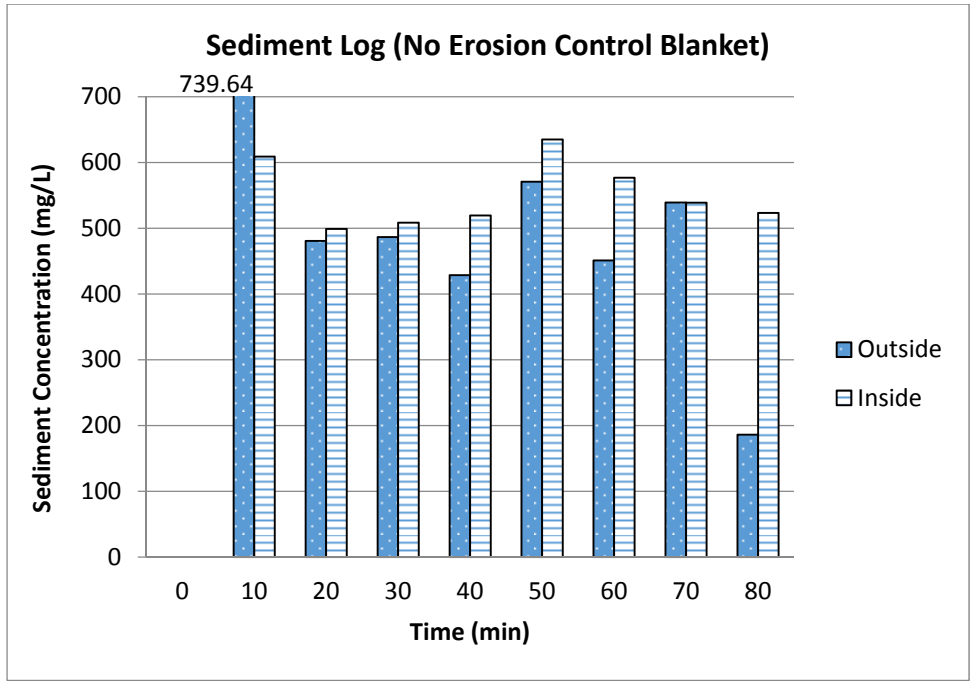
For the majority of water samples analyzed, sediment concentrations (Figure 5.5) tended to be higher inside the inlet than outside the product. Turbidity had an opposite trend (Figure 5.6). The exposed soil inside the sediment log may have contributed to elevated sediment concentration if the water had not been slowed enough by the product. A small amount undercutting at the overlaps of the product may have also been an issue.

Figure 5.5 Soil concentrations for sediment log without an erosion control blanket.

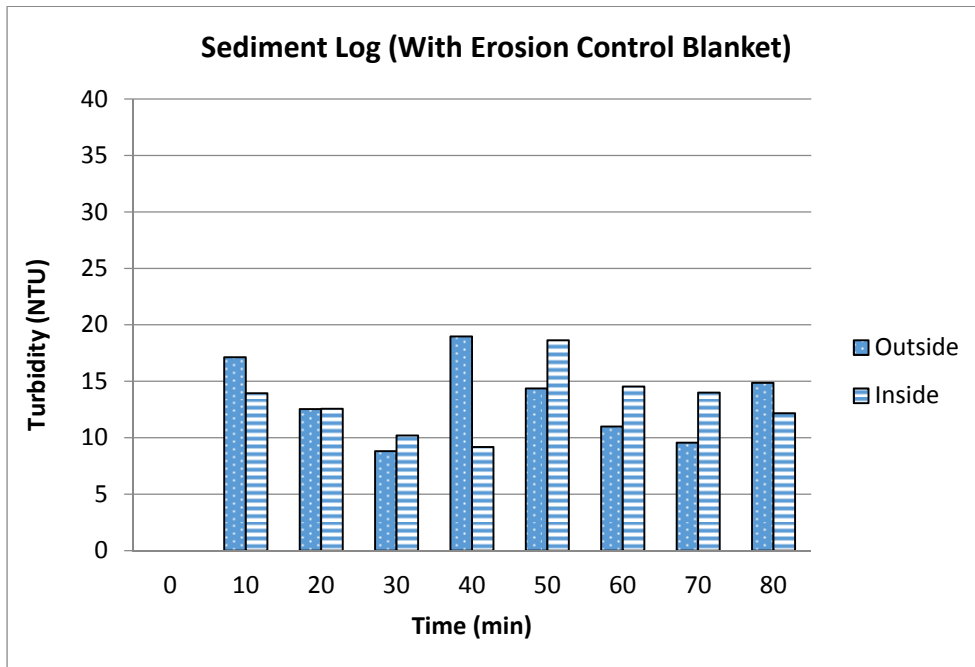
For this test, sediment concentrations typically were lower inside the inlet (Figure 5.7). Turbidity fluctuated greatly throughout the entire test (Figure 5.8). The reduction in sediment concentration was much more consistent and better at the 79 gpm (5 L/s) flow rate than at the 158 gpm (10 L/s) rate.

Figure 5.8 Turbidity for sediment log with erosion control blanket.

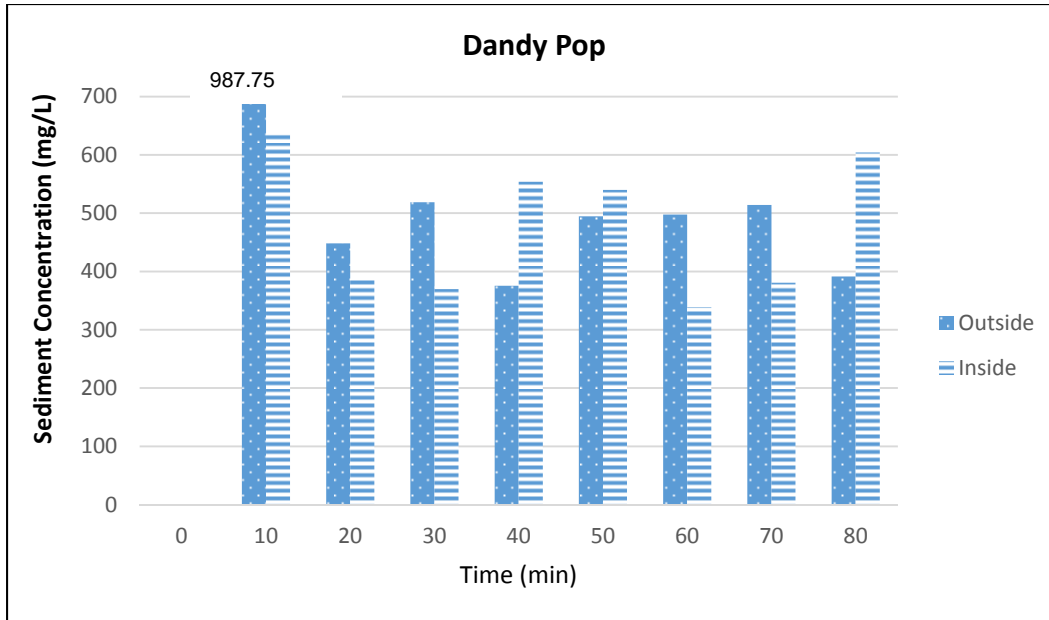
Sediment concentrations fluctuated, but fairly consistent, throughout the testing (Figure 5.9). Problems arose with the hand pump at around 60 minutes; therefore, the last two samples were collected inside of main tent of the product. Those two samples were only partially filtered since they had not passed through the final bottom section of fabric over the manhole. Overall, the product seemed to reduce sediment concentration. Turbidity fluctuated throughout the testing, occurring mostly when we increase the flow rate (Figure 5.10).

**Figure 5.9 Sediment concentrations for Dandy Pop.**

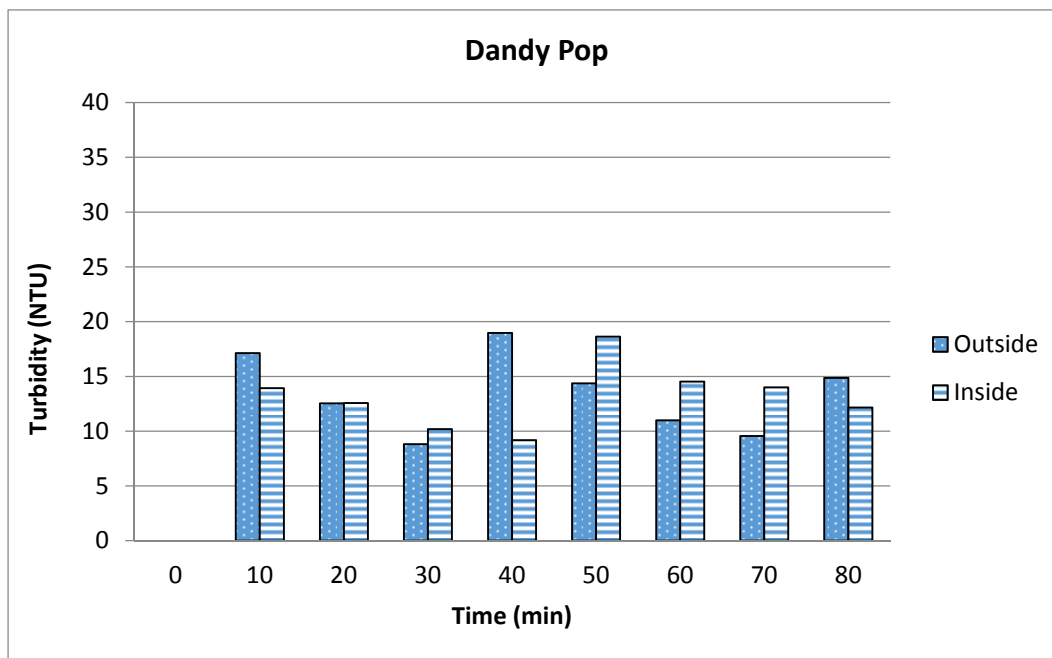
**Figure 5.10 Turbidity for Dandy Pop.**

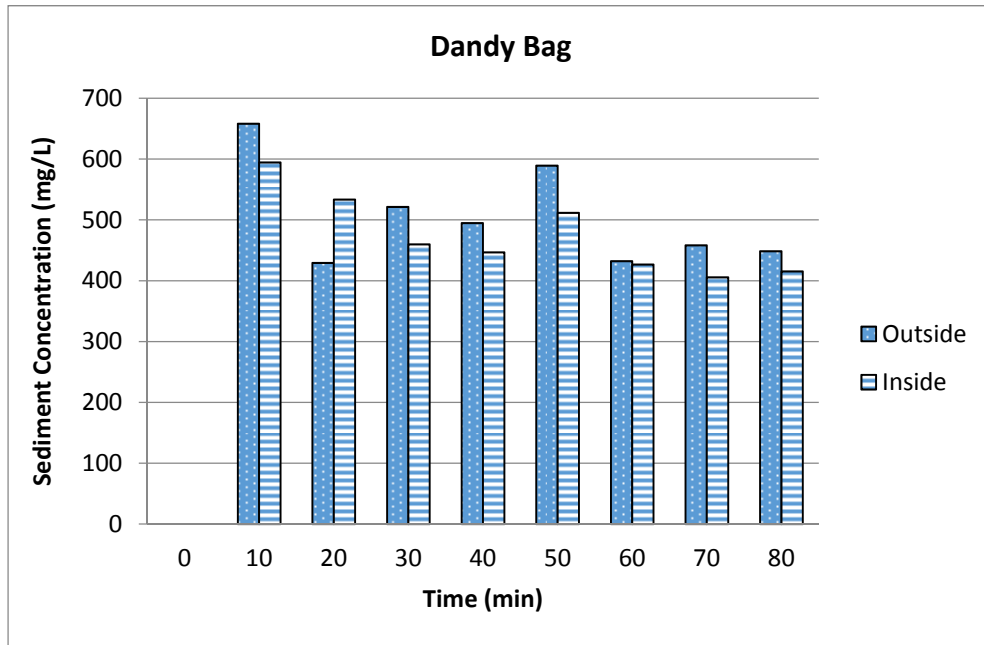
Sediment concentrations (Figure 5.11) and turbidity (Figure 5.12) were consistently lower inside the inlet than outside the product for at both flow rates. This product worked quite well.

Figure 5.11 Sediment concentration for Dandy Bag.

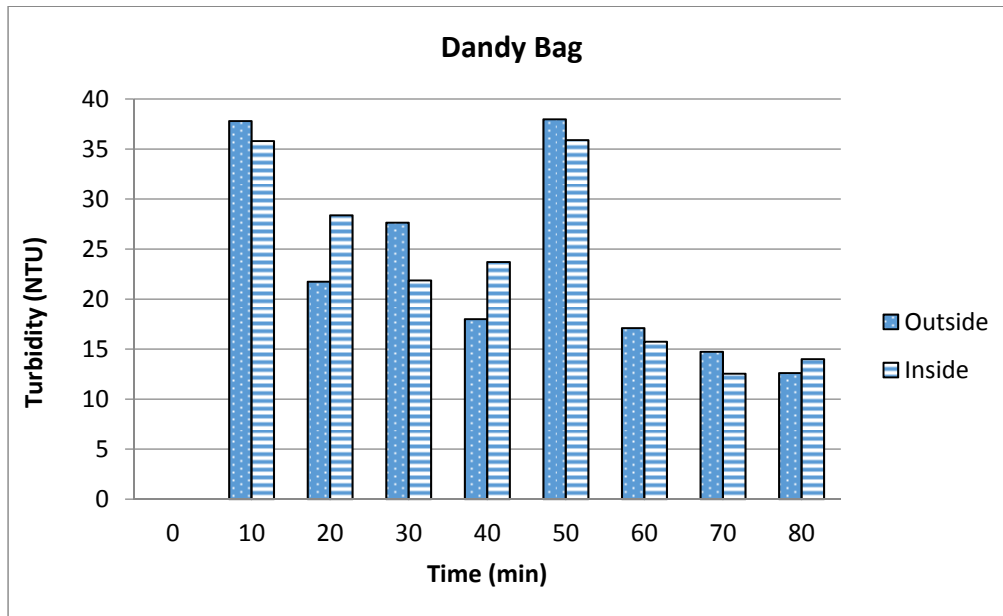
Figure 5.12 Turbidity for the Dandy Bag.

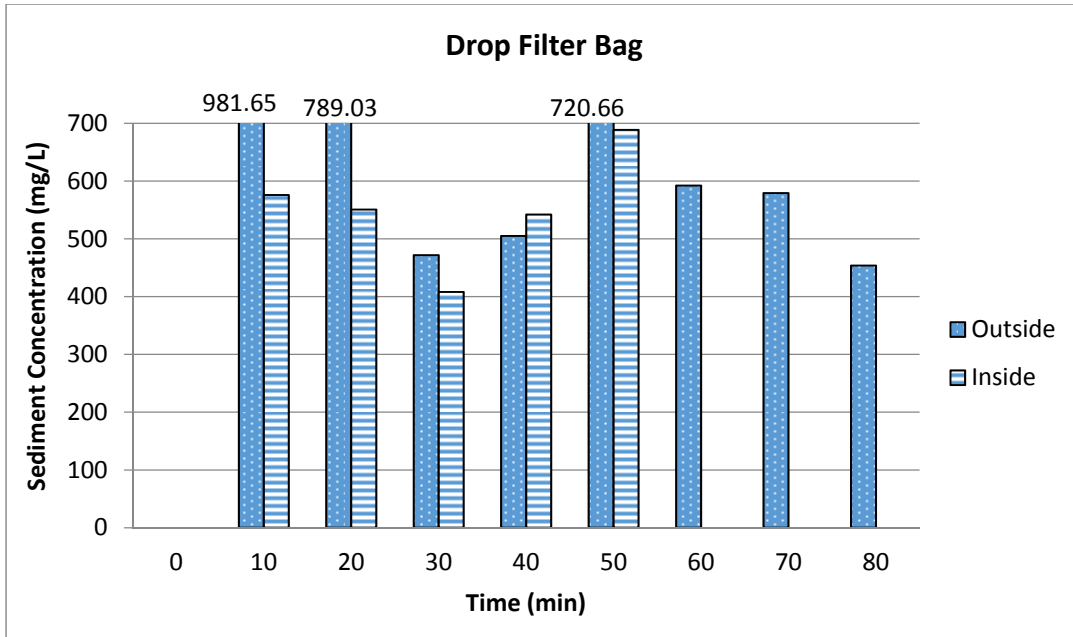
For lower flow rates, sediment concentrations (Figure 5.13) and turbidity (Figure 5.14) remained slightly lower inside the inlet compared to outside the product. As time went on, ponding grew severe and made it difficult for the product to continue filtering out sediment; likewise, taking samples became difficult. Around 60 minutes, it was noted that most of the flow had bypassed the product. Consequently, water samples could not be collected through the hand pump.

Figure 5.13 Sediment concentrations for drop filter bag.

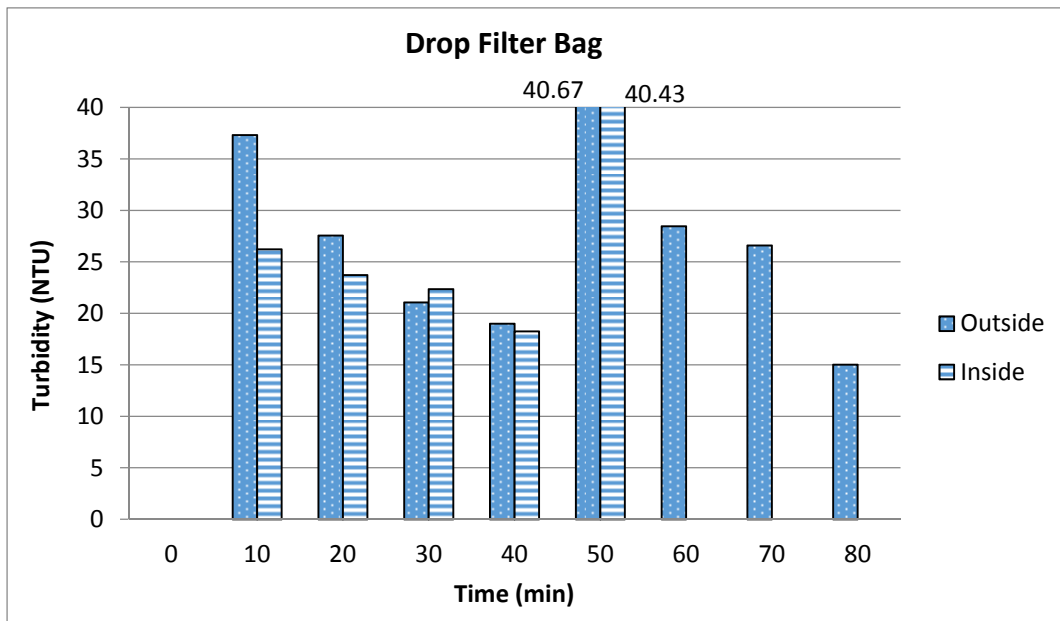
Figure 5.14 Turbidity for drop filter bag.

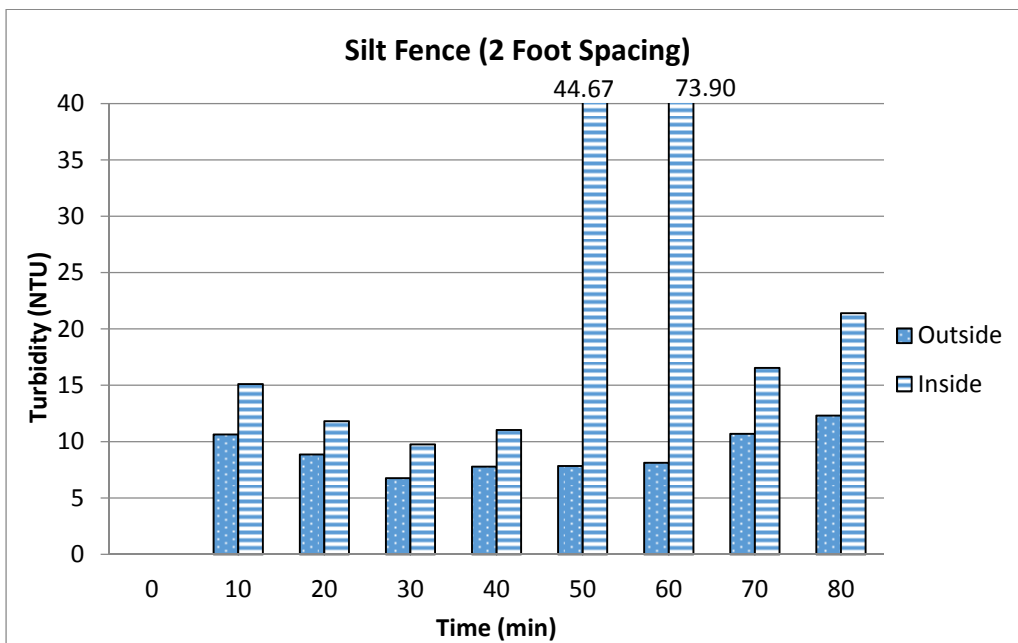
There was a high sediment concentration throughout the test (Figure 5.15). This was due to severe undercutting of the product. This can be seen in the results, where a huge spike in concentration and turbidity is seen around 50 minutes when the north stake failed due to undercutting (Figure 5.16).

Figure 5.16 Turbidity for silt fence with 2 foot gap.

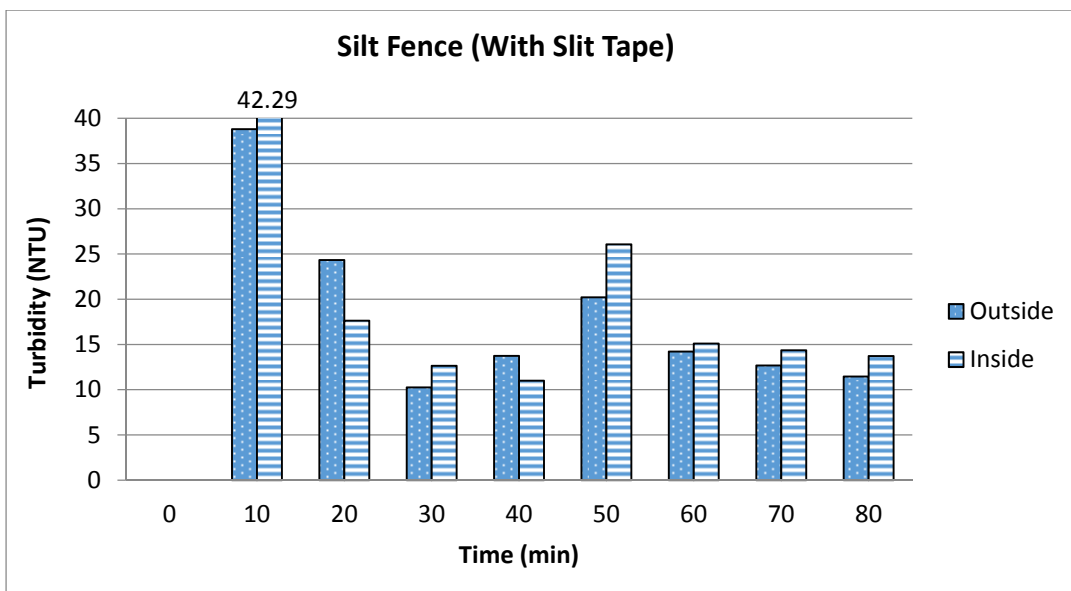
Sediment concentrations (Figure 5.17) were lower inside the fabric compared to outside for most of the water samples analyzed. It was also noted that the sediment concentration were similar inside the fabric for both high and low flow rates. Turbidity was fairly consistent throughout the experiment (Figure 5.18).

Figure 5.18 Turbidity for silt fence with woven monofilament fabric.

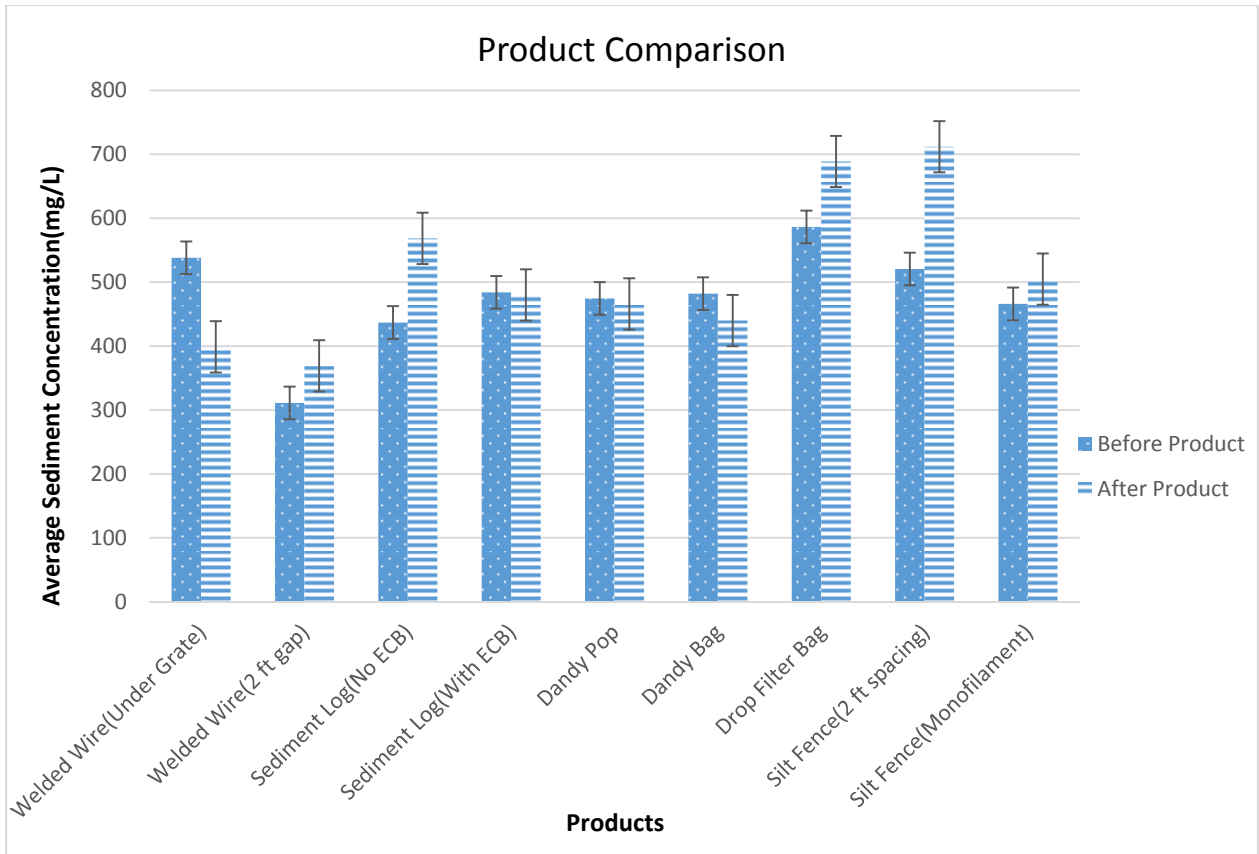
Figure 6.2 and the accompanying discussion provide a comprehensive performance overview of each product under 158 gpm (10 L/S) flow. The product recommendations are based on observations and results, along with ease of installation. For 158 gpm (10 L/S), the percent sediment concentration reduction is as follows:

- Welded wire (around Grate): 25.90%
- Welded wire (at 2 foot gap): -18.61%
- Sediment log (no ECB): -30.15%
- Sediment log (with ECB): 0.82%
- Dandy Pop: 1.81%
- Dandy Bag: 8.75%
- Drop filter bag: -17.45%
- Silt fence (with a woven slit tape fabric at 2 foot spacing): -36.7%
- Silt fence (with monofilament fabric): -8.35%

**Figure 6.2 Product Comparison under 158 gpm flow**

Although the silt fence (with monofilament fabric) had small increase of sediment concentration, it was able to handle high loads when compared to other products tested. The welded wire (2 foot gap), sediment log (no ECB), drop filter bag, and silt fence (at 2 foot spacing) are not recommended, as they experienced an increase in sediment concentration. Overlaps in the welded wire allowed water to seep through the product easily. This was the weak point for the product for the sediment discharge. In case of sediment log, water could seep through the gaps if the overlapping of logs was not placed well. Trenching and proper compaction must be practiced, as undercutting is a potential problem with both products. Proper maintenance for the drop filter bag is suggested, as debris could heavily prevent proper filtration. Debris likely filled the drop filter bag, which led to the product filtering minimal amounts.
