# **EVALUATION OF DITCH INLET PROTECTION PRODUCTS FOR SEDIMENT RETENTION**

Research Report No. FHWA-ICT-16-003

A white paper prepared as part of  
**ICT-R27-102**  
**Installation and Performance Testing of  
Ditch Checks and Inlet Protection Structures**

Illinois Center for Transportation

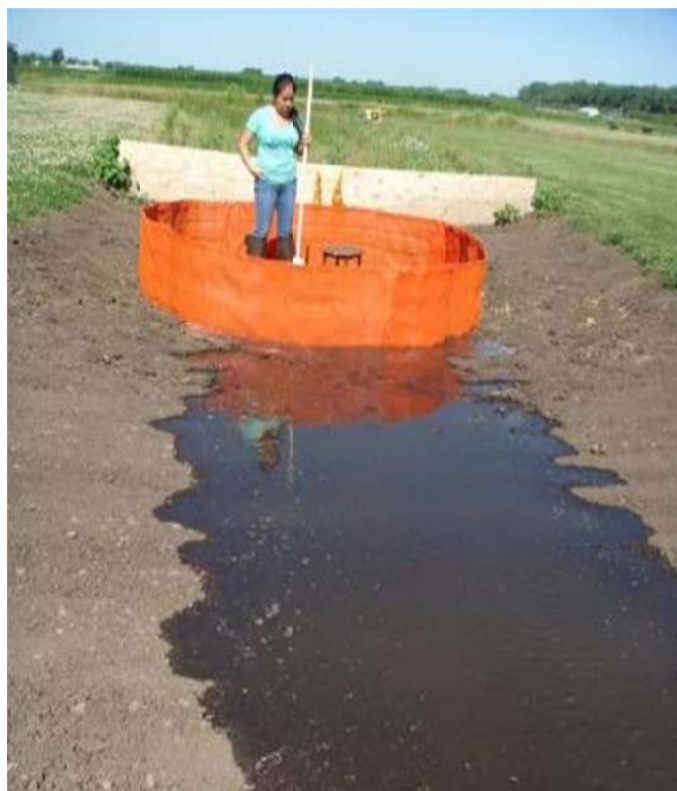
Figure A.2 Welded-wire woven monofilament fabric after testing started.

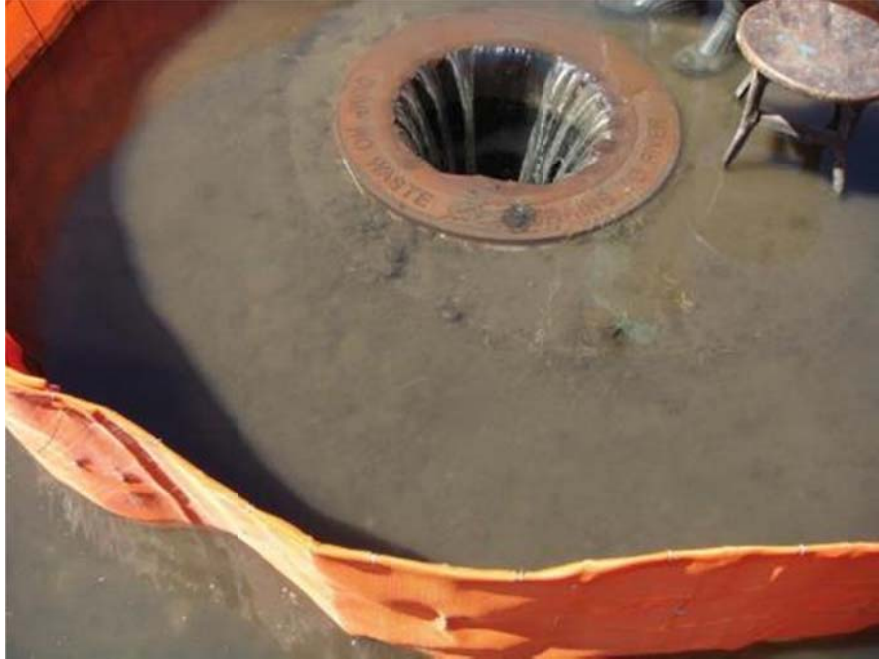
Figure A.3 Welded-wire woven monofilament fabric entering manhole.

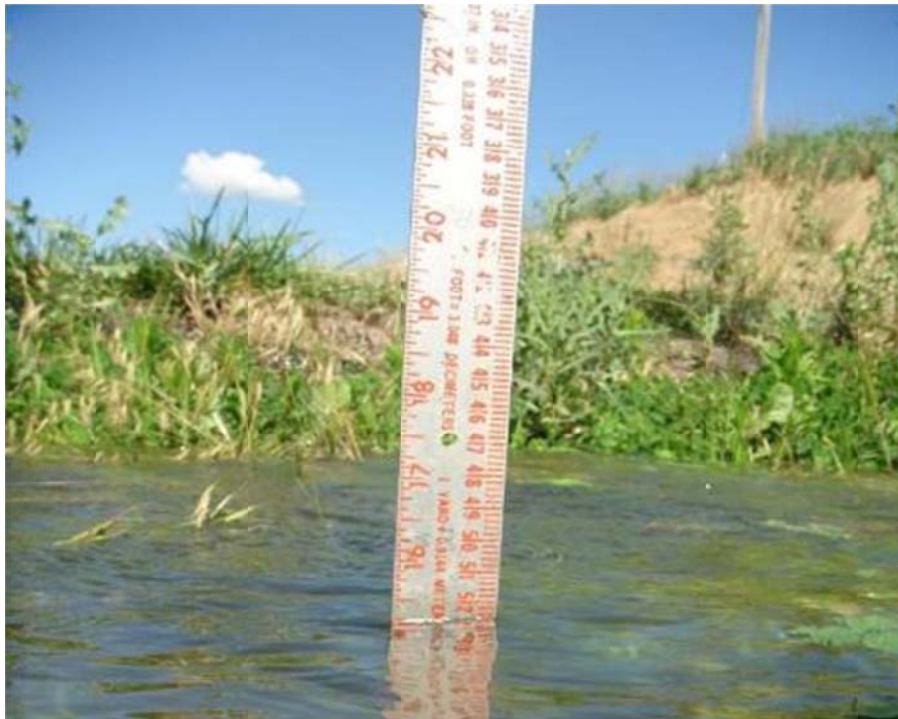
Figure A.4 Measuring depth in front of welded-wire woven monofilament fabric.

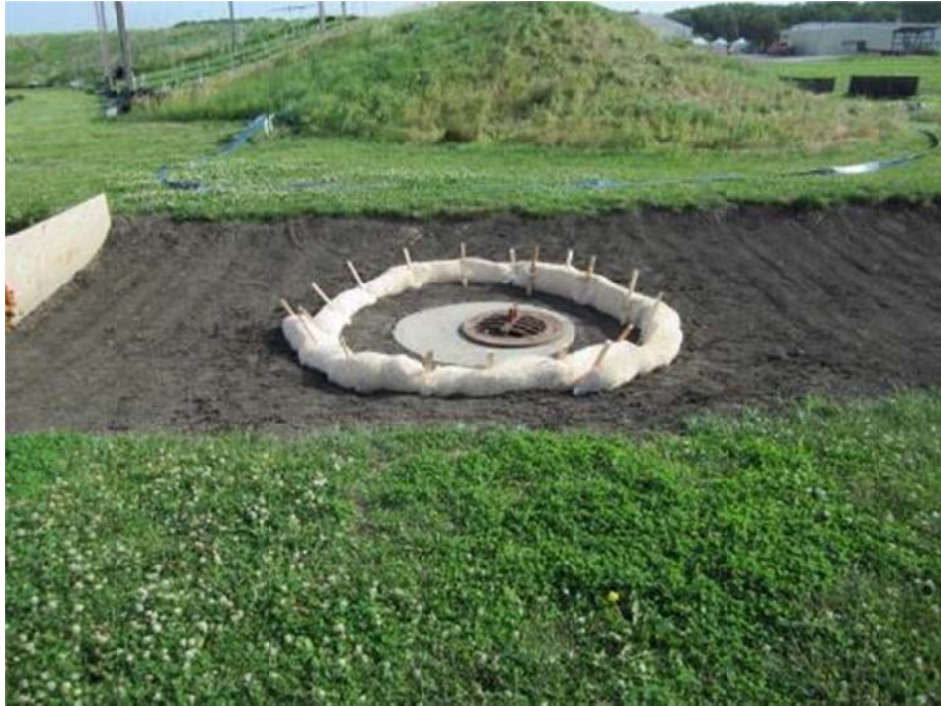
**Figure A.5 Sediment log, pre-testing.**

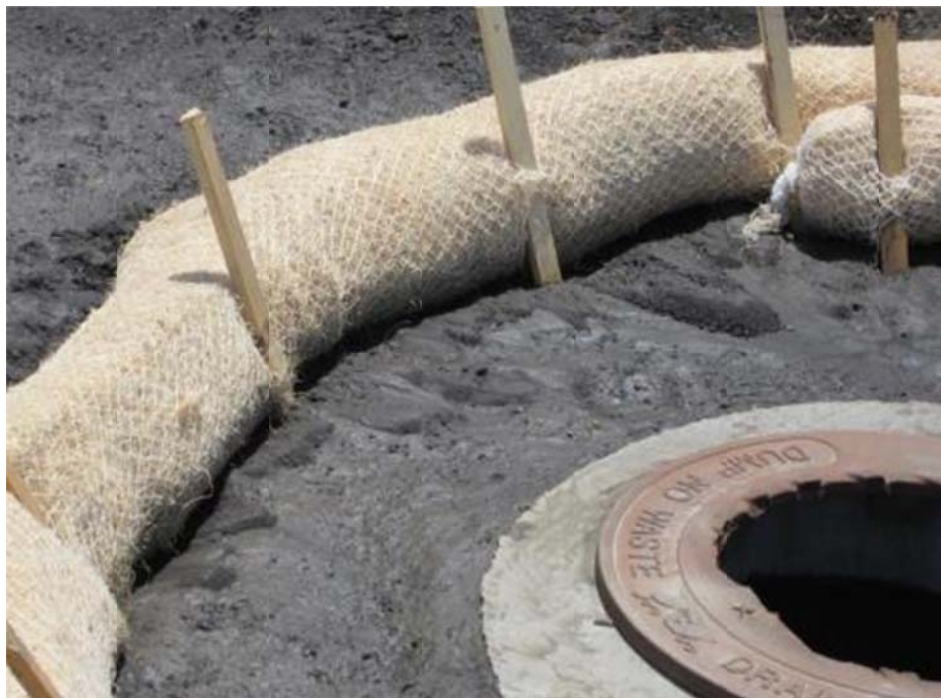
**Figure A.6 Sediment log installation.**

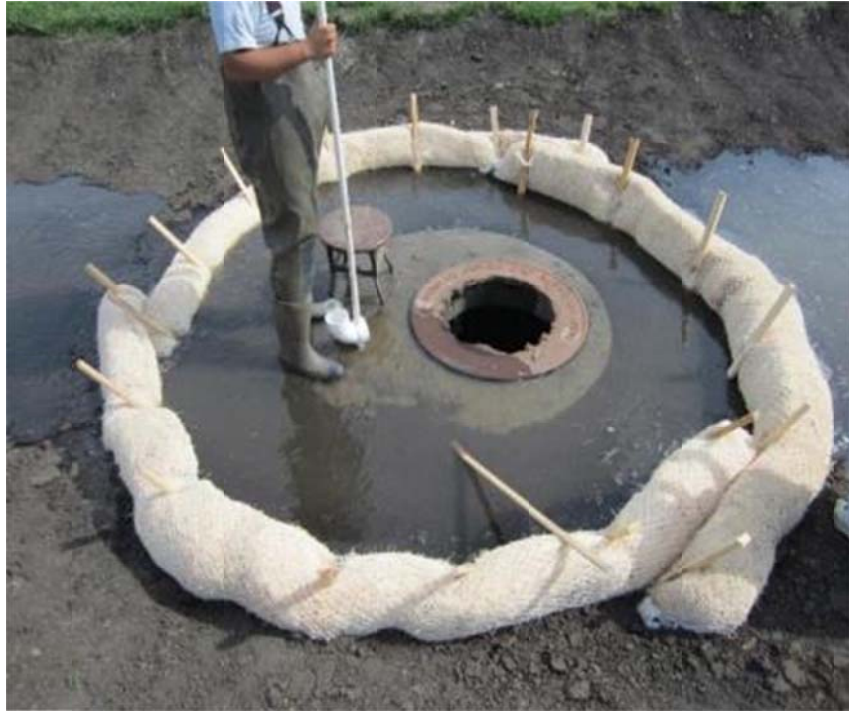
**Figure A.7 Sediment log during testing.**

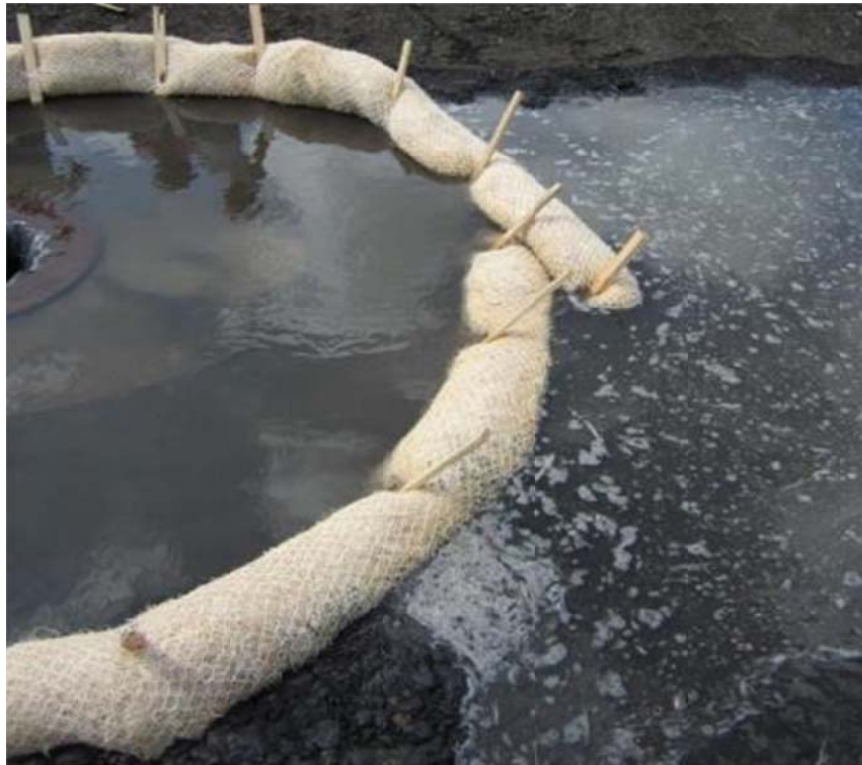
**Figure A.8 Sediment log water accumulation.**

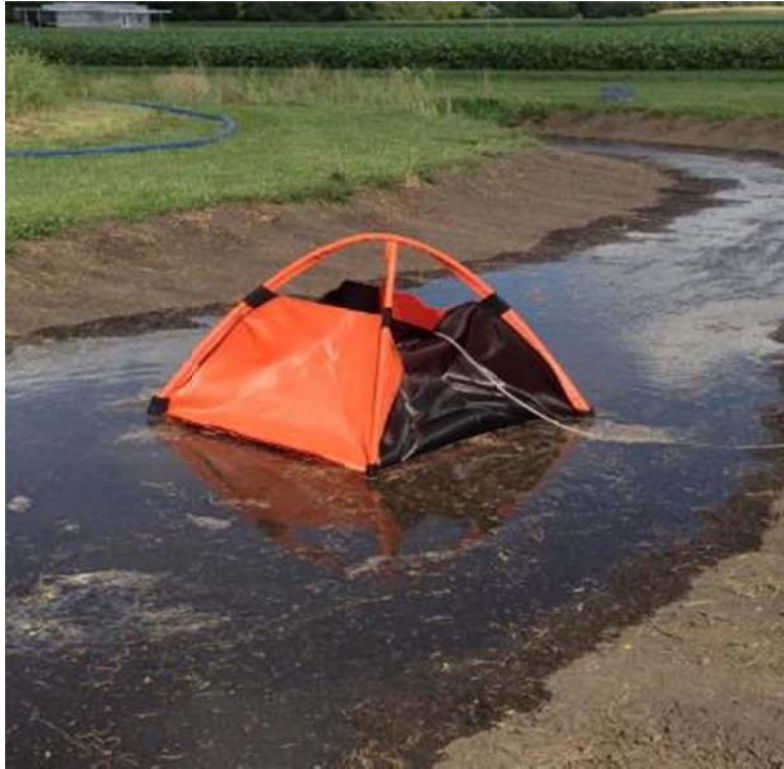
**Figure A.9 Dandy Pop during testing.**

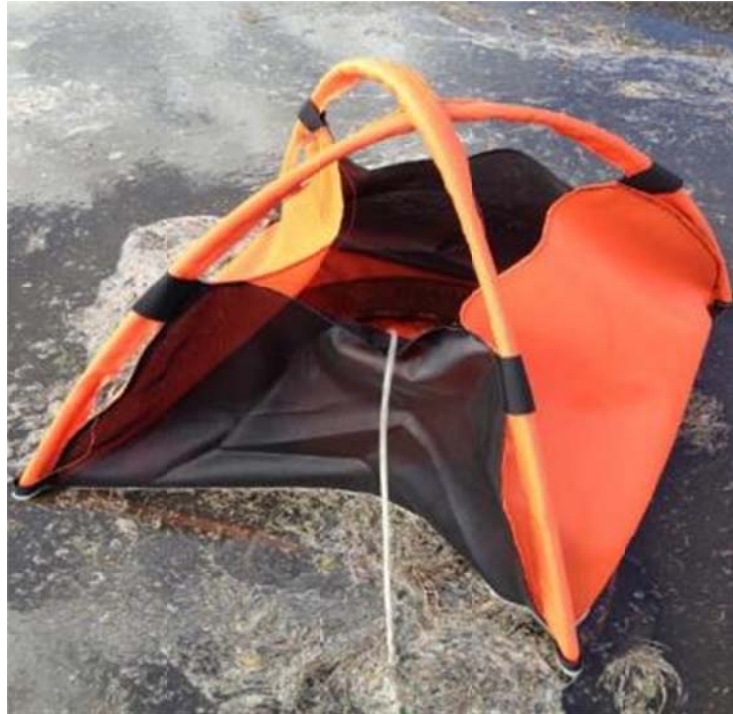
**Figure A.10 Hand pump for sample collection with Dandy Pop.**

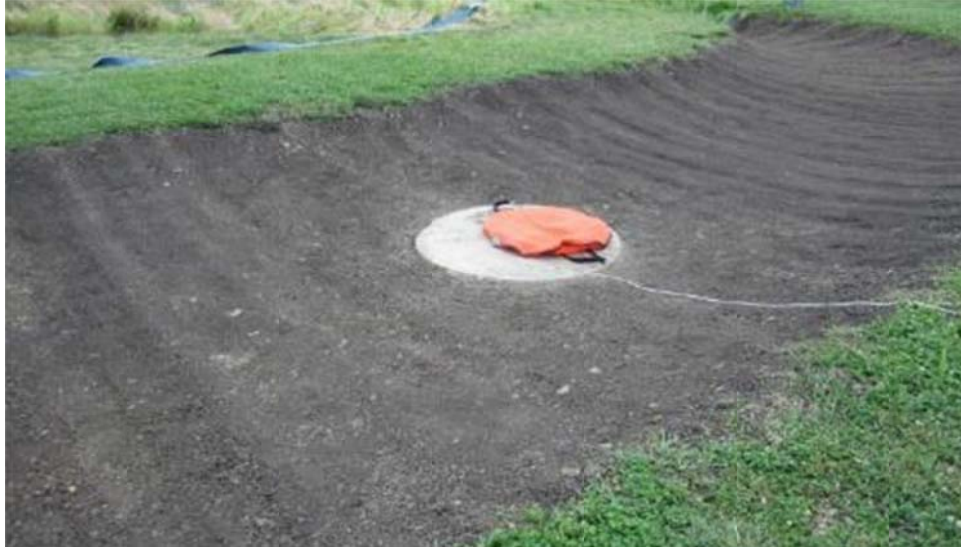
**Figure A.11 Dandy Bag, pre-testing.**

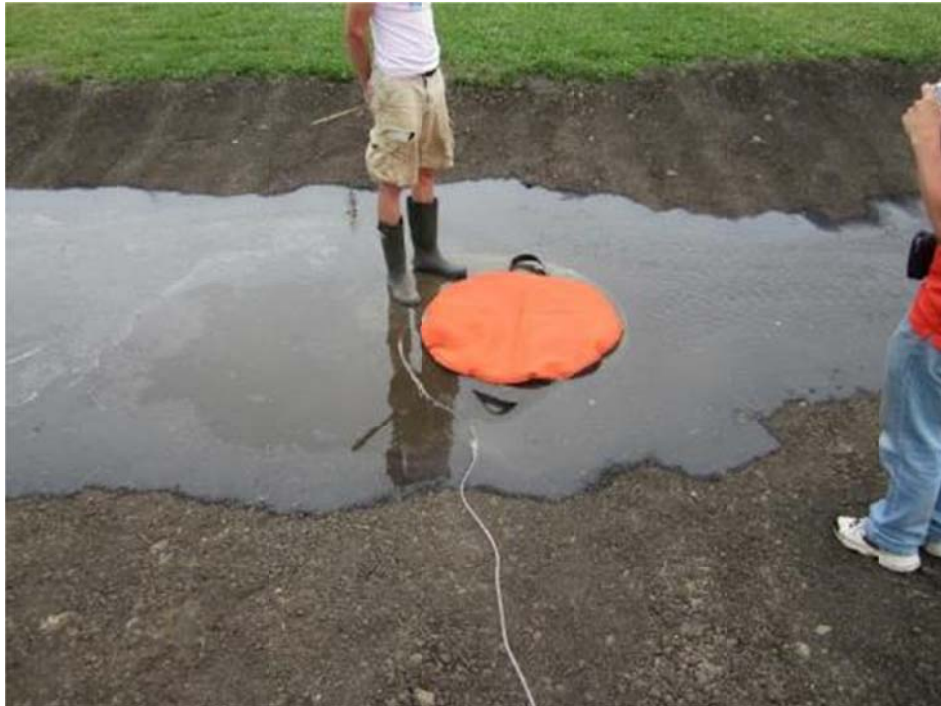
**Figure A.12 Dandy Bag during testing.**

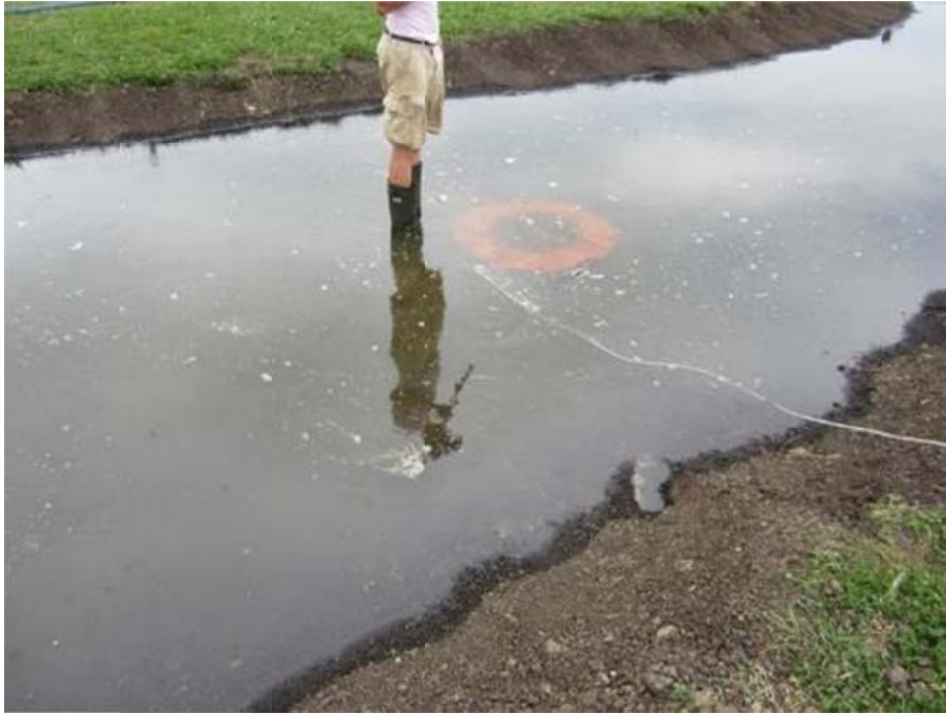
**Figure A.13 Dandy Bag submerged.**

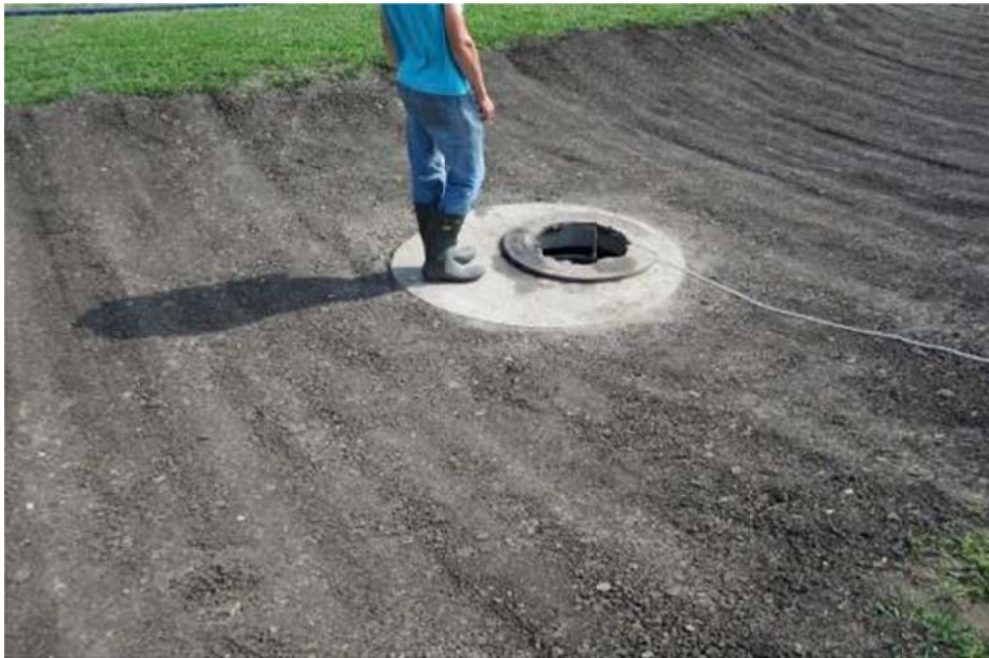
**Figure A.14 Drop filter bag, pre-testing.**

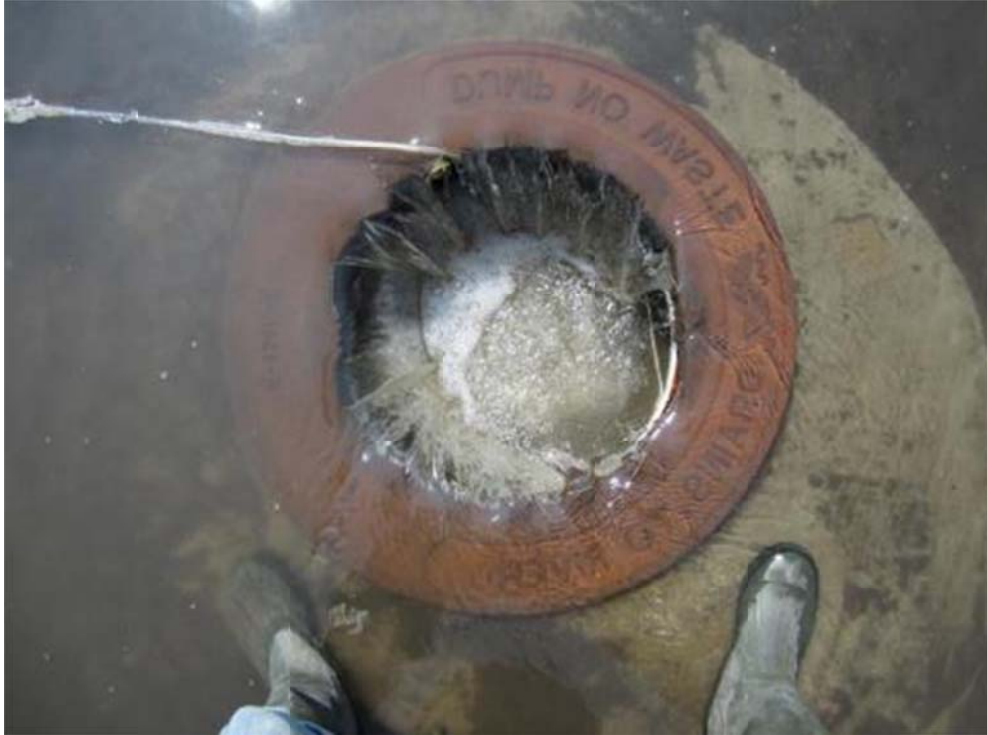
**Figure A.15 Drop filter bag, with water overflowing product.**

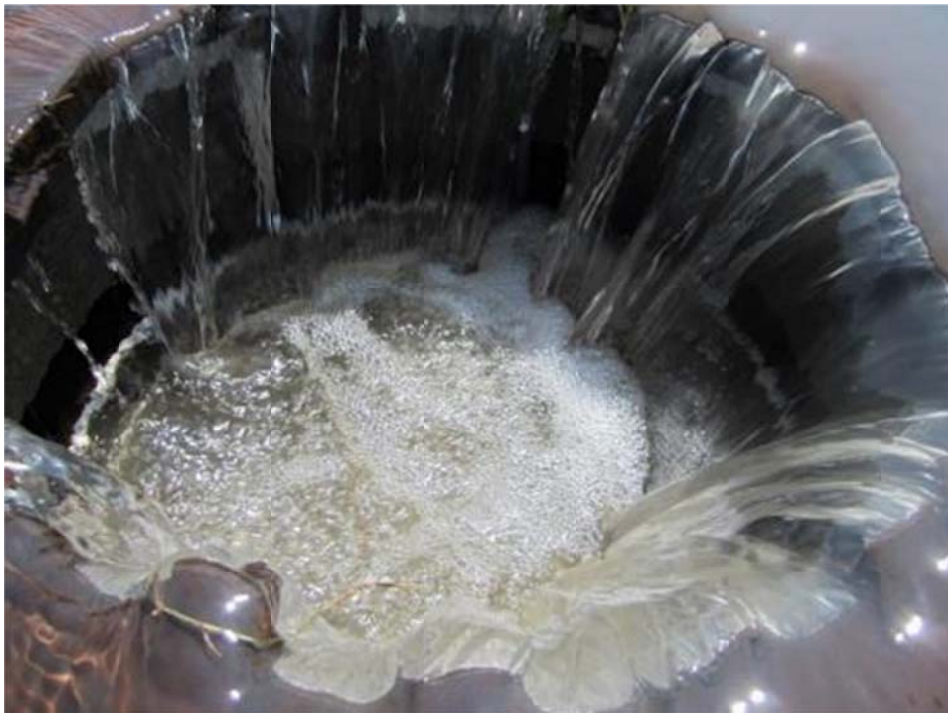
**Figure A.16 Drop filter bag overflowing manhole.**

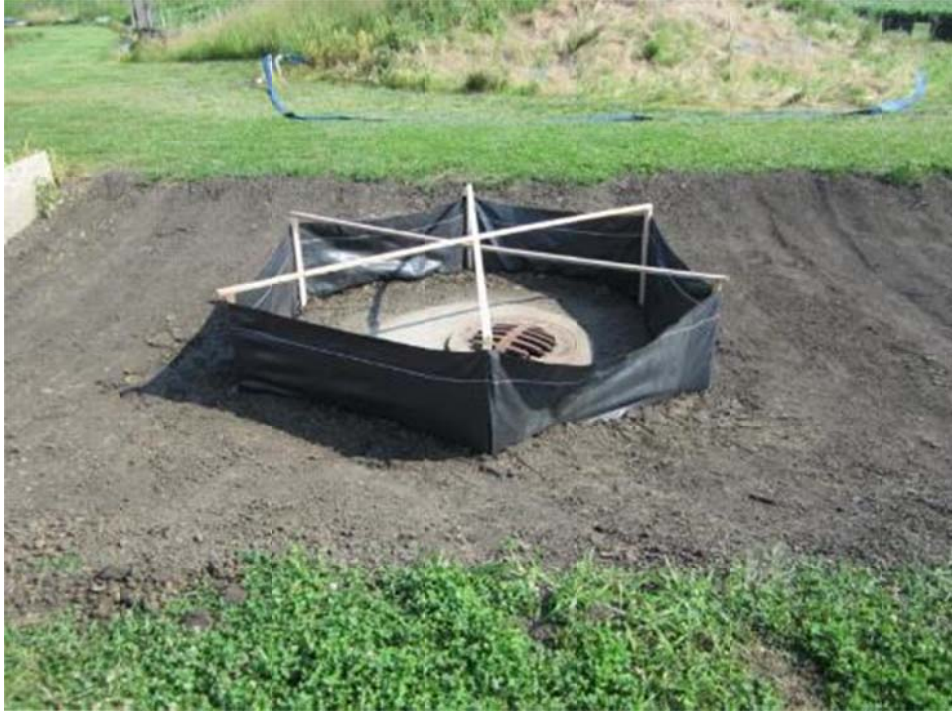
**Figure A.17 Silt fence (2 foot gap), pre-testing.**

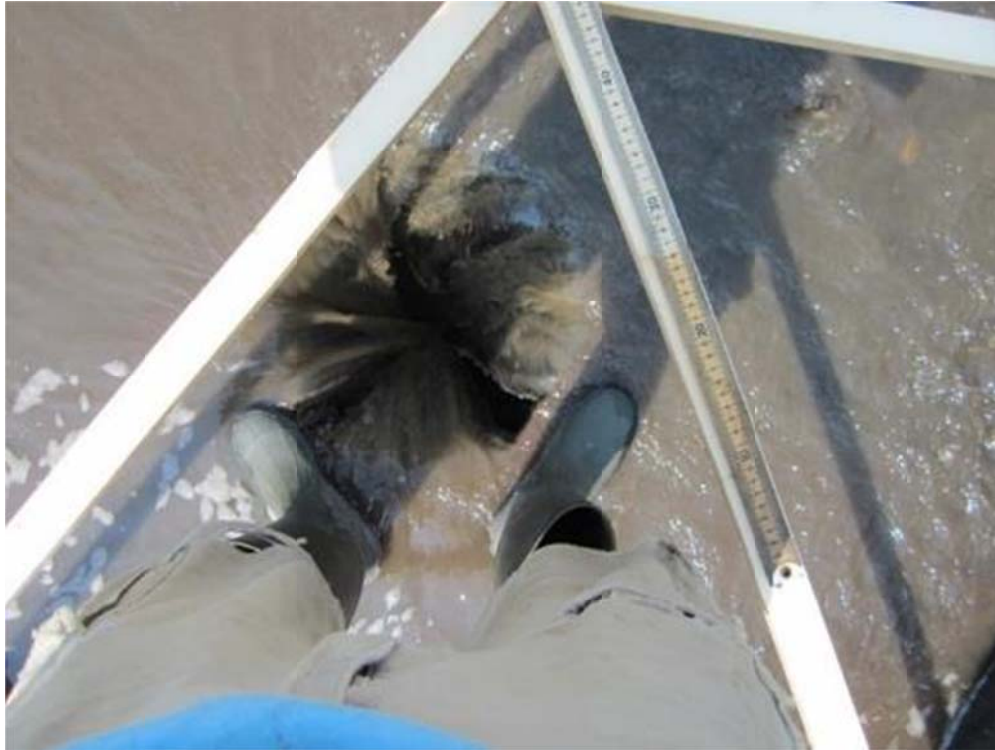
**Figure A.19 Silt fence (2 foot gap) product failure.**

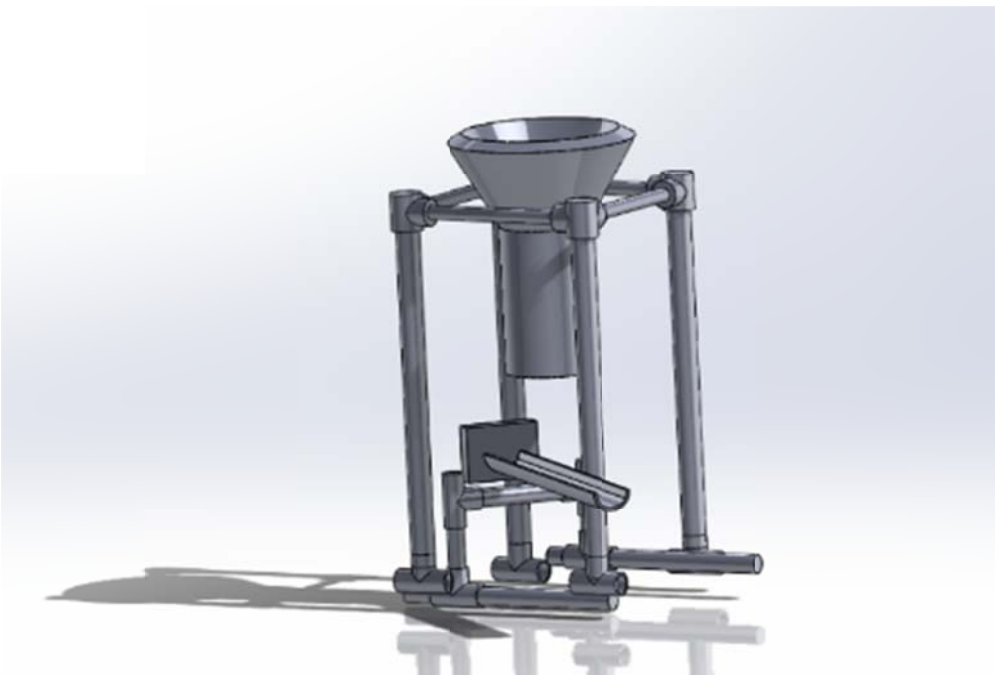
**Figure A.20 Water catchment system solid works assembly.**
