EVALUATION OF FLARED-END INLET PROTECTION PRODUCTS FOR SEDIMENT RETENTION

Research Report No. FHWA-ICT-16-004

A white paper prepared as part of
ICT-R27-102
Installation and Performance Testing of
Ditch Checks and Inlet Protection Structures

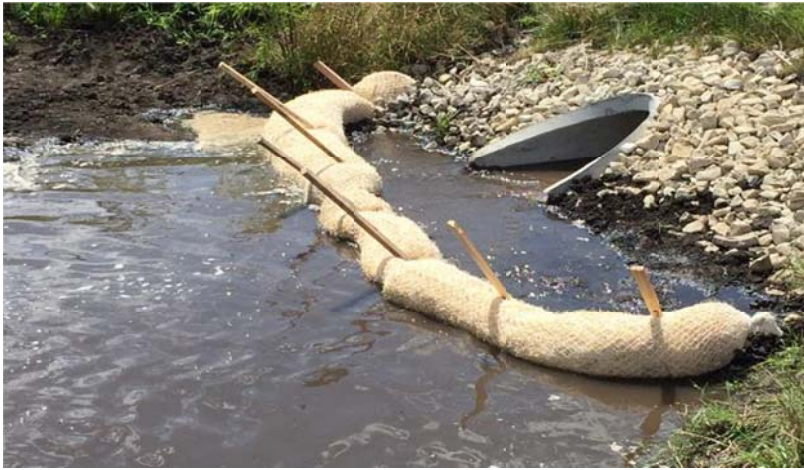
Manufactured by American Excelsior, Curlex sediment logs (Figure 3.1) are made of curled excelsior wood fiber rolls of various diameters. They are designed to reduce hydraulic energy and to filter runoff. Sediment logs provide temporary, biodegradable channel interruption by slowing water velocity to reduce shear stress over the channel, thereby minimizing soil degradation in the channel and enhancing vegetation establishment (American Excelsior 2015).

Figure 3.1 Sediment log.

1. Dig a trench 0.5 foot (6 inches) deep; place product in front of the flared-end inlet.
2. Place product into trench; hammer stakes 2 feet into the ground at 45 degrees toward the flow.
3. Place stakes every 2 feet around the log.
4. Backfill the trench with excess soil; compact soil to secure product firmly.

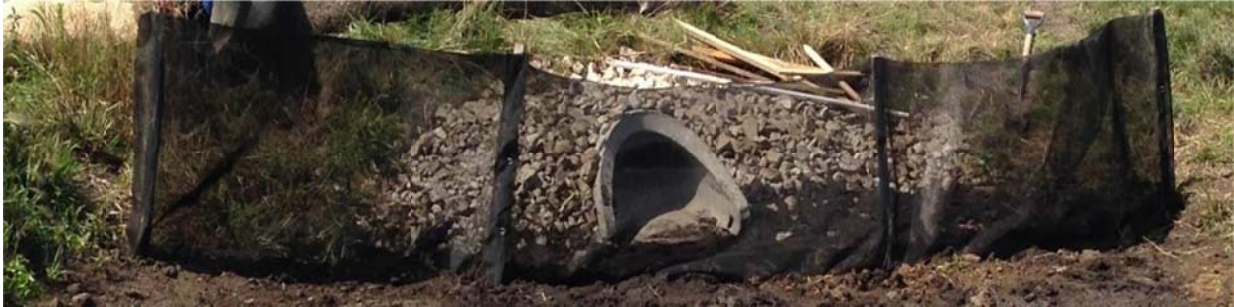
The silt fence with woven monofilament fabric (Figure 3.2) is more porous than standard IDOT silt fence fabric. It holds sediment particles while letting water pass through the product.

Figure 3.2 Silt fence with woven monofilament.

1. Dig a trench 0.5 foot (6 inches) deep in front of the flared-end inlet.
2. Staple the fabric to wooden stakes, if they are not already attached.
3. Hammer wooden stakes at least 2 feet within the trench.
4. Backfill trench with excess soil; compact soil to secure product firmly.

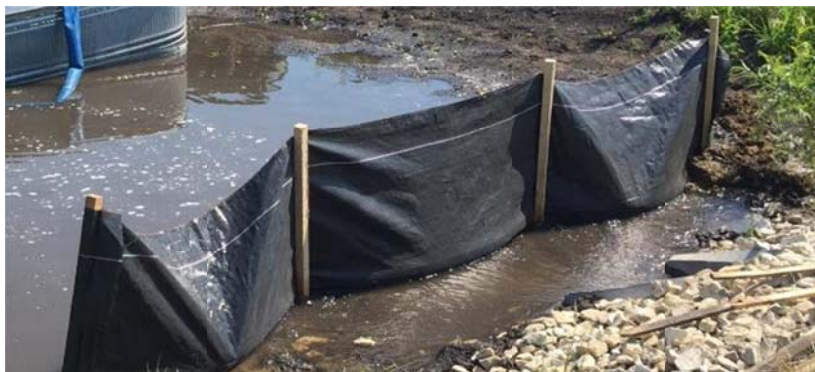
The silt fence with IDOT-approved fabric (Figure 3.3) is used to filter sediment particles from construction sites, barren land, and tilled agricultural land. It prevents sediment from entering water bodies, helping to ensure that water quality will not suffer and aquatic life remains safe (EPA 2012). Silt fences should be installed on level land and kept in place until the soil becomes stabilized. The installation method is the same as for the silt fence with woven monofilament fabric.

Figure 3.3 Silt fence with IDOT-approved fabric.

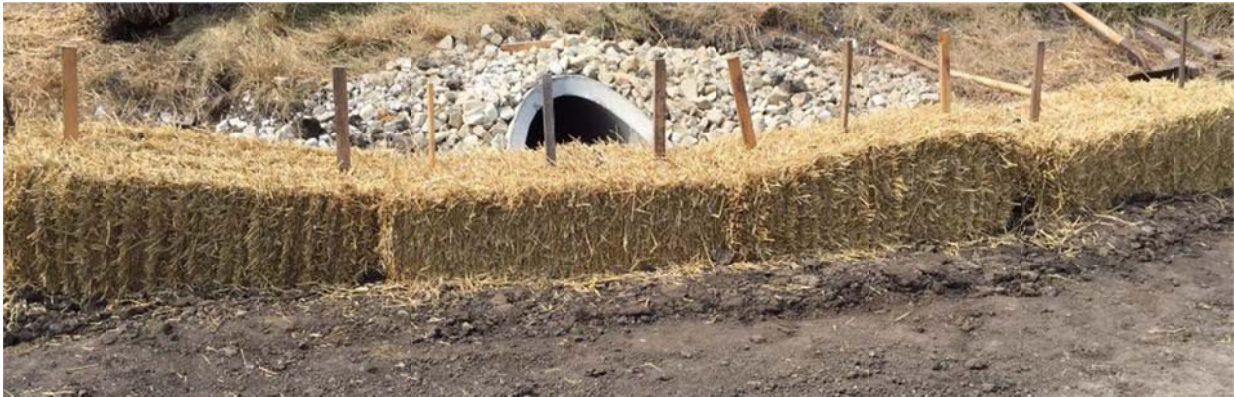
Straw bales (Figure 3.4) are temporary sediment retention products commonly used on construction sites to filter sediment. They are usually installed by placing straw bales in a row and tying them with wire or nylon or polypropylene string. When used in a channel, straw bales should weigh at least 50 pounds. An average straw bale should contain at least 5 cubic feet of material and be 30 inches in length (Broz et al. 2003). The straw bale tested in this study was purchased from a local store and was 41 inches long, 19 inches wide, and 12 inches high.

Figure 3.4 Straw bales.

1. Dig a trench 0.5 foot (6 inches) deep; place product in front of the flared-end inlet.
2. Place product inside trench; ensure firm placement.
3. Hammer wooden stakes through the bales, making sure that the stakes are buried at least 2 feet deep underneath the bales.

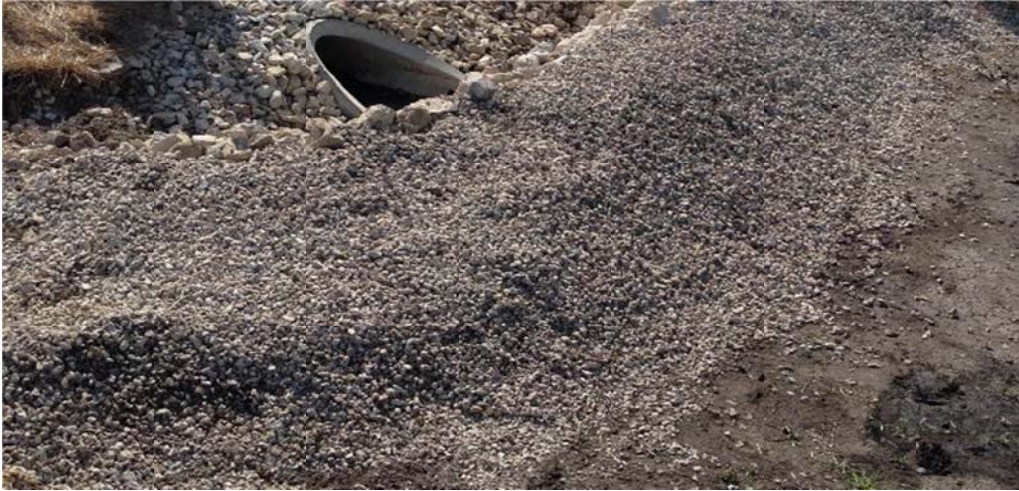
Another product that was evaluated as a flared-end protection measure was a stone check dam (Figure 3.5). The structure consisted of riprap stones that were layered in front of the inlet. This setup caused water to pond upstream of the product, allowing sediment to settle before entering the inlet. Stone can be used under any flow and is often best used in conjunction with other best management practice (BMP) products. Large stones are primarily used for high flows, while small stones are used for low flows for trapping fine sediment. Upon installation, they can be designed for temporary or permanent use.

Figure 3.5 Flared-end inlet protection using stone.

1. Dig a 0.5 foot (6 inches) deep trench to extend across the channel in front of the flared-end inlet.
2. Place geotextile fabric inside trench.
3. Place 4 to 6 inch diameter stone on top of geotextile fabric with the structure size to stand between 1 to 5 feet in height as needed.
4. Place 0.75 inch diameter stone on upstream side of the structure.
5. Ensure the structure has a minimum width of 2 feet and extends around the inlet.

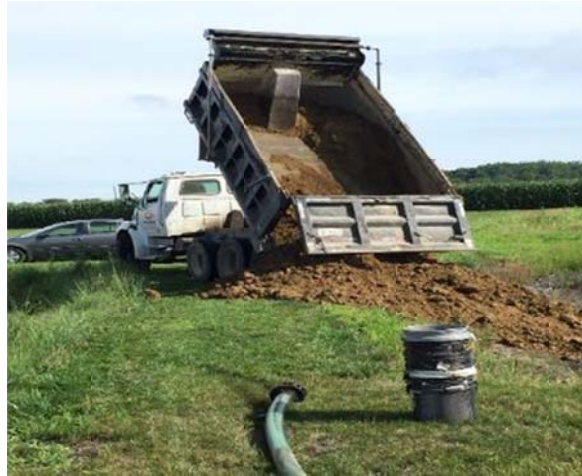
To test the sediment filtration by flared-end inlet protection products, certain procedures were followed. Before the field tests began, the test channel was tilled and leveled to an approximately parabolic shape (Figure 3.6).

Figure 3.6 Preparation of field for testing.

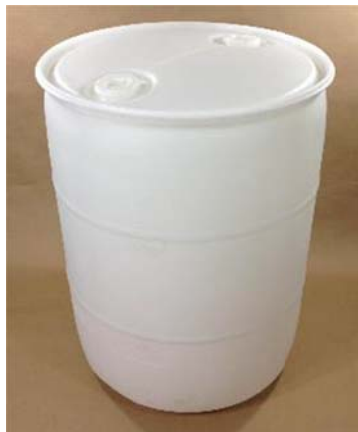
To calibrate flow, a volume time measurement using a 158 gallon (100 L) graduated water bucket (Figure 3.7). The time duration to fill the bucket entirely to 158 gallon (100 L) was noted with a stopwatch, and the flow rate was calculated by dividing the total volume by time. The average time to fill 158 gallon (100 L) was calculated to be around 10 seconds, providing a flow rate of 158 gallons/minute (gpm) or 10 L/s.

Figure 3.7 Graduated water bucket (with 158 gallons capacity) used for flow calibration (Source: Yankee Containers®).

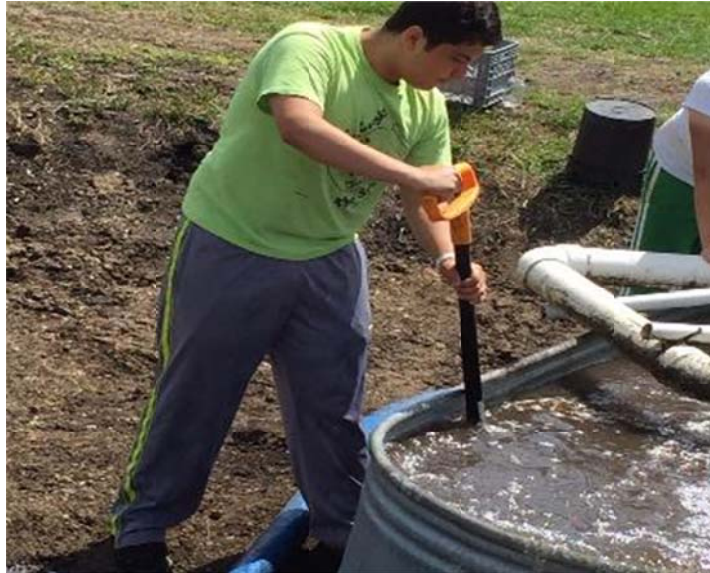
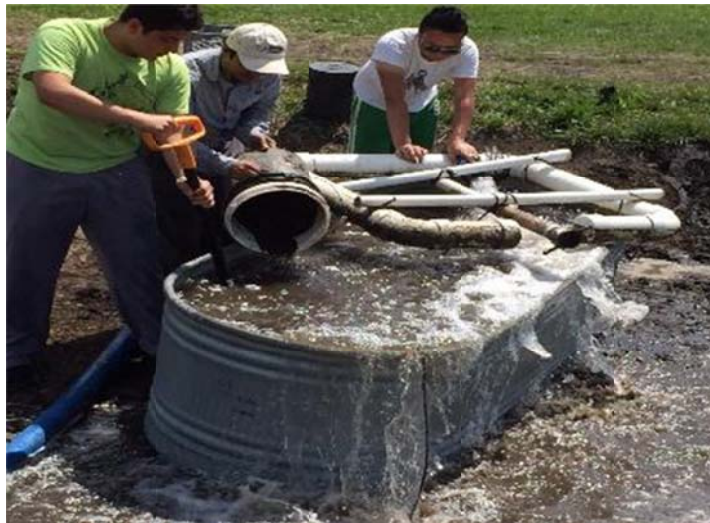
The total duration of the test was 30 minutes. Water from the pump was discharged at a rate of 158 gpm (10 L/s) and was poured into a 300 gallon tank. At the beginning of the test, one 5 gallon bucket of clay soil was added to the tank and stirred continuously throughout the experiment (Figure 3.8). Another 5 gallon bucket of clay soil was added to the tank 10 and 20 minutes after the initial addition (Figure 3.9). Continuous mixing prevented any soil from settling to the bottom.

Figure 3.8 Sediment mixing.

Figure 3.9 Adding clay soil.

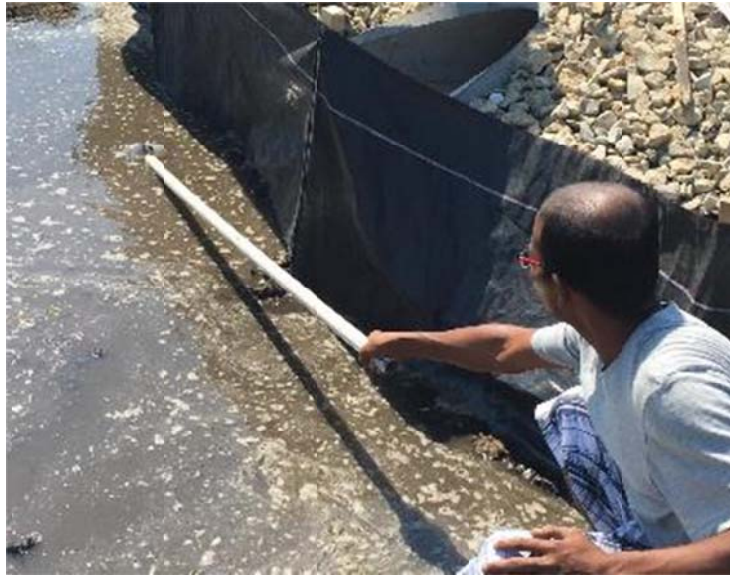
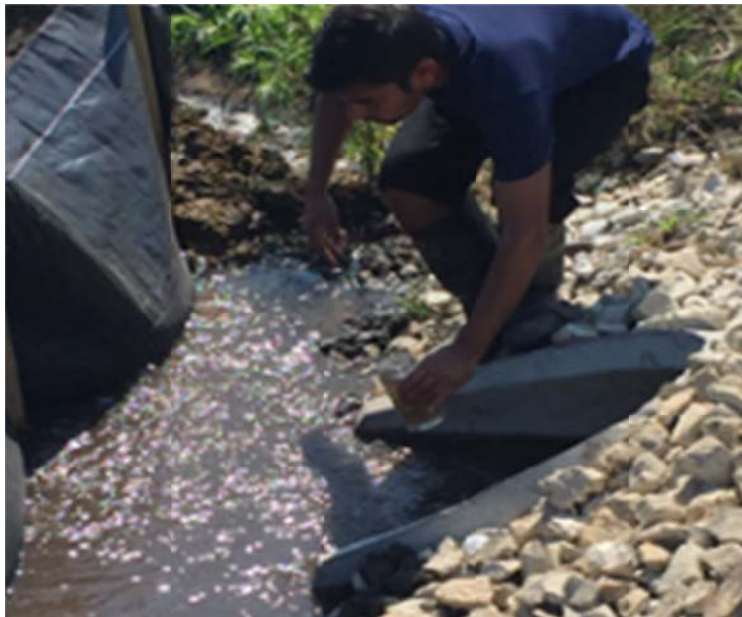
Samples were collected before the product (Figure 3.10) and after the product (Figure 3.11). Samples were collected every 5 minutes until the 30 minute mark, along with a sample taken when the test initially began. The soil mixture tank was stirred continuously to ensure that the samples would have a consistent homogenous soil concentration.

Figure 3.10 Sample taken before product.

Figure 3.11 Sample taken after product.

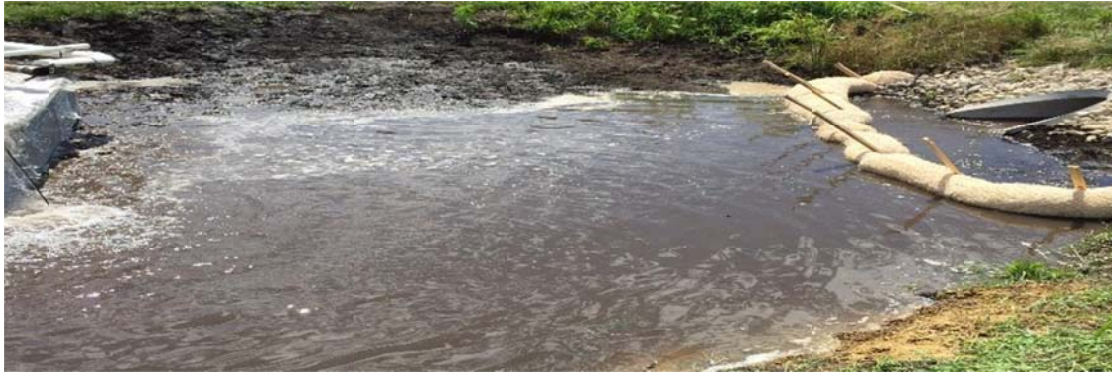
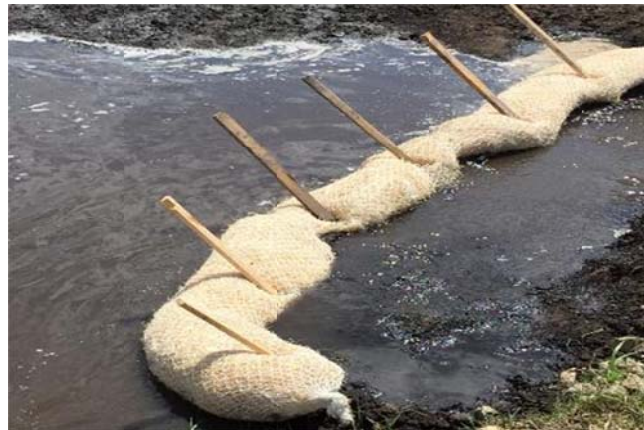
The sediment log proved to drain efficiently under the experimental flow rate of 158 gpm (10 L/s). Water started to pond around the product at 3-1/2 minutes (Figure 4.1). Slight undercutting of the product was observed, likely due to increased ponding (Figure 4.2). The channel was completely drained 9-1/2 minutes after testing concluded. At the end of testing, it was observed that the product was free of any rips or tears. This product worked well for sediment retention but created ponding at the same time.

Figure 4.1 Sediment log at 158 gpm (10 L/s) flow rate.

Figure 4.2 Undercutting observed underneath the product.

- **Ponding:** Ponding was apparent but average compared to other products tested. This product be routinely cleaned after each rainfall event. Ponding resulted in undercutting near the stakes, which eroded soil within the trench.

- **Product failure:** Undercutting was the biggest issue with this product, which is primarily associated with improper trenching. Therefore, proper installation and maintenance are strongly recommended for this product. If not properly maintained, sediment logs are capable of tearing or ripping.

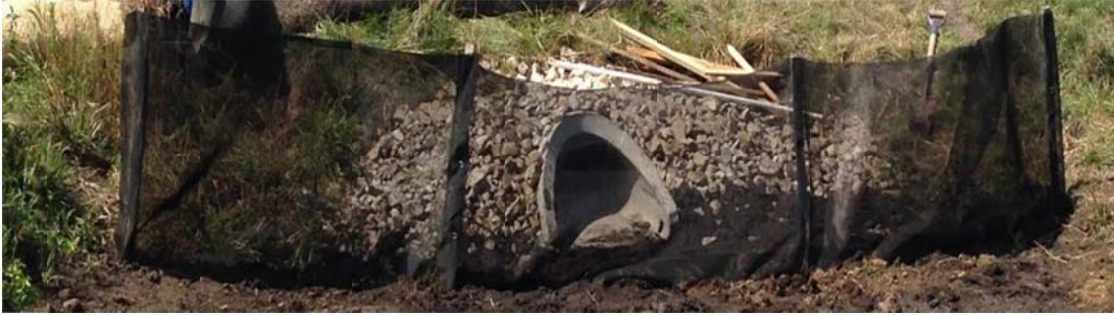
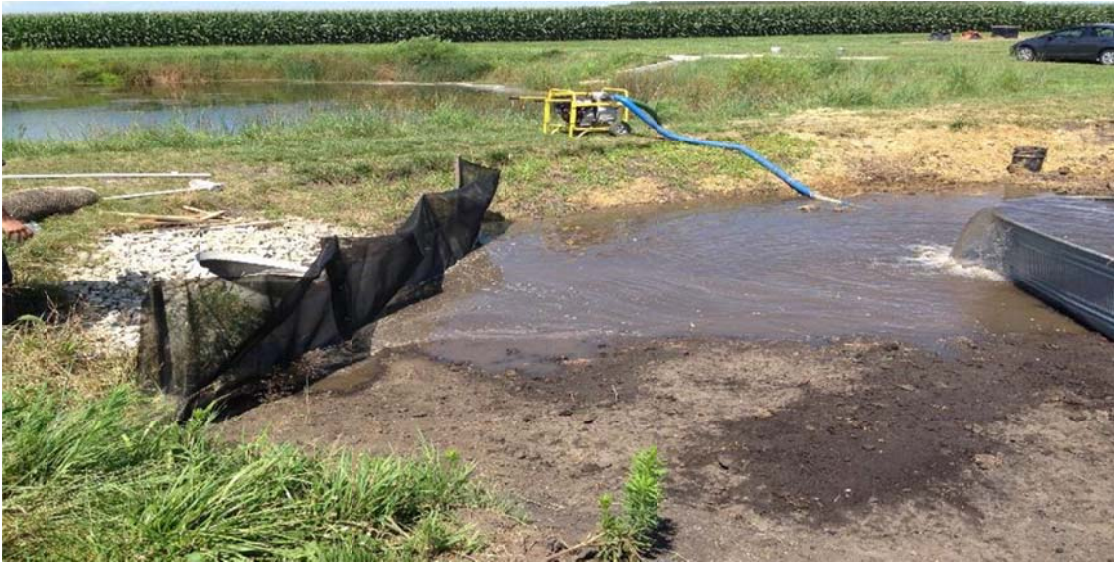
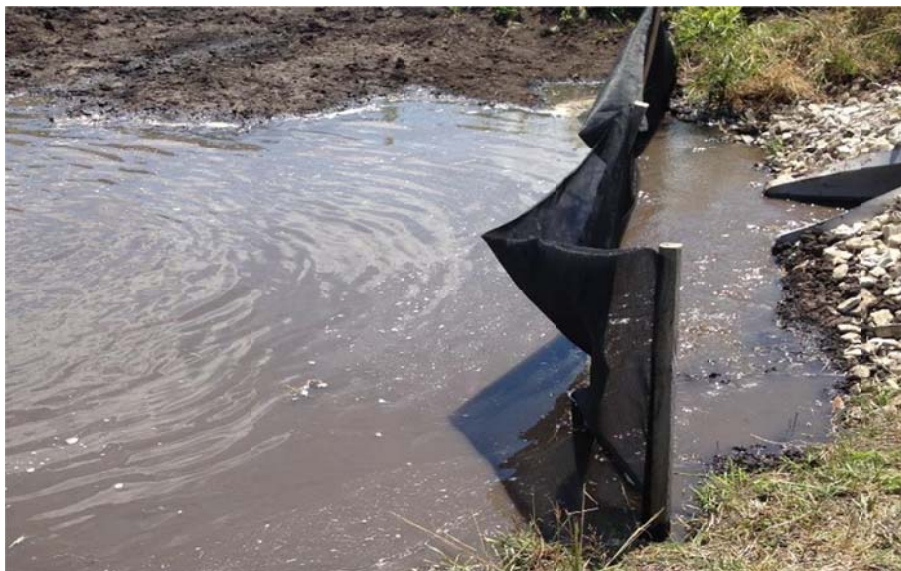
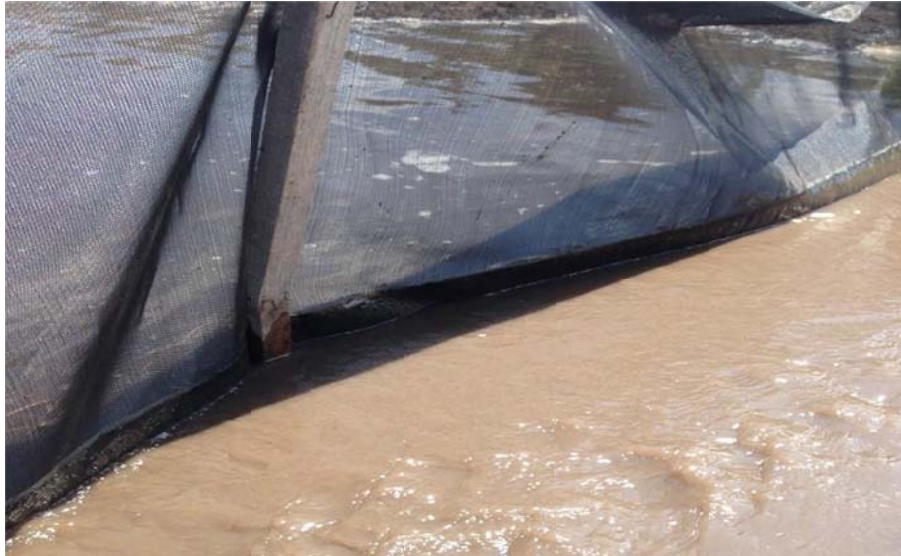
The silt fence with woven monofilament fabric (Figure 4.3) proved to drain efficiently under the experimental flow rate of 158 gpm (10 L/s) (Figure 4.4). Due to the product's permeable mesh, water passed through with minimal amounts of ponding (Figure 4.5). This was evidenced by the slight water level difference, around 1 to 3 inches, between the upstream/downstream sides (Figure 4.6). Slight ponding occurred through the experiment, with no observed undercutting. This product worked well for sediment retention but created ponding at the same time.

Figure 4.3 Silt fence (woven monofilament).

Figure 4.4 Silt fence (woven monofilament) at 158 gpm (10 L/s) flow rate.

Figure 4.5 Flow through the silt fence (woven monofilament) during the test.

Figure 4.6 Observed water level difference upstream and downstream of the silt fence (woven monofilament).

- **Ease of installation:** This product was quite difficult to install due to the need for proper trenching, staking, and tightness between the stakes. It was observed that undercutting will occur regardless of how well the product is installation and may lead to product failure if neglected.
- **Ponding:** Ponding was apparent but average compared to other products tested. For optimal use, routine cleaning should be done after each rainfall event.
- **Product failure:** Undercutting could be the biggest potential problem with this product if it is not installed properly. Poor compaction can lead to undercutting and cause erosion around the stakes, causing them to wobble and fail.

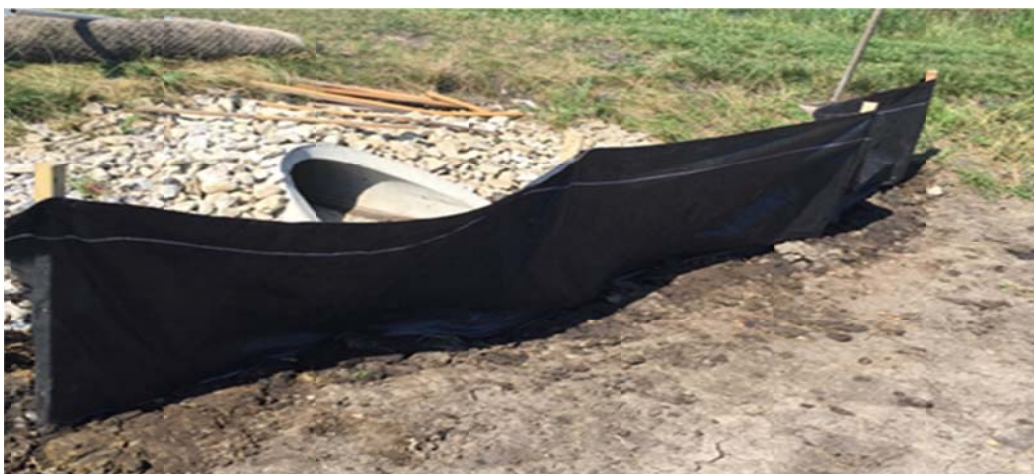
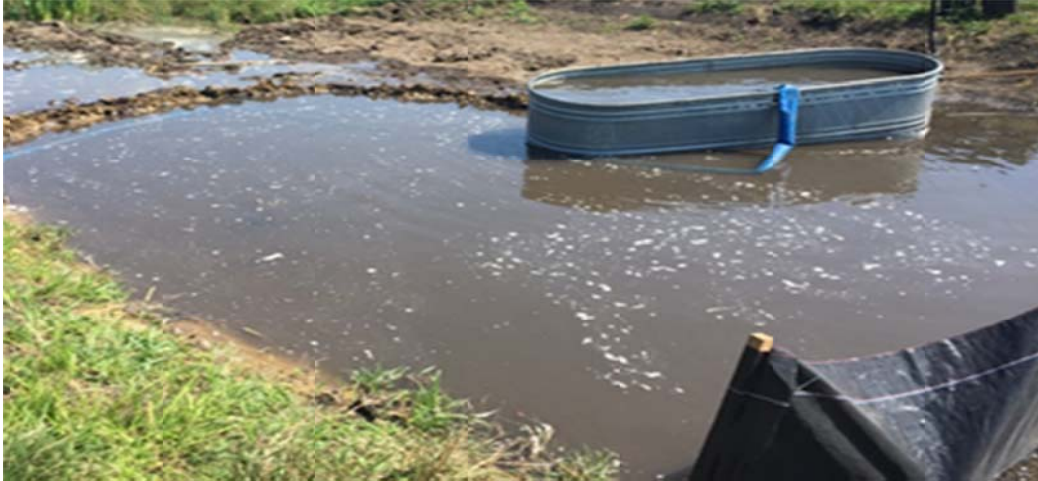
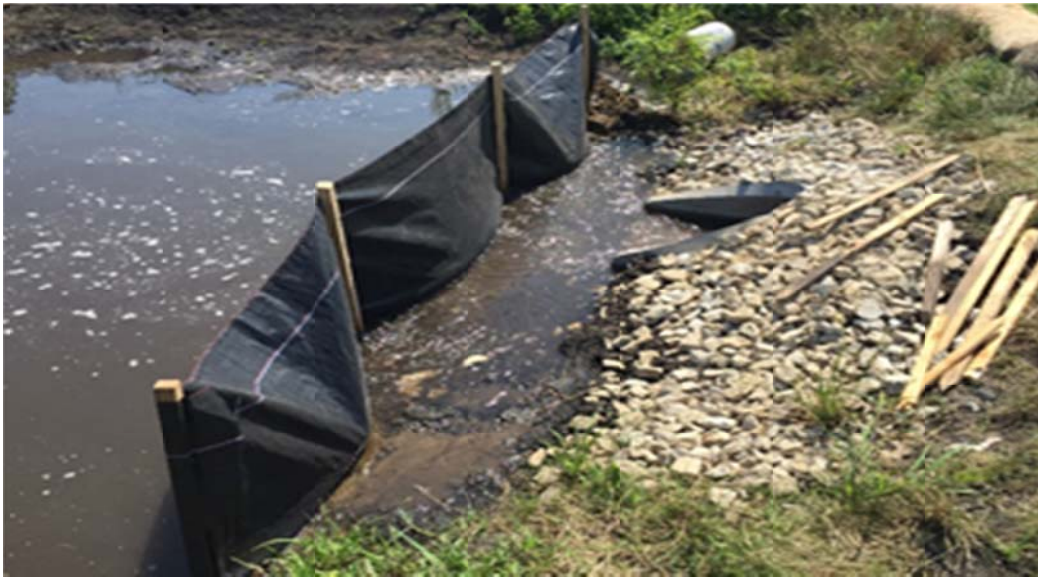
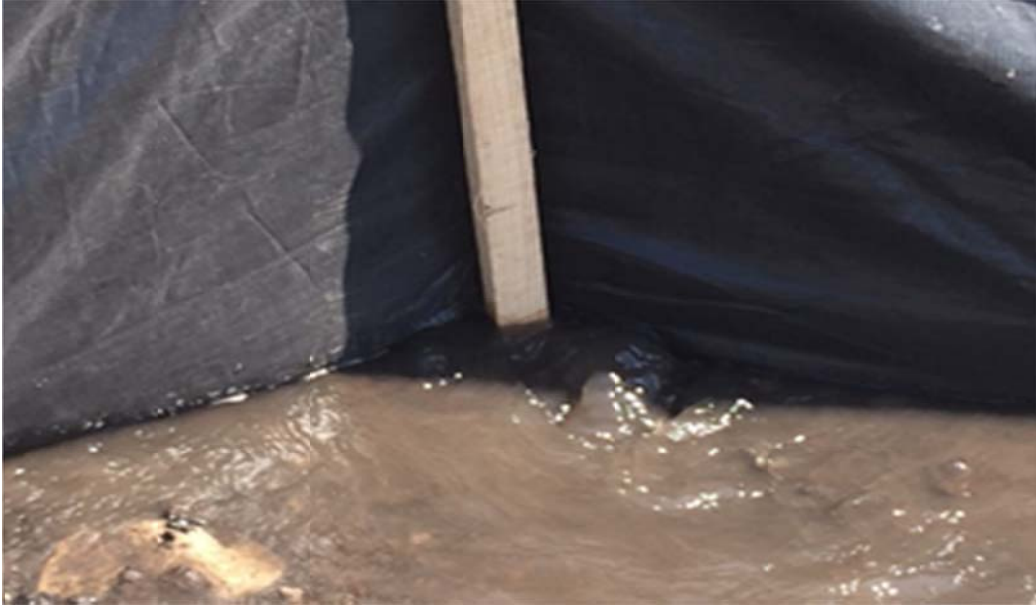
Water passed through the IDOT-approved fabric of the silt fence (Figure 4.7) at 1-1/2 minutes, with heavy ponding at 4-1/2 minutes (Figure 4.8). As ponding increased, water pressure on the material and stakes also increased (Figure 4.9). By 8 minutes, signs of severe undercutting were observed (Figure 4.10). Despite meticulous effort to ensure compacting was done well around the silt fence, the hydrostatic pressure created by ponded water caused undercutting. The undercutting started initially near the center, but it eventually was observed at every stake. By the end of the experiment, the entire channel was flooded due to the ponding. Based on the observations of severe undercutting, it can be concluded that the product failed during the experiment and is inadequate for field use for a flow rate of 158 gpm (10 L/s) or higher.

Figure 4.7 Silt fence with IDOT-approved fabric.

Figure 4.8 Heavy ponding (silt fence with IDOT-approved fabric).

Figure 4.9 Water pressure stressing the silt fence with IDOT-approved fabric.

Figure 4.10 Product undercutting (silt fence with IDOT-approved fabric).

- **Ponding:** This product performed very poorly; it immediately ponded after testing started. Ponding resulted in undercutting near the stakes, which eroded soil within the trench.

- **Product failure:** Undercutting can the biggest potential problem with this product. The poor porosity of the material creates significant ponding. Extreme ponding puts a considerable amount stress on the product as the water level rises, which will lead to increased chances of failure. Extreme ponding can also lead to undercutting and will cause erosion around the stakes, causing them to wobble and fail.

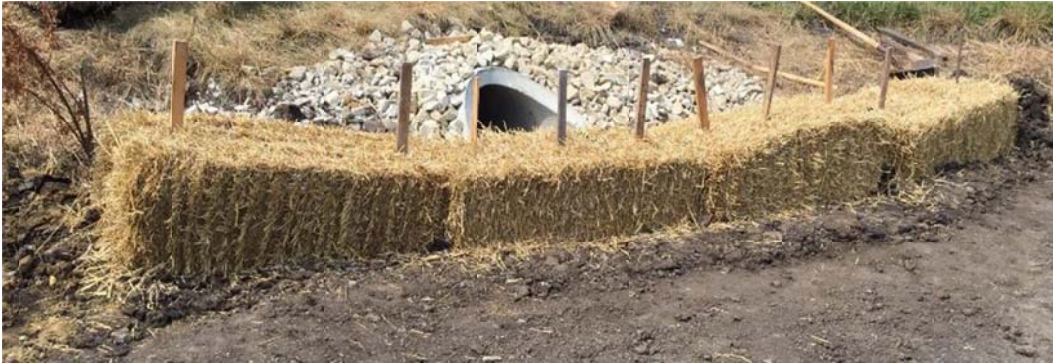
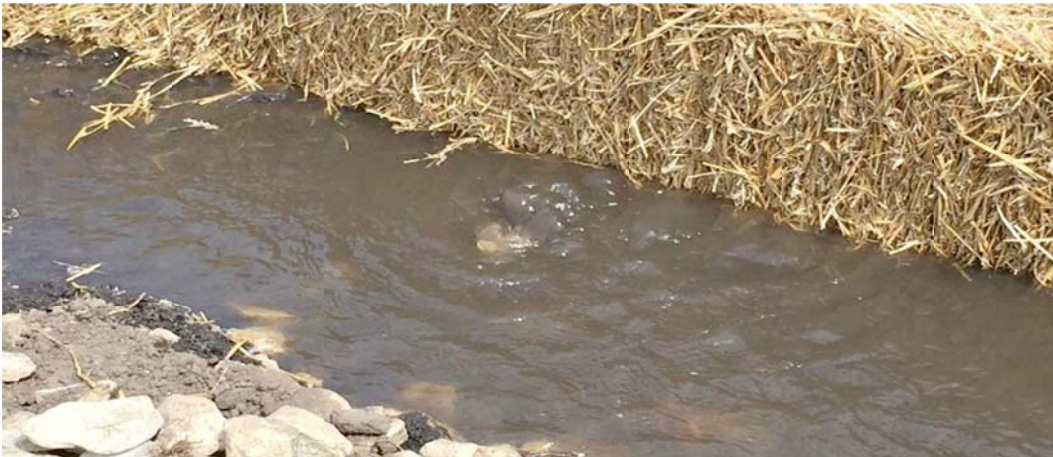
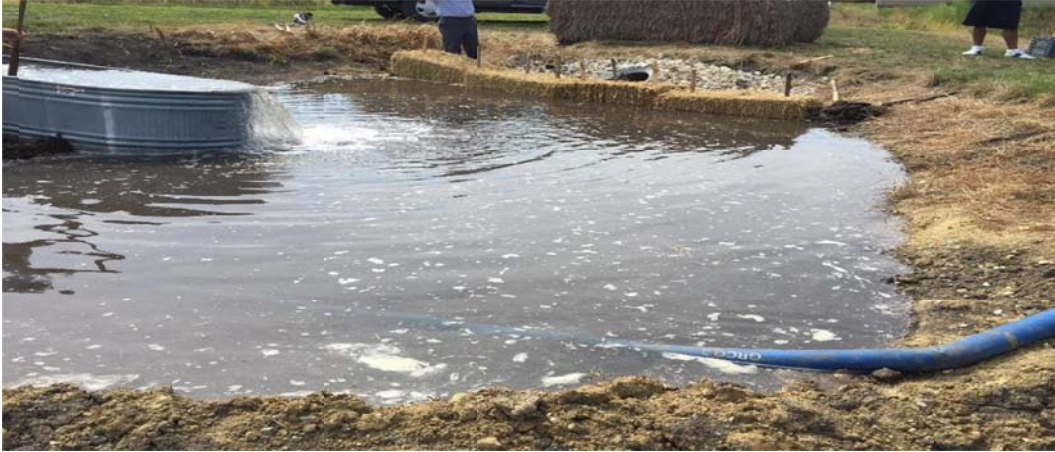
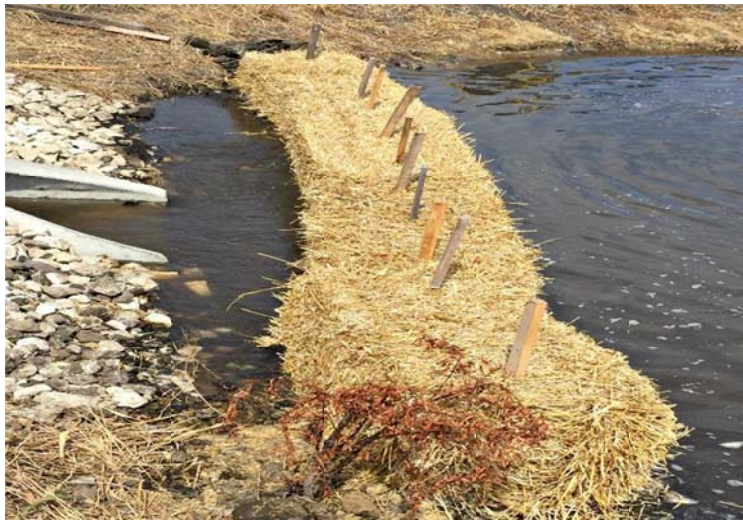
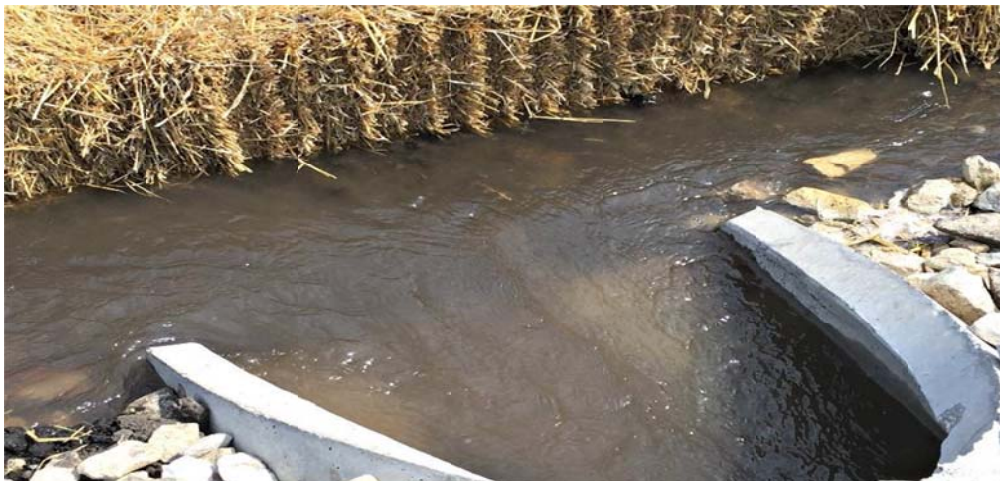
It was observed during the test that it took around 2 minutes for flow to penetrate the product (Figure 4.11). Ponding started to occur around 3 minutes after the test began. Heavy ponding occurred at 6-1/2 minutes, along with undercutting near the center of the product (Figure 4.12). Due to extensive ponding, hay and other debris circulated in front of the product, clogging the product. Extreme ponding occurred around 10 minutes into testing, which nearly flooded the entire channel, with deep undercutting at multiple locations (Figures 4.13). As a result of this undercutting, it was observed that a heavy amount of sediment entered the inlet (Figures 4.14 and 4.15). It was also observed that loose hay straws entered the inlet along with the flow. This can lead to clogging of the inlet over the time. Due to heavy amounts of ponding and undercutting, the straw bale can be considered a product failure and inadequate for field use for a flow rate of 158 gpm (10 L/s) or higher.

Figure 4.11 Straw bale.

Figure 4.12 Product undercutting.

Figure 4.13 Extreme ponding during testing.

Figure 4.14 Unfiltered sediment passing through product.

Figure 4.15 Unfiltered sediment entering inlet.

- **Ponding:** This product performed very poorly; it immediately ponded after testing started. Ponding resulted in undercutting near the stakes, which eroded soil within the trench.

- **Product failure:** Undercutting was a large problem with this product. Extreme ponding puts a considerable amount of stress on the product as the water level rises, leading to increased chances of product failure.

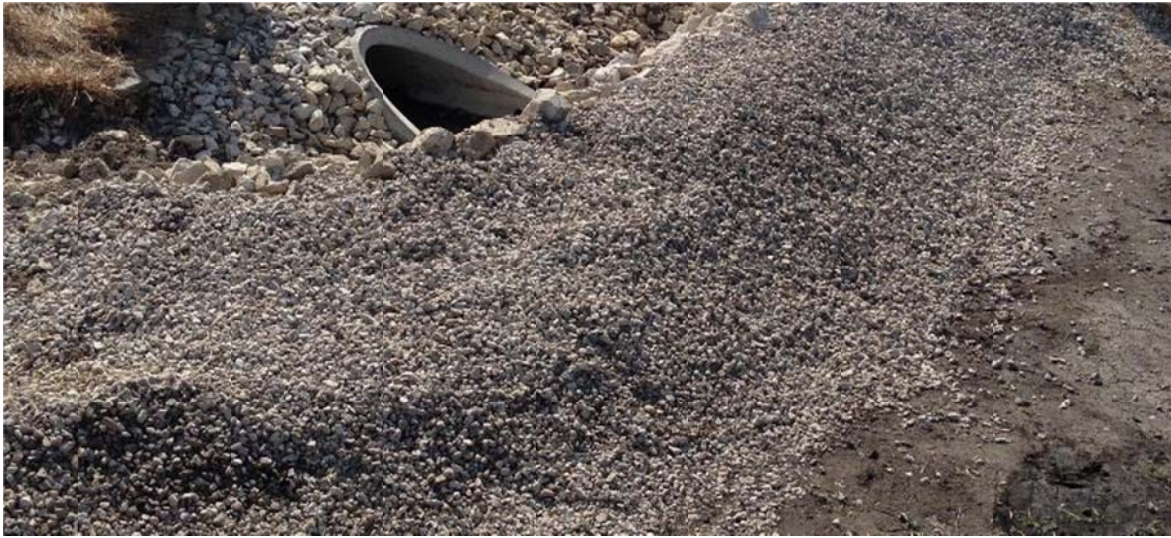
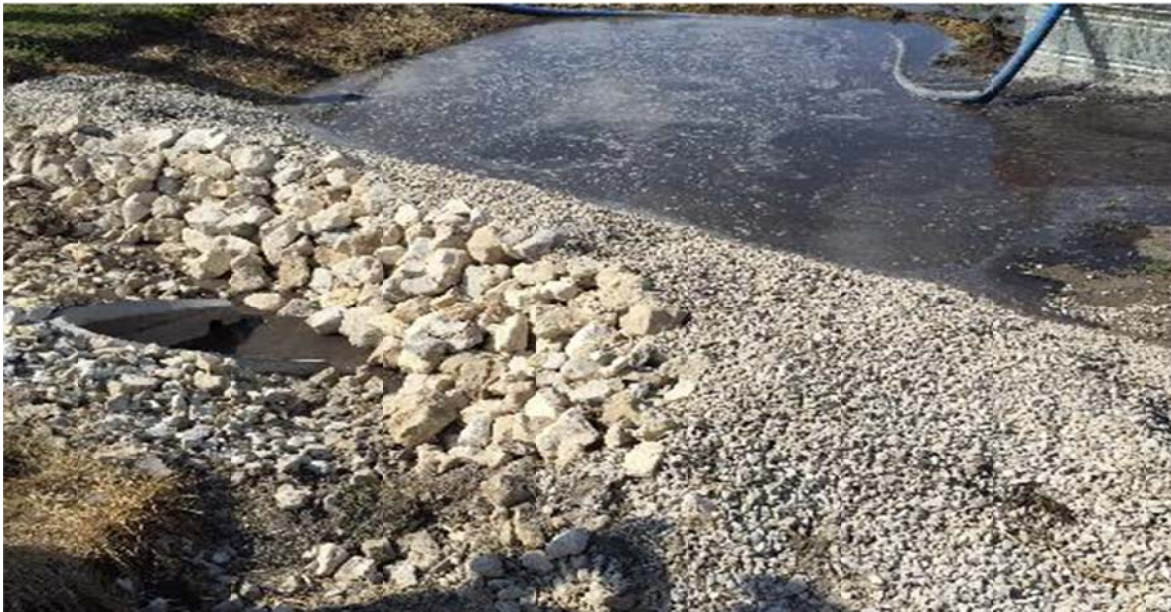
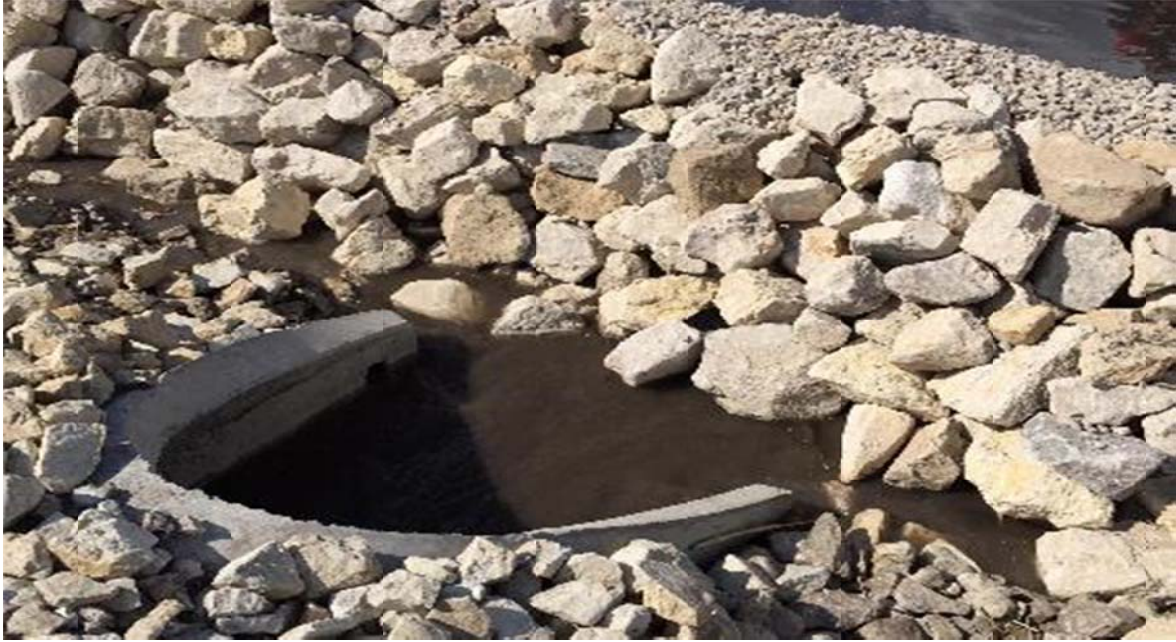
Water passed through the stone check dam (Figure 4.16) product within 1 minute and immediately ponded the channel. Water went through the stone unrestricted, with no signs of undercutting (Figure 4.17). Water passed through the product unfiltered, as evidenced by the observation that water entering the flared-end inlet was dark (Figure 4.18). This continued through the entire experiment, with ponding steadily increasing with time. Upon the completion of the experiment, it was observed that the product took around 15 minutes to drain entirely into the inlet. It was therefore determined that this product is inadequate for field use.

Figure 4.16 Stone check dam.

Figure 4.17 Flooding observed during testing at around 5 minutes.

Figure 4.18 Flow with high sediment leaving the product.

- **Sediment removal:** This was among the least effective products tested. Water was able to pass through the stone media more easily than it did with other products.
- **Ease of installation:** This product was quite difficult to install; the required volume of stone took a long time to install. This product required much time, precision, and resources and will create problems in the field if crews do not install the product correctly. Once installed, it would be very difficult to remove the product from the channel.
- **Ponding:** This product resulted in ponding as soon as the experiment started.
- **Product failure:** This product was unable to filter any sediment.

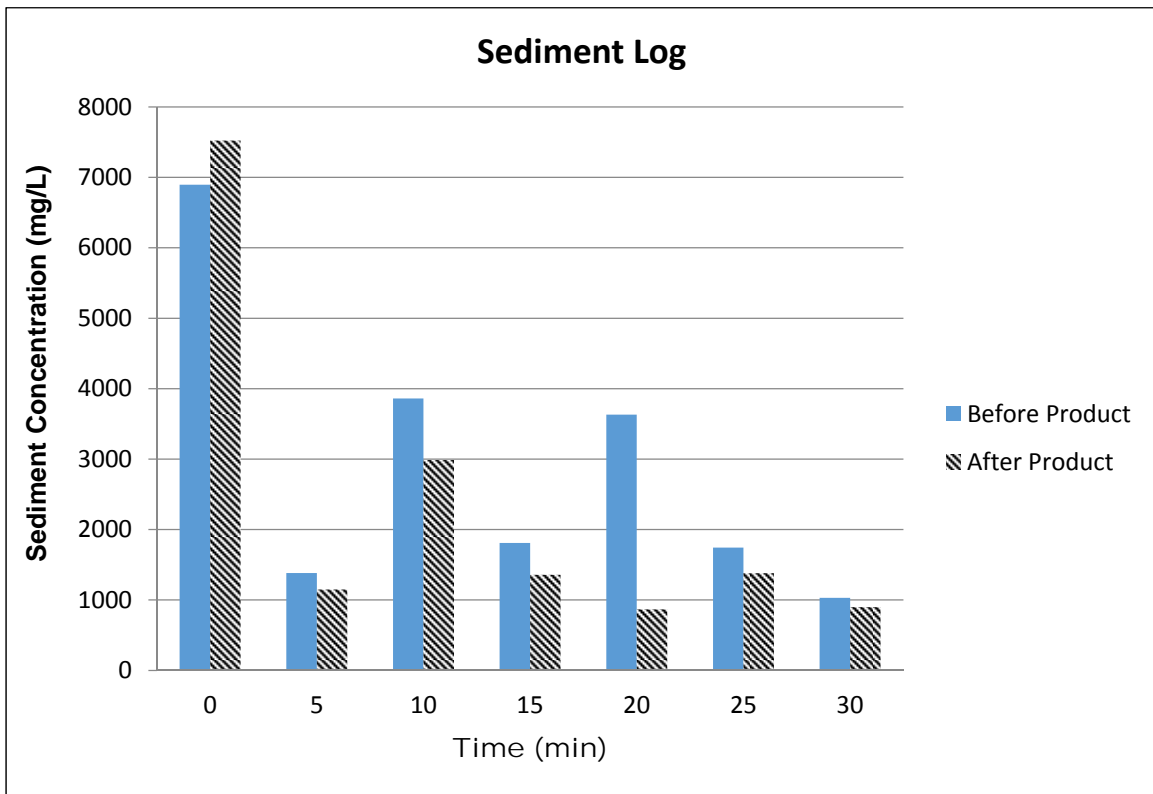
Sediment decreased with increasing time, and occurred throughout the experiment (Figure 5.1). The measured sediment concentration was the highest for the first sample collected at the beginning of the experiment. This was likely due to loose particles picked up from the dry surface. Despite the added sediment at 10 and 20 minutes, there was a consistent trend of efficient filtration, as shown in the graph. This product worked efficiently and consistently kept sediment concentrations low despite undercutting.

Figure 5.1 Sediment concentrations for sediment log.

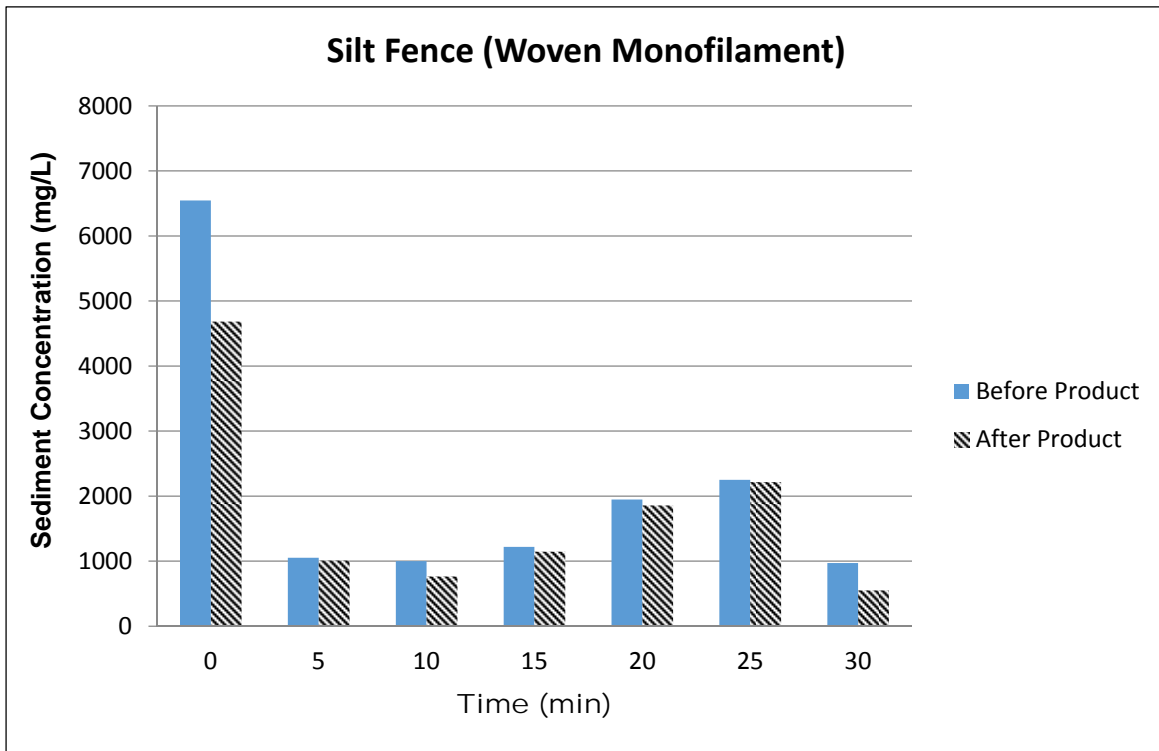
Sediment decreased with increasing time, and occurred throughout the experiment (Figure 5.2). The measured sediment concentration was the highest for the first sample collected at the beginning of the experiment. This was likely due to loose particles picked up from the dry surface. Despite the increased ponding, the silt fence was still able to filter efficiently. These observations provide evidence that the woven monofilament fabric performs considerably better than the standard IDOT-approved silt fence fabric.

Figure 5.2 Sediment concentrations for silt fence (woven monofilament).

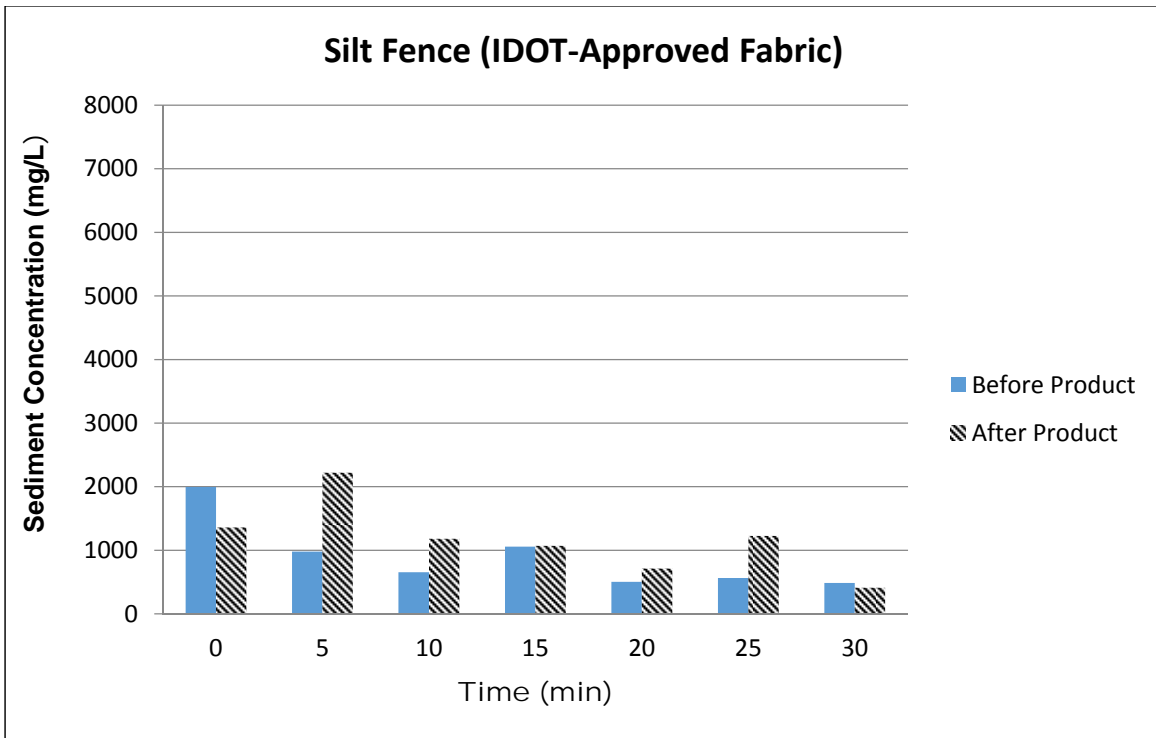
Sediment concentration increased throughout the experiment (Figure 5.3). The channel immediately flooded, which led to increased water pressure on the silt fence. The high pressure of water from the increased ponding led to undercutting, as shown in the graph, where higher values occurred after the product. Sediment concentration changes slightly fluctuated before the product throughout the entire experiment, as the channel was completely flooded at that point. Ponding caused soil to settle upstream, thus explaining the low sediment concentrations before the product. Because there was immense ponding, any added soil would merely swirl in the pool formed in front of the fence. This explains why the sediment concentrations showed little variability throughout the duration of the experiment.

Figure 5.3 Sediment concentrations for silt fence (IDOT-approved fabric).

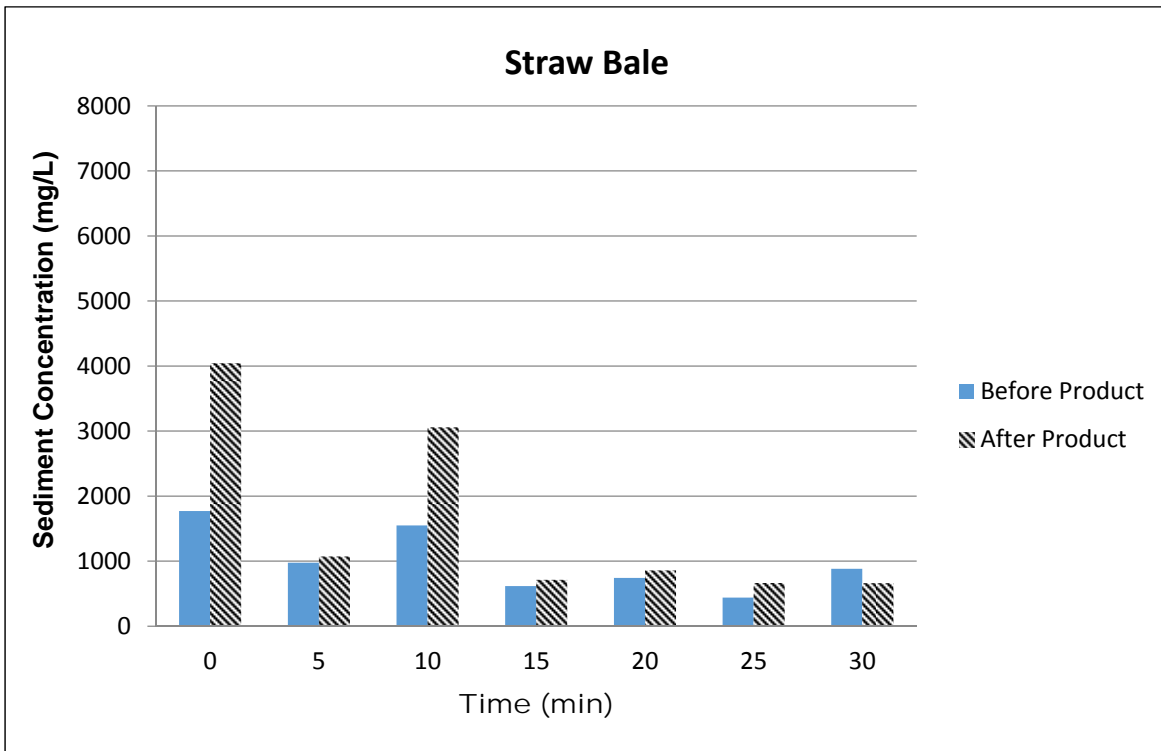
This product was very ineffective in trapping sediment, with a consistent increase of sediment concentration over time (Figure 5.4). The channel immediately flooded and resulted in increased water pressure against the straw bale. With increased pressure, undercutting inevitability occurred, transporting sediment into the inlet. This undercutting lead to higher sediment concentration after the product, as illustrated in Figure 5.4. Ponding caused the soil to settle upstream, thus explaining the low sediment concentrations before the product.

Figure 5.4 Sediment concentrations for straw bale.

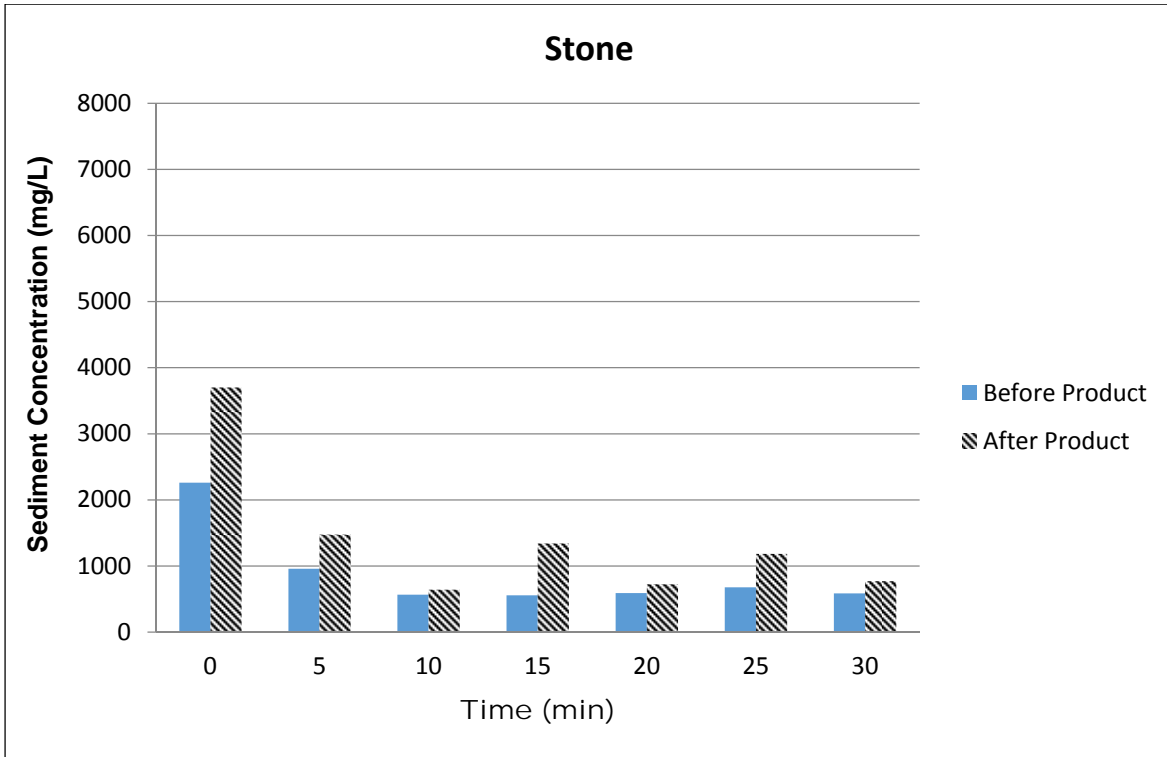
Sediment concentrations were consistently higher after the product compared to before the product (Figure 5.5). Sediment concentration values were fairly consistent before the product, due to the ponding created by the product. The flooding caused a pool to form in front of the product. Consequently, any added soil merely swirled around in the pool formed in front of the product and could not alter the sediment concentration substantially

Figure 5.5 Sediment concentrations for stone.
