EVALUATION OF FLARED-END INLET PROTECTION PRODUCTS FOR SEDIMENT RETENTION

Research Report No. FHWA-ICT-16-004

A white paper prepared as part of
ICT-R27-102
Installation and Performance Testing of
Ditch Checks and Inlet Protection Structures

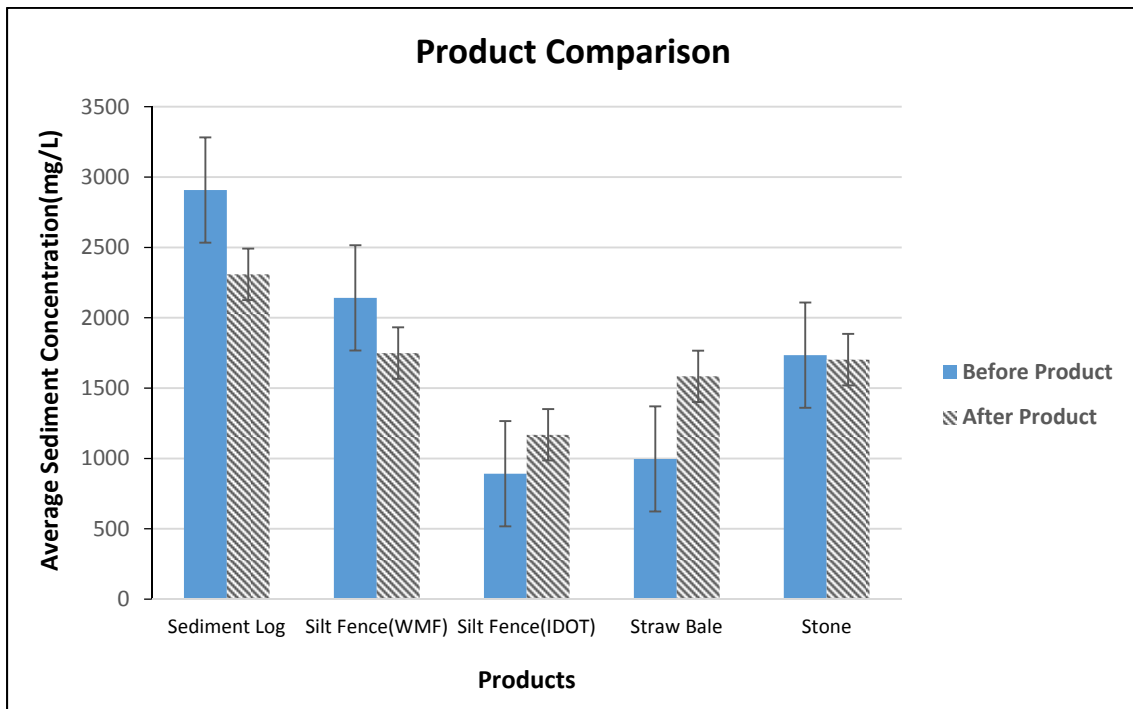
Figure 6.1 summarizes the comprehensive performance of each product. The following product recommendations are made based on observations and results, along with ease of installation.

- Sediment log: 25.97%
- Silt fence with woven monofilament fabric: 22.44%
- Silt fence with IDOT-approved fabric: -23.69%
- Straw bale: -37.06%
- Stone: 1.89%

Figure 6.1 Comparison of average sediment concentration of flared-end inlet protection products.

Based on the observations and data analysis, the sediment log and silt fence with woven monofilament fabric performed better than the other products for reducing sediment concentration. The sediment log performed the best of the products tested, achieving the highest percent reduction in sediment concentration. The sediment log can also be considered a better alternative to the silt fence with woven monofilament fabric because it is biodegradable and less affected by wind (due to product height). It was observed that both products created some ponding during the tests. Both products provided a good balance between sediment retention and ponding with routine cleanup and maintenance, making
