Demonstration Project using Railroad Flatcars for Low-Volume Road Bridges

Iowa DOT Project TR-444

REPORT

Department of Civil and Construction Engineering

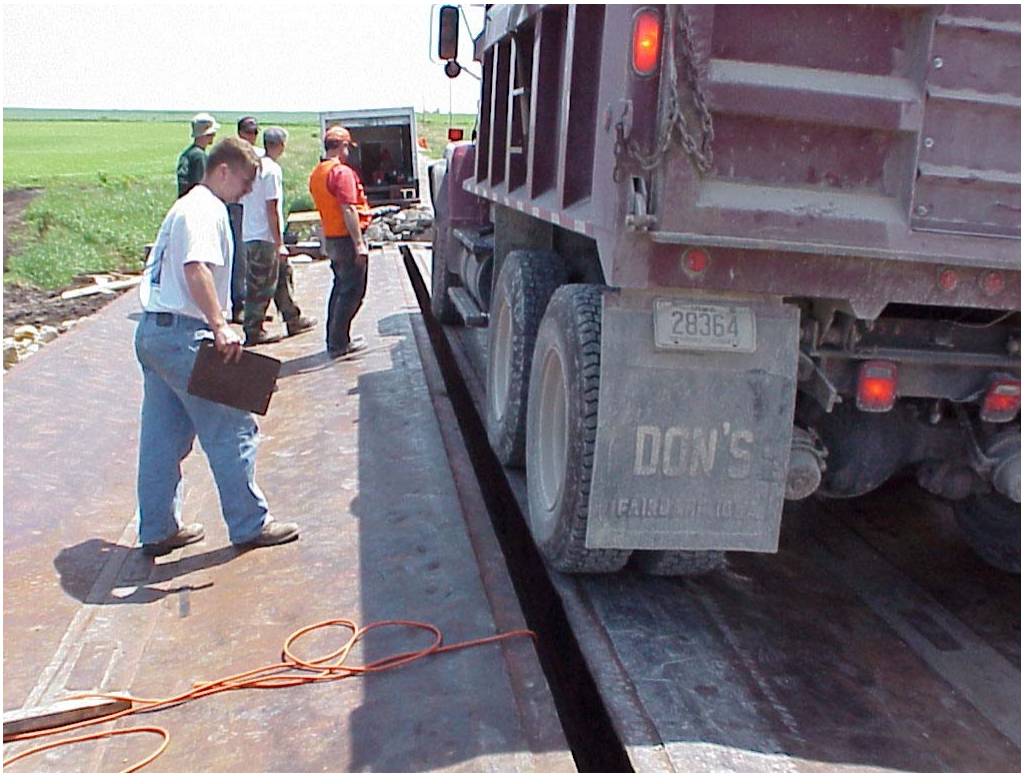
Figure 4.17. North eccentric transverse position of the truck in BCB LT1.

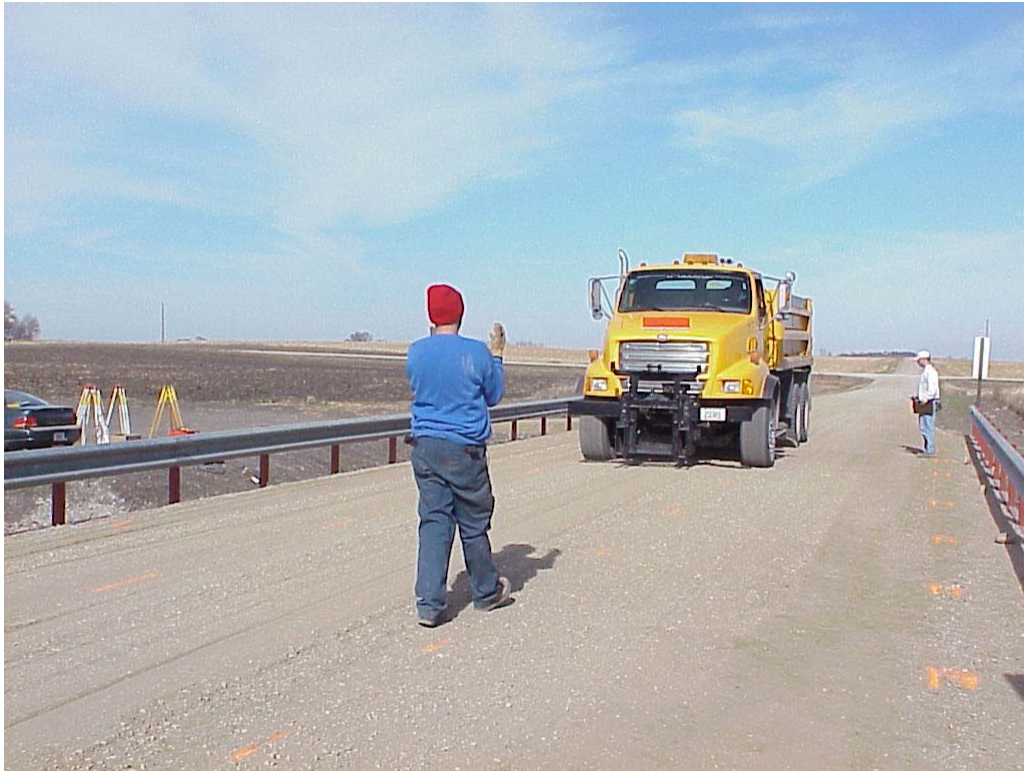
Figure 4.25. Testing the finished WCB immediately following completion of construction.
