Advancing Implementation of Geosynthetic Reinforced Soil-Integrated Bridge Systems (GRS-IBS)

Final Report
October 2017

RUSTIC ROAD GRS-IBS: DESIGN, BIDDING, CONSTRUCTION, AND PERFORMANCE

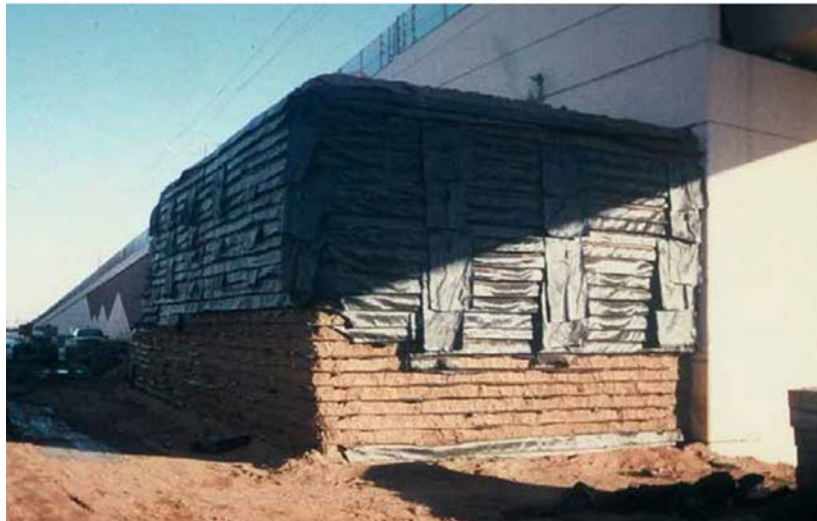
Figure 2. Free-standing GRS structure

GRS refers to the composite material consisting of compacted soil and closely spaced (≤ 12 in. per FHWA regulation) layers of geosynthetic reinforcement. The FHWA *Composite Behavior of Geosynthetic Reinforced Soil Mass* report (Wu et al. 2013) explains that strength and stiffness of a soil mass are improved by reinforcement, which increases confinement of the soil while reducing lateral movement and dilation. As demonstrated by Figure 2, GRS is internally stable; the wall facing for GRS is not structural.

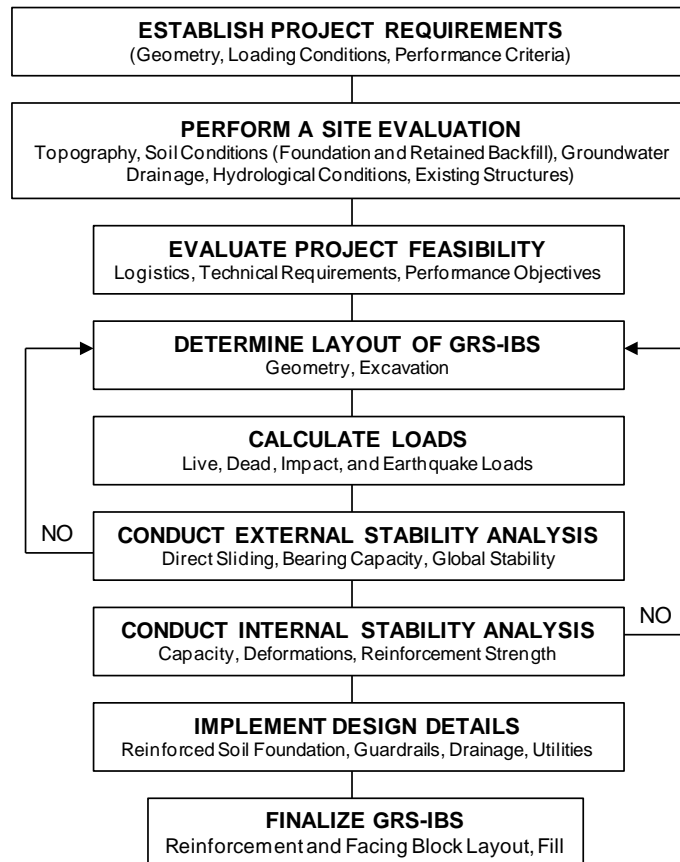
Figure 4. Design steps from *Geosynthetic Reinforced Soil Integrated Bridge System Interim Implementation Guide*

A detailed GRS-IBS design procedure is presented in Chapter 4 of the FHWA guide, which begins with the outline of the procedure shown in Figure 4.

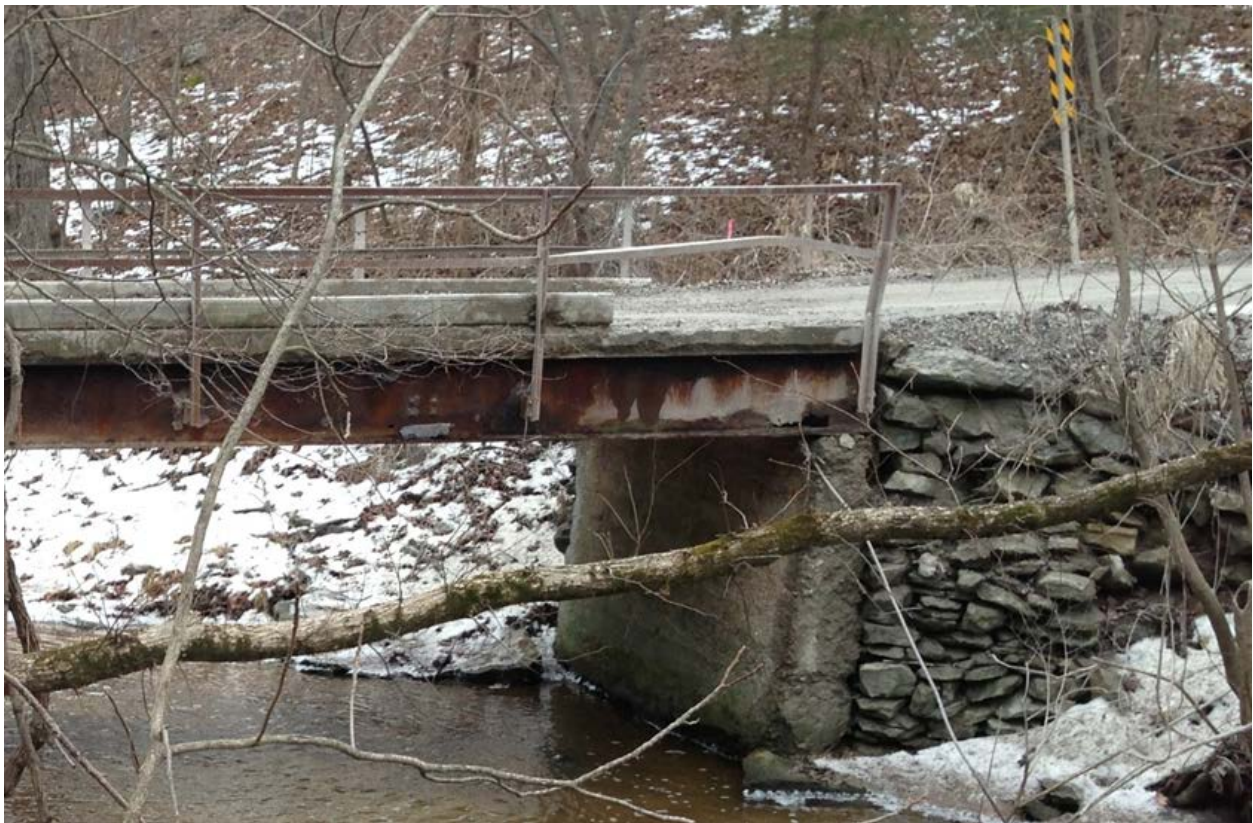
Figure 5. Original Rustic Road bridge showing deterioration of the outer girder, including corrosion through an entire portion of the web near the abutment

Rustic Road is a low-volume road just east of Columbia, in Boone County, Missouri. The road crosses the North Fork of Grindstone Creek to provide passage to approximately 10 residences before reaching a dead end. In 2013, deterioration of the original Rustic Road bridge (Figure 5) led to a bridge load rating that precluded fire trucks from crossing it.

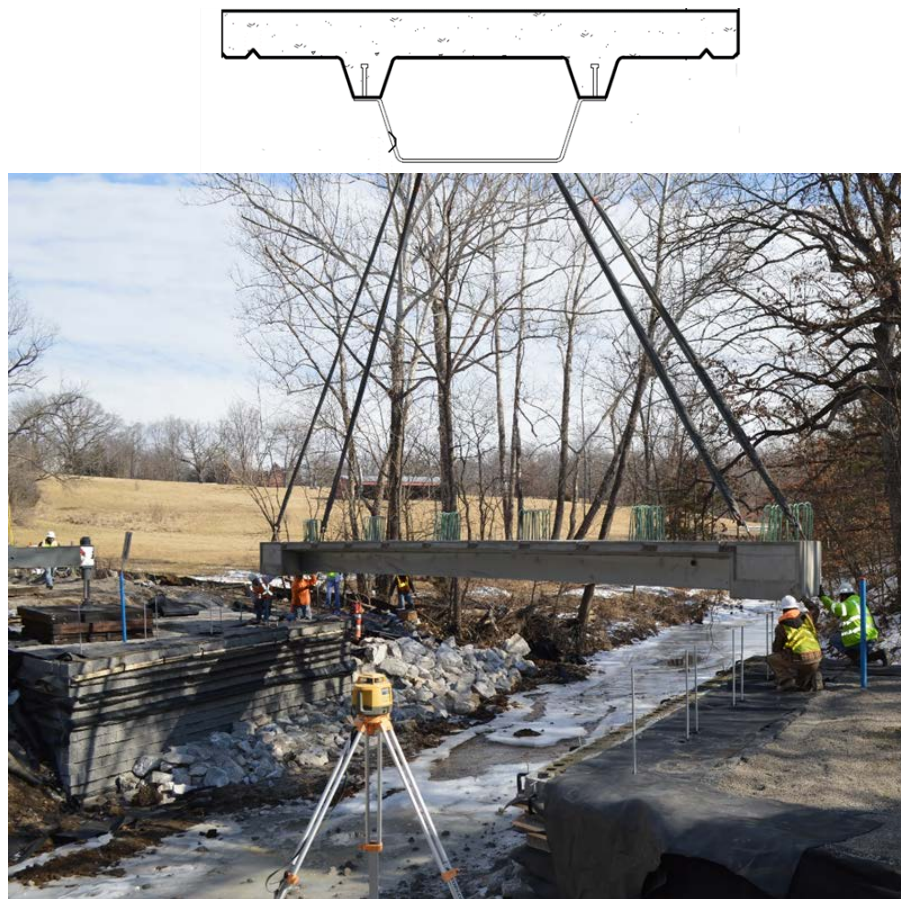
Figure 6. Tub girders with precast bridge deck: cross-section (top) and tub girder being lowered into place (bottom)

GRS-IBS was not the only innovative initiative included in the Rustic Road bridge replacement project. The superstructure consists of four tub girders with attached precast bridge deck sections (as shown in Figure 6).

The crew ensured that the holes through the girders were aligned with anchor bolts (Figures 30–32). (Figure 6 also shows the lowering of the first girder.)

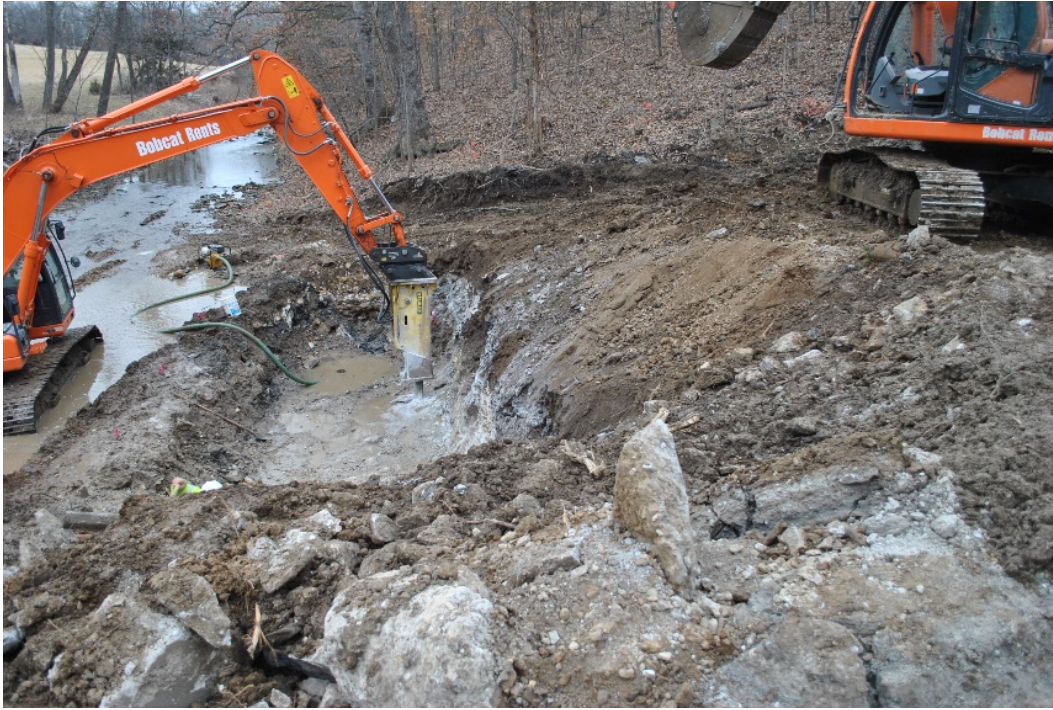
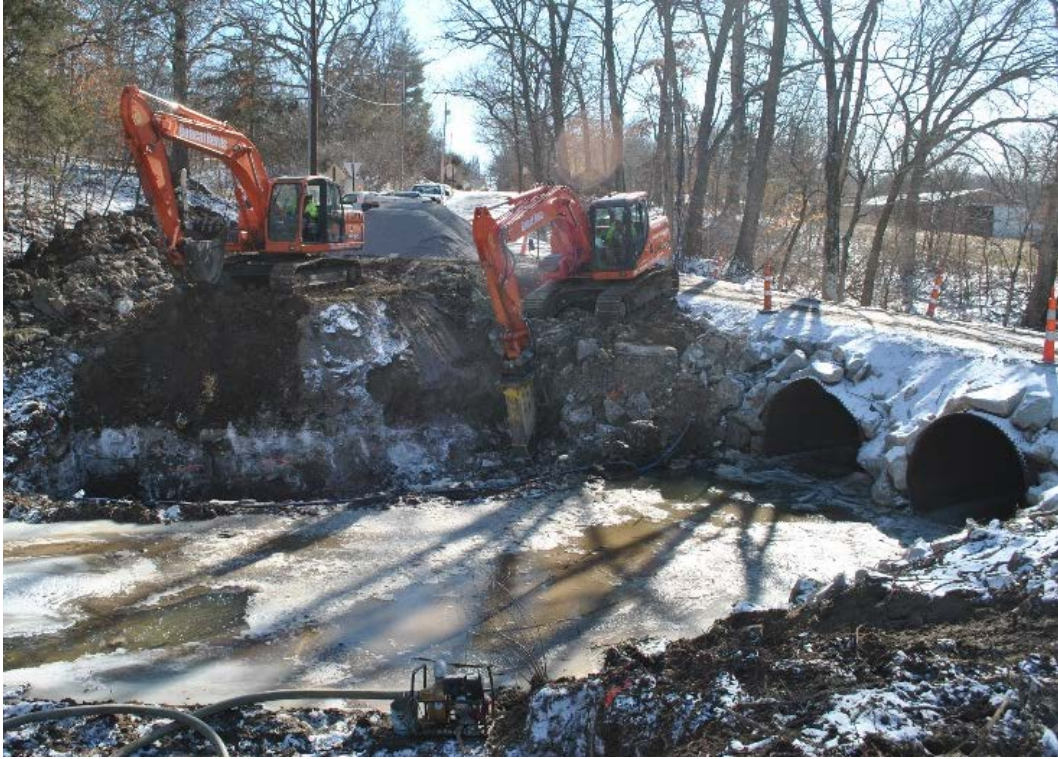
project required deviations. For example, limestone bedrock was encountered at depths shallower than anticipated, requiring excavation via a rock chipping hammer (Figures 7 and 8) to achieve adequate abutment embedment.

Figure 7. Rock chipping hammer being used to excavate limestone bedrock below south abutment

Figure 8. Rock chipping hammer and backhoe being used to excavate limestone bedrock below south abutment

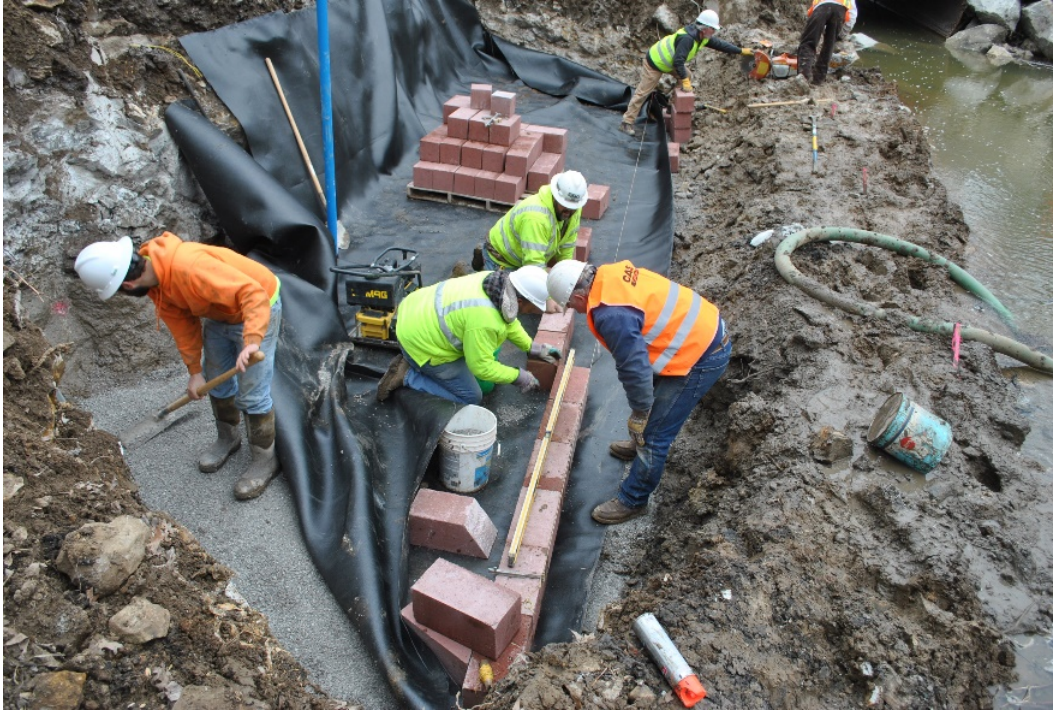
Figure 10. Placement of bottom row of CMU blocks for south abutment with red blocks used for first five rows for scour indication and leveling of the bottom row being critical per the FHWA implementation guide

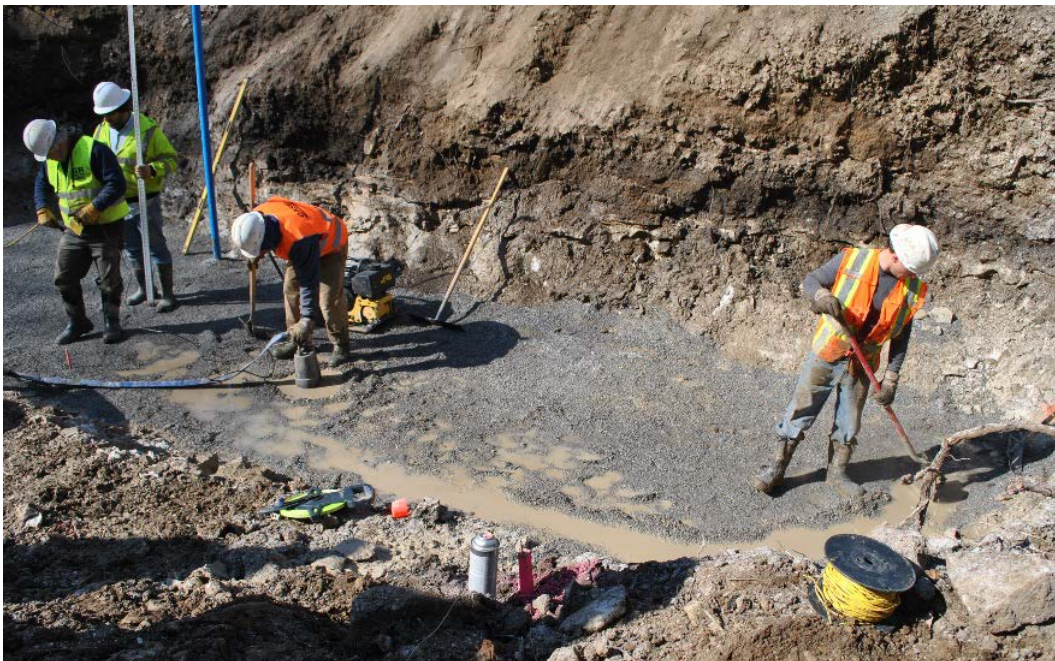
Persistent seepage entered the excavation for the north abutment from a permeable layer exposed by the excavation. A submersible pump was used to remove water from the excavation prior to compaction (Figure 15).

Figure 15. Pump being used to remove seepage water from north abutment prior to compacting

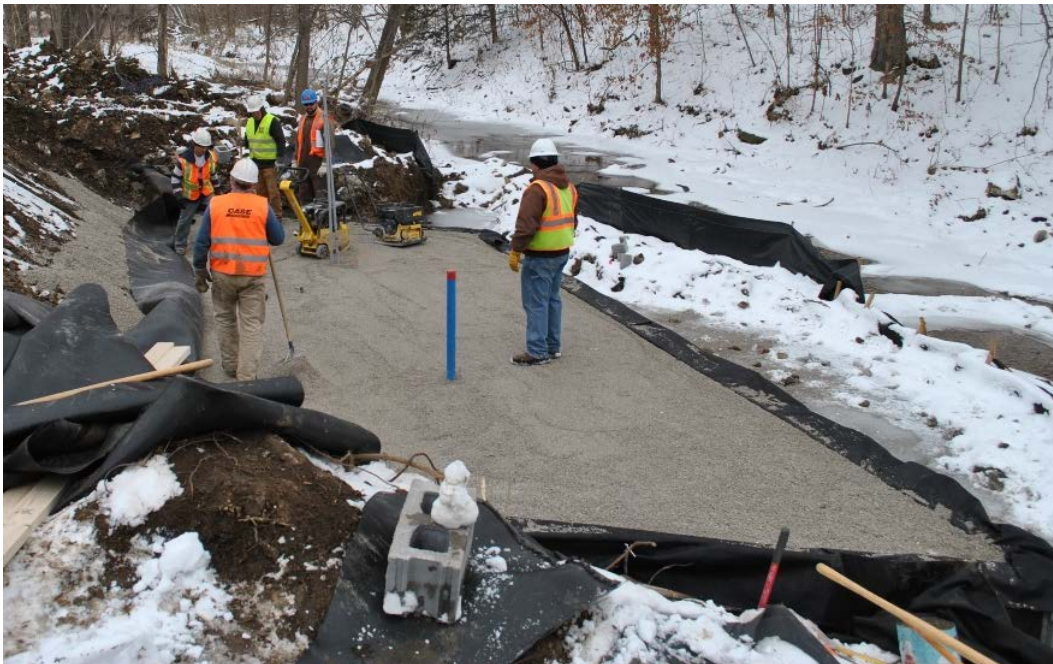
Figure 17. Compacting tenth course of GRS of north abutment after placing second telltale device for measuring settlement

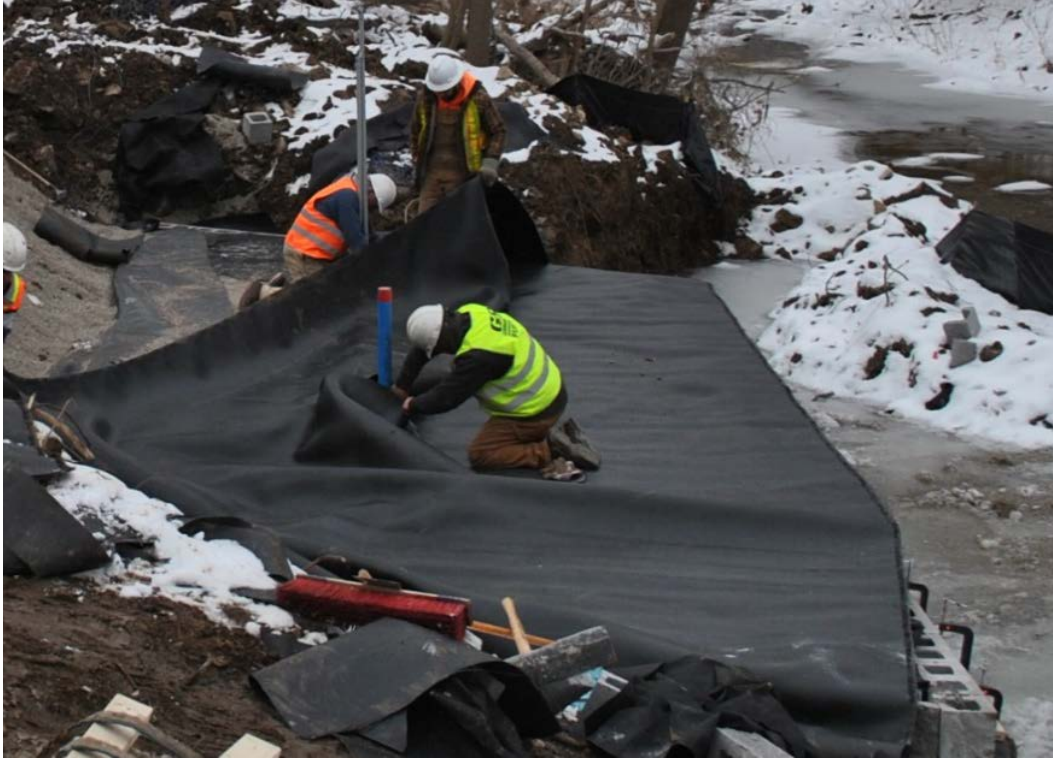
Figure 18. Placing reinforcement around instrumentation (inclinometer and telltales) atop tenth course of GRS of north abutment

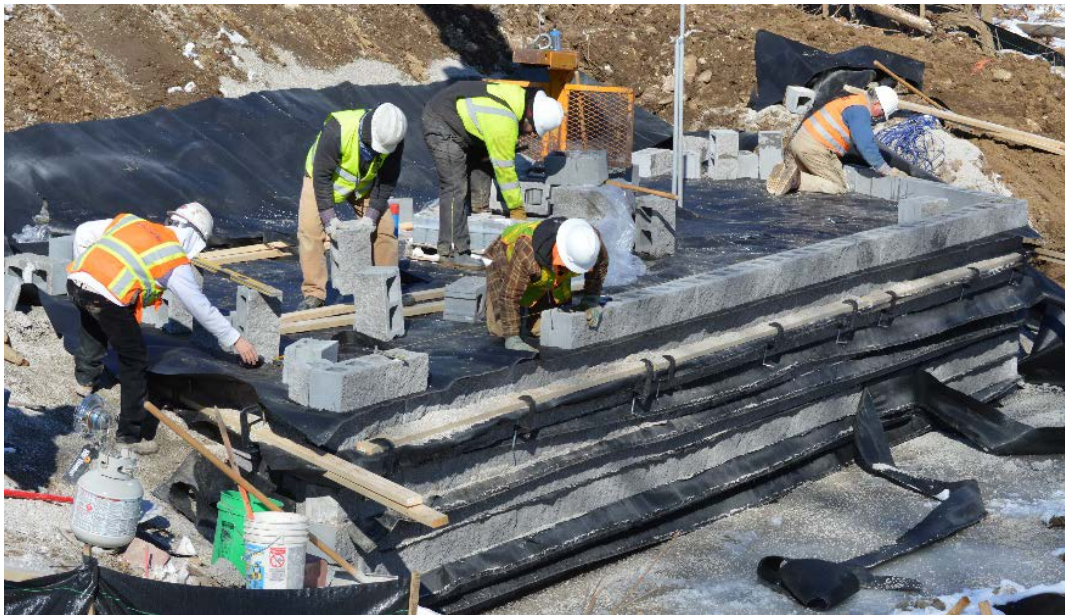
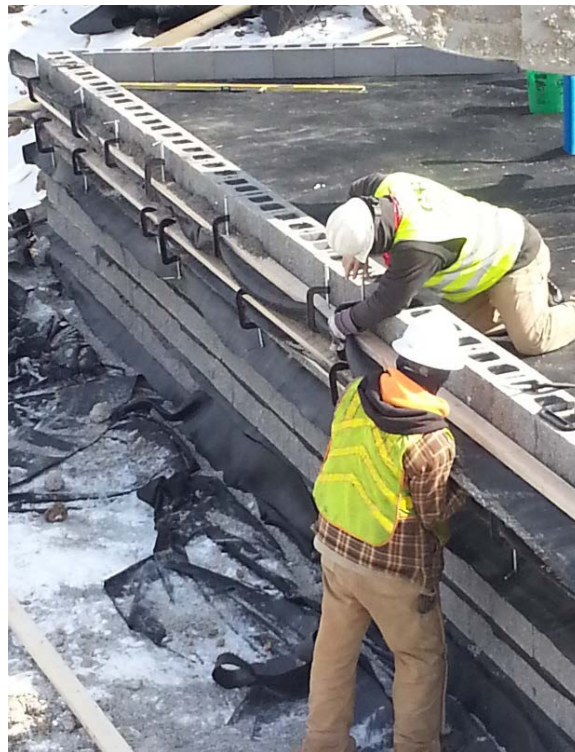
passes. To reduce the displacement, the crew clamped lumber to the reinforcement extending out in front of the wall from just beneath the course being compacted (Figures 20 and 21).

Figure 20. Leveling CMU blocks ahead of placing backfill with boards clamped to reinforcement used to prevent movement of blocks for previous course during compaction

Figure 21. Securing boards to reinforcement to prevent movement of the CMU blocks during compaction

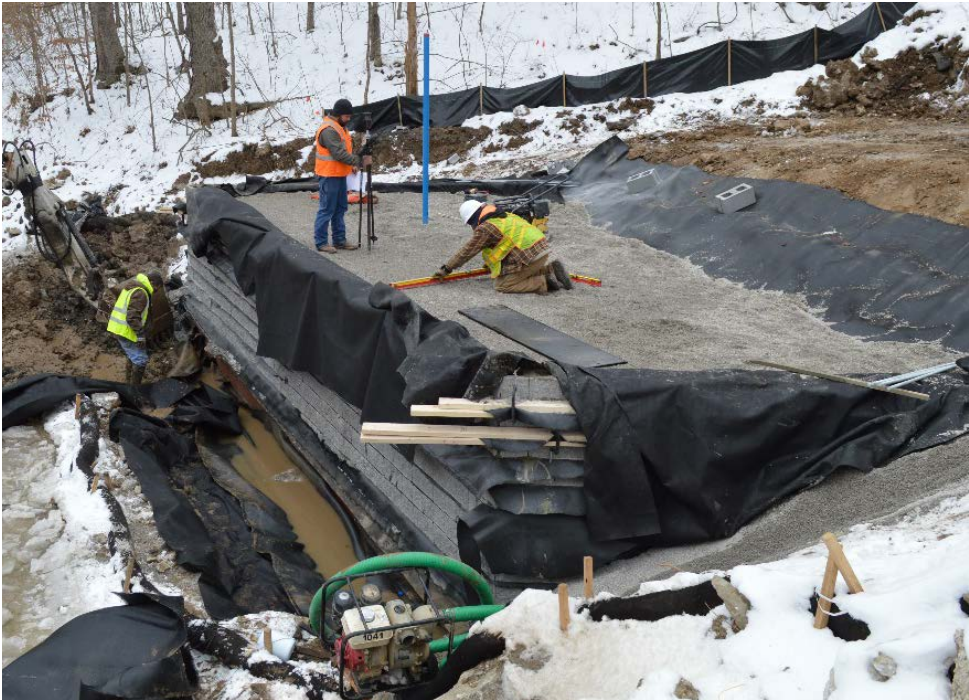
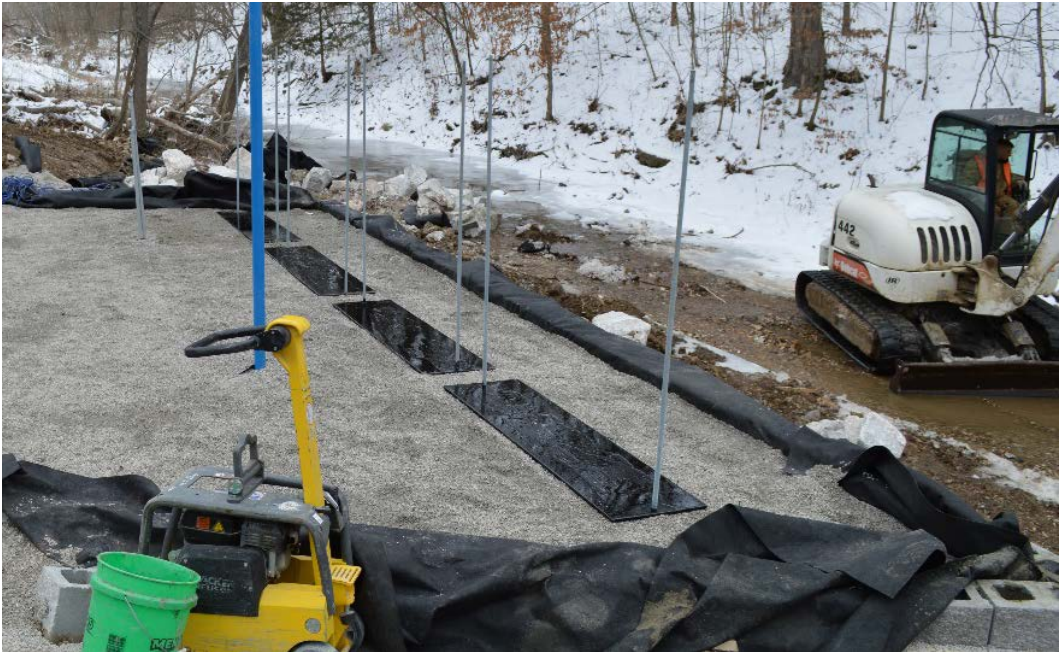
Anchors were necessary to provide resistance against buoyancy forces against the tub girders (Figures 22 and 23).

Figure 22. Surveying and leveling to place anchor plates for girders

Figure 23. Four anchor plates (one per girder) placed approximately 3 ft below the top of each abutment within the backfill

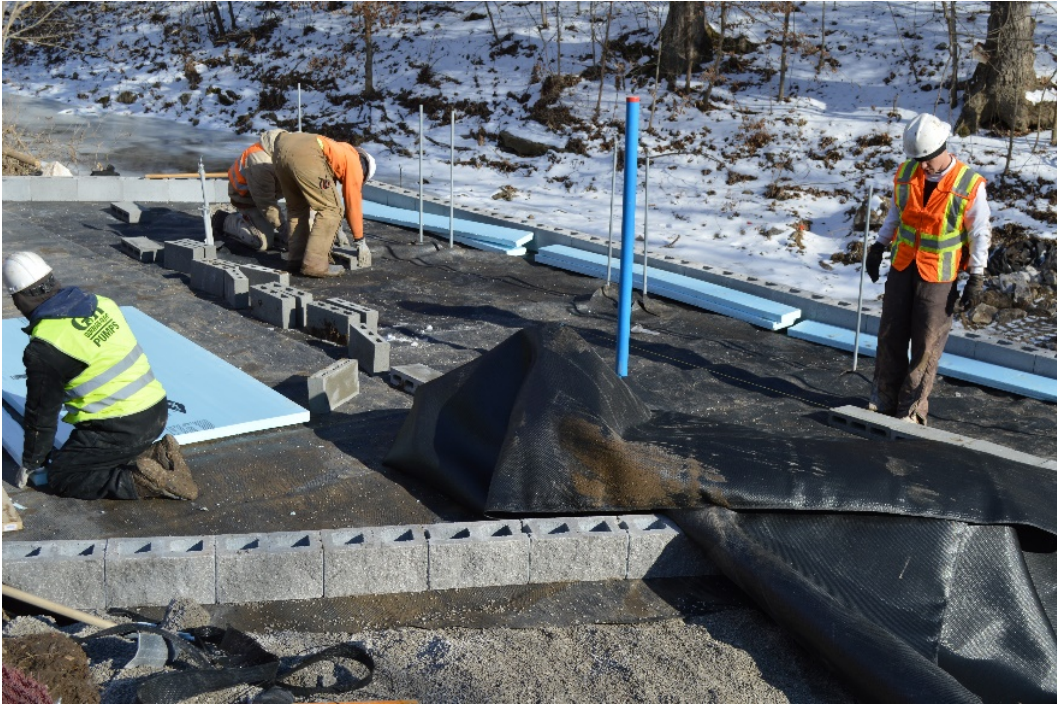
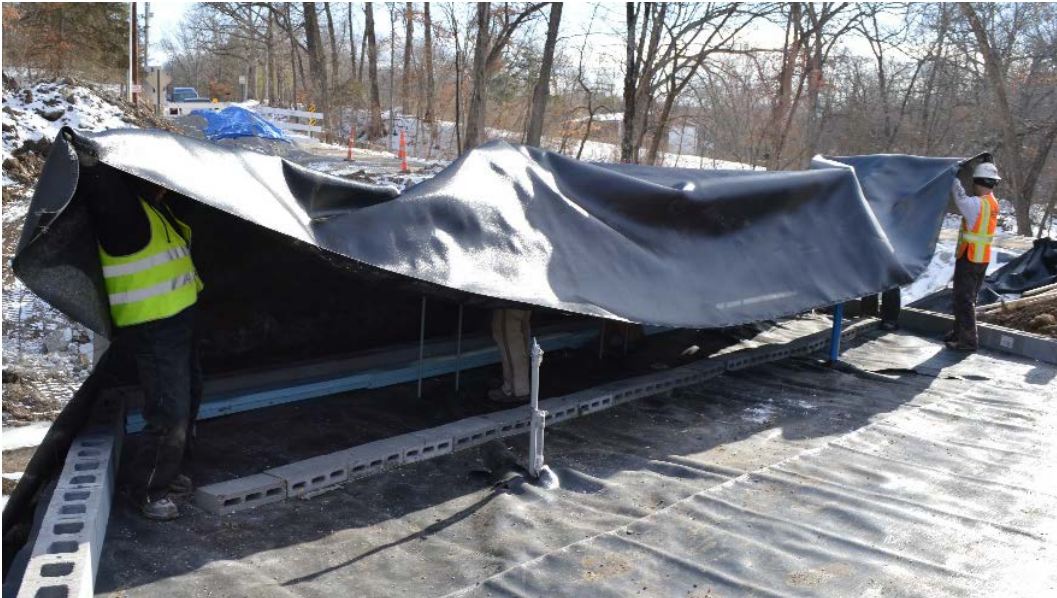
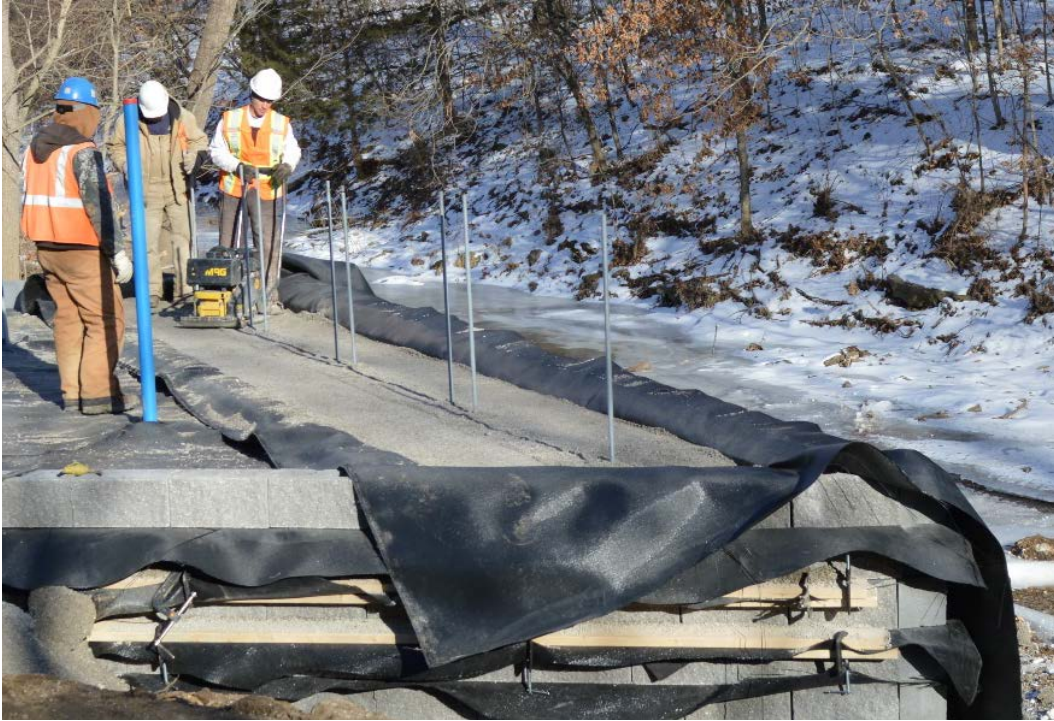
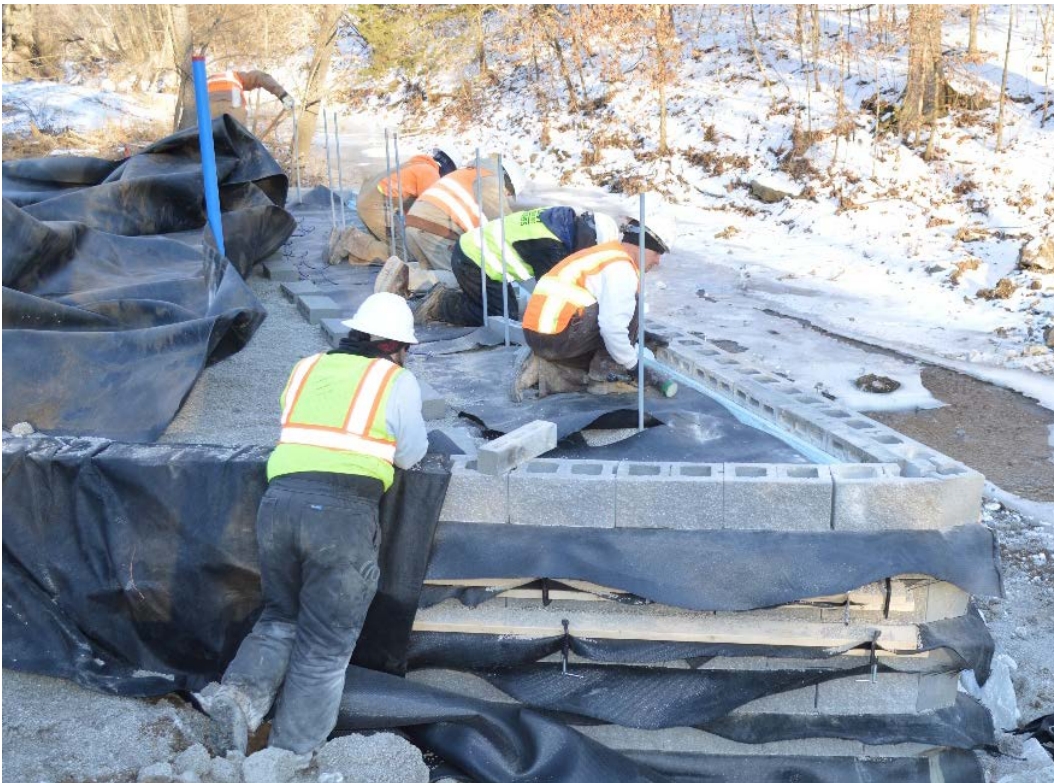
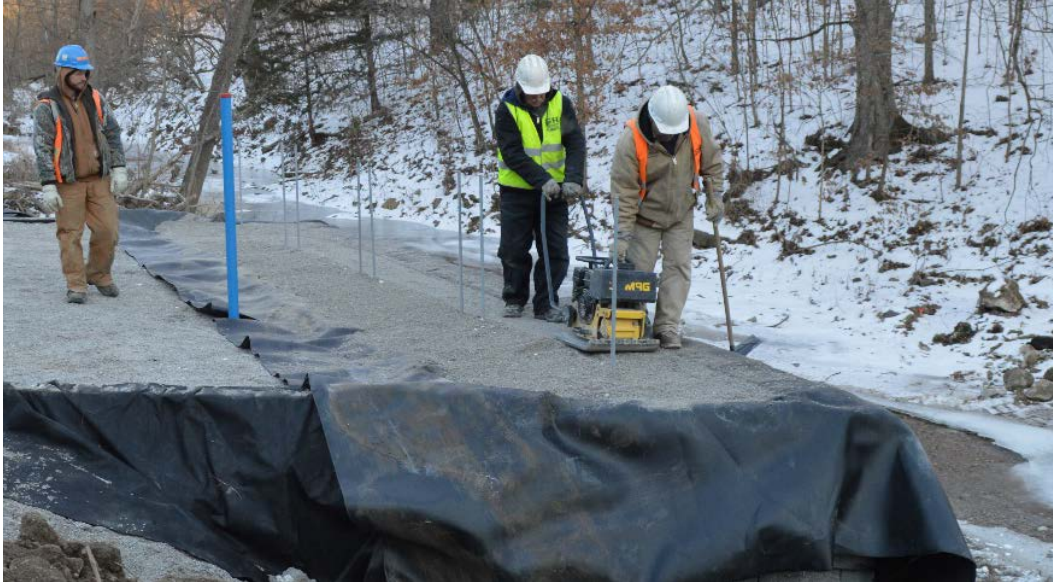
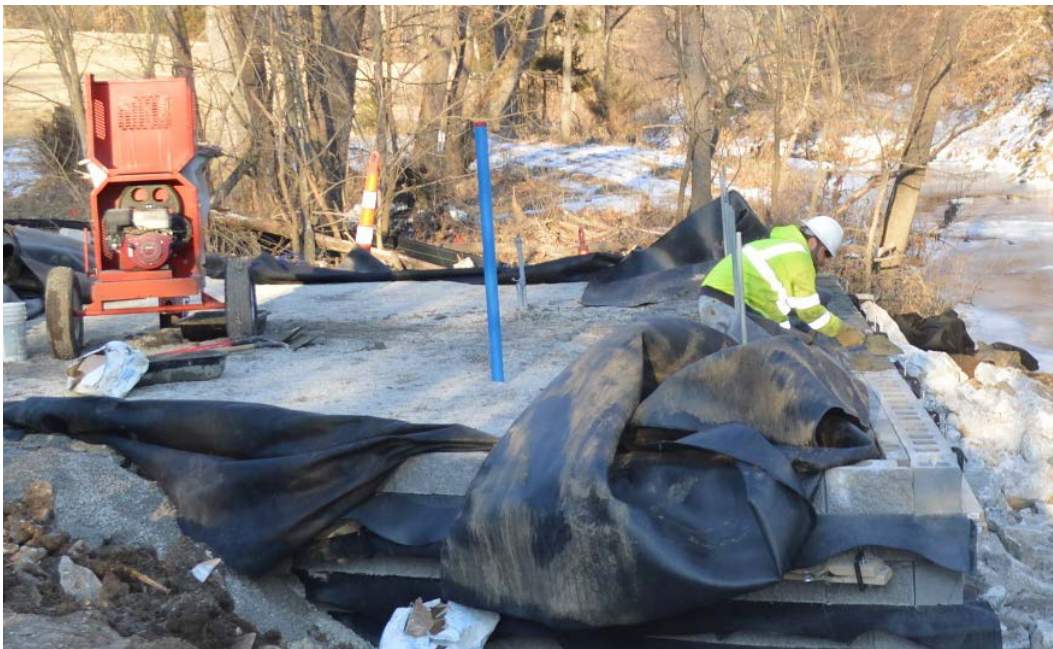
The beam seat consisted of two 4 in. thick layers of aggregate wrapped with reinforcement. Styrofoam was placed in the front of each layer, and a row of narrow CMU blocks was placed in the back of each layer for each abutment (Figures 24–29).

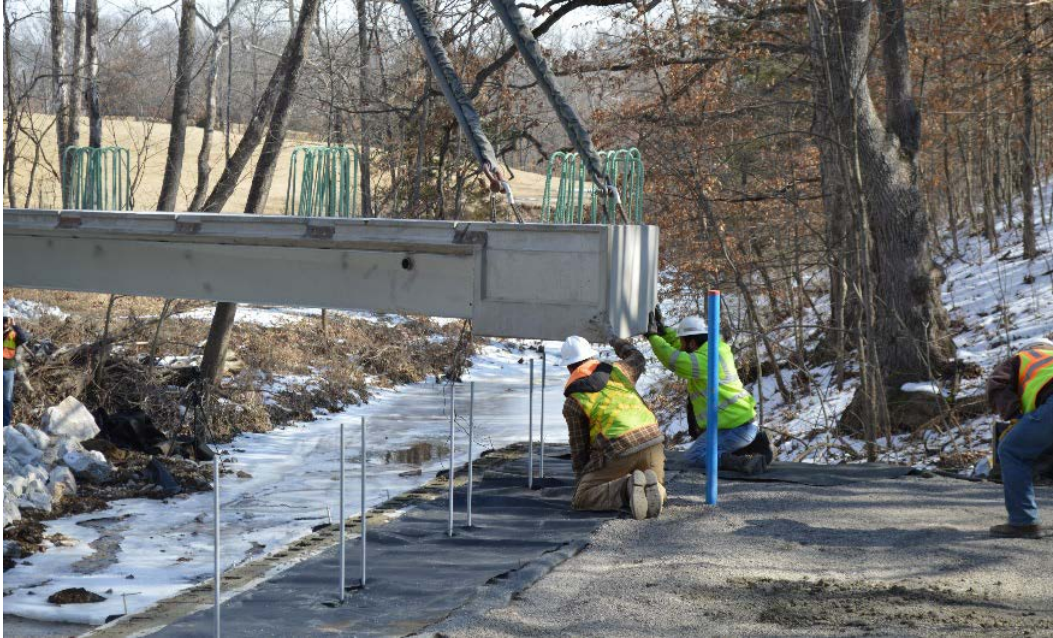
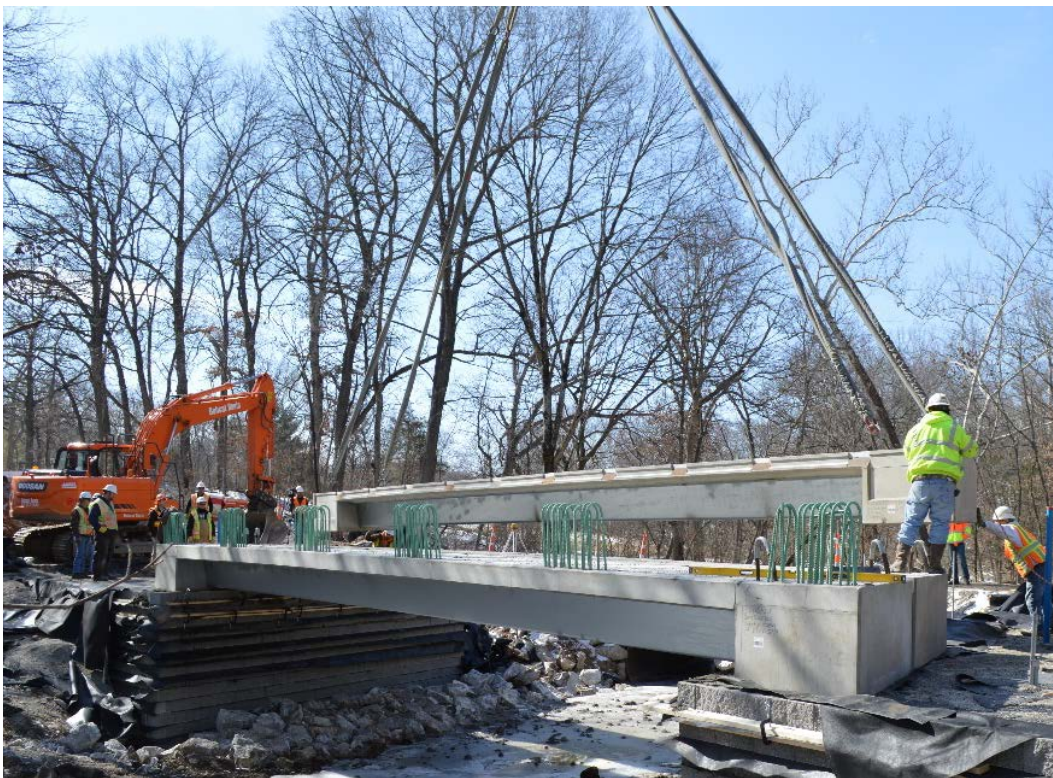
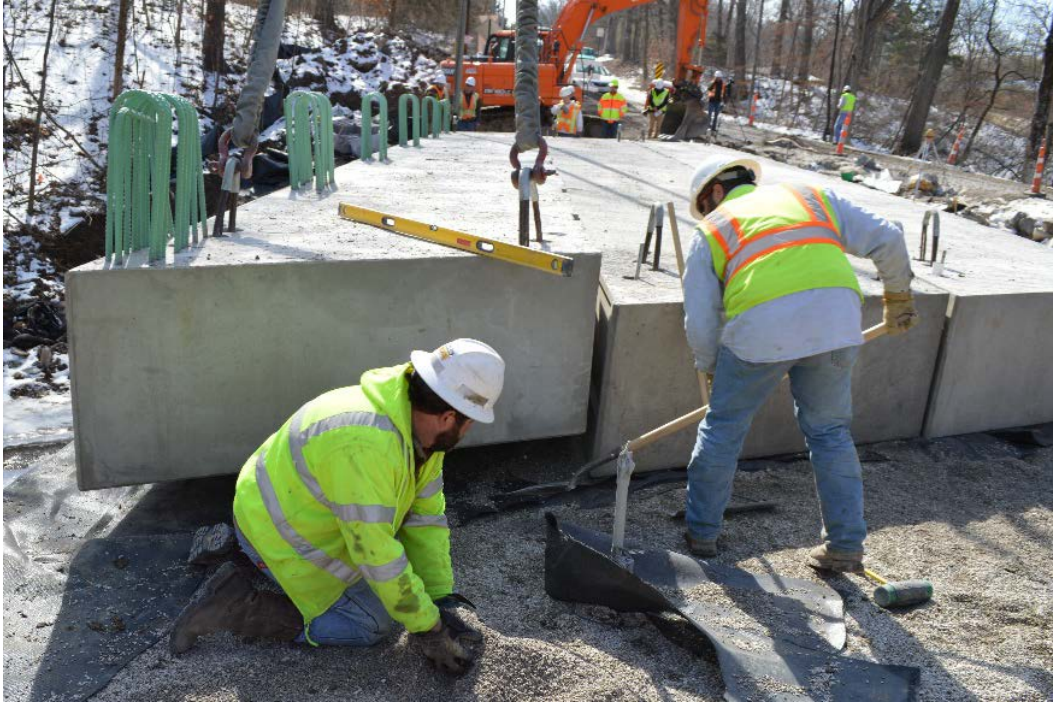
Figure 32. Crew places additional aggregate below first girder to achieve level surface

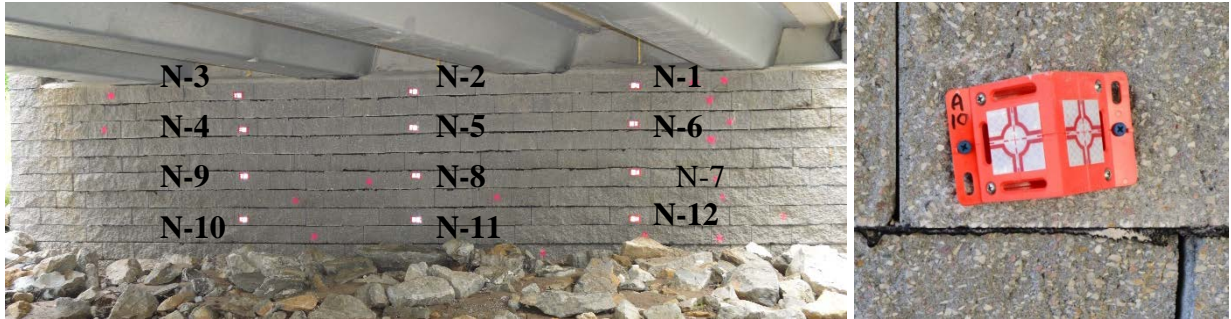
External movement is a critical indicator of the performance of any bridge system. External movement refers to displacement of the outside surfaces of the GRS-IBS, including settlement of the bridge or abutments and lateral displacement of the abutments (e.g., bulging). External movement of the GRS-IBS was primarily monitored via land surveying of the four corners of the bridge as well as 24 survey targets installed on the face of the abutments. The reflective targets are shown in Figure 35.

Figure 35. A grid of 12 reflective survey markers bolted to CMU blocks were installed on the face of each abutment: grid for north abutment with marker labels as established by the crew (left) and close-up view of a reflective marker (right)

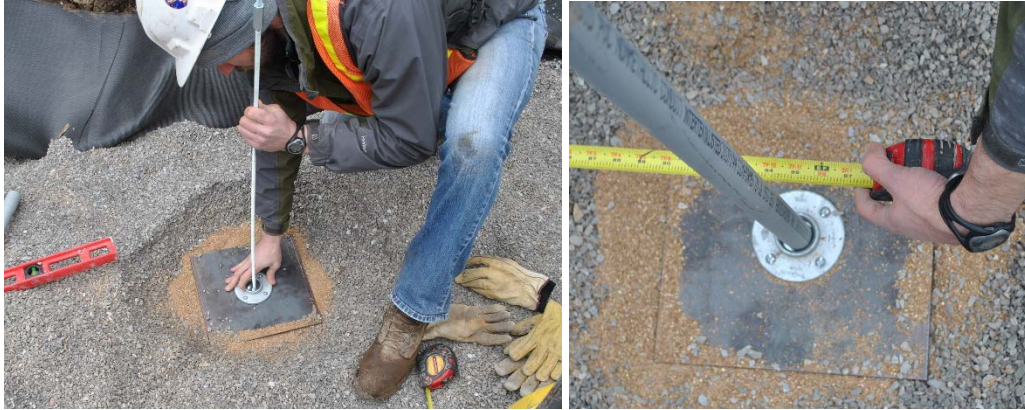
As shown in Figure 36, the settlement plate devices consist of 12 in. square, 0.25 in. thick steel plates that were embedded in the backfill, with threaded steel rods extending up from the plates to the top of the abutment.

Figure 36. Installation of bottom settlement plate: placement and leveling on thin layer of coarse sand (left) and placement of loose PVC sleeve over steel rod to prevents friction between rod and aggregate (right)

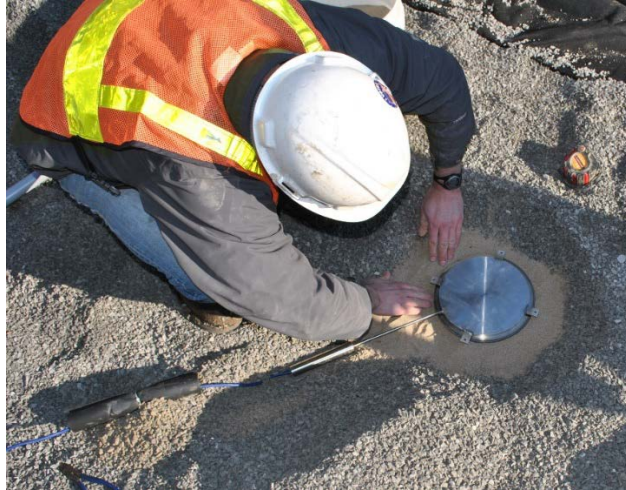
Figure 38. Installation of EPC-1 near bottom of north abutment

Vibrating-wire earth pressure cells were used. One of the instruments is shown in Figure 38.

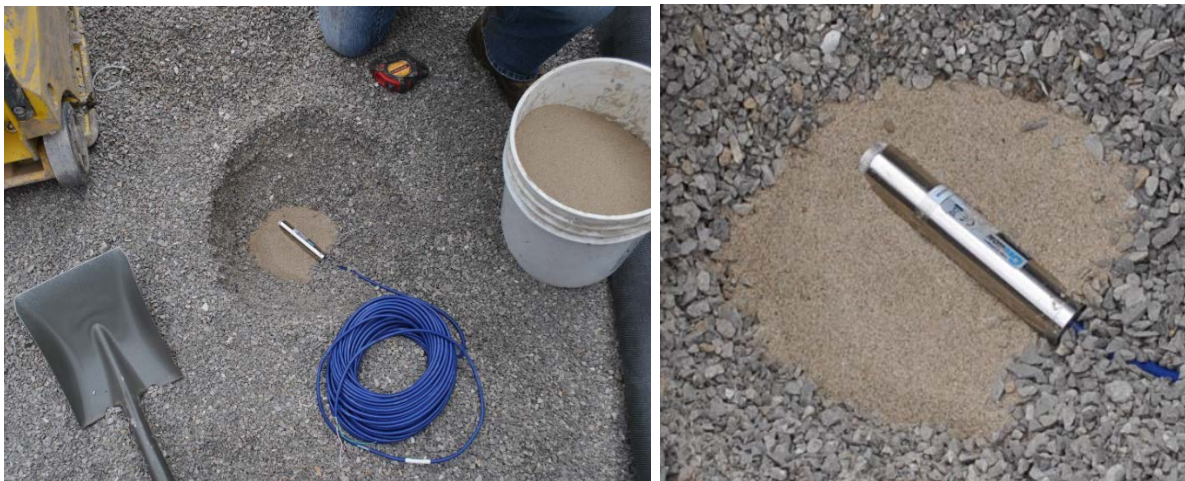
Figure 40 shows a piezometer during installation. The piezometers were installed inside sand pockets within the GRS backfill to stabilize pore pressure measurements.

Figure 40: Piezometer PZ-1: installation in sand pocket within GRS backfill (left) and close-up view of vibrating wire piezometer (right)

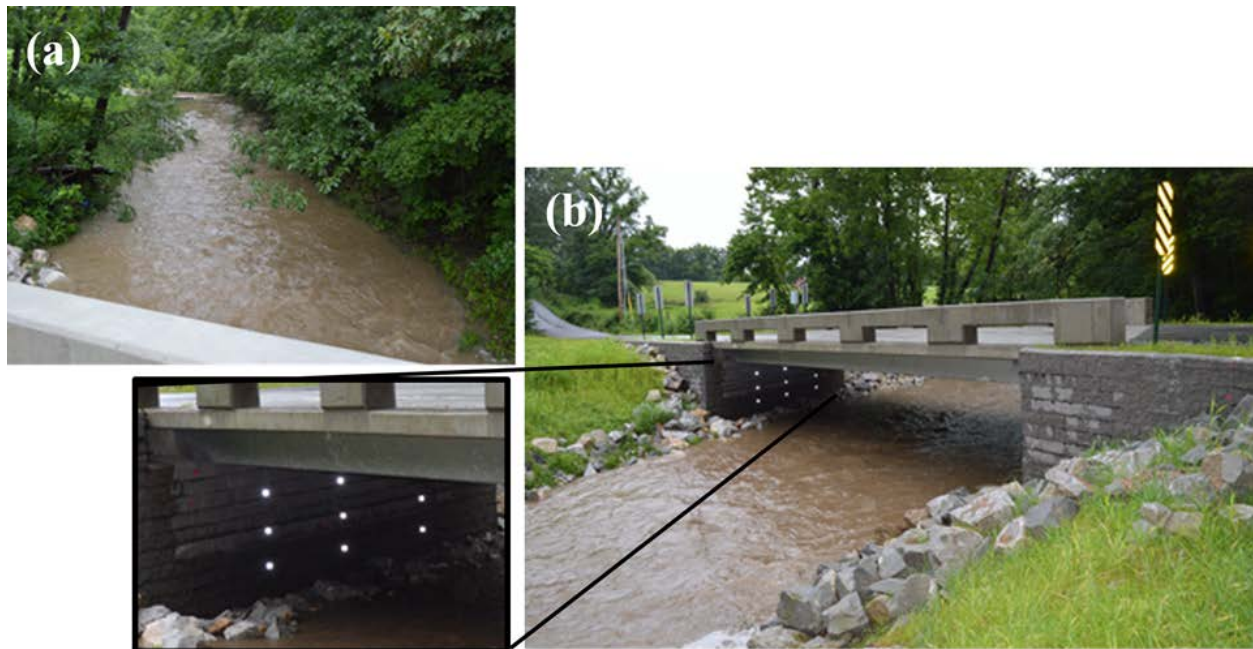
In late June and early July 2015, a series of rain events in Boone County led to a significant water level increase in the North Fork of Grindstone Creek, as shown in Figure 41.

Figure 41. Rustic Road GRS-IBS during July 2015 high water event: looking upstream from on top the bridge showing creek high up its banks (upper left) and looking at north abutment (right) with close-up view (lower left)

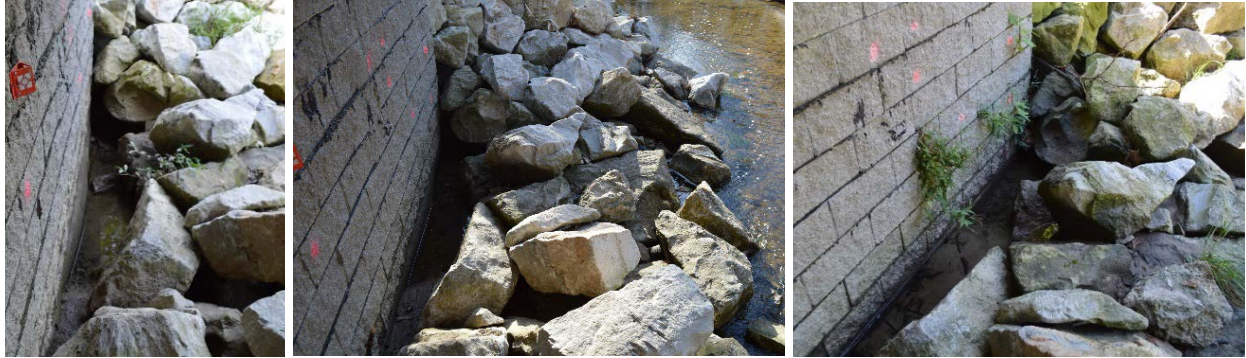
During a site visit in August 2015, one month after the high water event, a gap was observed between the downstream (west) corner of the south abutment and the rip rap scour protection as shown in Figure 42 (left). No changes in the gap were observed throughout the course of subsequent monitoring (Figure 42 center and right).

Figure 42: Downstream corner of south abutment: August 31, 2015 (left), February 25, 2016 (center), and September 22, 2016 (right)

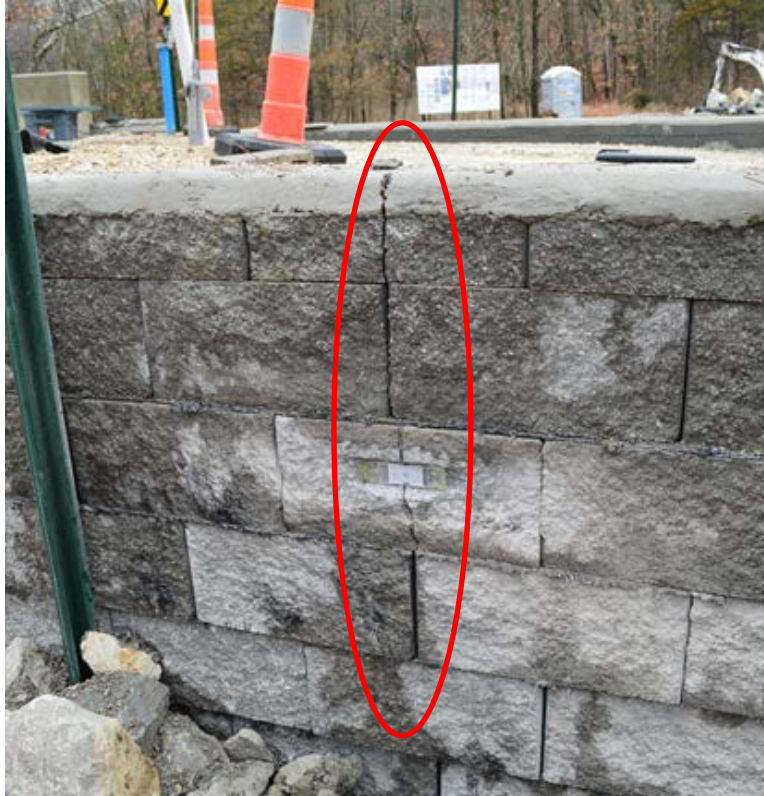
Figure 43. Crack on east wing of north abutment wall

Shortly after construction, cracks were observed in the CMU blocks at the top of each wing wall. All four cracks developed approximately 10 ft back from each abutment corner. The cracks extended from the top of the wing wall down two or three rows of CMU blocks, as shown in Figure 43.

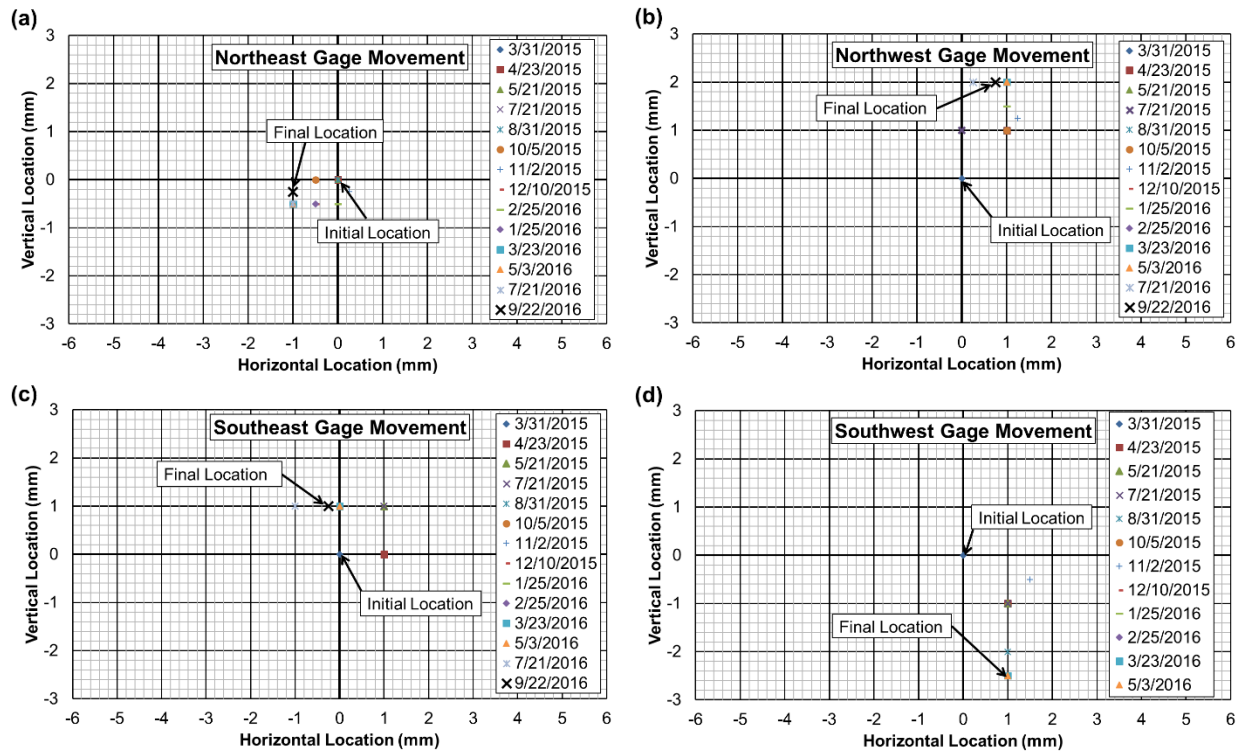
As described in the rest of this chapter, the survey data indicated little external movement, and the settlement plate and inclinometer data indicated little internal movement. Crack gage data is shown in Figure 45.

For each gage, initial (installed) and final (September 22, 2016) locations of the gage crosshair
