Advancing Implementation of Geosynthetic Reinforced Soil-Integrated Bridge Systems (GRS-IBS)

Final Report
October 2017

RUSTIC ROAD GRS-IBS: DESIGN, BIDDING, CONSTRUCTION, AND PERFORMANCE

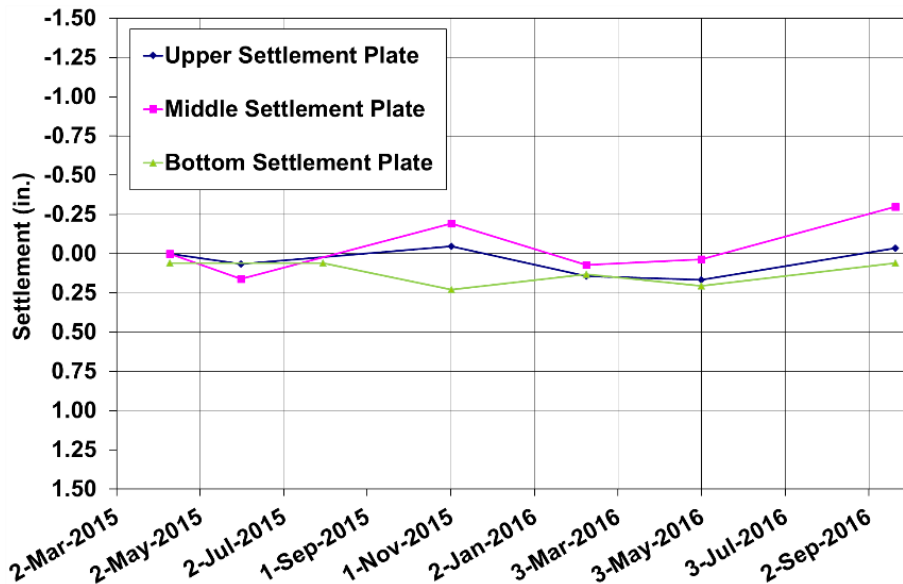
Figure 45. Settlement of settlement plates, as determined by survey results

Figure 45 is a plot of settlement plate results based on surveying the settlement plate rods.

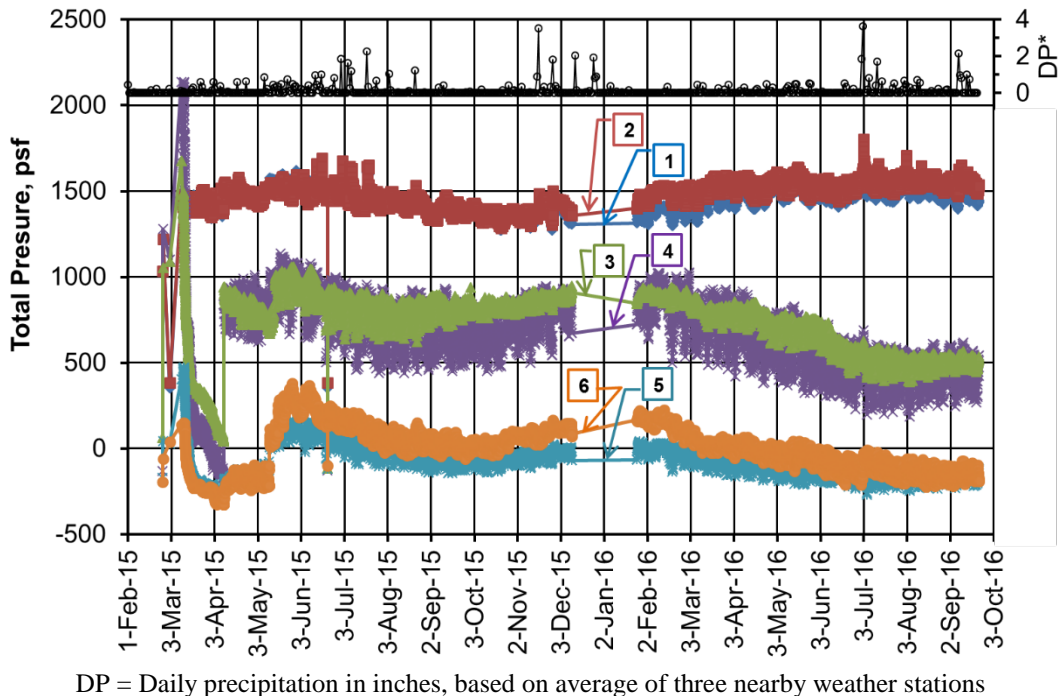
Total stresses from the earth pressure cells throughout the monitoring period are plotted in Figure 47.

Figure 47. Daily precipitation and earth pressures (total stresses) in north abutment from vibrating wire earth pressure cells

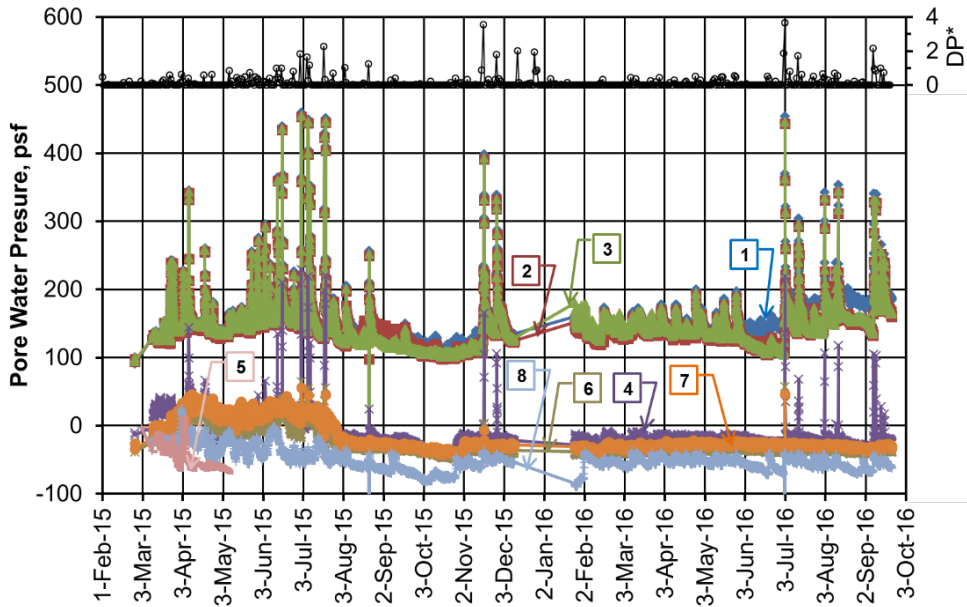
Pore water pressure results from the vibrating wire piezometers are plotted in Figure 48. For instrument locations, refer to Figure 39.

DP = Daily precipitation in inches, based on average of three nearby weather stations

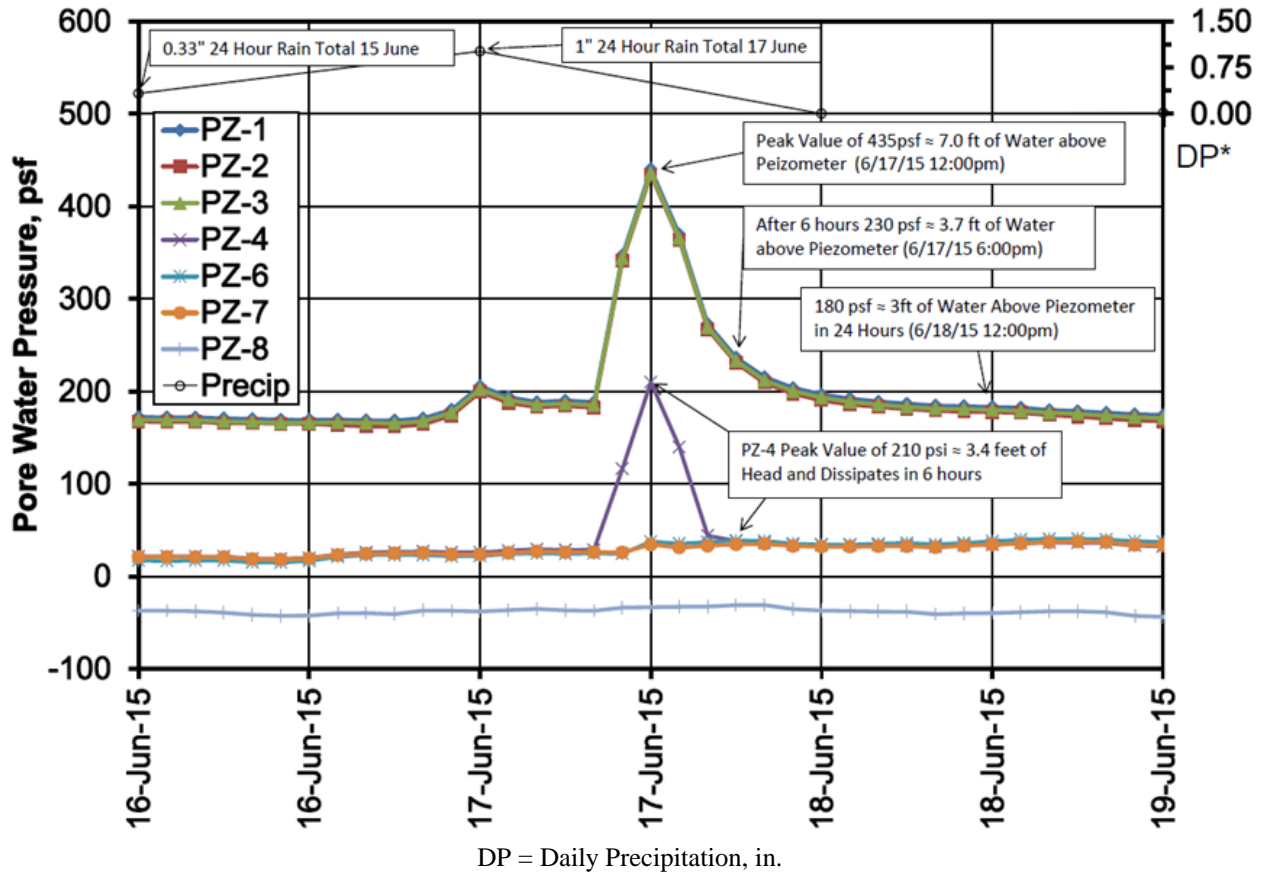
Figure 49. Close examination of change in pore pressures during one precipitation event

The signal for one of the piezometers, PZ-5, became unstable about two months after the end of construction. The observed pore pressures were mostly consistent with time, but several locations showed peaks that appear to be in response to precipitation events. The peaks dissipated quickly. To examine the drainage more quickly, pore pressure data during one precipitation event was plotted in Figure 49. Indeed, the pore pressures generated in response to the precipitation event dissipate within six hours of the event.
