INSTALLATION OF FOG GUIDANCE LIGHTS
ON AFTON MOUNTAIN

Virginia Highway & Transportation Research Council
(A Cooperative Organization Sponsored Jointly by the Virginia
Department of Highways & Transportation and the University of Virginia)
Charlottesville, Virginia
August 1976
VHTRC 77-R12

SUMMARY

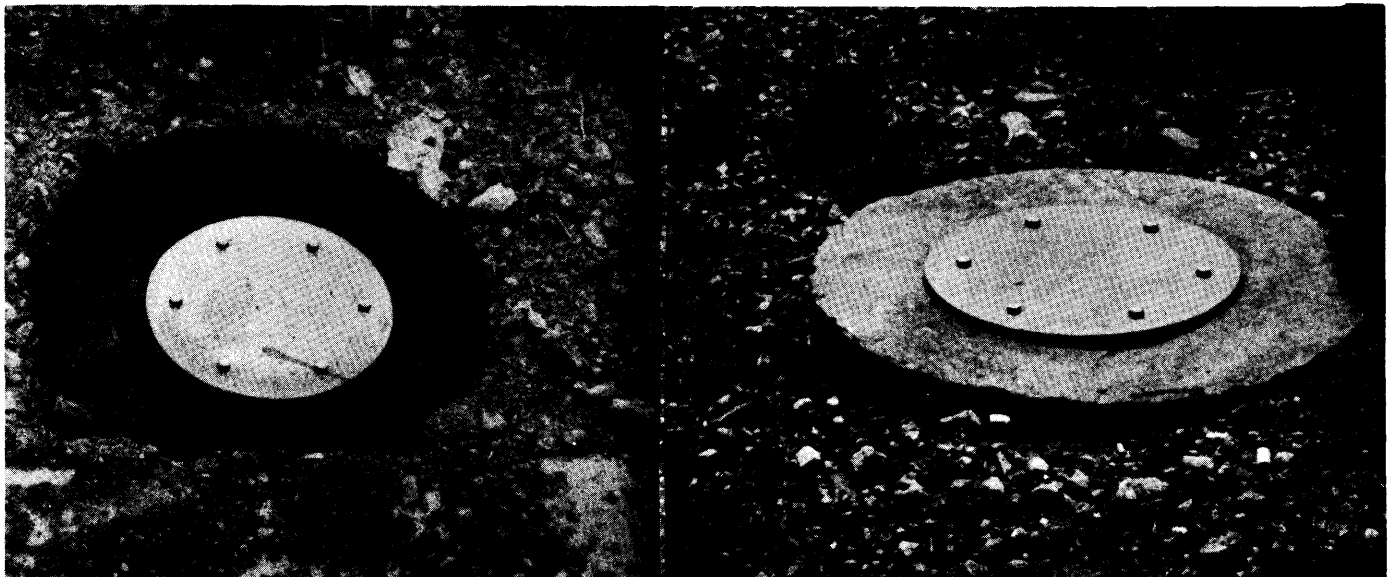
Figure 13. Transformer housing before and after concrete was poured.

The galvanized transformer housings (cans) measuring 12 in. (305 mm) in diameter and 13 in. (330 mm) in height and having a metal top secured by 6 bolts were installed in line with the conduit and were placed on 4 in. (102 mm) of porous material for drainage. The holes for the transformer cans were bored with an earth auger using a rock bit. Figure 12 shows the placement of the transformer housing and conduit within the trench. The smaller conduit to the left goes to the light. After the housings were placed and the conduit was attached, the trench was back-filled and compacted, and the hole around the housing was partially filled and compacted as shown in Figure 13. Concrete was then poured around the housing to stabilize and protect it. The trenching and laying of conduit progressed with no major problems, except that rock was encountered at a few places. This phase of construction was performed from the beginning of the project until it was approximately three-fourths finished, at which time the laying of conduit was completed.

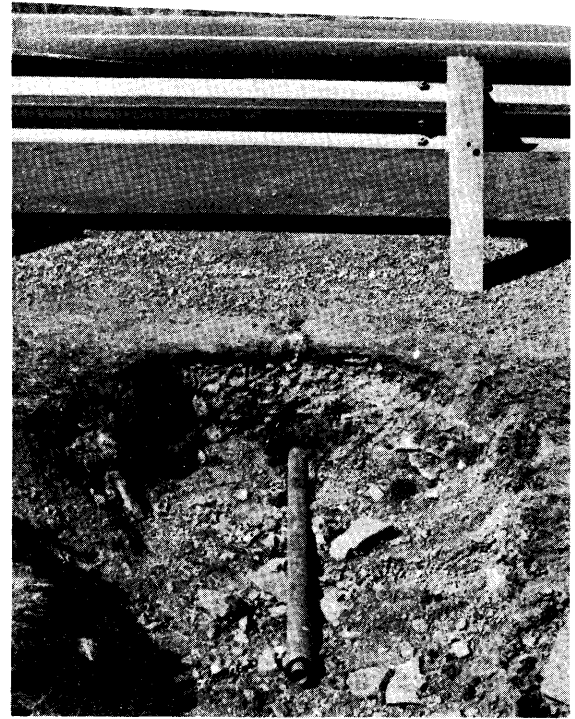
Figure 15. Equipment used to bore under the road and an installed pipe sleeve.

Pipe sleeves were used to protect the conduits carrying electrical conductors under the road. The Department strongly discourages cutting pavement surfaces on the traveled way, so boring under the road was necessary. The largest size sleeve installed under the road was 12 in. (304.8 mm) in diameter and the smallest 2 in. (50.8 mm). This boring consumed a great amount of time and effort. Figure 15 shows the equipment employed to drill under the road and a pipe sleeve after installation.

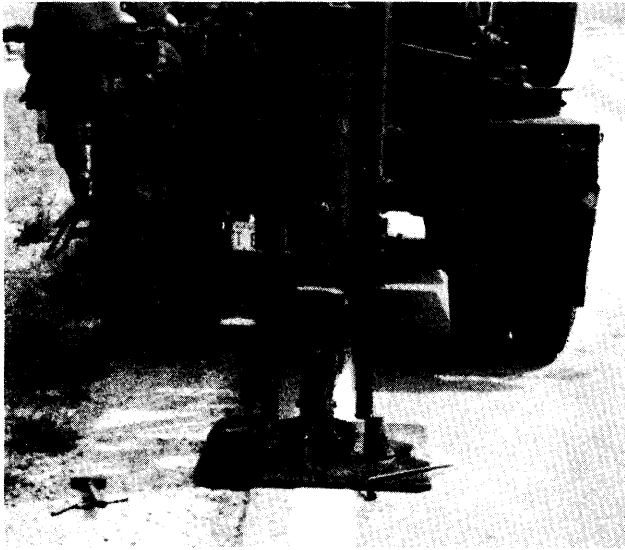
Figure 22. Equipment used to punch holes for light installation and the hole punched.

The majority of the lights were located on the main line. Holes for these lights were punched with a modified pile driver. A hollow, circular steel die, 12.5 in. (317.5 mm) in diameter was driven at least 3.5 in. (90 mm) into the pavement to make a hole as shown in Figure 22. In most cases the plug came out when the die was removed; if this didn't happen, hand tools were used to remove it and even up the bottom.

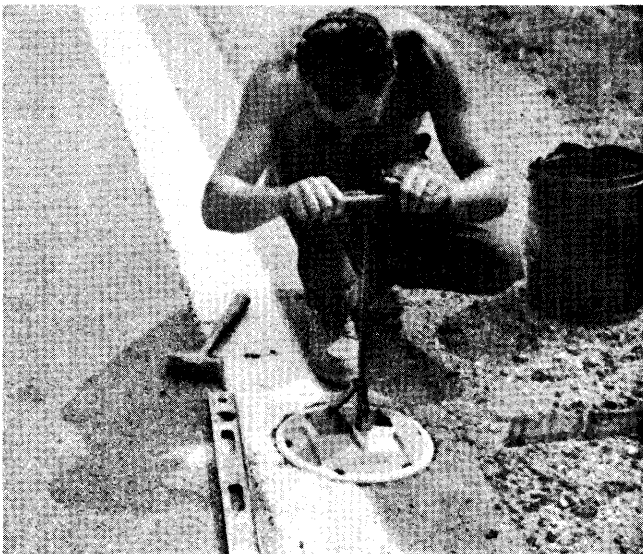
Figure 23. Pavement light being set and being aimed with a stringline.

The lights on the main line were aimed to come to a point 200 ft. (61 m) distant on the centerline. This aiming, as previously mentioned, was to give a good target value to the motorist, and therefore give a clear road delineation, and to prevent the loss of light off the shoulder edge. Figure 23 shows the light being set and being aimed by the stringline method.

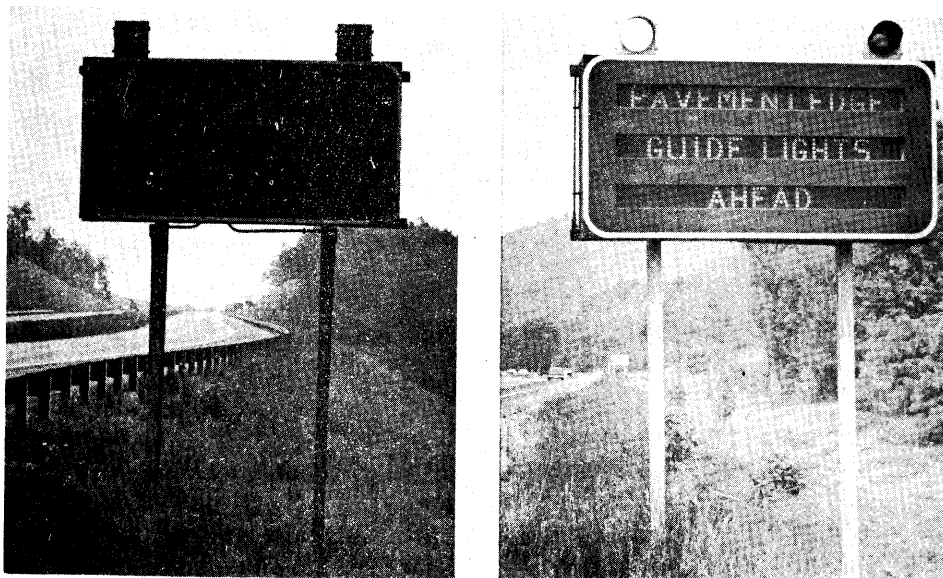
Figure 28. Advance information sign.

The final two items that need discussing are the sign and the raised pavement markers on the bridges and in the gore area. On each end of the project, 500 ft. (152.4 m) in front of the lights there are signs with the message "Pavement Edge Guidelights Ahead". These are matrix signs with horizontal louvres that present a black matt face when the lights are not on. On top of the signs are two 12-in. (304.8 mm) 100-watt alternating amber flashing lights with a frequency of 60 flashes per minute. The signs operate on 115-volt, 60-cycle alternating current. These information signs are activated when any detector

in the system senses fog. The signal to turn the signs on is transmitted by a tone generator. The letters in the message are of the 8 in. (203.2 mm) series D type. Figure 28 shows the sign in the non-activated and activated stages.
