Midwest States Accelerated Testing Program: Well Bonded Superpave Overlays on Hot Mix Asphalt

Final Report

Kansas State University Transportation Center

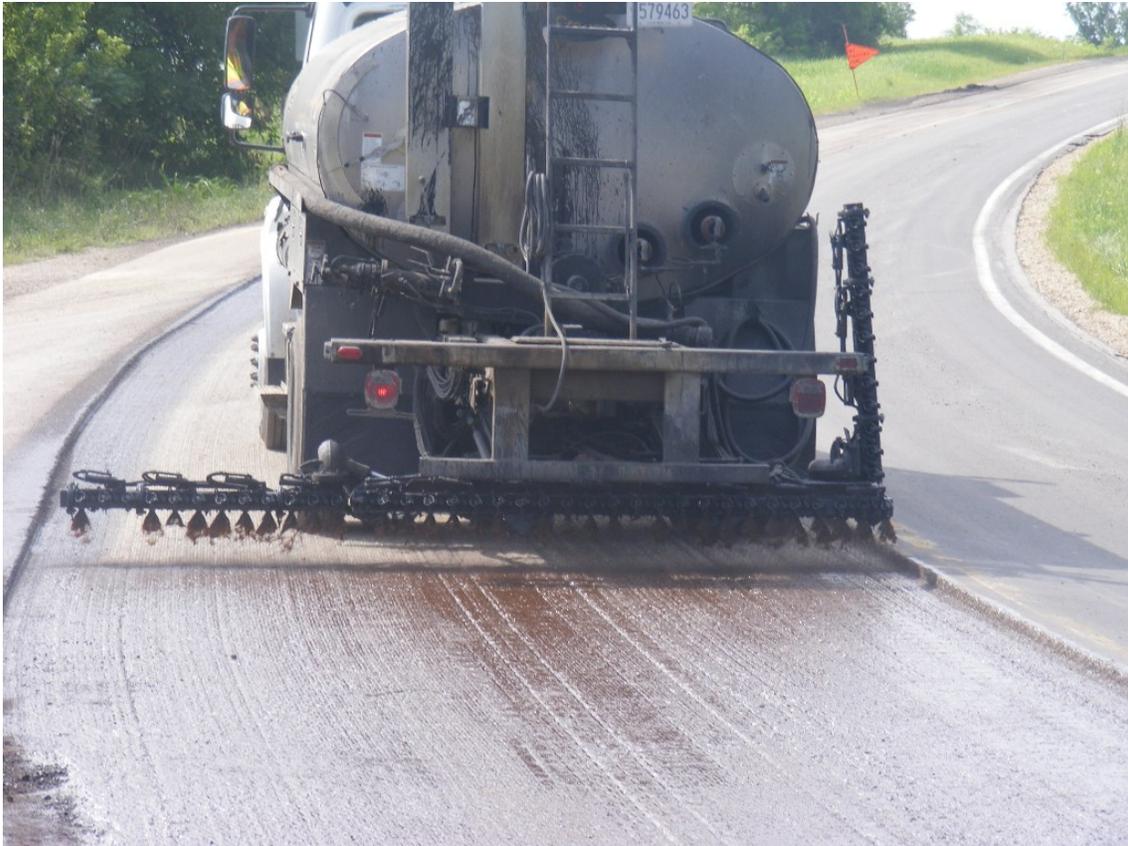
As mentioned earlier, most tack coats are produced from an asphaltic material which is emulsified to allow for spray application. The supplied materials are diluted with a maximum of 35–43% water. Once an emulsion is sprayed on a surface and is exposed to the air, water evaporates in a process known as “breaking” (Brown et al., 2009). What begins as a rich brown layer turns into a sticky black layer as shown in Figure 1.1.

Figure 1.1: Tack Coat Application

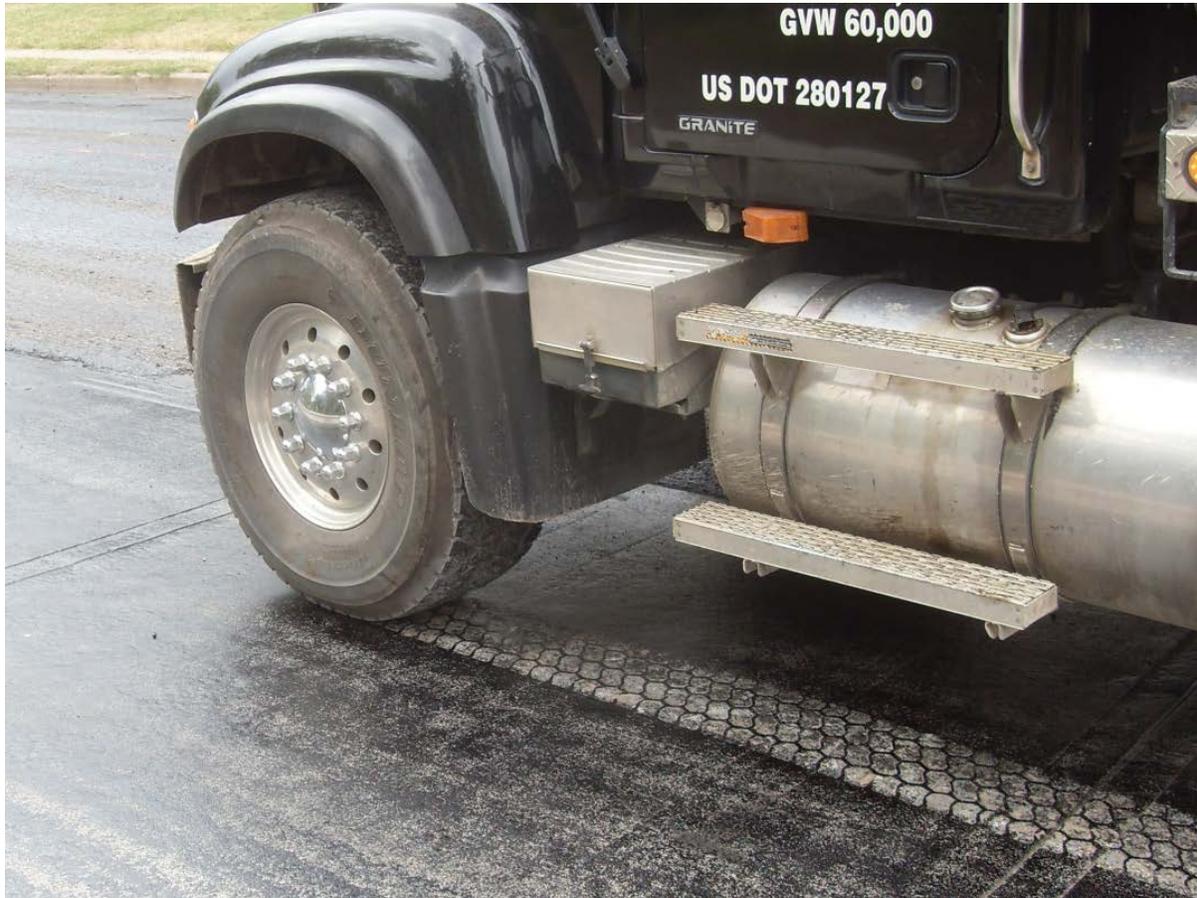
Figure 1.2: Tack Pick Up by Truck Tire

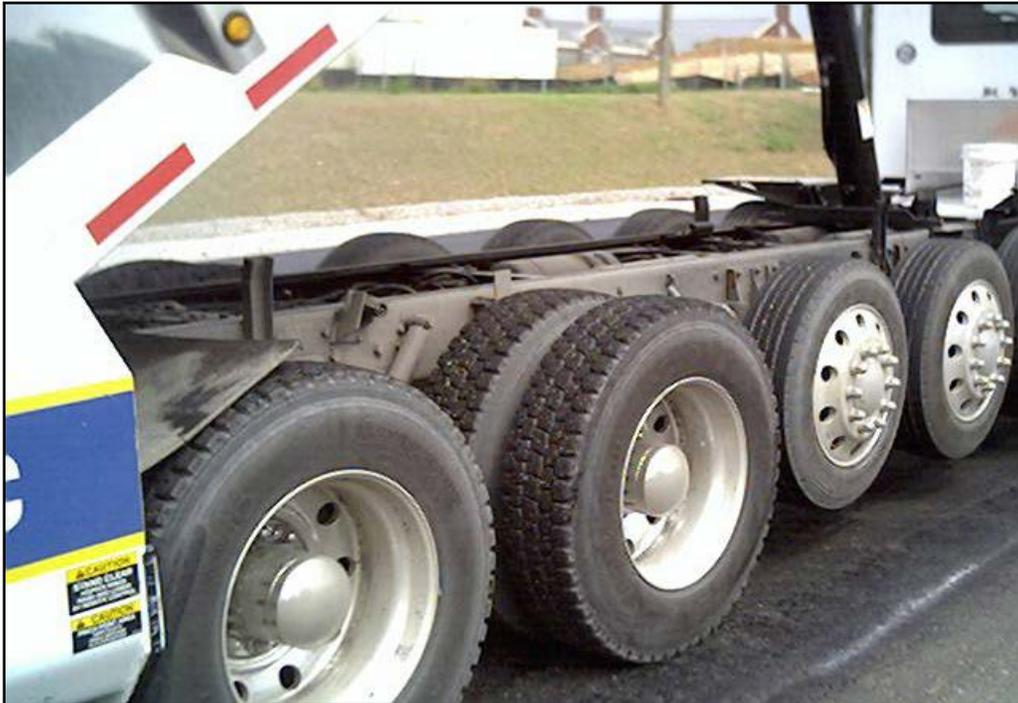
Figure 2.3: Trackless Tack Performance Testing in Virginia

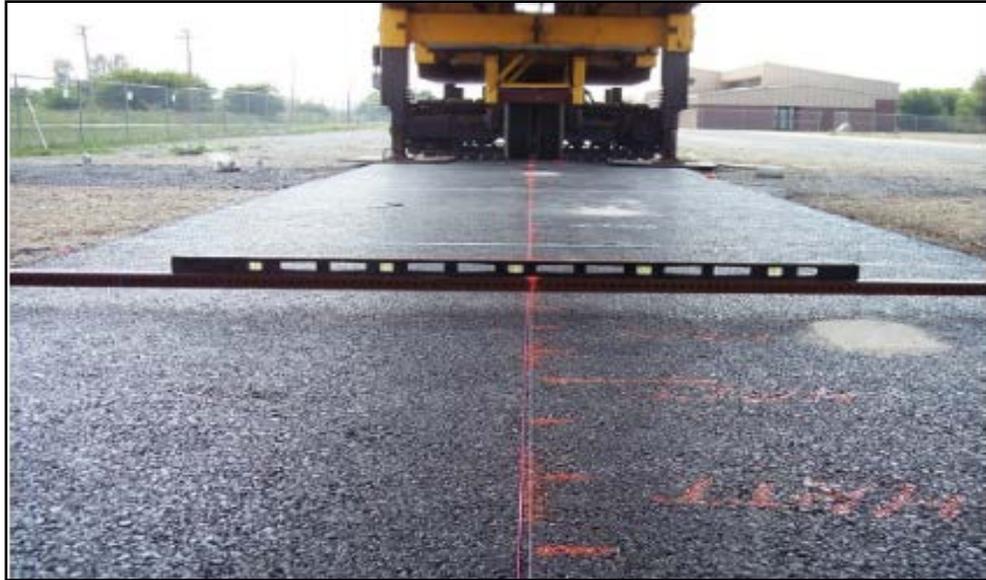
Figure 2.5: Surface Profile Measurements after APT Loading
Source: Leng et al. (2009)

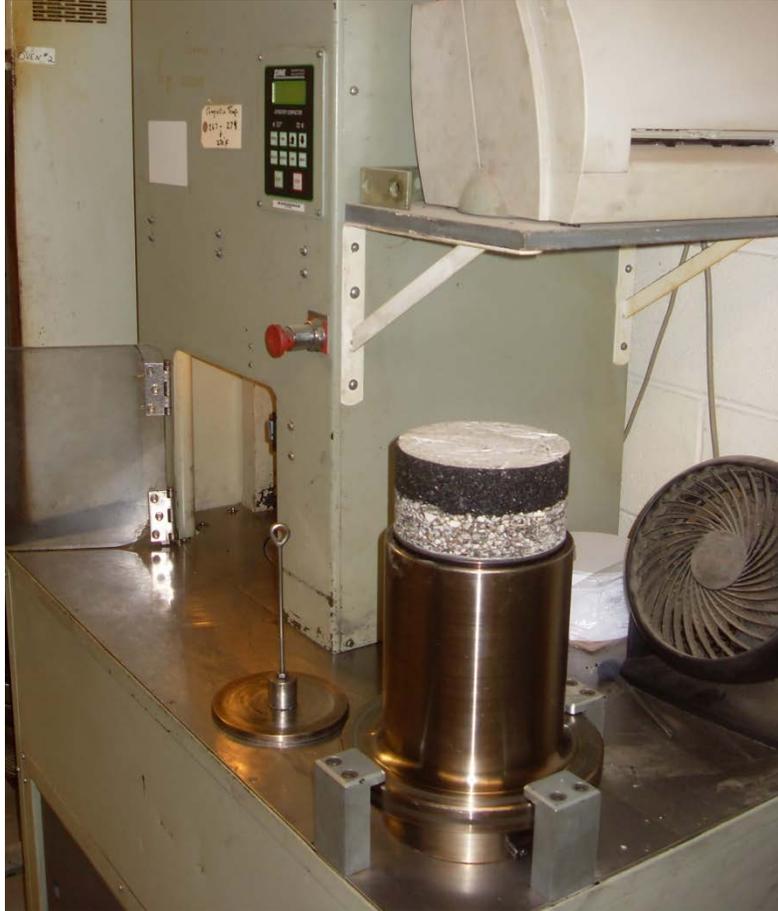
Figure 3.3: Superpave Gyratory Compactor with Compacted Sample Extruded from Mold

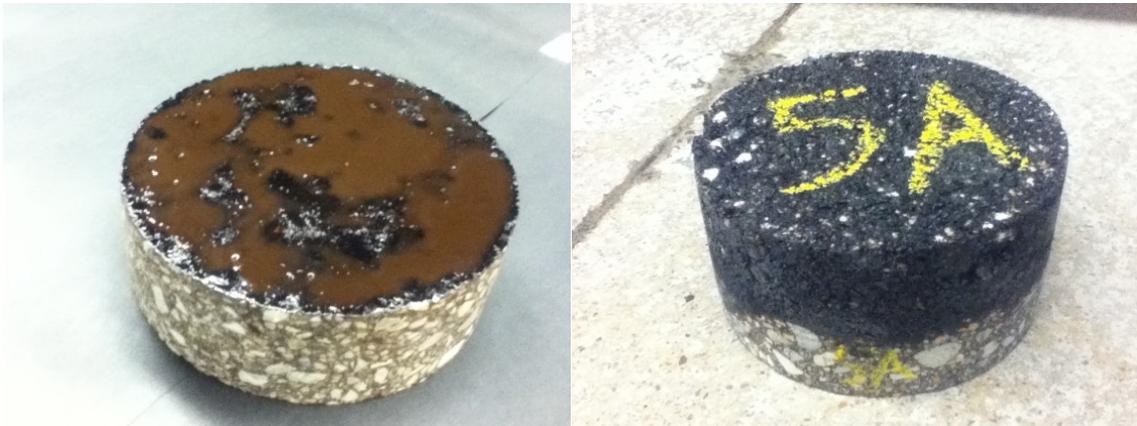
Figure 3.4: Core with Tack that is Breaking and Core with Compacted Overlay

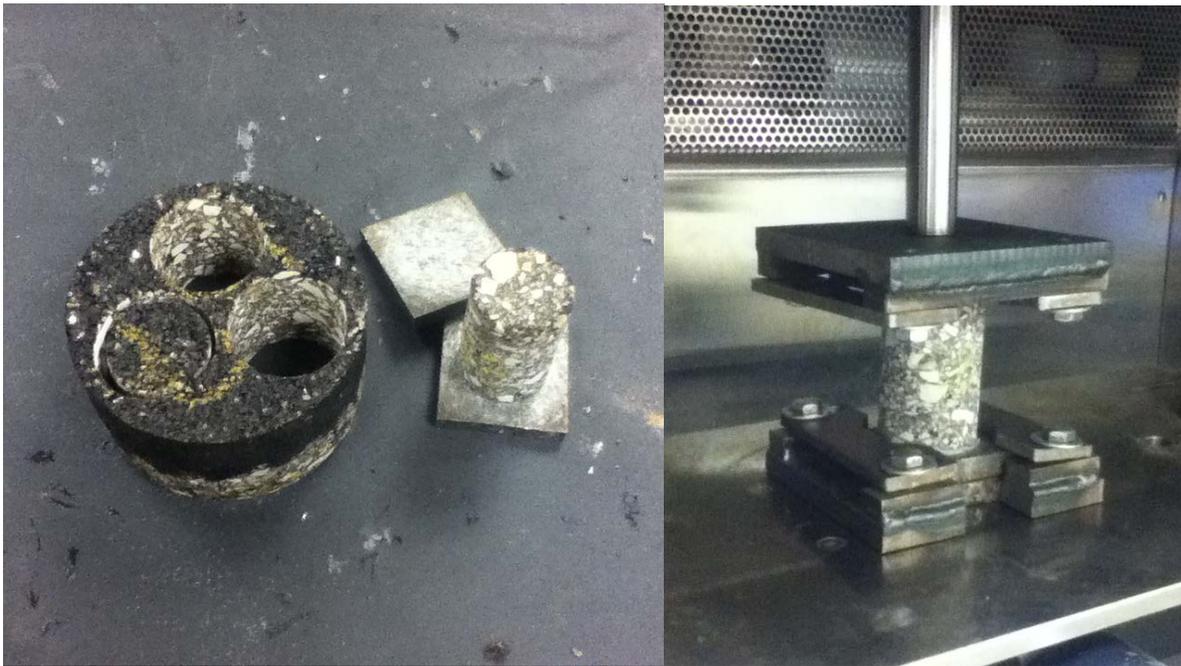
Figure 3.5: (a) Epoxying to Steel Plates, (b) Sample Loaded in the UTM

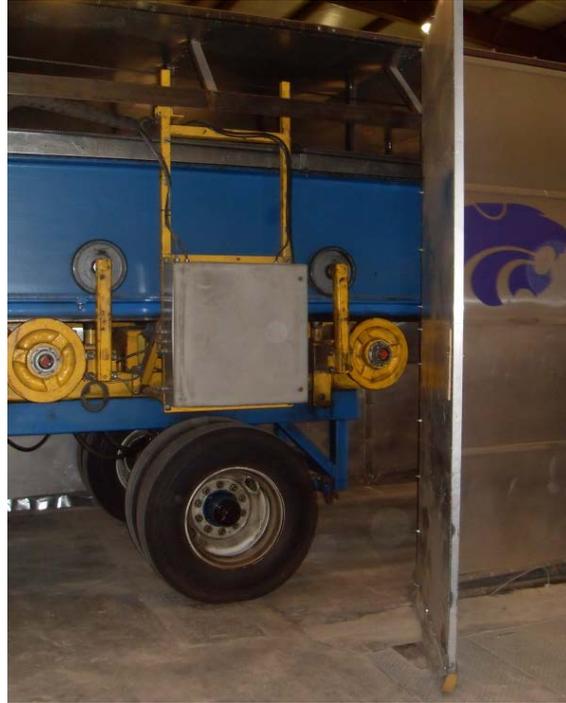
The APT load assembly hydraulically applies loading to a single axle with dual tires as it moves across the test pit, traveling at about 7 mph (11.3 km/hr; Figure 4.1). A protective housing insulates the system and enables air conditioners to maintain steady temperatures. This custom-built machine also introduces wander to deviate up to 6 in. (150 mm) either way with a truncated normal distribution to simulate more realistic load application (Figure 4.2). When operating without any interruption, 100,000 passes are possible per week.

Figure 4.1: APT Load Assembly

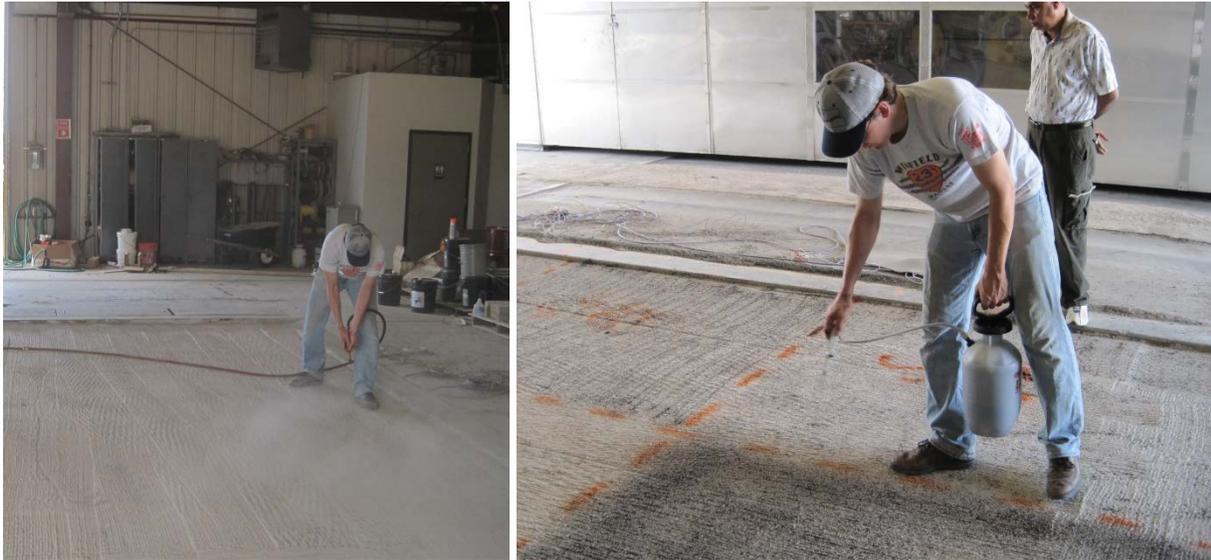
Figure 4.3: (a) Cleaning Surface with Compressed Air, (b) Applying Tack with Hand Sprayer

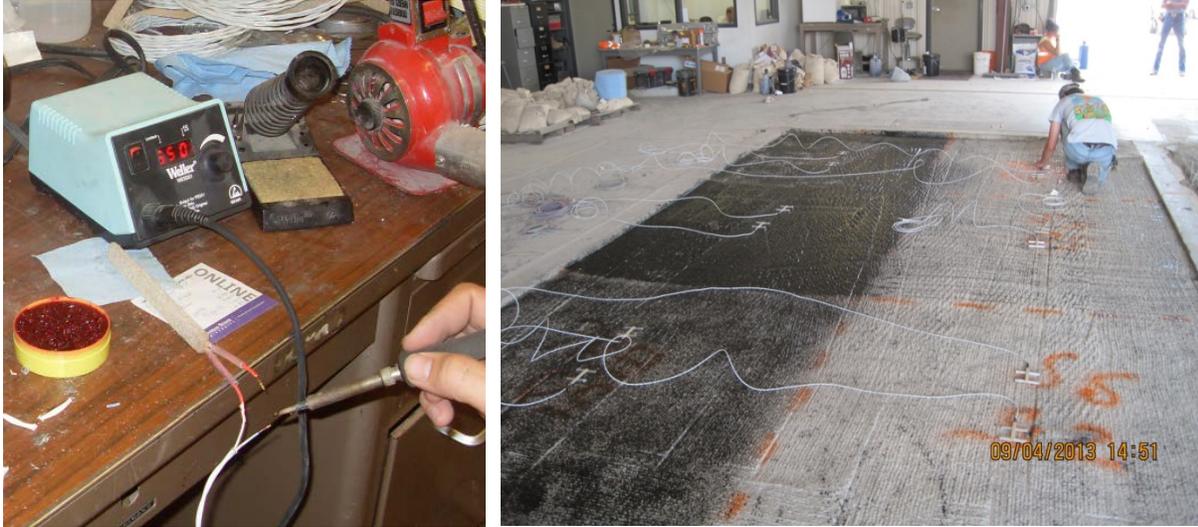
Twelve H-Bar strain gages from Tokyo Sokki Kenkyujo Co., Ltd., were used to measure the strain at the interface between the two layers. Previous experience has shown the stock lead wires perform poorly in the extreme conditions of hot HMA, so they were replaced with high quality shielded wiring (Figure 4.4a). The soldered connection at the base of the strain gage was covered by heat shielding. The strain gage was epoxied to two notched aluminum bars and attached to the milled surface using metal staples after the tack had been sprayed. Two strain gages were allotted for each test section, for a total of 12 gages installed, all in the longitudinal direction as shown in Figure 4.4b. The gage length was 2.4 in. (60 mm), with a gage factor of $2.09 \pm 1\%$. Resistance was $120 \pm 0.5 \Omega$. Before paving, the gages and wires were covered with a shovelful of HMA and hand compacted in an effort to protect them from the paver.

Figure 4.4: (a) Soldering New Lead Wires onto Strain Gages, (b) Installing Strain Gages after Tack is Applied

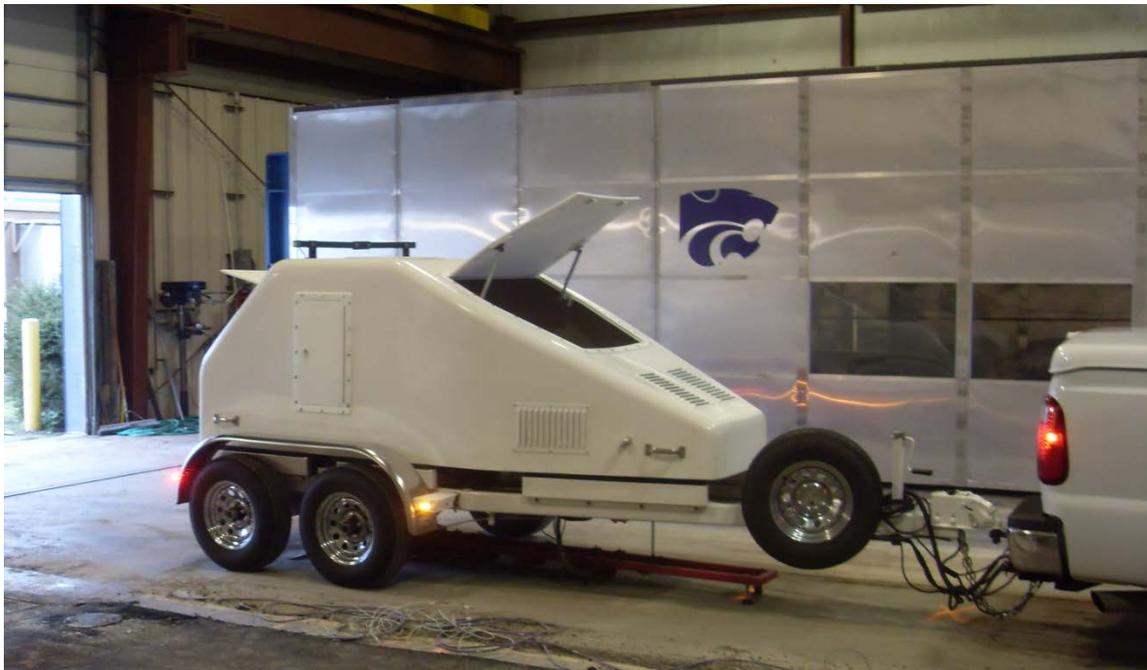
After construction, a falling weight deflectometer (FWD) test was performed on each test section to verify that the subbase was uniform for the test sections. A weight is dropped and the surface deflection is recorded by seven sensors that are offset at certain radial distances in a straight line. This process is automated and can be seen in Figure 4.6. Figure 4.7 displays the eastbound and westbound test points and the direction in which the sensors were aligned.

Figure 4.6: FWD with APT in Background

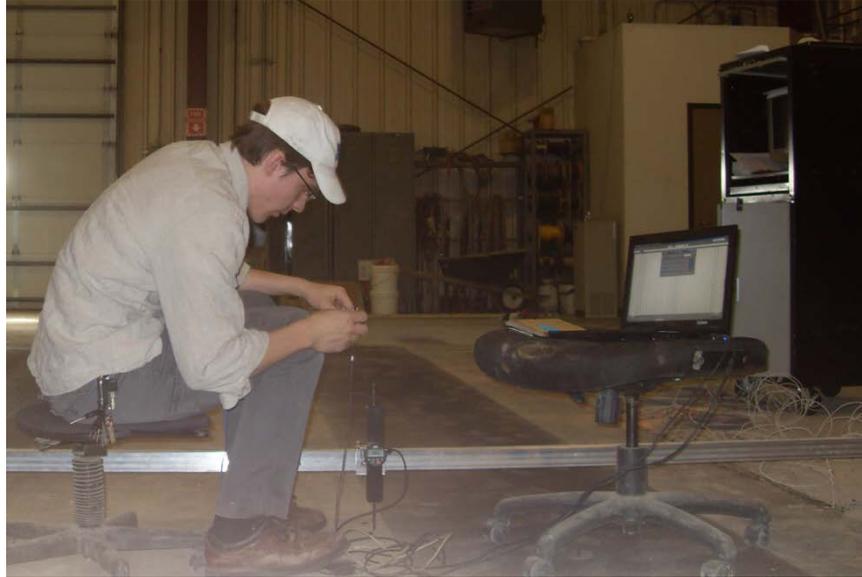
Elevation at every 0.5 inch (12.7 mm) was measured across the 14-ft (4.6-m) section. A laptop was attached to the set up to expedite the profiling process.

Figure 4.8: Transverse Profile Being Taken Using a Chicago Dial Indicator

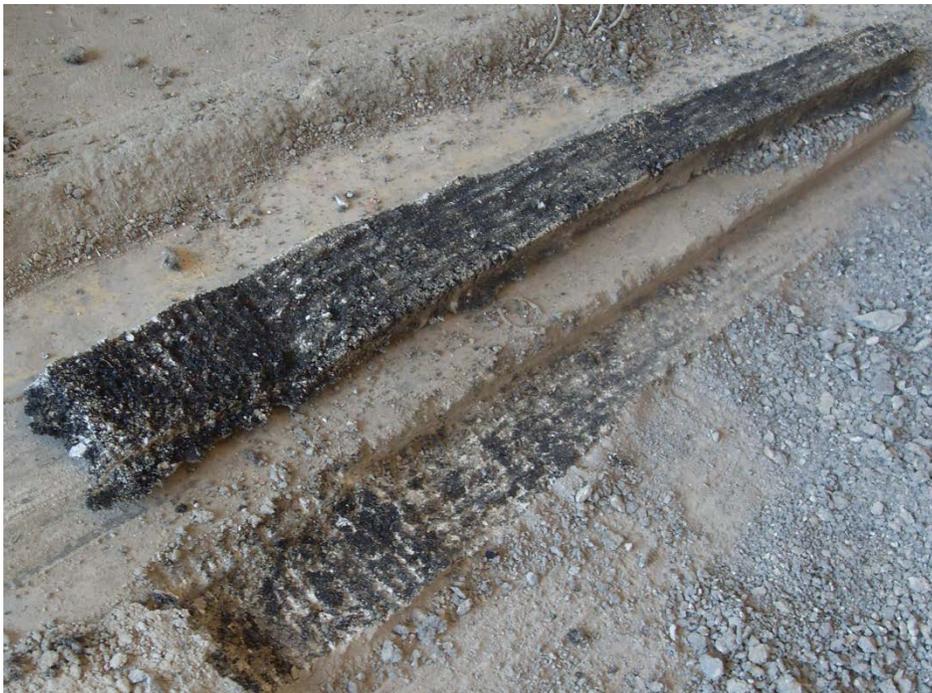
Figure 5.26: Edge of SE Section Easily Debonded during Milling

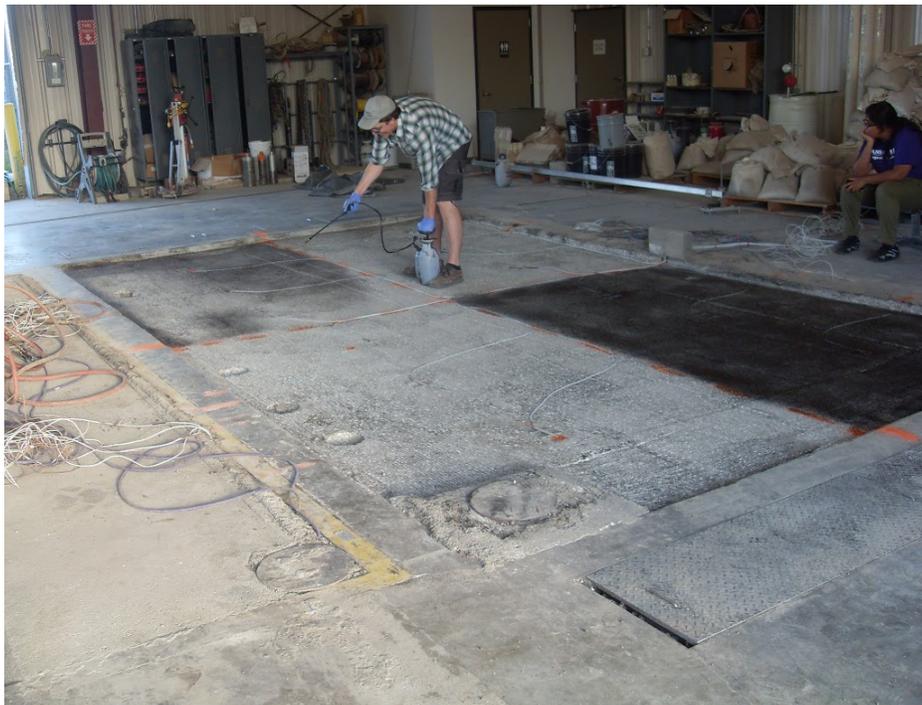
Figure 6.2: SS-1HP Tack Coat Application

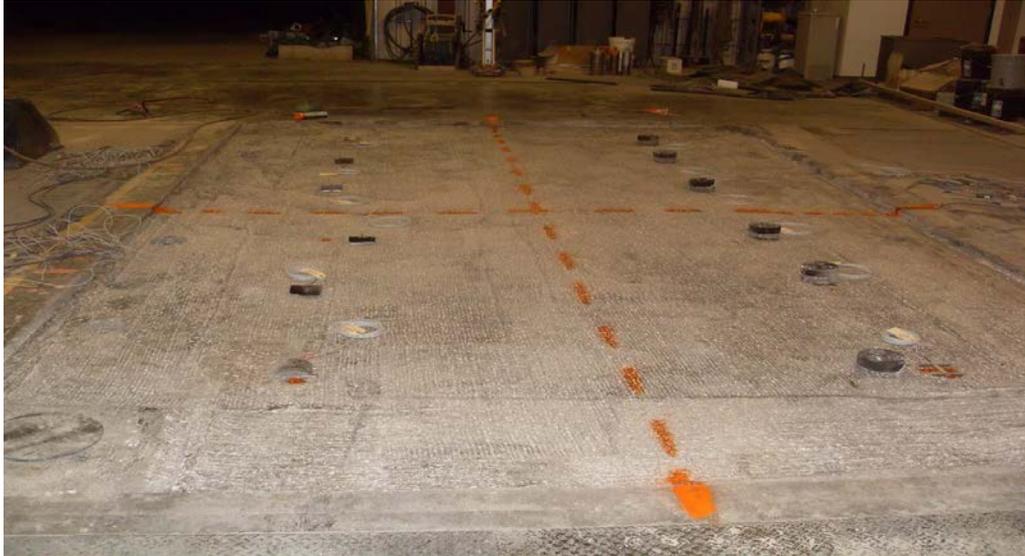
Figure 6.3: Installed Strain Gauges
