TERMINATION AND ANCHORAGE OF TEMPORARY CONCRETE BARRIERS

MIDWEST ROADSIDE SAFETY FACILITY

MwRSF Research Report No. TRP-03-209-09

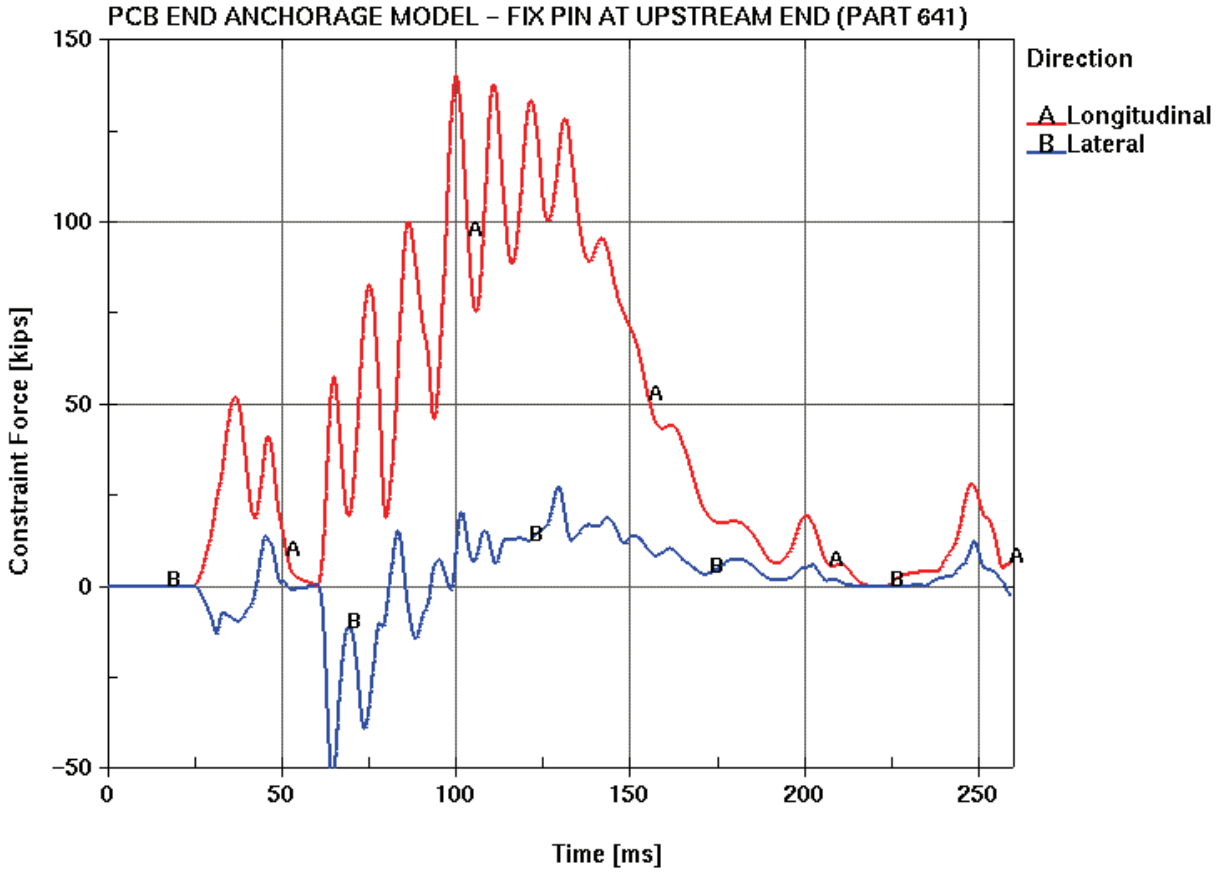
Figure 1. Case 1 – Pinned-End Constraint Loads

Initially, the design loads were determined for a free-standing barrier system with the first upstream barrier constrained with a simple pinned-end condition at the end connection pin (i.e., rotation allowed about the vertical axis of the end pin only and no translation of the pin allowed). This “ideal” case was used to provide an understanding of the loads imparted to an anchor system where translation was not allowed as well as an indication of the vehicle and barrier performance. As expected, the 2000P vehicle was smoothly redirected by the barrier system, but at the cost of relatively high loads to the end constraint, as shown in Figure 1 and Figure 2. Longitudinal barrier loads were measured at approximately 140 kips (623 kN). As mentioned previously in the discussion of the design criteria, a rigid connection tends to create higher anchor loads. Thus, some deflection of the end anchor was desired to reduce these loads to manageable levels.

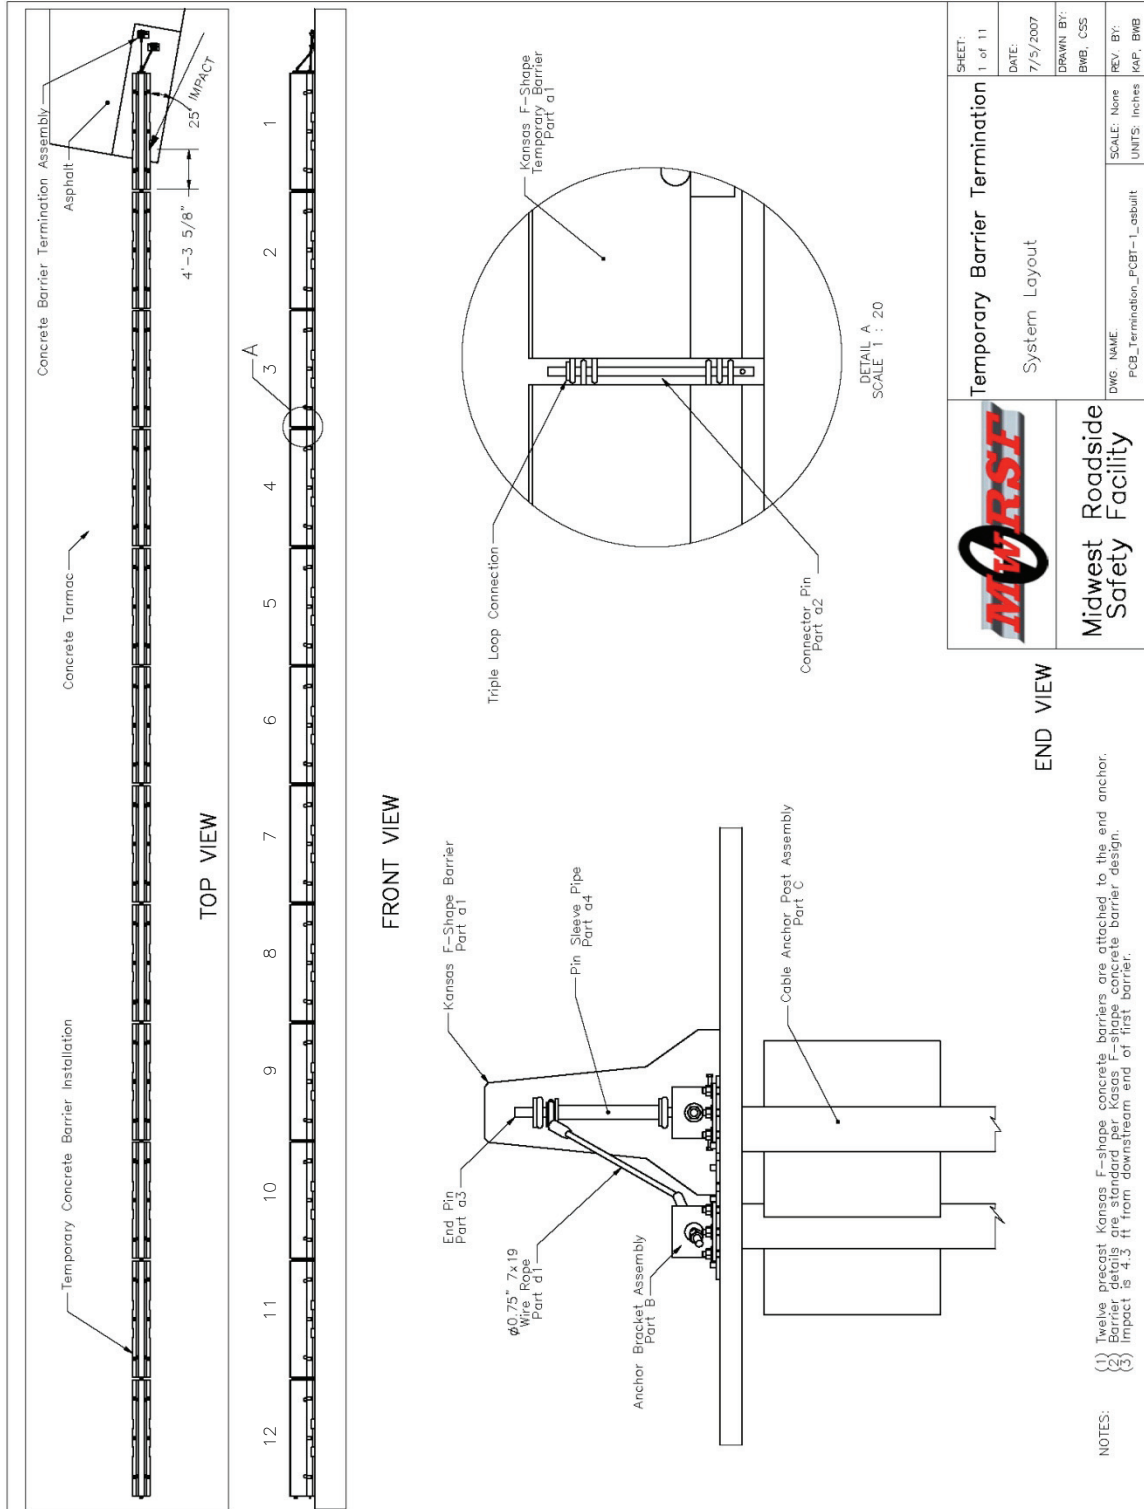
Figure 8. Test Installation Layout, Test No. TTCB-1

The cable assemblies were comprised of a ¾-in. (19-mm) diameter, 7x19 wire rope, BCT cable end fitting, a Crosby heavy-duty HT thimble, and a 115-HT mechanical splice, as shown in Figures 17 and 18. It should be noted that the wire ropes were ordered as 6x19 IWRC IPS wire ropes in order to be consistent with the wire rope specifications for W-beam guardrail cable anchorages. However, the manufacturer substituted the 7x19 wire rope as an equivalent to the 6x19 IWRC IPS. The substitution was not determined until the wire ropes were disassembled after the full-scale crash test. One 54 ¾ in. (1,391 mm) long cable assembly was aligned with the longitudinal axis of the barrier system. This cable assembly was attached with one end fixed between the lower barrier loops on an additional connection pin on the upstream end of the barrier and the other end attached to the anchor post. The end connector pin utilized a second 2 ½-in. wide x 4-in. long x ½-in. thick (64-mm x 102-mm x 13-mm) ASTM A36 steel plate and a ½-in. diameter x 10-in. long (13-mm diameter x 254-mm long) Grade 8 hex bolt and nut at the bottom of the pin to prevent the pin from pulling out of the barrier loops when the anchorage was loaded. The second cable assembly measured 48 3/8 in. (1,229 mm) long, and it was attached from just below the top barrier loop on the connector pin on the end of the barrier to the offset anchor post, as shown in Figures 8 through 10 and 21. A pin sleeve, made from 1 ½ in. (38 mm) Schedule 40 pipe, was used to keep the anchor cables in the correct vertical positions. The use of the pin sleeve also allowed the cable anchorages to be attached at the same vertical position on the end pin regardless of which end of the F-shape barrier was used. Thus, if the barrier ends were reversed, the offset cable would attach to the connection pin between the top two barrier

loops, and the in-line cable would attach to the connection pin between the pin sleeve and lower barrier loop.

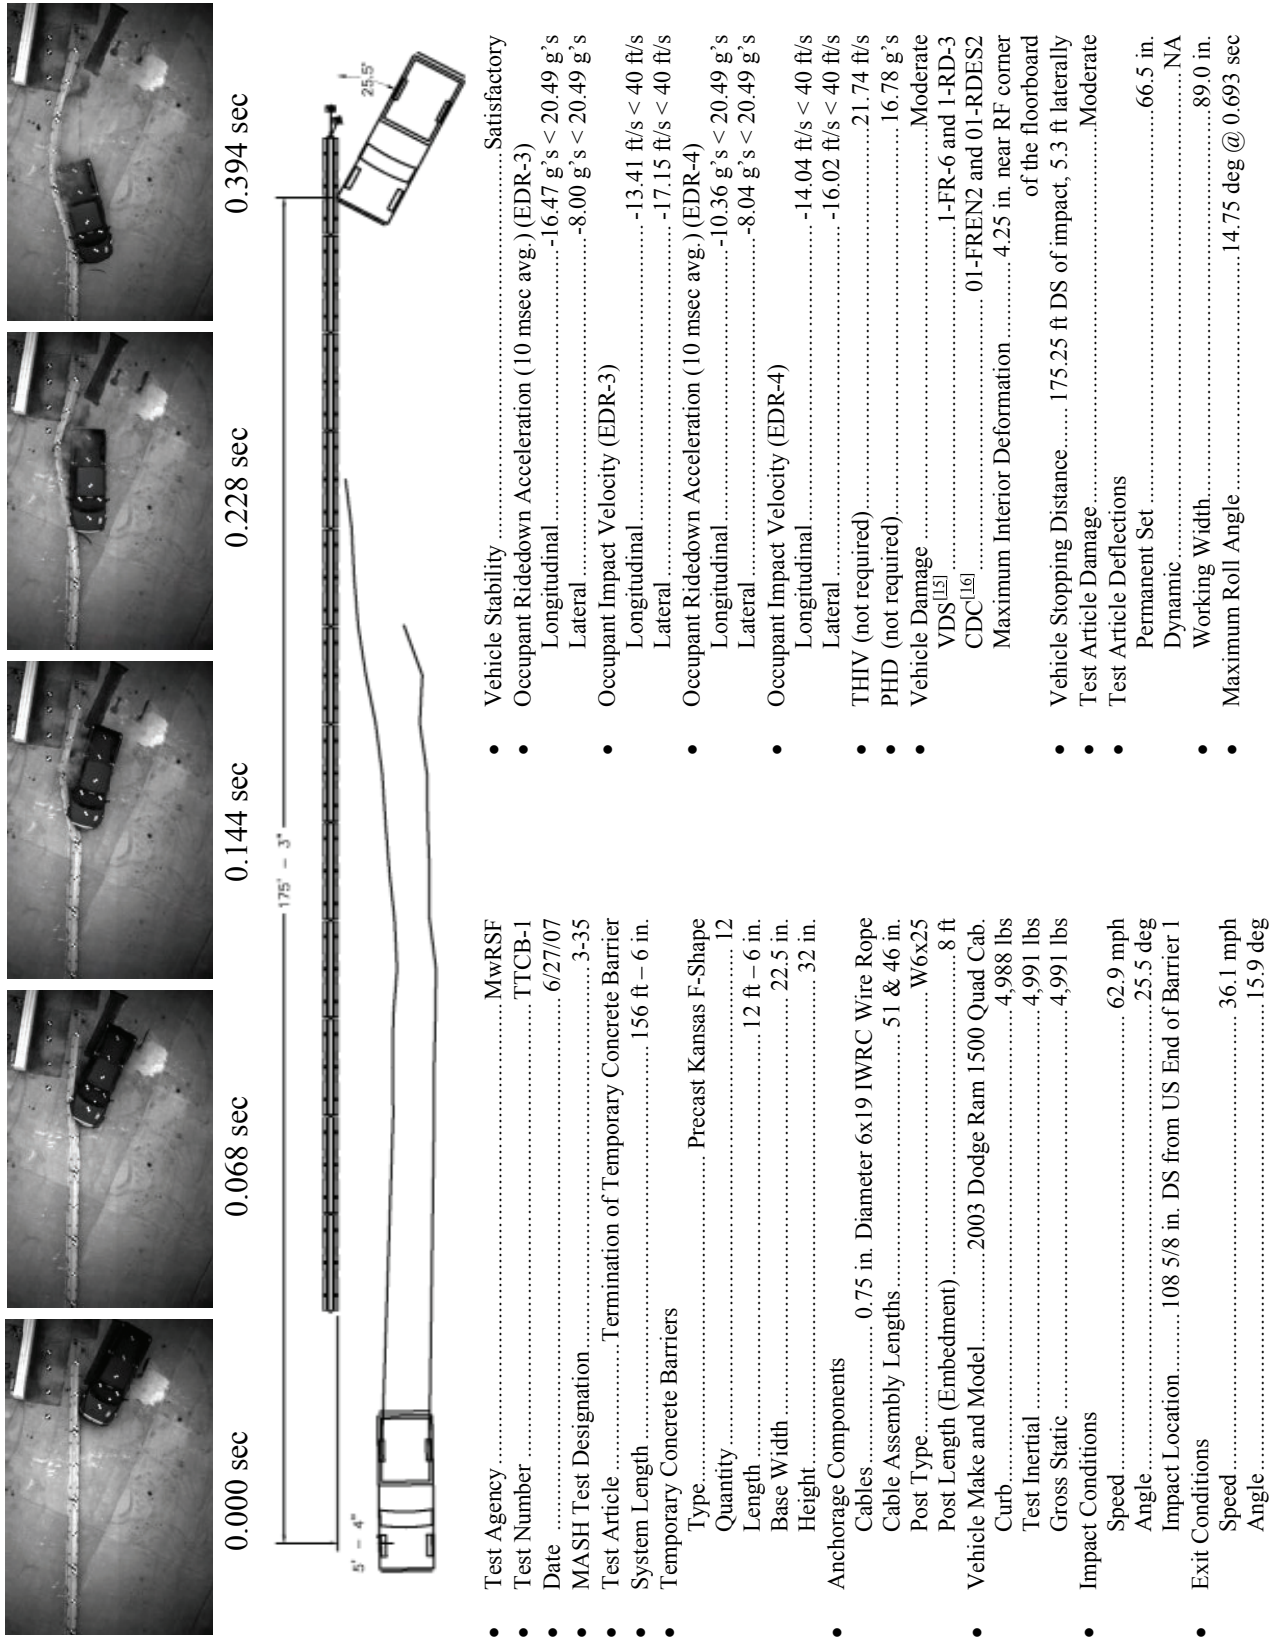
Figure 26. Summary of Test Results and Sequential Photographs, Test No. TTCB-1

The analysis of the test results for test no. TTCB-1 showed that the temporary concrete barrier termination and anchorage system adequately contained and redirected the vehicle. There were no detached elements nor fragments which showed potential for penetrating the occupant compartment nor presented undue hazard to other traffic. The deformation of, or intrusion into, the occupant compartment was minimal and did not pose a threat to cause serious injury. The test vehicle did not penetrate nor ride over the barrier and remained upright during and after the collision. Vehicle roll, pitch, and yaw angular displacements were noted, as shown in Appendix E, and were deemed acceptable because they did not adversely influence occupant risk safety criteria nor cause rollover. After impact, the vehicle exited the barrier at an angle of 15.9 degrees and did not intrude into adjacent traffic lanes. Therefore, test no. TTCB-1, conducted on a termination and anchorage system for temporary concrete barrier, was determined to be acceptable according to the TL-3 safety performance criteria found in the MASH using test designation no. 3-35.

• Anchorage Components		Lateral	-4.88 m/s < 12.2 m/s
Cables	19 mm Diameter 6x19 IWRC Wire Rope	• THIV (not required)	6.63 m/s
Cable Assembly Lengths	2195 & 1168 mm	• PHD (not required)	16.78 g's
Post Type	W152x37.2	• Vehicle Damage	Moderate
Post Length (Embedment)	2.44 m	VDS ^[15]	1-FR-6 and 1-RD-3
Vehicle Make and Model	2003 Dodge Ram 1500 Quad Cab	CDC ^[16]	01-FREN2 and 01-RDES2
Curb	2,263 kg	Maximum Interior Deformation	108 mm near RF corner of the floorboard
Test Inertial	2,264 kg	• Vehicle Stopping Distance	53.4 m DS of impact, 1.6 m Laterally
Gross Static	2,264 kg	• Test Article Damage	Minimal

• Impact Conditions		• Test Article Deflections	
Speed	101.3 km/h	Permanent Set	1,689 mm
Angle	25.5 deg	Dynamic	NA
Impact Location	2.76 m DS from US End of Barrier 1	Working Width	2,261 mm

• Exit Conditions		• Maximum Roll Angle	14.75 deg @ 0.693 sec
Speed	58.1 km/h		
Angle	15.9 deg

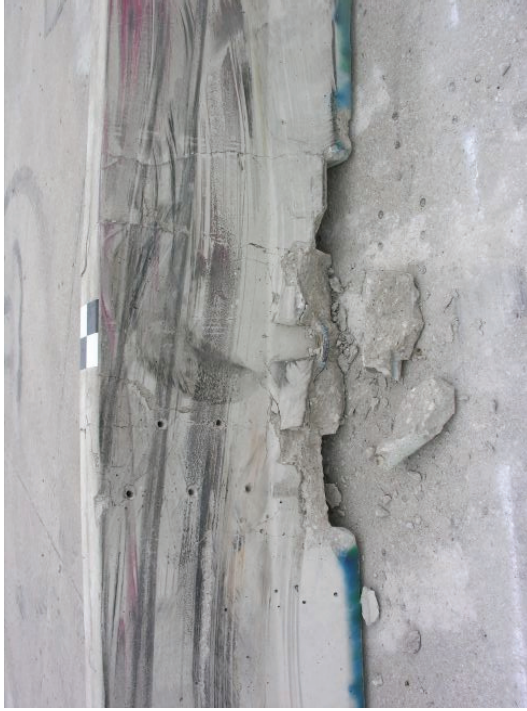
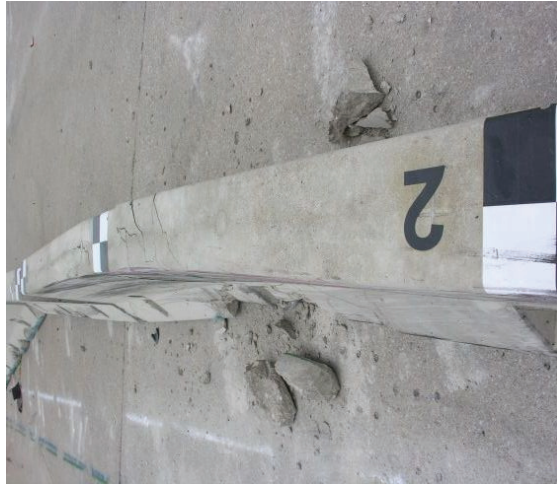
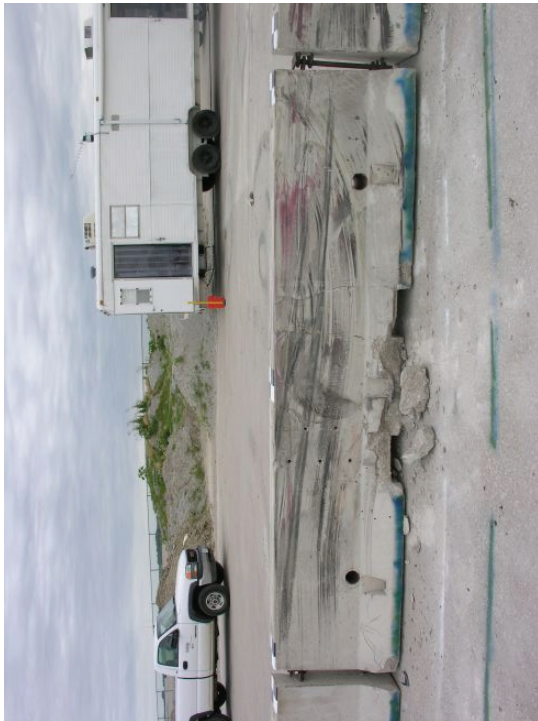
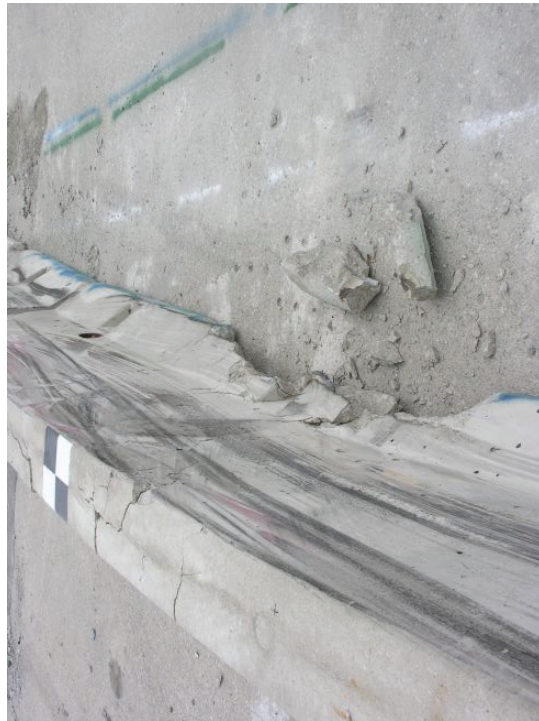
Figure 35. System Damage - Barrier No. 2, Test No. TTCB-1

The most extensive barrier damage occurred to barrier no. 2, as shown in Figures 35 and 36. Cracks were found through the entire cross section of the barrier spanning the middle 60 in. (1,524 mm) of barrier no. 2. These cracks were typically hairline cracks on the front surface of the barrier, but opened up larger gaps on the back surface. The front-side of barrier no. 2 had two 12-in. wide x 6-in. tall x 4-in. deep (305-mm x 152-mm x 102-mm) concrete pieces break away from the toe near the center of the barrier. Barrier no. 2 was permanently bowed such that the center of the barrier was 3.125 in. (79 mm) off line. Spalling and gouging was found in various areas on the front face of the barrier.

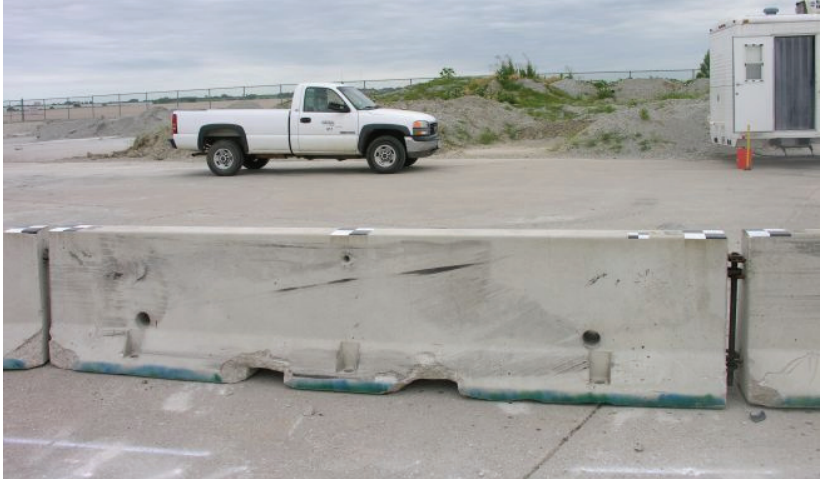
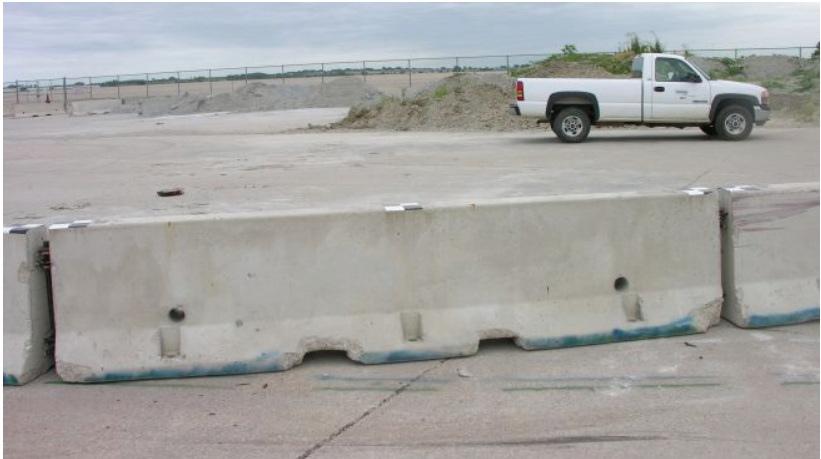
Figure 37. System Damage - Barrier Nos. 3-5, Test No. TTCB-1

Spalling was also found at the edges of the joint between barrier nos. 2 and 3. Barrier no. 3 contained tire marks beginning 20 in. (508 mm) from the upstream end and continued down the length of the barrier, as shown in Figure 37. A maximum permanent set deflection of 66.5 in. (1,689 mm) was measured at the downstream end of barrier no. 3. No dynamic deflection measurement was available because the barriers were still in motion and the end of the available high-speed video footage taken from the overhead view. Various tire and vehicle body contact marks were found from the middle of barrier no. 4 to the upstream side of barrier no. 5. The remaining barriers remained undamaged.

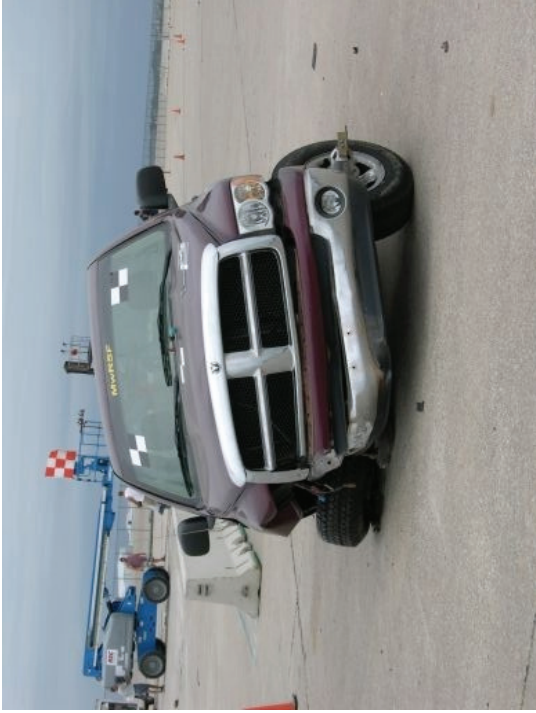
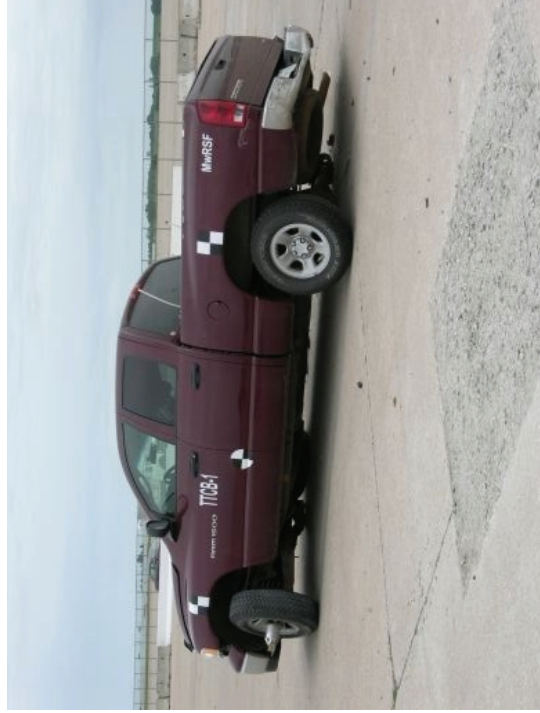
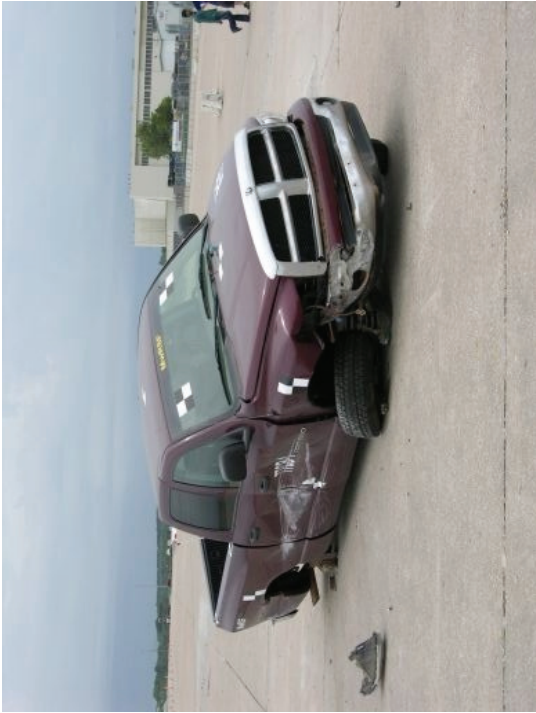
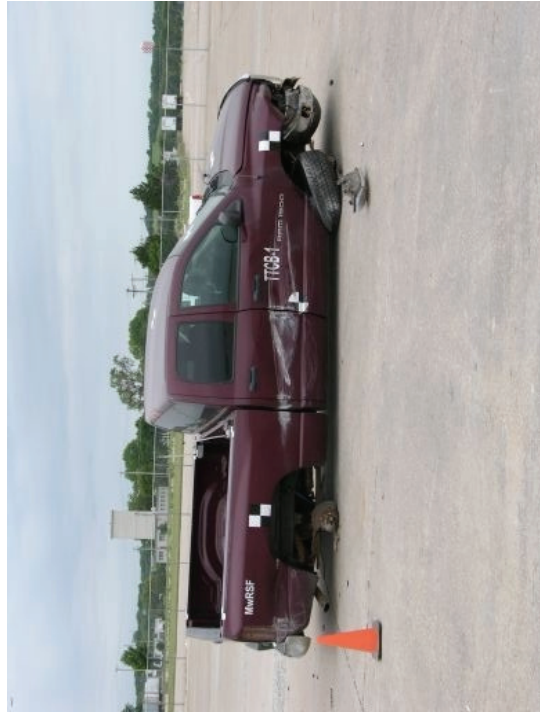
Figure 40. Vehicle Damage, Test No. TTCB-1

The damage to the vehicle was moderate, as shown in Figures 40 through 45. The most extensive damage was concentrated at the right-front corner of the pickup truck where the quarter panel was crushed inward. The right side of the front bumper was also crushed in toward the engine compartment, and the right side of the grill was torn apart, as shown in Figure 41. Also, the entire front bumper was shifted downward approximately 2.5 in. (64 mm). The right-front tire was detached from the pickup truck and was resting flat underneath the right-side occupant compartment. The right-front control arm was fractured, and the tie rod had broken off,

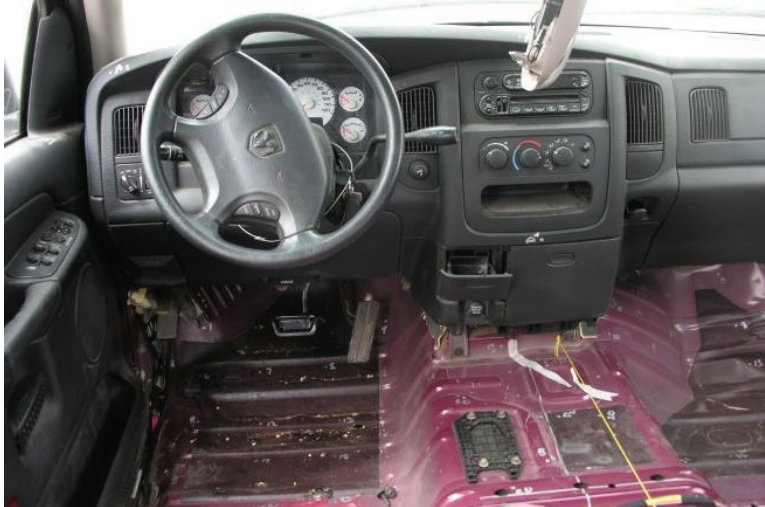
Figure 45. Vehicle Damage, Occupant Compartment, Test No. TTCB-1

Occupant compartment deformations to the right front of the floorboard, as shown in Figure 45, were judged insufficient to cause serious injury to the vehicle occupants. A maximum longitudinal deformation of 4 in. (102 mm) was located along the right side of the floorboard. A maximum lateral deformation of 3 in. (76 mm) was located at the front of the right-side floorboard. A maximum vertical deformation of 4.25 in. (108 mm) was located near the right-front corner of the floorboard. Deformations were recorded from two separate locations before and after the test. Complete occupant compartment deformations and the corresponding locations are provided in Appendix D.
