Use of Concrete Pavement Overlays on U.S. 58 in Virginia

Final Report VCTIR 14-R16

USE OF CONCRETE PAVEMENT OVERLAYS ON U.S. 58 IN VIRGINIA

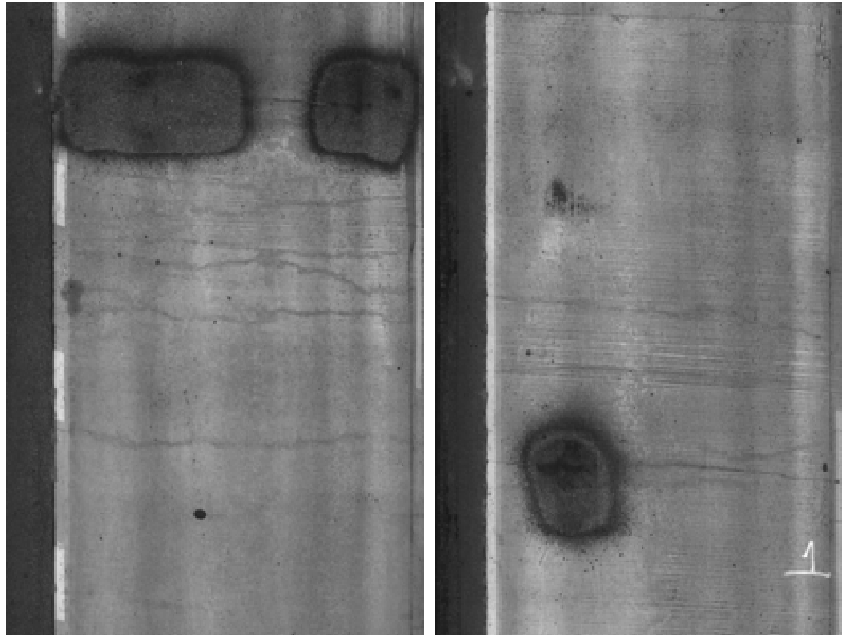
A visual distress survey and video imaging were used to collect the pavement distress information along with the GPS location. Figure 1 shows the video image of distresses on a portion of the section where bonded overlay was used. The distresses shown in Figure 2 were observed visually before the unbonded overlay was placed. Distressed areas must be patched prior to placement of the bonded overlay. Distressed areas should be filled in with asphalt prior to placing the asphalt separation layer, but full-depth concrete patching is not required.

Figure 1. Video Images of Bonded Section Before Construction

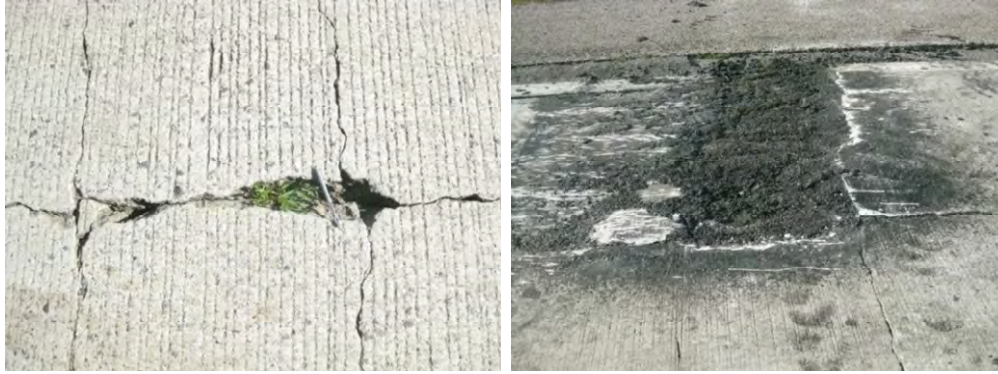
Figure 2. Visual Distress Observed on Unbonded Section Before Construction

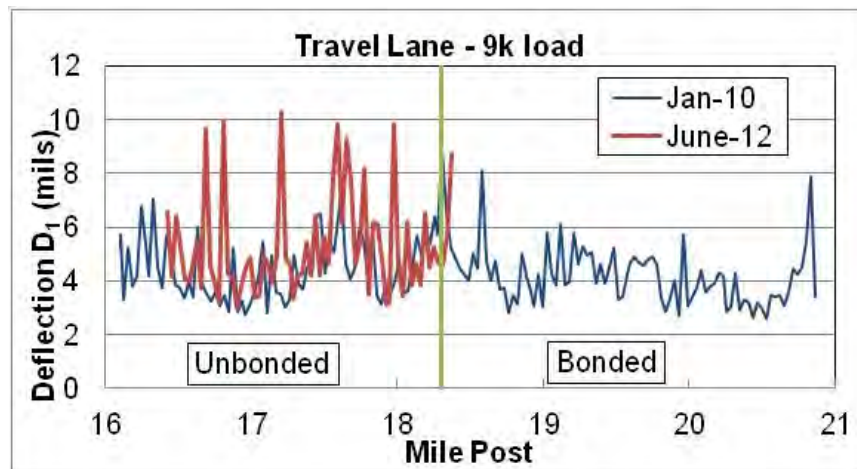
The structural condition of the pavement was evaluated with FWD data for the entire section during the design phase in 2010. A few points were measured again right before the construction in 2012. The deflection under the load for this existing CRCP section, which is presented in Figure 3, provides the overall condition of the pavement. It is important to note that two different vendors conducted the test in 2012 and in 2010.

Figure 3. Falling Weight Deflectometer Deflection Under 9,000-lb Load

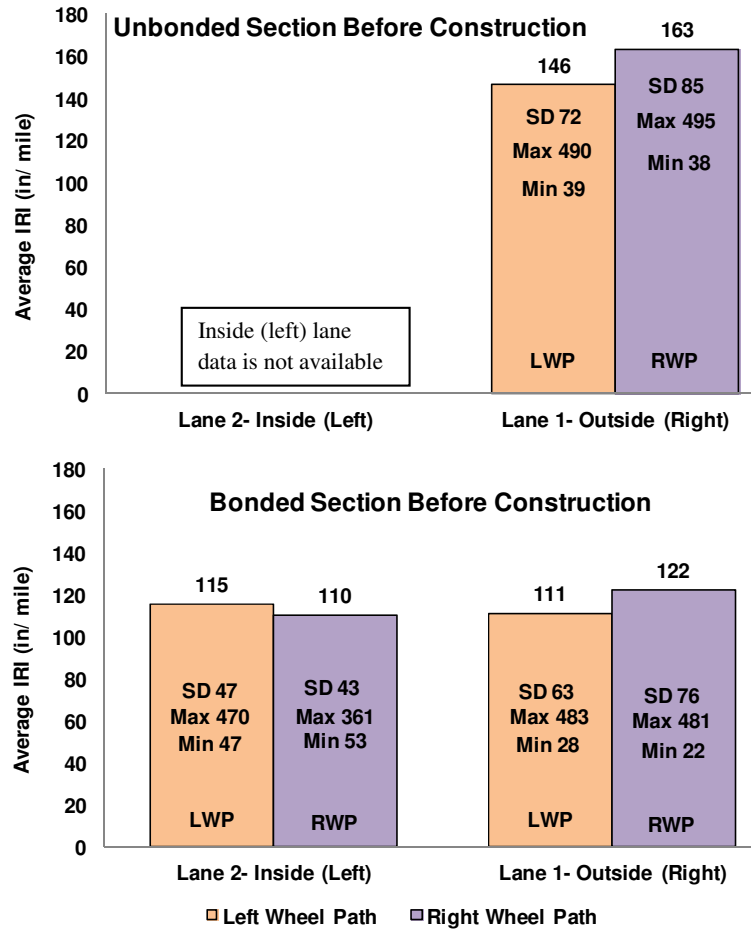
The IRI was measured before construction, and the average IRIs for the bonded and unbonded sections are provided in Figure 4. The average IRI ranged from 110 to 163 in 2012 for the section to receive the concrete overlays. The average IRI for the asphalt section ranged from 101 to 131 in 2005 (most recent data). The CRCP had a variable transverse cross slope and variable longitudinal profile, which contributed to high IRI values. To correct these deficiencies as per the contractor's suggestion, VDOT approved placing thicker pavement (up to an additional 1 in) to ensure that a uniform cross slope and longitudinal profile be achieved and the minimum required thicknesses (7 in for unbonded and 4 in for bonded) of the sections be maintained.

Figure 4. Summary International Roughness Index (IRI) Values Before Overlay

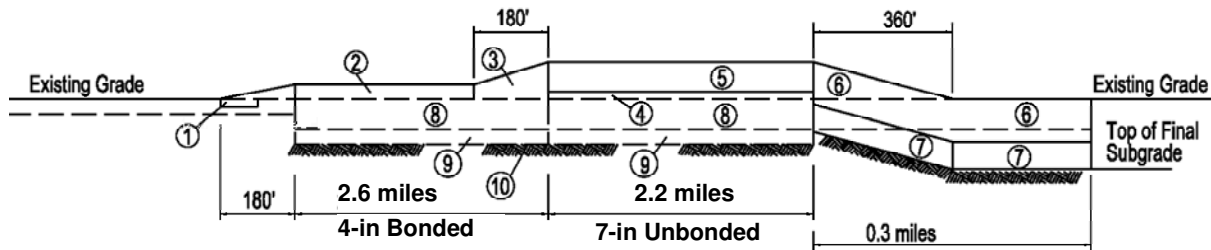
Elevation for Bonded and New JPCP Unbonded
Concrete Overlay on Concrete Pavement

1. See ACOT-1 Detail
2. 4" Bonded Concrete Overlay
3. Bonded Concrete Overlay 4" to 8"
4. 1" Asphalt Separation Layer
5. 7" Unbonded Jointed Plain Concrete Overlay
6. Full Depth Reconstruction (11" JPCP)
7. 10" Aggregate Base Type I, size 21 B
8. Existing 8" CRCP
9. Existing 6" CTA
10. Subgrade

Transition 45ft/in 4" = 180'
8" = 360'
Unbonded OL is 6'x6' panels

Figure 5. Sketch of Proposed Overlay Thickness on U.S. 58

Chapter VI of the VDOT *Manual of Instructions*, (MOI)-Materials Division,⁹ and the AASHTO 1993 pavement design guide⁶ were used to design the bonded and unbonded overlays and new JPCP. Traffic data used in the design were obtained from the 2009 VDOT Traffic Engineering Division traffic estimates reports,¹⁰ and growth rate was calculated based on historical traffic data and the compound growth rate. A back-calculated average modulus of subgrade reaction (K) value was used. Existing portland cement concrete (PCC) design distress parameters were assumed from field evaluations using distress rating data from the VDOT Pavement Management System (PMS). The existing PCC thickness of 8 in was used based on measurements obtained from cores (which varied from 7.25 to 9.5 in) and the original design sheet. The eastern end of the pavement was in good enough condition to be upgraded with a bonded concrete overlay. The existing CRCP surface was shot blasted and wetted before the placement of the 4-in bonded overlay. The western part of the pavement was more distressed than the eastern part, and a 7-in-thick unbonded overlay was needed for best performance. Figure 5 shows the bonded and unbonded and new JPCP sections. The inside shoulder was trench widened by 1 ft the entire length of the project.

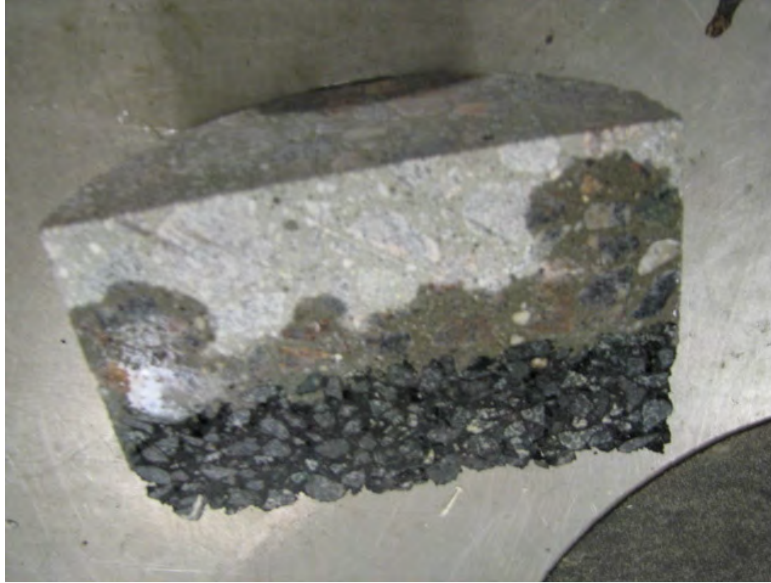
The 7-in-thick unbonded overlay has a 6-ft joint spacing without any dowels, tie bars along the centerline and shoulder, and a 1-in-thick asphalt separation layer. Although dowels are not used with thinner unbonded overlays, dowels are recommended¹¹ for pavements that are 8 in thick and thicker and when the joint spacing is 12 ft or more. An open-graded mixture was selected because it can provide for drainage as long as the voids are not filled with concrete paste when the overlay is placed. A mockup indicated the HCC does not fill the voids in the porous friction course (PFC). A slice from the mockup is shown in Figure 6.

Figure 6. Slice From Mockup of a Hydraulic Cement Concrete Overlay Placed on a Porous Friction Course

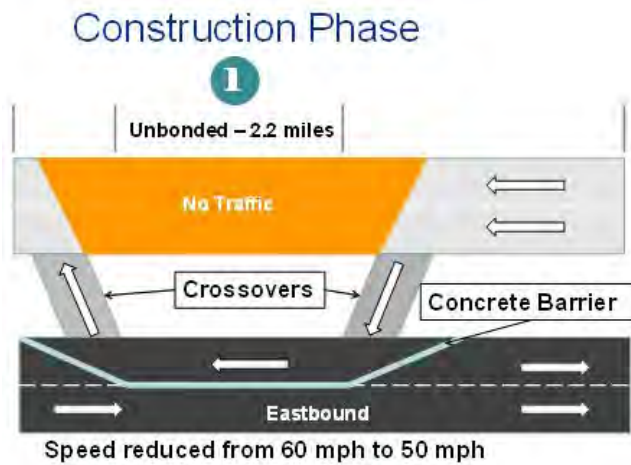
Figure 8. Phase 1 Crossovers. Unbonded = unbonded hydraulic cement concrete.

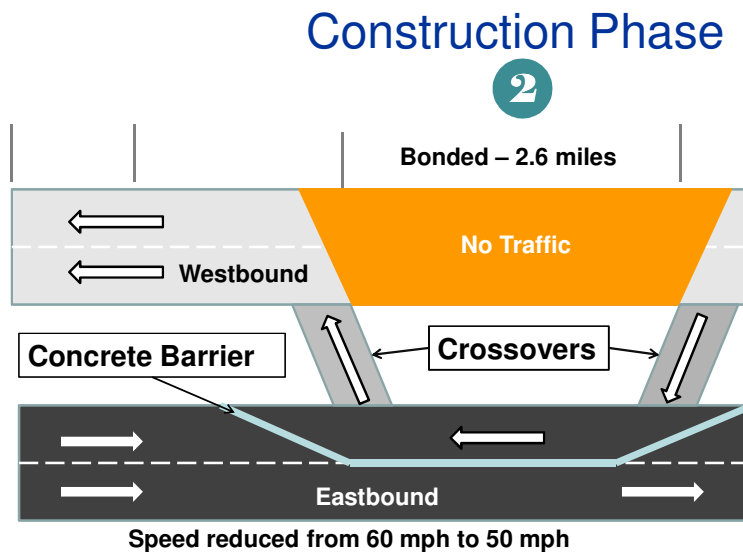
Figure 9. Phase 2 Crossovers. Bonded = bonded hydraulic cement concrete.

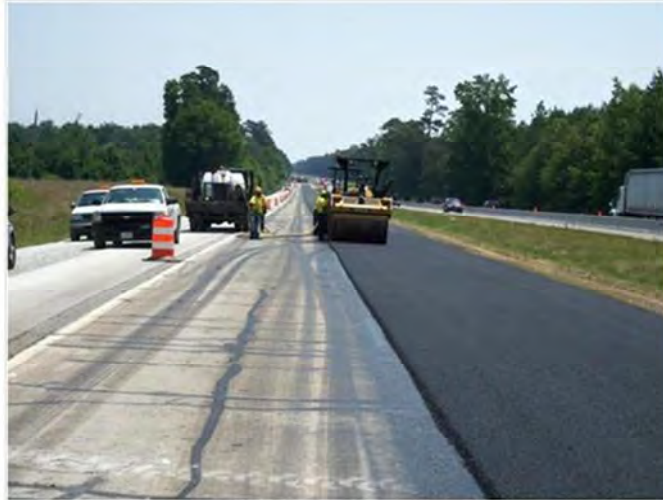
The bonded and unbonded sections required specific surface preparation before concrete overlay placement. The unbonded section did not need any repair of distresses, as a separation layer was used before 7 in of concrete was placed. A PFC 1 in thick was paved for the entire width including the shoulder as shown in Figure 10. Prior to placement of the PFC, old patches were milled to get a level surface and cracks were sealed with hot pour asphalt. A few large distressed areas were filled with the PFC mixture as it was placed.

Figure 10. Porous Friction Course As Separation Layer for Unbonded Section

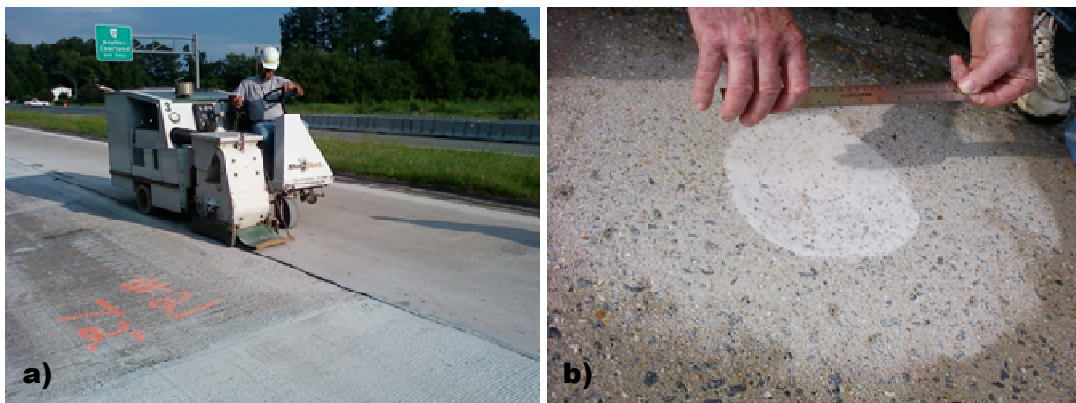
The bonded section was prepared by patching failed sections with full-depth concrete prior to shot blasting (Figure 11) and pre-wetting. Sand patch and bond tests were performed to ensure proper cleaning and surface preparation, as the success of this section depended on bonding with the old concrete. A water truck ran ahead of the paver to keep the surface wet; the truck driver was careful about not contaminating the surface and drove on the surface only when necessary.

Figure 11. Surface Preparation for Bonded Section: a) shot blasting; b) sand patch test

The VDOT special provision¹² for the bonded overlay required the surface to be cleaned and textured by shot blasting to achieve a minimum macrotexture depth (ASTM E965⁷) of 0.06 in. The contractor was not able to achieve the minimum texture with up to four passes of the shot blast equipment. Initially it was speculated that the shot blast equipment was not powerful enough to achieve the texture. So surface tensile strength tests (ASTM C1583⁸) were conducted on a section of the pavement that had been textured with zero to four passes of the shot blaster. The results of the tests are shown in Table 1. Although there was no relationship between the number of passes and the surface tensile strength, the surface tensile strengths were higher than the 175 psi minimum believed to provide good bond strength.¹³ Because of the high surface tensile strengths, the surface cleaning was approved and the contractor was allowed to place the overlay. The average surface tensile strength of 501 psi was considered to be reasonable considering that compression tests on cores from the original pavement indicated strengths of approximately 7,000 psi for sections in good condition.

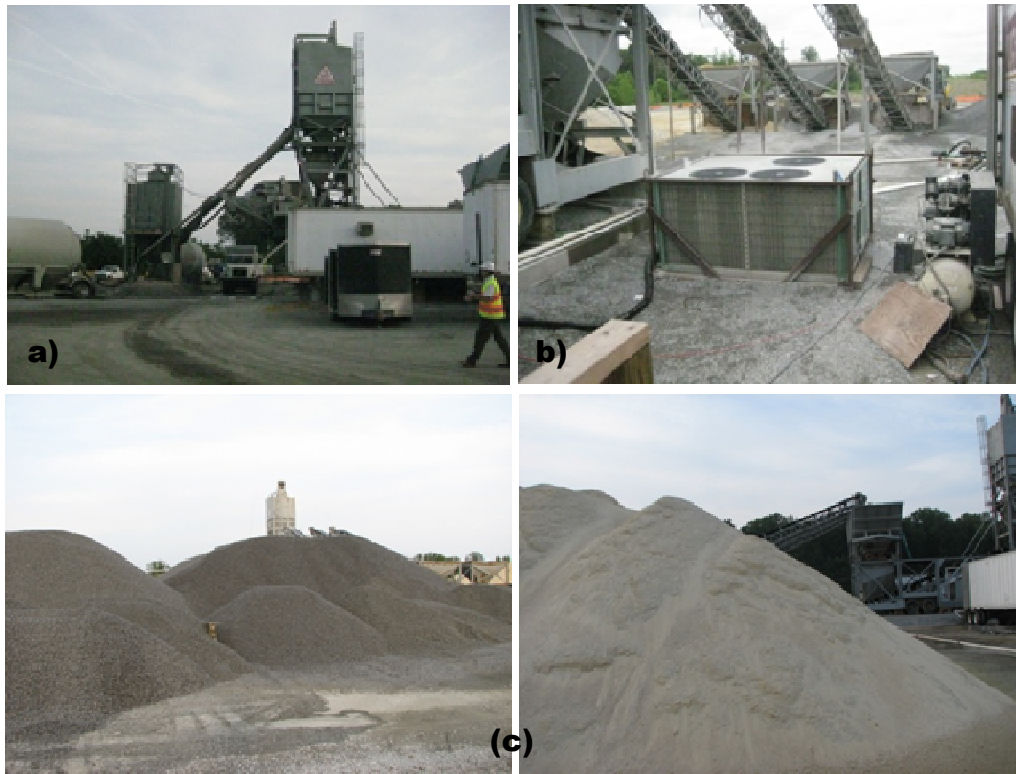
Concrete was batched at a central mixture plant about 4 mi from the job site, as shown in Figure 12. The aggregates were stored on concrete slabs to prevent contamination with the soil. The aggregate stockpiles are also shown in Figure 12. The stockpiles were wetted with sprinklers to cool the material and to keep it at the desired moisture content: free moisture in the coarse aggregate was about 2.5 percent and in the fine aggregate about 3.5 percent. The moisture condition of the aggregates was determined at the beginning of each day and then whenever needed throughout the day to maintain uniformity. The weather was hot, and the mixture water was cooled using a chiller shown in Figure 12.

Figure 12. Concrete Plant: a) plant setup; b) chiller to cool the water; c) aggregate stockpile

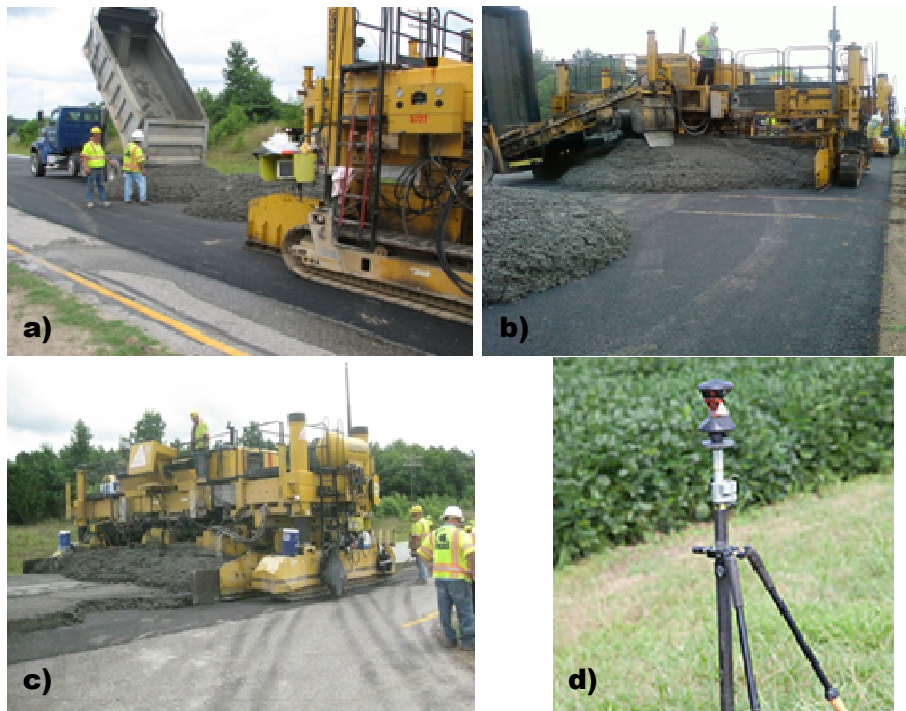
Concrete was batched at the plant using the stationary mixer and delivered to the job site about 4 mi away using dump trucks (Figure 13). Two agitating trucks were also used to facilitate sampling, but the agitators were not used and the loads were carried as with the dump trucks. Each load was 9.5 yd³ of concrete. Mixing time was 65 sec and total time to load, mix, and discharge into the truck was 1.5 to 2.5 min. The trucks traveled from the plant and dumped the concrete in front of the spreader in 15 to 20 min. A two-track paver just behind the spreader was used. The paving operation was stringless but used a GPS-enabled laser guidance system, as shown in Figure 13.

Figure 13. Paving Operation: a) trucks dumping concrete in front of spreader; b) side discharge; c) two-track paver; d) GPS-enabled laser guidance system

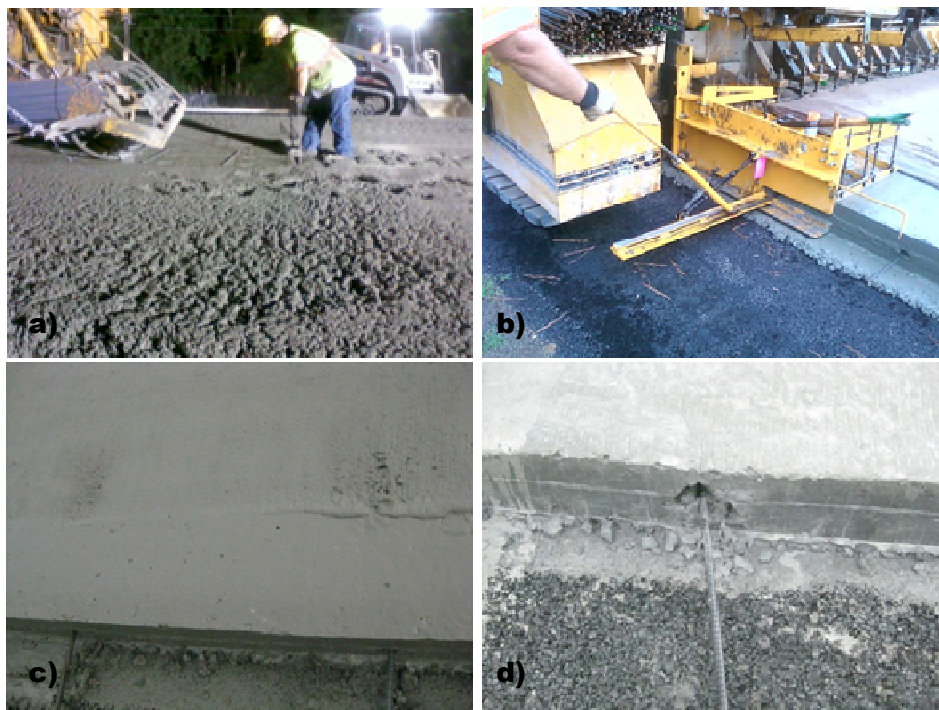
The unbonded section used tie bars at the center of the road along the longitudinal joint and along both edges to tie the shoulders. Behind the spreader, there was a wheel to insert the tie bars; however, because of a problem, many of them did not get inserted (pushed), so they were inserted manually as shown in Figure 14. The tie bars at the edges connecting the shoulders were pushed into concrete at the edge behind the paver, as shown in Figure 14. Figure 14 also shows the wavy edge rather than a straight vertical edge. Figure 14 shows the disturbance on the surface and the hole created on the side because of the insertion of the tie bars. These tie bars disturbed the edge and made it difficult to have a straight vertical edge/face. Considerable hand finishing was needed to provide the vertical edge. This in turn may have impacted the ride quality.

Figure 14. Tie Bar Placement in Unbonded Section: a) insertion in middle of lanes; b) insertion at edges; c) surface disturbance; d) hole at edge

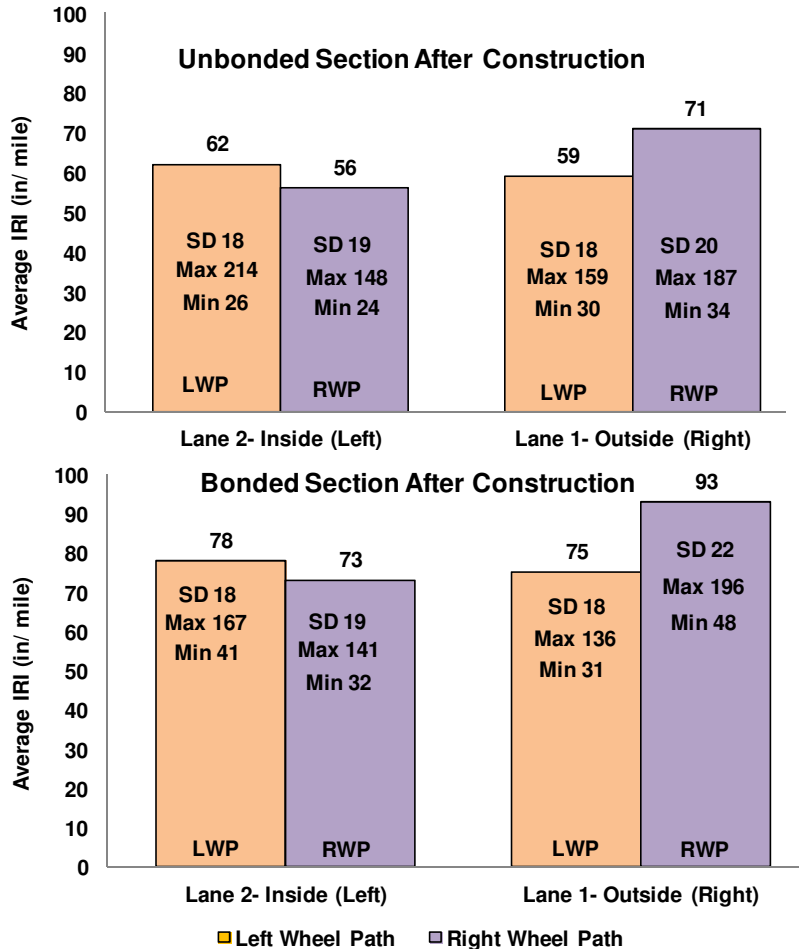
The initial as-constructed IRI was measured before the overlays were opened to traffic. Both sections achieved a good ride quality, as shown in Figure 15. The contractor had implemented an adjustment in the longitudinal profile by incorporating variable overlay thicknesses to improve the ride quality in addition to stringless laser-controlled grading;

Figure 15. Ride Quality As Measured by International Roughness Index (IRI) Values: a) average IRI for unbonded section; b) average IRI for bonded section. SD = standard deviation.

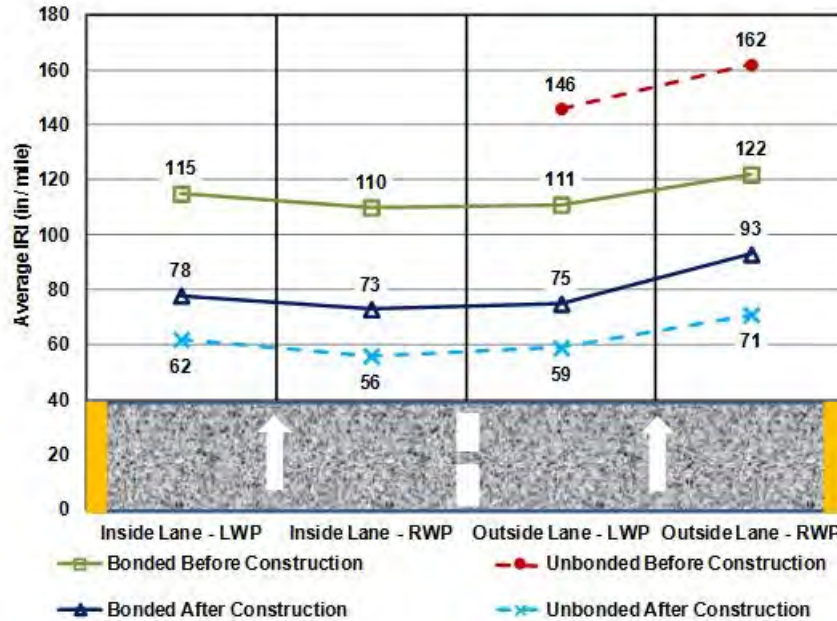
a significant improvement was observed after overlay construction. This resulted in a variable thickness of the pavement: the bonded thickness varied from 4 to 4.5 in, and the unbonded thickness varied from 6.8 to 8.1 in. The variation in thickness was allowed without pay adjustment other than for the additional concrete. The unbonded section had a better ride than the bonded section because the paver track was riding on a smoother surface, i.e., the PFC separation layer. Figure 16 shows that the ride quality of both overlays was much better than that of the original CRCP.

Figure 16. Improvements in Ride Quality As Measured by International Roughness Index (IRI) Values. LWP = left wheel path; RWP = right wheel path.

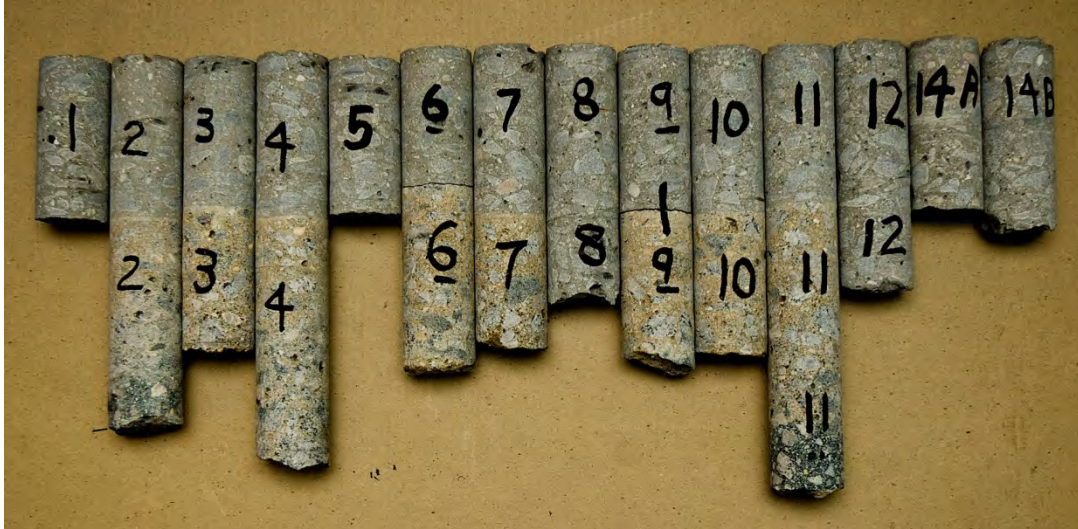
The success of a bonded overlay depends on good bonding between the new overlay and the existing old pavement surface. On January 16, 2013, 14 randomly selected areas were cored to check the bond strength of the newly paved bonded overlay on U.S. 58. These 2-in cores, shown in Figure 17, were also used to verify the overlay thickness. Bond strength was measured in the VCTIR laboratory in accordance with a procedure similar to that in ASTM C1583.⁷ The results were as follows:

- Seven cores failed at the bond interface when they were being drilled (Cores 1, 5, 6, 9, 14A, and 14B over the old concrete surface and Core 12 over a new patch). This is a high failure rate.
- Four cores failed within 0.4 in of the top surface of the overlay (Cores 2, 4, 7, and 11). The average tensile rupture strength was very good at 275 psi.
- Two cores failed in the old concrete within 0.4 in of the bottom of the core (Cores 3 and 10). The average tensile rupture strength was very good at 270 psi.
- One core failed over a patch. The bond strength was poor at 75 psi. At least two more cores over a patch are needed to evaluate the bond strength.
- The average bond strength for the six cores (Cores 2, 3, 4, 7, 10, and 11) over the old pavement was very good at 273 psi.

Figure 17. Cores to Verify Bond Strength and Thickness of Bonded Overlay

Initial bond strength results for I-85 (4-in overlay) and I-295 (2-in overlay) in 1995 were 239 and 251 psi, respectively.^{2,3} It is assumed that the cores failed on U.S. 58 during drilling and extraction because of the stresses caused by the drilling and extraction operation (the core barrel rotated with some wobble). The bond tests clearly showed that the U.S. 58 bonded overlay was bonded, as were the overlays on I-85 and I-295 (overlaid with SMA after 17 years to match the adjacent pavement overlay), which are still performing well after 18 years.

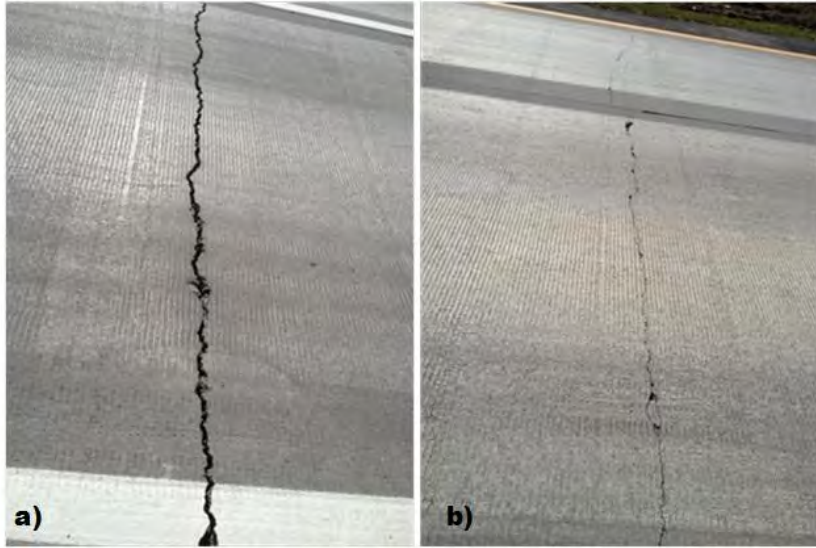
The overlaid pavement was visually inspected for distress after 4 months of traffic. As expected, many transverse shrinkage cracks were observed in the bonded overlay. Figure 18 shows some of the cracked section on newly bonded overlay, and Figure 19 shows a typical crack on the I-85 bonded overlay, which is still performing well after 18 years. Most cracks on the U.S. 58 bonded overlay were tight and typical of a bonded overlay that contains cracks that have reflected from the pavement. A few of the cracks were wider than normal (as wide as $\frac{3}{4}$ in), and further investigation revealed the pavement was moving with changes in temperature in the vicinity of the wide cracks. Cores revealed the movement was accommodated by the loss of bond between the concrete and the steel. Either the steel that was cut during the patching was not spliced adequately and early age movement caused a loss in bond or the steel in the pavement had lost bond and should have been patched prior to placement of the overlay. Plans have been developed to patch areas with wide cracks. The unbonded overlay shown in Figure 20 did not have cracks reflected from the pavement.

Figure 18. Cracks on Bonded Overlay: a) a wide crack; b) regular shrinkage crack

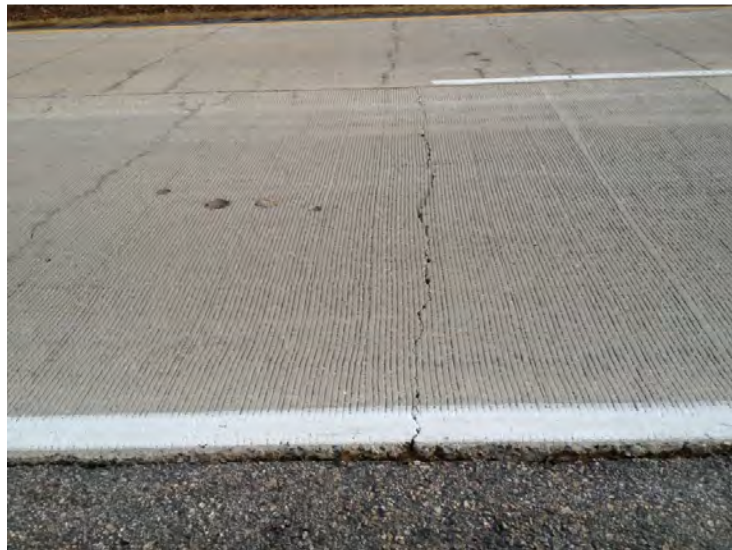
Figure 19. Cracks on 4-in Bonded Overlay on I-85

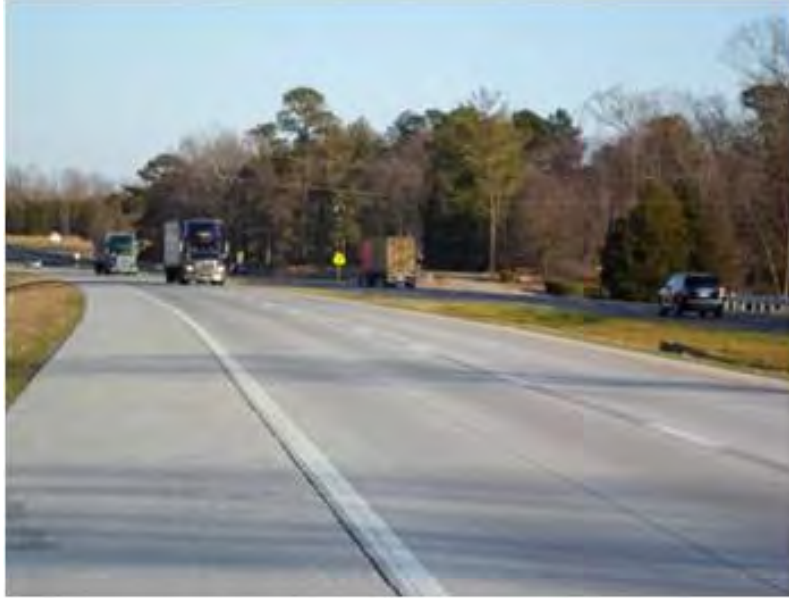
Figure 20. Unbonded Overlay With Concrete Shoulder
