PAVEMENT MARKING COMPARISON STUDY – I-89 LIQUID MARKINGS

Ian Anderson, Research Engineer
Vermont Agency of Transportation
Research Section

Experimental Feature
Reporting on Work Plan 2013-R-03

Final Report 2018-05

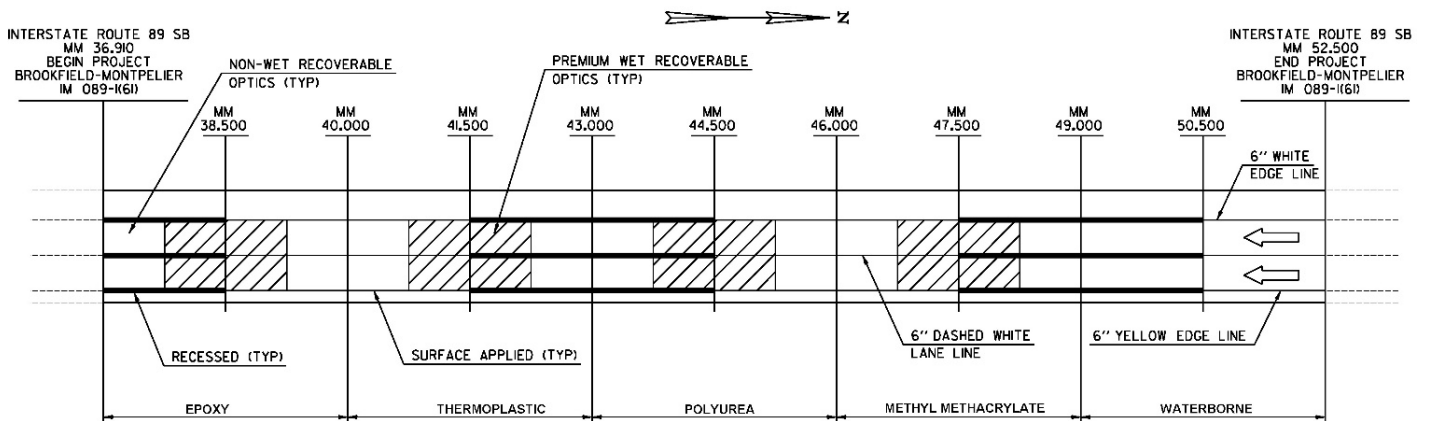
Figure 1: Project Layout Diagram

EXPERIMENTAL PAVEMENT MARKING LAYOUT

Binder		MM	MM	Optics	Surface/Recess	Test Section
Waterborne	Ennis-Flint Fast Dry	52.49	50.5	Utah Blend	Surface	1, 2
		50.5	49	Utah Blend	Recess	3, 4
MMA	Swarco Swarcoplast Thin Film MMA 5090	49	48.25	Utah Blend	Recess	5, 6
		48.25	47.5	Plus 9 Spots	Recess	7, 8
		47.5	46.75	Plus 9 Spots	Surface	9, 10
		46.75	46	Utah Blend	Surface	11, 12
Polyurea	3M LPM 5000	46	45.25	Utah Blend	Surface	13, 14
		45.25	44.5	90p	Surface	15, 16
		44.5	43.75	90p	Recess	17, 18
		43.75	43	Utah Blend	Recess	19, 20
Thermoplastic	Sherwin Williams' Smart Mark™ Hydro	43	42.25	Utah Blend	Recess	21, 22
		42.25	41.5	Visimax	Recess	23, 24
		41.5	40.75	Visimax	Surface	25, 26
		40.75	40	Utah Blend	Surface	27, 28
Epoxy	Epoplex LS65	40	39.25	Utah Blend	Surface	29, 30
		39.25	38.5	Visimax	Surface	31, 32
		38.5	37.75	Visimax	Recess	33, 34
		37.75	36.93	Utah Blend	Recess	35, 36

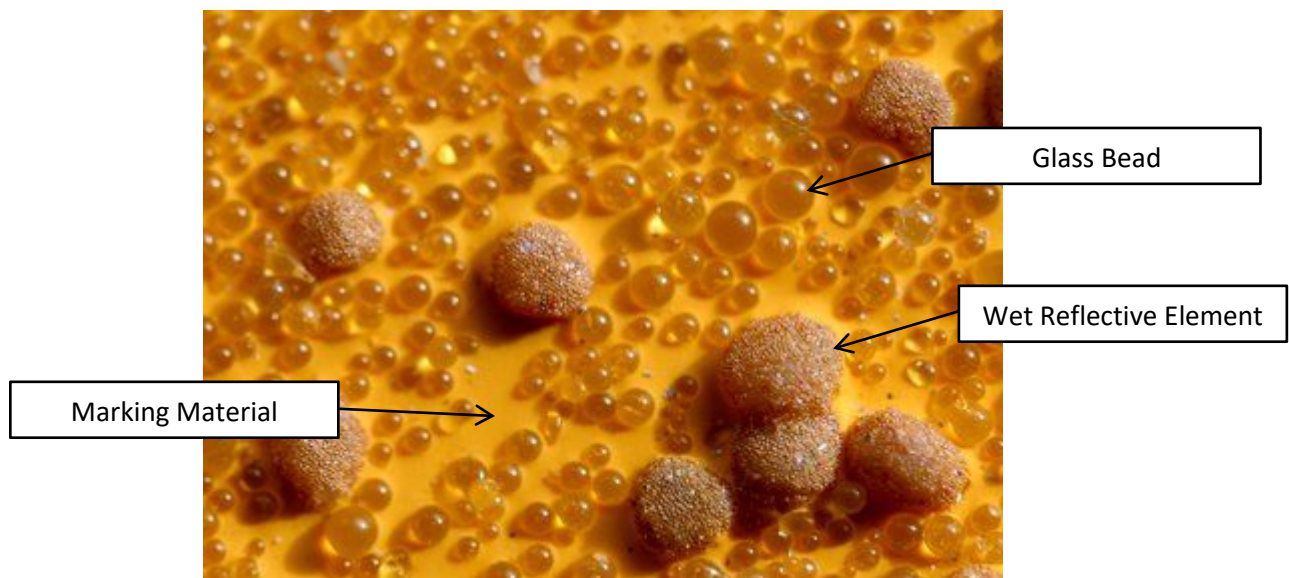
Figure 2: 3M Optics, Glass Bead and Wet Reflective elements

The Utah Blend is a specified gradation of glass beads, and thus considered a Premium Optic. Utah Blend optics were used on all pavement marking materials in this project as a control to test the Wet Reflective elements against. The Utah Blend has a larger maximum bead size, and variable gradation from typical AASHTO Type 1 beads, increasing the chance the light will be reflected. Wet Reflective elements differ from the glass beads in their composition, being smaller ceramic beads clustered around a central core, rather than a singular sphere. The ceramic beads reflect light from their surface, and are colored in conjunction with the desired pavement marking. The clustered structure aids in the ability to reflect light in a wet condition, as they have lower surface tension and shed water faster than conventional glass beads. Wet Reflective elements are used in conjunction with glass beads, providing both dry and wet retroreflectivity. In this study, all Wet Reflective elements were combined with the Utah Blend in a double drop, in which the Utah Blend is applied first, followed by Wet Reflective elements. An image showing both glass beads and Wet Reflective elements can be seen in Figure 2.

A proper application of beads results in the top layer of optic beads embedded to about 60% of the diameter of the bead. There should be consistent quality of both optic beads and paint so that the dry-film paint thickness and bead coverage promotes even retroreflectivity across both directions of road travel in two lane highways. Inadequate paint thickness results in under-embedded beads. This will result in improperly anchored beads that will fall out prematurely. In addition to bead pop-out, under-embedded beads cause a large percentage of the light that enters them to exit out the back. Too much paint results in over-embedded beads. While over-embedded beads may remain in the binder, reduced exposure limits light entrance and resultant retroreflectivity [6]. The retroreflectivity values in markings with over embedded beads increase over time with wear of the marking material by tires. Plowing does lead to retroreflectivity recovery because the

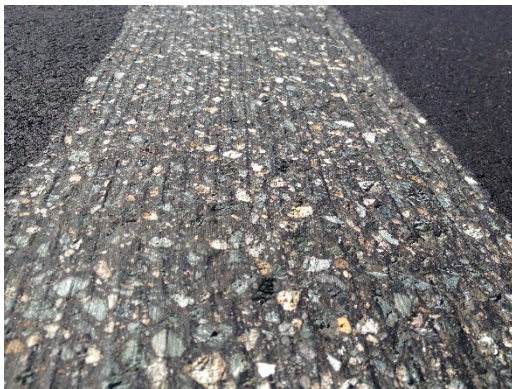
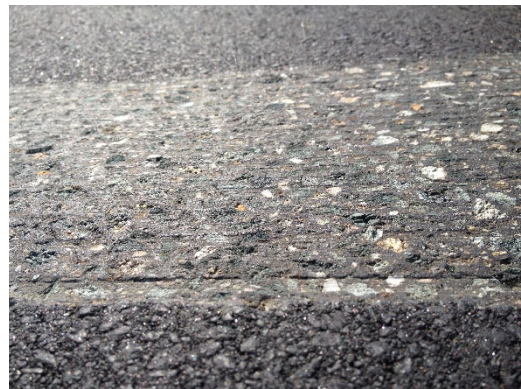
Figure 3: Recessed pavement section for marking application

The project was awarded to Pike Industries, Inc. headquartered in Belmont, NH. All markings were applied by L&D Inc from Barre, VT from August 11th, 2014 to August 20, 2014. At the time of application, temperature, relative humidity, precipitation/cloud cover, wind condition, ambient air, and pavement temperatures were recorded. All environmental requirements for the marking installations were met at the time of placement. The project plan called for the comparison of four different durable liquid pavement markings. The research section added in the Waterborne paint marking as a constant for the test. Along with the different liquids being tested, there were also two optics categories tested on each binder type (Utah Blend and Utah Blend with wet reflective elements). Each paint deck was half surface-applied and half recess-applied. The recessed sections were measured and their depths recorded to ensure compliance with required marking thickness. Examples of recesses for lane markings can be seen in Figure 3.

placement showed the target recess depth was not consistent with the thickness of the marking material with inadequate recess depth for thermoplastic and excess depth for polyurea.

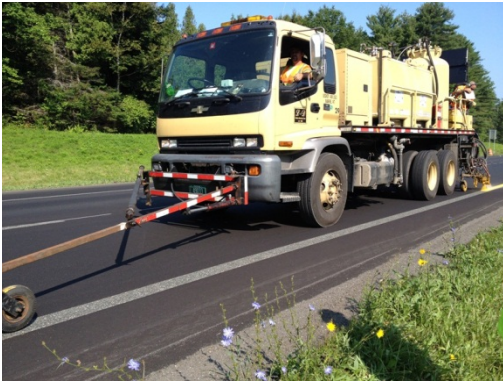
Figure 4: Applying the yellow waterborne stripe.

Both white and yellow waterborne markings were applied on August 11, 2014 from mile marker 52.495 to mile marker 49.0 with a truck. The average depth for the recessed white lines was 62.1 mils and the yellow lines were 60.07 mils. On the day of the application, the average temperature was 68°F and there was no precipitation. Below in Figures 4-6 are pictures of the waterborne application process.

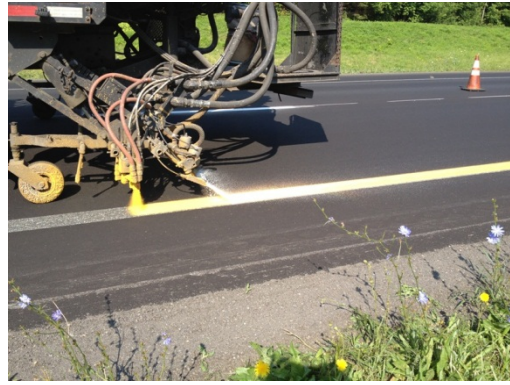
Figure 5: Waterborne binder and optic package being applied.

Only Utah Blend beads were used, in a single drop. The liquid marking application and surface applied optic beads are distinctly visible in two separate process streams at the back of the truck in Figures 5 and 6. During the application, observers noticed that excess beads bounced or rolled off the marking because of insufficient material to capture them.

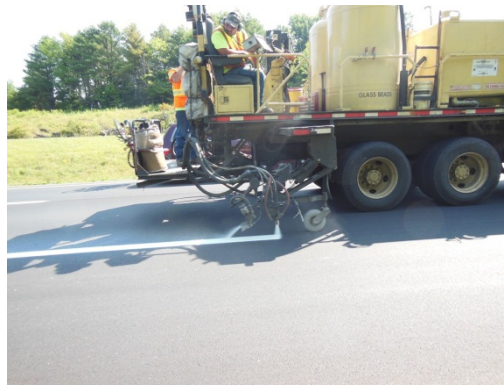
Figure 6: White waterborne binder and optic package being applied.

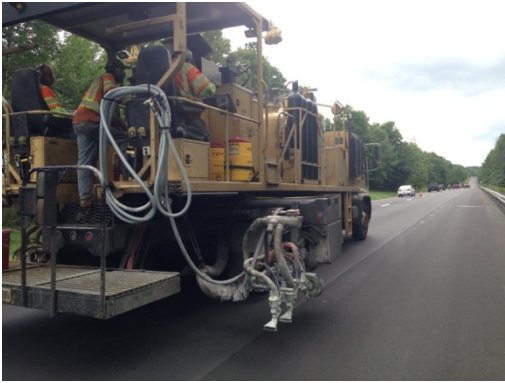
Figure 9: Polyurea application truck, featuring two chutes for application of a double drop of optics.

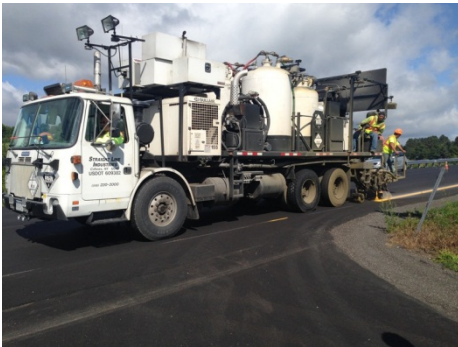
Figure 11: Epoxy markings being applied by the truck.

On August 18, all of the Epoxy markings were completed from mile marker 40.0 to the end of the project at mile marker 36.93. Markings were spray applied by a truck with double drop system. Recess depth readings were only taken on the yellow (passing lane) side and averaged 81.29 mils. The average temperature for the day of the Epoxy markings was 56°F with only traces of precipitation. Figures 11 and 12 shows the application process of the Epoxy paint.

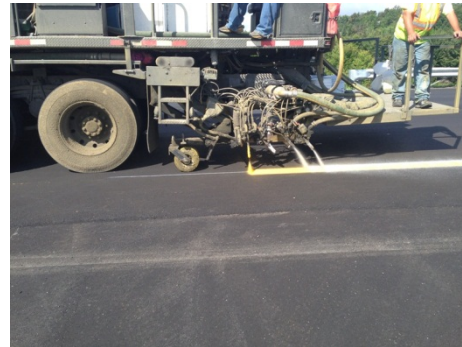
Figure 12: Yellow Epoxy binder and optic package being applied through two chutes for a double drop.

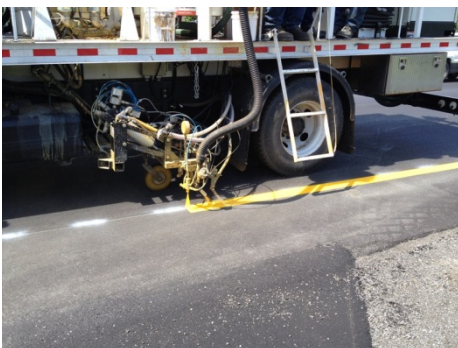
Figure 13: MMA markings being applied by the truck with double drops.

The final markings of the project (MMA) were applied on August 20 with a temperature of 63°F. Methyl Methacrylate markings were spray applied from mile markers 49.0 to 47.5 with a truck. Again, only the yellow recessed lines were measured and averaged 72 mils. Figures 13 and 14 shows the application process of the Methyl Methacrylate.

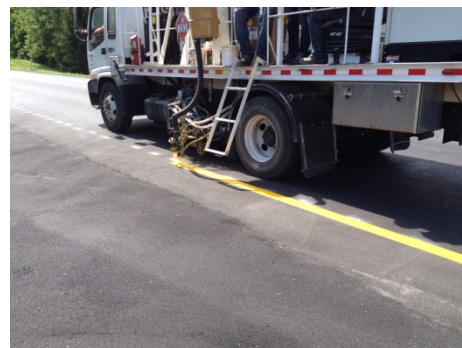
Figure 14: Optic package and paint being applied.

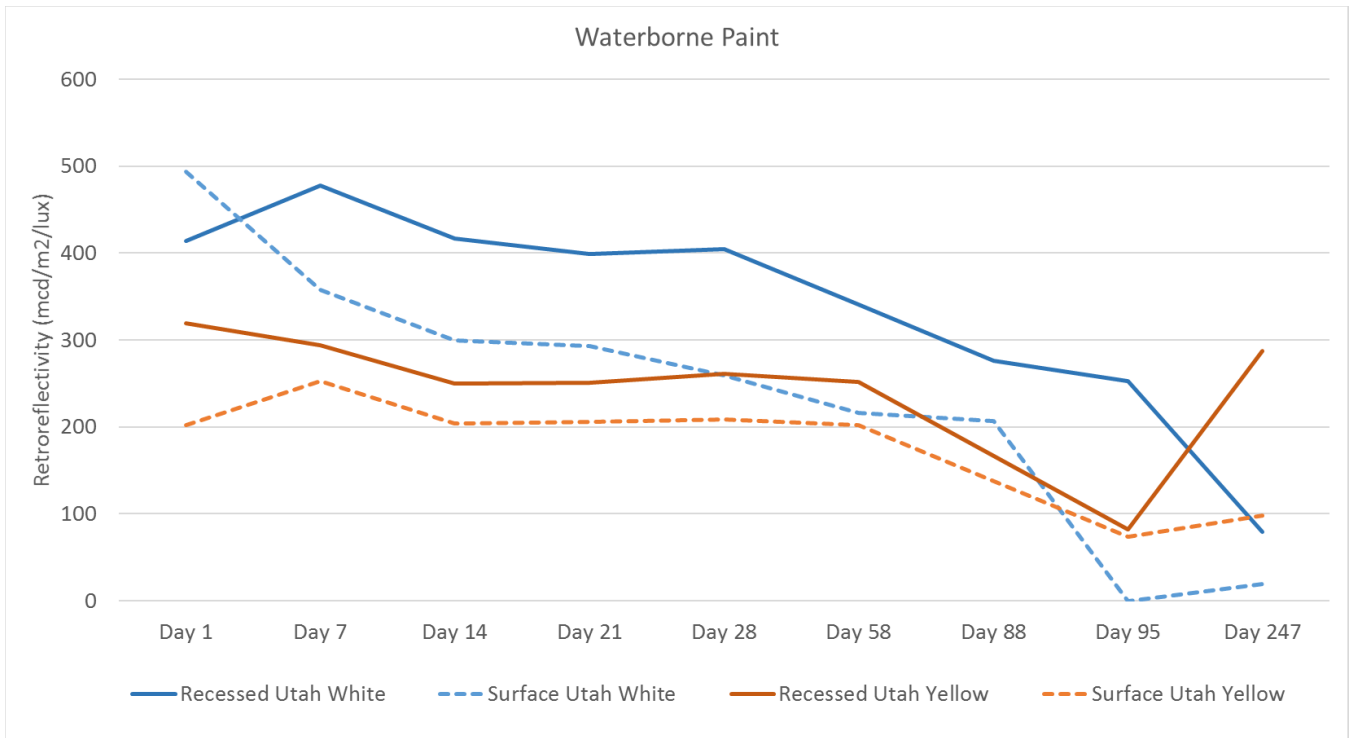
Figure 15: Waterborne Paint Performance

Figure 15-19 below show the average reflectivity for each marking material/optics/application type. Note the variations in the X and Y axes between the figures. Monitoring was ceased before the end of the study if the test sites were deemed in need of replacement. Figure 20 shows the results of each material and application with combined optics types. Figure 21 shows the overall performance by material type, with combined optics and application. Photos of the pavement markings at installation, and at the end of its observation are shown in Appendix A.

The optics packages resulted in two general observations related to dry retroreflectivity. The Utah Blend only test sections showed lower rates of deterioration with lower initial values. With the polyurea and thermoplastic, Wet Reflective elements produced higher initial values but dropped off precipitously in several test sections. With the epoxy and MMA, Utah Blend sections showed similar initial retroreflectivity values to the Wet Reflective optic, and similar results over the course of testing. White lines have generally higher retroreflectivity values, though after the start of winter maintenance (at 95 days) results are mixed.

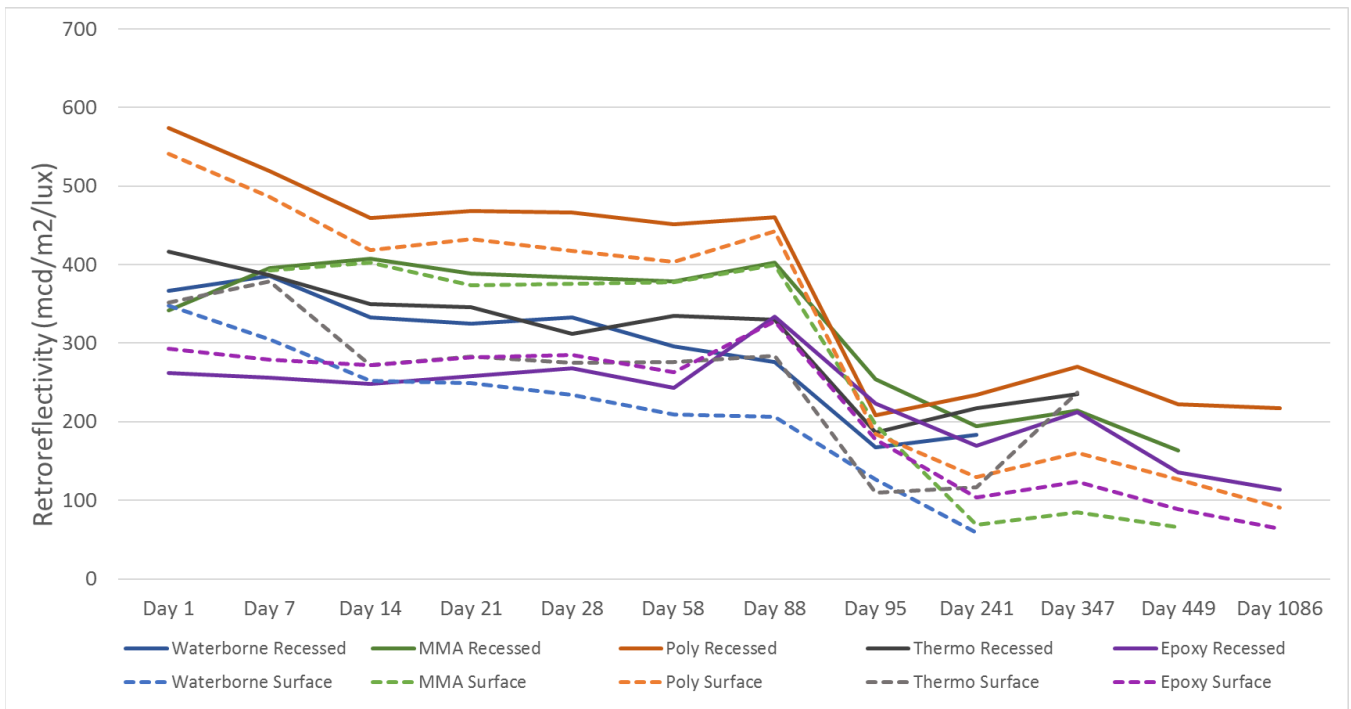
Figure 20: Pavement Marking Performance by Application

Overall, recessed markings performed much better than the surface applied markings. Most surface applied markings showed issues with wear and missing visible markings. The single best performing marking material, optics package and placement technique for retroreflectivity was the Yellow recessed polyurea with wet reflective elements.

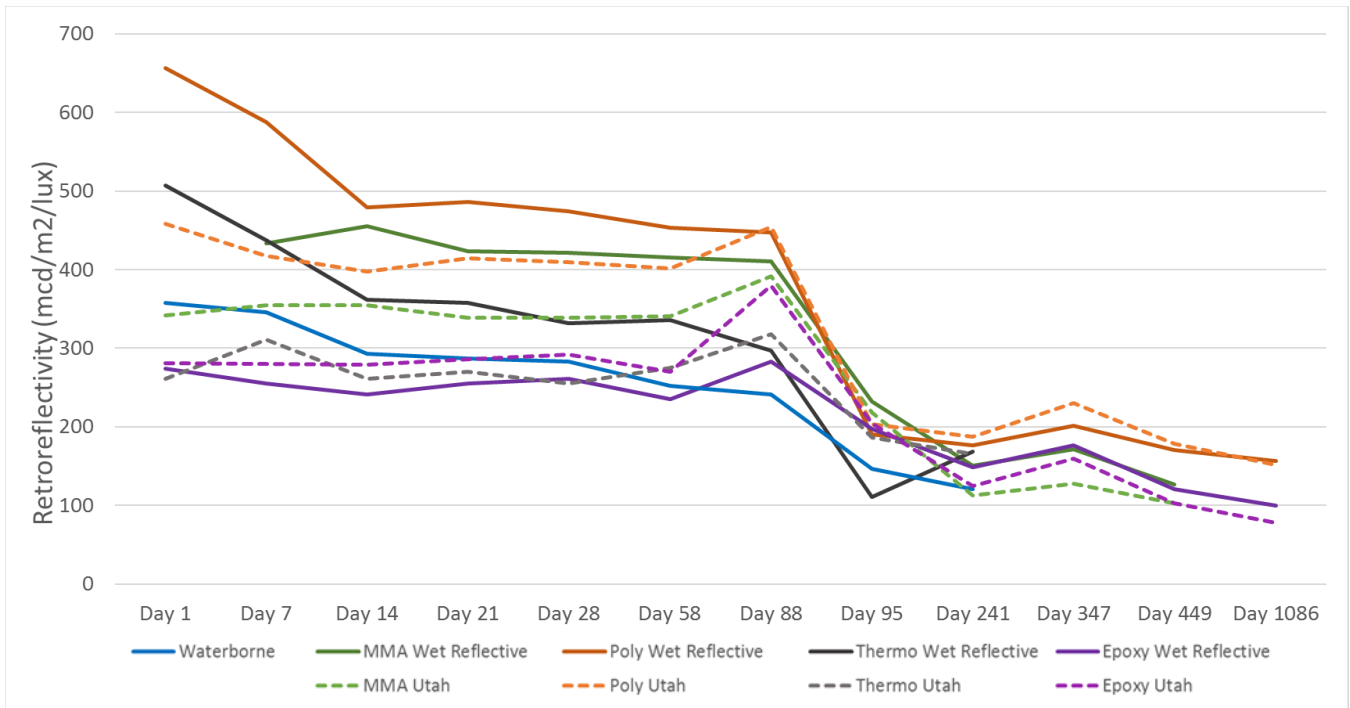
Figure 21: Pavement Marking by Optics Package

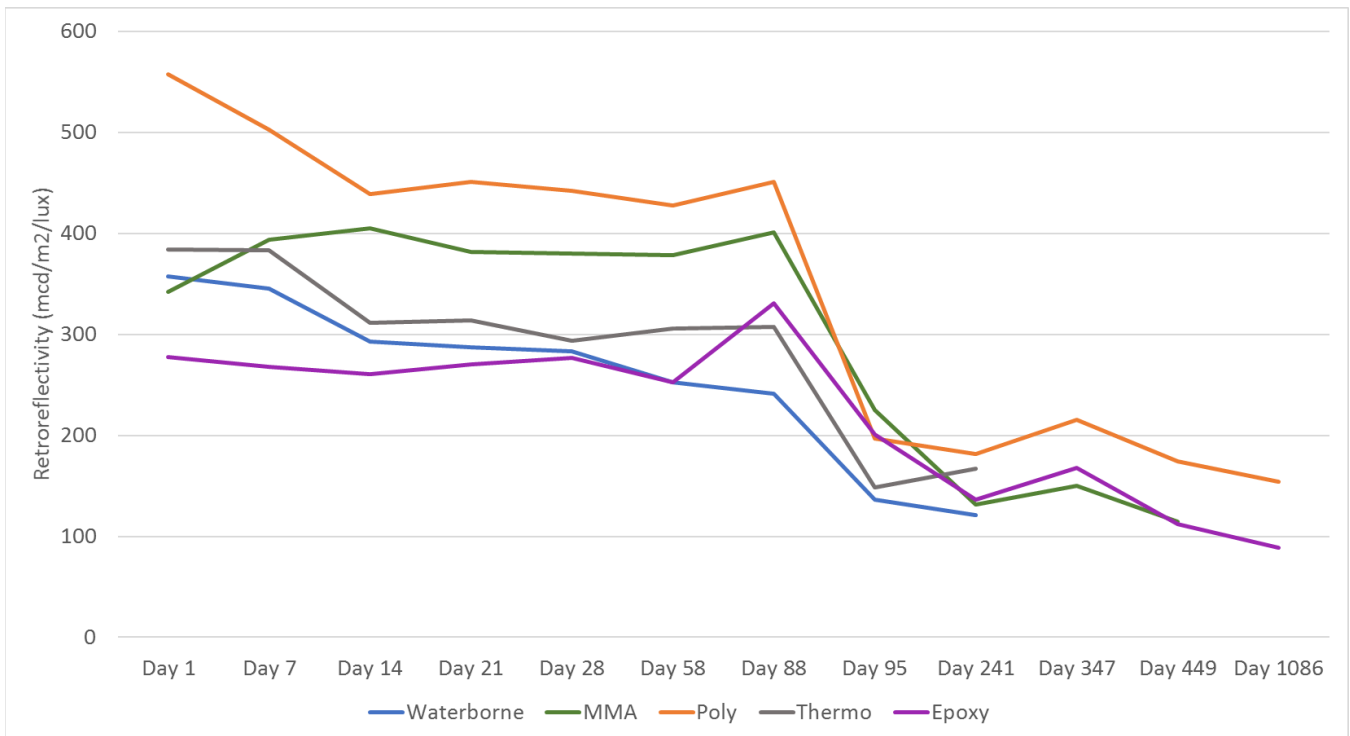
Figure 22: Pavement Marking by Material

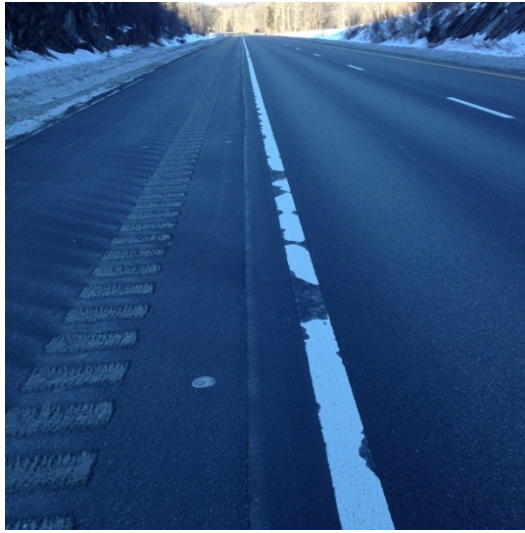
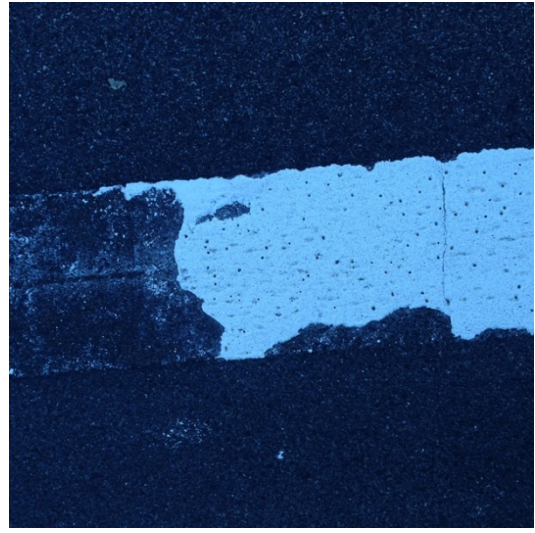
In the December 2014, the district staff notified research personnel that sections of the thermoplastic markings were missing or severely damaged. Research personnel then proceeded to go out to observe the markings. Below, Figures 23–26 shows the damaged and missing Thermoplastic markings. It appears that plowing caused major localized damage to the lines which had been applied only a couple months before the damage occurred. This may be due to the binder not being heated to the specified temperature. Field notes indicate the thermoplastic was brittle and could be lifted up with the edge of a key showing clear delamination. In other places thermoplastic was not visible at all from being scraped up by the plow. During the same site visit, waterborne was noted to be fading significantly where there is a sharp incline just before Berlin Exit 7 off-ramp (TS 1 and 2). The two failing test sites were both surface applied. Test sites 3 and 4 were both recessed and provided much better visual and retroreflective results.

Figure 23: TS 25 Damage Overview

Figure 24: TS 25 Line Damage Close-up

In May 2015, the thermoplastic and waterborne were repainted due to wear (visual line loss) and loss of retroreflectivity. After the first plow and salt, waterborne markings had declined by as much as 96% for the white lines and 51% for the yellow lines and thermoplastic markings had declined retroreflectivity as much as 77% in the white lines and 80% for the yellow line.

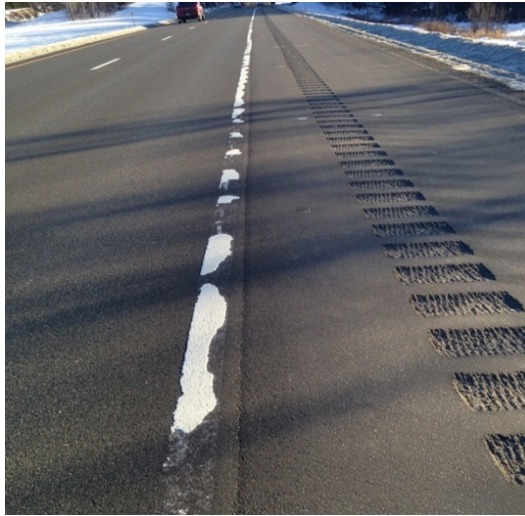
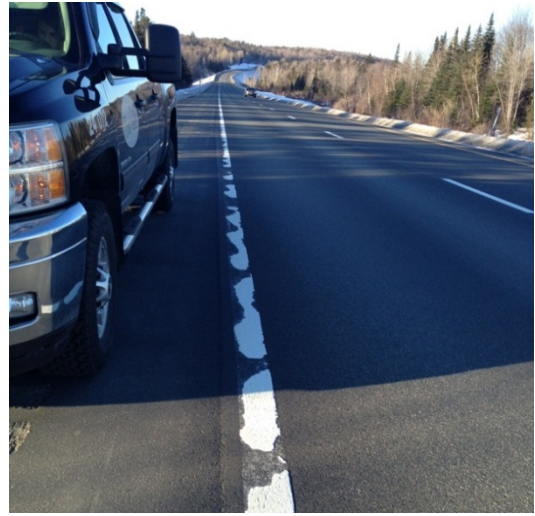
Figure 25: TS 28 Damage Overview

Figure 26: TS 28 Damage Overview
