# **Quasi-Static Research Testing of Workstation Tables**

Office of Research, Development and Technology Washington, DC 20590

DOT/FRA/ORD-19/08 Final Report
April 2019

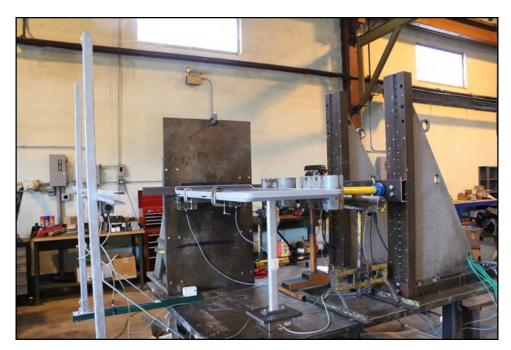
Figure 2 – Table A Test Setup

The first table tested, Table A, was mounted to the wall and further supported with a table leg the aisle-side of the table (see Figure 2). The second table, Table B, was a purely cantilevered mount via the sidewall structure (see Figure 3).

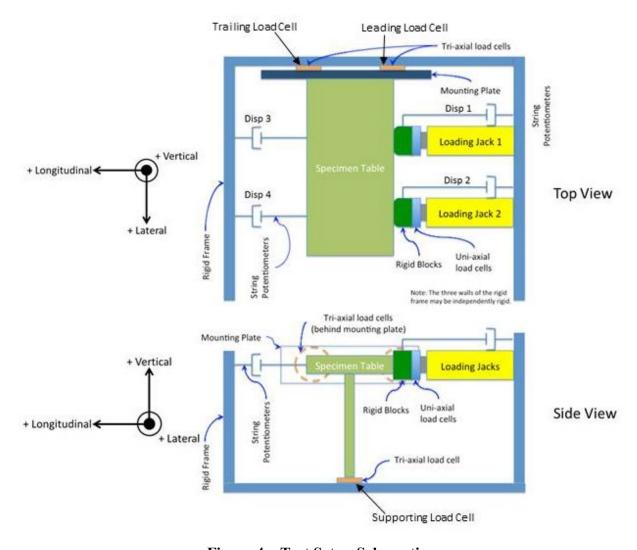
Figure 4 – Test Setup Schematics

The test fixture consisted of rigid walls and a floor to which the table was mounted and against which the test load was reacted. In general, two parallel loads (in the transverse direction to the table, longitudinally with respect to the car) were applied to the edge of the table top, centered at the seating positions, through two independent actuators (loading jacks). The applied axial loads, as well as the reacted tri-axial loads on the wall and floor, were measured, along with the deflection (also referred to as crush) at the loading points and the deflection of the unloaded edge of the table. Figure 4 shows schematics of the test setup.

Data were processed before being analyzed. All channels were zeroed and displacement measurements were converted to inches. Additionally, all force measurements were directionally corrected to conform to the defined global coordinate system shown in Figure 4.

See test schematics in Figure 4 for sensor locations.

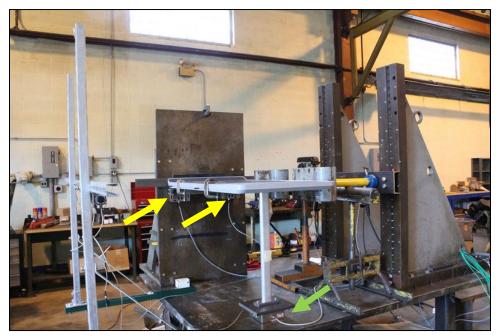
Figure 5 – Photo of Table A Setup

Figure 5 shows the Table A setup prior to testing. Two tri-axial load cells were located at the attachment of the table top to the wall (indicated by the yellow arrows). A third tri-axial load cell was located at the attachment of the table leg to the floor (indicated by the green arrow).

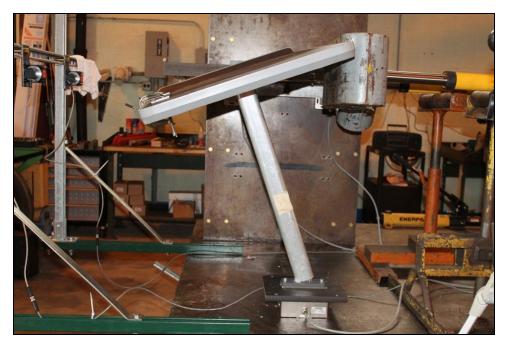
Figure 6 – Photo of Table A during Testing

Figure 6 shows Table A during testing. The table's edge only deformed slightly, but the bolts attached to the thin sheet metal that formed the lower table surface ripped through the sheet metal. The table top detached completely from the two wall mounting points. This behavior allowed the table to intrude into the facing passengers' space (on the left in the picture). Based on table drawings from the manufacturer, the nominal clearance is 19.7 inches between the table top and the seat back. Therefore, table top displacement greater than 4.7 inches would encroach on the minimum clearance space of 15 inches. The survival space was breached as the resting position of the table encroached over 2 inches into the passengers' survival space. The test was stopped after the loading ram had displaced approximately 10 inches, with minimal resistance from the table top after the first 2 to 3 inches of displacement. The failure of the sheet metal underneath the table top and the table leg connection at the floor occurred after approximately 1 inch of travel of the loading rams. Subsequently, the reaction loads measured at the load cells rapidly decreased. It was evident that even with continued loading, the table would not comply with the minimum energy absorption requirement or the minimum space requirement.

Due to the support failure as shown in Figure 6, loading the table any further would not have produced any meaningful results. Thus, testing for Table A was aborted before the load reached 2,250 lbf. As can be seen in Table 2, the energy absorbed by Table A did not achieve the target 6,250 in-lbf.

Requirement	Result	Pass/Fail
The table and any table components must remain attached to the test fixture.	See photo in Figure 6, depicting the table leg separated from the floor mounting.	Fail
A minimum of 15 inches of survivable space, measured post-test, must be preserved for facing occupants based on the predominant seat pitch used for seats surrounding tables.	15-inch minimum survival space was not preserved.	Fail
The energy absorbed by the plastic (permanent) table deformation at each seat position must be at least 6,250 in-lbf before the force reaches 2,250 lbf.	Fixture failure—test aborted before target energy could be reached.	Fail

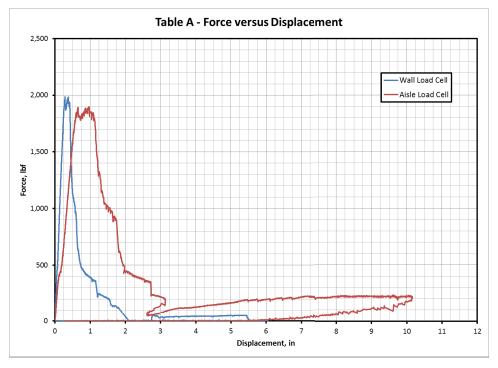
Figure 7 – Table A Force versus Displacement at Both Blocks

Figure 7 shows the force versus displacement cross-plot of both body blocks for Table A. As seen in the plot, the maximum force applied by the wall block was 1,988 lbf. The maximum force experienced at the aisle block was 1,898 lbf.

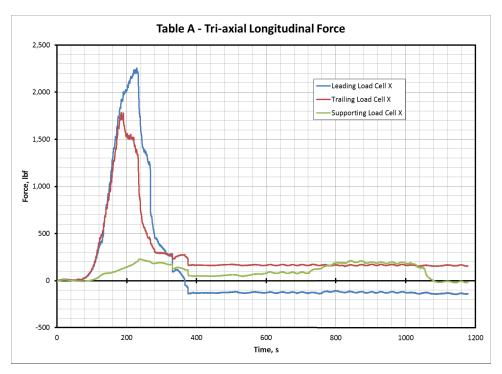
Figure 8 – Table A Longitudinal Force Time Histories from Tri-axial Load Cells

The Table A tri-axial load cell time histories are shown in Figure 8, Figure 9, and Figure 10.

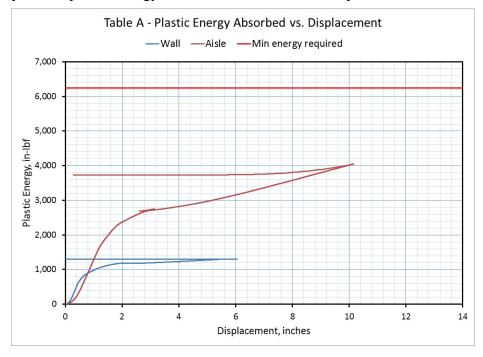
Figure 11 – Table A - Plastic Energy versus Displacement

Figure 11 depicts the plastic energy absorbed as a function of displacement for both load cells.

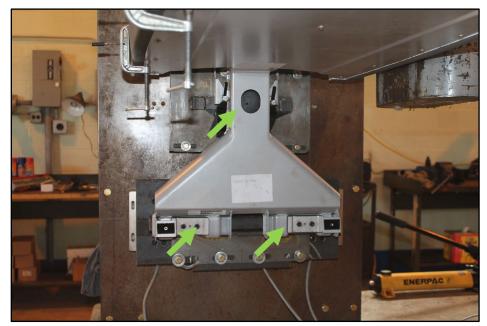
Figure 12 - Table B Pre-Test Photo Depicting Locations of Load Cells

Figure 12 shows the attachment of Table B to the wall, prior to testing. The test setup is identical to the previous test, with the exception of the location of the three tri-axial load cells in the mounting locations. In this test, all three tri-axial load cells were located at the attachment of the table to the wall, secured between the vertical side wall and rigid, steel plates—one slightly below the height of the table top, and two at the same height, near the bottom of the cantilever attachment. The approximate locations are denoted by green arrows.

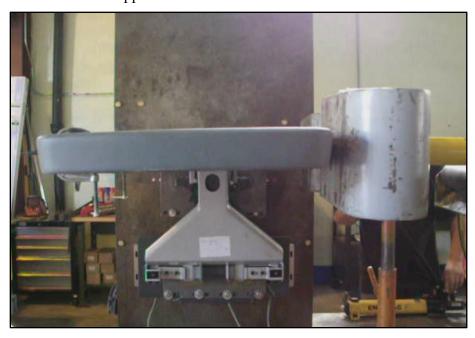
#### Figure 13 – Photo of Table B during Test

Figure 13 shows Table B during testing. This picture shows longitudinal displacement of the table structure relative to its support.

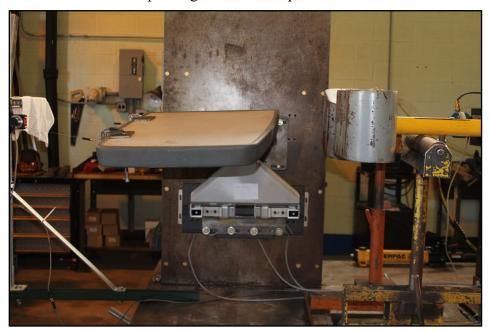
Figure 14 – Photo of Table B Post-Test

Figure 14 shows a picture of Table B after testing. Based on table drawings from the manufacturer, the nominal clearance is 19.9 inches between the table top and the opposing seat back. Therefore, table top displacement greater than 4.9 inches would encroach on the minimum clearance space of 15 inches. The survival space was breached as the resting position of the table encroached 2 to 3 inches into the passengers' survival space.

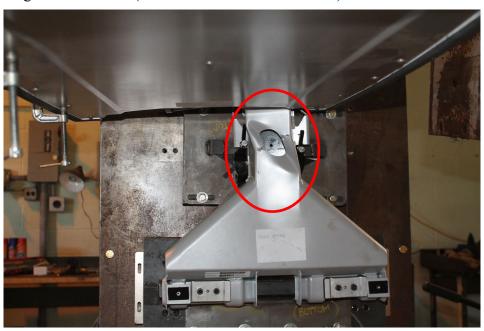
#### Figure 15 – Photo of Table B Post-Test Showing Support Frame Deformation

Figure 15 shows an under-table view of Table B after testing. As shown, the support frame had experienced high shear stresses (see deformation in circled area).

Requirement	Result	Pass/Fail
The table and any table components must remain attached to the test fixture.	See Figure 15; the table remained attached but the mounting yielded.	Pass
During and after crushing of the table, a minimum of 15 inches of survivable space must be preserved for facing occupants based on the predominant seat pitch used for seats surrounding tables.	12 to 12.4 inches of survival space preserved.	Fail
The energy absorbed by the plastic (permanent) table crush must be at least 6,250 in-lbf at each seat position before the force reaches 2,250 lbf.	The required plastic energy was absorbed on both the wall and aisle side of the table.	Pass

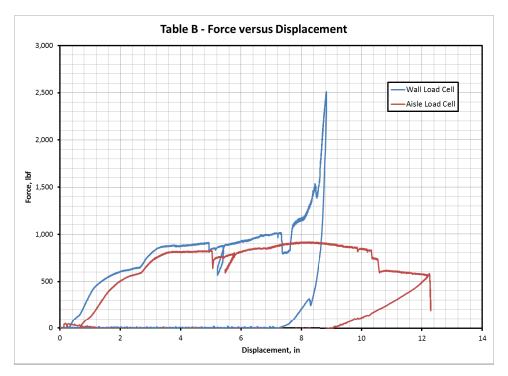
Figure 16 – Table B Force versus Displacement at Both Blocks

Figure 16 shows the force versus displacement cross-plot for both body blocks for Table B. As shown in the plot, the maximum force experienced at the wall block was 2,509 lbf. As the applied load was increasing quickly, the motion of the ram nearest the wall was not stopped until the applied load exceeded the limit of 2,250 lbf. When computing the plastic energy absorbed, the energy absorbed when the force was above the 2,250 lbf limit was subtracted from the total plastic energy. The highest force experienced at the aisle block was 920 lbf.

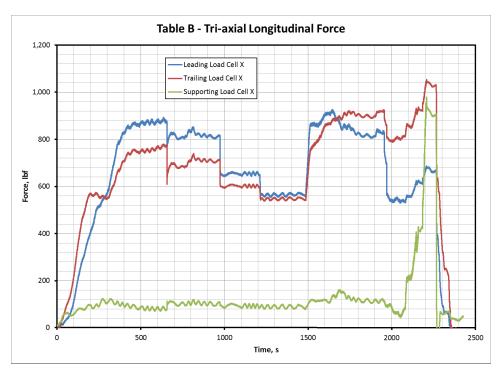
Figure 17 – Table B Longitudinal Force Time Histories from Tri-axial Load Cells

The Table B tri-axial load cell time histories are shown in Figure 17, Figure 18, and Figure 19.

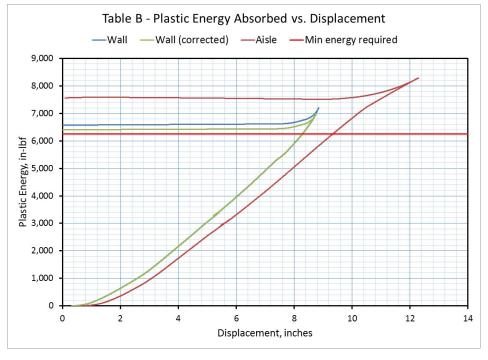
Figure 20 - Plastic Energy Absorbed Versus Displacement

Figure 20 depicts the plastic energy absorbed as a function of displacement for both load cells.

At the load cell nearest the wall, the plastic energy absorbed by the table was 6,993 in-lbf. At the load cell nearest the aisle, the plastic energy absorbed by the table absorbed was 7,560 in-lbf. The plastic energy absorbed while the load was above 2,250 lbf was subtracted from the total plastic energy absorbed. In both cases, the table absorbed more plastic energy than the minimum of 6,250 in-lbf before the force reached 2,250 lbf.
