Impact of Environmental Factors on Pavement Performance in the Absence of Heavy Loads

PUBLICATION NO. FHWA-HRT-16-084

MARCH 2019

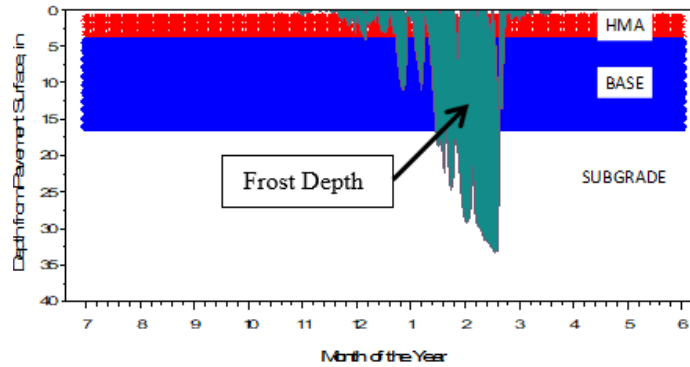
Figure 49 shows examples of freeze areas with calculated frost depths using the ICM.

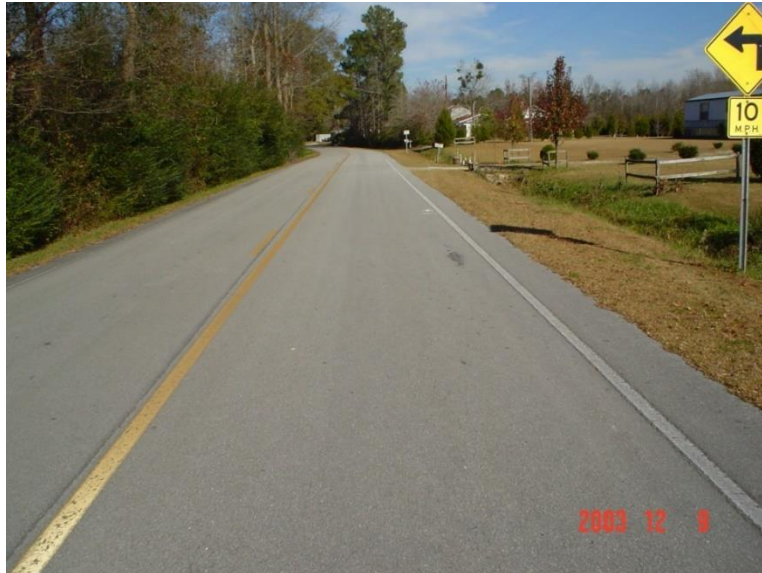
Figure 52 presents a photo of alligator cracking in an SPS-8 project in North Carolina in 2003. The project team reviewed the photo and decided that a very low amount of truck traffic had been applied to this pavement. They concluded that, although it appears as alligator cracking, the cracking present was not traditional bottom-up, AC fatigue, or load initiated.

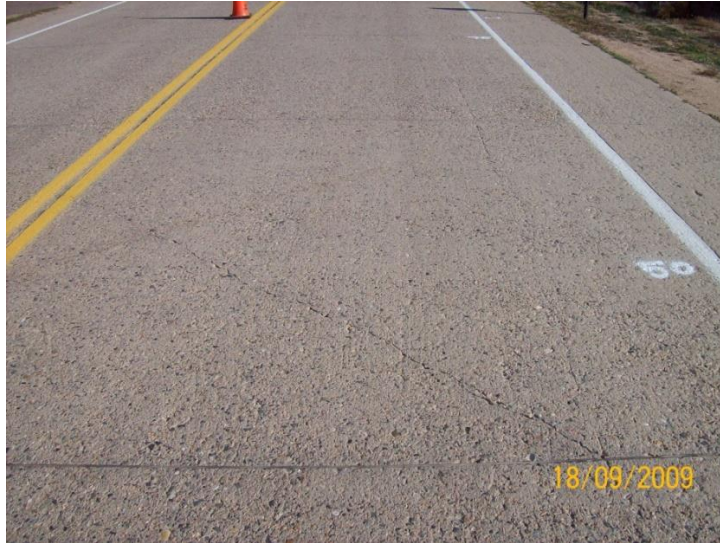
Figure 53 shows a photo of transverse cracking for SPS-8 project 0811 in Colorado in 2009. The photo shows that the transverse cracking exhibited by this pavement was actually a diagonal crack and clearly not the traditional midpanel truck-load- or fatigue-initiated crack. This crack was probably caused by foundation movement. Note that this cracking did not continue to increase as fatigue transverse cracking typically does. This type of crack was clearly environmental or construction related. This is another example of cracking being classified according to the LTPP distress data-collection protocols but misleading as to actual cause of the distress (load, environmental, construction, etc.).

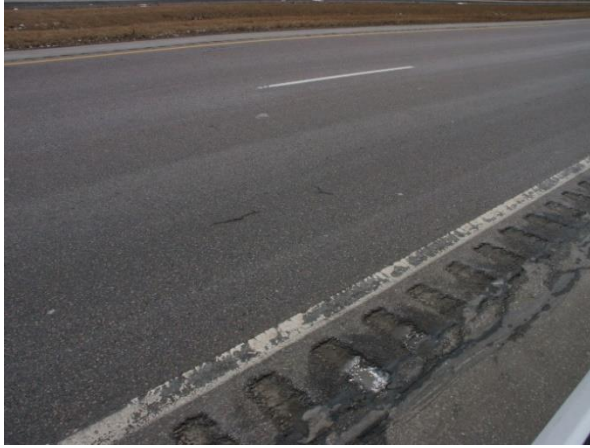
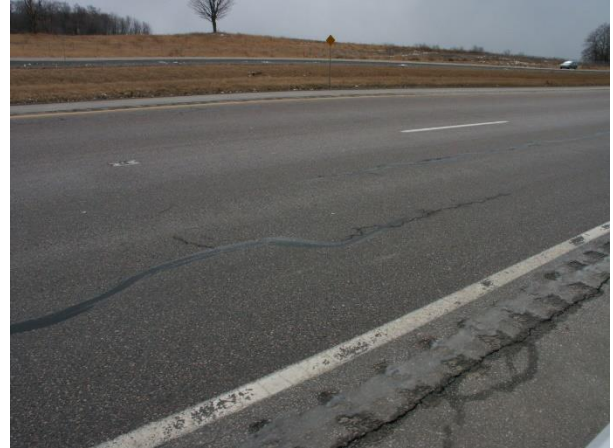
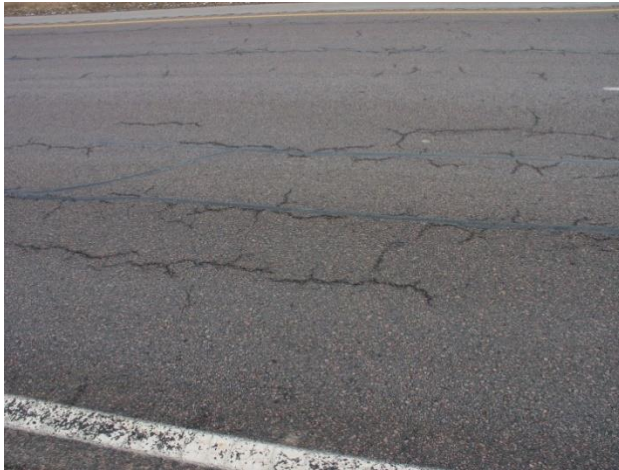
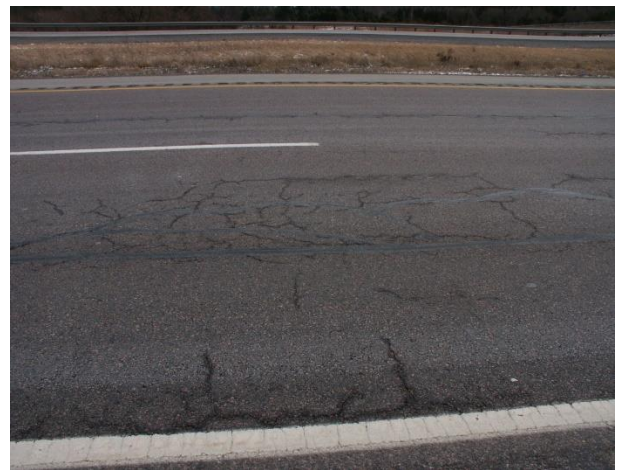
Figure 54 shows different stages of longitudinal cracking distress and how this distress can be confused with alligator cracking. Note the similarity of this distress to bottom-up fatigue alligator cracking.

A. View of first stage—occurrence of short longitudinal cracks in and/or adjacent to the wheel path.

C. Second view of first stage—occurrence of short longitudinal cracks in and/or adjacent to the wheel path.

B. Second stage—occurrence of parallel longitudinal cracks.

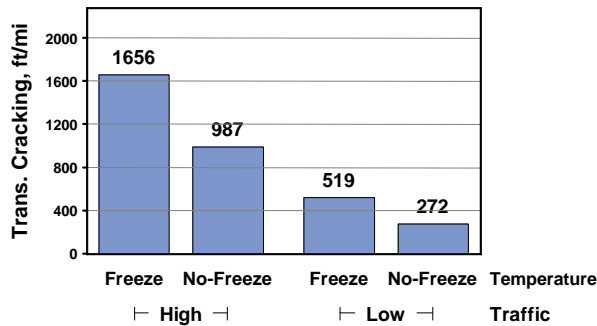
Figure 80 presents graphs showing the impact of freeze and nonfreeze climates on AC transverse cracking for low- and high-trafficked projects.

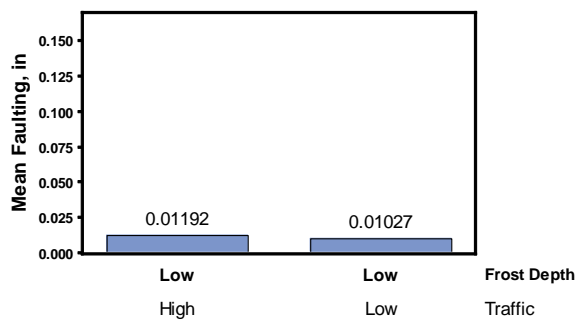
Figure 128 shows the impact of low and high frost depth on JPCP transverse joint faulting for low- and high-trafficked projects.
