**Bridges with Premature Concrete Deterioration:
Fatigue Testing of Full-Scale, Prestressed
Concrete Box Girders Failing in Shear**

Research Report 1857-3

*STRUCTURAL ASSESSMENT OF IN-SERVICE BRIDGES
WITH PREMATURE CONCRETE DETERIORATION*

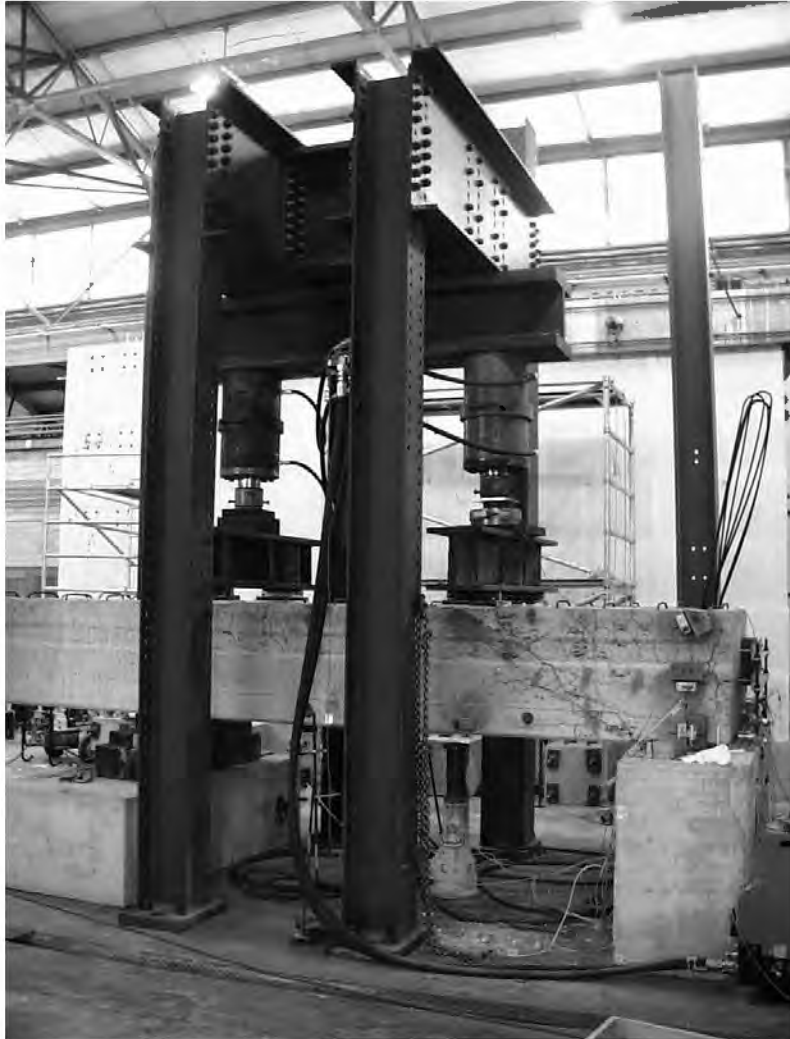
Figure 3.3 Loading setup for shear-dominated fatigue specimens

was 46 in. (1.17 m) from the center of the support, producing a shear span of approximately $2d$, where d is the distance from the extreme compression fiber to the centroid of the longitudinal tension reinforcement. The bonded length of the prestressing strands, from the end of the girder to the center of the bearing pad, was 9.5 in. (0.24 m). A portion of each compression strut (one compression strut per web) fell within each of the following regions (Appendix A): the solid end block and the top flange, thus increasing the combined web thickness in these regions from 10 in. (0.25 m) to the entire width of the girder, 48 in. (1.22 m); and the internal void chamfers, thus varying the combined web thickness in this region from 10 in. (0.25 m) to 16 in. (0.41 m). For a description of compression strut, and an explanation of the strut-and-tie-model, see MacGregor (1997).

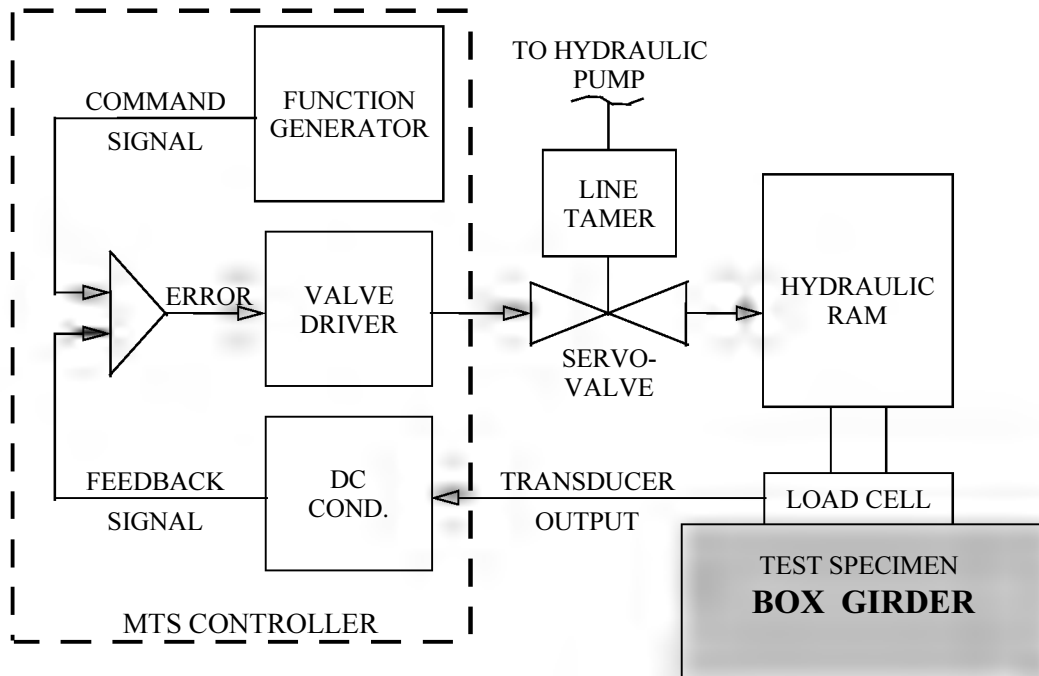
Figure 3.6 Schematic representation of the closed-loop system used for static and fatigue tests (Graddy 1995)

A closed-loop system, shown schematically in Figure 3.6, was used to control applied loads during tests. An MTS controller monitored the load on specimens through the load cell, compared it with the command signal, and supplied the appropriate corrective signals to the valve driver controlling the flow of fluid through the hydraulic rams. If the load deviated from the command signal by some pre-set limit, the controller was programmed to stop the test by removing pressure from the hydraulic rams. These limits, as well as the command signal, required occasional adjustments during each test to maintain smooth and continuous application of load cycles (Graddy 1995). Sinusoidal loading was used, at frequencies between 0.25 Hz and 1.3 Hz.

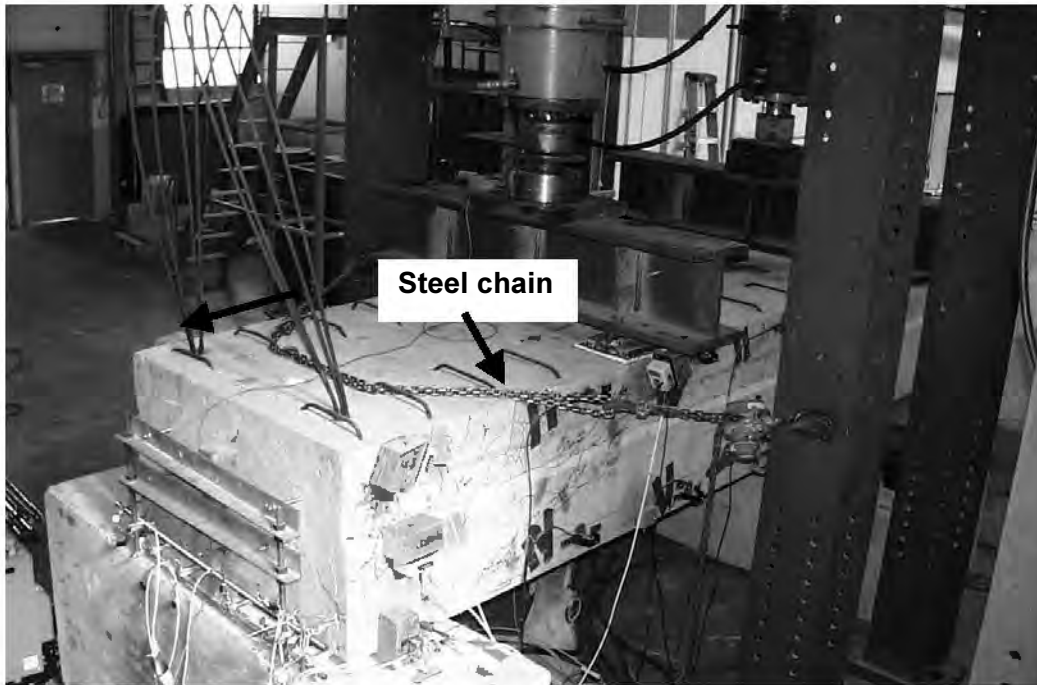
Figure 4.9 Longitudinal girder restraint placed after 10,000 load cycles

After 10,000 load cycles, the girder had moved 0.75 in. (19 mm) south in relation to the test frame and support blocks, while remaining centered in the east-to-west direction. To rectify this situation, the transverse spreader beams were re-centered and the entire test setup was inspected. The concrete support blocks were not adjusted, however, due to the difficulty involved with suspending the girder and moving the blocks simultaneously. There was no damage to the test setup, and modifications were made to restrain the girder from moving again. A steel chain was used to hold the girder stationary in relation to the test frame for the remainder of the load cycles (Figure 4.9). After the chain was placed, there was no significant girder movement for the remainder of the test.

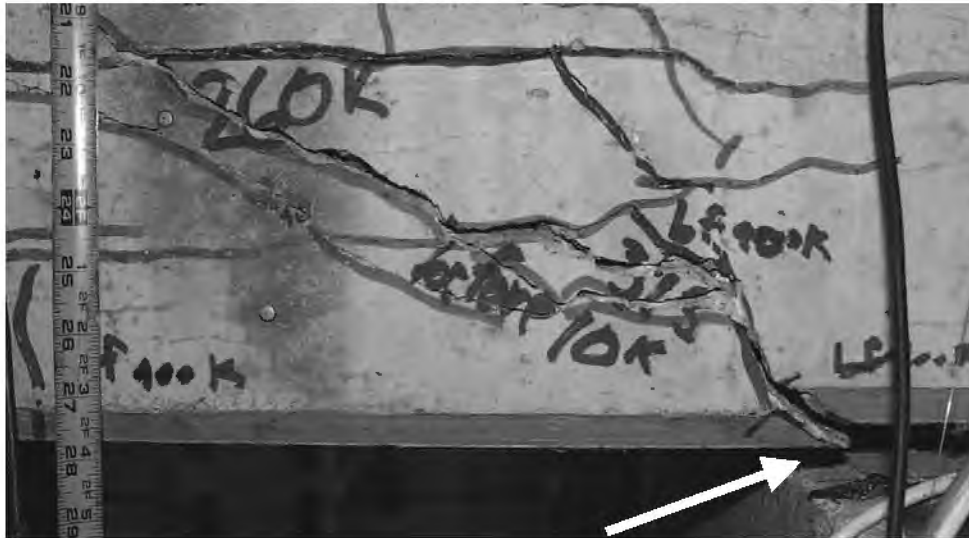
Figure 4.12 Displaced concrete section at the bottom of the east web of BG3N at failure

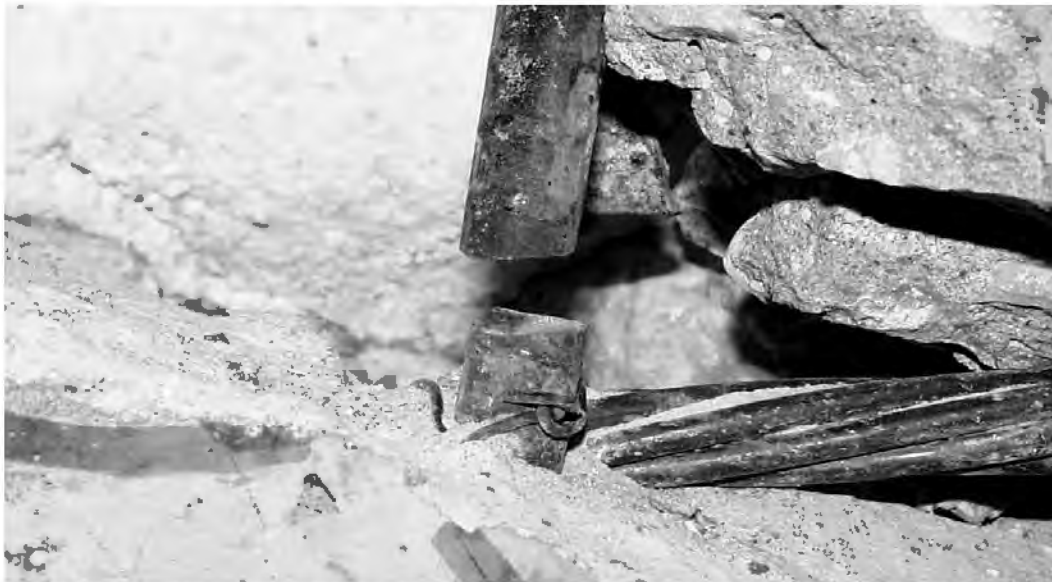
Figure 4.13 Fractured shear reinforcement (stirrup) in the east web of BG3N at failure, after removal of concrete

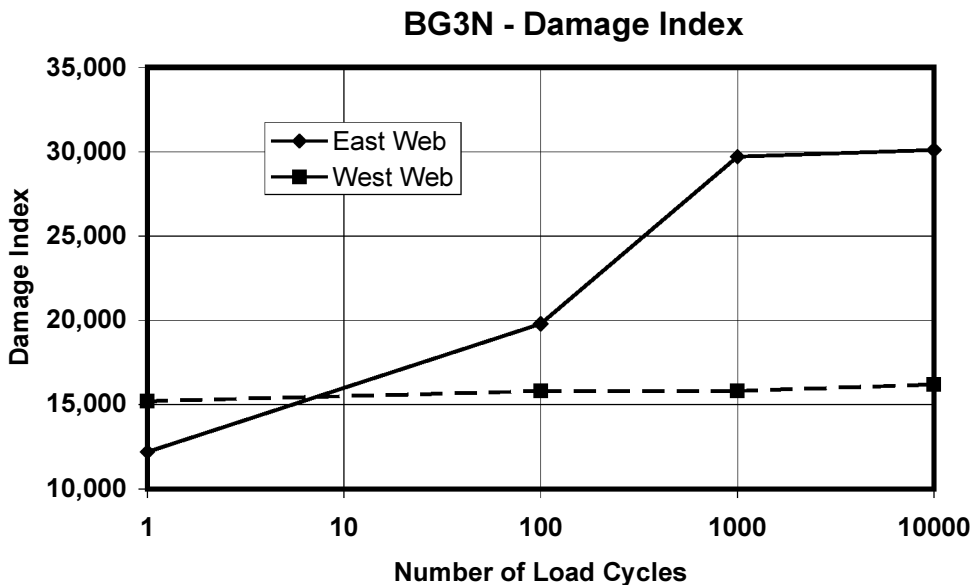
Figure 4.20 Change in damage index for BG3N

Crack ratio (CR) and damage index (DI) were monitored as defined in Section 3.6.3. Figure 4.19 shows the change in crack ratio with the number of load cycles, and Figure 4.20 shows the change in damage index with the number of load cycles. The total increases in crack ratio and damage index during fatigue testing were more pronounced in the east web. The increase in east-web crack ratio was 56 percent, and the corresponding change in damage index was 154 percent.

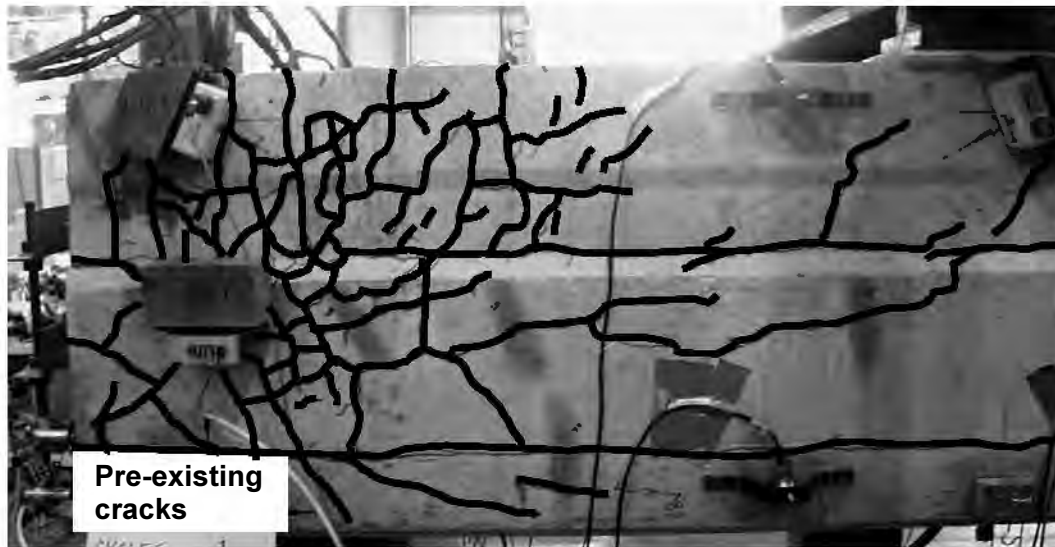
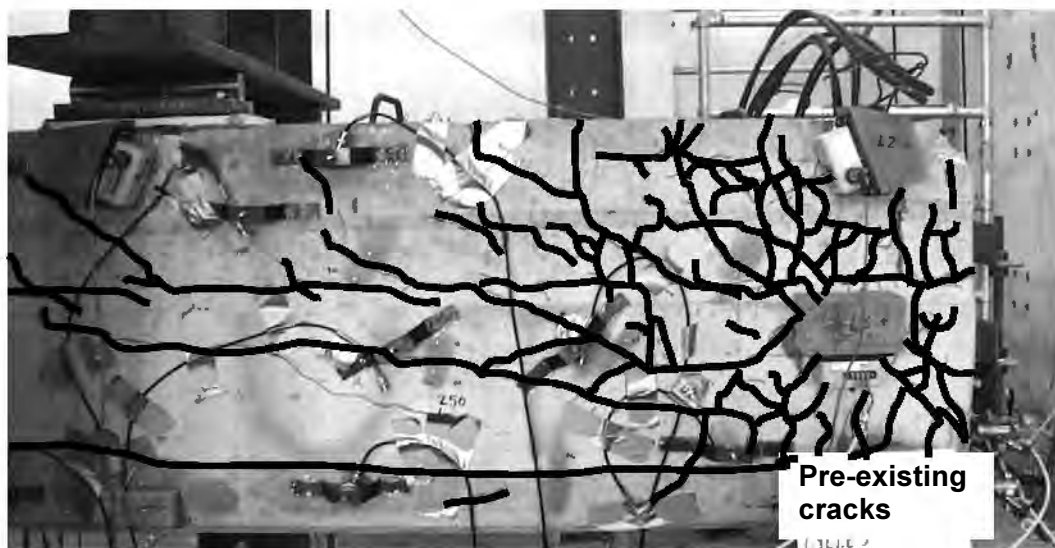
Figure 4.21 Pre-existing cracks in the east web of BG3S

Figure 4.22 Pre-existing cracks in the west web of BG3S

The pre-existing cracks in the east and west webs of BG3S are shown in Figures 4.21 and 4.22.

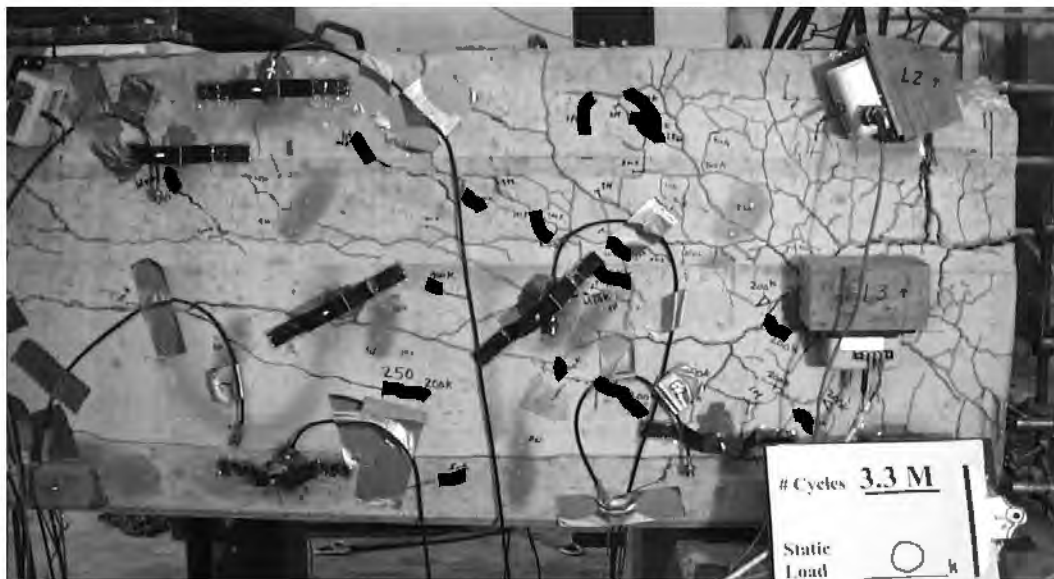
Figure 4.25 Shear-induced cracks in the east web of BG3S after 3,328,600 load cycles

Figure 4.26 Shear-induced cracks in the west web of BG3S after 3,328,600 load cycles

After these cracks were marked, the load was returned to zero. The fatigue loading procedure and periodic quasi-static loadings then proceeded as detailed in Section 3.7.2. During this loading procedure of 3,328,600 load cycles, only slight additional diagonal cracking formed, and most of this additional cracking was short extensions of existing diagonal cracks (Figures 4.25 and 4.26).

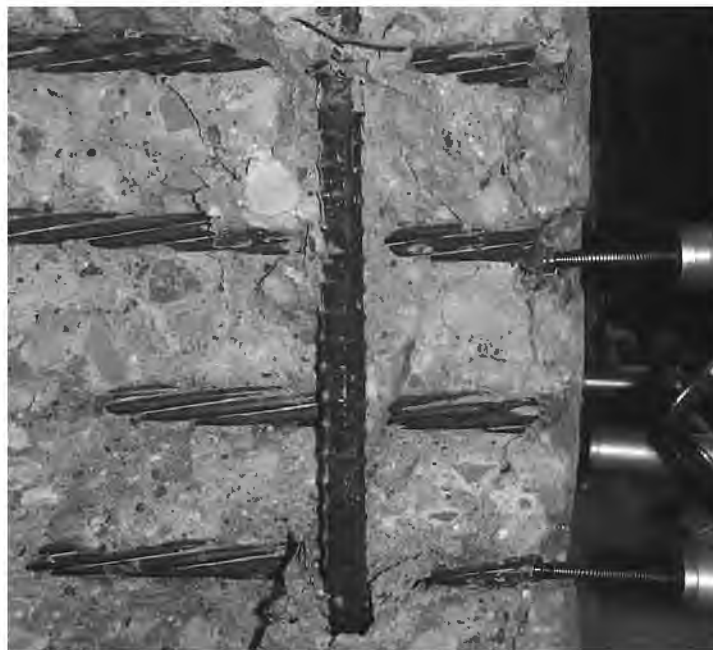
Figure 4.32 Slip of exterior prestressing strands after failure of BG3S

There was no significant slip of prestressing strands during the fatigue test. In the final moments of the quasi-static test to failure, however, as the concrete cover spalled off and the web concrete crushed, several interior prestressing strands and all of the strands nearest to the exterior surfaces of the webs slipped (Figure 4.32). The amount of slip was not measured accurately by the linear potentiometers because as the girder failed, the potentiometers slipped off of the ends of the prestressing strands. Slip was verified by visual inspection, and was manually measured to be between 0.125 in. (3 mm) and 0.25 in. (6 mm) for the interior strand, and approximately 0.5 inch (13 mm) for the exterior strand.
