ZONE OF INTRUSION FOR PERMANENT 9.1° SINGLE-SLOPE CONCRETE
BARRIERS

A THESIS

Three WDOT 9.1-degree single-slope concrete barriers, with top heights of 36 in. (914 mm), 42 in. (1,067 mm), and 56 in. (1,422 mm) (Standard 14B32), were analyzed for Zone of Intrusion (ZOI) and working width using nonlinear finite element analysis (FEA). Tire-barrier friction, vehicle-barrier friction, barrier stiffness, mesh size, tire deflation, and suspension component failures were all found to have effects on simulation results. The zone of intrusion and working width were evaluated for each barrier under varying tire deflation and suspension failure conditions and determined to have a maximum value of 12.2 in. (310 mm) for the front fender and 9.4 in. (240 mm) for the rest of the vehicle. The working width for each barrier was determined to be 24 in. (610 mm).

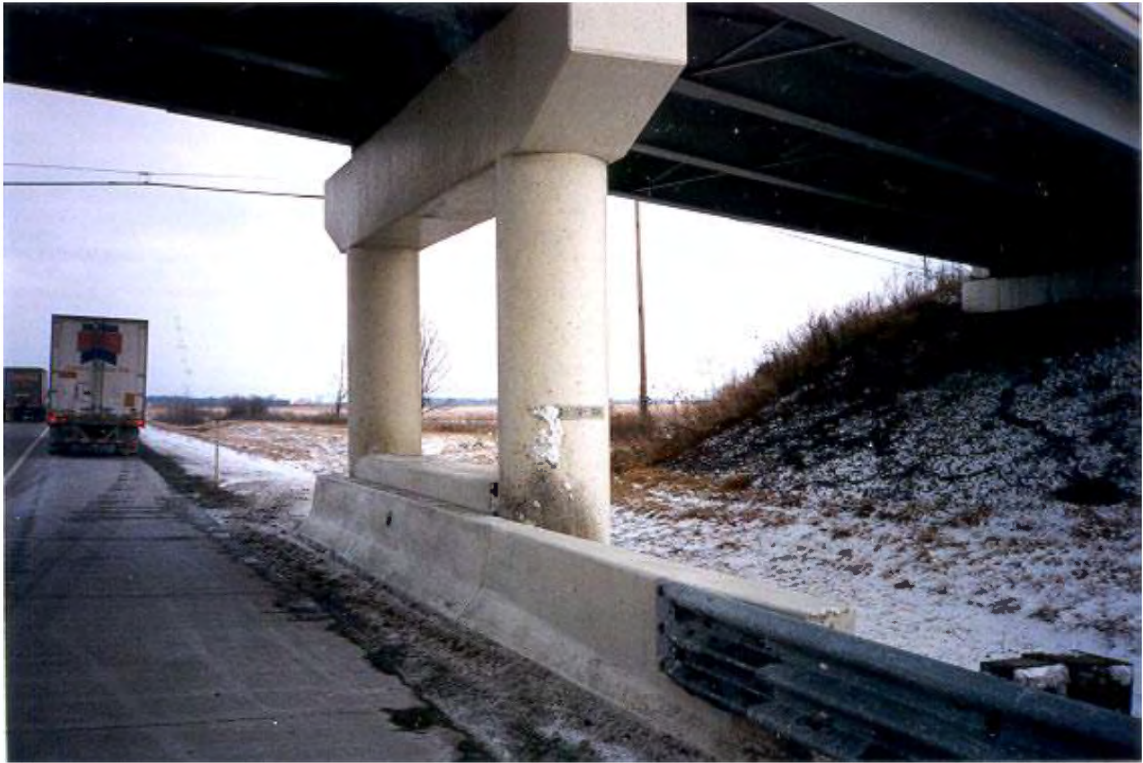
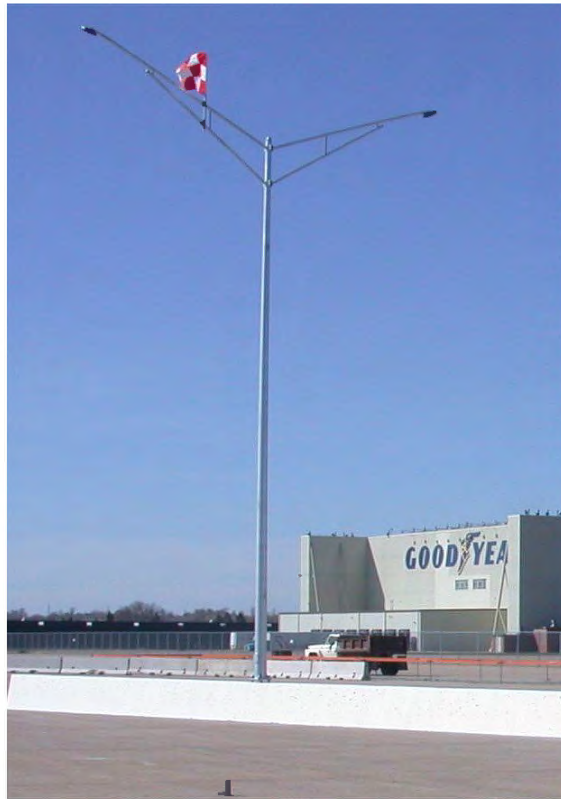
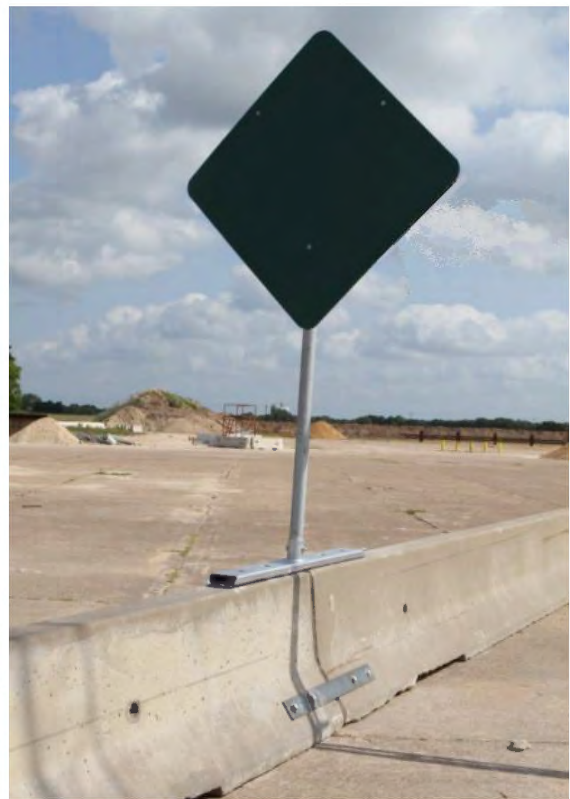
Figure 1. Hazards Located Within the Zone of Intrusion

In 2003, a report was published by the Midwest Roadside Safety Facility (MwRSF) discussing barrier attachments and their effect on impacting vehicles [10]. Researchers noted that breakaway and rigid attachments to barrier may penetrate into the occupant compartment or cause excessive vehicle accelerations. Both of these conditions are hazardous to the occupants, and cause the system to fail the full-scale crash criteria set forth in MASH and NCHRP Report No. 350. A few examples of hazards located within the zone of intrusion are shown in Figure 1.

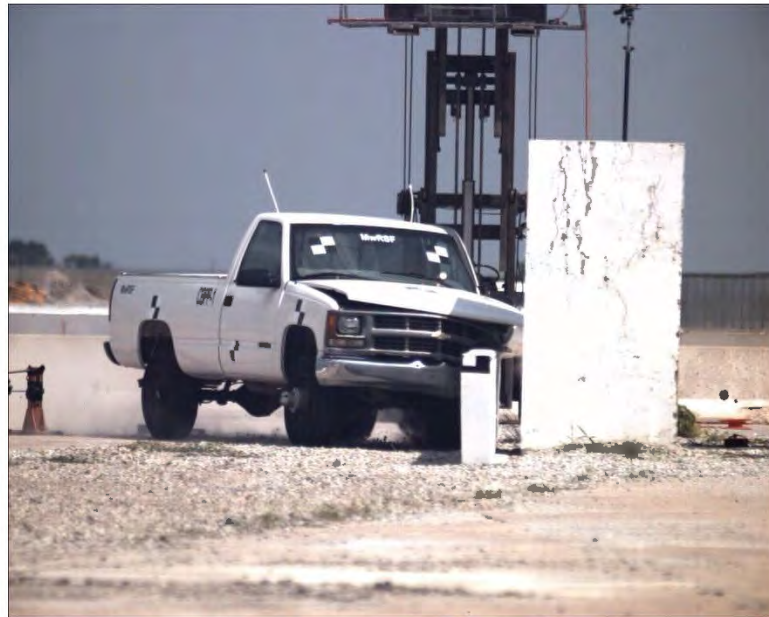
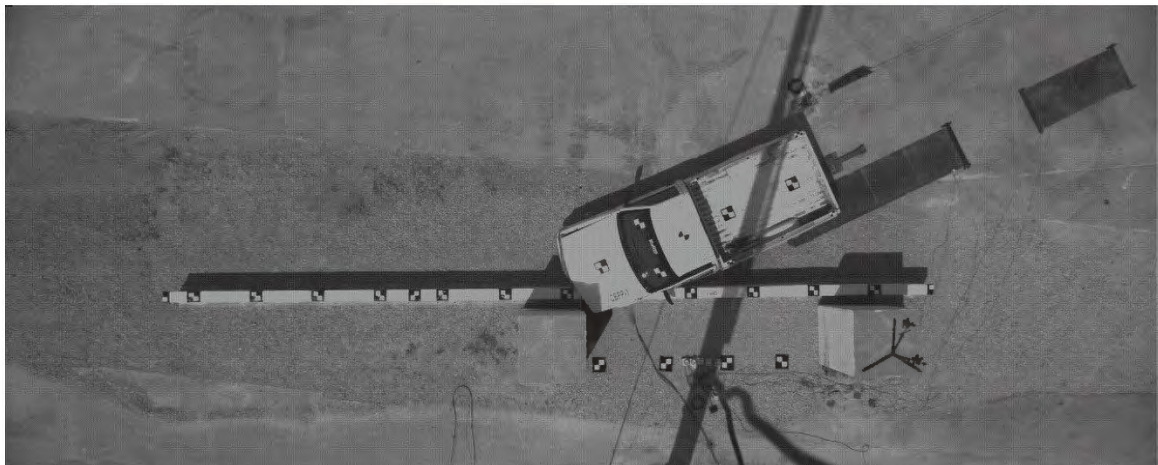
Figure 4. Impacting a Bridge Pier in the ZOI

Similar studies have had similar results. In 2007, MwRSF conducted a test on a concrete bridge pier protection system [14]. The barrier consisted of a 32-in. (813-mm) tall, vertical-faced permanent concrete barrier with bridge piers located 16¾ in. (425 mm) behind the front face of the barrier. As determined by overhead video analysis, the vehicle hood protruded 19.8 in. (503 mm) beyond the front face of the barrier and struck the bridge pier, as shown in Figure 4. This behavior did not negatively affect the test, and after some deformation of the vehicle hood, the vehicle continued to redirect downstream. The occupant safety was not compromised during the test. Once again, no dummy was used during this test, so it is unknown as to whether or not the system would have passed if a dummy was placed in the vehicle.

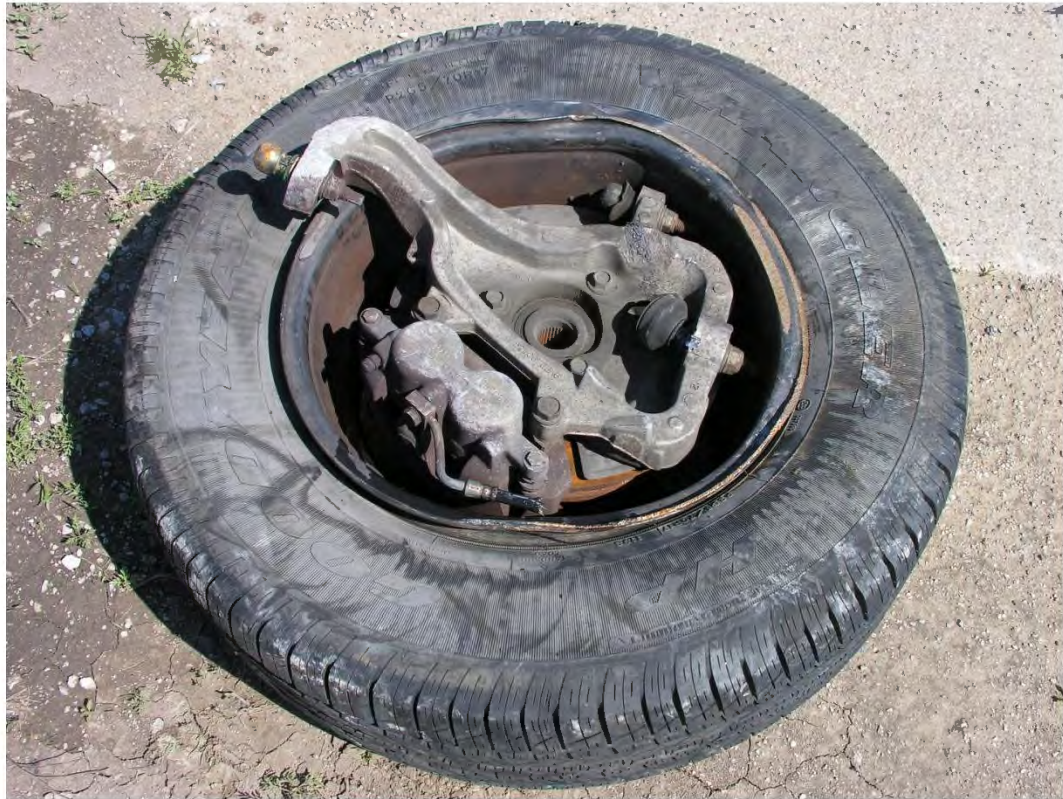
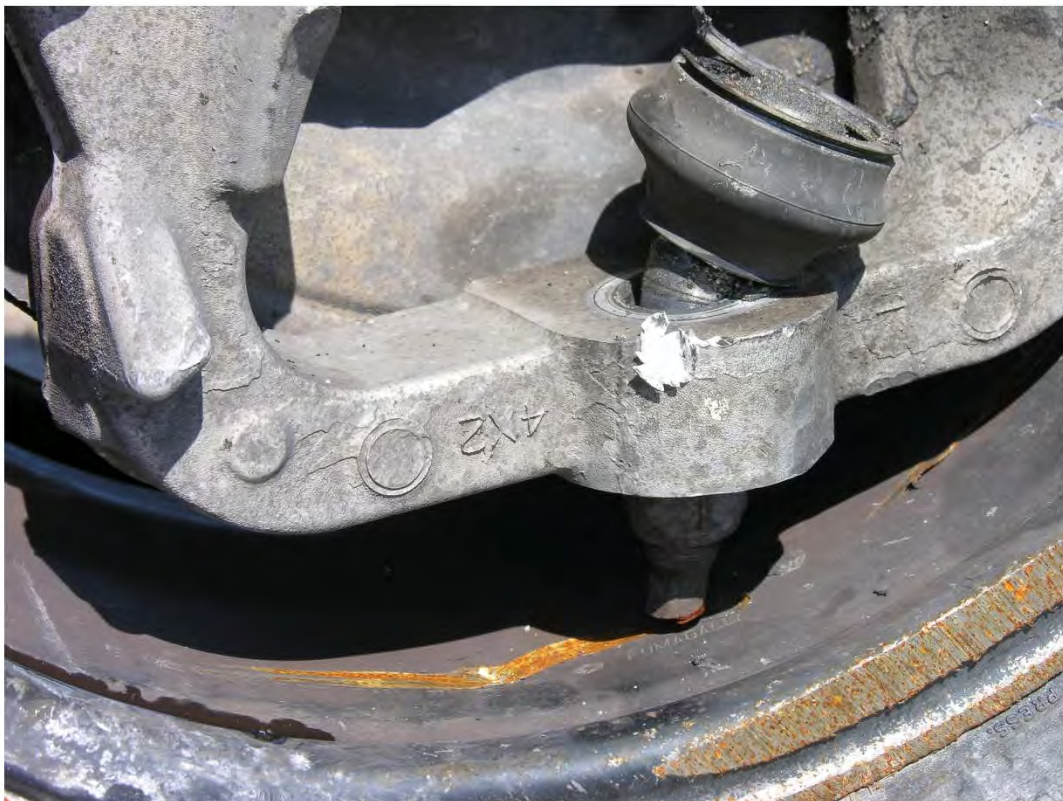
Figure 7. Inside of Wheel Damage, Test No. PCMB-1

Test No. PCMB-1 was conducted on a 32-in. (812-mm) tall, h F-shape barrier using a Dodge Ram Quad Cab 1500 vehicle [16]. Damage to the impacting wheel consisted of rim deformation, scuffing, contact marks, and tire tearing. The ball connection attaching the wheel to the lower control arm was bent forward, as shown in Figure 7. There was no fracture of any of the ball joints on the wheel assembly, and it appeared that the suspension failed when the ball joints pulled out of their respective sockets.

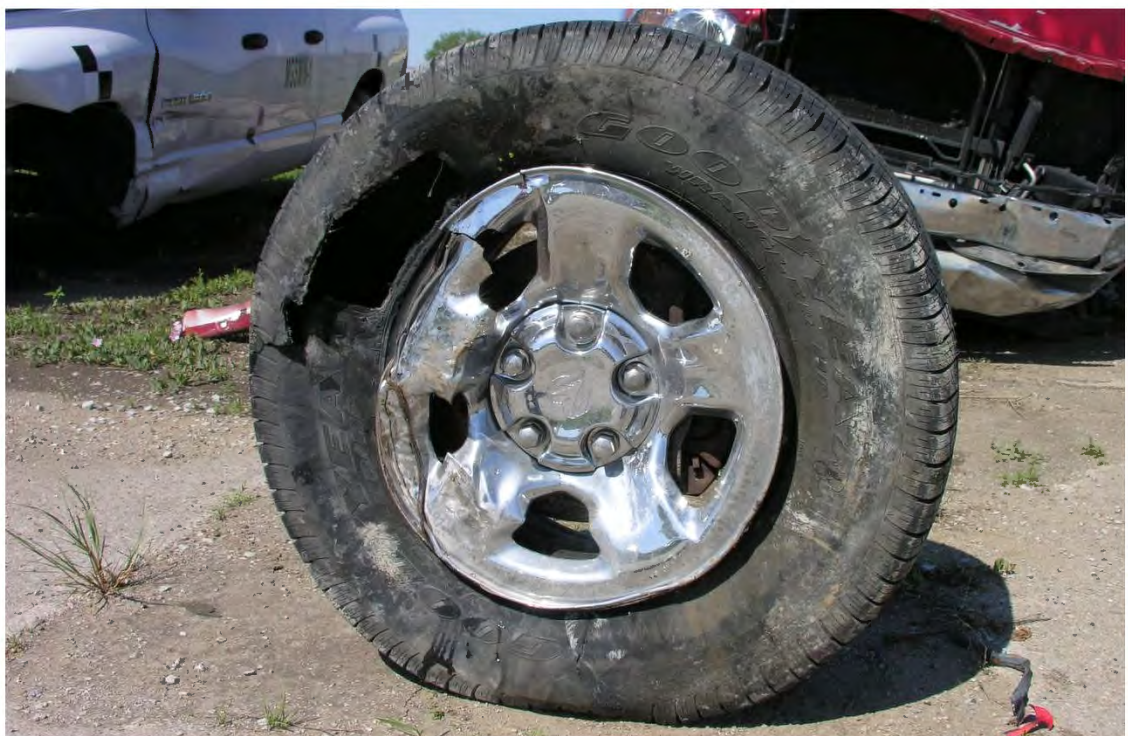
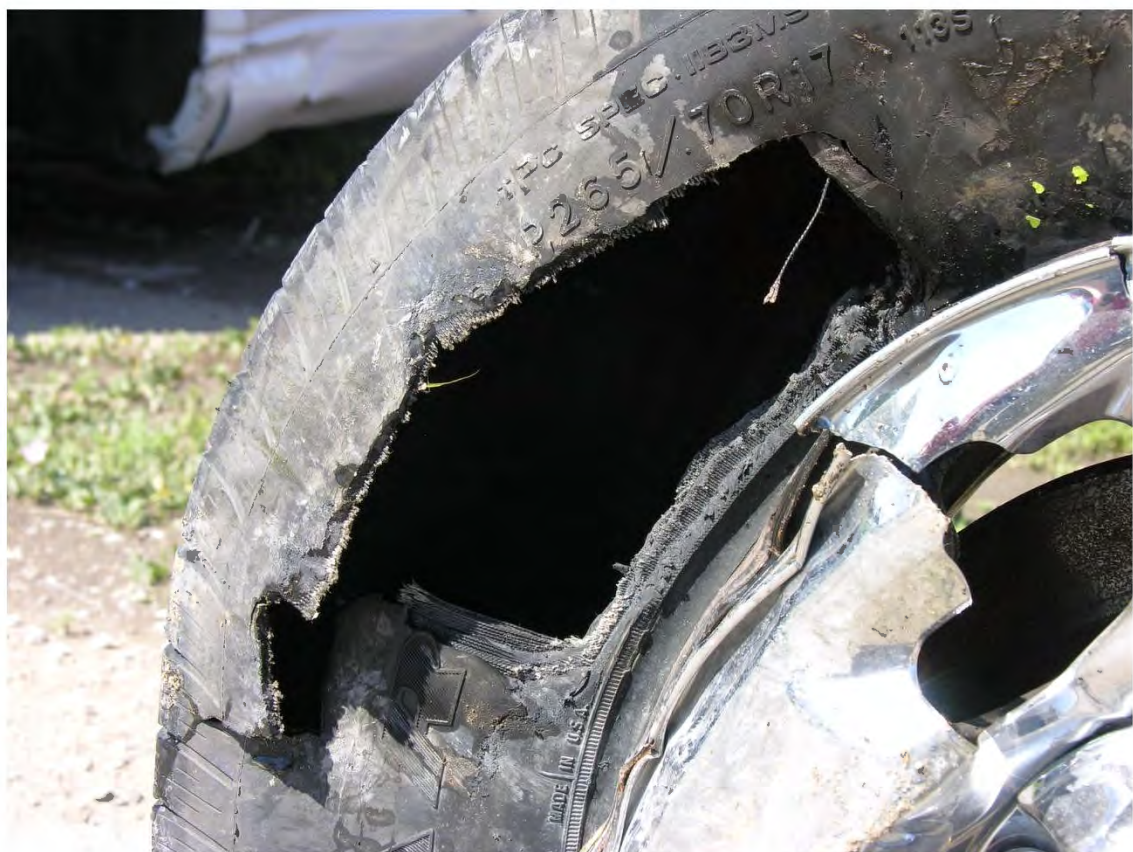
Figure 8. Outside of Wheel Damage, Test No. PCMB-1

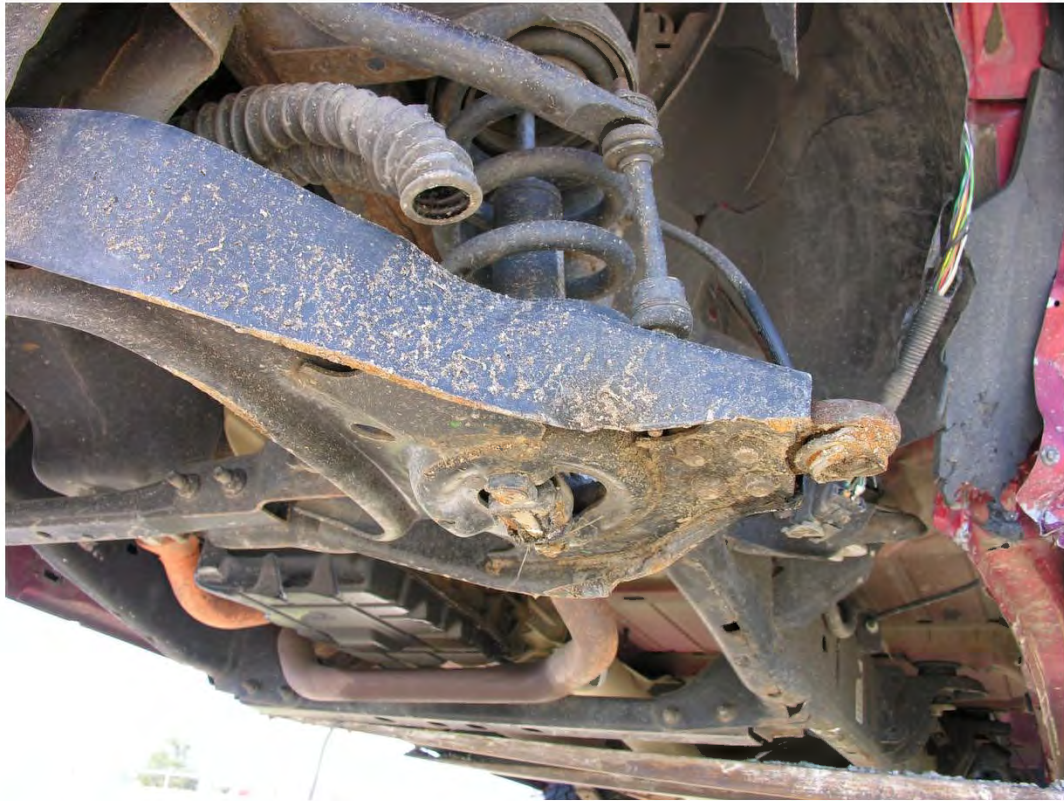
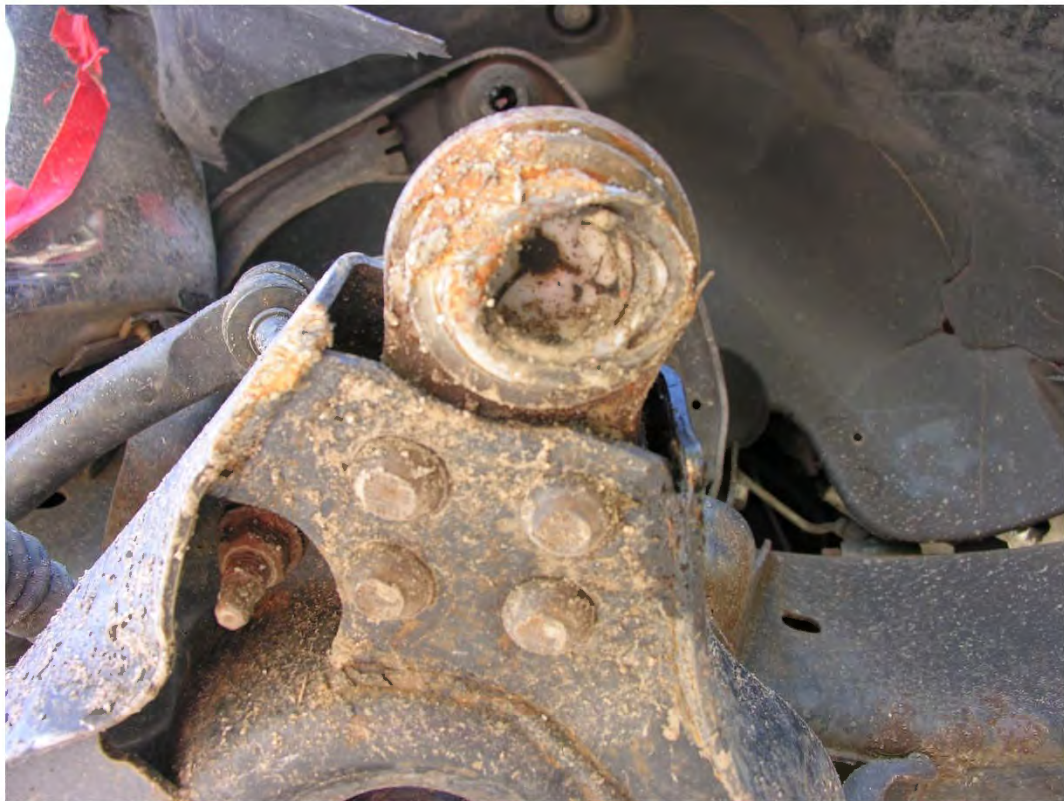
Figure 9. Lower Control Arm Damage, Test No. PCMB-1

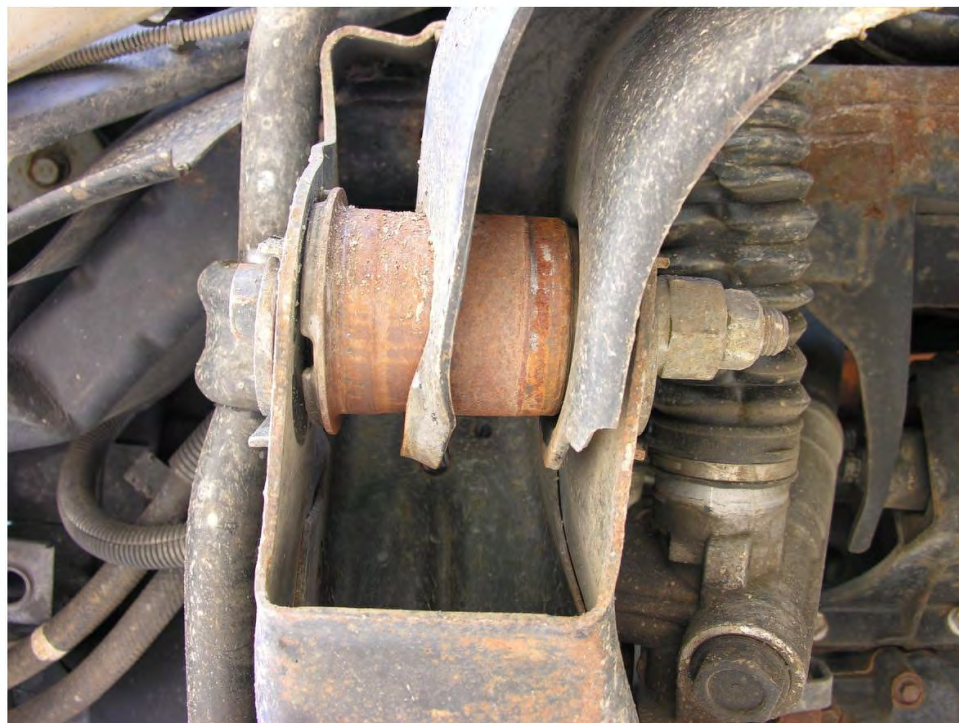
Front Connection Slip (View looking toward longitudinal centerline of vehicle)

Figure 10. Lower Control Arm Connection Slip, Test No. PCMB-1

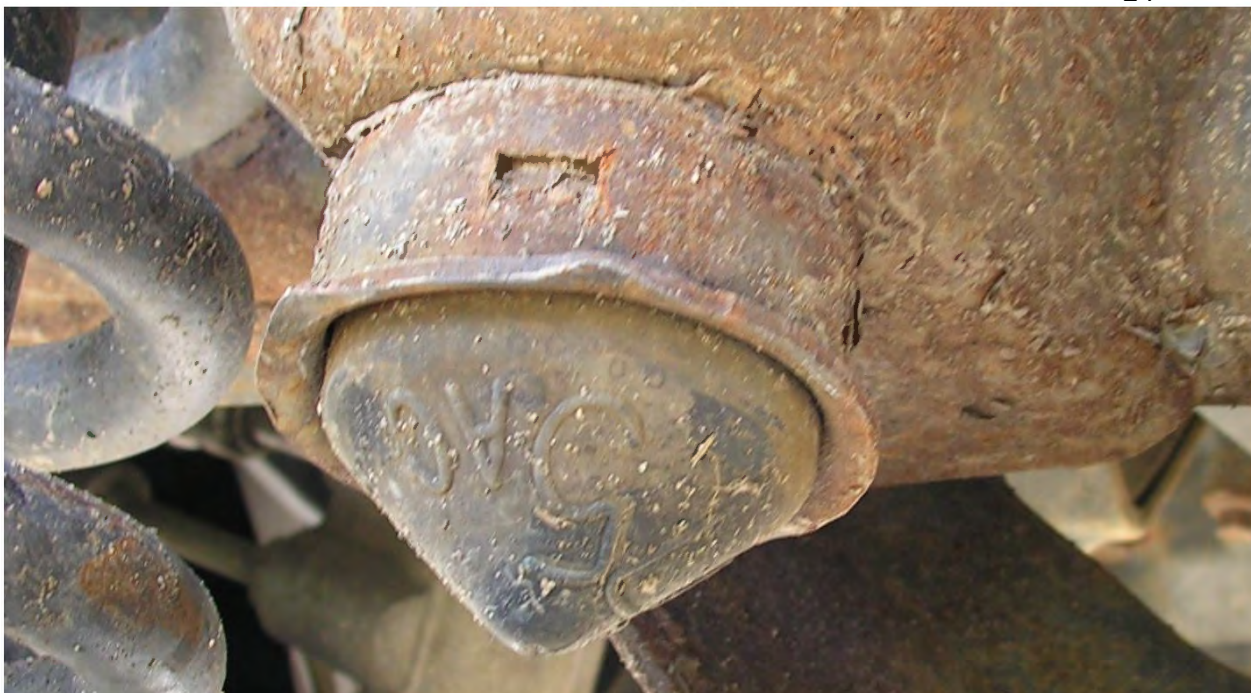
Figure 11. Bump Stop and Upper Control Arm Damage, Test No. PCMB-1

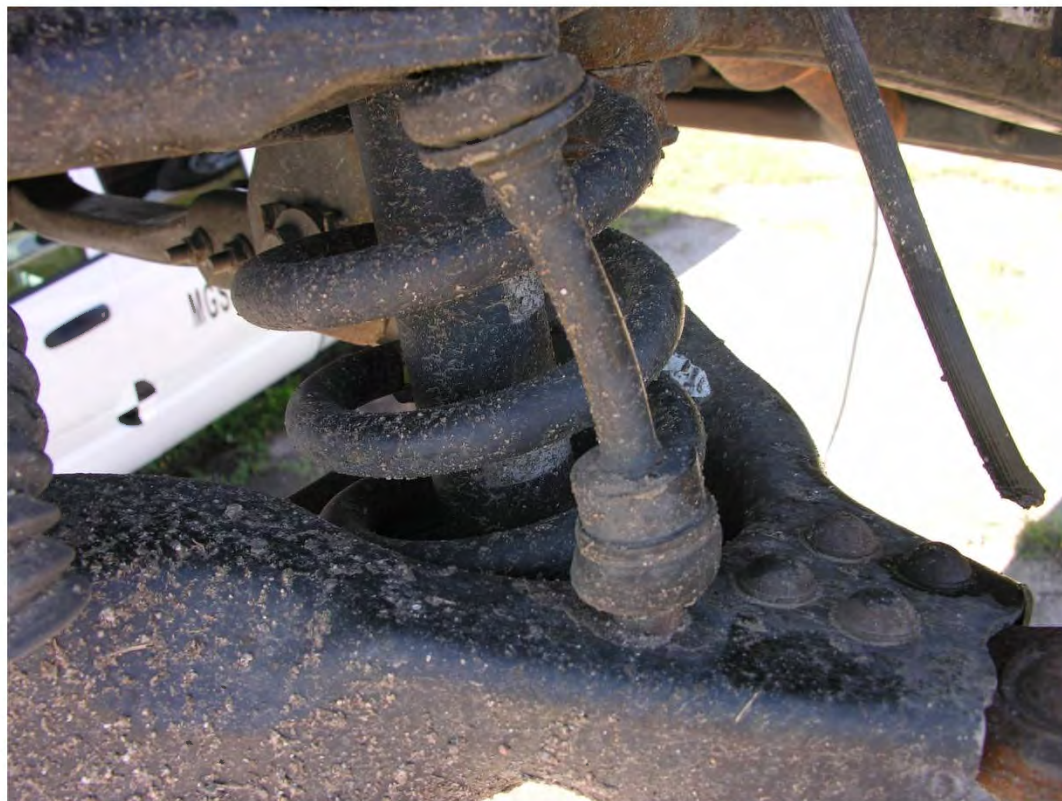
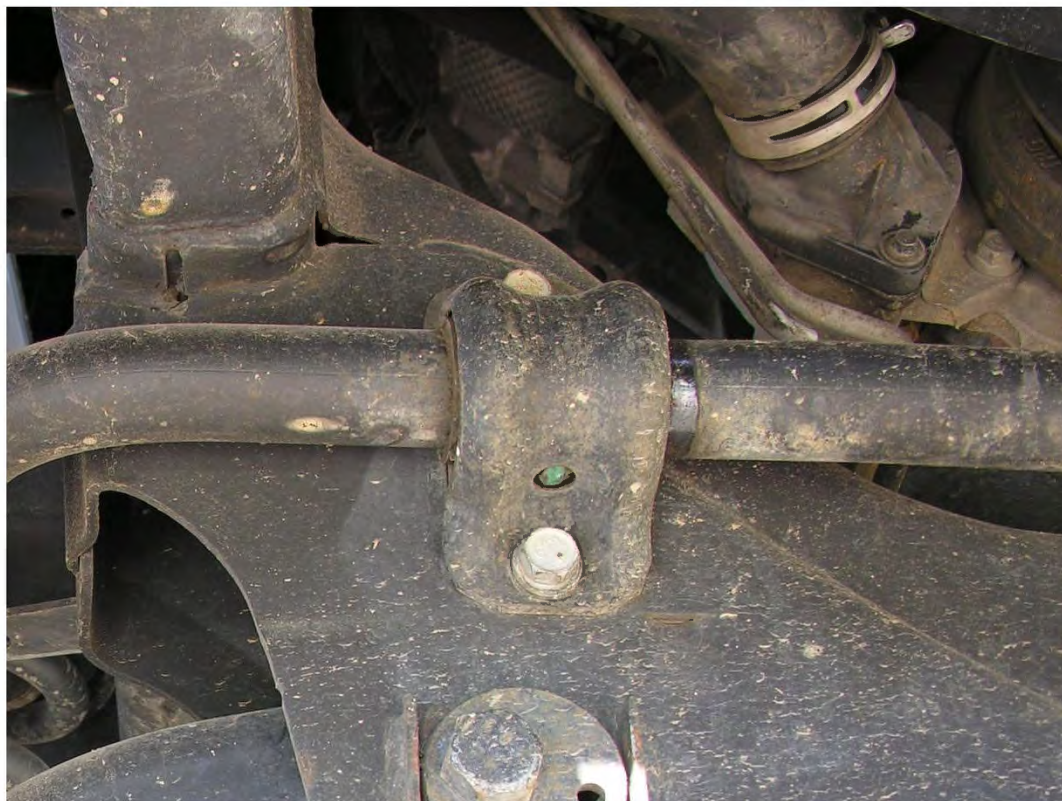
Figure 12. Roll Bar and Connecting Pin Damage, Test No. PCMB-1

The link connecting the roll bar to the lower control arm was bent, as shown in Figure 12. Also, the impact side of the roll bar was twisted and bent downward. The roll bar shifted $\frac{1}{8}$ in. (3 mm) toward the impacting side, as determined from the scrape marks seen around the link connecting the roll bar to the frame of the vehicle, shown at the bottom of Figure 12.

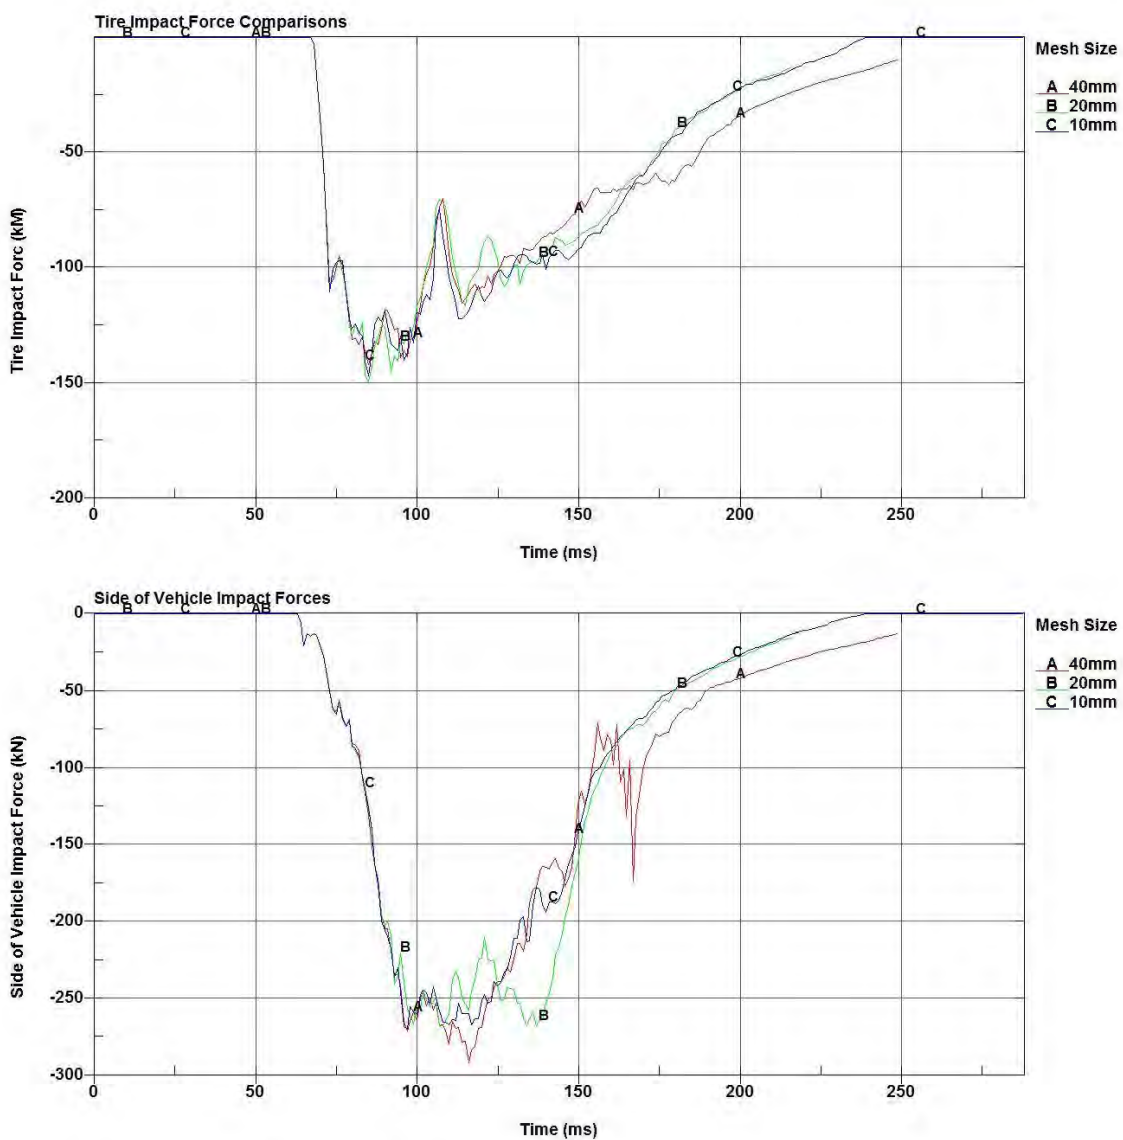
Figure 21. Tire and Vehicle Body Impacting Forces for Varying Barrier Mesh Sizes

Tire and vehicle body impact forces were measured and plotted for the simulation runs, as shown in Figure 21. The smallest mesh produced the softest impact with the lowest peak force values. The largest mesh showed the highest peak lateral forces as the vehicle impacted the barrier. There was a significant difference in the impact forces exerted by the 0.79-in. (20-mm) and 1.57-in. (40-mm) mesh sizes, while the medium and small mesh sizes had similar force values

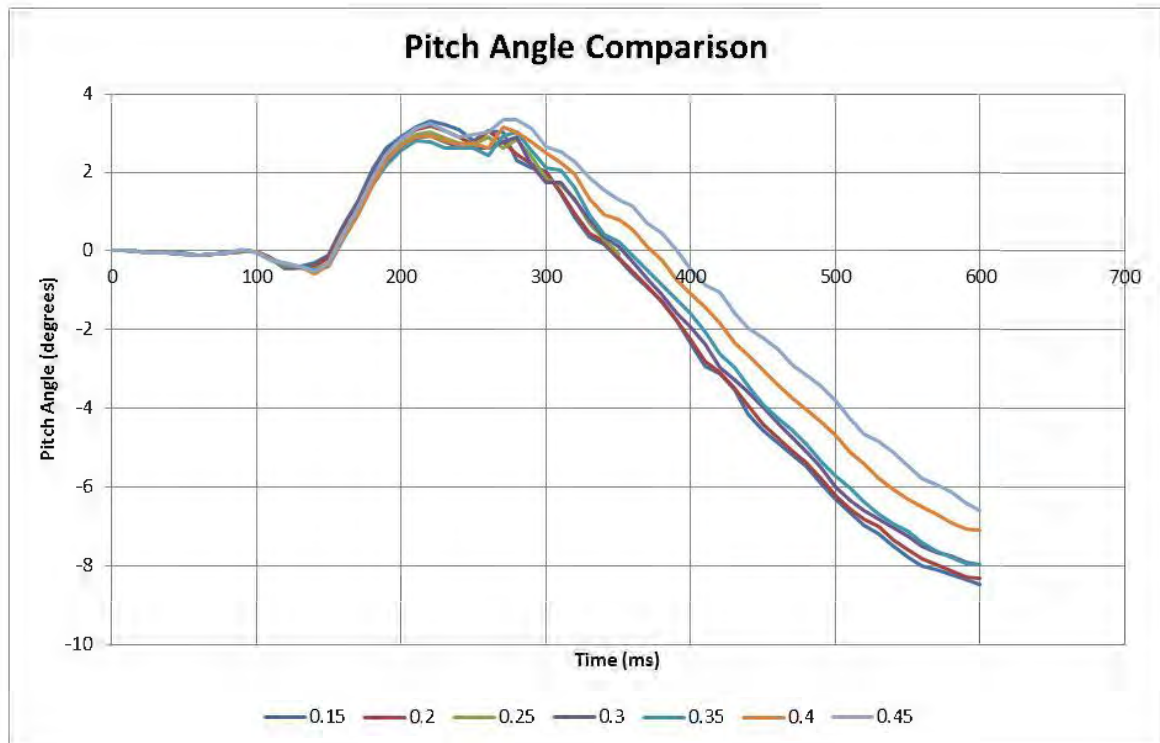
Figure 30. Vehicle Pitch Angle Measured from Instrument Mounting Panel

dimensions were 23.6 in. by 23.6 in. (600 mm by 600 mm). The pitch motion was measured using two nodes from this panel along the longitudinal axis of the vehicle, and the result was plotted in Figure 30. It was noted that this pitch angle closely resembled the actual pitch angle from visual inspection of the vehicle during the simulation.

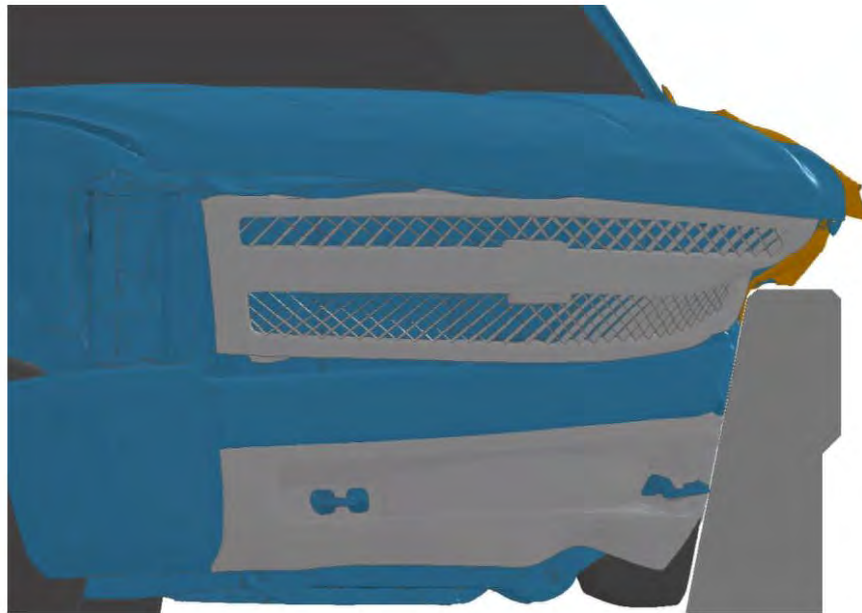
Figure 33. Fender Protrusion Over the Barrier (Note: Fender is orange for distinction)

The left fender point protruded the farthest behind the barrier in each simulation. After impact, the front corner of the left fender pulled away from the vehicle, as shown in Figure 33. The hood protruded beyond the barrier as well, but it was on average 1.6 in. (40 mm) less than the fender.

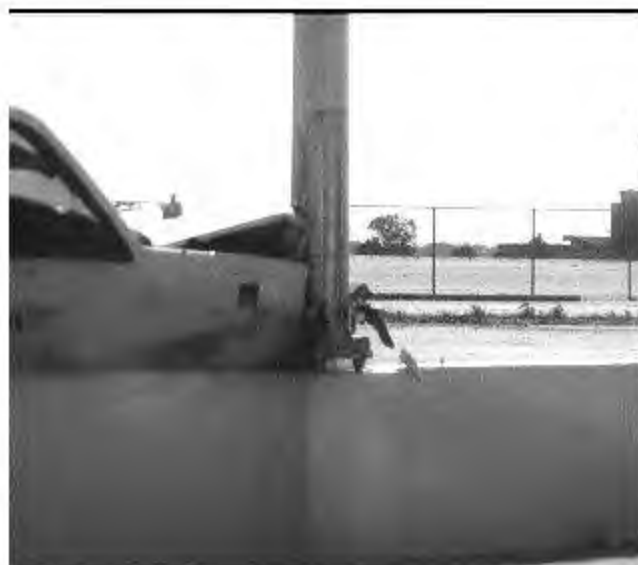
Figure 34. Fender Impact with a Rigid Pole [11]

An impact between the front fender and a hazard behind the barrier may not pose a risk to the occupant. During the initial ZOI study, the fender impacted the rigid pole during the test, which did not pose a significant risk to the occupants, as shown in Figure 34. Longitudinal loads on the fender caused the fender to crush without imparting significant accelerations to the occupant compartment [11]. Thus, if a point on the fender was used to determine the maximum ZOI, it may be too conservative of an estimate of the actual ZOI. The ZOI of the front fender was included in Table 7 for reference. Note that this test did not utilize a dummy occupant and did not take head ejection criteria into consideration.

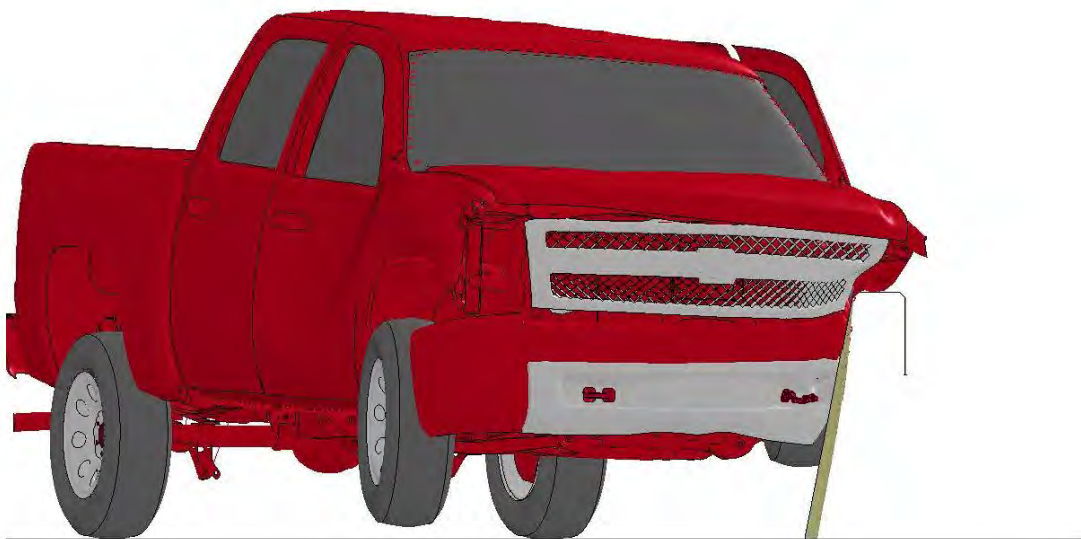
Figure 42. Elastic Barrier Deformation during Impact

Barrier deformation at the impact location varied for each simulation. As noted previously, the differing barrier profile at the impact location may affect the post-impact trajectory of the vehicle. The barrier shape at impact was found by taking a cross-section of the barrier at impact and showing the initial and final deformed states, as shown in Figure 42. The deformed barrier shapes for each of the elastic barrier simulations are shown in Figure 43.

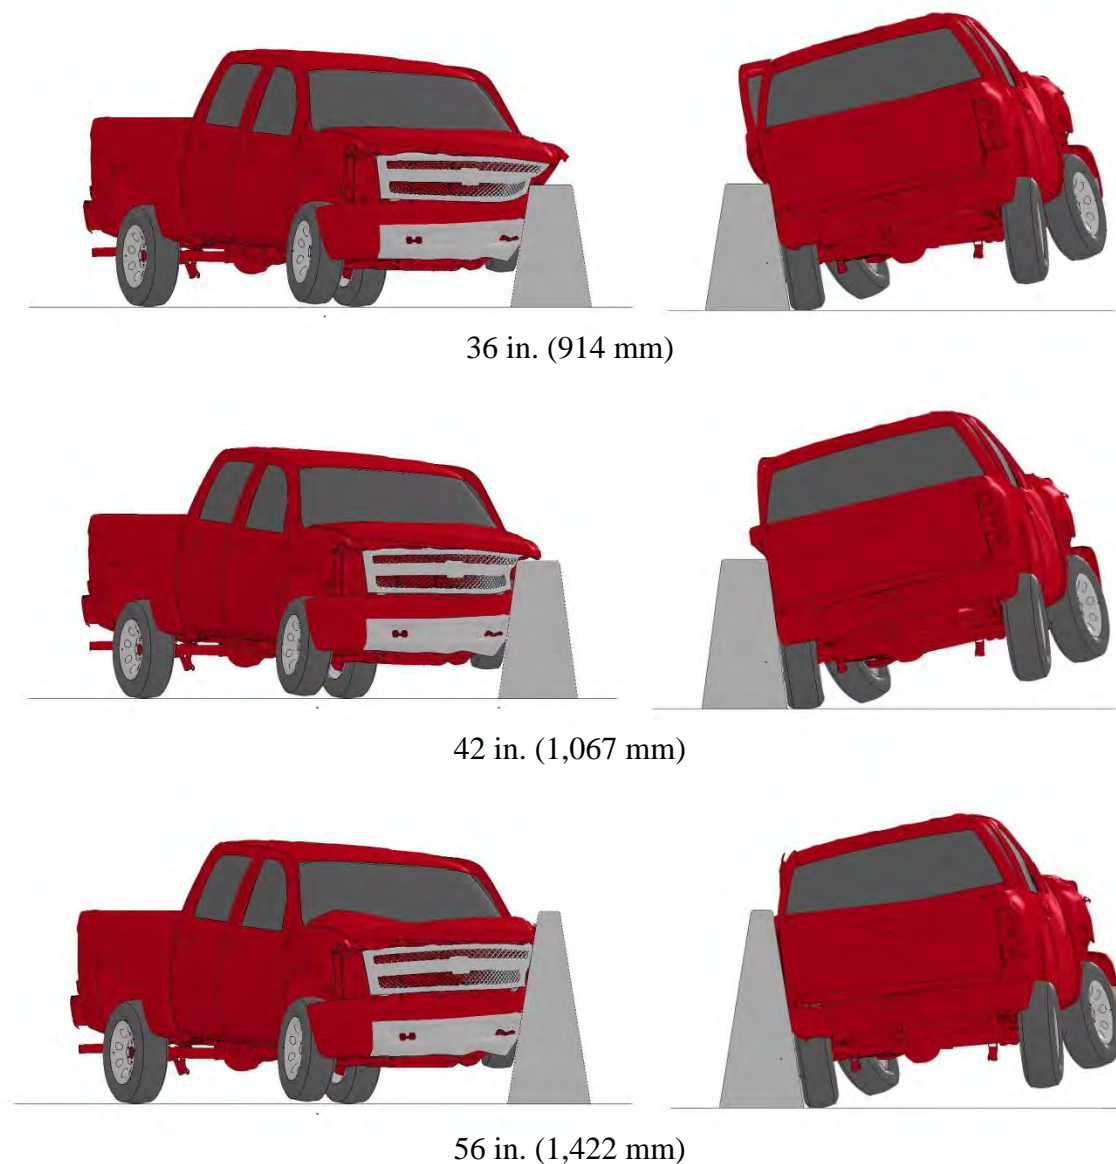
Figure 60. Maximum ZOI Positions for the Tire Deflation Model

The maximum protrusions behind the barrier during the impact and tailslap phases of the tire deflation simulations are shown in Figure 60.

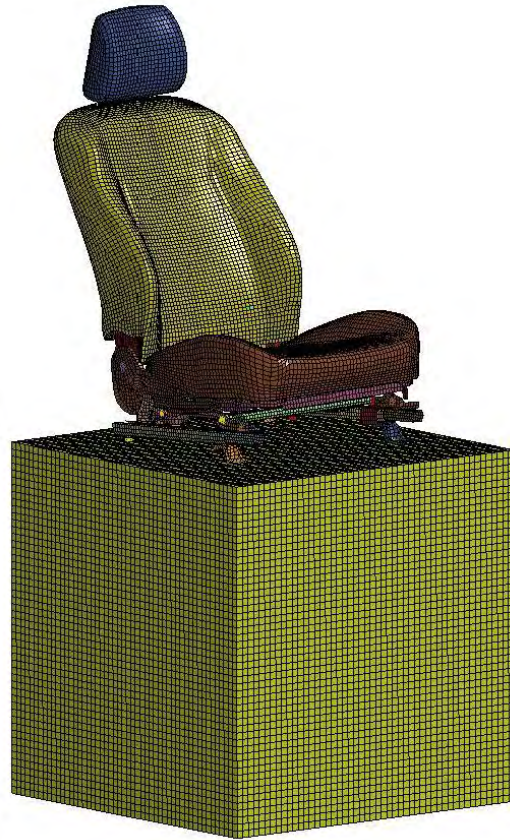
Figure 71. Seat and Rigid Block Model

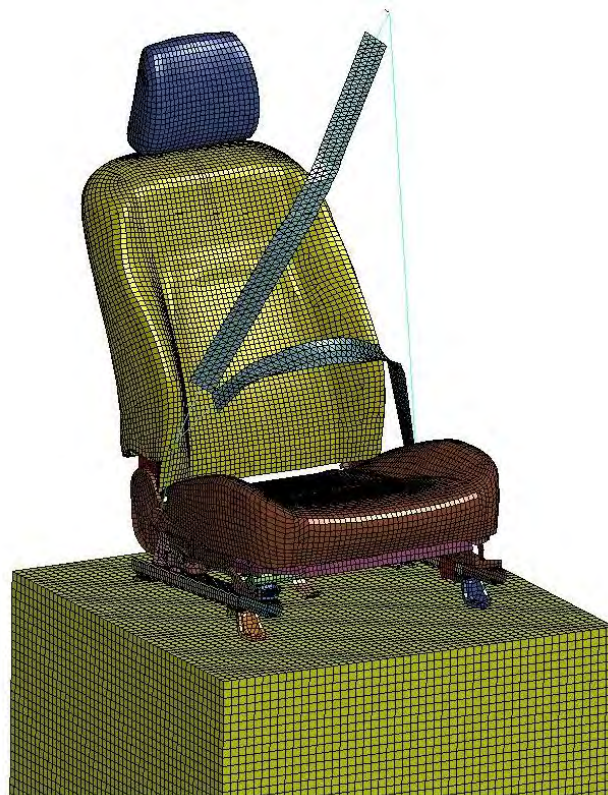
Figure 75. Seatbelt, Seat, and Rigid Block Model

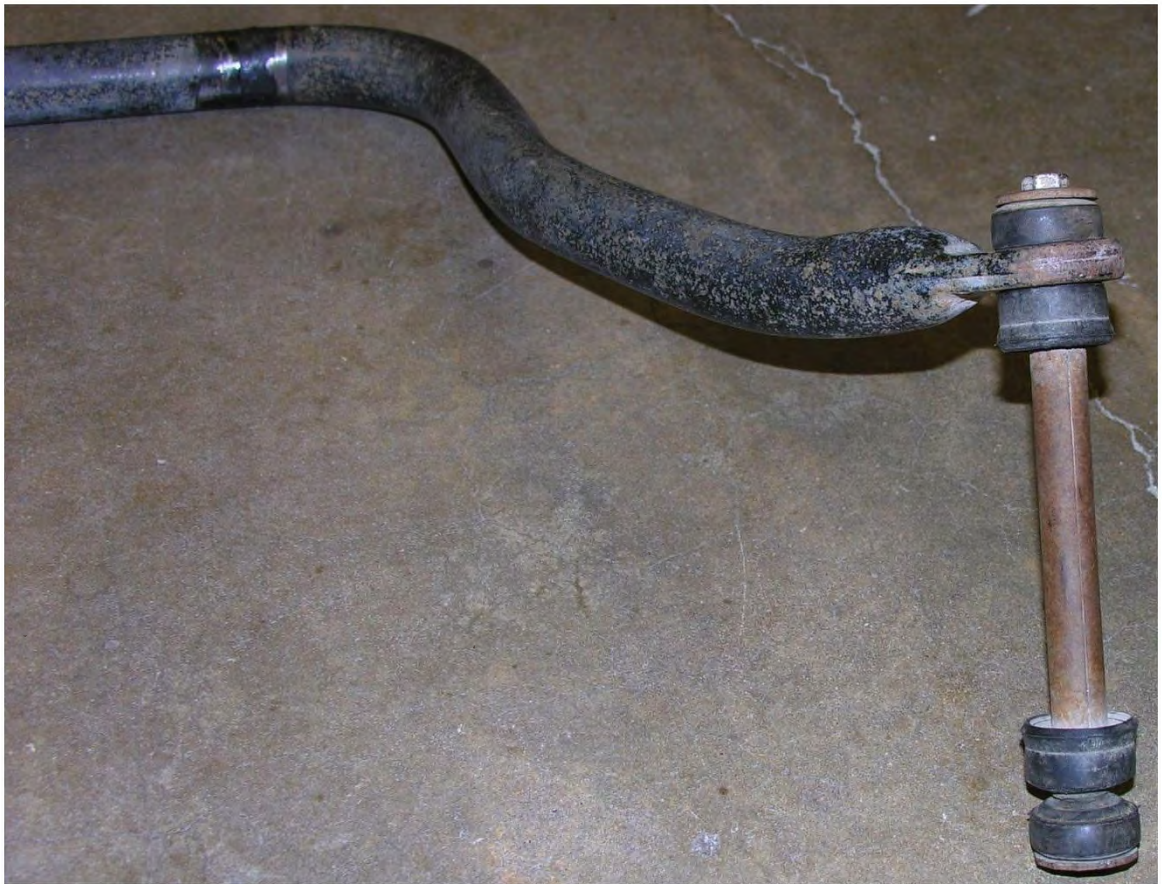
Figure B-1. Actual Anti-Roll Bar and Pin Connection
