DEVELOPMENT AND *MASH* TL-4 EVALUATION OF TxDOT RUBBER MOUNTED SINGLE SLOPE BARRIER

Test Report 0-6895-R1

Cooperative Research Program

TEXAS A&M TRANSPORTATION INSTITUTE

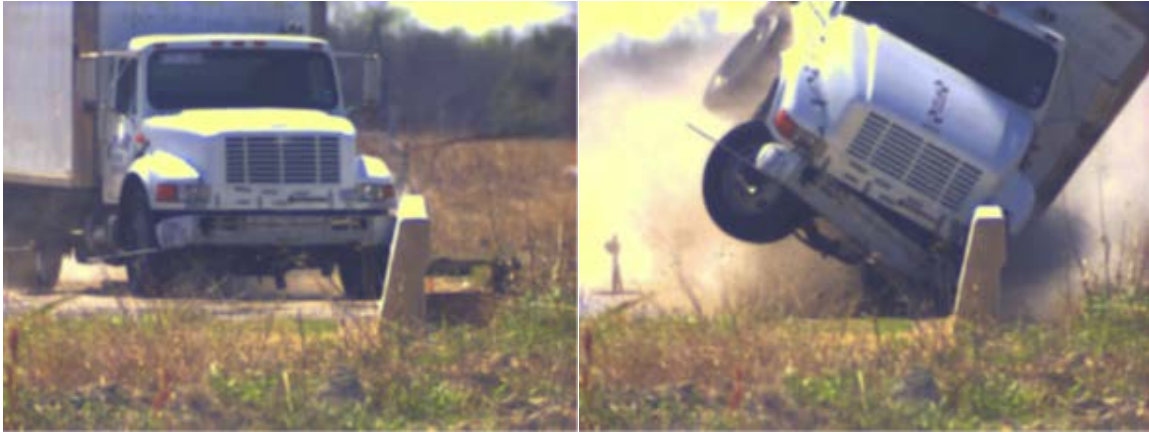
Figure 2.3. Sequences Showing SUT Impacting a 36-inch Tall Texas SSTR.

No notable occupant compartment deformation from the test was noted, but the impact to the vehicle itself was significant. Damages included a left front tire blow-out and bumper deformity. Other damages included the left frame rail, front axle, front U-bolts and springs, front tire rod, steering rod, left rear U-bolts and springs, and drive shaft. All of these were deformed as a result of the test. This test was considered a success per *MASH* evaluation criteria.

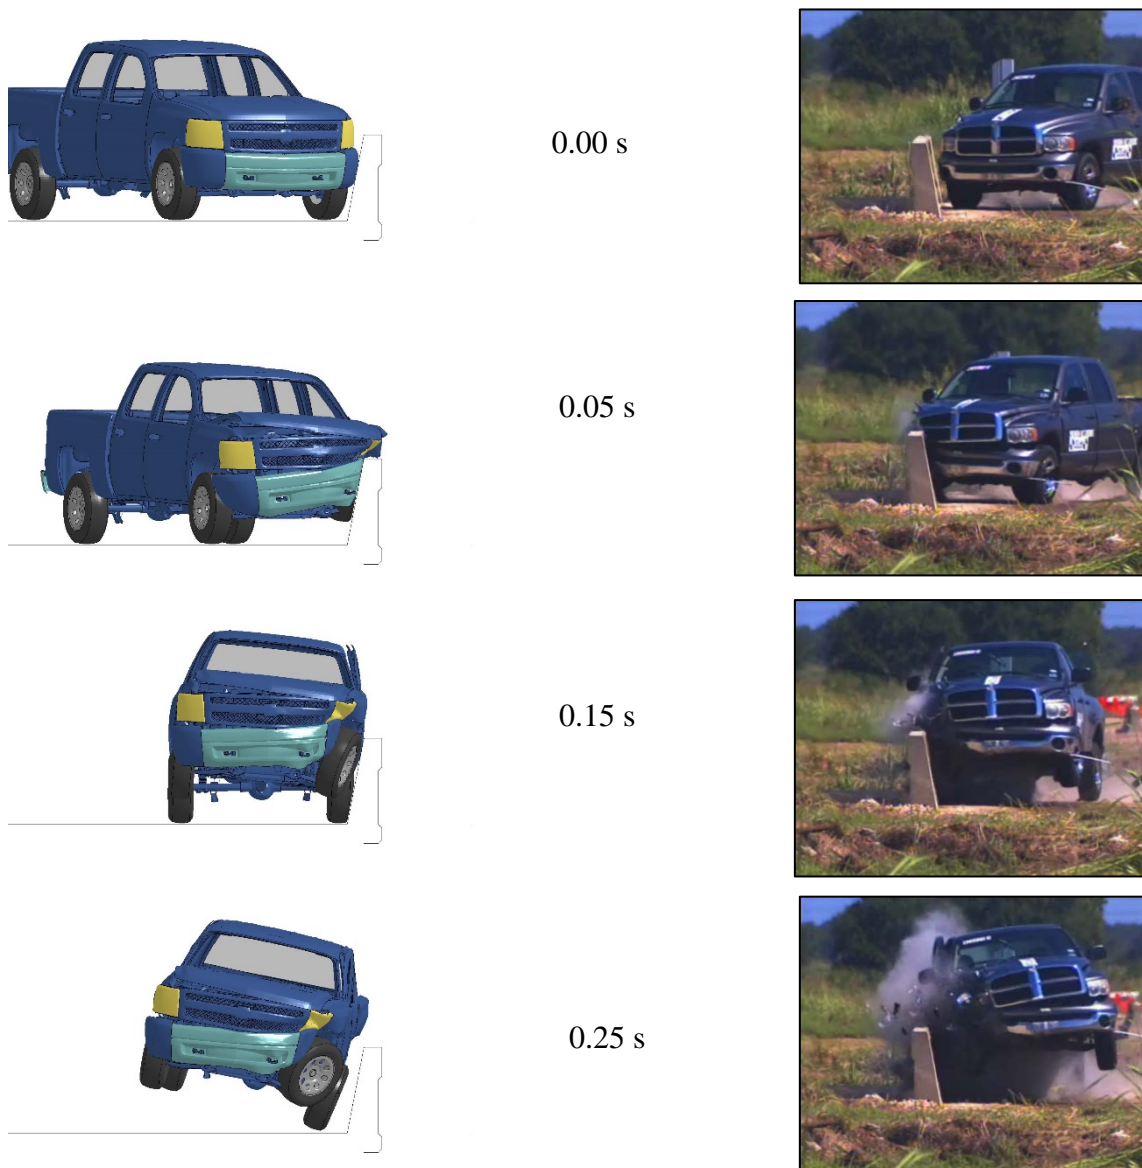
Figure 2.6. Sequential Comparison of Pan Form Test (Right) and Simulation (Left) under MASH Test 3-11 Impact Conditions.

Comparison of the results from the Pan Form Retrofit test and the finite element simulation point to a reasonable correlation. Figure 2.6 presents a photographic comparison of the simulation and the crash test. Table 2.1 shows the occupant risk values for the simulation. The X-acceleration, Y-acceleration, and the angular displacements for the crash test are shown in Figures 2.7 through 2.9, respectively.

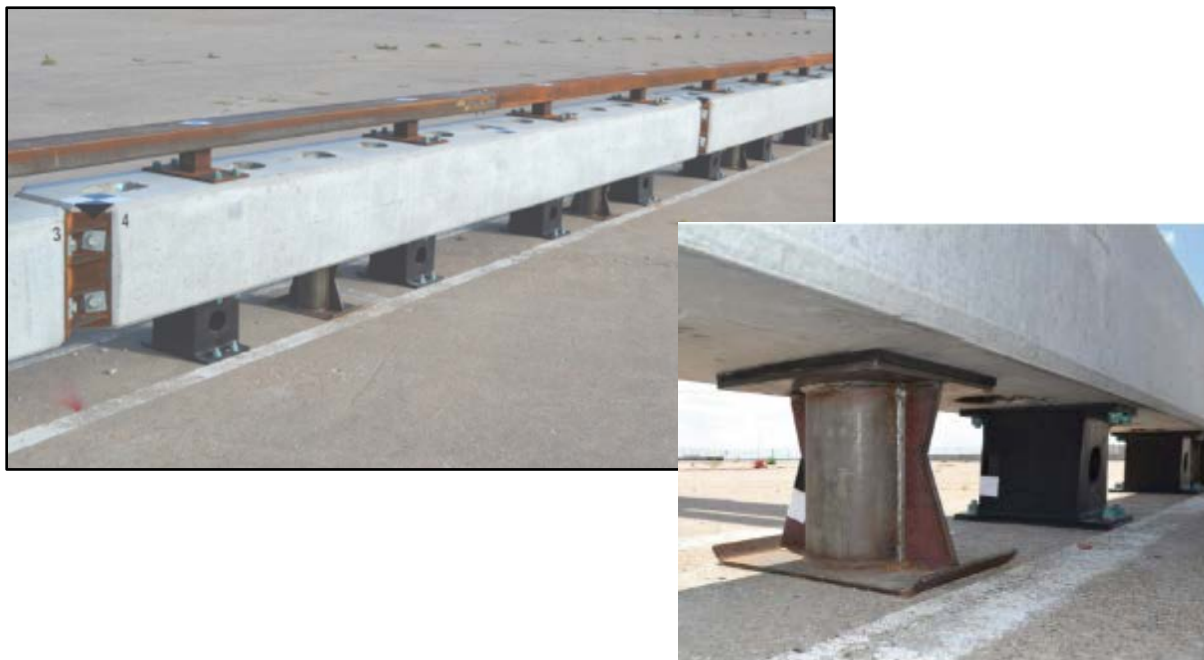
Figure 2.22. Concrete Beam Barrier with Alternating Steel and Rubber Post from MwRSF.

Researchers at the Midwest Roadside Safety Facility (MwRSF) developed a concrete barrier that employs precast concrete sections, steel rail on top, positively attached rubber footings, and sliding steel footings (12). Figure 2.22 shows this hybrid system. The rigid concrete barrier was designed to be a high containment longitudinal barrier. Elastomer (rubber) support posts, or shear fenders, were used to absorb energy by restoring their pre-crash position. This selection was based on restorability, resistance, flexibility, moldability, and successful performance in several safety tests. The shear fenders measured 11⁵/₈ inches × 10 inches × 15³/₄ inches and were attached to the concrete beam. They were also meant to extend the time of vehicle impact, thus reducing the force imparted to the vehicle.

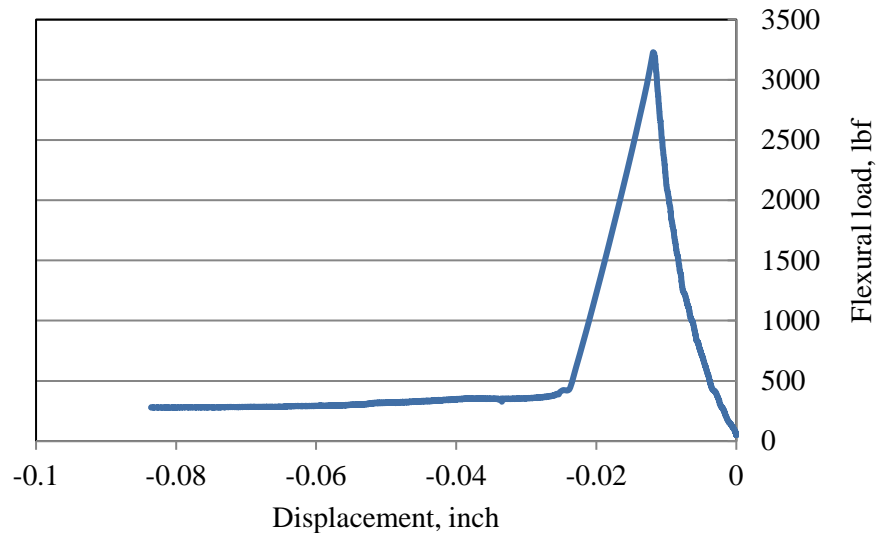
Figure 3.4. Load-Deflection Curve for Gnet.25 Sample.

As per ASTM C1609, flexural toughness was determined by calculating the area under the flexural testing load-deflection curve up to 0.08 inch deflection. Figure 3.4 shows a sample load-deflection curve **Error! Reference source not found.** The area under the curve was automatically calculated by the flexural testing device software. However, the machine was unable to capture the load-deflection data for the samples that exhibited brittle and abrupt failure, and provided incorrect toughness values. For these mentioned cases, the trapezoid method was incorporated to manually calculate the toughness value from the load-deflection curve.

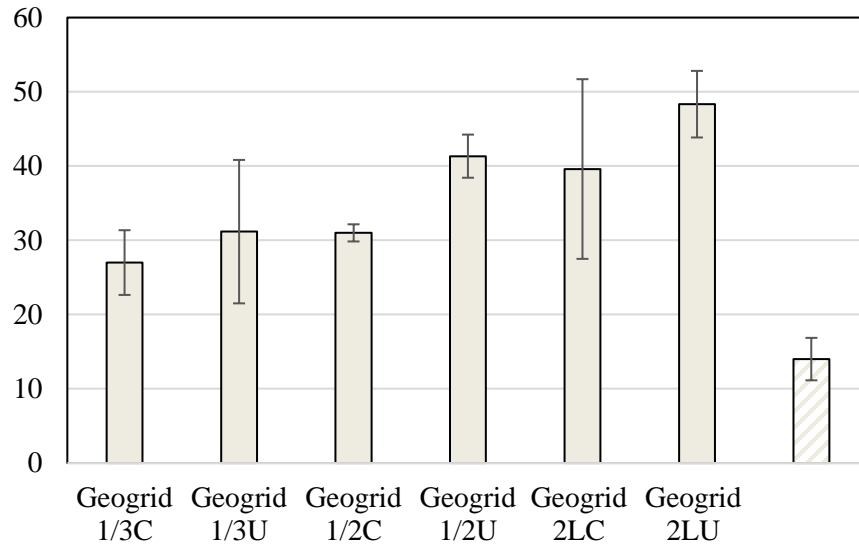
Figure 3.8. Number of Blows to Initial Crack Data Comparison for Geogrid Samples and Control.

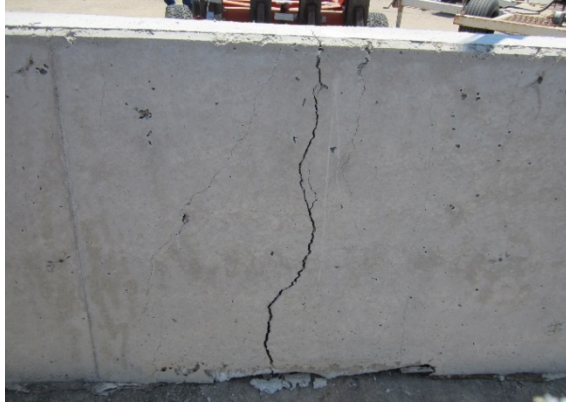
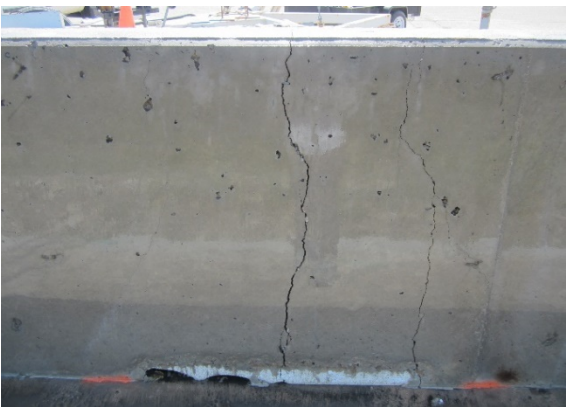
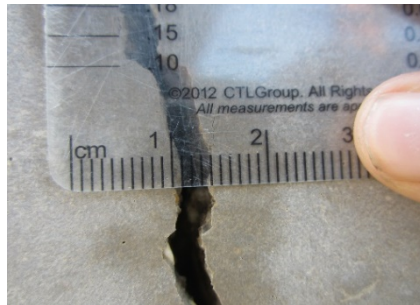
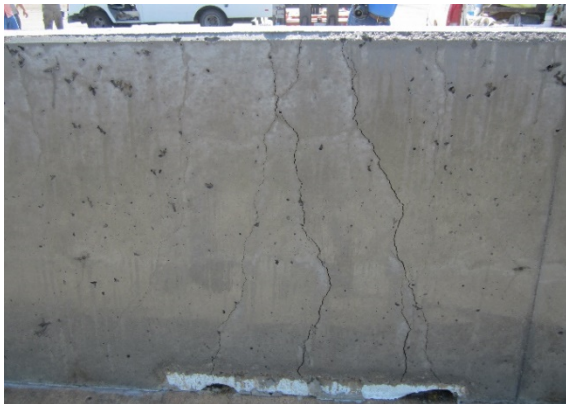
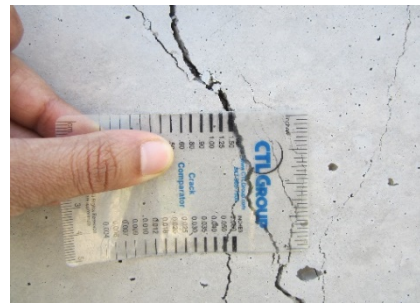
(a) CR10FGnet crack pattern

(b) CR10FGnet maximum crack width measurement

(c) Control mixture crack pattern

(d) Control maximum crack width measurement

(e) PR5FCR5F crack pattern

(f) PR5FCR5F maximum crack width measurement

- c) Figure 3.19 shows images of the crash barriers taken after field bogie test was performed to analyze crack pattern and crack opening. The crack pattern of the CR10FGnet mixture showed a zipper effect on the mixture. Impact loading induced zipper-like effect after initiation of the crack. Therefore, a single straight-line crack formation was observed. PR5FCR5F blend performed well in arresting the crack propagation; thus, thin width cracks with a branched pattern was observed for this mixture. Maximum crack opening for the control was smaller than CR10FGnet, but larger than PR5FCR5F mixture.

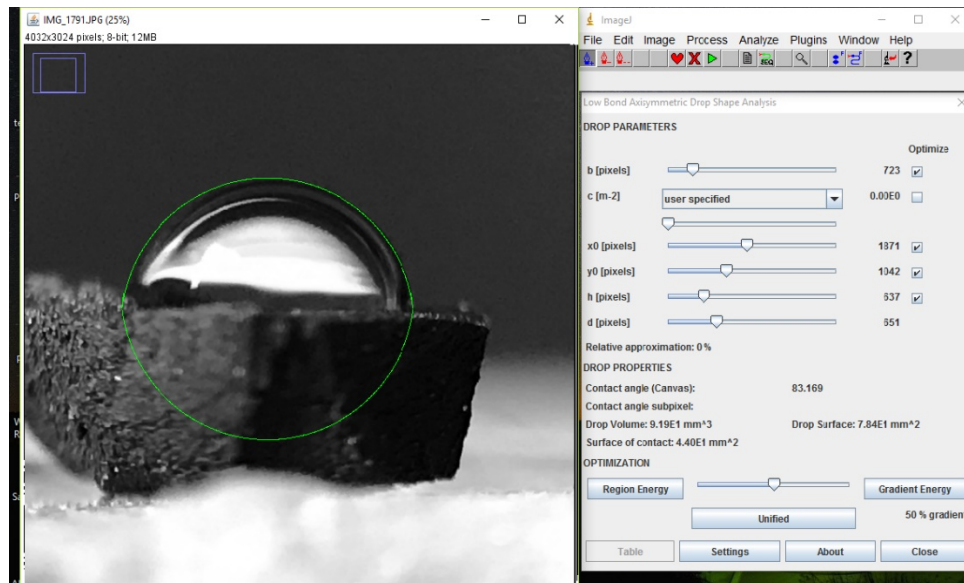
Figure 3.20. Drop Analysis on Surface of Rubber using ImageJ Plugin.

Two sets of 2-inch mortar cube samples were cast, one containing treated rubber particles and the other containing untreated particles. Compressive strength testing was performed at 7 and 28 days as an indirect way to assess change in bond properties. Additionally, the change in contact angle of the water on the surface of the rubber was assessed. The contact angle technique was incorporated to determine the wettability of rubber. Images of 0.5µL water droplets on the surface the surface of rubber was captured, and the ImageJ software plugin was utilized to analyze and determine the wetting angle of rubber before and after treatment (see Figure 3.20). A decrease in the angle of contact between the rubber and water indicates an increase in hydrophilicity.

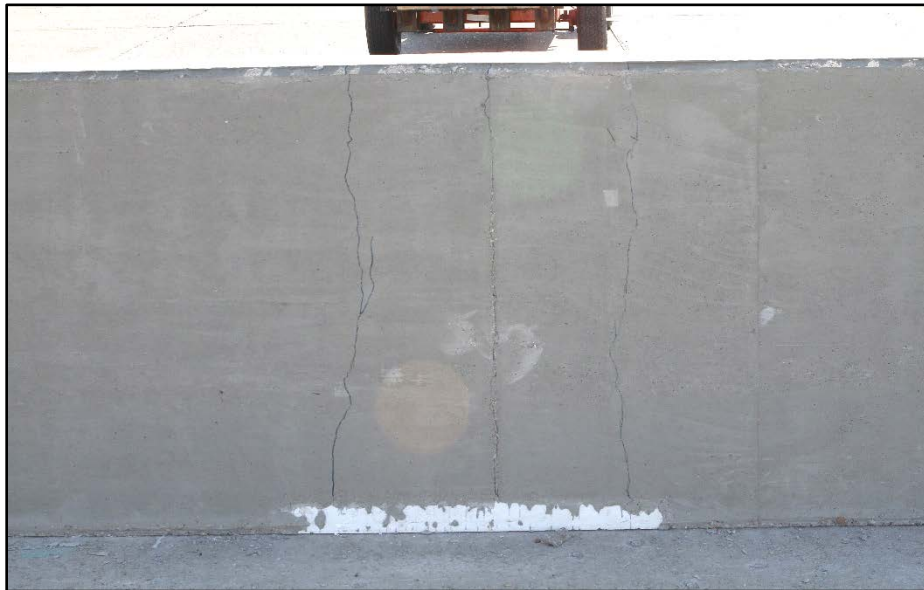
Figure 5.7. Field Side-Center of Barrier after Test No. 468957-B4.

Maximum deflection of the barrier was 22.3 inches and maximum permanent deflection was 1¼ inches. Three vertical cracks (one at centerline and two 12 inches to each side of centerline) were noted on the field side. Figures 5.3 through 5.7 show damage to the barrier.

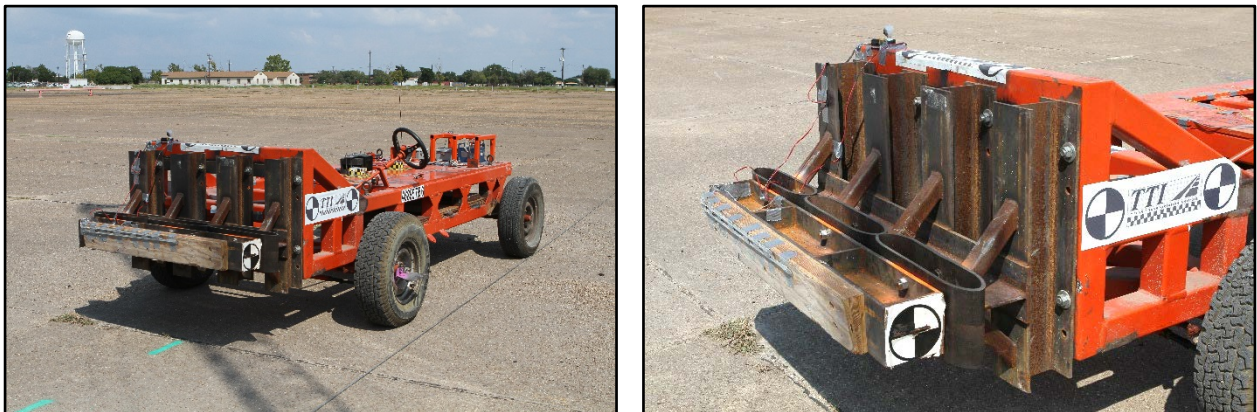
Figure 5.24. Bogie Vehicle after Test No. 468957-B7.

The pipe shapes had been replaced from the previous test. Figure 5.24 shows damage to the bogie vehicle. Maximum crush of the pipe shapes in the nose was 10 inches. The vehicle rebounded 26 ft from the traffic face of the barrier.

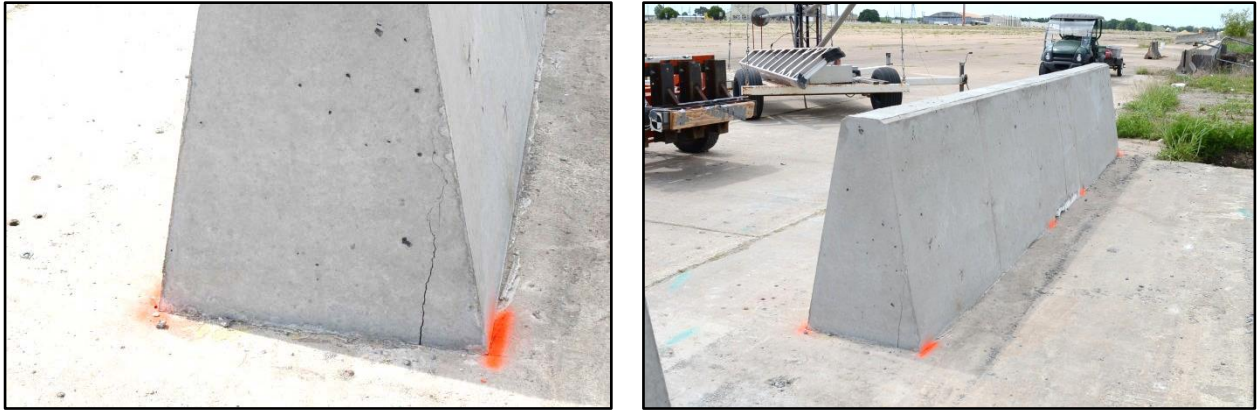
Figure 5.29. Right End and Field Side of Barrier after Test No. 468957-B8.

Maximum deflection of the barrier was 2.14 inches and maximum permanent deflection was 0.88 inch. Multiple vertical cracks radiated 3.5 ft to both sides of impact on the traffic side. Cracks on the field side were noted at center and 15 inches to the right of the crack at center. A crack was also noted in the ends on the field side corners of the barrier, as shown in Figures 5.29 and 5.30. Figures 5.29 through 5.33 show damage to the barrier.

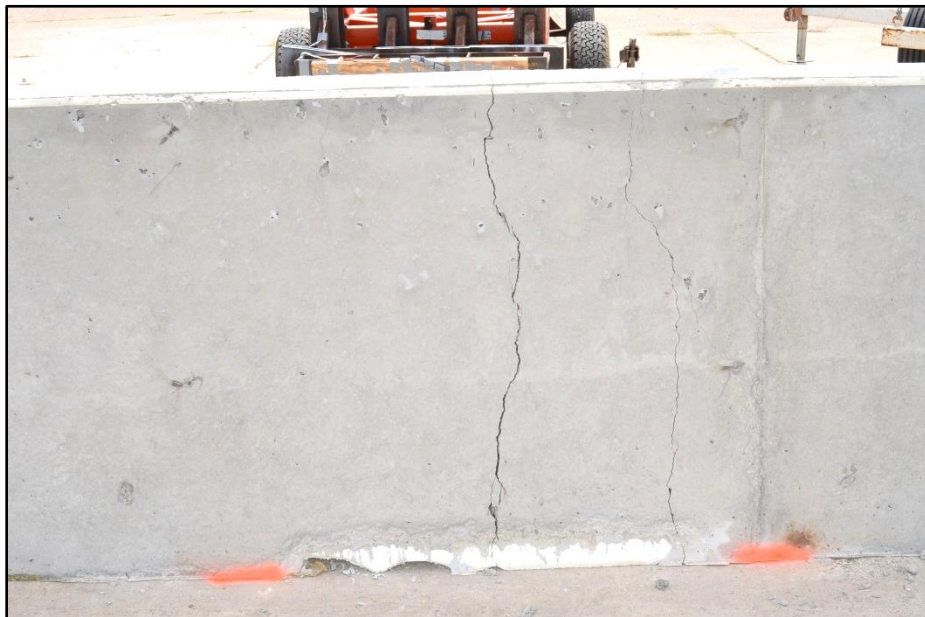
Figure 5.33. Field Side-Center of Barrier after Test No. 468957-B8.

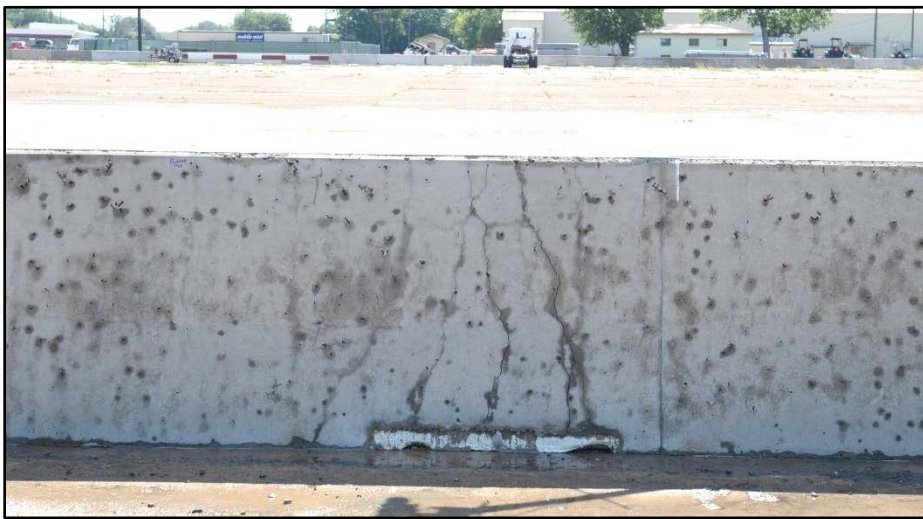
Figure 5.42. Field Side-Center of Barrier after Test No. 468957-B9.

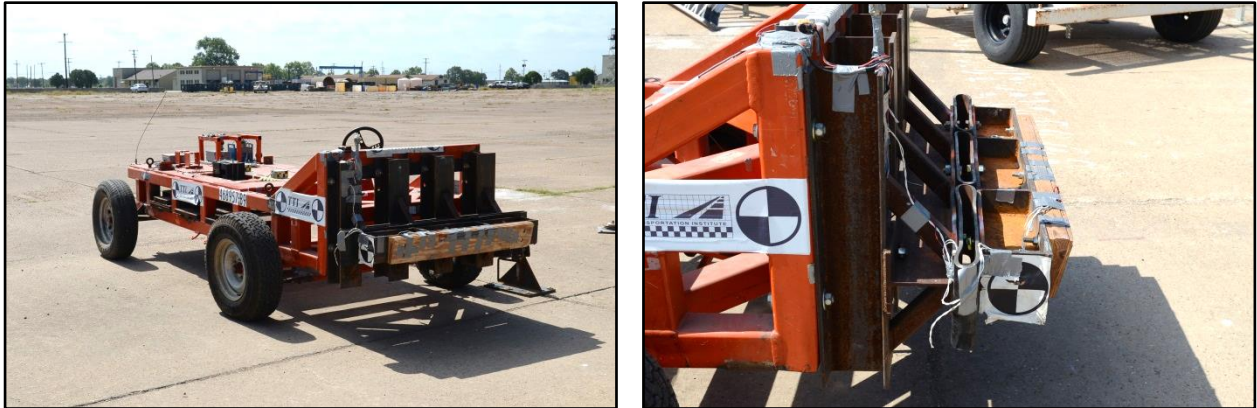
Figure 5.43. Bogie Vehicle after Test No. 468957-B9.

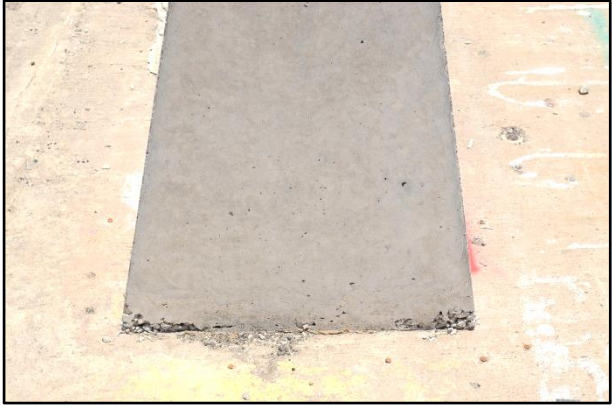
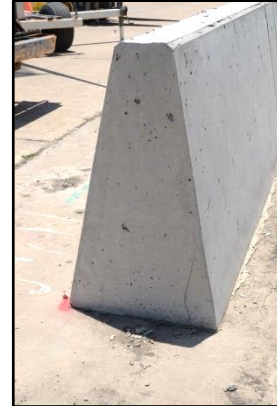
Figure 5.47. Right End and Field Side of Barrier after Test No. 468957-B10.

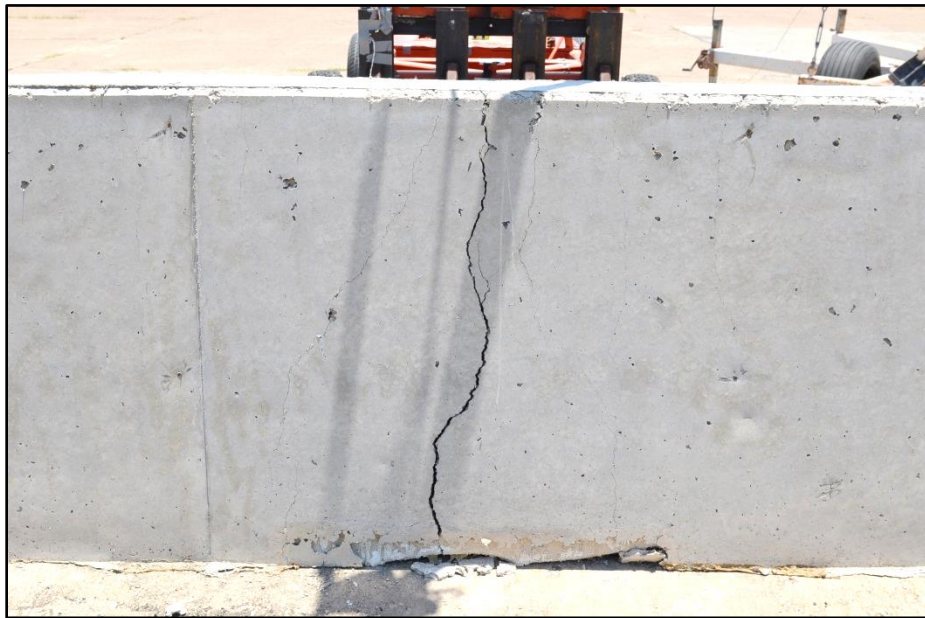
Figure 5.51. Field Side-Center of Barrier after Test No. 468957-B10.

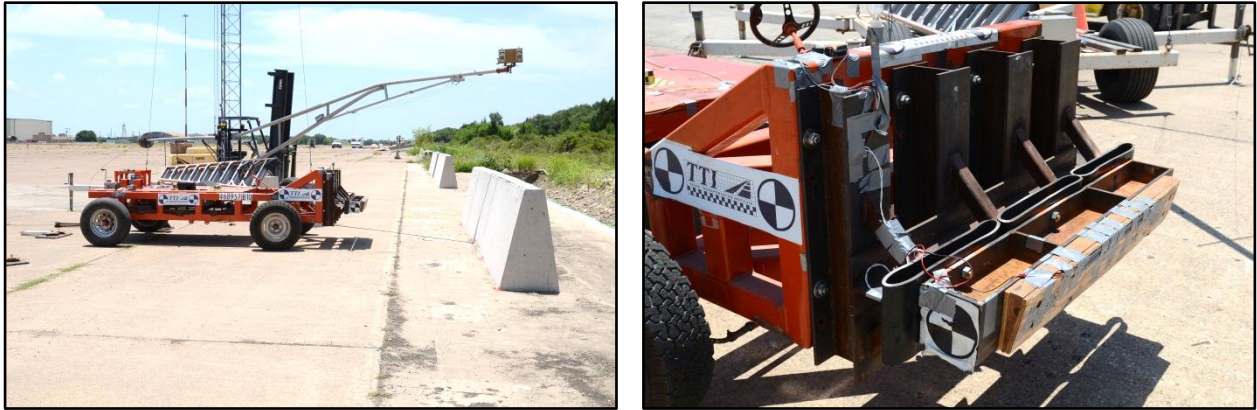
Figure 4.52. Bogie Vehicle after Test No. 468957-B10.

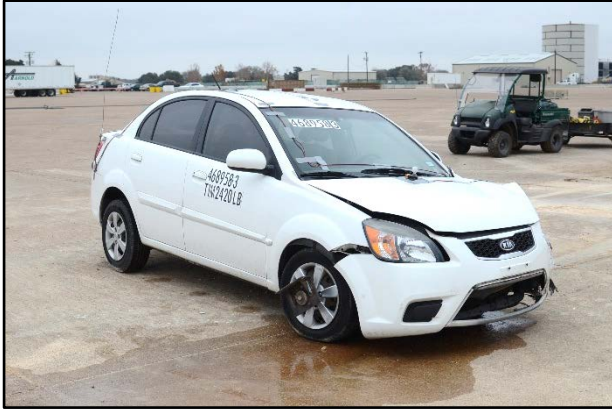
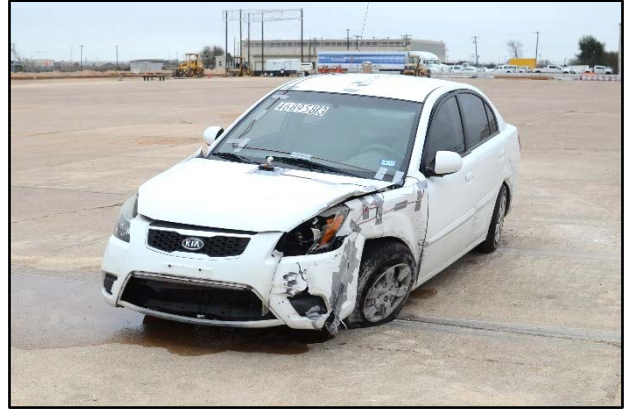
Figure 9.4. Test Vehicle after Test No. 468958-3.

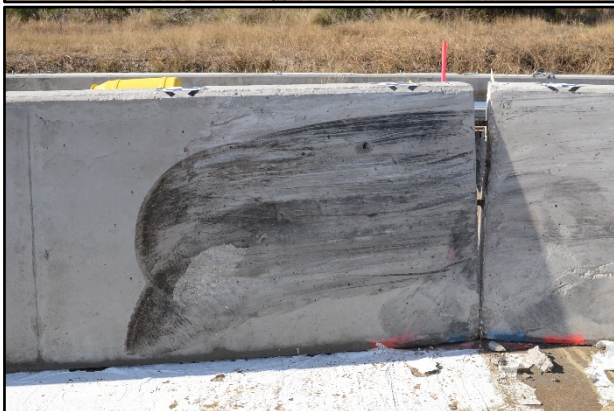
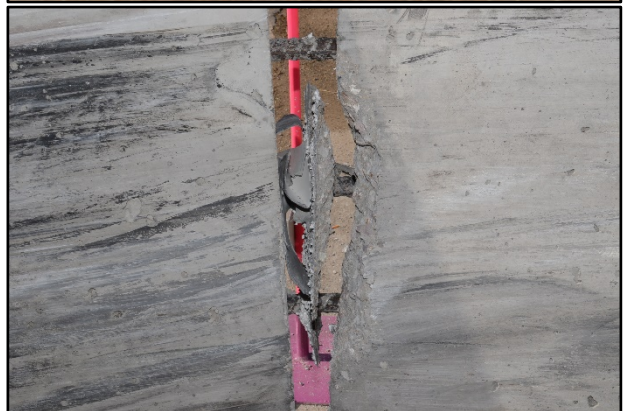
Figure 10.4. Damage to Barrier #1 after Test No. 468958-2.

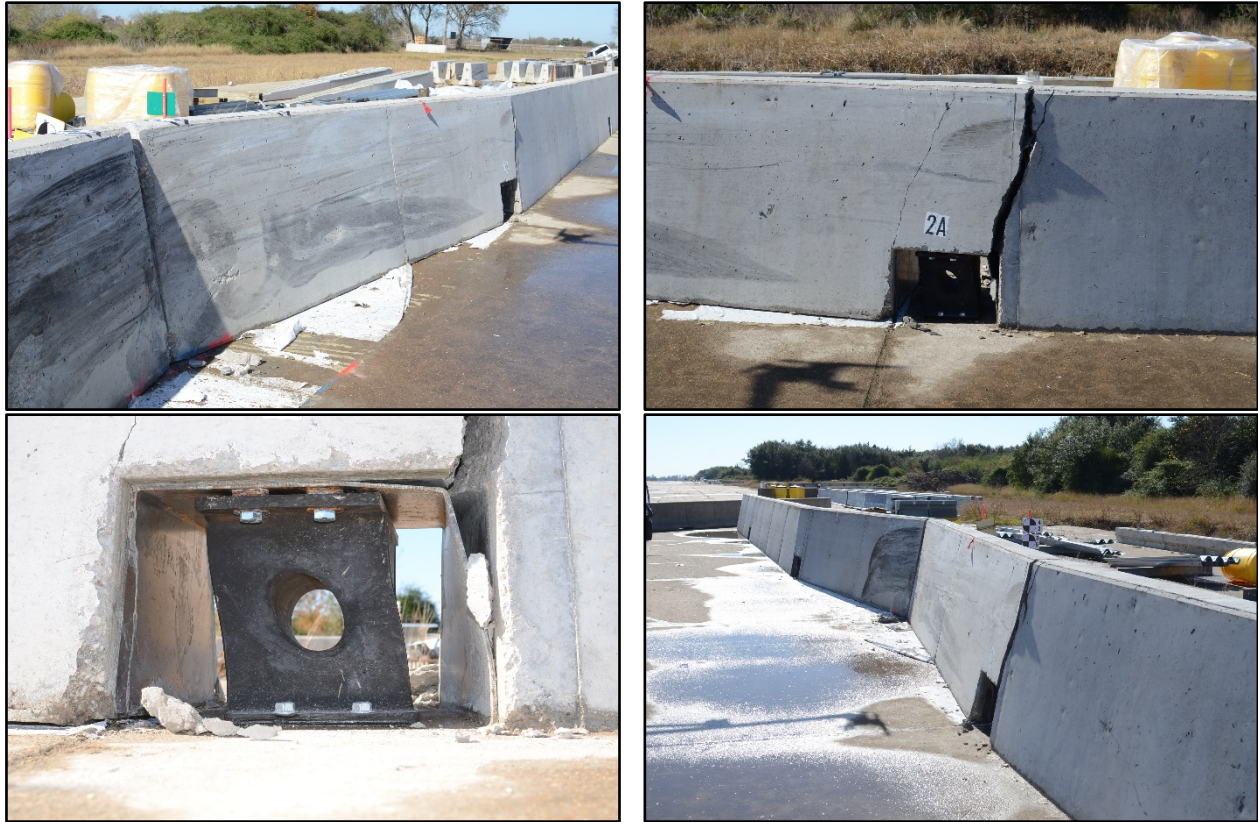
Figure 10.5. Damage to Barrier #2 after Test No. 468958-2.

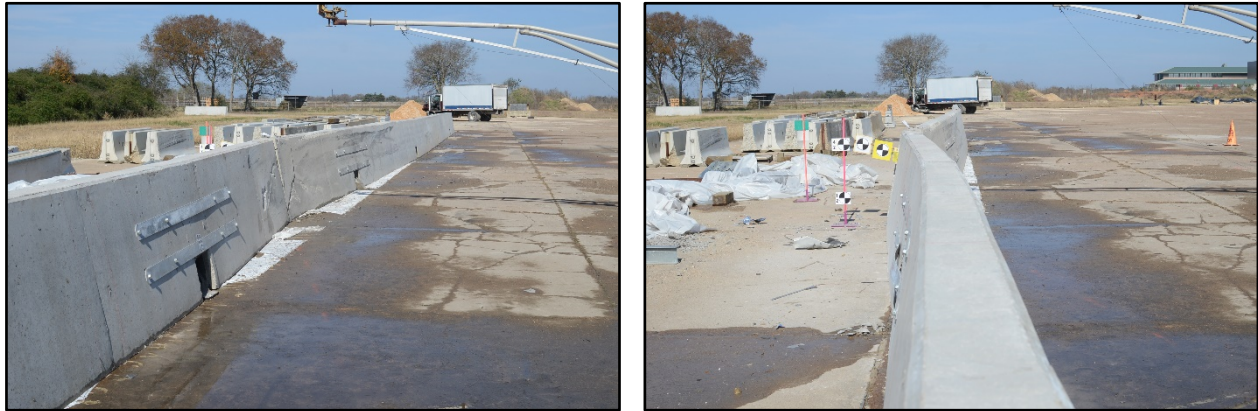
Figure 11.3. TxDOT Rubber Mounted Single Slope Barrier/Test Vehicle after Test No. 468958-3.

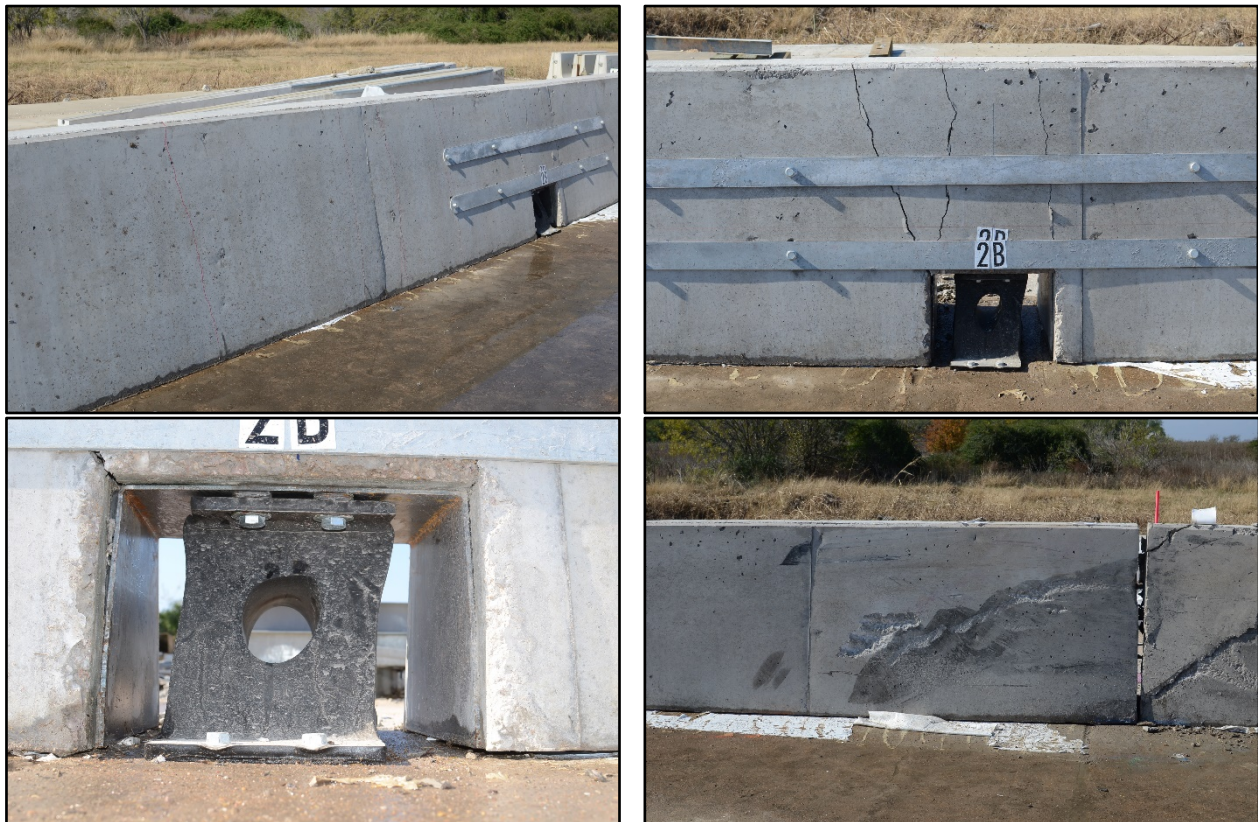
Figure 11.4. Damage to Barrier #2 after Test No. 468958-3.

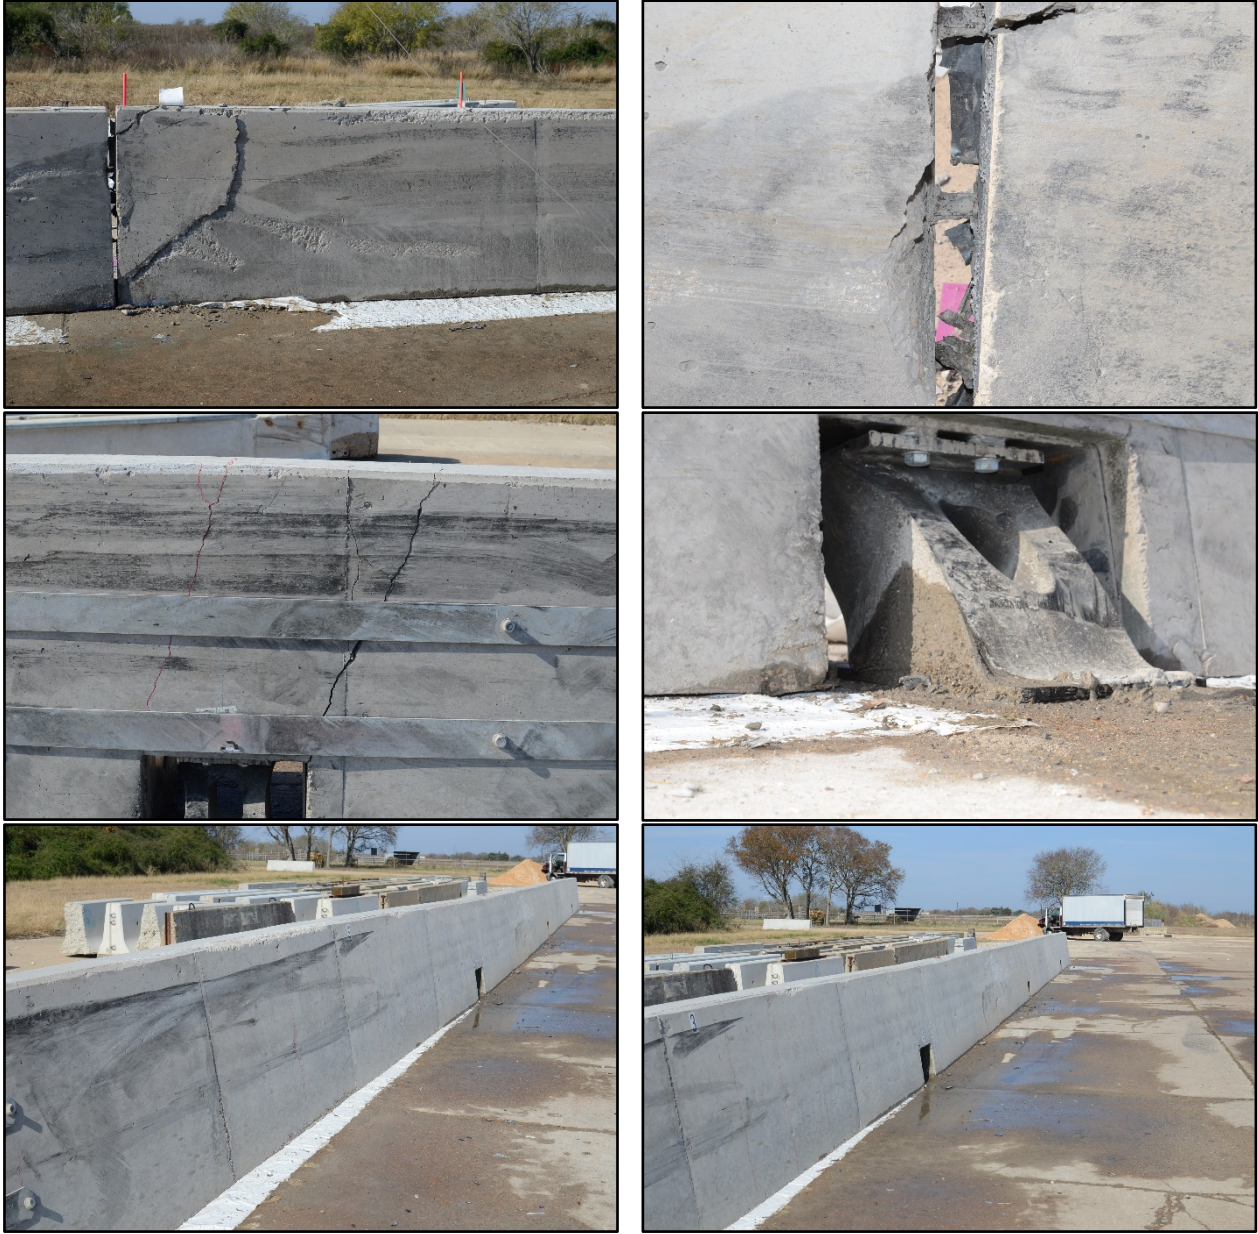
Figure 11.5. Damage to Barrier #3 after Test No. 468958-3.

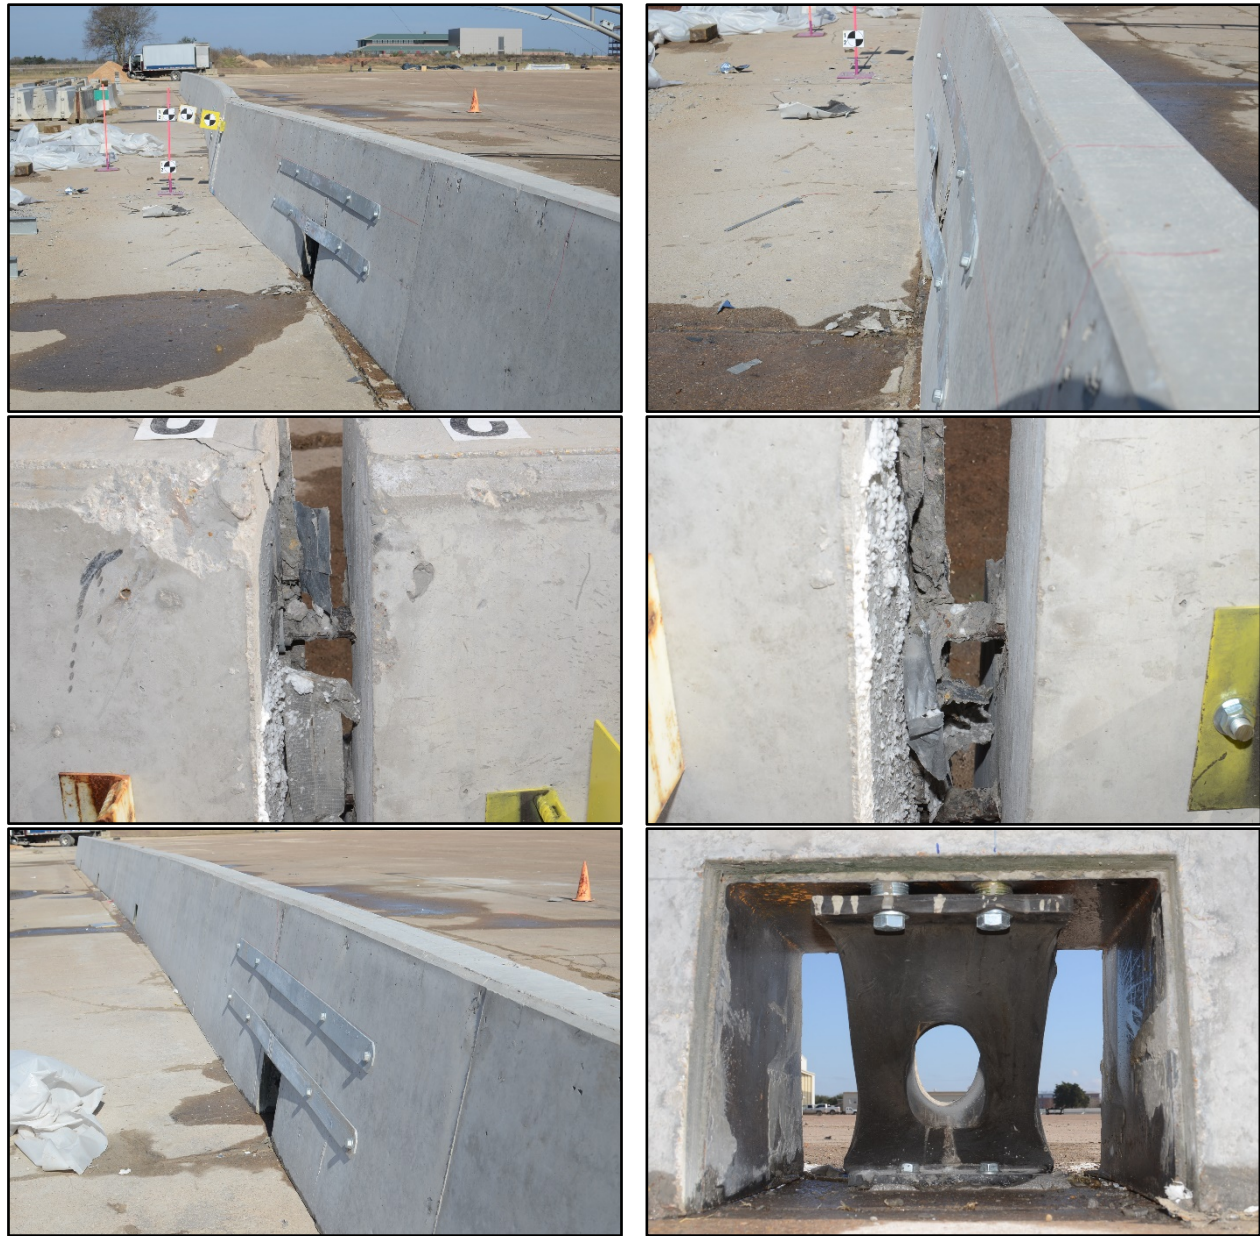
Figure 11.6. Damage to Field Side of Barrier after Test No. 468958-3.
