**BRIDGE DECK PATCHING MATERIALS**

**Final Report**

**PennDOT/MAUTC Partnership, Work Order No. 10  
Research Agreement No. 510401**

**June 2008**

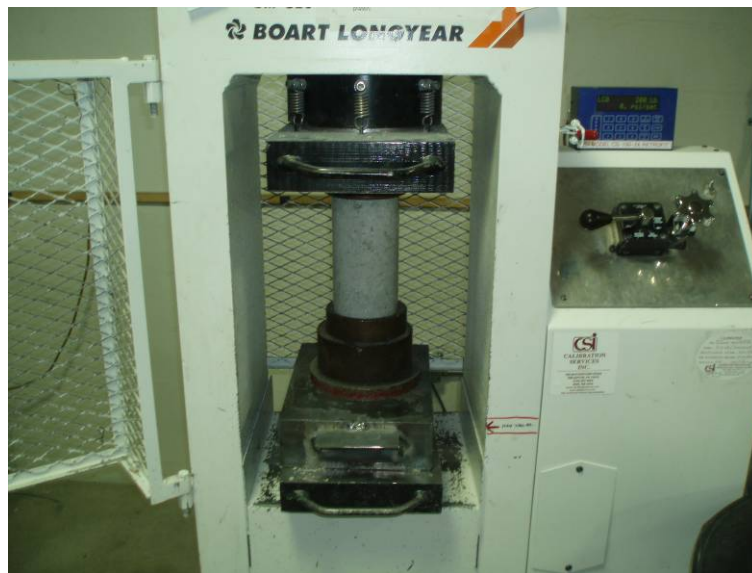
Apply a compressive load on a concrete cylinder at an increasing rate until the specimen fails (Figure 2-1). The compressive strength of the specimen is then found by dividing the maximum load seen by the cylinder by its cross-sectional area (ASTM 2006).

Figure 2-1: ASTM C 39

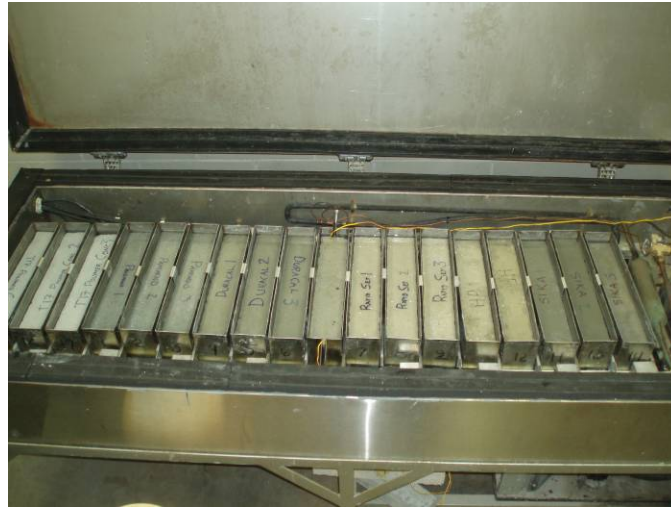
Molded beam specimens submerged in water (Figure 2-2) are cycled between thawing [40°F (4.4°C)] and freezing [0°F (-17.8°C)] temperatures for “300 cycles or until the relative dynamic modulus of elasticity (a measurement of the solidity of the

material's microstructure) reaches 60% of the initial modulus, whichever occurs first.”

This test is repeated using salt water (ASTM 2006).

Figure 2-2: ASTM C 666

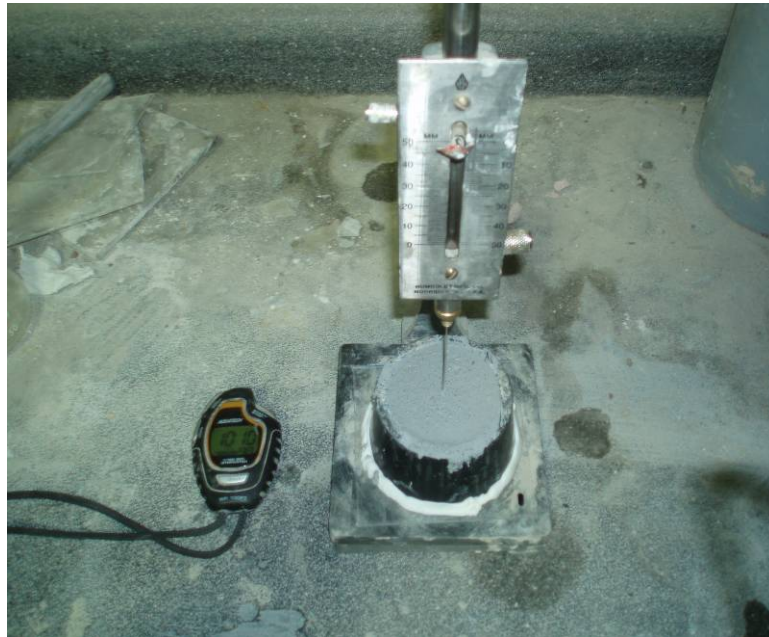
Mortars of the patching material are made and placed in a 1.57-inch (40-mm) high mold. Then, the initial and final setting time is determined by a Vicat needle, which is a weighted, 0.039-inch (1-mm) diameter needle that is mounted directly above the mortar, and is released, allowing it to drop into the specimen (Figure 2-3). The time when the needle only penetrates 0.98 inch (25 mm) into the mortar marks the time of initial setting, and the time when the needle cannot penetrate at all into the mortar marks the time of final setting (ASTM 2006).

Figure 2-3: ASTM C 191

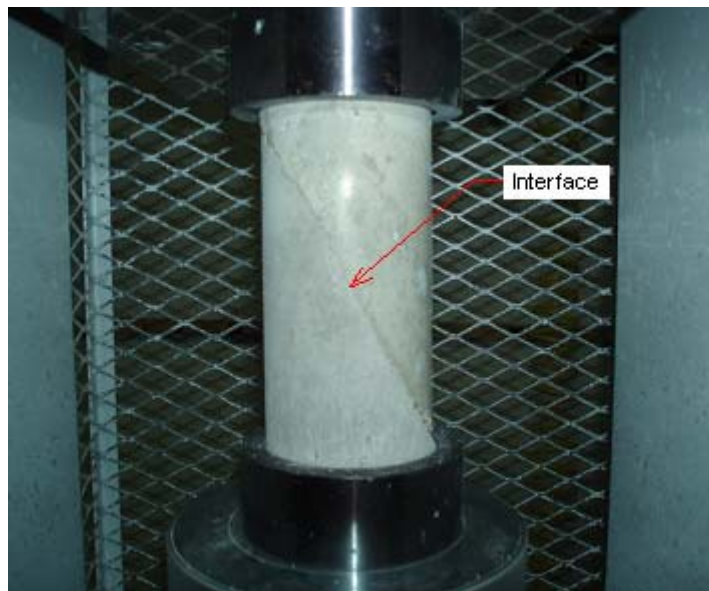
A composite cylinder is composed of two equal volume sections, whose interface forms a 30-degree angle with vertical (Figure 2-4). The bottom half is base concrete and the other half is that of the patching material. A bonding system is not applied at the interface unless required by the manufacturer. Then, a compressive strength test (ASTM C 39) is run on the hybrid cylinder. The bond strength is determined by dividing the load at failure by the area of the interface between the two sections (ASTM 2006).

Figure 2-4: ASTM C 928 and ASTM C 882

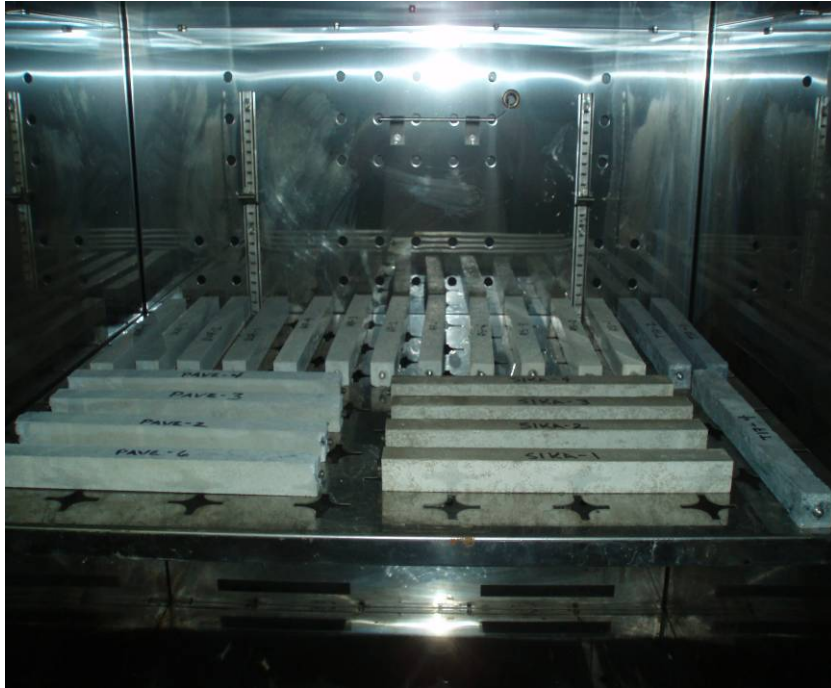
The specimens are heated again at 210°F (99°C), and then cooled at a temperature of 73°F (23°C) for 16 hours and measured. They are then heated again to 210°F (99°C) for 16 hours and removed one at a time and measured. The coefficient of thermal expansion can then be determined by dividing the length of the specimen at the elevated temperature by the length at the lower temperature and the temperature change  $[L_E / (L_L * \Delta T)]$ ; where  $L_E$  = Length at elevated temperature,  $L_L$  = Length at lower temperature,  $\Delta T$  = Change in temperature] (ASTM 2006).

Figure 2-5: ASTM C 531 M (Specimens heated in oven)

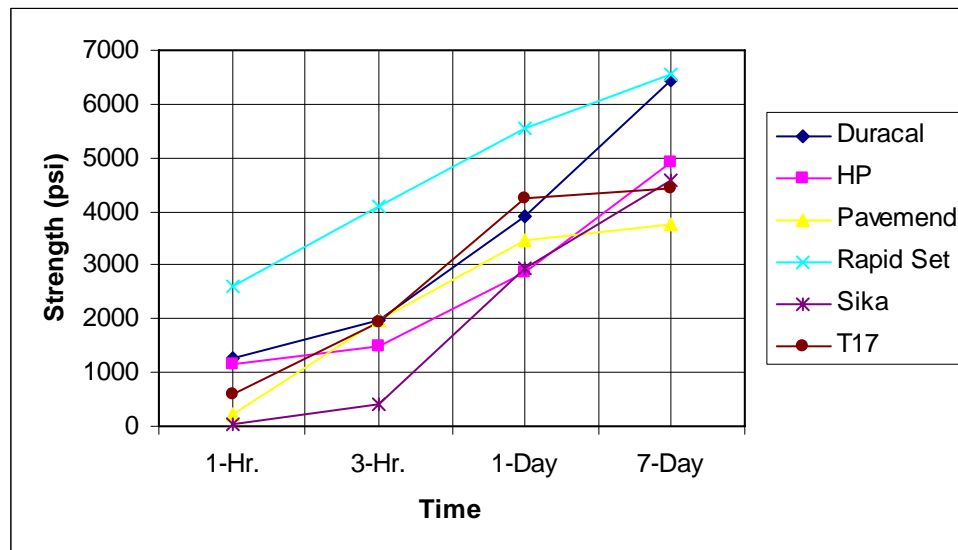
Material	1-Hr. (psi)	3-Hr. (psi)	1-Day (psi)	7-Day (psi)
Duracal	1250	1960	3920	6440
HP	1170	1490	2860	4900
Pavemend	240	1960	3450	3760
Rapid Set	2620	4110	5540	6570
Sika	20	410	2950	4590
T17	600	1920	4240	4430

Figure 2-6: Compression, Cylinders – ASTM C 39

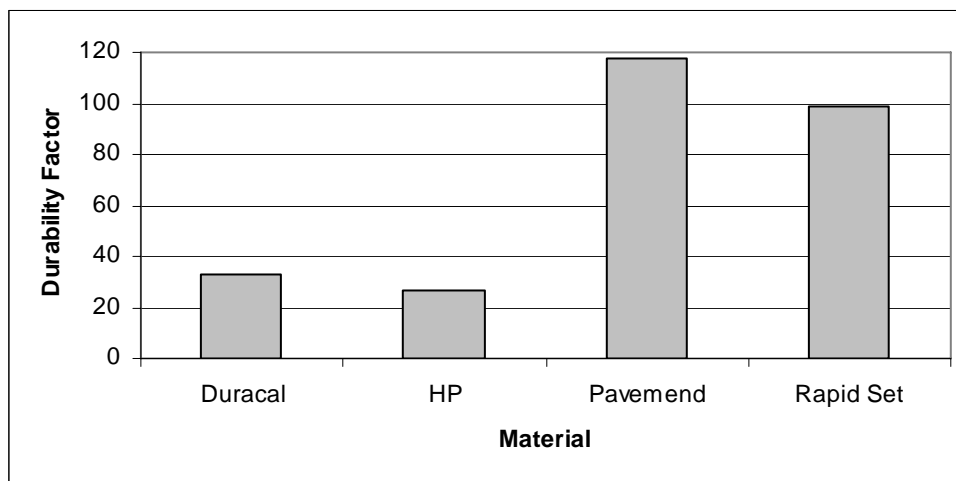
Material	Durability Factor	Comments
Duracal	33	Scaling; Outer Layer Deteriorated
HP	26	Severe deterioration; Unrecognizable
Pavemend	118	Perfect Condition
Rapid Set	99	Depressions and scaling, but not severe

Figure 2-8: Freeze-Thaw – ASTM C 666 (Salt Water)

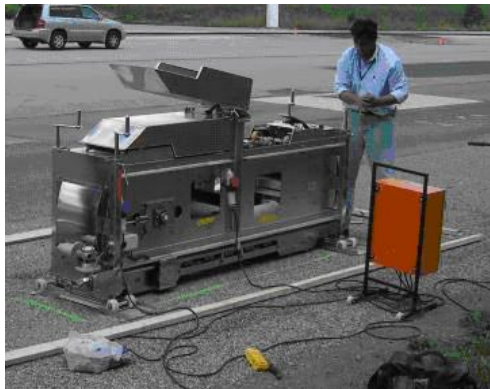
- Durability of the patch under repetitive tire loading was evaluated using the MMLS3 (Mobile Model Load Simulator - 3rd scale), shown in Figure 3-1.

Figure 3-1: MMLS3

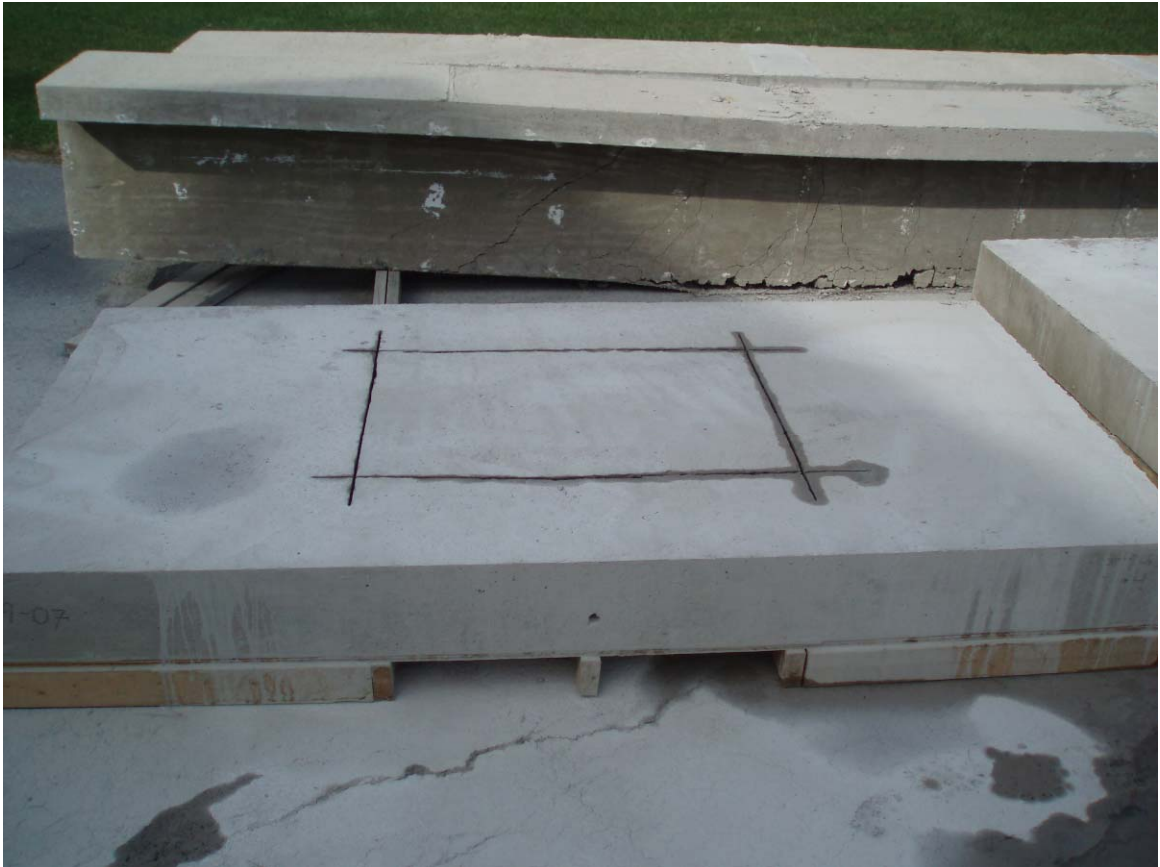
1. Mark the areas of deteriorated concrete on the bridge deck that are in need of replacement.
2. Saw cut around the perimeter of the marked areas, making sure that all of the perimeter angles are right angles (Figure 3-6).

Figure 3-6: Saw-Cut Test Slab

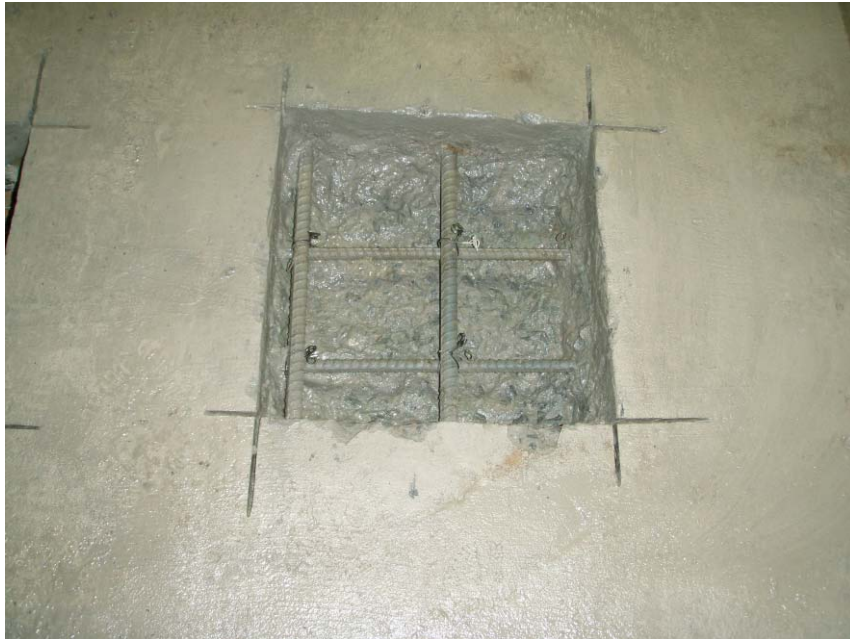
3. Jackhammer out the area within the saw-cut until solid substrate concrete is reached. For this testing, two different depths were considered: Half depth (Figure 3-7), which extends to 1 inch below the top mat of rebar (about 4 inches; according to PennDOT, this is a Type II patch), and full depth (Figure 3-8), which extends the entire way through the slab (8-inches deep in this case; according to PennDOT, this is a Type III patch).

Figure 3-7: Jackhammered Patch Area – Half Depth

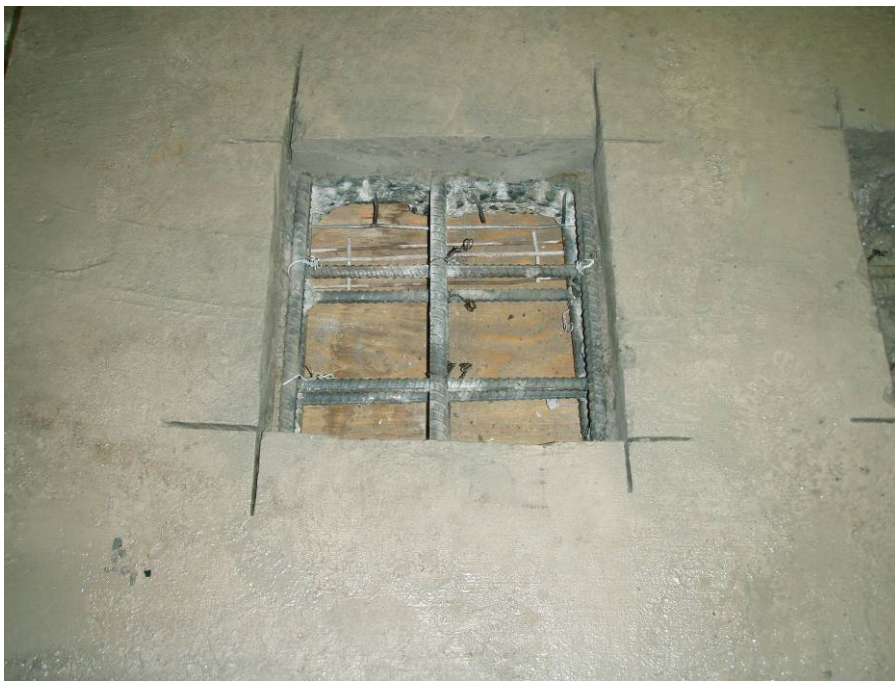
Figure 3-8: Jackhammered Patch Area – Full Depth

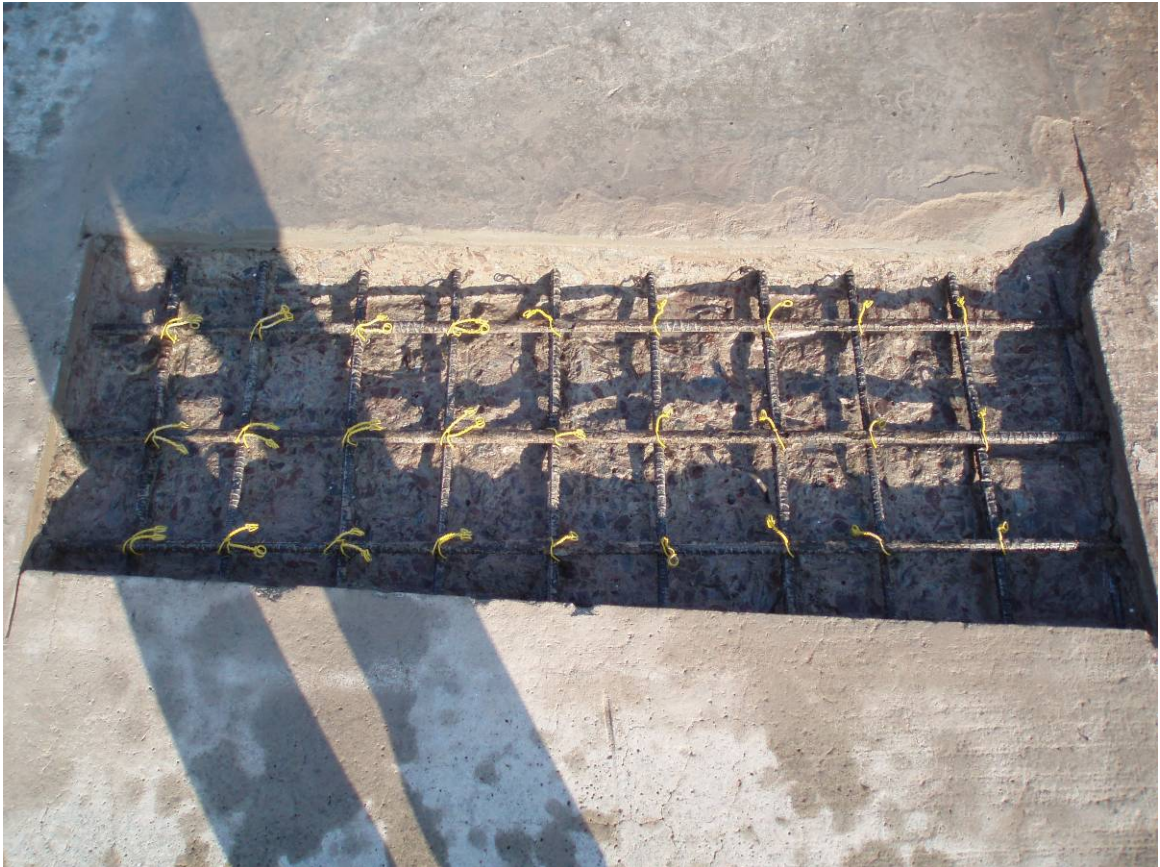
4. Clean debris off of concrete and exposed rebar by either grinding or sandblasting, and then replace any rebar ties that may have been destroyed or damaged during jackhammering (Figure 3-9).

Figure 3-9: Cleaned Patching Hole

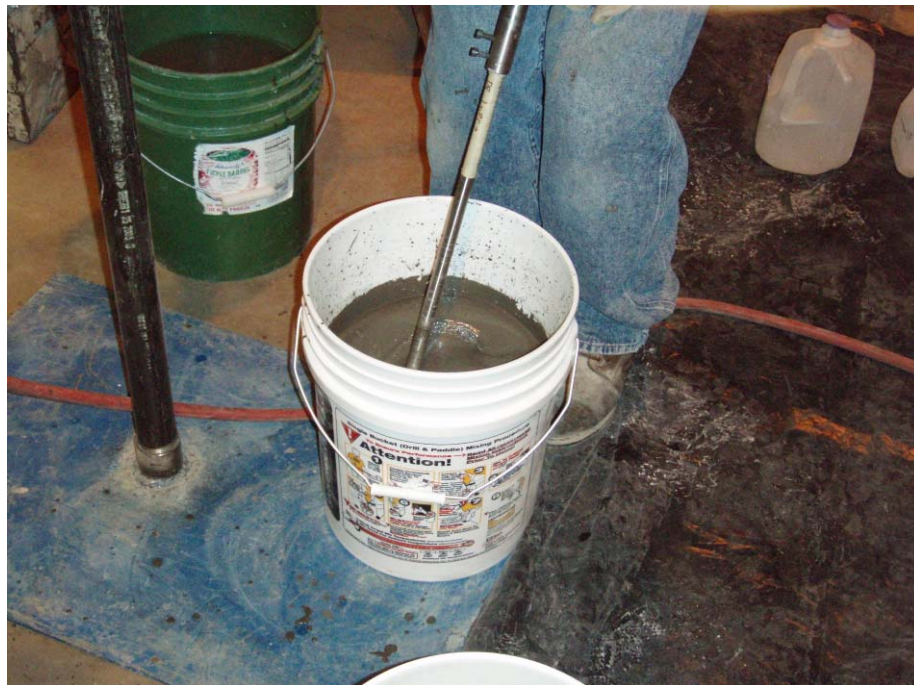
1. Ensure that the patching hole is dry and clean.
2. Using a paddle mixer with a drill capable of 300 rpm, loosen the material in the bucket.
3. Add 1 gallon of water to the bucket, and mix thoroughly until the material reaches 95°F, using a thermal gun to check the temperature (Figure 3-10).

Figure 3-10: Mixing Pavemend 15.0

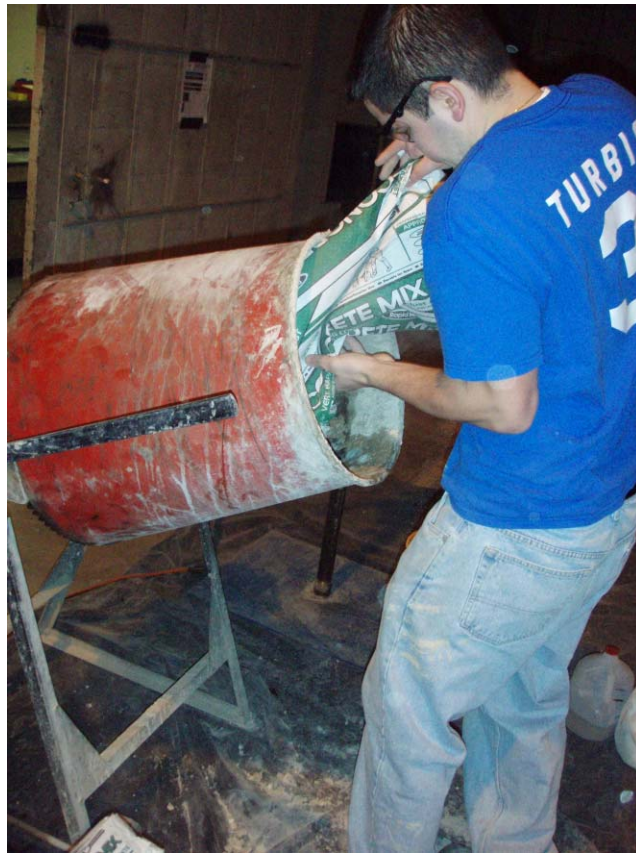
1. Ensure that the patching hole is clean, and wet the hole to saturated surface dry conditions.
2. Wet, then drain the concrete mixer.
3. Add the water (0.45 gal per bag of material) and latex (0.45 gal per bag of material) to the mixer and turn on the mixer.
4. Add the concrete mix to the mixer, and mix for 1 to 3 minutes, whenever constant consistency is reached (Figure 3-12).

Figure 3-12: Mixing Rapid Set

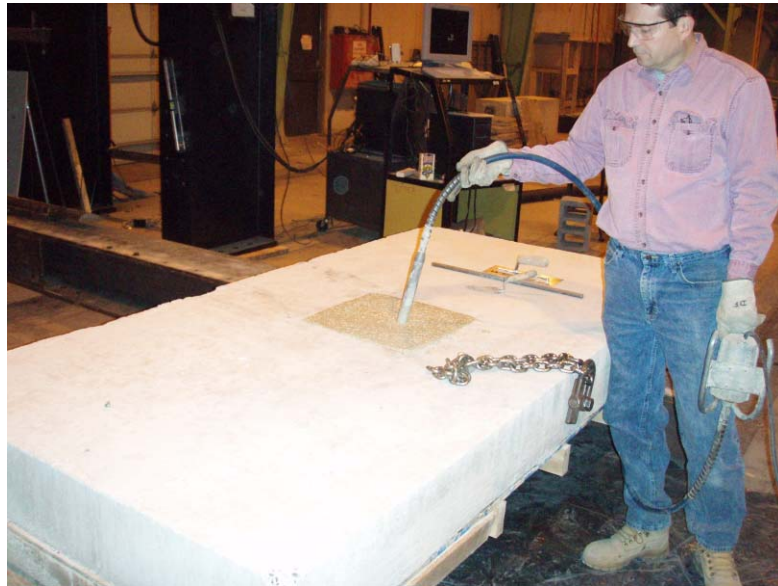
6. Pack material tighly into hole. This task is made easiest by the use of a vibrator (Figure 3-13).

Figure 3-13: Vibrating Rapid Set

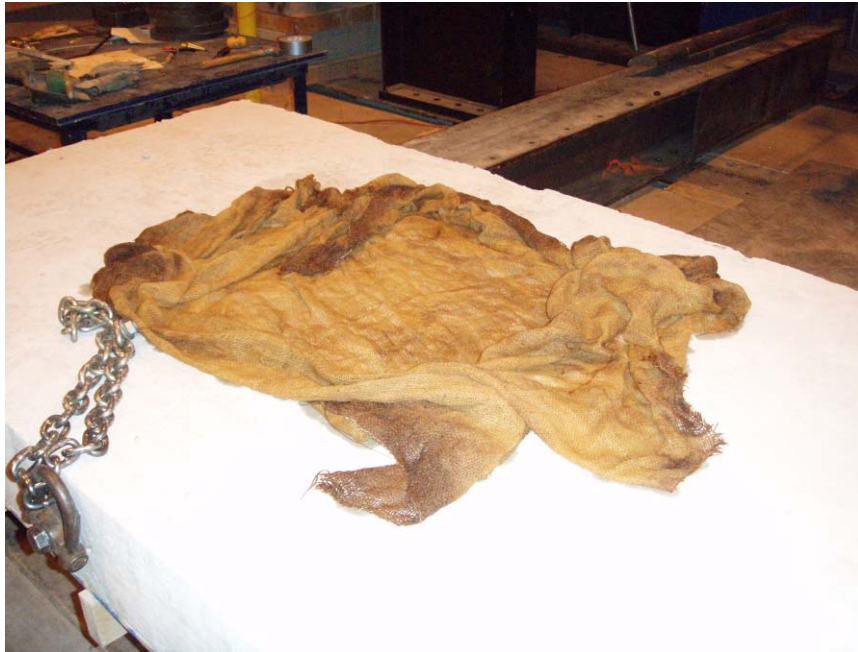
7. Finish surface as soon as possible with dry trowel or straight edge.
8. Once material loses sheen, place wet burlap over the patch for 1 hour (Figure 3-14).

Figure 3-14: Wet Curing Rapid Set

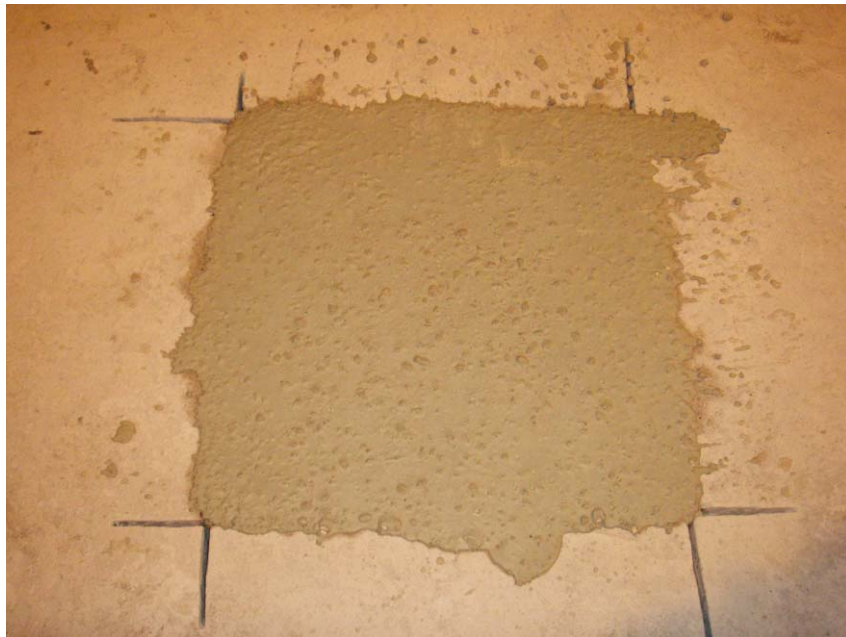
9. Remove burlap after 1 hour to reveal final product (Figure 3-15).

Figure 3-15: Rapid Set Patch

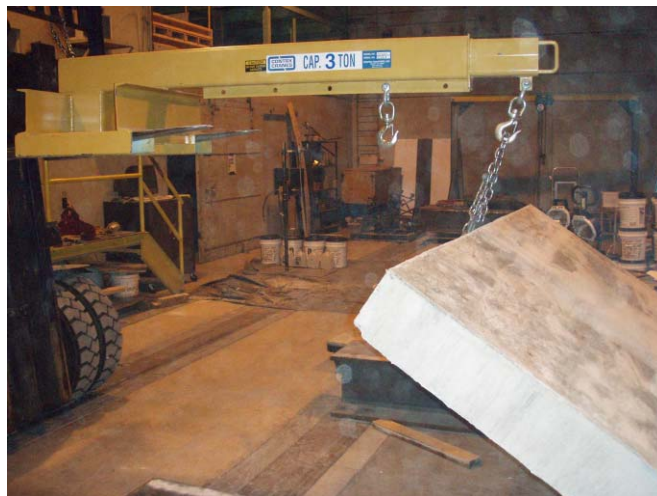
1. Patches are placed in 8-ft-by-4-ft slabs by using previously described procedures in Sections 3.2.1.1 and 3.2.1.2, and allowed to cure for 1 hour.
2. Slabs are then flipped over so that the patch is located on the bottom of the slab (Figure 3-16). This is done so that the patch will be in tension (worst-case scenario) when it is loaded.

Figure 3-16: Flipping Slap

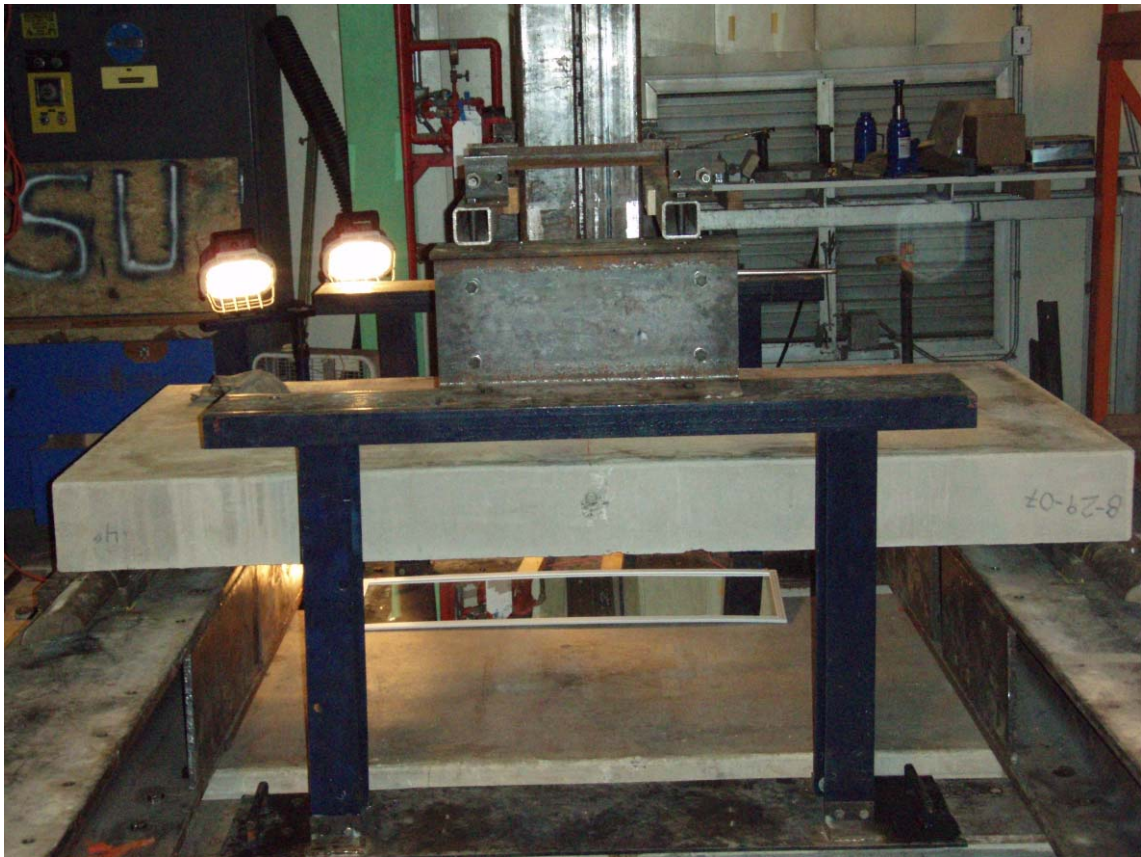
3. Slabs are placed beneath the actuator where the load can be applied. Note that the span is 7-ft 6-inches long for the 8-ft slabs due to a 3-inch overhang on either side (Figure 3-17).

Figure 3-17: Slab Under Actuator

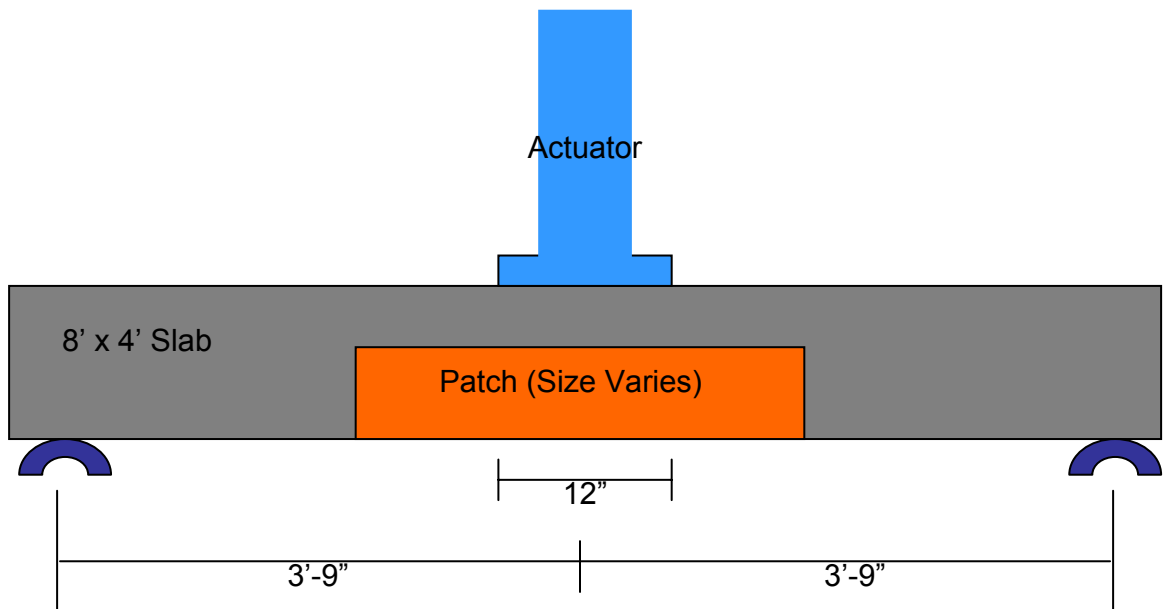
4. After the patch has reached 3-hour strength, the slab is loaded until failure (maximum load that slab can hold, as indicated by electronic actuator system), stopping every 5-kip increment to record the load and the deflection from the electronic system. Figure 3-18 is a schematic of the testing.

Figure 3-18: Three-Point Bending Test Schematic

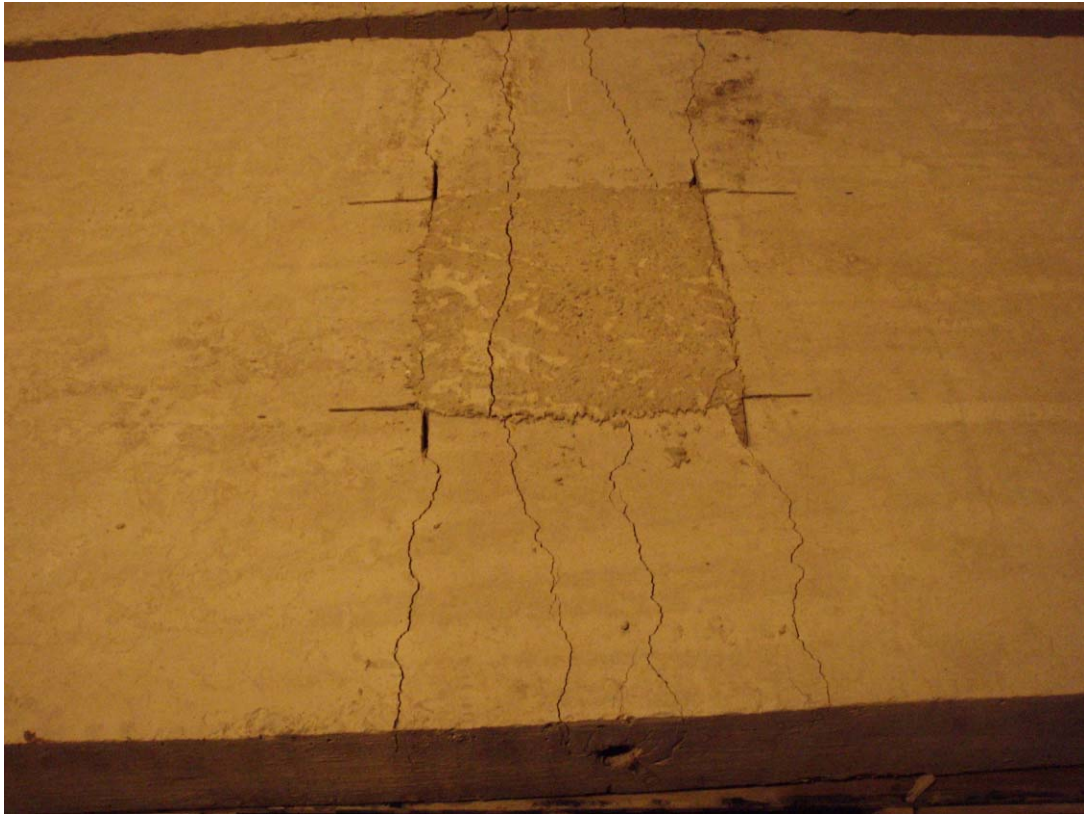
Figure 3-20: Cracking of Rapid Set Slab

Both materials (Pavemend and Rapid Set) performed well under three-point loading. Neither material truly separated from the substrate concrete, even after the maximum load was reached and the specimen began deflecting heavily while losing the load. There was, however, slight cracking around the patch/substrate interface for all slabs, as demonstrated in Figure 3-19 and Figure 3-20. All slabs failed at loads greater than the load associated with the calculated nominal moment capacity, which was 37.3 kips (Figure 3-21). In fact, all slabs failed at loads greater than 50 kips, except the large,

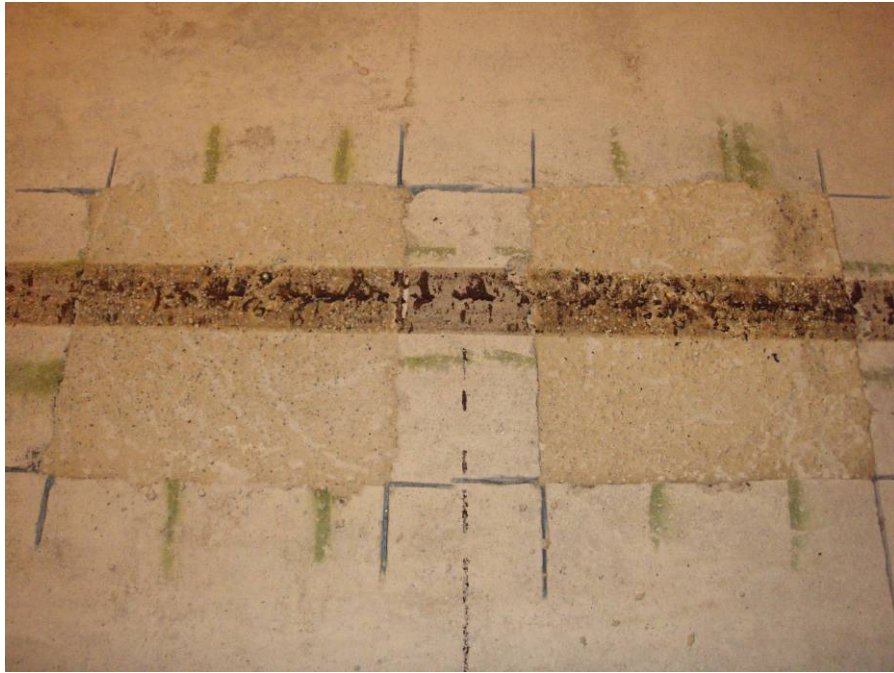
Figure 3-26: Repetitive Tire Loading – Rapid Set Patches

The results for the repetitive tire load simulation were very favorable for both materials. Any abrasive damage for Pavemend 15.0 was negligible after 200,000 cycles, as demonstrated by Figure 3-25, which shows the patches after the completion of this testing. There was also negligible damage to the Rapid Set patches, but interestingly there was a small amount of damage to the base material at the interface (Figure 3-26 and Figure 3-27). In spite of this, it is deemed that both have excellent resistance to abrasion after 3-hour strengths are achieved because only minor deterioration was observed. See Appendix B for more photographs of the tested patches.

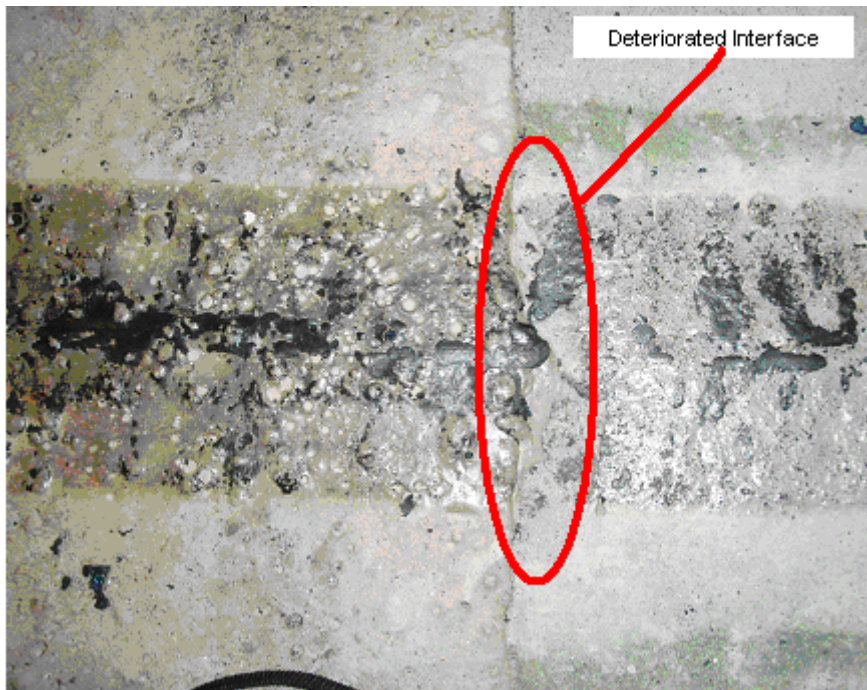
Figure 3-27: Repetitive Tire Loading – Rapid Set Patches – Deteriorated Interface

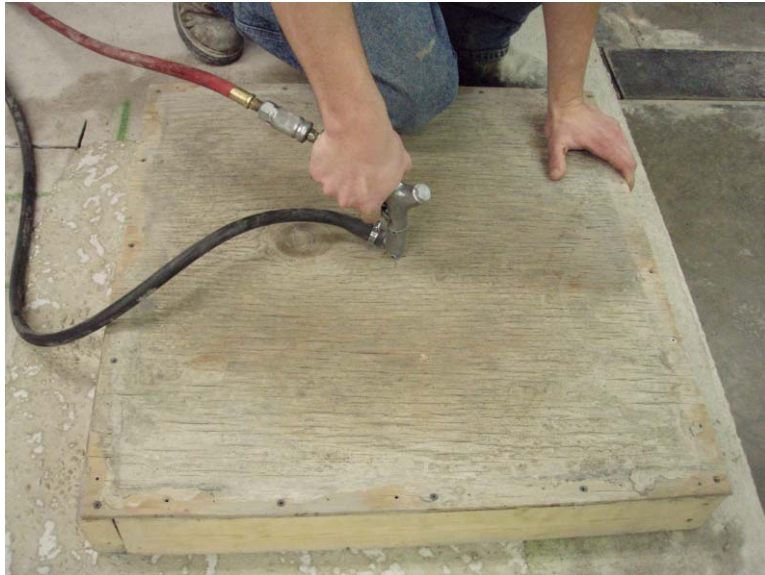
1. Patches are placed in 6-ft-by-4-ft slabs by use of procedures described in Sections 3.2.1.1 and 3.2.1.2 and allowed to obtain 3-hour strength.
2. Once 3-hour strength is reached, the sandblast nozzle is placed 3 inches above the surface of the specimen and the surface is blasted with sand (Grade 20 on 30) for 1 minute. Since this particular grade of sand was not available during testing, the test was run instead with grade 60 on 120 sand for an extended period of time, 90 seconds. A wooden box was used, as seen in Figure 3-28, to both contain the sand particles and to ensure uniform blasting distances (3 inches) throughout.

Figure 3-28: Sandblasting Specimen – ASTM C 418

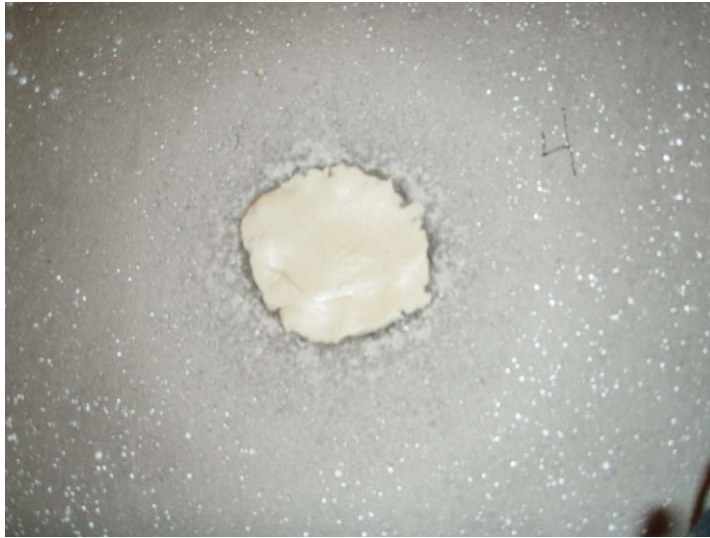
3. At completion of sandblasting, a mass of clay is weighed and pressed into the hole made by the blast. The hole is filled until it is flush with the surface and then the remaining mass of clay is weighed again to determine how much clay is in the cavity (Figure 3-29). This step is performed eight times for each of the three specimens (Pavemend 15.0 patch, Rapid Set patch, and base concrete [control]).

Figure 3-29: Sandblasted Hole Filled With Clay – ASTM C 418

4. The volume of the clay in the cavity is determined by using  $V = W / D$ , where  $V$  is the volume of the cavity,  $W$  is the weight of clay in the cavity, and  $D$  is the specific gravity of the clay (set equal to 2.0 by the manufacturer). (ASTM 2006)

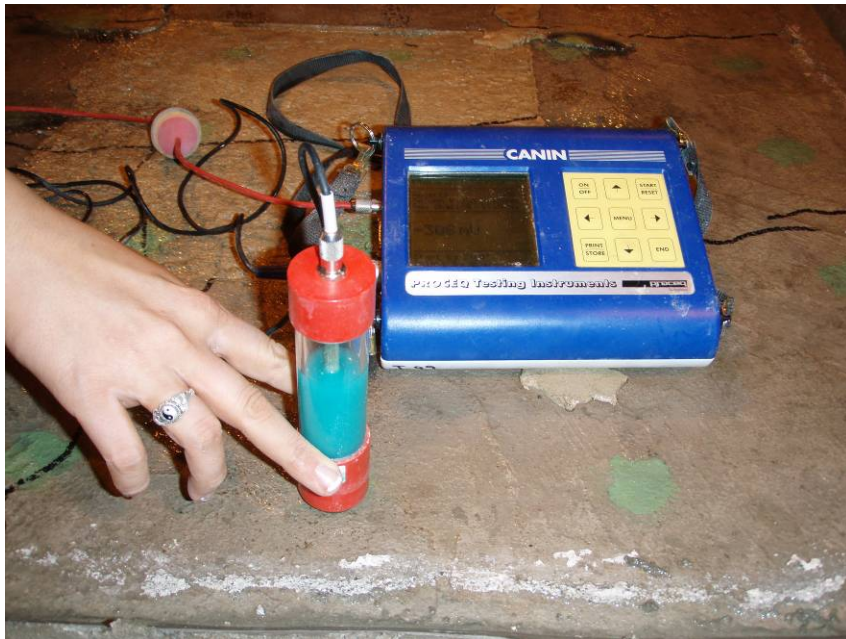
Figure 3-32: Half-Cell Potential Readings

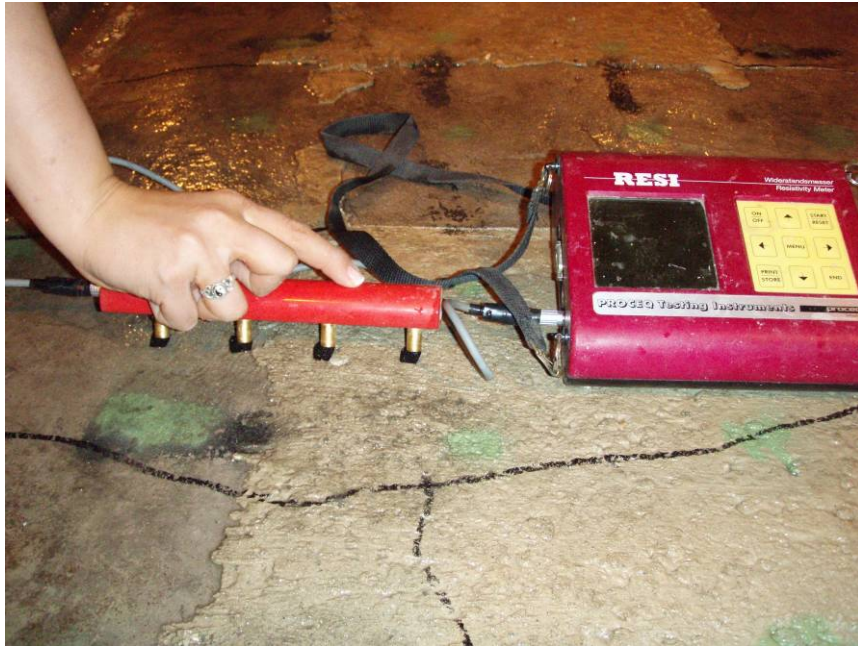
3. Measurements of the resistivity of the concrete are also taken along with the half-cell readings. These measurements are taken on both patches (half depth and full depth), at the patch/base concrete interface, and on the base concrete. Based on the fundamental principle of Ohm's Law ( $I=V/R$ ), the current is reduced when the resistance is increased. As shown in Figure 1-1, the ionic current flows through the concrete. Therefore, the resistance provided by the concrete directly relates to the rate of corrosion. Resistivity measurements are used to quantitatively determine this resistance. This is accomplished by use of a Wenner Probe, which actually consists of four probes (Figure 3-33). The outer two probes pass a current through the concrete, while the inner two measure the voltage difference. From this, it calculates the resistance, which helps determine how fast or slow the rate of corrosion can occur within the given concrete (Page 1990).

Figure 3-33: Resistivity Measurements

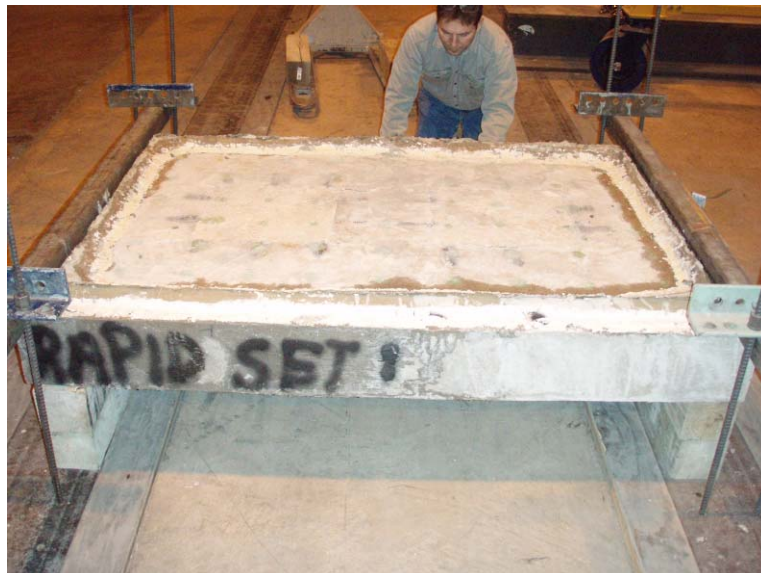
Figure 3-35: Cracking Corrosion Slab – Top View

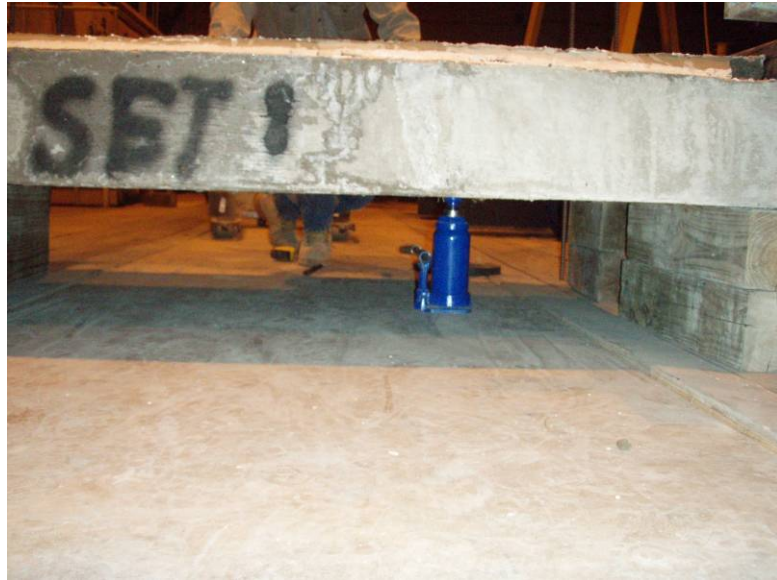
Figure 3-36: Cracking Corrosion Slab – Side View

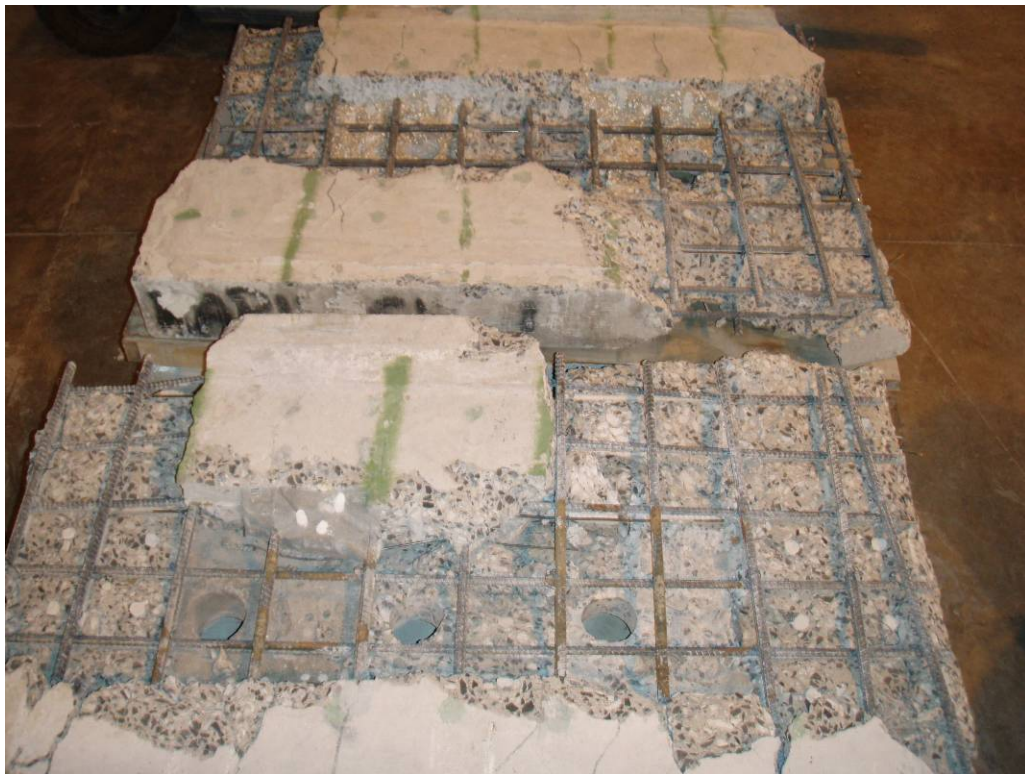
After coring the sample, the concrete cover on the center strip of the ponding slab (where the patches were located) was removed to reveal the extent of corrosion damage in the reinforcement. Refer to Figure 3-44. The Pavemend 15.0 slab had noticeably more rust on the reinforcement. This rust was only located in the areas where the patches were located. The Rapid Set slab, on the other hand, had much less corrosion taking place. There was no rust in areas outside of the patch, just like in the Pavemend slab, but inside the patch area there was only minor rusting, most likely from the exposure to the environment that the rebar received when the holes were originally jackhammered out.

Figure 3-44: Slabs After Autopsy (Rapid Set on Top, Pavemend on Bottom)

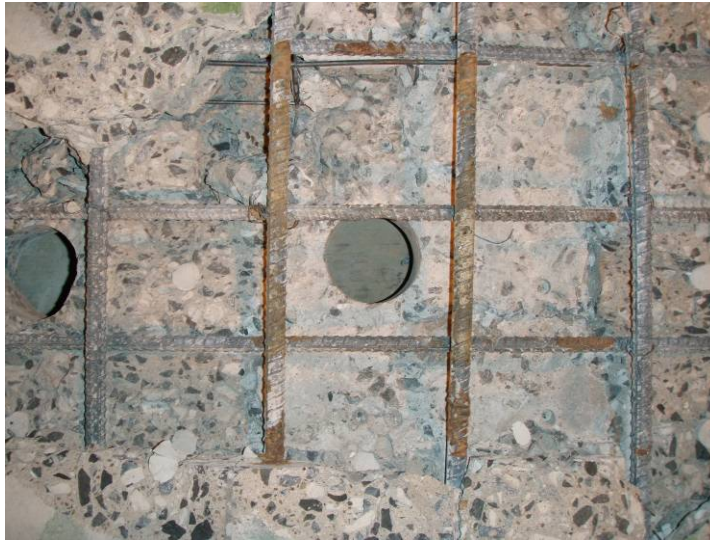
Refer to Figure 3-45 and Figure 3-46 to view the rust on the reinforcement within the Pavemend 15.0 slab. Note, on the second picture, the gap between the rusted areas. This non-rusted area corresponds to the strip of base concrete between the patch areas.

Figure 3-45: Pavemend 15.0 Corrosion Slab – Close-Up 1

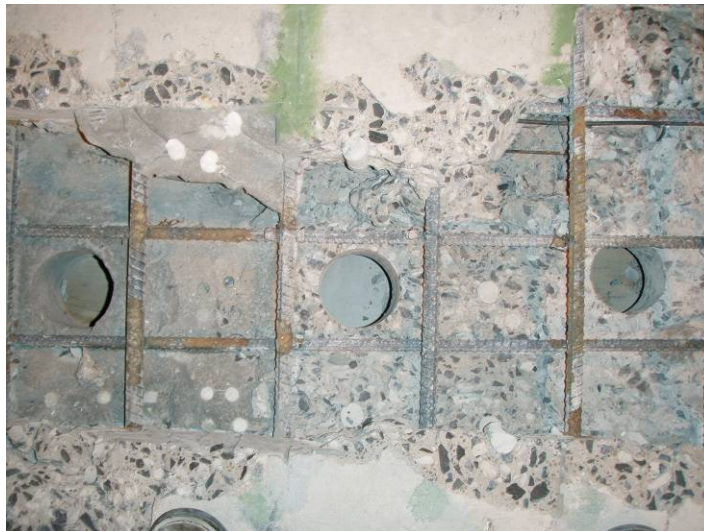
Figure 3-46: Pavemend 15.0 Corrosion Slab – Close-Up 2

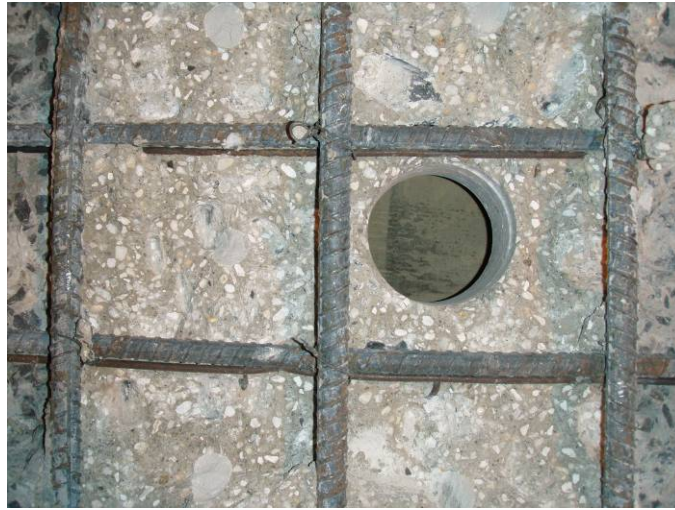
Refer to Figure 3-47 and Figure 3-48 to view the state of the reinforcement within the Rapid Set slab. From the first picture, it may be difficult to see that there is any rust on the reinforcement since the corrosion taking place within this slab was relatively minor, but by viewing the more extreme close-up in the second picture, it is noticeable that there is some rust on the rebar.

Figure 3-47: Rapid Set Corrosion Slab – Close-Up 1

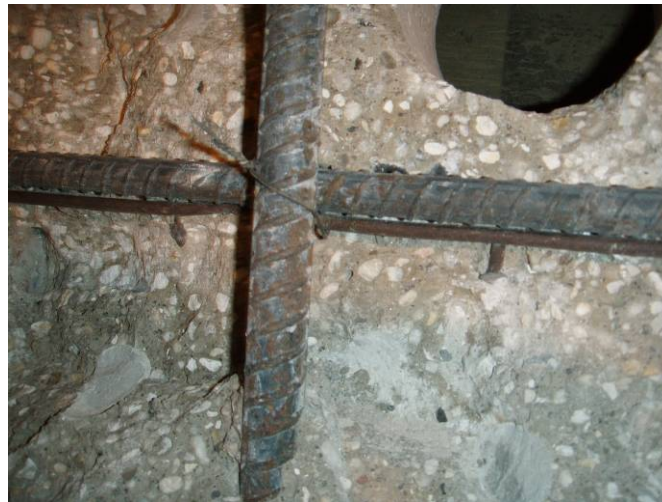
Figure 3-48: Rapid Set Corrosion Slab – Close-Up 2

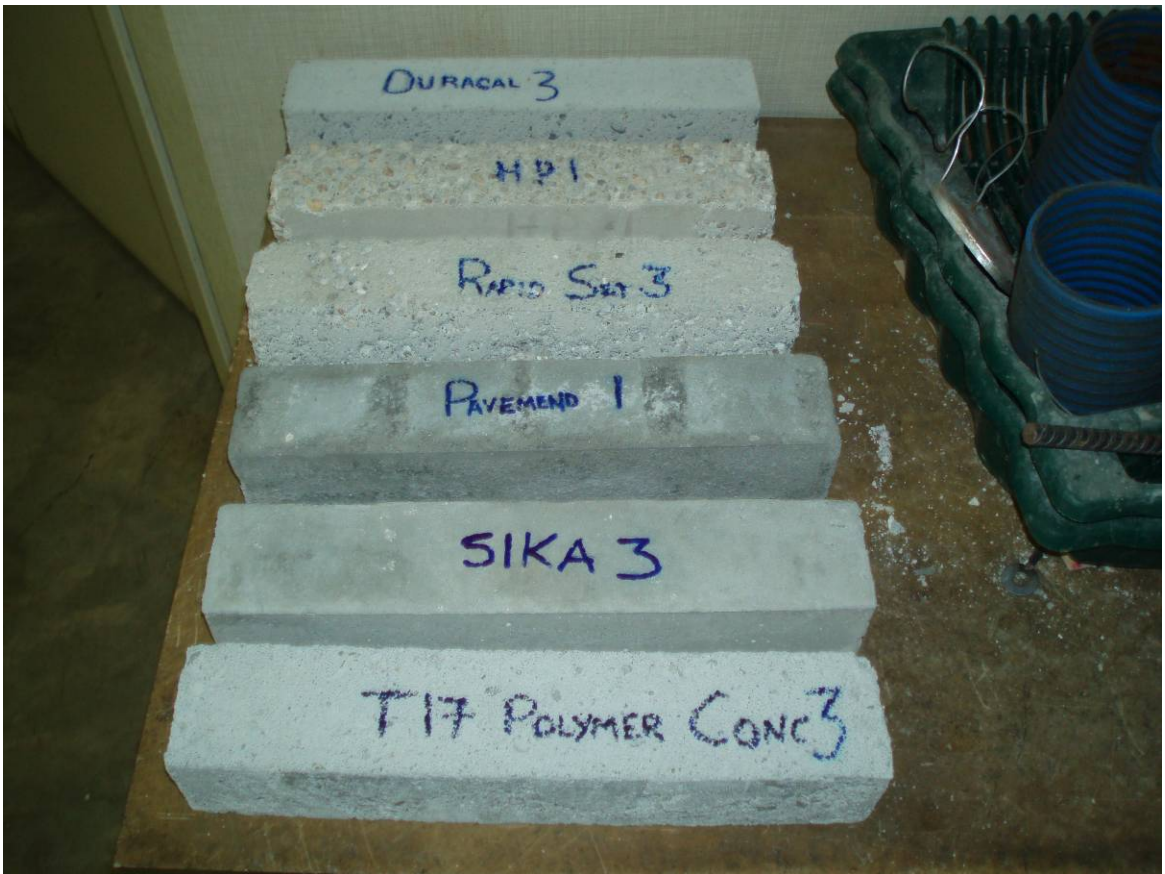
Figure A-1 shows the freeze-thaw specimens. Table A-5 through Table A-10 contain the ASTM C 666 (in regular water) results from the ASTM testing. Note that the “Fundamental Transverse Frequency” is the frequency of a wave that is propagated through the material. (The wave is caused by tapping the material with a hammer.) The “Relative Dynamic Modulus of Elasticity” is then determined by the following equation:

Figure A-1: Regular Water Freeze-Thaw Specimens
