**BRIDGE DECK PATCHING MATERIALS**

**Final Report**

**PennDOT/MAUTC Partnership, Work Order No. 10  
Research Agreement No. 510401**

**June 2008**

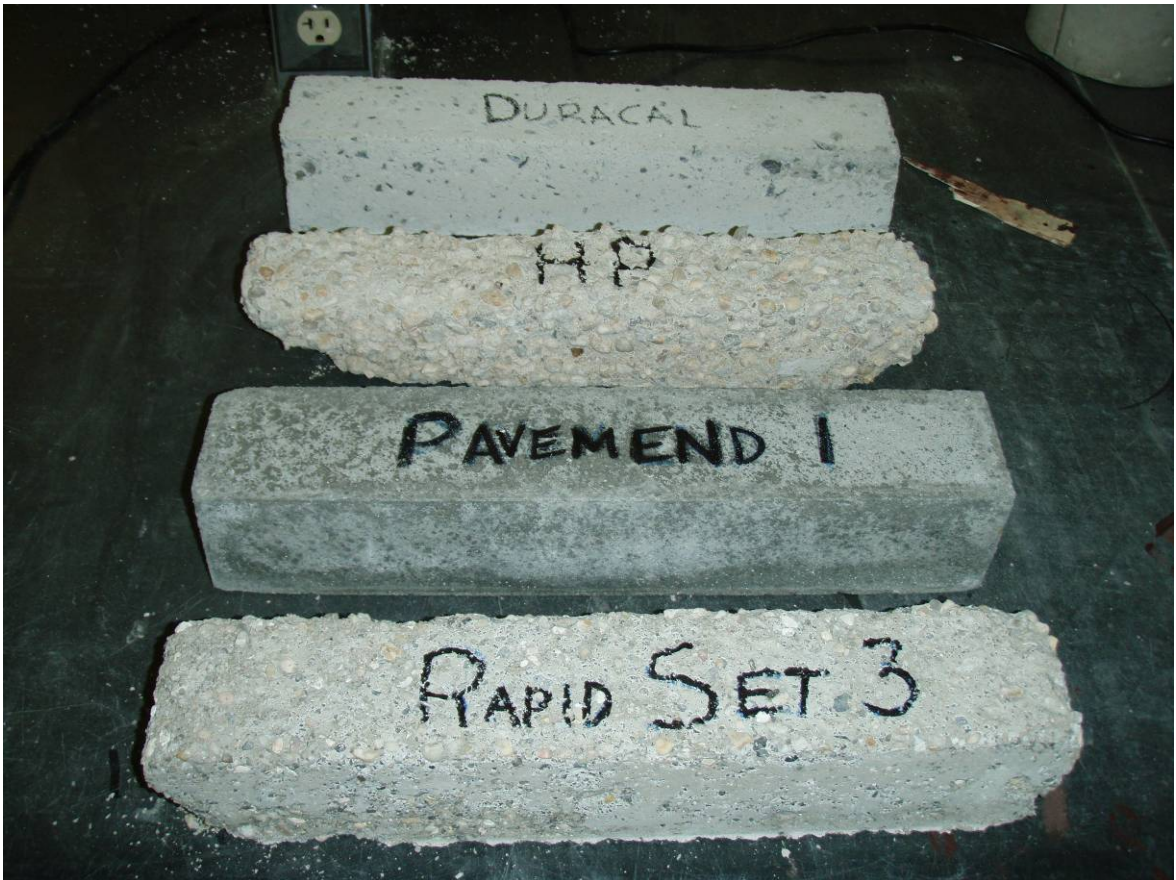
Figure A-2 shows the specimens used in salt water freeze-thaw testing. Table A-11 through Table A-14 contain the ASTM C 666 (in salt water) results from the ASTM testing.

Figure A-2: Salt Water Freeze-Thaw Specimens

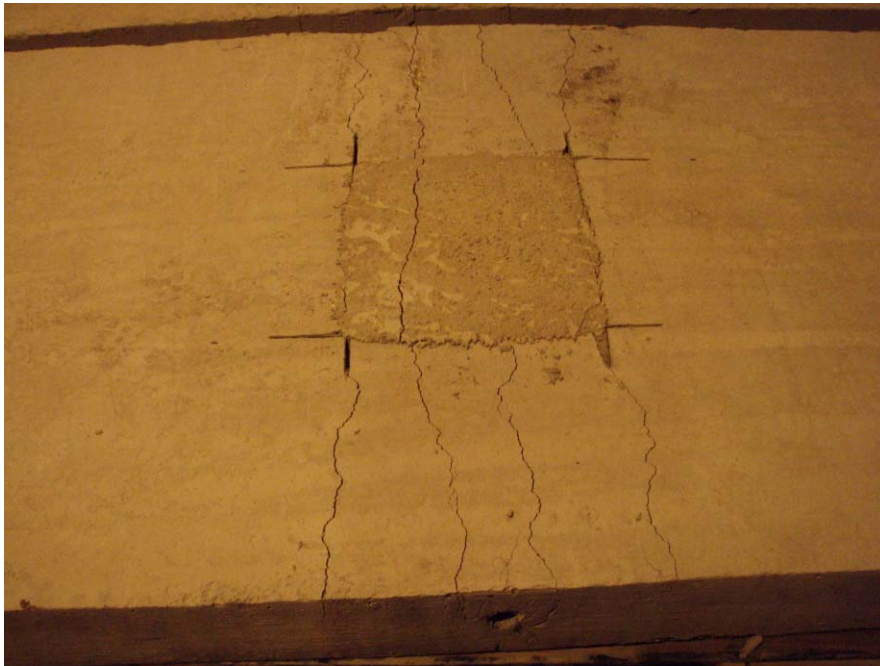
Figure **B-2**: Three-Point Loading – Rapid Set – Small, Shallow

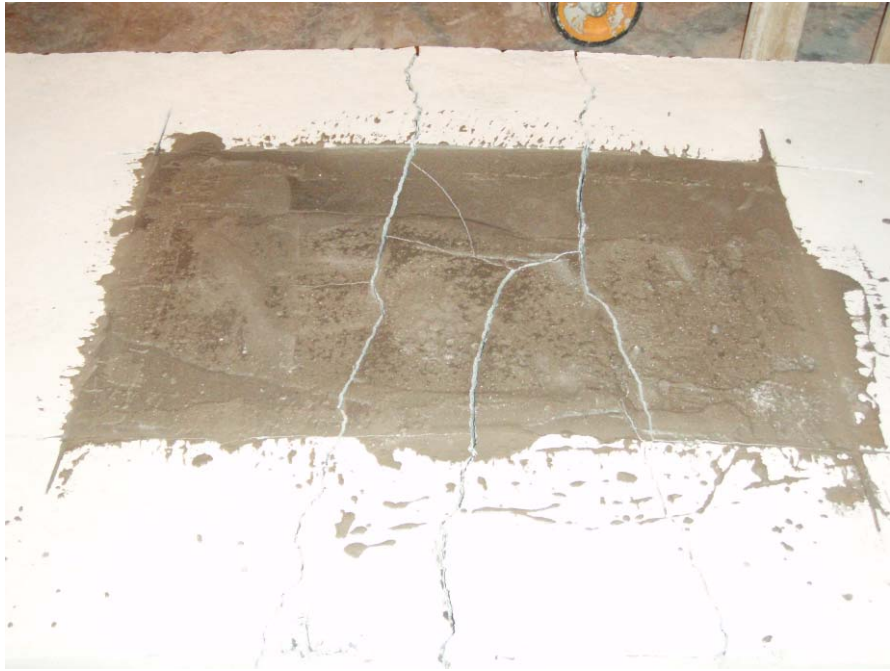
Figure **B-3**: Three-Point Loading – Pavemend 15.0 – Large, Shallow

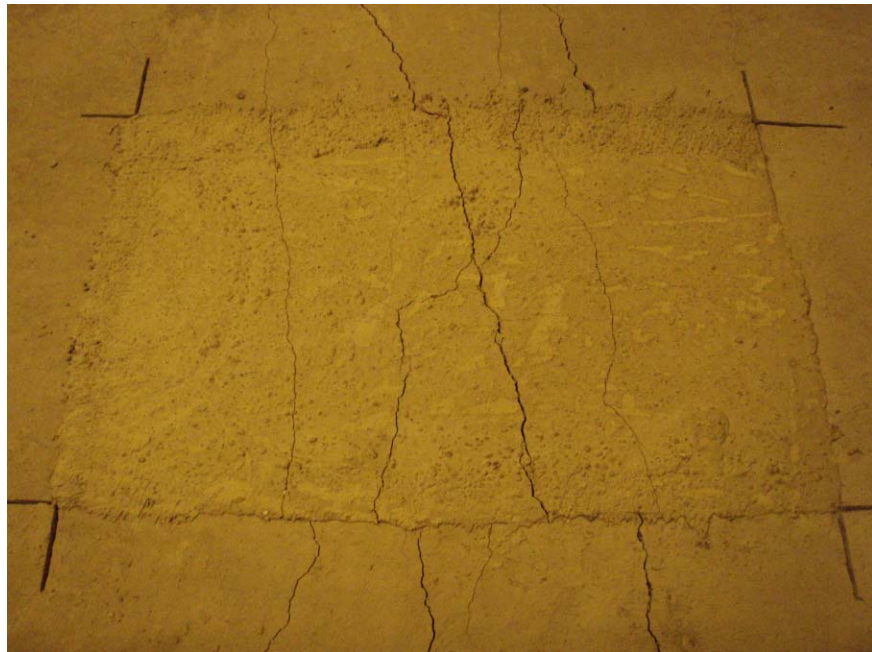
Figure **B-4**: Three-Point Loading – Rapid Set – Large, Shallow

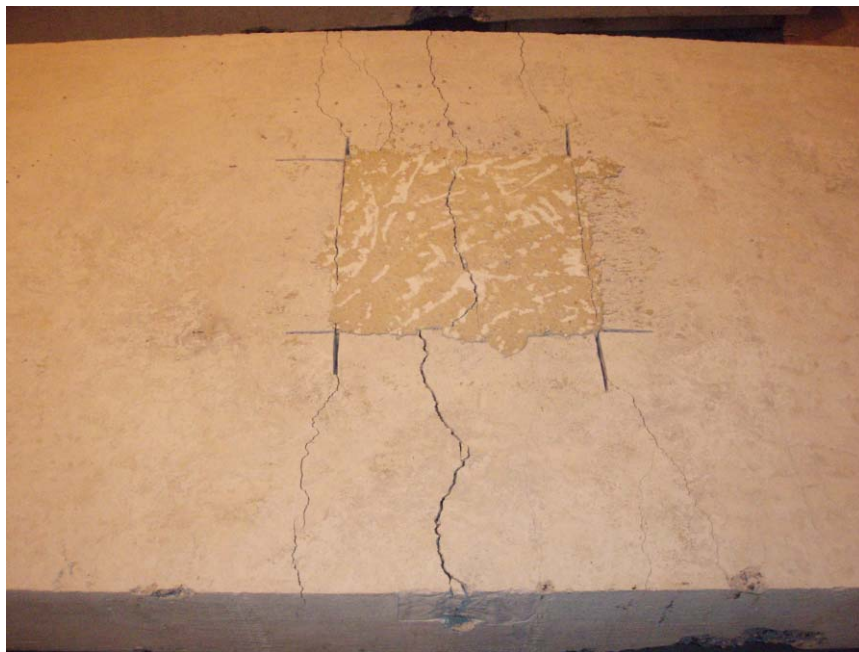
Figure B-6: Three-Point Loading – Rapid Set – Small, Deep

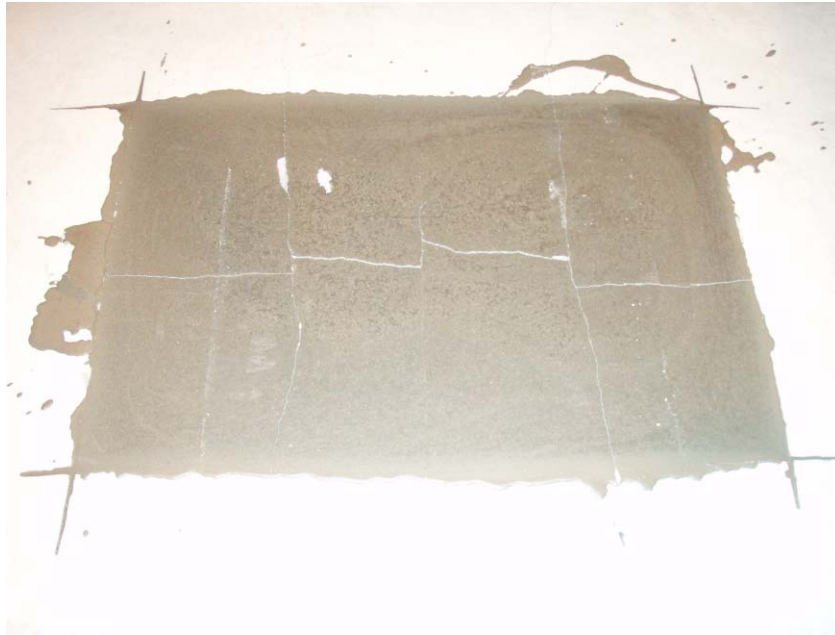
Figure B-7: Three-Point Loading – Pavemend 15.0 –Large, Deep

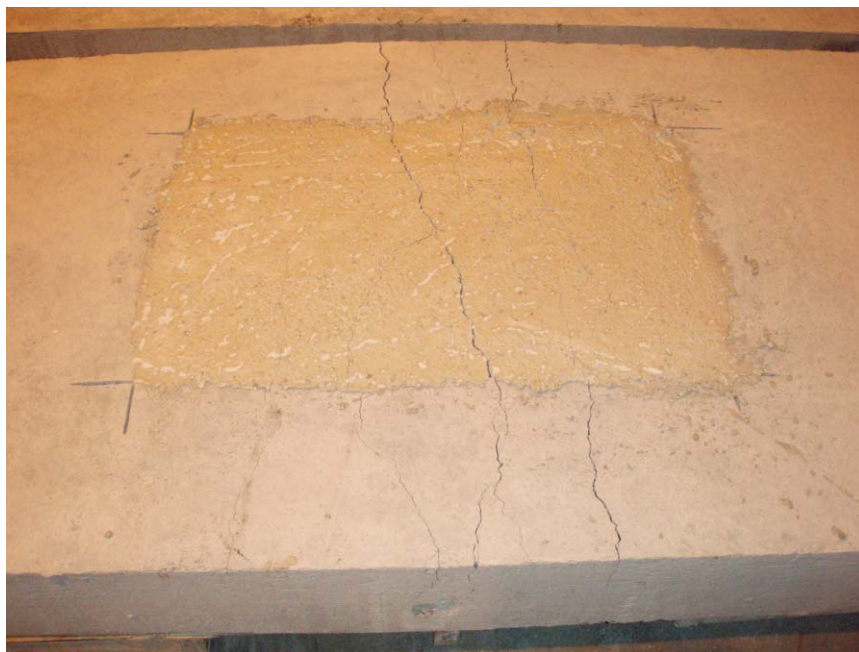
Figure B-8: Three-Point Loading – Rapid Set – Large, Deep

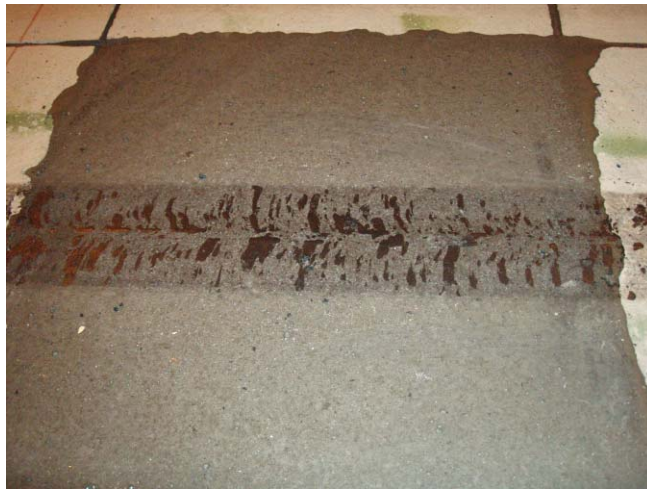
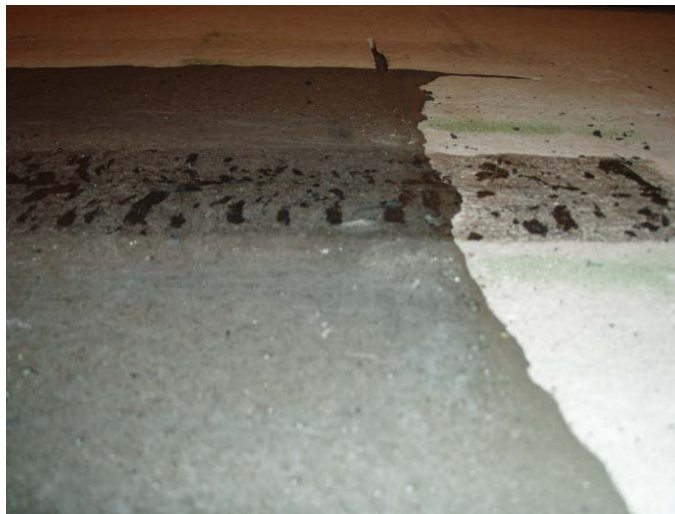
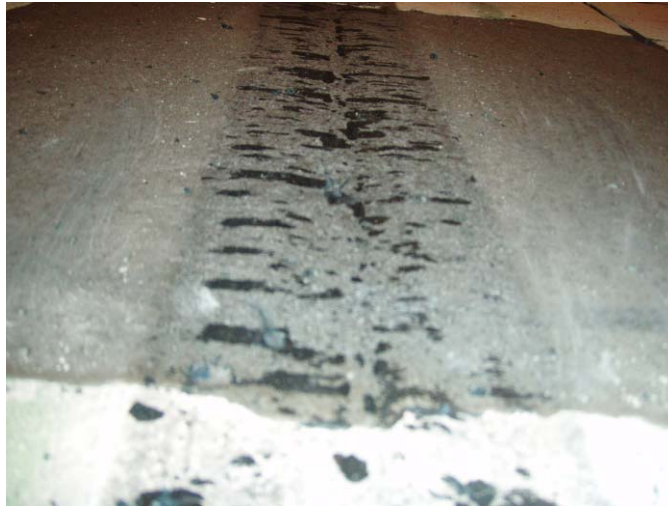
Refer to Figure B-9, Figure B-10, and Figure B-11 to see photographs of the Pavemend 15.0 patches after 200,000 repetitive tire loads have been run on them.

Figure B-9: Pavemend 15.0 Patch after Tire Load Simulation – Close-up 1

Figure B-10: Pavemend 15.0 Patch after Tire Load Simulation – Close-up 2

Figure **B-11**: Pavemend 15.0 Patch after Tire Load Simulation – Close-up 3

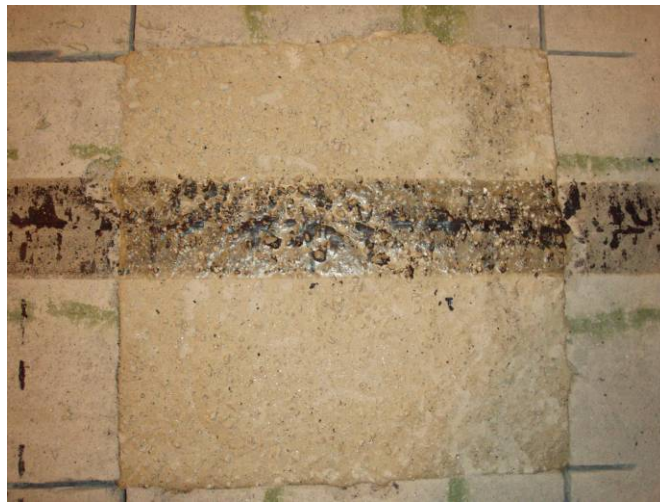
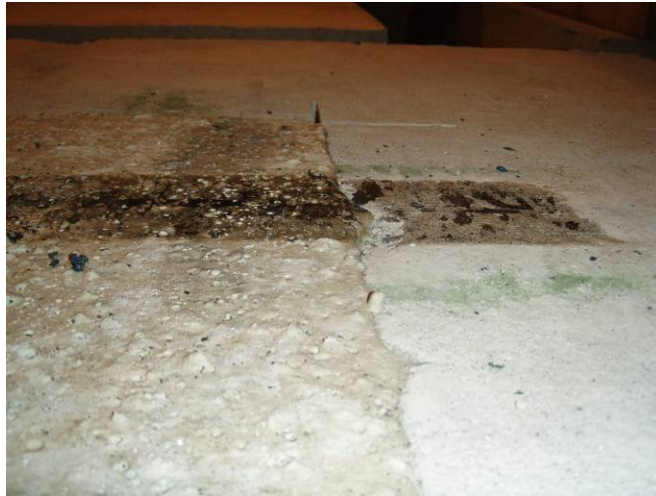
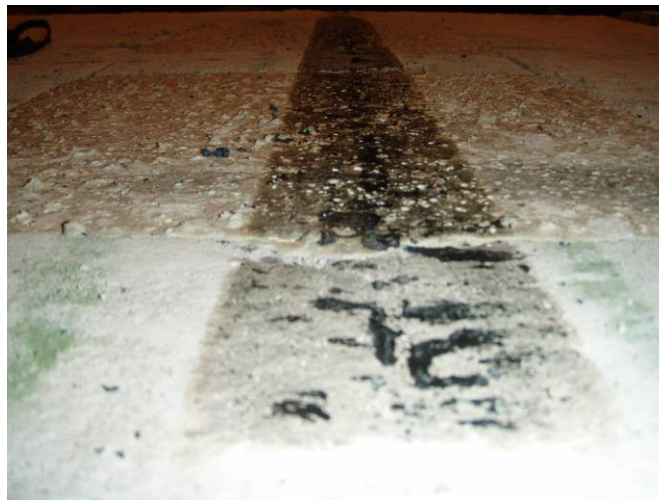
Refer to Figure **B-12**, Figure **B-13**, and Figure **B-14** to see photographs of the Rapid Set patches after 200,000 repetitive tire loads have been run on them.

Figure **B-12**: Rapid Set Patch after Tire Load Simulation – Close-up 1

Figure B-13: Rapid Set Patch after Tire Load Simulation – Close-up 2

Figure B-14: Rapid Set Patch after Tire Load Simulation – Close-up 3
